# IndianOil

## JOURNEY RISK MANAGEMENT (JRM) STUDY

### Salem Terminal TO CPS AGENCIES

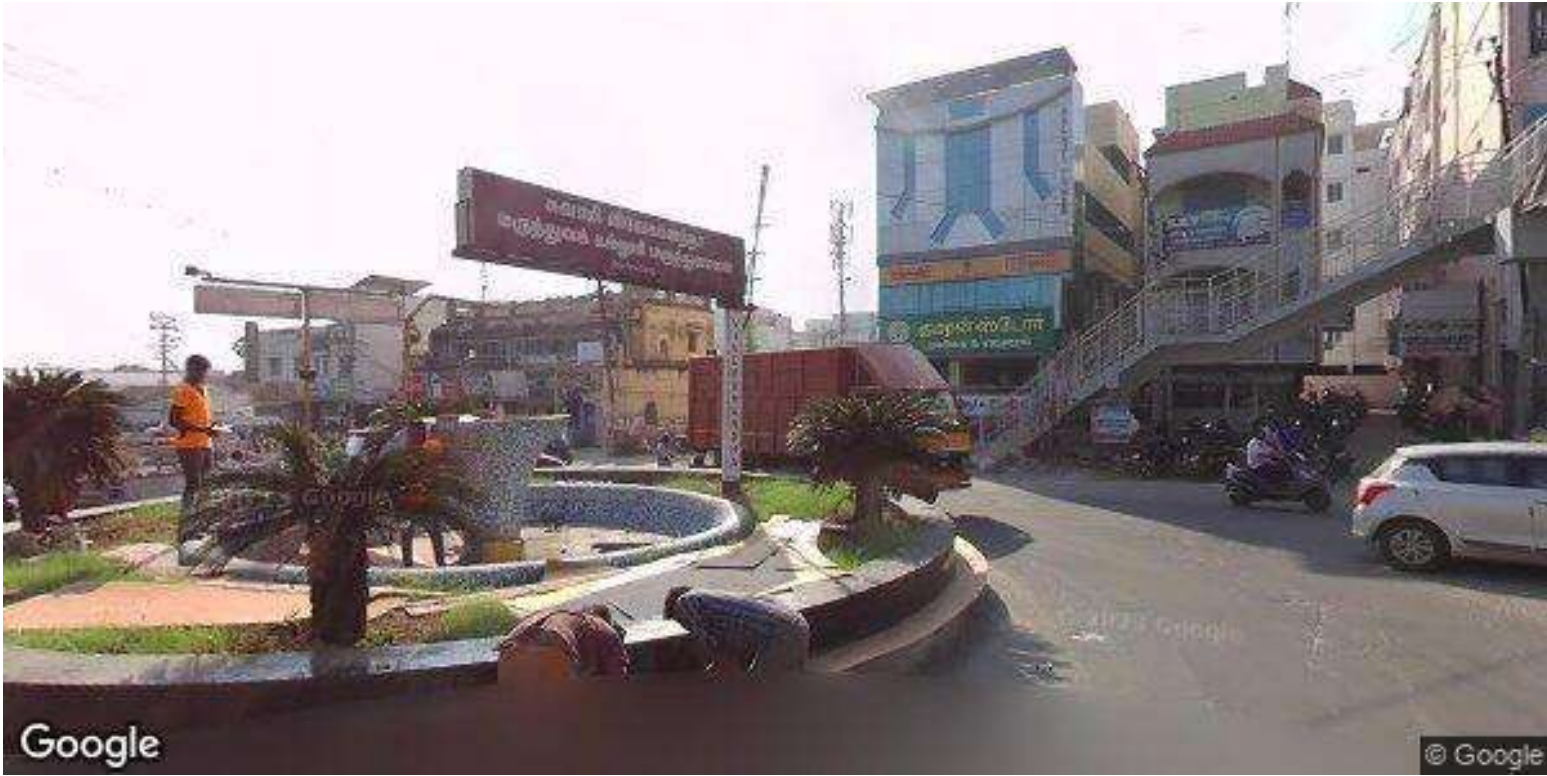
Coordinates: 11.38395, 77.89480

Risk Type: Roundabout

Risk Level: High

Speed Limit: 15 KM/Hr

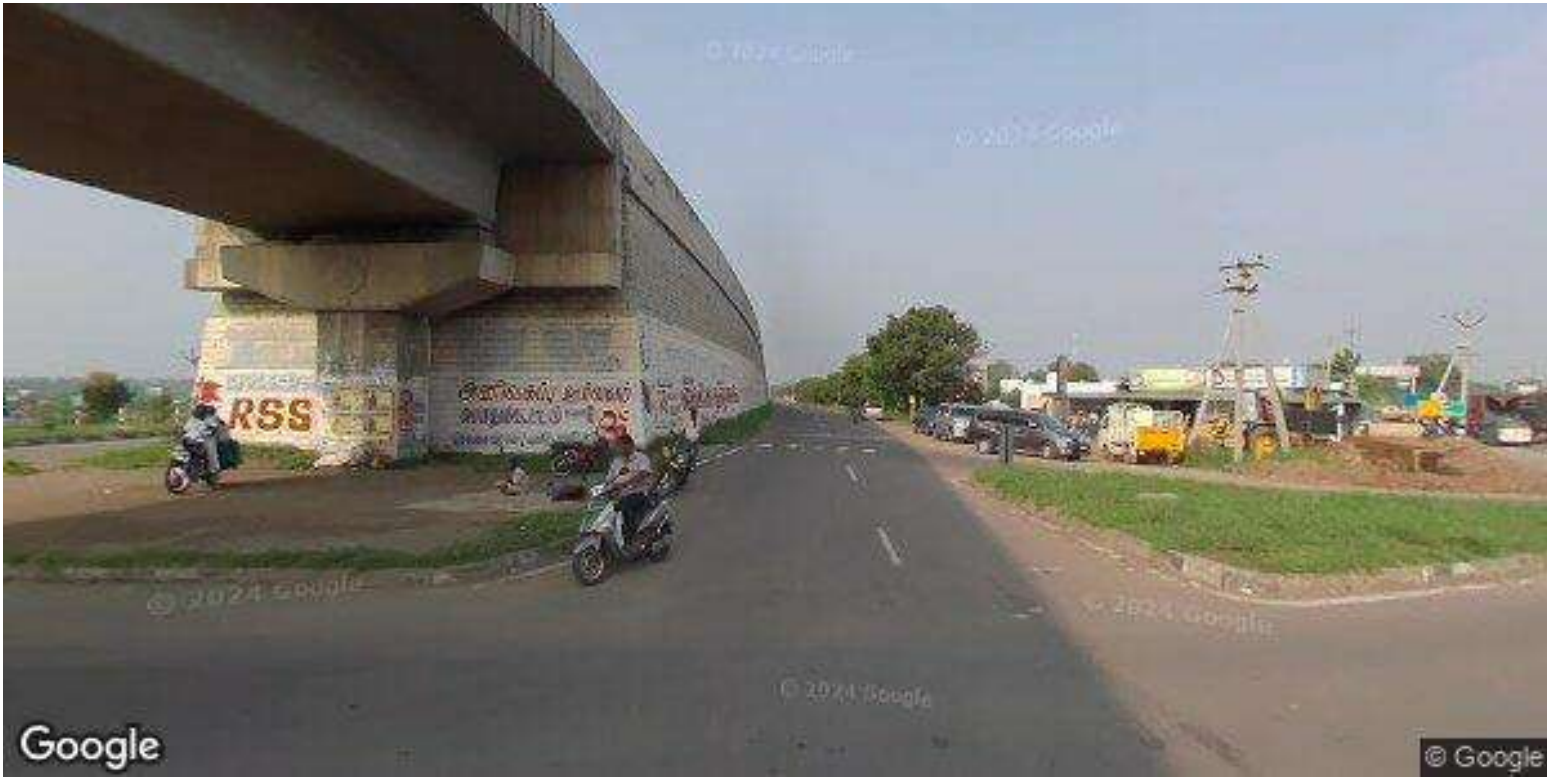
**Risk Type:** Roundabout  
**Risk Level:** High  
**Speed Limit:** 15 KM/Hr  
**Coordinates:** 11.20387, 78.12203

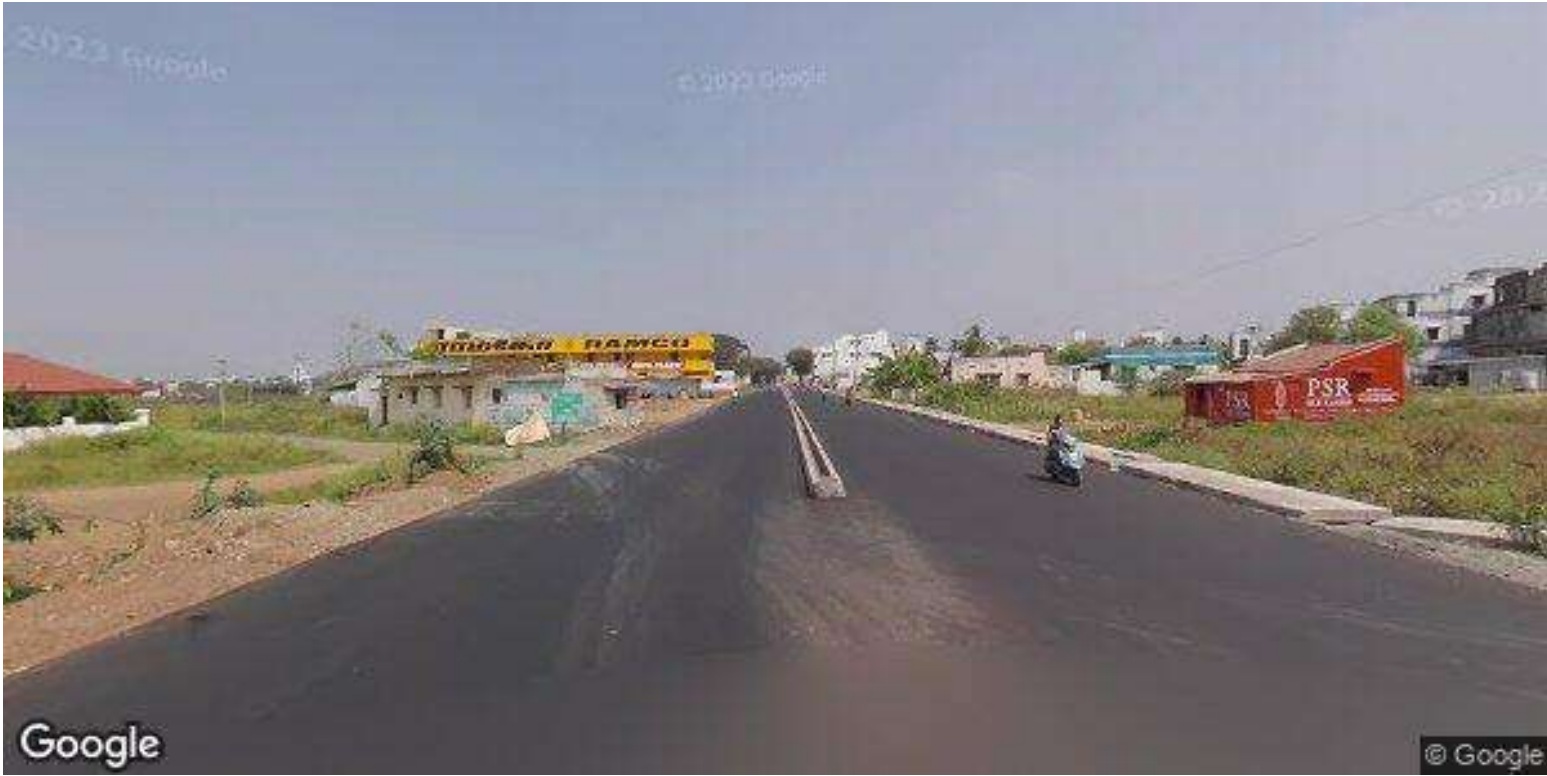
**Risk Type:** U-Turn  
**Risk Level:** High  
**Speed Limit:** 10 KM/Hr  
**Coordinates:** 11.2089758, 78.1355753

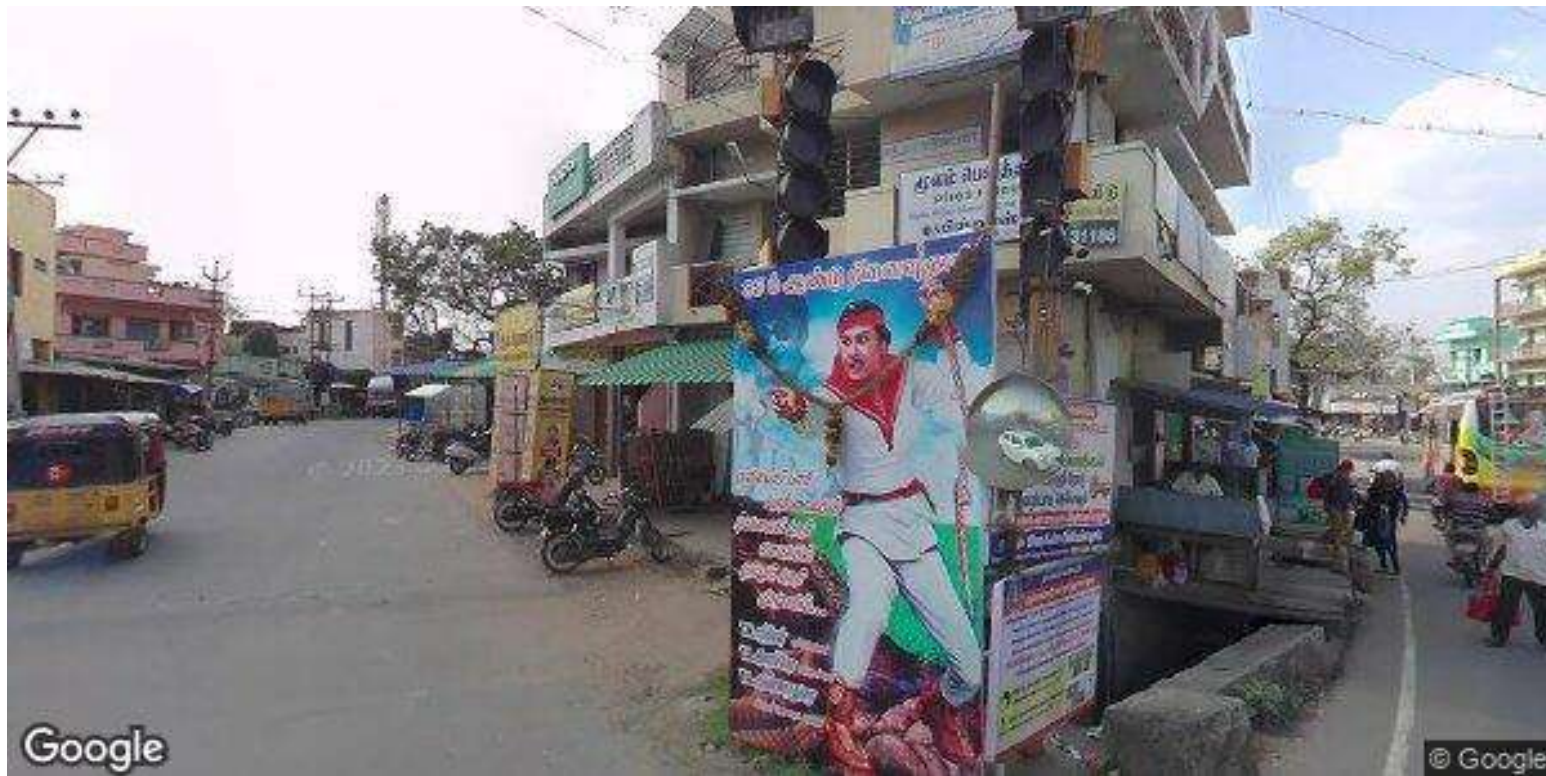
**Coordinates:** 11.38342, 77.89975

**Risk Type:** Turn

**Risk Level:** Medium

**Speed Limit:** 30 KM/Hr

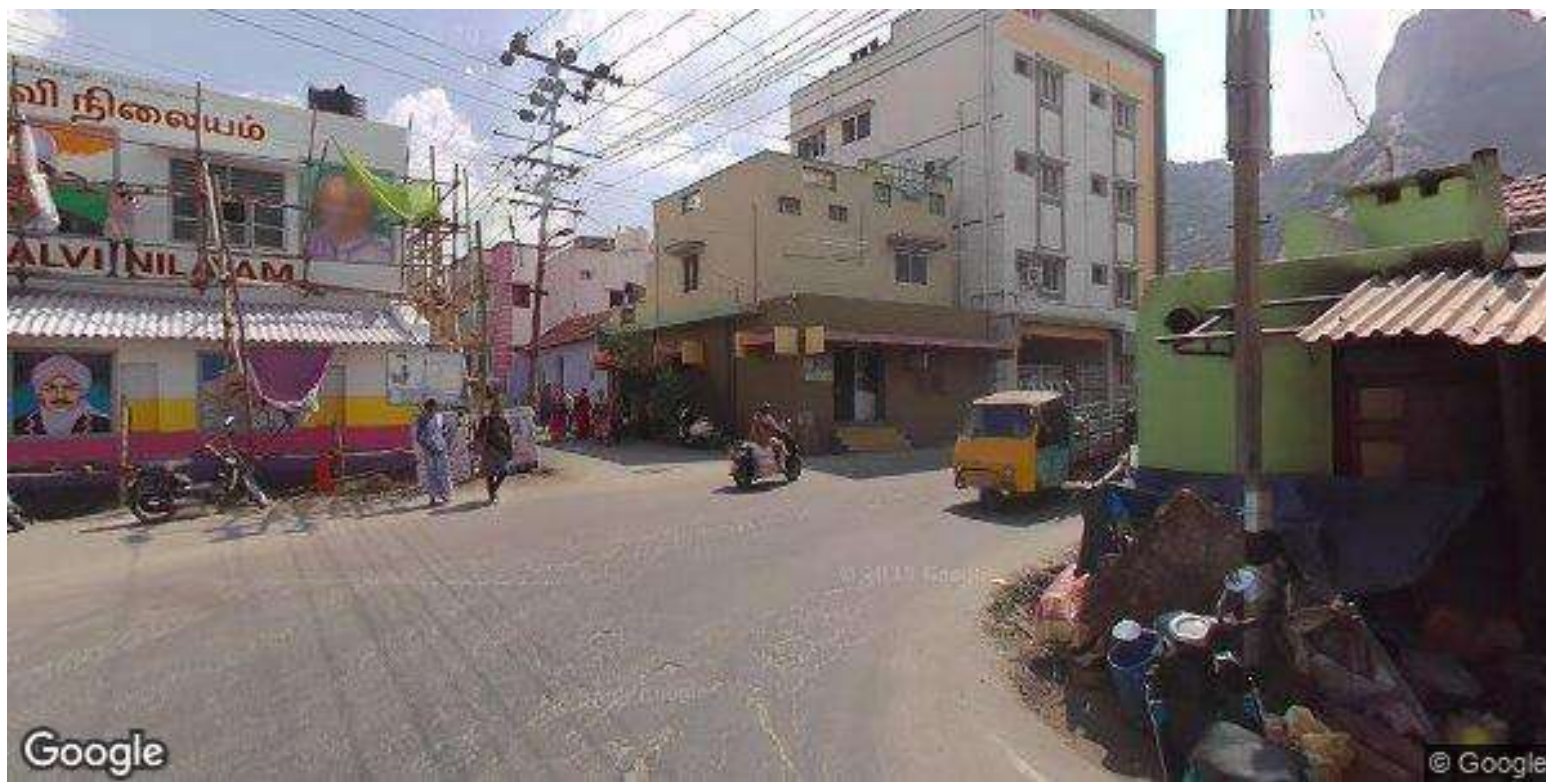
**Coordinates:** 11.38186, 77.90258

**Risk Type:** Turn

**Risk Level:** High

**Speed Limit:** 15 KM/Hr

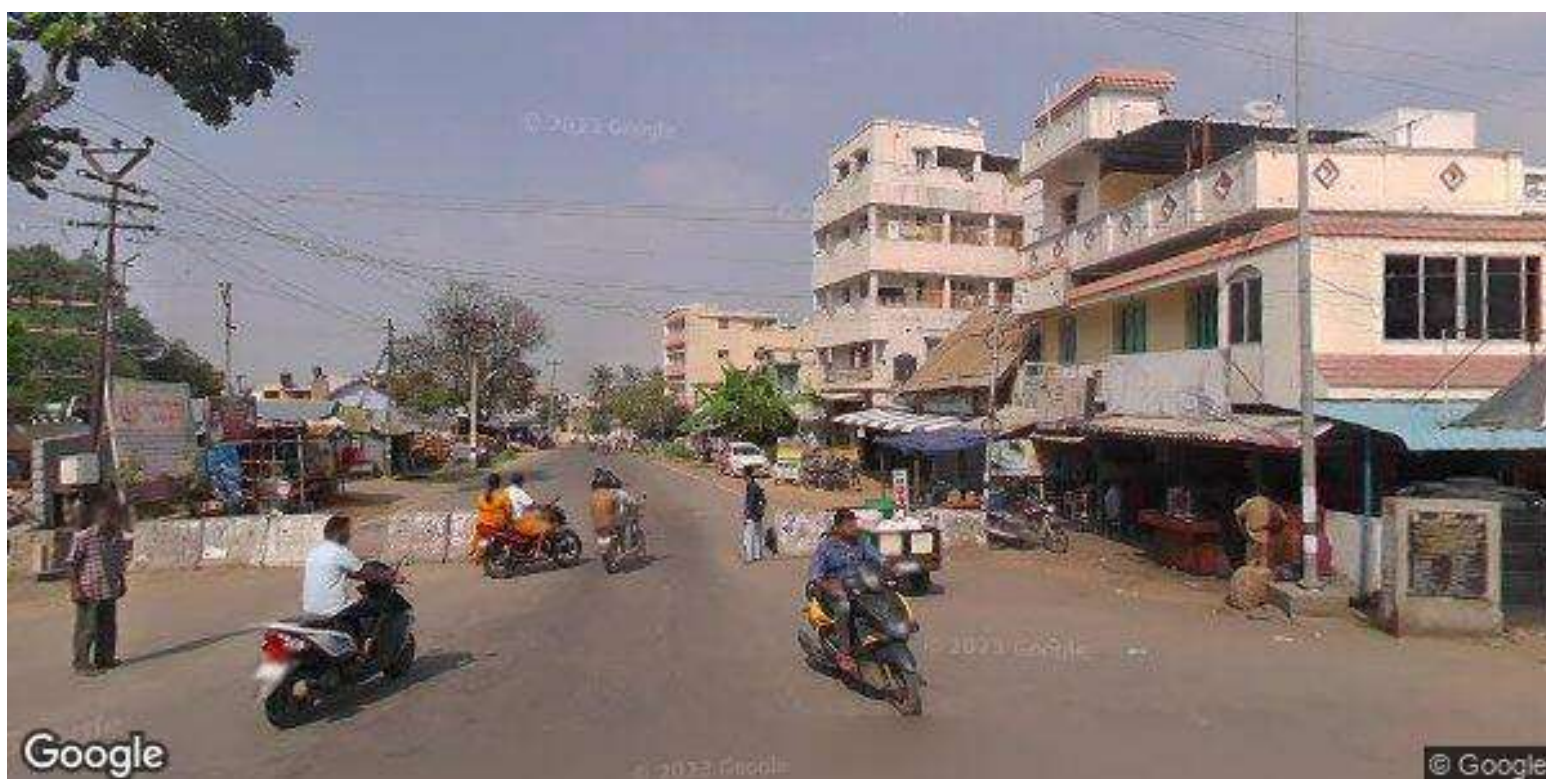
**Coordinates:** 11.37841, 77.90140

**Risk Type:** Blind Spot

**Risk Level:** Blind Spot

**Speed Limit:** 10 KM/Hr

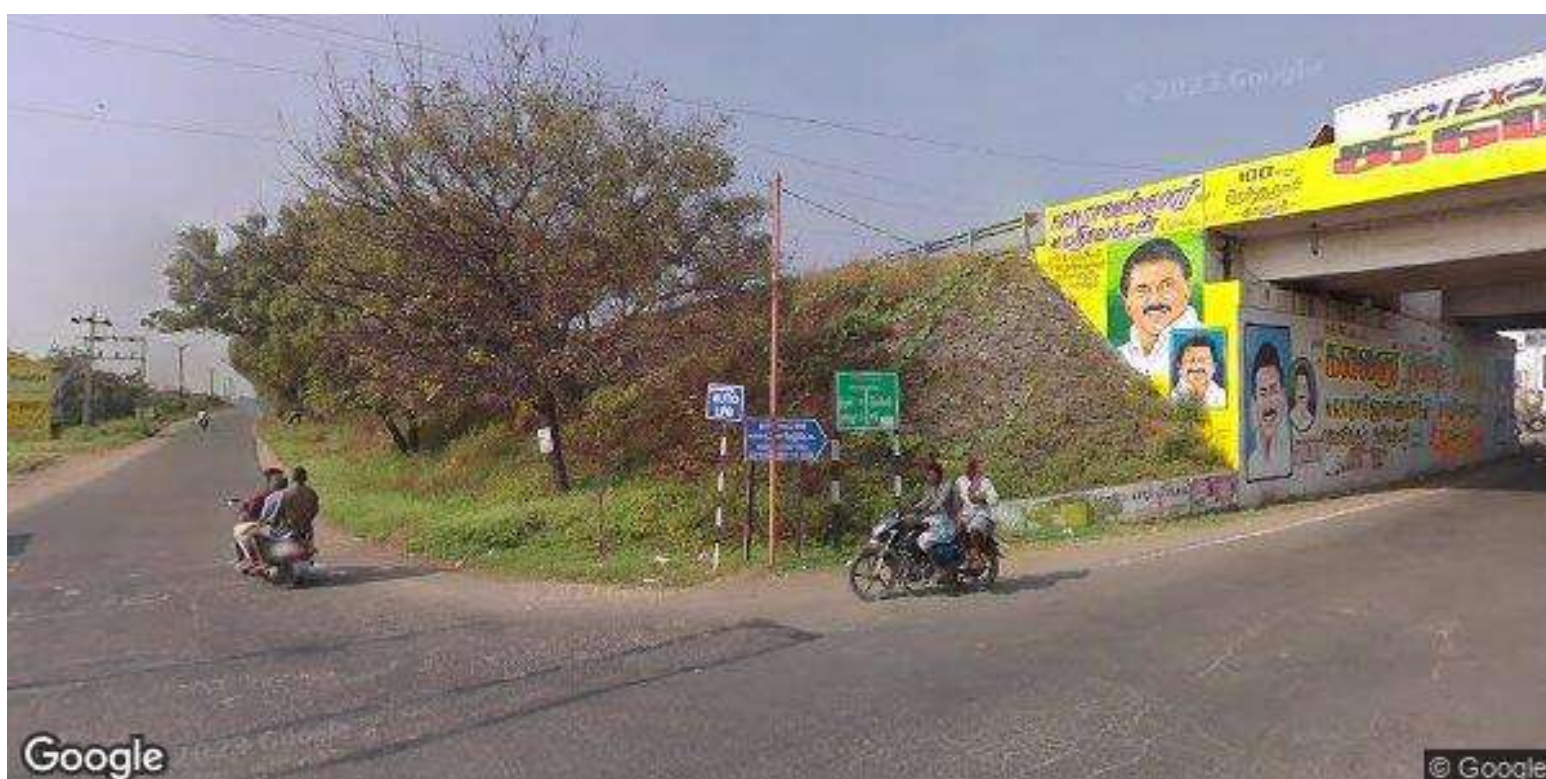
**Risk Type:** Blind Spot  
**Risk Level:** Blind Spot  
**Speed Limit:** 10 KM/Hr  
**Coordinates:** 11.23936, 78.14267

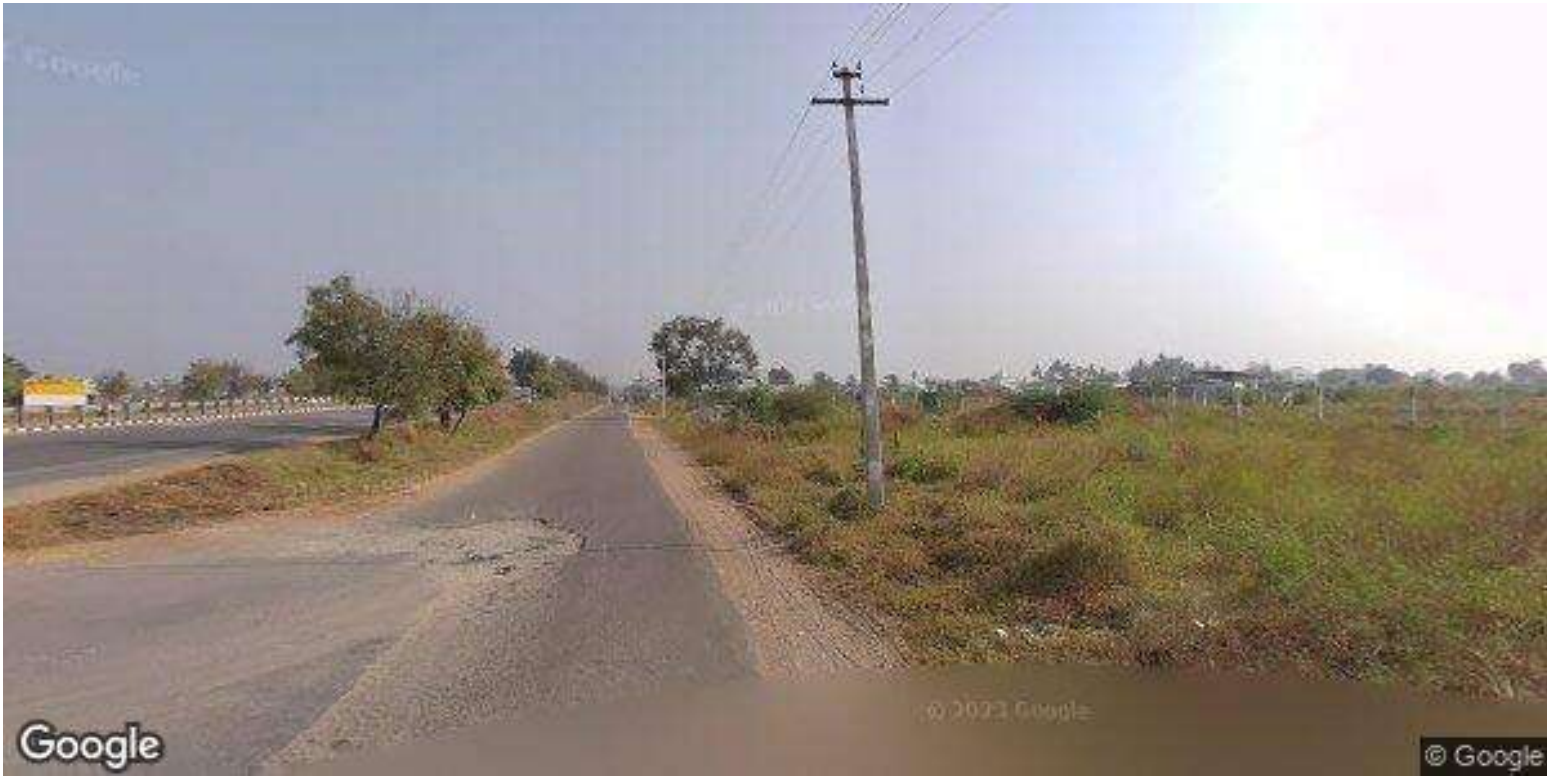
**Risk Type:** Turn  
**Risk Level:** High  
**Speed Limit:** 15 KM/Hr  
**Coordinates:** 11.22817, 78.13576

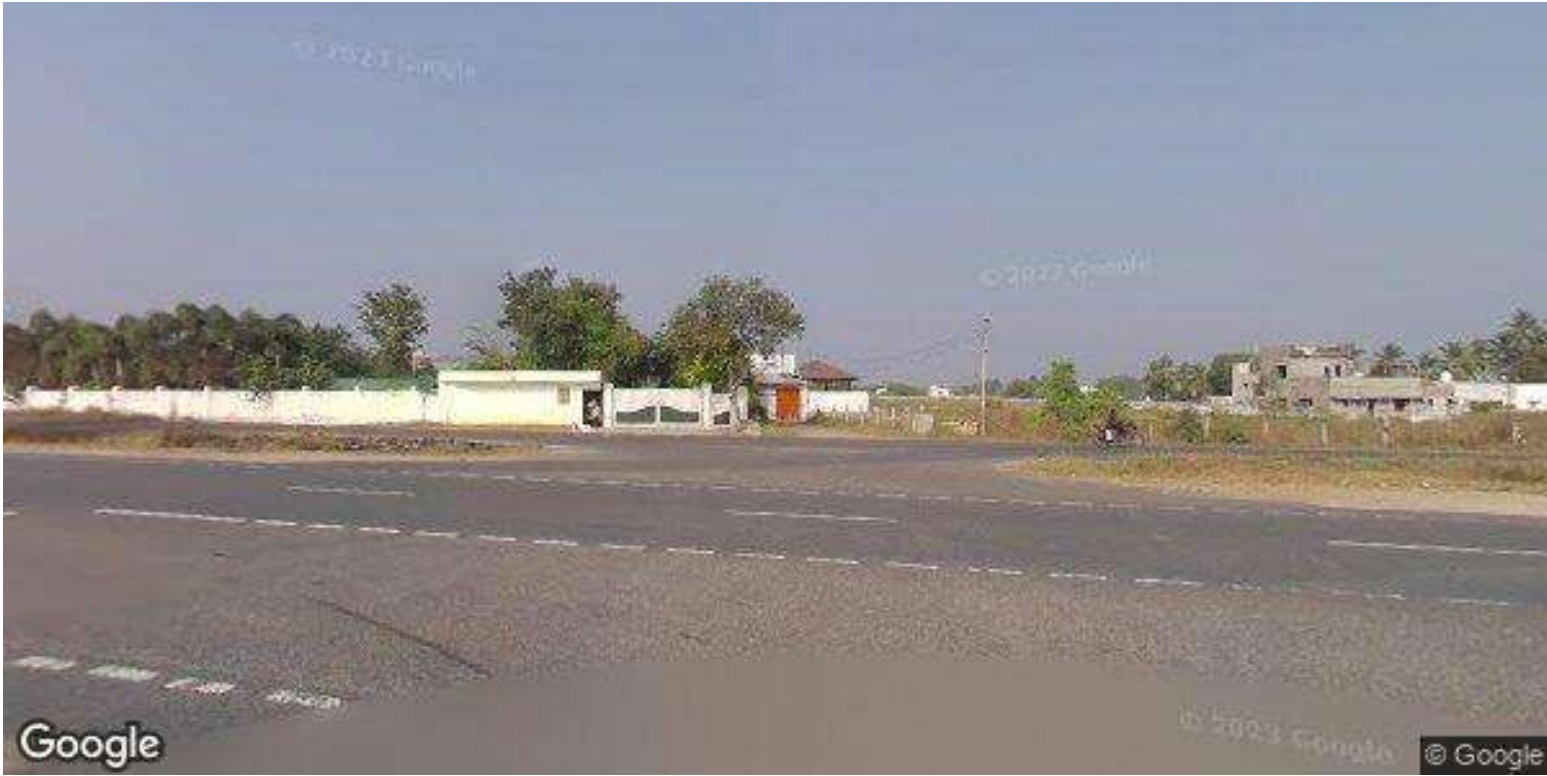
**Risk Type:** Turn  
**Risk Level:** High  
**Speed Limit:** 15 KM/Hr  
**Coordinates:** 11.22822, 78.13561

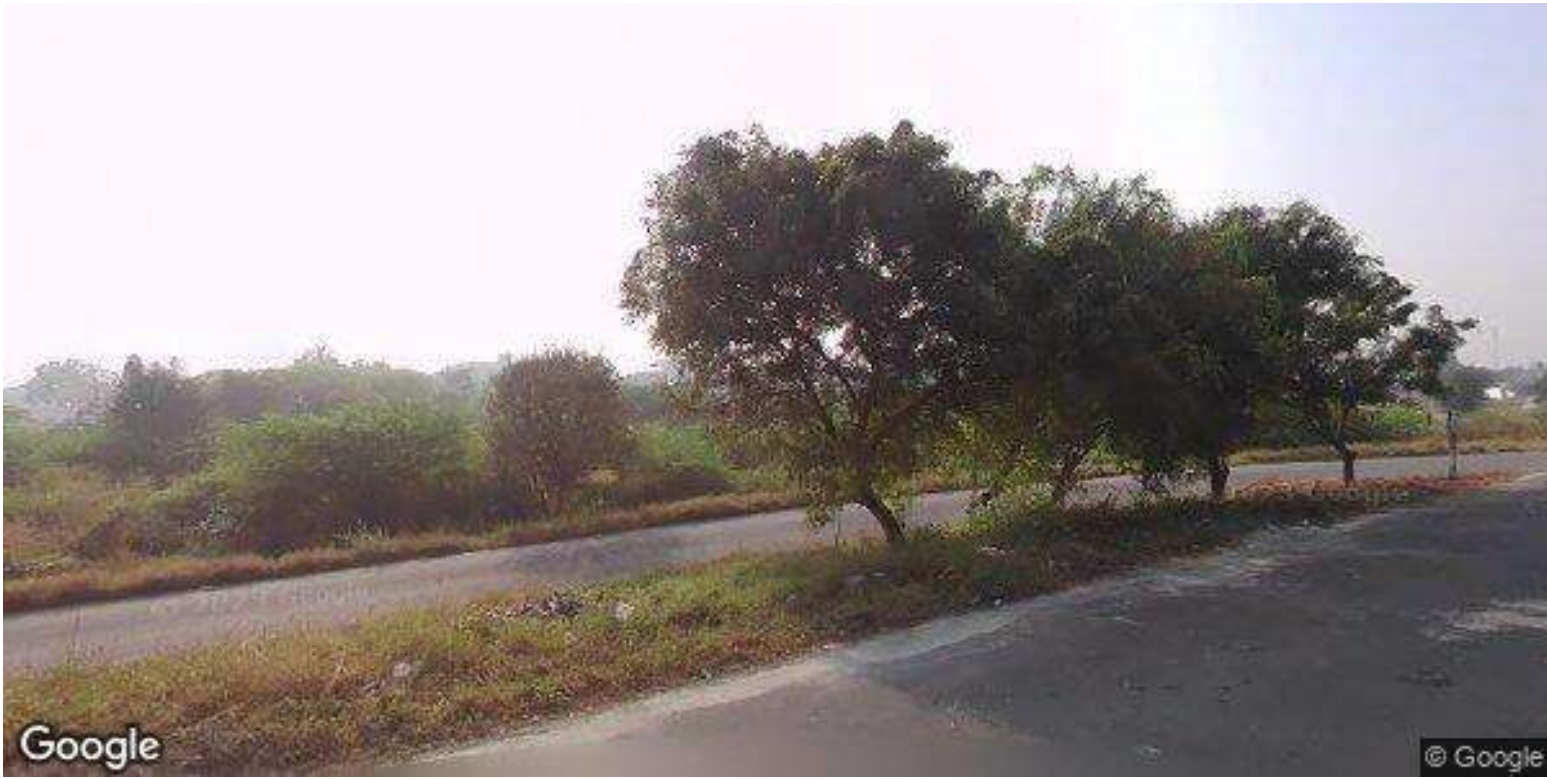
**Risk Type:** Turn  
**Risk Level:** Medium  
**Speed Limit:** 30 KM/Hr  
**Coordinates:** 11.20882, 78.12464

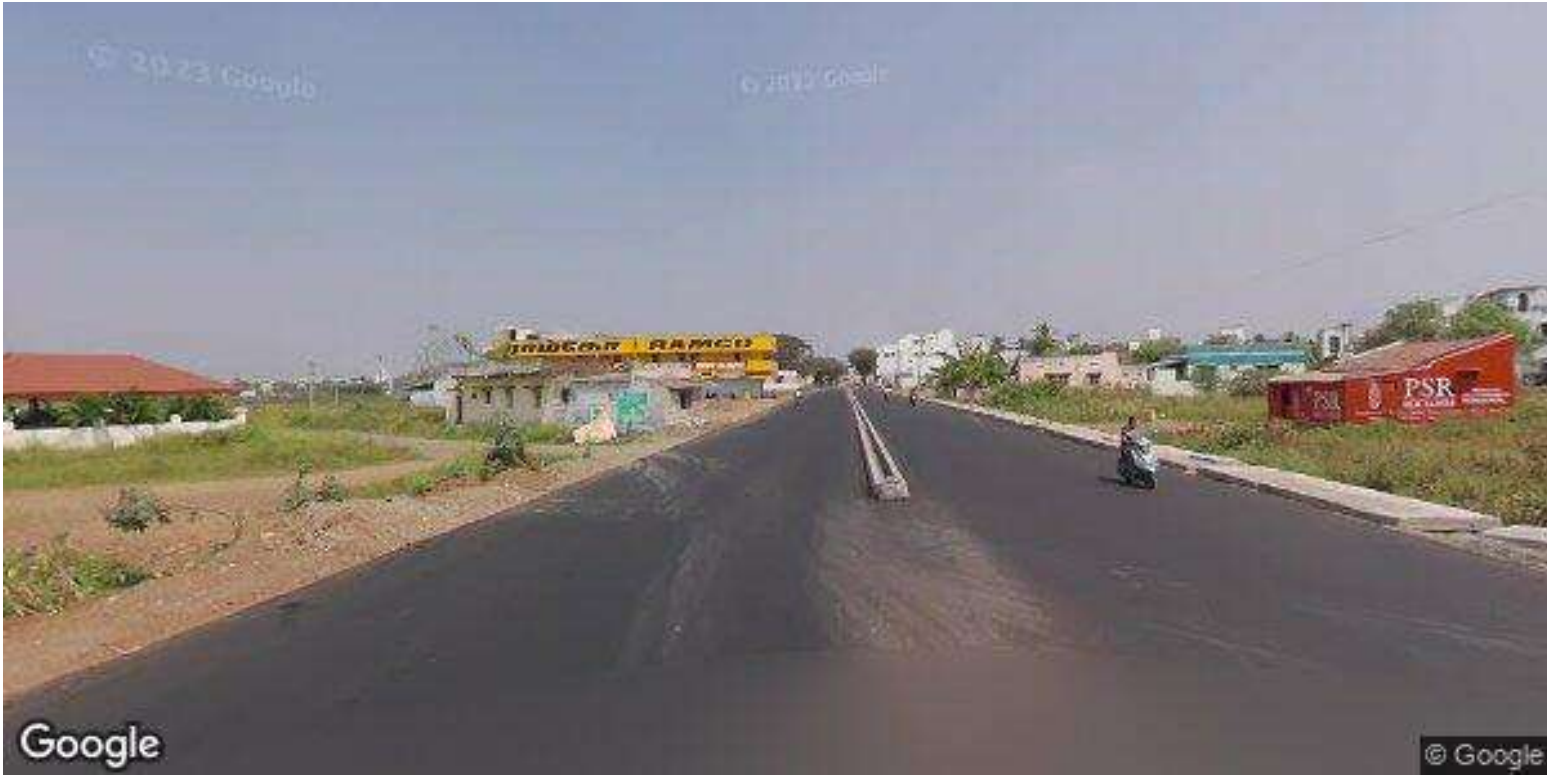
**Risk Type:** Blind Spot  
**Risk Level:** Blind Spot  
**Speed Limit:** 10 KM/Hr  
**Coordinates:** 11.20898, 78.13558

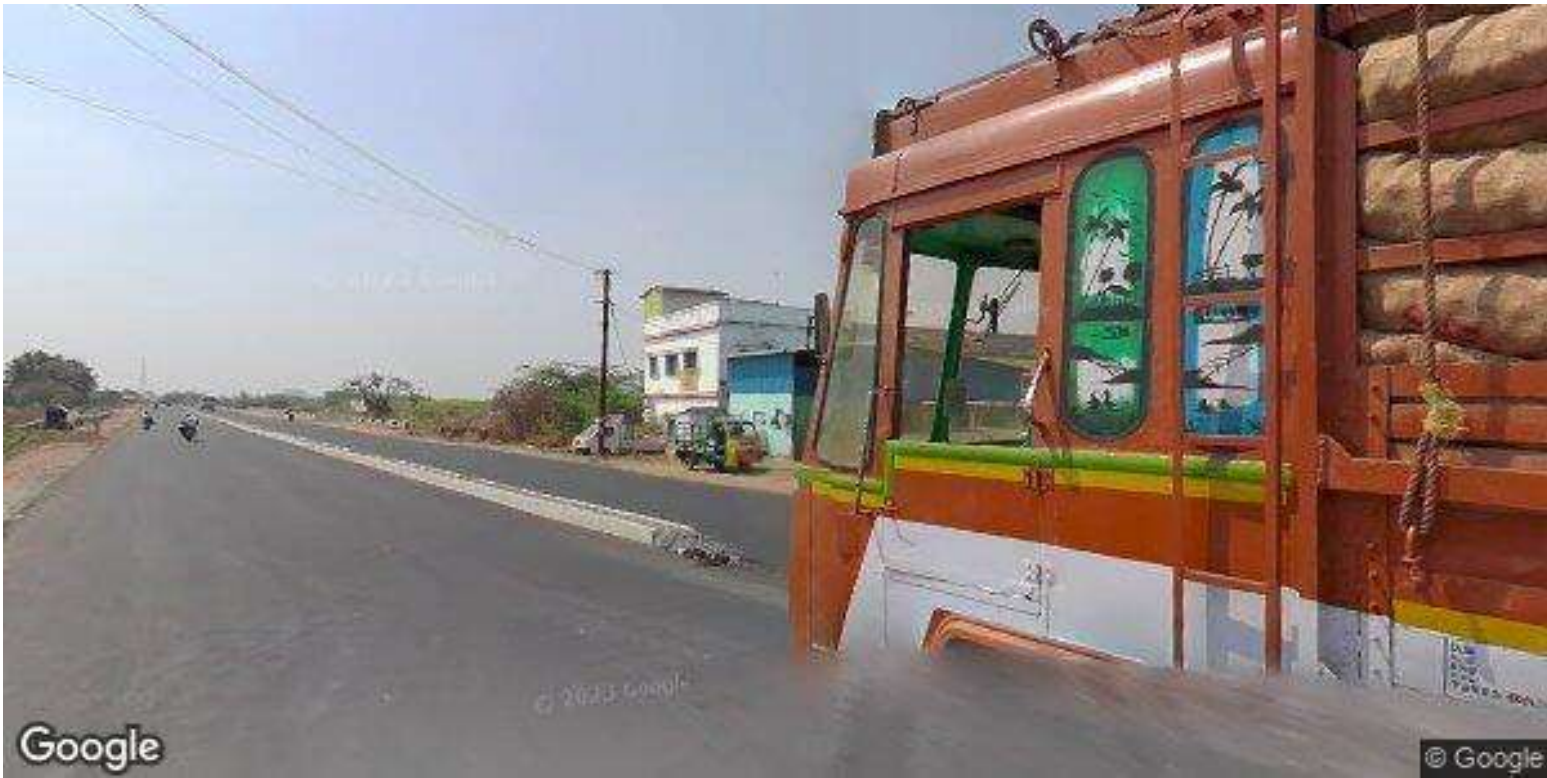
**Risk Type:** Turn  
**Risk Level:** High  
**Speed Limit:** 15 KM/Hr  
**Coordinates:** 11.20890, 78.13558

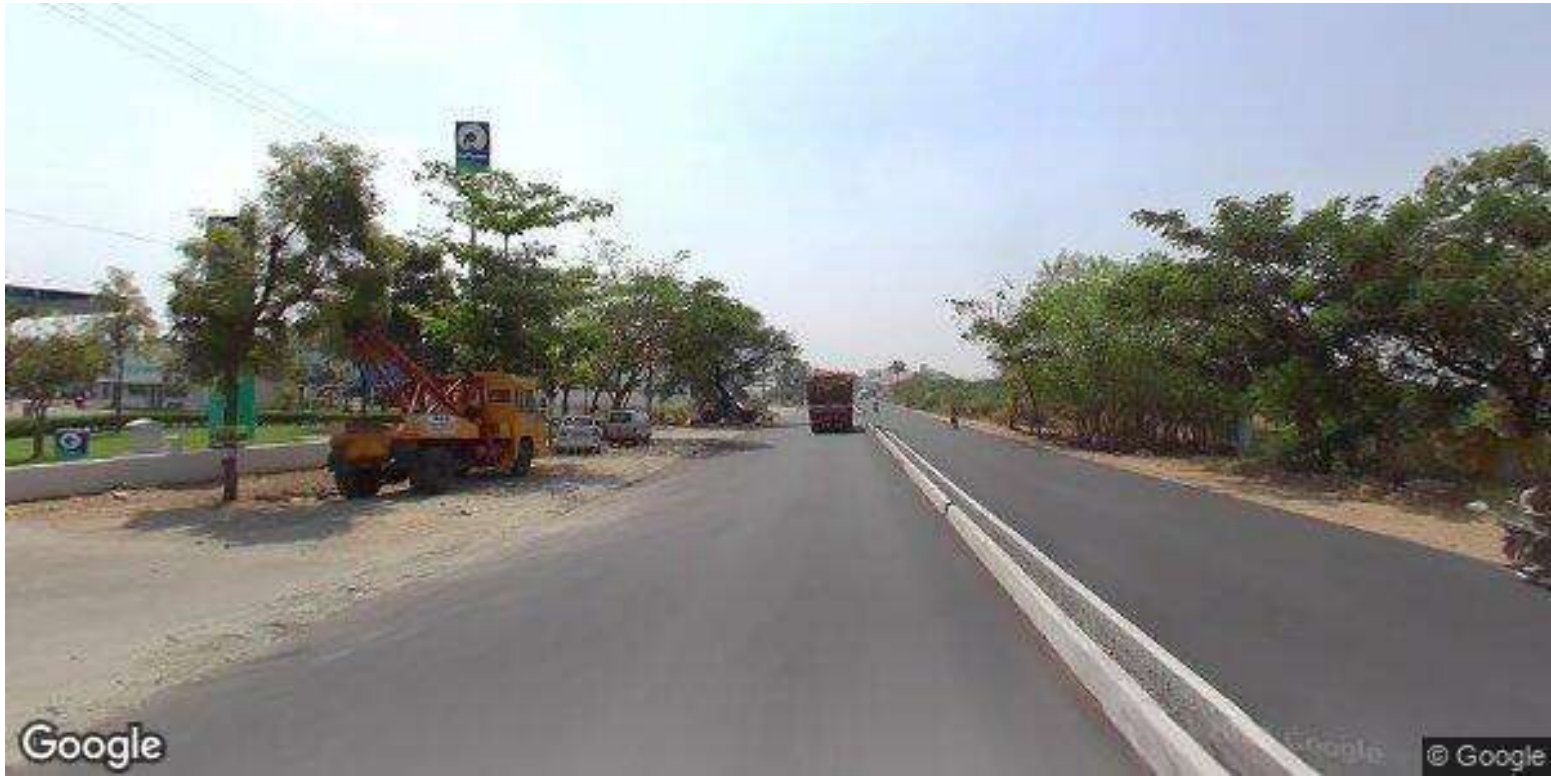
**Risk Type:** Turn  
**Risk Level:** High  
**Speed Limit:** 15 KM/Hr  
**Coordinates:** 11.20761, 78.13016

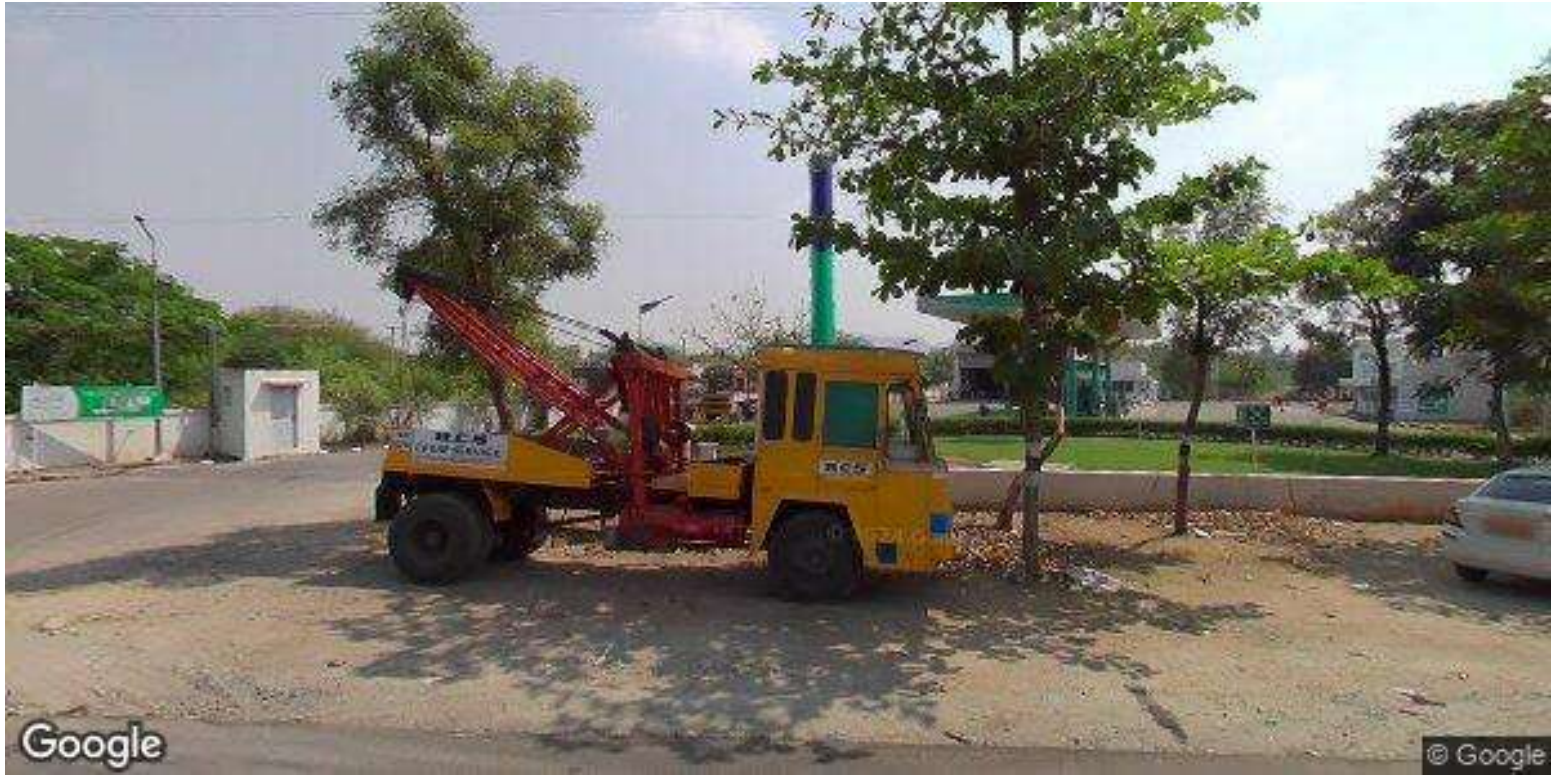
**Risk Type:** Turn  
**Risk Level:** High  
**Speed Limit:** 15 KM/Hr  
**Coordinates:** 11.20730, 78.13013

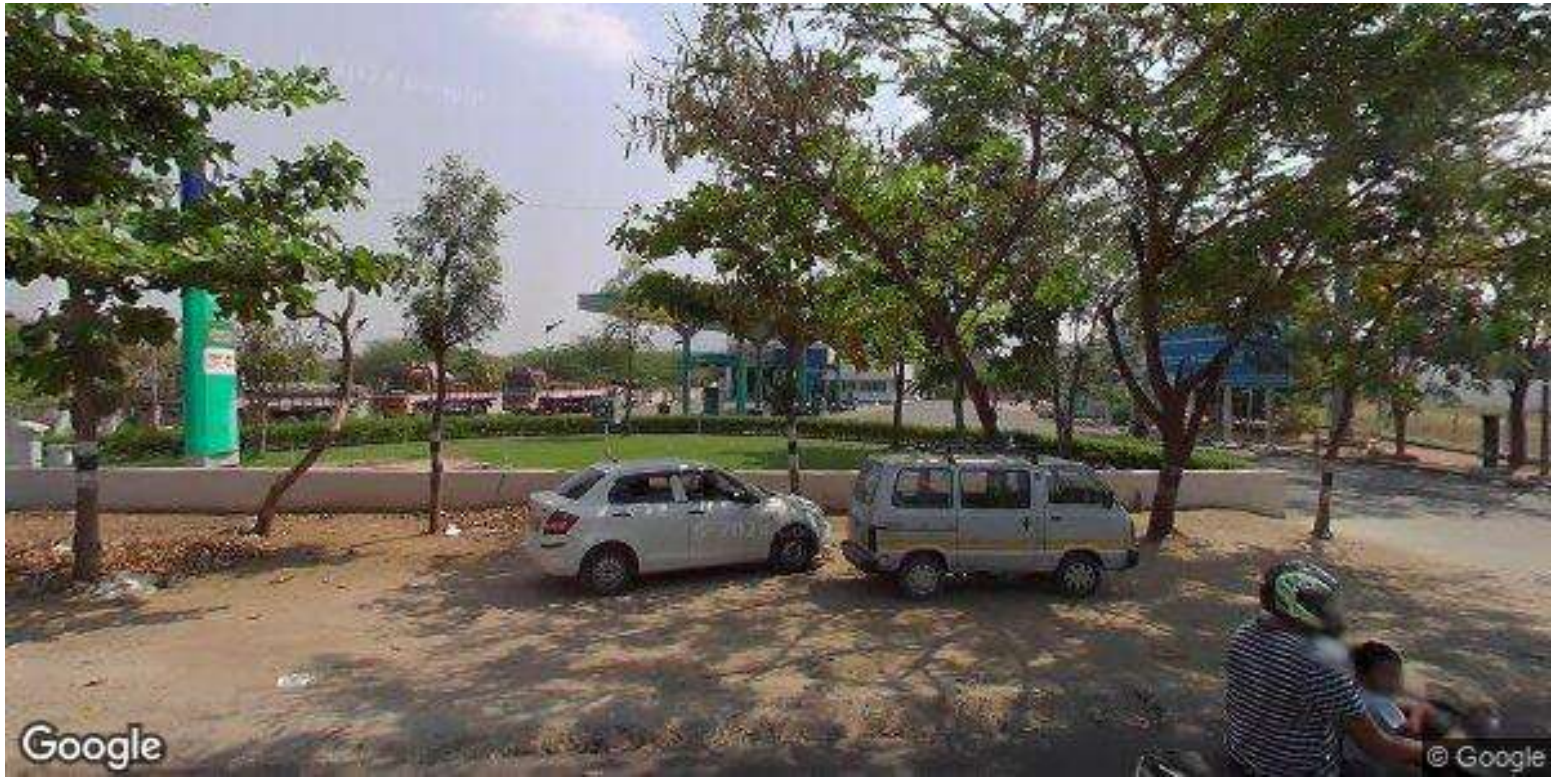
**Coordinates:** 11.20721, 78.13001

**Risk Type:** Turn

**Risk Level:** High

**Speed Limit:** 15 KM/Hr
