# IndianOil

## JOURNEY RISK MANAGEMENT (JRM) STUDY

### Salem Terminal TO S S N AGENCIES

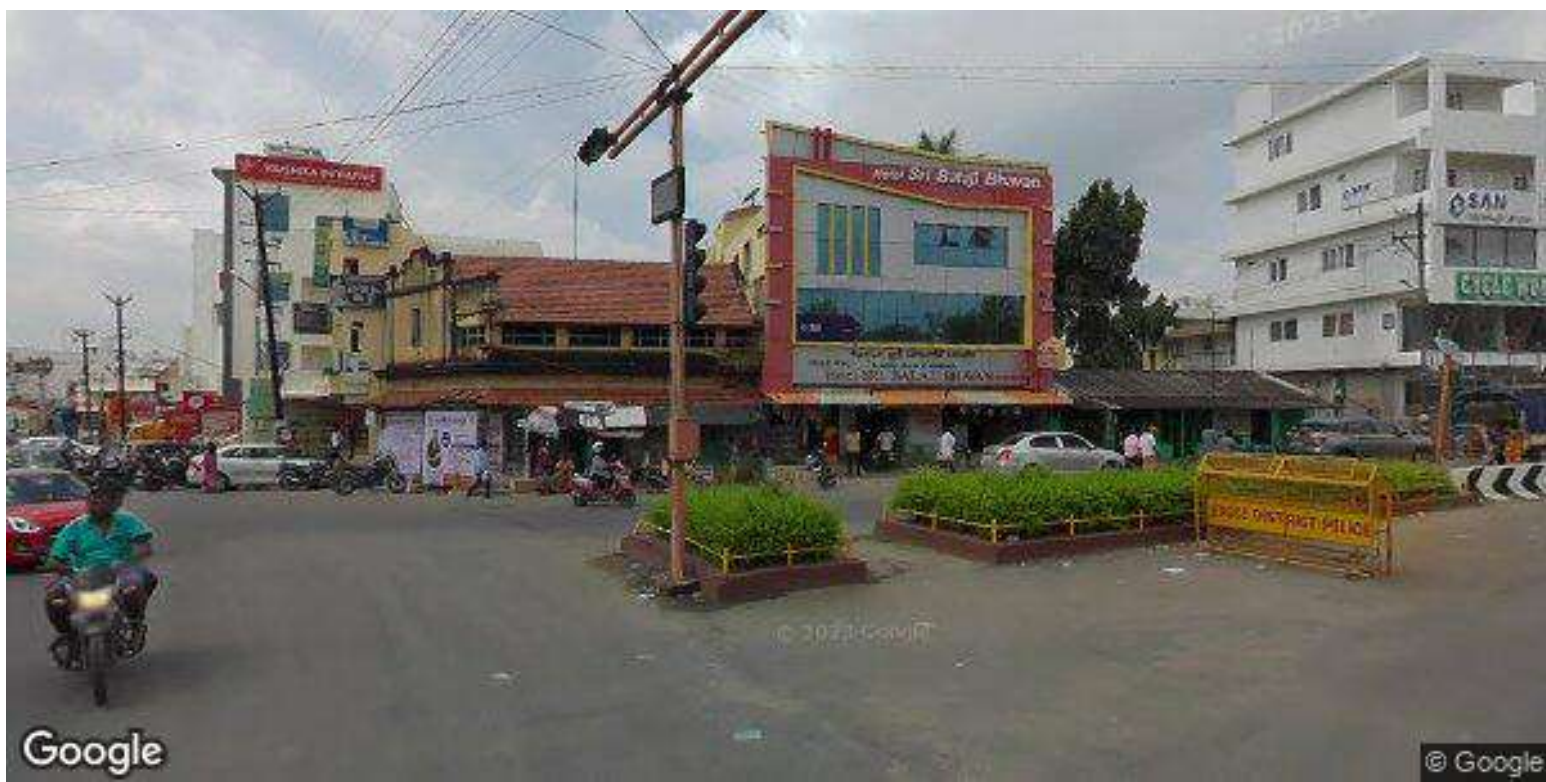
**Coordinates:** 11.27925, 77.58494

**Risk Type:** Roundabout

**Risk Level:** High

**Speed Limit:** 15 KM/Hr

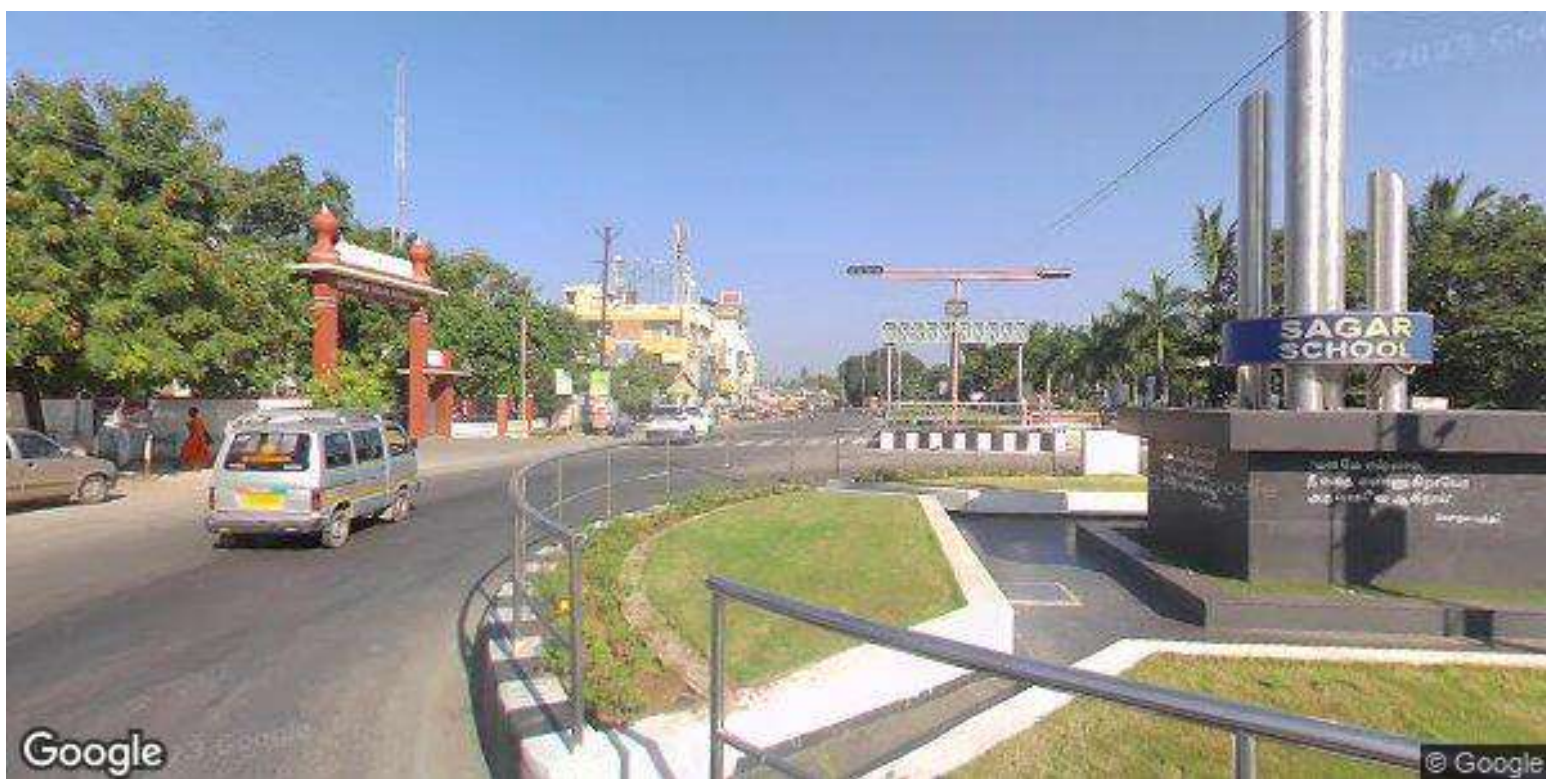
**Coordinates:** 11.27732, 77.58658

**Risk Type:** Roundabout

**Risk Level:** High

**Speed Limit:** 15 KM/Hr

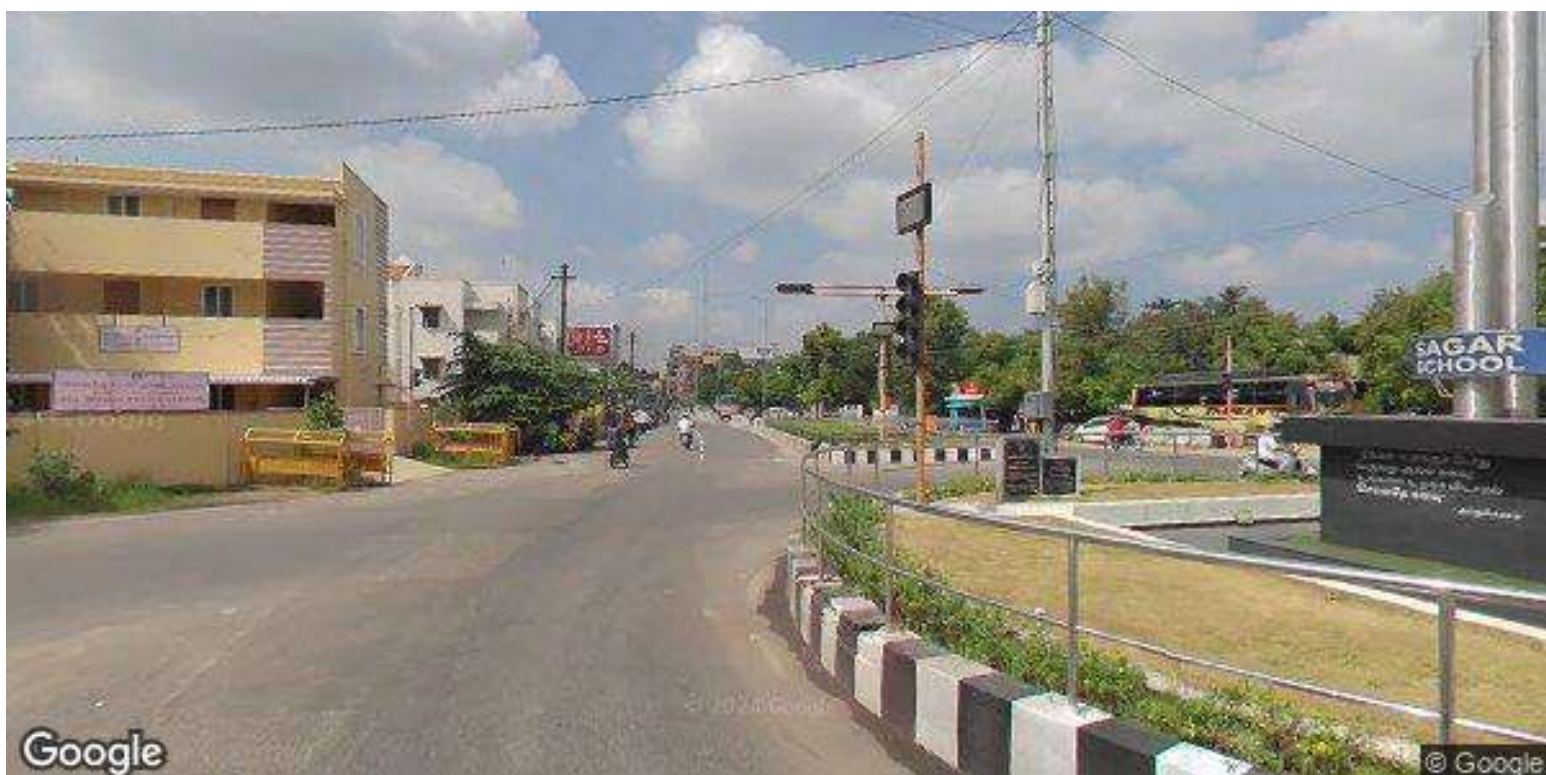
**Risk Type:** Roundabout  
**Risk Level:** High  
**Speed Limit:** 15 KM/Hr  
**Coordinates:** 11.27718, 77.58674

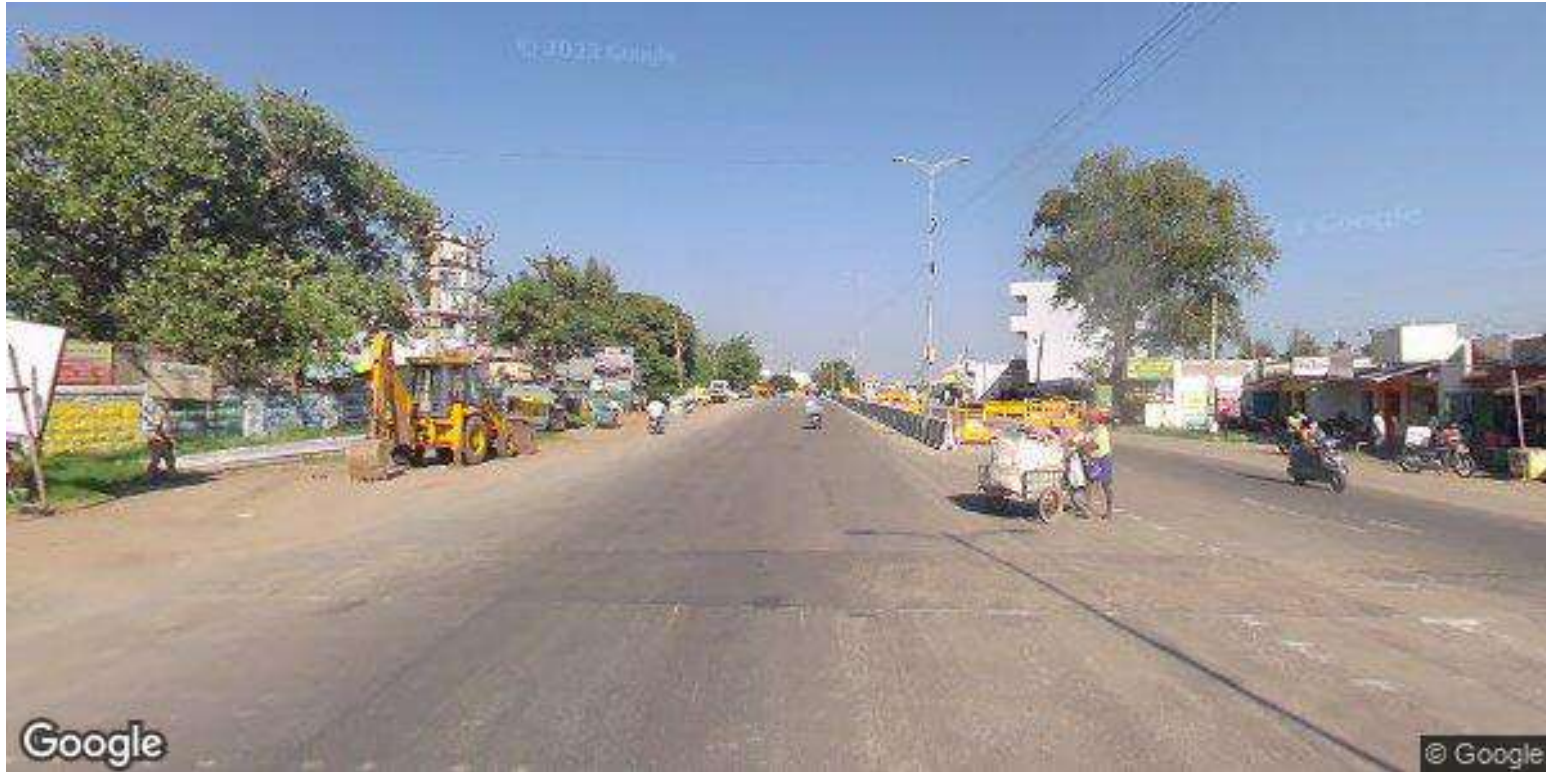
**Risk Type:** U-Turn  
**Risk Level:** High  
**Speed Limit:** 10 KM/Hr  
**Coordinates:** 11.278222, 77.5896496

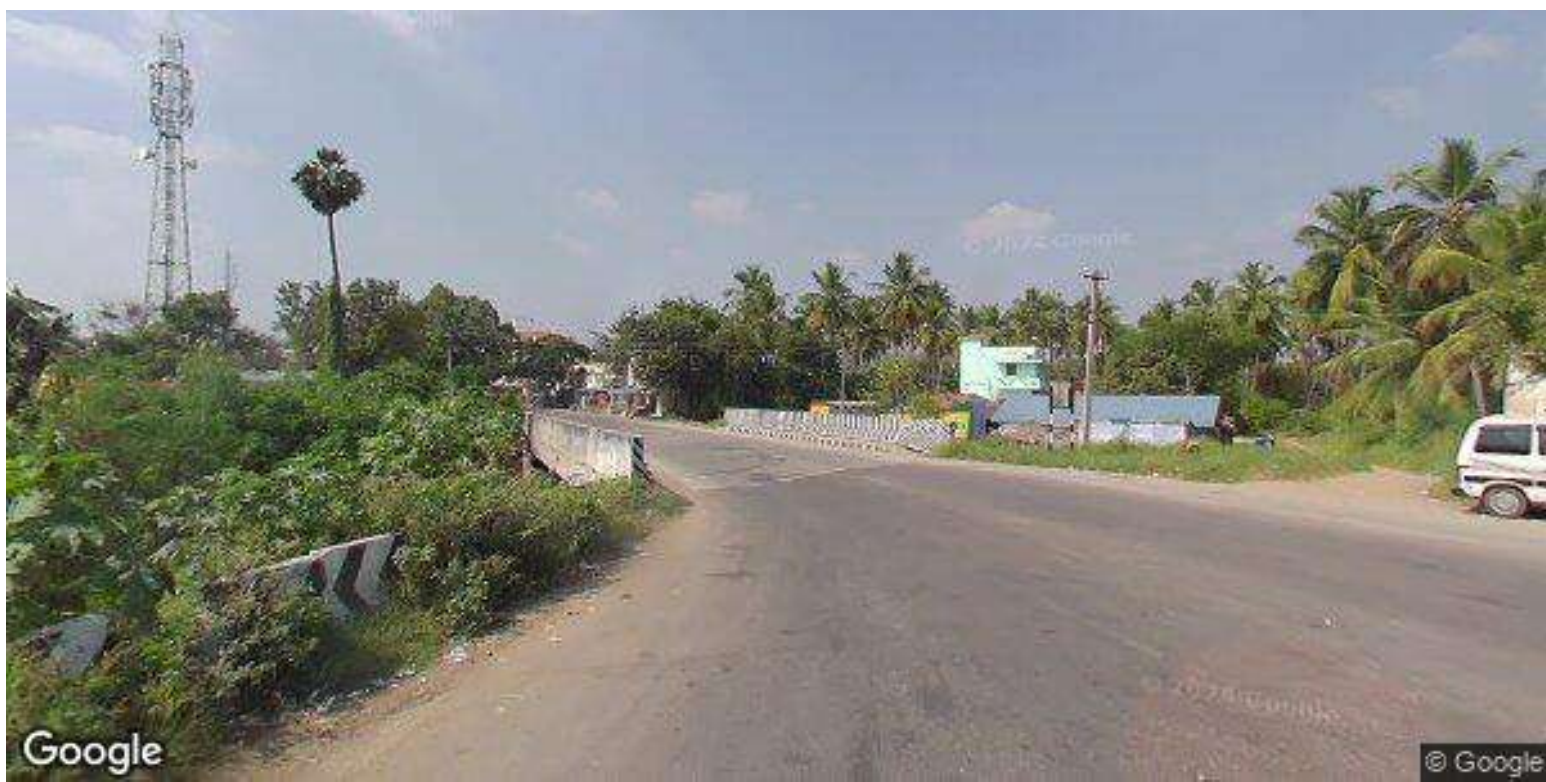
**Coordinates:** 11.44893, 77.87413

**Risk Type:** Turn

**Risk Level:** Medium

**Speed Limit:** 30 KM/Hr

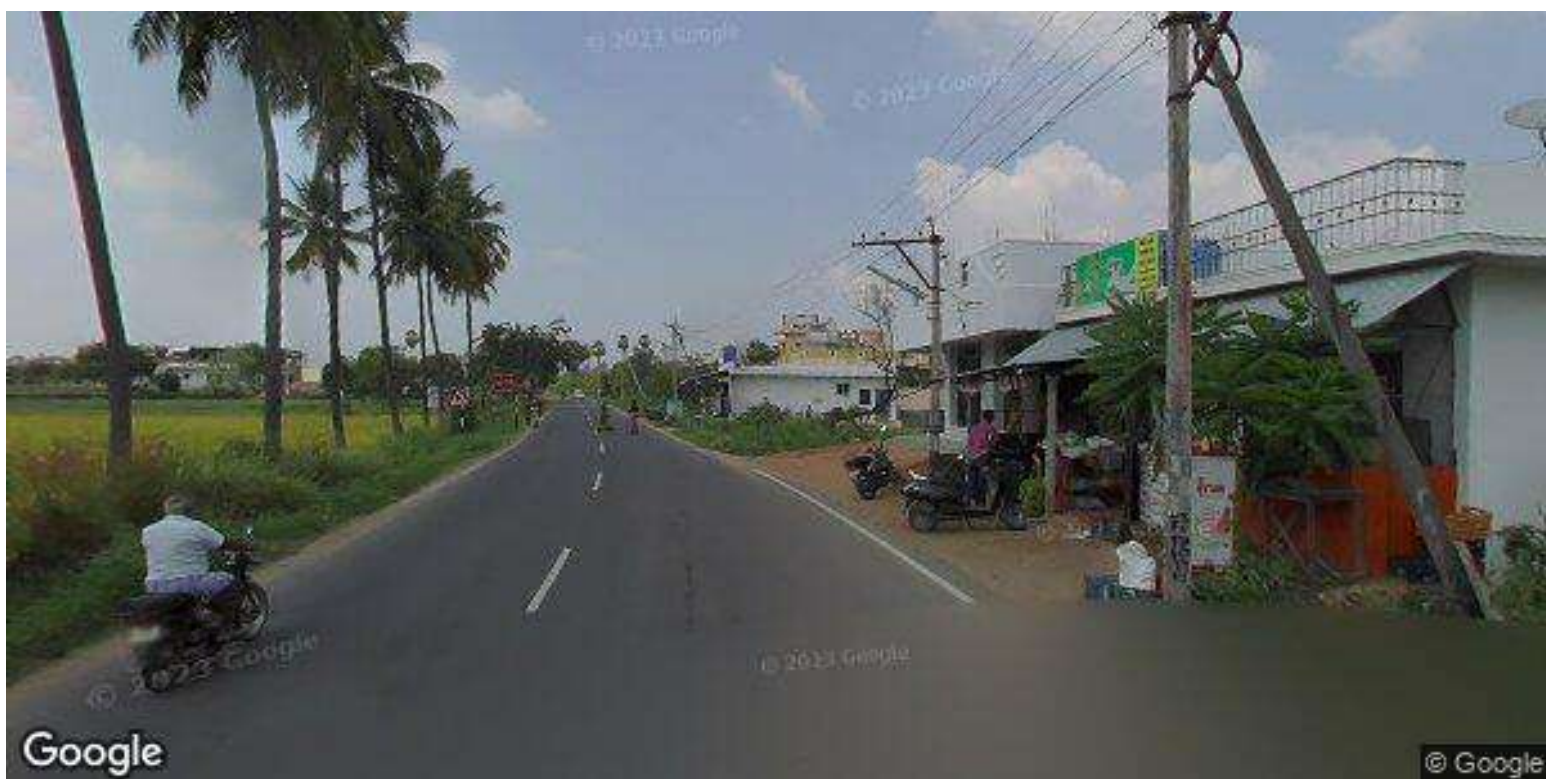
**Coordinates:** 11.45127, 77.86734

**Risk Type:** Turn

**Risk Level:** Medium

**Speed Limit:** 30 KM/Hr

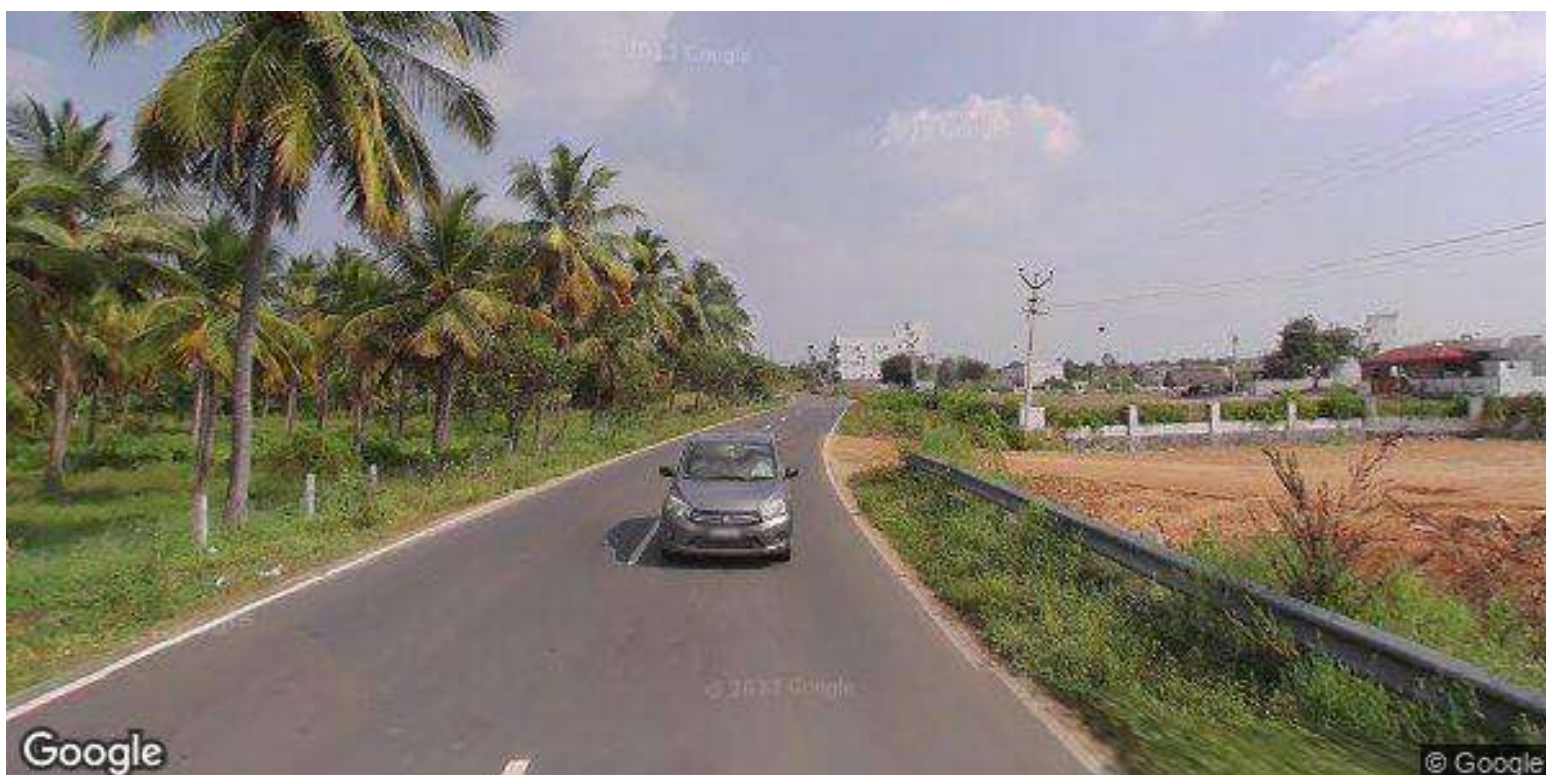
**Risk Type:** Turn  
**Risk Level:** Medium  
**Speed Limit:** 30 KM/Hr  
**Coordinates:** 11.45354, 77.85798

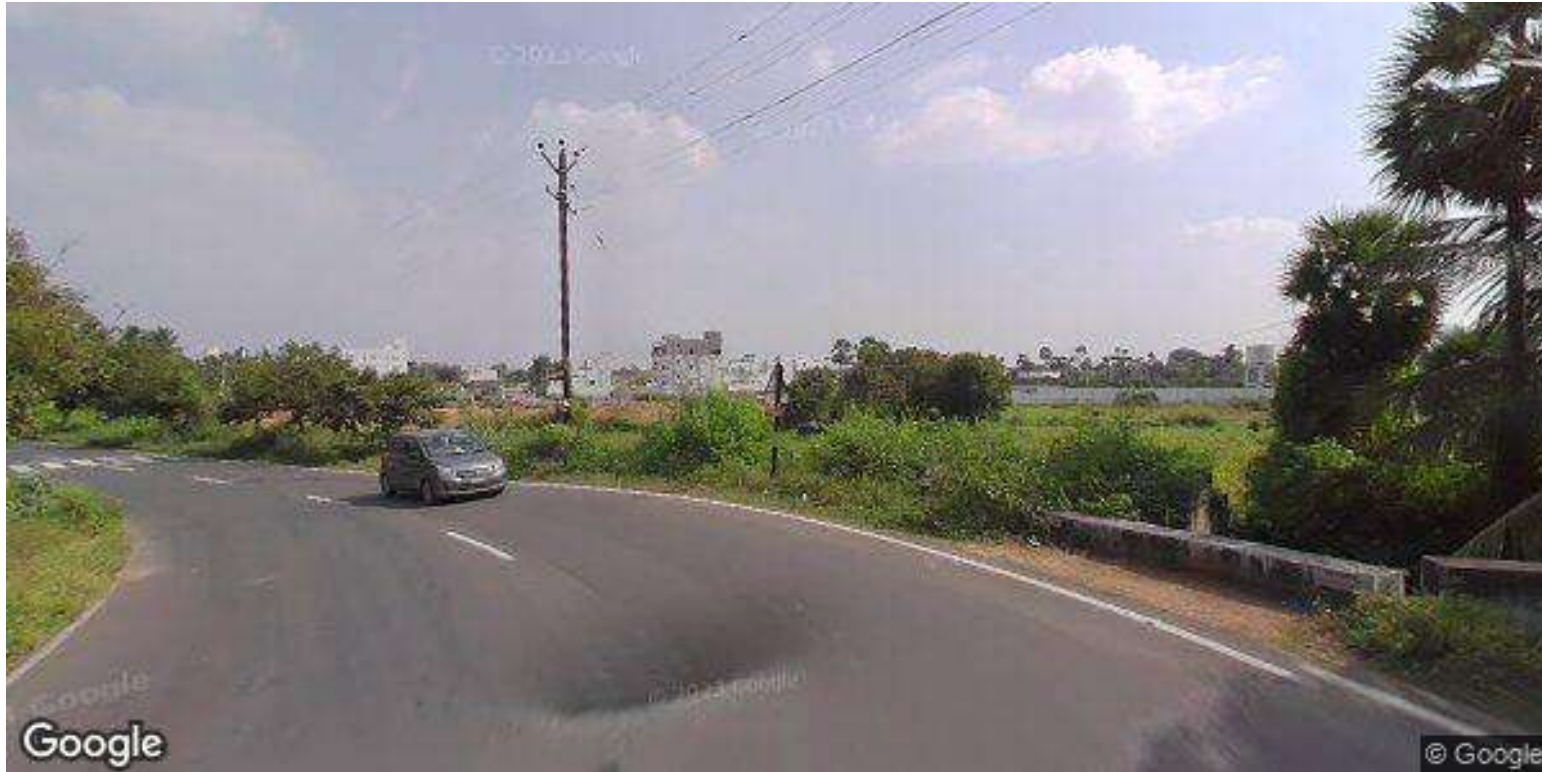
**Risk Type:** Turn  
**Risk Level:** High  
**Speed Limit:** 15 KM/Hr  
**Coordinates:** 11.45350, 77.85700

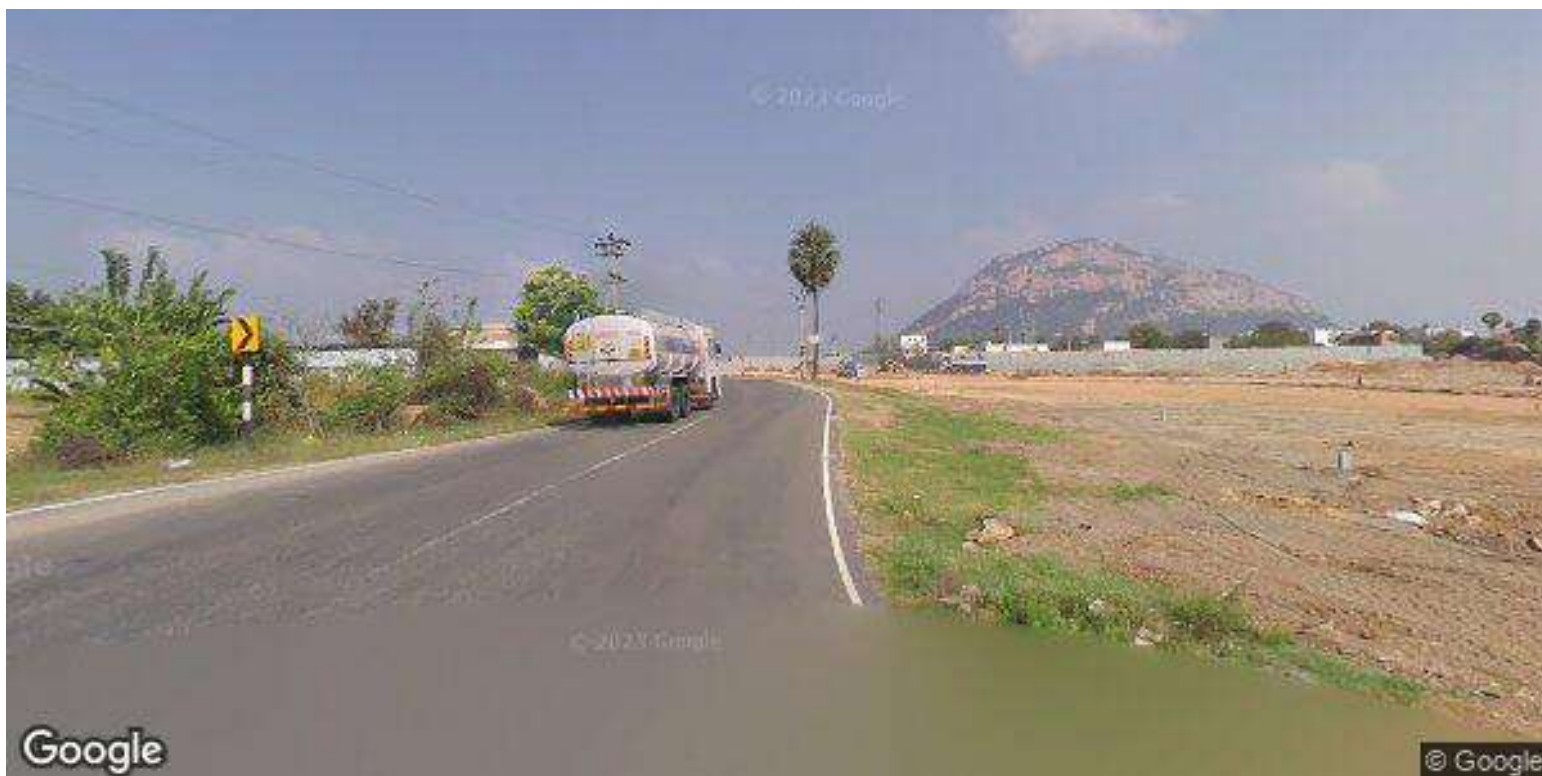
**Risk Type:** Turn  
**Risk Level:** Medium  
**Speed Limit:** 30 KM/Hr  
**Coordinates:** 11.45845, 77.85141

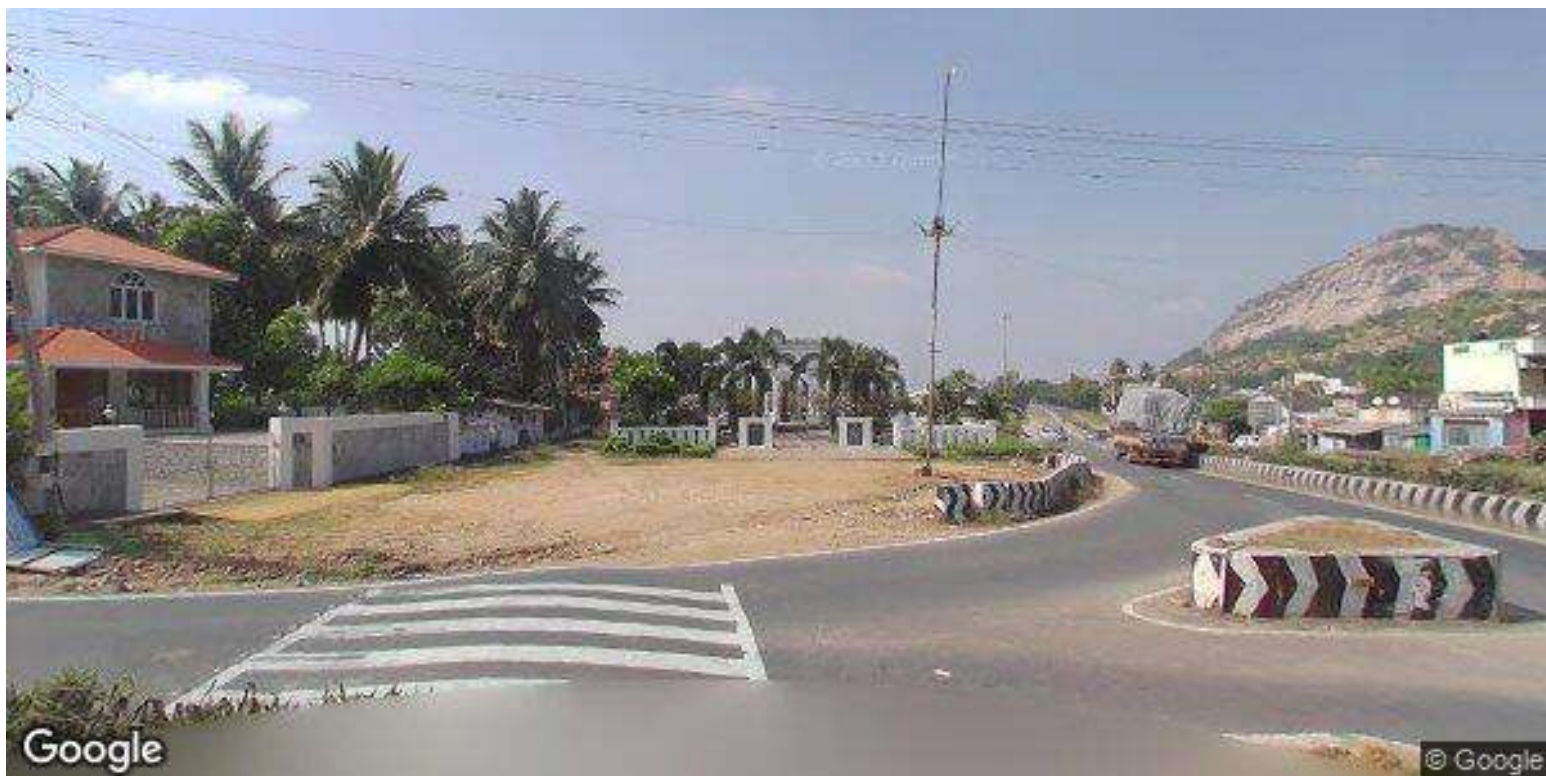
**Coordinates:** 11.46311, 77.84934

**Risk Type:** Turn

**Risk Level:** Medium

**Speed Limit:** 30 KM/Hr

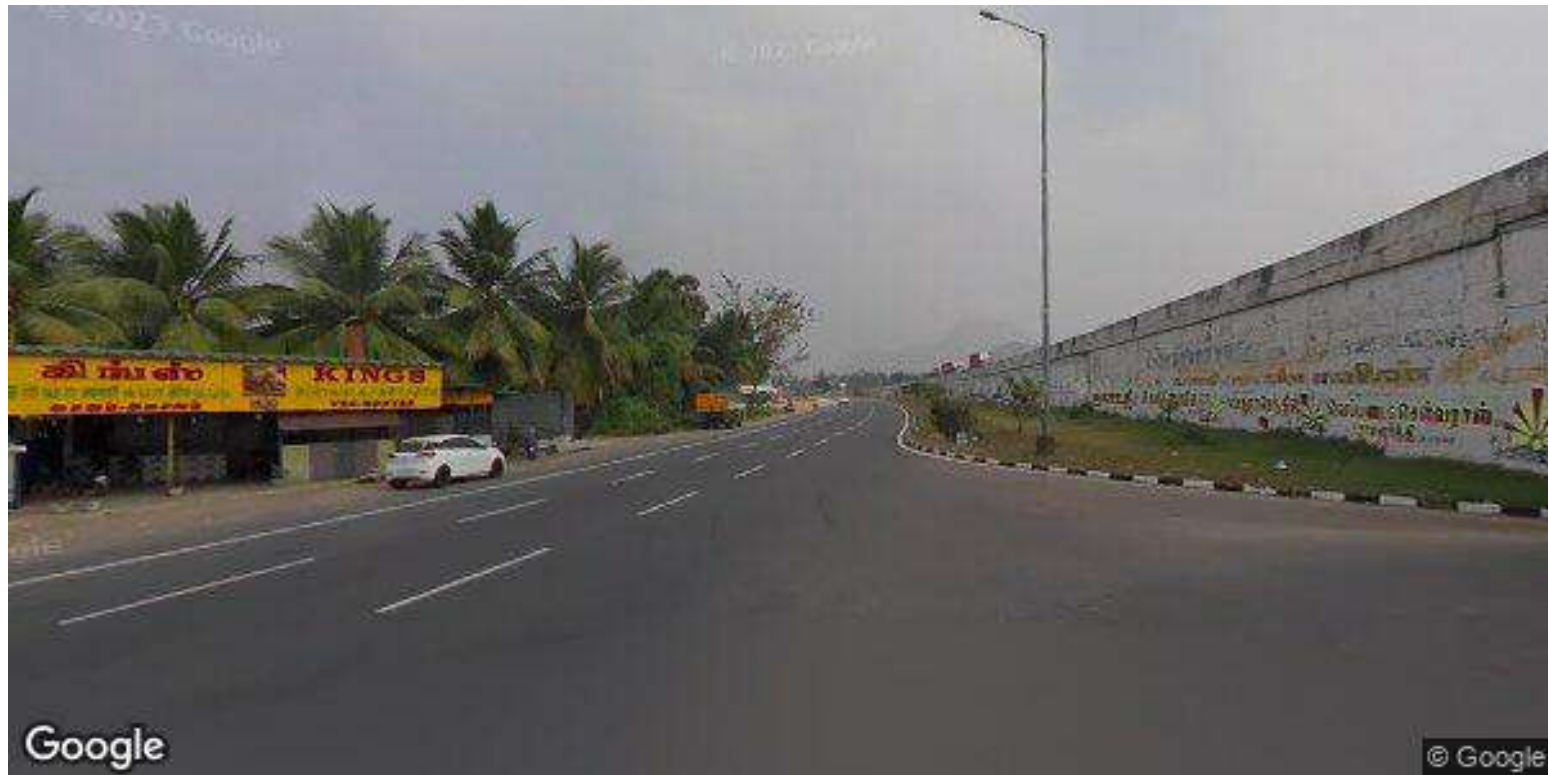
**Coordinates:** 11.45634, 77.81673

**Risk Type:** Blind Spot

**Risk Level:** Blind Spot

**Speed Limit:** 10 KM/Hr

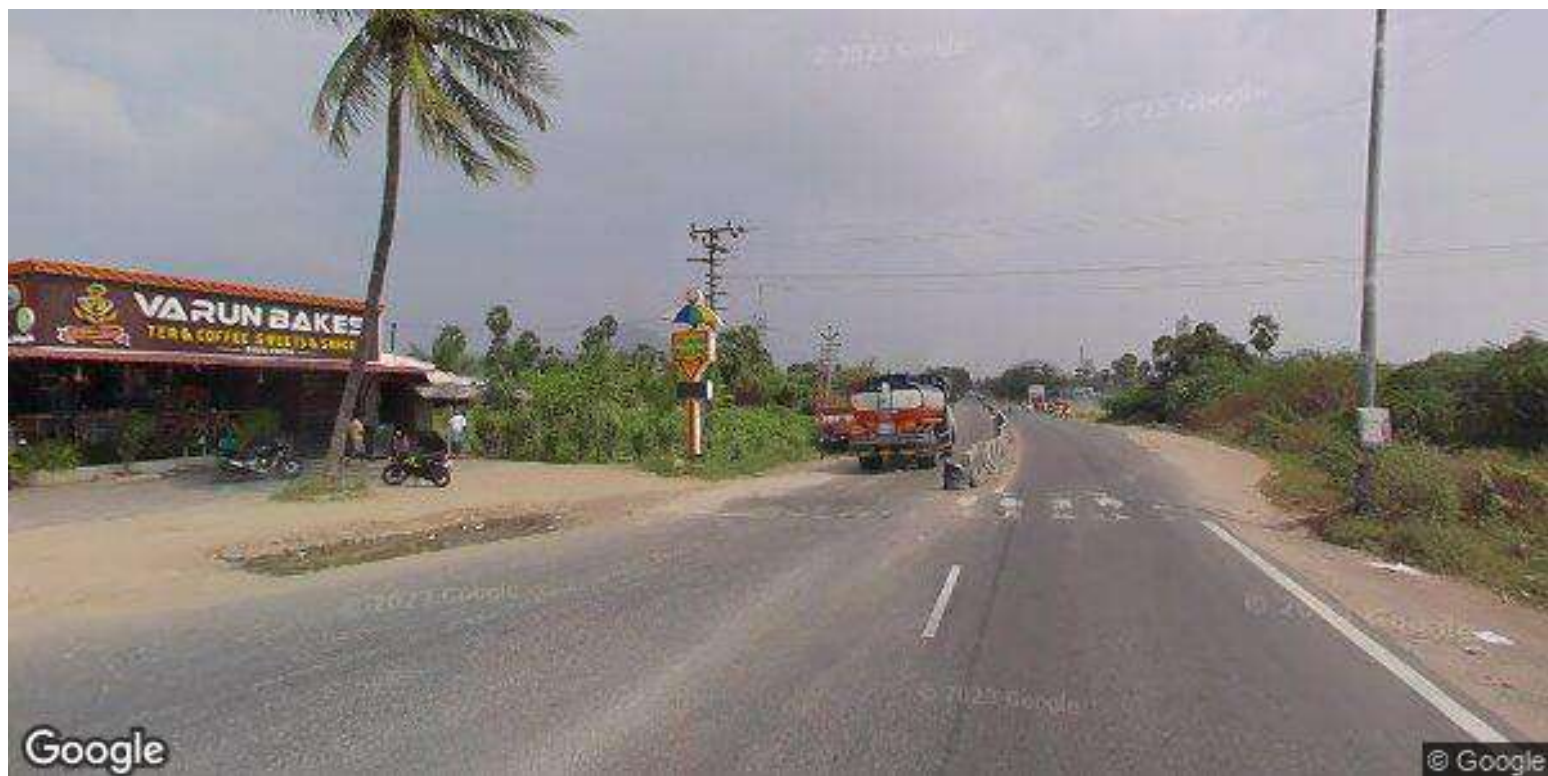
**Coordinates:** 11.45543, 77.81740

**Risk Type:** Blind Spot

**Risk Level:** Blind Spot

**Speed Limit:** 10 KM/Hr

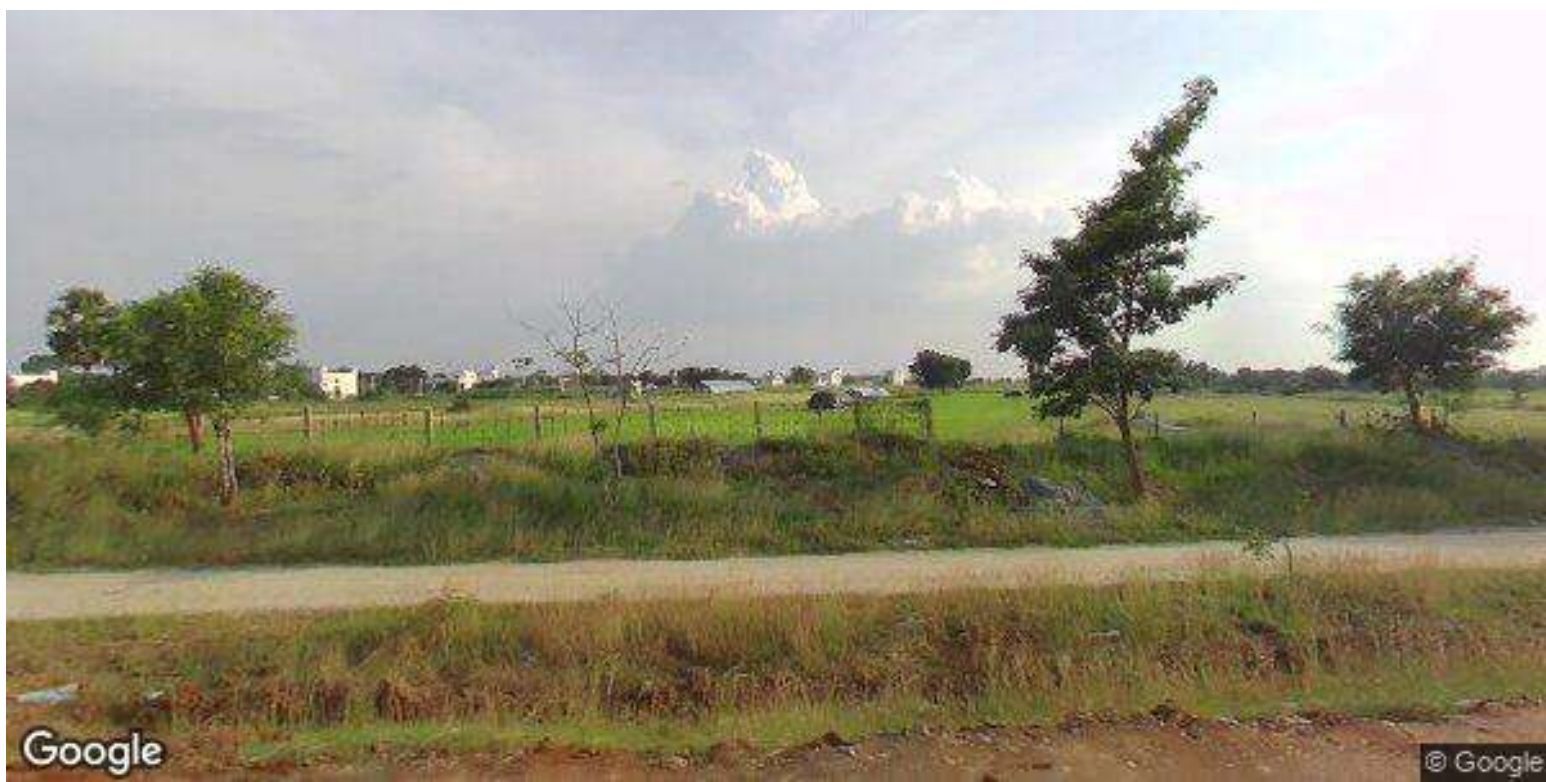
**Coordinates:** 11.29288, 77.59030

**Risk Type:** Turn

**Risk Level:** Medium

**Speed Limit:** 30 KM/Hr

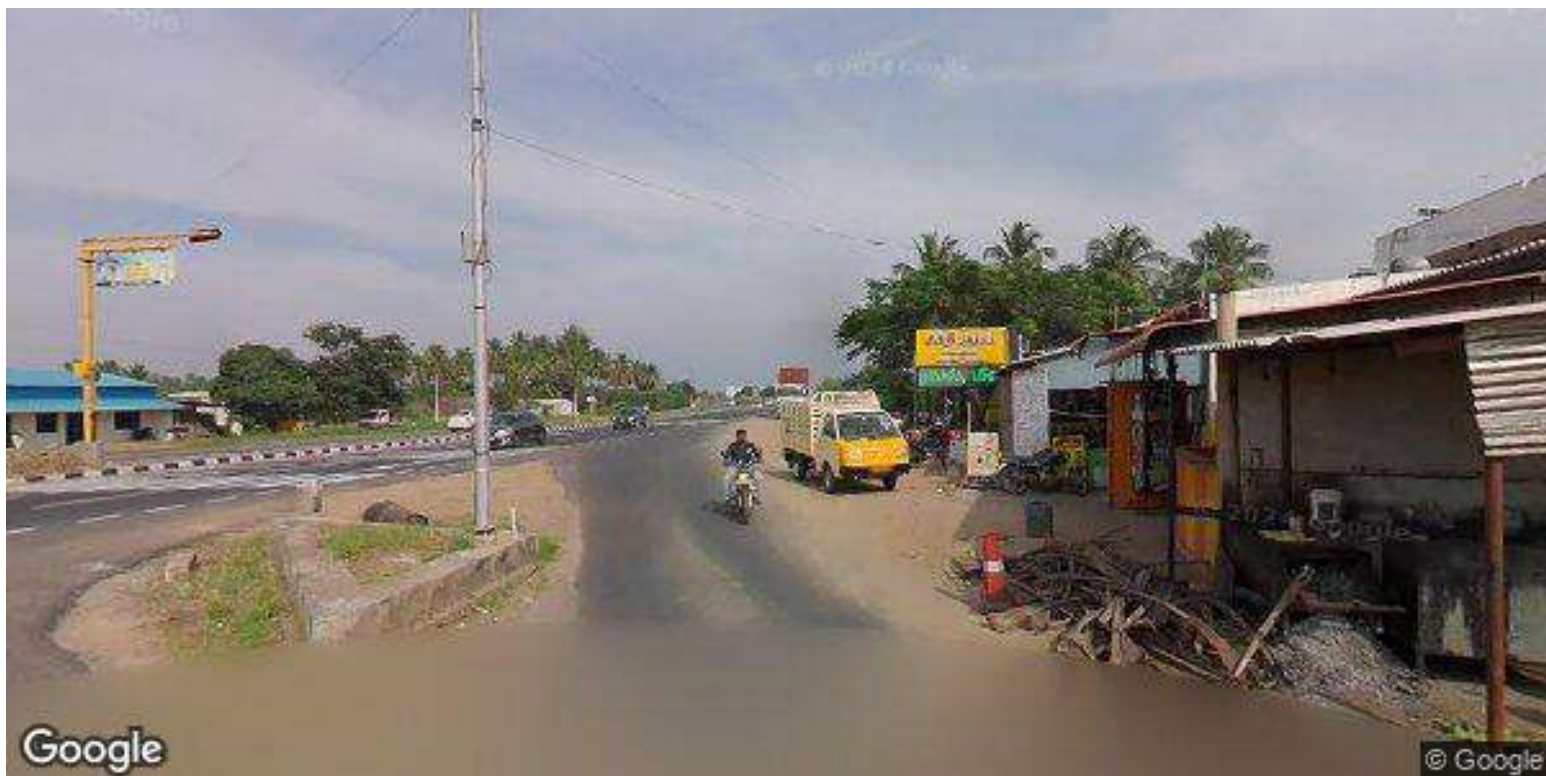
**Coordinates:** 11.29164, 77.58609

**Risk Type:** Turn

**Risk Level:** High

**Speed Limit:** 15 KM/Hr

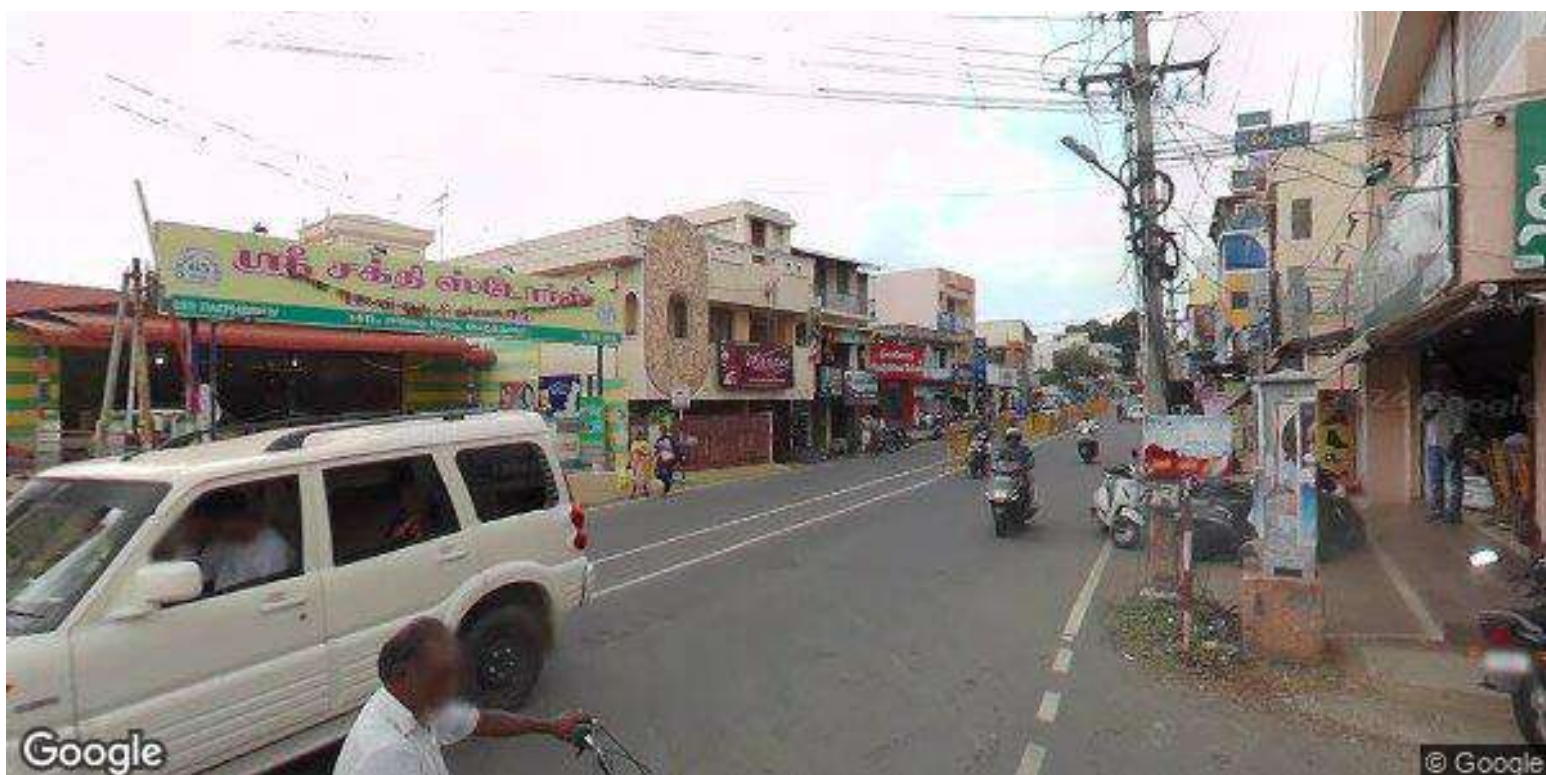
**Risk Type:** Blind Spot  
**Risk Level:** Blind Spot  
**Speed Limit:** 10 KM/Hr  
**Coordinates:** 11.27735, 77.58485

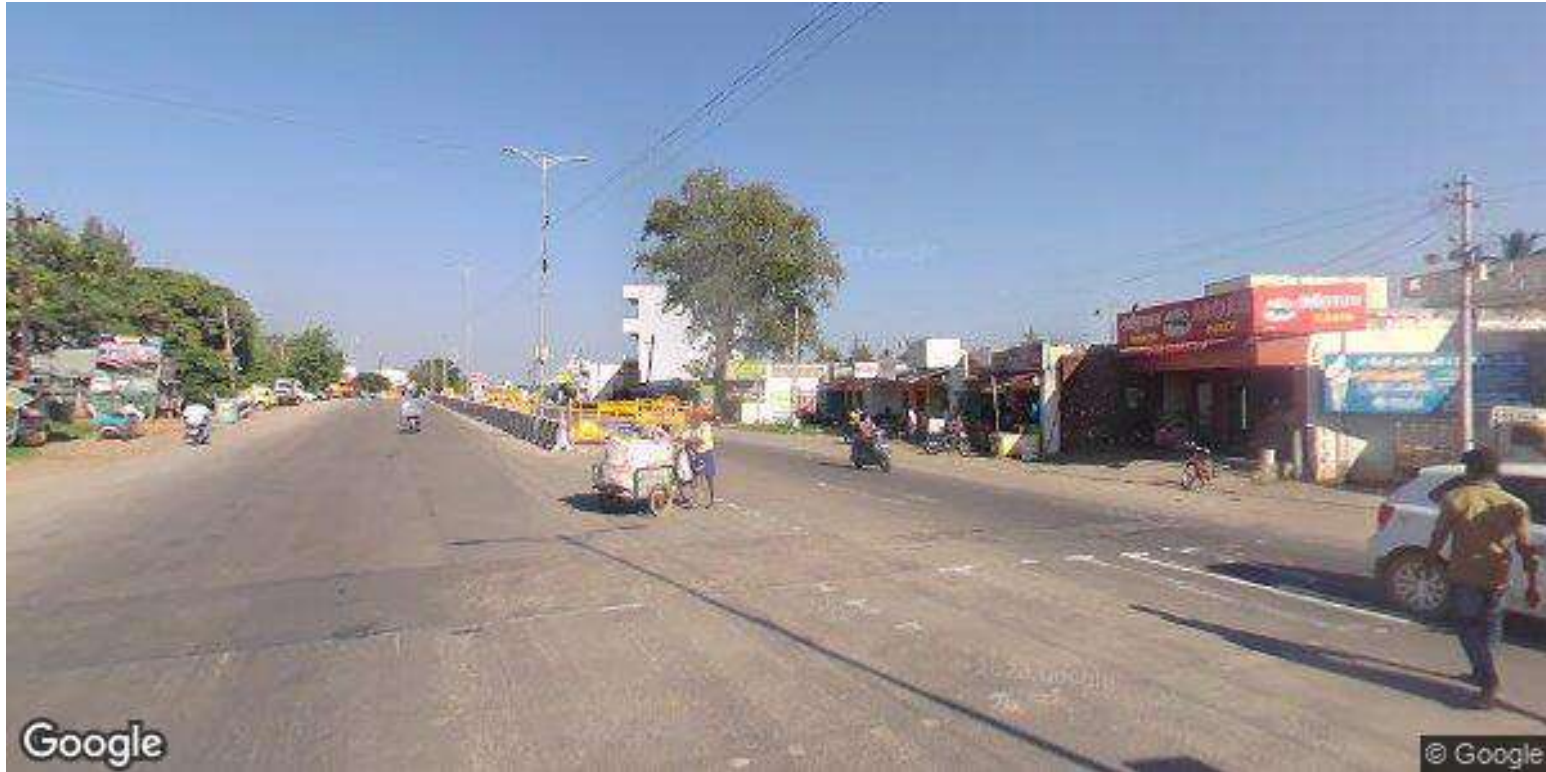
**Risk Type:** Blind Spot  
**Risk Level:** Blind Spot  
**Speed Limit:** 10 KM/Hr  
**Coordinates:** 11.27822, 77.58965

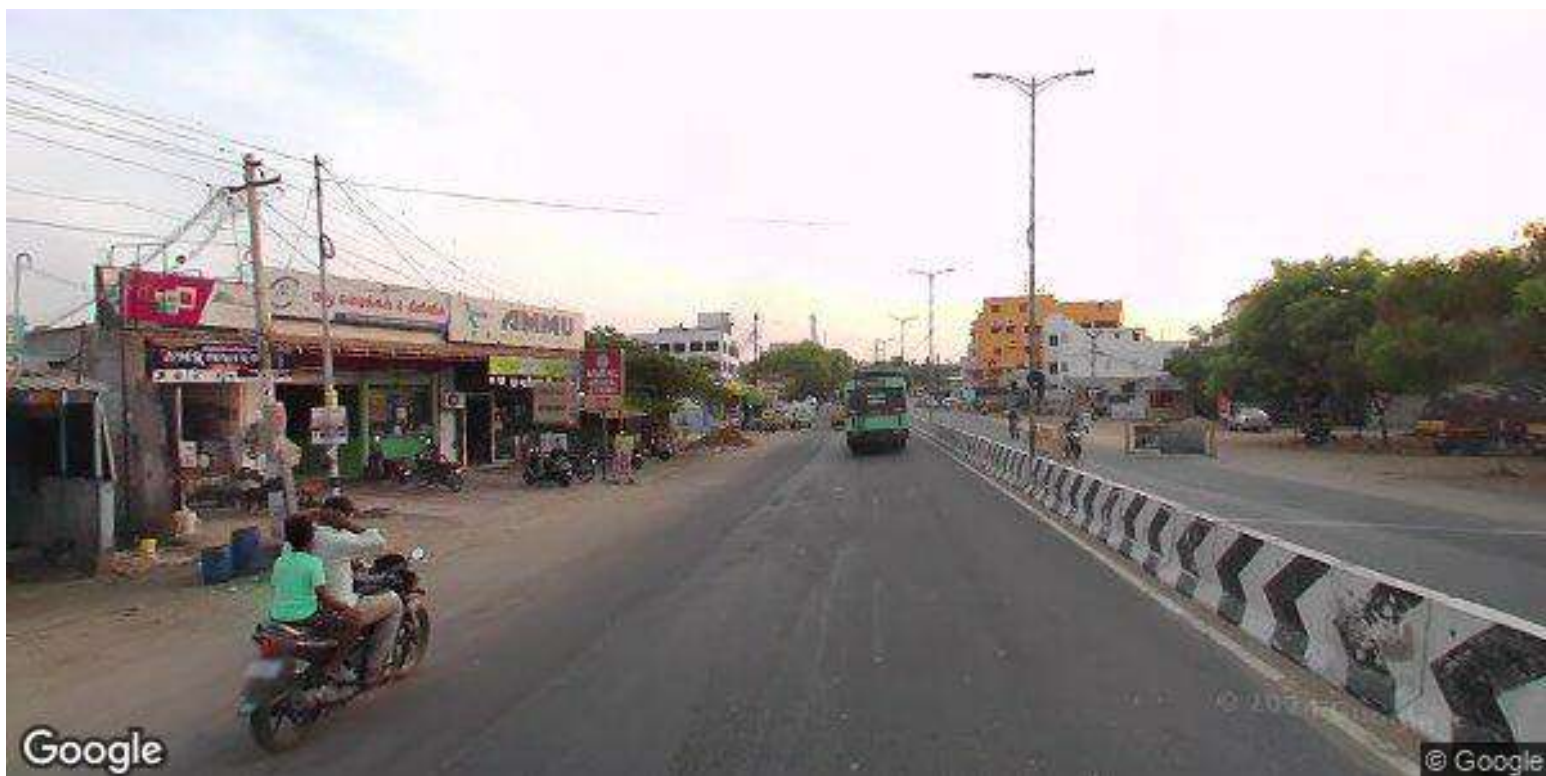
**Risk Type:** Turn  
**Risk Level:** Medium  
**Speed Limit:** 30 KM/Hr  
**Coordinates:** 11.27811, 77.58960

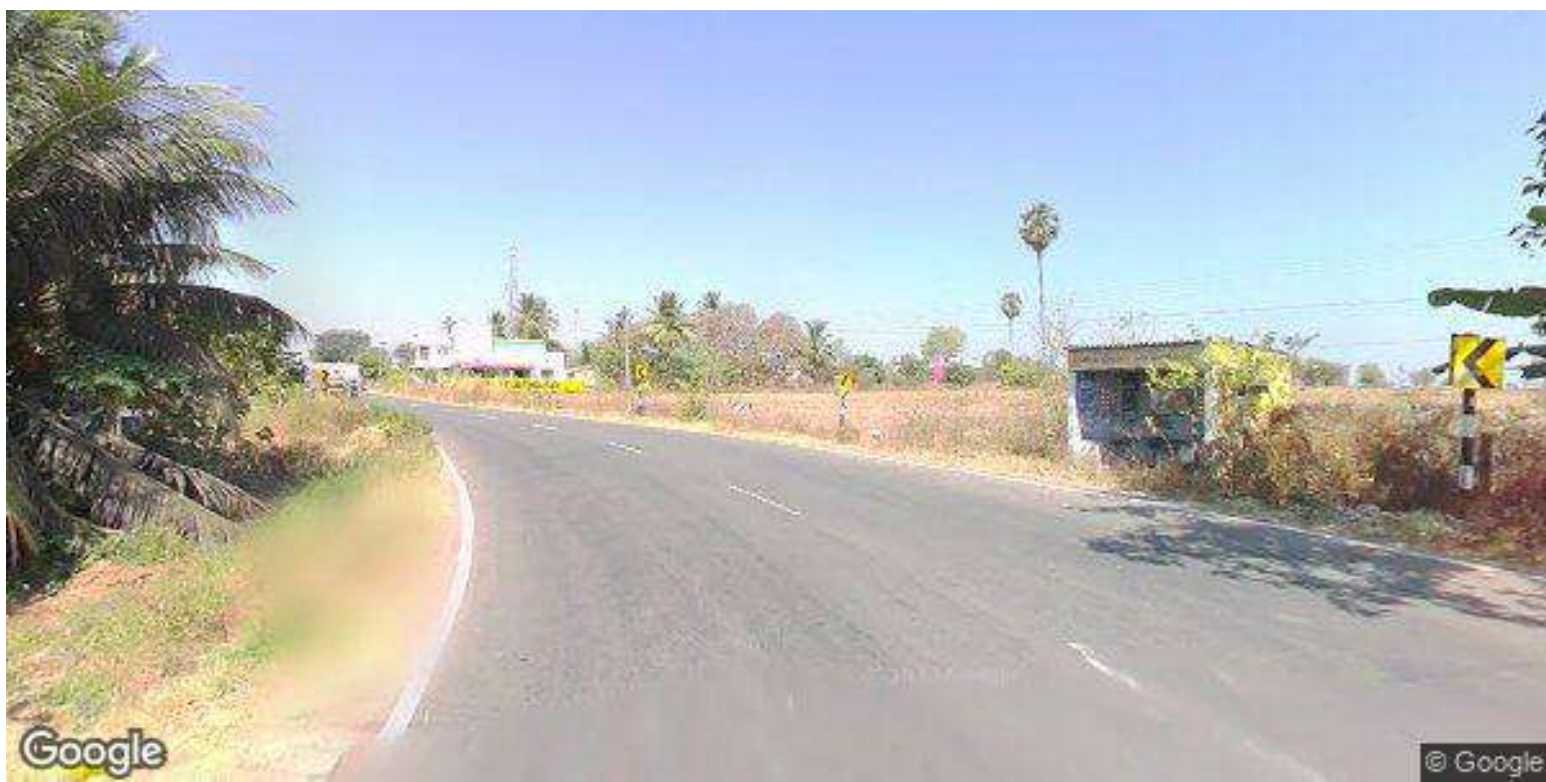
**Coordinates:** 11.29283, 77.53812

**Risk Type:** Turn

**Risk Level:** Medium

**Speed Limit:** 30 KM/Hr

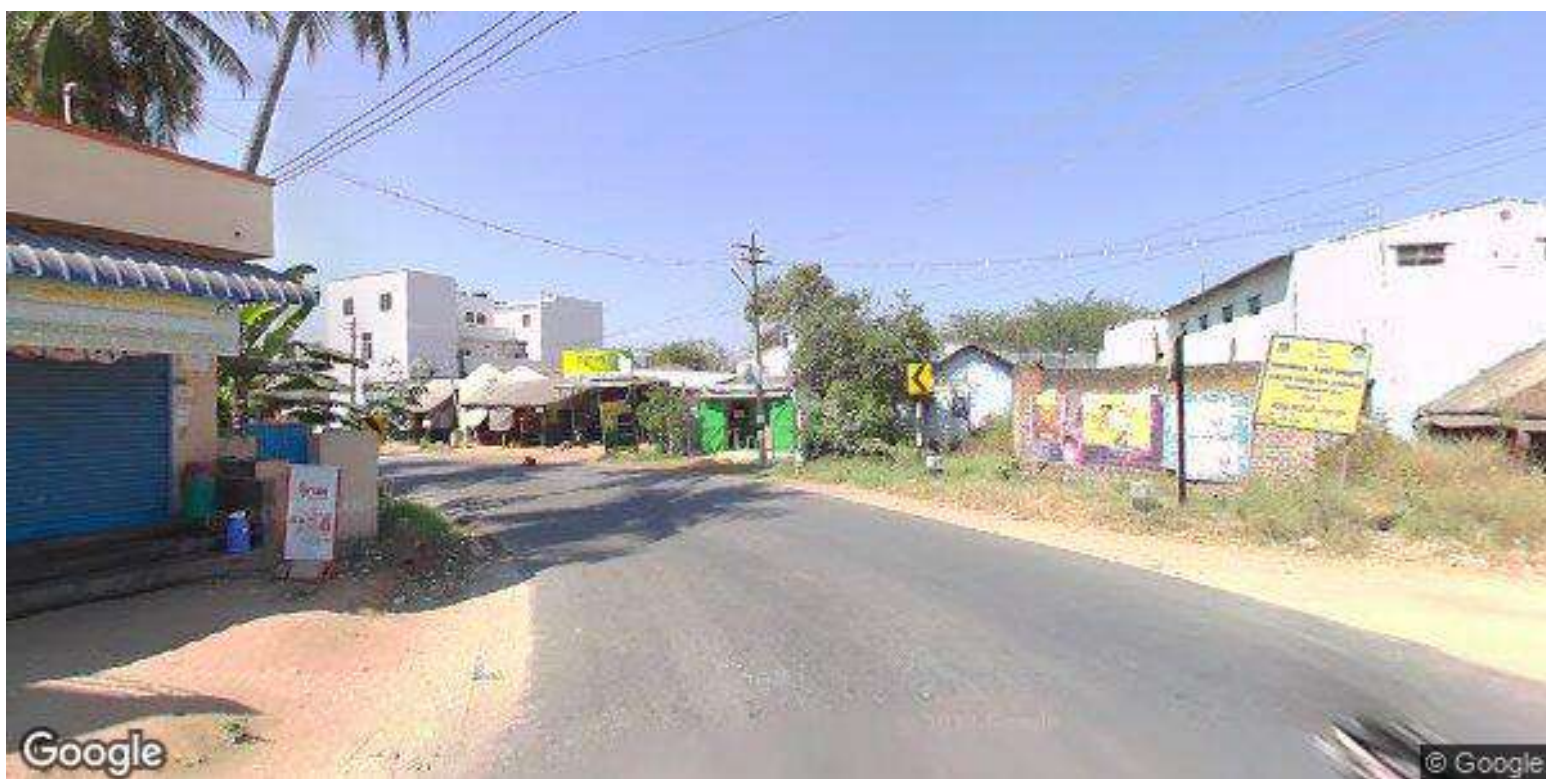
**Coordinates:** 11.29250, 77.53034

**Risk Type:** Turn

**Risk Level:** Medium

**Speed Limit:** 30 KM/Hr
