# IndianOil

## JOURNEY RISK MANAGEMENT (JRM) STUDY

### Salem Terminal TO S S N AGENCIES

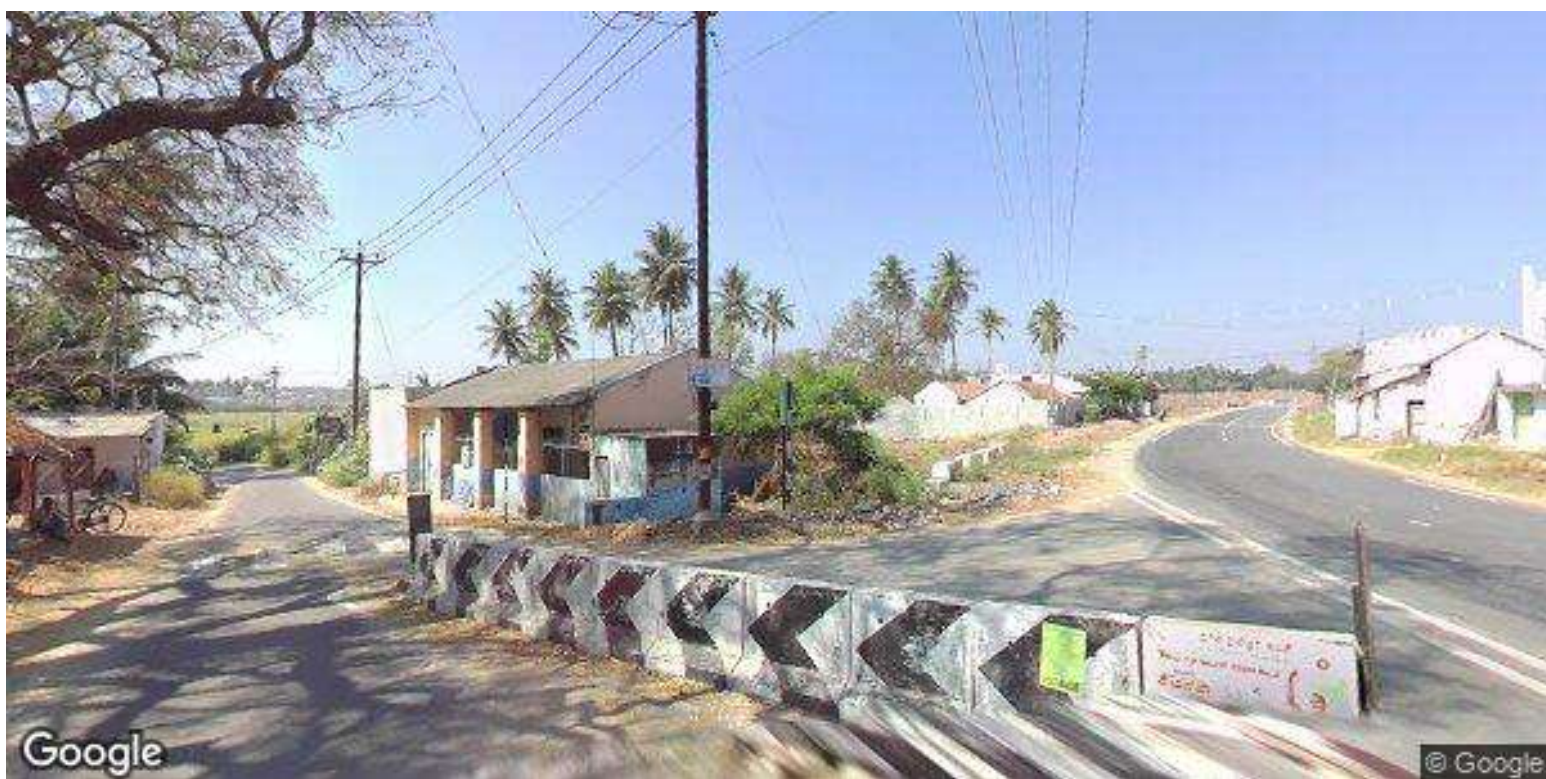
**Coordinates:** 11.29190, 77.52987

**Risk Type:** Turn

**Risk Level:** Medium

**Speed Limit:** 30 KM/Hr

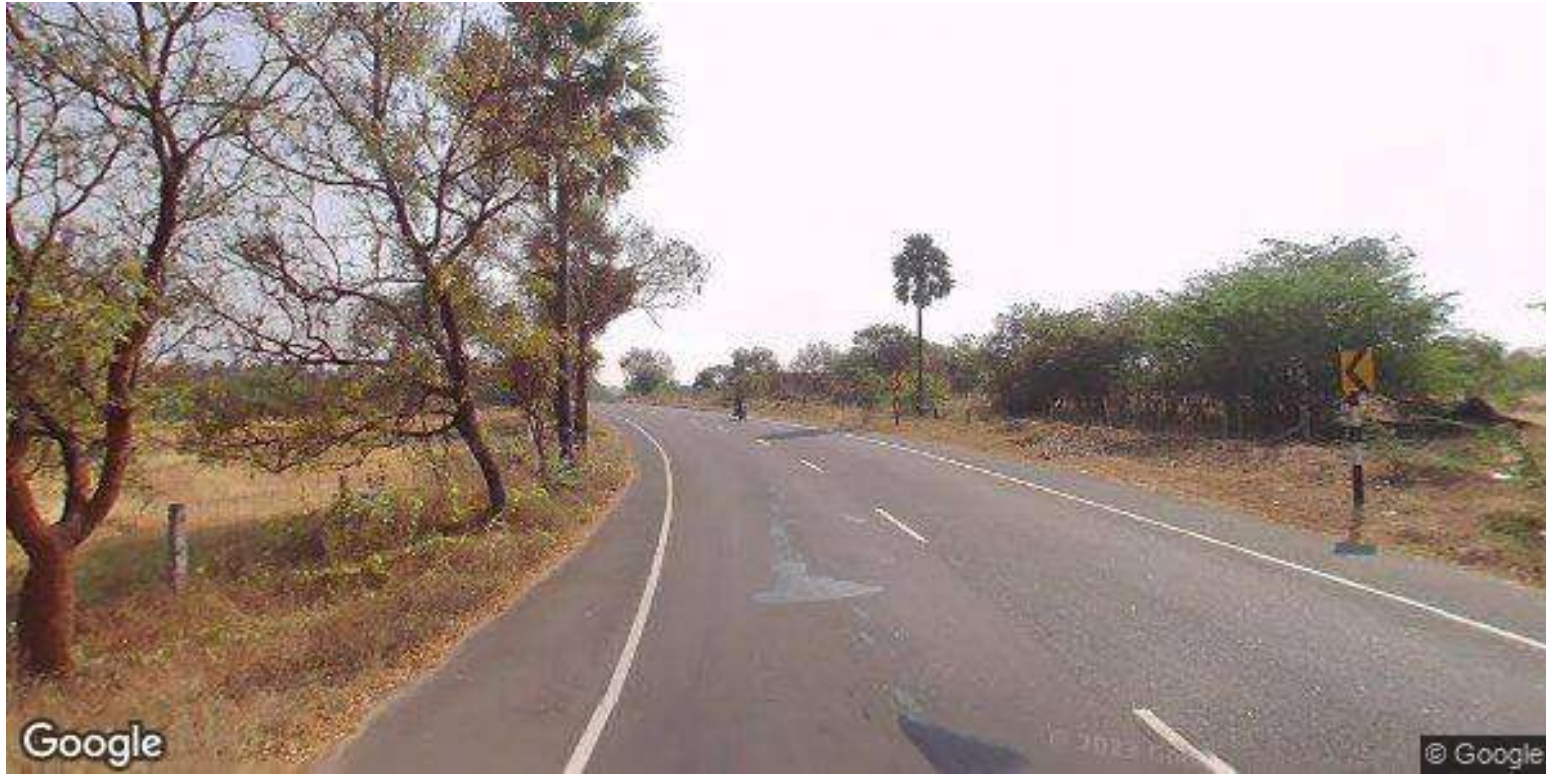
**Coordinates:** 11.28315, 77.48041

**Risk Type:** Turn

**Risk Level:** Medium

**Speed Limit:** 30 KM/Hr
