# IndianOil

## JOURNEY RISK MANAGEMENT (JRM) STUDY

### Salem Terminal TO PRANAV AGENCY

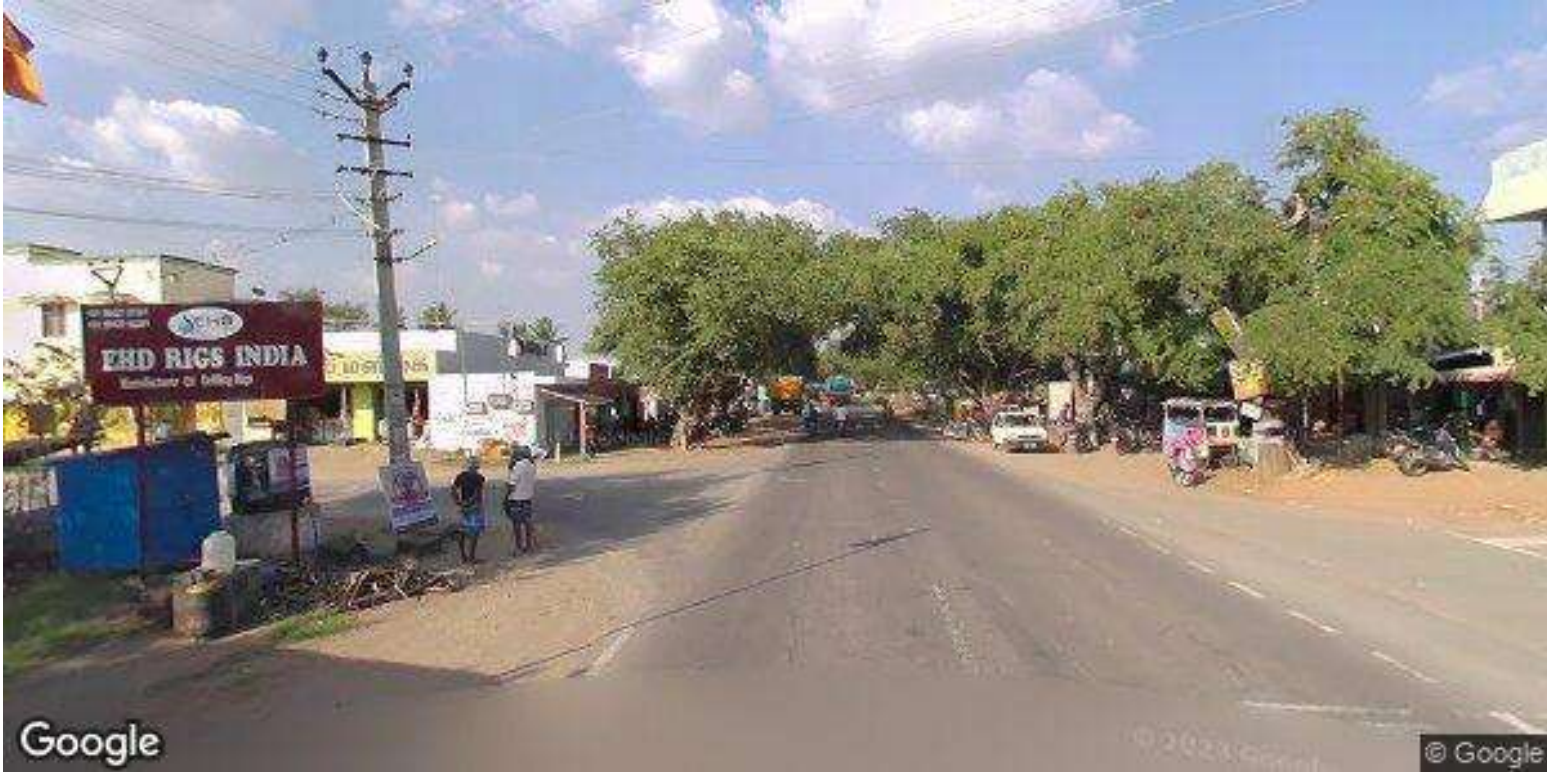
**Risk Type:** Blind Spot  
**Risk Level:** Blind Spot  
**Speed Limit:** 10 KM/Hr  
**Coordinates:** 11.41975, 77.88075

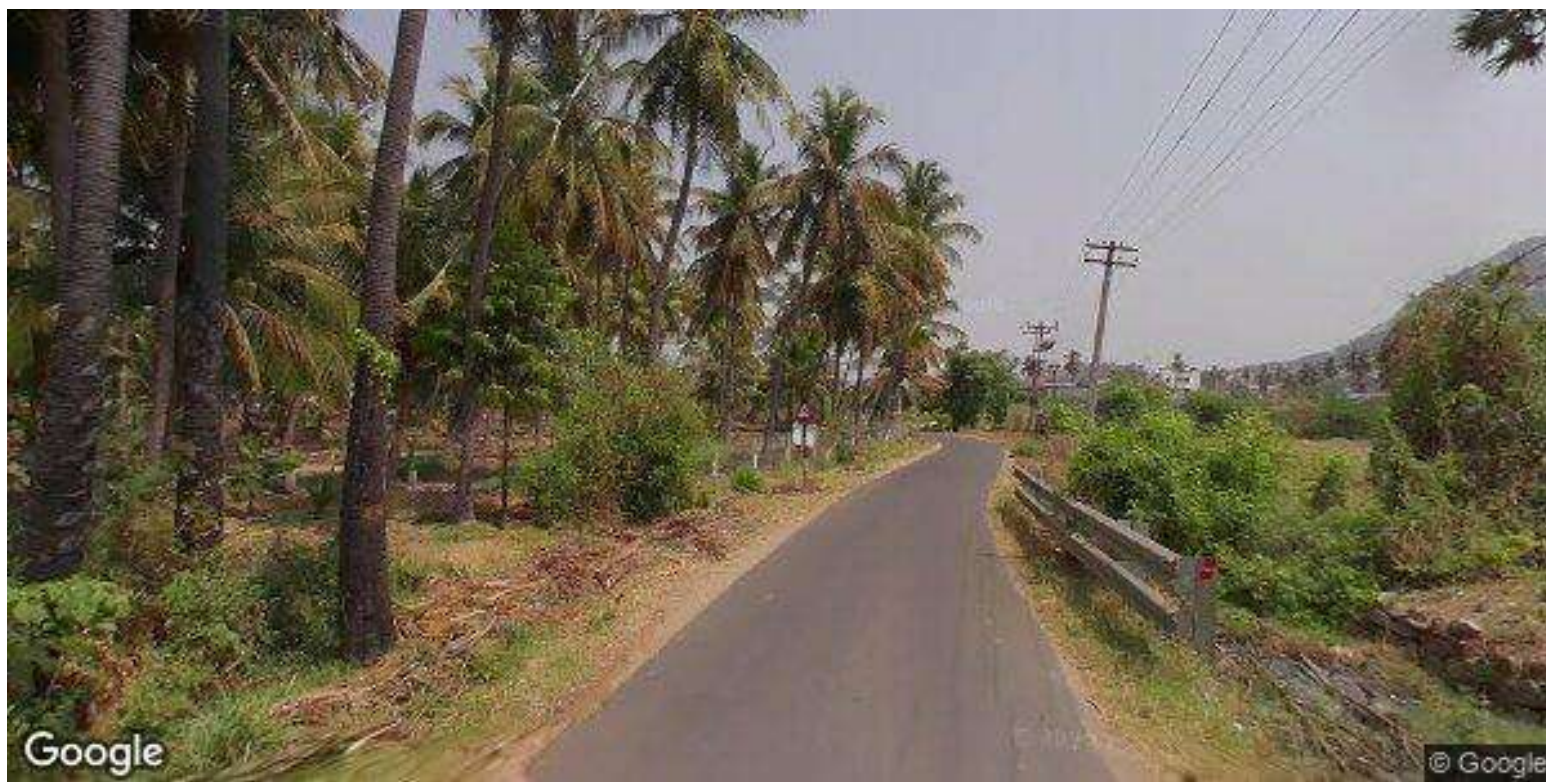
**Coordinates:** 11.41876, 77.88487

**Risk Type:** Turn

**Risk Level:** Medium

**Speed Limit:** 30 KM/Hr

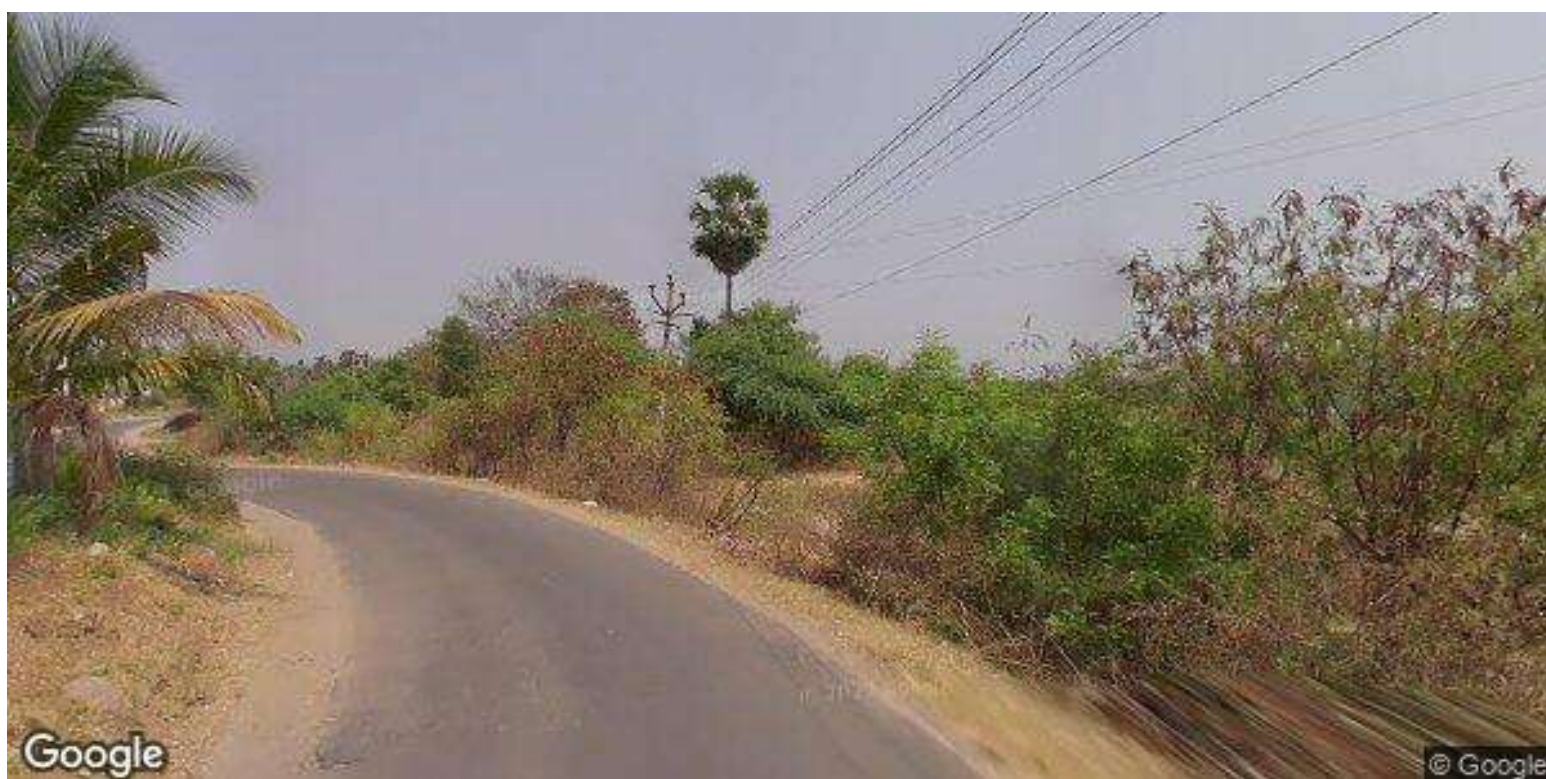
**Coordinates:** 11.41829, 77.88568

**Risk Type:** Turn

**Risk Level:** Medium

**Speed Limit:** 30 KM/Hr

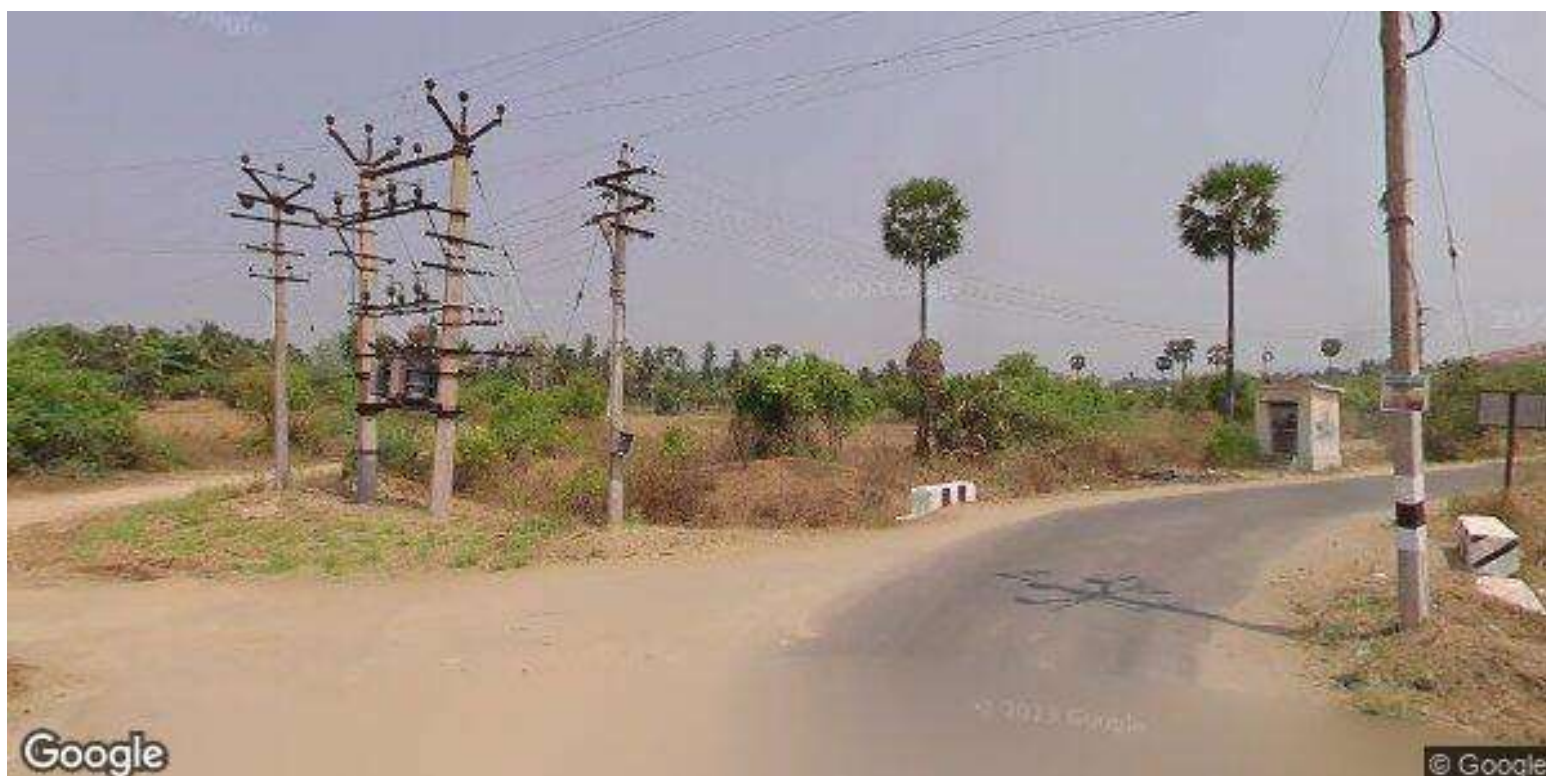
**Risk Type:** Turn  
**Risk Level:** High  
**Speed Limit:** 15 KM/Hr  
**Coordinates:** 11.41859, 77.88692

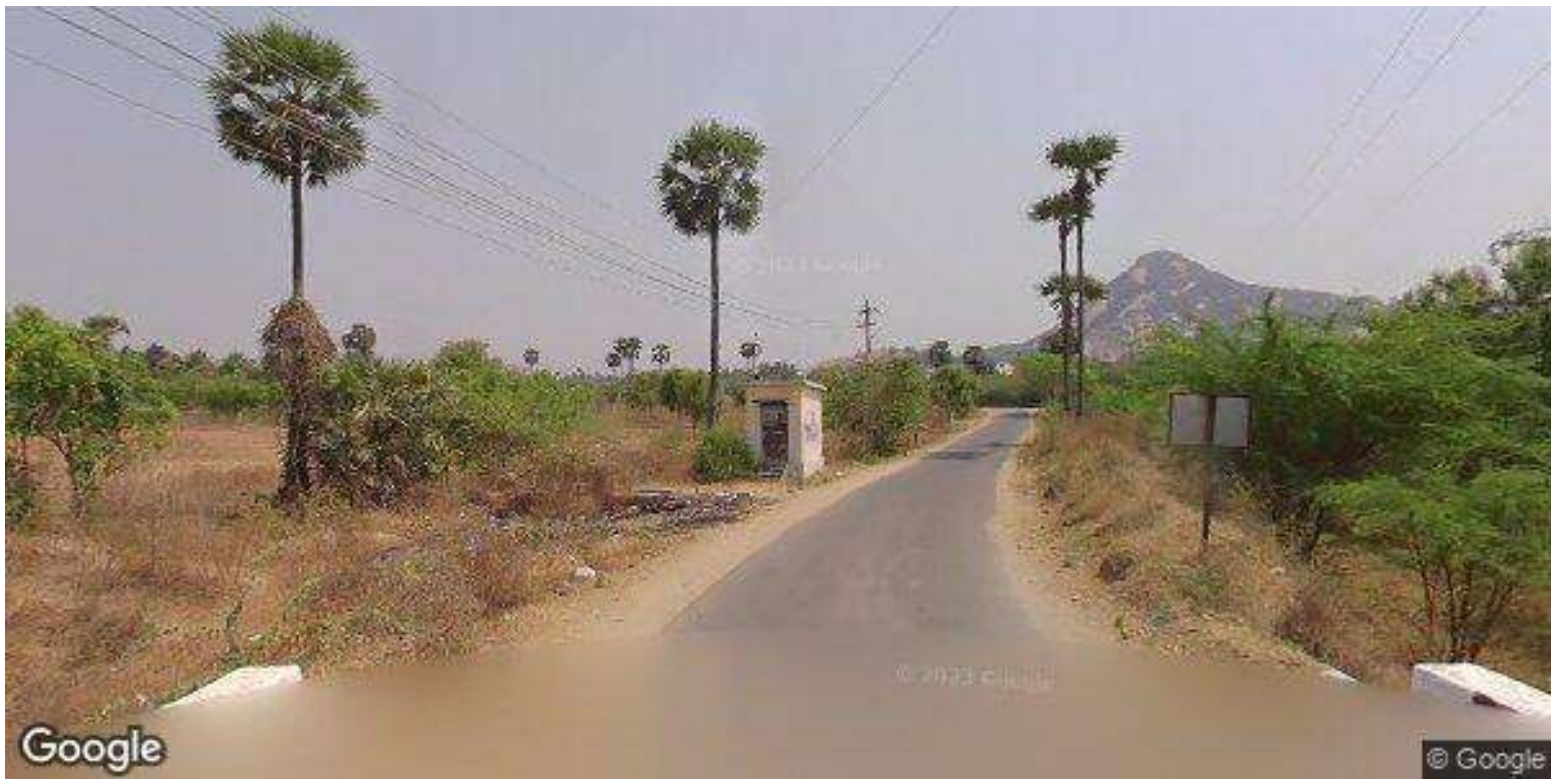
**Risk Type:** Turn  
**Risk Level:** Medium  
**Speed Limit:** 30 KM/Hr  
**Coordinates:** 11.41852, 77.88700

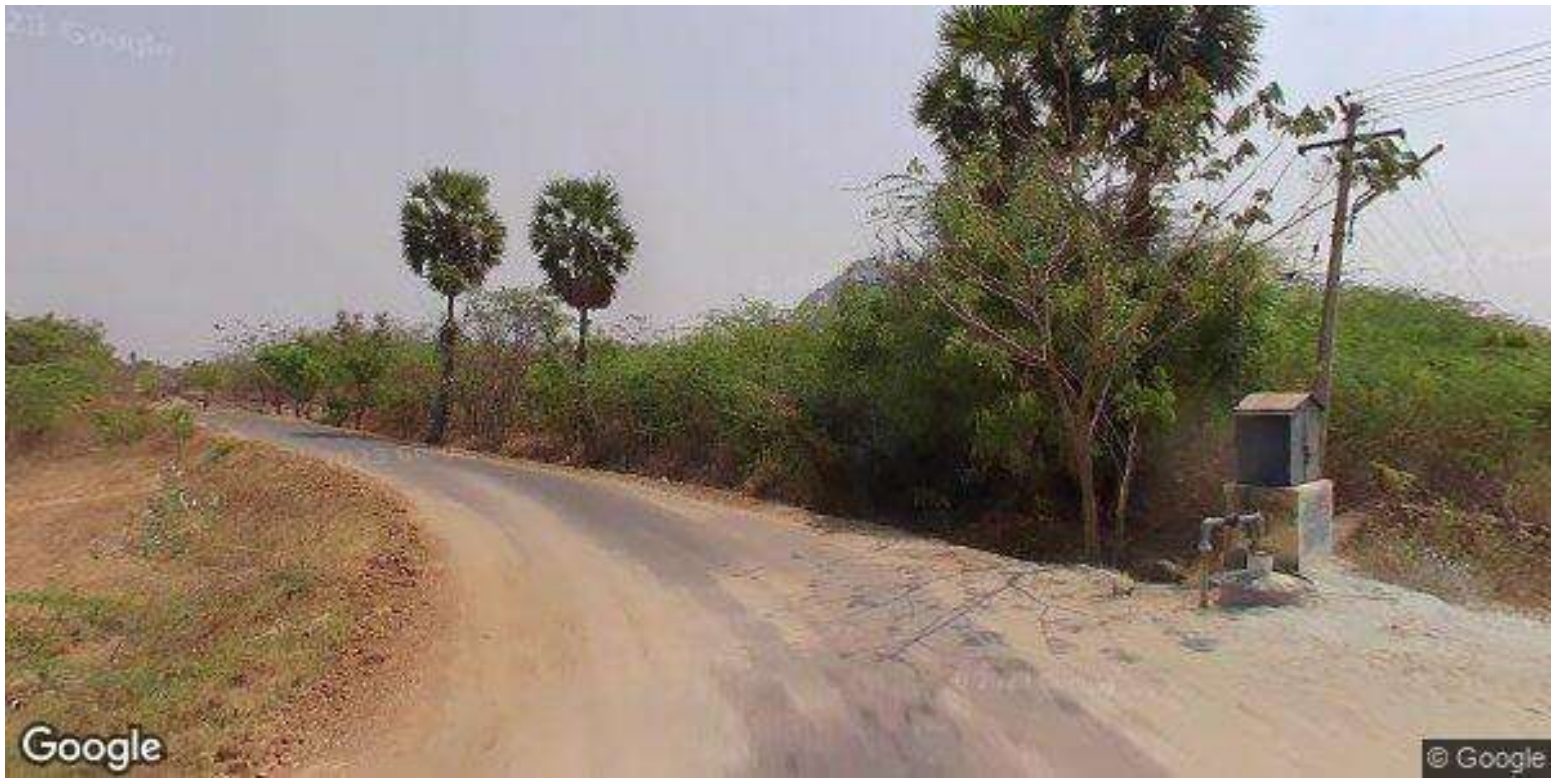
**Risk Type:** Turn  
**Risk Level:** Medium  
**Speed Limit:** 30 KM/Hr  
**Coordinates:** 11.41769, 77.88730

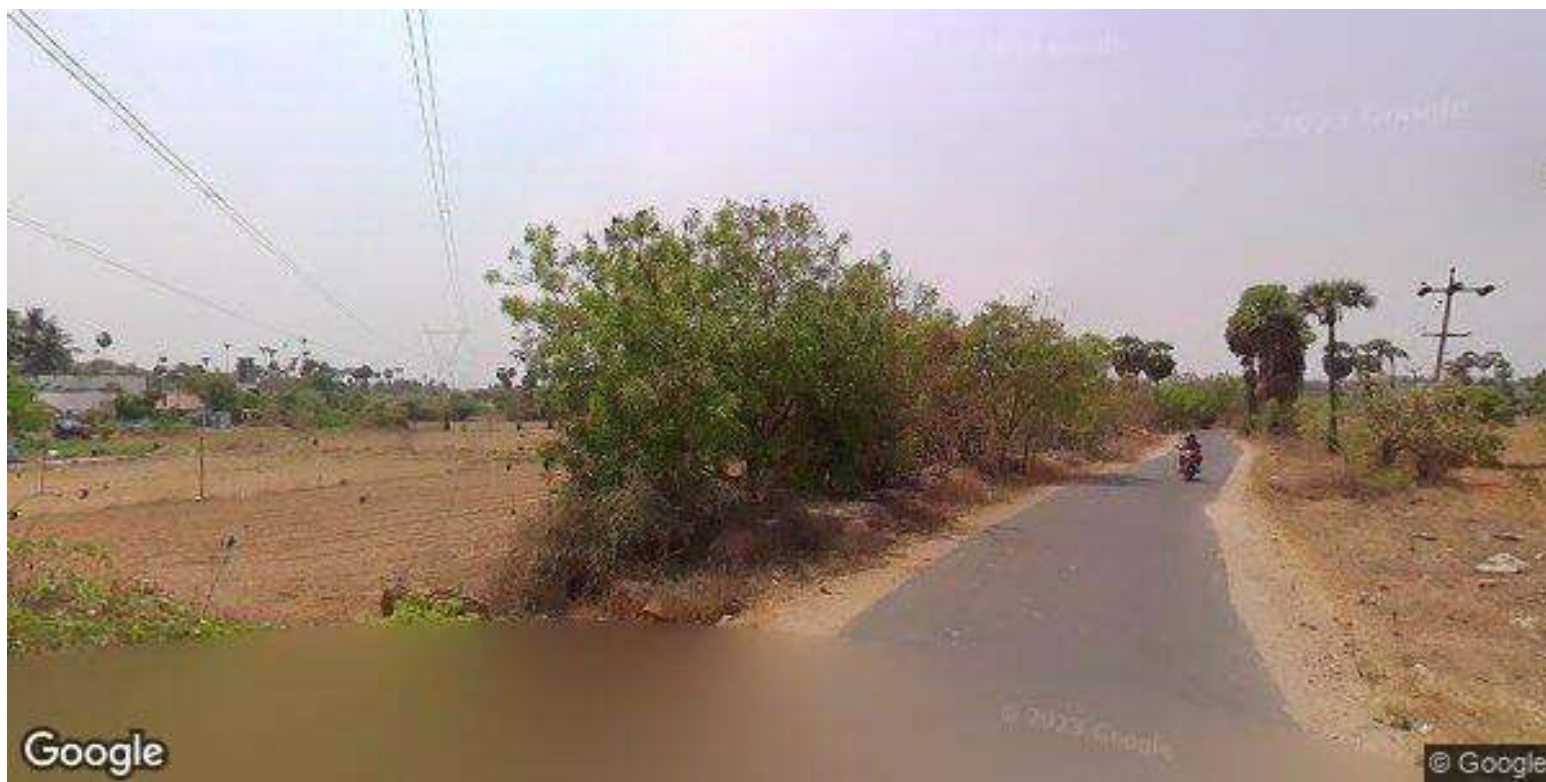
**Coordinates:** 11.41630, 77.89077

**Risk Type:** Turn

**Risk Level:** Medium

**Speed Limit:** 30 KM/Hr

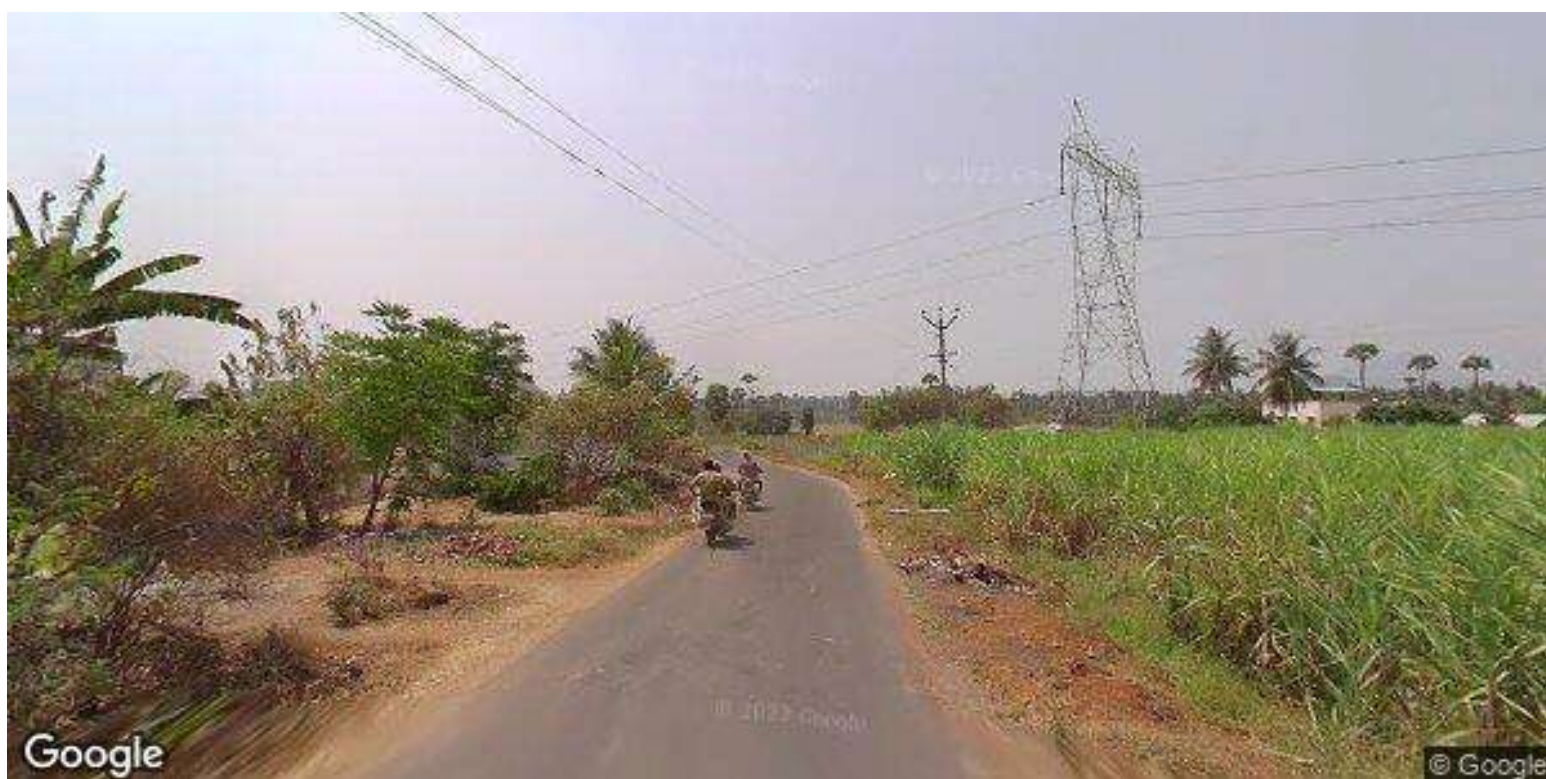
**Coordinates:** 11.41601, 77.89198

**Risk Type:** Turn

**Risk Level:** Medium

**Speed Limit:** 30 KM/Hr

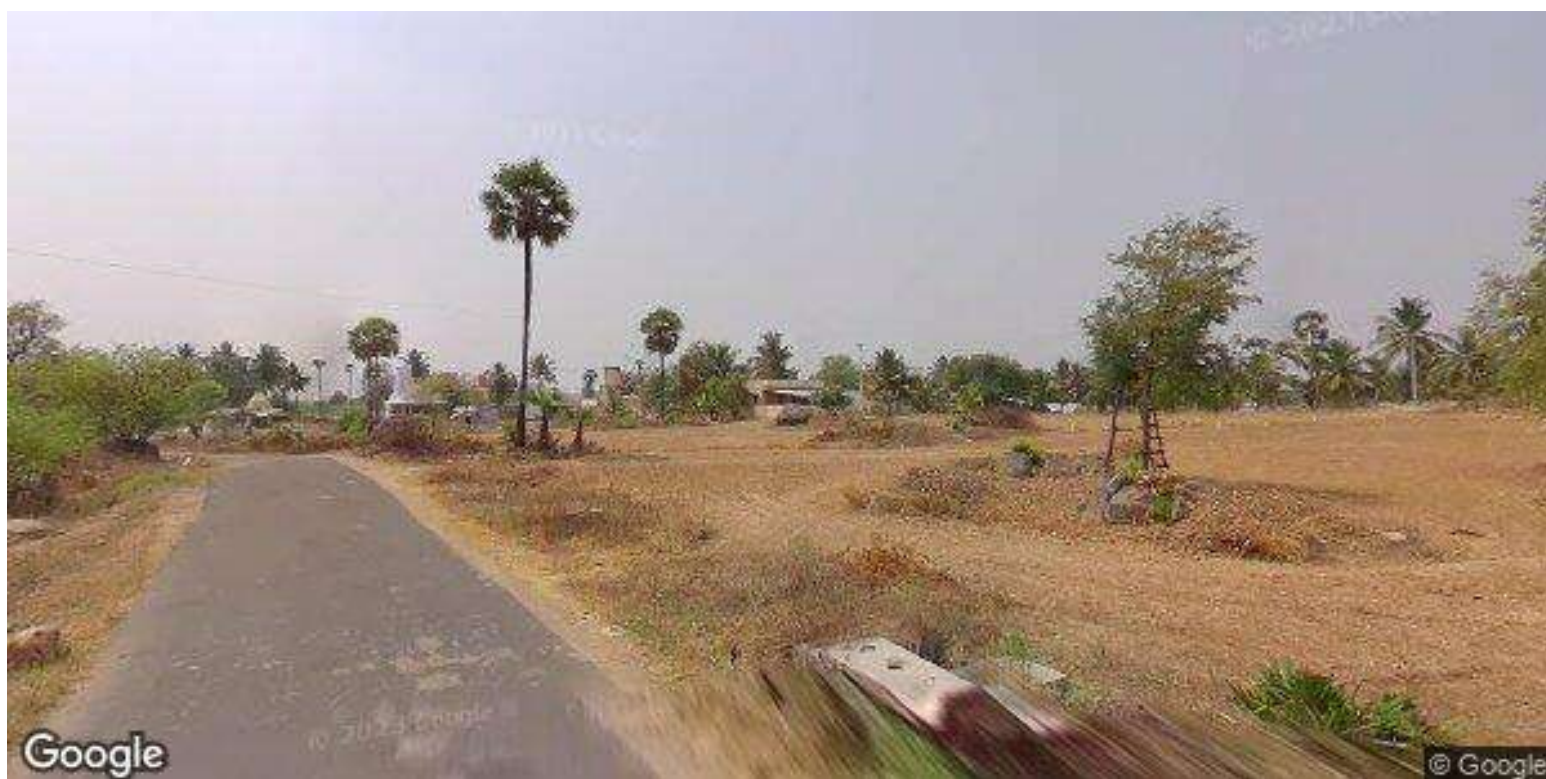
**Risk Type:** Turn  
**Risk Level:** Medium  
**Speed Limit:** 30 KM/Hr  
**Coordinates:** 11.41603, 77.89479

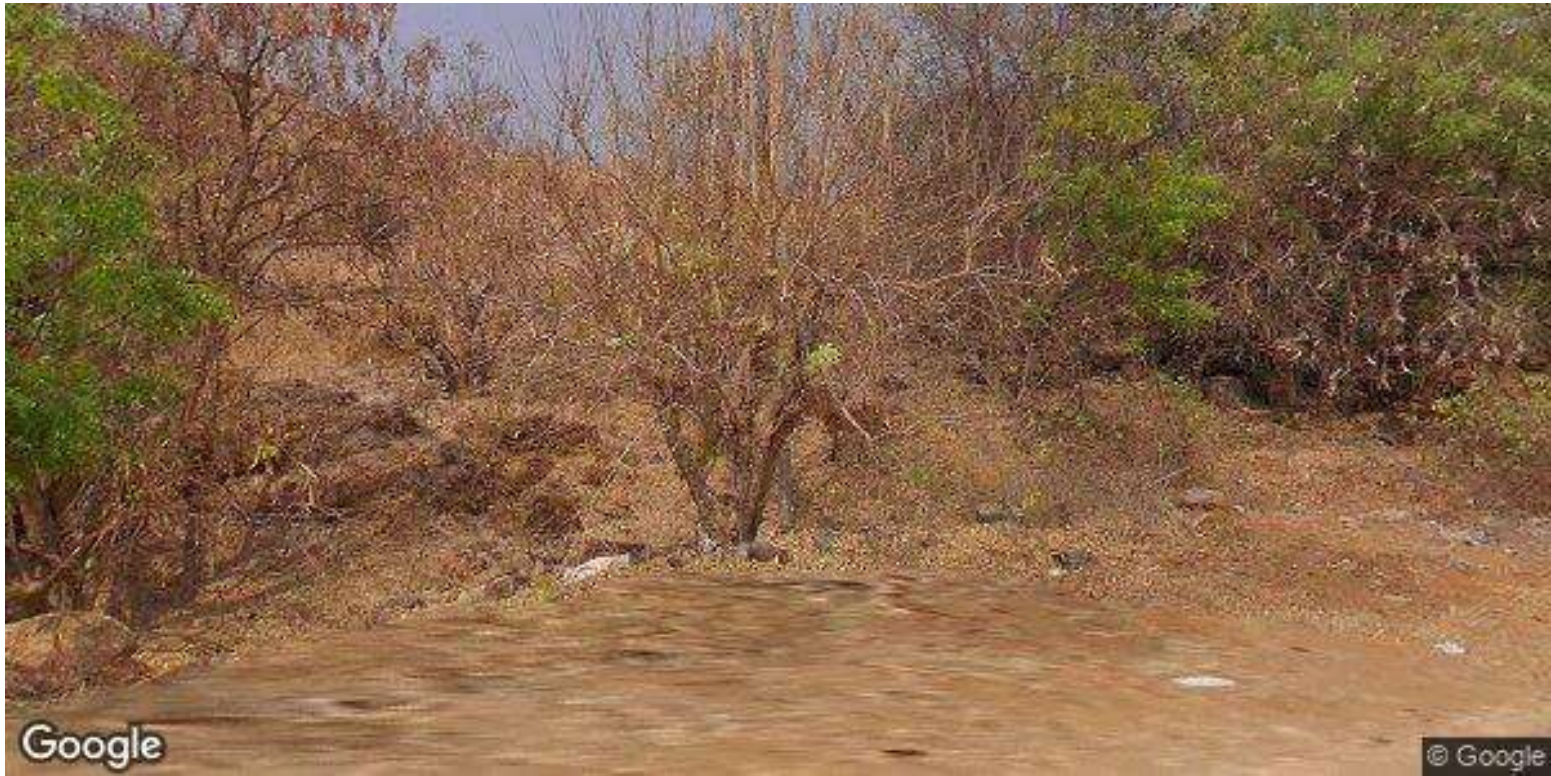
**Risk Type:** Turn  
**Risk Level:** Medium  
**Speed Limit:** 30 KM/Hr  
**Coordinates:** 11.41439, 77.90025

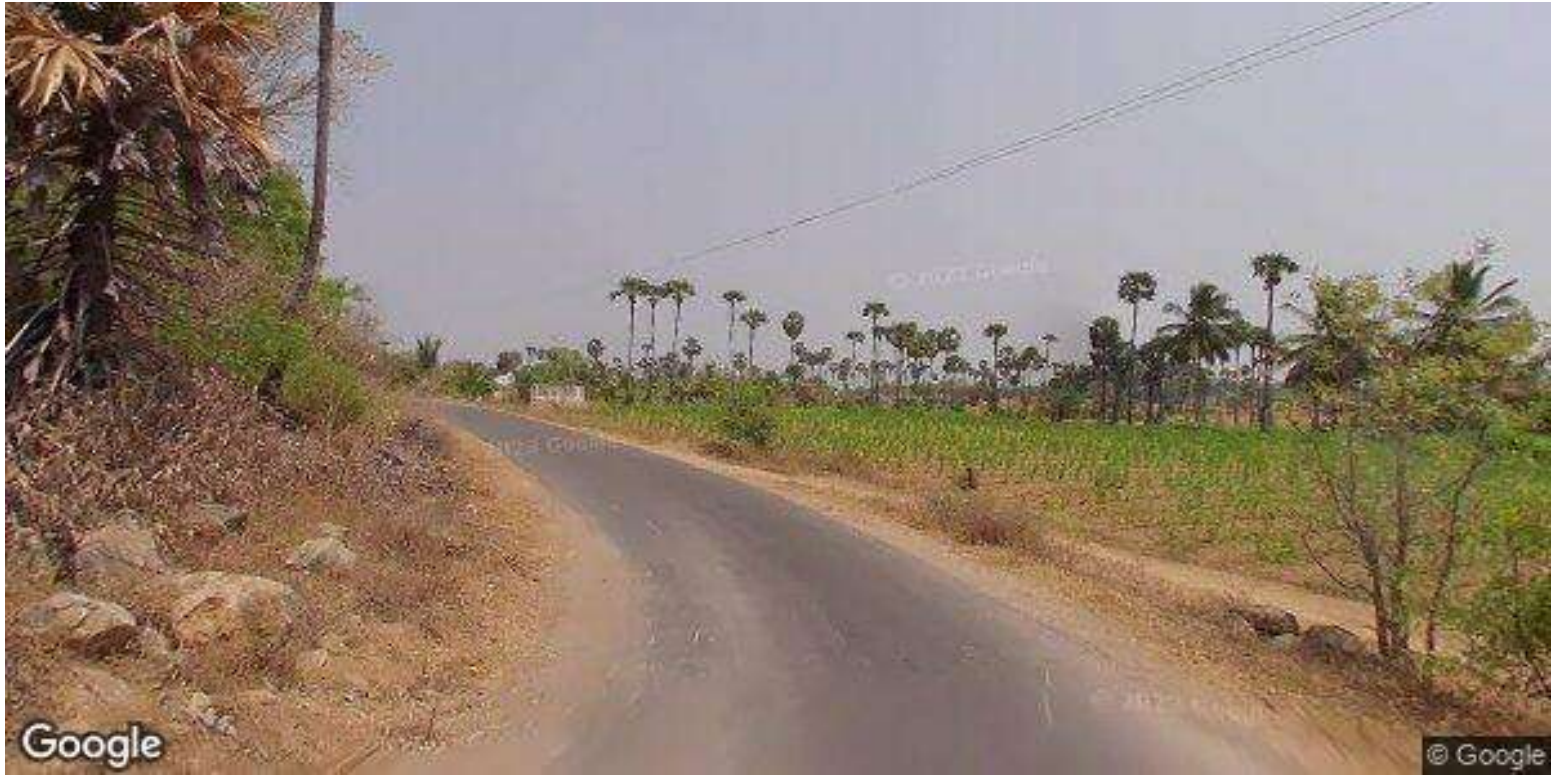
**Risk Type:** Turn  
**Risk Level:** Medium  
**Speed Limit:** 30 KM/Hr  
**Coordinates:** 11.41377, 77.90073

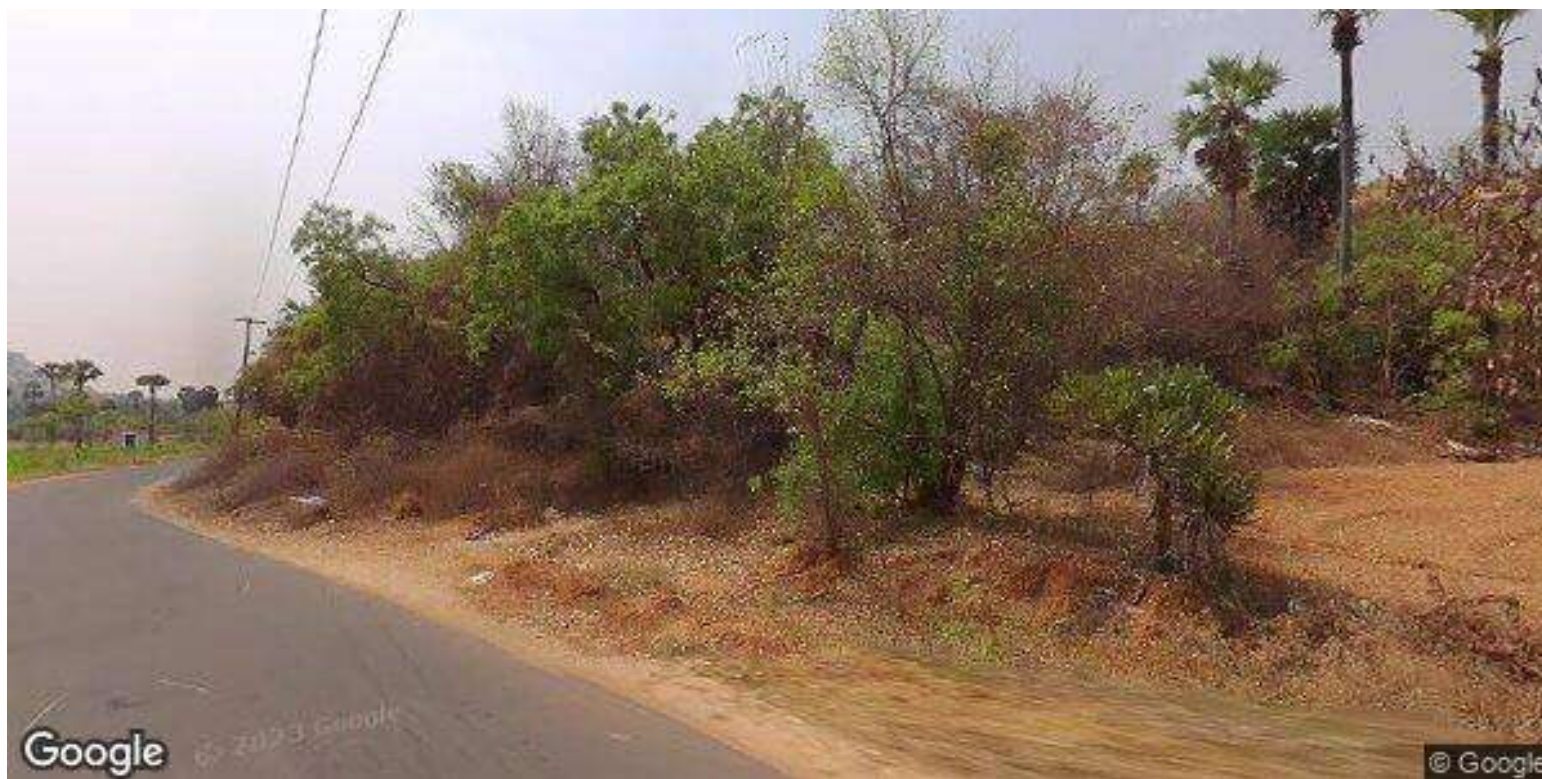
**Coordinates:** 11.41389, 77.90161

**Risk Type:** Turn

**Risk Level:** Medium

**Speed Limit:** 30 KM/Hr

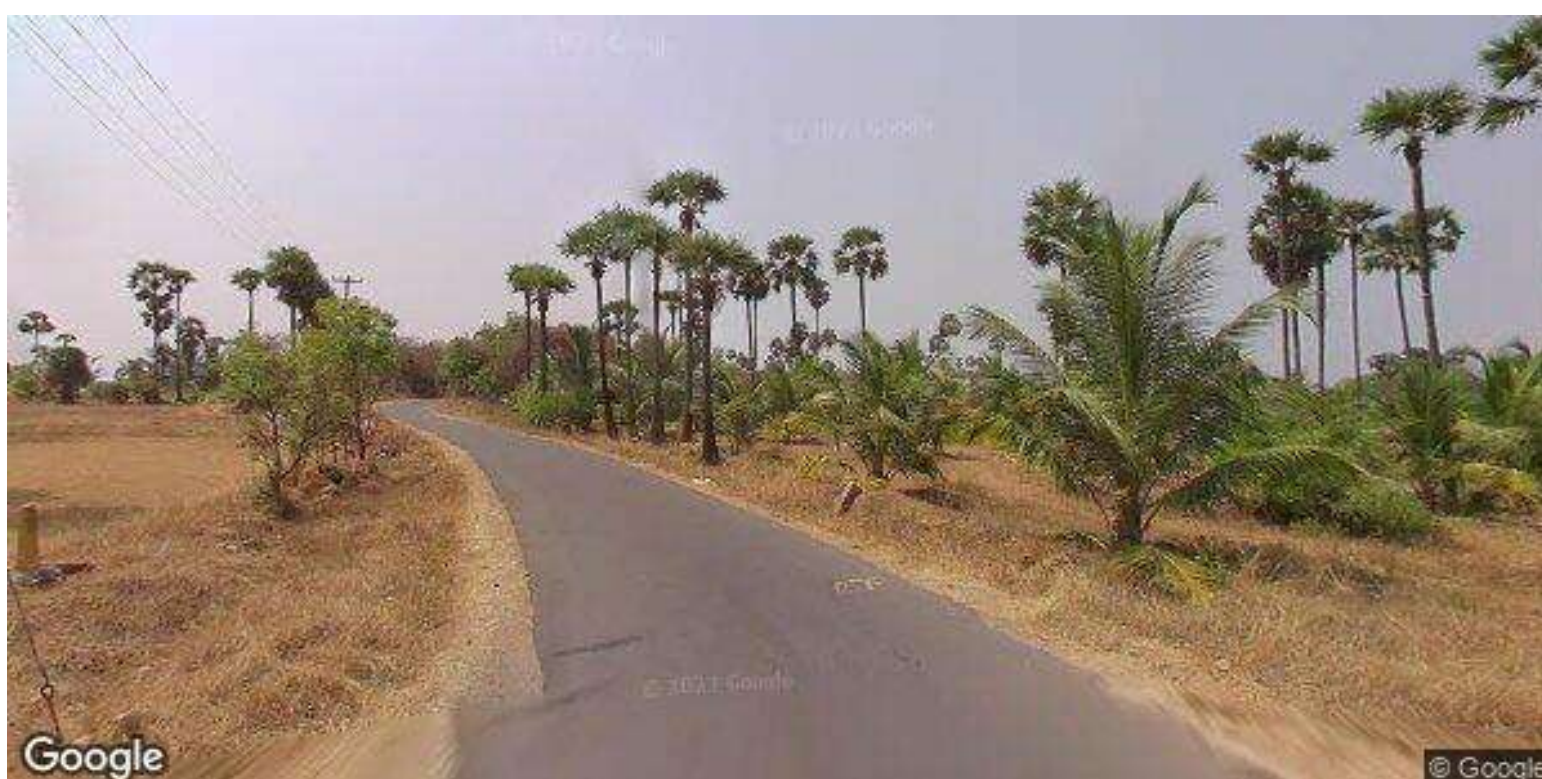
**Coordinates:** 11.41325, 77.90313

**Risk Type:** Turn

**Risk Level:** Medium

**Speed Limit:** 30 KM/Hr

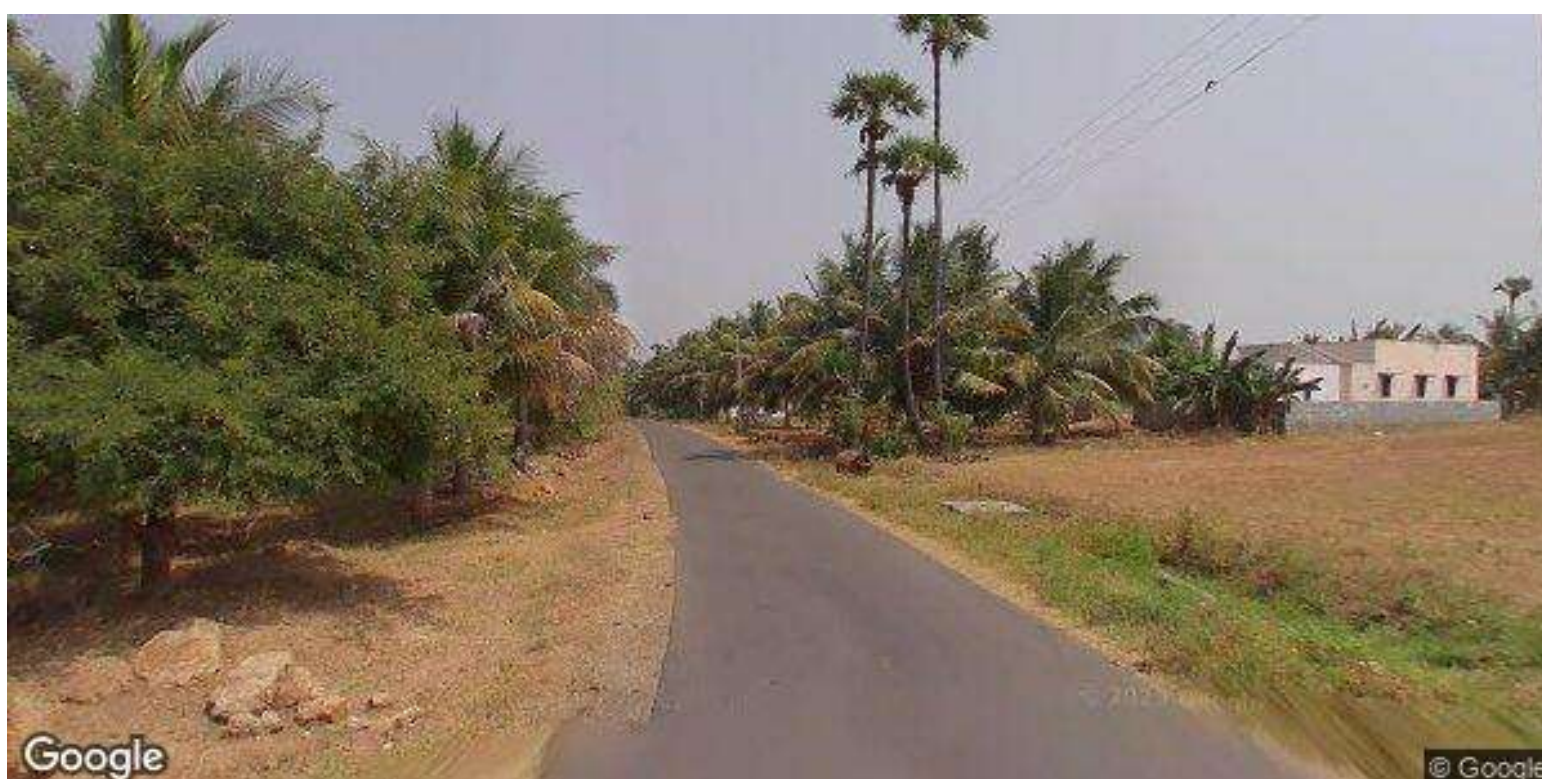
**Risk Type:** Turn  
**Risk Level:** Medium  
**Speed Limit:** 30 KM/Hr  
**Coordinates:** 11.41276, 77.90349

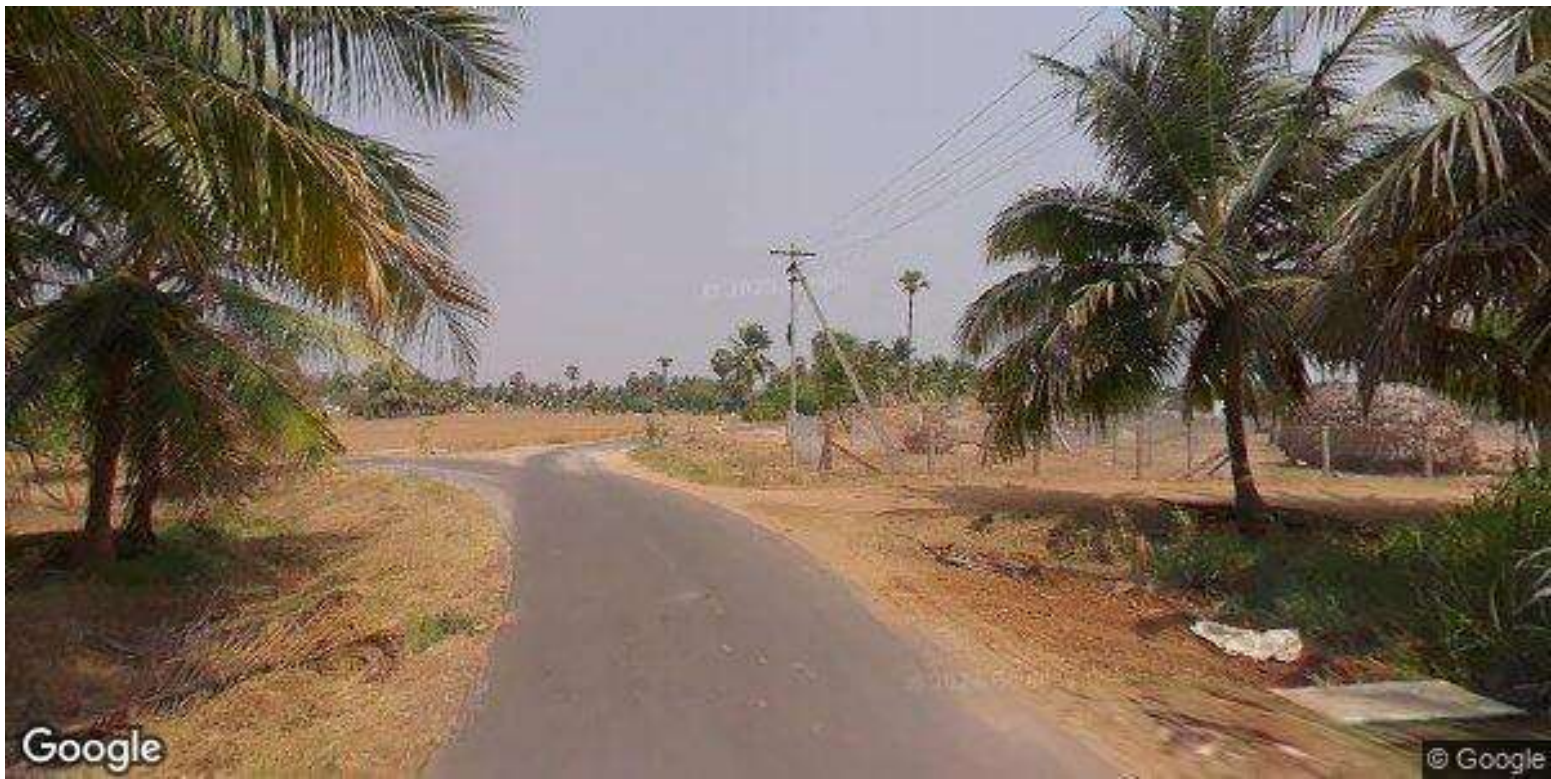
**Risk Type:** Turn  
**Risk Level:** Medium  
**Speed Limit:** 30 KM/Hr  
**Coordinates:** 11.41227, 77.90470

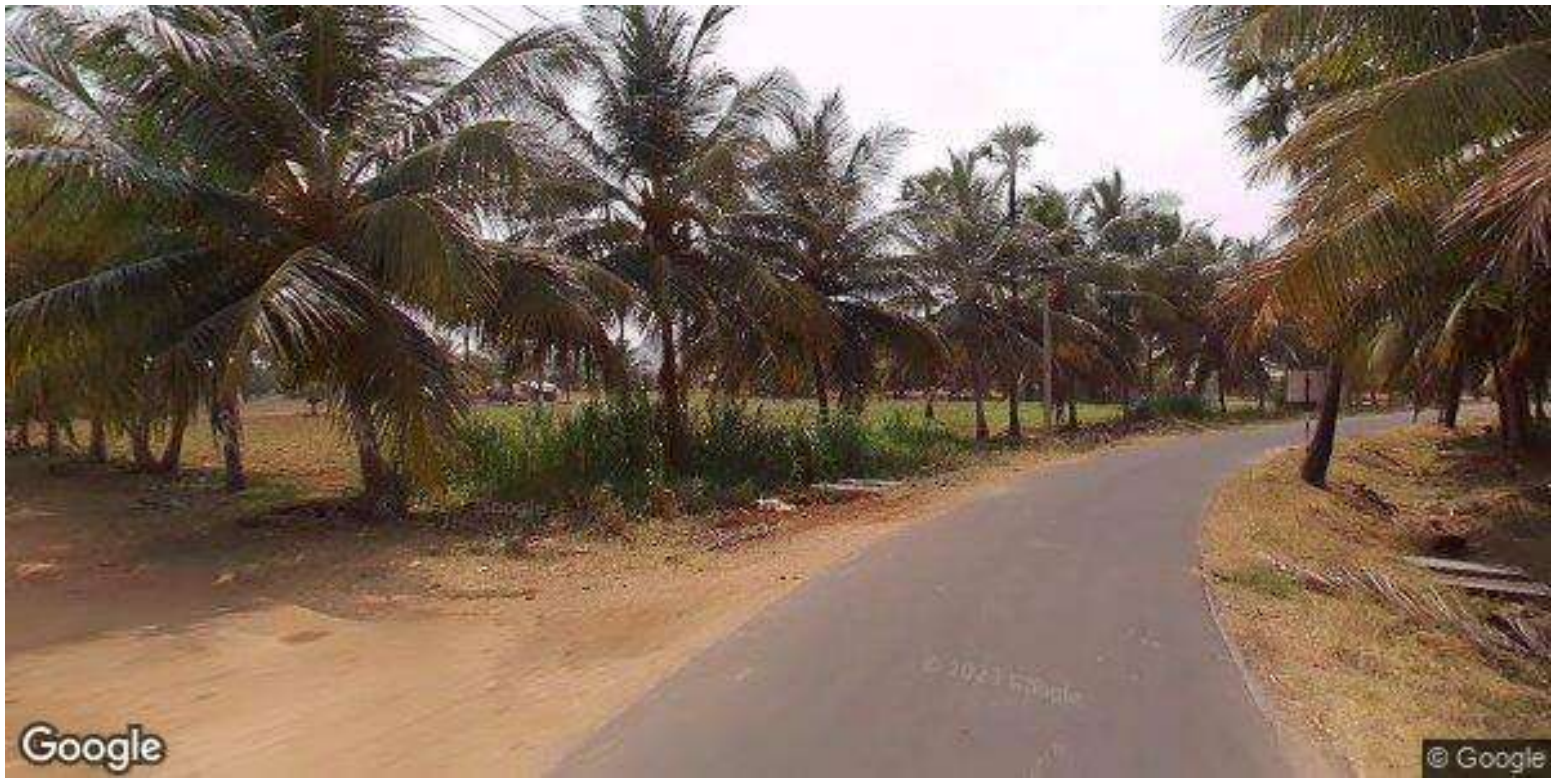
**Risk Type:** Turn  
**Risk Level:** High  
**Speed Limit:** 15 KM/Hr  
**Coordinates:** 11.41230, 77.90485

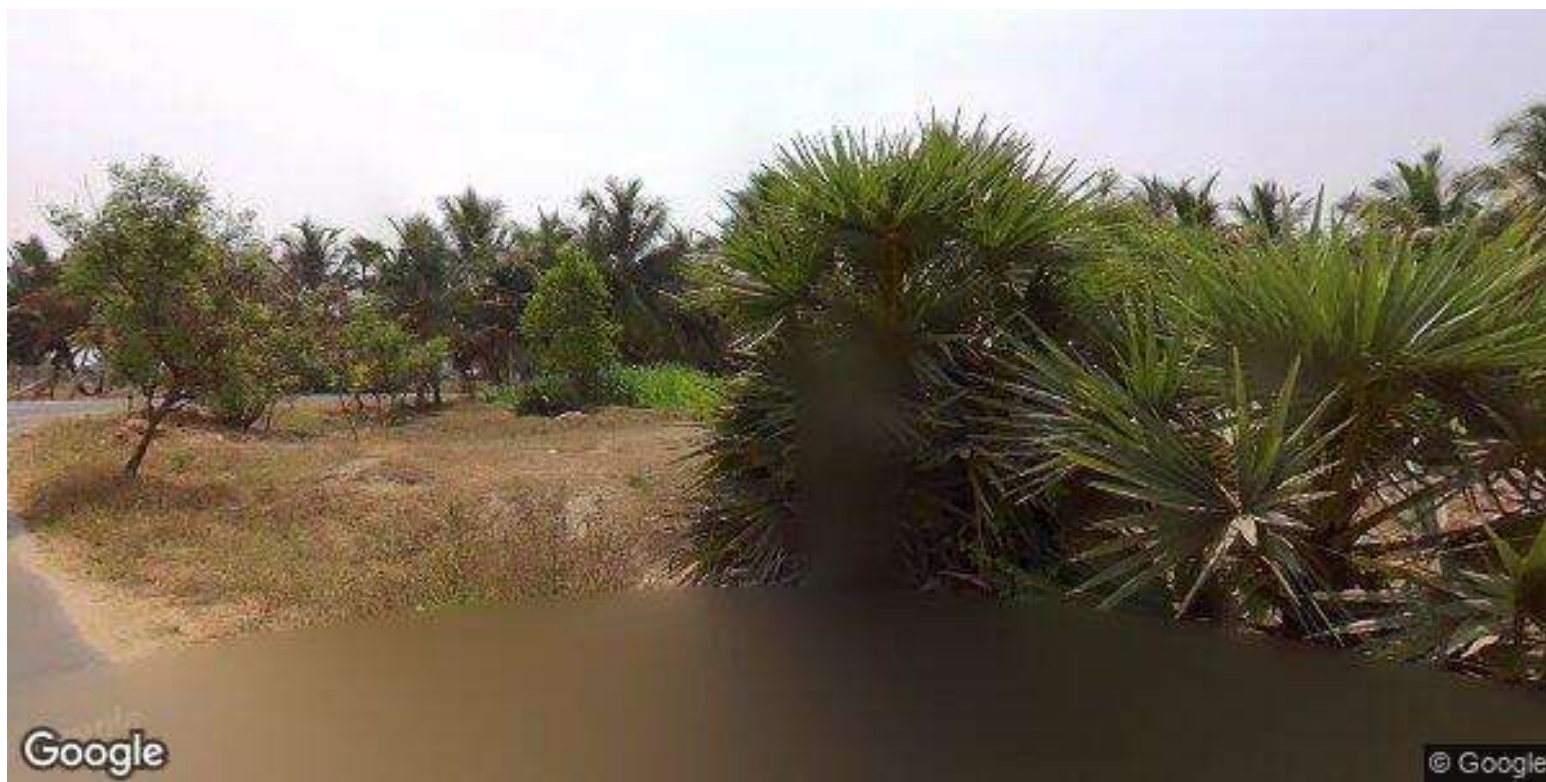
**Coordinates:** 11.41262, 77.90506

**Risk Type:** Turn

**Risk Level:** Medium

**Speed Limit:** 30 KM/Hr

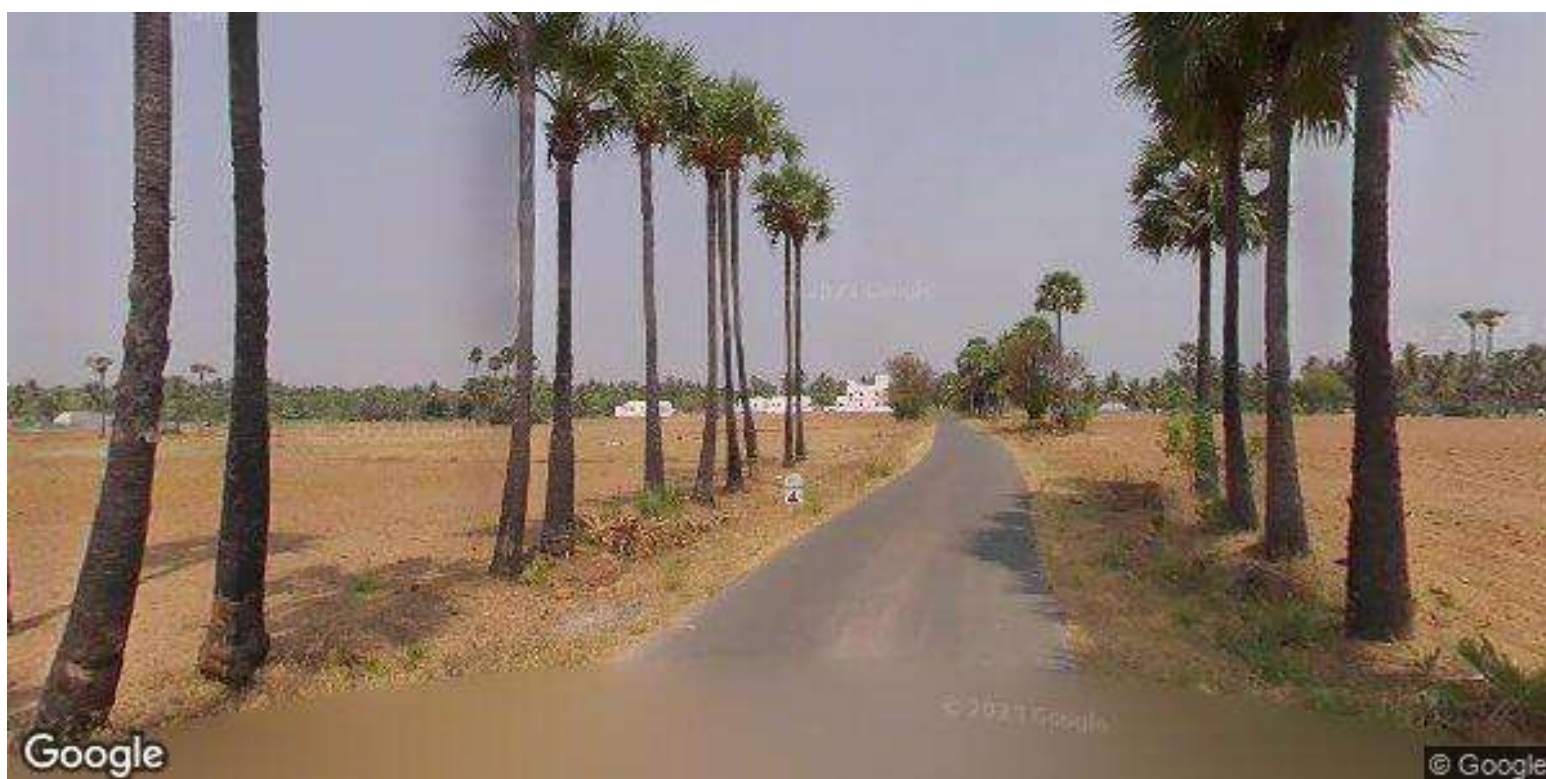
**Coordinates:** 11.41273, 77.90524

**Risk Type:** Turn

**Risk Level:** Medium

**Speed Limit:** 30 KM/Hr
