# IndianOil

## JOURNEY RISK MANAGEMENT (JRM) STUDY

### Salem Terminal TO PRANAV AGENCY

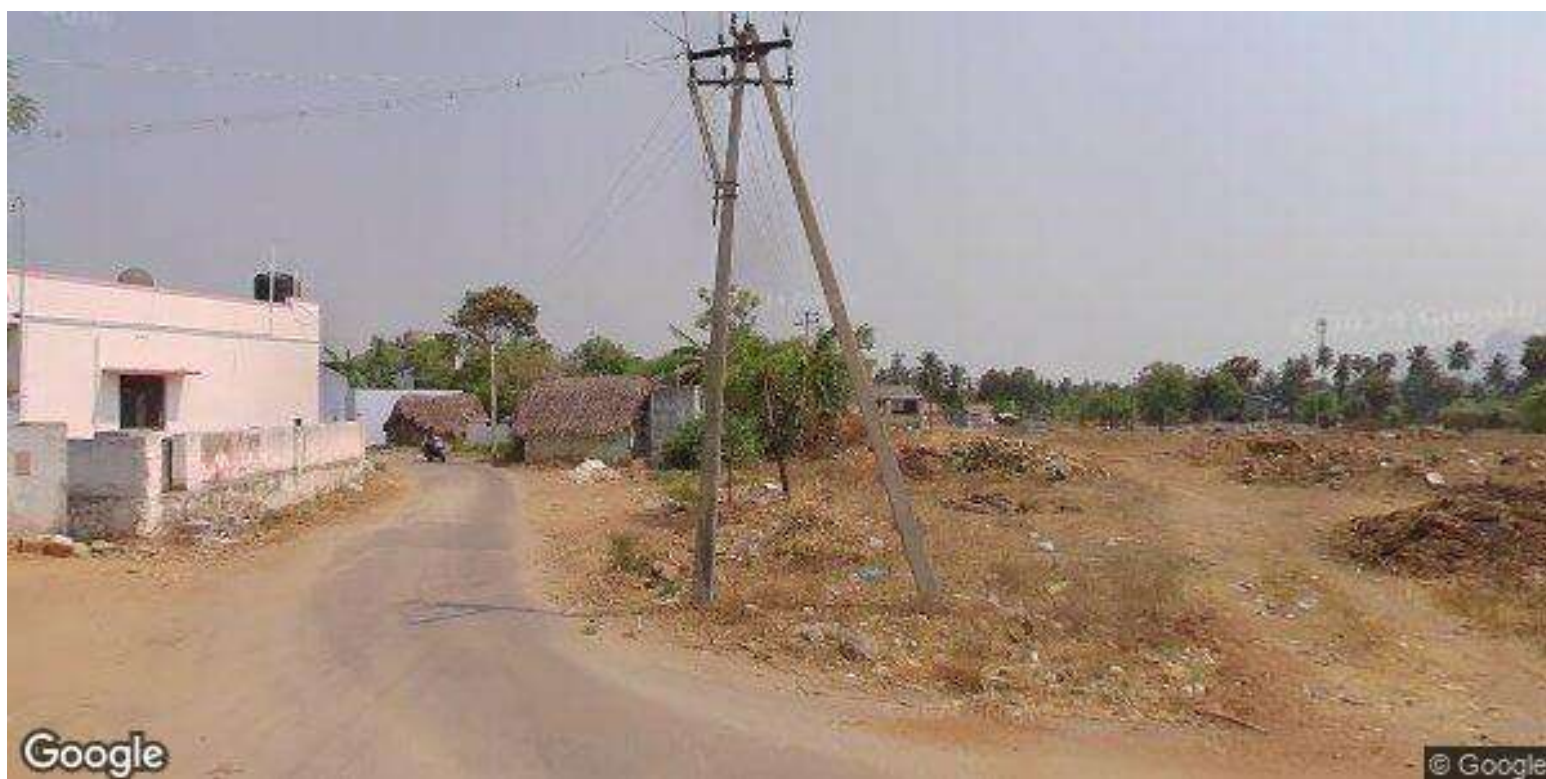
**Coordinates: 11.41329, 77.90978**

**Risk Type: Turn**

**Risk Level: High**

**Speed Limit: 15 KM/Hr**

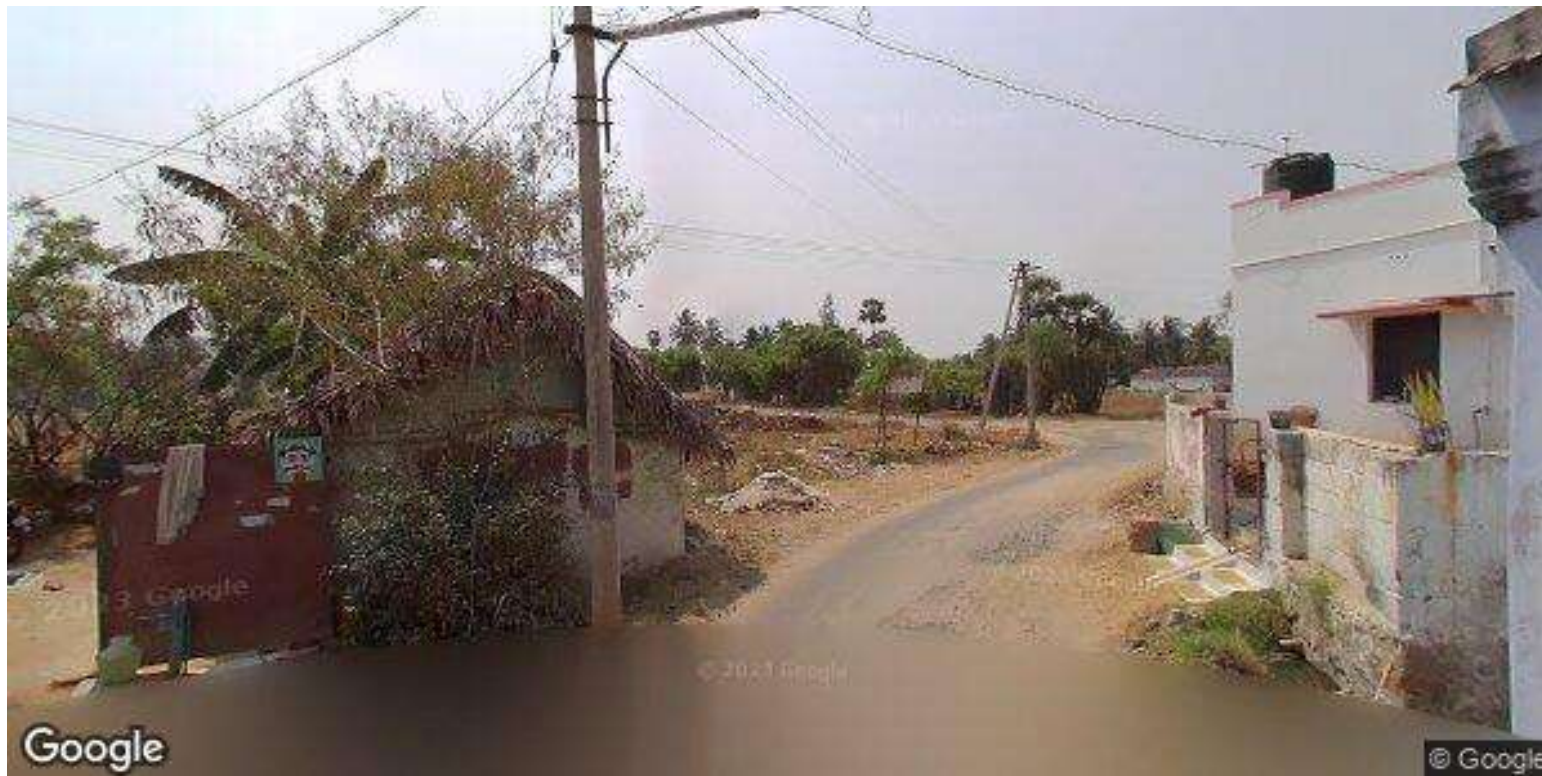
**Coordinates: 11.41314, 77.91006**

**Risk Type: Turn**

**Risk Level: Medium**

**Speed Limit: 30 KM/Hr**

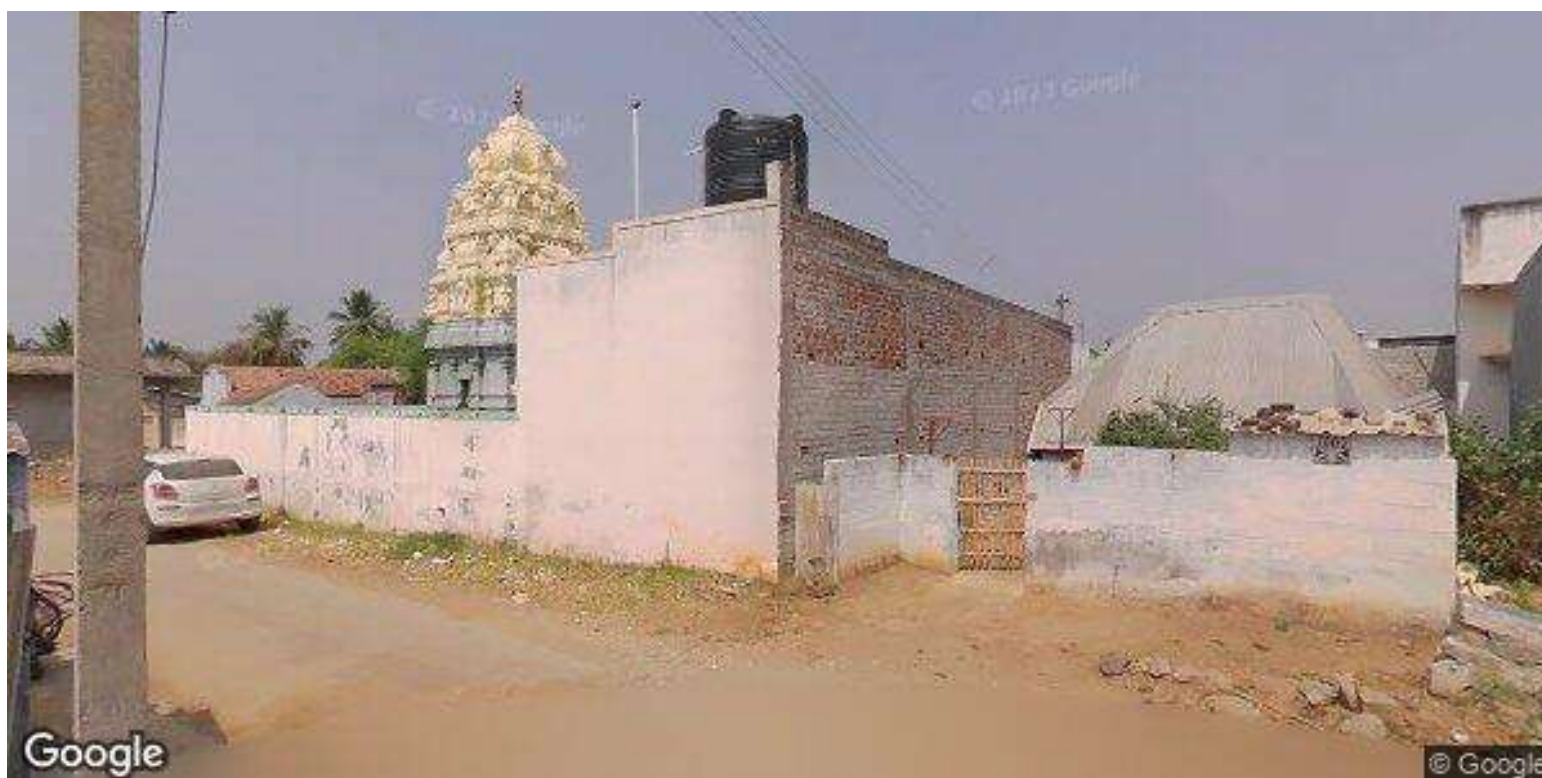
**Coordinates: 11.41313, 77.91057**

**Risk Type: Turn**

**Risk Level: High**

**Speed Limit: 15 KM/Hr**

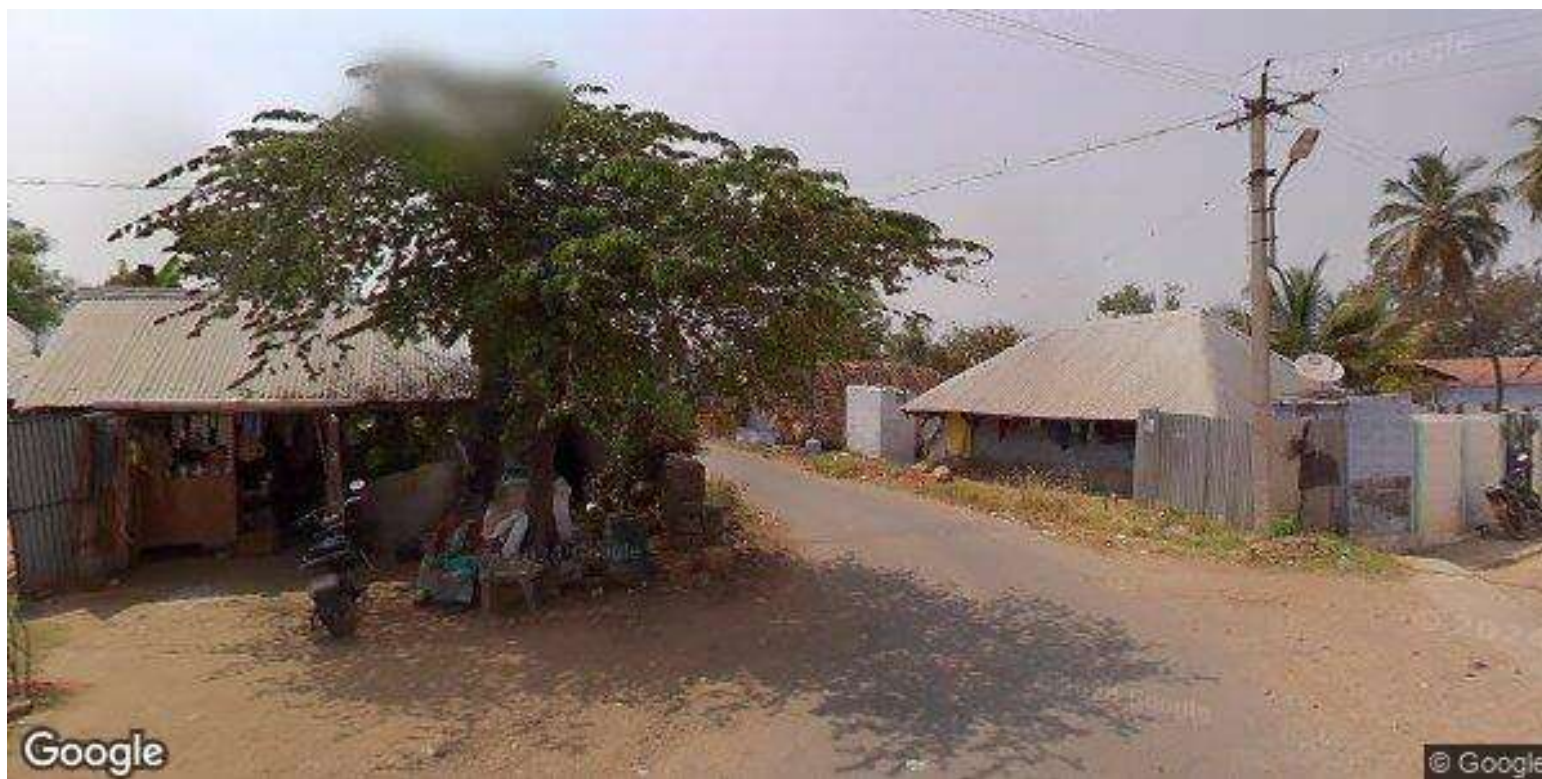
**Coordinates:** 11.41307, 77.91058

**Risk Type:** Turn

**Risk Level:** High

**Speed Limit:** 15 KM/Hr

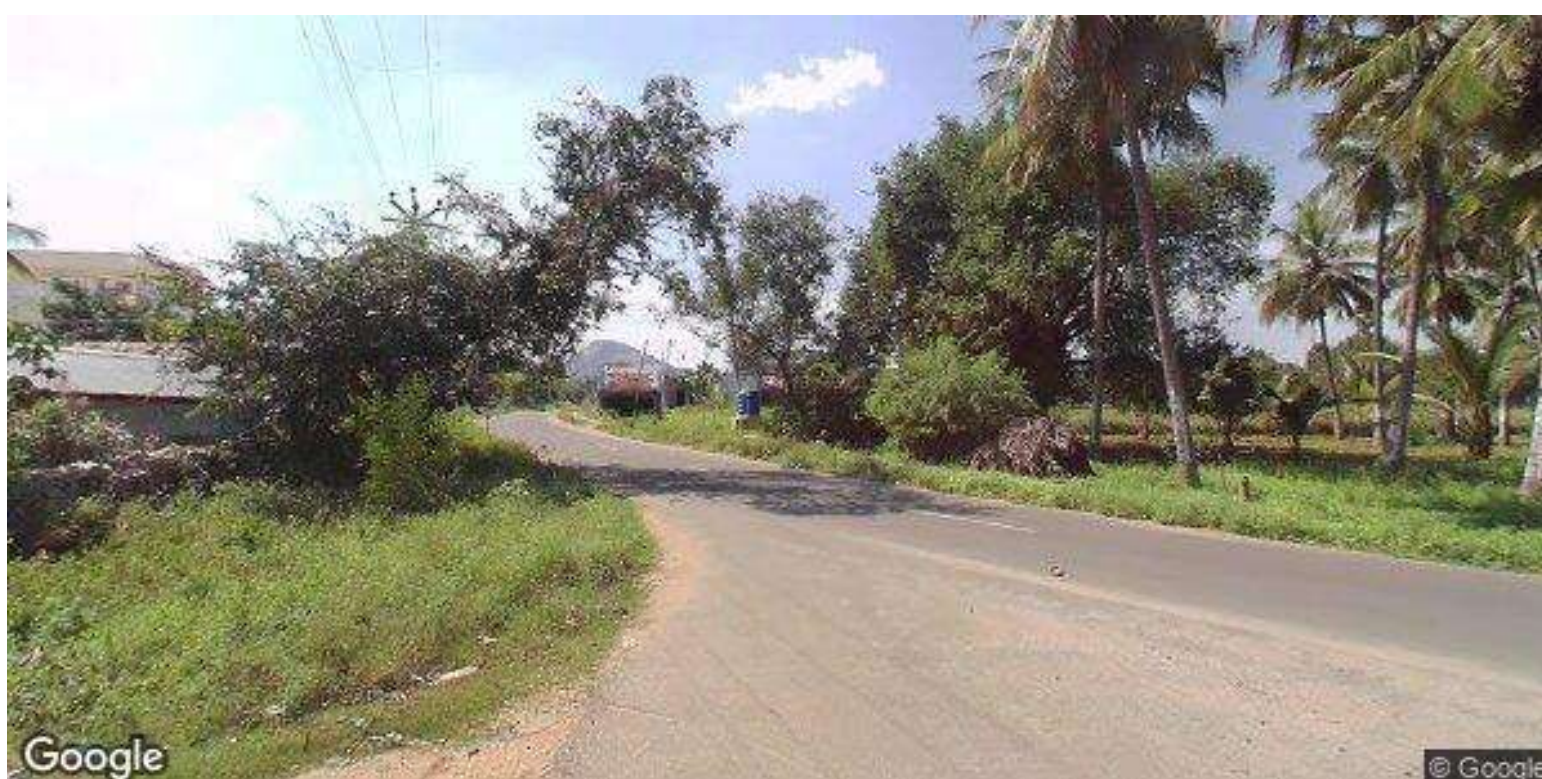
**Coordinates:** 11.41334, 77.91266

**Risk Type:** Turn

**Risk Level:** Medium

**Speed Limit:** 30 KM/Hr

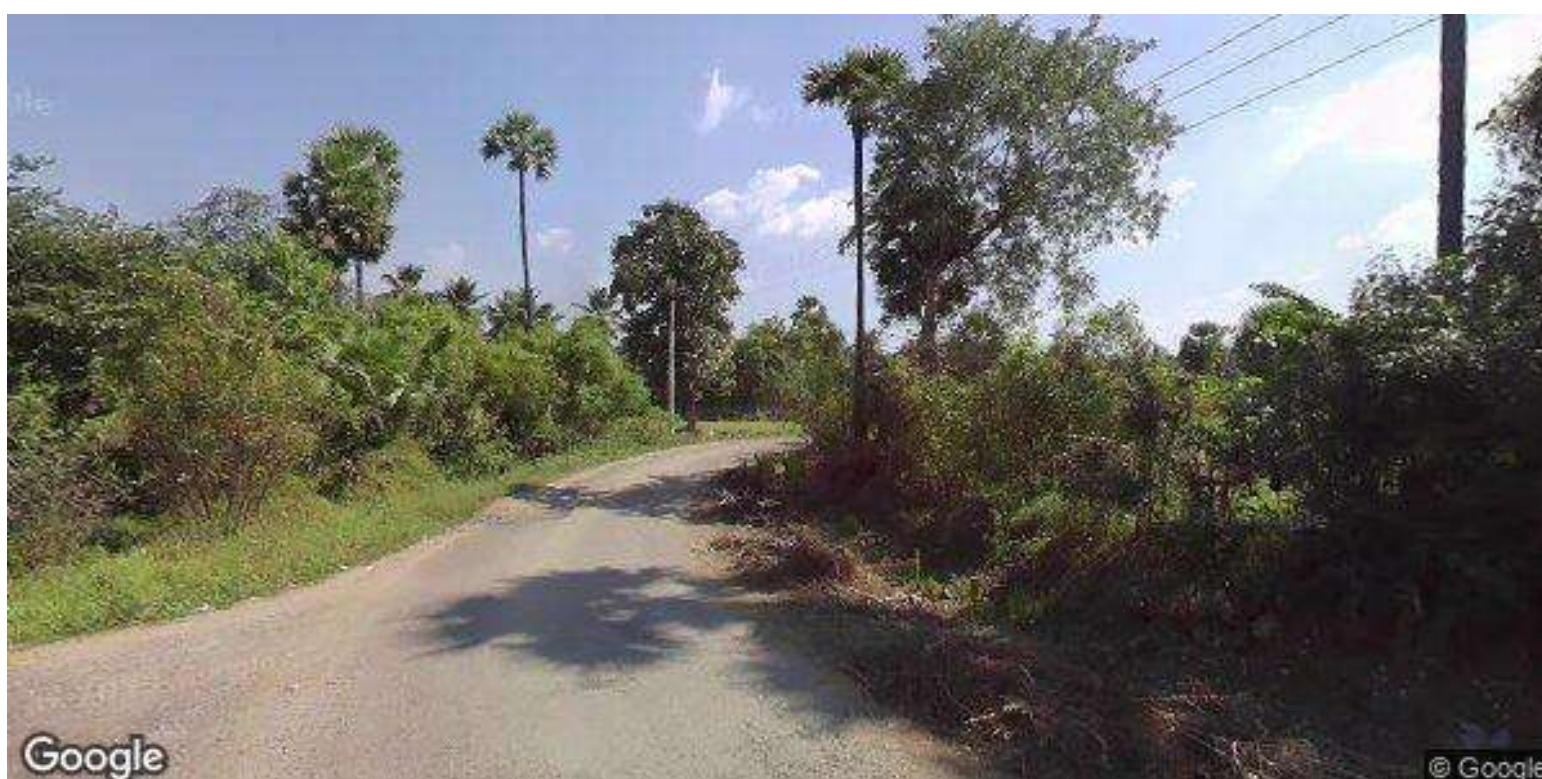
**Risk Type:** Turn  
**Risk Level:** High  
**Speed Limit:** 15 KM/Hr  
**Coordinates:** 11.41424, 77.91433

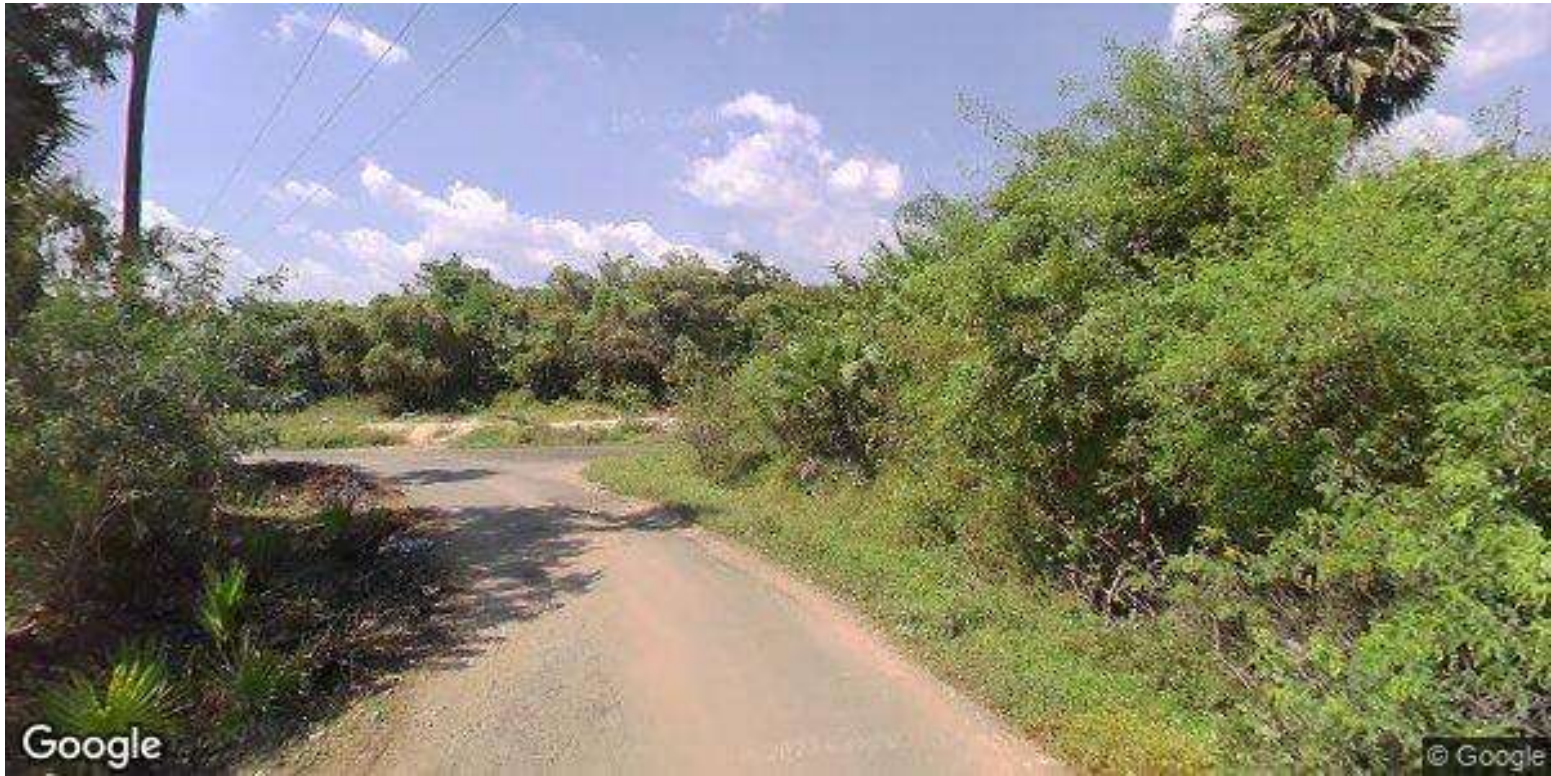
**Risk Type:** Turn  
**Risk Level:** Medium  
**Speed Limit:** 30 KM/Hr  
**Coordinates:** 11.41409, 77.91458

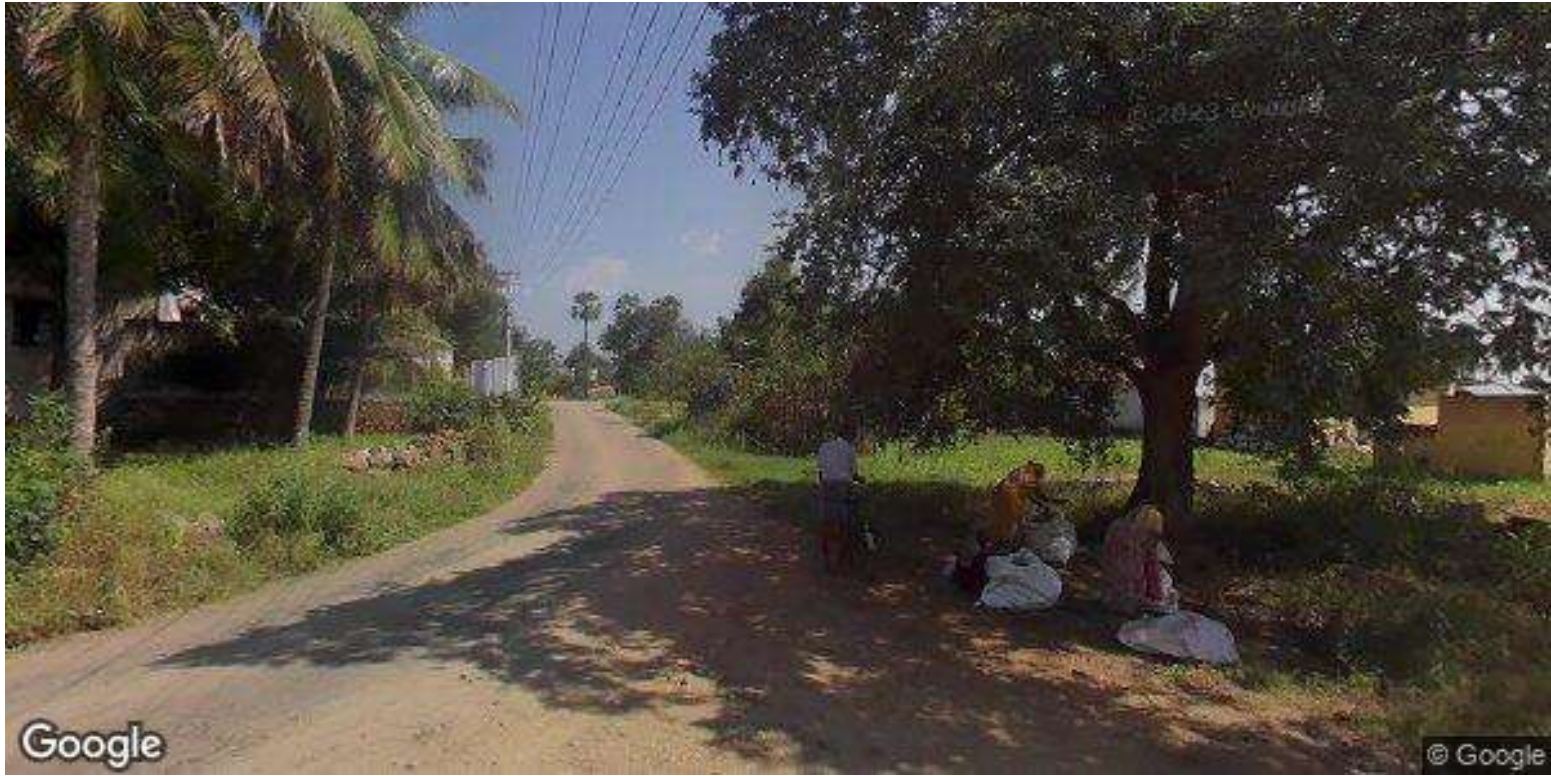
**Risk Type:** Turn  
**Risk Level:** High  
**Speed Limit:** 15 KM/Hr  
**Coordinates:** 11.41208, 77.91551

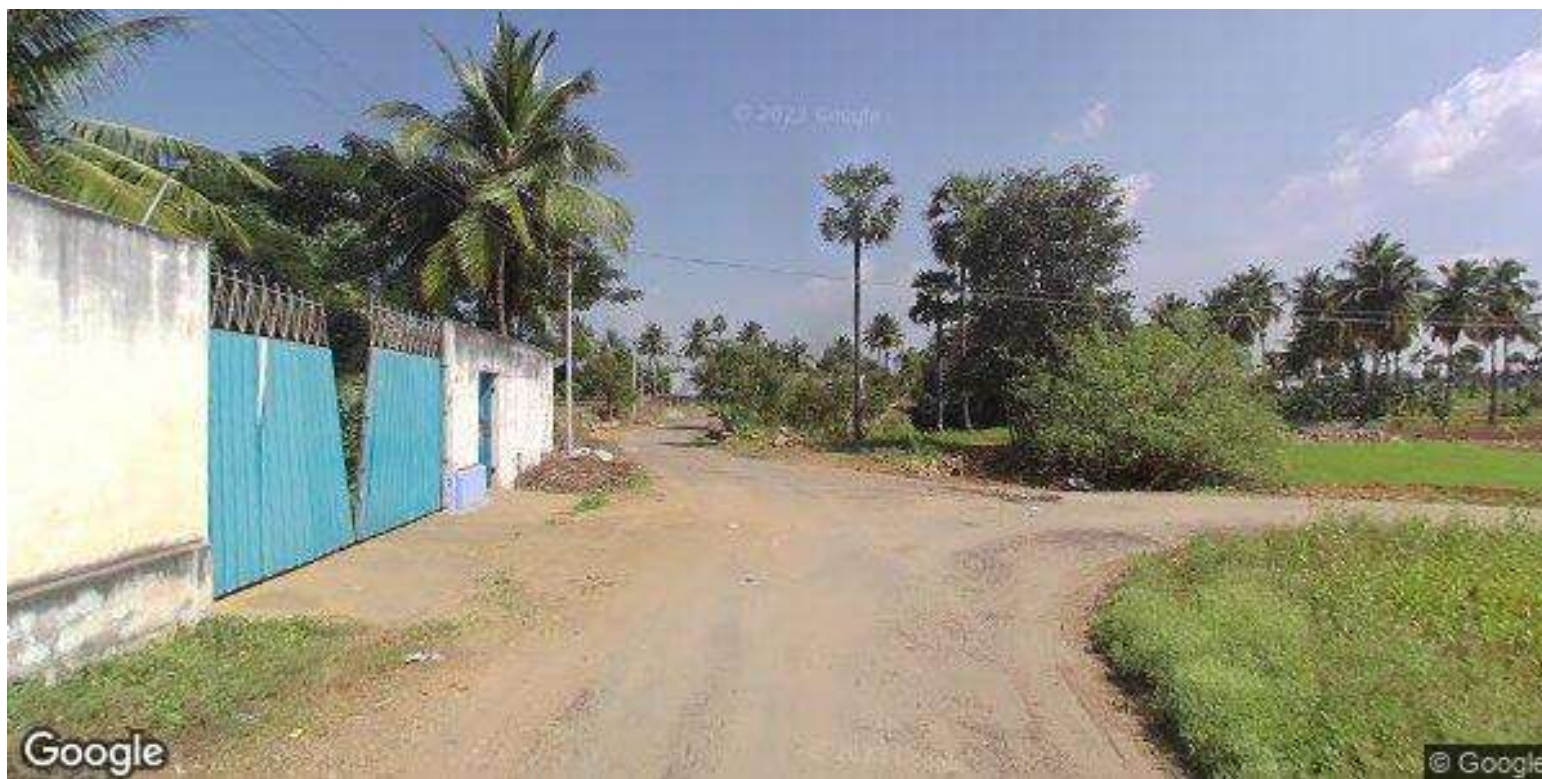
**Coordinates:** 11.41207, 77.91604

**Risk Type:** Turn

**Risk Level:** Medium

**Speed Limit:** 30 KM/Hr

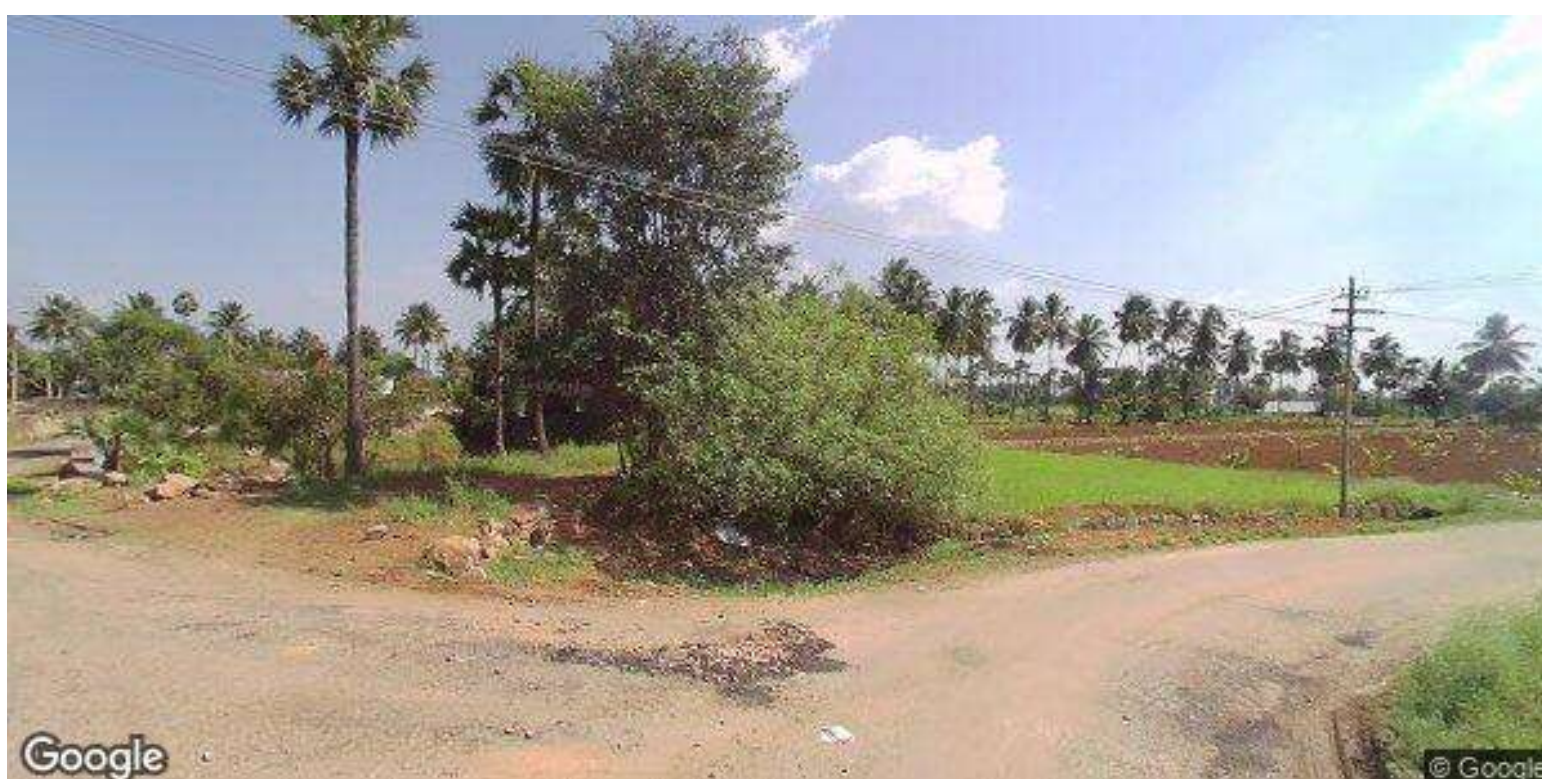
**Coordinates:** 11.41204, 77.91610

**Risk Type:** Turn

**Risk Level:** High

**Speed Limit:** 15 KM/Hr

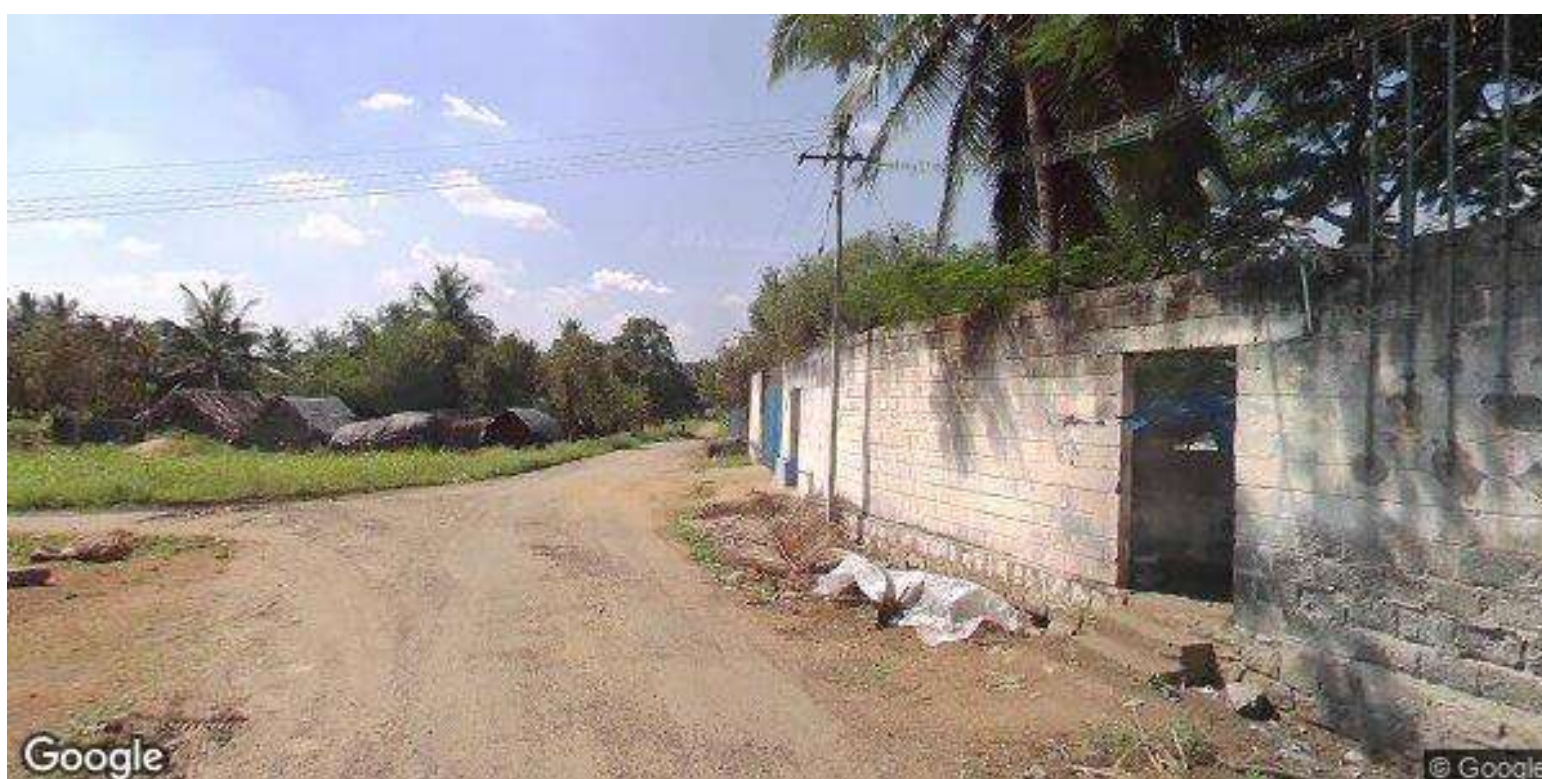
**Risk Type:** Turn  
**Risk Level:** Medium  
**Speed Limit:** 30 KM/Hr  
**Coordinates:** 11.41216, 77.91626

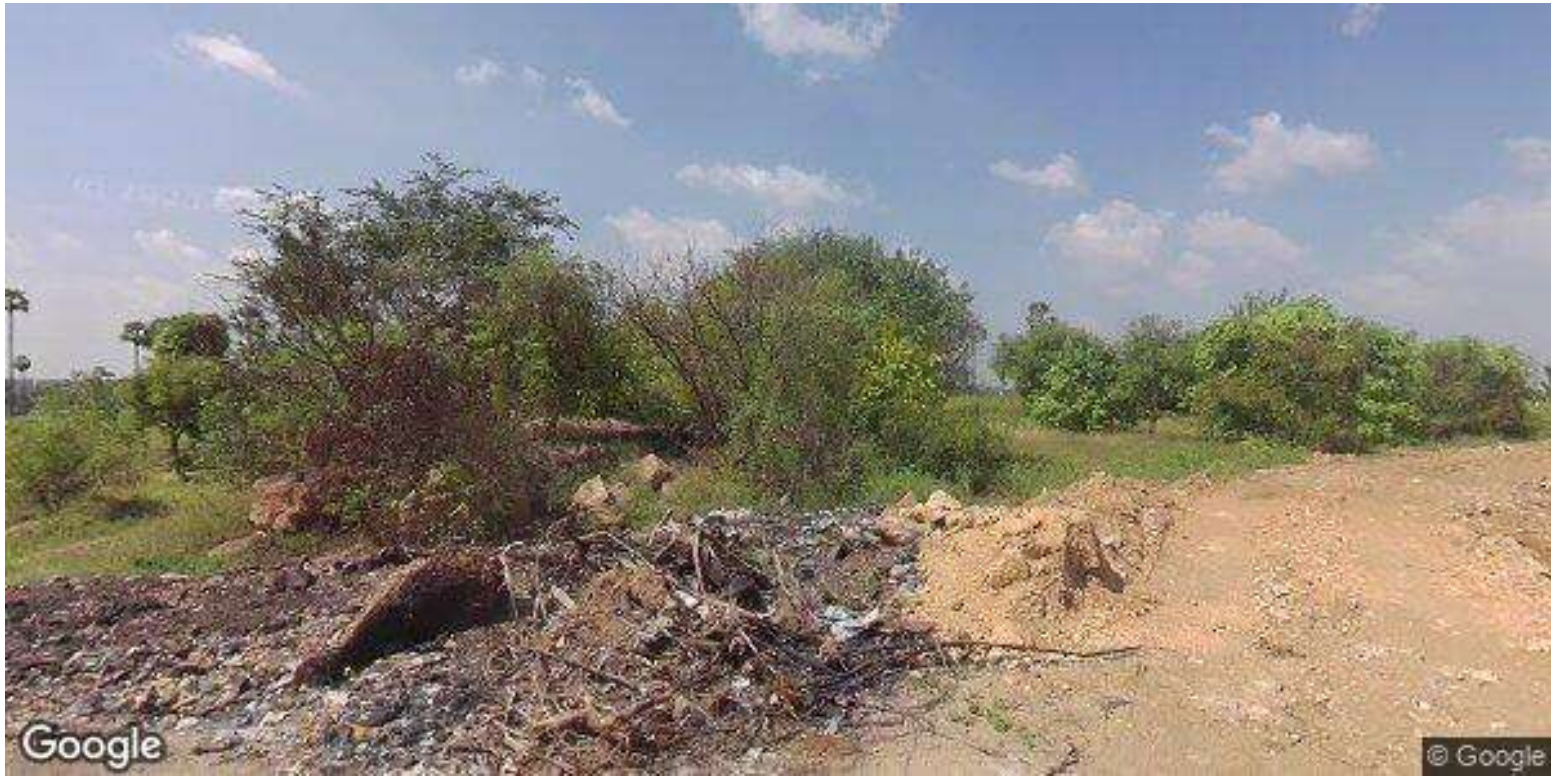
**Risk Type:** Turn  
**Risk Level:** High  
**Speed Limit:** 15 KM/Hr  
**Coordinates:** 11.41347, 77.92096

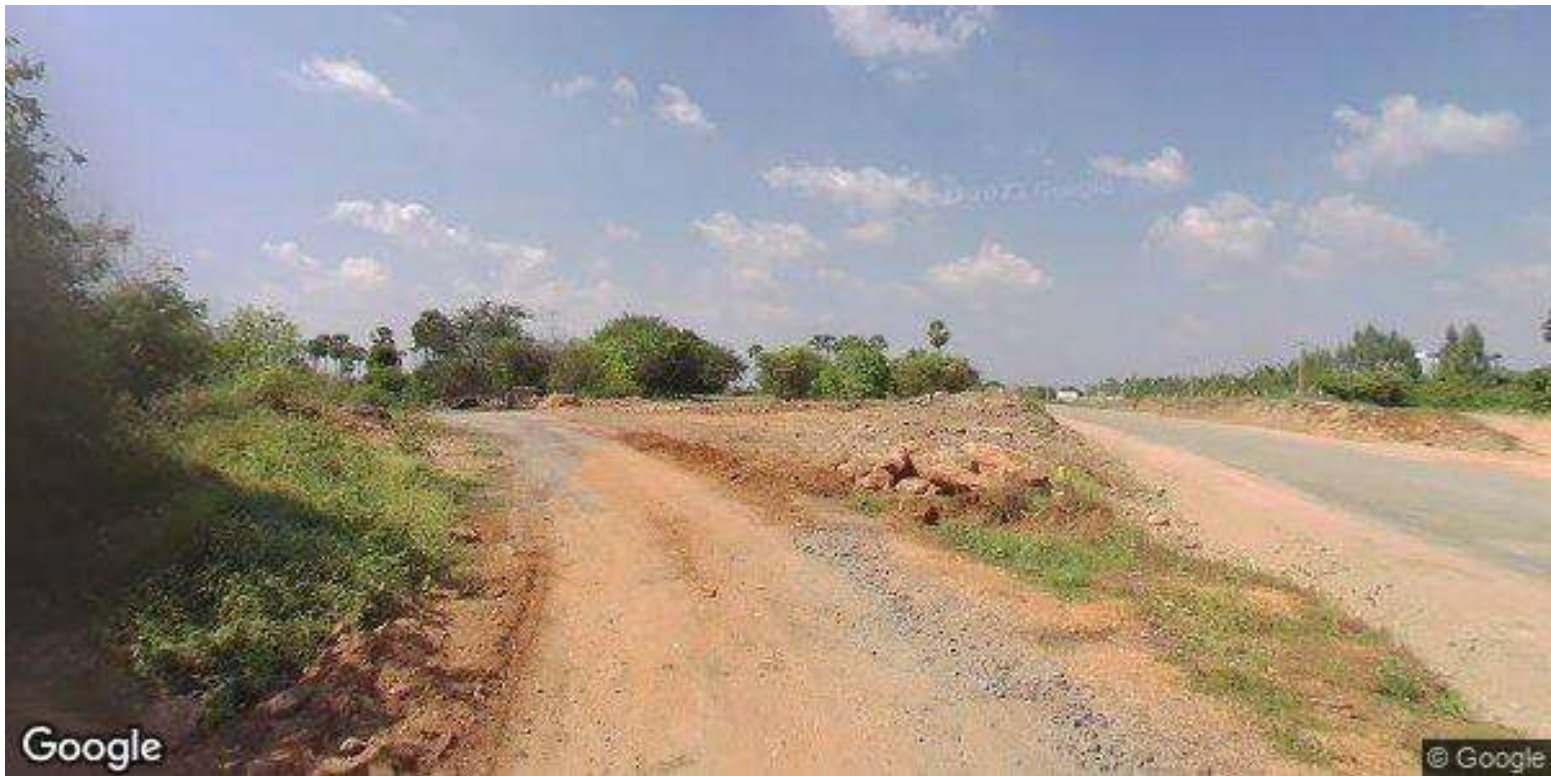
**Risk Type:** Turn  
**Risk Level:** Medium  
**Speed Limit:** 30 KM/Hr  
**Coordinates:** 11.41336, 77.92130

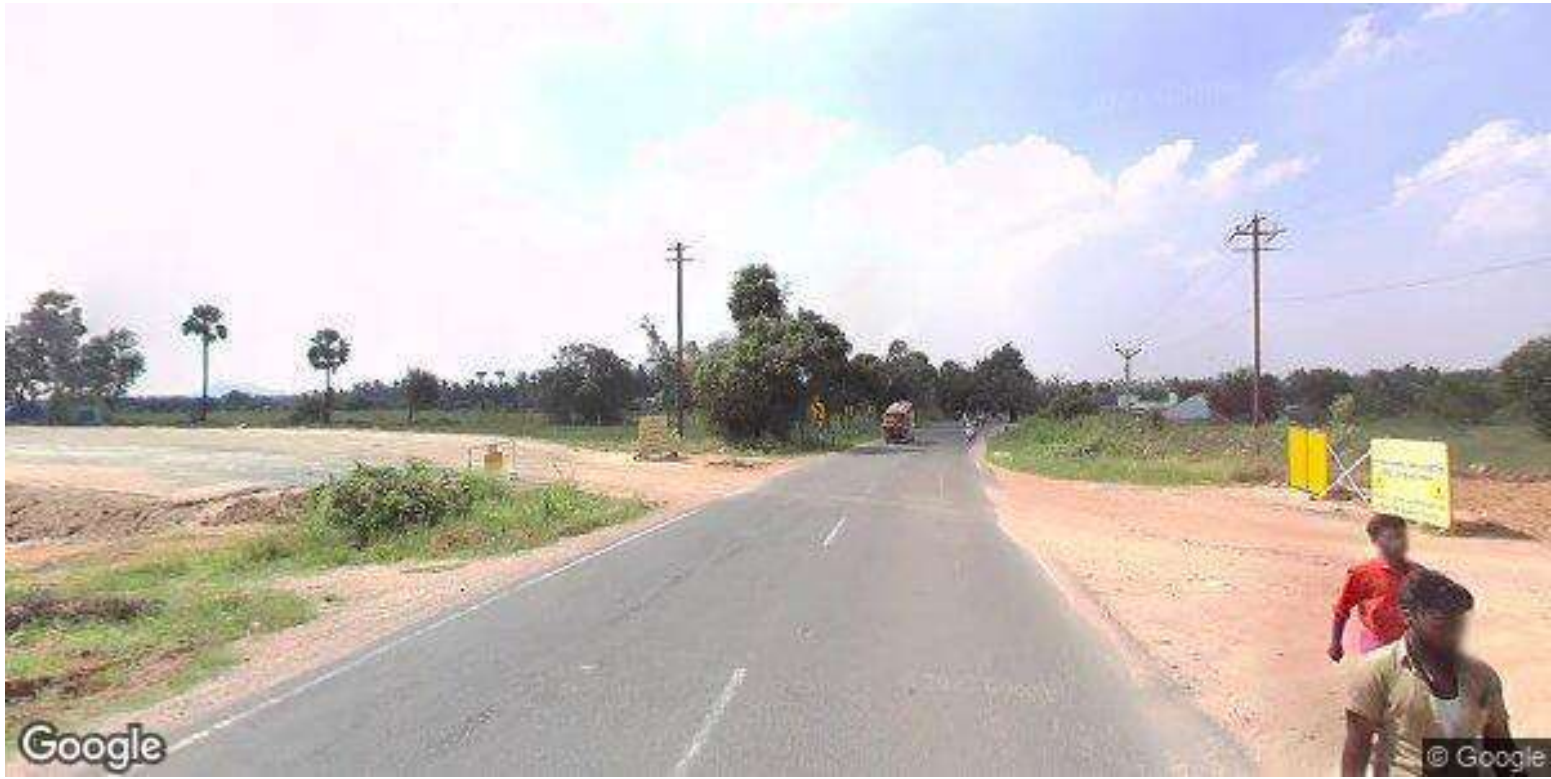
**Risk Type:** Turn  
**Risk Level:** High  
**Speed Limit:** 15 KM/Hr  
**Coordinates:** 11.40566, 77.92355

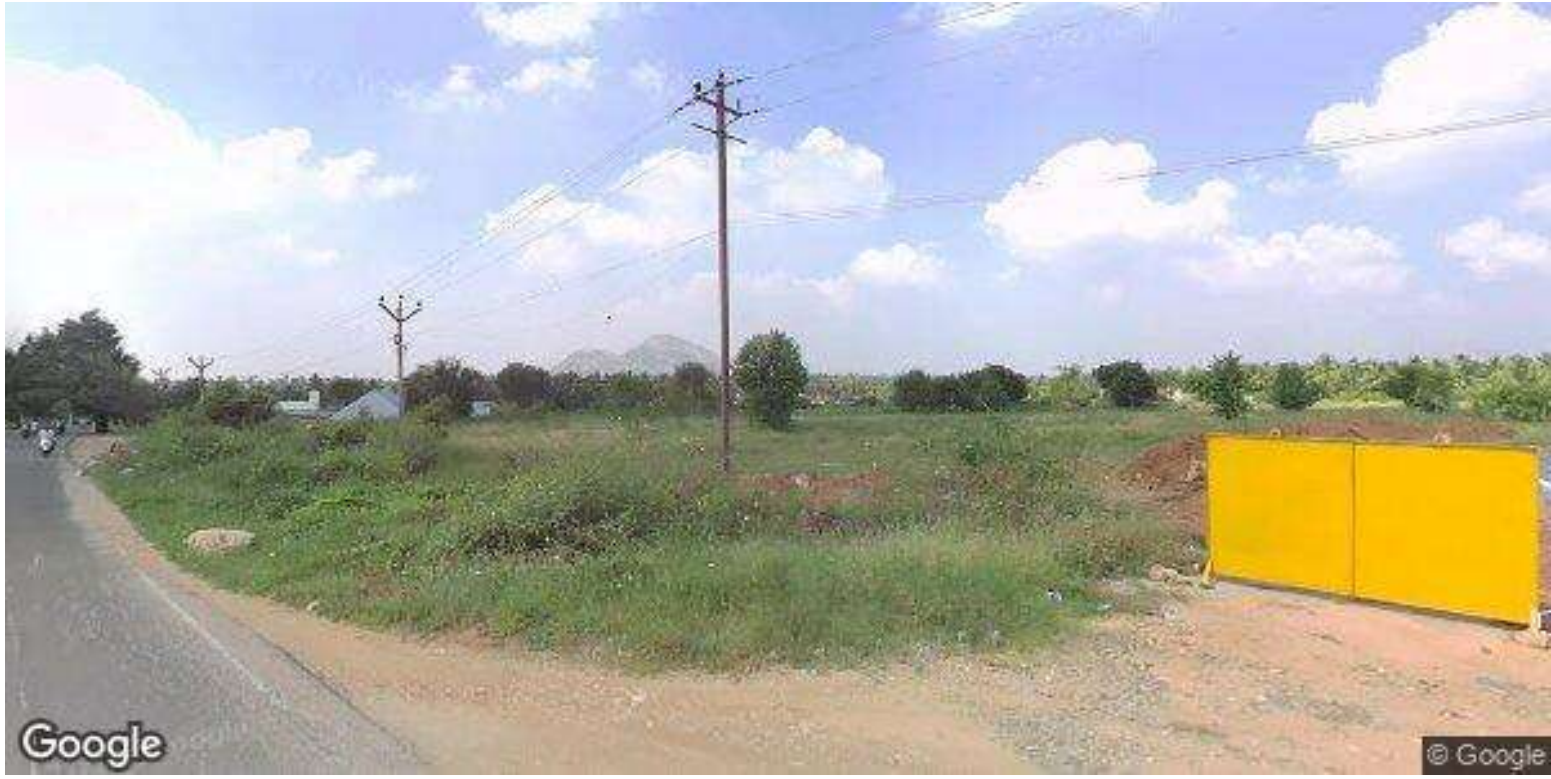
**Risk Type:** Turn  
**Risk Level:** High  
**Speed Limit:** 15 KM/Hr  
**Coordinates:** 11.40557, 77.92343

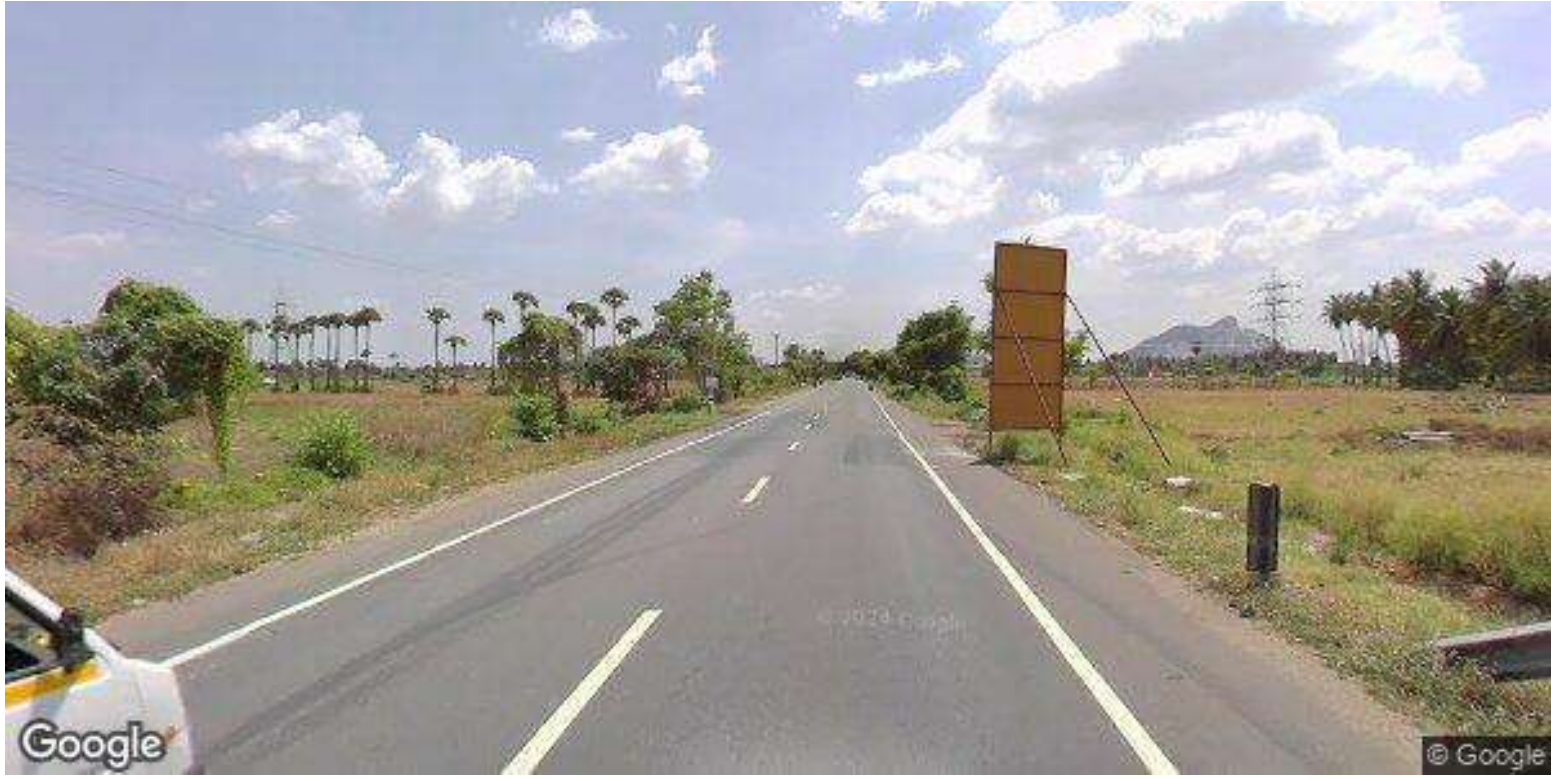
**Risk Type:** Blind Spot  
**Risk Level:** Blind Spot  
**Speed Limit:** 10 KM/Hr  
**Coordinates:** 11.36920, 77.94568

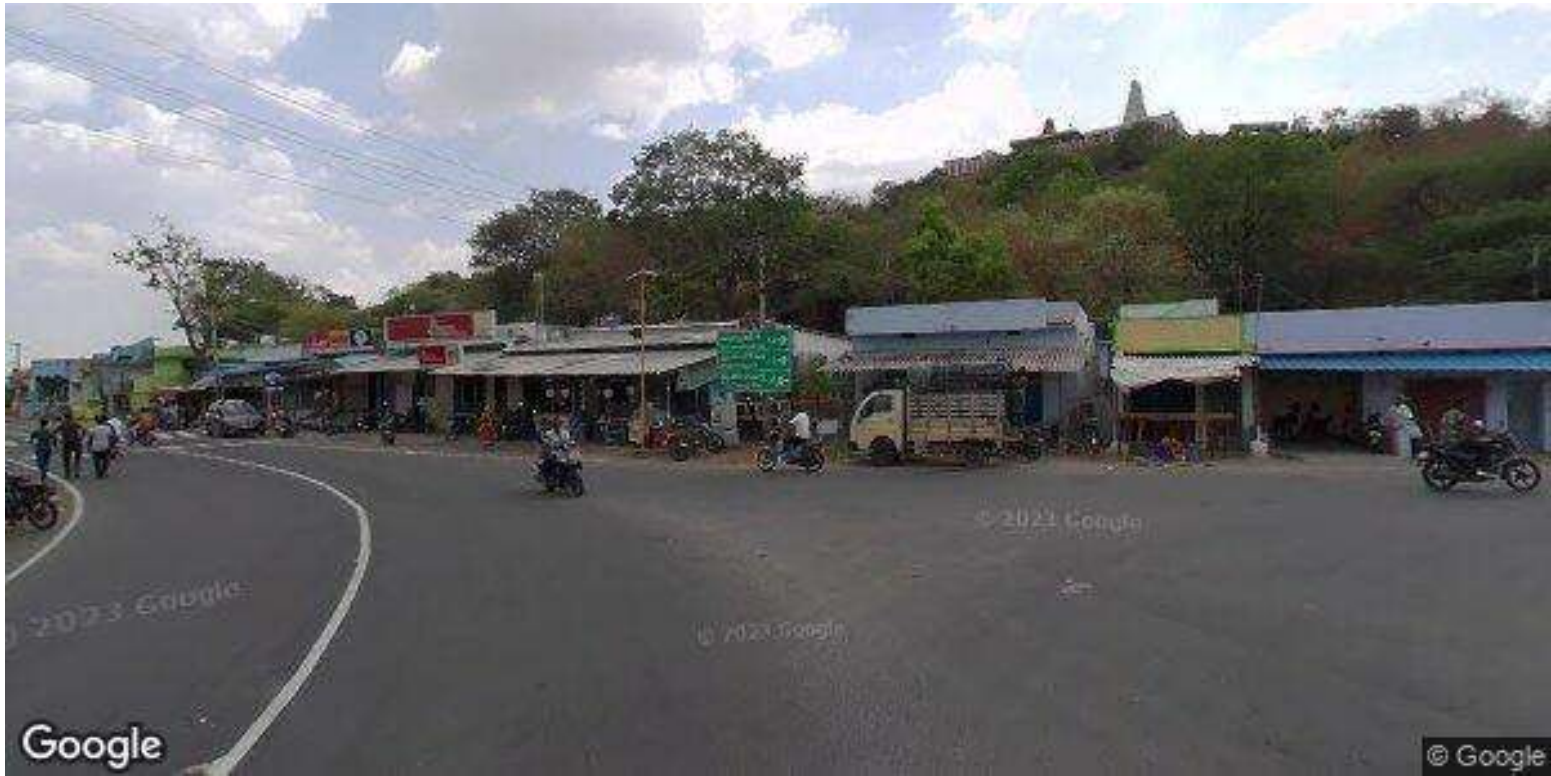
**Risk Type:** Turn  
**Risk Level:** Medium  
**Speed Limit:** 30 KM/Hr  
**Coordinates:** 11.41463, 78.08067

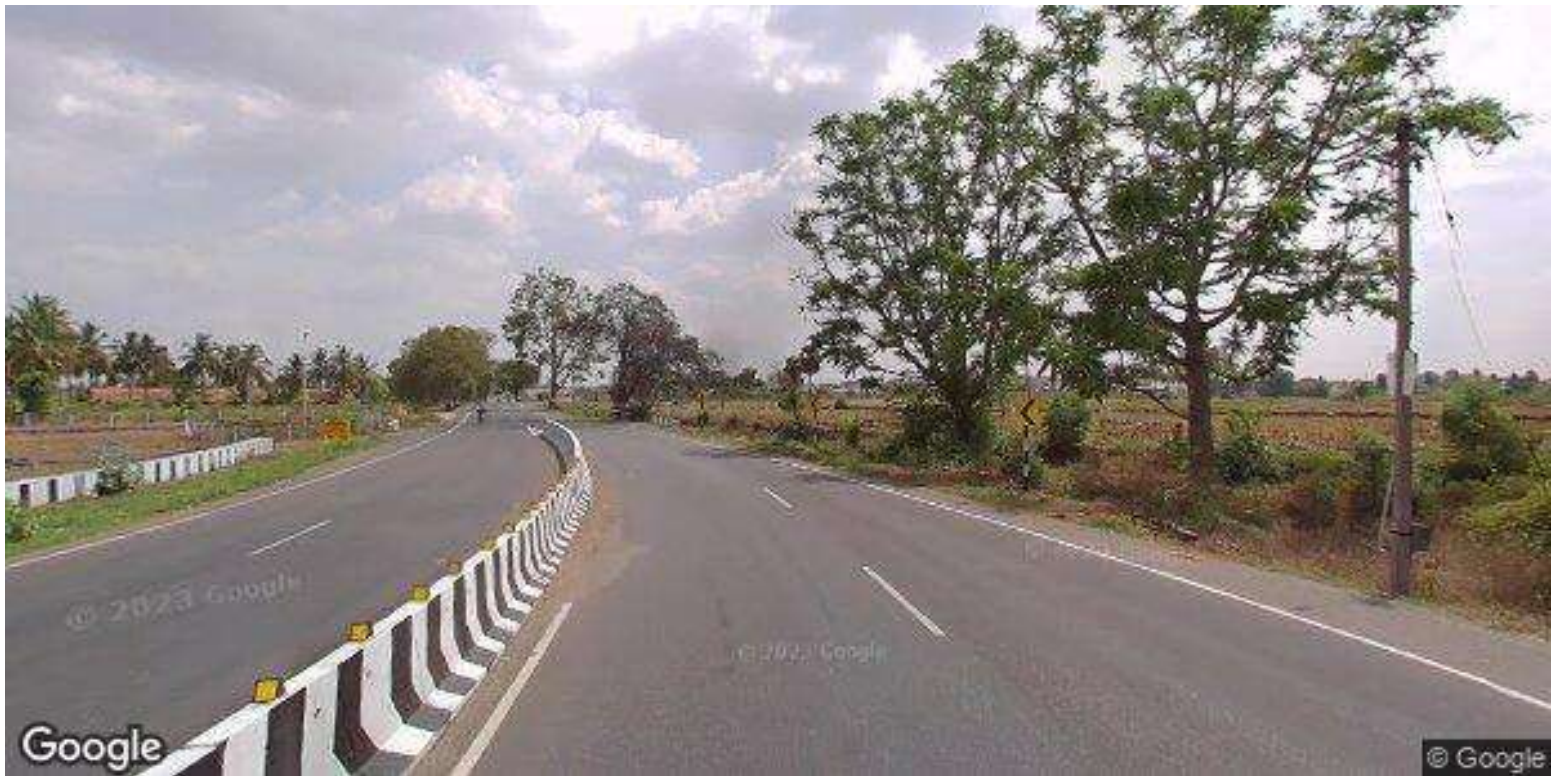
**Risk Type:** Turn  
**Risk Level:** Medium  
**Speed Limit:** 30 KM/Hr  
**Coordinates:** 11.43248, 78.12074
