# IndianOil

## JOURNEY RISK MANAGEMENT (JRM) STUDY

### Salem Terminal TO PRANAV AGENCY

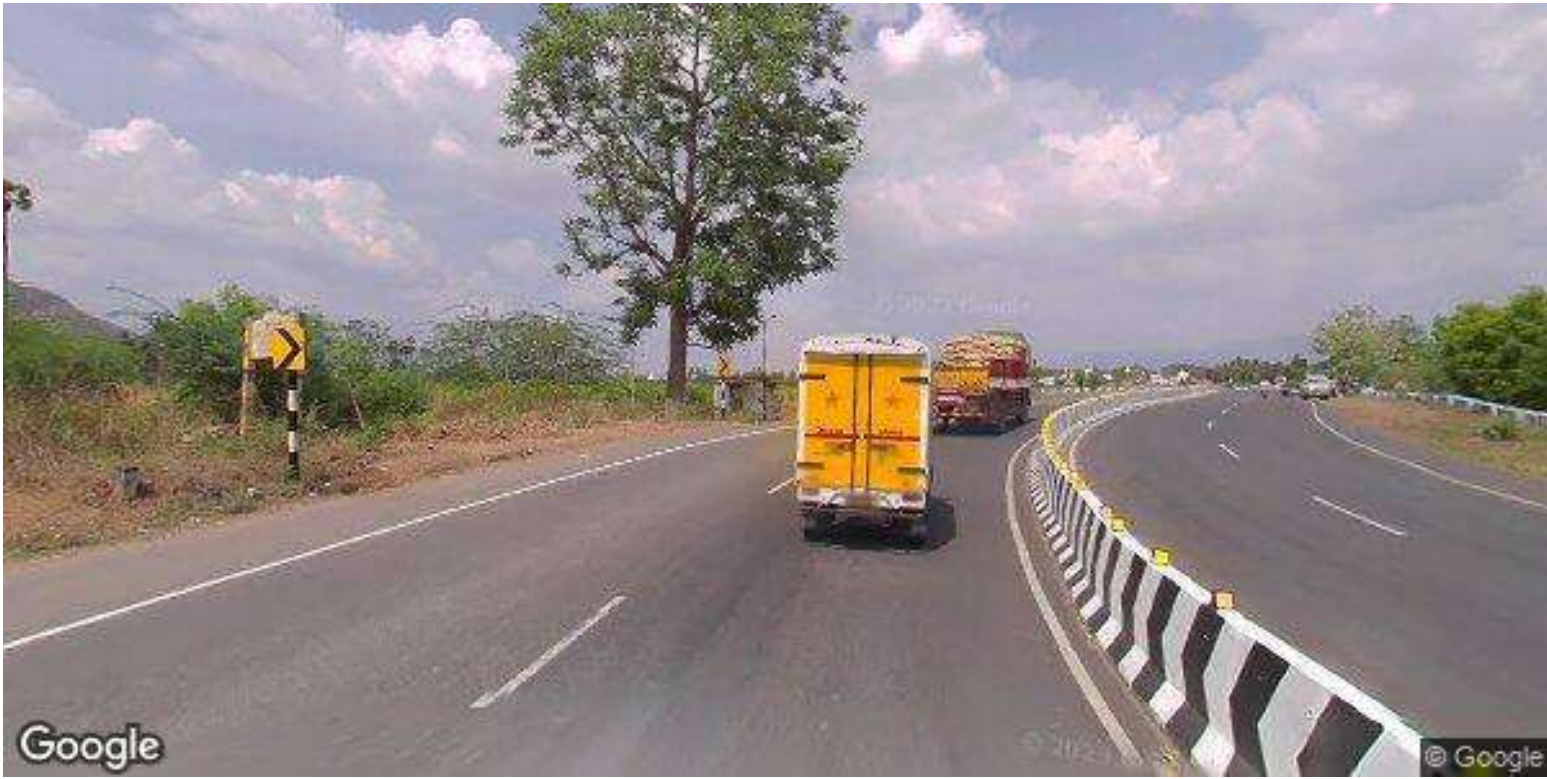
**Coordinates:** 11.43257, 78.12096

**Risk Type:** Turn

**Risk Level:** Medium

**Speed Limit:** 30 KM/Hr
