## JOURNEY RISK MANAGEMENT (JRM) STUDY

### Salem Terminal to K.K FUELS

#### Objective of the JRM Report

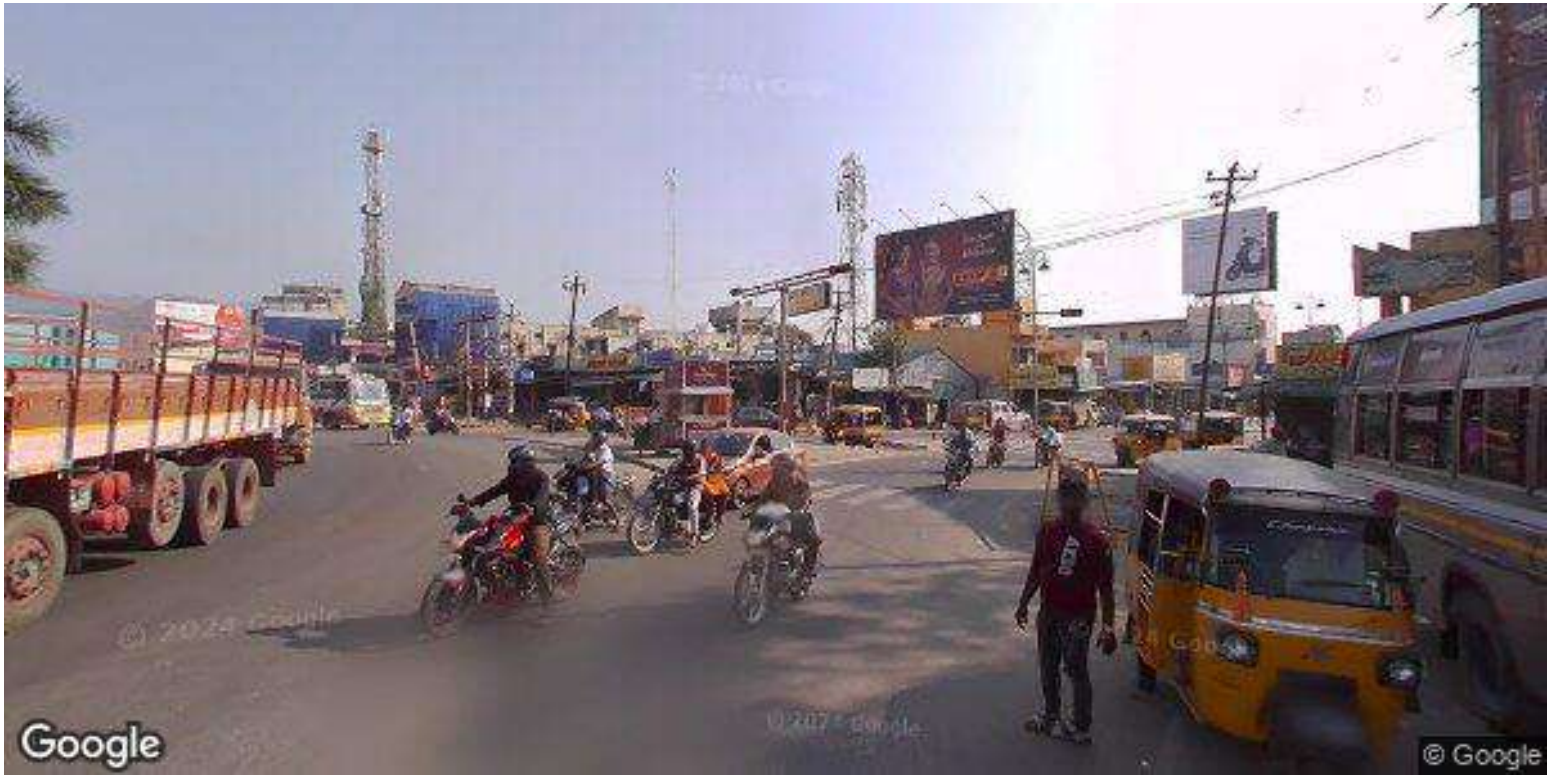
Coordinates: 11.63266, 78.12699

Risk Type: Roundabout

Risk Level: High

Speed Limit: 15 KM/Hr

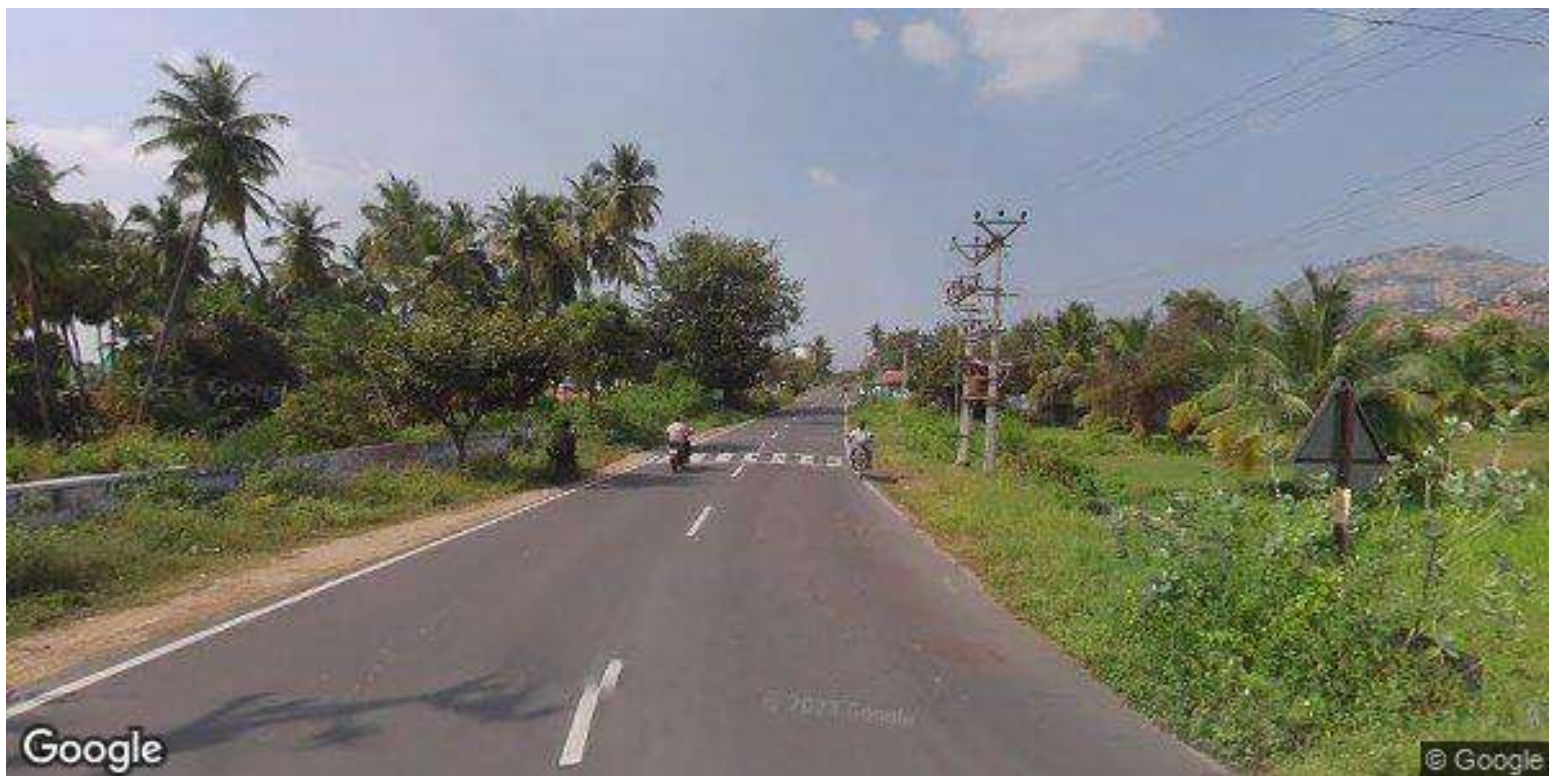
**Coordinates: 11.45352, 77.85698**

**Risk Type: Turn**

**Risk Level: High**

**Speed Limit: 15 KM/Hr**

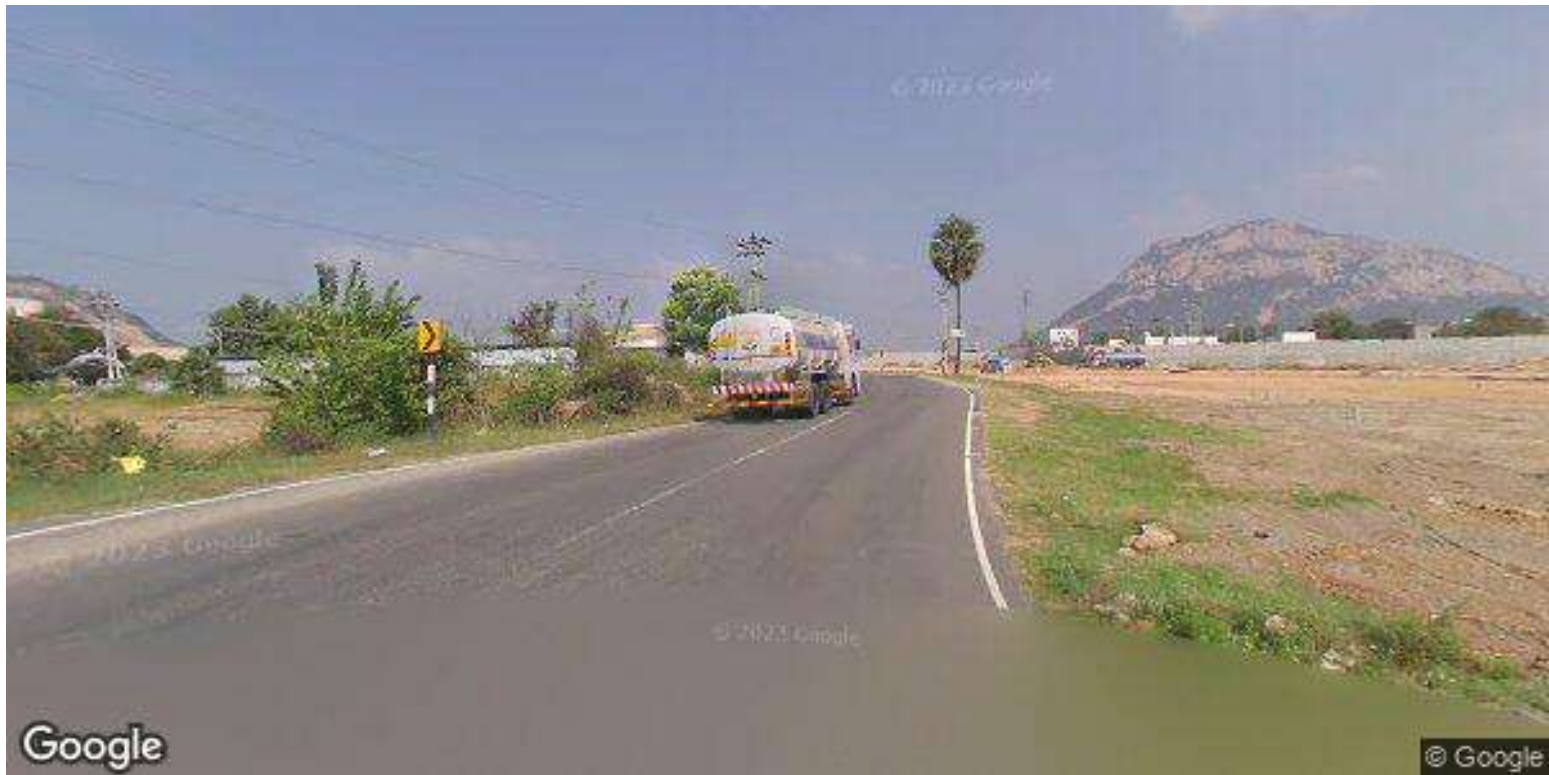
**Coordinates: 11.45847, 77.85140**

**Risk Type: Turn**

**Risk Level: Medium**

**Speed Limit: 30 KM/Hr**

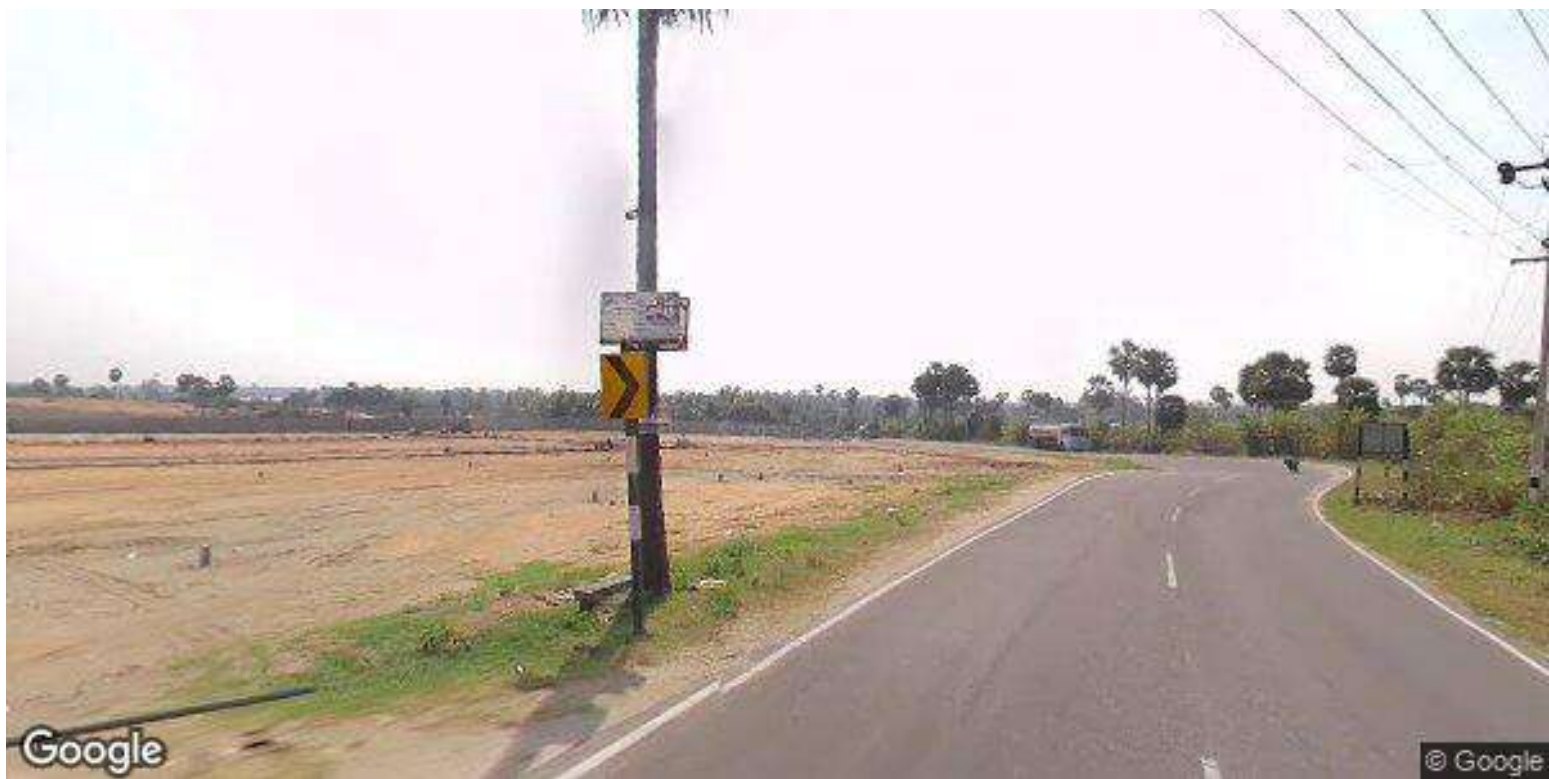
**Coordinates: 11.45898, 77.85135**

**Risk Type: Turn**

**Risk Level: Medium**

**Speed Limit: 30 KM/Hr**

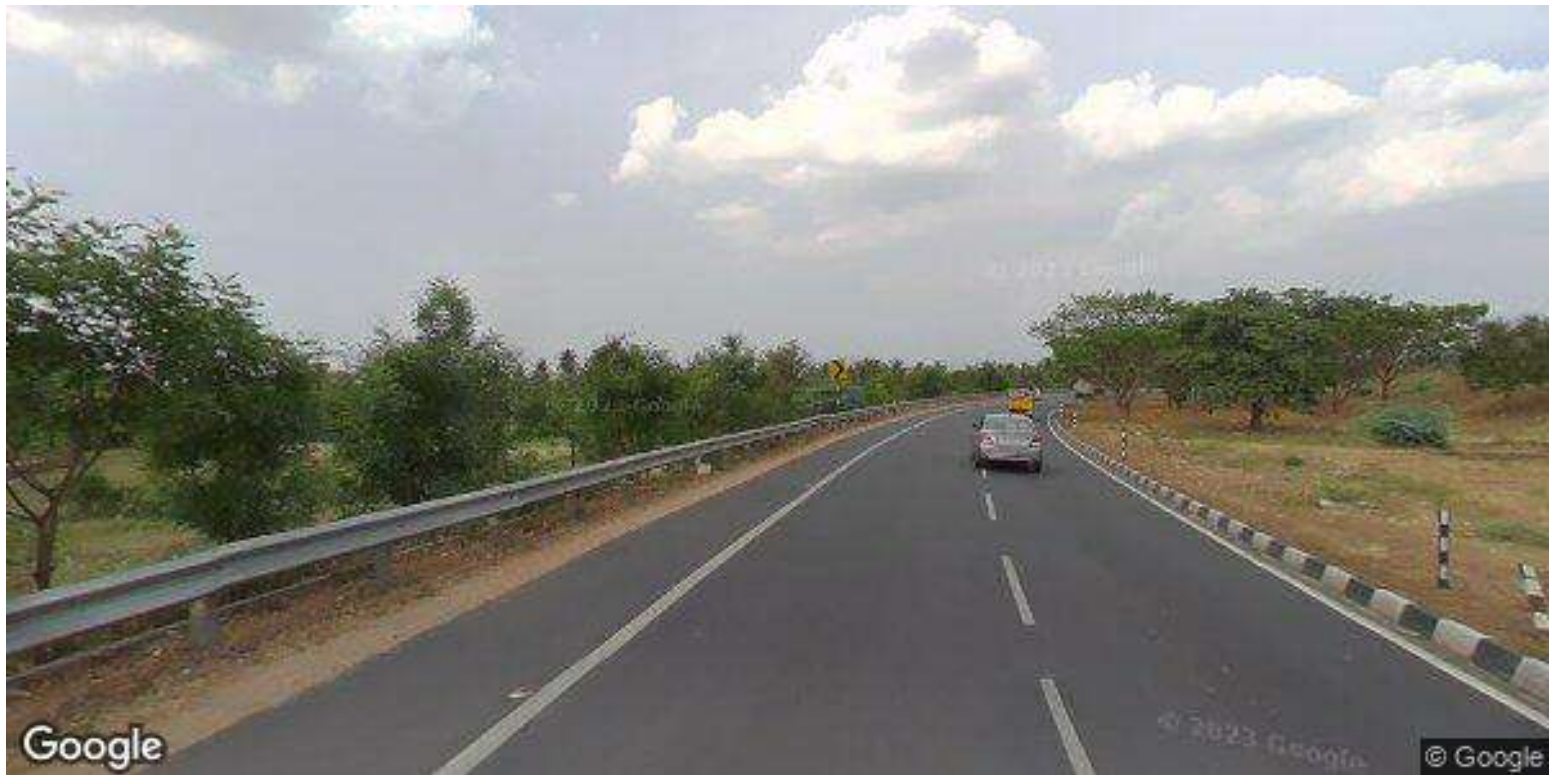
**Coordinates:** 11.53560, 77.95773

**Risk Type:** Turn

**Risk Level:** Medium

**Speed Limit:** 30 KM/Hr

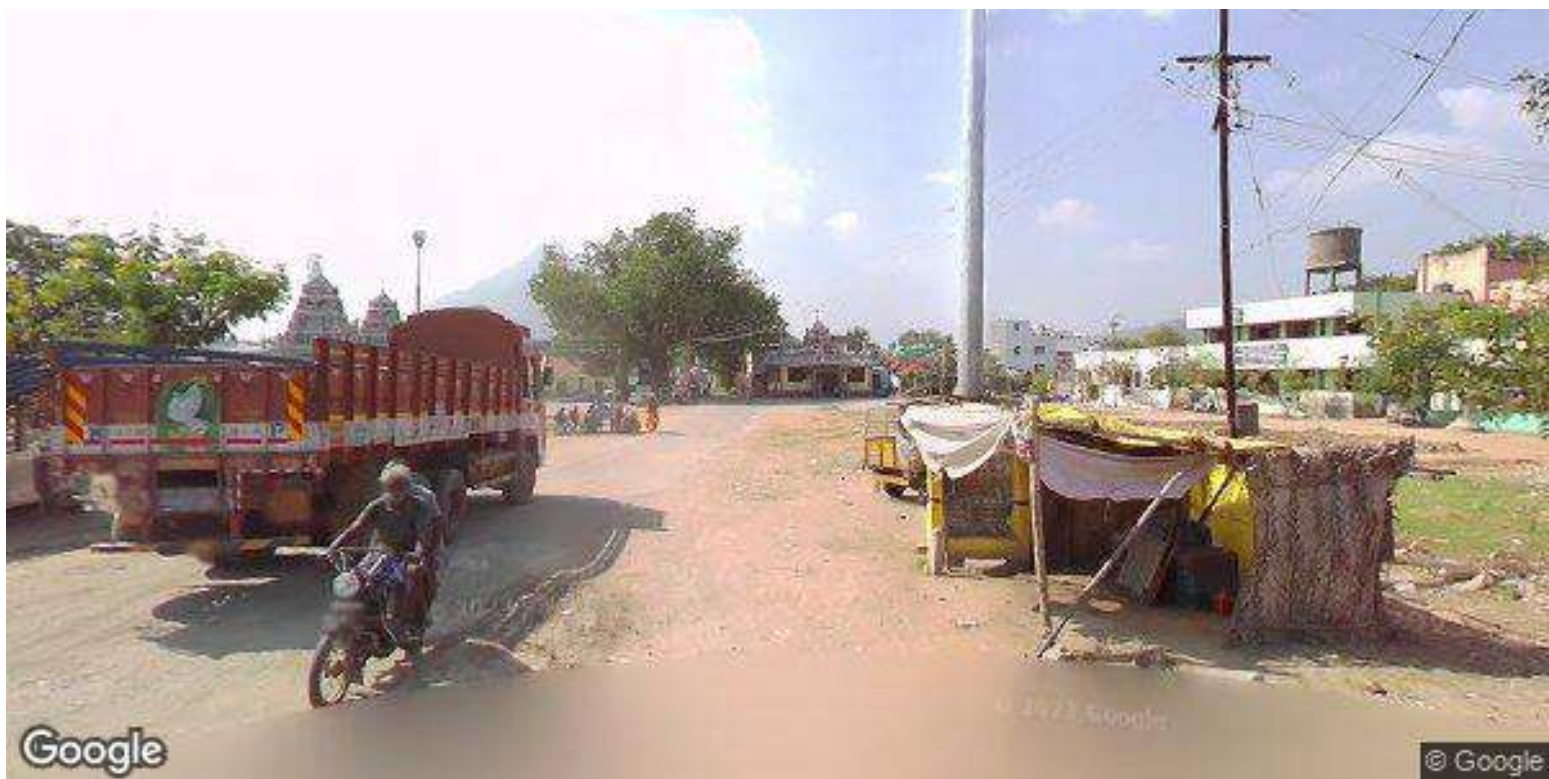
**Coordinates:** 11.62145, 78.10740

**Risk Type:** Blind Spot

**Risk Level:** Blind Spot

**Speed Limit:** 10 KM/Hr

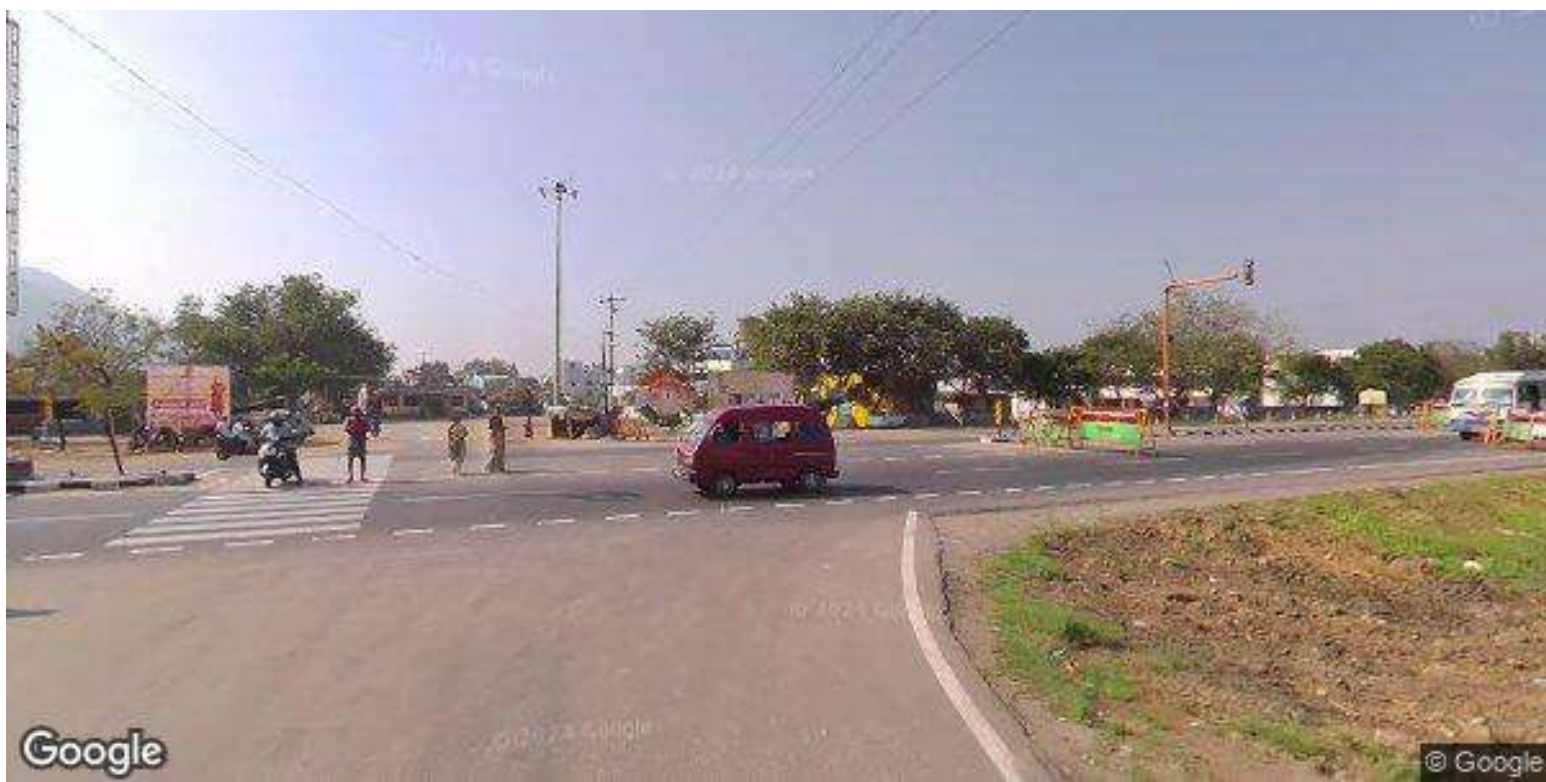
**Coordinates:** 11.62130, 78.10776

**Risk Type:** Turn

**Risk Level:** High

**Speed Limit:** 15 KM/Hr

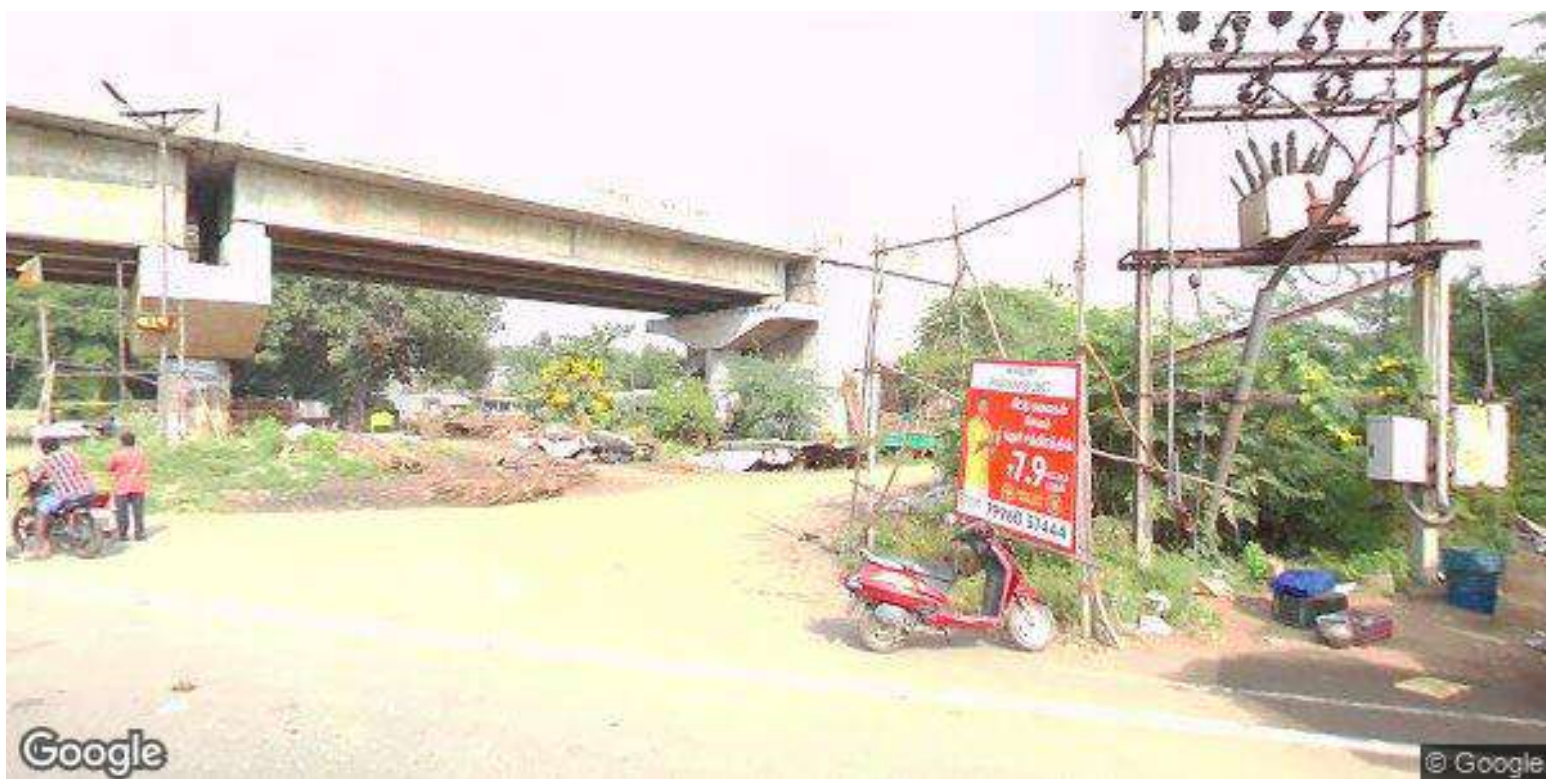
**Coordinates:** 11.61235, 78.10438

**Risk Type:** Blind Spot

**Risk Level:** Blind Spot

**Speed Limit:** 10 KM/Hr

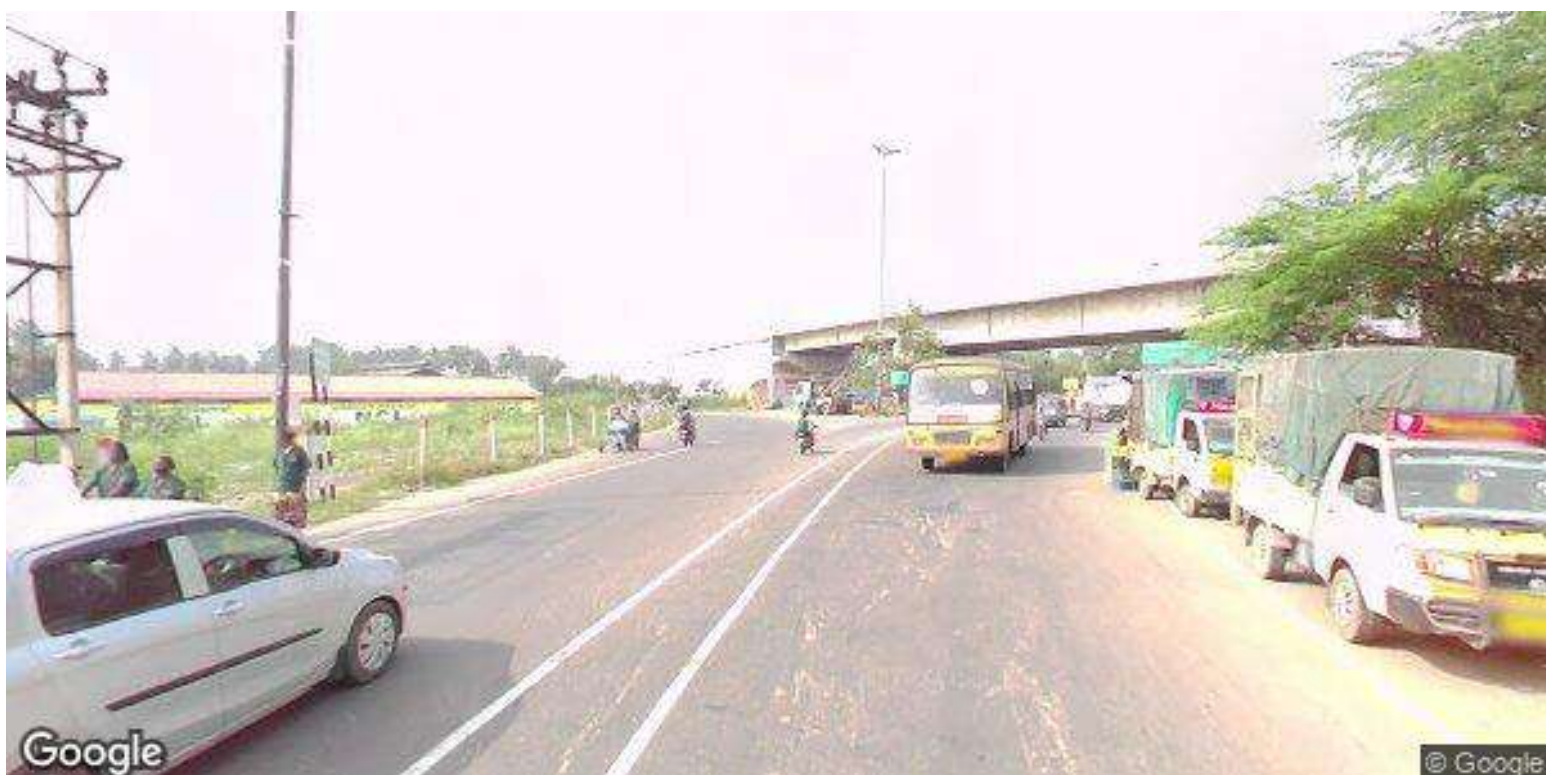
**Coordinates: 11.61224, 78.10469**

**Risk Type: Turn**

**Risk Level: Medium**

**Speed Limit: 30 KM/Hr**

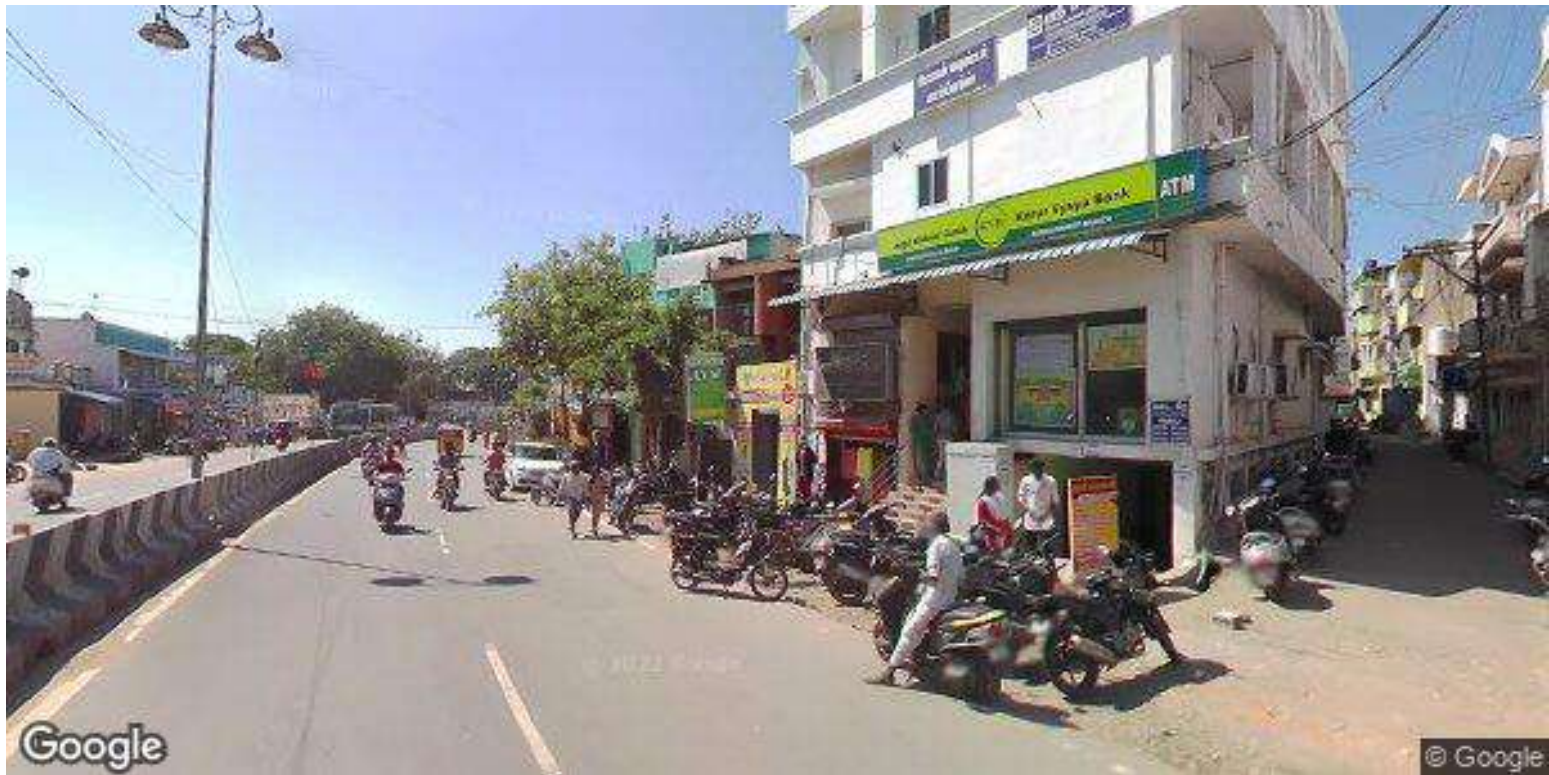
**Coordinates: 11.62537, 78.12040**

**Risk Type: Turn**

**Risk Level: Medium**

**Speed Limit: 30 KM/Hr**

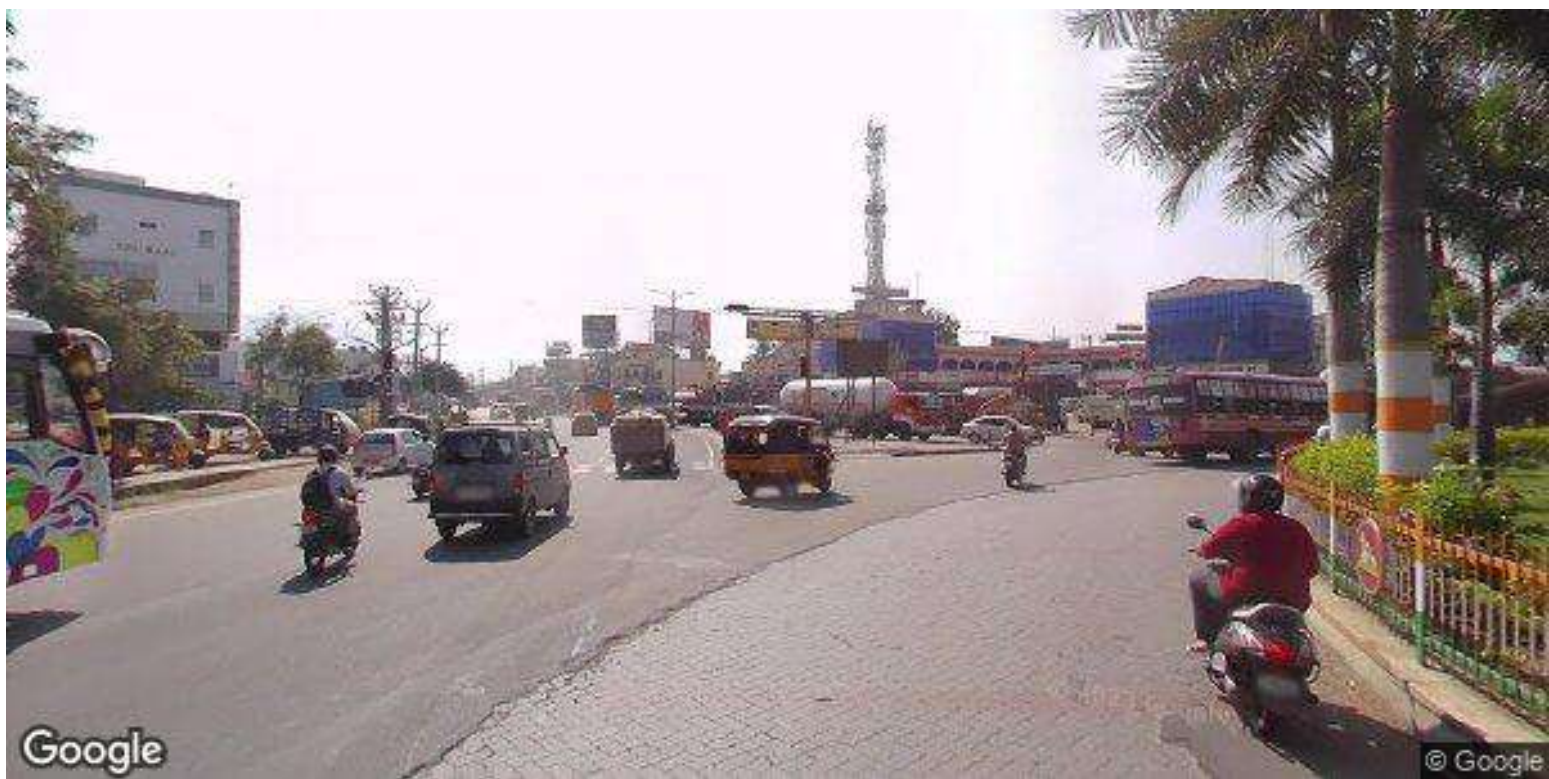
**Coordinates: 11.63283, 78.12757**

**Risk Type: Turn**

**Risk Level: Medium**

**Speed Limit: 30 KM/Hr**

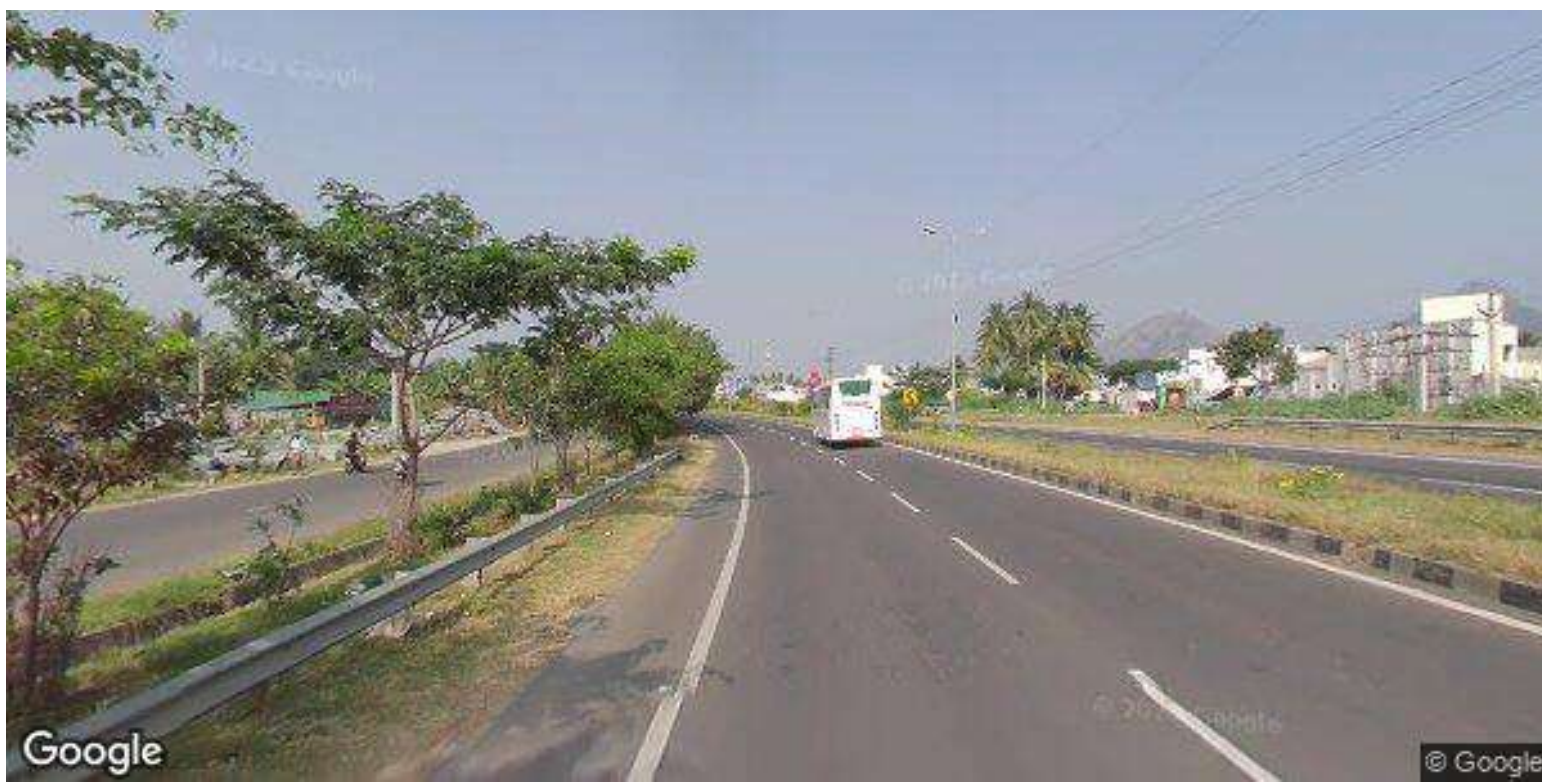
**Coordinates:** 11.62901, 78.16571

**Risk Type:** Turn

**Risk Level:** Medium

**Speed Limit:** 30 KM/Hr

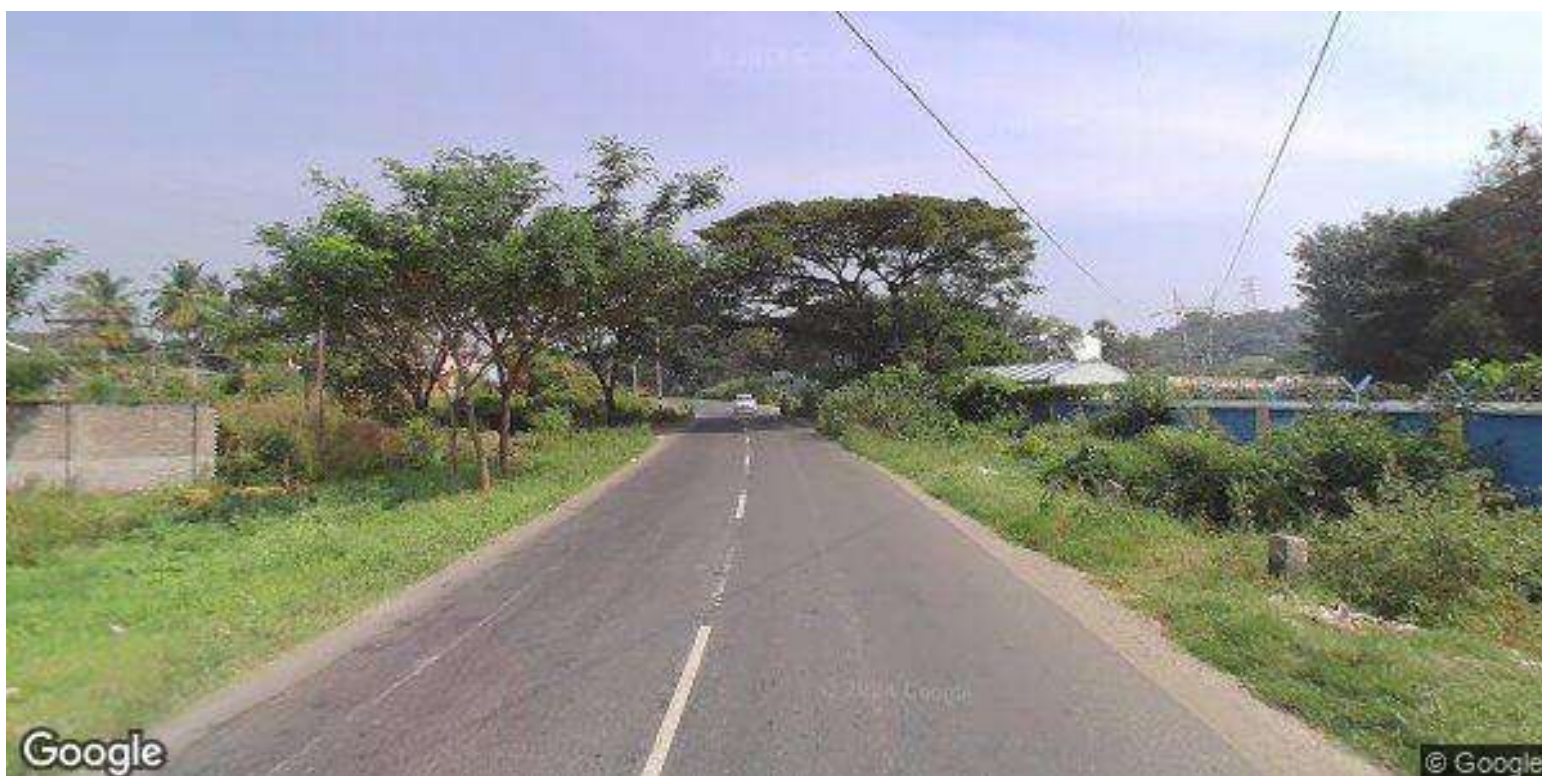
**Coordinates:** 11.65803, 78.20452

**Risk Type:** Turn

**Risk Level:** Medium

**Speed Limit:** 30 KM/Hr

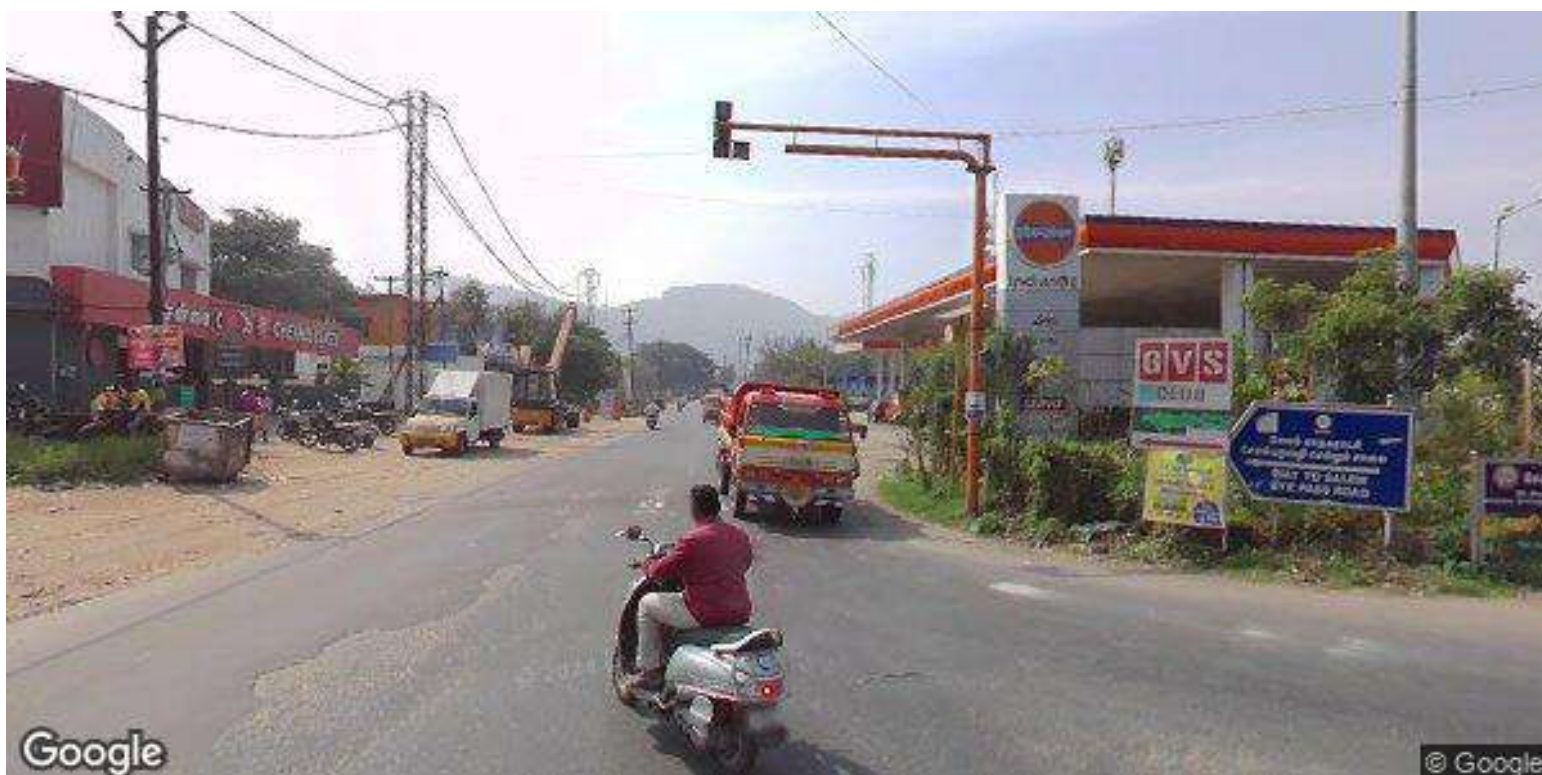
**Coordinates: 11.66354, 78.20645**

**Risk Type: Turn**

**Risk Level: Medium**

**Speed Limit: 30 KM/Hr**

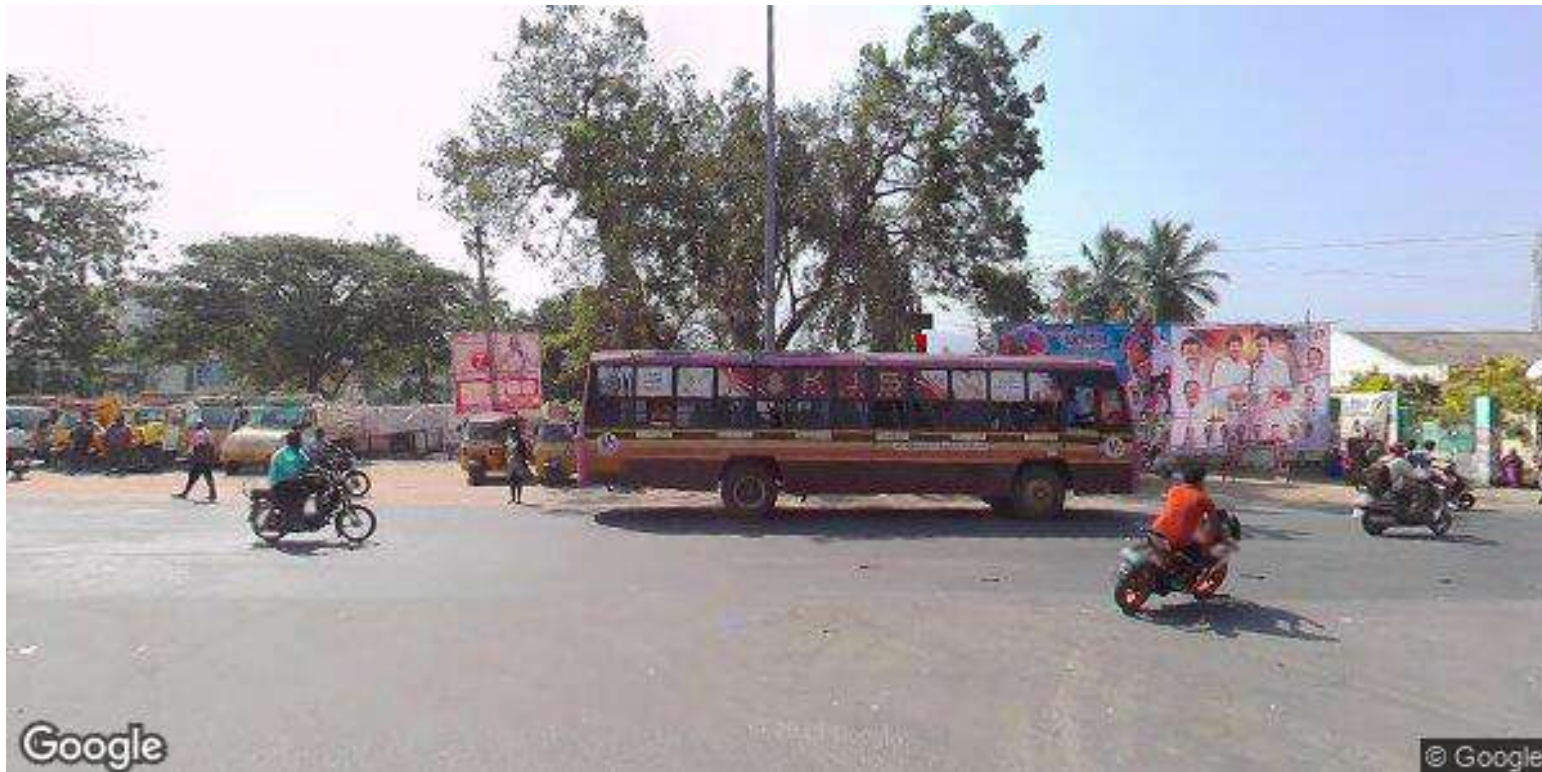
**Coordinates: 11.67120, 78.23136**

**Risk Type: Blind Spot**

**Risk Level: Blind Spot**

**Speed Limit: 10 KM/Hr**

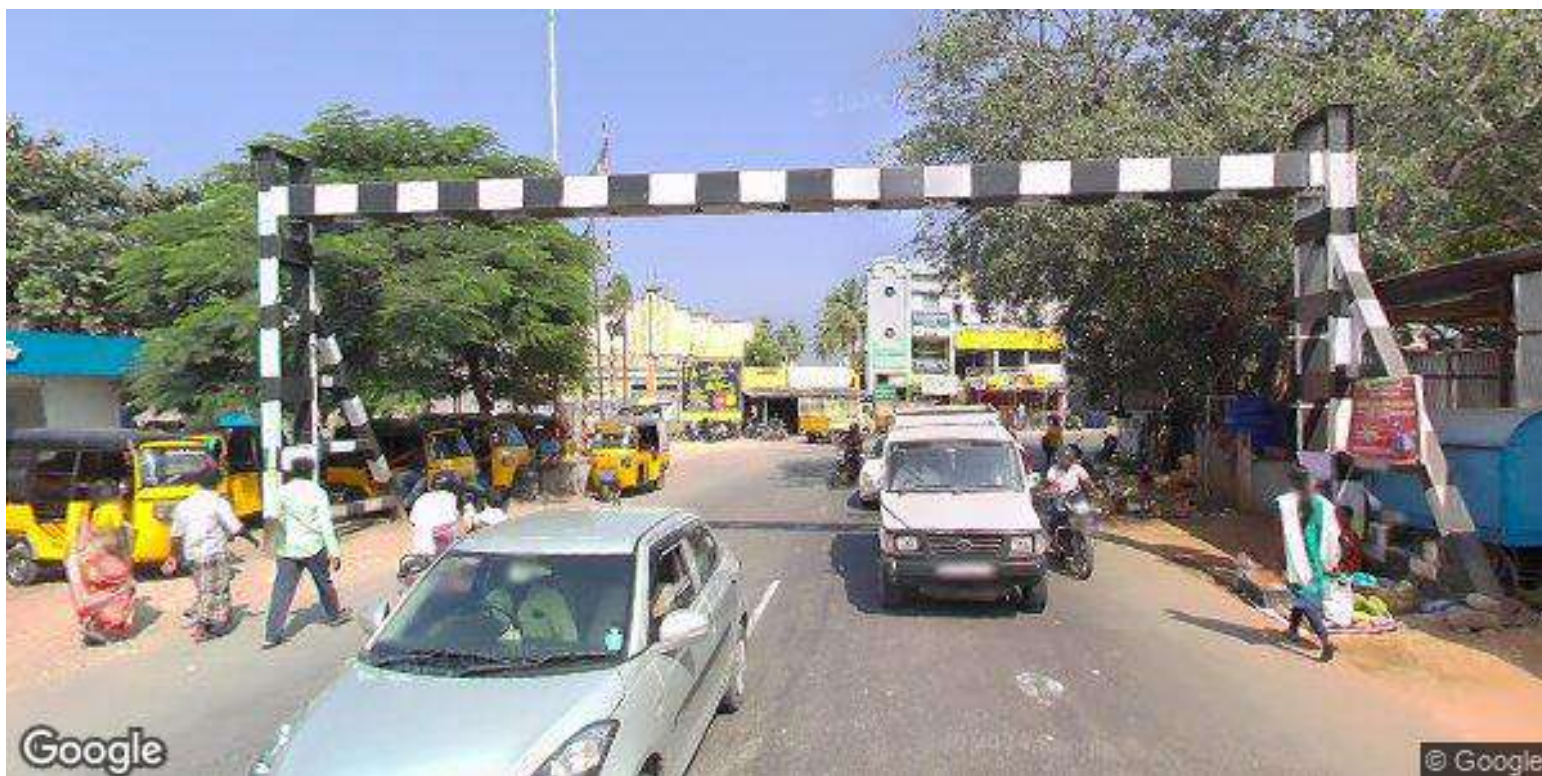
**Coordinates: 11.67171, 78.23139**

**Risk Type: Turn**

**Risk Level: High**

**Speed Limit: 15 KM/Hr**

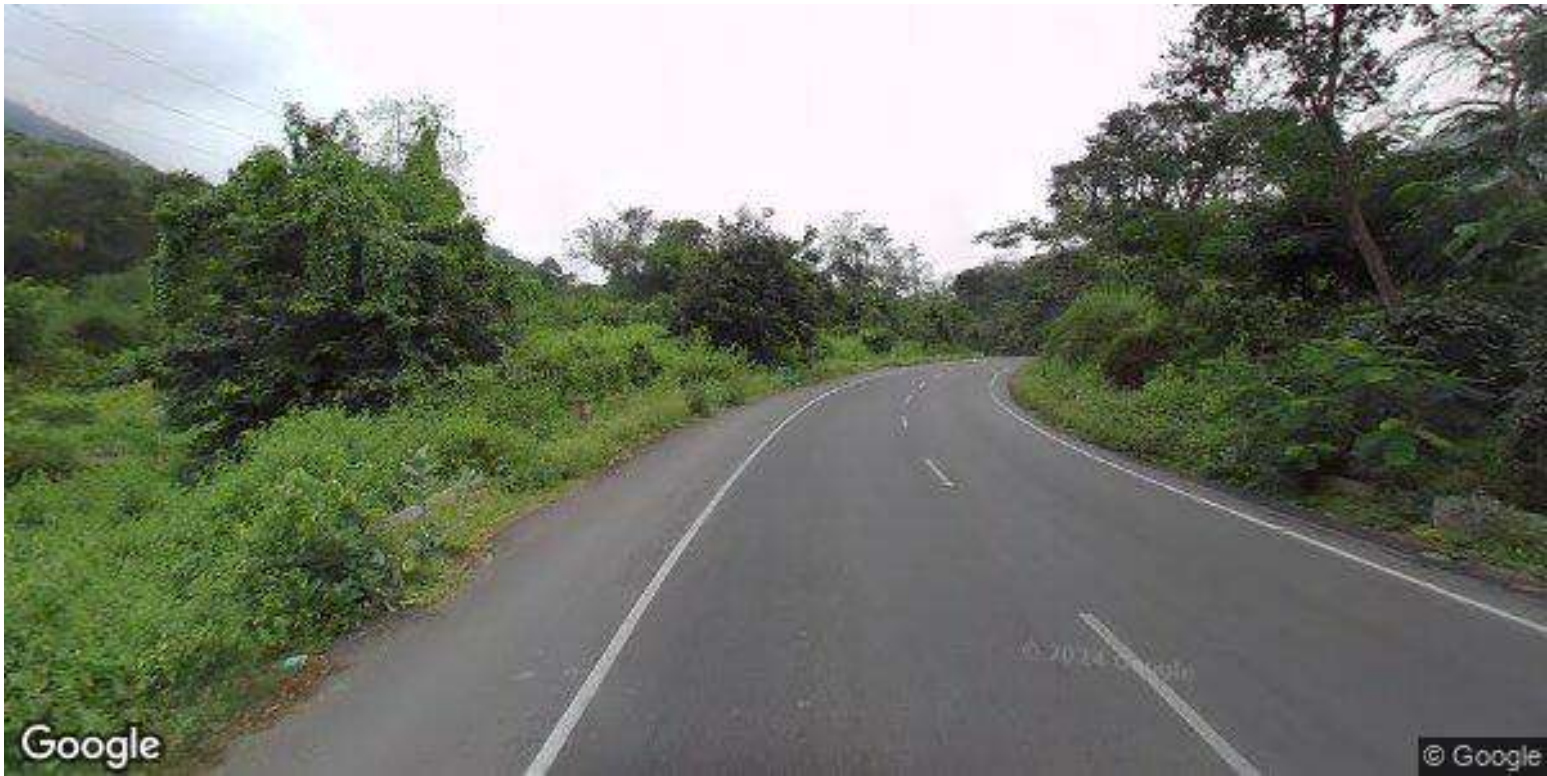
**Risk Type:** Turn  
**Risk Level:** Medium  
**Speed Limit:** 30 KM/Hr  
**Coordinates:** 11.79052, 78.32170

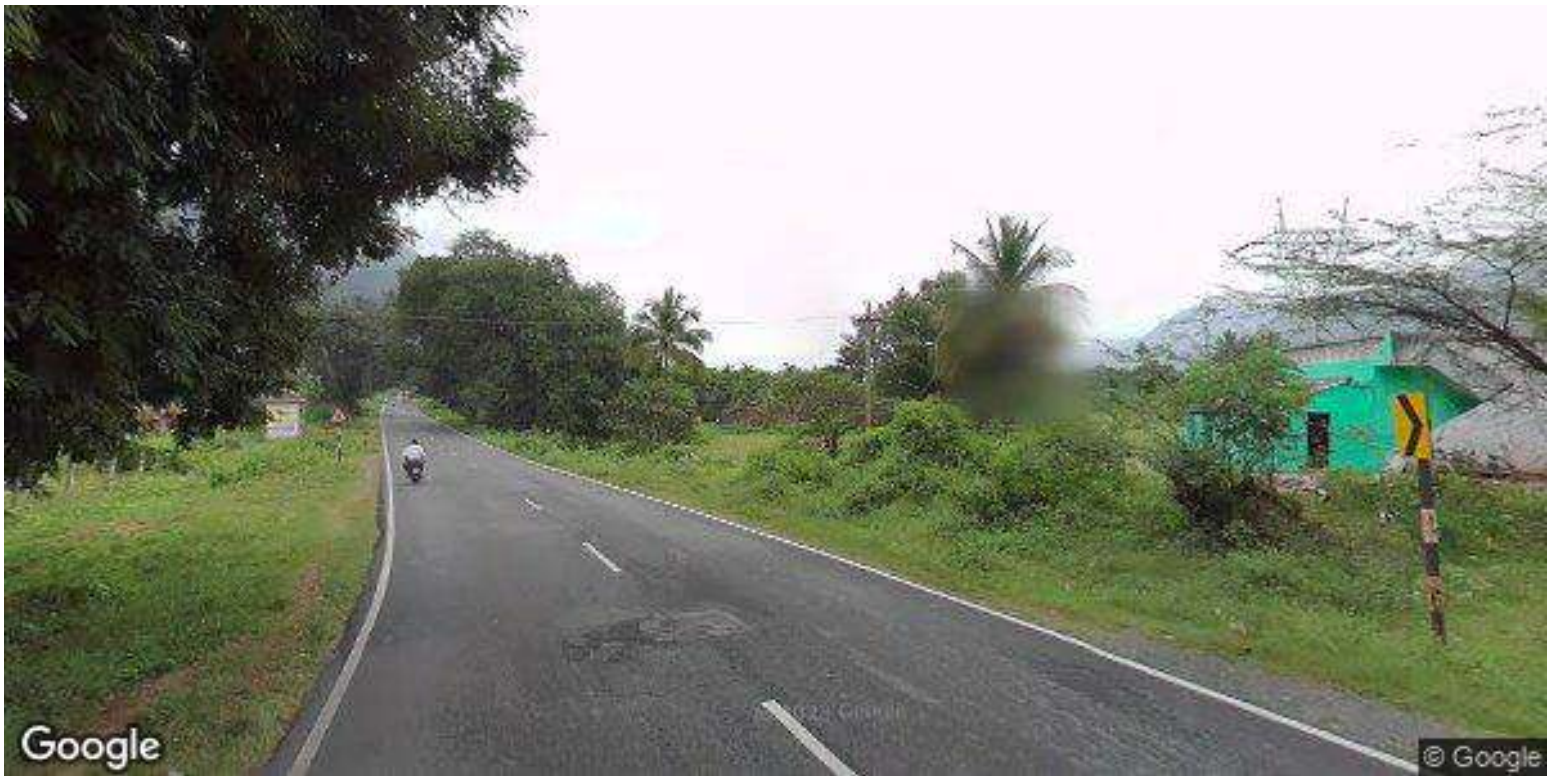
**Risk Type:** Turn  
**Risk Level:** Medium  
**Speed Limit:** 30 KM/Hr  
**Coordinates:** 11.81249, 78.34088

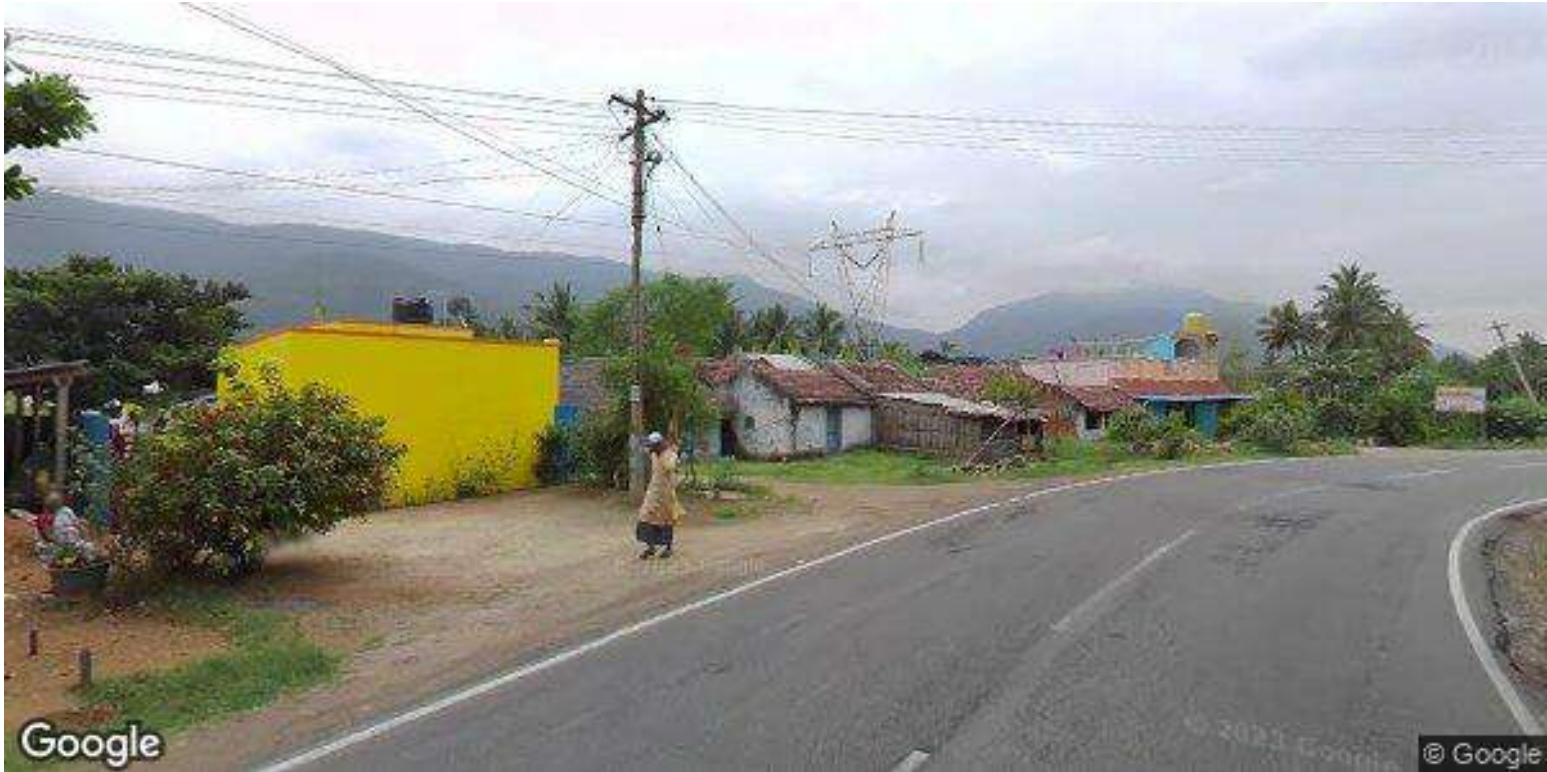
**Risk Type:** Turn  
**Risk Level:** Medium  
**Speed Limit:** 30 KM/Hr  
**Coordinates:** 11.83492, 78.35299
