## JOURNEY RISK MANAGEMENT (JRM) STUDY

### Salem Terminal to K.K FUELS

#### Objective of the JRM Report

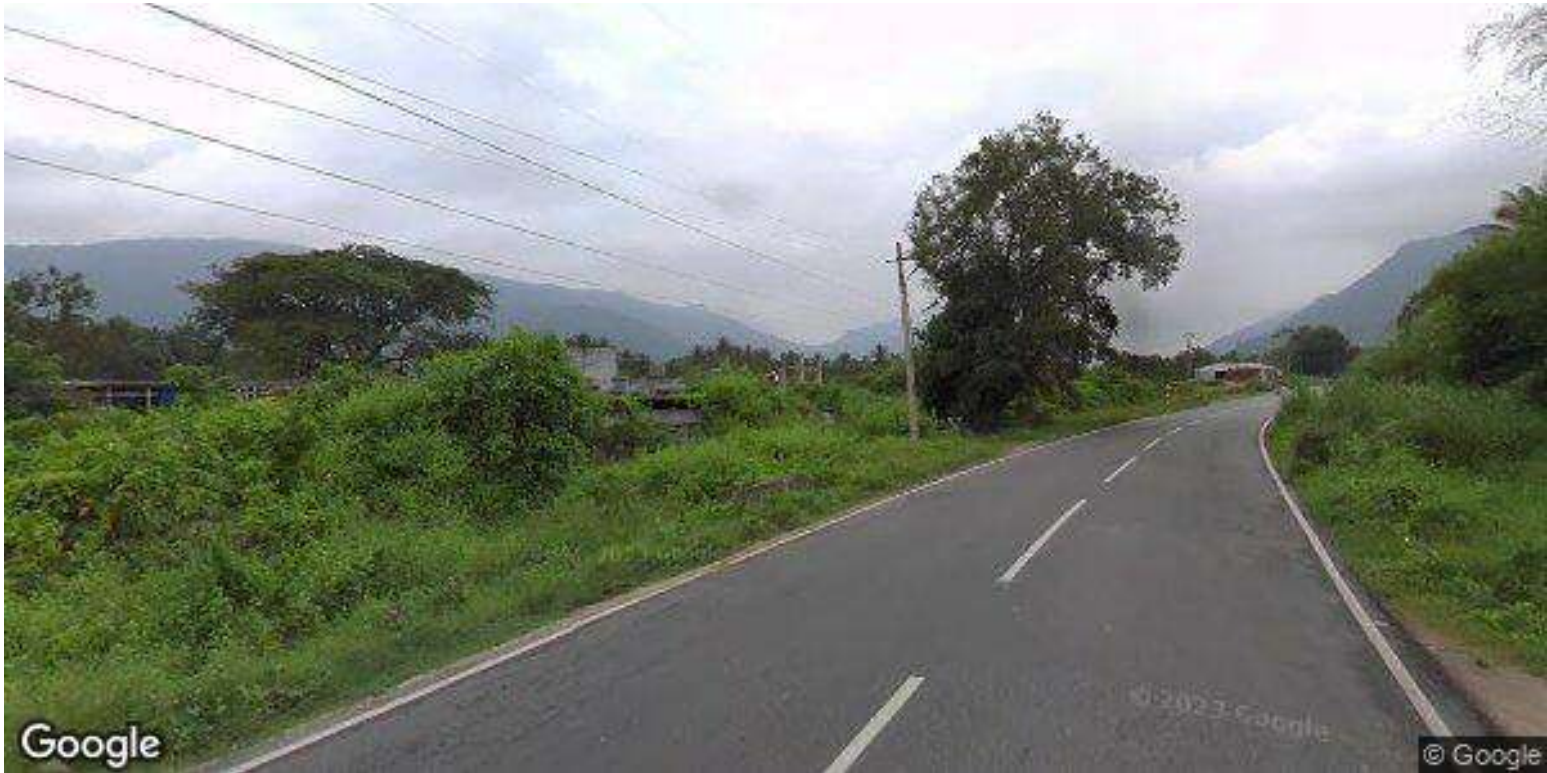
**Risk Type:** Turn  
**Risk Level:** Medium  
**Speed Limit:** 30 KM/Hr  
**Coordinates:** 11.84761, 78.36080

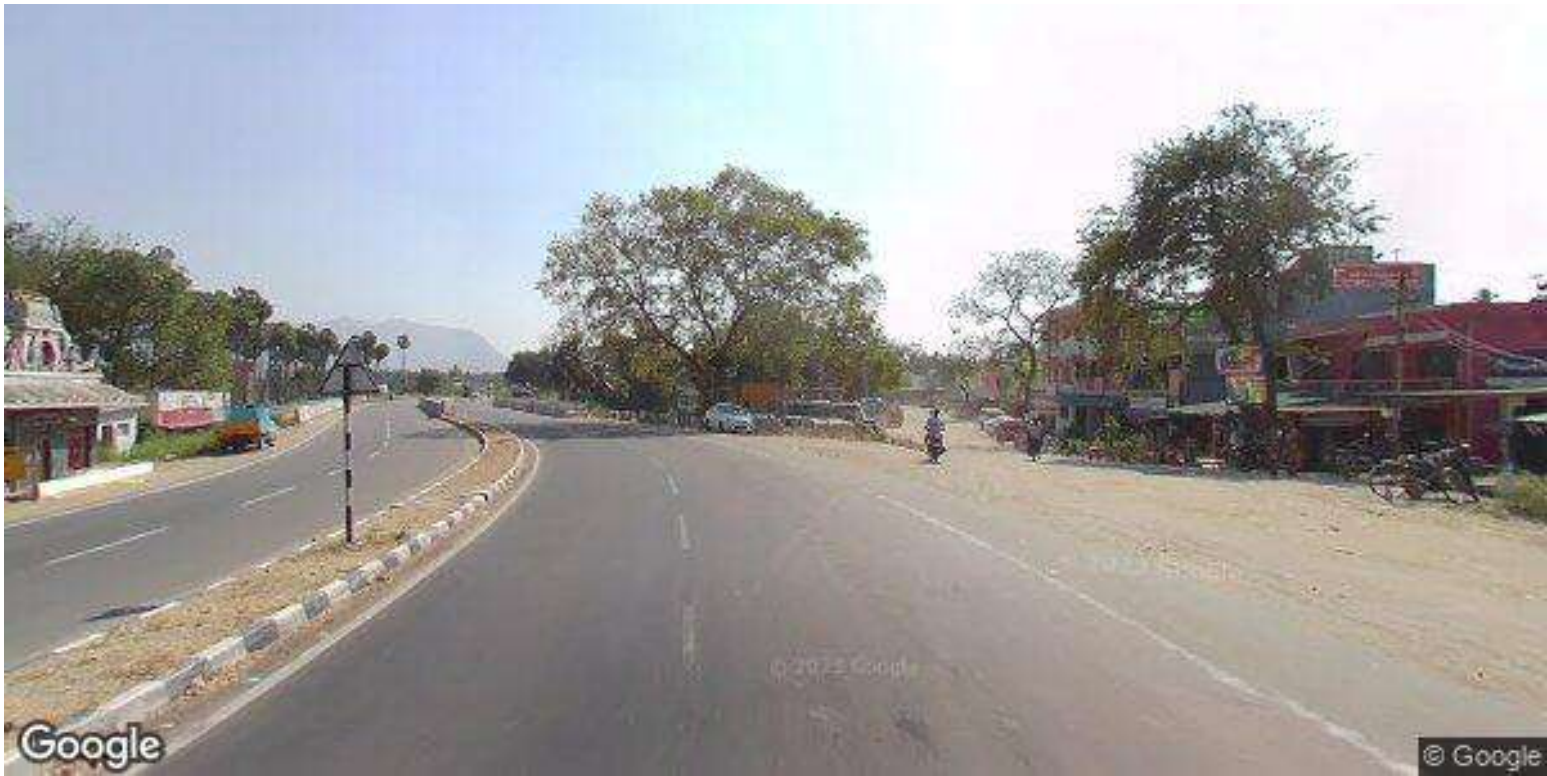
**Risk Type:** Turn  
**Risk Level:** Medium  
**Speed Limit:** 30 KM/Hr  
**Coordinates:** 11.99572, 78.44559

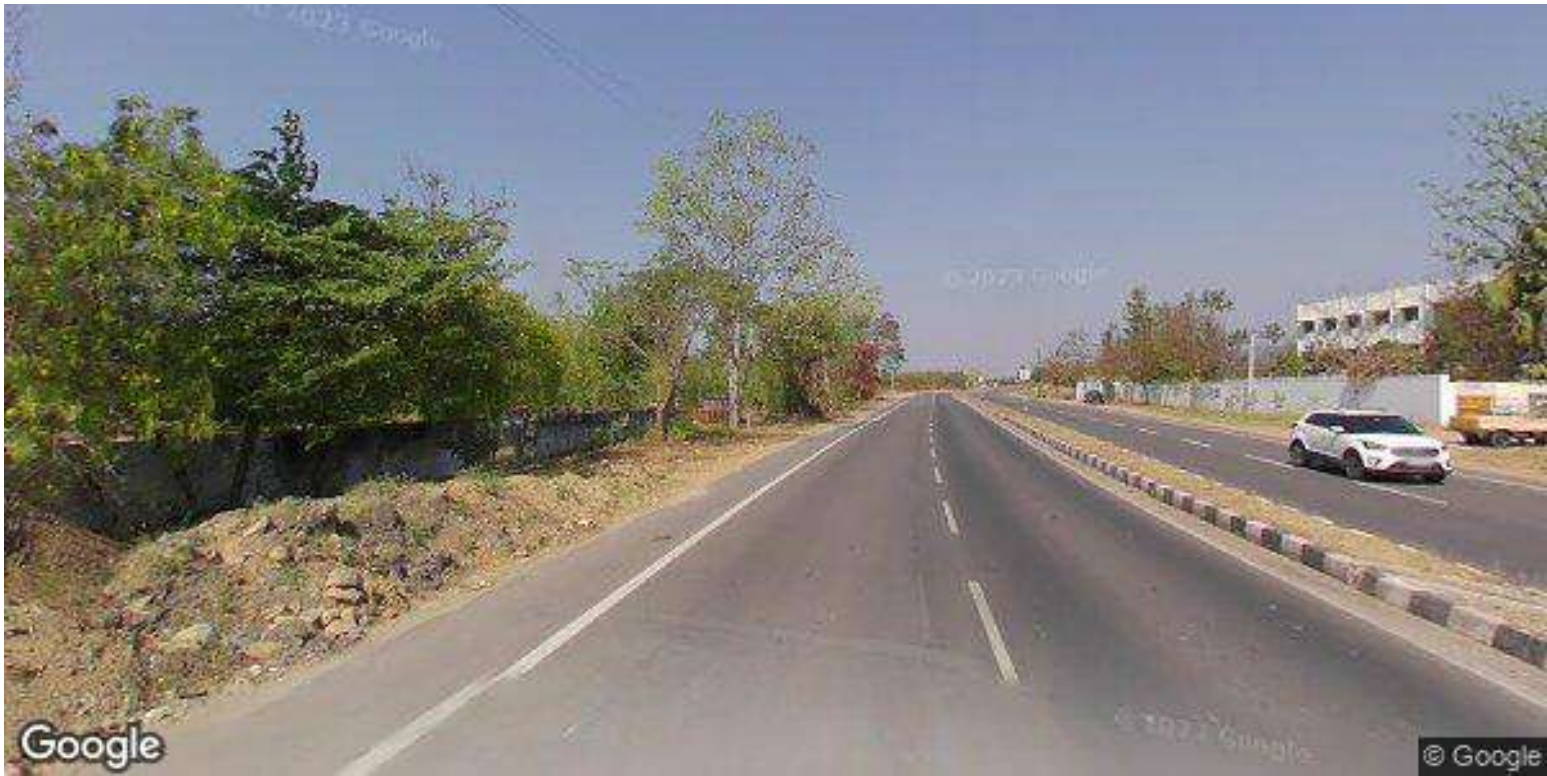
**Risk Type:** Turn  
**Risk Level:** Medium  
**Speed Limit:** 30 KM/Hr  
**Coordinates:** 12.01595, 78.45693

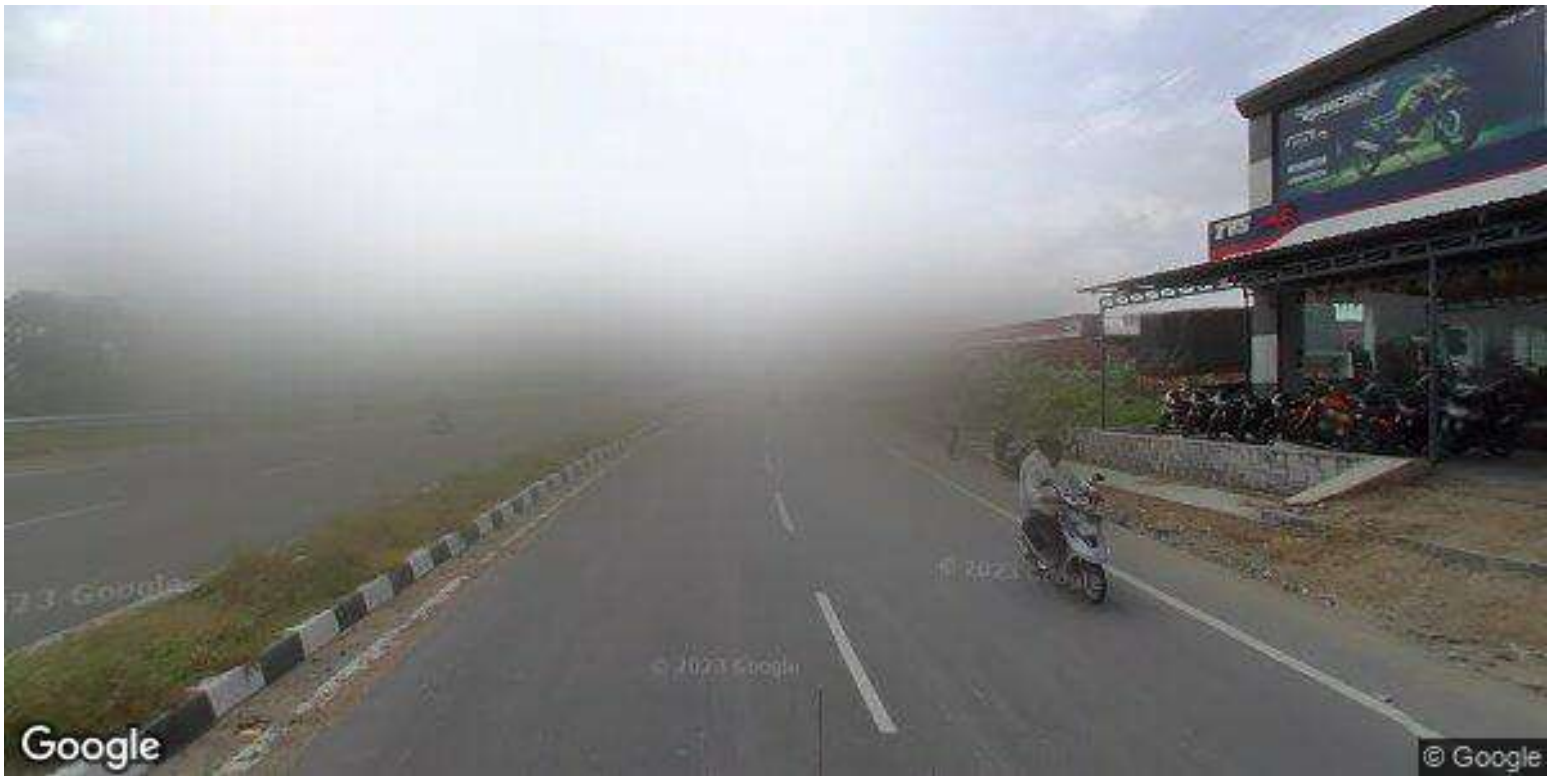
**Risk Type:** Turn  
**Risk Level:** Medium  
**Speed Limit:** 30 KM/Hr  
**Coordinates:** 12.04269, 78.48340

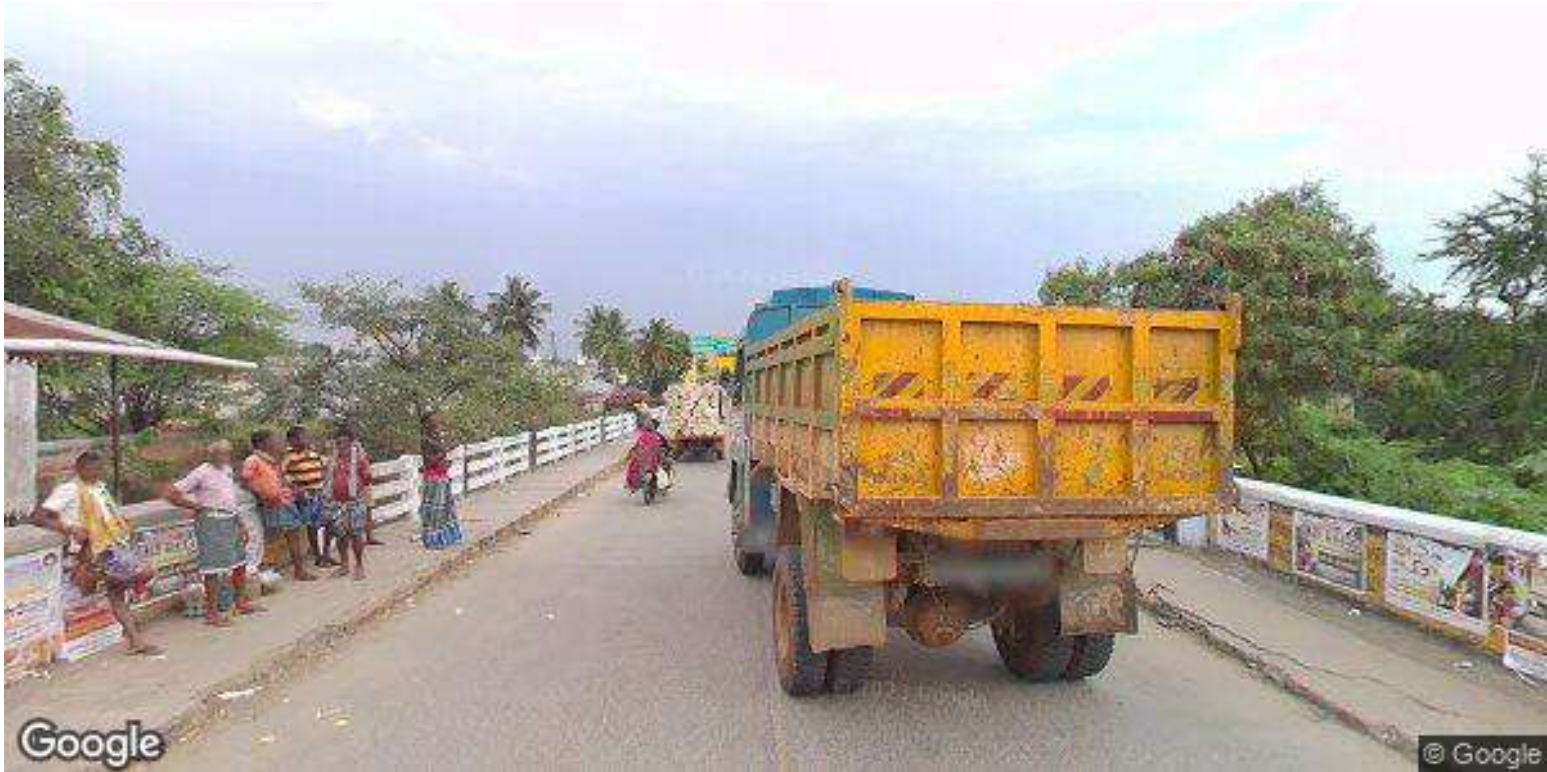
**Risk Type:** Turn  
**Risk Level:** High  
**Speed Limit:** 15 KM/Hr  
**Coordinates:** 12.04666, 78.48405

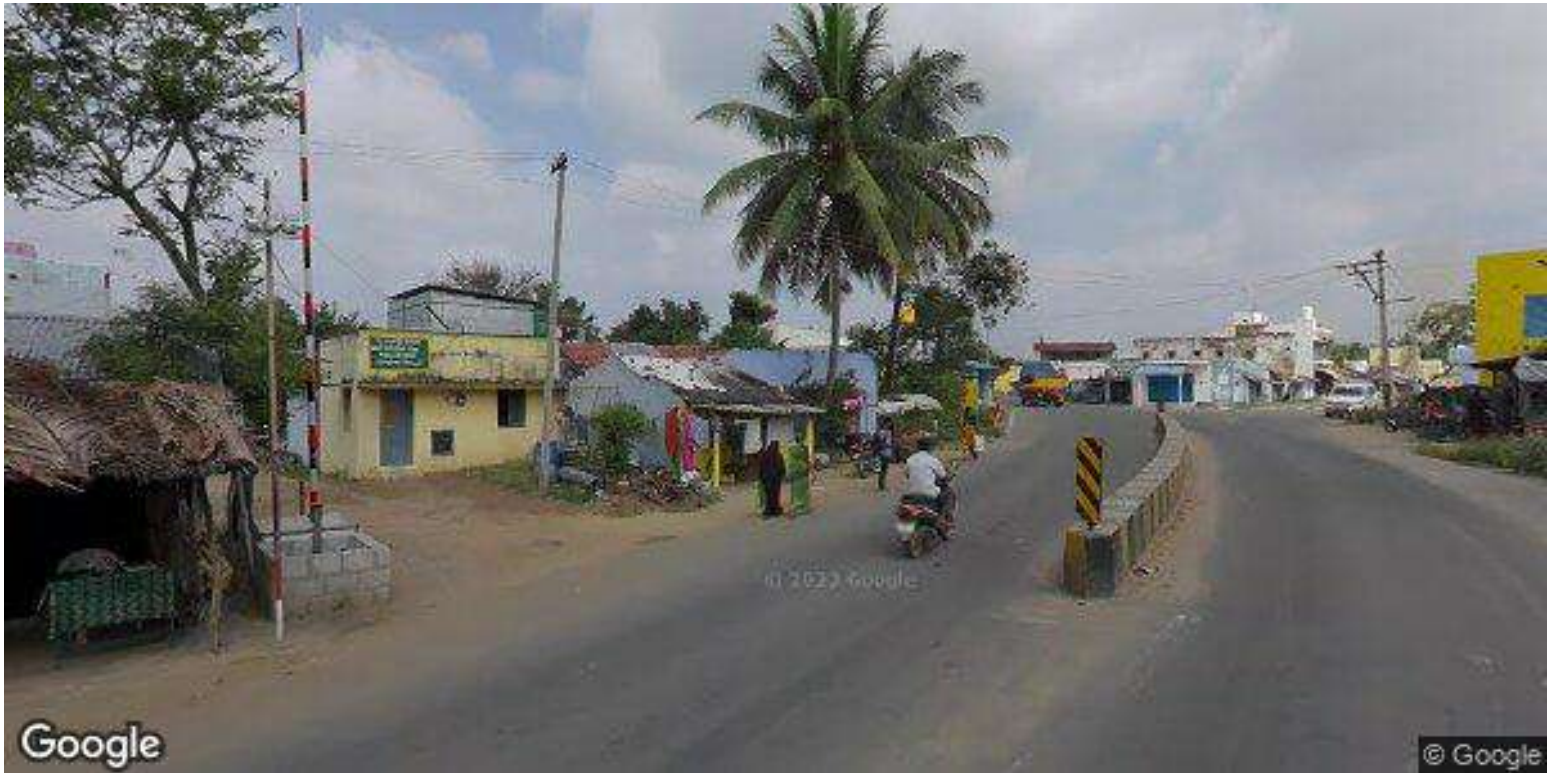
**Risk Type:** Turn  
**Risk Level:** Medium  
**Speed Limit:** 30 KM/Hr  
**Coordinates:** 12.04646, 78.48498

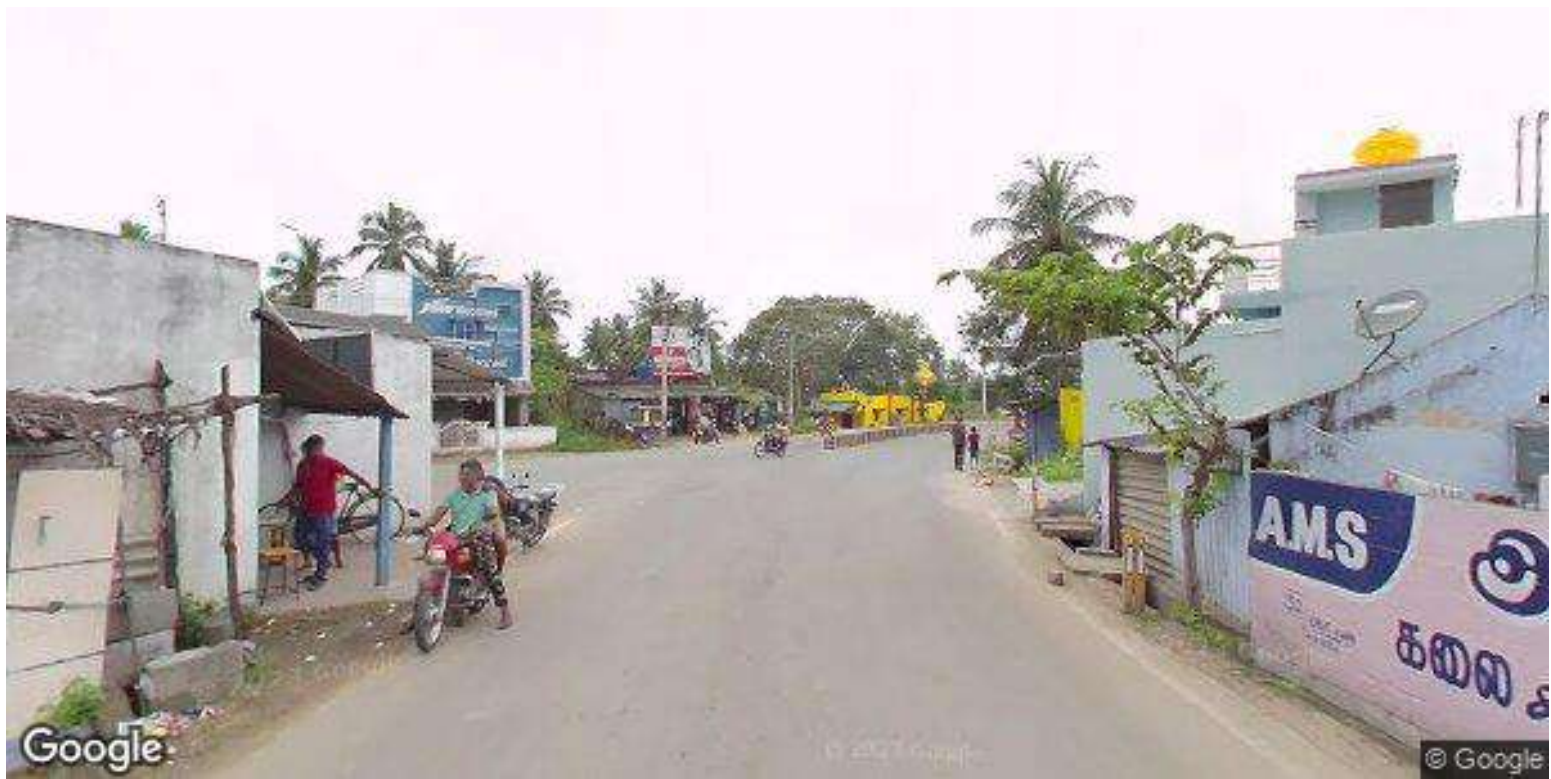
**Coordinates:** 12.04663, 78.48554

**Risk Type:** Turn

**Risk Level:** Medium

**Speed Limit:** 30 KM/Hr

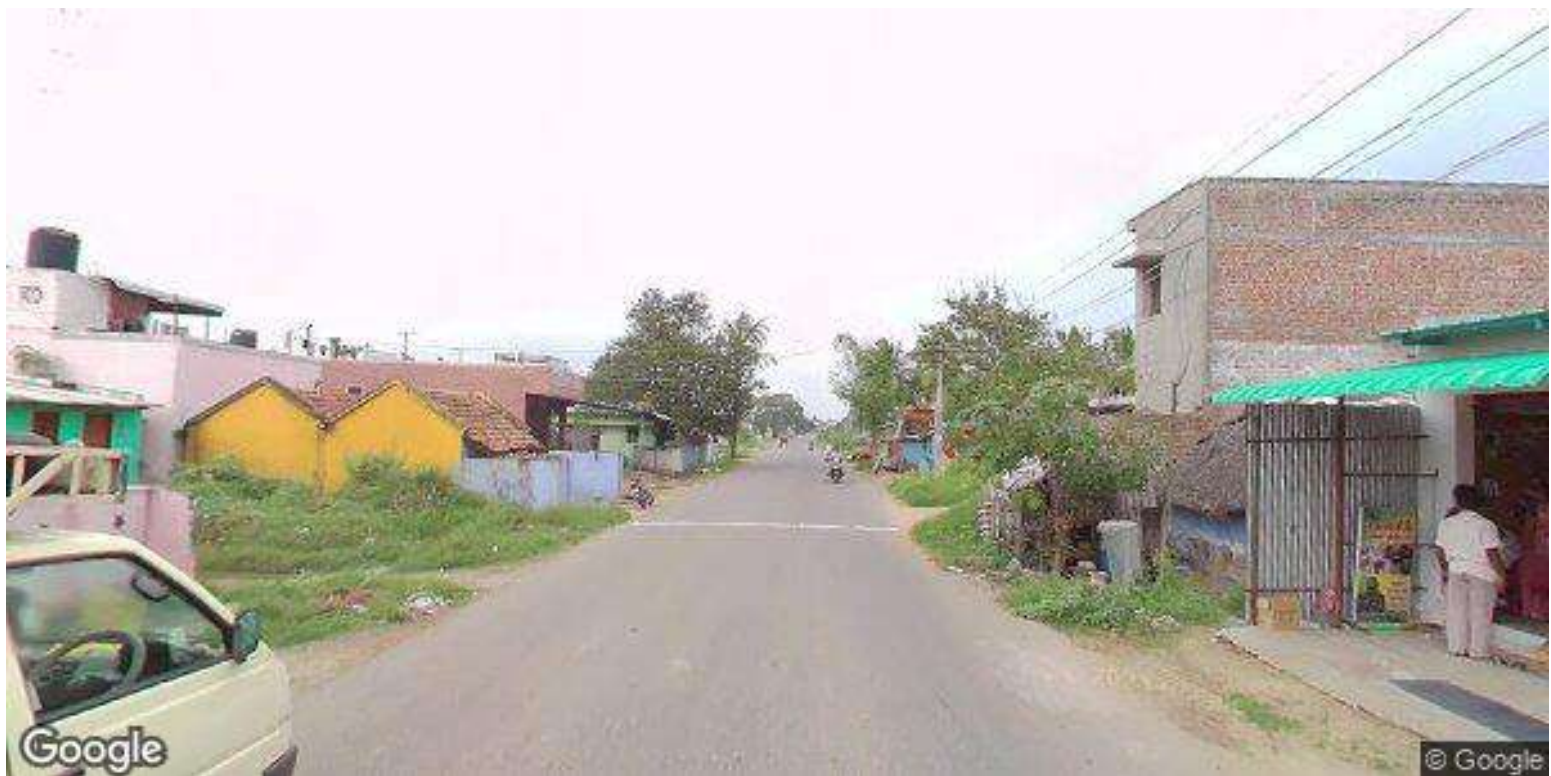
**Coordinates:** 12.04722, 78.48607

**Risk Type:** Turn

**Risk Level:** Medium

**Speed Limit:** 30 KM/Hr
