# IndianOil

## JOURNEY RISK MANAGEMENT (JRM) STUDY

### Salem Terminal to SRI MAHADHEV FUEL

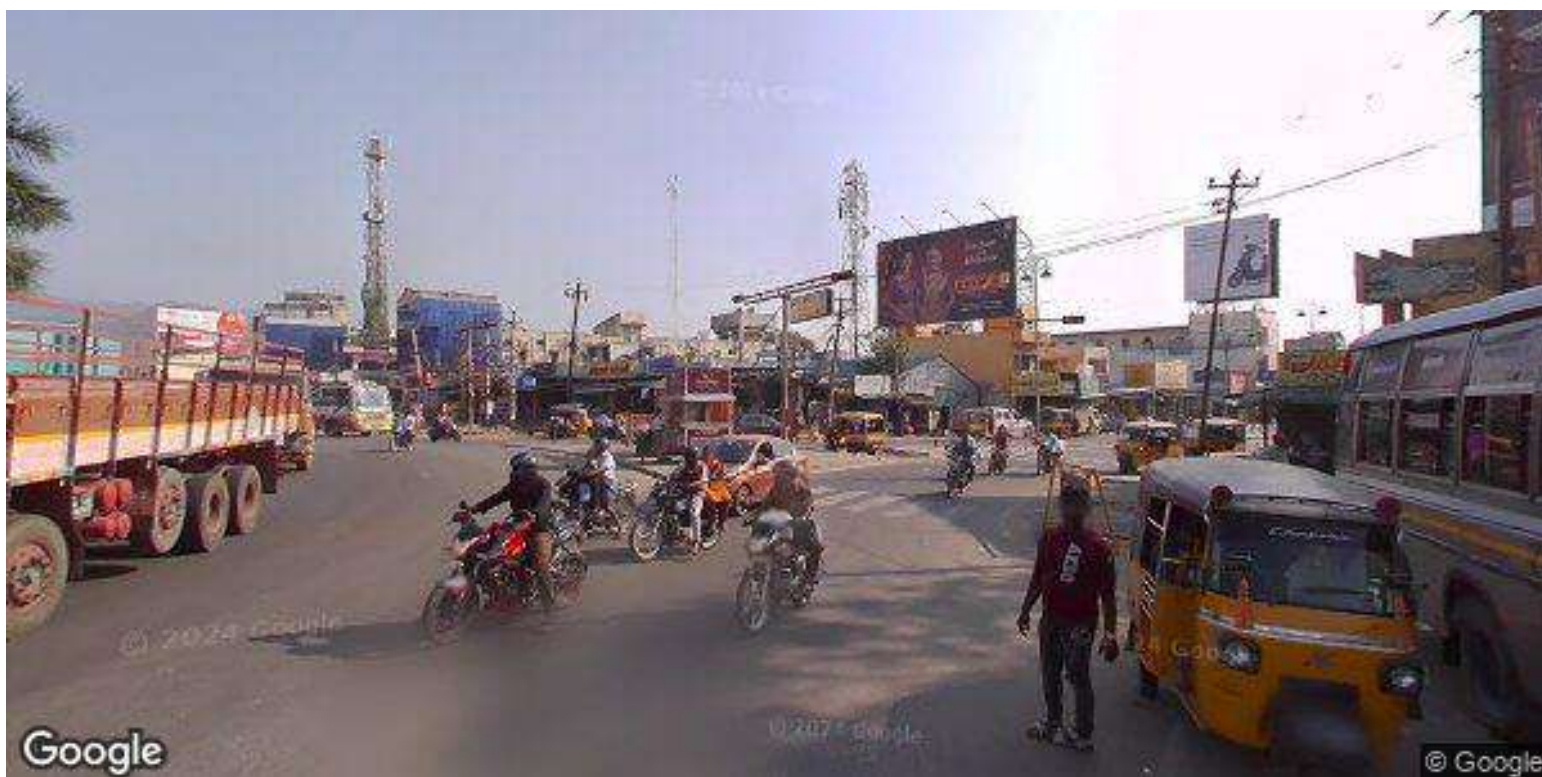
**Coordinates:** 11.63266, 78.12699

**Risk Type:** Roundabout

**Risk Level:** High

**Speed Limit:** 15 KM/Hr

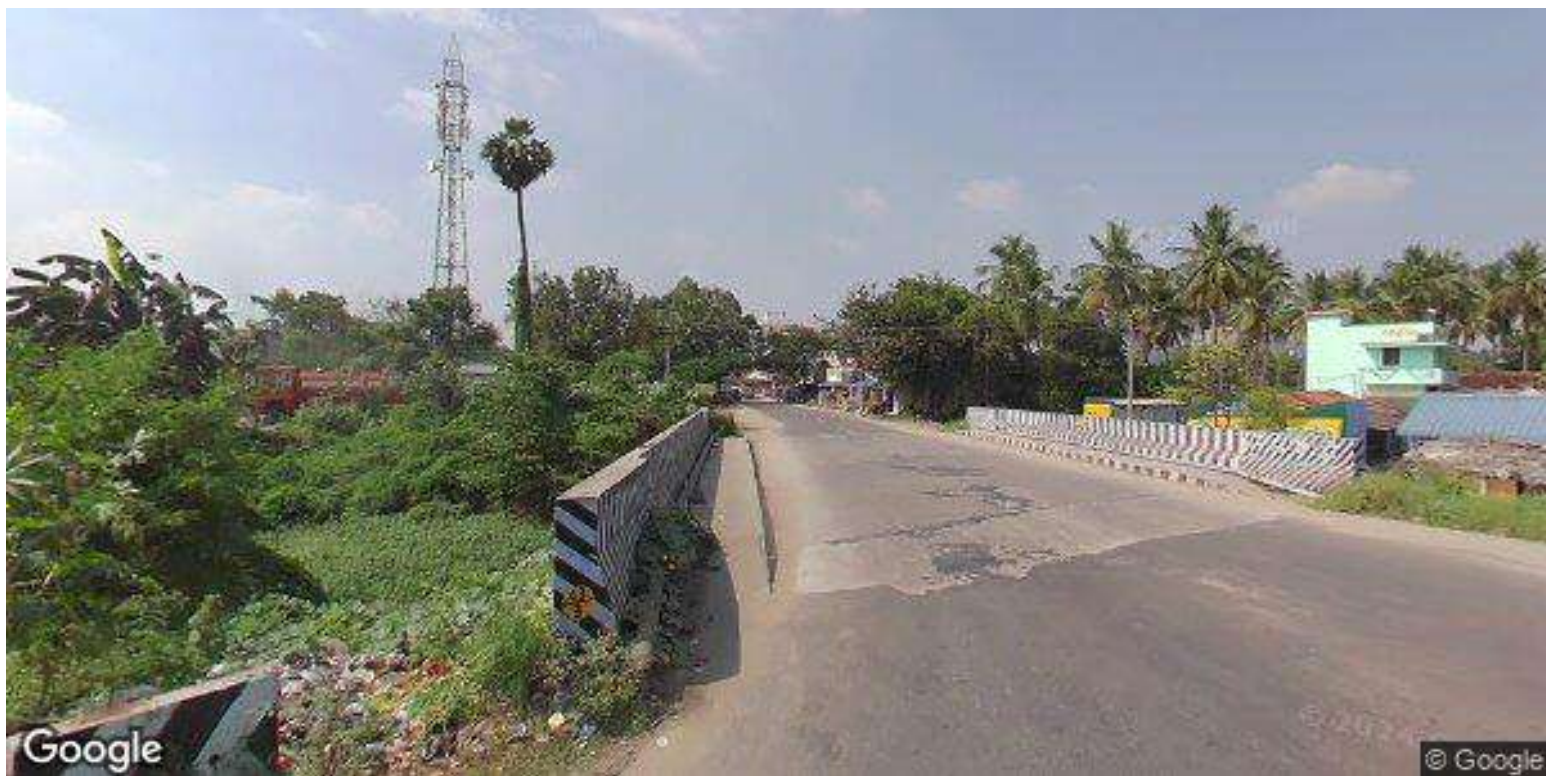
**Coordinates:** 11.44900, 77.87406

**Risk Type:** Turn

**Risk Level:** Medium

**Speed Limit:** 30 KM/Hr

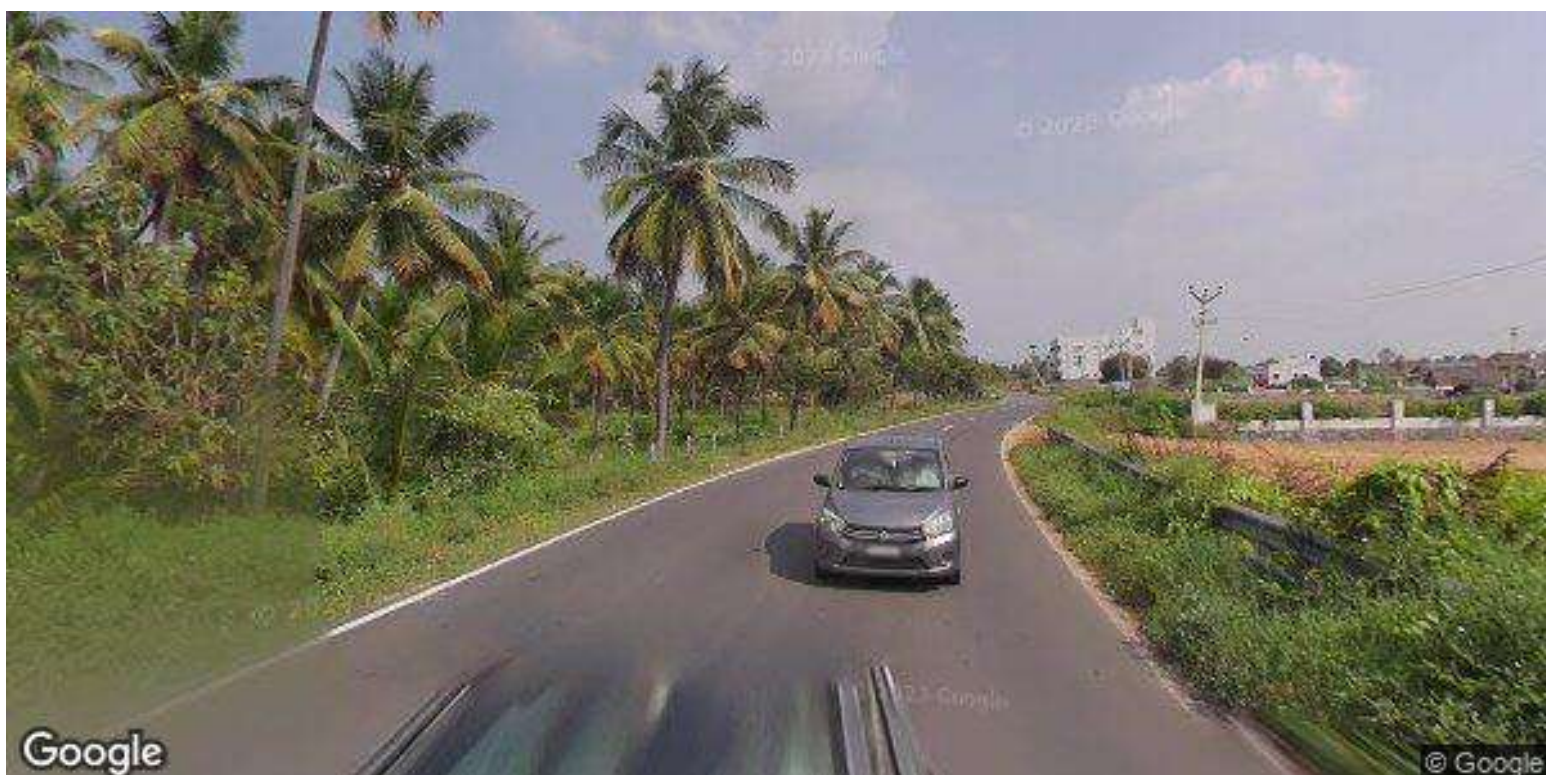
**Risk Type:** Turn  
**Risk Level:** Medium  
**Speed Limit:** 30 KM/Hr  
**Coordinates:** 11.45357, 77.85789

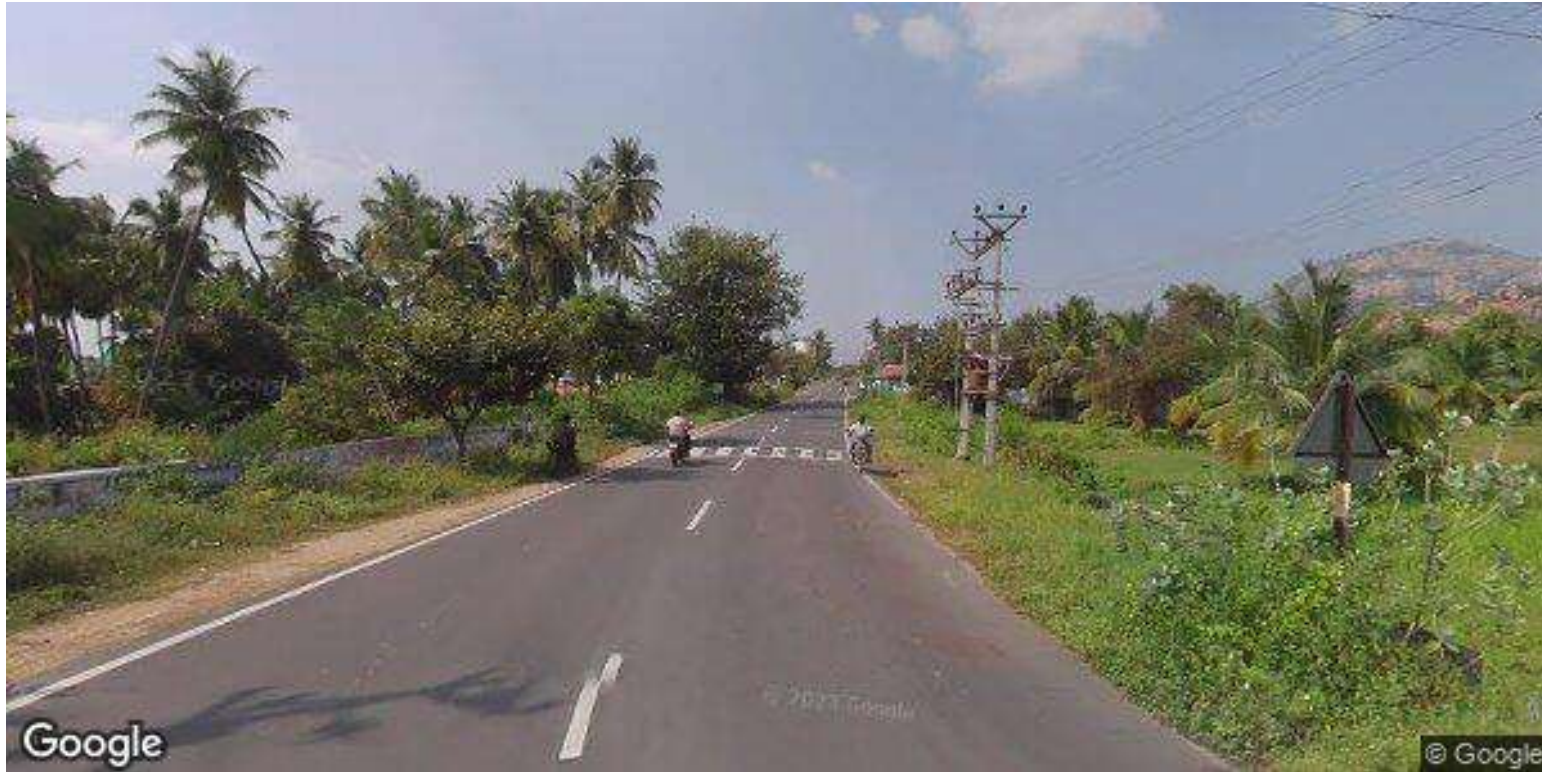
**Risk Type:** Turn  
**Risk Level:** High  
**Speed Limit:** 15 KM/Hr  
**Coordinates:** 11.45352, 77.85698

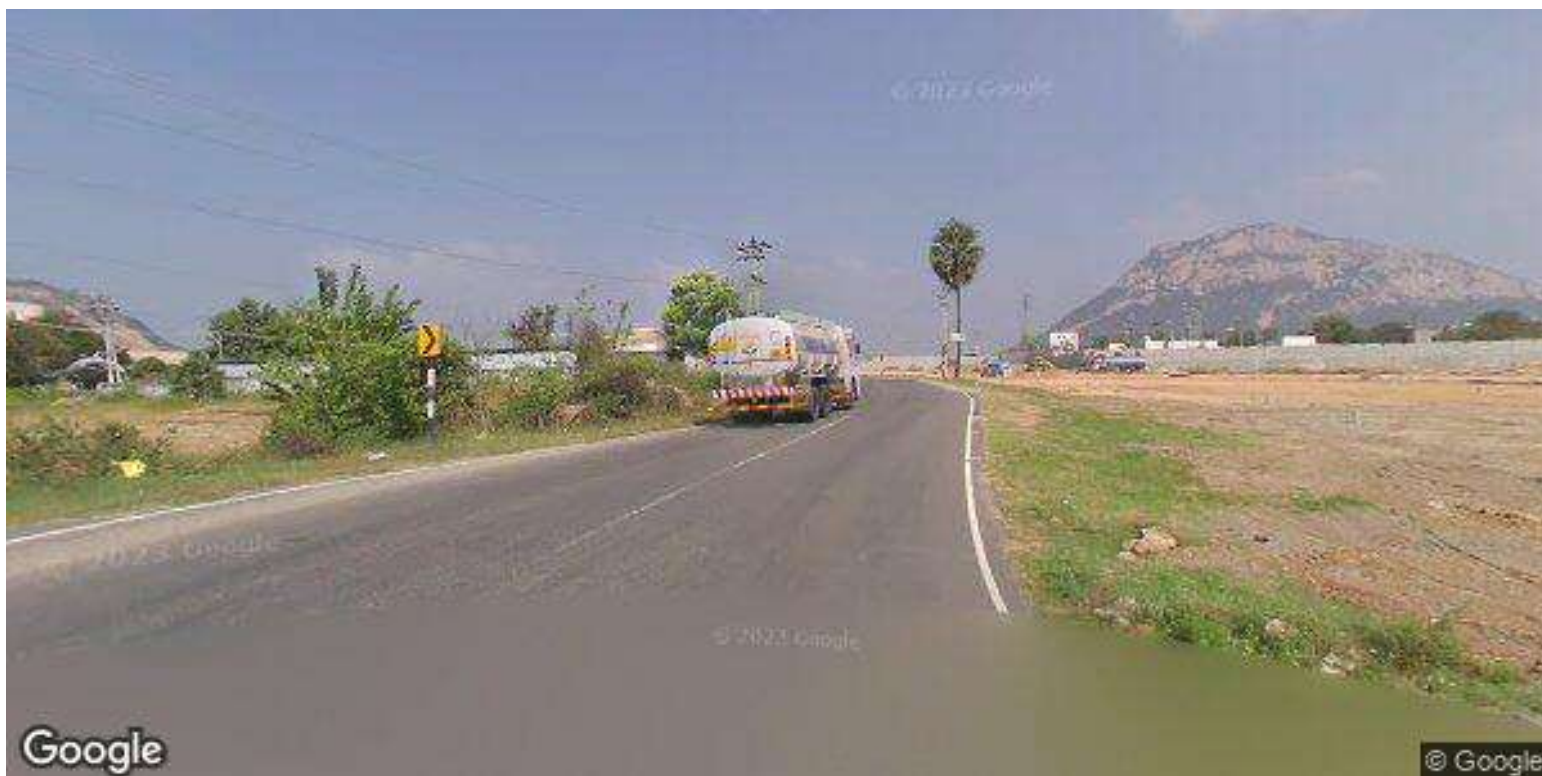
**Risk Type:** Turn  
**Risk Level:** Medium  
**Speed Limit:** 30 KM/Hr  
**Coordinates:** 11.45847, 77.85140

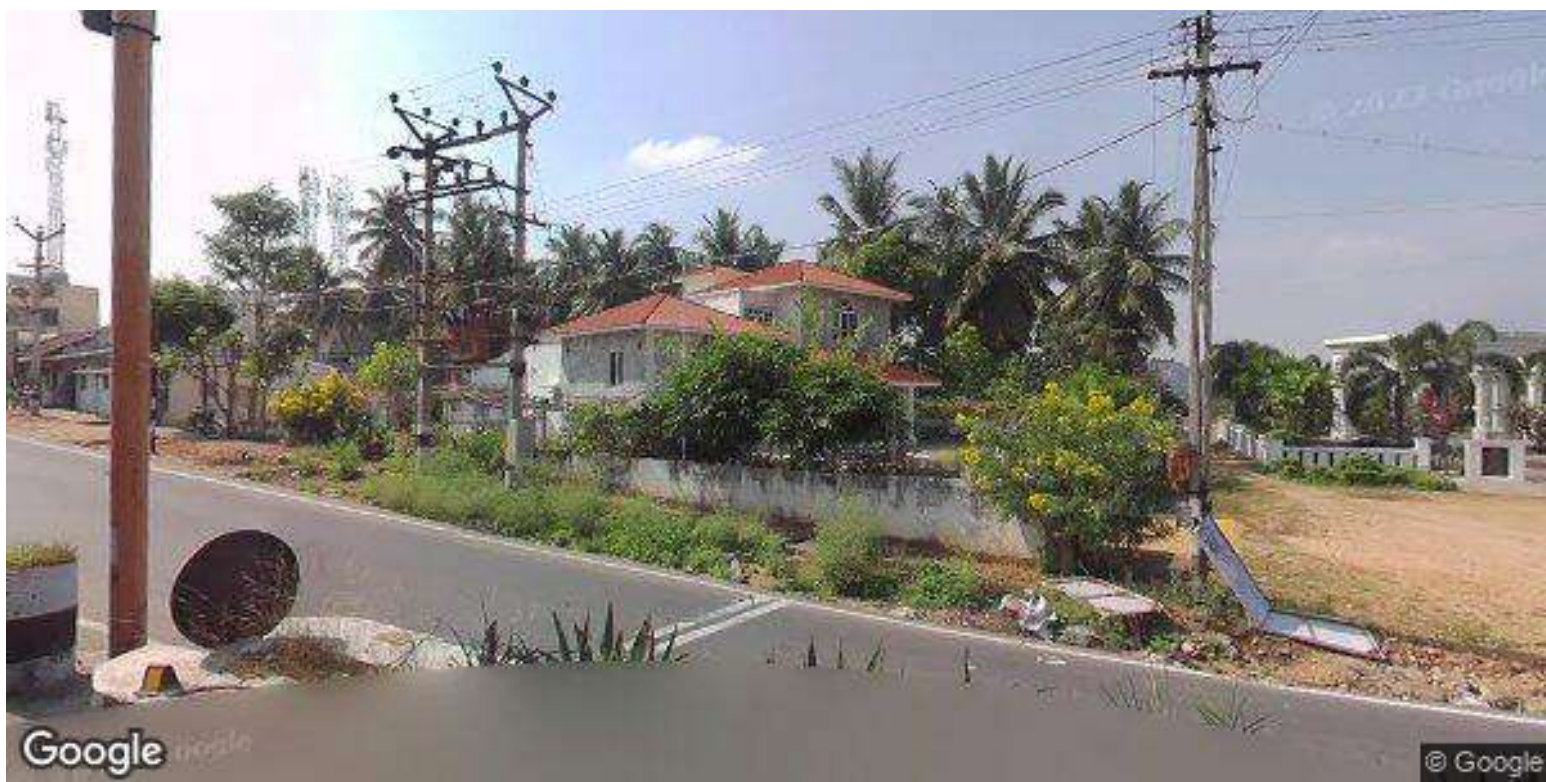
**Coordinates:** 11.46303, 77.84945

**Risk Type:** Turn

**Risk Level:** Medium

**Speed Limit:** 30 KM/Hr

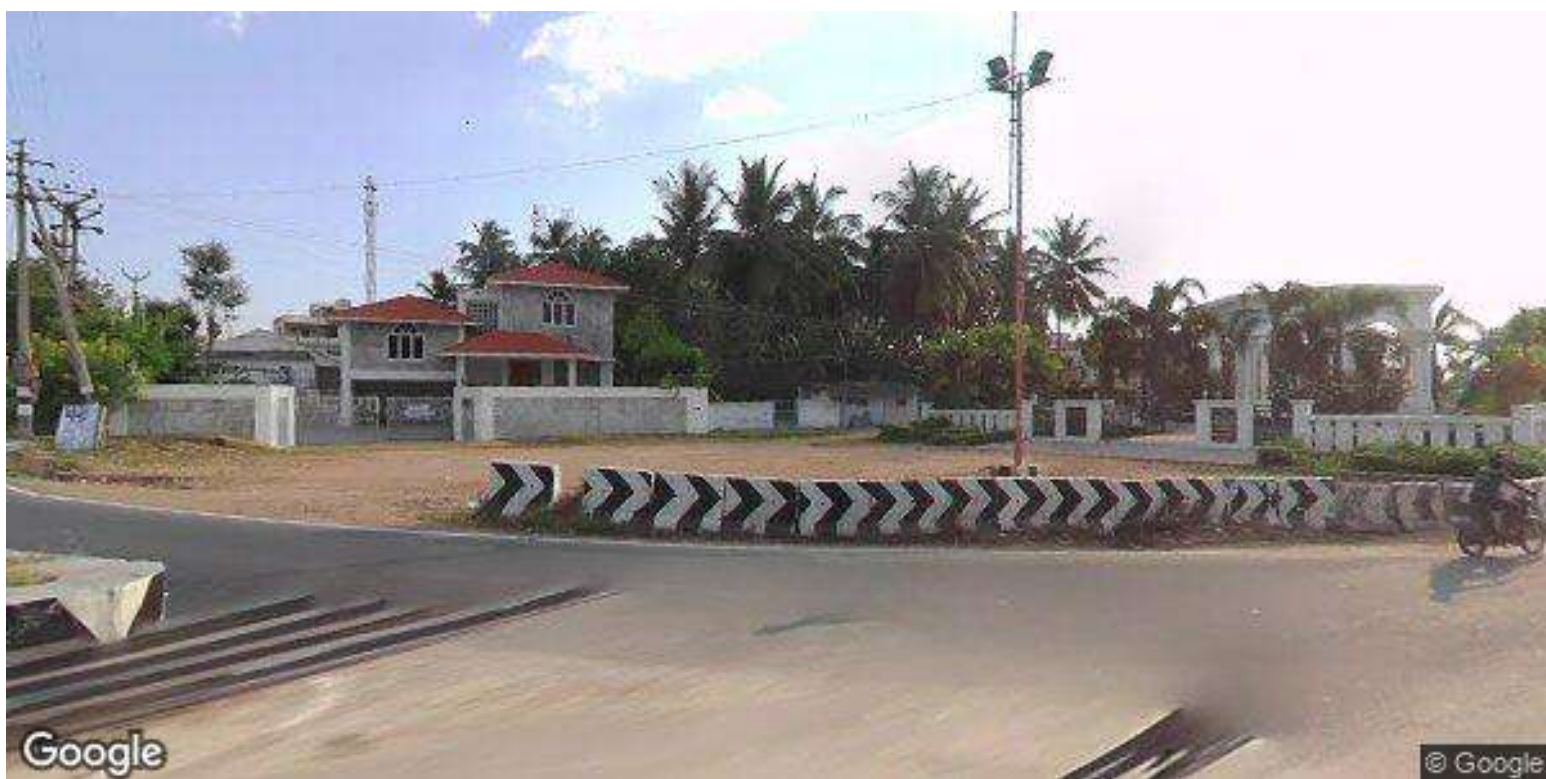
**Coordinates:** 11.46314, 77.84928

**Risk Type:** Turn

**Risk Level:** Medium

**Speed Limit:** 30 KM/Hr

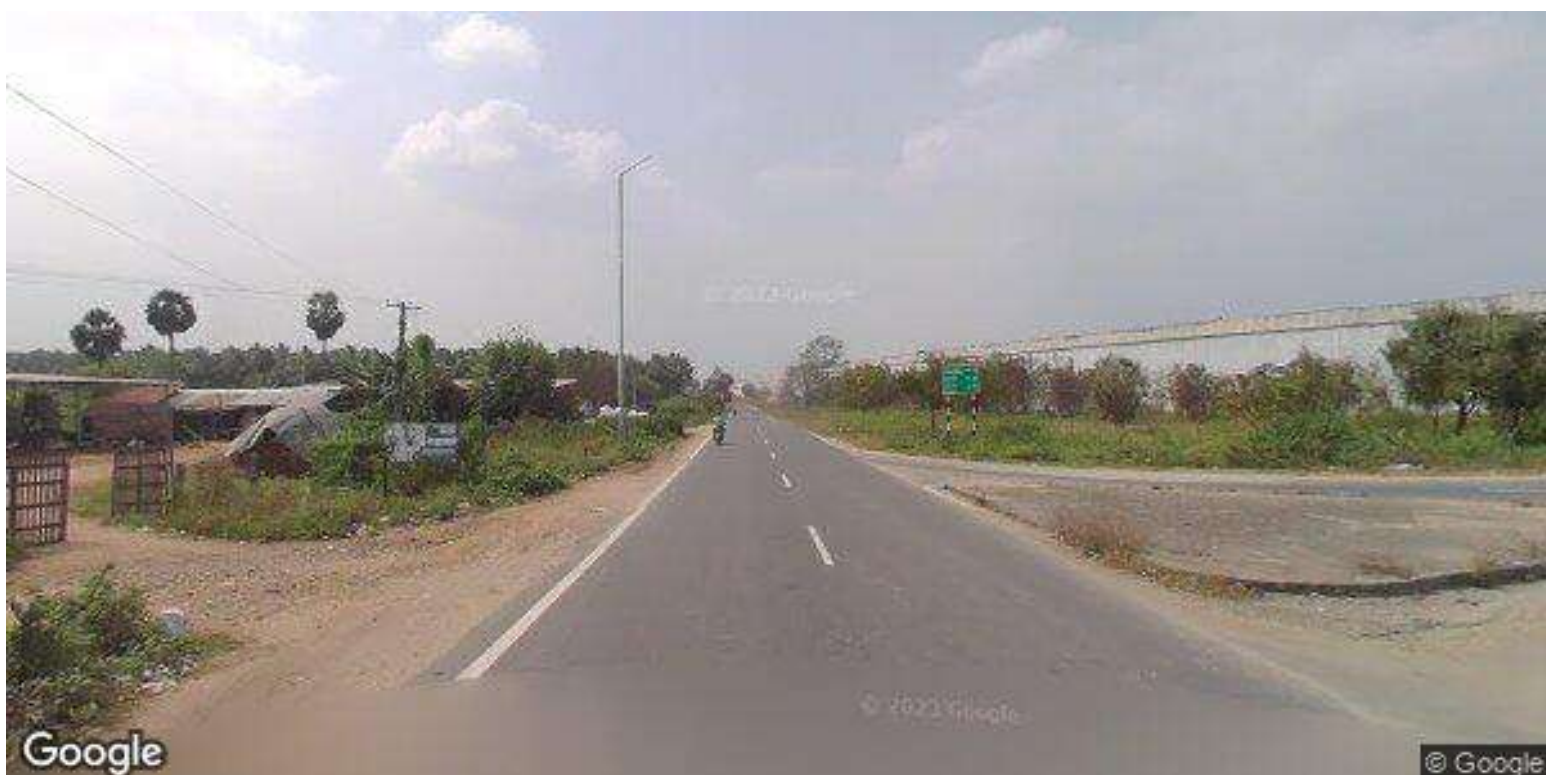
**Coordinates: 11.45542, 77.81725**

**Risk Type: Turn**

**Risk Level: High**

**Speed Limit: 15 KM/Hr**

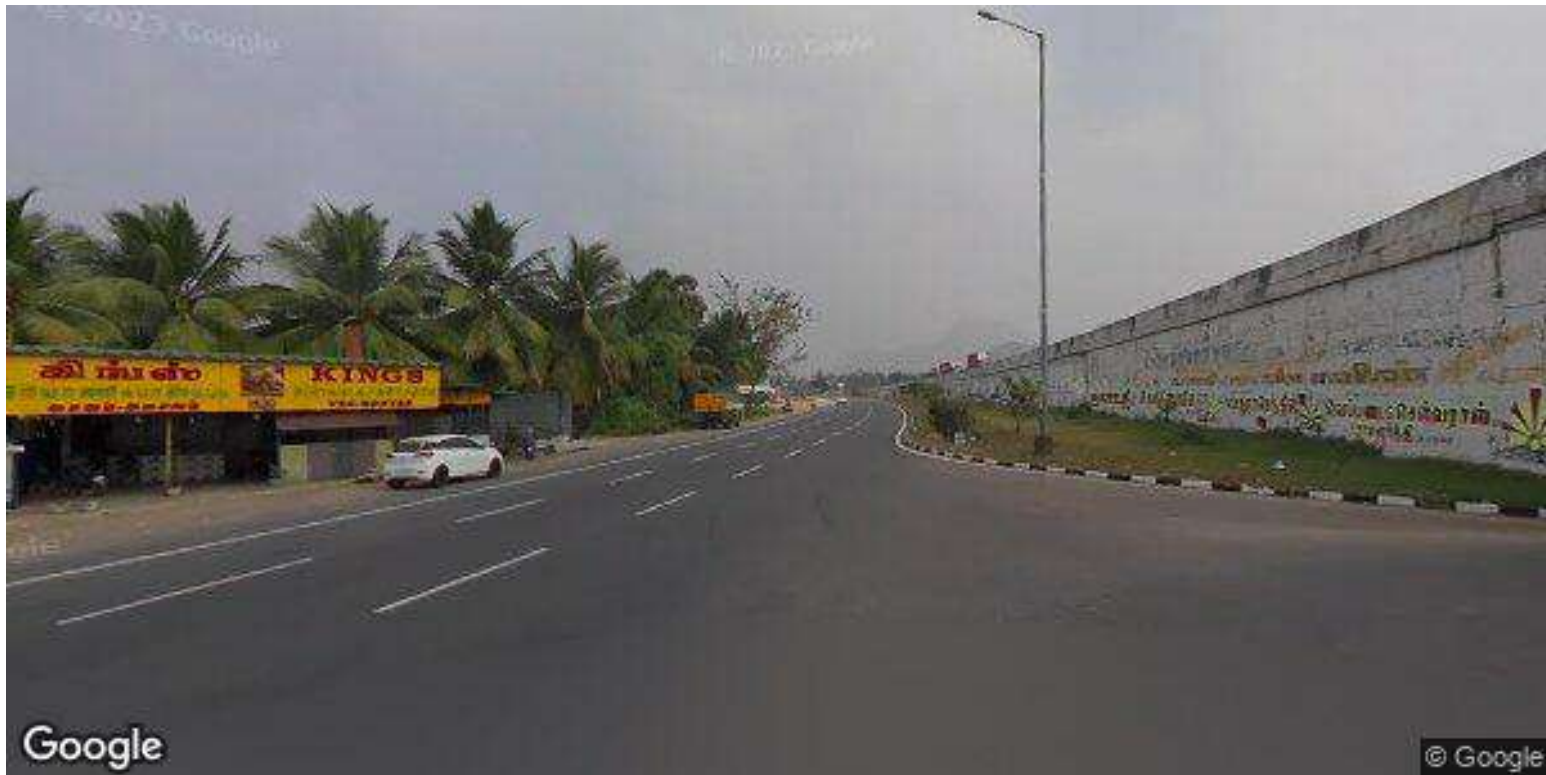
**Coordinates: 11.45634, 77.81673**

**Risk Type: Turn**

**Risk Level: High**

**Speed Limit: 15 KM/Hr**

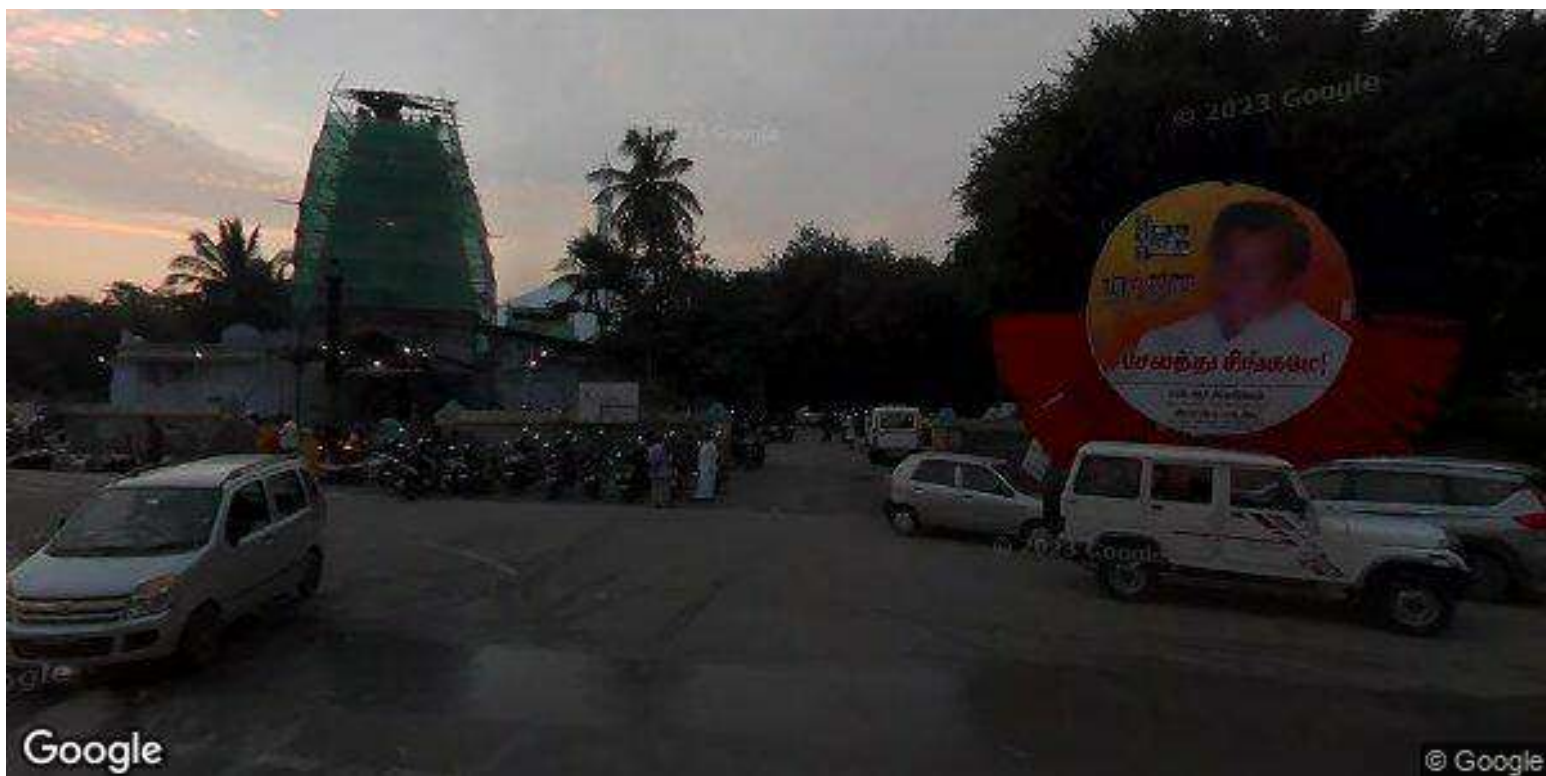
**Coordinates: 11.61233, 78.10397**

**Risk Type: Turn**

**Risk Level: High**

**Speed Limit: 15 KM/Hr**

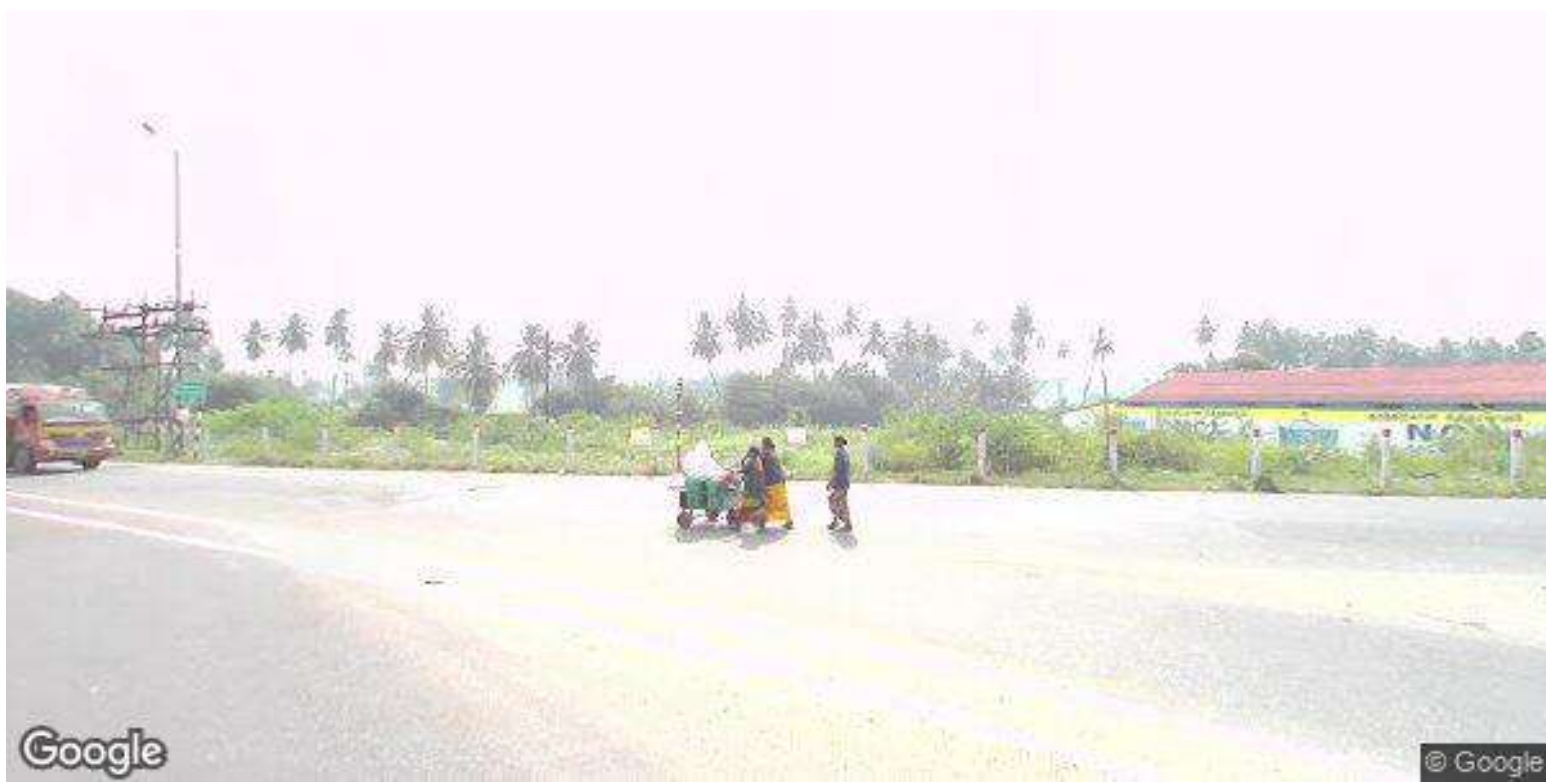
**Coordinates:** 11.61216, 78.10423

**Risk Type:** Turn

**Risk Level:** High

**Speed Limit:** 15 KM/Hr

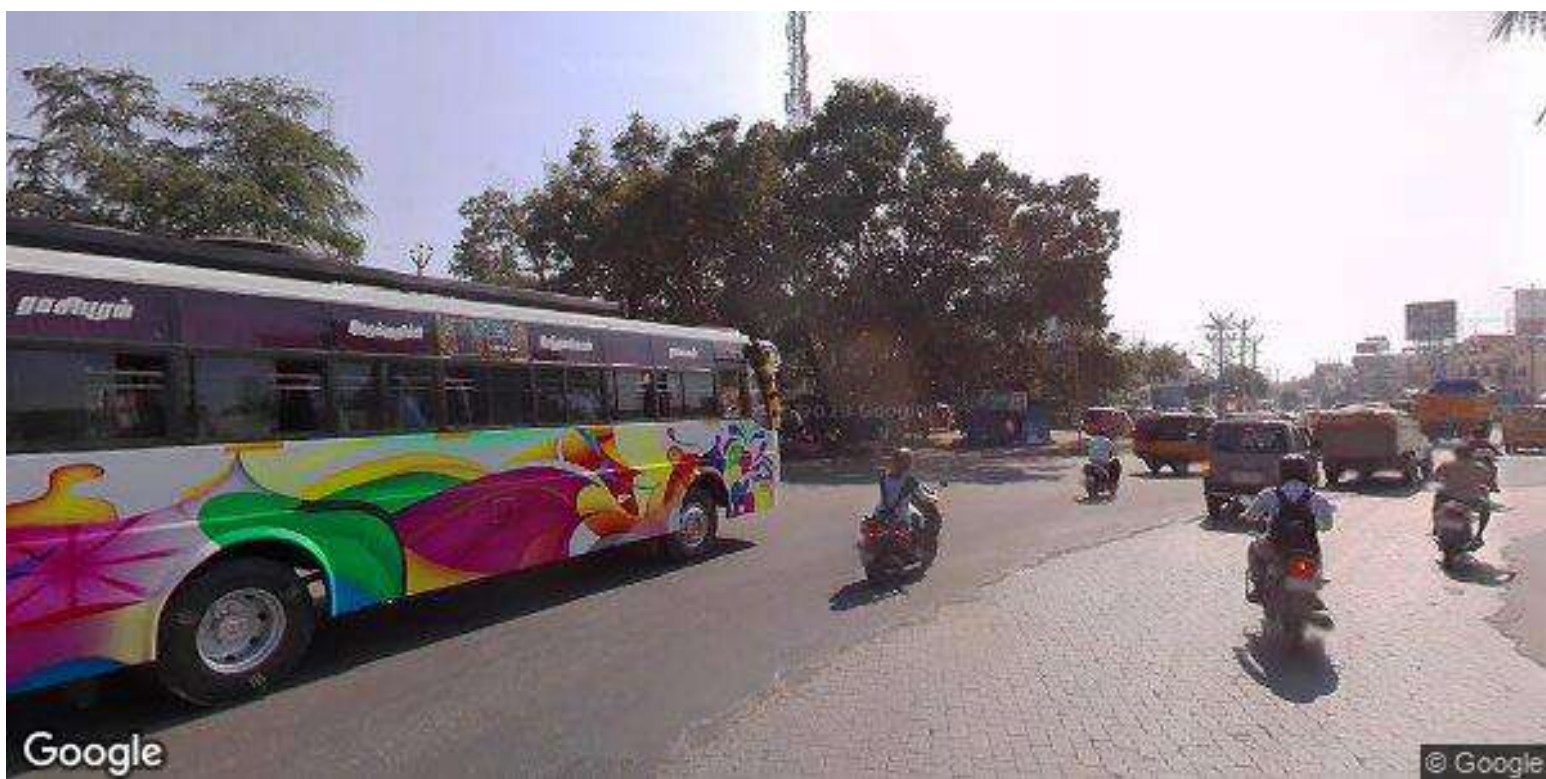
**Coordinates:** 11.63300, 78.12746

**Risk Type:** Turn

**Risk Level:** High

**Speed Limit:** 15 KM/Hr

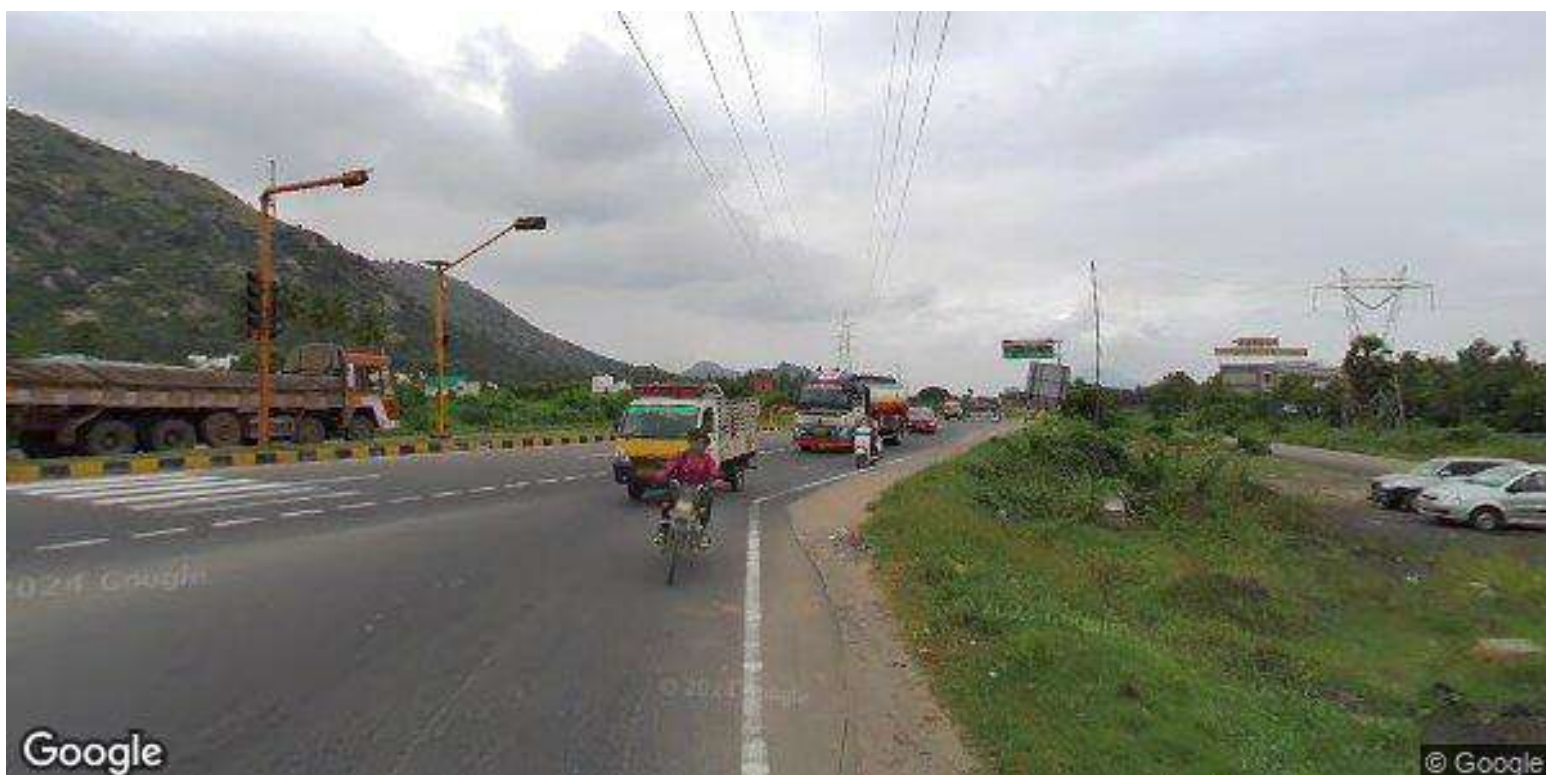
**Risk Type:** Turn  
**Risk Level:** Medium  
**Speed Limit:** 30 KM/Hr  
**Coordinates:** 11.65627, 78.20215

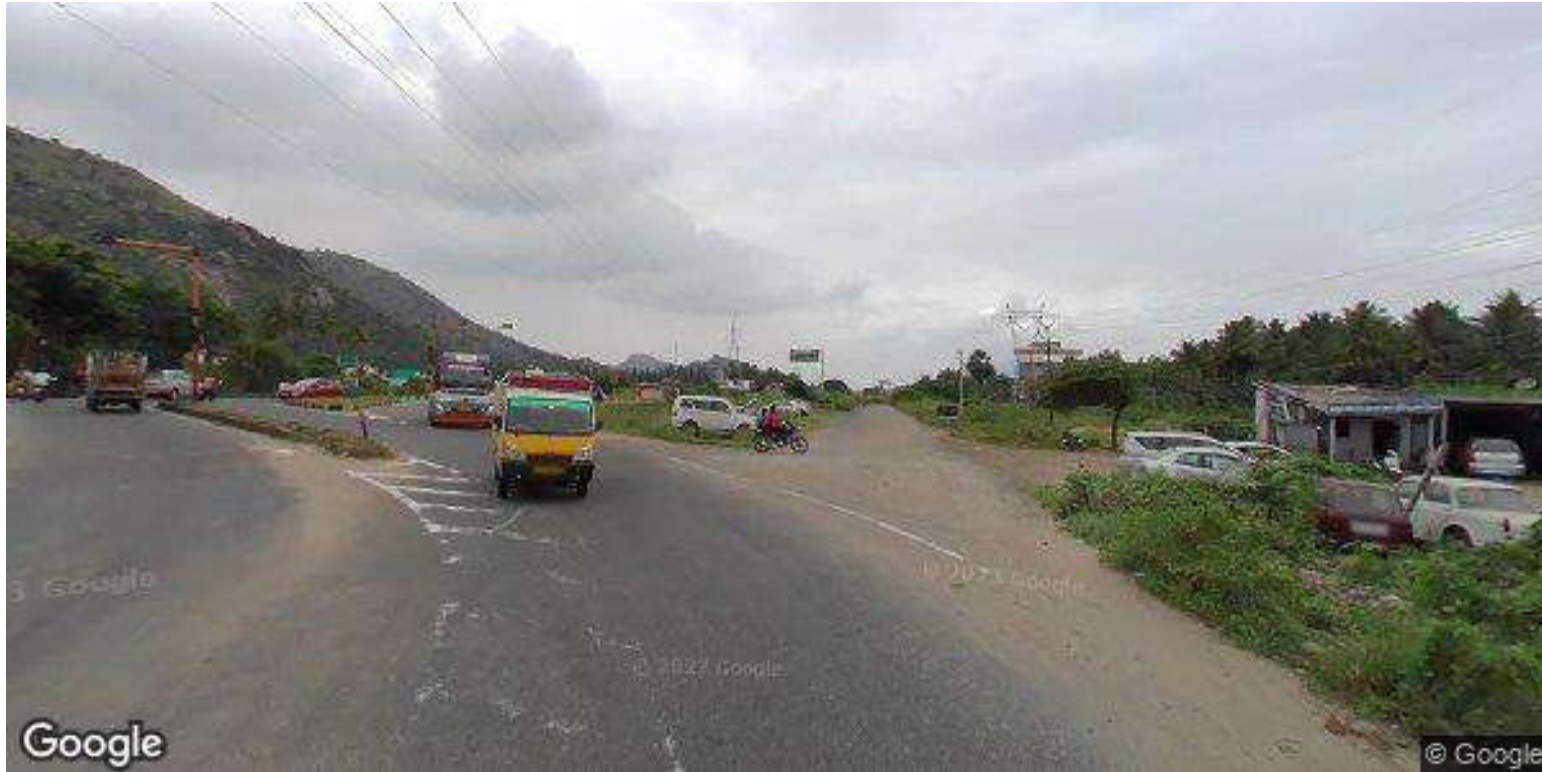
**Risk Type:** Turn  
**Risk Level:** Medium  
**Speed Limit:** 30 KM/Hr  
**Coordinates:** 11.65664, 78.20240

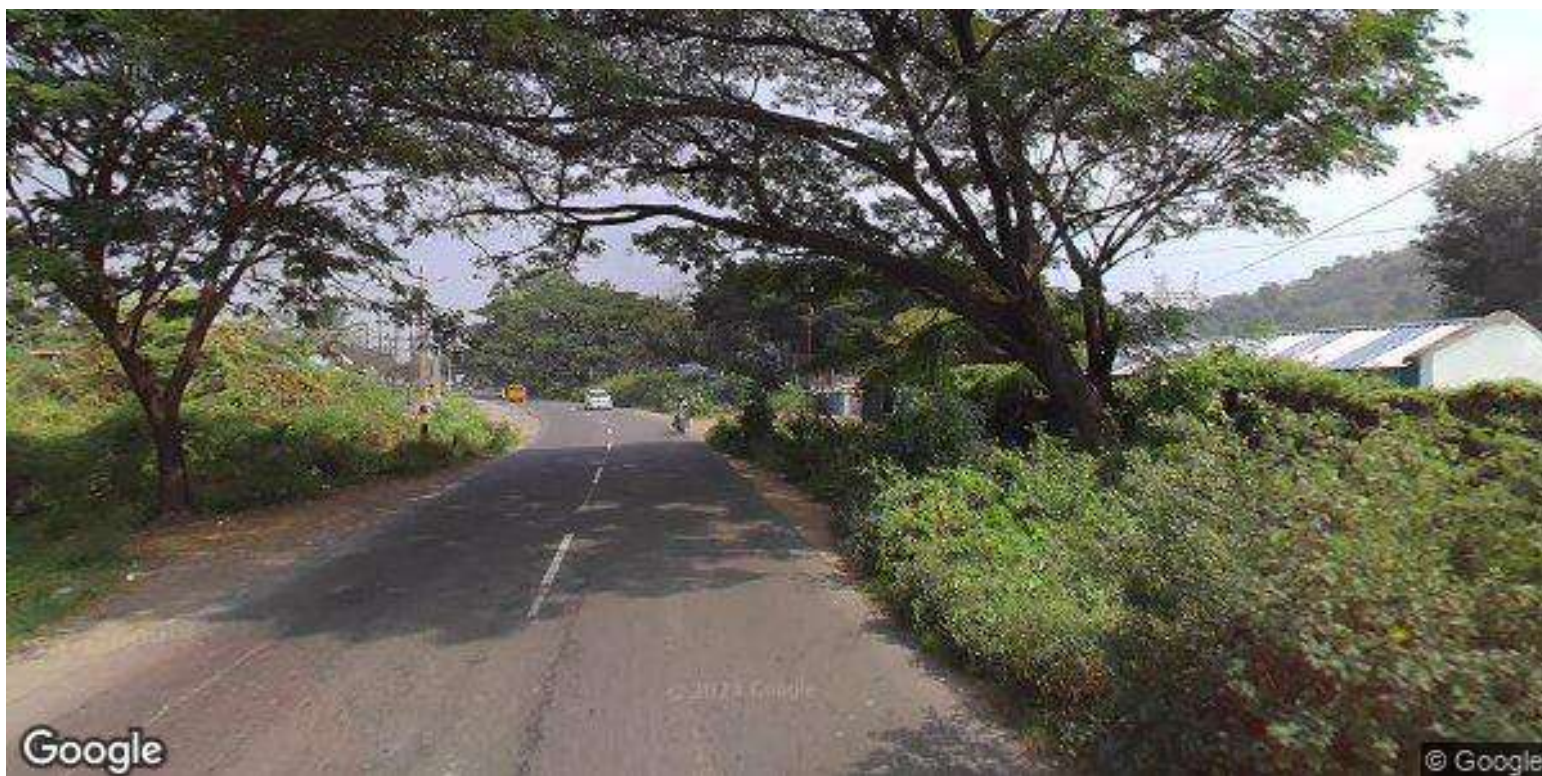
**Risk Type:** Turn  
**Risk Level:** Medium  
**Speed Limit:** 30 KM/Hr  
**Coordinates:** 11.65825, 78.20469

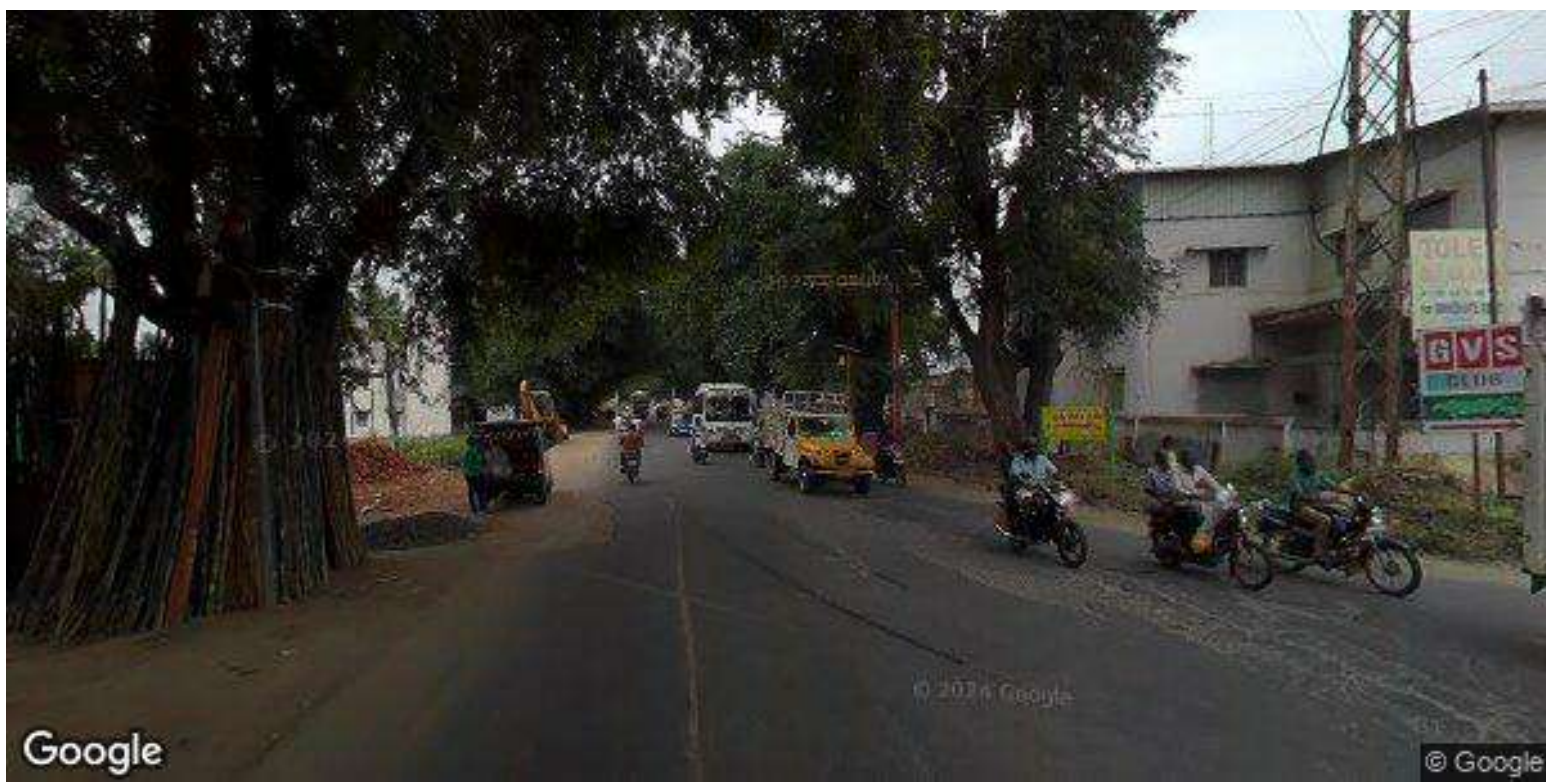
**Coordinates: 11.66380, 78.20648**

**Risk Type: Turn**

**Risk Level: High**

**Speed Limit: 15 KM/Hr**

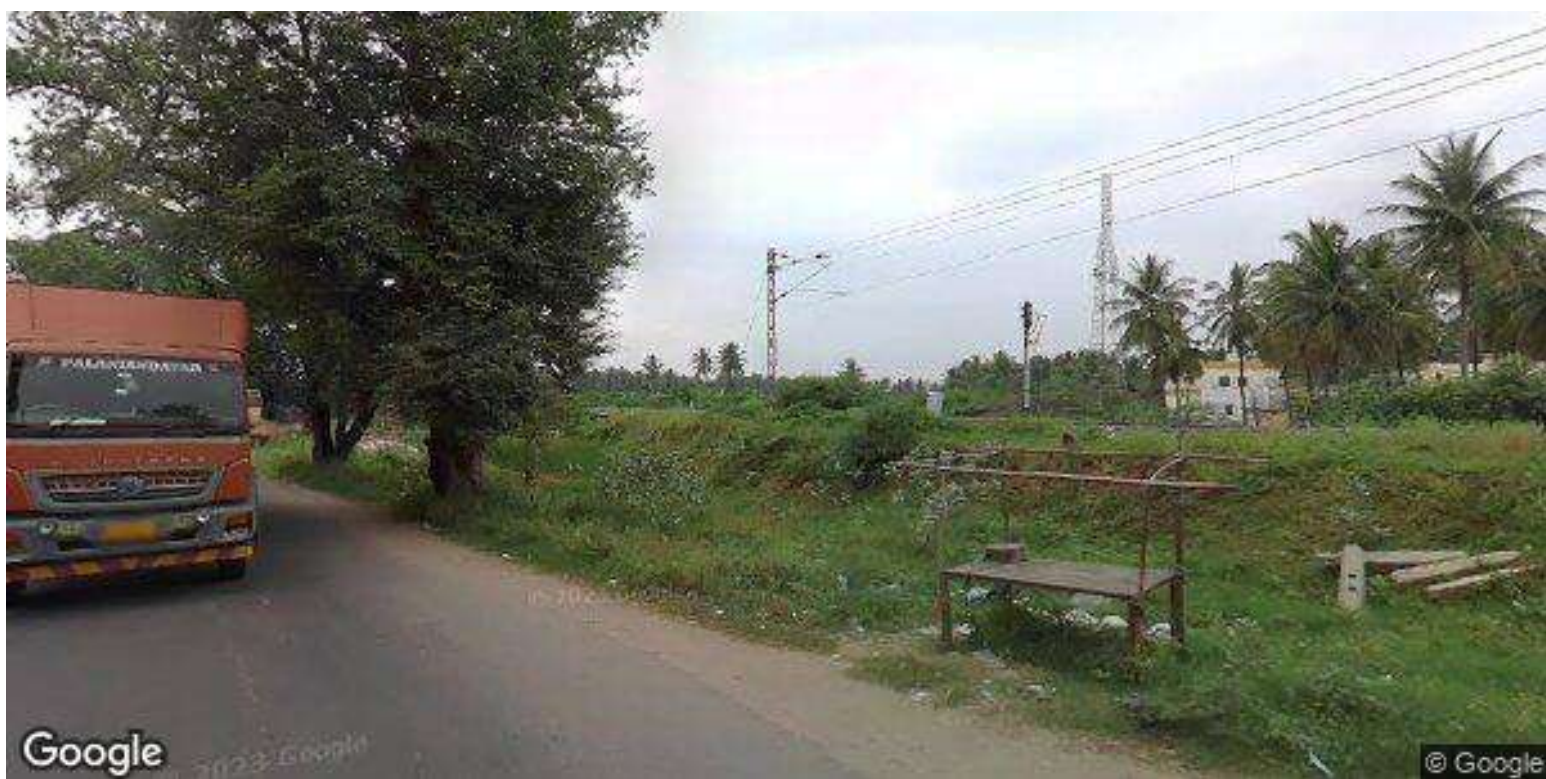
**Coordinates: 11.67128, 78.22971**

**Risk Type: Turn**

**Risk Level: Medium**

**Speed Limit: 30 KM/Hr**

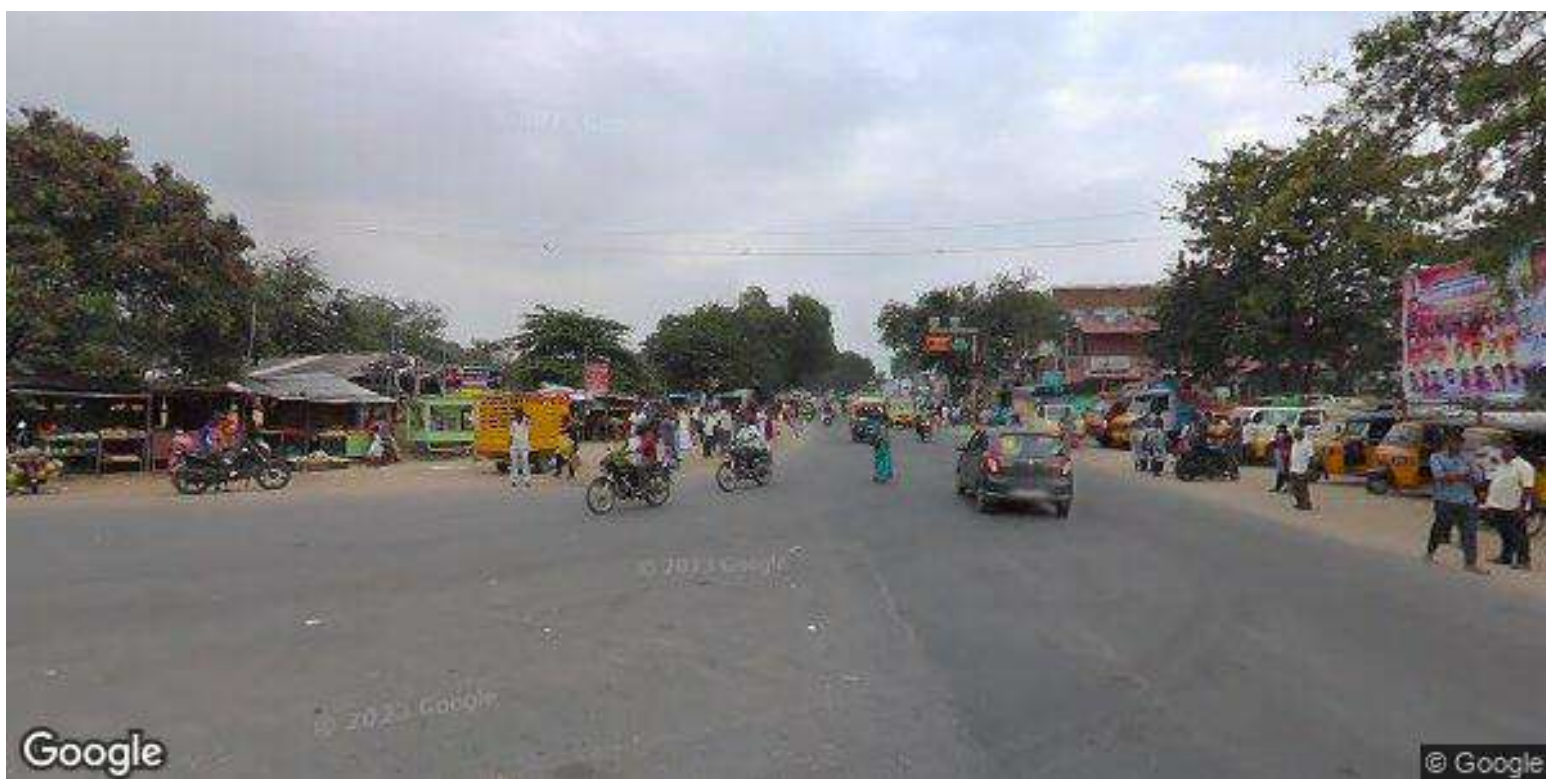
**Risk Type:** Turn  
**Risk Level:** High  
**Speed Limit:** 15 KM/Hr  
**Coordinates:** 11.67111, 78.23134

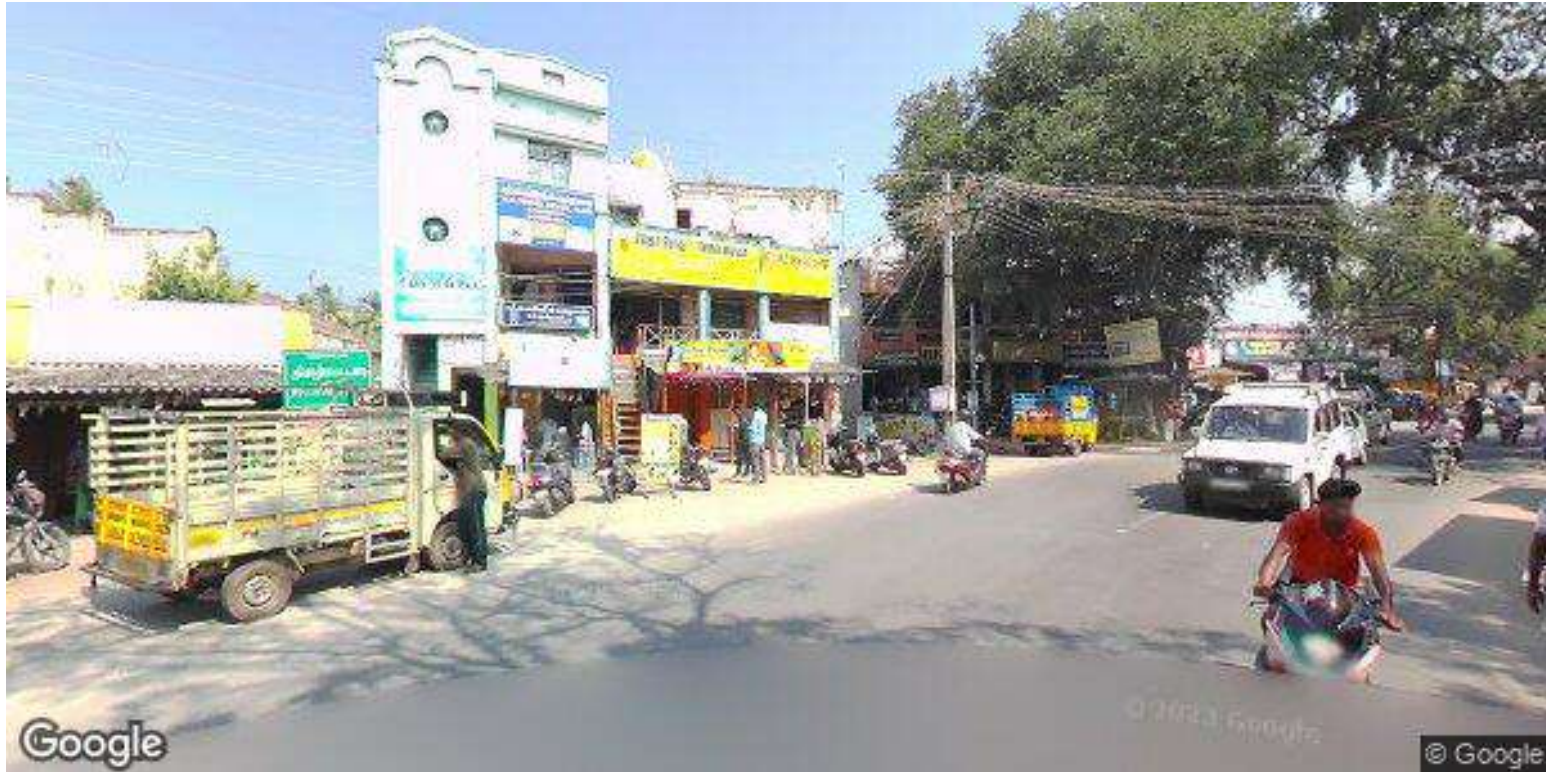
**Risk Type:** Turn  
**Risk Level:** Medium  
**Speed Limit:** 30 KM/Hr  
**Coordinates:** 11.67195, 78.23146
