# IndianOil

## JOURNEY RISK MANAGEMENT (JRM) STUDY

### Salem Terminal to SRI MAHADHEV FUEL

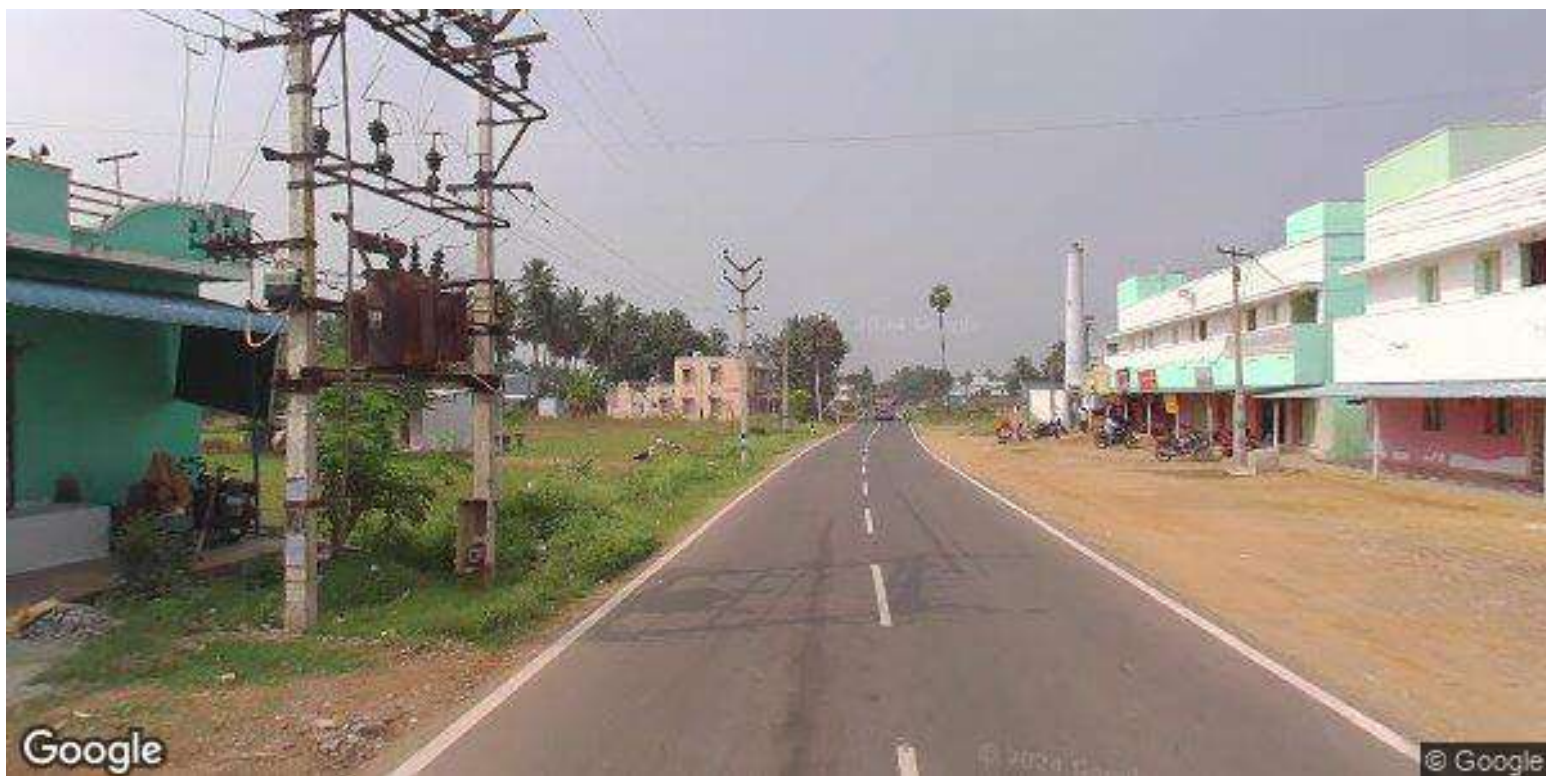
**Risk Type:** Turn  
**Risk Level:** Medium  
**Speed Limit:** 30 KM/Hr  
**Coordinates:** 11.67666, 78.24906

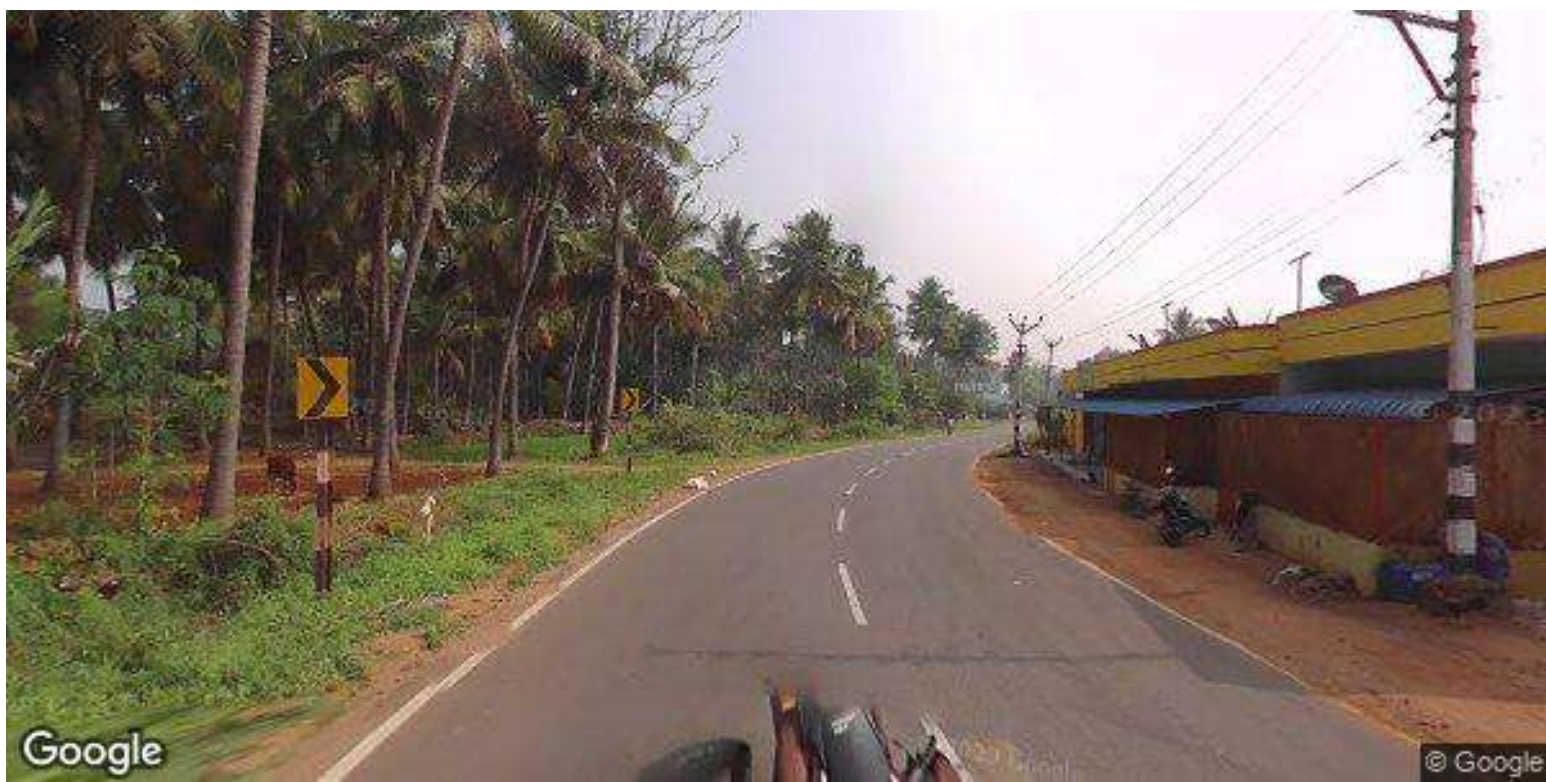
**Coordinates:** 11.68494, 78.26198

**Risk Type:** Turn

**Risk Level:** Medium

**Speed Limit:** 30 KM/Hr

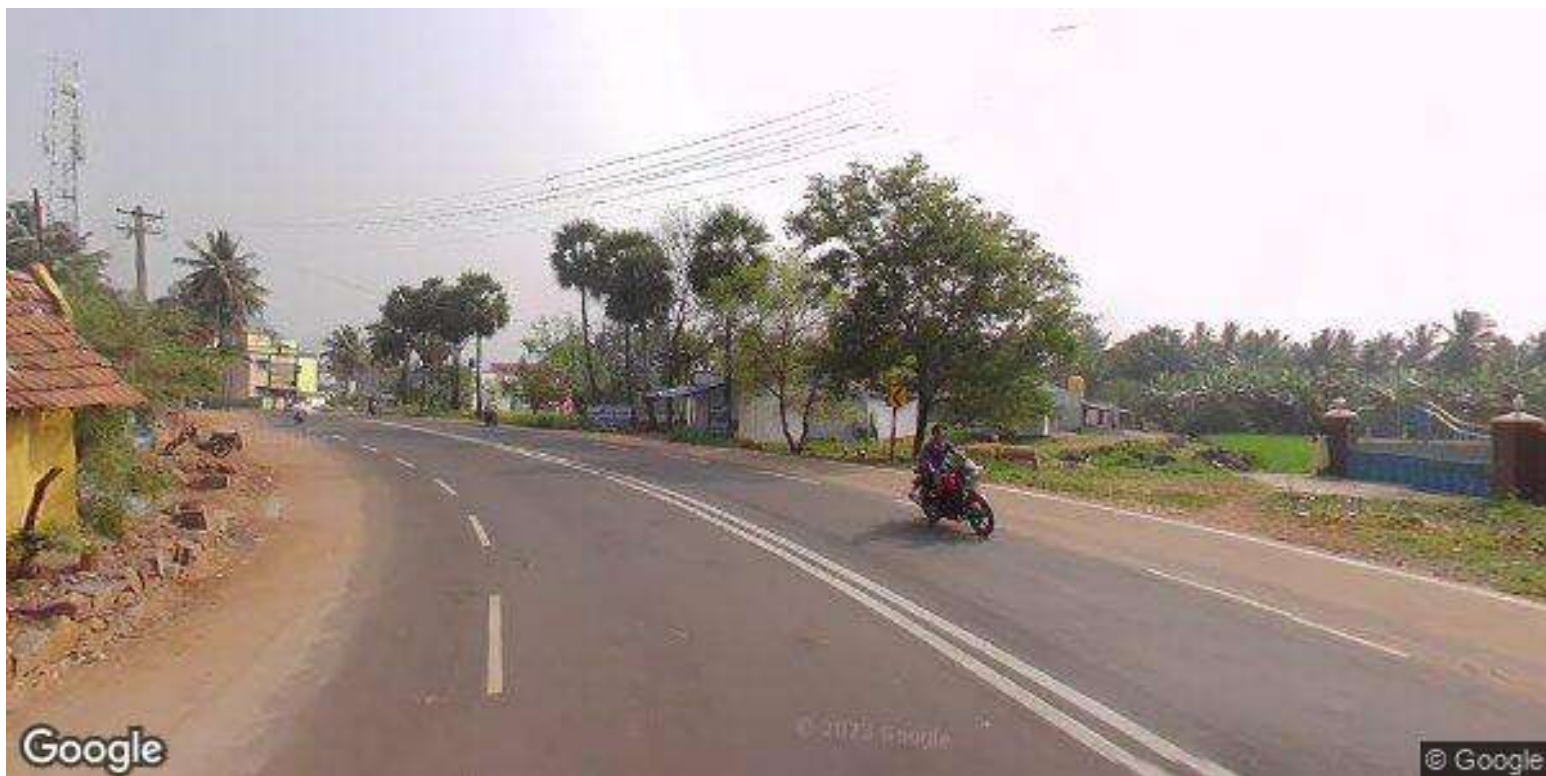
**Coordinates:** 11.68551, 78.26771

**Risk Type:** Turn

**Risk Level:** Medium

**Speed Limit:** 30 KM/Hr

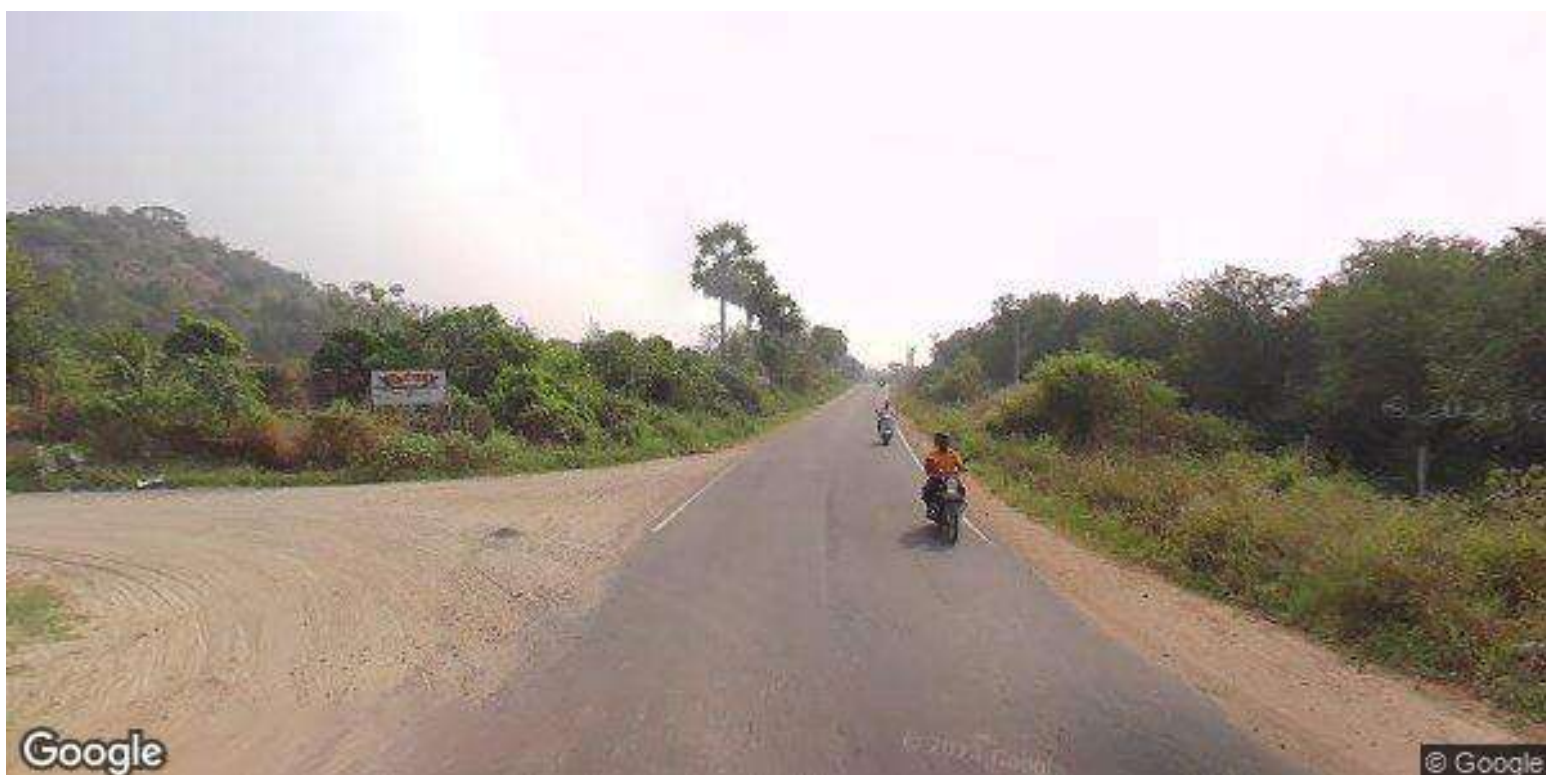
**Risk Type:** Turn  
**Risk Level:** Medium  
**Speed Limit:** 30 KM/Hr  
**Coordinates:** 11.68751, 78.27618

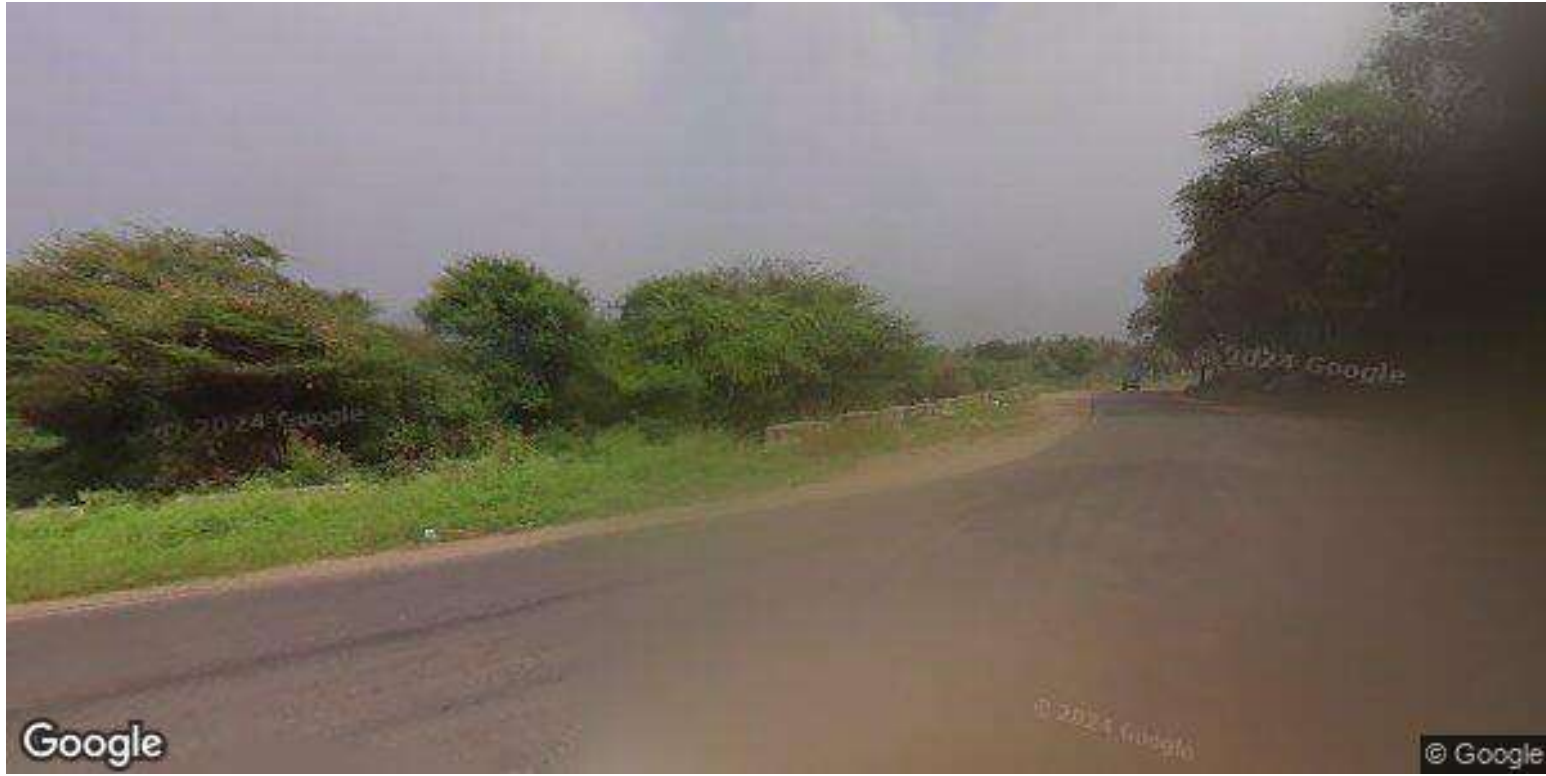
**Risk Type:** Turn  
**Risk Level:** Medium  
**Speed Limit:** 30 KM/Hr  
**Coordinates:** 11.68624, 78.28833

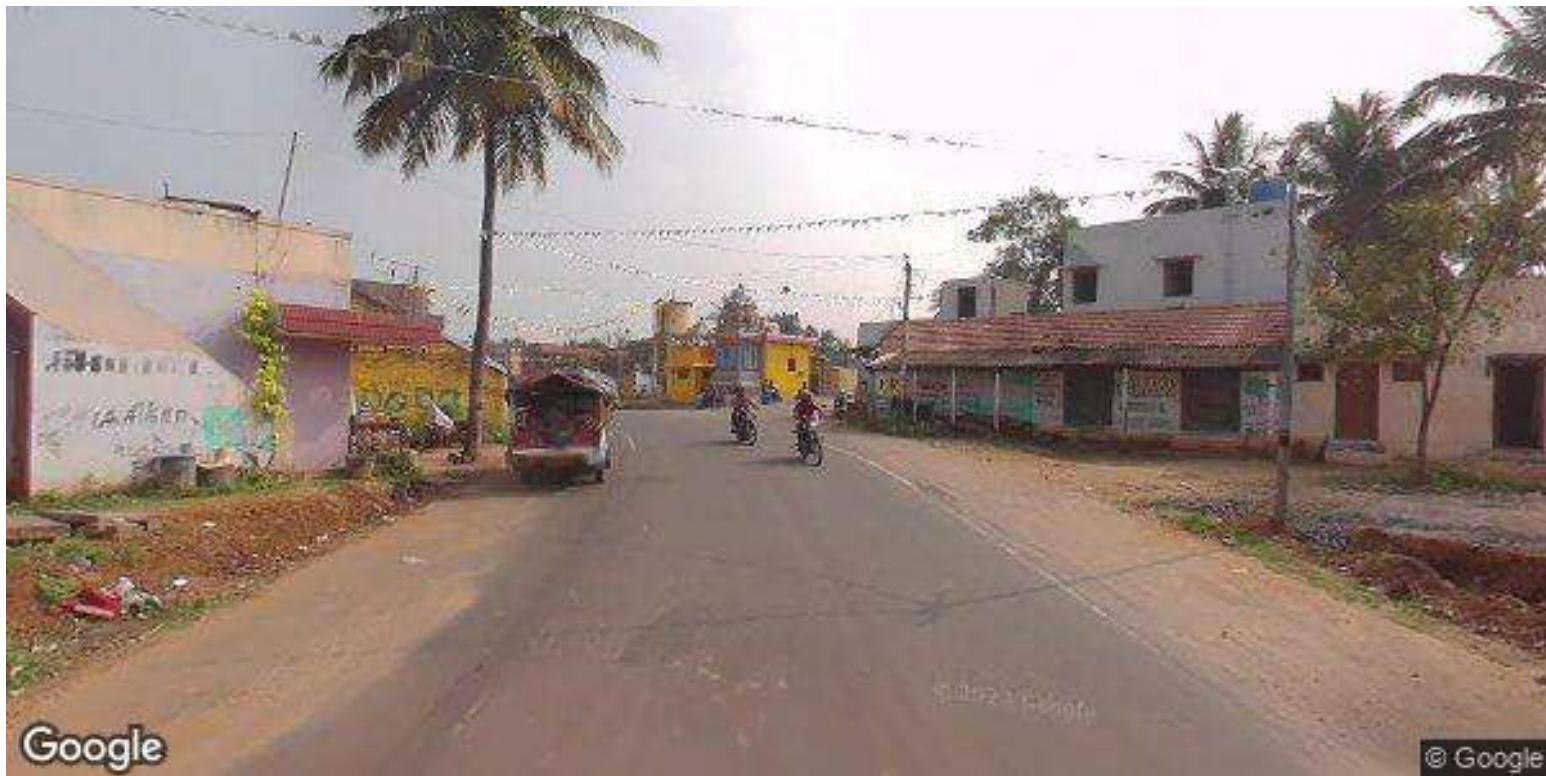
**Risk Type:** Turn  
**Risk Level:** Medium  
**Speed Limit:** 30 KM/Hr  
**Coordinates:** 11.68848, 78.29399

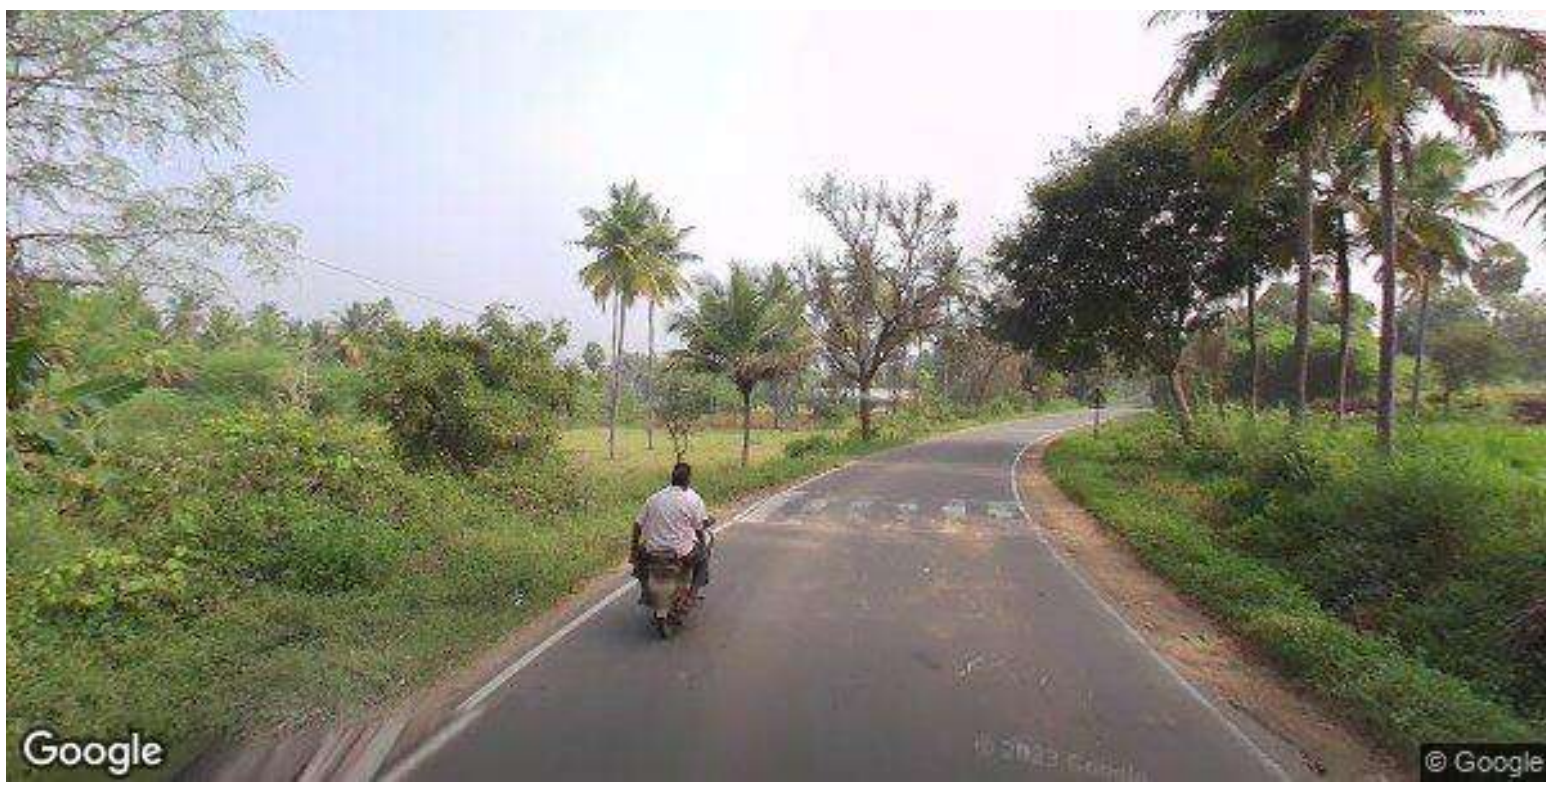
**Coordinates:** 11.70555, 78.31562

**Risk Type:** Turn

**Risk Level:** Medium

**Speed Limit:** 30 KM/Hr

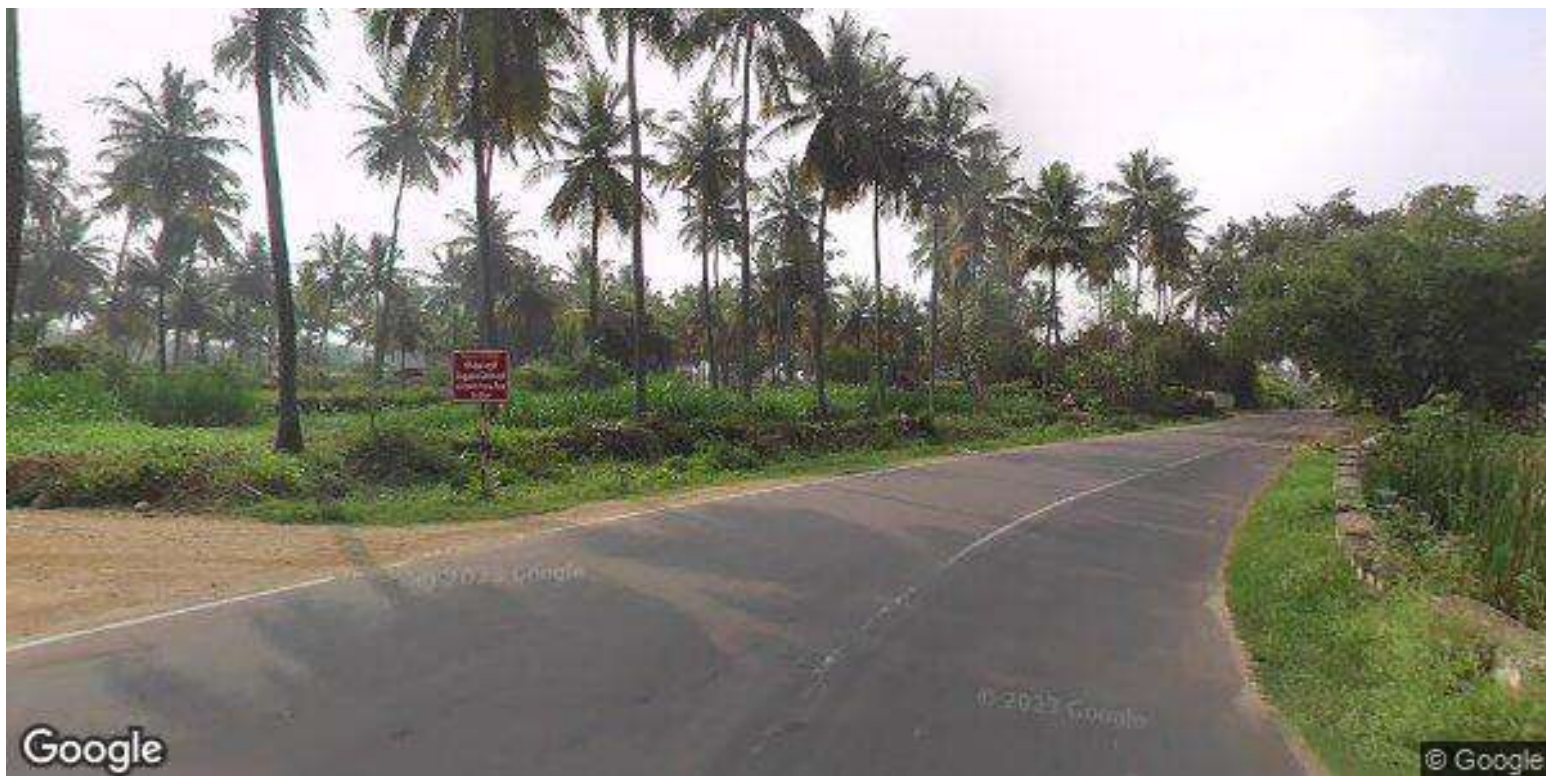
**Coordinates:** 11.70752, 78.31775

**Risk Type:** Turn

**Risk Level:** Medium

**Speed Limit:** 30 KM/Hr
