# IndianOil

## JOURNEY RISK MANAGEMENT (JRM) STUDY

### Salem Terminal TO AGNI FUEL

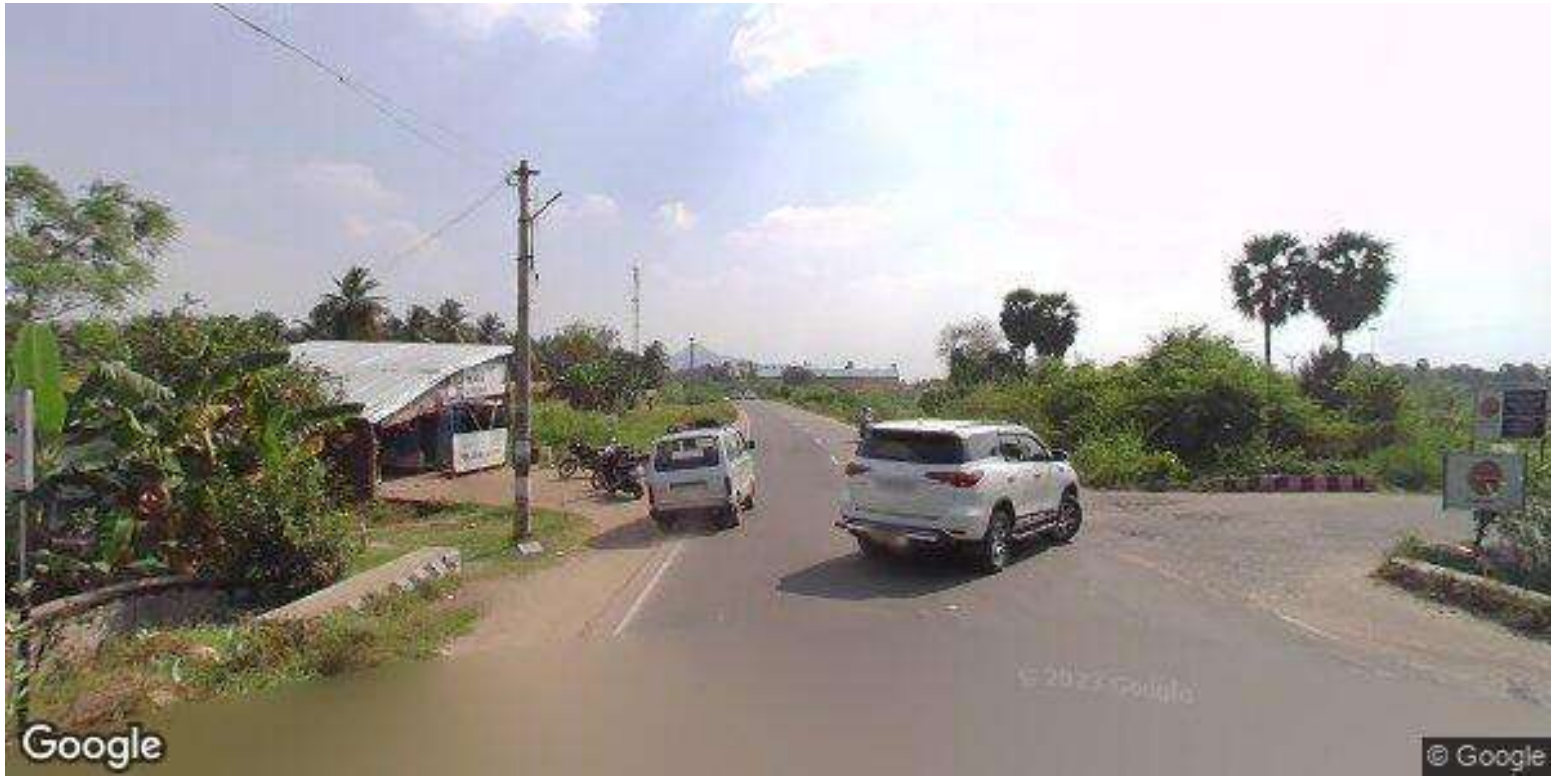
Risk Type: Blind Spot  
Risk Level: Blind Spot  
Speed Limit: 10 KM/Hr  
Coordinates: 11.44029, 77.87544

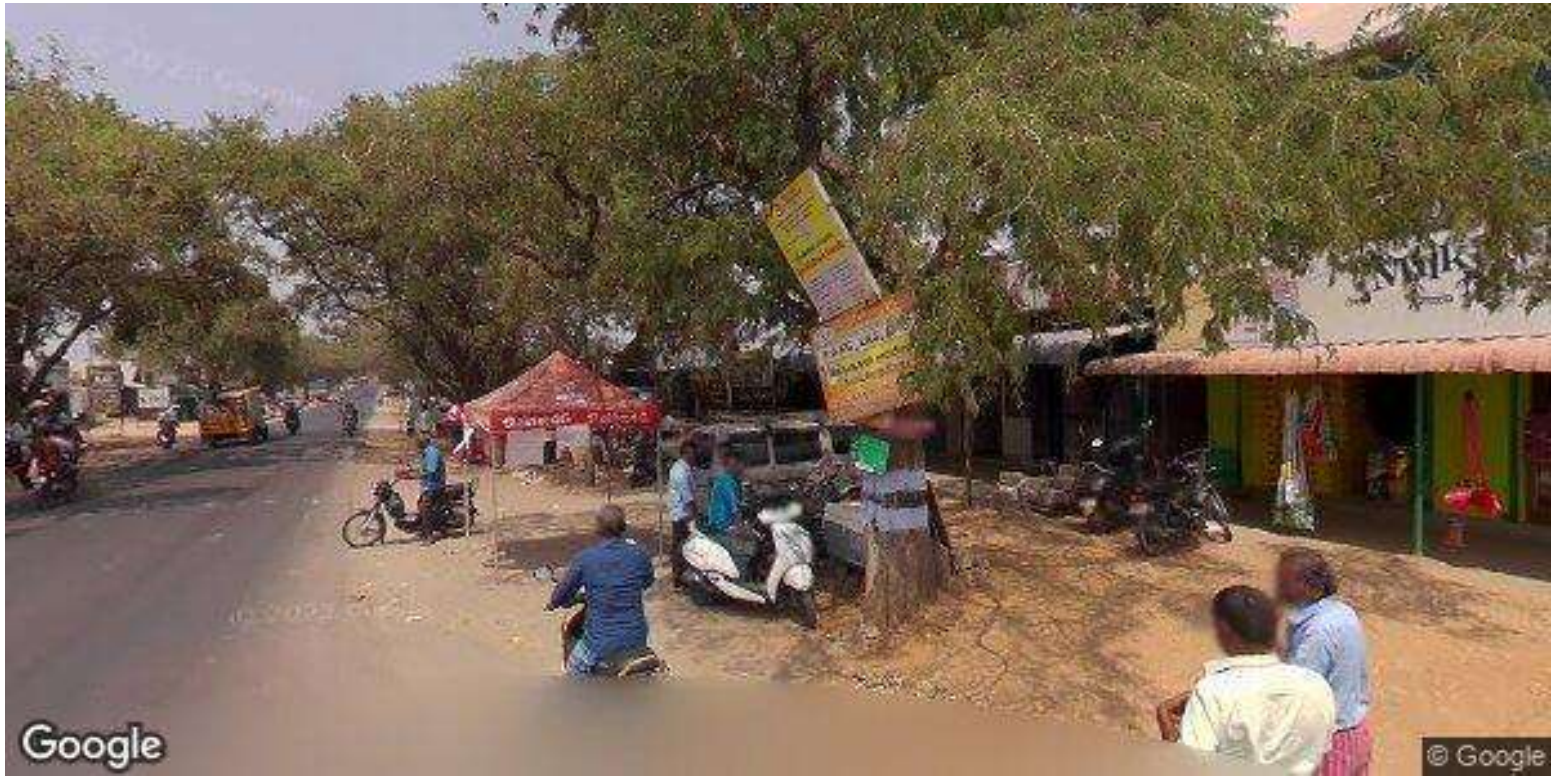
Risk Type: Blind Spot  
Risk Level: Blind Spot  
Speed Limit: 10 KM/Hr  
Coordinates: 11.41981, 77.88078

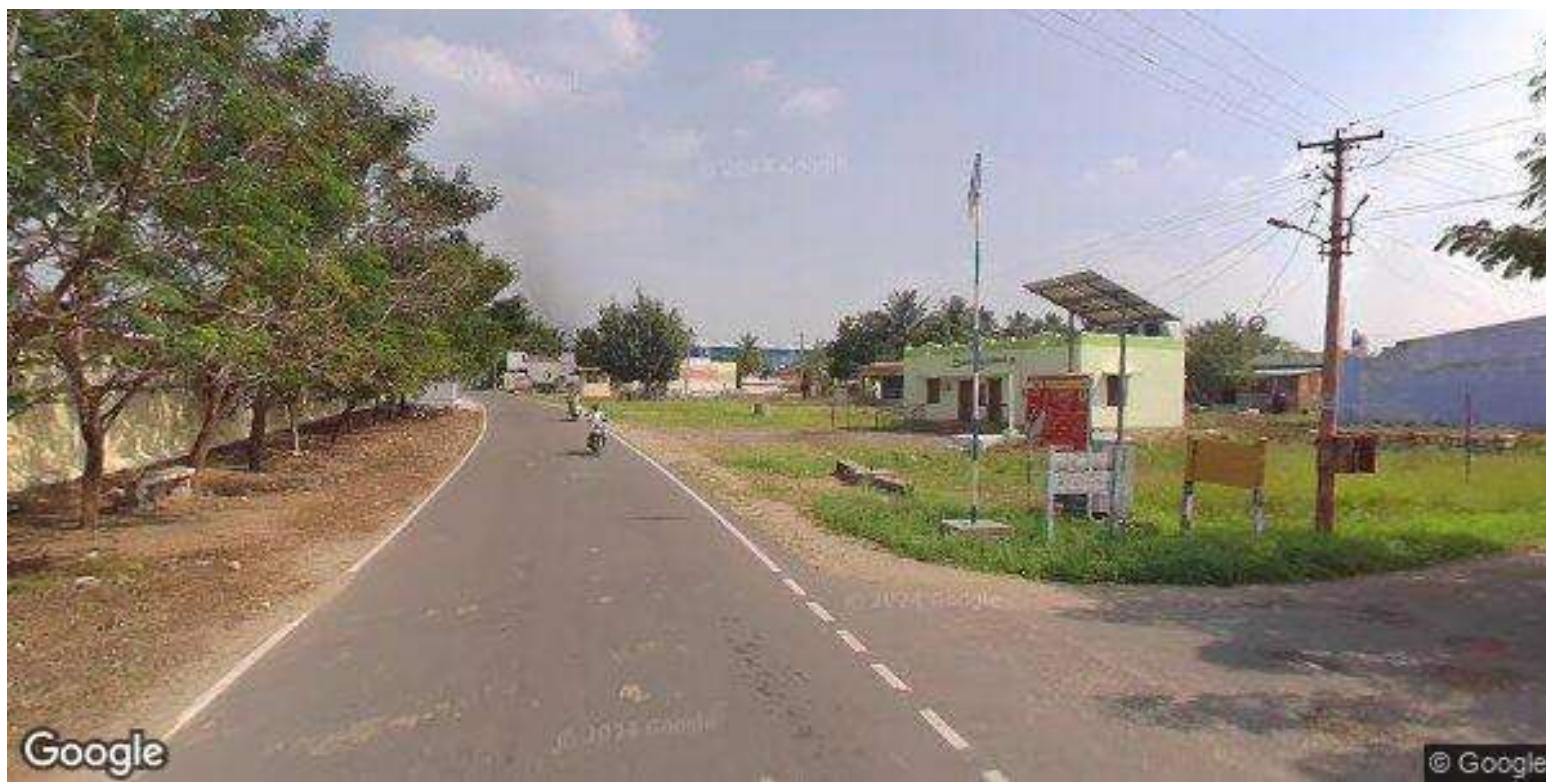
**Coordinates:** 11.42333, 77.87394

**Risk Type:** Blind Spot

**Risk Level:** Blind Spot

**Speed Limit:** 10 KM/Hr

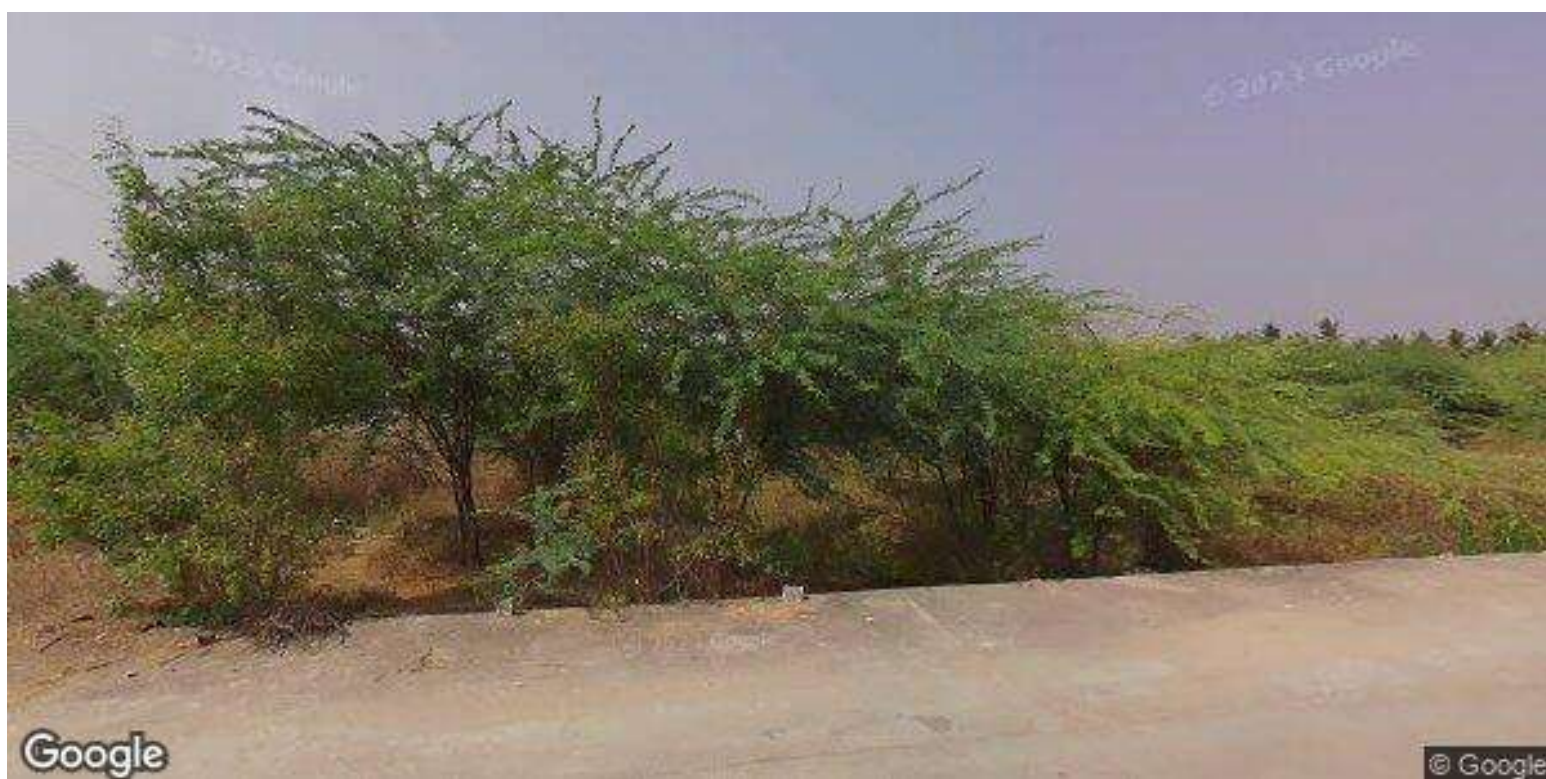
**Coordinates:** 11.41917, 77.87022

**Risk Type:** Turn

**Risk Level:** High

**Speed Limit:** 15 KM/Hr

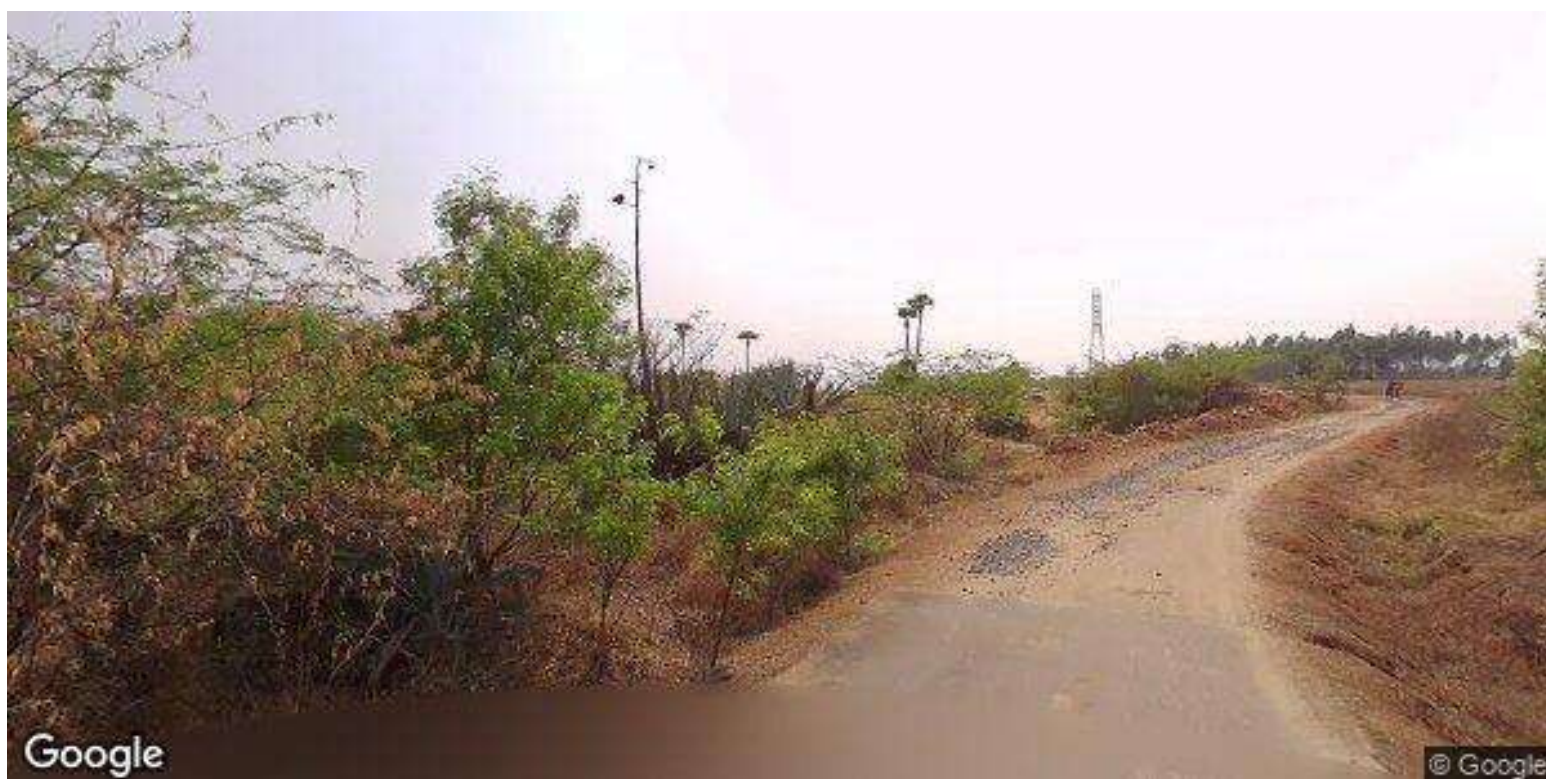
**Coordinates: 11.41642, 77.86800**

**Risk Type: Turn**

**Risk Level: Medium**

**Speed Limit: 30 KM/Hr**

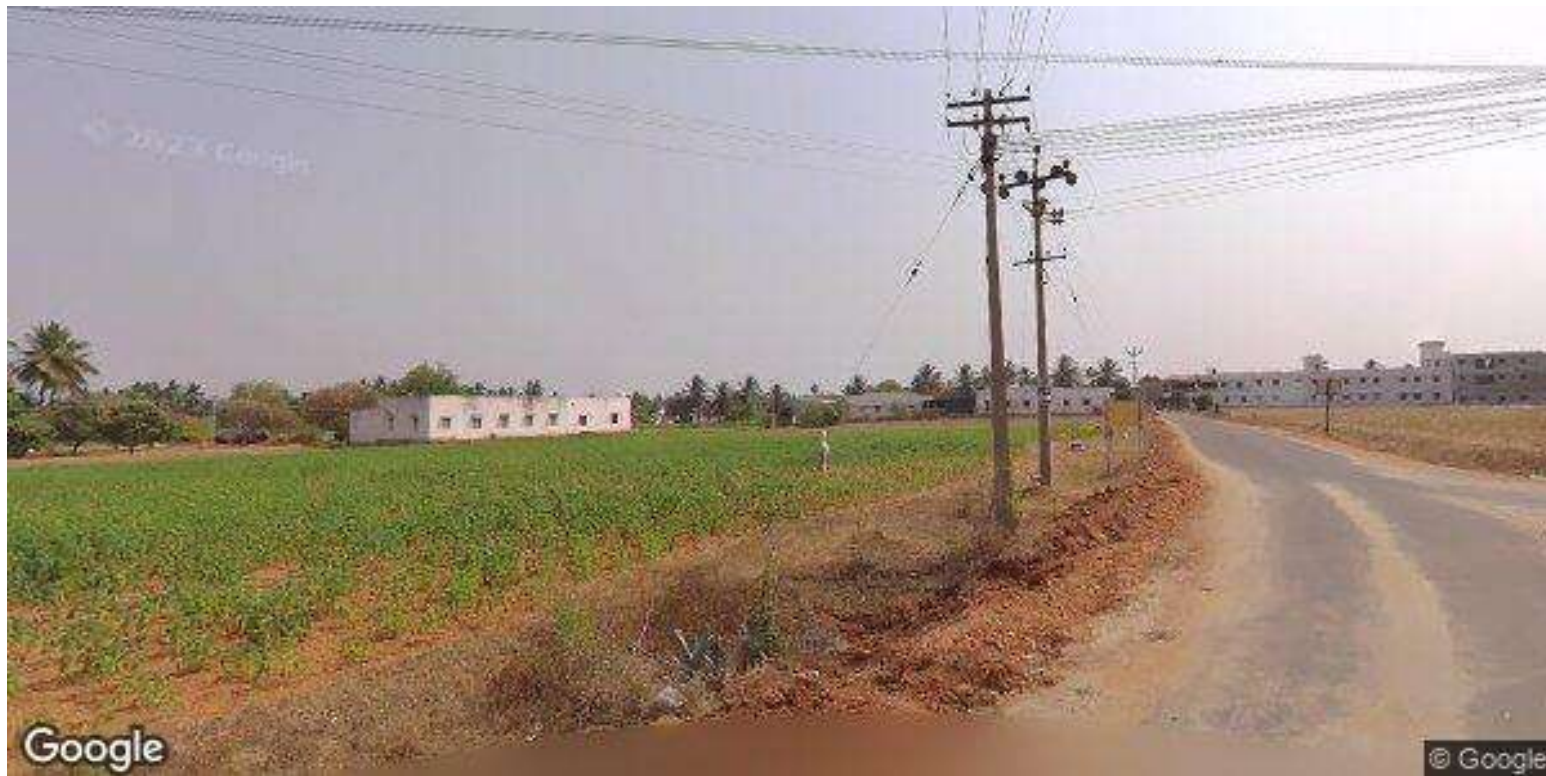
**Coordinates: 11.40478, 77.86020**

**Risk Type: Turn**

**Risk Level: High**

**Speed Limit: 15 KM/Hr**

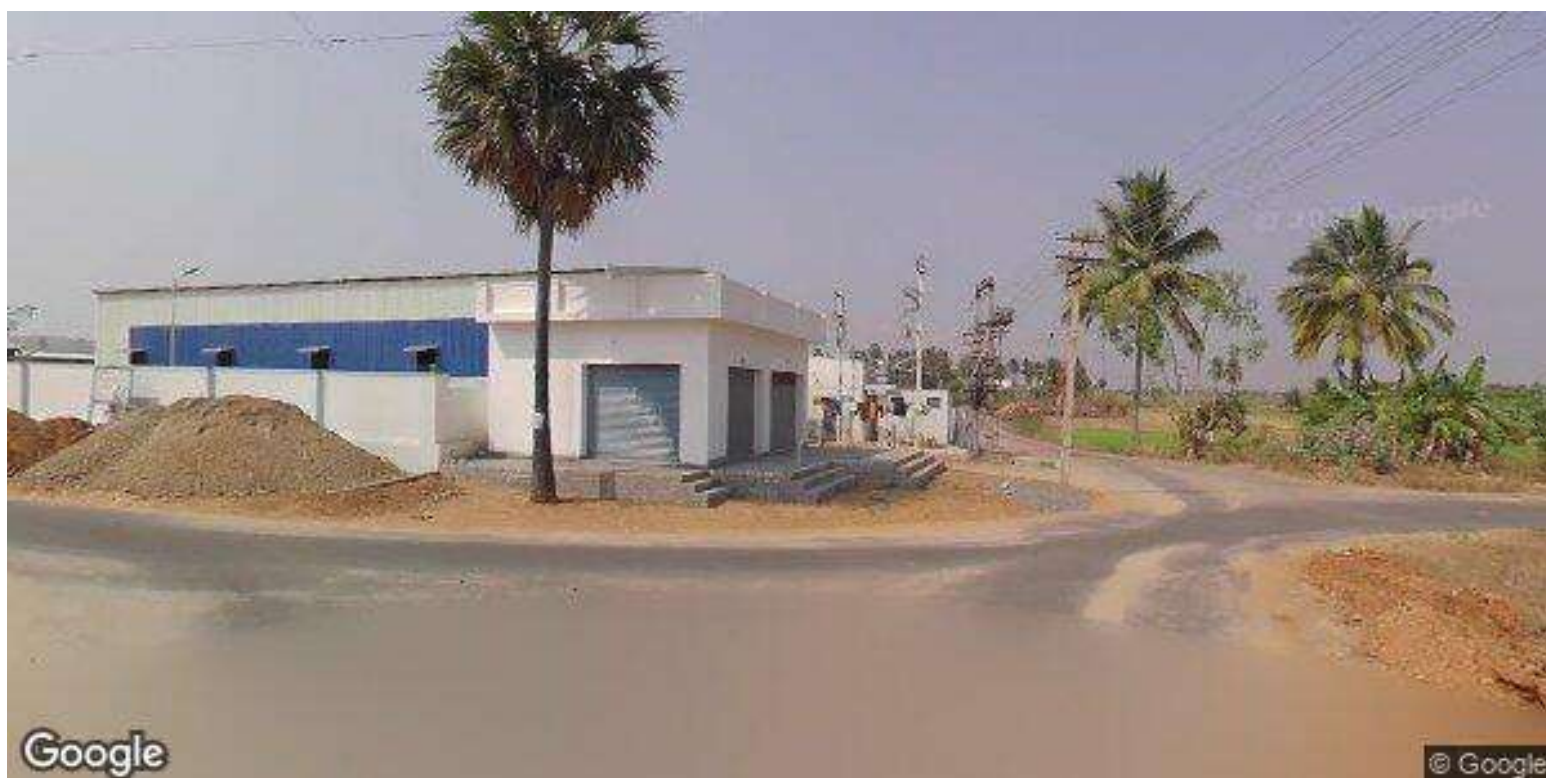
**Coordinates: 11.40471, 77.86004**

**Risk Type: Turn**

**Risk Level: High**

**Speed Limit: 15 KM/Hr**

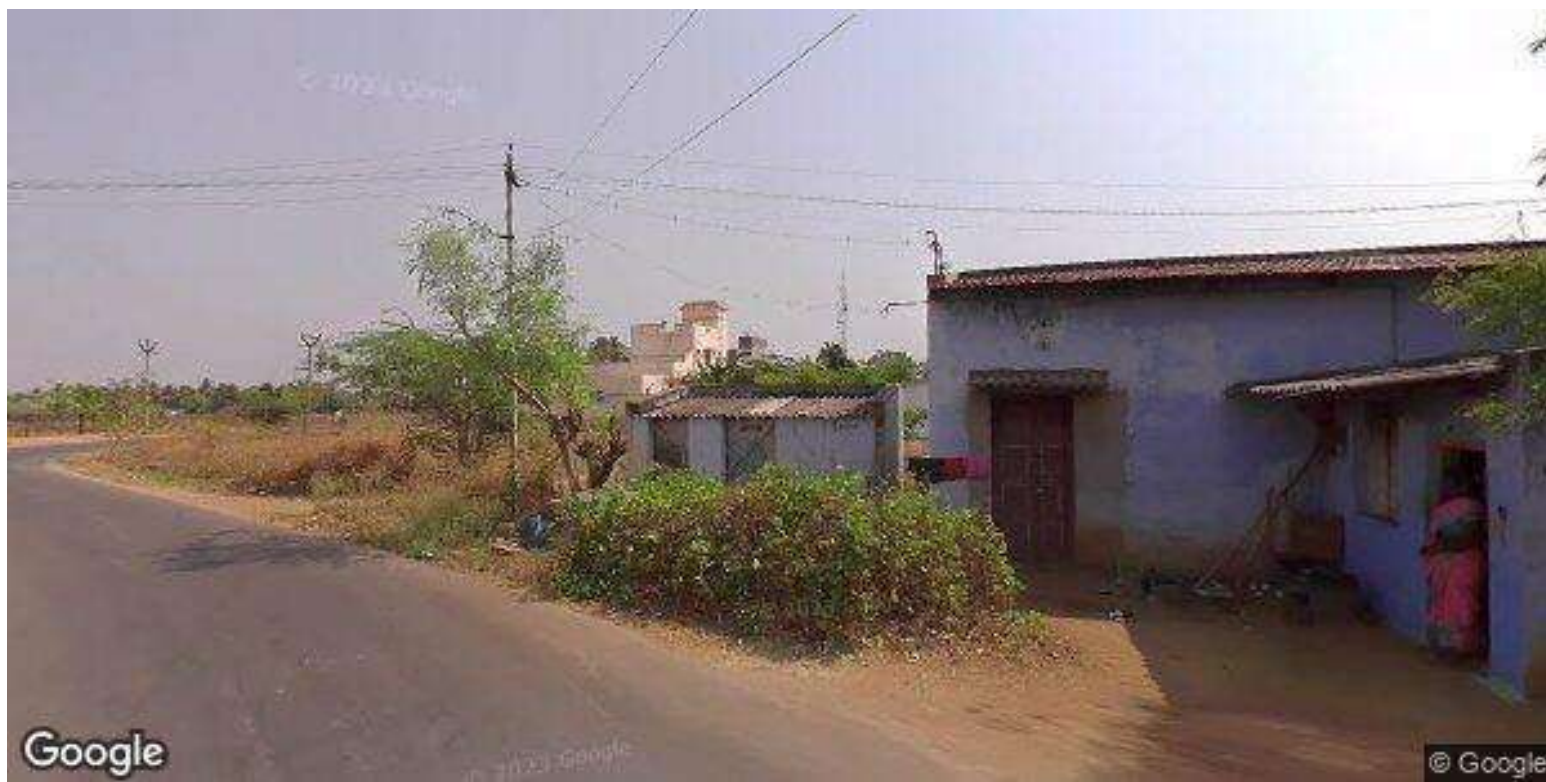
**Coordinates:** 11.39360, 77.85502

**Risk Type:** Turn

**Risk Level:** Medium

**Speed Limit:** 30 KM/Hr

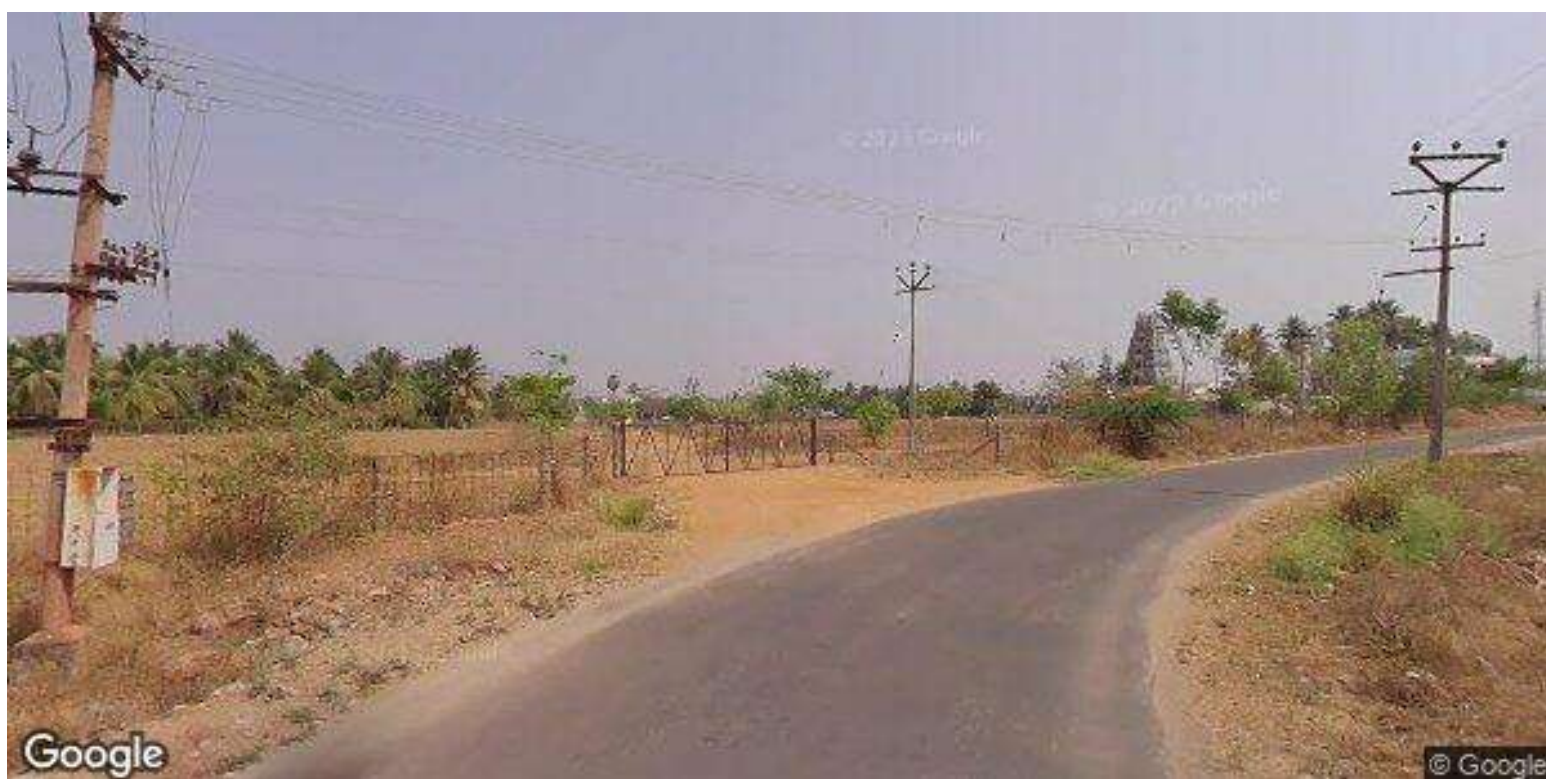
**Coordinates:** 11.39325, 77.85538

**Risk Type:** Turn

**Risk Level:** Medium

**Speed Limit:** 30 KM/Hr

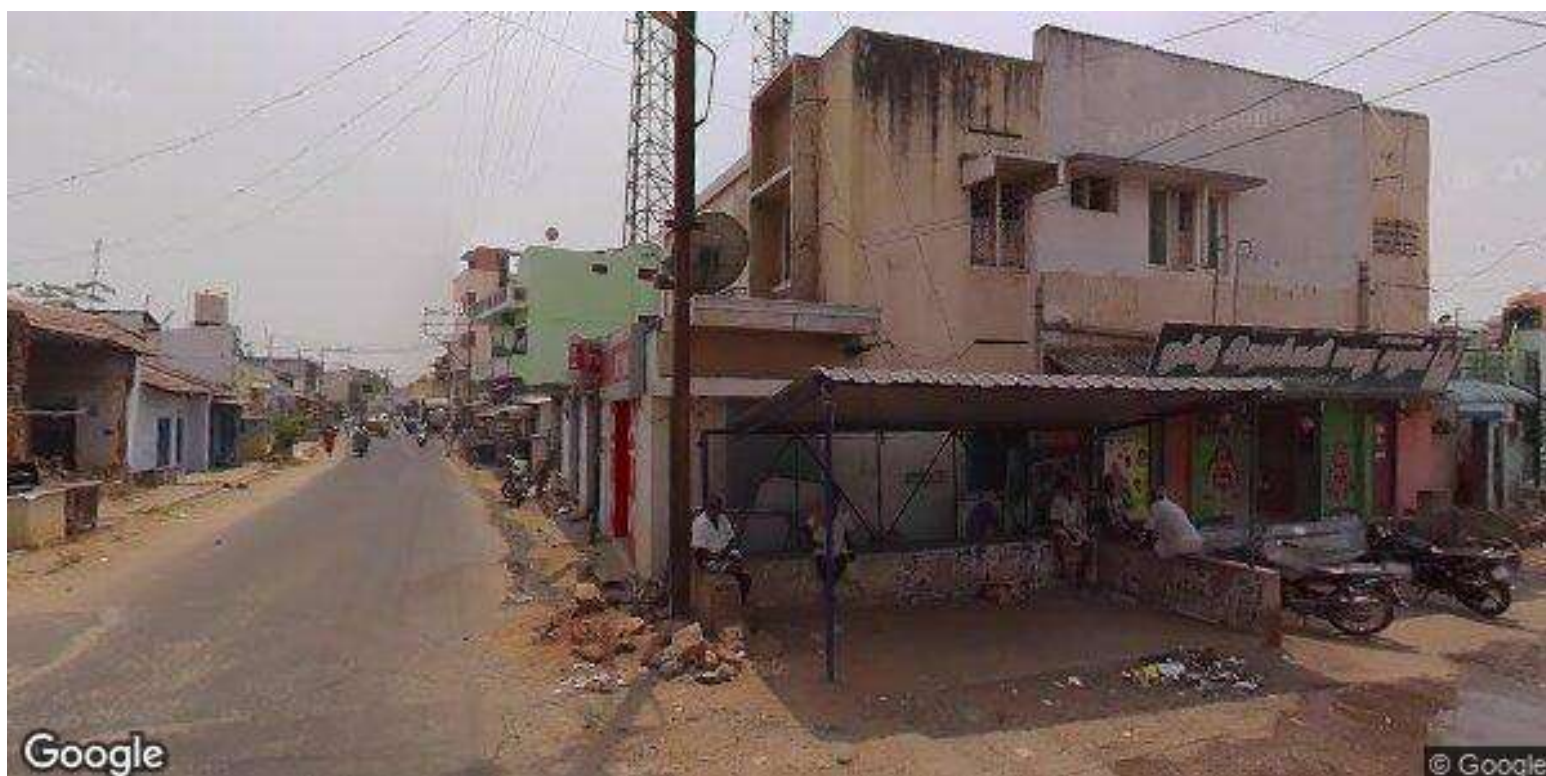
**Risk Type:** Turn  
**Risk Level:** High  
**Speed Limit:** 15 KM/Hr  
**Coordinates:** 11.39047, 77.85509

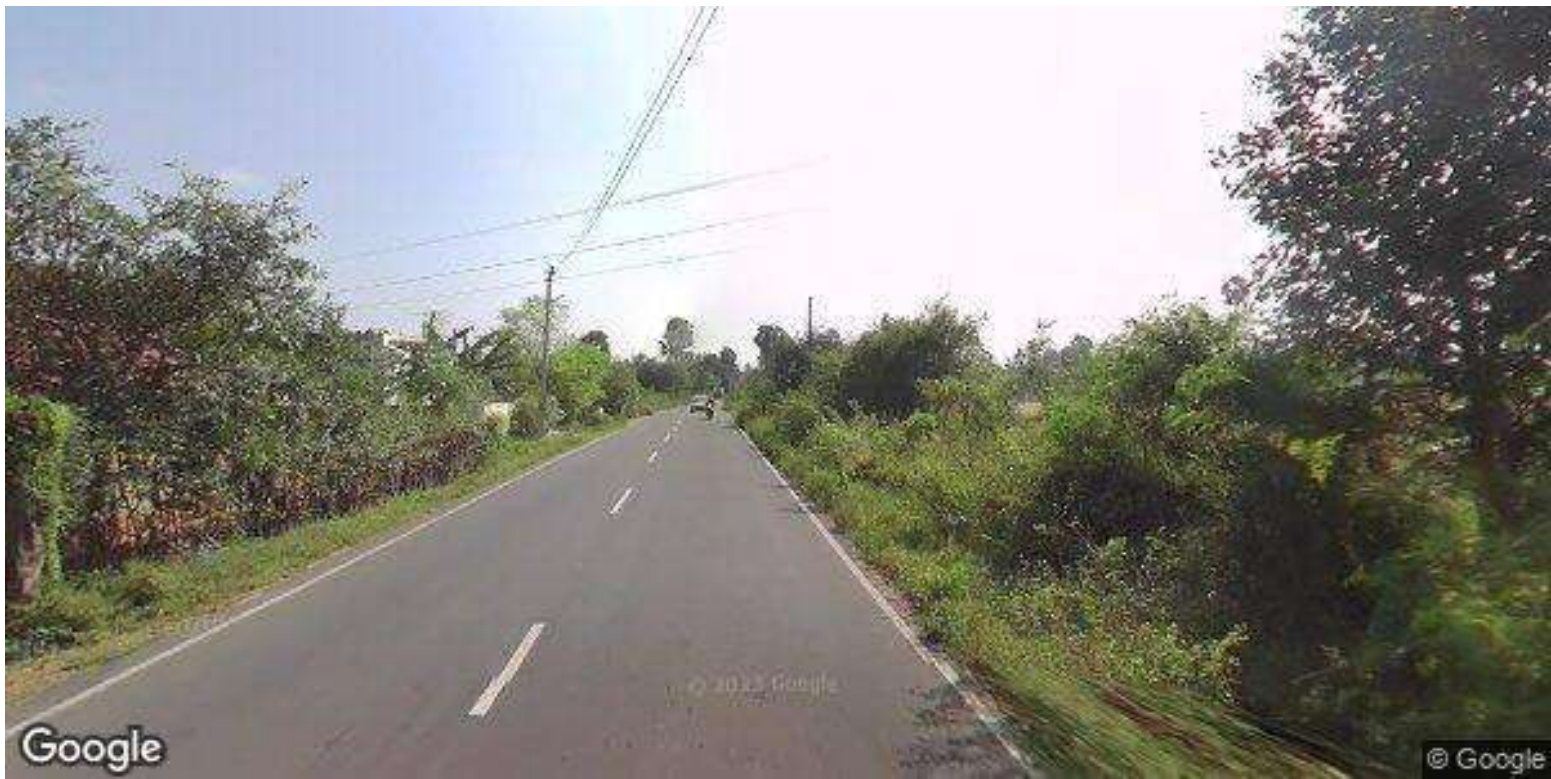
**Risk Type:** Blind Spot  
**Risk Level:** Blind Spot  
**Speed Limit:** 10 KM/Hr  
**Coordinates:** 11.39447, 77.83631

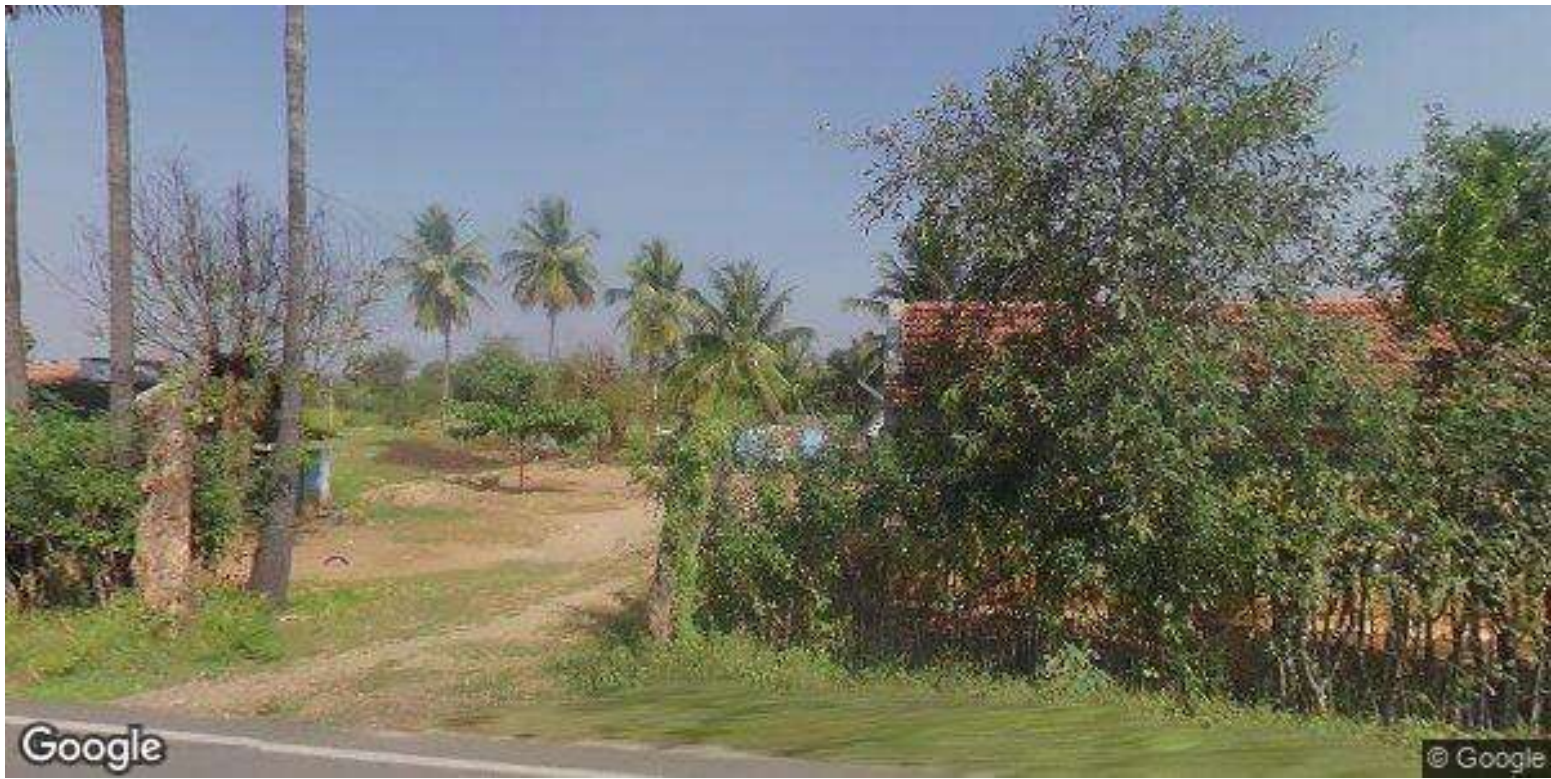
**Risk Type:** Turn  
**Risk Level:** High  
**Speed Limit:** 15 KM/Hr  
**Coordinates:** 11.39466, 77.83635
