# IndianOil

## JOURNEY RISK MANAGEMENT (JRM) STUDY

### Salem Terminal to ARUN FUEL

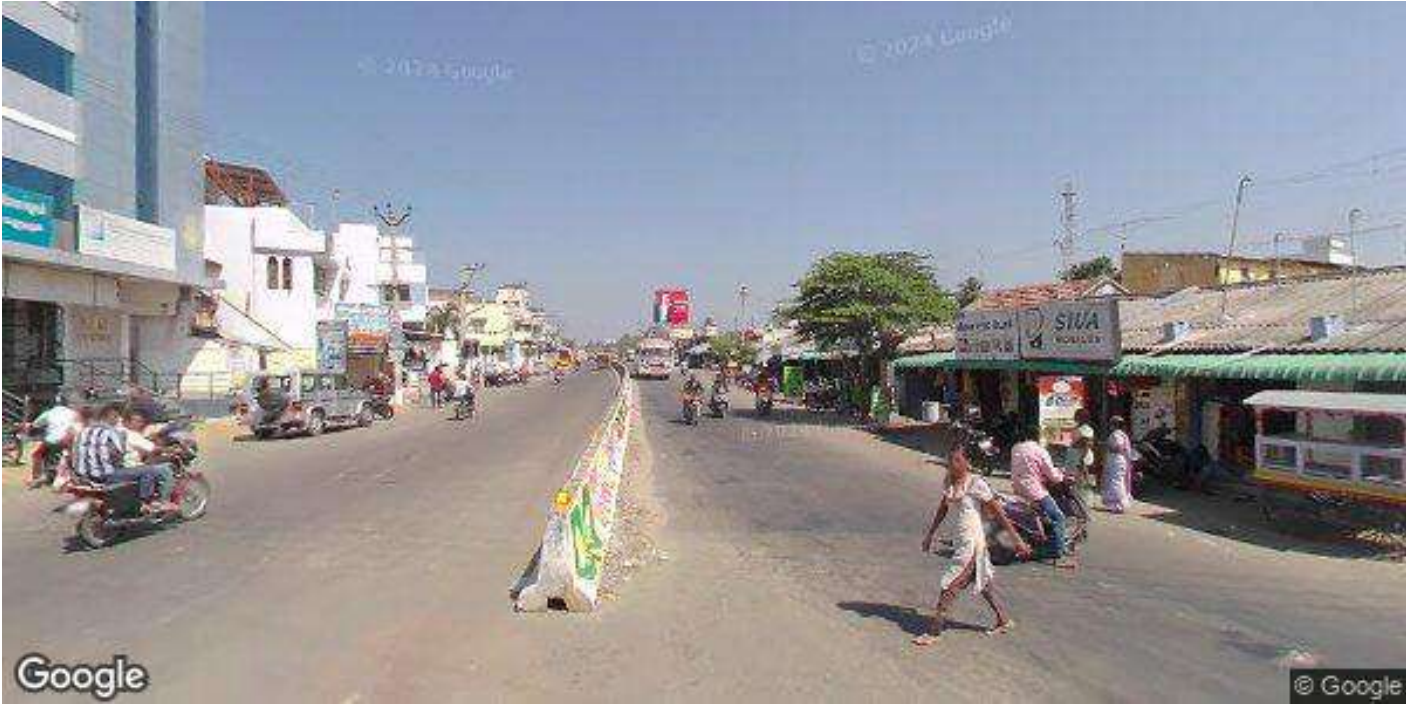
Risk Type: Roundabout

Risk Level: High

Speed Limit: 15 KM/Hr

Coordinates: 11.37086, 77.74828

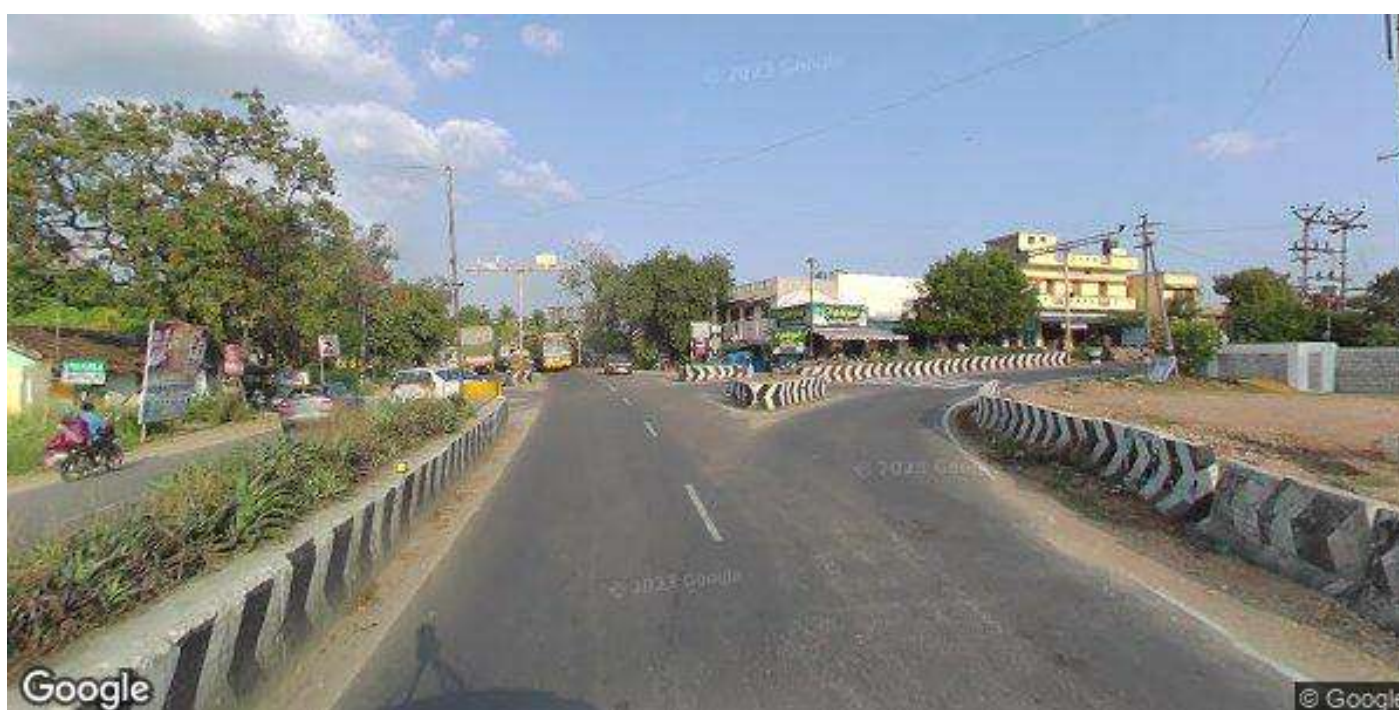
**Risk Type:** Turn  
**Risk Level:** Medium  
**Speed Limit:** 30 KM/Hr  
**Coordinates:** 11.46318, 77.84913

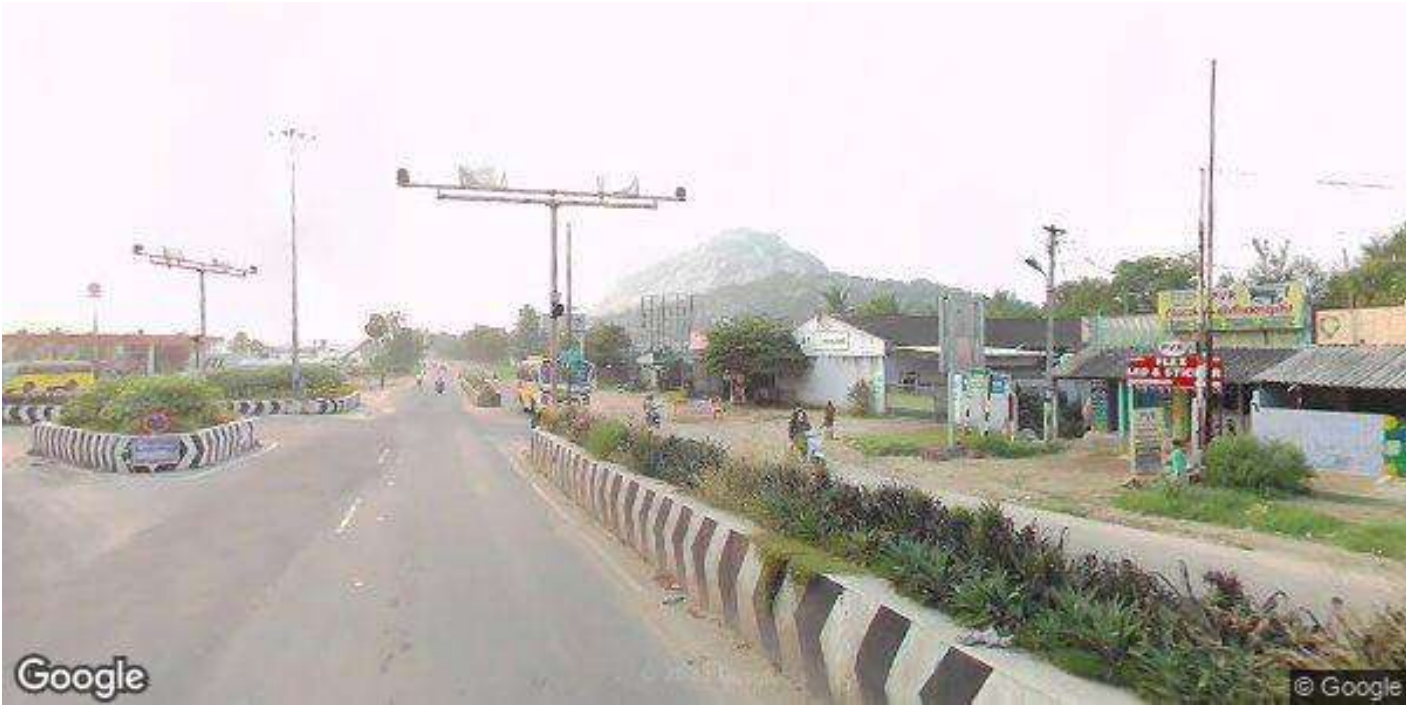
**Risk Type:** Turn  
**Risk Level:** Medium  
**Speed Limit:** 30 KM/Hr  
**Coordinates:** 11.46312, 77.84886

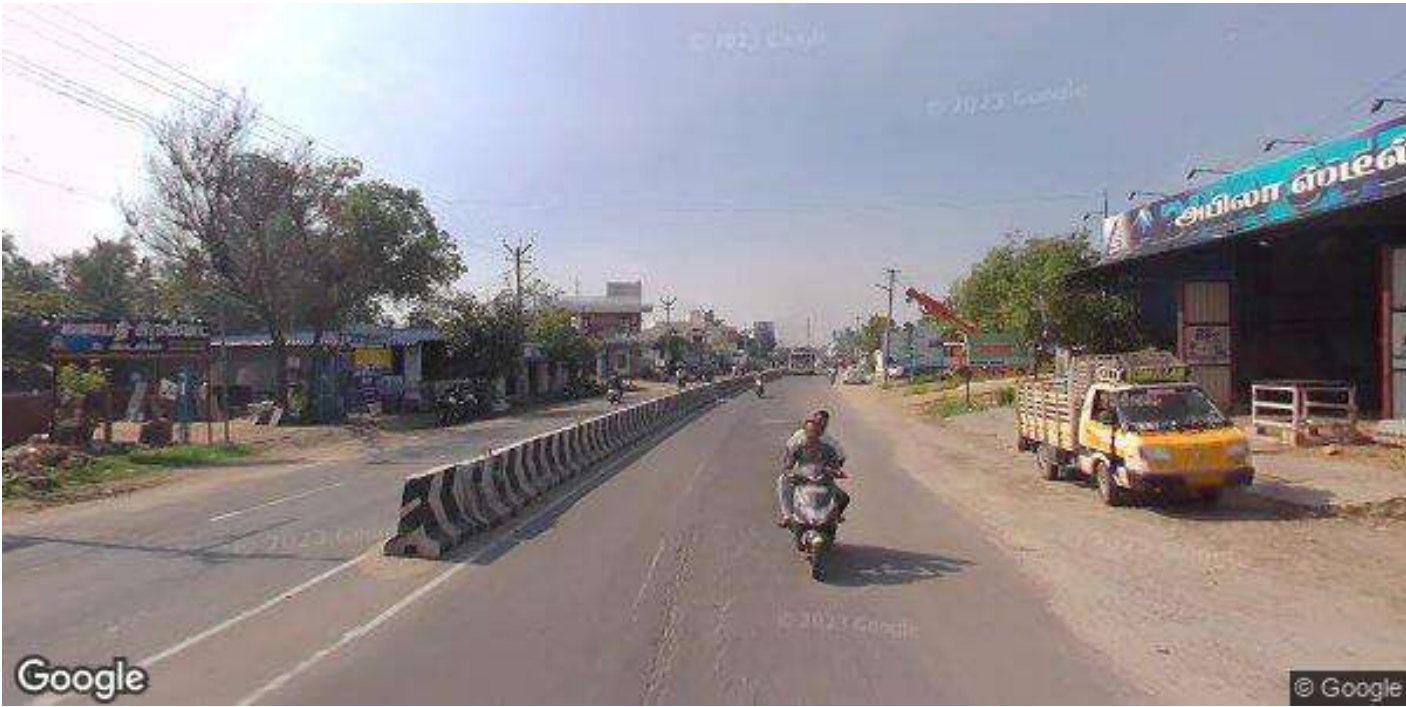
**Risk Type:** Turn  
**Risk Level:** High  
**Speed Limit:** 15 KM/Hr  
**Coordinates:** 11.37391, 77.75093
