# IndianOil

## JOURNEY RISK MANAGEMENT (JRM) STUDY

### Salem Terminal TO KPS FUEL AGENCY

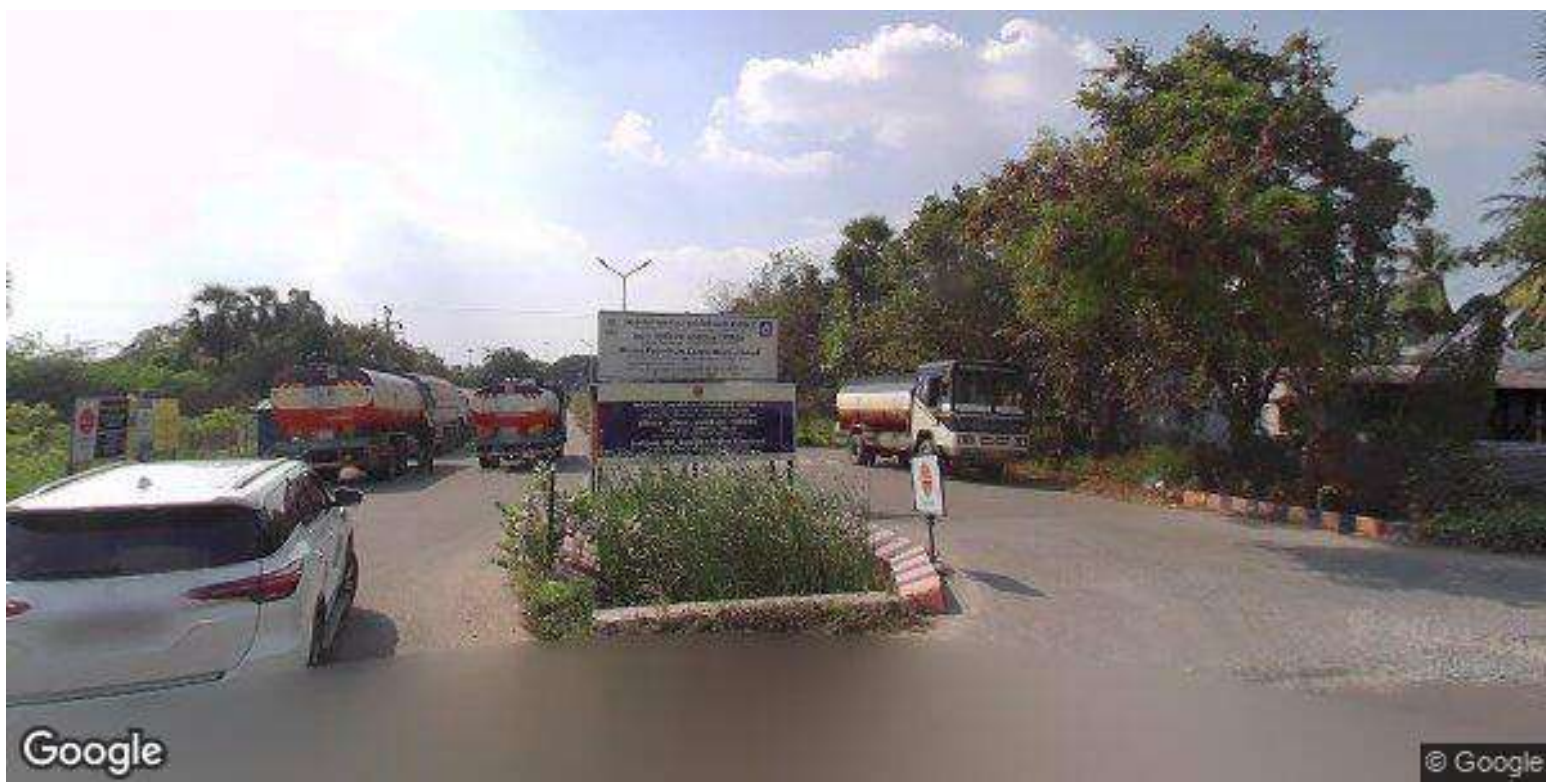
**Coordinates:** 11.44024, 77.87528

**Risk Type:** Turn

**Risk Level:** High

**Speed Limit:** 15 KM/Hr

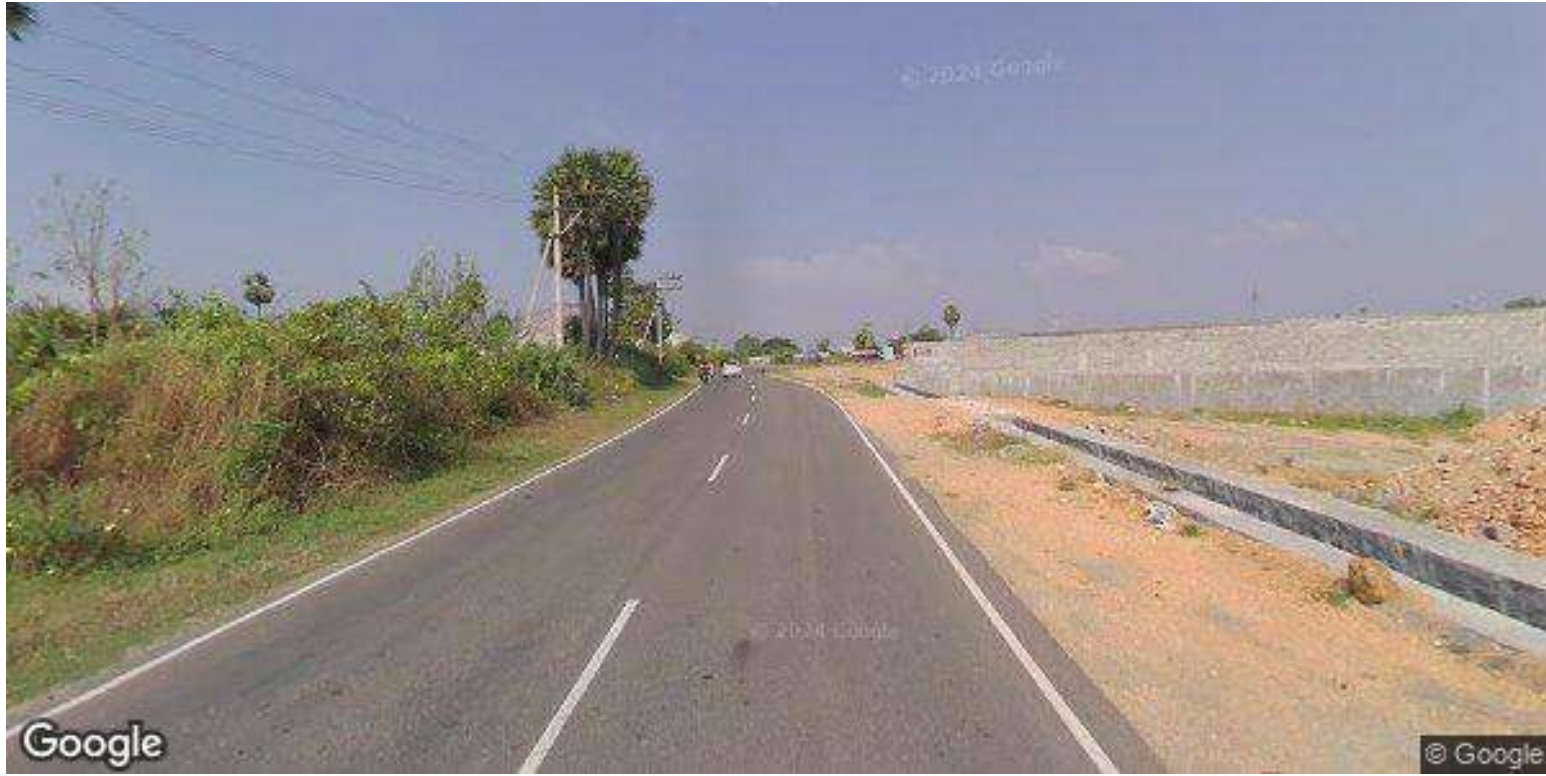
**Risk Type:** Turn  
**Risk Level:** Medium  
**Speed Limit:** 30 KM/Hr  
**Coordinates:** 11.45764, 77.85219

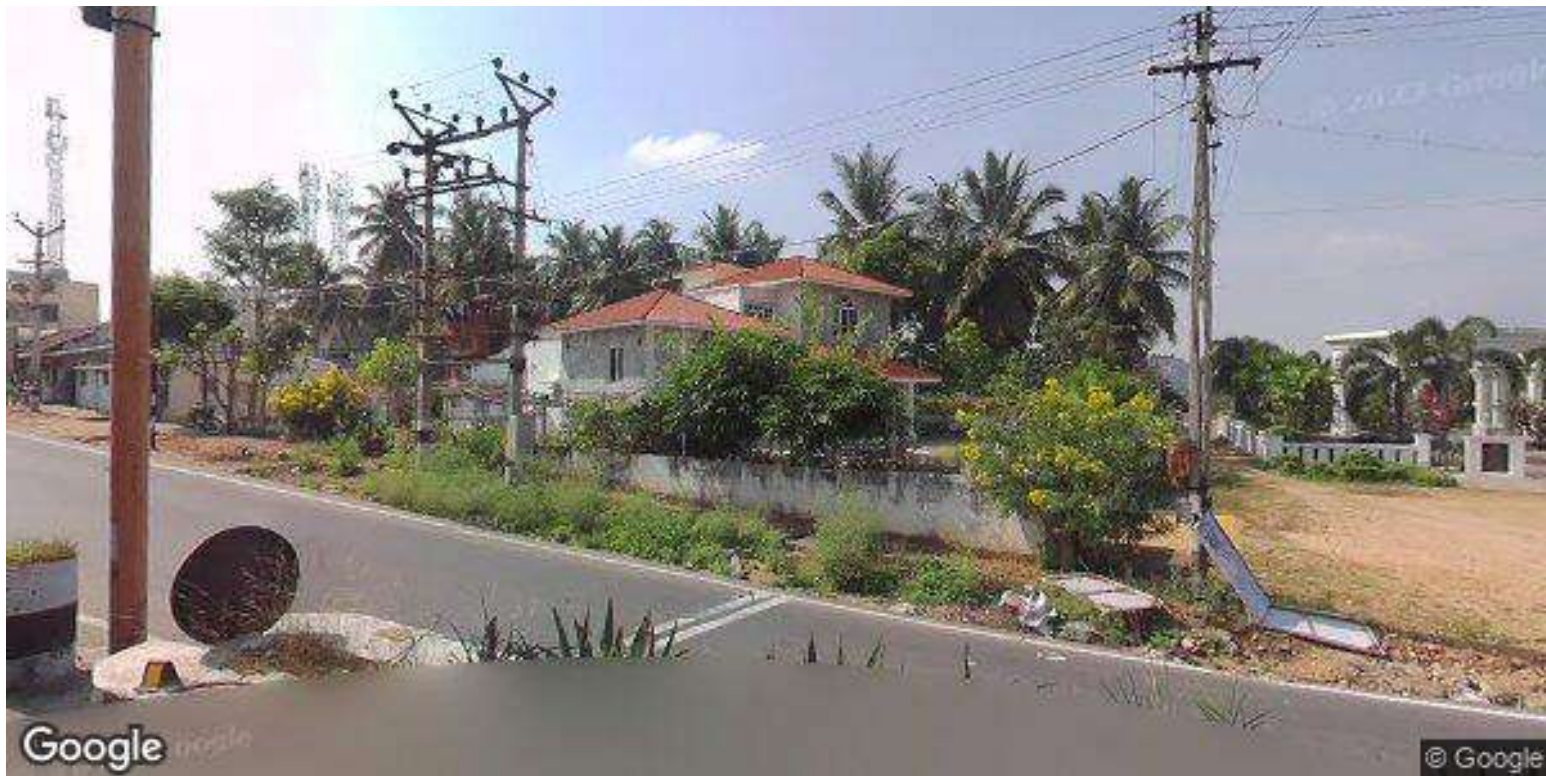
**Risk Type:** Turn  
**Risk Level:** High  
**Speed Limit:** 15 KM/Hr  
**Coordinates:** 11.46303, 77.84945

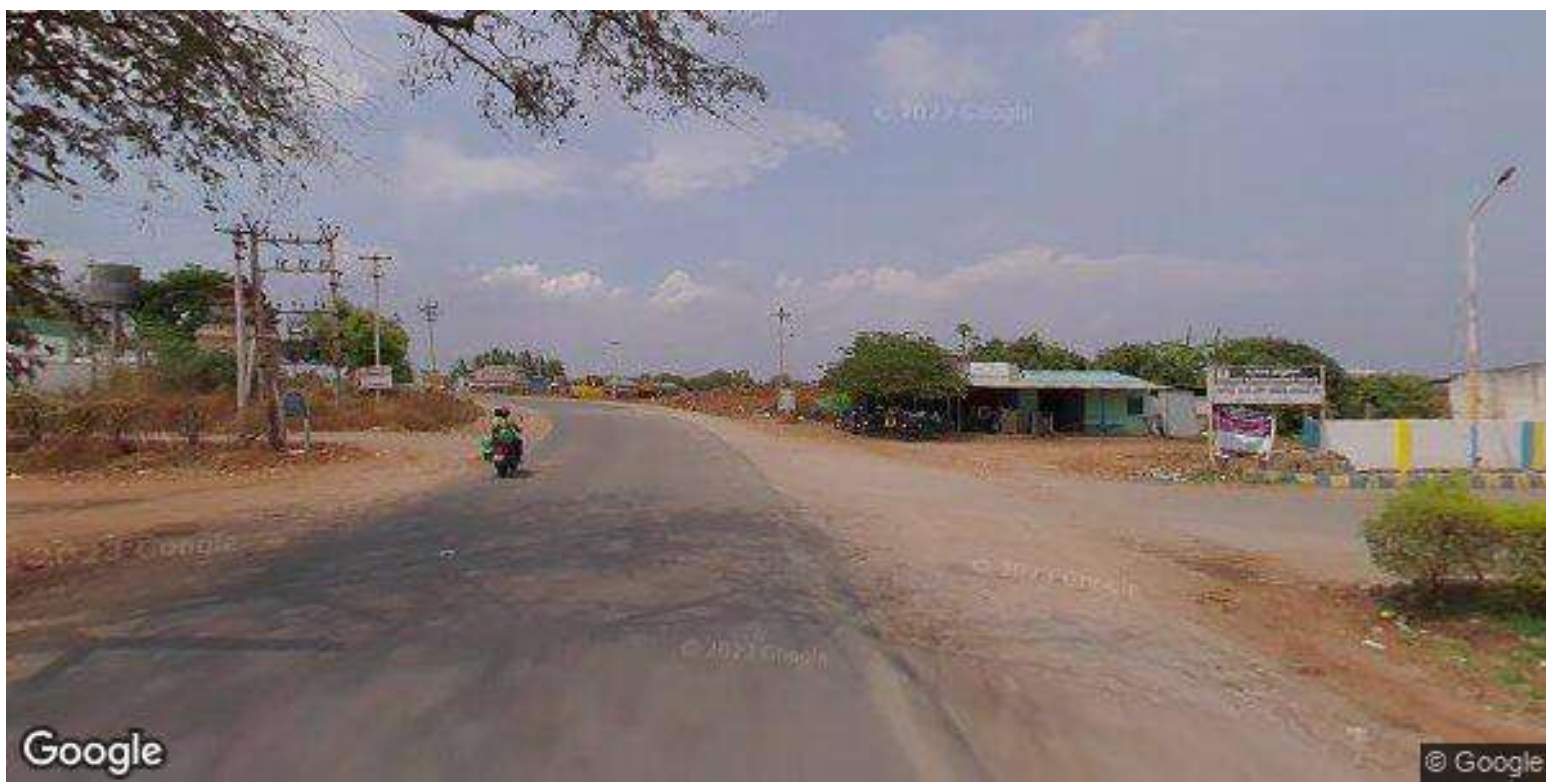
**Coordinates:** 11.58254, 77.90656

**Risk Type:** Turn

**Risk Level:** Medium

**Speed Limit:** 30 KM/Hr

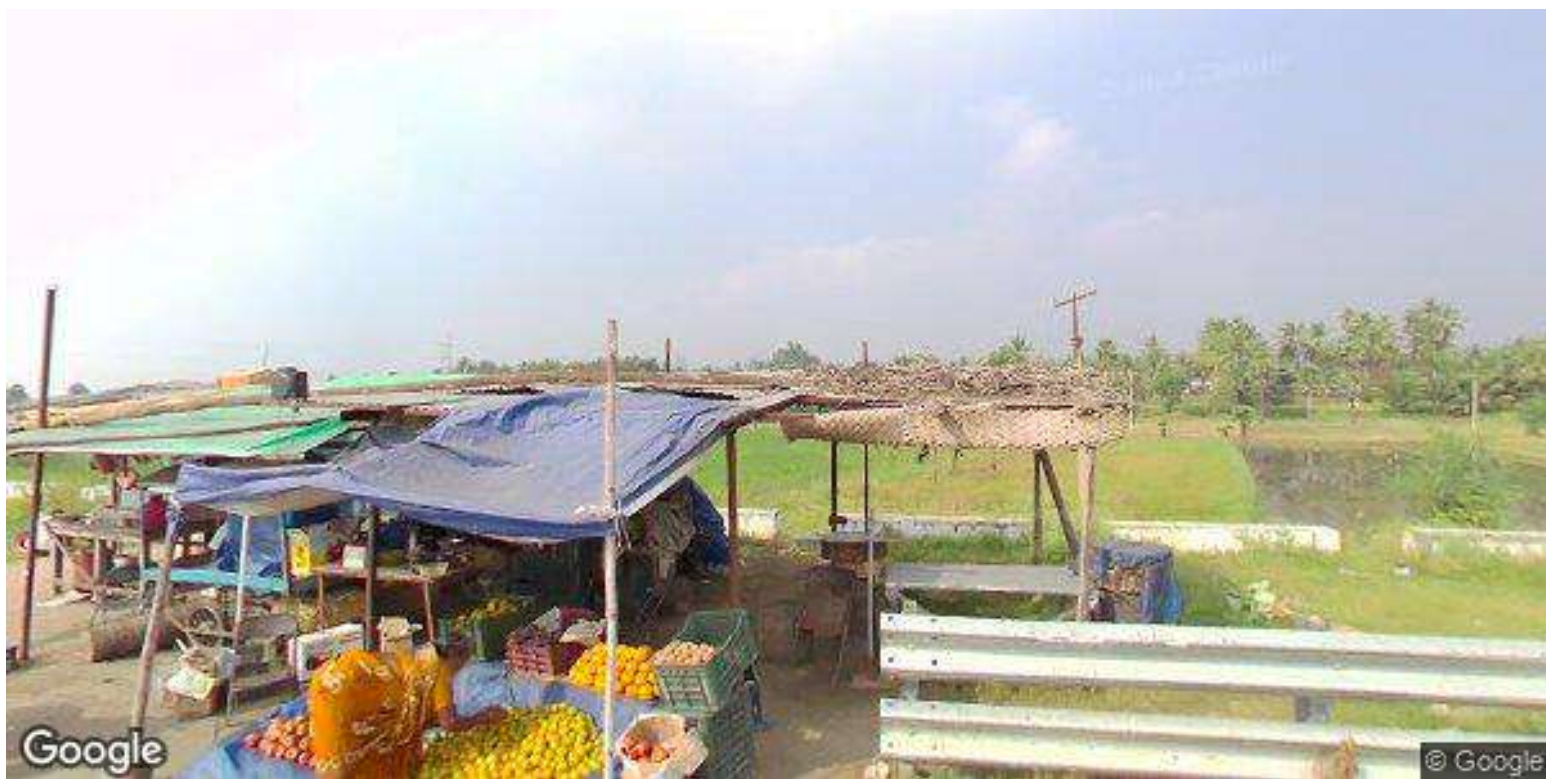
**Coordinates:** 11.67858, 77.96834

**Risk Type:** Turn

**Risk Level:** High

**Speed Limit:** 15 KM/Hr

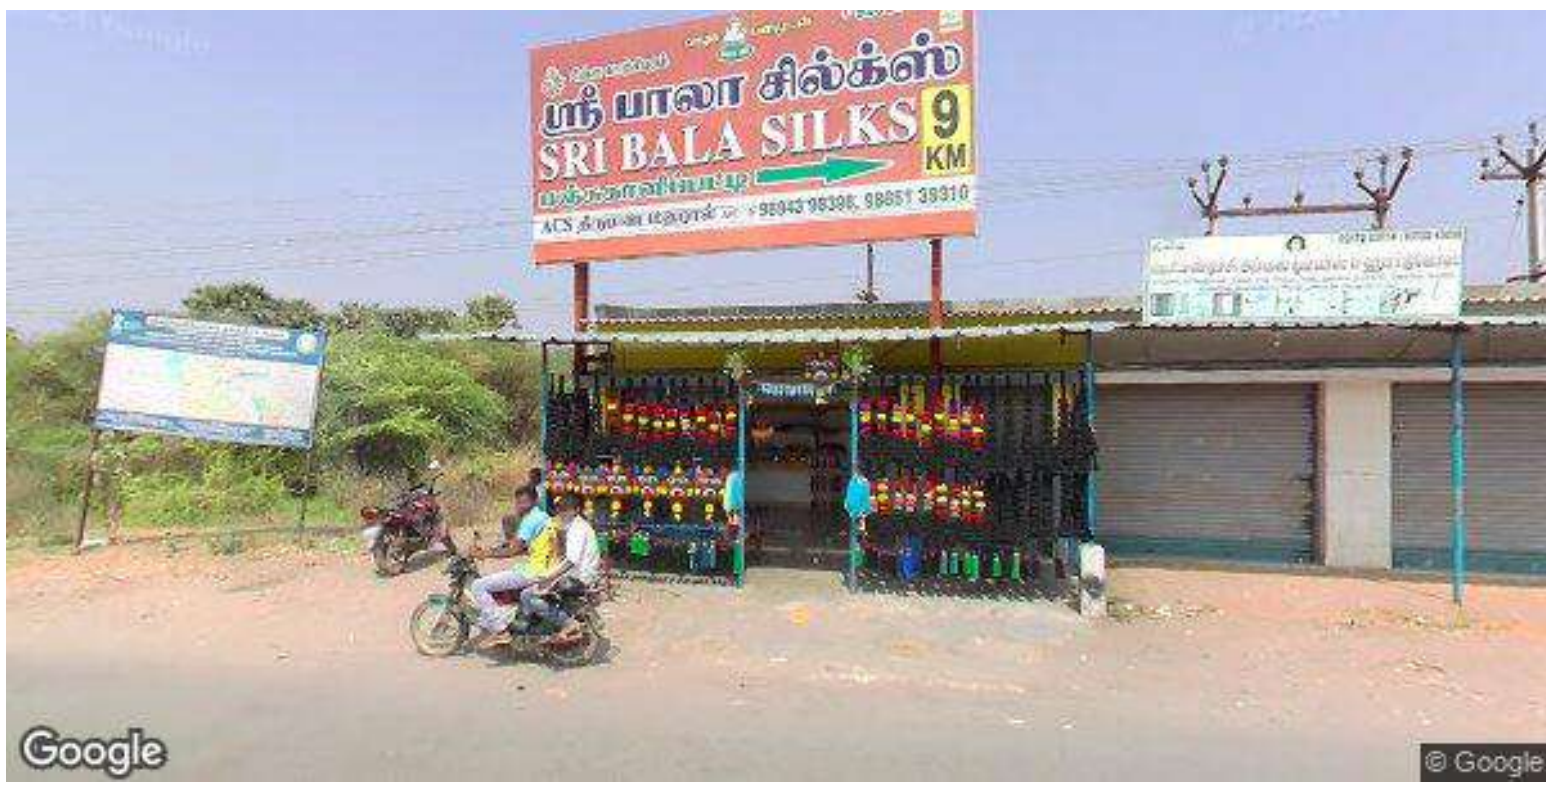
**Coordinates:** 11.70233, 77.97869

**Risk Type:** Turn

**Risk Level:** High

**Speed Limit:** 15 KM/Hr

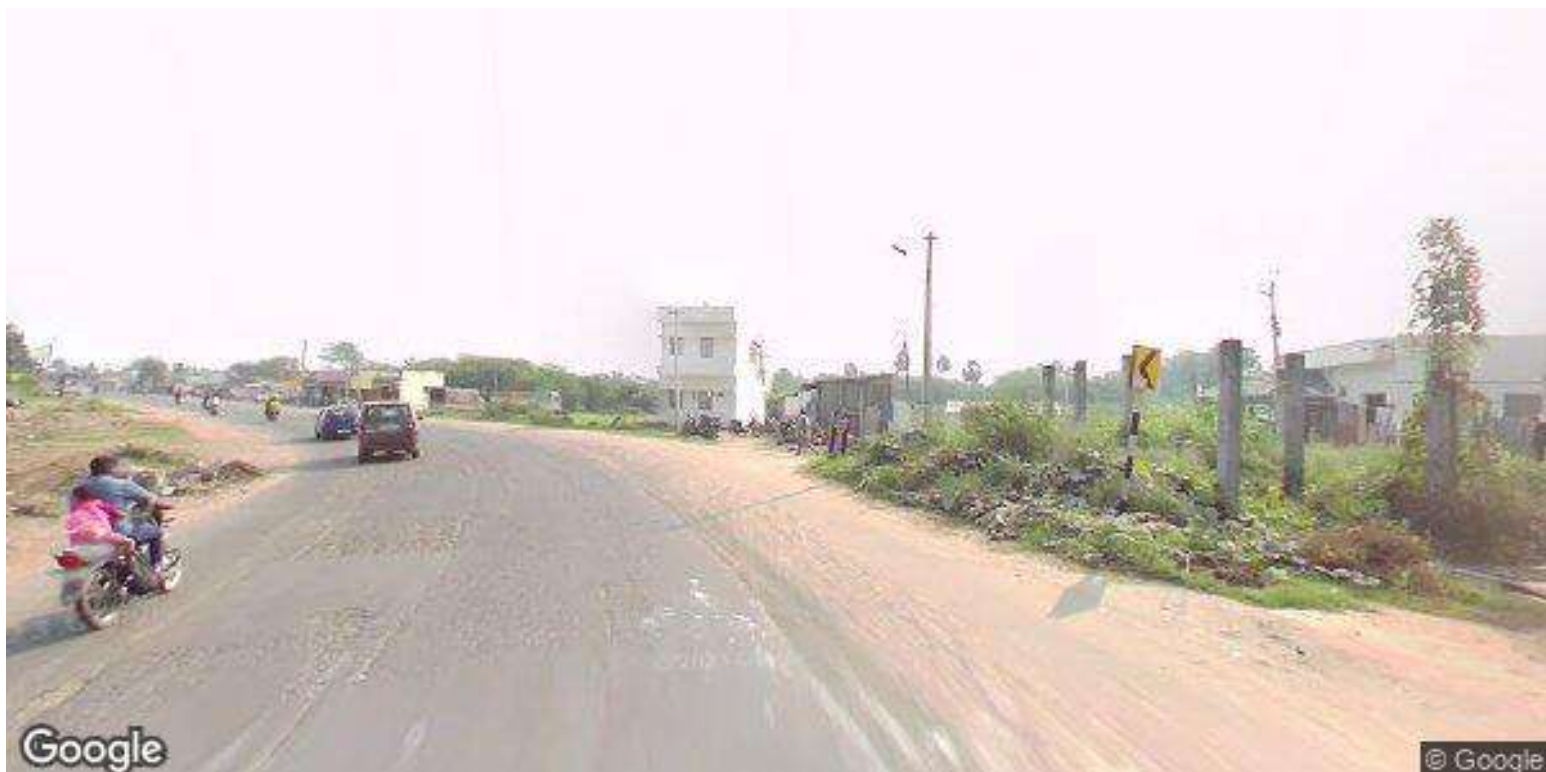
**Coordinates: 11.71916, 78.01117**

**Risk Type: Turn**

**Risk Level: Medium**

**Speed Limit: 30 KM/Hr**

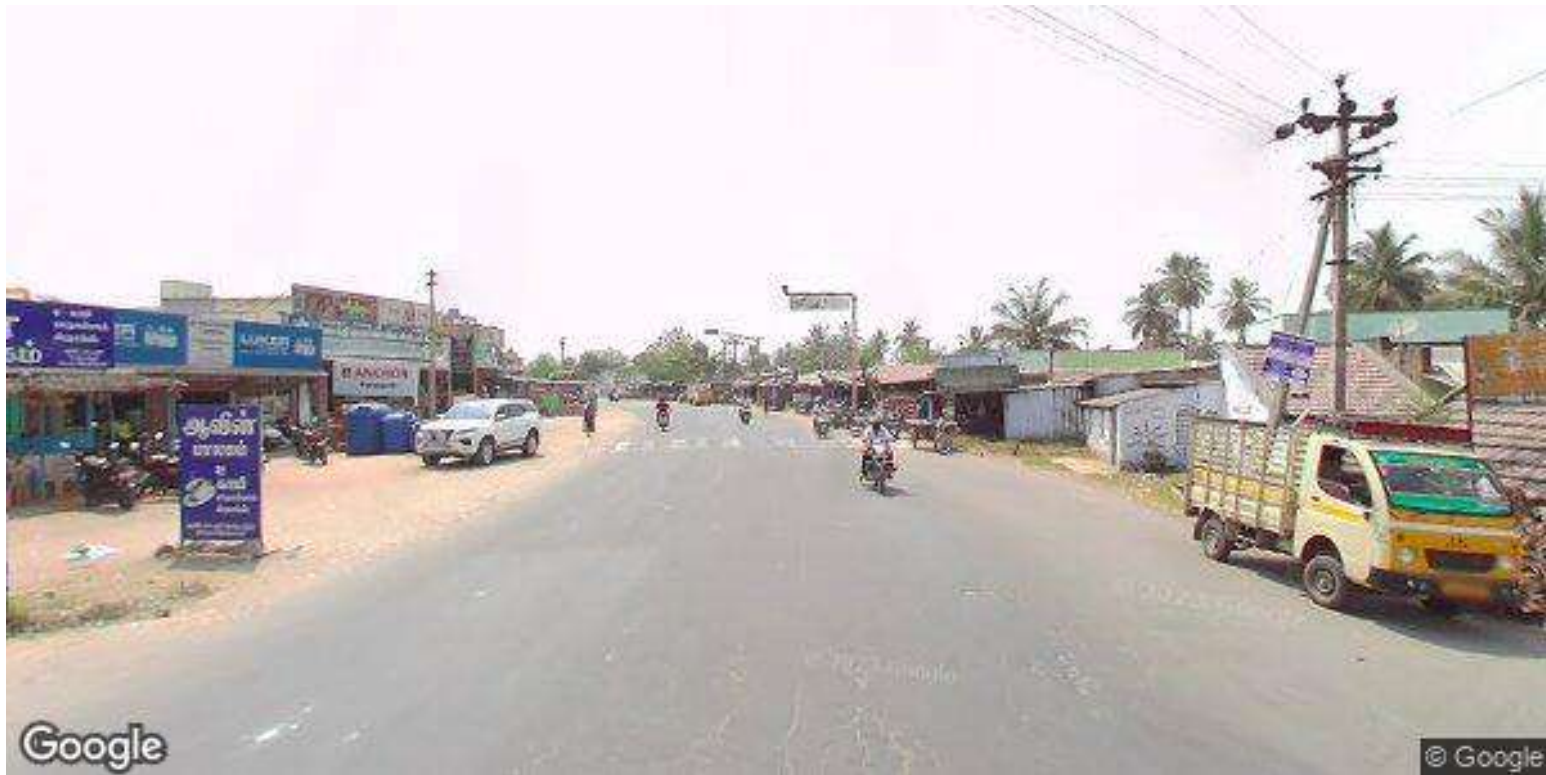
**Coordinates: 11.73787, 78.03528**

**Risk Type: Turn**

**Risk Level: Medium**

**Speed Limit: 30 KM/Hr**

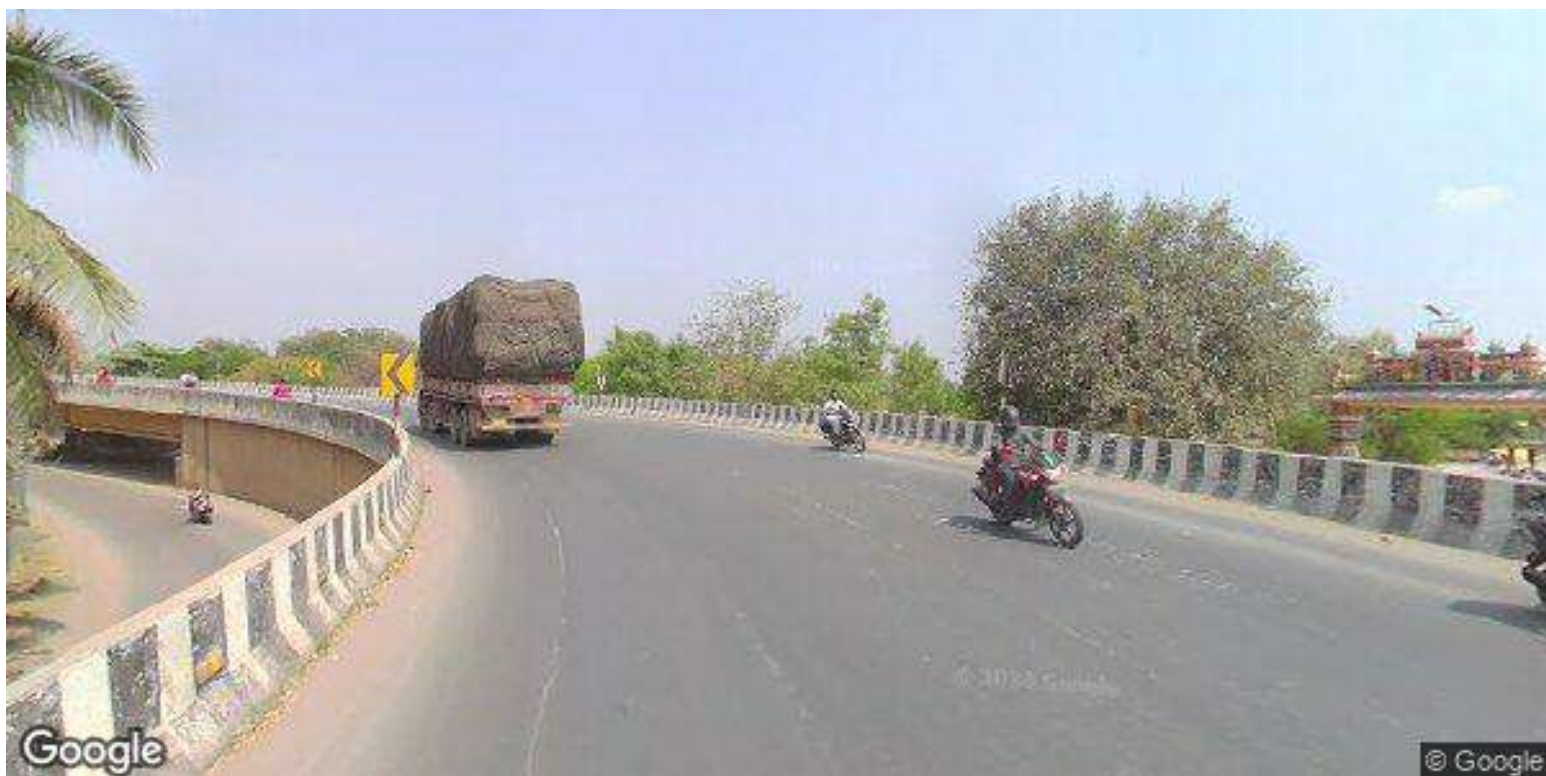
**Coordinates: 11.73651, 78.03868**

**Risk Type: Turn**

**Risk Level: High**

**Speed Limit: 15 KM/Hr**

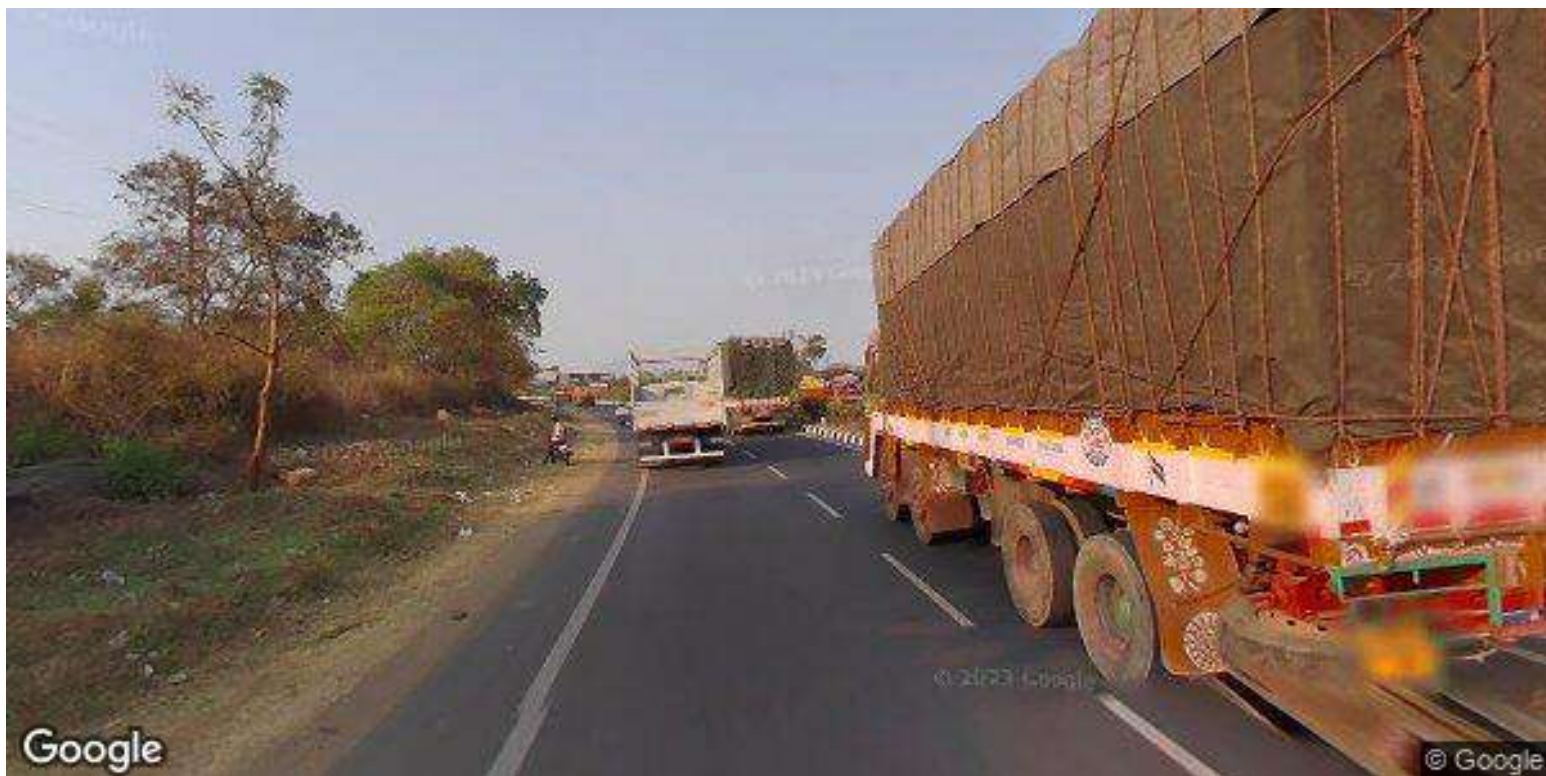
**Coordinates:** 11.77998, 78.05786

**Risk Type:** Turn

**Risk Level:** Medium

**Speed Limit:** 30 KM/Hr

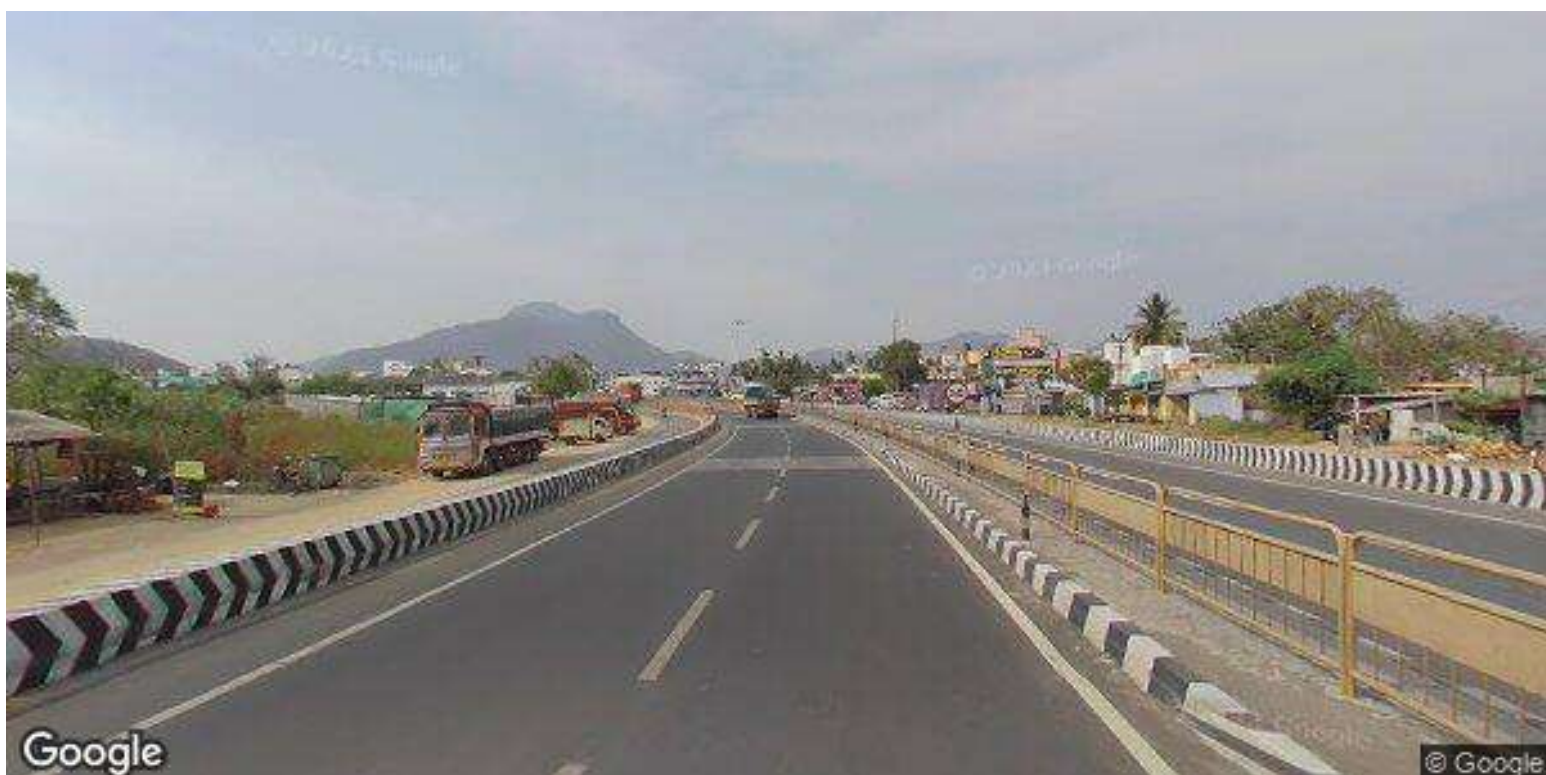
**Coordinates: 11.86915, 78.08382**

**Risk Type: Turn**

**Risk Level: Medium**

**Speed Limit: 30 KM/Hr**

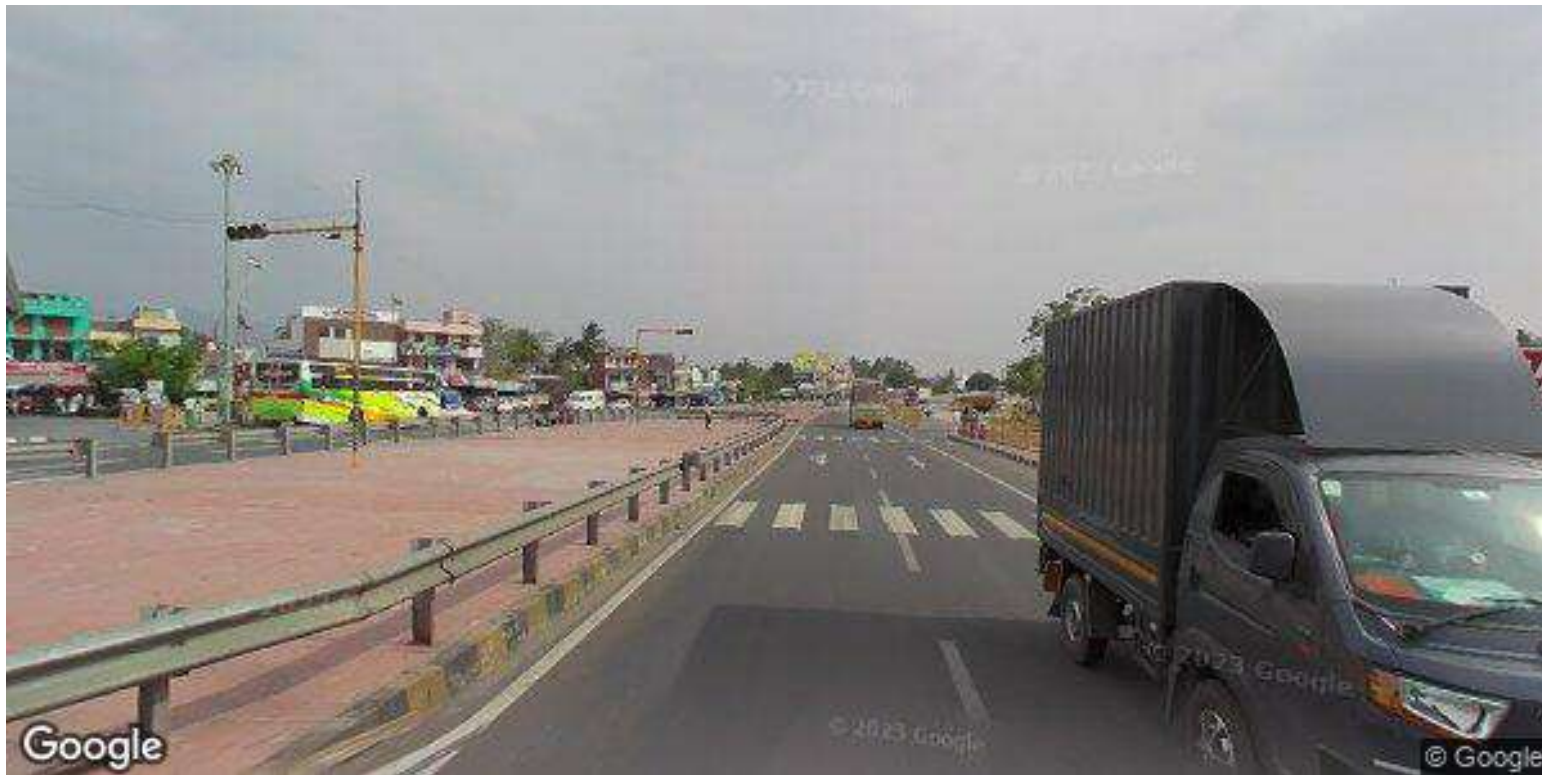
**Coordinates: 11.87099, 78.08358**

**Risk Type: Turn**

**Risk Level: High**

**Speed Limit: 15 KM/Hr**

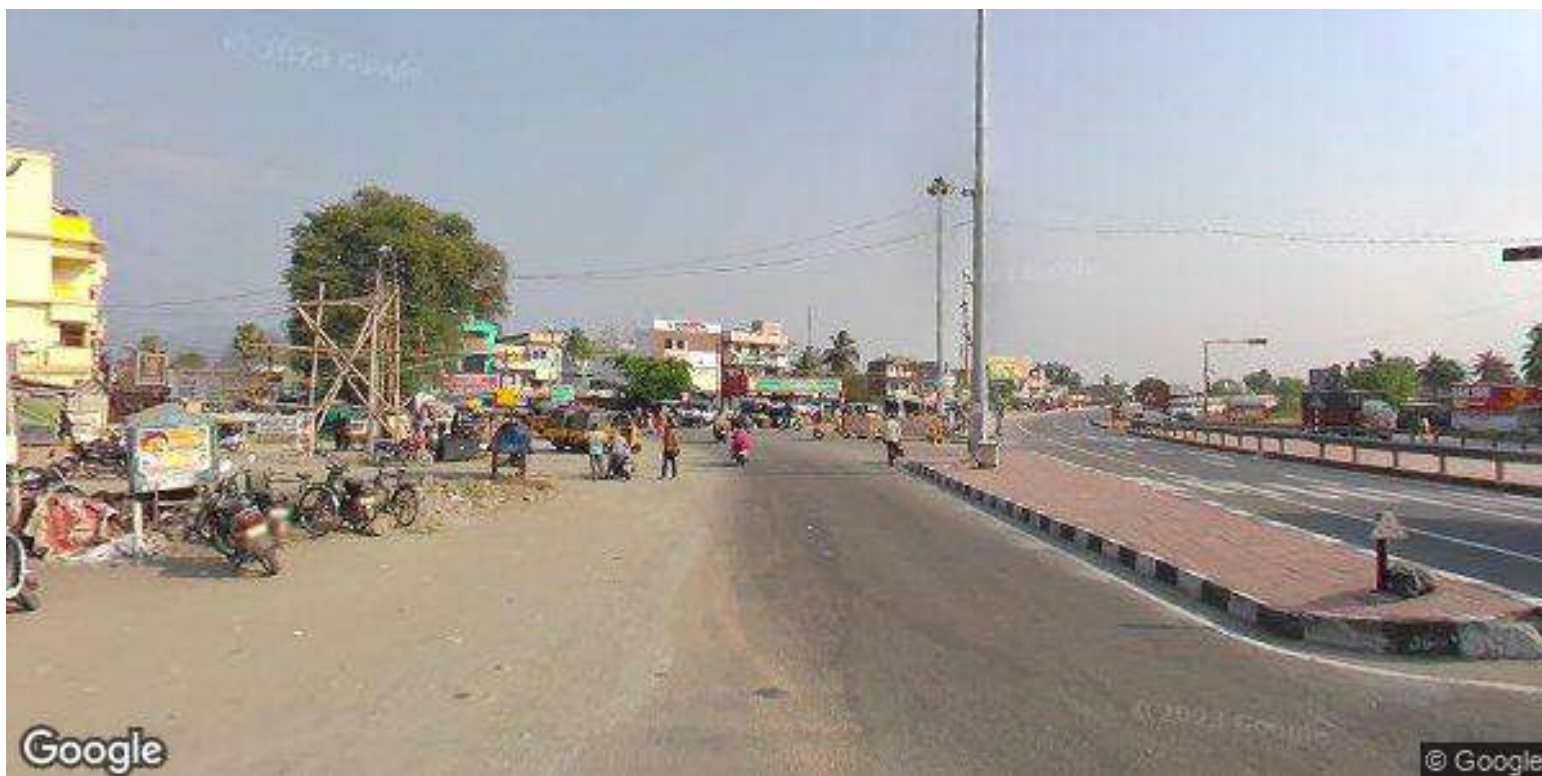
**Coordinates: 11.87110, 78.08383**

**Risk Type: Turn**

**Risk Level: High**

**Speed Limit: 15 KM/Hr**

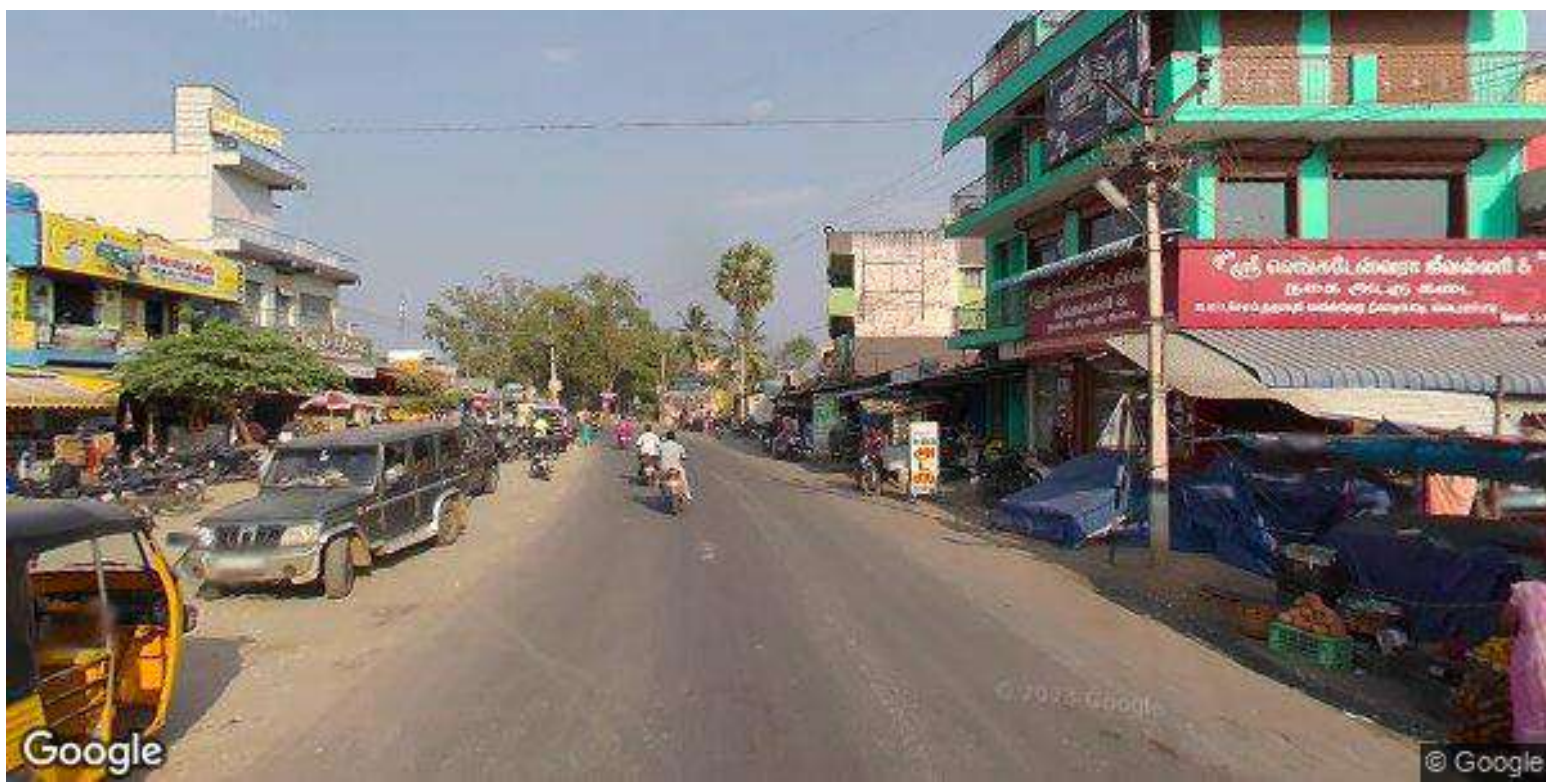
**Coordinates:** 11.87072, 78.08439

**Risk Type:** Turn

**Risk Level:** Medium

**Speed Limit:** 30 KM/Hr

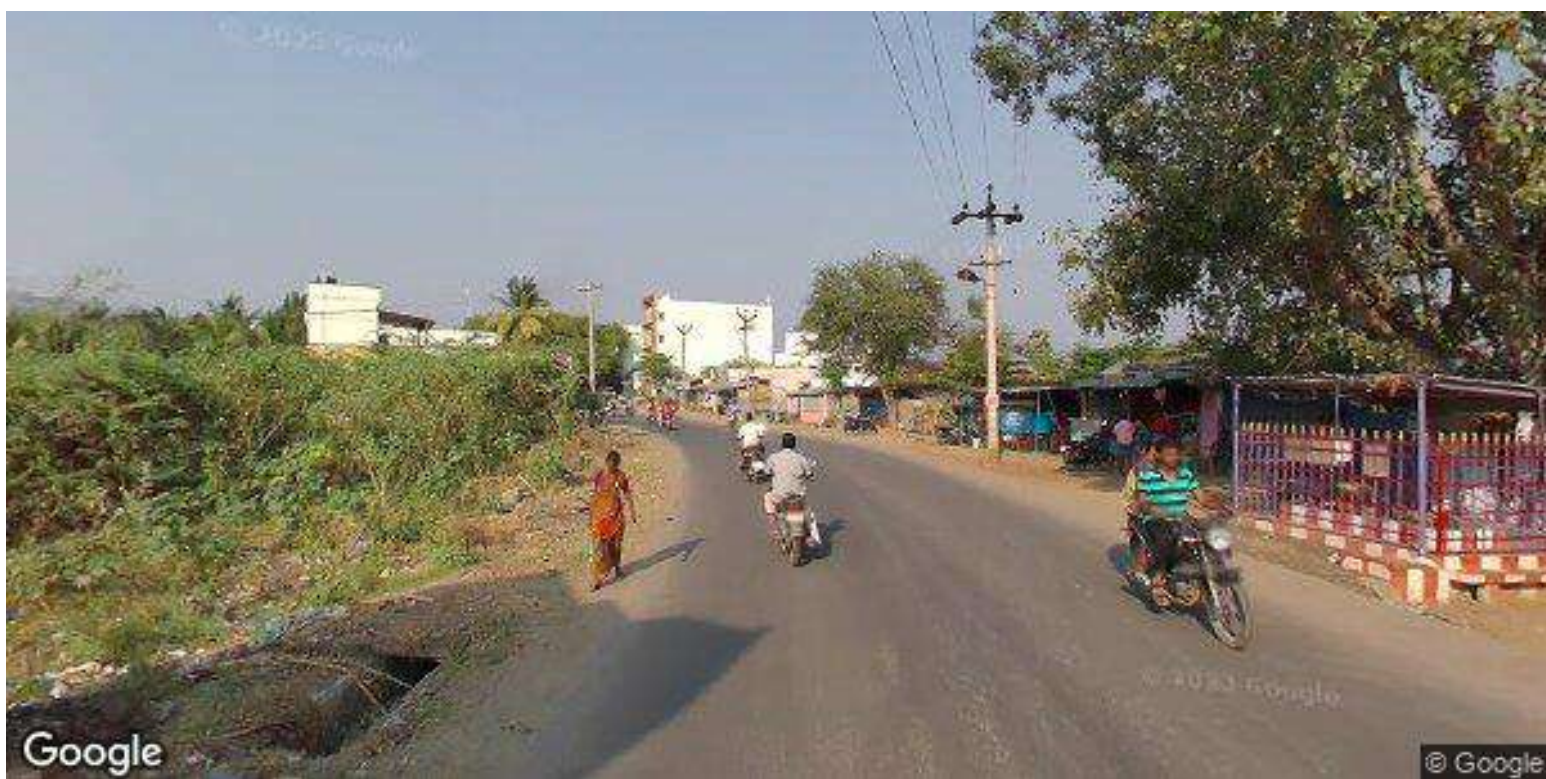
**Coordinates:** 11.87088, 78.08556

**Risk Type:** Turn

**Risk Level:** Medium

**Speed Limit:** 30 KM/Hr

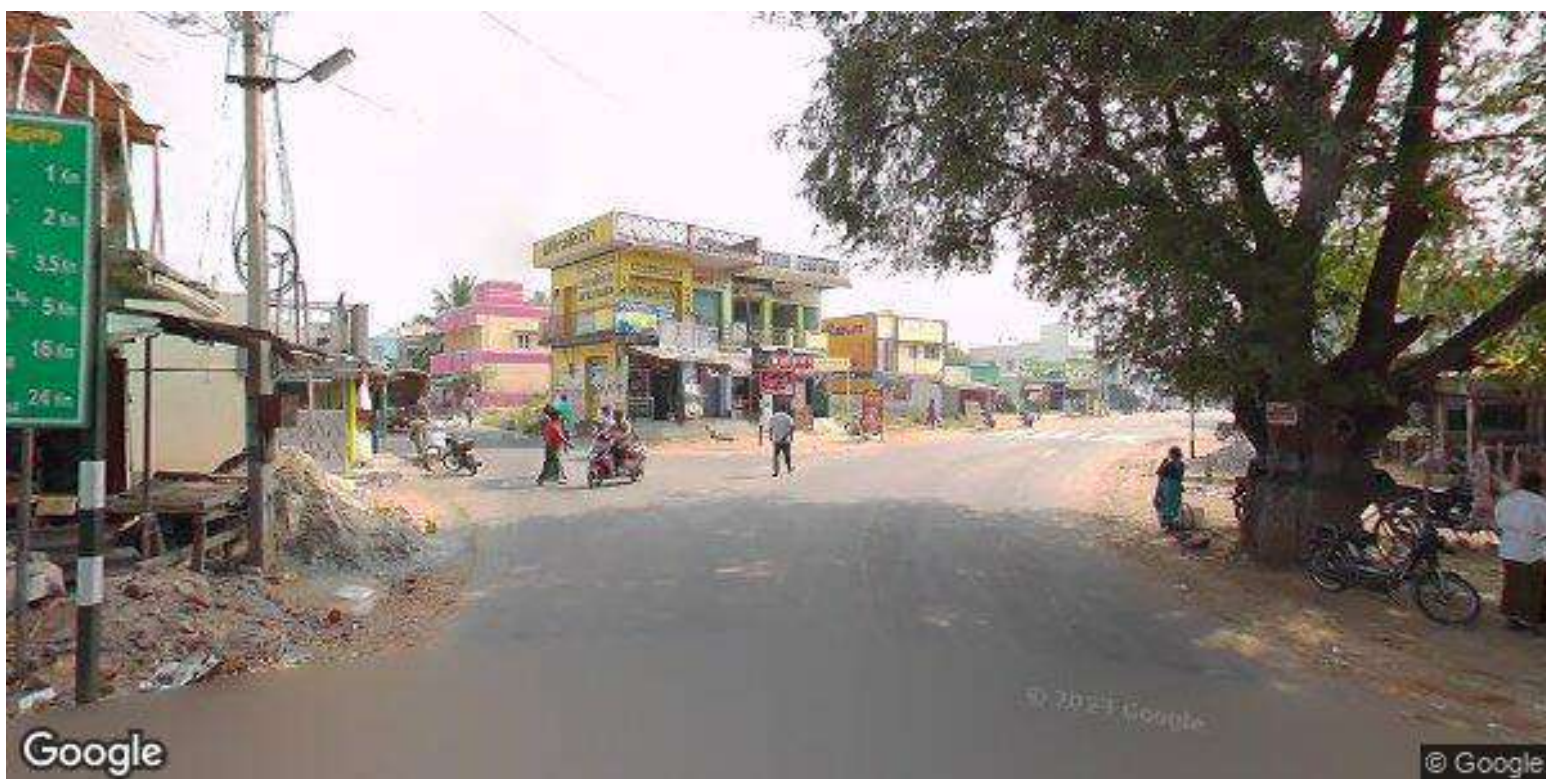
**Risk Type:** Turn  
**Risk Level:** High  
**Speed Limit:** 15 KM/Hr  
**Coordinates:** 11.87246, 78.08704

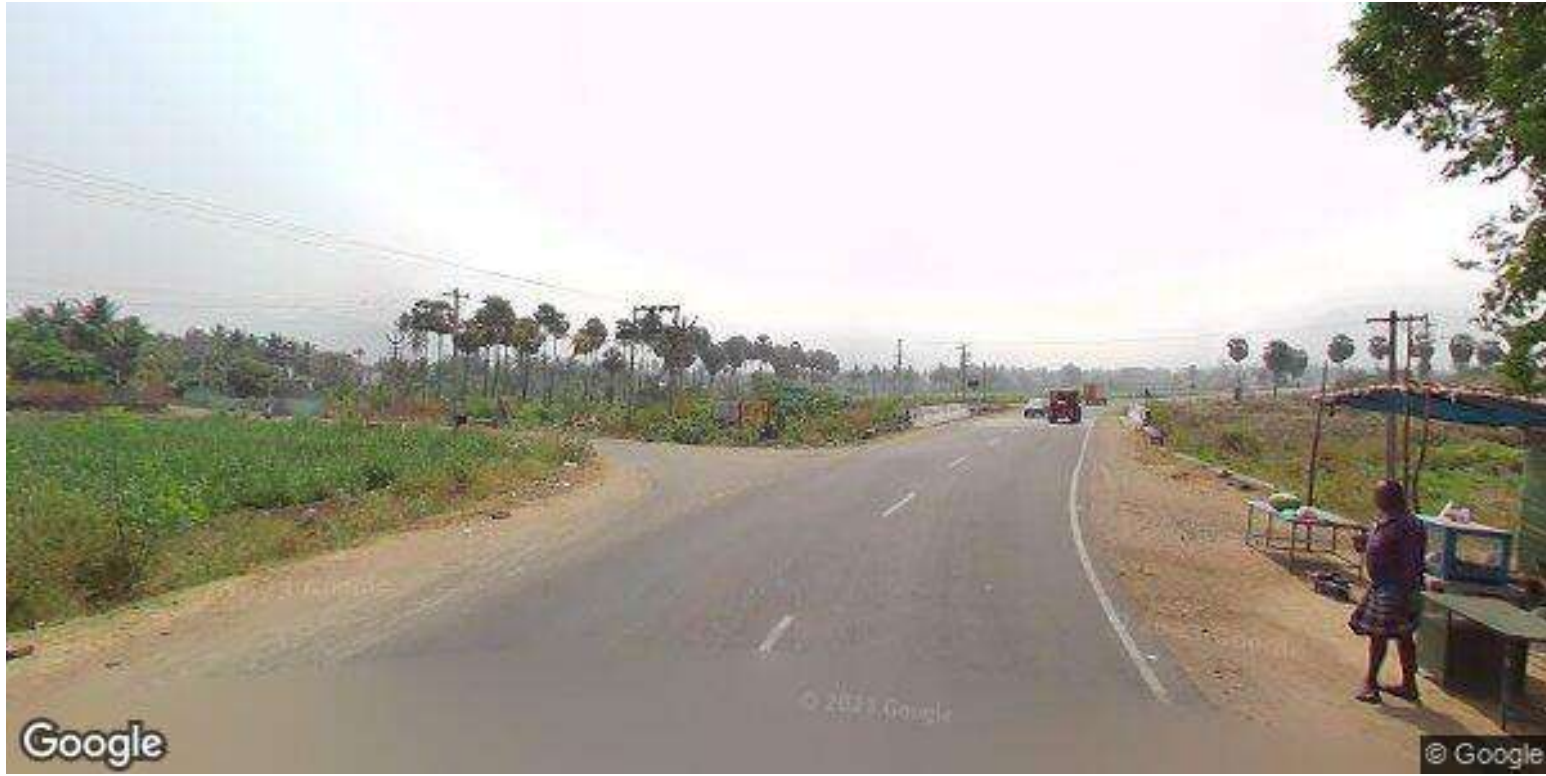
**Risk Type:** Turn  
**Risk Level:** High  
**Speed Limit:** 15 KM/Hr  
**Coordinates:** 11.86898, 78.12074

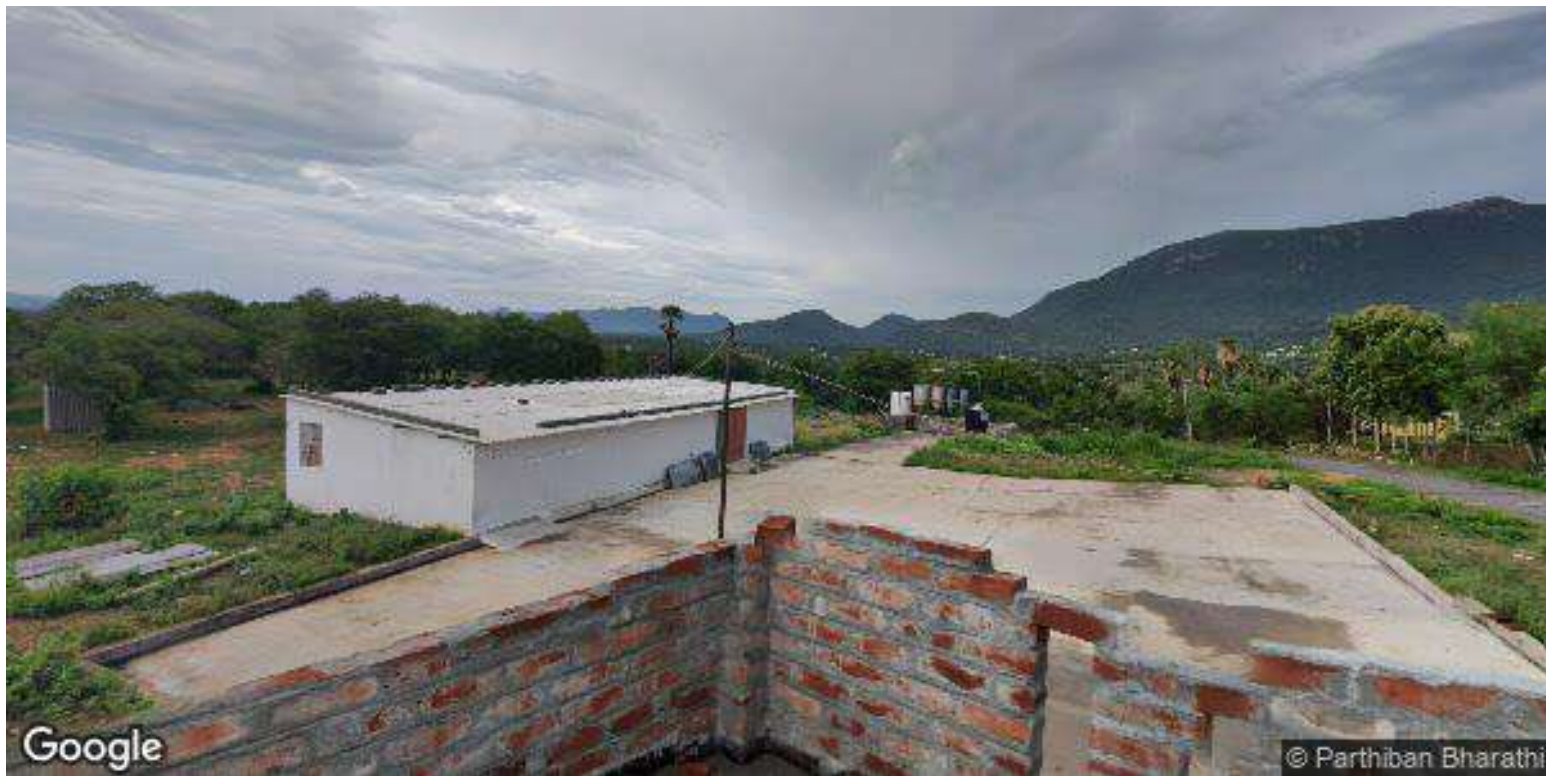
**Risk Type:** Turn  
**Risk Level:** Medium  
**Speed Limit:** 30 KM/Hr  
**Coordinates:** 11.95114, 78.20643

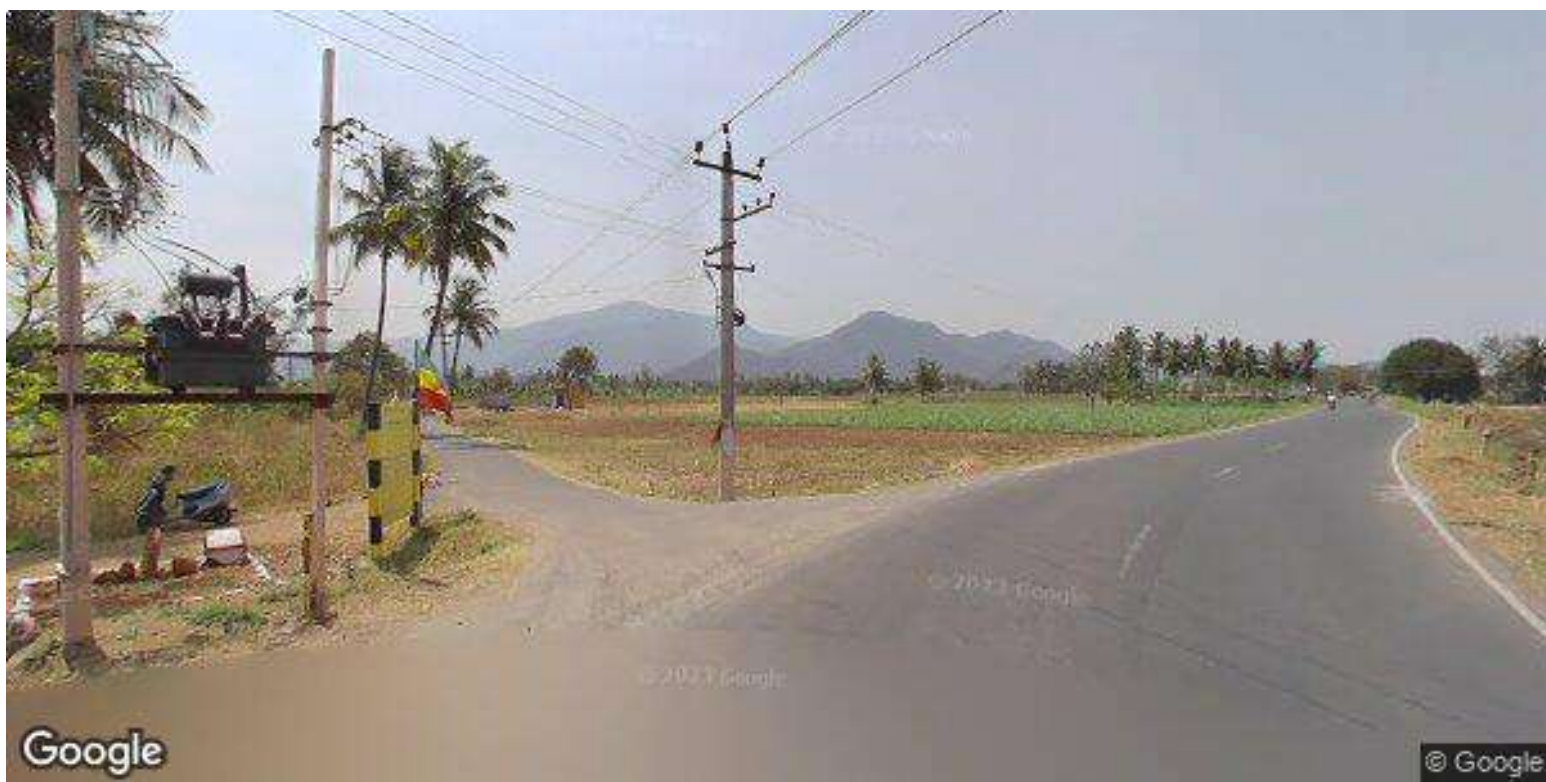
**Risk Type:** Turn  
**Risk Level:** High  
**Speed Limit:** 15 KM/Hr  
**Coordinates:** 11.97321, 78.23713
