# IndianOil

## JOURNEY RISK MANAGEMENT (JRM) STUDY

### Salem Terminal TO KPS FUEL AGENCY

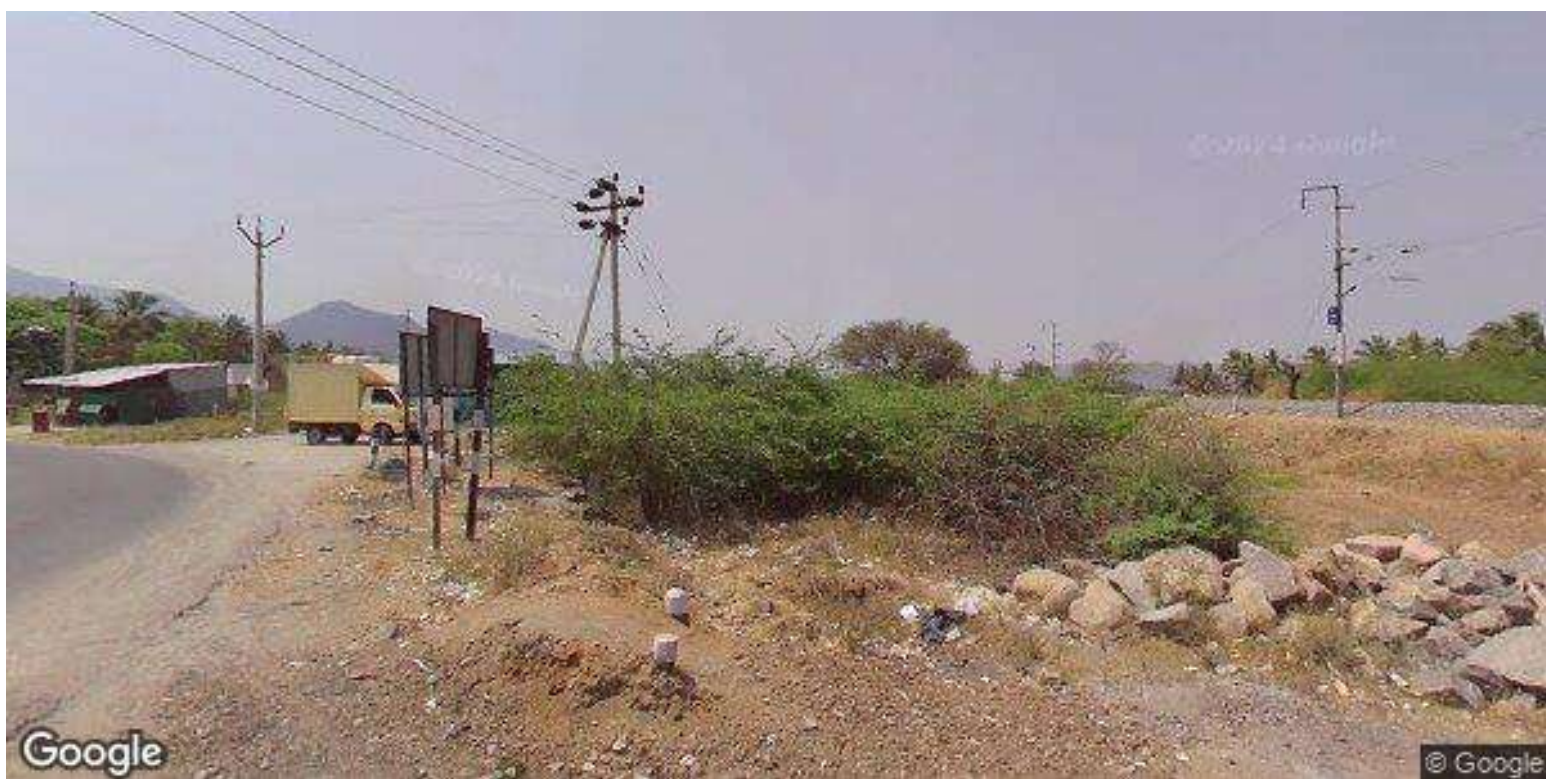
**Risk Type:** Turn  
**Risk Level:** High  
**Speed Limit:** 15 KM/Hr  
**Coordinates:** 11.97761, 78.23553

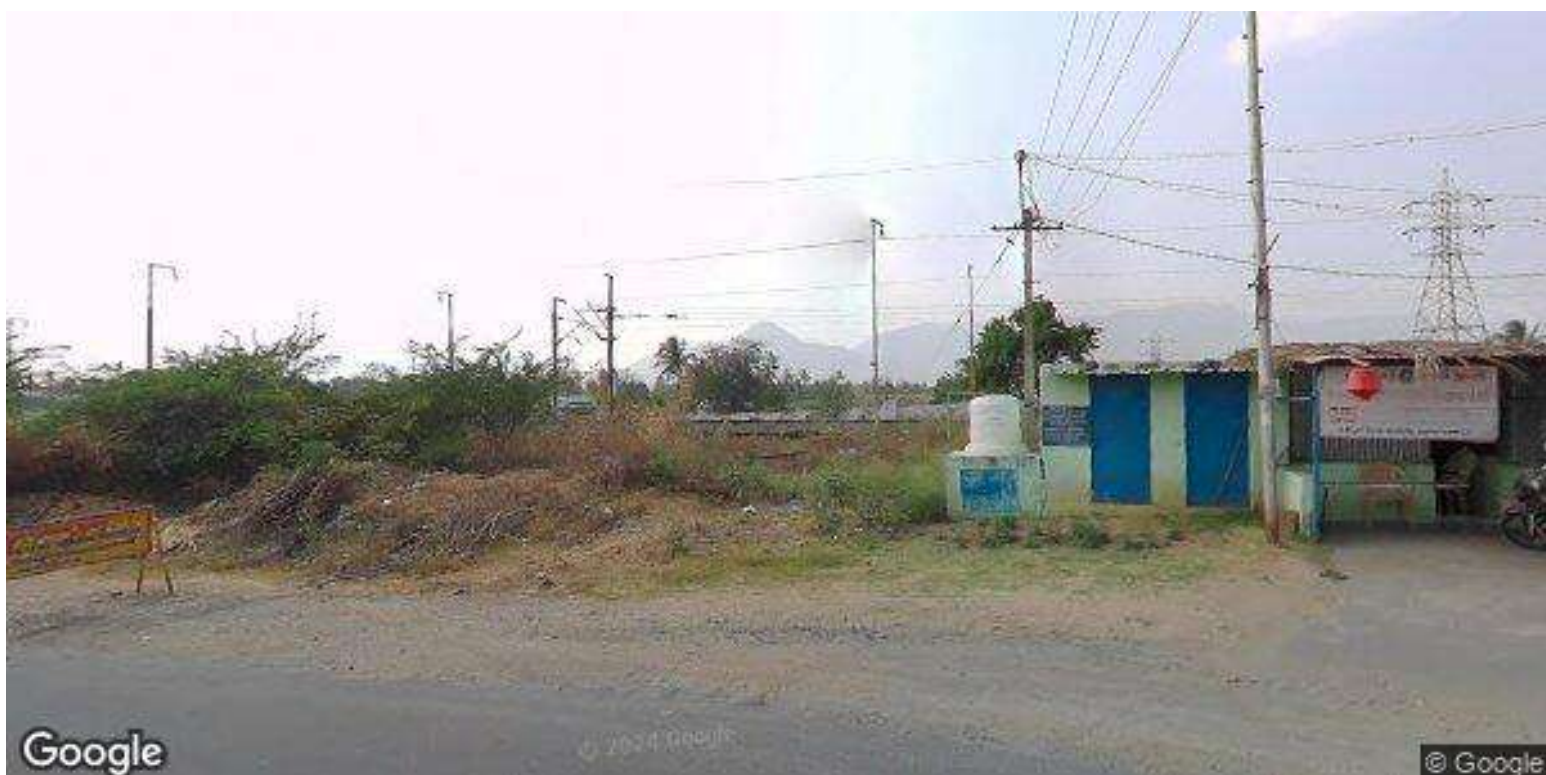
**Coordinates: 11.98244, 78.24307**

**Risk Type: Turn**

**Risk Level: High**

**Speed Limit: 15 KM/Hr**

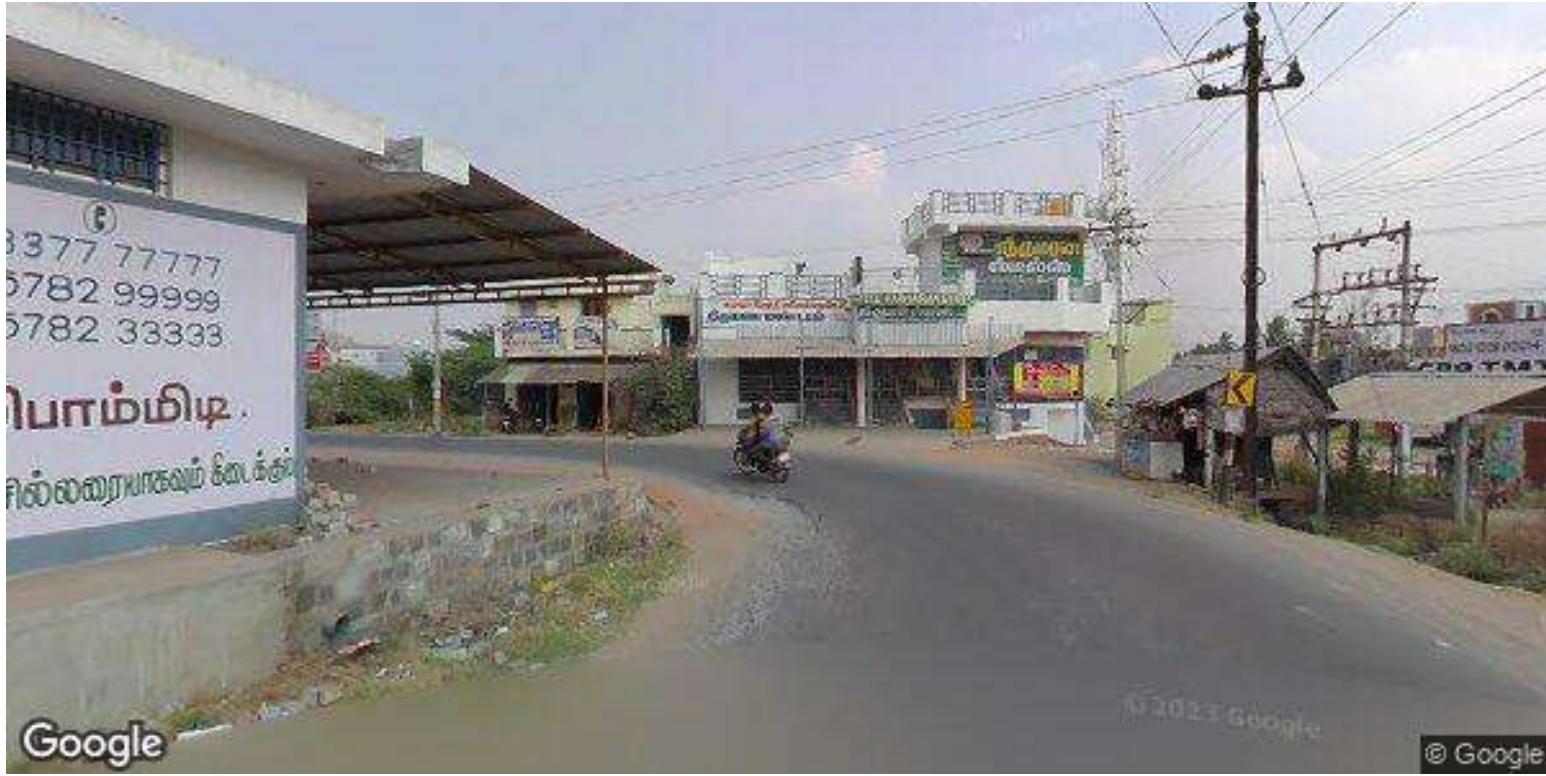
**Coordinates: 11.98207, 78.24331**

**Risk Type: Turn**

**Risk Level: High**

**Speed Limit: 15 KM/Hr**

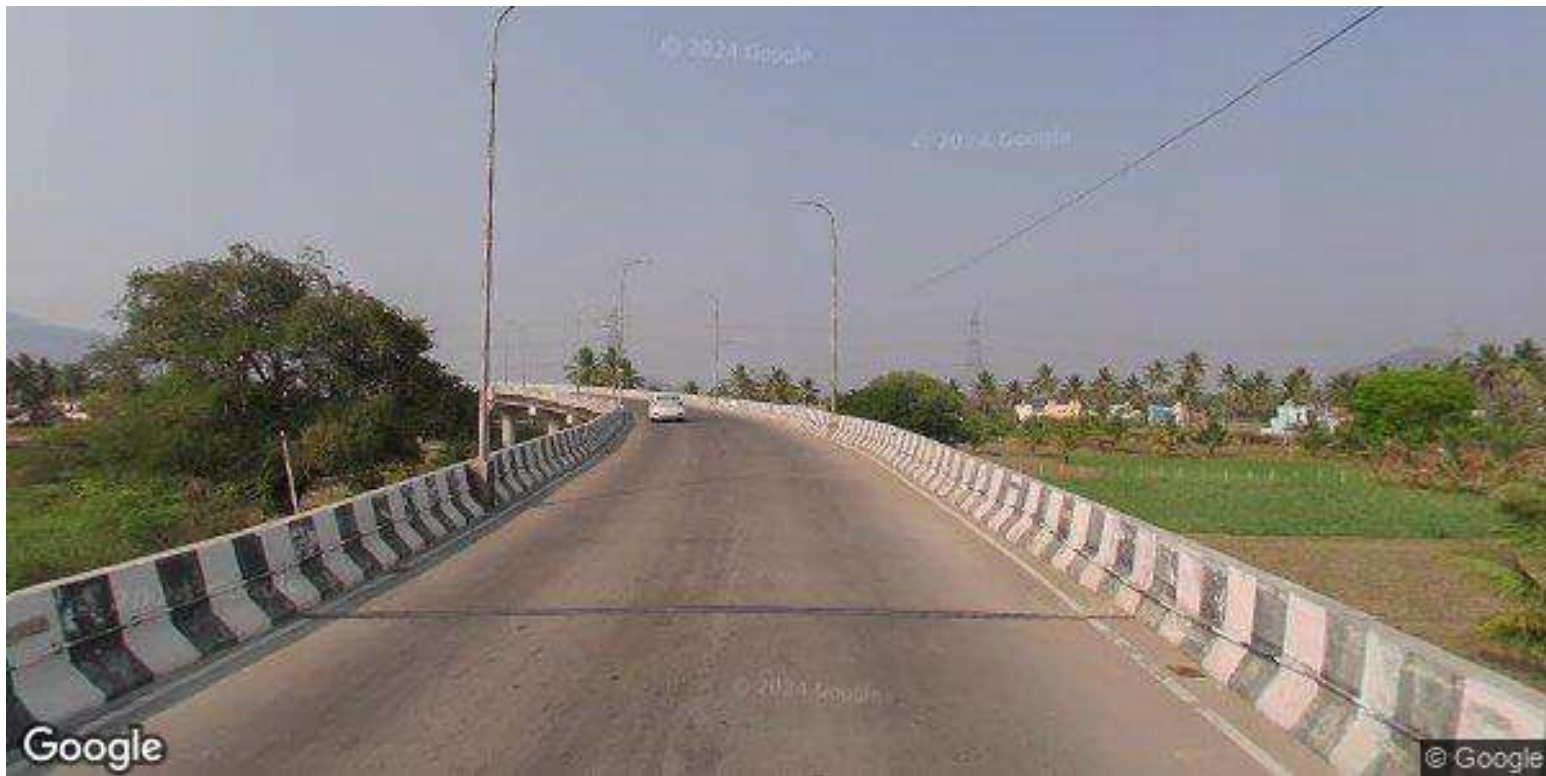
**Coordinates: 11.99285, 78.25796**

**Risk Type: Turn**

**Risk Level: Medium**

**Speed Limit: 30 KM/Hr**

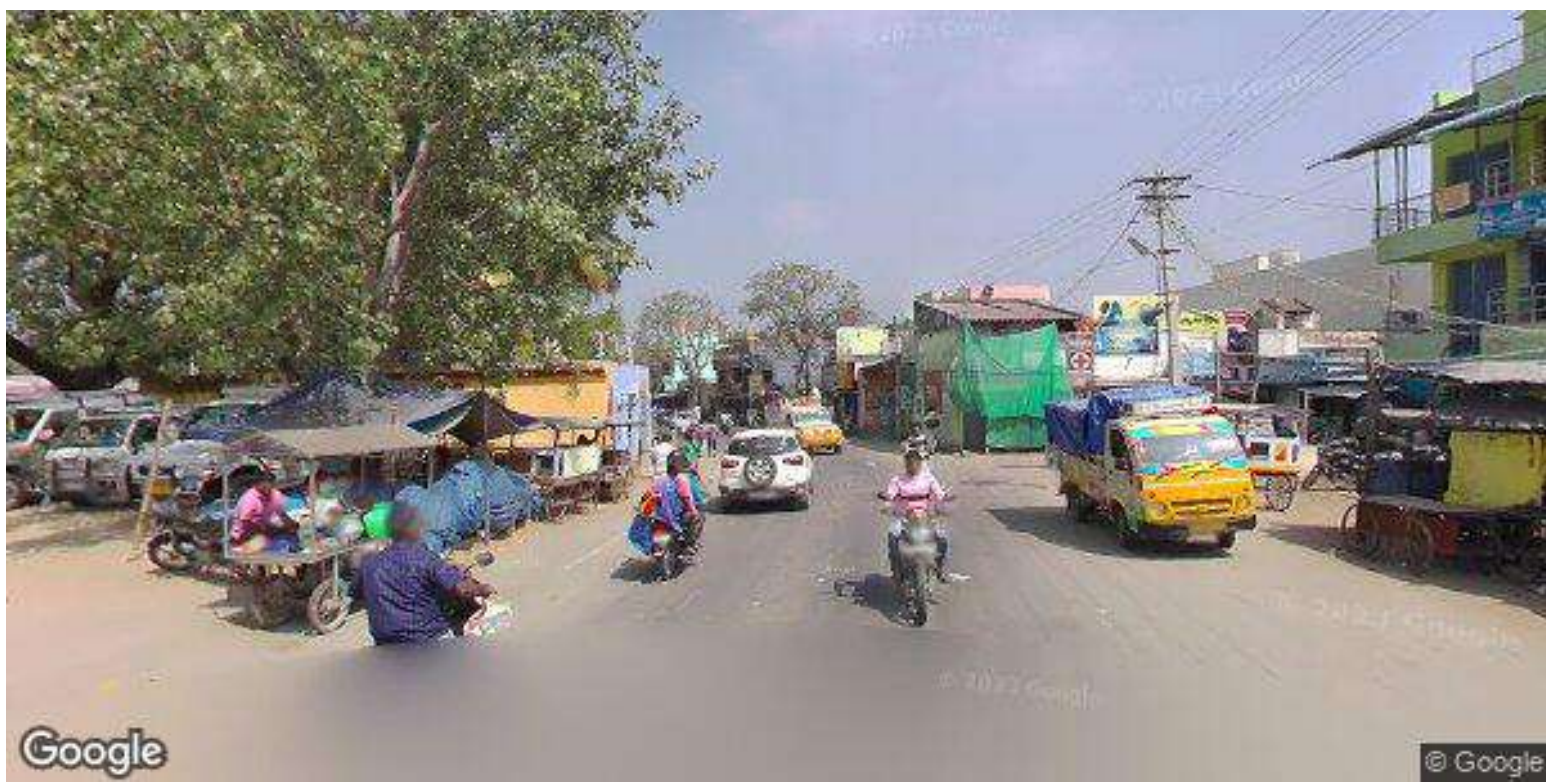
**Coordinates:** 12.08633, 78.29099

**Risk Type:** Turn

**Risk Level:** Medium

**Speed Limit:** 30 KM/Hr

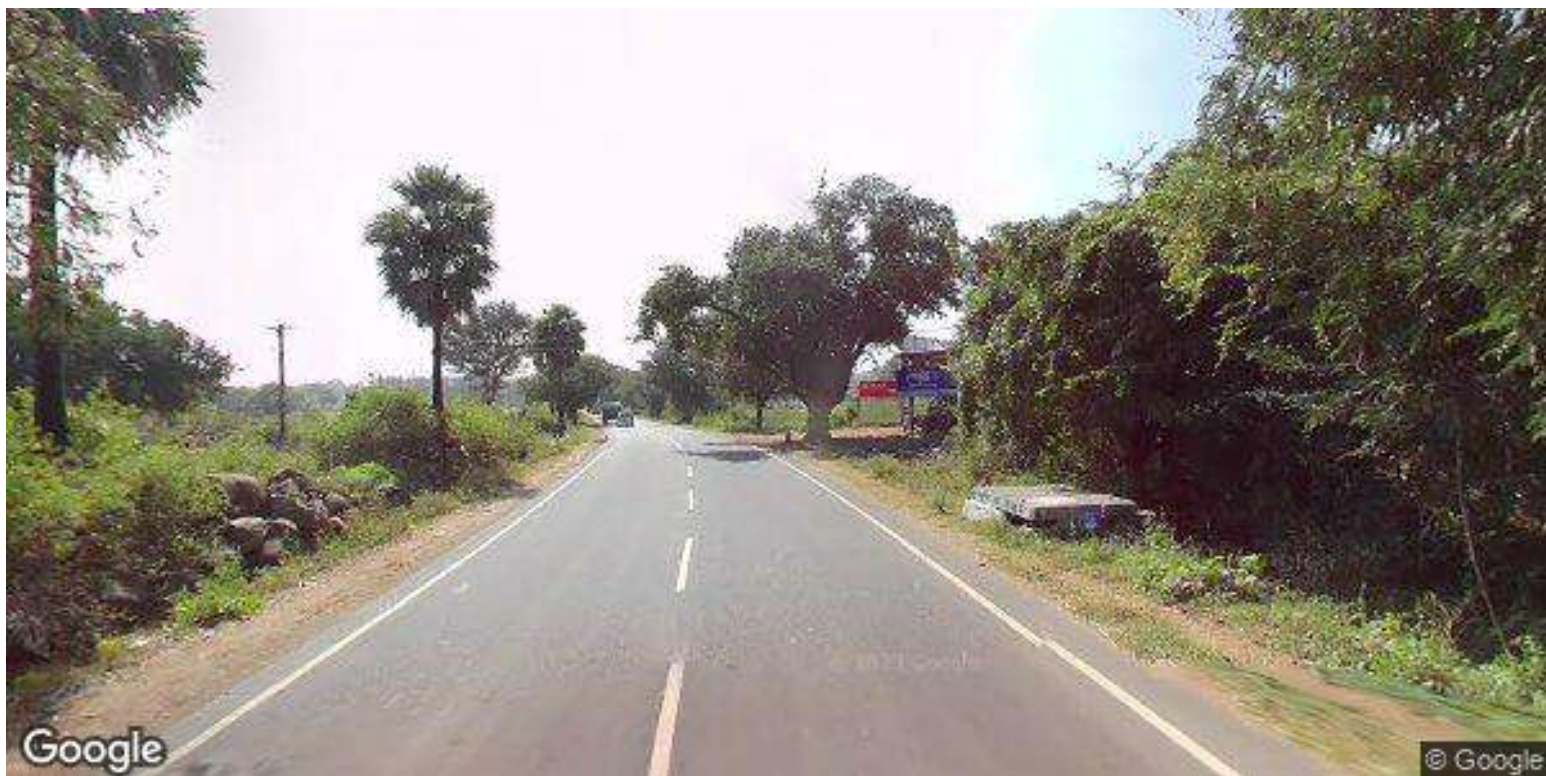
**Coordinates:** 12.11010, 78.28440

**Risk Type:** Turn

**Risk Level:** Medium

**Speed Limit:** 30 KM/Hr
