# IndianOil

## JOURNEY RISK MANAGEMENT (JRM) STUDY

### Salem Terminal TO UVANCHITRA AGENCIES

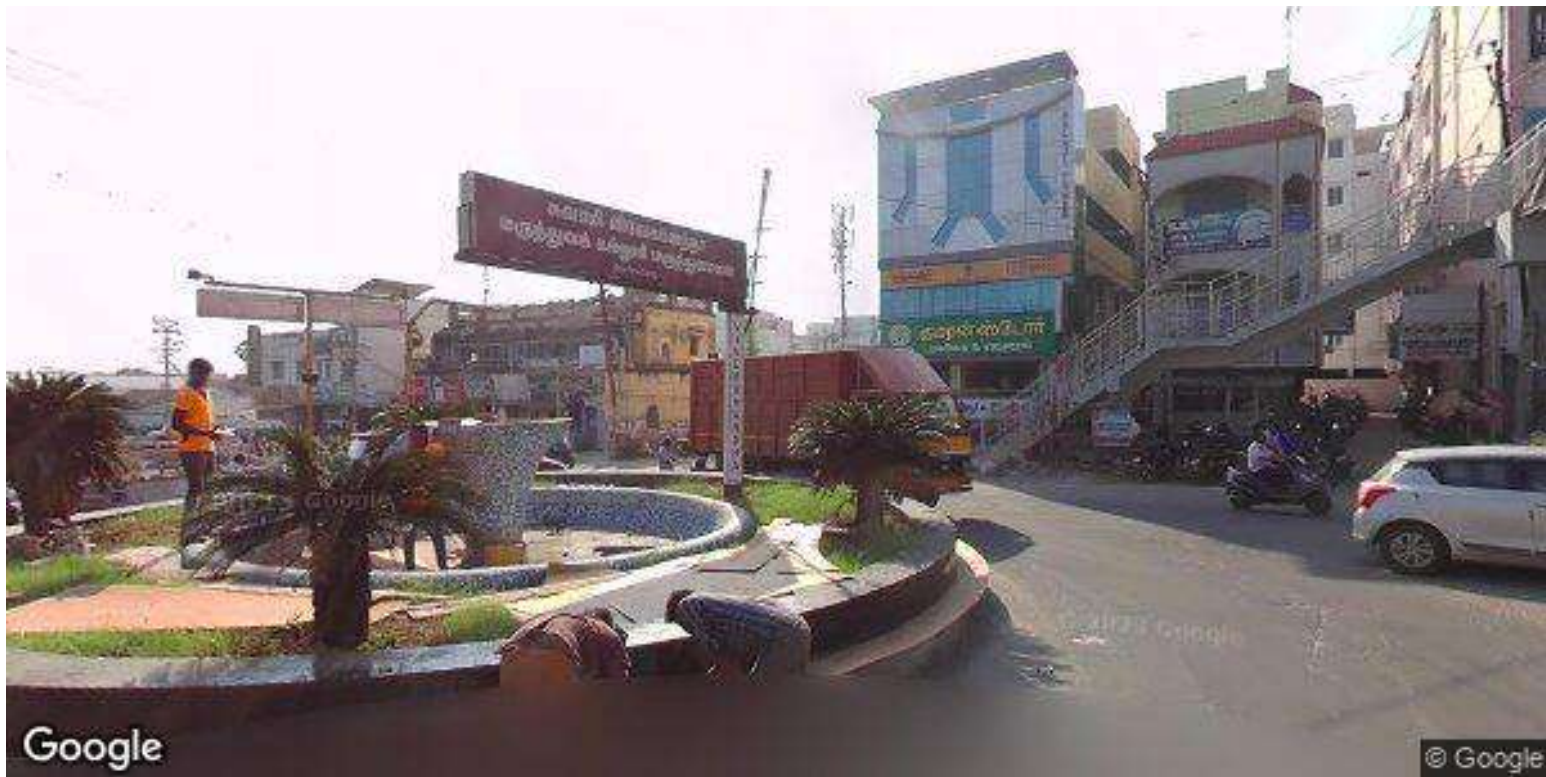
**Coordinates:** 11.38395, 77.89480

**Risk Type:** Roundabout

**Risk Level:** High

**Speed Limit:** 15 KM/Hr

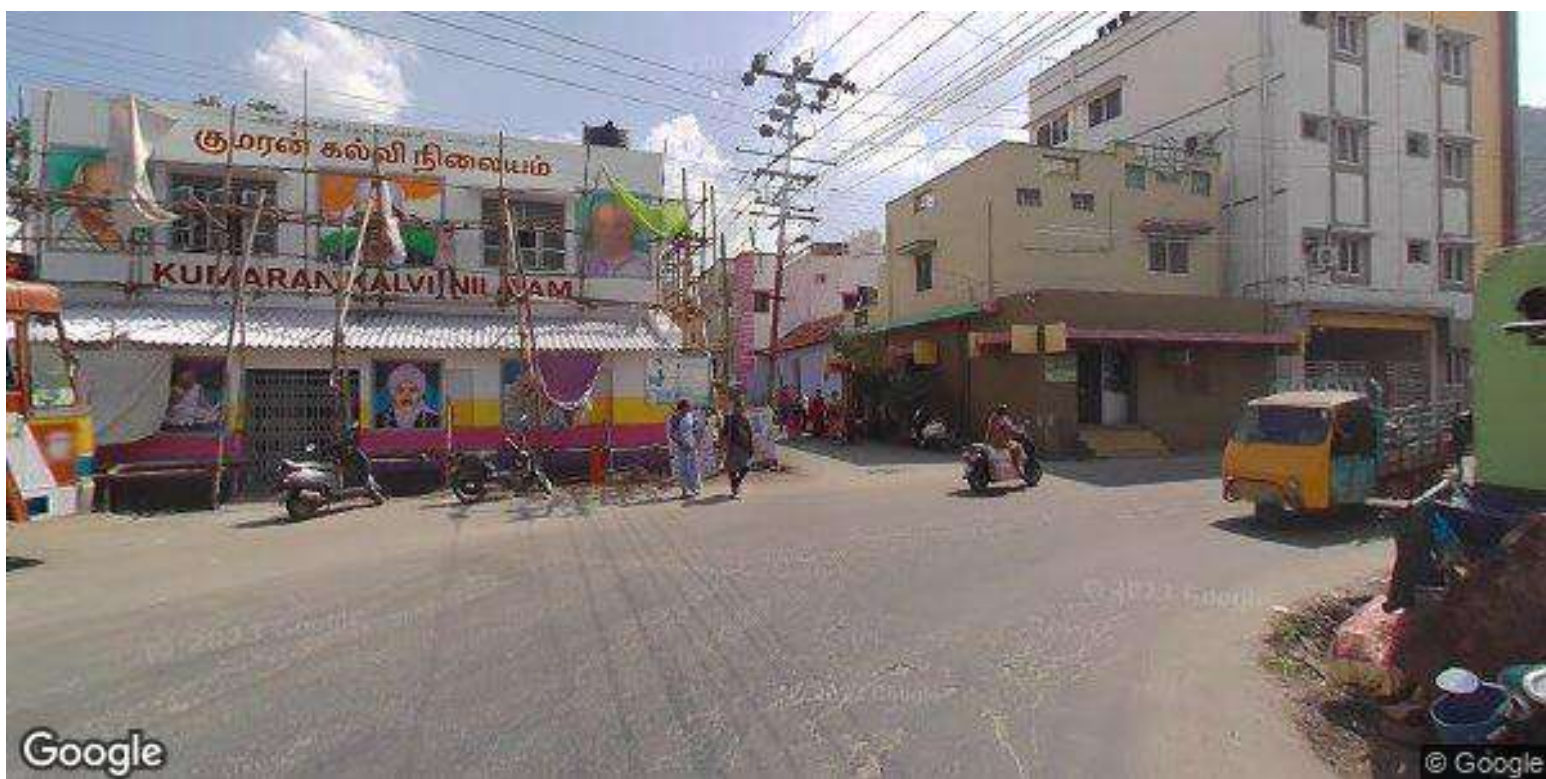
**Coordinates:** 11.38188, 77.90257

**Risk Type:** Turn

**Risk Level:** Medium

**Speed Limit:** 30 KM/Hr

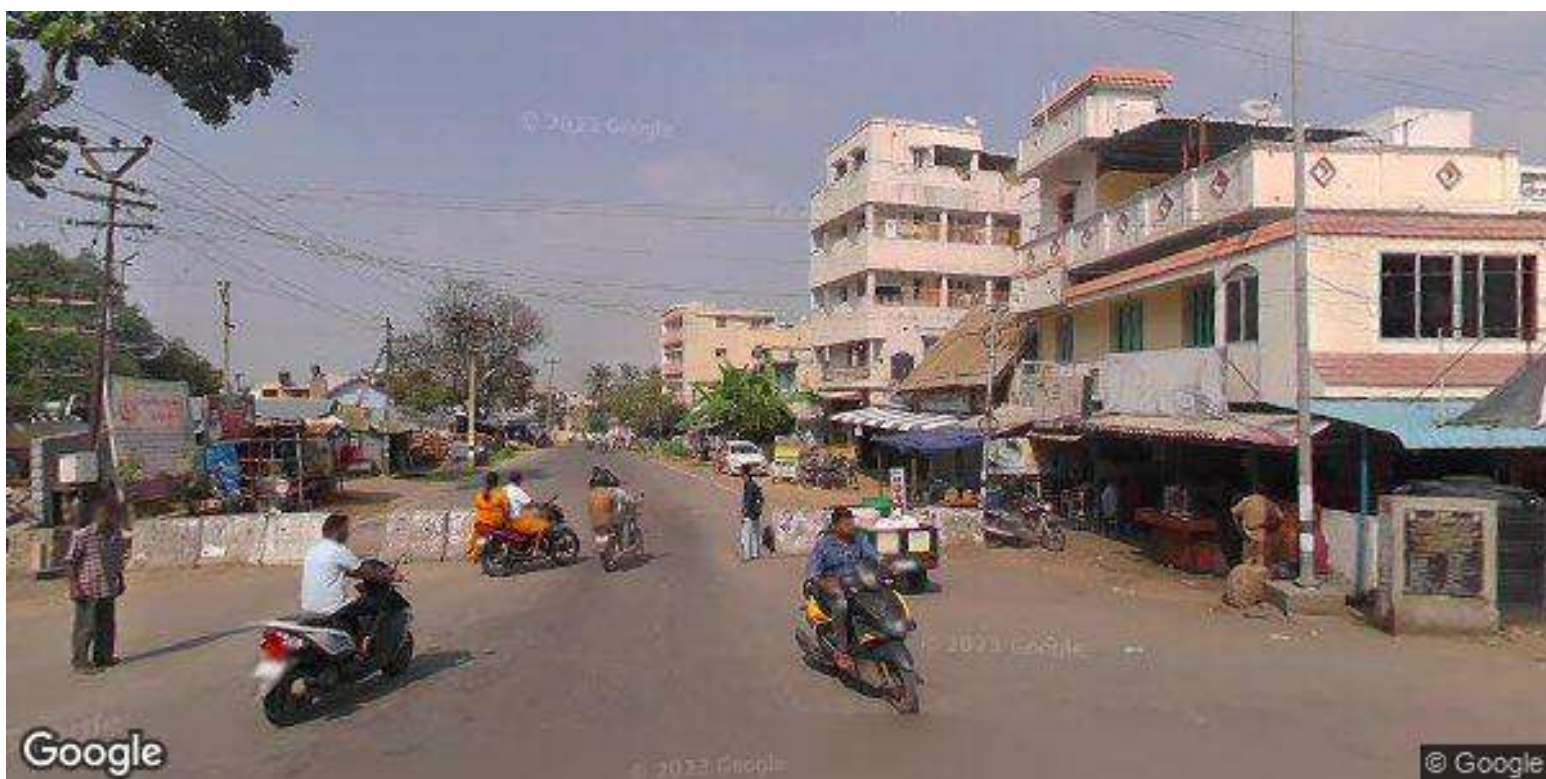
**Risk Type:** Blind Spot  
**Risk Level:** Blind Spot  
**Speed Limit:** 10 KM/Hr  
**Coordinates:** 11.37841, 77.90140
