# IndianOil

## JOURNEY RISK MANAGEMENT (JRM) STUDY

### Salem Terminal TO N. S. BHARANI FUELS

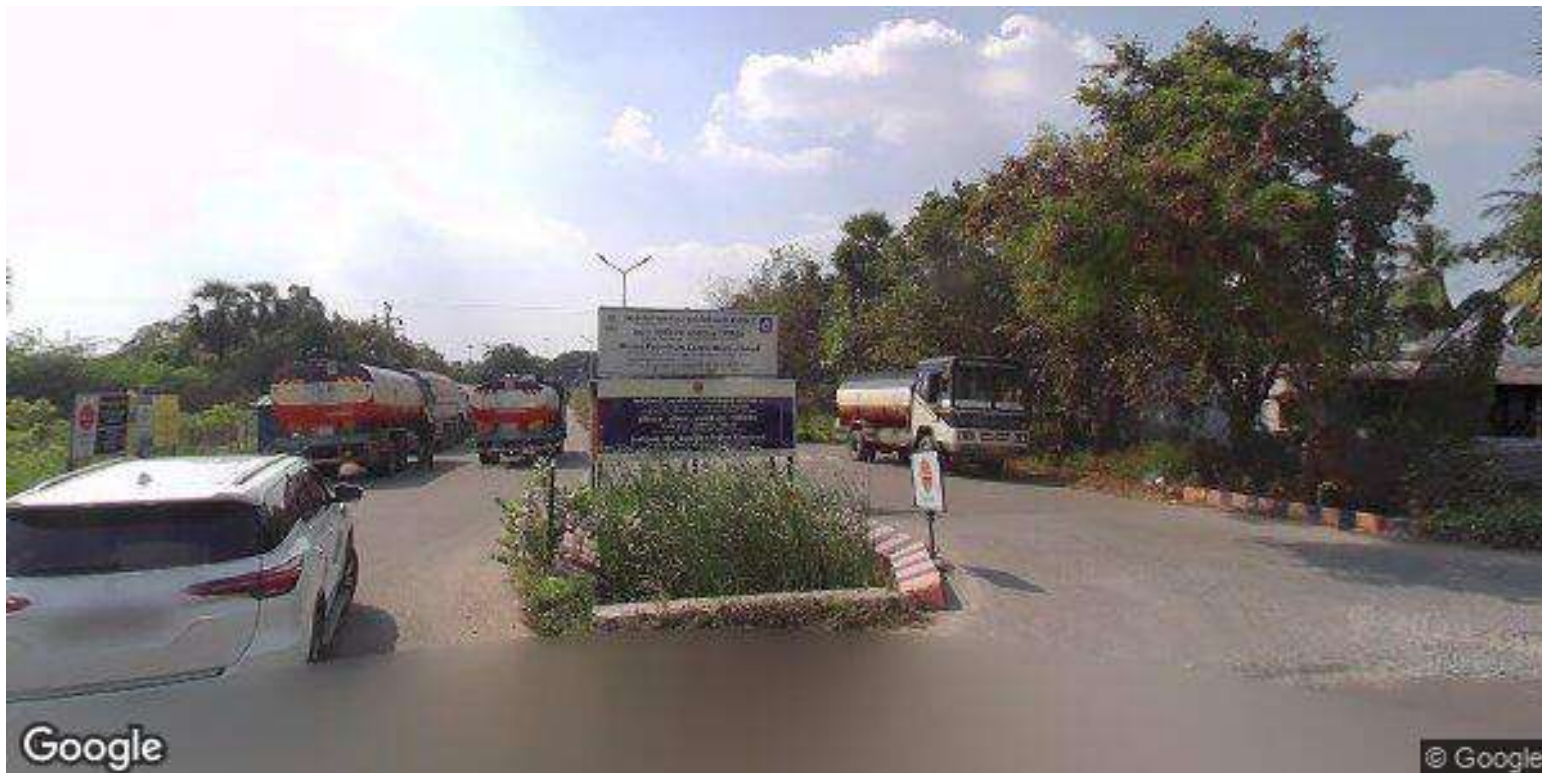
**Coordinates:** 11.44024, 77.87528

**Risk Type:** Turn

**Risk Level:** High

**Speed Limit:** 15 KM/Hr

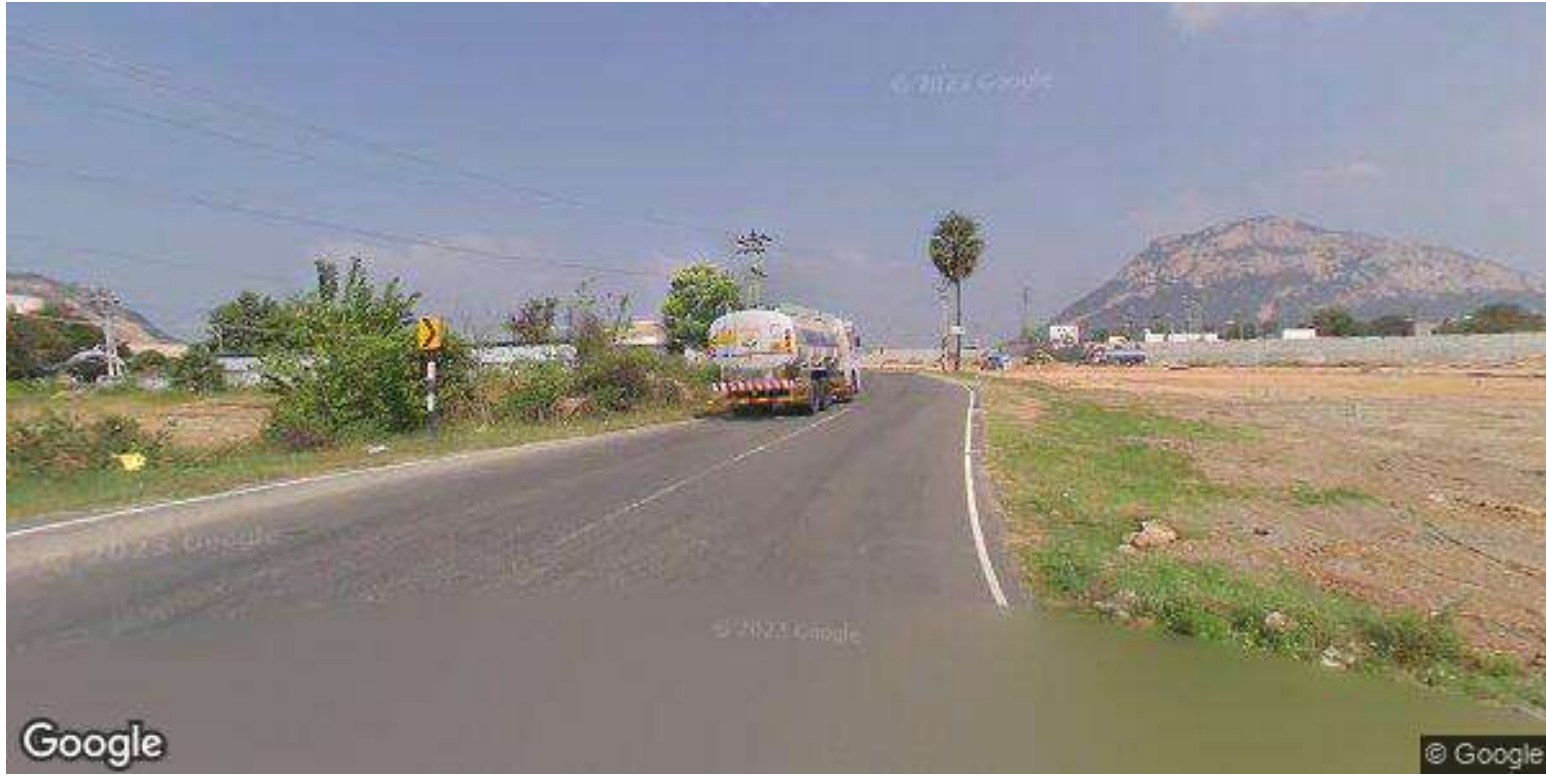
**Risk Type:** Turn  
**Risk Level:** Medium  
**Speed Limit:** 30 KM/Hr  
**Coordinates:** 11.45847, 77.85140

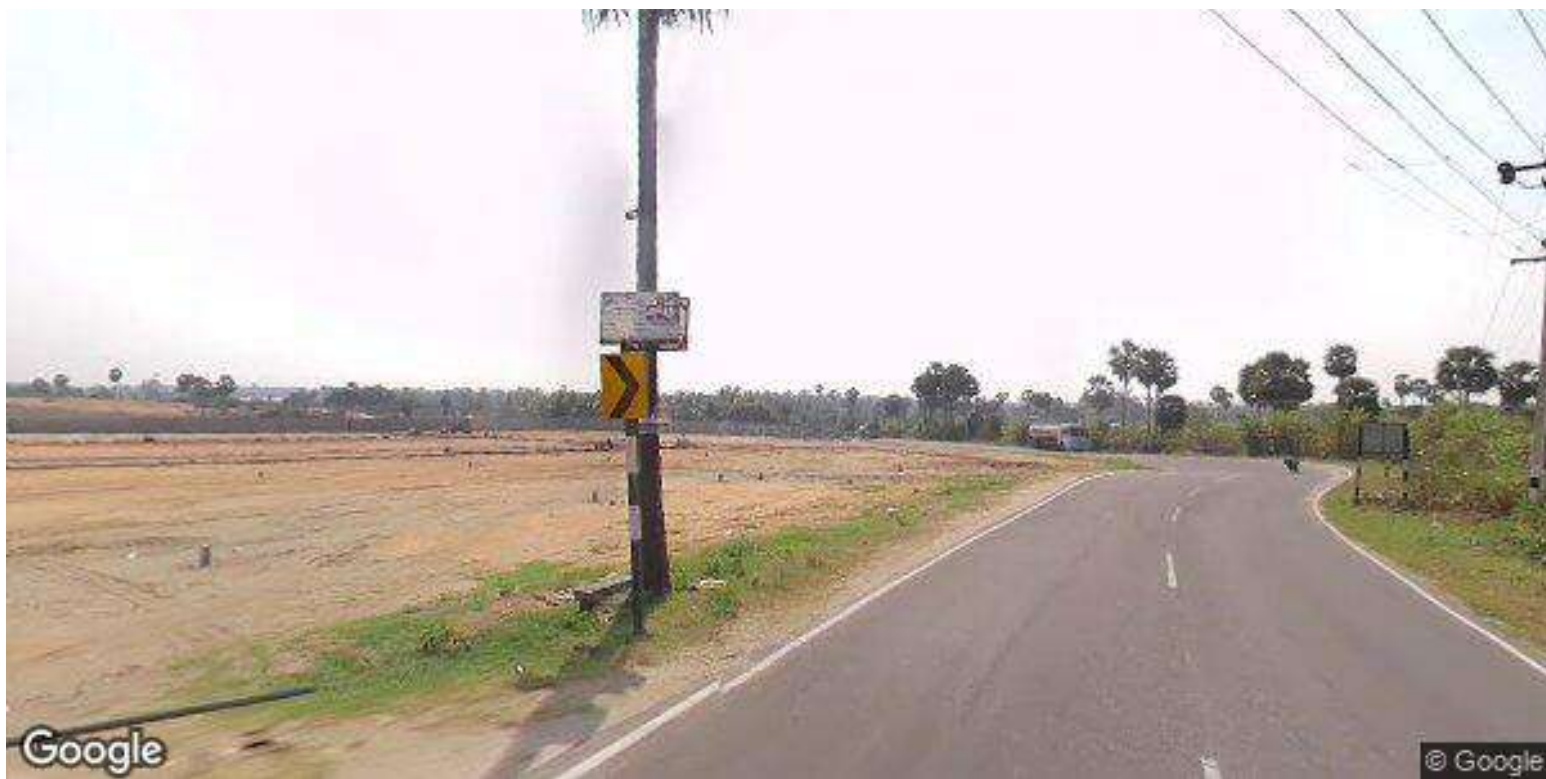
**Risk Type:** Turn  
**Risk Level:** Medium  
**Speed Limit:** 30 KM/Hr  
**Coordinates:** 11.45898, 77.85135

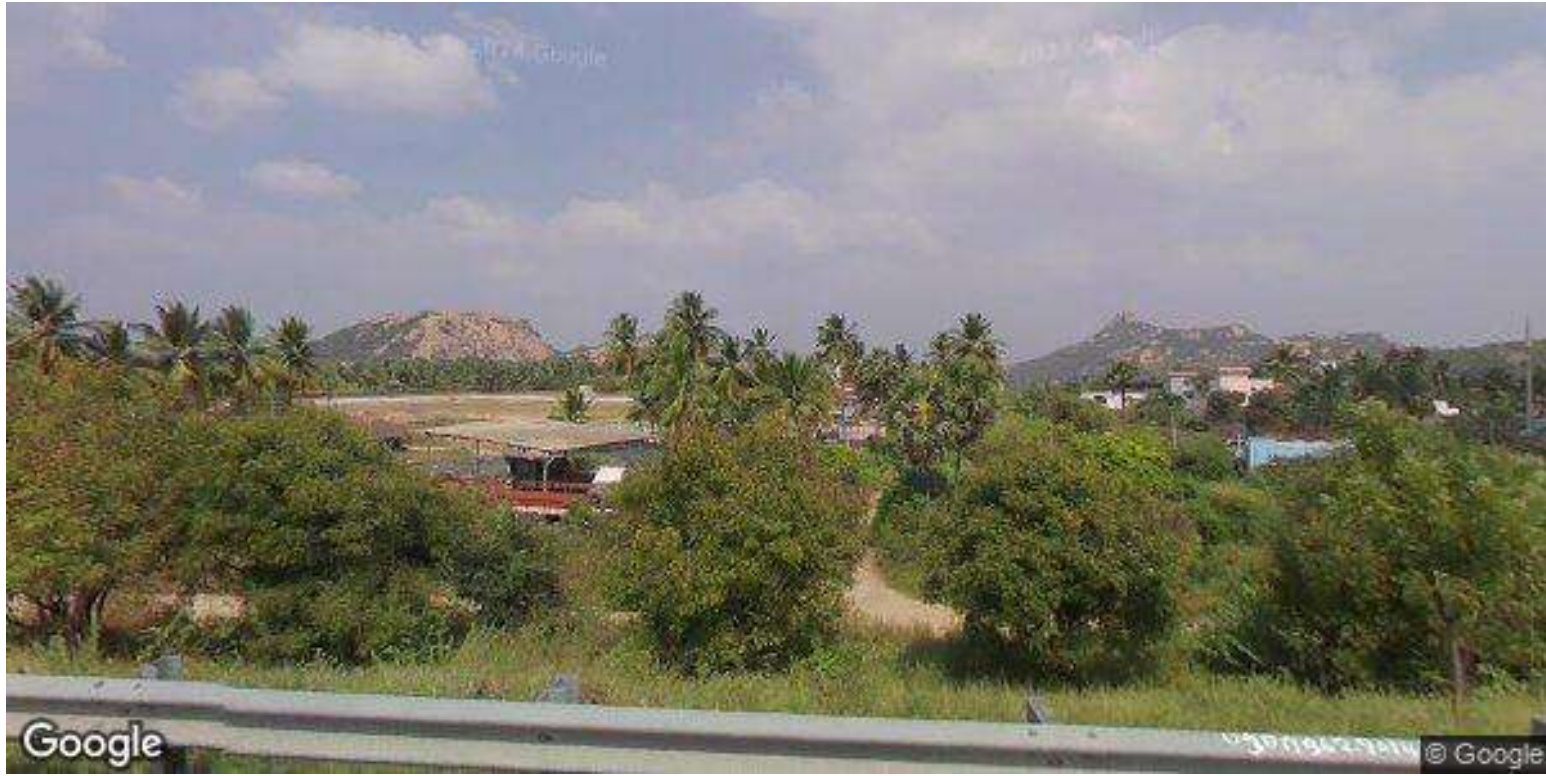
**Risk Type:** Turn  
**Risk Level:** High  
**Speed Limit:** 15 KM/Hr  
**Coordinates:** 11.49383, 77.88442

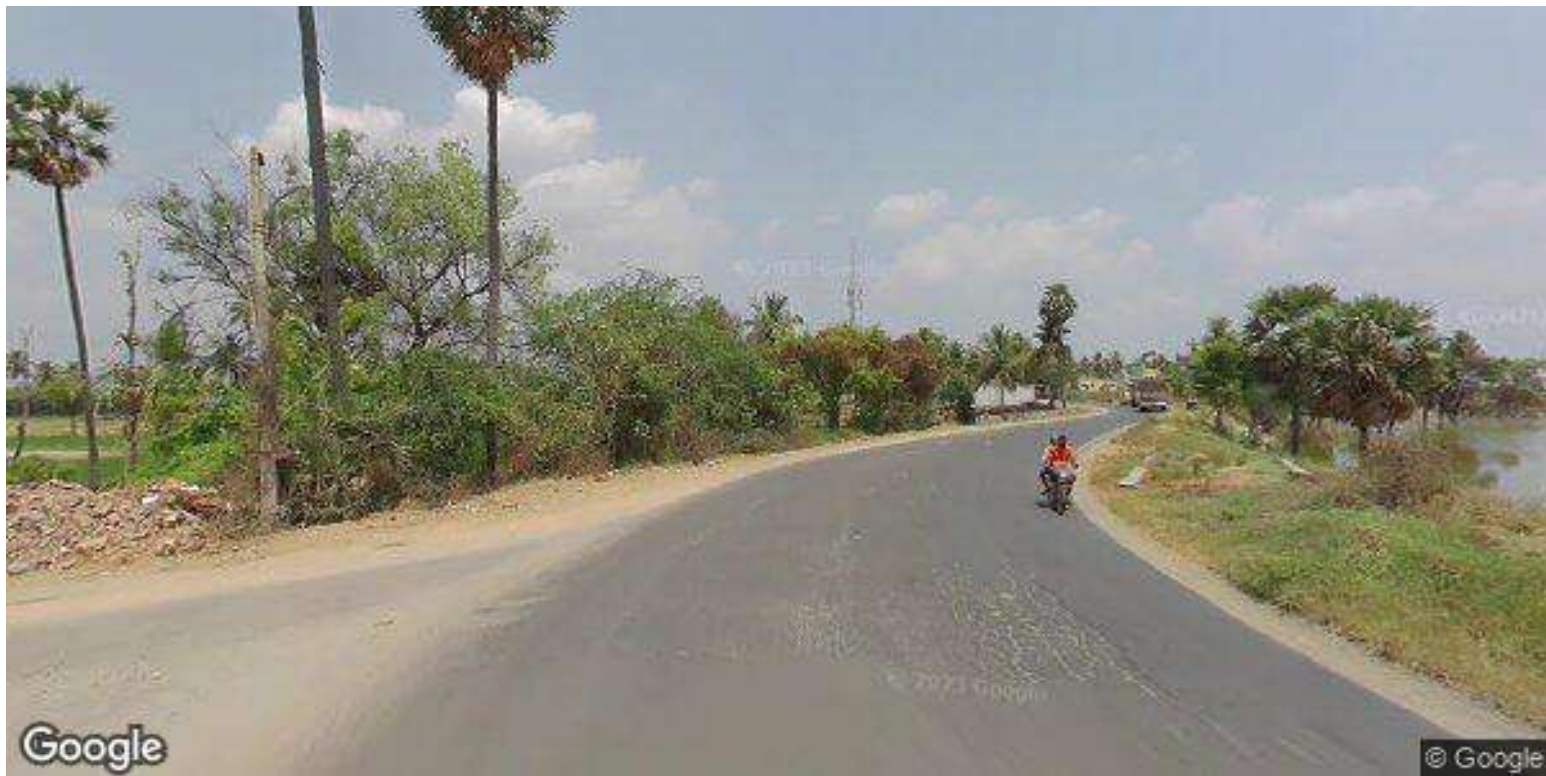
**Risk Type:** Turn  
**Risk Level:** Medium  
**Speed Limit:** 30 KM/Hr  
**Coordinates:** 11.56083, 77.89921

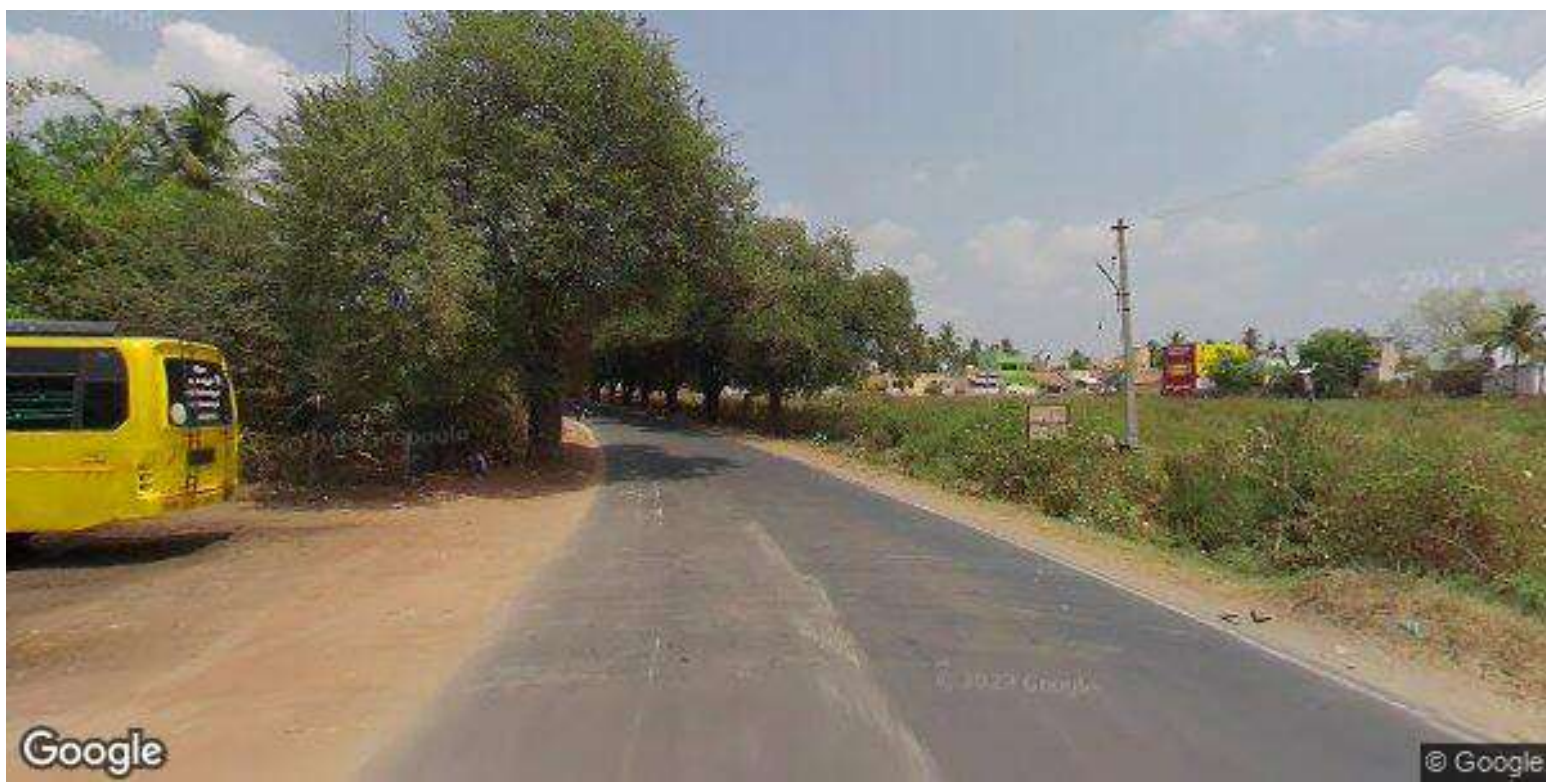
**Coordinates:** 11.56180, 77.90019

**Risk Type:** Turn

**Risk Level:** Medium

**Speed Limit:** 30 KM/Hr

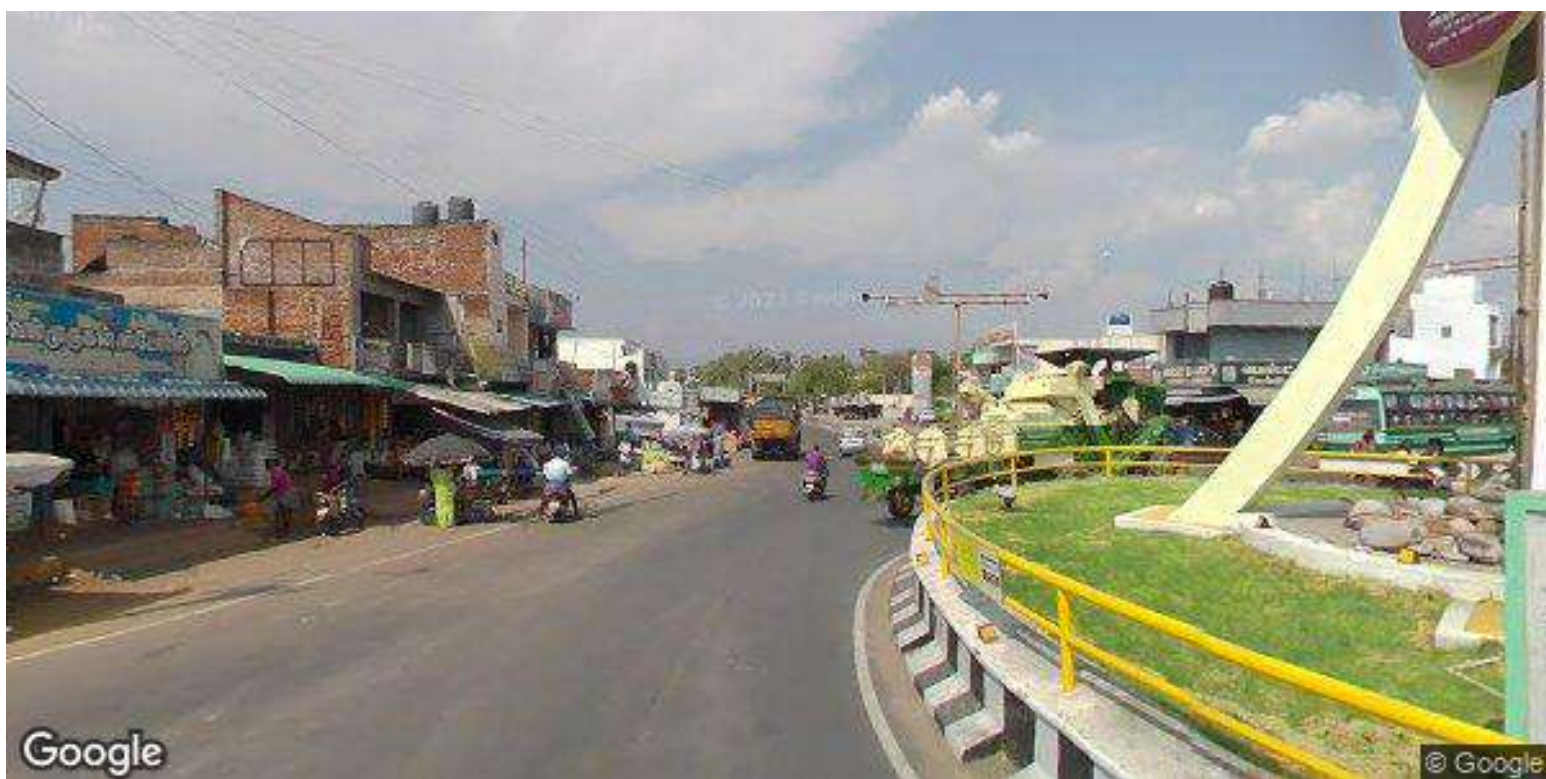
**Coordinates:** 11.57048, 77.90224

**Risk Type:** Turn

**Risk Level:** Medium

**Speed Limit:** 30 KM/Hr

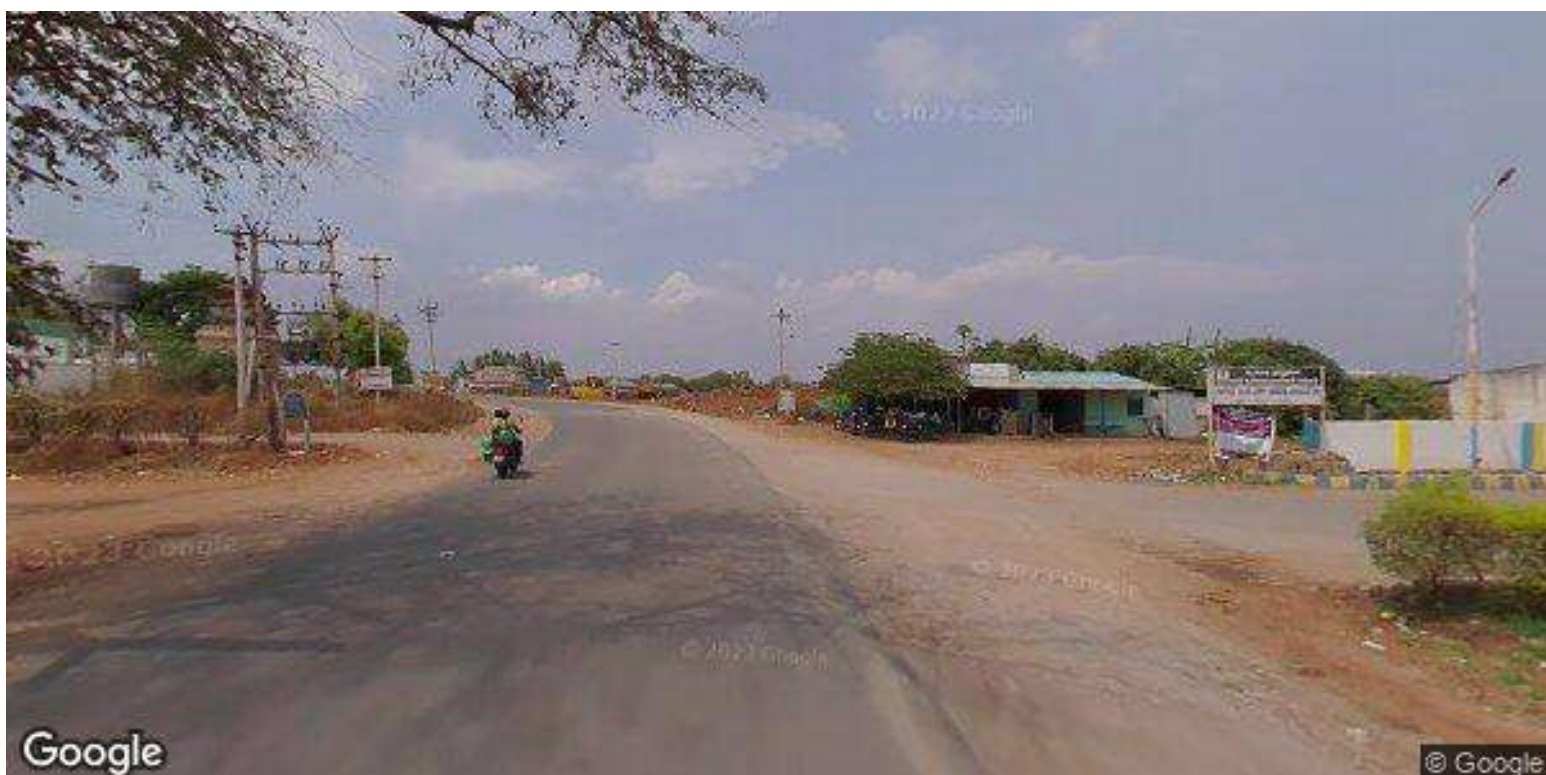
**Coordinates: 11.58254, 77.90656**

**Risk Type: Turn**

**Risk Level: Medium**

**Speed Limit: 30 KM/Hr**

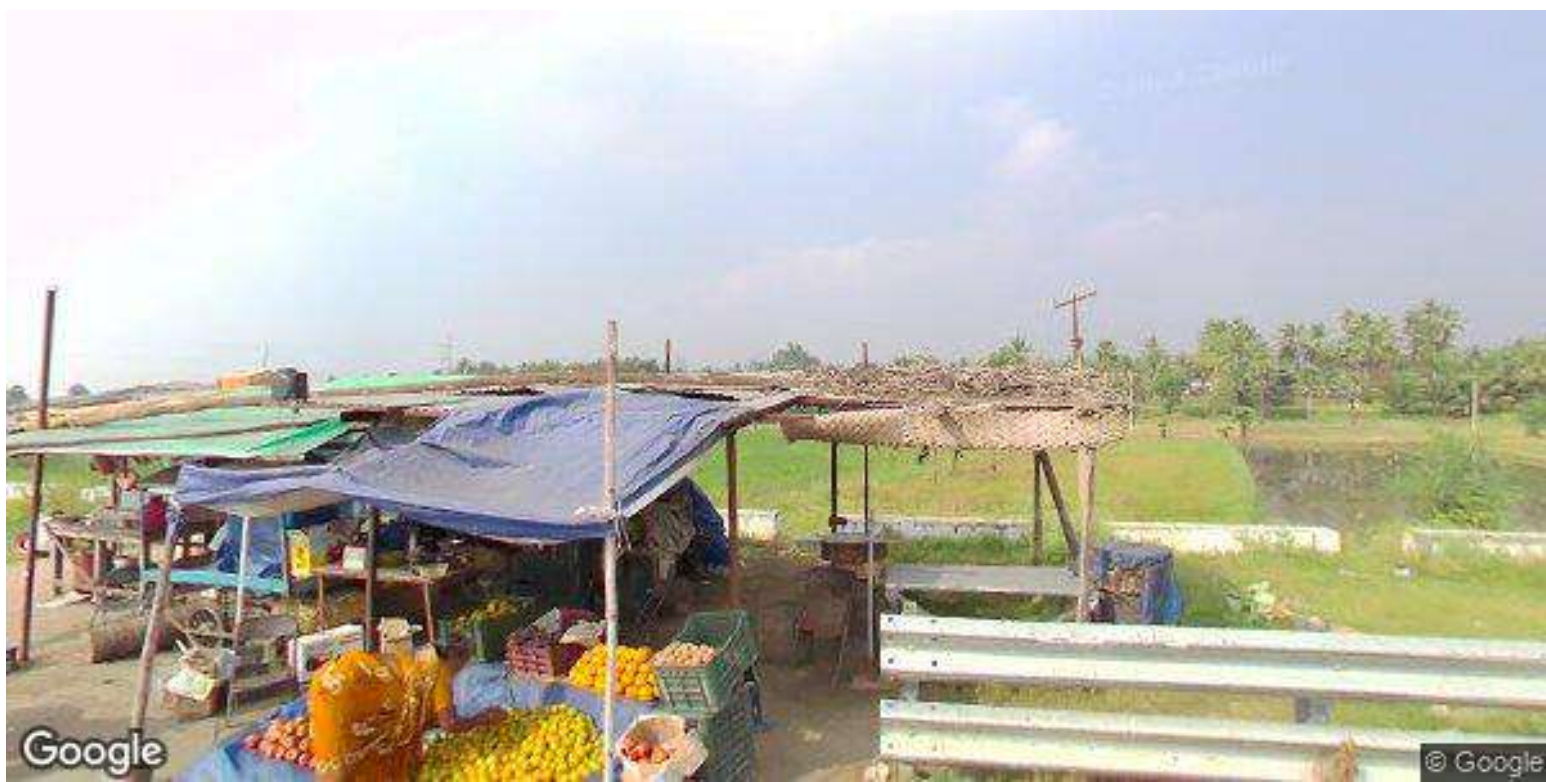
**Coordinates:** 11.67858, 77.96834

**Risk Type:** Turn

**Risk Level:** High

**Speed Limit:** 15 KM/Hr

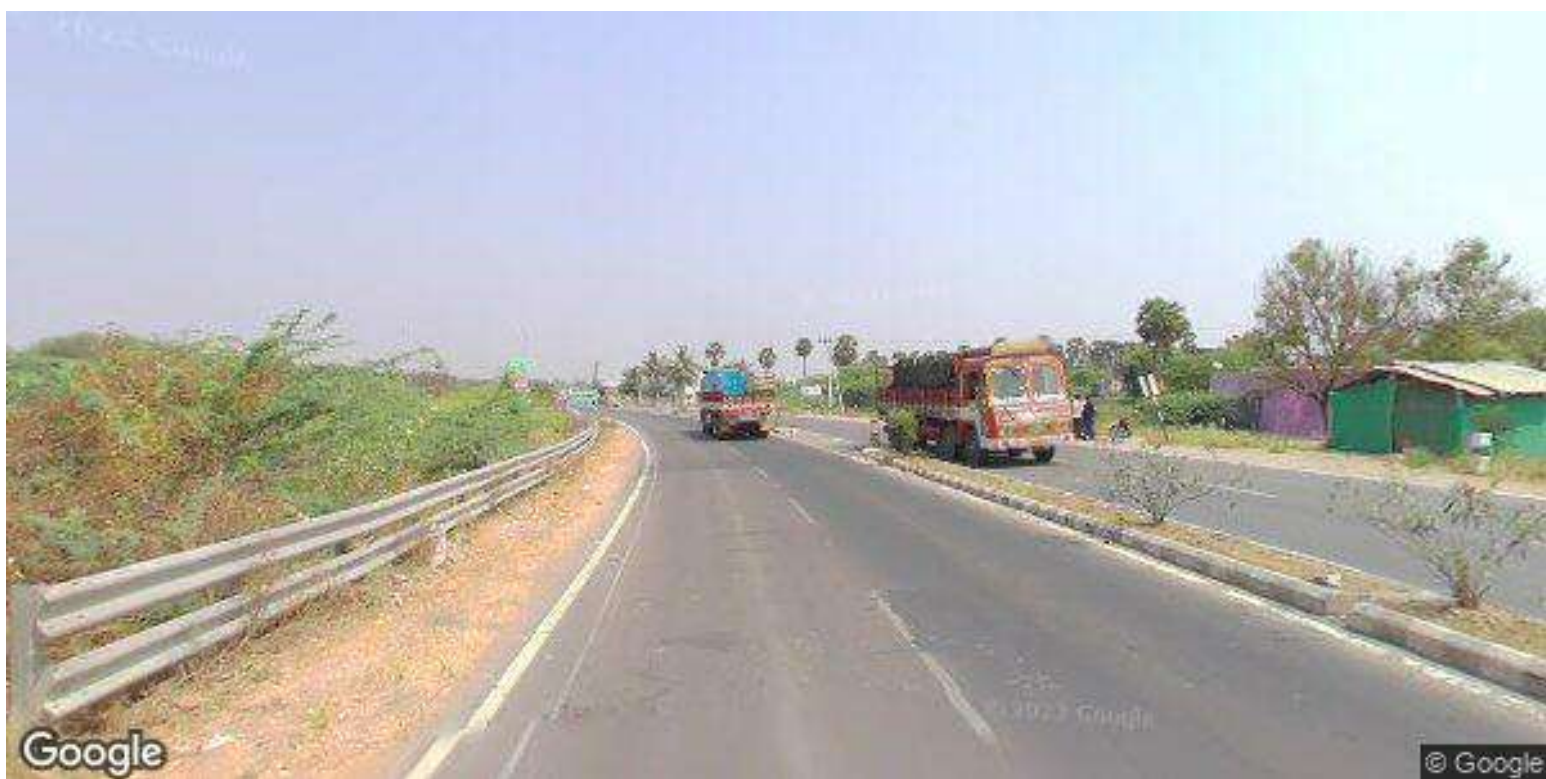
**Coordinates:** 11.70062, 77.97961

**Risk Type:** Turn

**Risk Level:** Medium

**Speed Limit:** 30 KM/Hr

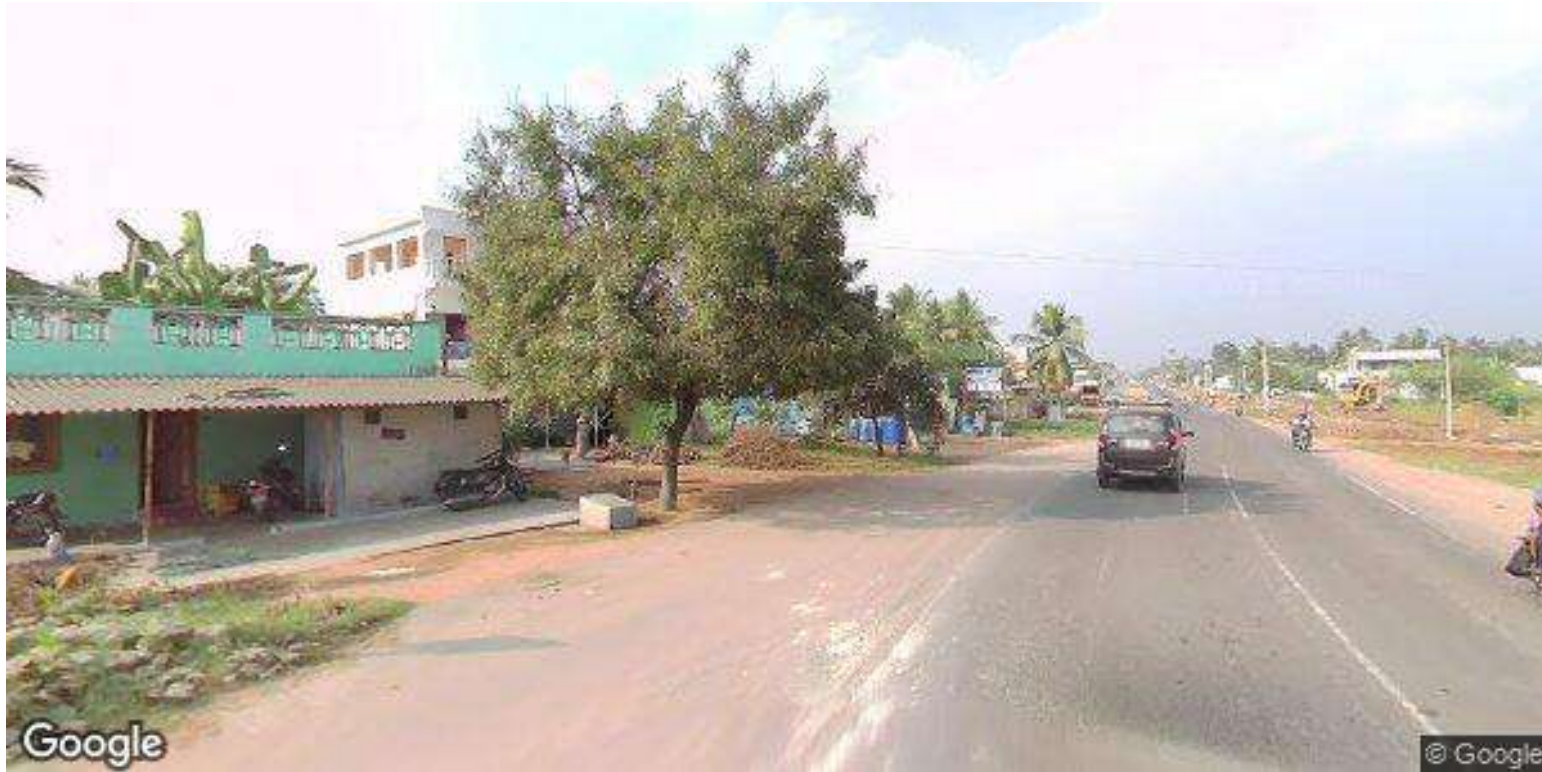
**Risk Type:** Turn  
**Risk Level:** Medium  
**Speed Limit:** 30 KM/Hr  
**Coordinates:** 11.71917, 78.01123

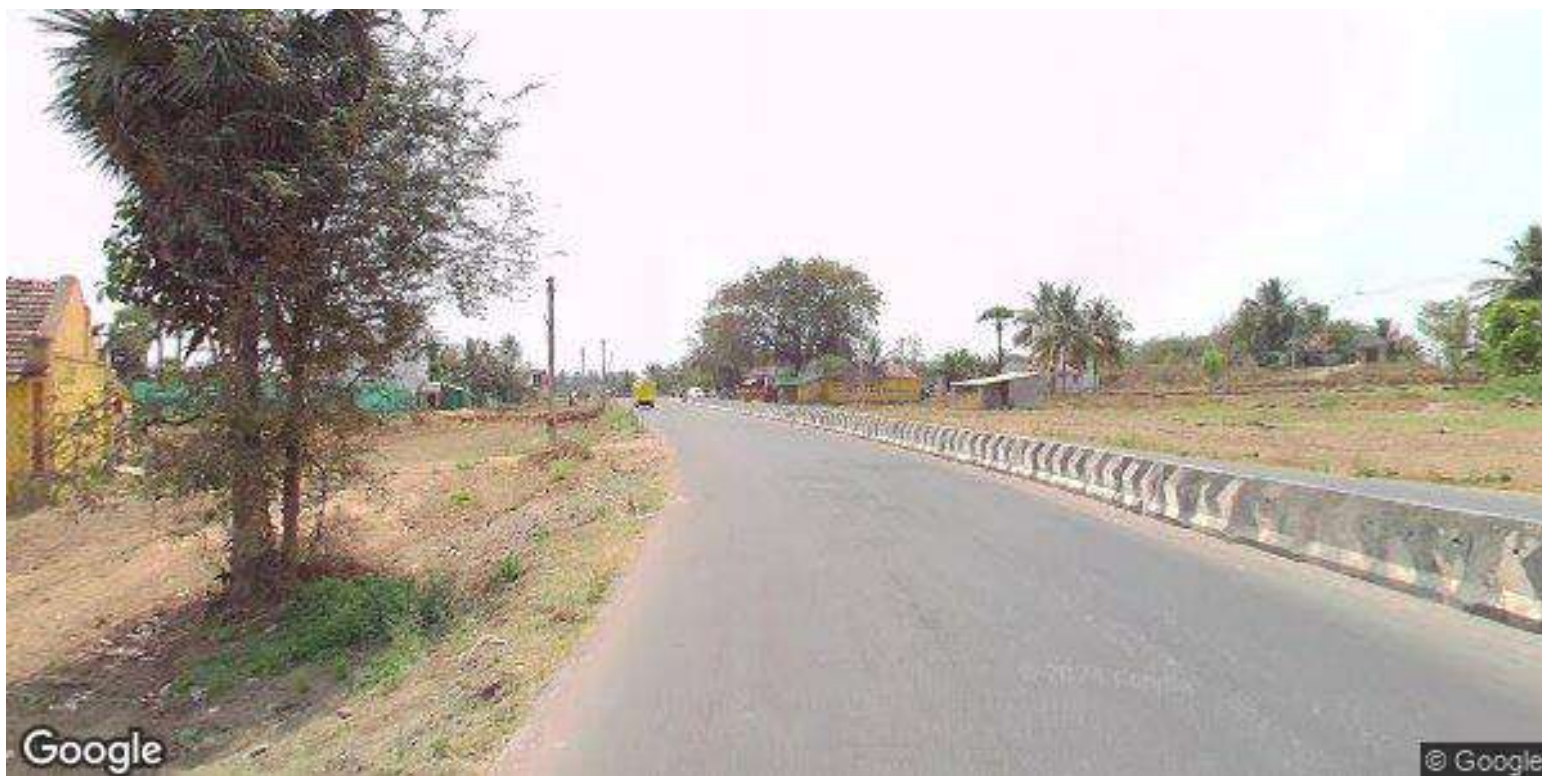
**Risk Type:** Turn  
**Risk Level:** Medium  
**Speed Limit:** 30 KM/Hr  
**Coordinates:** 11.72565, 78.01770

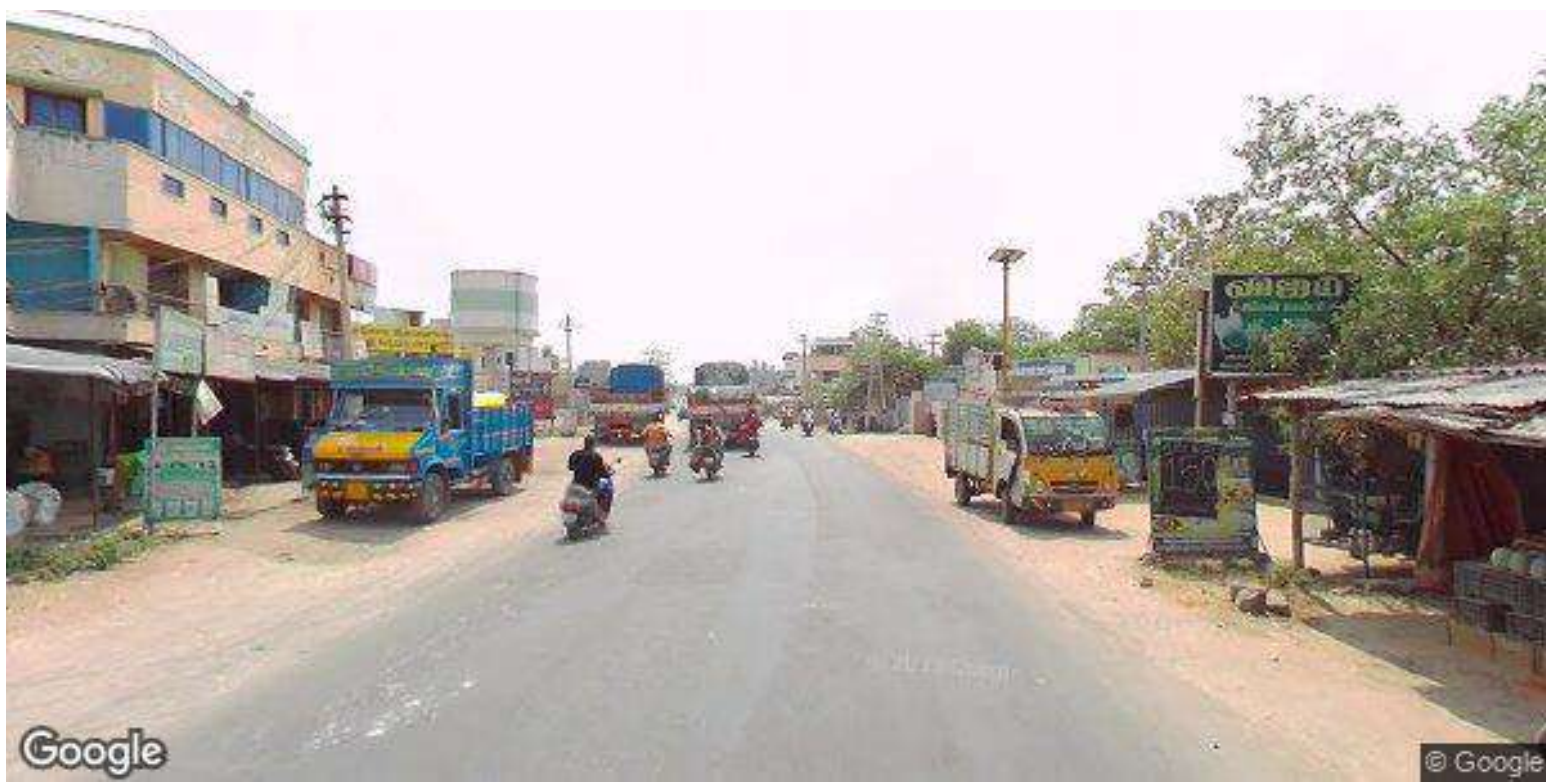
**Coordinates:** 11.73769, 78.03451

**Risk Type:** Turn

**Risk Level:** Medium

**Speed Limit:** 30 KM/Hr

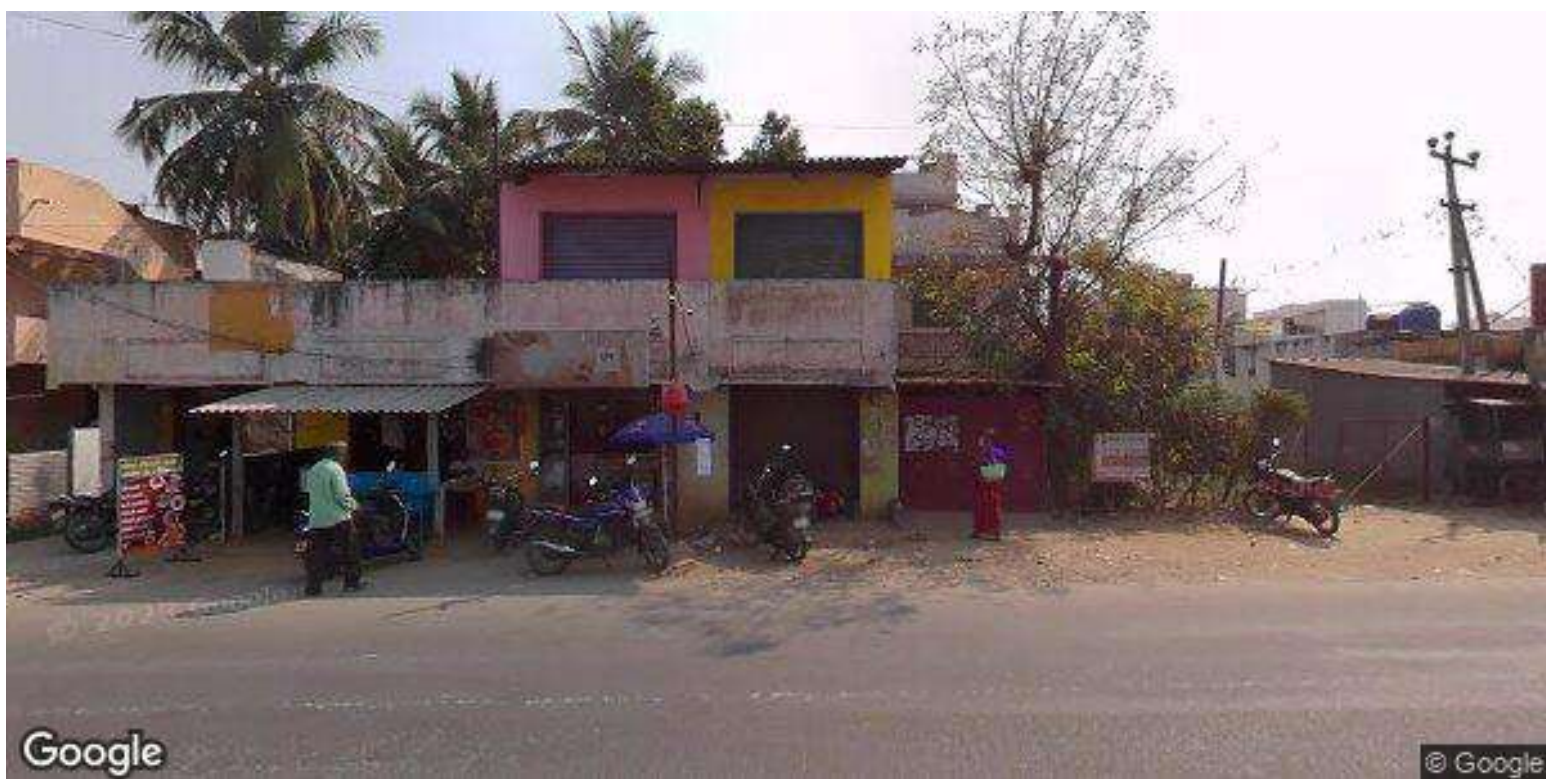
**Coordinates:** 11.73785, 78.03551

**Risk Type:** Turn

**Risk Level:** Medium

**Speed Limit:** 30 KM/Hr

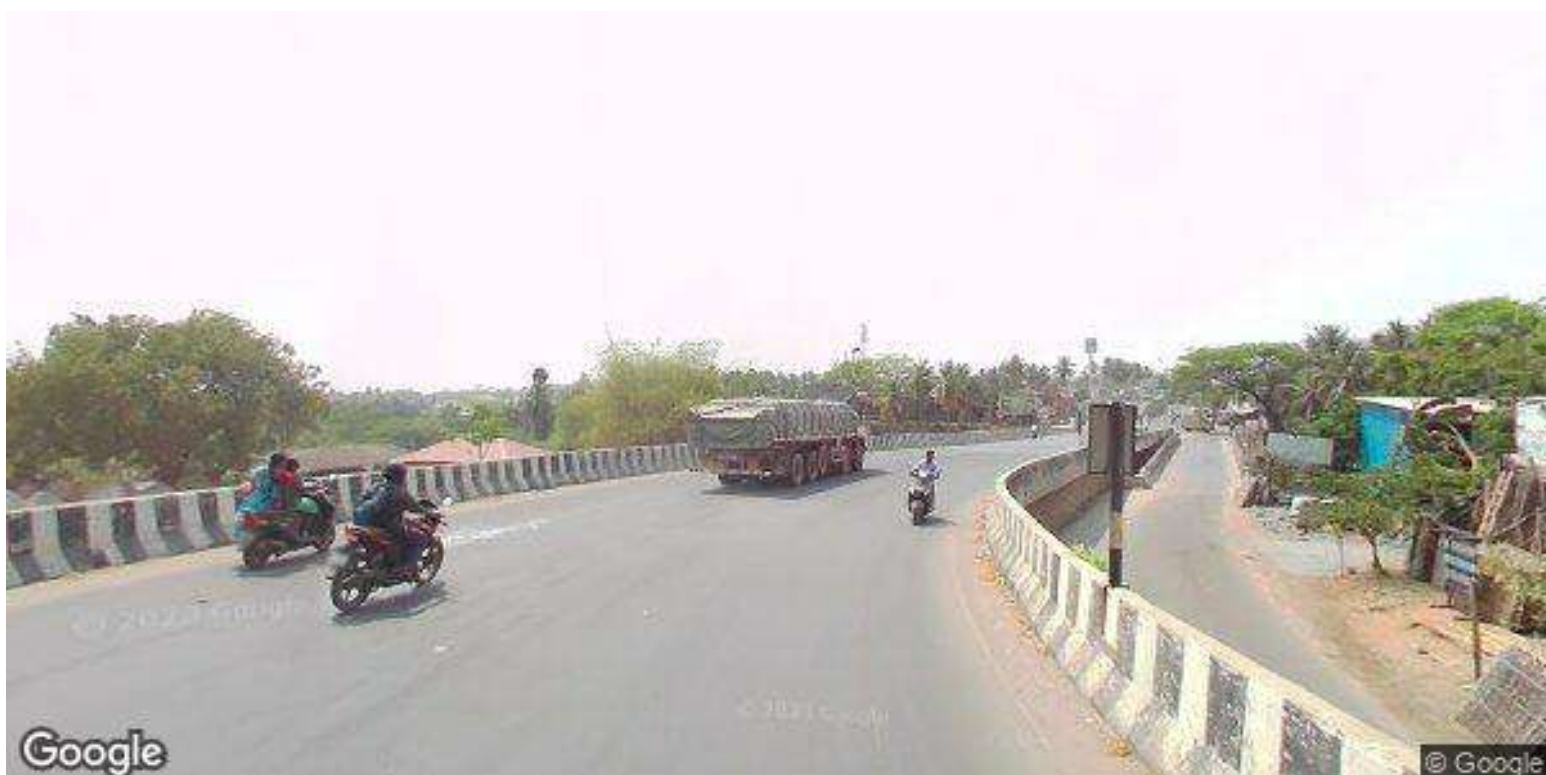
**Risk Type:** Turn  
**Risk Level:** High  
**Speed Limit:** 15 KM/Hr  
**Coordinates:** 11.73651, 78.03871

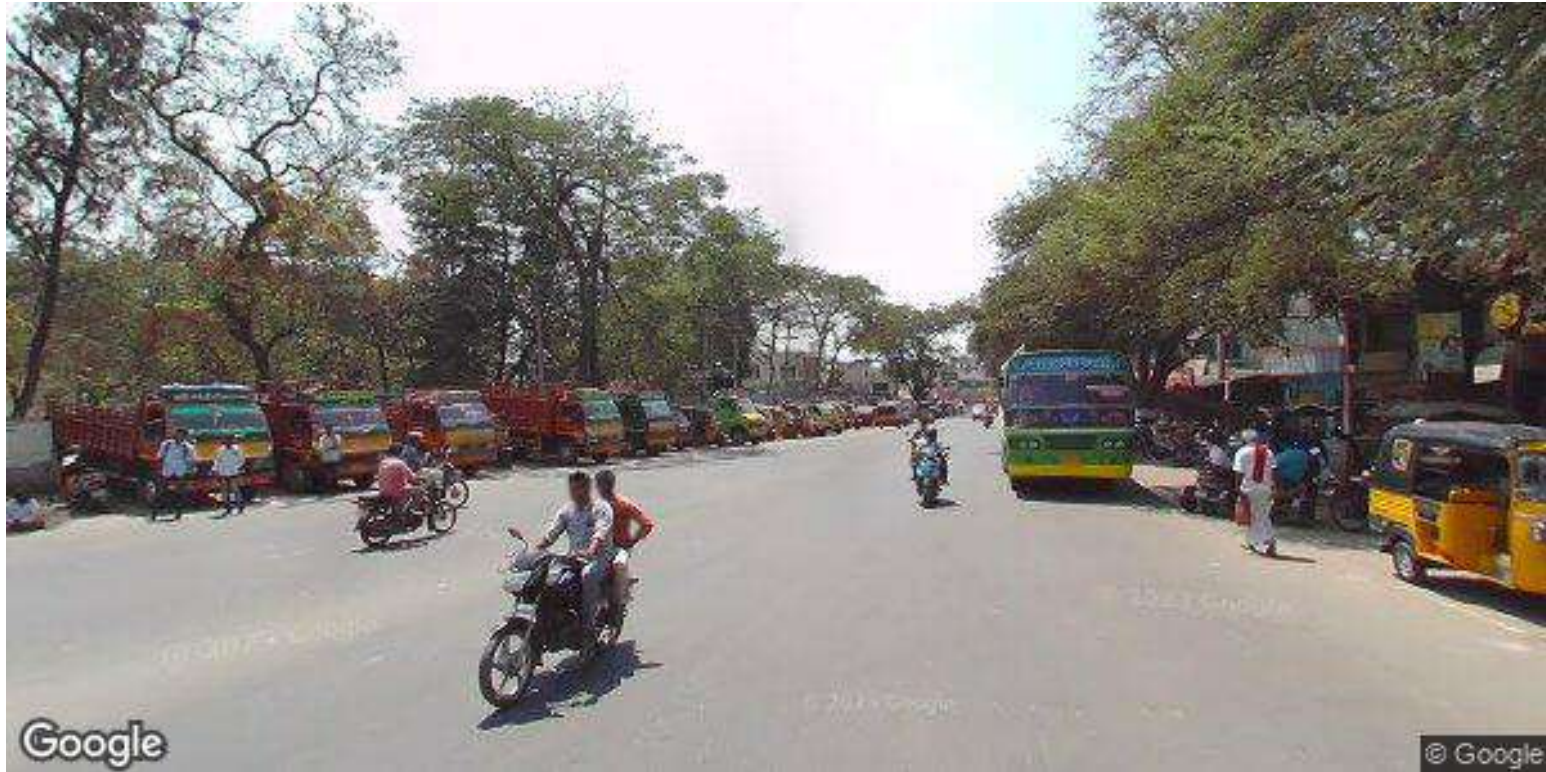
**Risk Type:** Turn  
**Risk Level:** Medium  
**Speed Limit:** 30 KM/Hr  
**Coordinates:** 11.74265, 78.04710

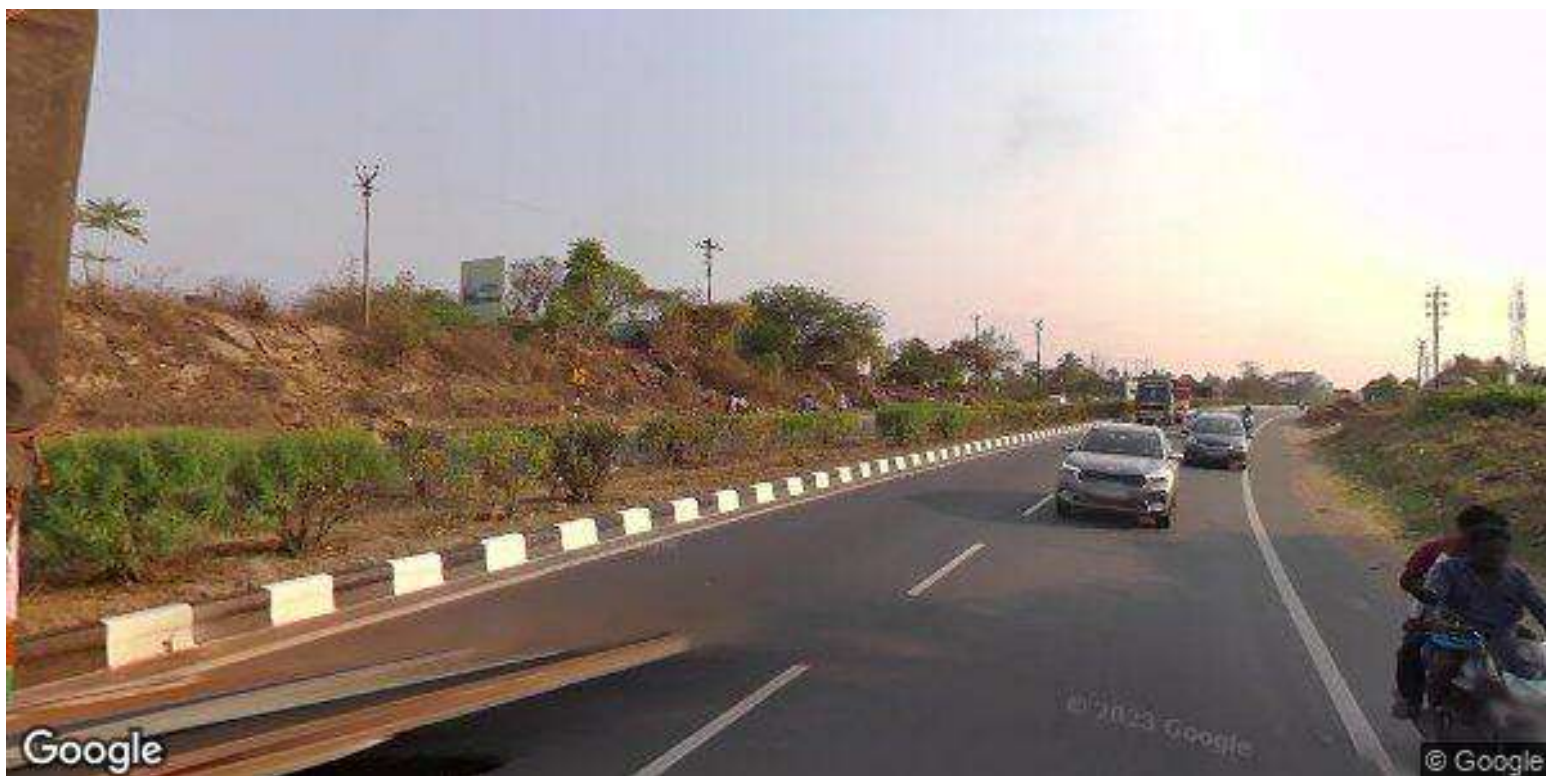
**Risk Type:** Turn  
**Risk Level:** Medium  
**Speed Limit:** 30 KM/Hr  
**Coordinates:** 11.78005, 78.05788

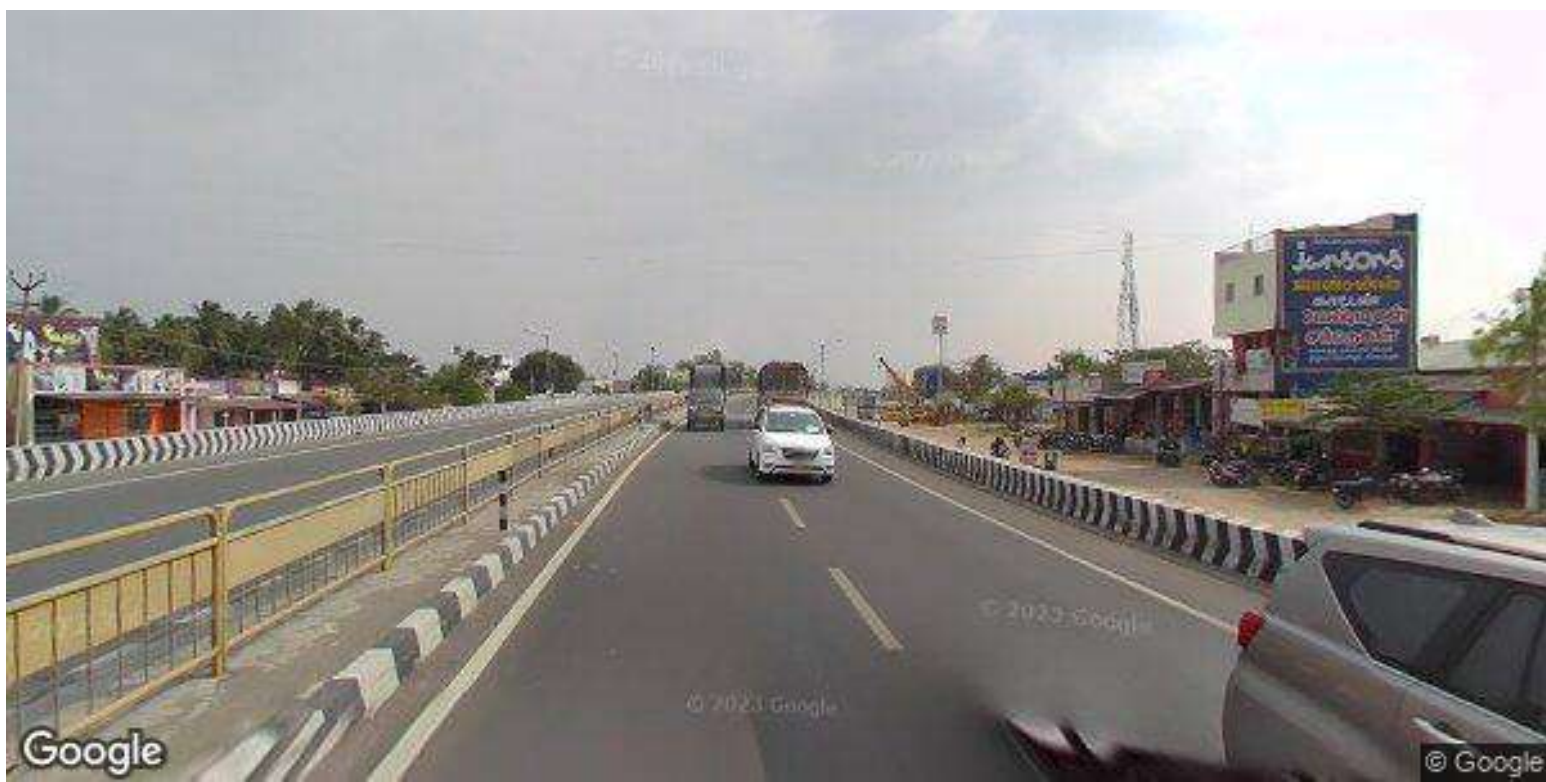
**Coordinates:** 11.86928, 78.08384

**Risk Type:** Turn

**Risk Level:** Medium

**Speed Limit:** 30 KM/Hr

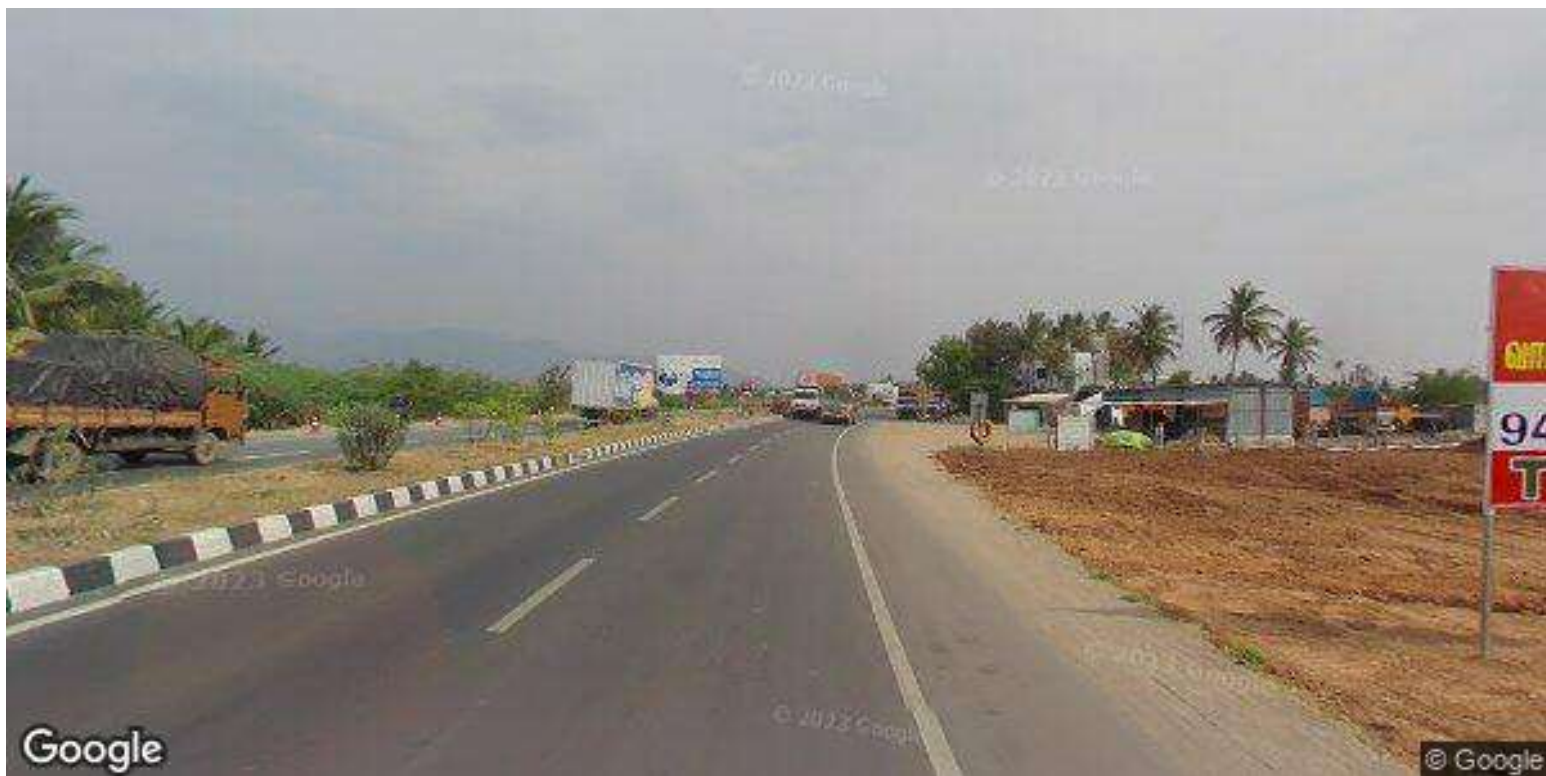
**Coordinates:** 11.88009, 78.08164

**Risk Type:** Turn

**Risk Level:** Medium

**Speed Limit:** 30 KM/Hr
