# IndianOil

## JOURNEY RISK MANAGEMENT (JRM) STUDY

### Salem Terminal TO N. S. BHARANI FUELS

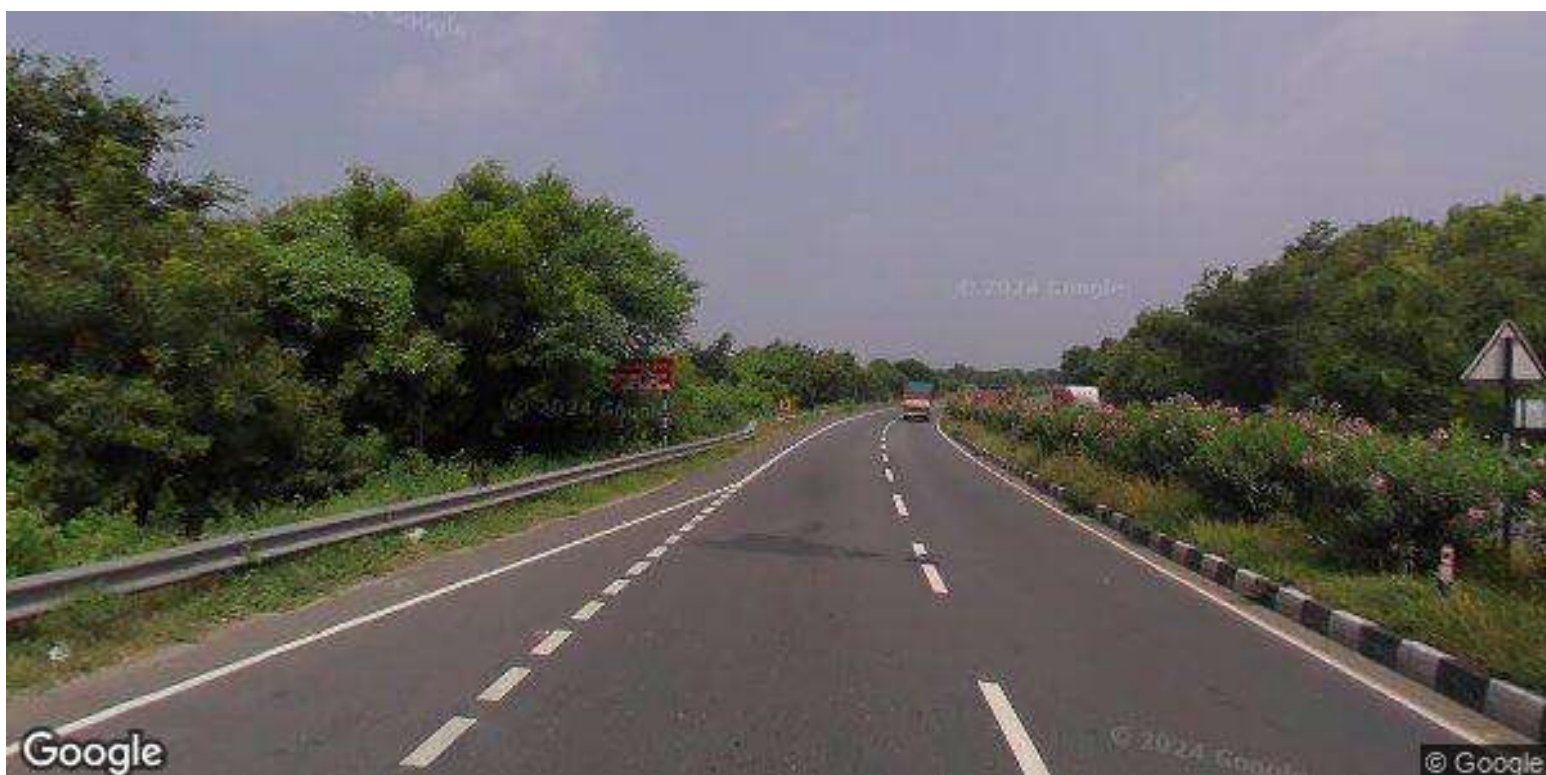
**Risk Type:** Turn  
**Risk Level:** Medium  
**Speed Limit:** 30 KM/Hr  
**Coordinates:** 11.91277, 78.05853

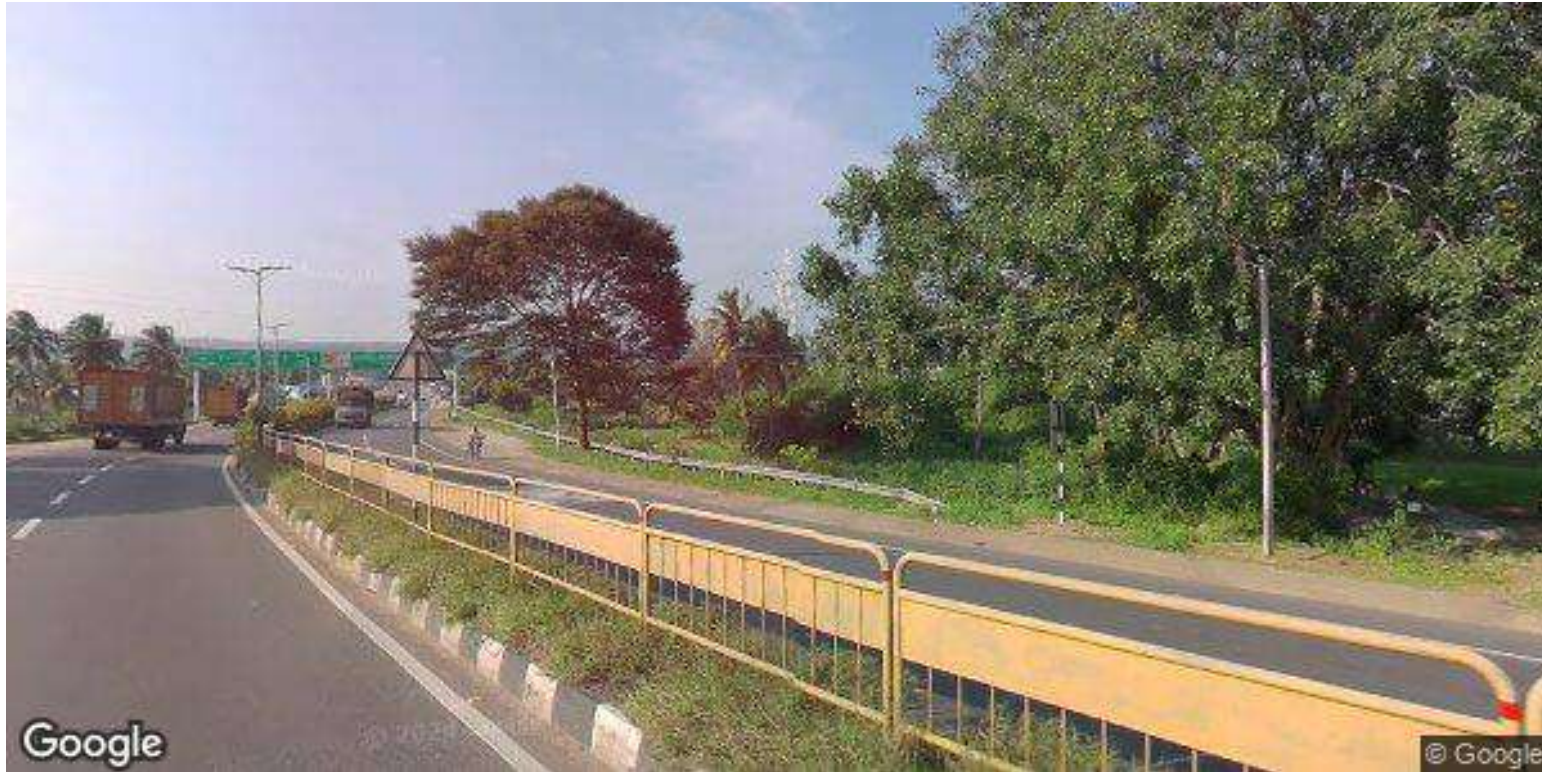
**Risk Type:** Turn  
**Risk Level:** Medium  
**Speed Limit:** 30 KM/Hr  
**Coordinates:** 11.93746, 78.05331

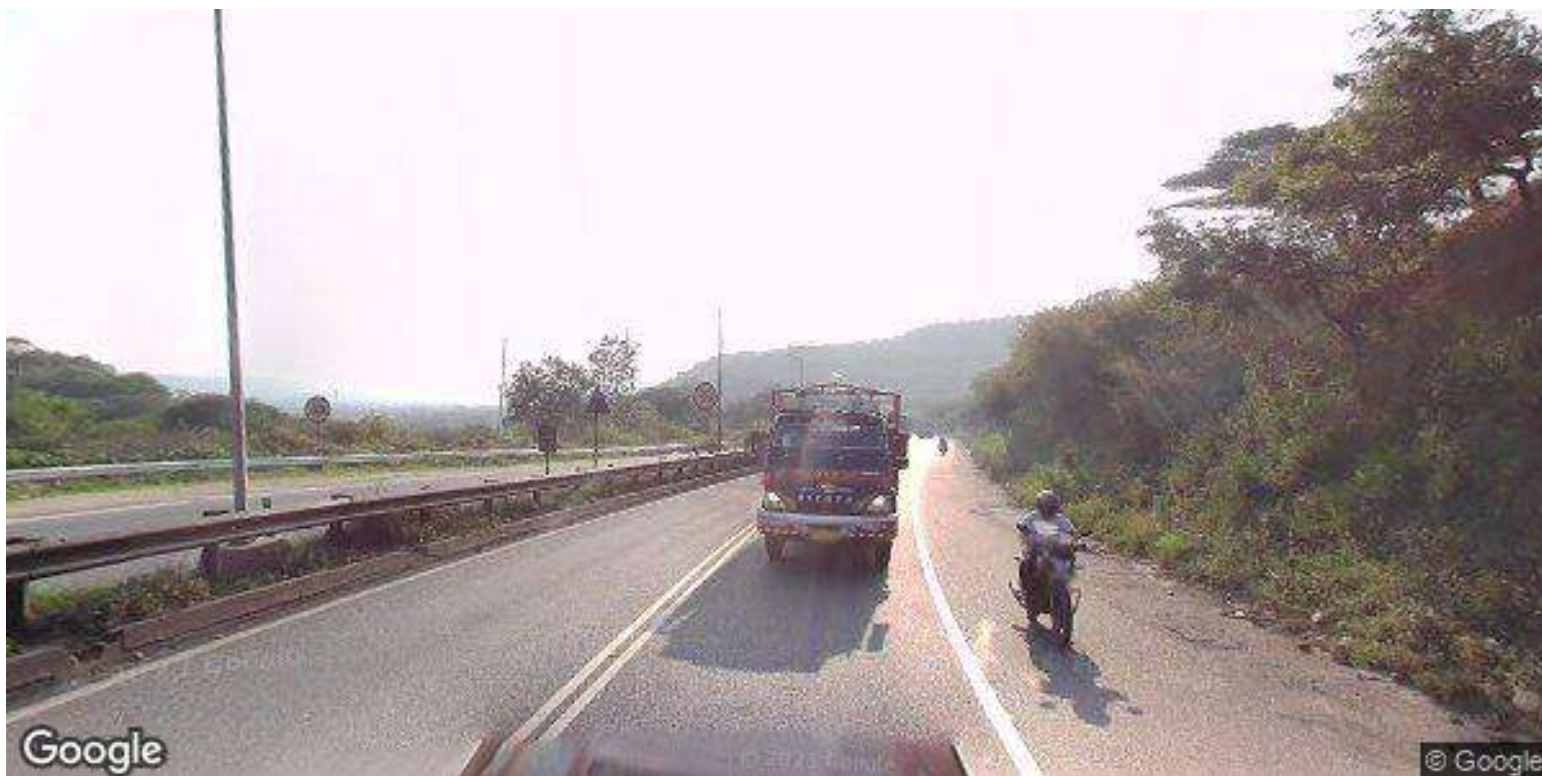
**Risk Type:** Turn  
**Risk Level:** Medium  
**Speed Limit:** 30 KM/Hr  
**Coordinates:** 11.95803, 78.04964

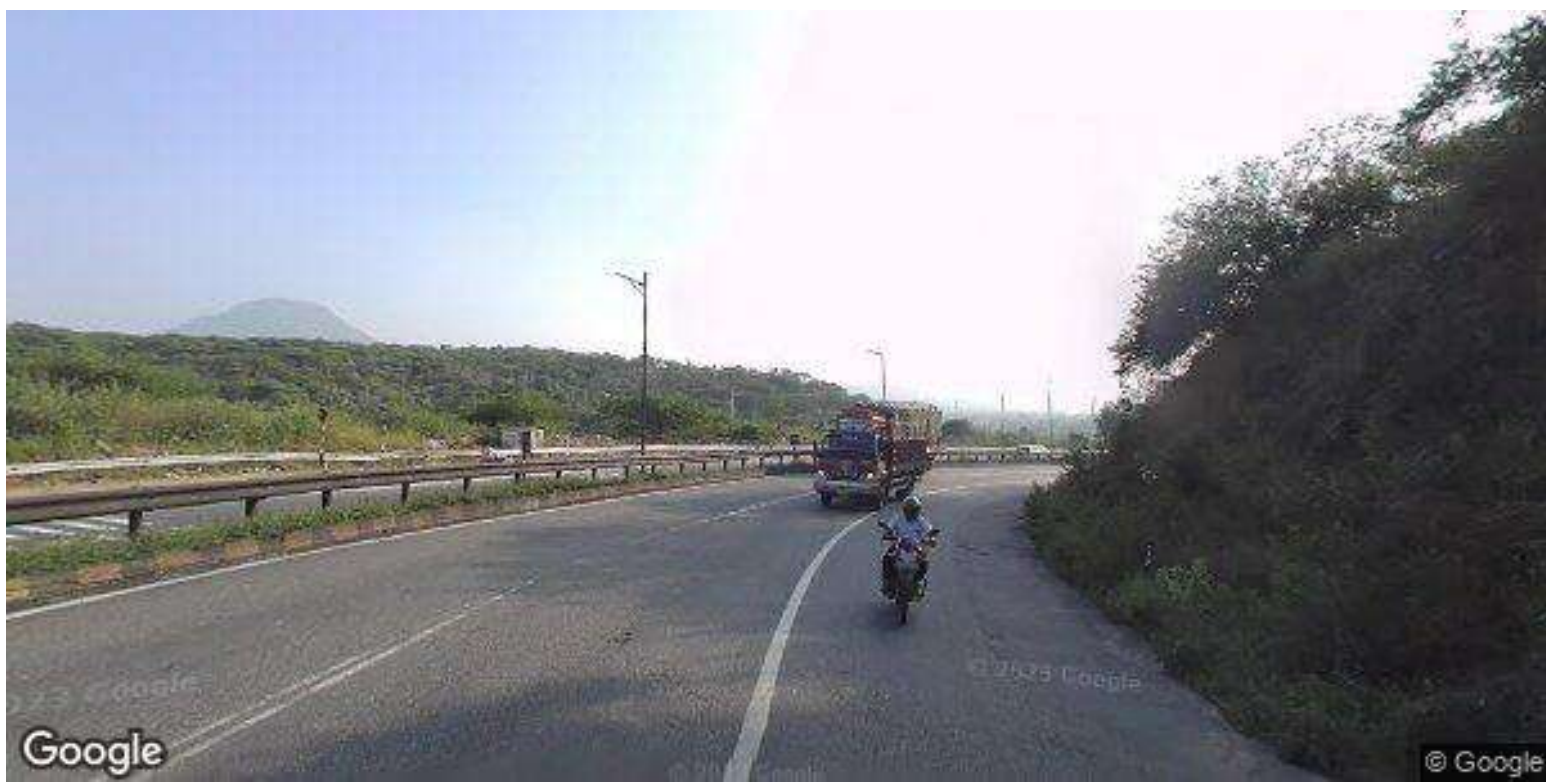
**Coordinates:** 11.95854, 78.04990

**Risk Type:** Turn

**Risk Level:** Medium

**Speed Limit:** 30 KM/Hr

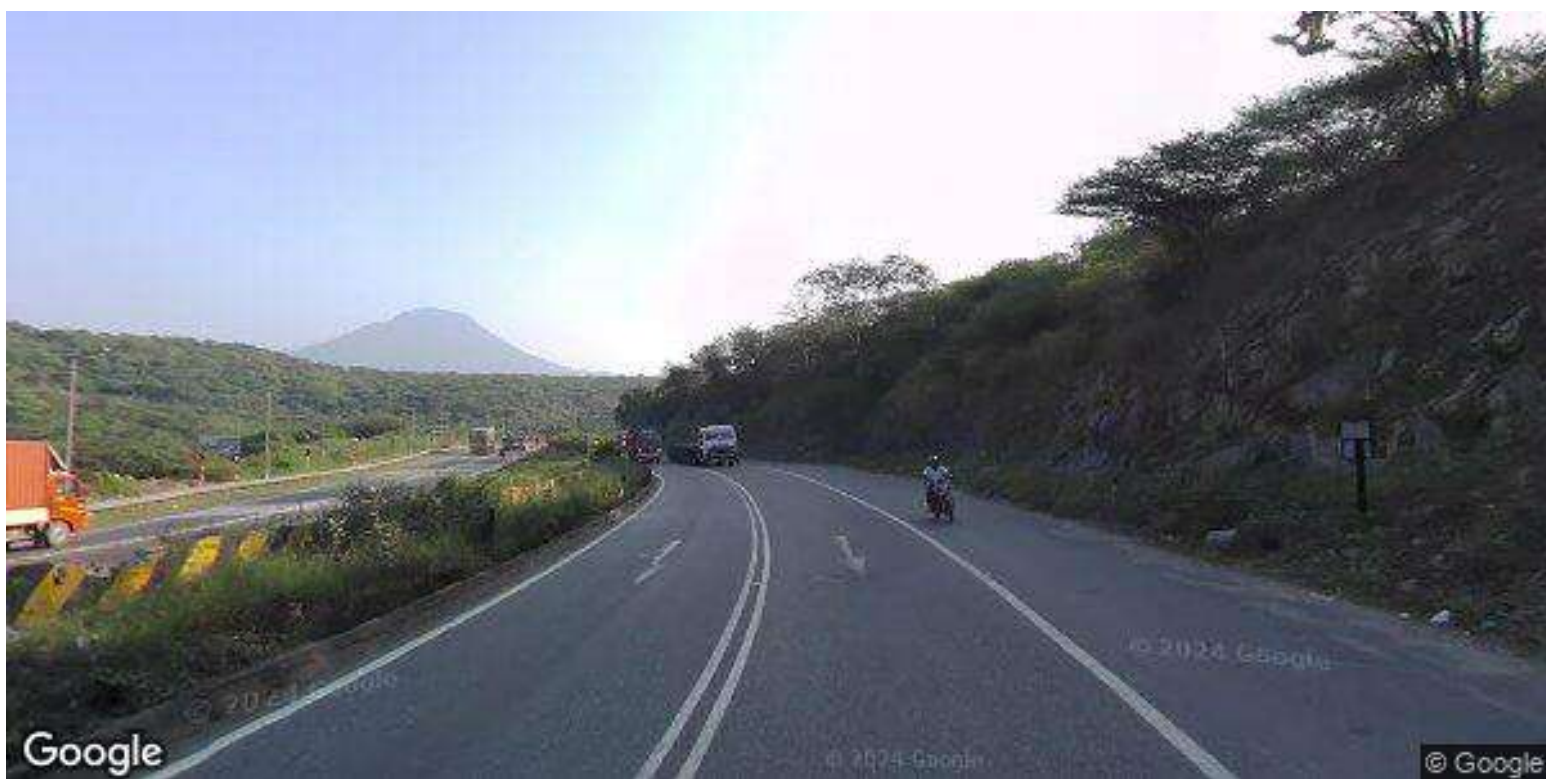
**Coordinates:** 11.96015, 78.04945

**Risk Type:** Turn

**Risk Level:** Medium

**Speed Limit:** 30 KM/Hr

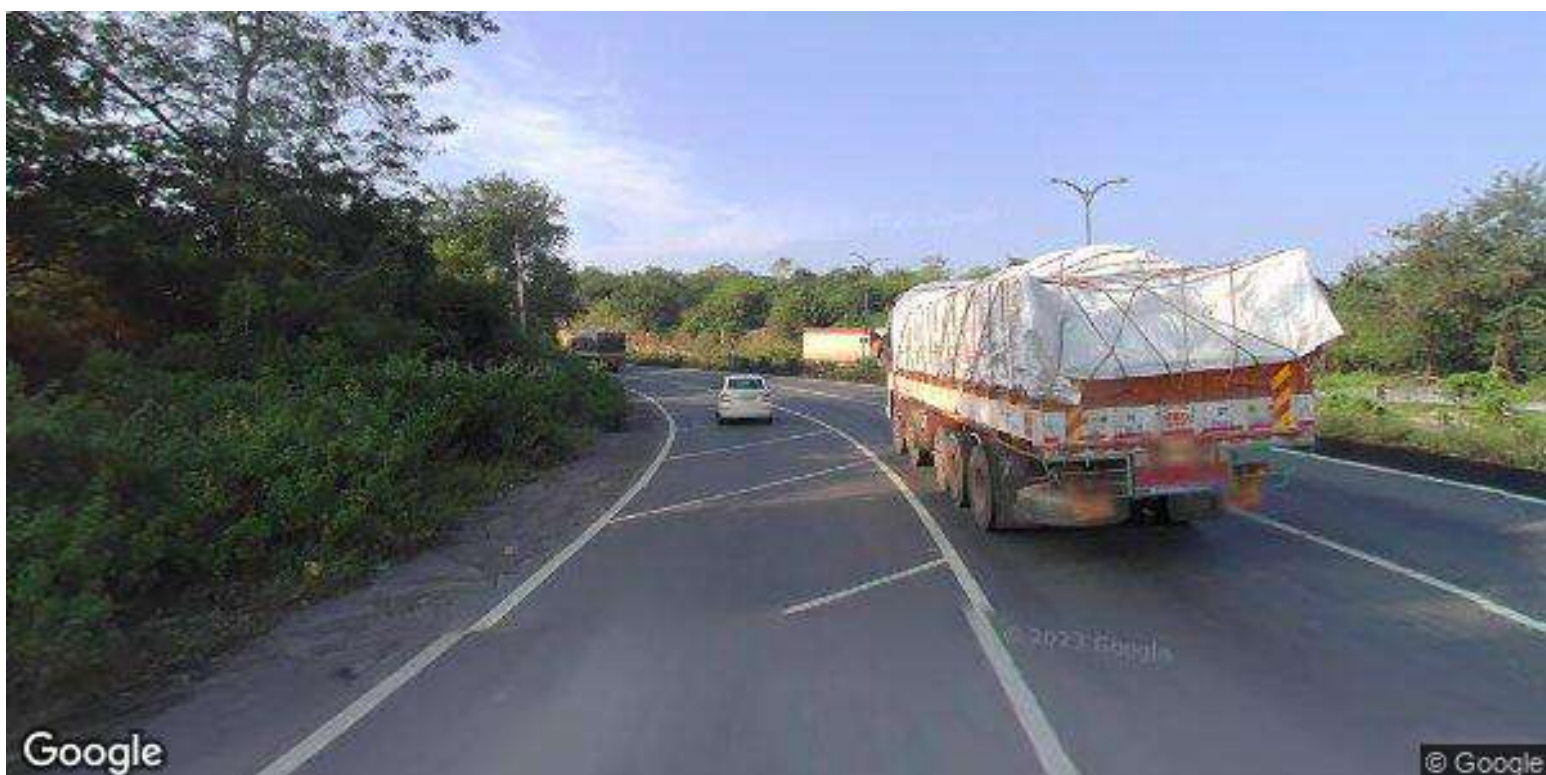
**Risk Type:** Turn  
**Risk Level:** Medium  
**Speed Limit:** 30 KM/Hr  
**Coordinates:** 11.96370, 78.05142

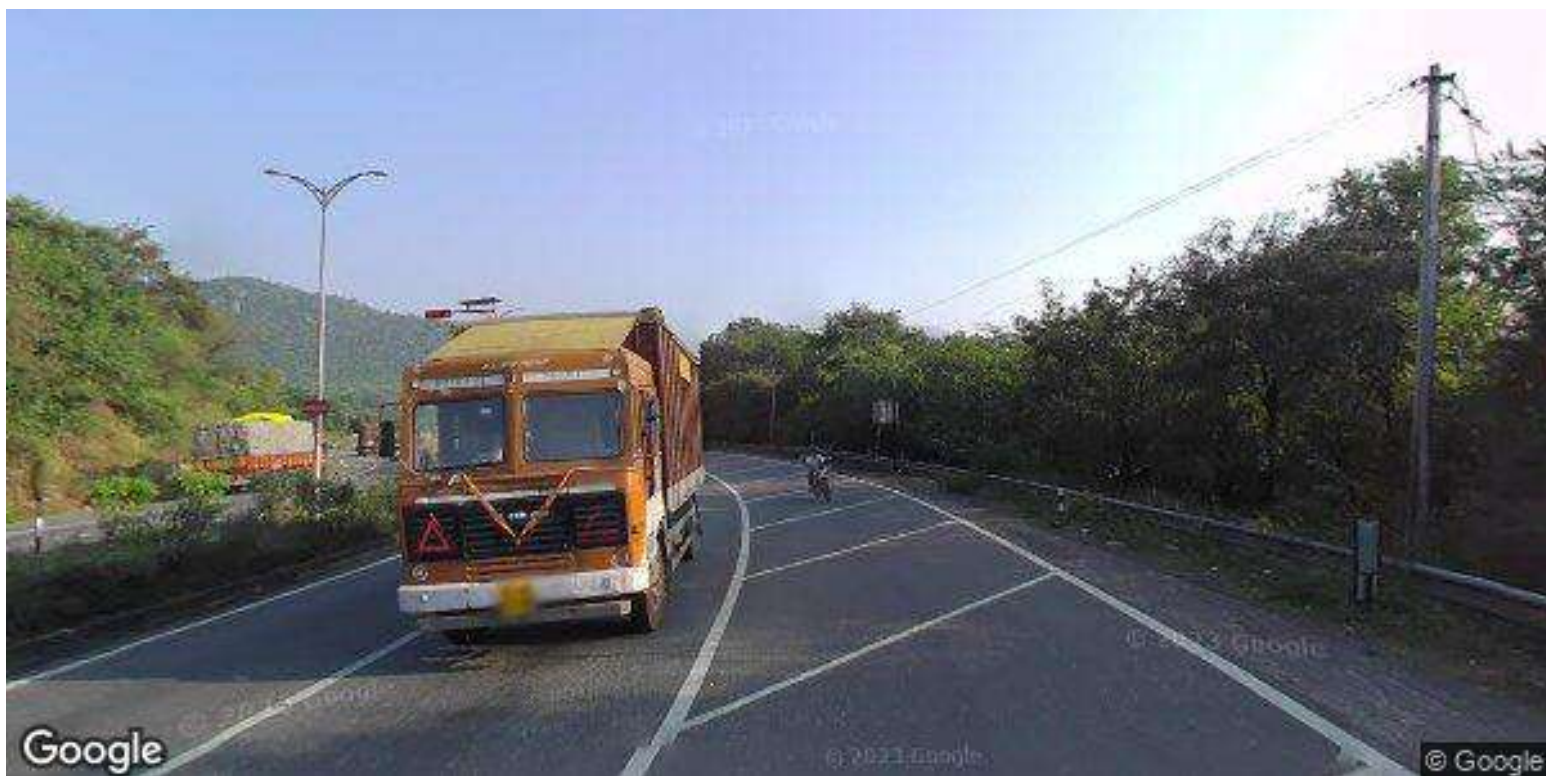
**Risk Type:** Turn  
**Risk Level:** High  
**Speed Limit:** 15 KM/Hr  
**Coordinates:** 11.96542, 78.04938

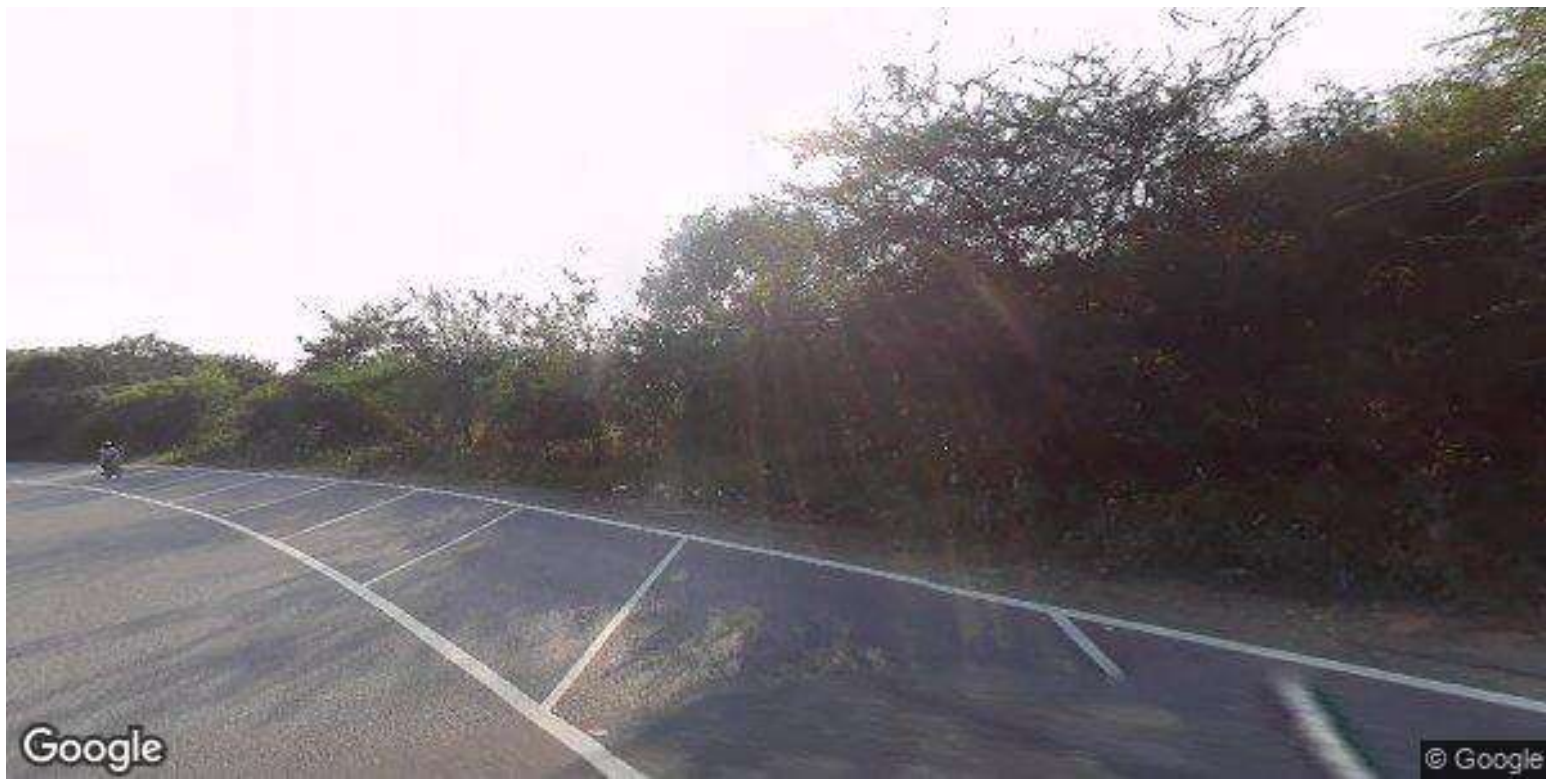
**Coordinates:** 11.96650, 78.04927

**Risk Type:** Turn

**Risk Level:** High

**Speed Limit:** 15 KM/Hr

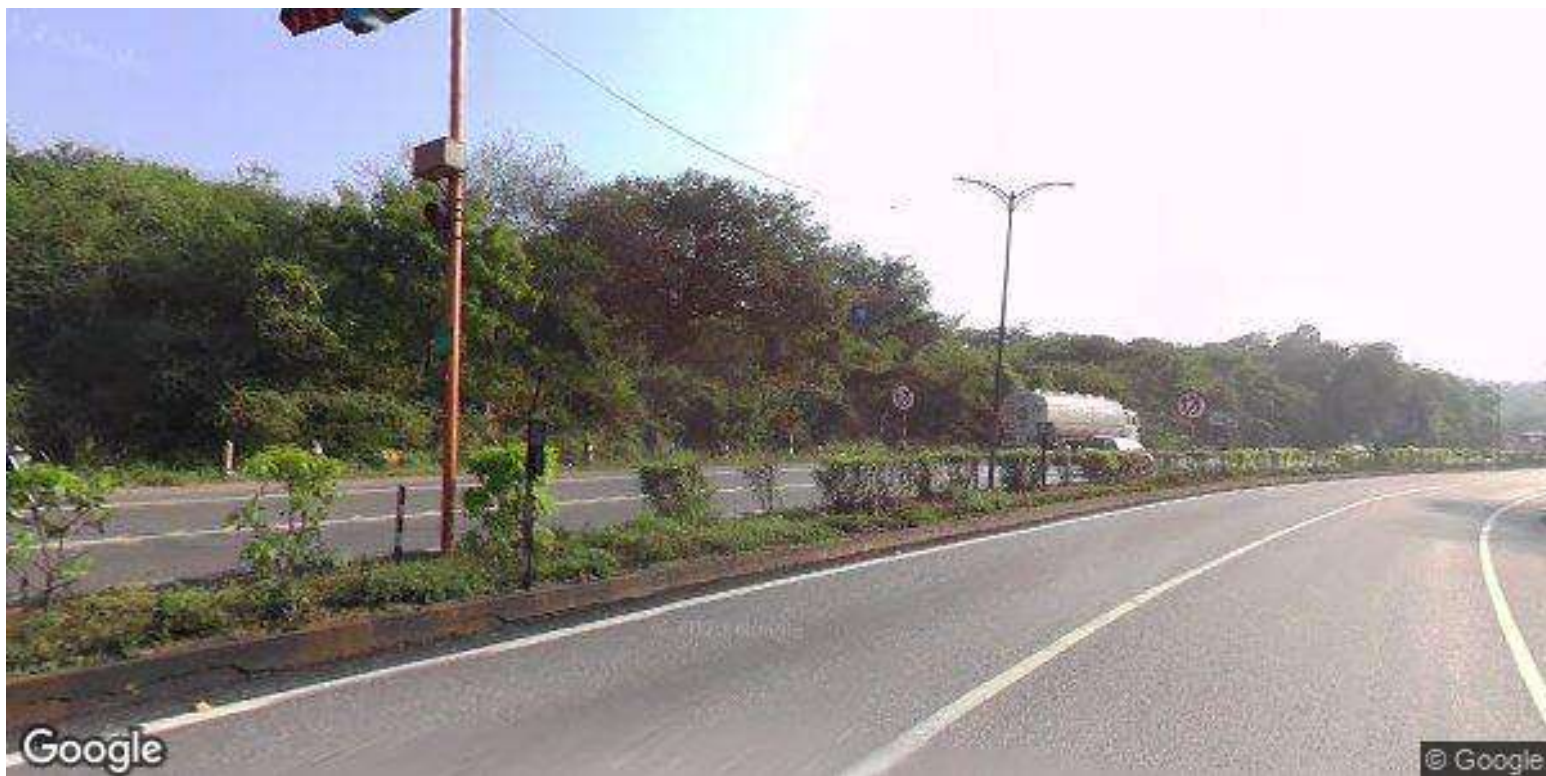
**Coordinates:** 11.96804, 78.05080

**Risk Type:** Turn

**Risk Level:** Medium

**Speed Limit:** 30 KM/Hr

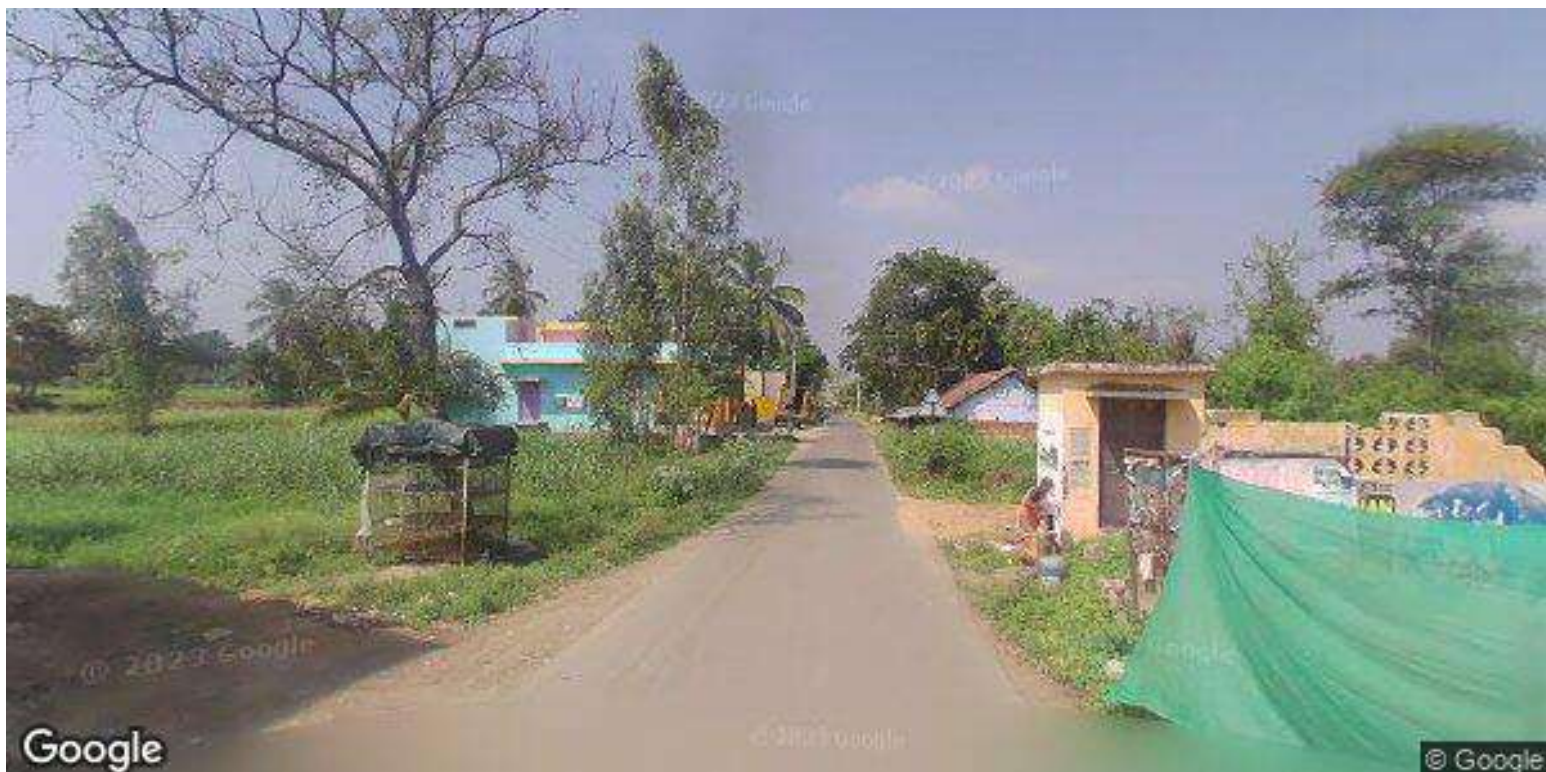
**Risk Type:** Turn  
**Risk Level:** High  
**Speed Limit:** 15 KM/Hr  
**Coordinates:** 12.01399, 78.08651

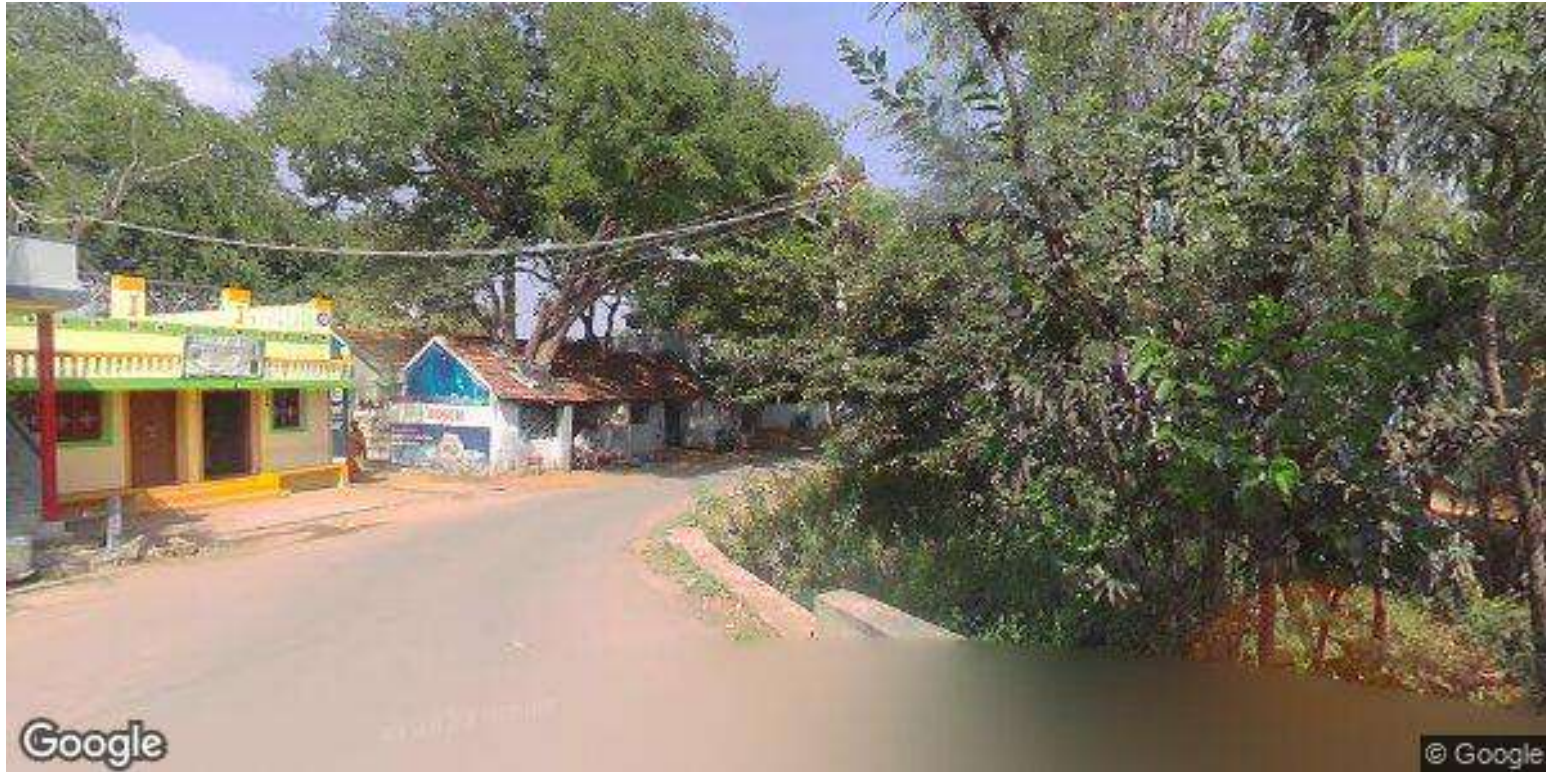
**Risk Type:** Turn  
**Risk Level:** Medium  
**Speed Limit:** 30 KM/Hr  
**Coordinates:** 12.01914, 78.08227

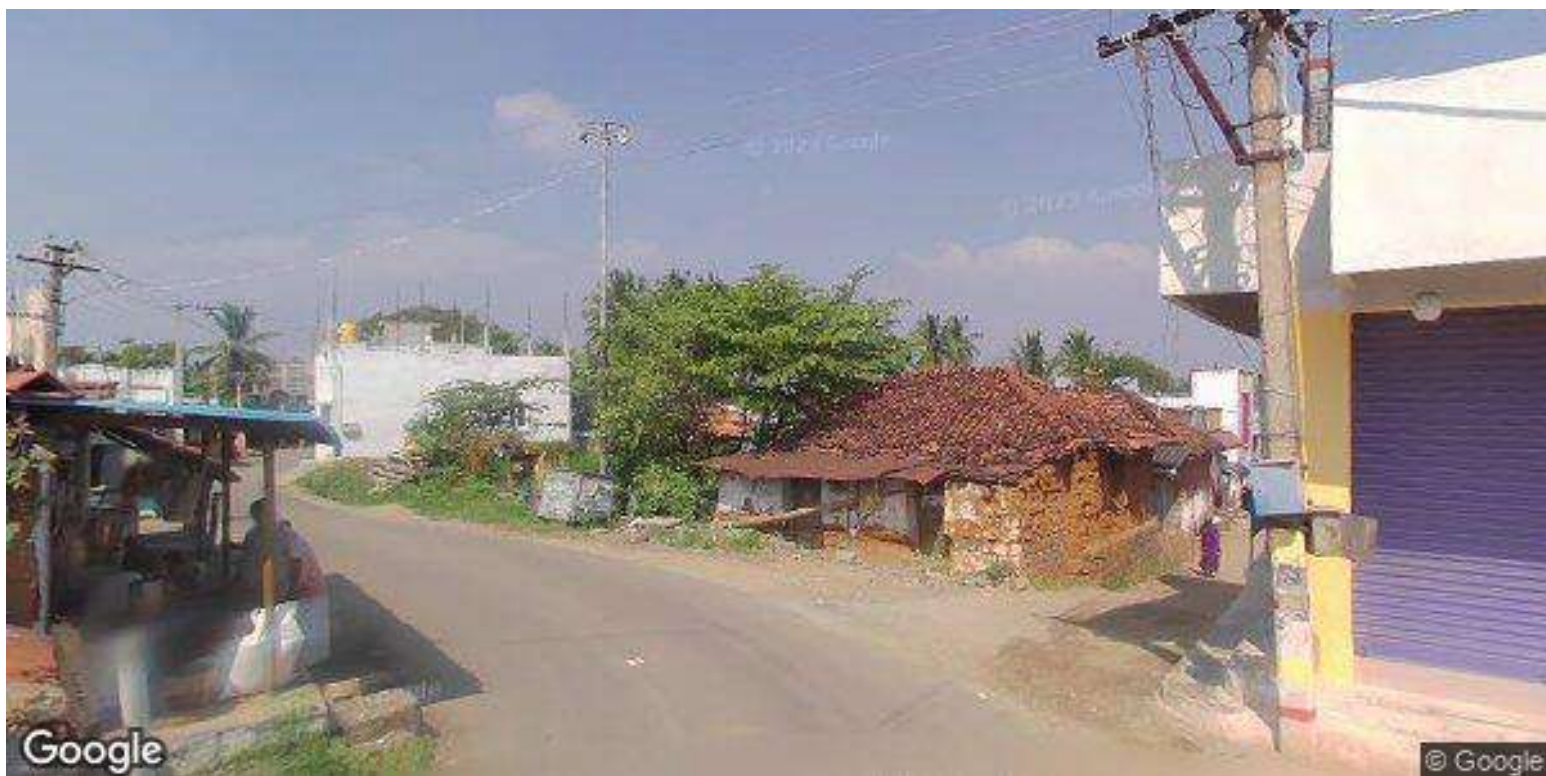
**Risk Type:** Turn  
**Risk Level:** High  
**Speed Limit:** 15 KM/Hr  
**Coordinates:** 12.02037, 78.08260

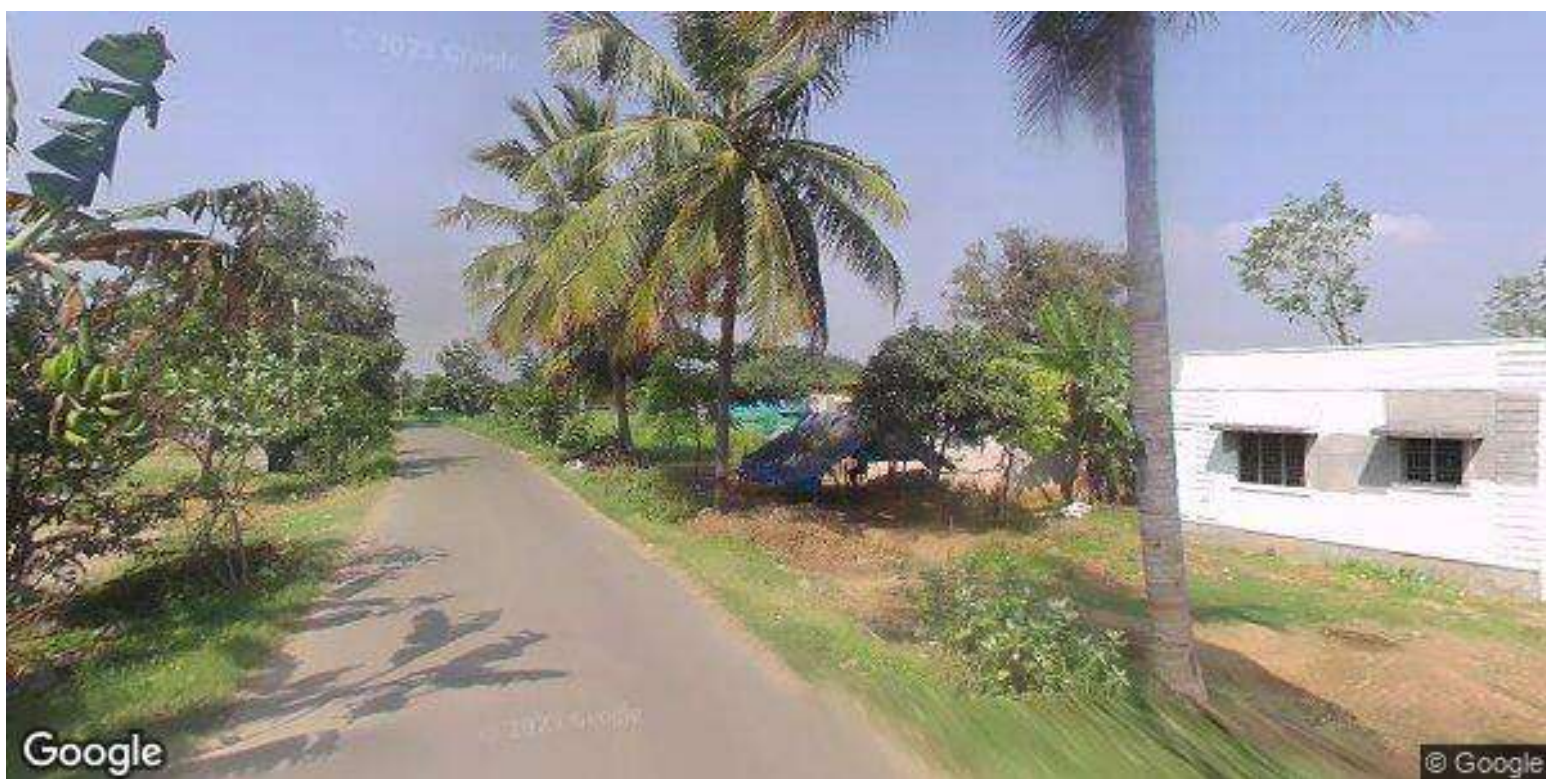
**Coordinates:** 12.02139, 78.08167

**Risk Type:** Turn

**Risk Level:** Medium

**Speed Limit:** 30 KM/Hr

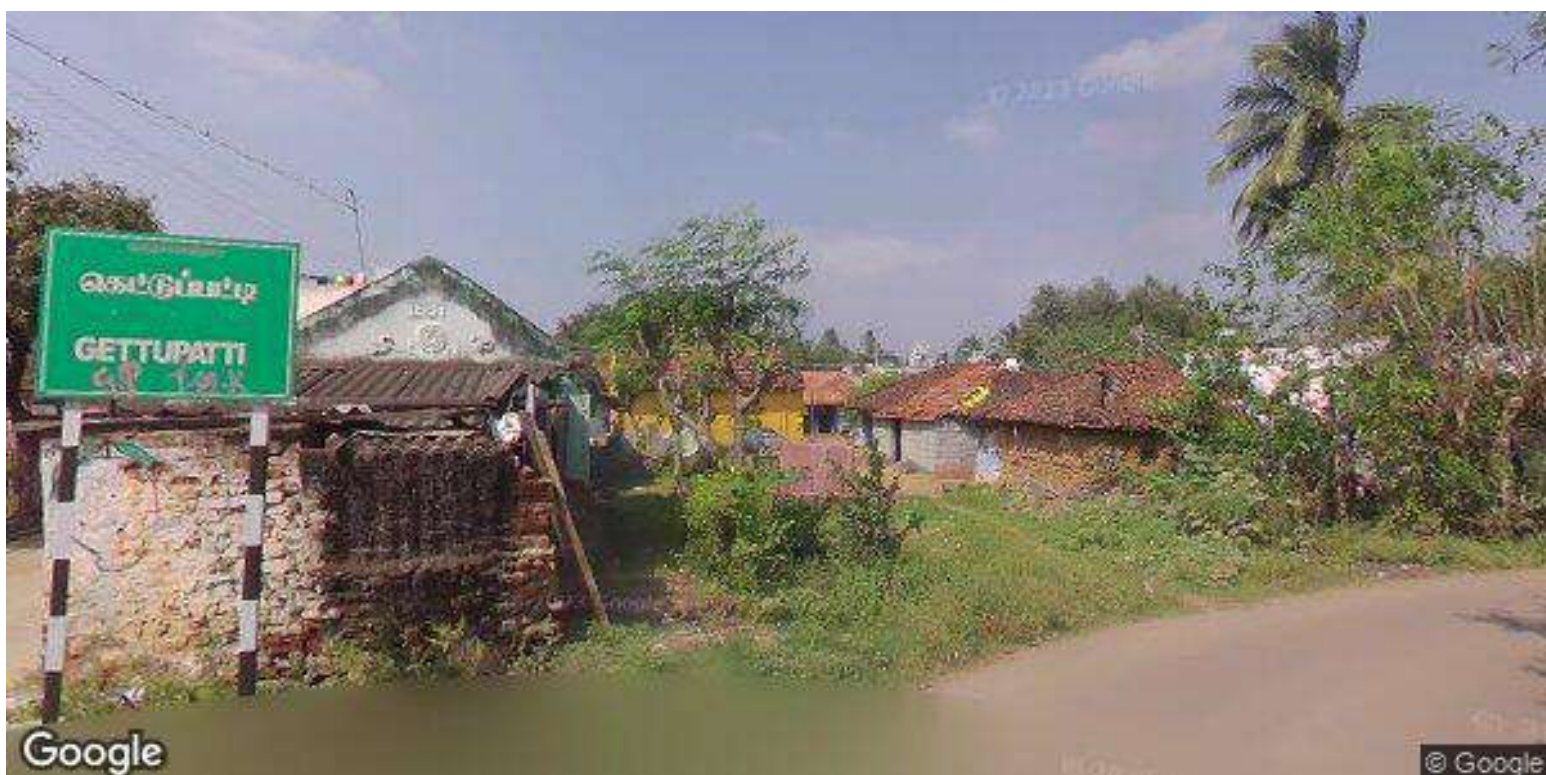
**Risk Type:** Blind Spot  
**Risk Level:** Blind Spot  
**Speed Limit:** 10 KM/Hr  
**Coordinates:** 12.02306, 78.07557

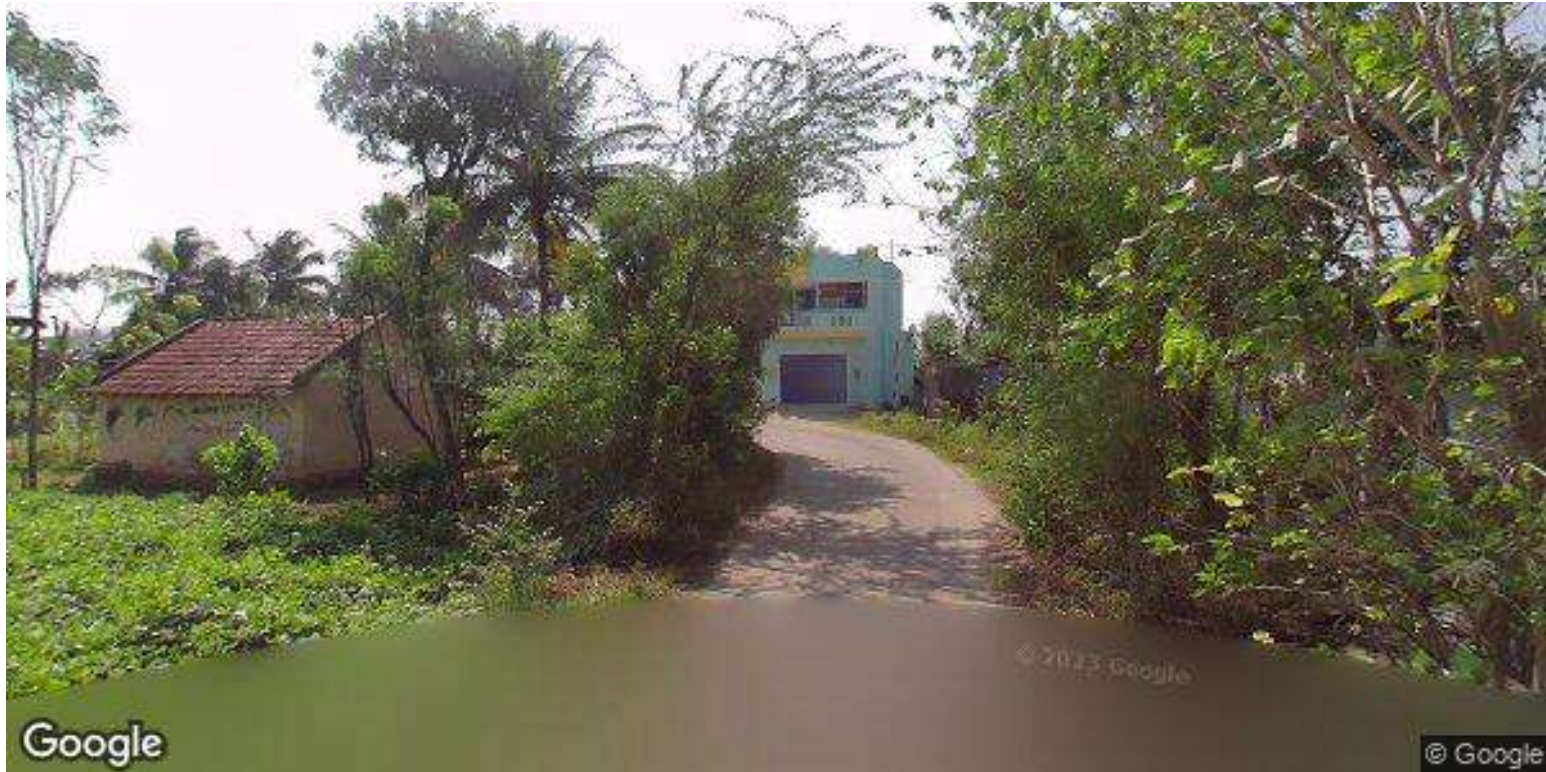
**Risk Type:** Turn  
**Risk Level:** Medium  
**Speed Limit:** 30 KM/Hr  
**Coordinates:** 12.02328, 78.07564

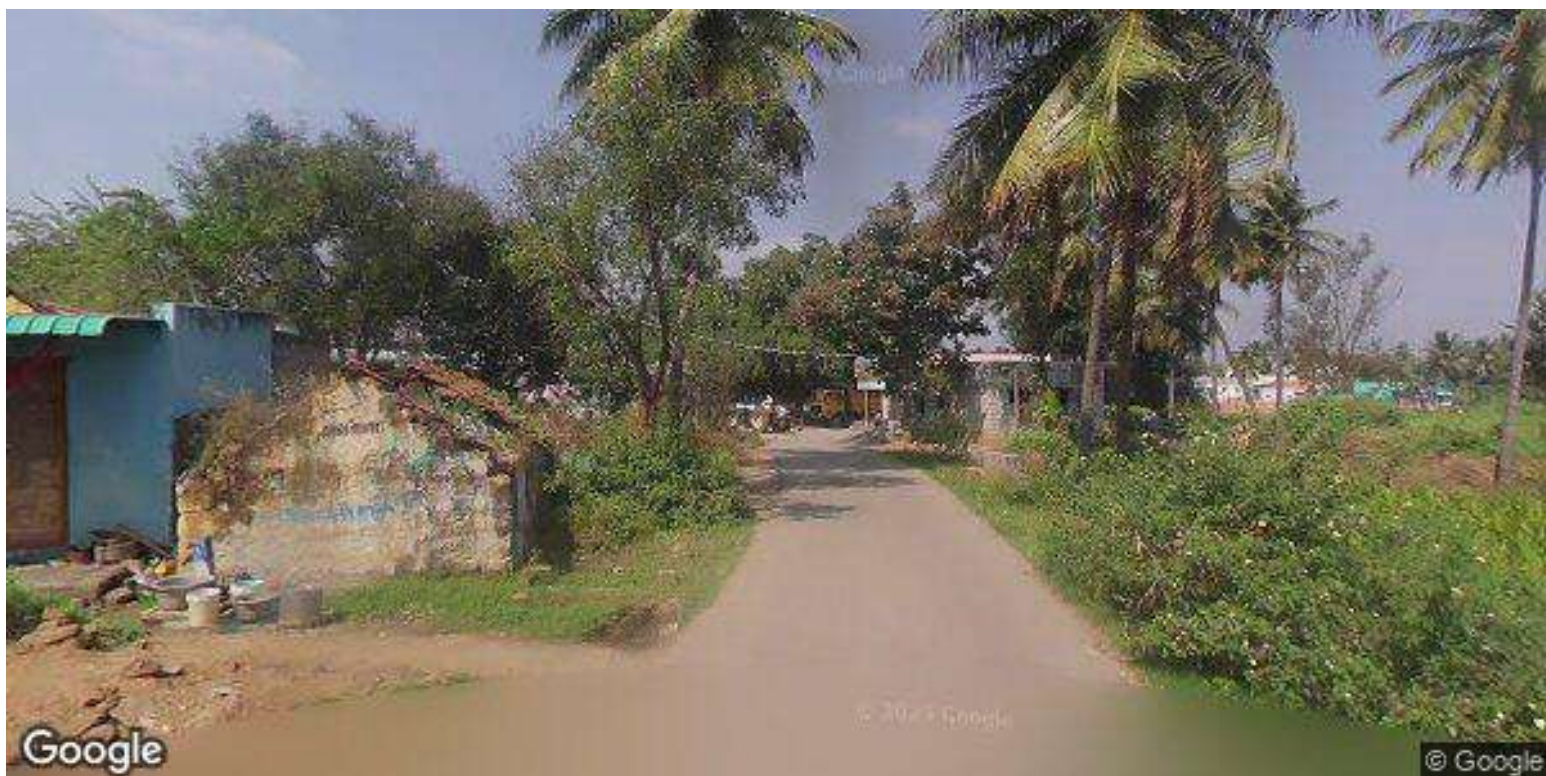
**Risk Type:** Turn  
**Risk Level:** Medium  
**Speed Limit:** 30 KM/Hr  
**Coordinates:** 12.02349, 78.07557

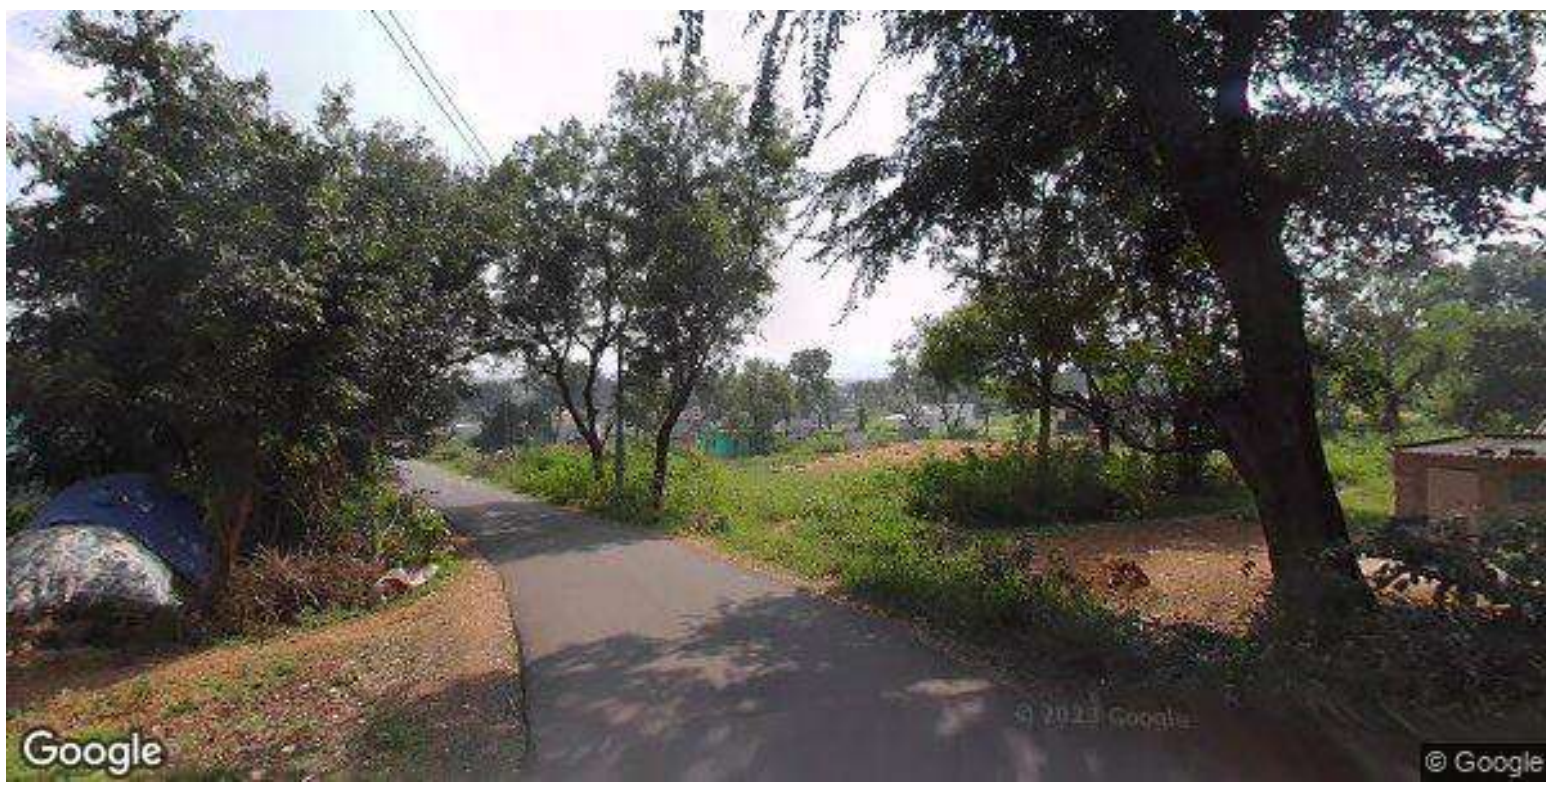
**Coordinates:** 12.02465, 78.07231

**Risk Type:** Turn

**Risk Level:** High

**Speed Limit:** 15 KM/Hr

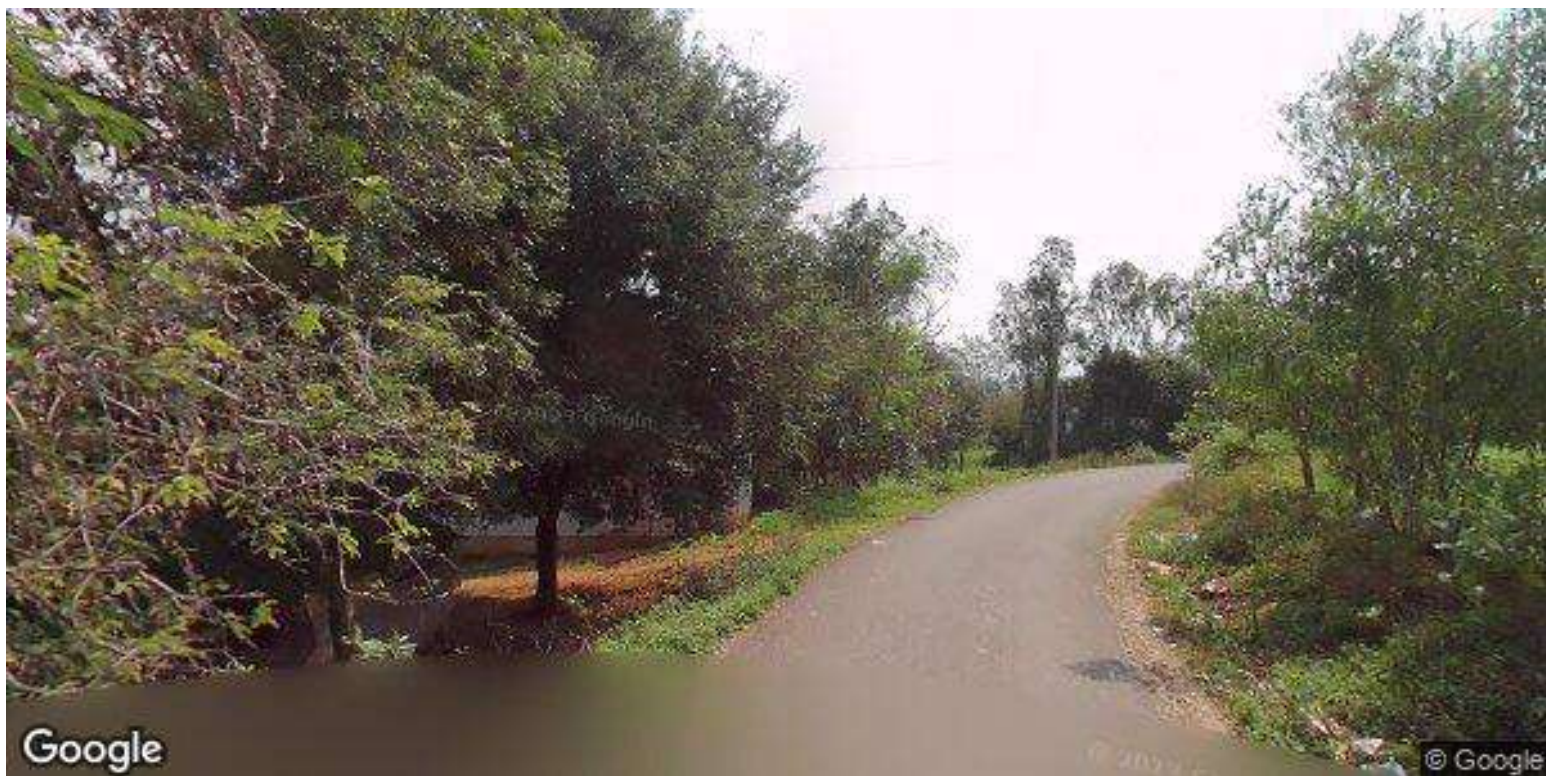
**Coordinates:** 12.02566, 78.07211

**Risk Type:** Turn

**Risk Level:** High

**Speed Limit:** 15 KM/Hr

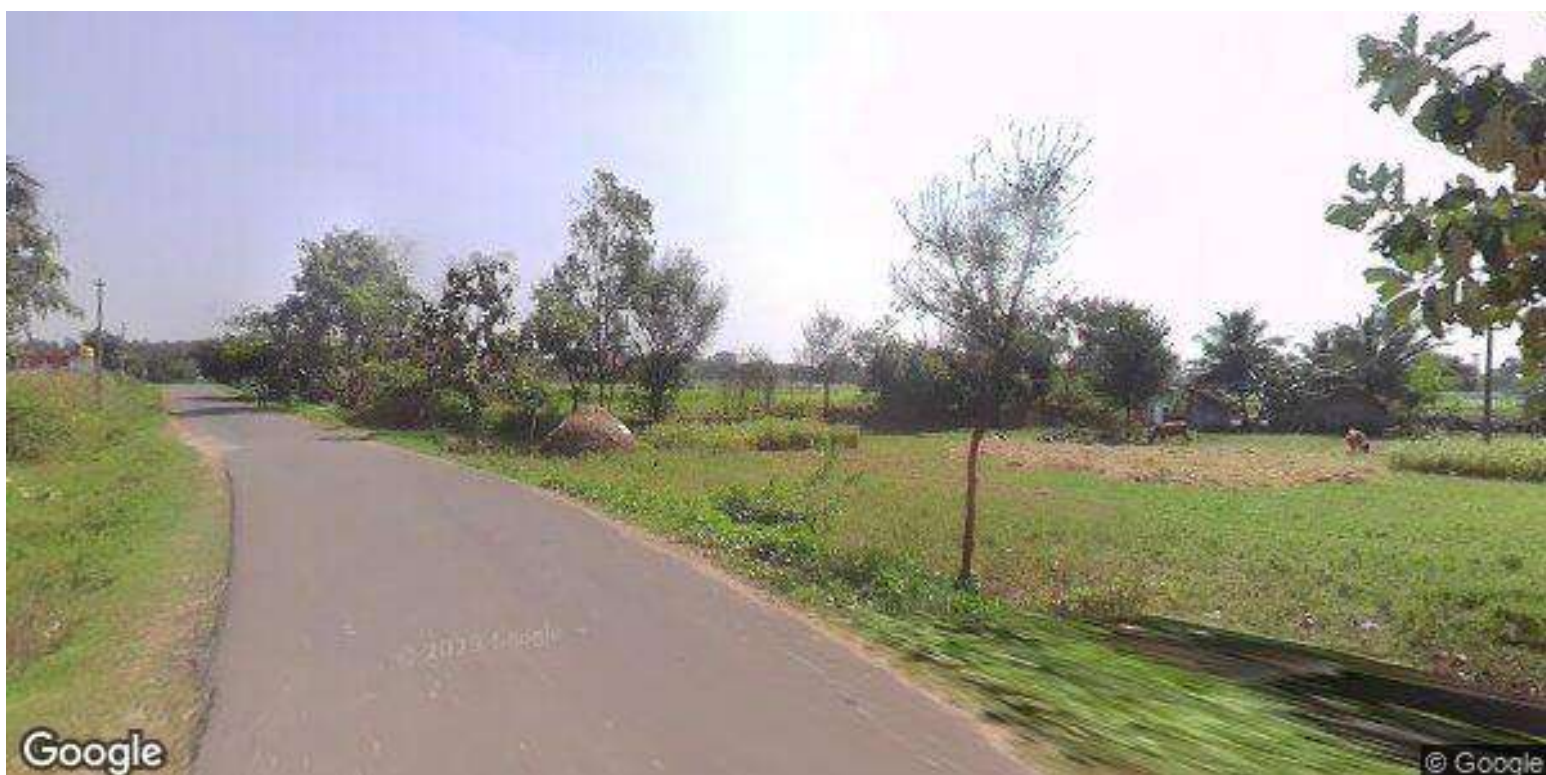
**Coordinates:** 12.02707, 78.06514

**Risk Type:** Turn

**Risk Level:** Medium

**Speed Limit:** 30 KM/Hr
