# IndianOil

## JOURNEY RISK MANAGEMENT (JRM) STUDY

### Salem Terminal TO N. S. BHARANI FUELS

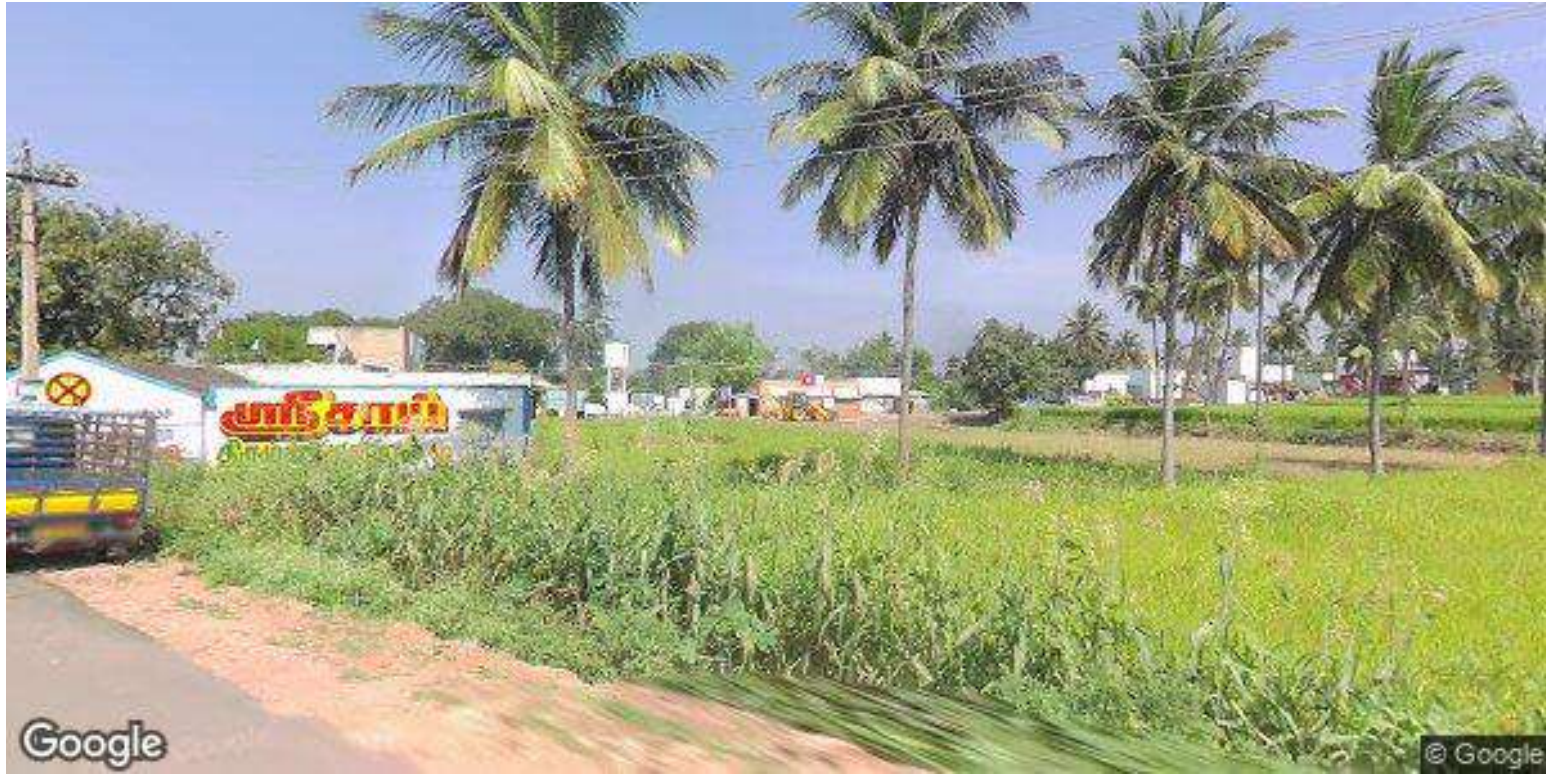
**Coordinates:** 12.03020, 78.06332

**Risk Type:** Turn

**Risk Level:** Medium

**Speed Limit:** 30 KM/Hr
