# IndianOil

## JOURNEY RISK MANAGEMENT (JRM) STUDY

### Salem Terminal TO GOPALAKRISHNA AGENCY UNIT - II

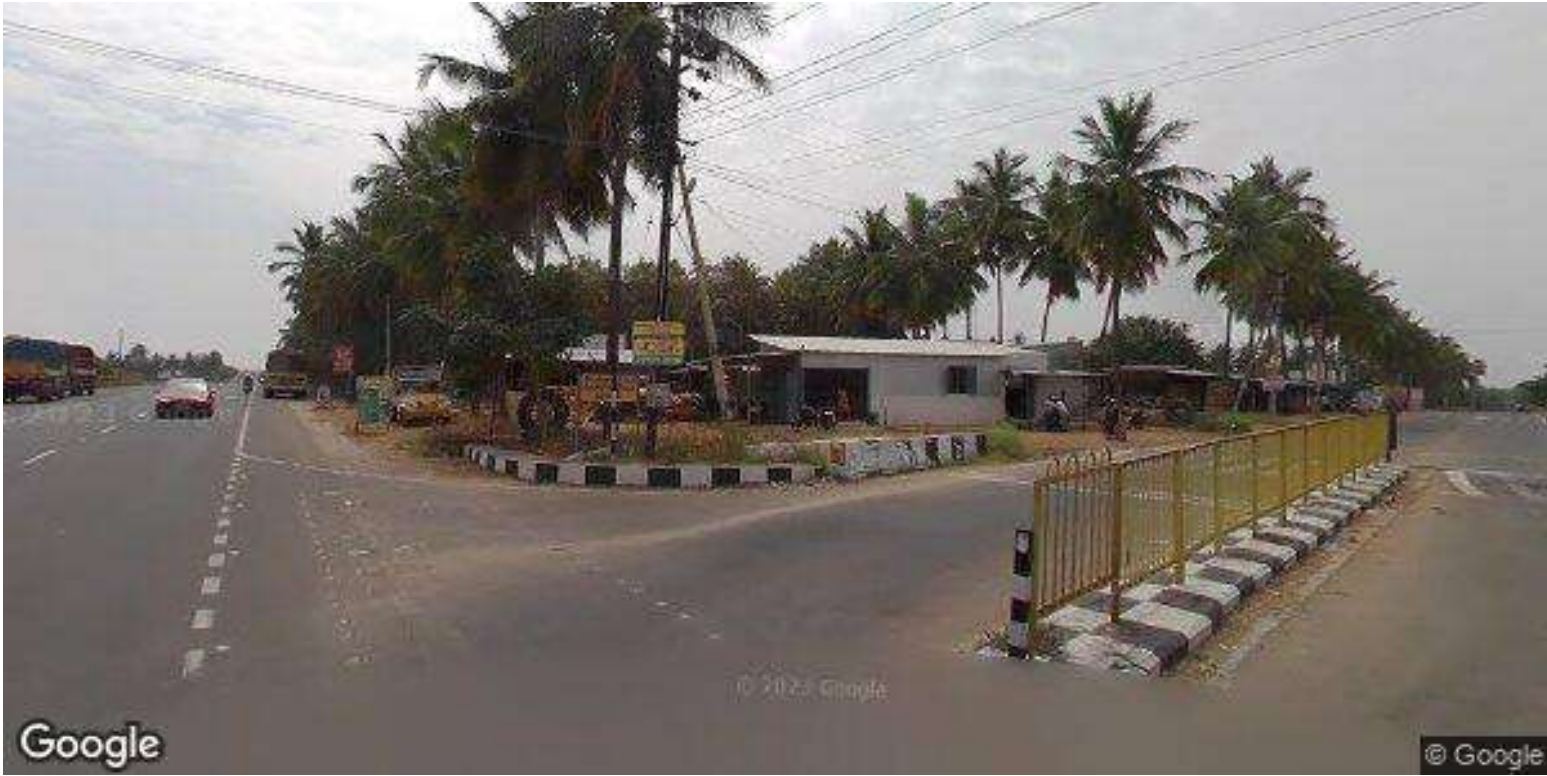
Coordinates: 11.30859, 77.92918

Risk Type: Turn

Risk Level: High

Speed Limit: 15 KM/Hr
