# IndianOil

## JOURNEY RISK MANAGEMENT (JRM) STUDY

### Salem Terminal TO VARUN FUEL AGENCY

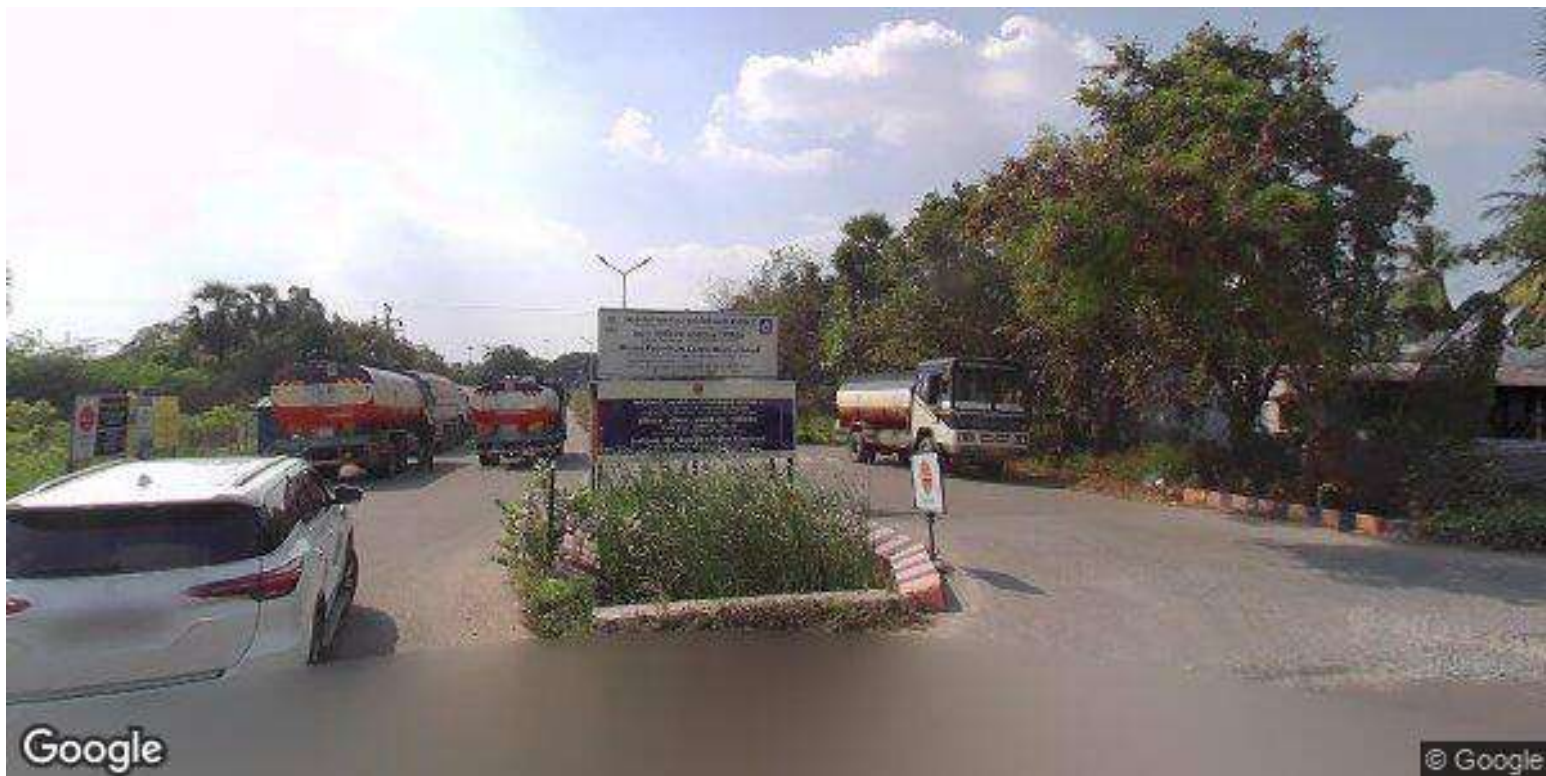
**Coordinates:** 11.44024, 77.87528

**Risk Type:** Turn

**Risk Level:** High

**Speed Limit:** 15 KM/Hr

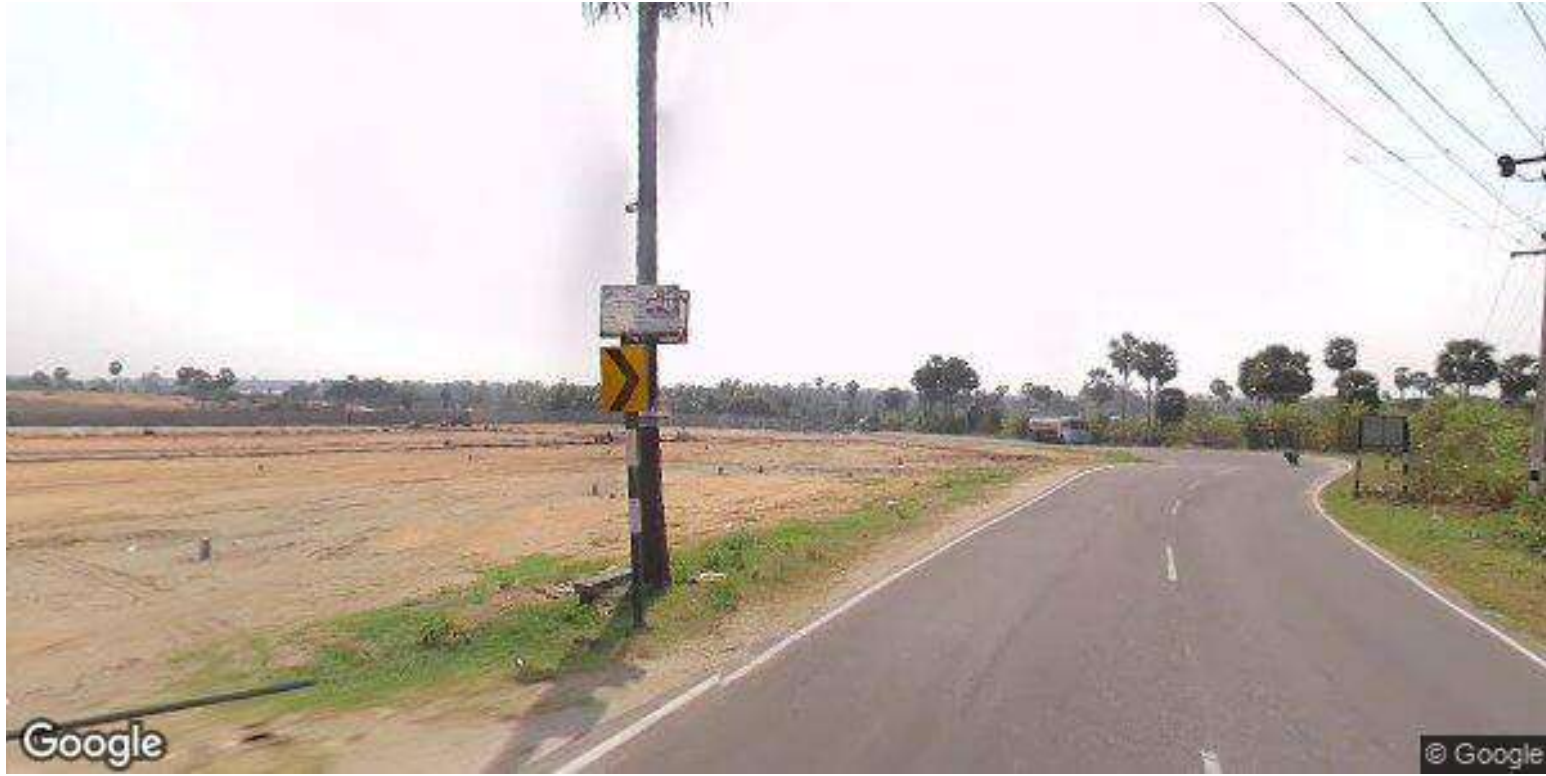
**Risk Type:** Turn  
**Risk Level:** Medium  
**Speed Limit:** 30 KM/Hr  
**Coordinates:** 11.45898, 77.85135

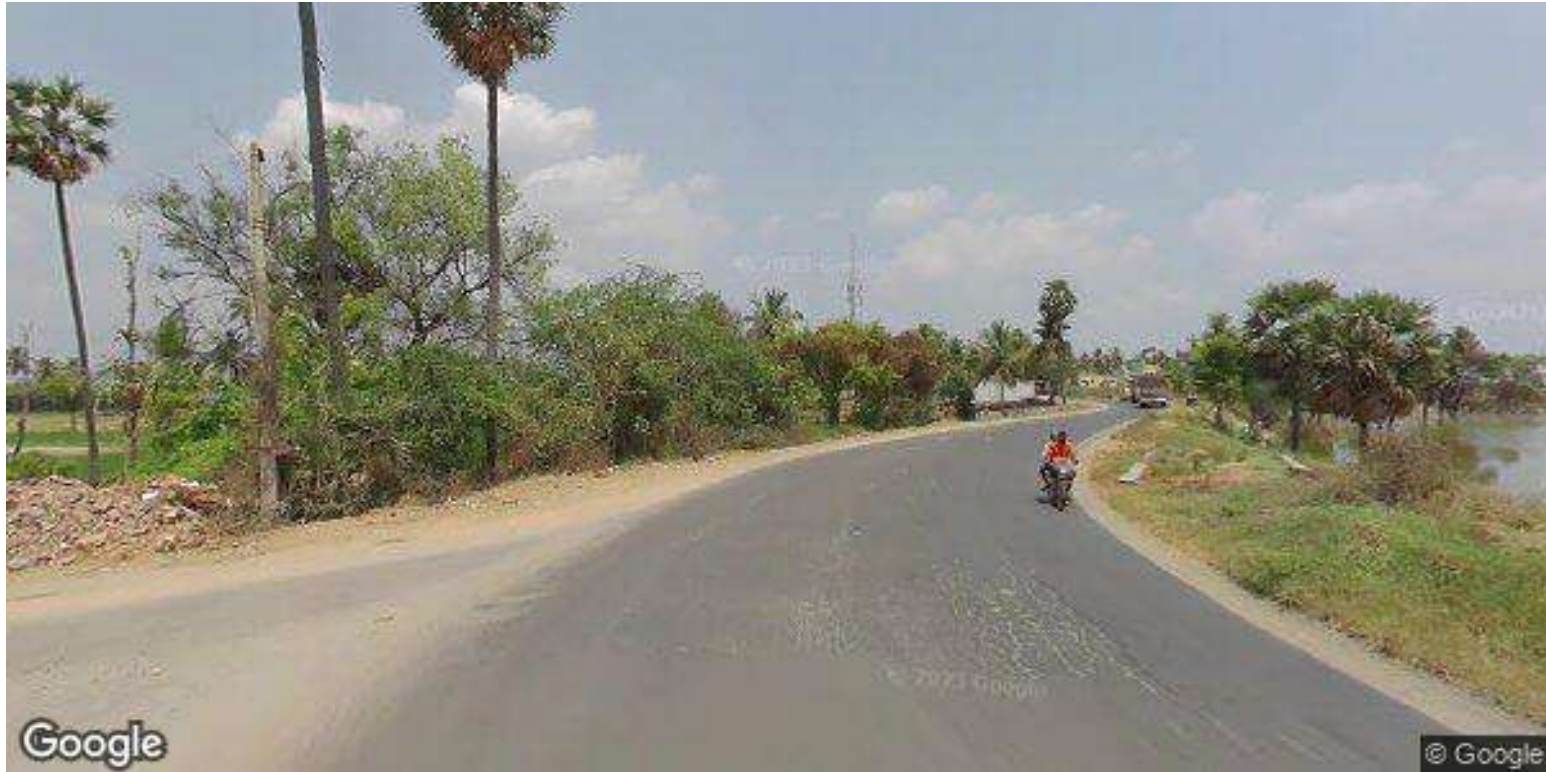
**Risk Type:** Turn  
**Risk Level:** Medium  
**Speed Limit:** 30 KM/Hr  
**Coordinates:** 11.56083, 77.89921

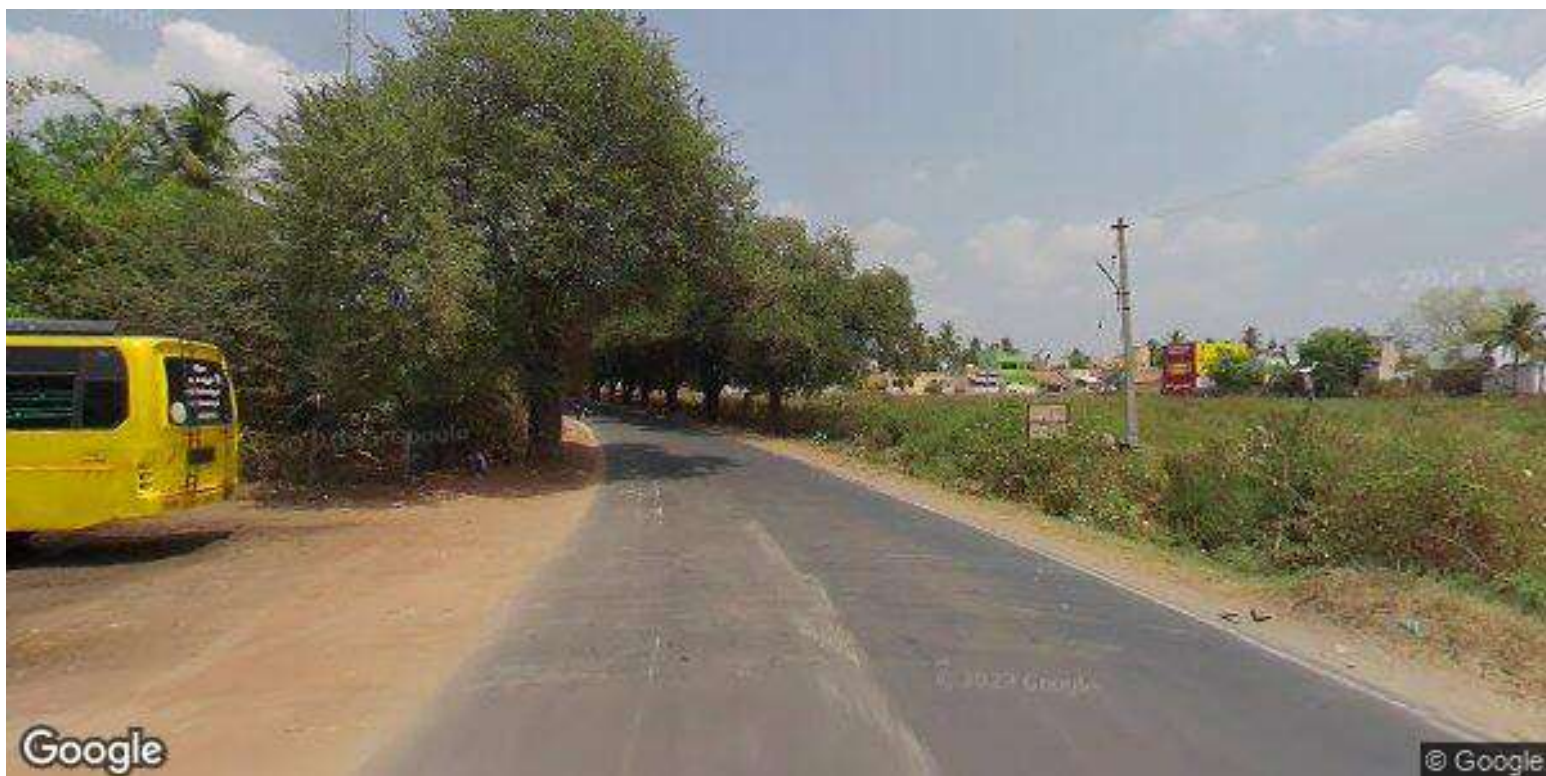
**Risk Type:** Turn  
**Risk Level:** Medium  
**Speed Limit:** 30 KM/Hr  
**Coordinates:** 11.56180, 77.90019

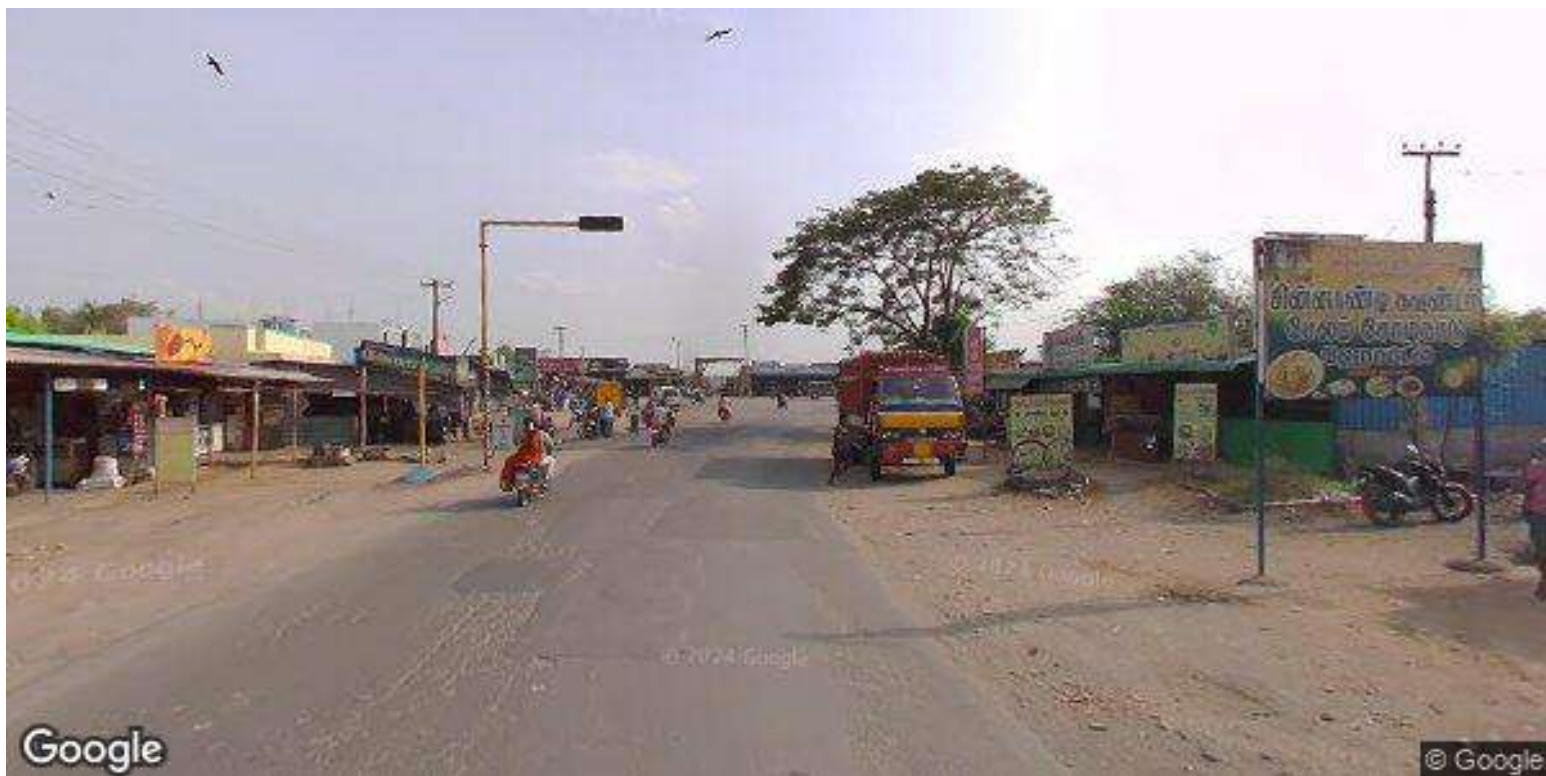
**Coordinates:** 11.64217, 77.95200

**Risk Type:** Turn

**Risk Level:** Medium

**Speed Limit:** 30 KM/Hr

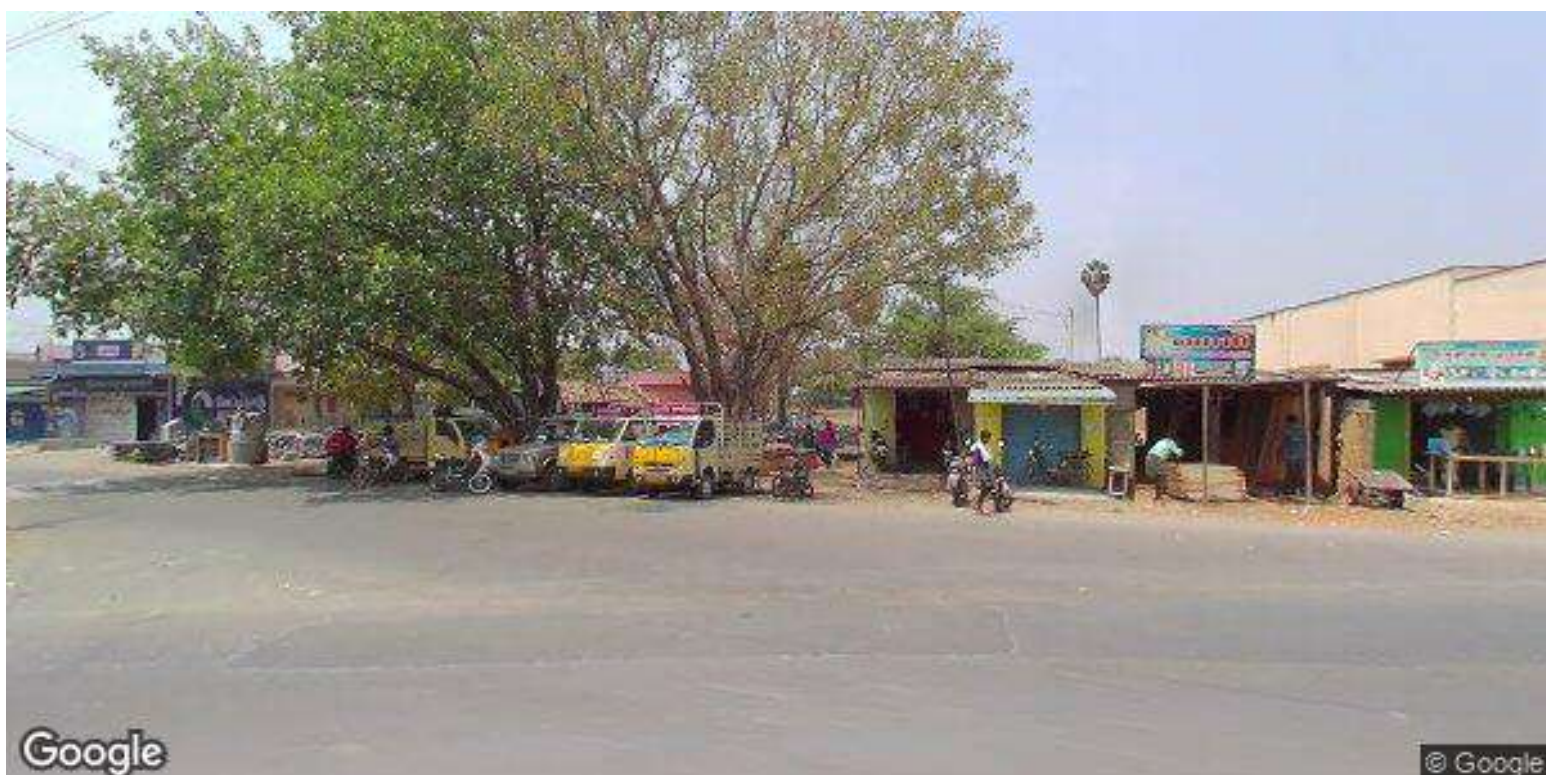
**Coordinates: 11.64712, 77.95118**

**Risk Type: Turn**

**Risk Level: Medium**

**Speed Limit: 30 KM/Hr**

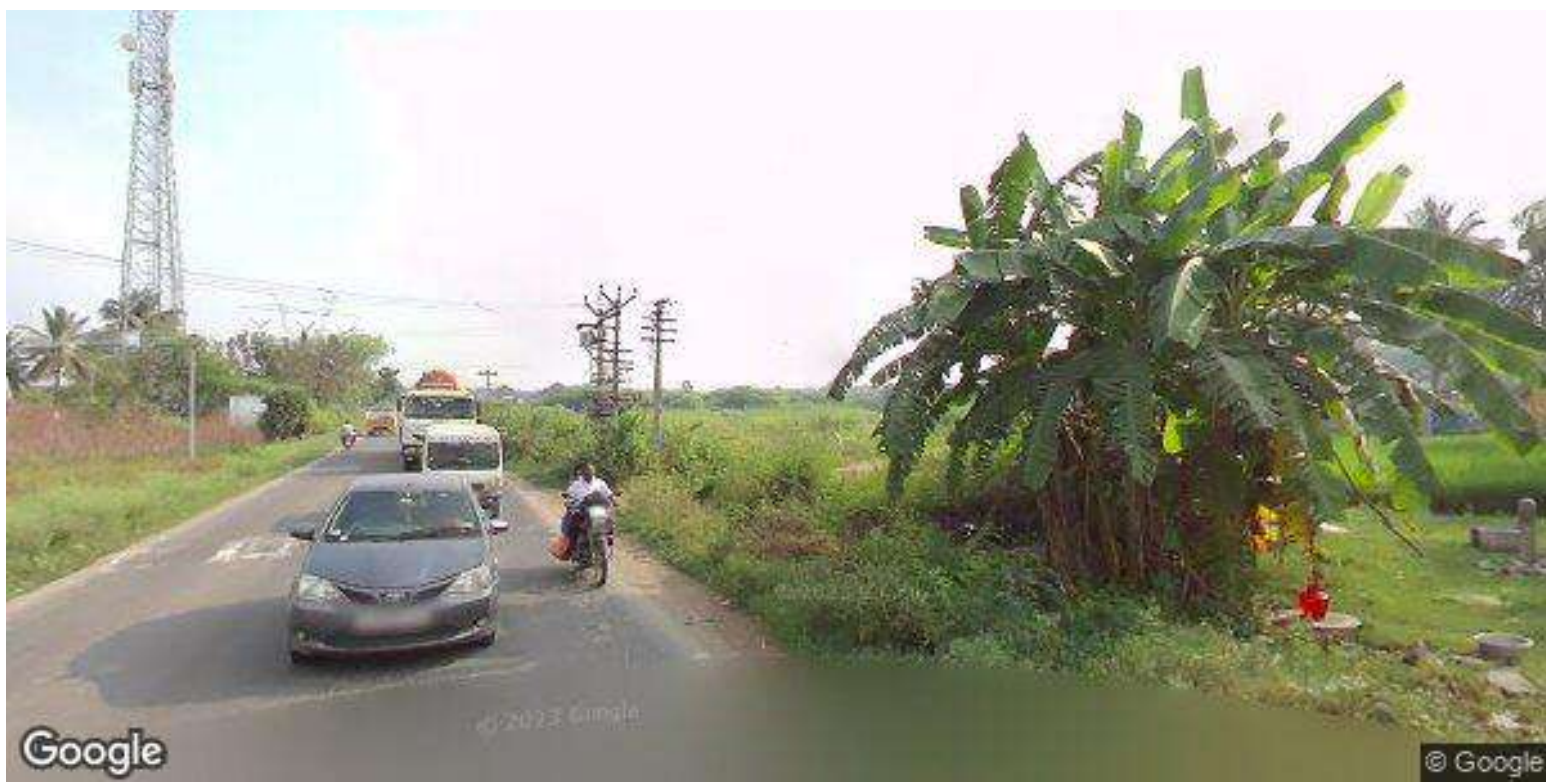
**Coordinates:** 11.71394, 77.99572

**Risk Type:** Turn

**Risk Level:** Medium

**Speed Limit:** 30 KM/Hr

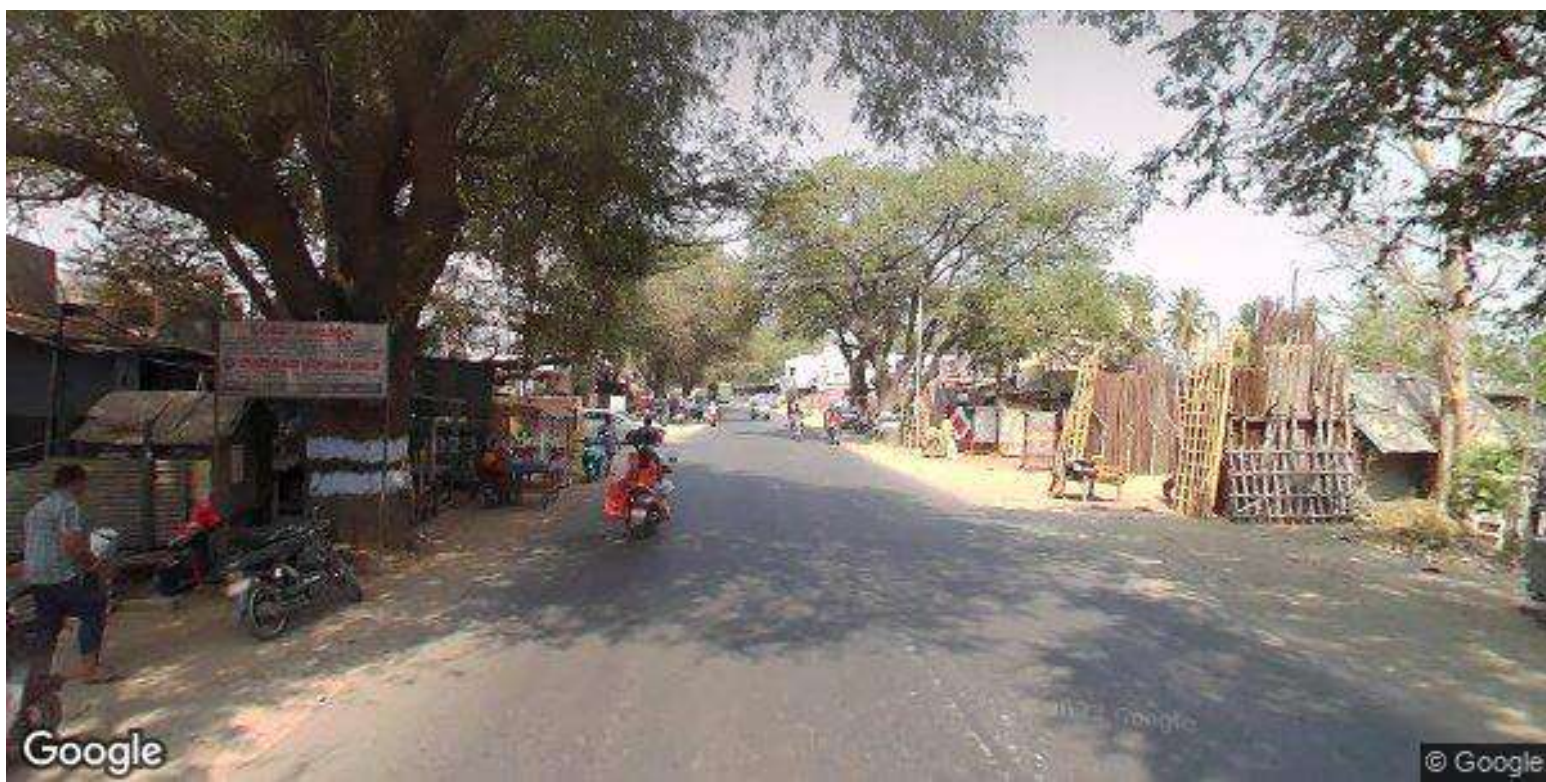
**Coordinates:** 11.74120, 78.04588

**Risk Type:** Turn

**Risk Level:** Medium

**Speed Limit:** 30 KM/Hr

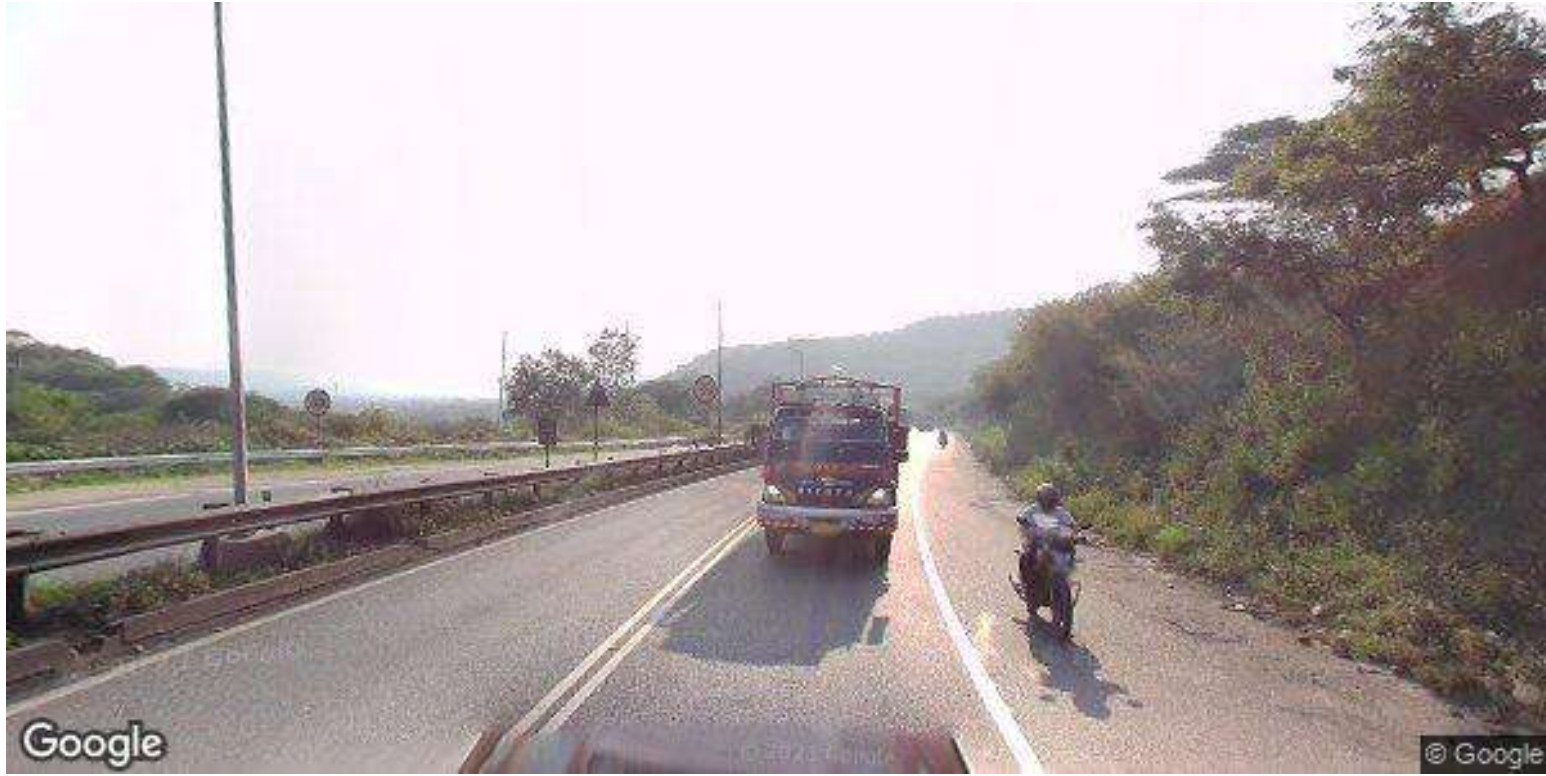
**Risk Type:** Turn  
**Risk Level:** Medium  
**Speed Limit:** 30 KM/Hr  
**Coordinates:** 11.95803, 78.04964

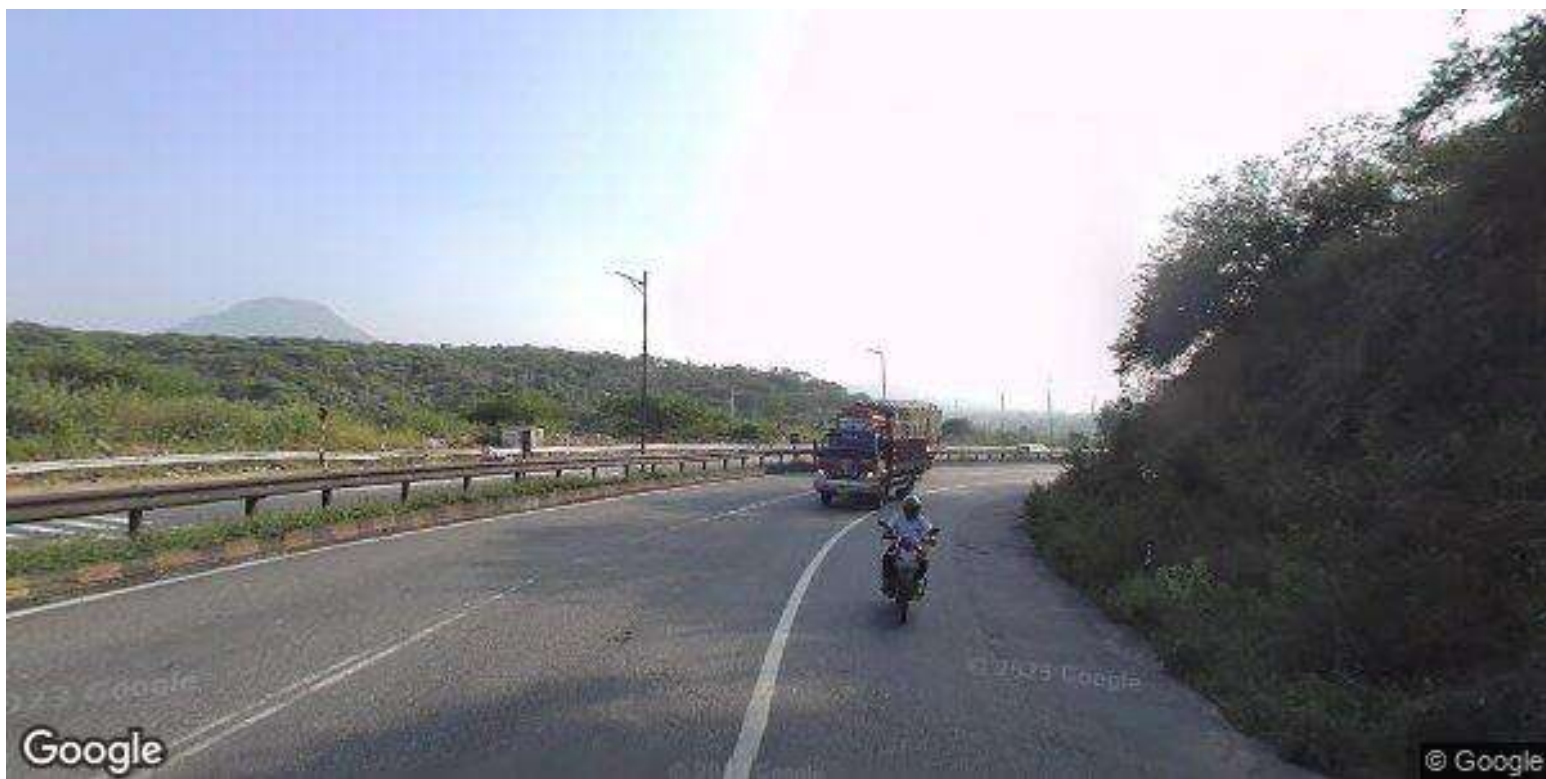
**Risk Type:** Turn  
**Risk Level:** Medium  
**Speed Limit:** 30 KM/Hr  
**Coordinates:** 11.95854, 78.04990

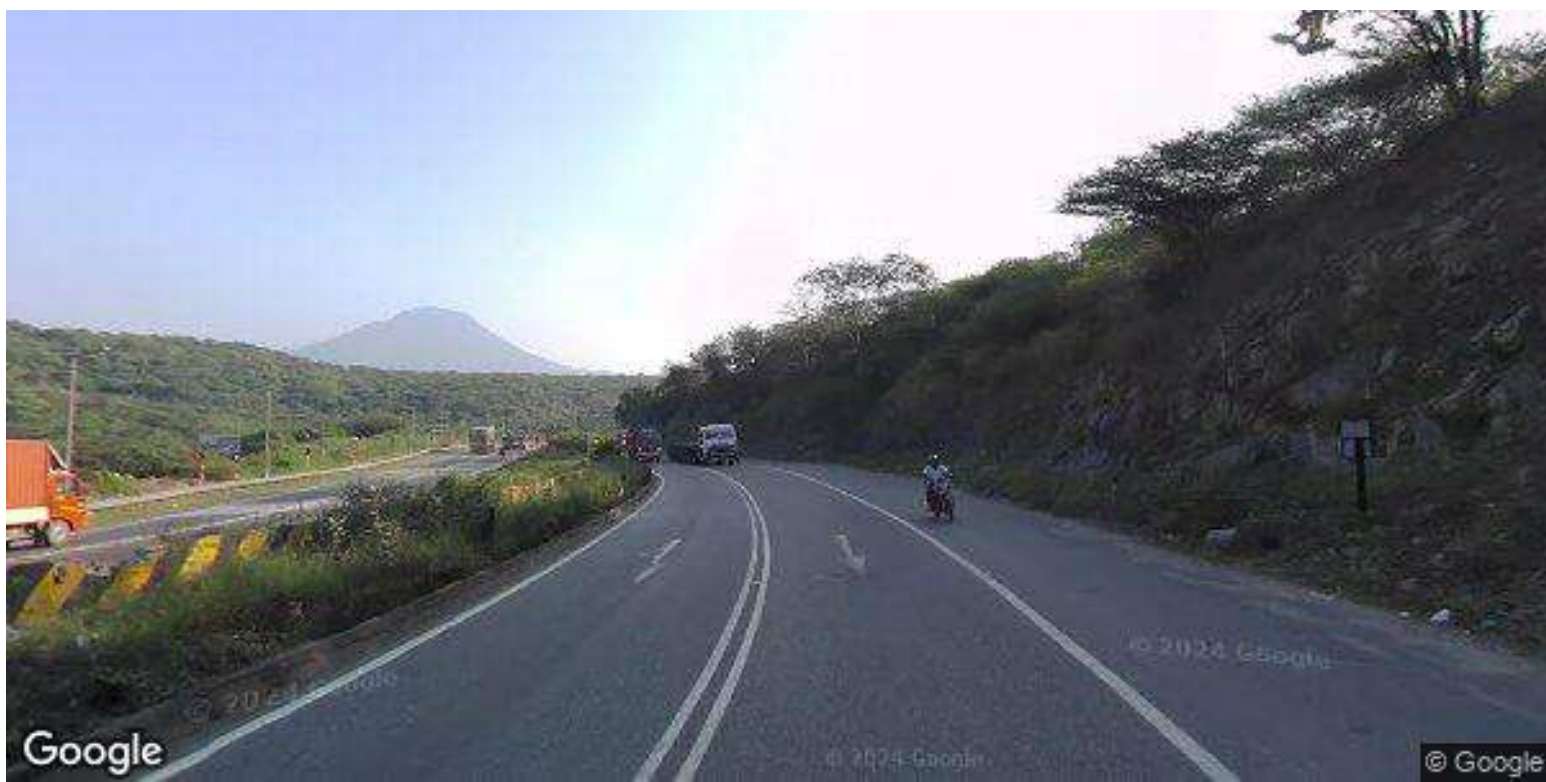
**Coordinates:** 11.96015, 78.04945

**Risk Type:** Turn

**Risk Level:** High

**Speed Limit:** 15 KM/Hr

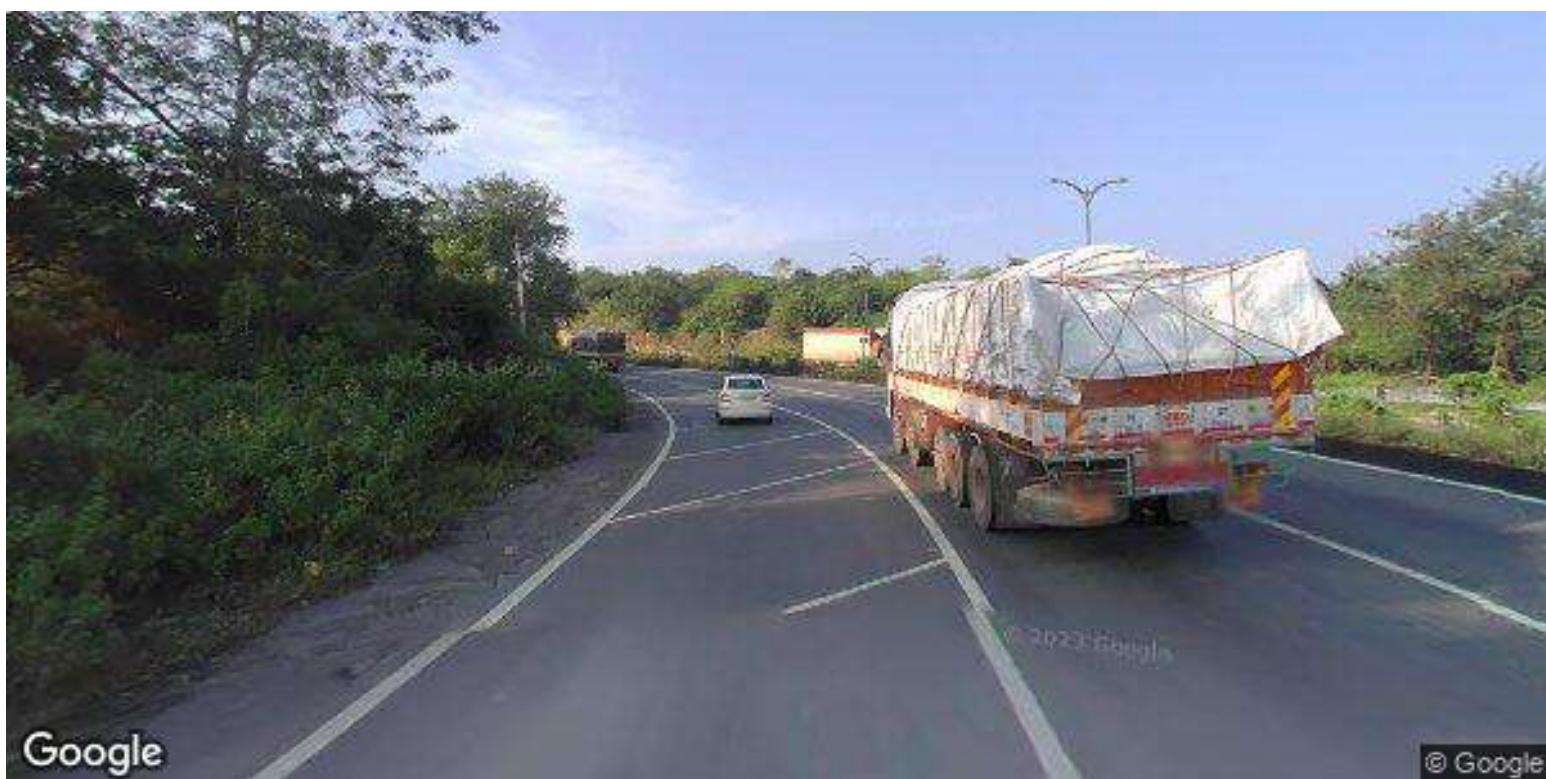
**Coordinates:** 11.96370, 78.05142

**Risk Type:** Turn

**Risk Level:** Medium

**Speed Limit:** 30 KM/Hr

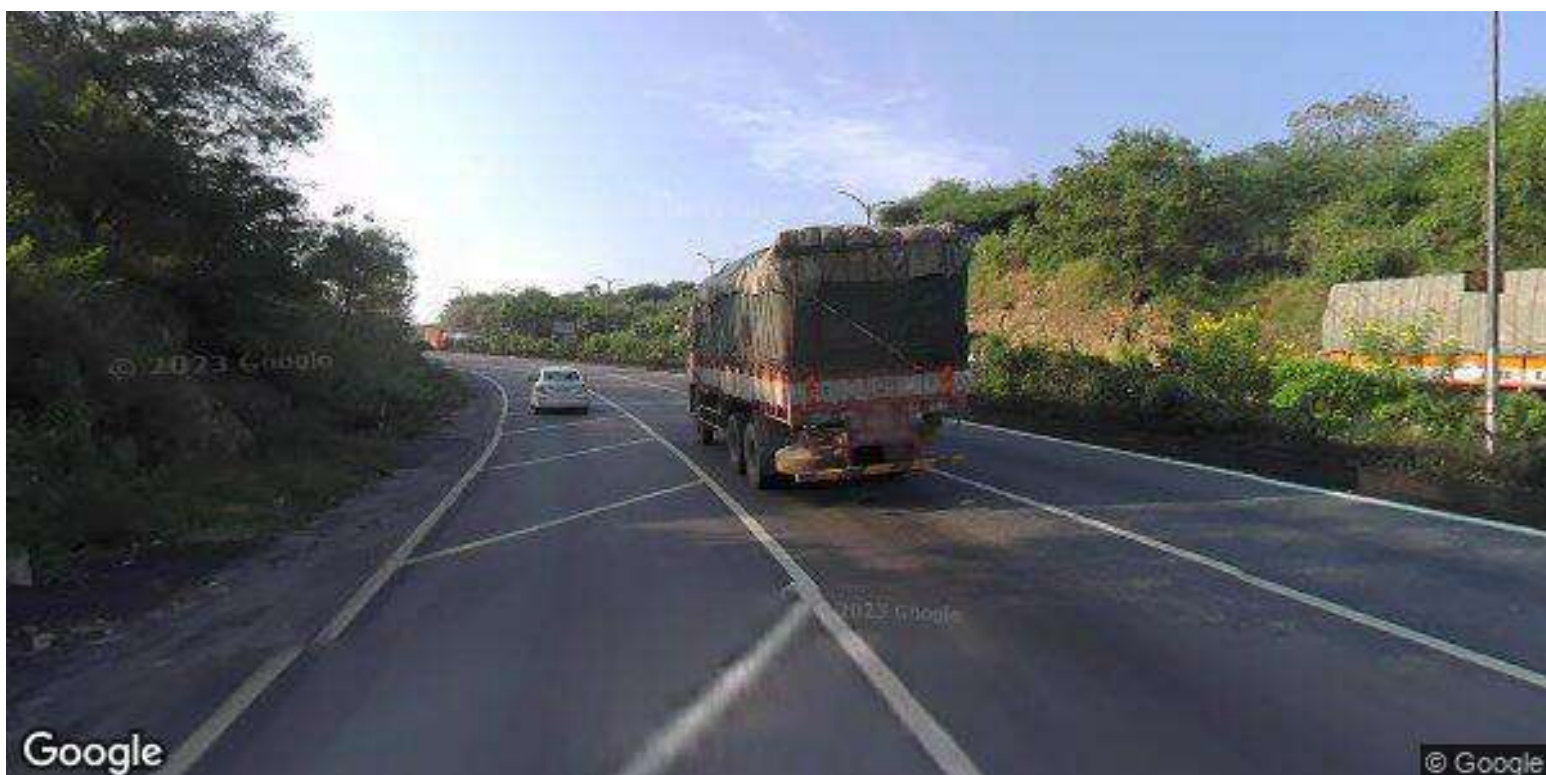
**Risk Type:** Turn  
**Risk Level:** Medium  
**Speed Limit:** 30 KM/Hr  
**Coordinates:** 11.96433, 78.05113

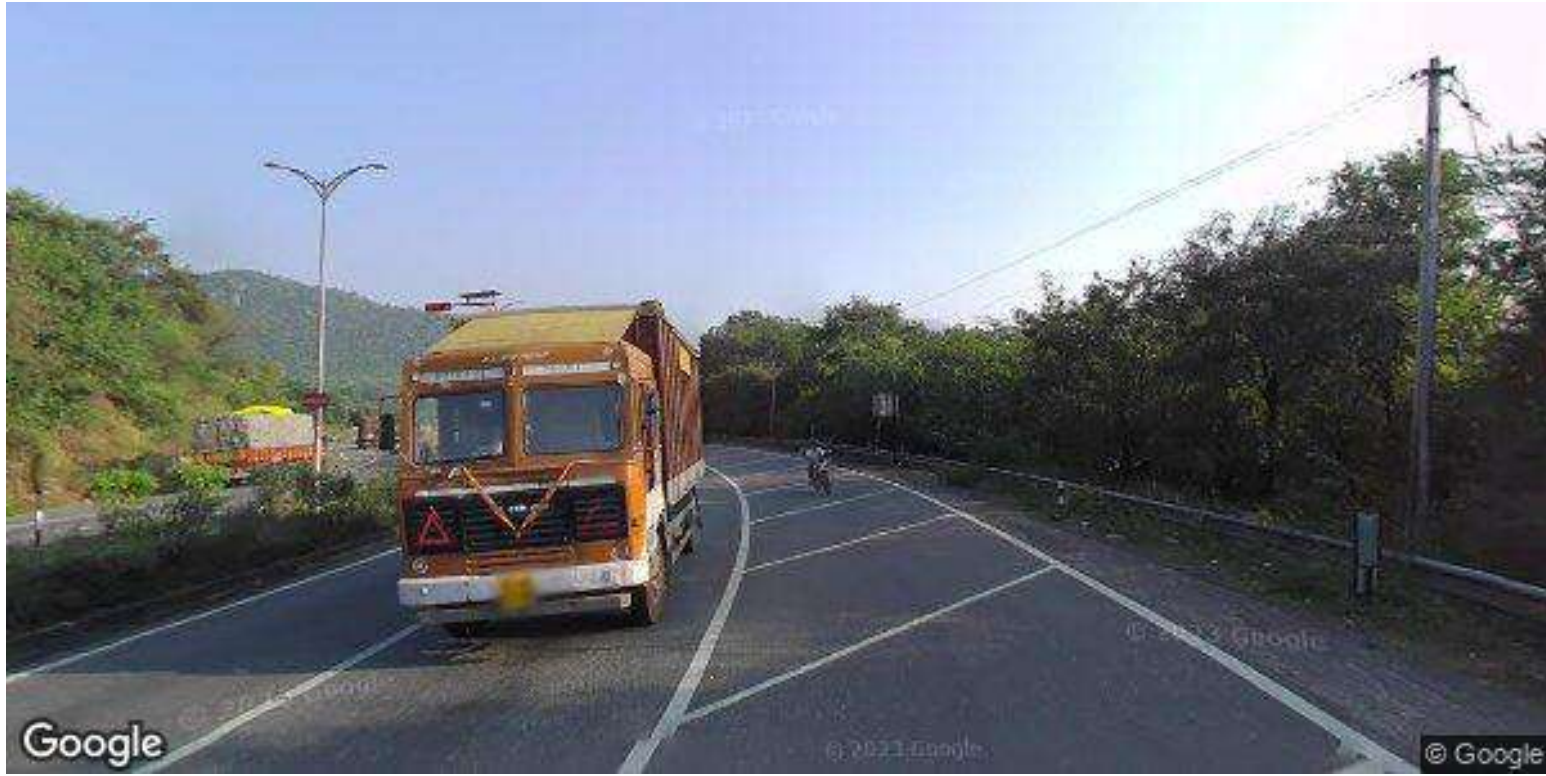
**Risk Type:** Turn  
**Risk Level:** High  
**Speed Limit:** 15 KM/Hr  
**Coordinates:** 11.96542, 78.04938

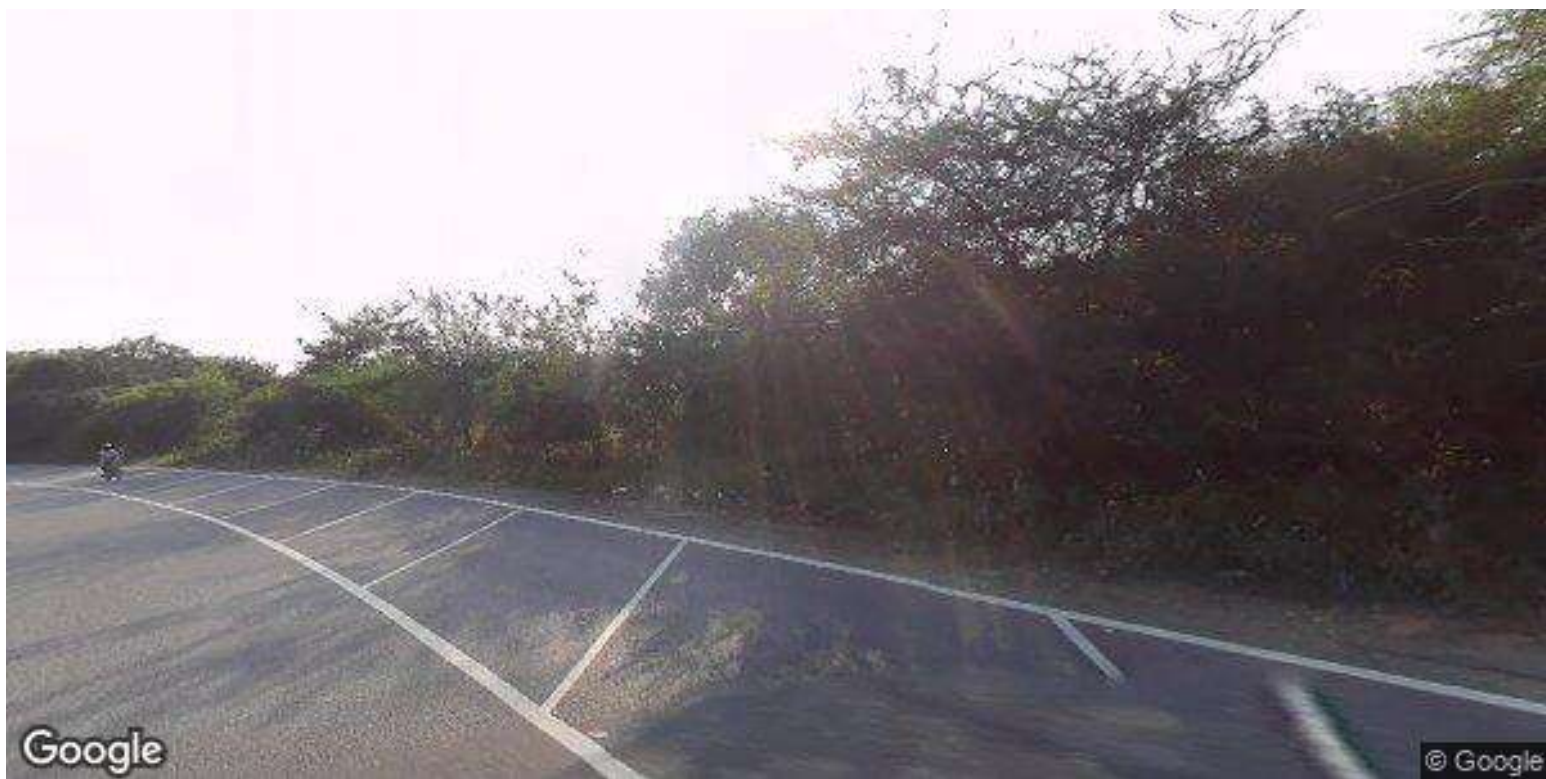
**Risk Type:** Turn  
**Risk Level:** High  
**Speed Limit:** 15 KM/Hr  
**Coordinates:** 11.96650, 78.04927

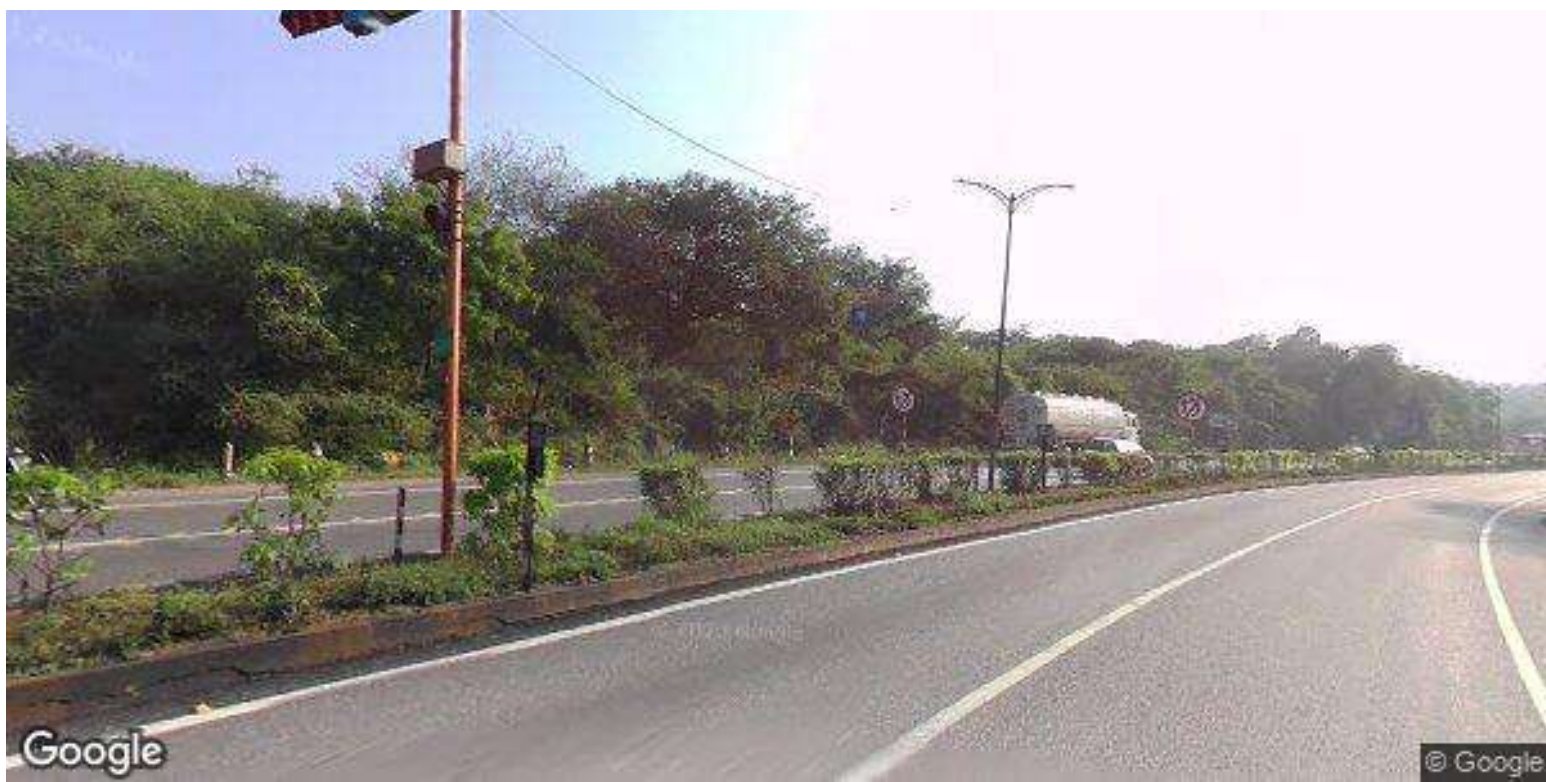
**Coordinates:** 11.96804, 78.05080

**Risk Type:** Turn

**Risk Level:** Medium

**Speed Limit:** 30 KM/Hr

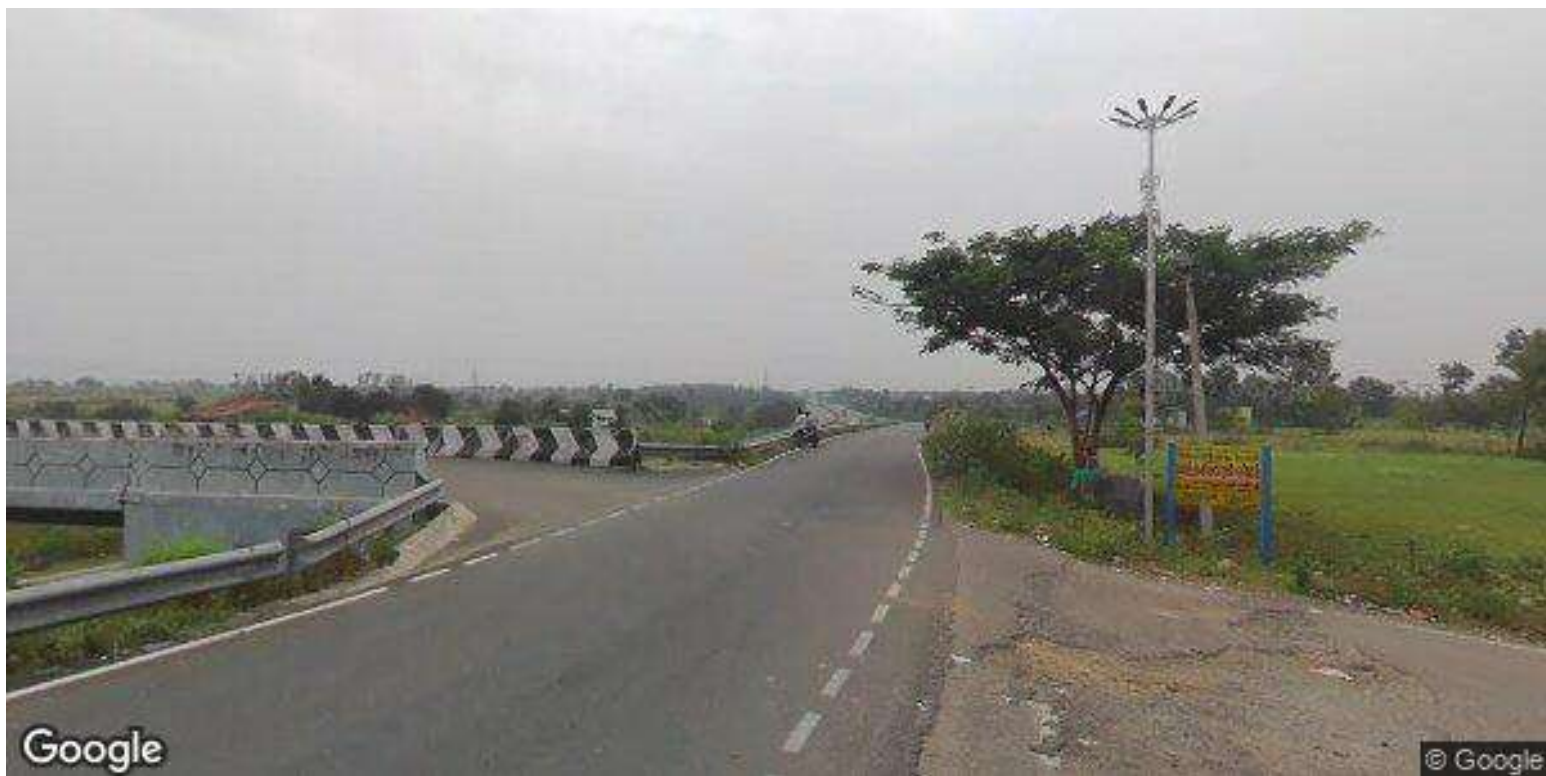
**Coordinates:** 12.09201, 78.11462

**Risk Type:** Blind Spot

**Risk Level:** Blind Spot

**Speed Limit:** 10 KM/Hr

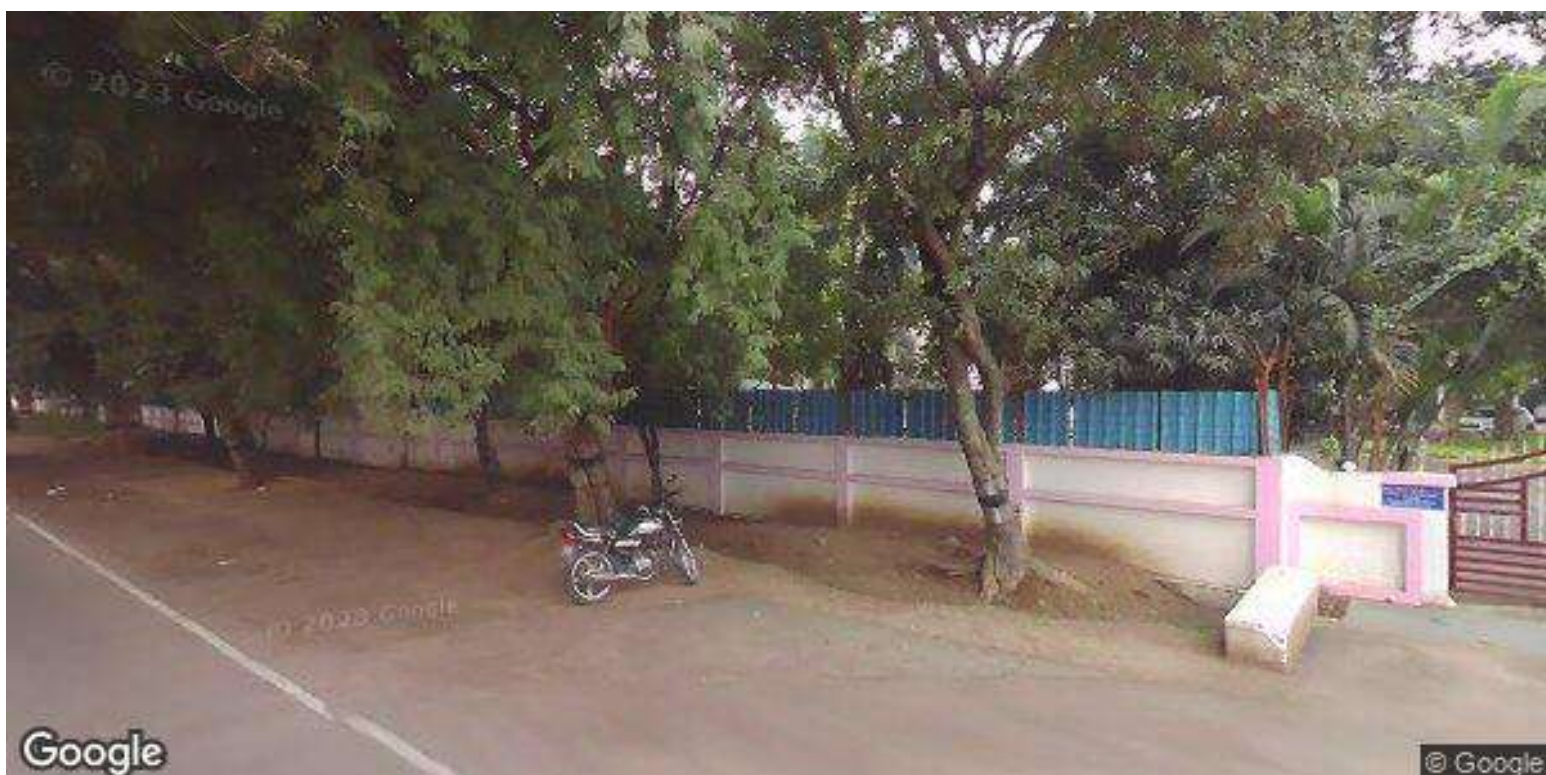
**Risk Type:** Turn  
**Risk Level:** High  
**Speed Limit:** 15 KM/Hr  
**Coordinates:** 12.08762, 78.12236
