# IndianOil

## JOURNEY RISK MANAGEMENT (JRM) STUDY

### Salem Terminal TO VARUN FUEL AGENCY

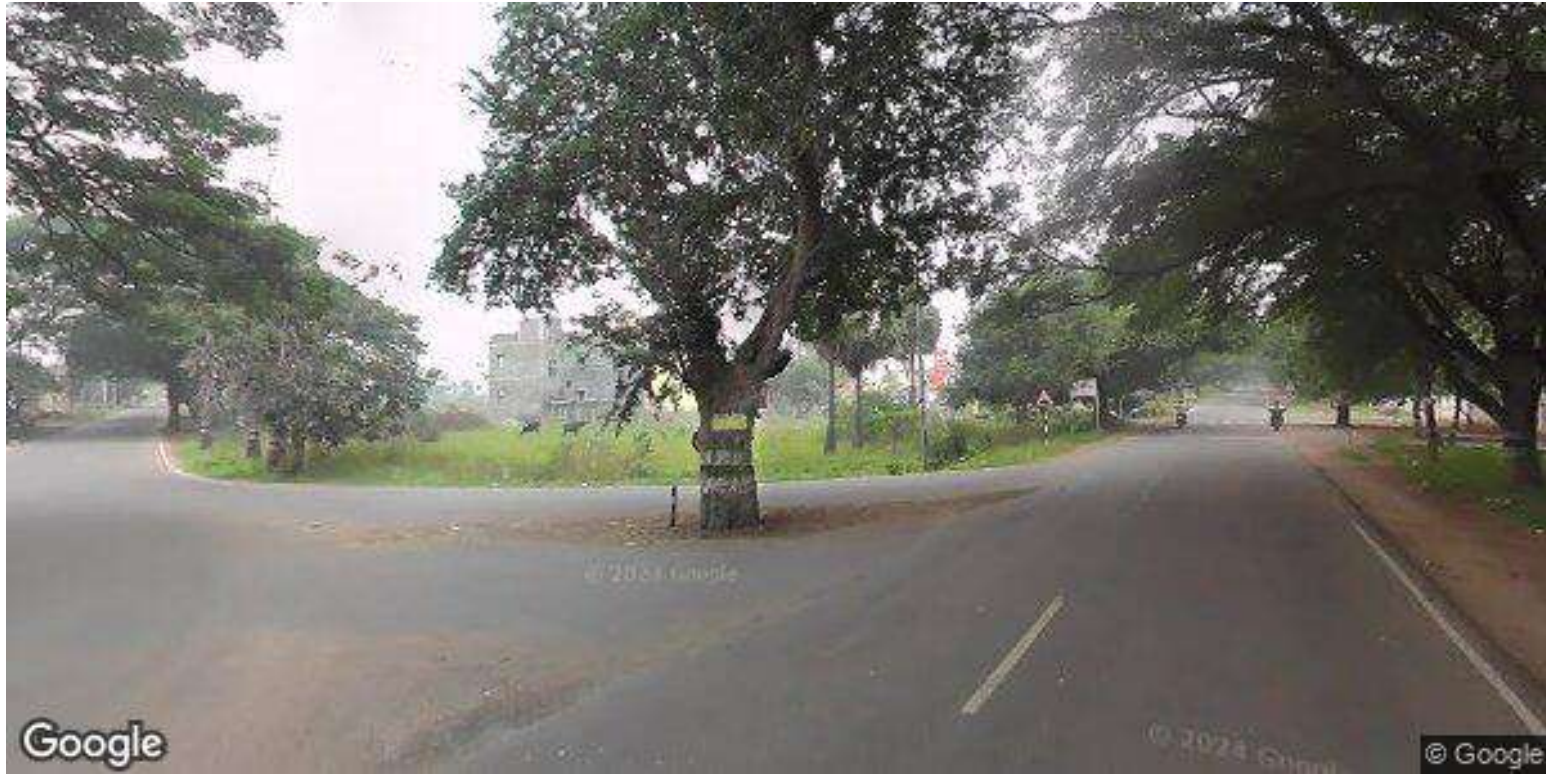
**Risk Type:** Turn  
**Risk Level:** High  
**Speed Limit:** 15 KM/Hr  
**Coordinates:** 12.08688, 78.12234

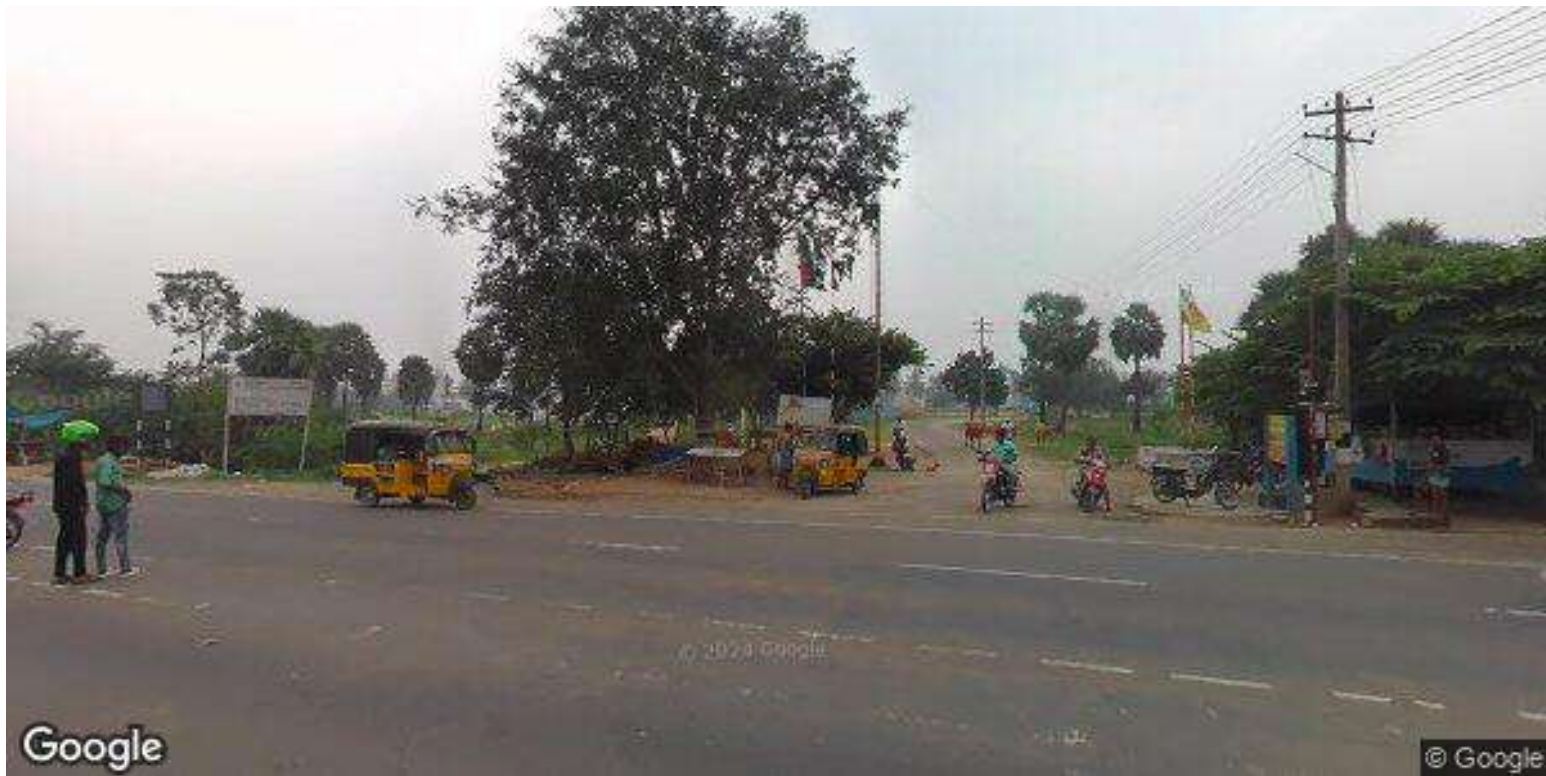
**Risk Type:** Turn  
**Risk Level:** High  
**Speed Limit:** 15 KM/Hr  
**Coordinates:** 12.08464, 78.12765

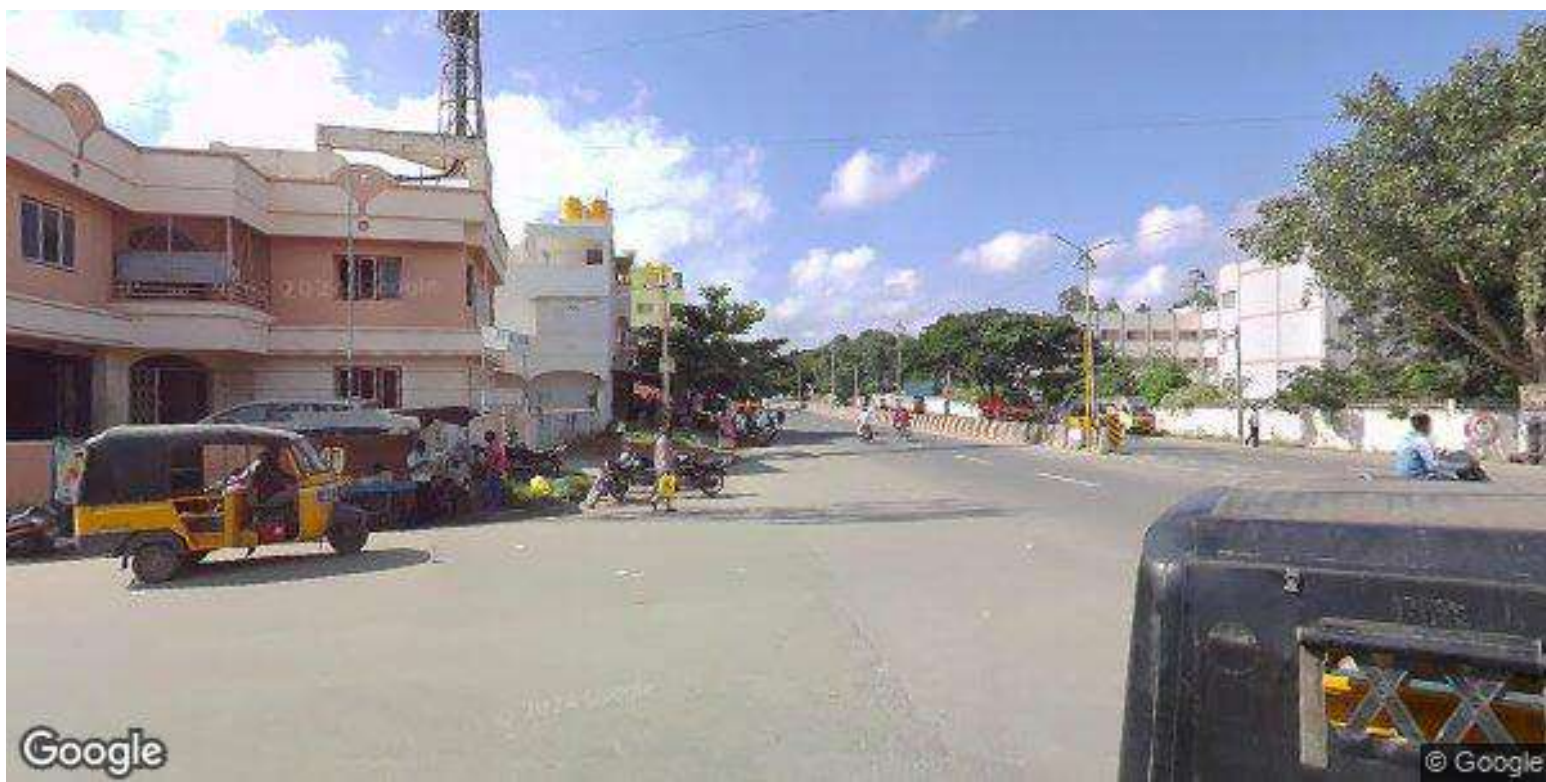
**Coordinates:** 12.10313, 78.14568

**Risk Type:** Turn

**Risk Level:** High

**Speed Limit:** 15 KM/Hr

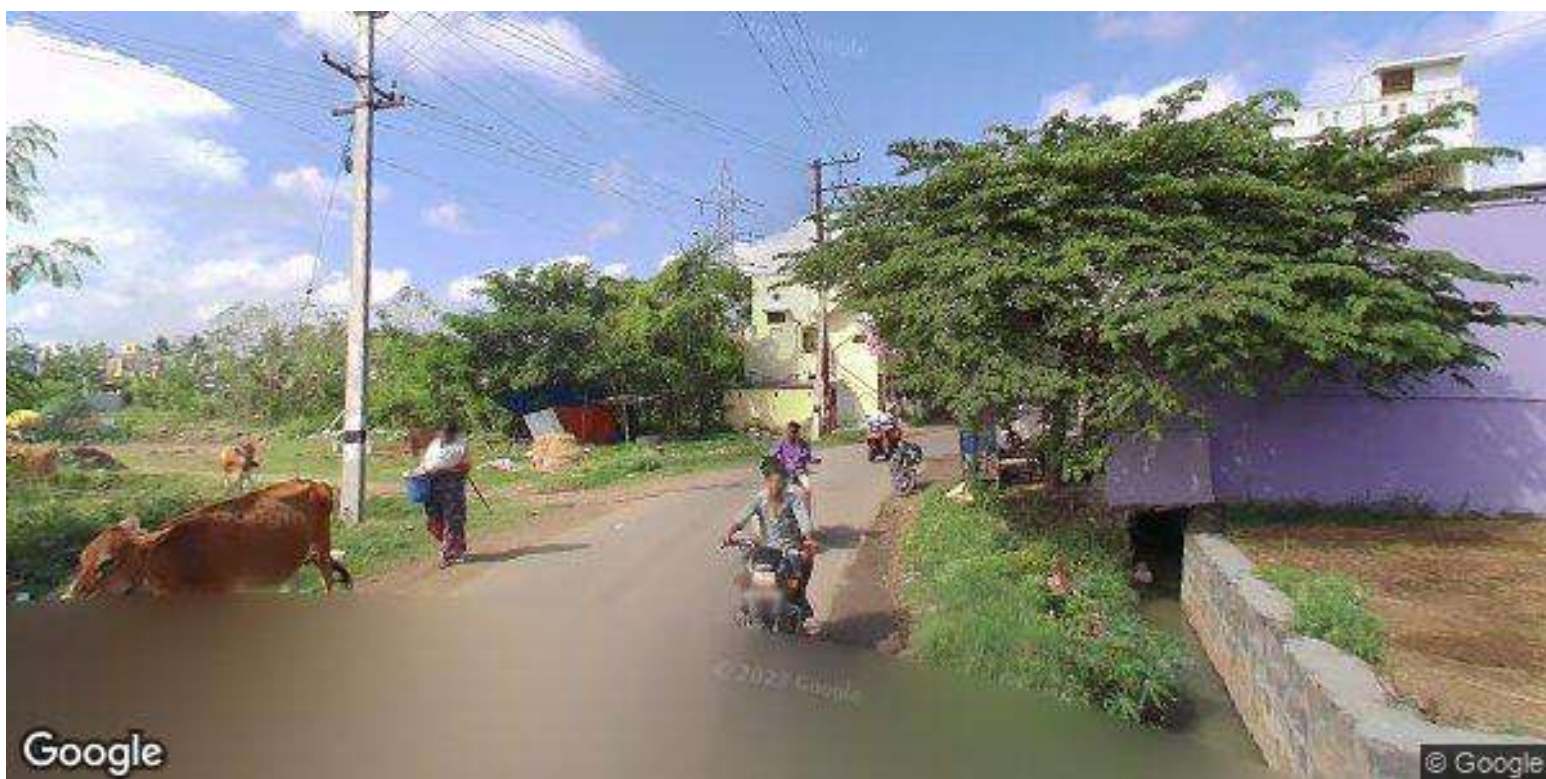
**Coordinates:** 12.10181, 78.14798

**Risk Type:** Turn

**Risk Level:** Medium

**Speed Limit:** 30 KM/Hr

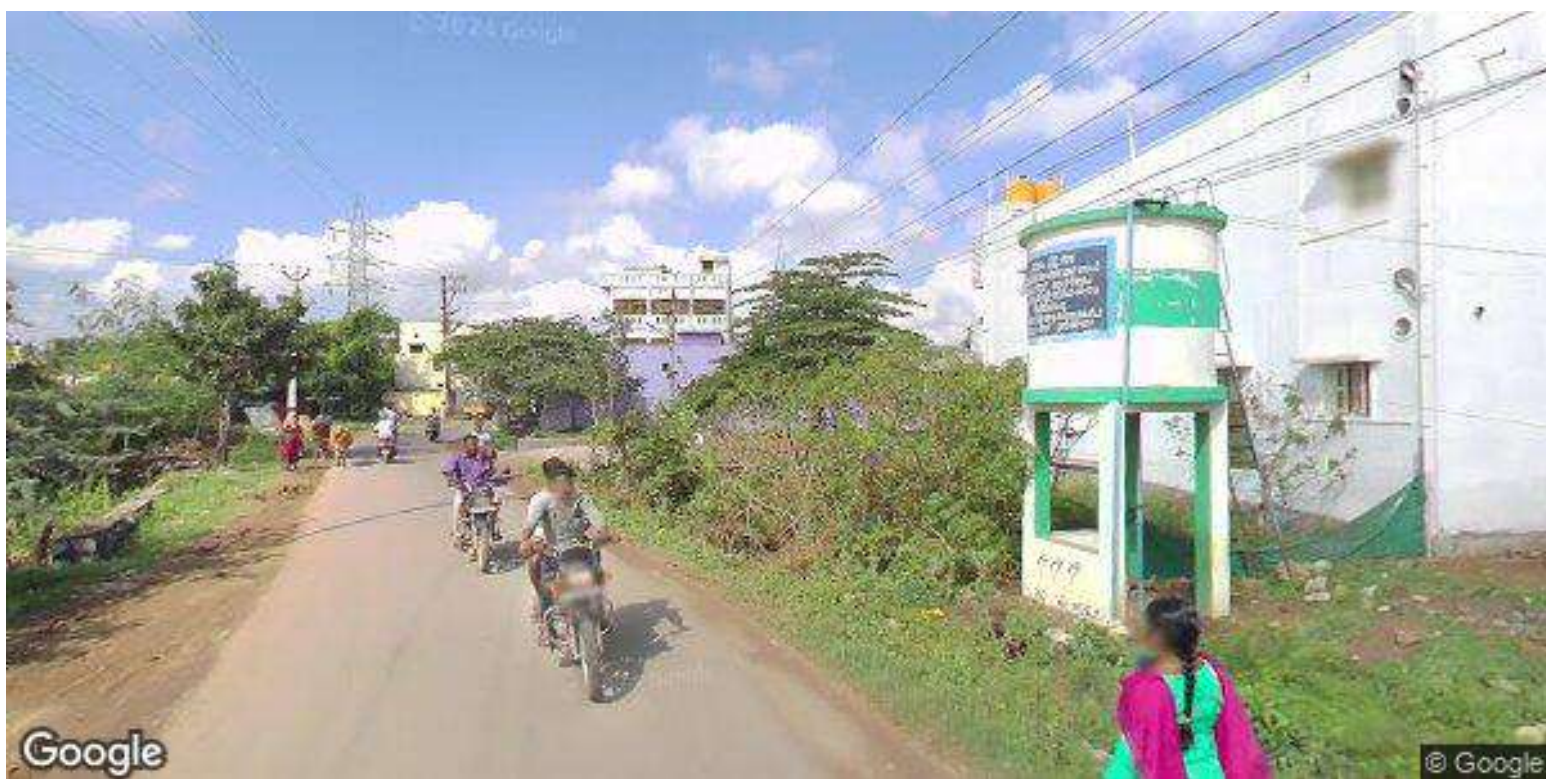
**Risk Type:** Turn  
**Risk Level:** High  
**Speed Limit:** 15 KM/Hr  
**Coordinates:** 12.10183, 78.14823

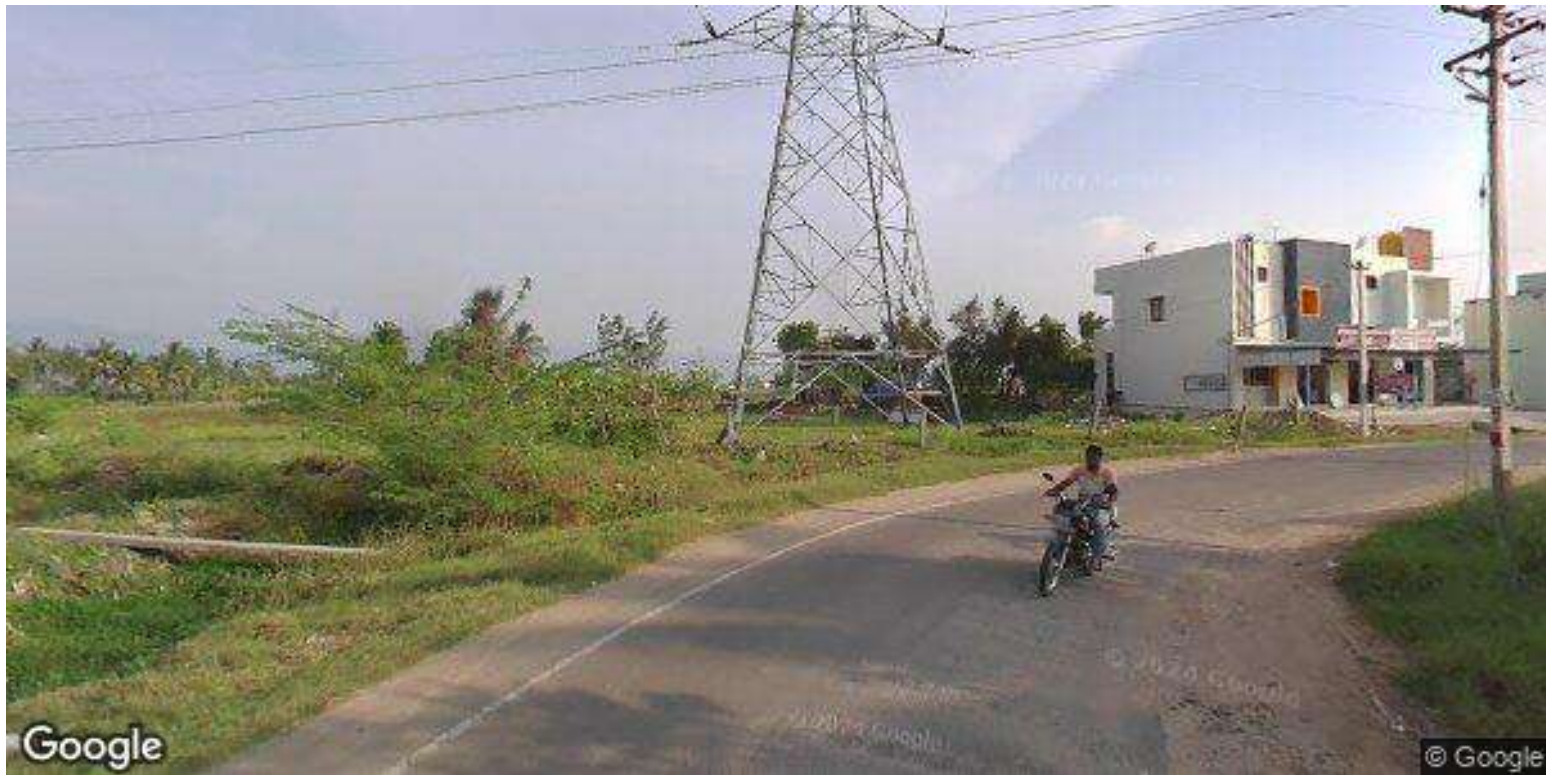
**Risk Type:** Turn  
**Risk Level:** High  
**Speed Limit:** 15 KM/Hr  
**Coordinates:** 12.09968, 78.14988

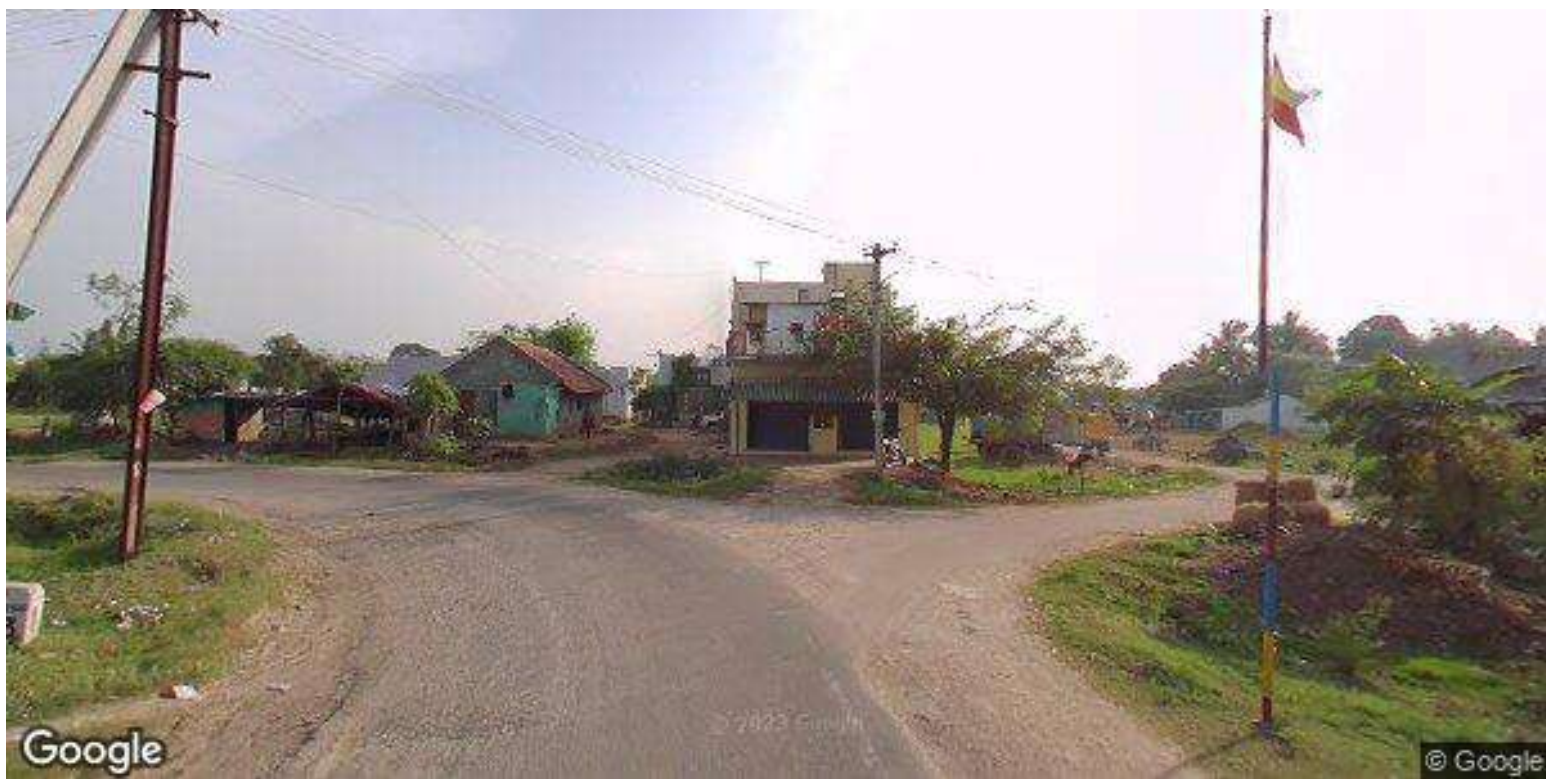
**Risk Type:** Turn  
**Risk Level:** High  
**Speed Limit:** 15 KM/Hr  
**Coordinates:** 12.09652, 78.14894

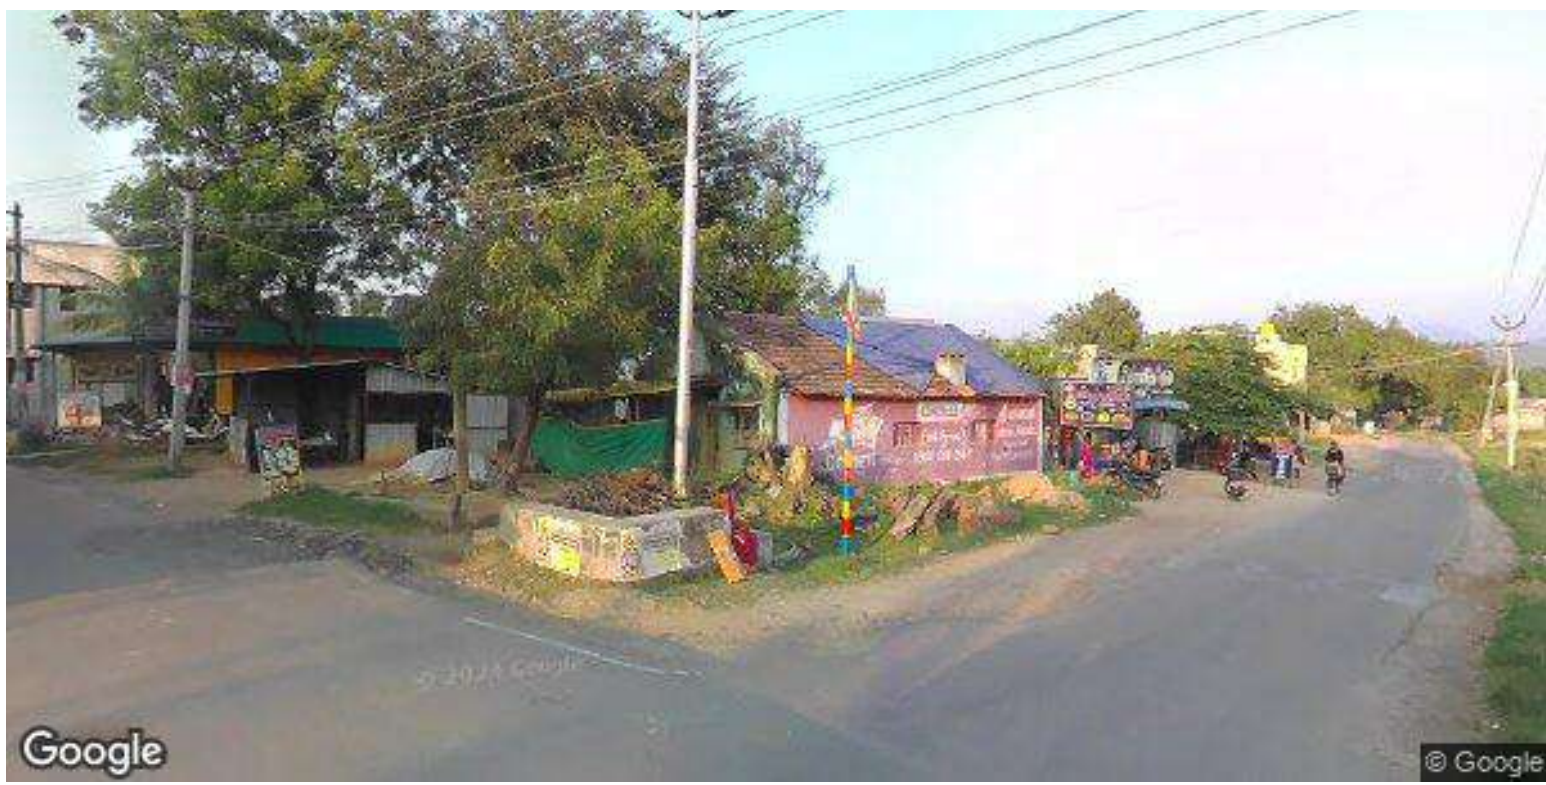
**Coordinates:** 12.09165, 78.16520

**Risk Type:** Blind Spot

**Risk Level:** Blind Spot

**Speed Limit:** 10 KM/Hr

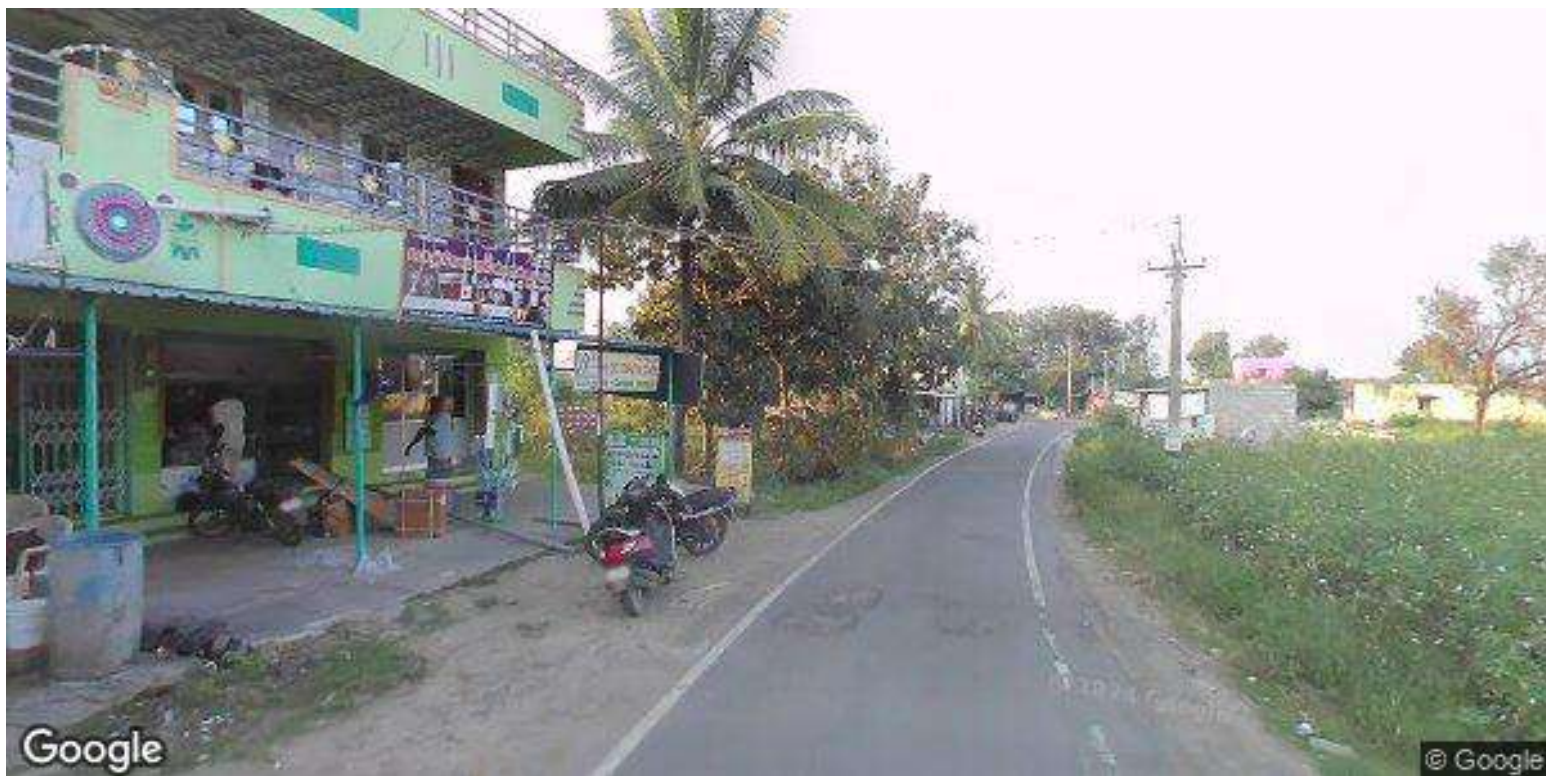
**Coordinates:** 12.09093, 78.16513

**Risk Type:** Turn

**Risk Level:** Medium

**Speed Limit:** 30 KM/Hr
