## JOURNEY RISK MANAGEMENT (JRM) STUDY

### Salem Terminal TO SRI STAR AGENCIES

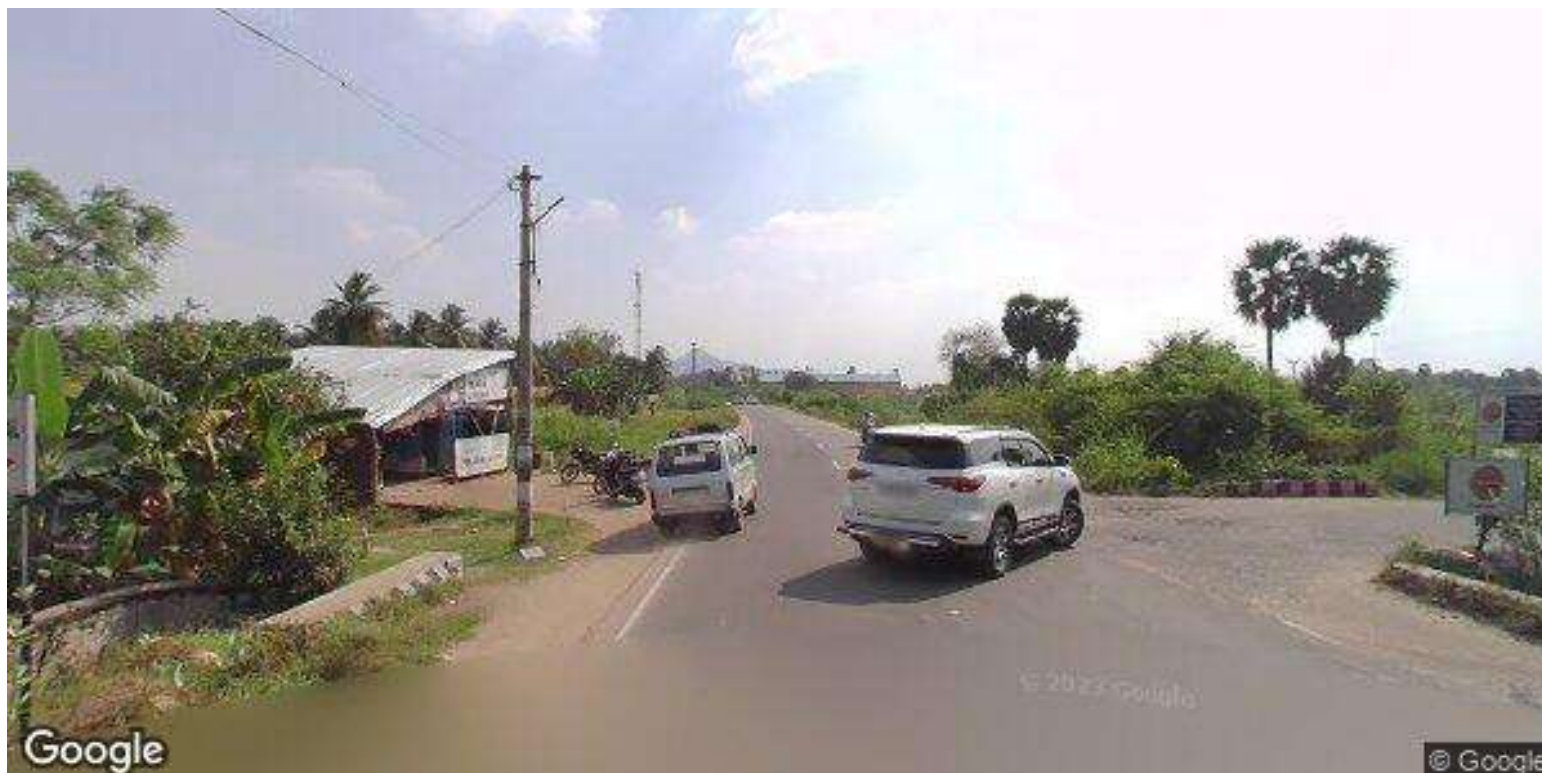
**Coordinates:** 11.44029, 77.87544

**Risk Type:** Turn

**Risk Level:** High

**Speed Limit:** 15 KM/Hr

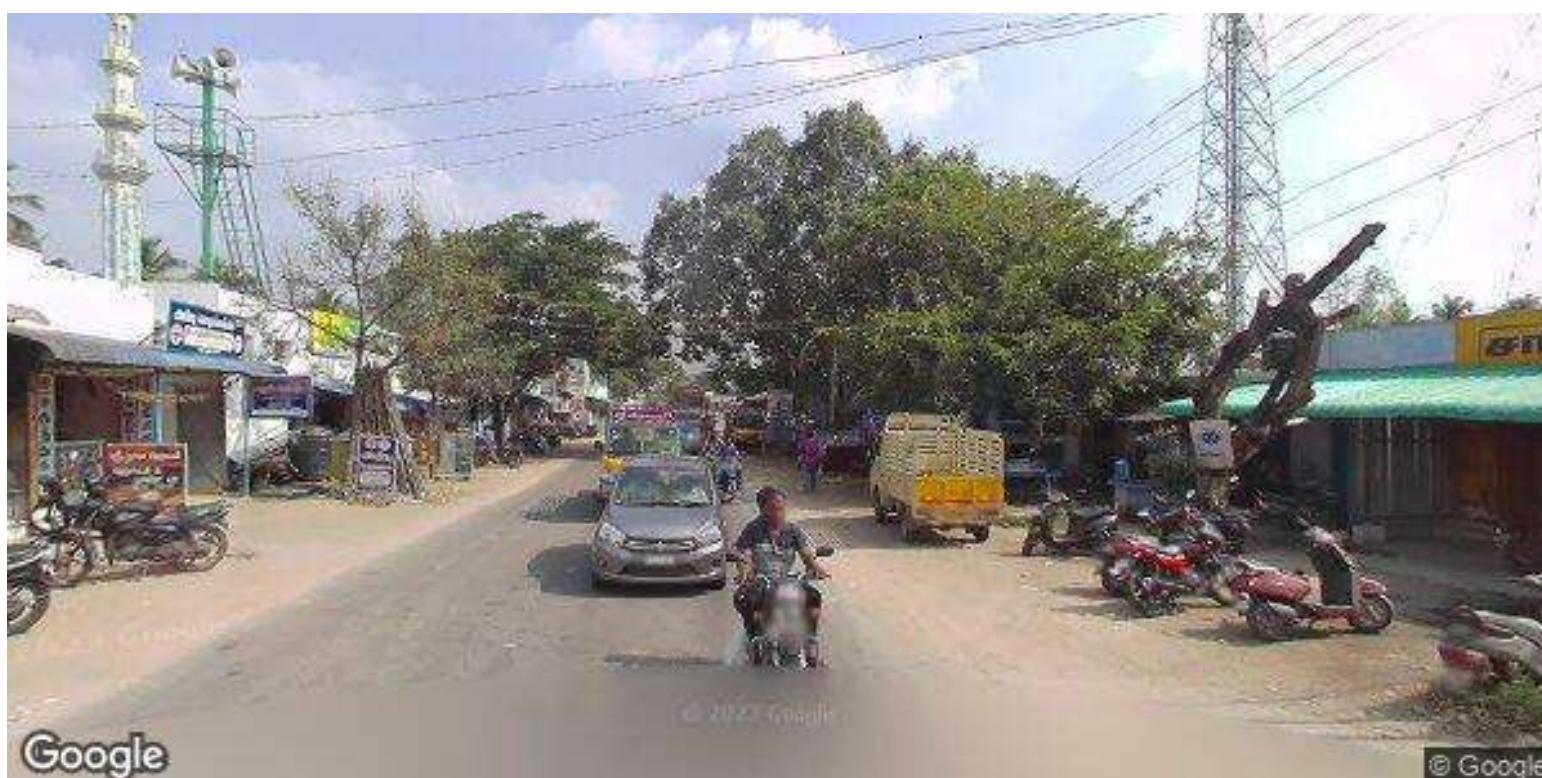
**Coordinates:** 11.44958, 77.87296

**Risk Type:** Blind Spot

**Risk Level:** Blind Spot

**Speed Limit:** 10 KM/Hr

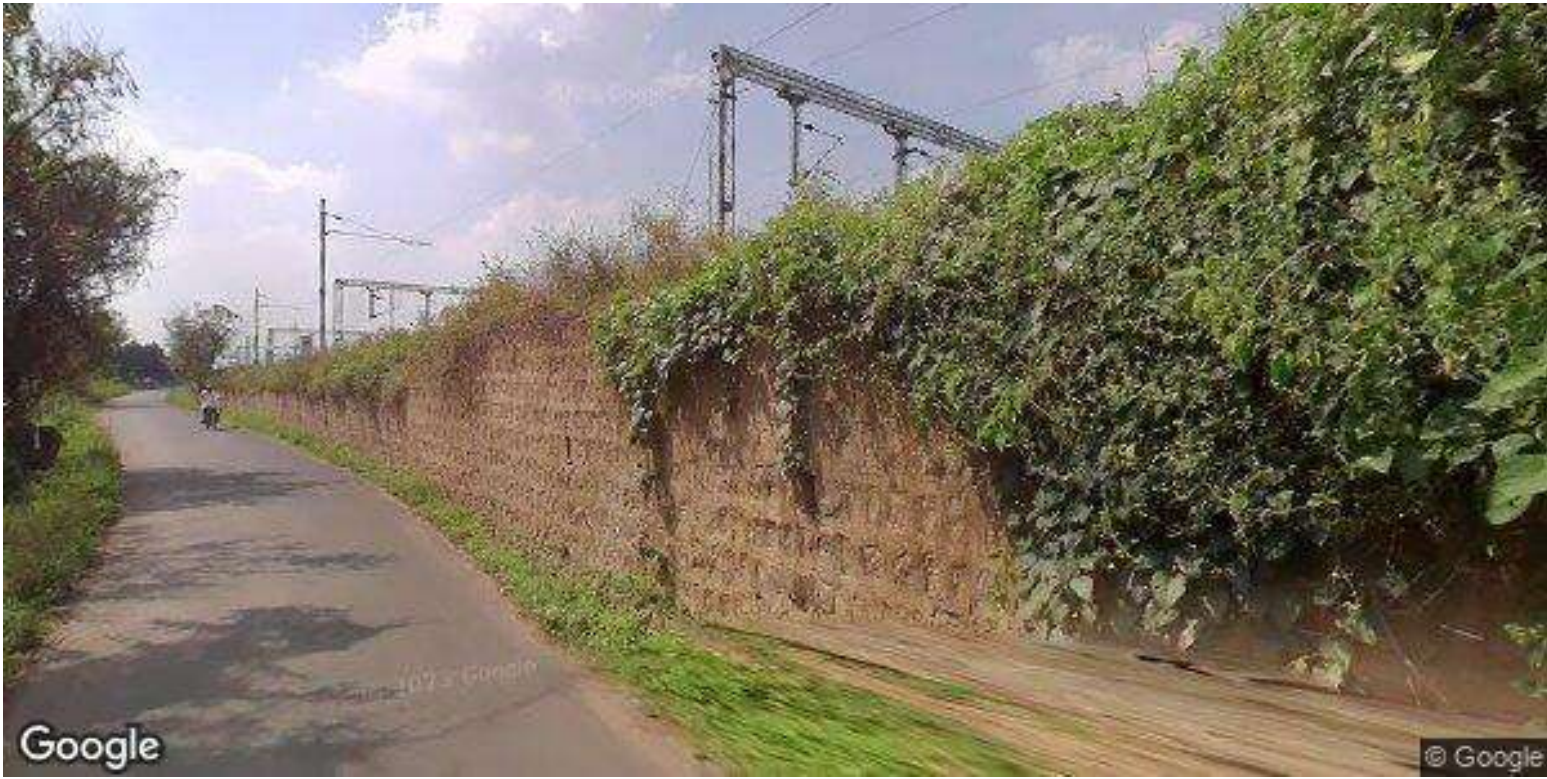
**Risk Type:** Turn  
**Risk Level:** Medium  
**Speed Limit:** 30 KM/Hr  
**Coordinates:** 11.44561, 77.87070

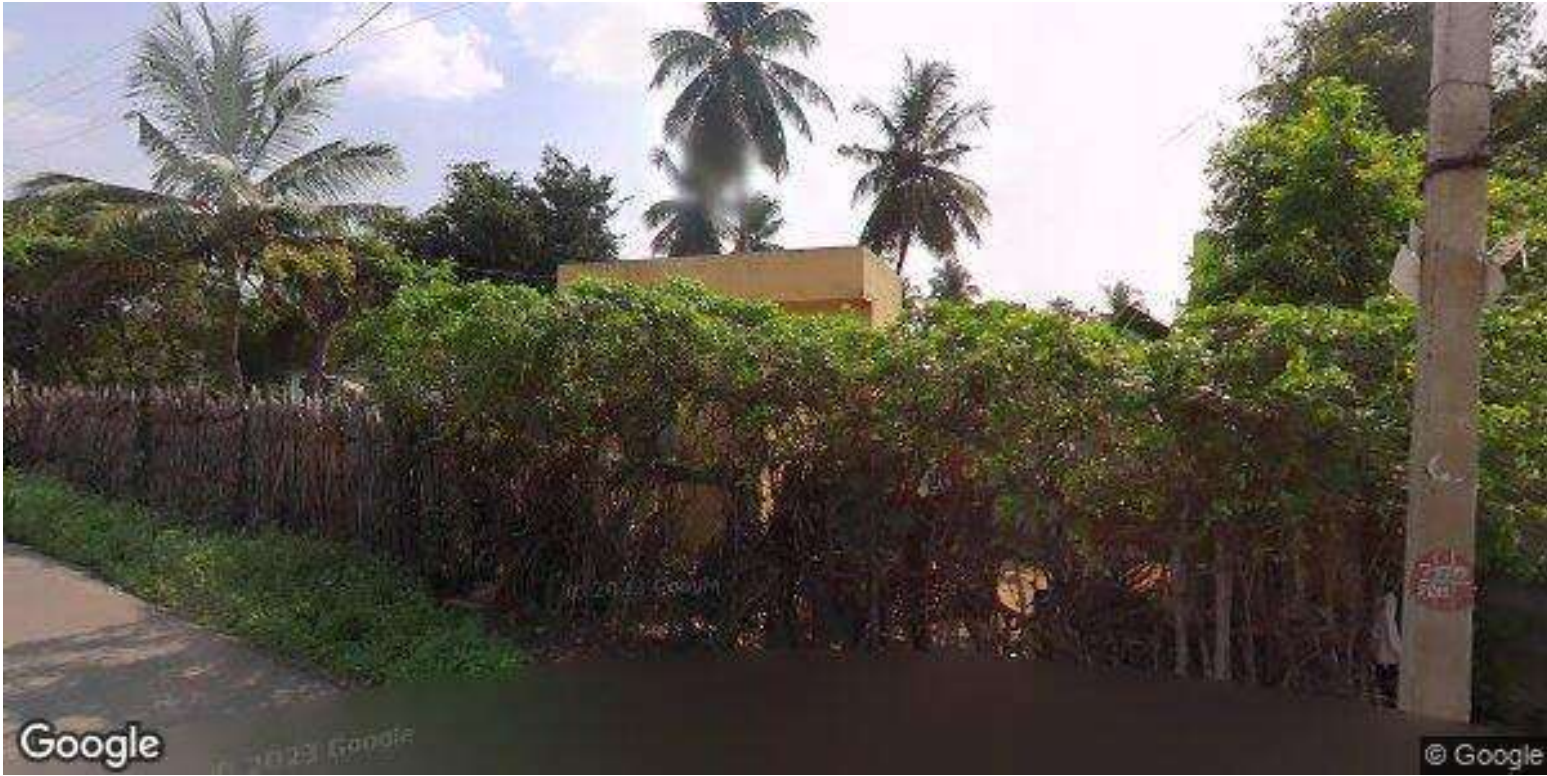
**Risk Type:** Blind Spot  
**Risk Level:** Blind Spot  
**Speed Limit:** 10 KM/Hr  
**Coordinates:** 11.43502, 77.86063

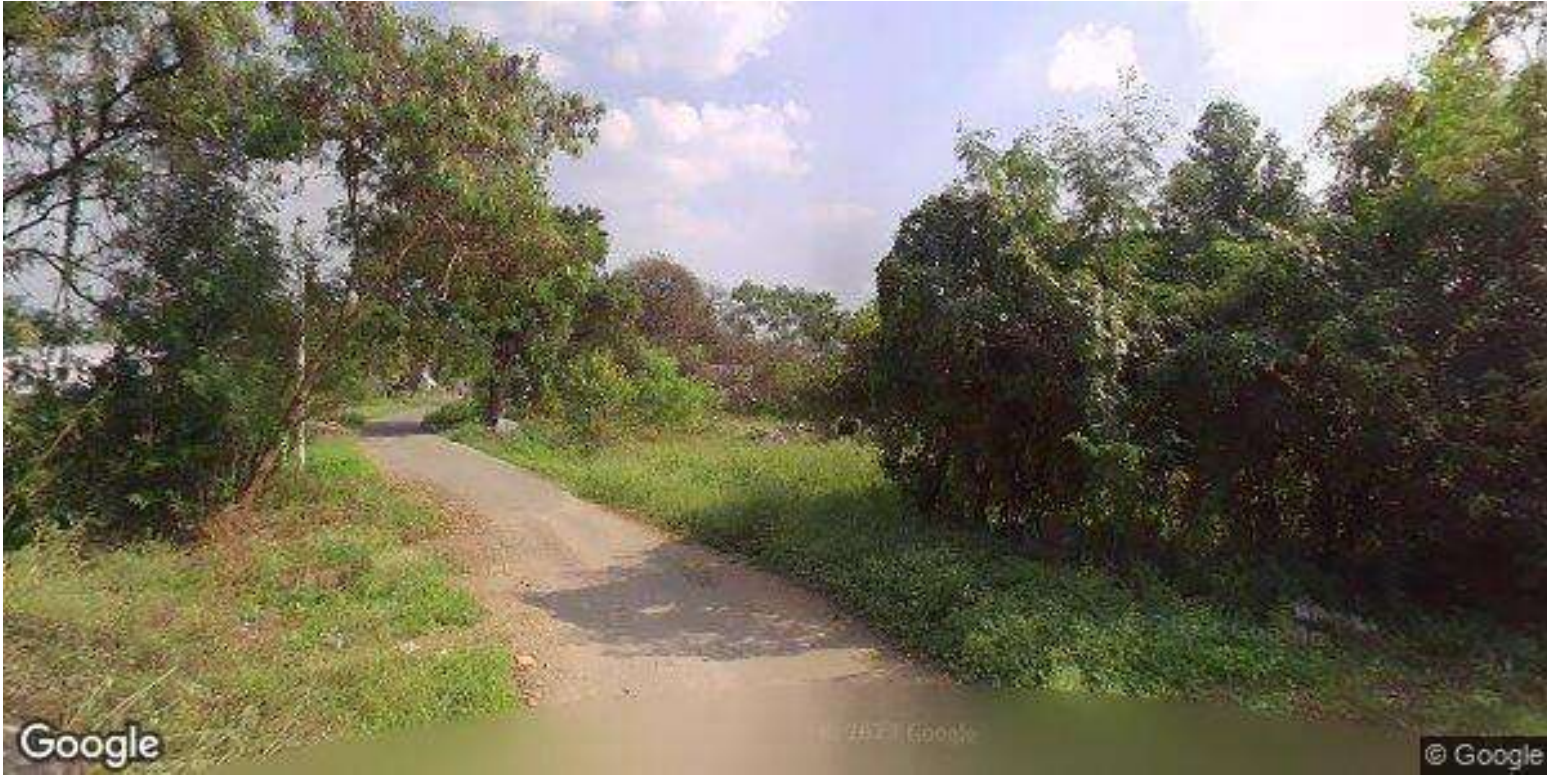
**Risk Type:** Turn  
**Risk Level:** Medium  
**Speed Limit:** 30 KM/Hr  
**Coordinates:** 11.43535, 77.85967

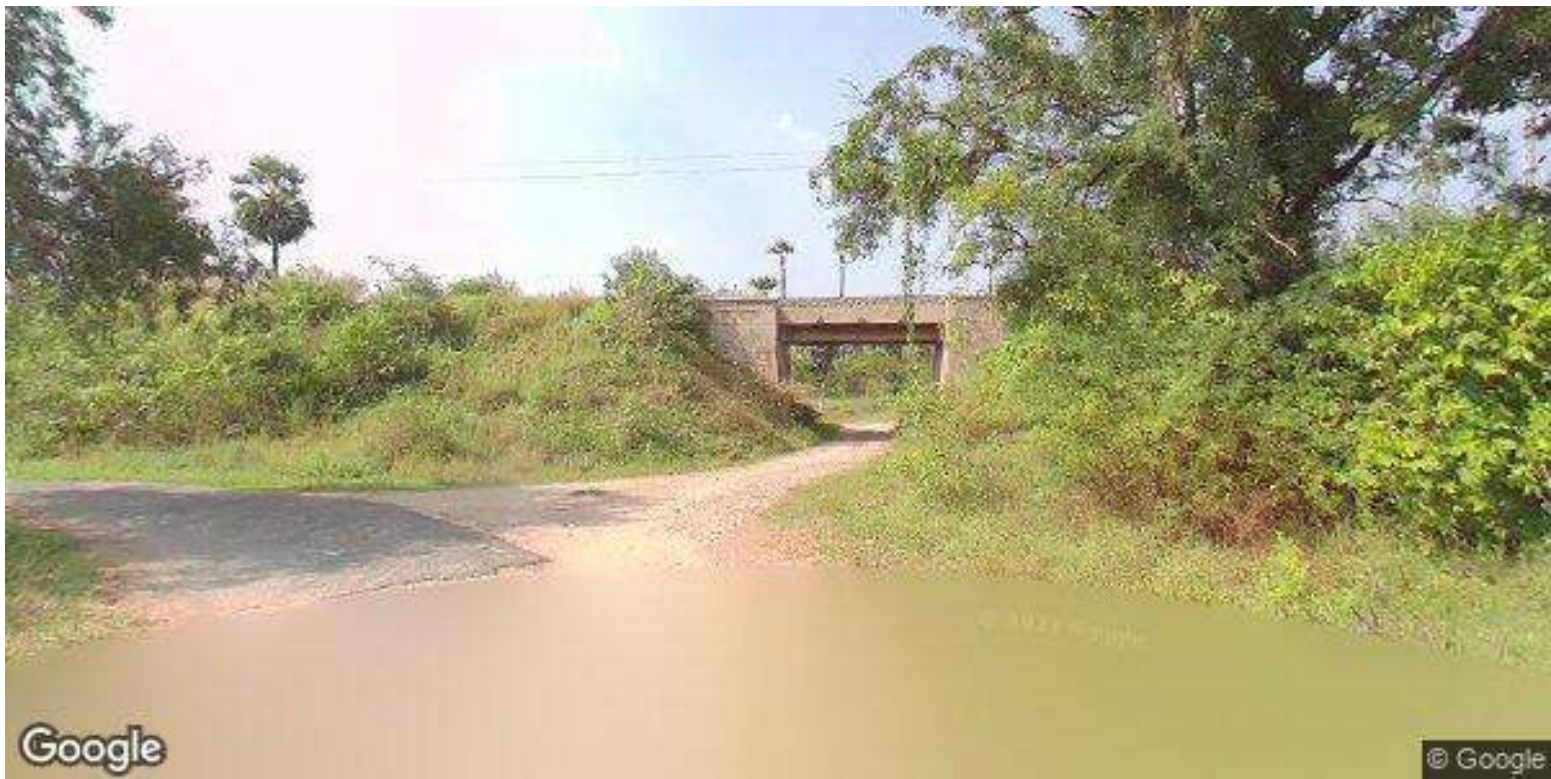
**Risk Type:** Turn  
**Risk Level:** Medium  
**Speed Limit:** 30 KM/Hr  
**Coordinates:** 11.43548, 77.85957

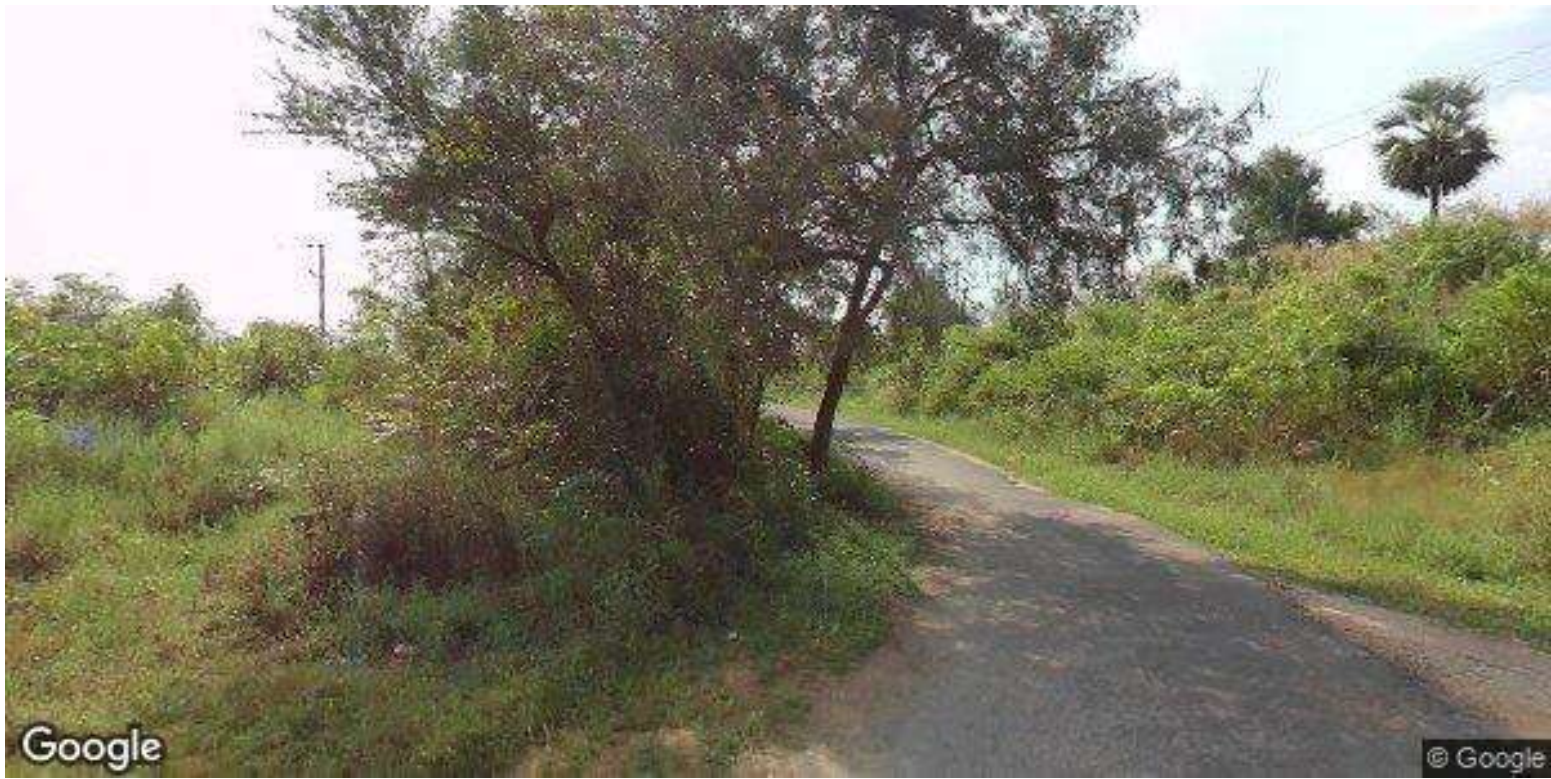
**Risk Type:** Turn  
**Risk Level:** Medium  
**Speed Limit:** 30 KM/Hr  
**Coordinates:** 11.43551, 77.85951

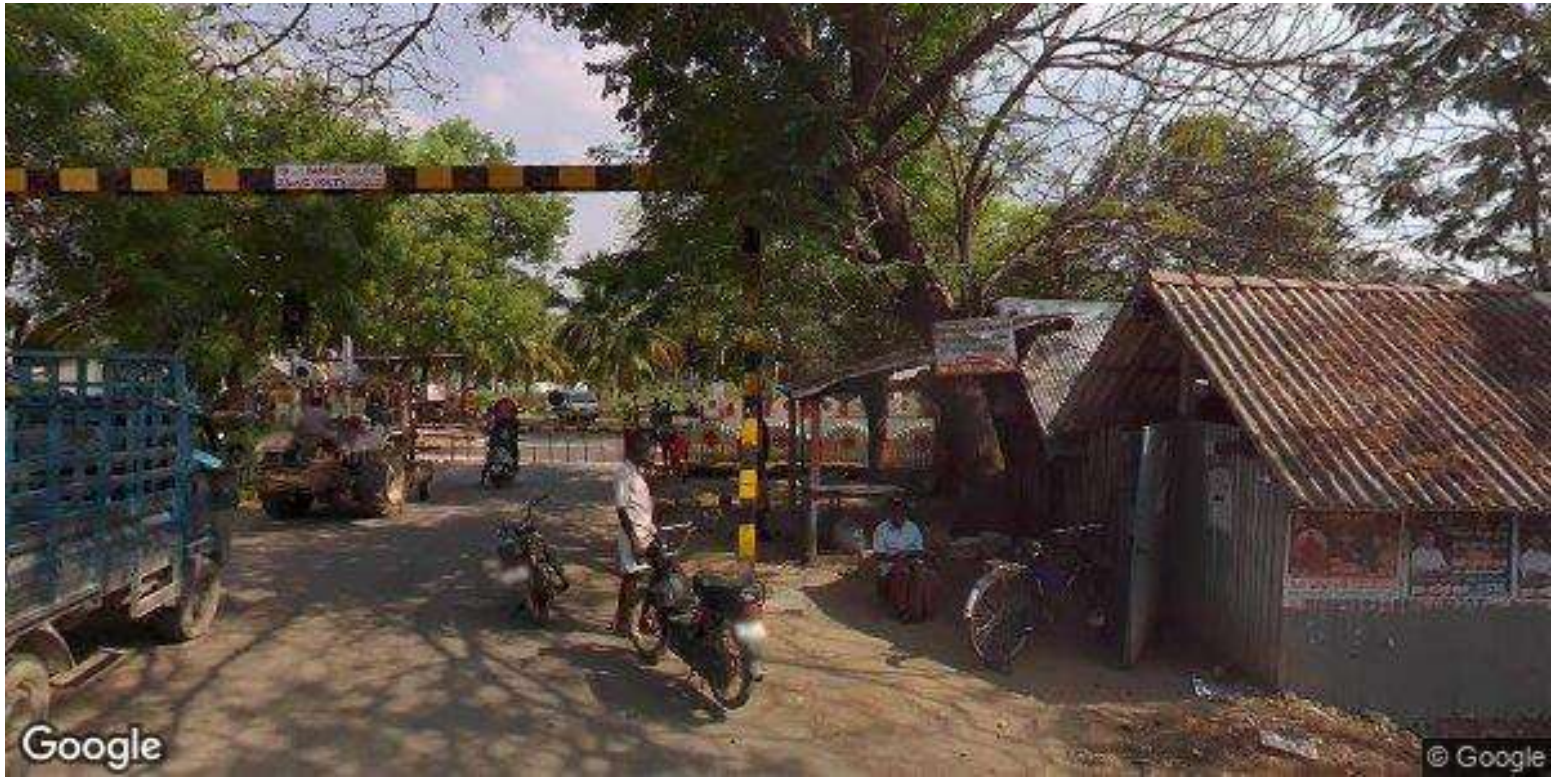
Coordinates: 11.41960, 77.84301

Risk Type: Turn

Risk Level: High

Speed Limit: 15 KM/Hr
