# IndianOil

## JOURNEY RISK MANAGEMENT (JRM) STUDY

### Salem Terminal to SHRI AMARAVATHI FUELS

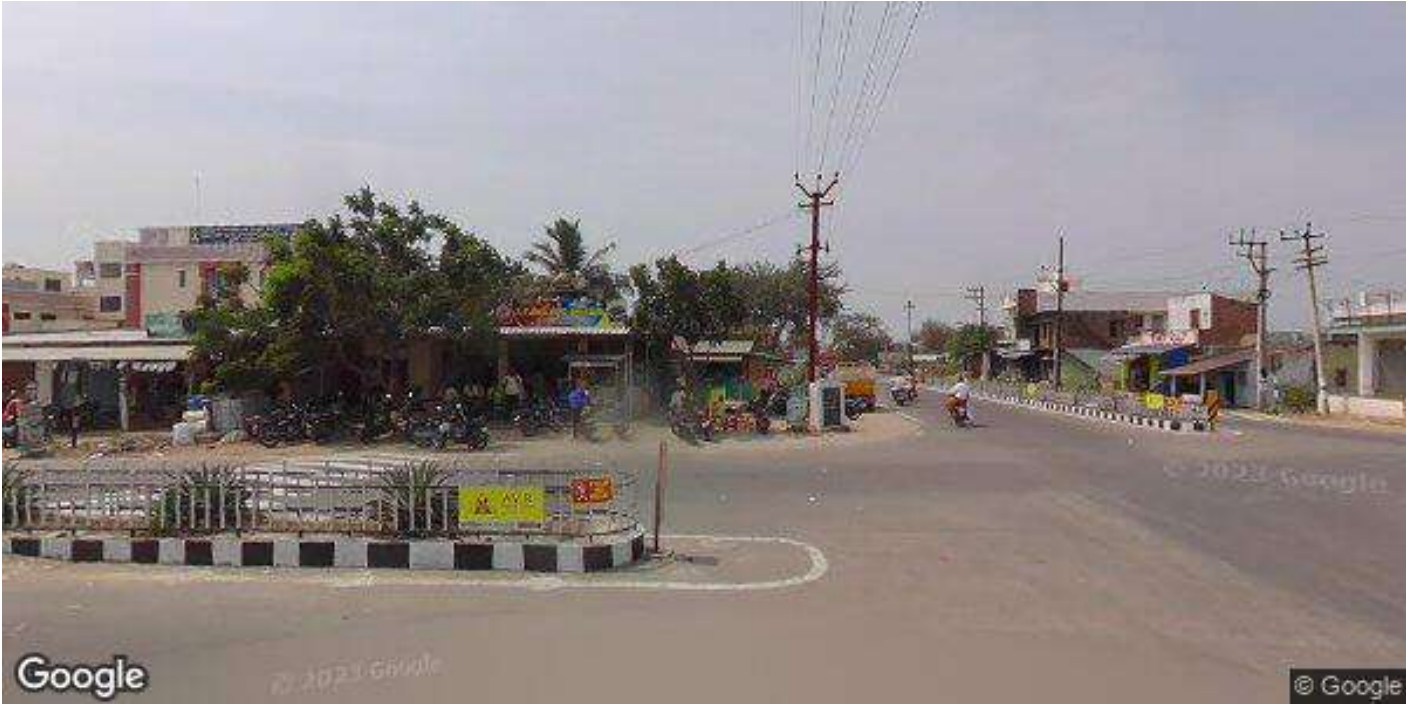
Coordinates: 11.58300, 77.85813

Risk Type: Roundabout

Risk Level: High

Speed Limit: 15 KM/Hr

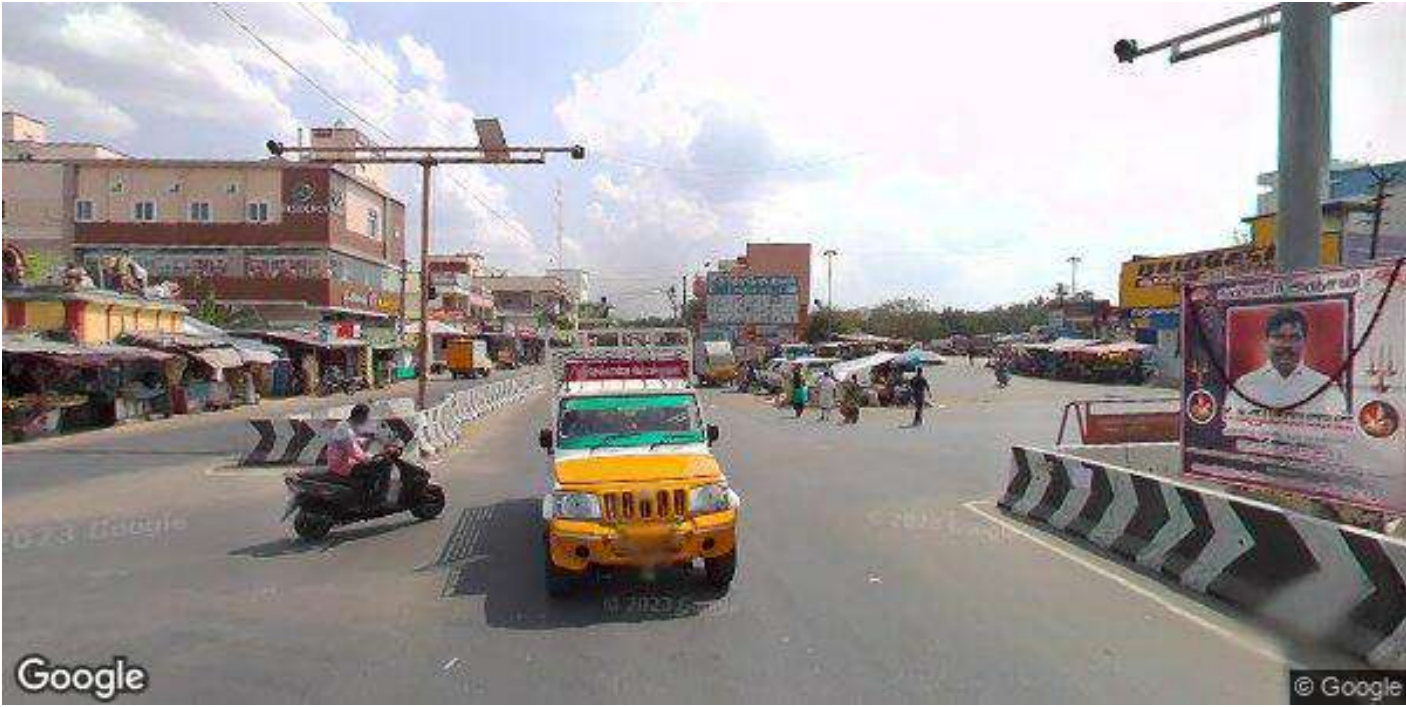
Coordinates: 11.57045, 77.90222

Risk Type: Roundabout

Risk Level: High

Speed Limit: 15 KM/Hr

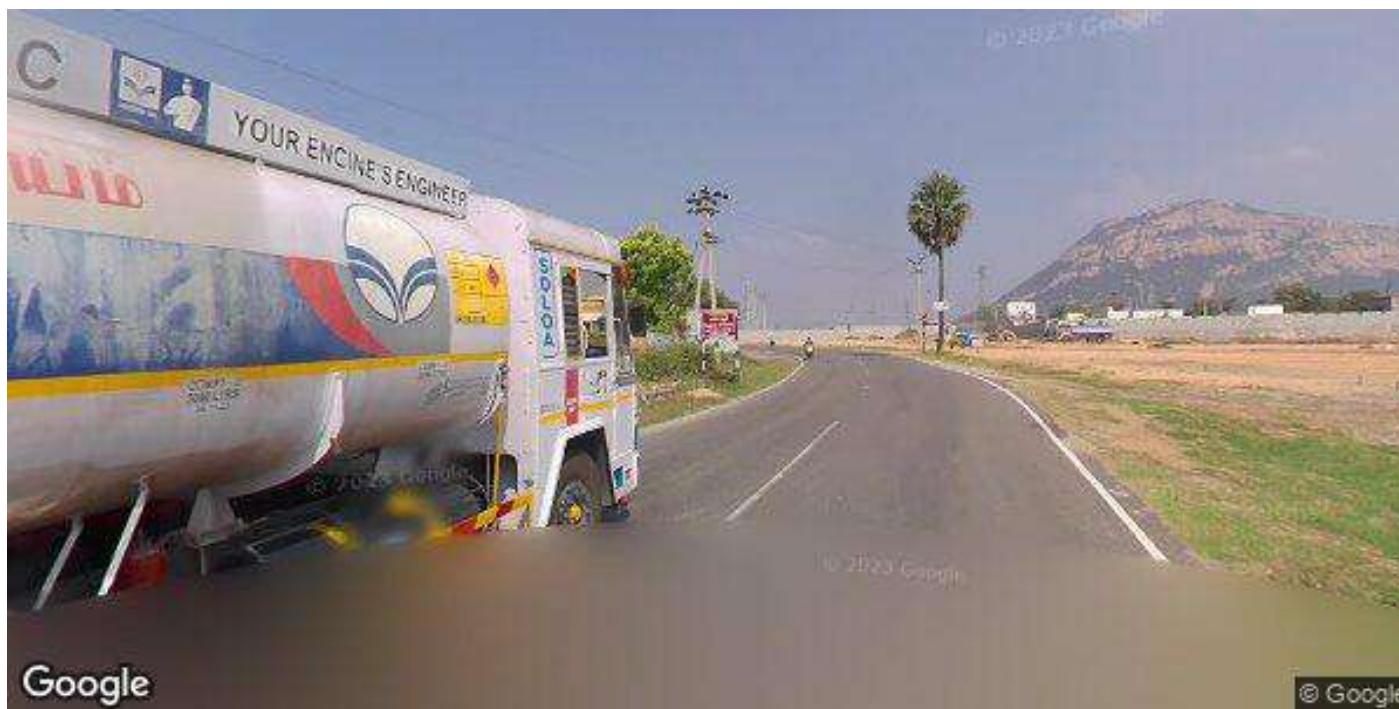
**Risk Type:** Turn  
**Risk Level:** Medium  
**Speed Limit:** 30 KM/Hr  
**Coordinates:** 11.45853, 77.85139

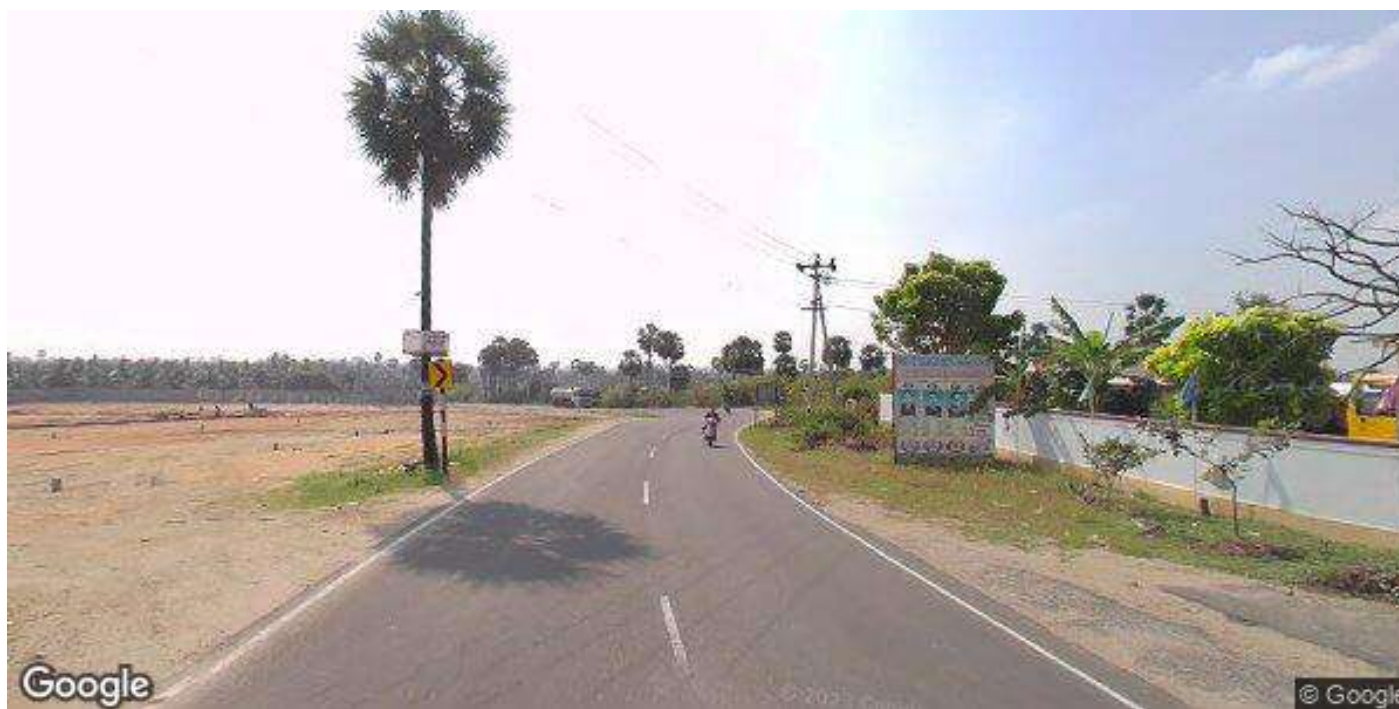
**Risk Type:** Turn  
**Risk Level:** Medium  
**Speed Limit:** 30 KM/Hr  
**Coordinates:** 11.45906, 77.85132

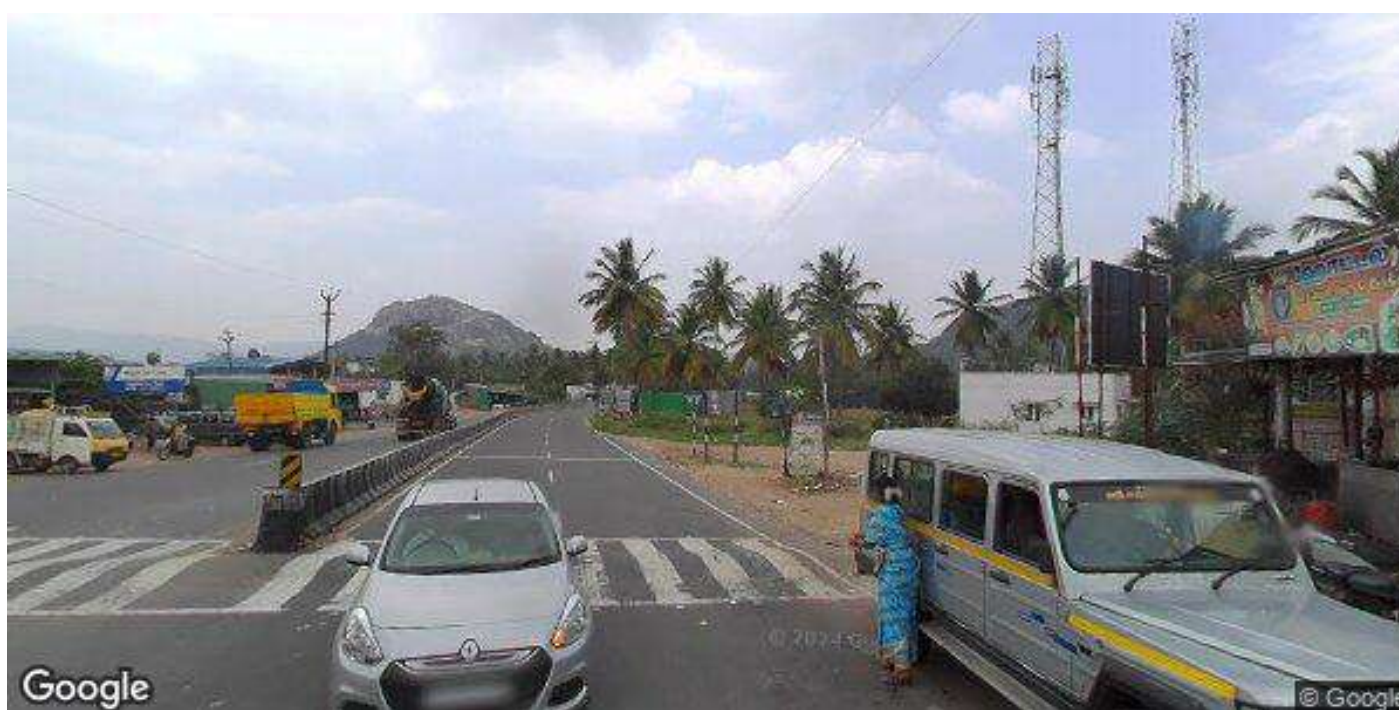
**Risk Type:** Blind Spot  
**Risk Level:** Blind Spot  
**Speed Limit:** 10 KM/Hr  
**Coordinates:** 11.49397, 77.86740

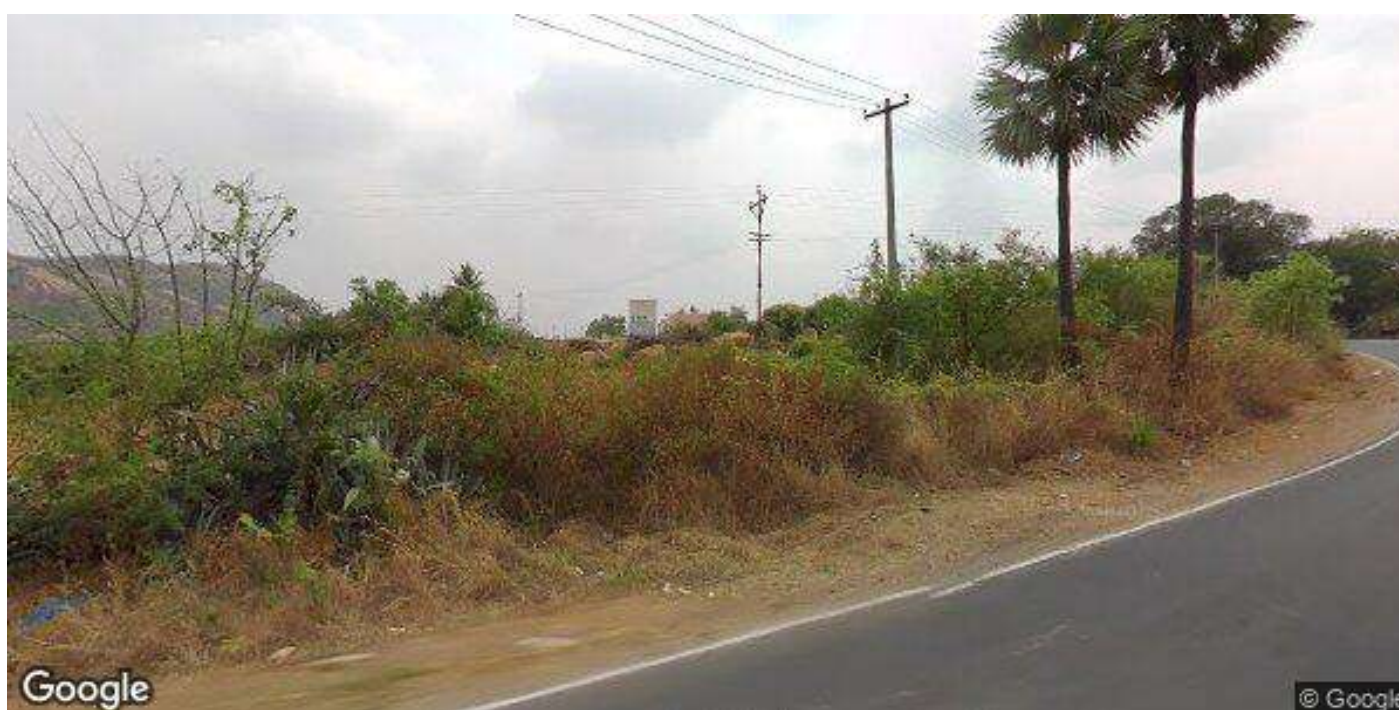
**Risk Type:** Turn  
**Risk Level:** Medium  
**Speed Limit:** 30 KM/Hr  
**Coordinates:** 11.50885, 77.86037

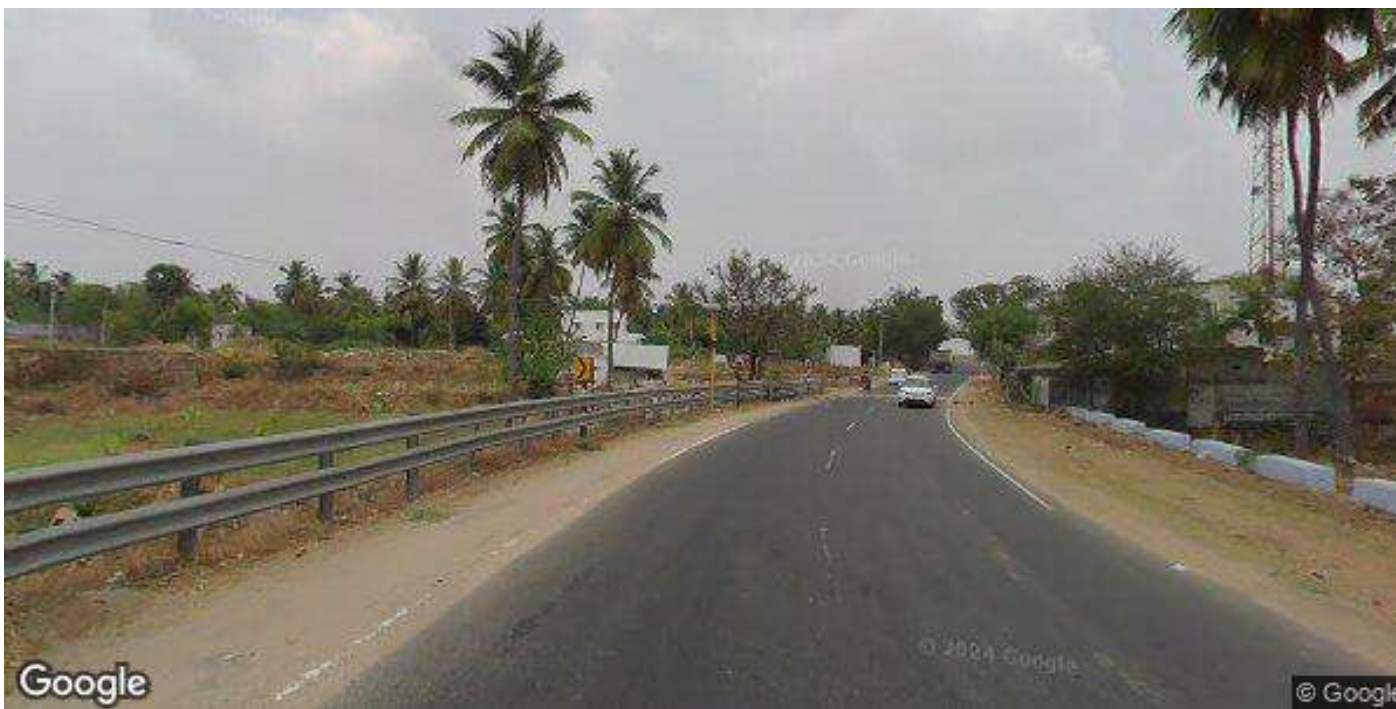
**Risk Type:** Turn  
**Risk Level:** Medium  
**Speed Limit:** 30 KM/Hr  
**Coordinates:** 11.52571, 77.85522

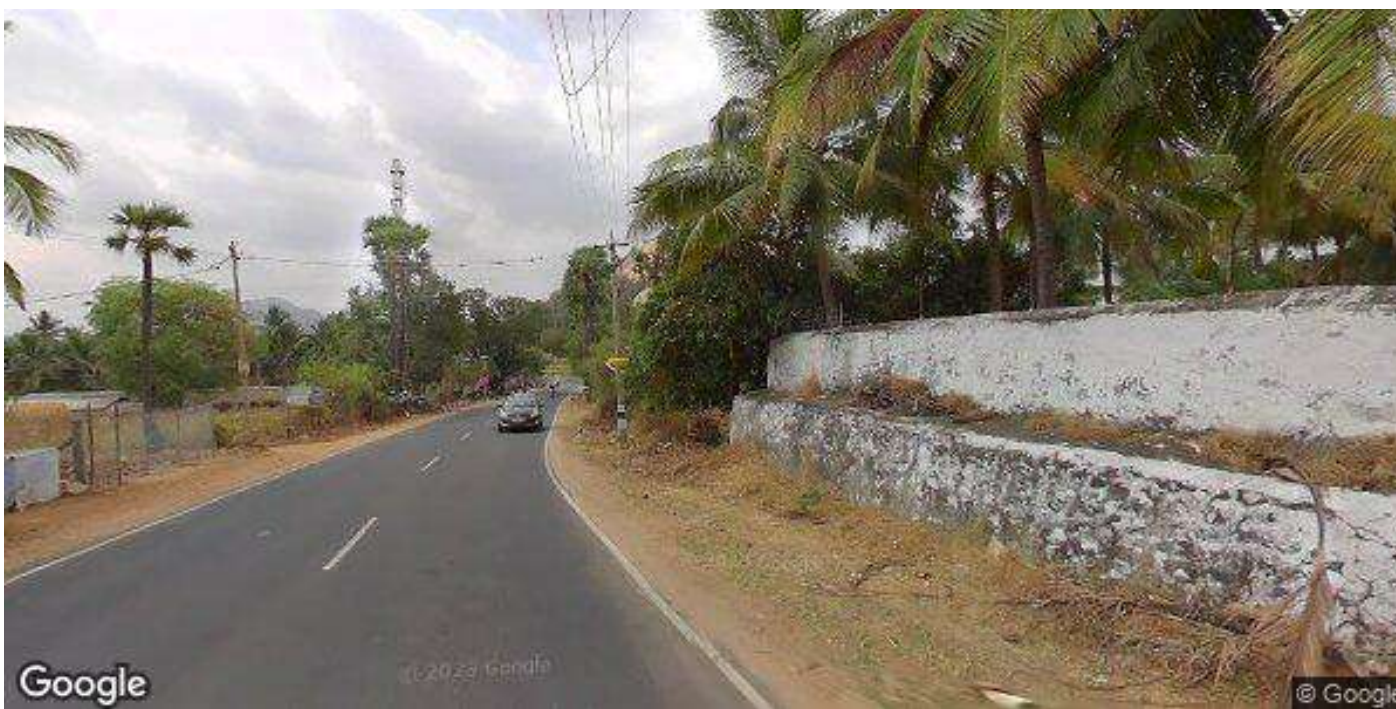
**Risk Type:** Turn  
**Risk Level:** Medium  
**Speed Limit:** 30 KM/Hr  
**Coordinates:** 11.52744, 77.85582

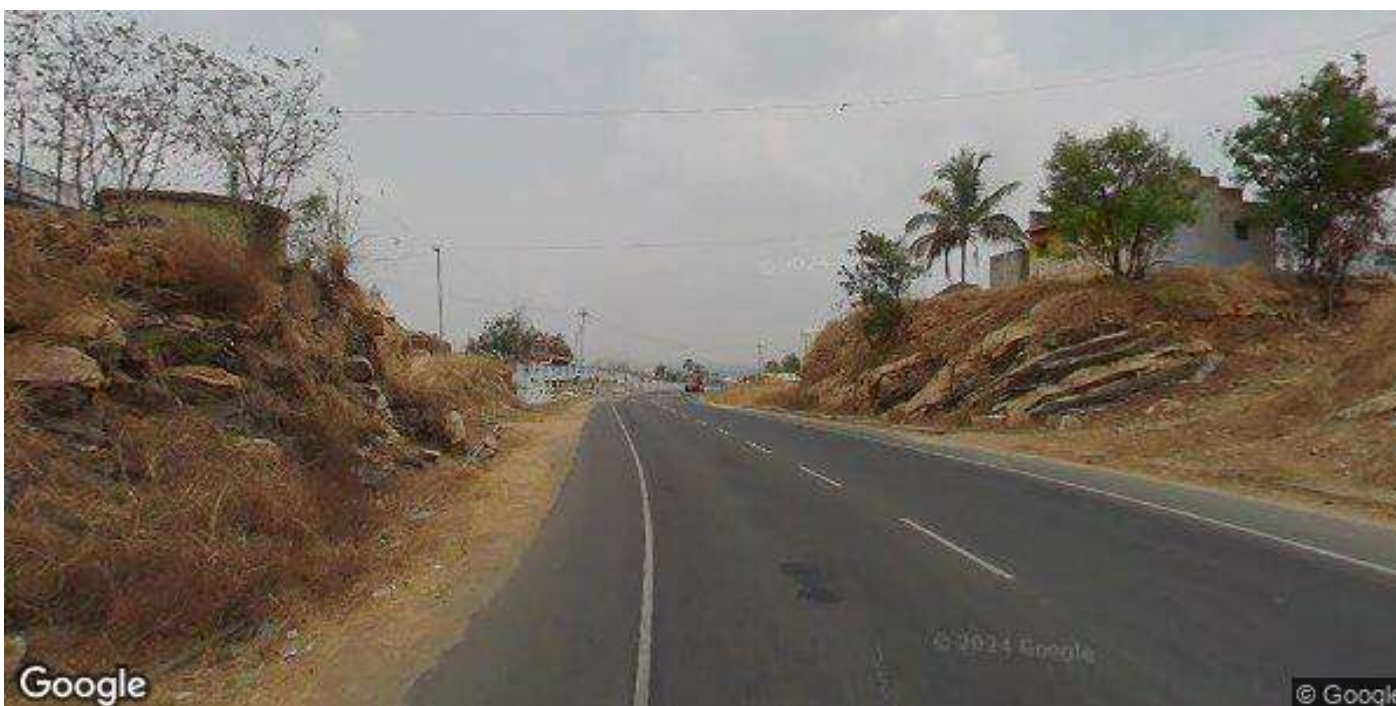
**Risk Type:** Turn  
**Risk Level:** Medium  
**Speed Limit:** 30 KM/Hr  
**Coordinates:** 11.55049, 77.85513

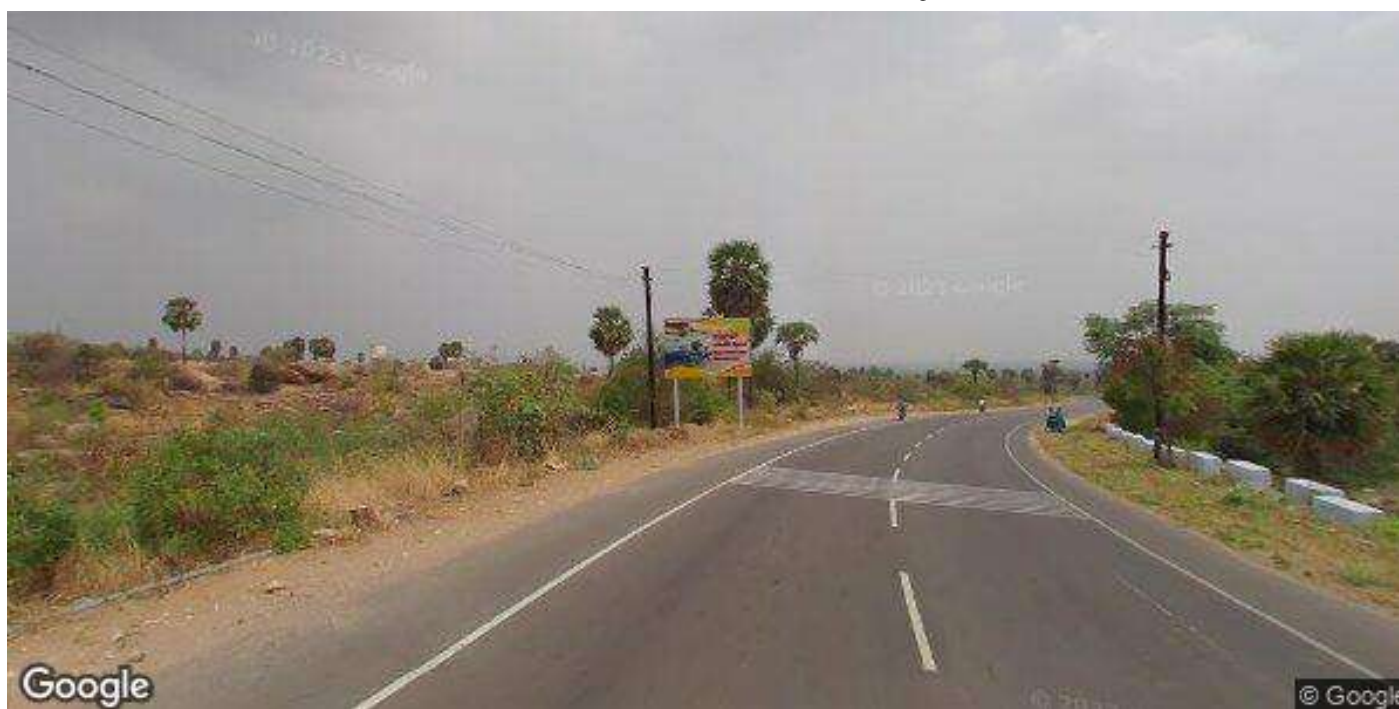
**Risk Type:** Turn  
**Risk Level:** Medium  
**Speed Limit:** 30 KM/Hr  
**Coordinates:** 11.55460, 77.85624

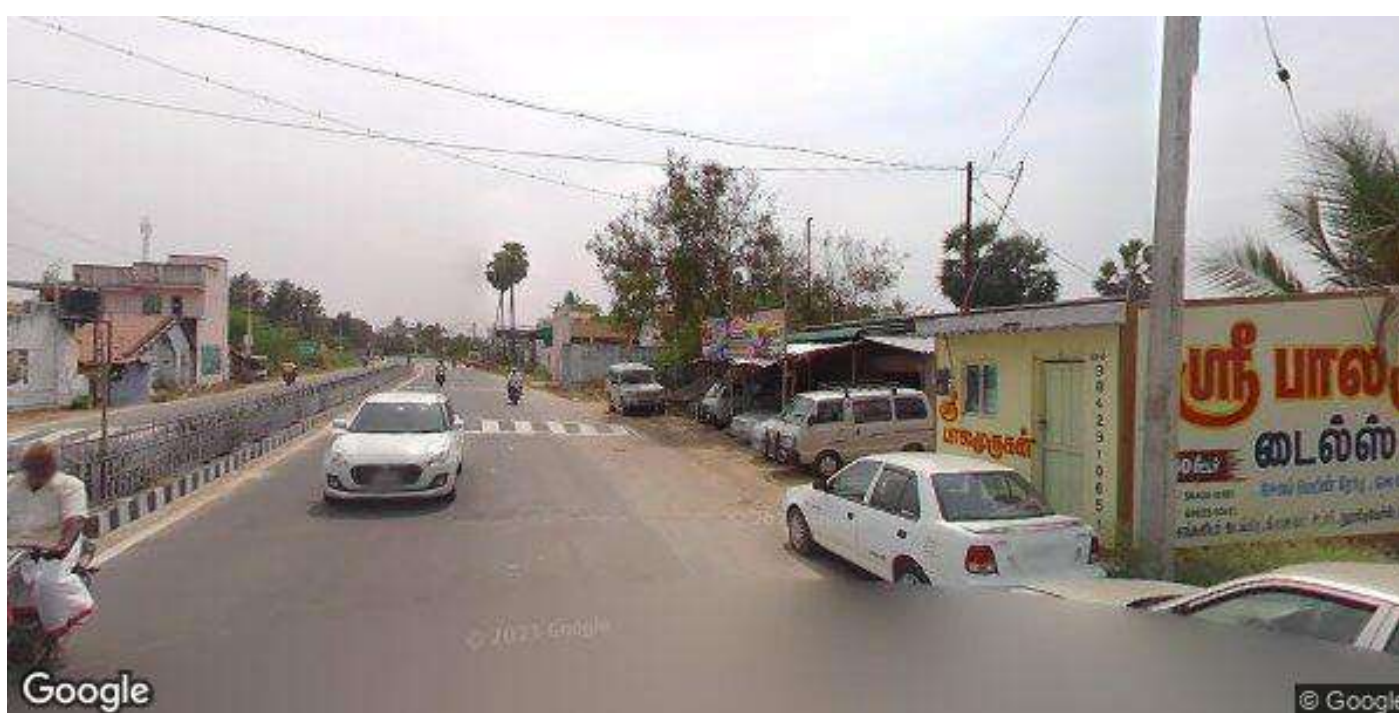
**Risk Type:** Turn  
**Risk Level:** High  
**Speed Limit:** 15 KM/Hr  
**Coordinates:** 11.57893, 77.85430

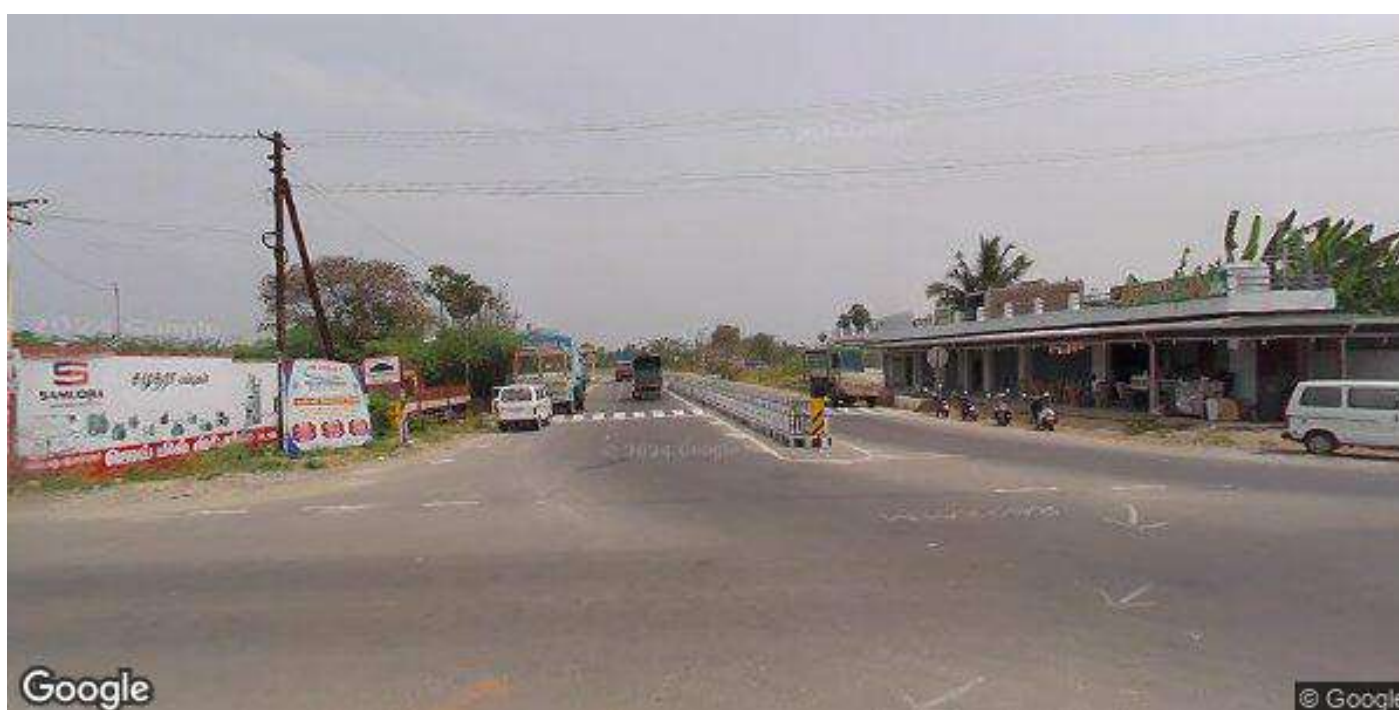
**Risk Type:** Turn  
**Risk Level:** Medium  
**Speed Limit:** 30 KM/Hr  
**Coordinates:** 11.57903, 77.85441

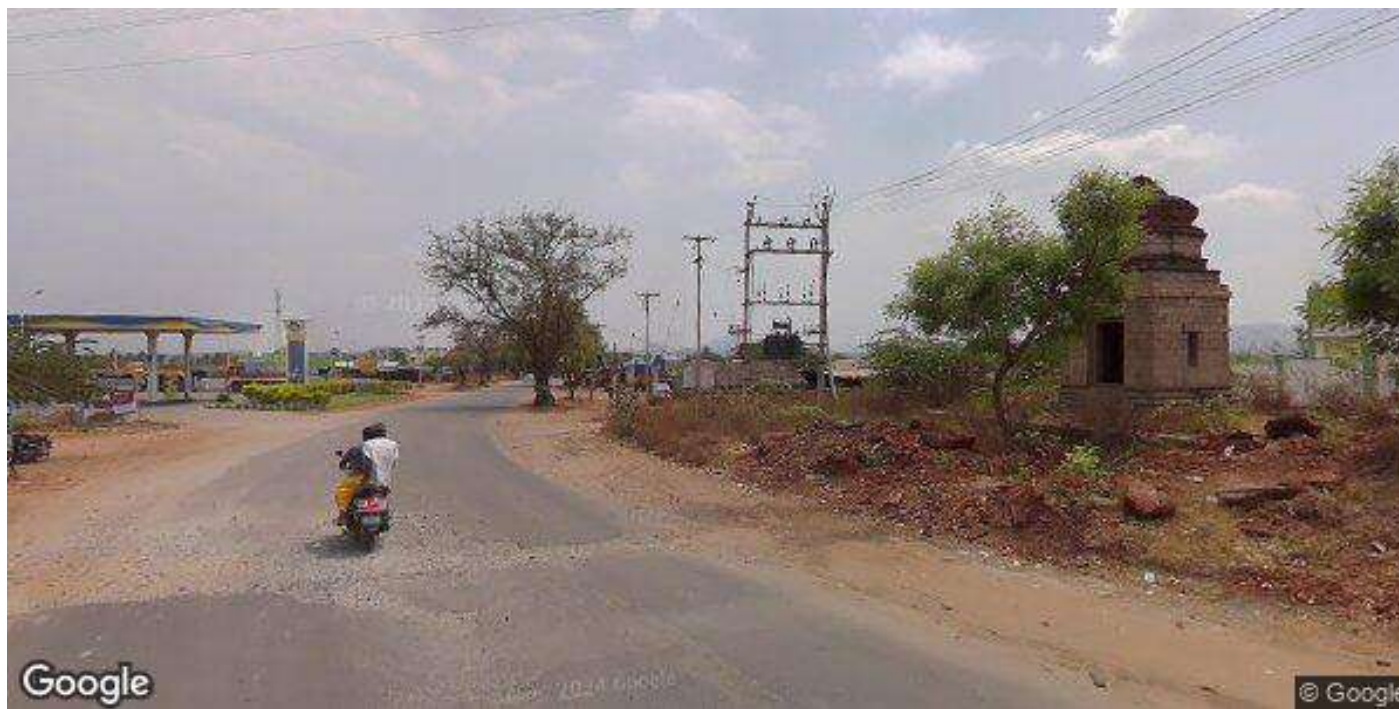
**Risk Type:** Turn  
**Risk Level:** Medium  
**Speed Limit:** 30 KM/Hr  
**Coordinates:** 11.58304, 77.90656

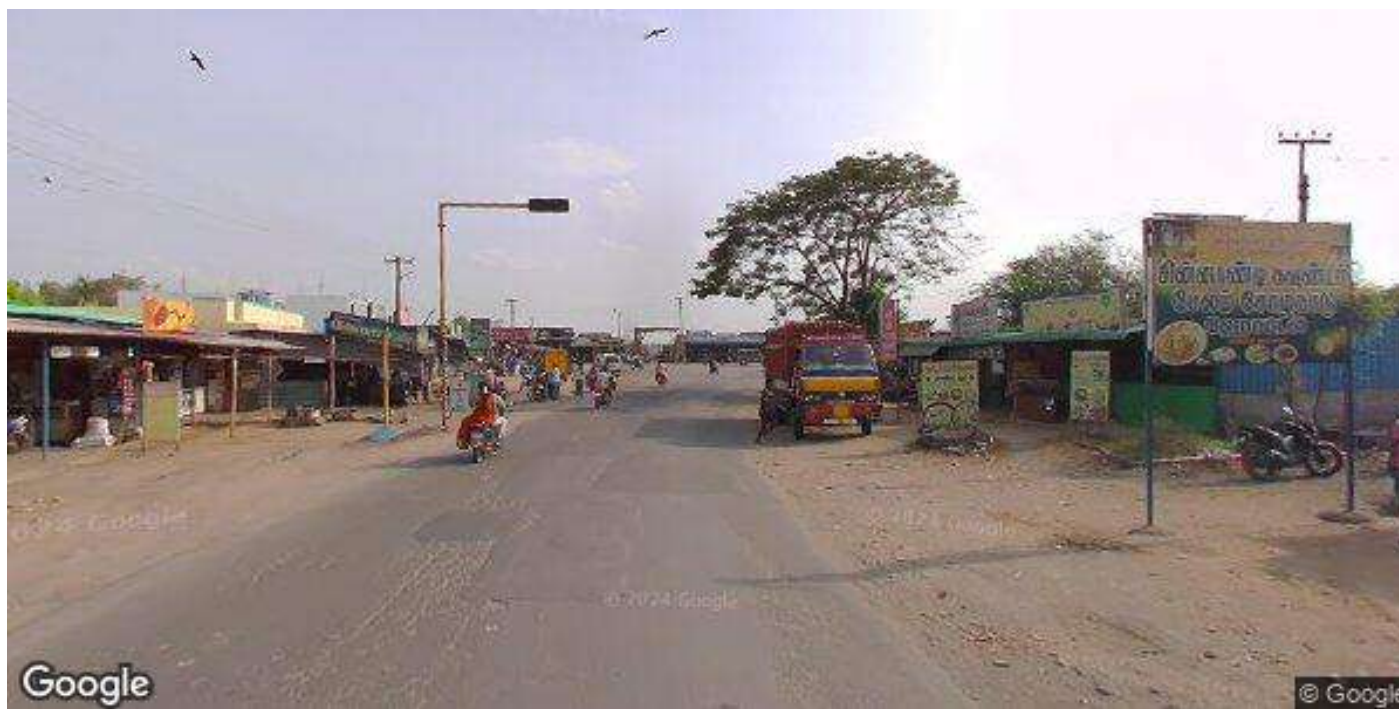
**Risk Type:** Turn  
**Risk Level:** Medium  
**Speed Limit:** 30 KM/Hr  
**Coordinates:** 11.64217, 77.95200

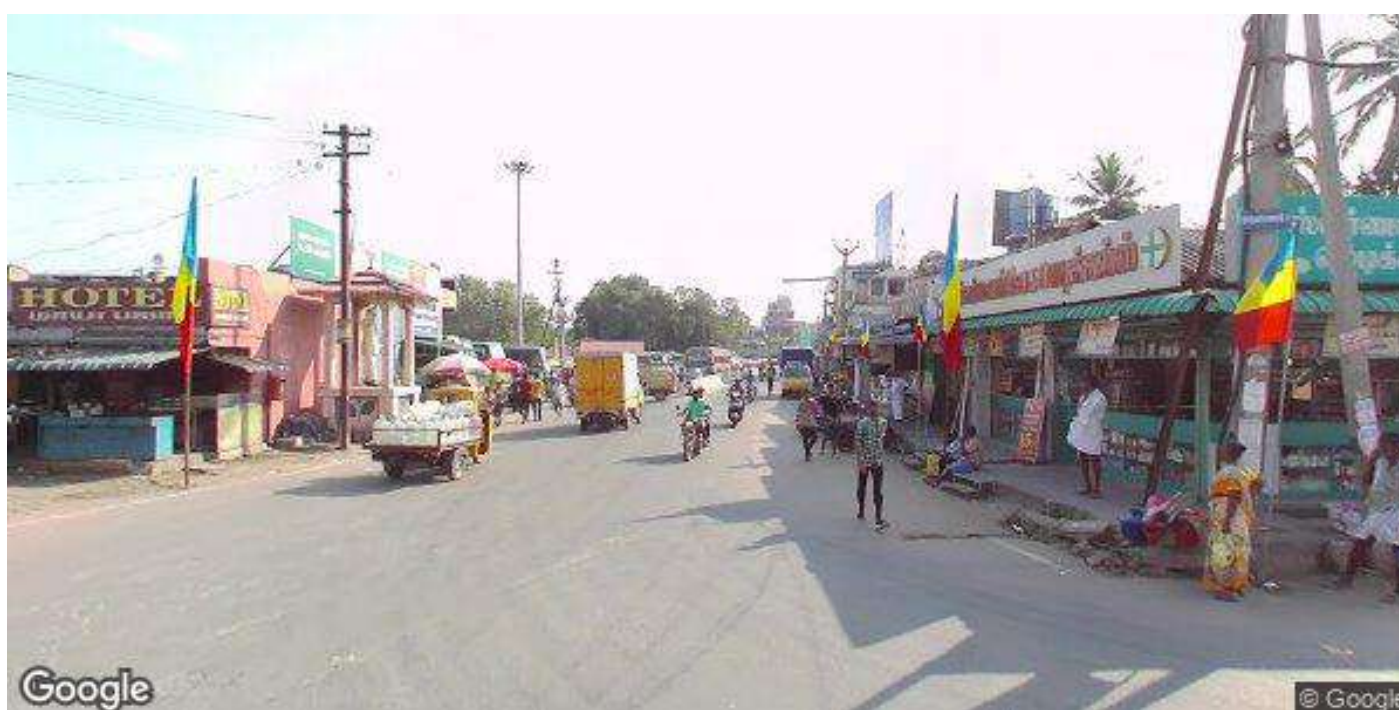
**Risk Type:** Blind Spot  
**Risk Level:** Blind Spot  
**Speed Limit:** 10 KM/Hr  
**Coordinates:** 11.69590, 77.97114

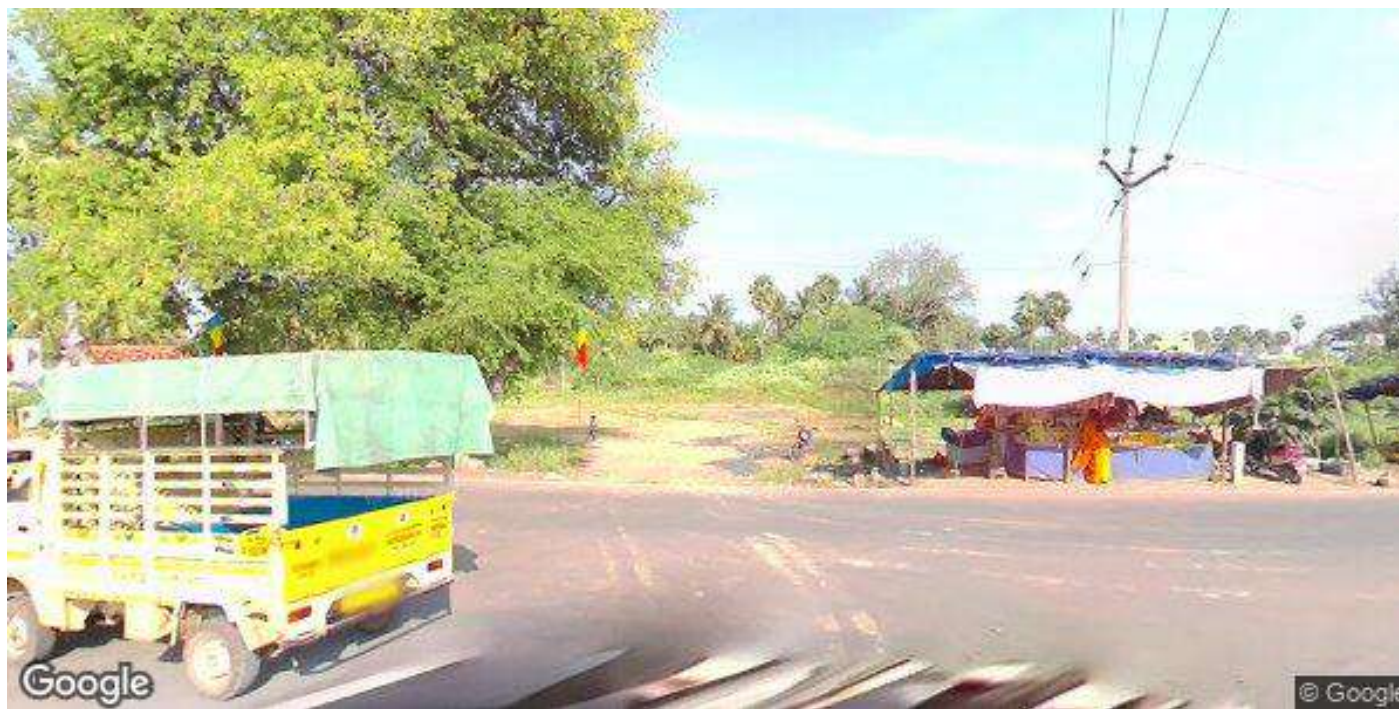
**Risk Type:** Turn  
**Risk Level:** High  
**Speed Limit:** 15 KM/Hr  
**Coordinates:** 11.70133, 77.96363

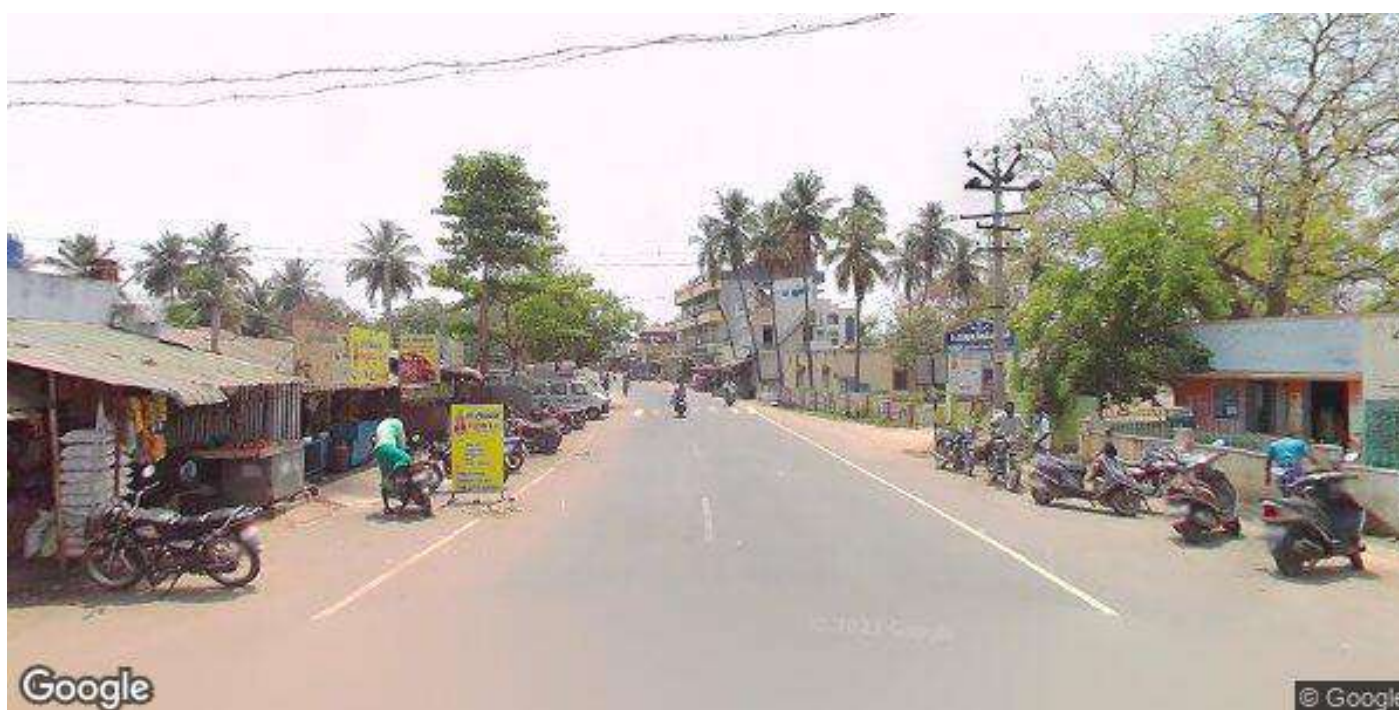
**Risk Type:** Turn  
**Risk Level:** Medium  
**Speed Limit:** 30 KM/Hr  
**Coordinates:** 11.73415, 77.96718

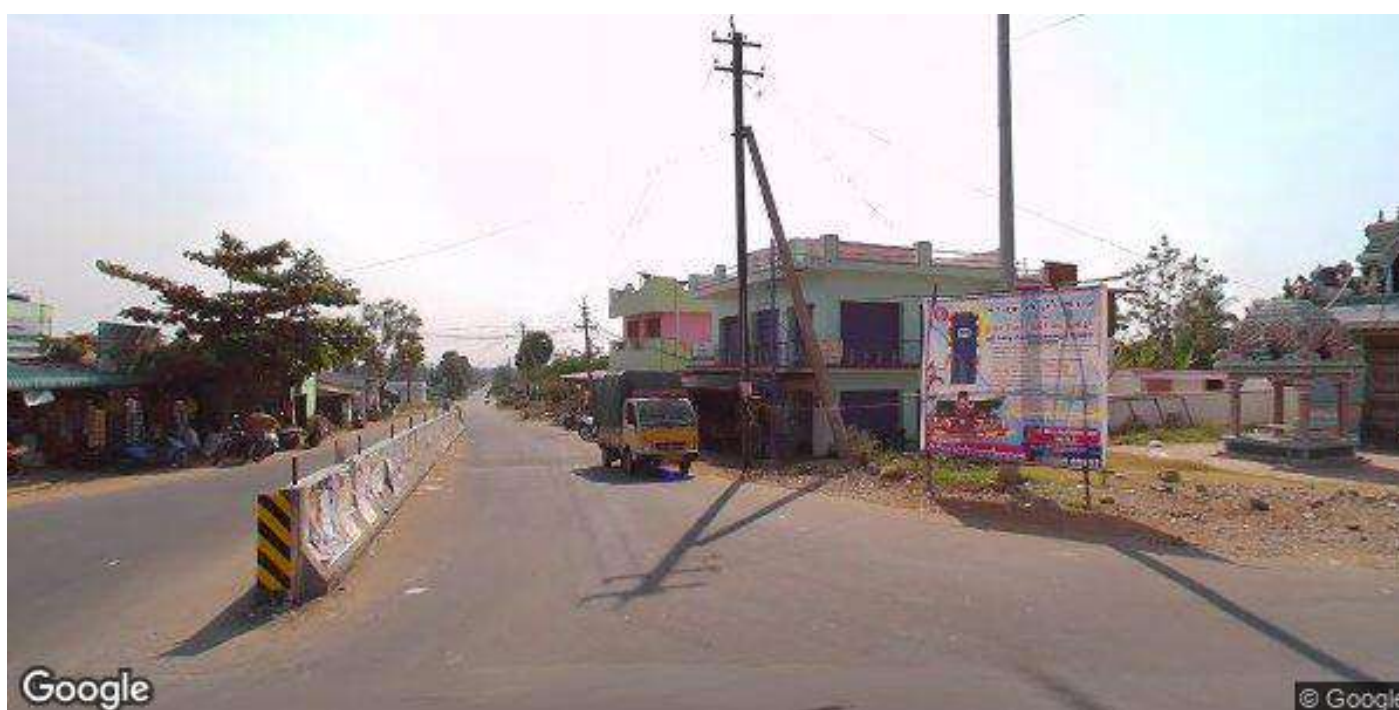
**Risk Type:** Turn  
**Risk Level:** High  
**Speed Limit:** 15 KM/Hr  
**Coordinates:** 11.77772, 77.99628
