# IndianOil

## JOURNEY RISK MANAGEMENT (JRM) STUDY

### Salem Terminal to SHREE RAMACHANDRAN PETROLEUM

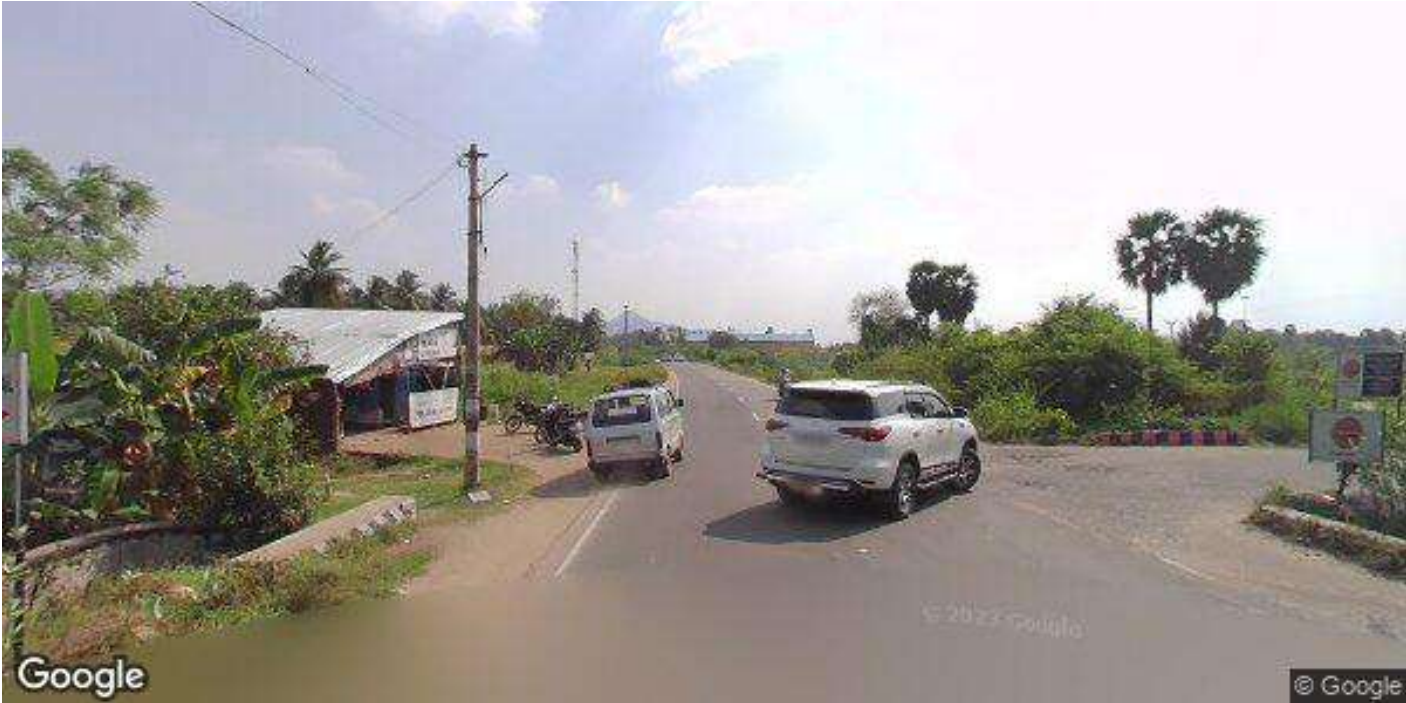
**Risk Type:** Turn  
**Risk Level:** High  
**Speed Limit:** 15 KM/Hr  
**Coordinates:** 11.44029, 77.87544

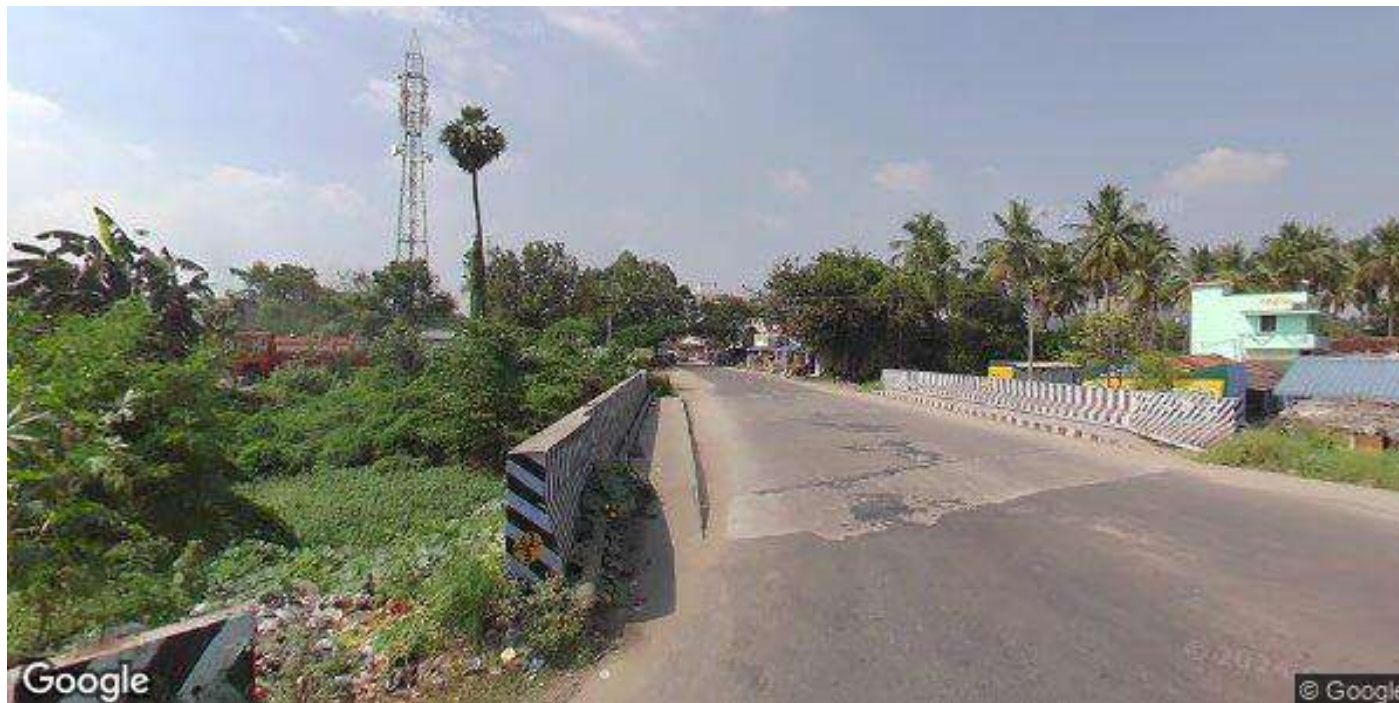
**Risk Type:** Turn  
**Risk Level:** Medium  
**Speed Limit:** 30 KM/Hr  
**Coordinates:** 11.44900, 77.87406

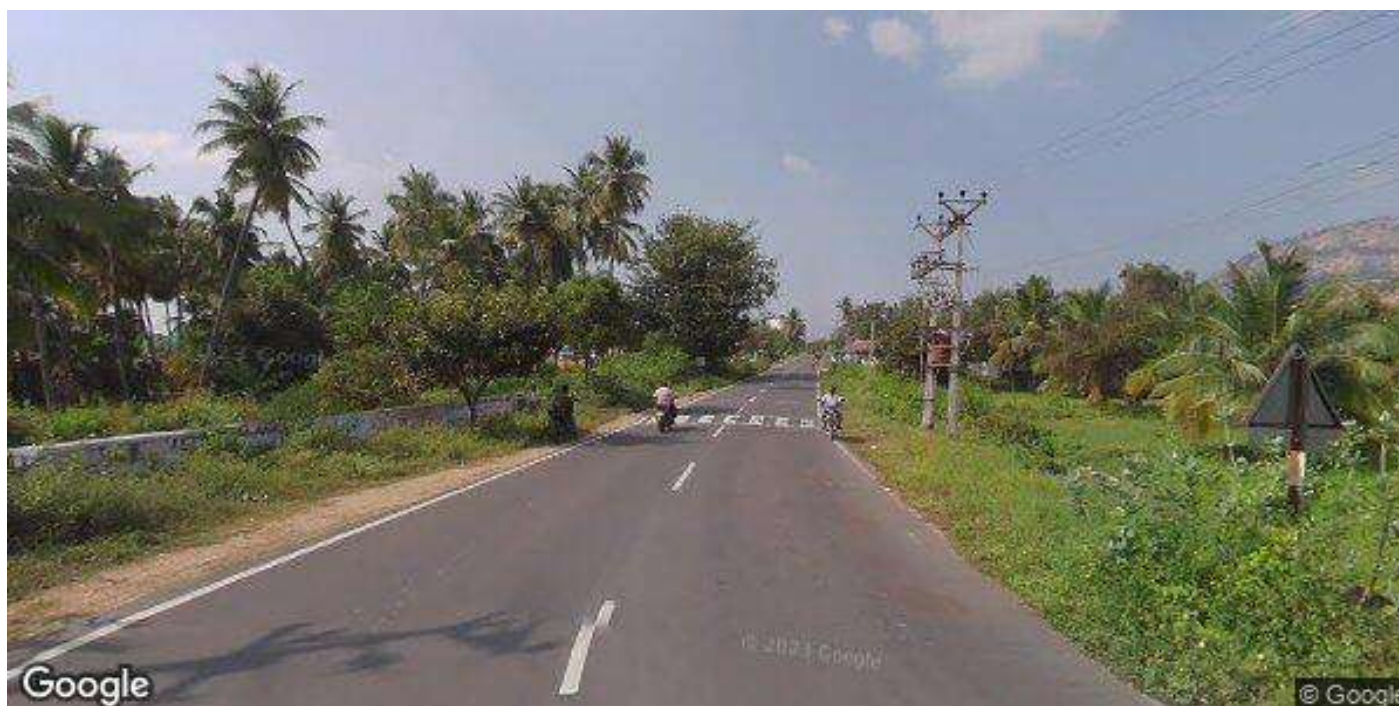
**Risk Type:** Turn  
**Risk Level:** High  
**Speed Limit:** 15 KM/Hr  
**Coordinates:** 11.45353, 77.85697

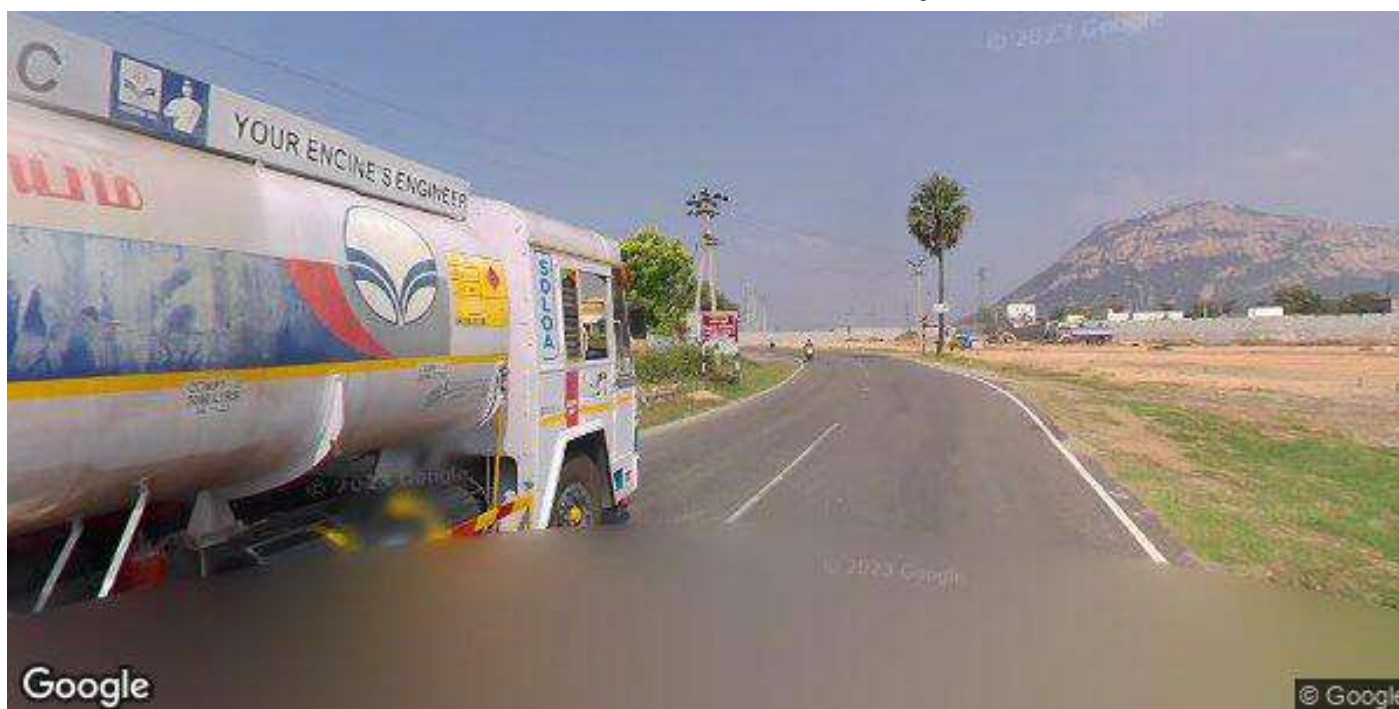
**Risk Type:** Turn  
**Risk Level:** Medium  
**Speed Limit:** 30 KM/Hr  
**Coordinates:** 11.45853, 77.85139

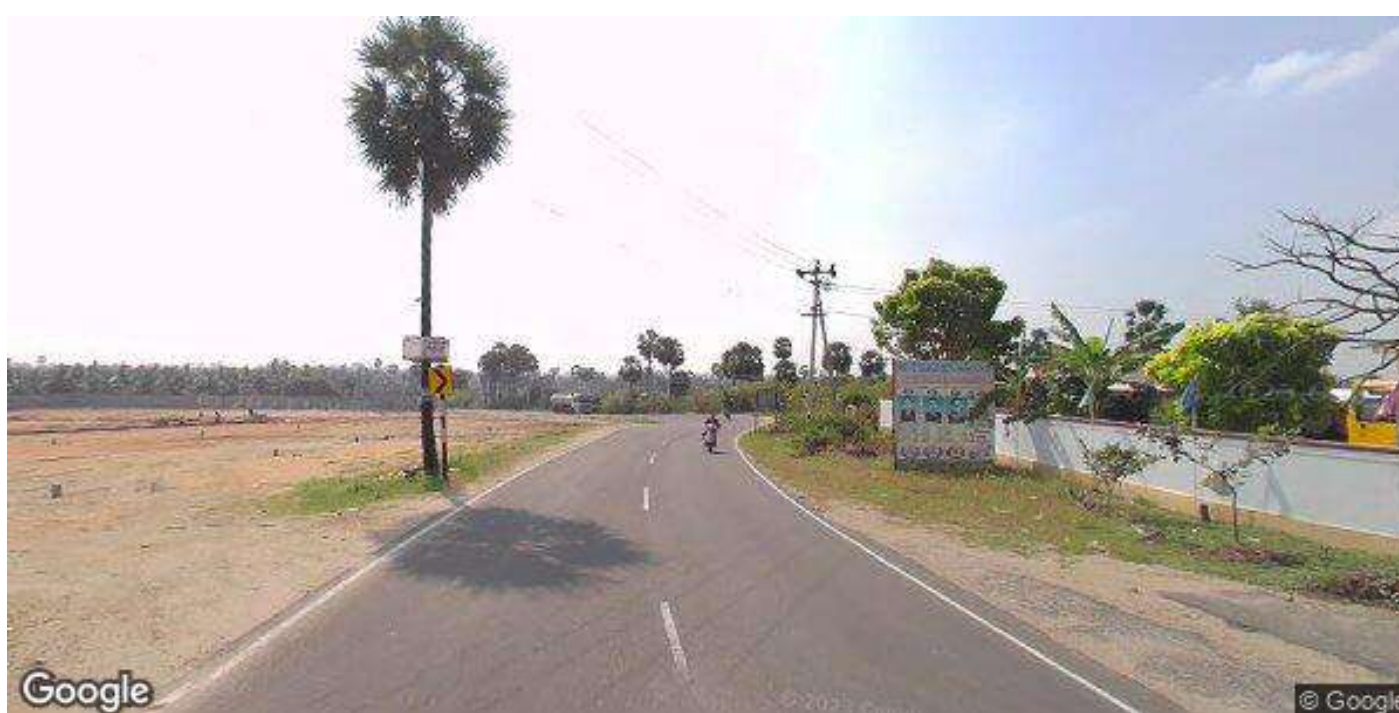
**Risk Type:** Turn  
**Risk Level:** Medium  
**Speed Limit:** 30 KM/Hr  
**Coordinates:** 11.45906, 77.85132

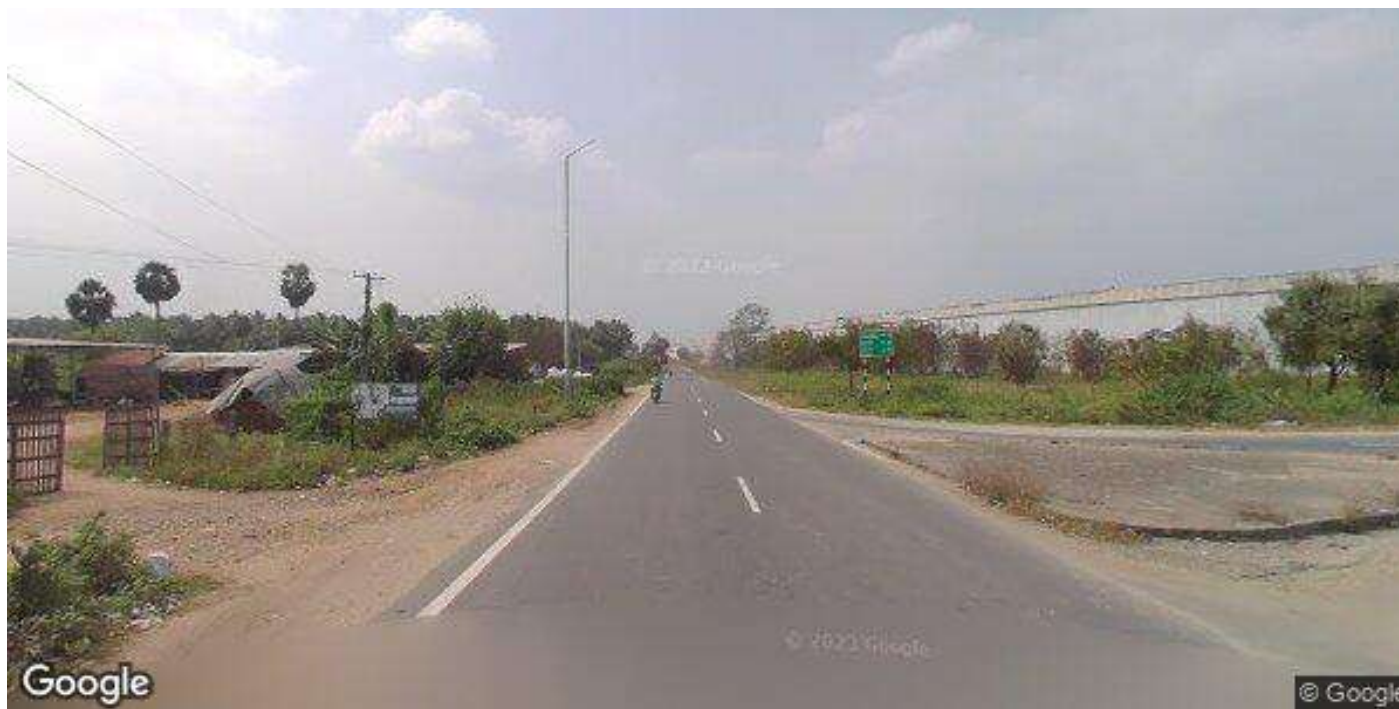
**Risk Type:** Turn  
**Risk Level:** High  
**Speed Limit:** 15 KM/Hr  
**Coordinates:** 11.45542, 77.81725

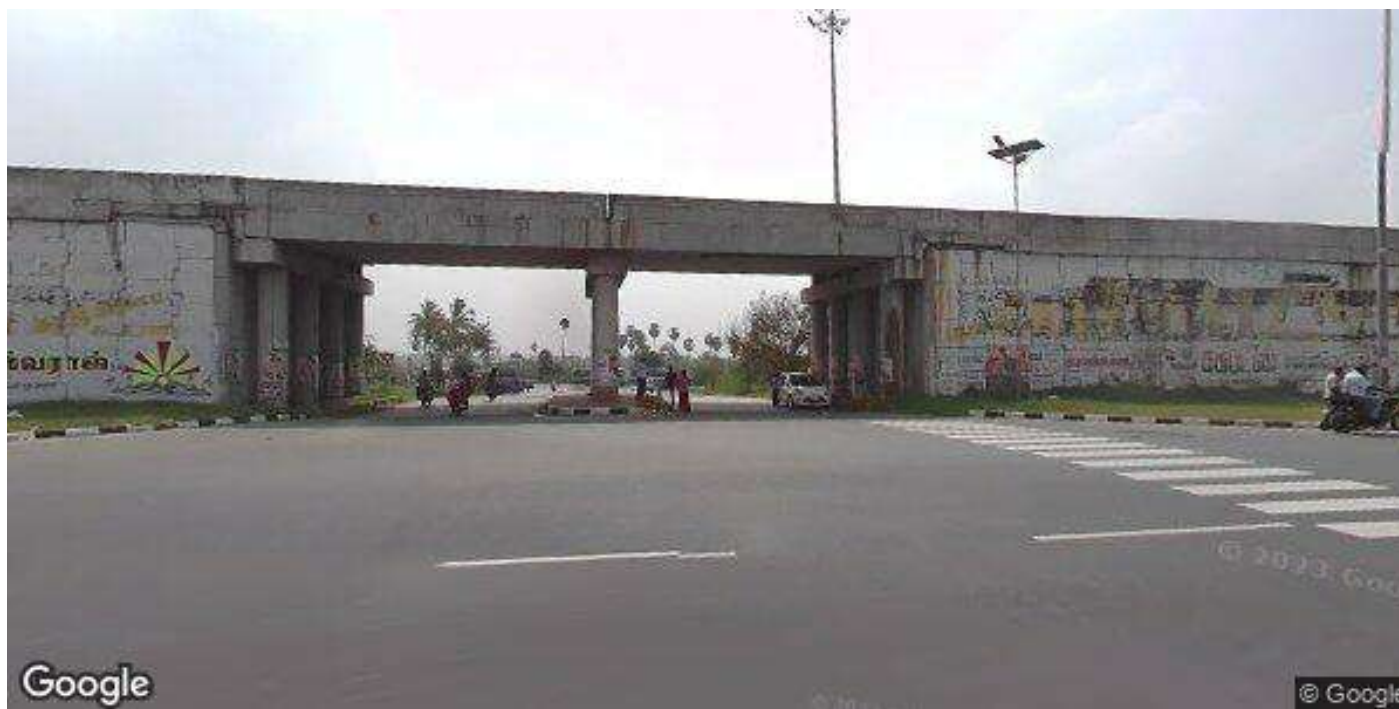
**Risk Type:** Turn  
**Risk Level:** High  
**Speed Limit:** 15 KM/Hr  
**Coordinates:** 11.45636, 77.81678

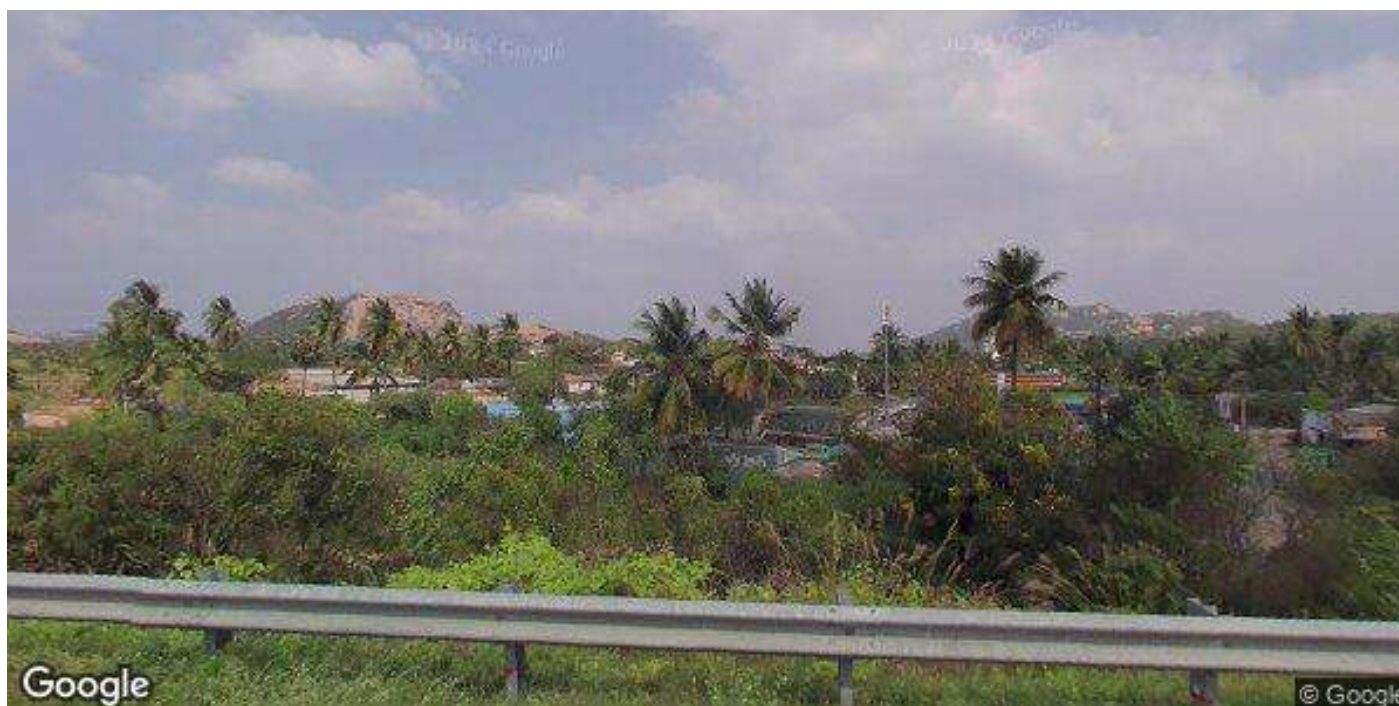
**Risk Type:** Turn  
**Risk Level:** Medium  
**Speed Limit:** 30 KM/Hr  
**Coordinates:** 11.49383, 77.88501

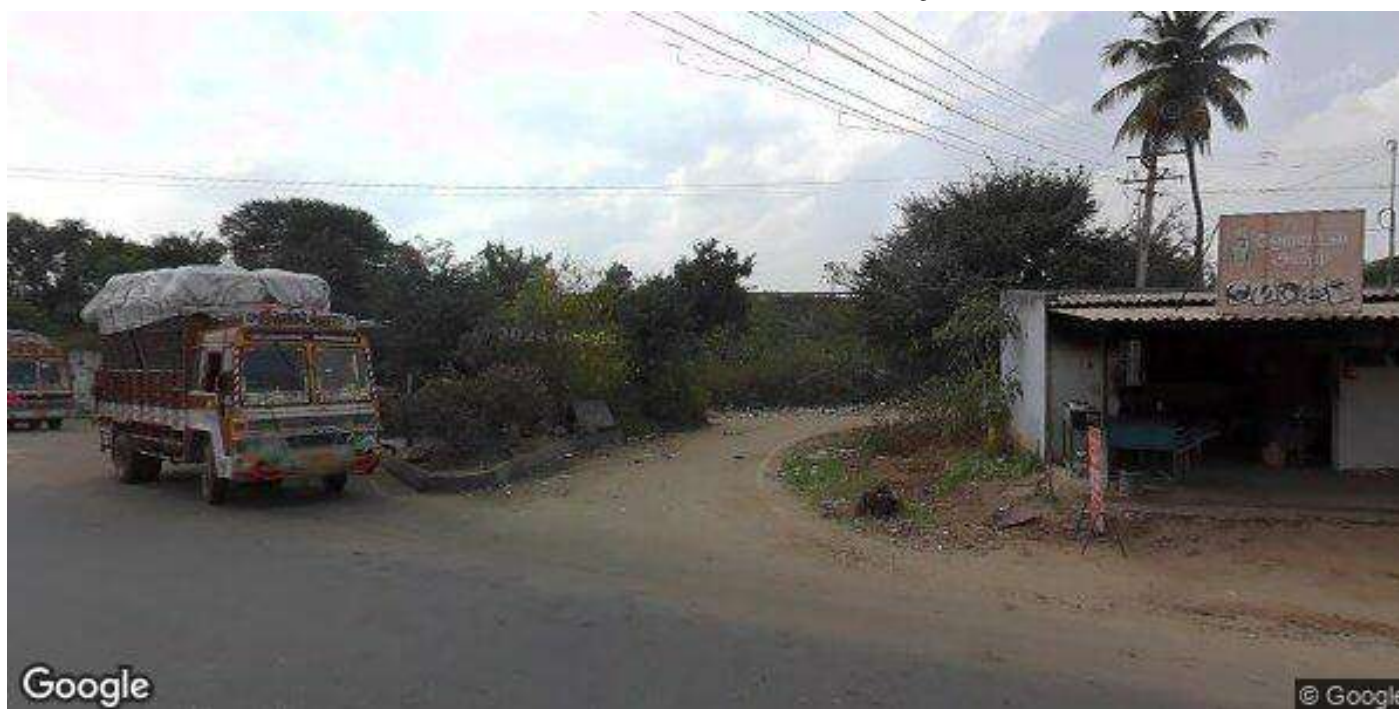
**Risk Type:** Blind Spot  
**Risk Level:** Blind Spot  
**Speed Limit:** 10 KM/Hr  
**Coordinates:** 11.49400, 77.88538

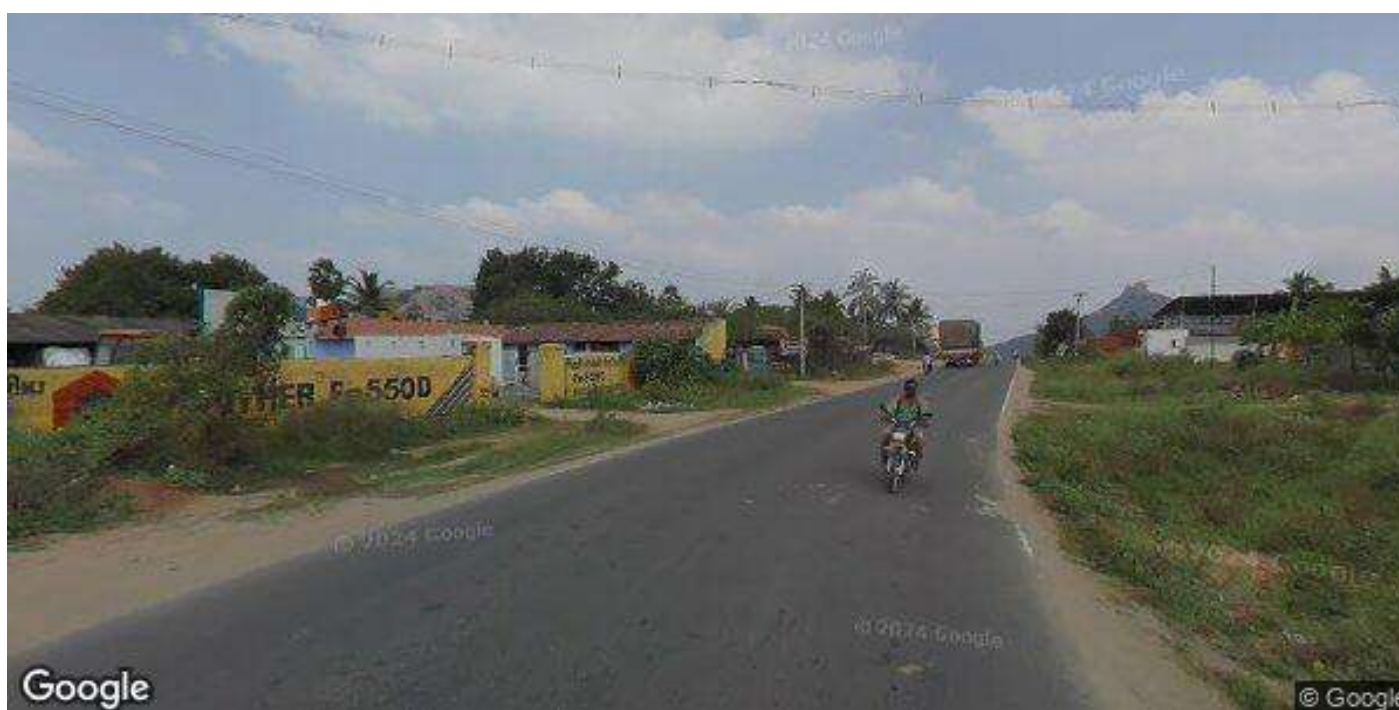
**Risk Type:** Turn  
**Risk Level:** High  
**Speed Limit:** 15 KM/Hr  
**Coordinates:** 11.49469, 77.88488

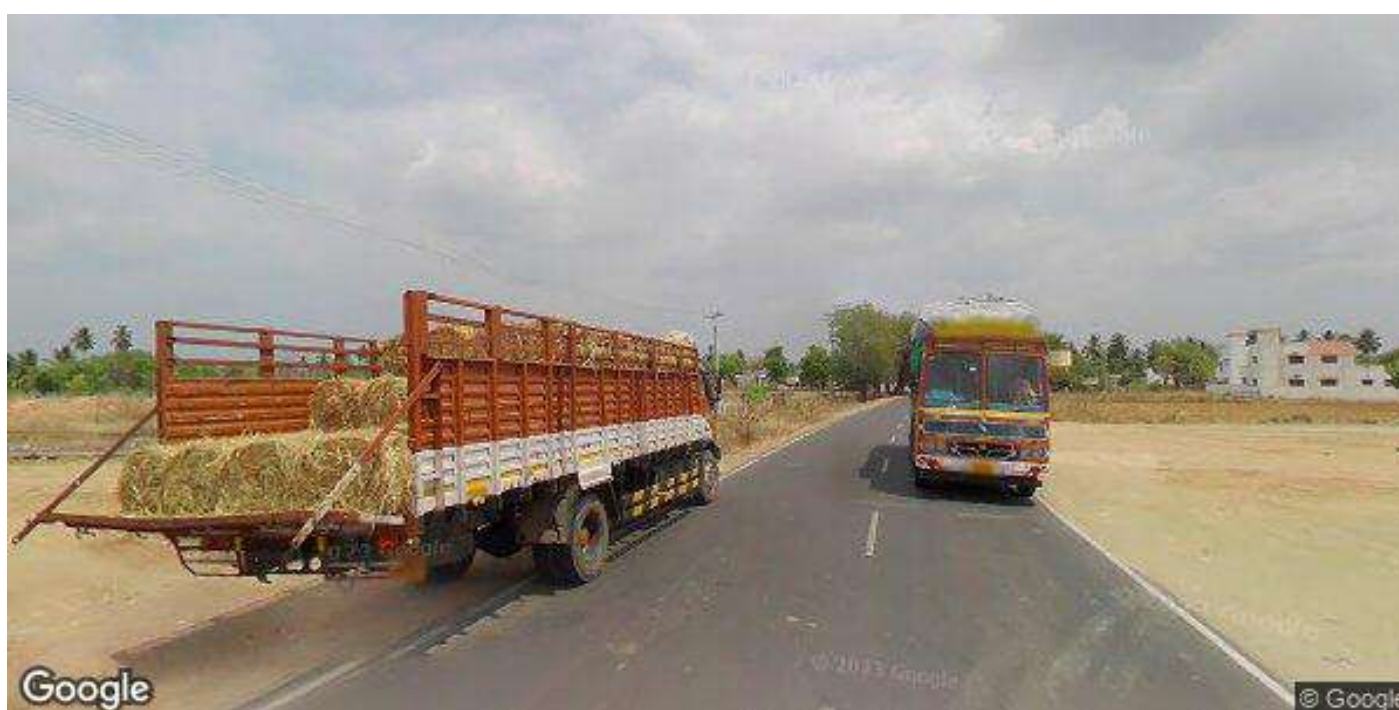
**Risk Type:** Turn  
**Risk Level:** Medium  
**Speed Limit:** 30 KM/Hr  
**Coordinates:** 11.55594, 77.89757

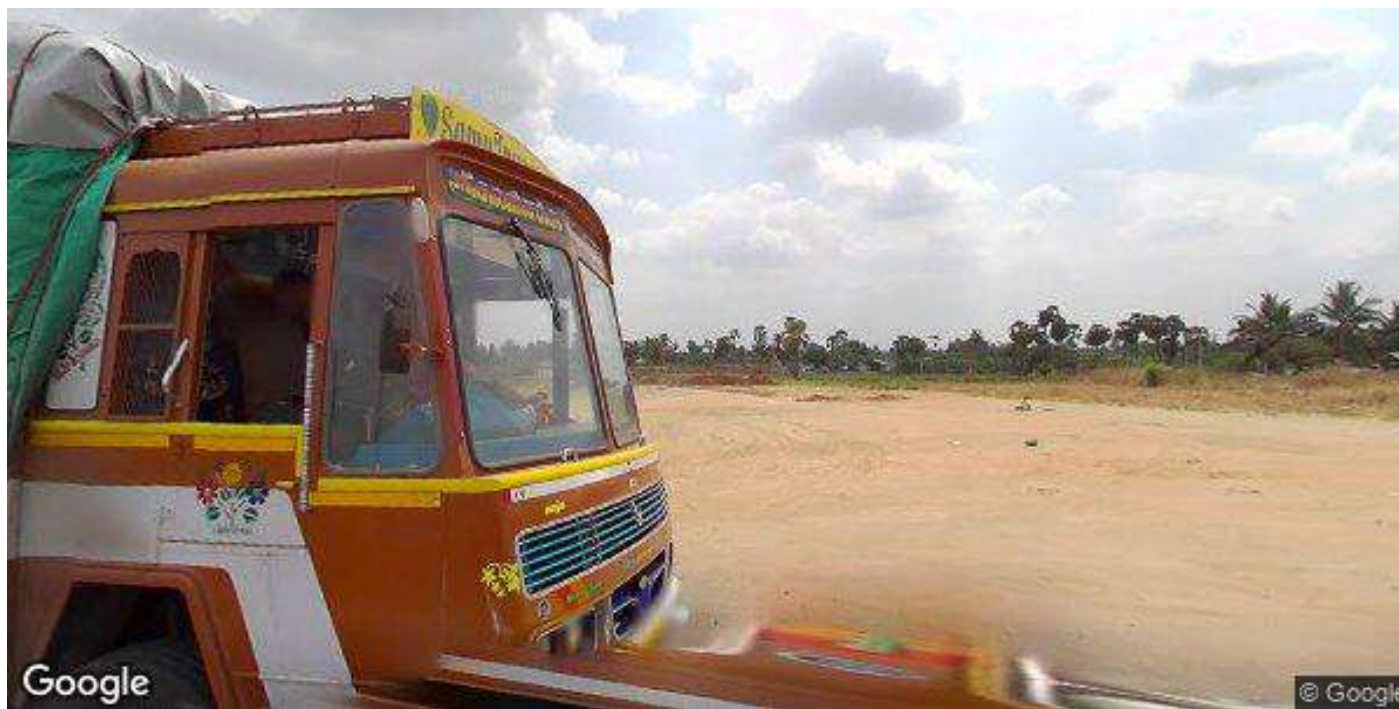
**Risk Type:** Turn  
**Risk Level:** Medium  
**Speed Limit:** 30 KM/Hr  
**Coordinates:** 11.55618, 77.89789

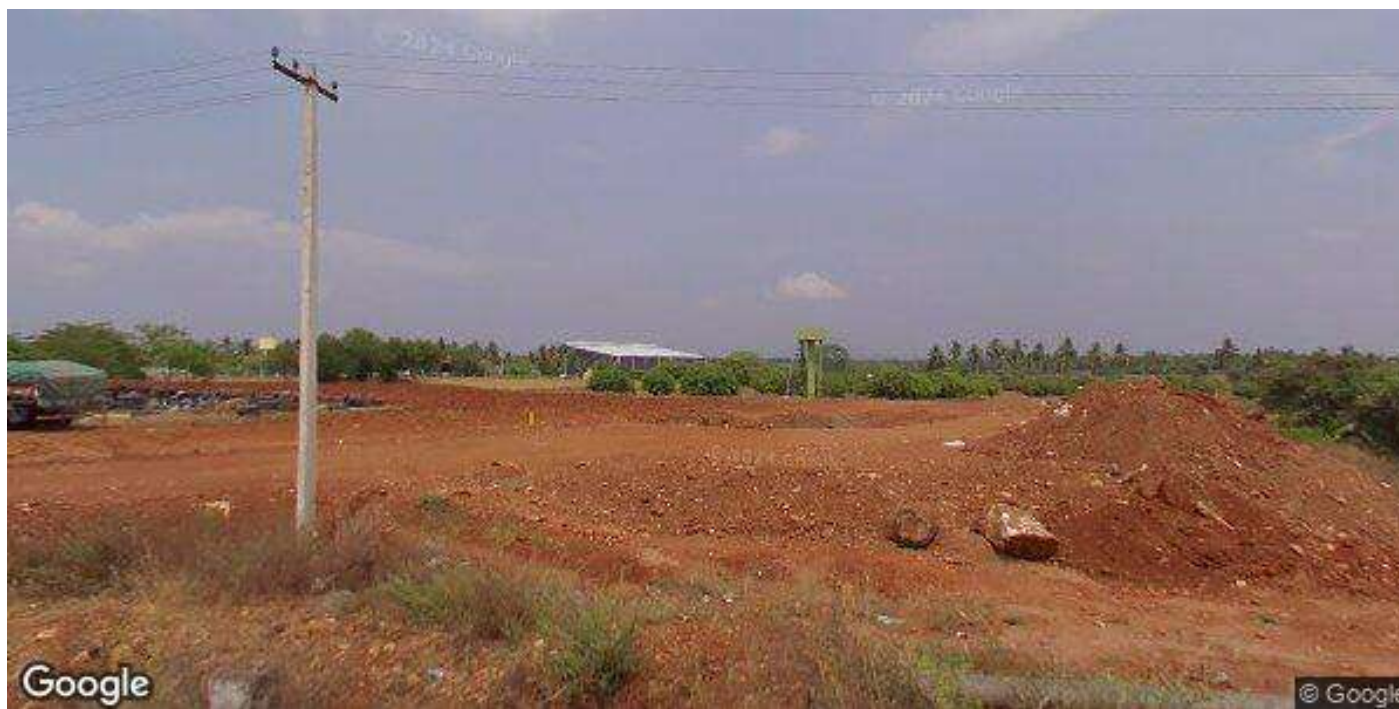
**Risk Type:** Turn  
**Risk Level:** Medium  
**Speed Limit:** 30 KM/Hr  
**Coordinates:** 11.58318, 77.90659

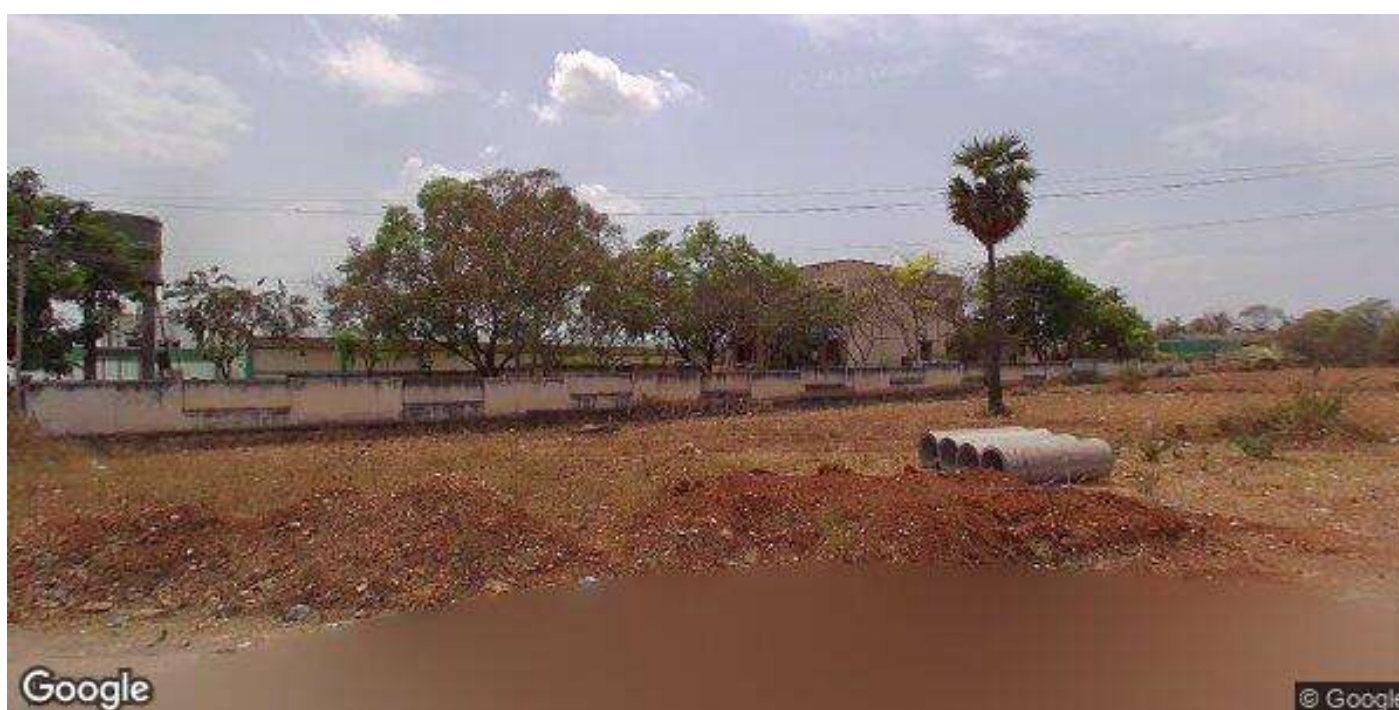
**Risk Type:** Turn  
**Risk Level:** Medium  
**Speed Limit:** 30 KM/Hr  
**Coordinates:** 11.58340, 77.90637

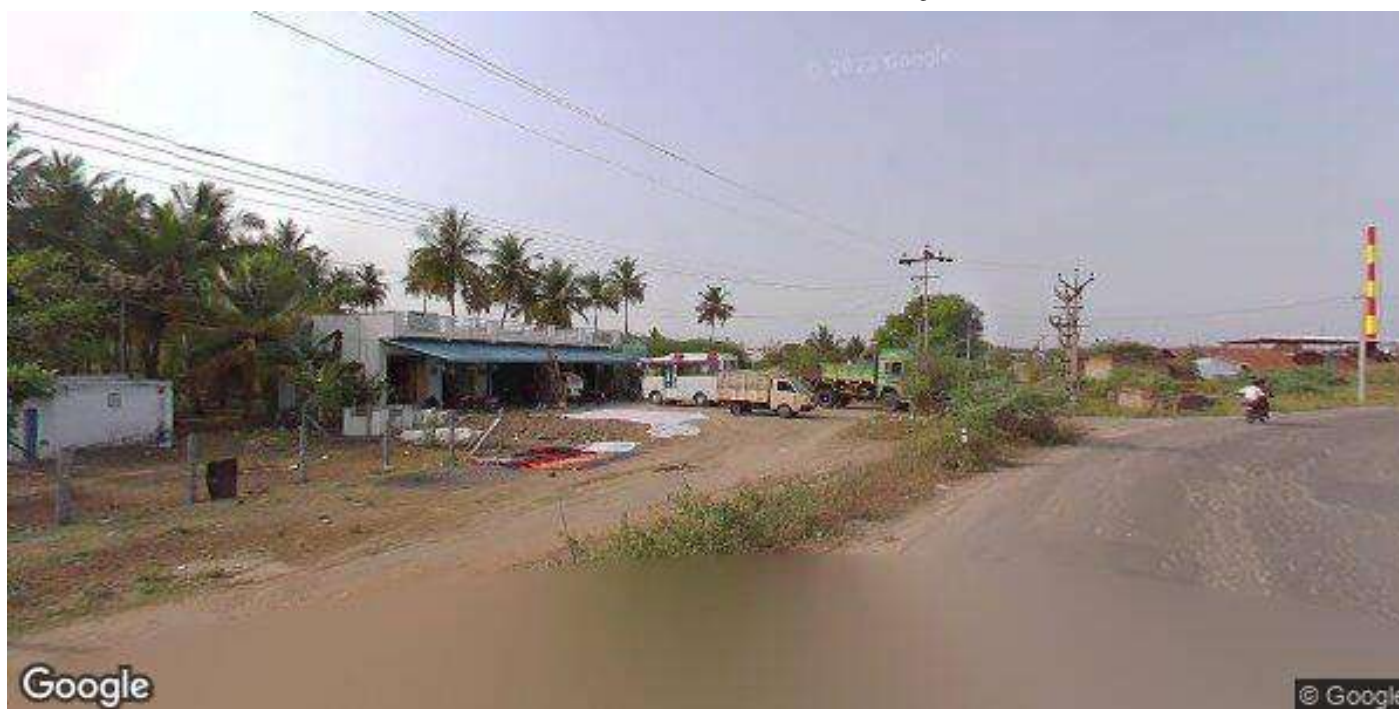
**Risk Type:** Turn  
**Risk Level:** Medium  
**Speed Limit:** 30 KM/Hr  
**Coordinates:** 11.63832, 77.94818

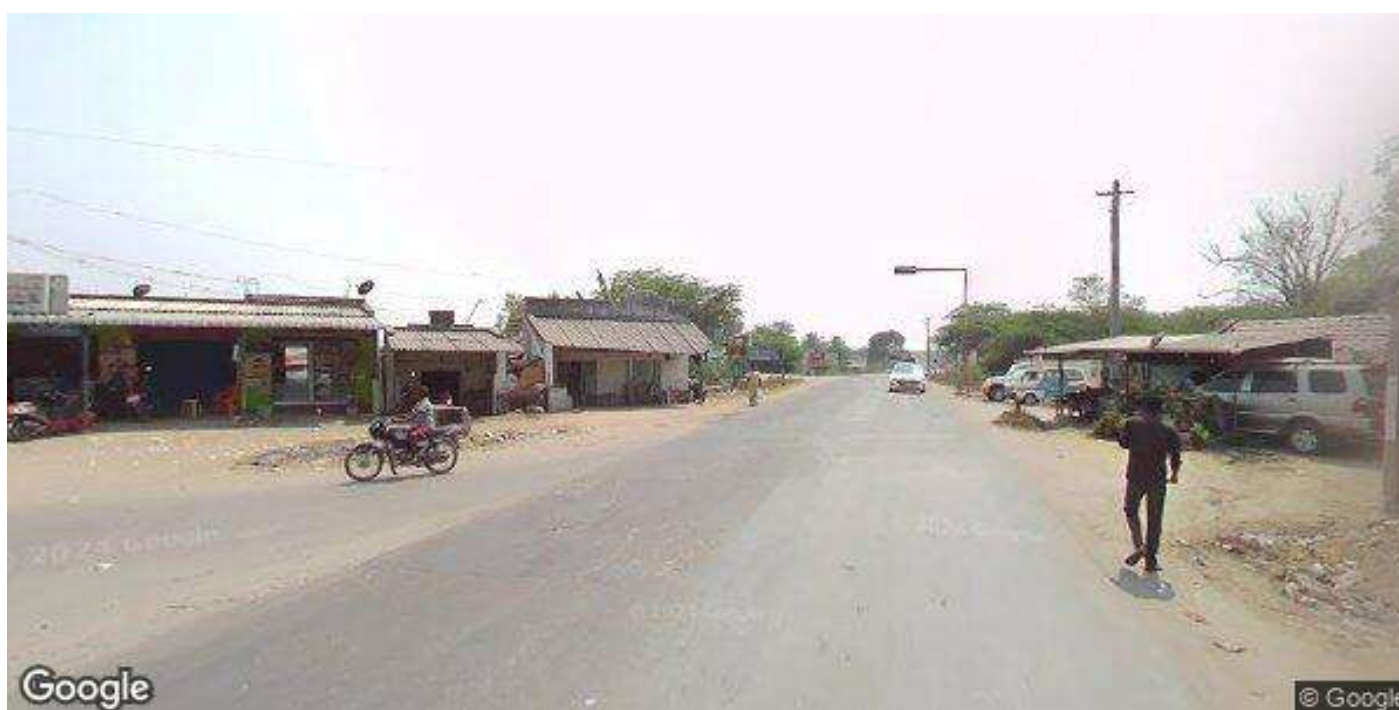
**Risk Type:** Turn  
**Risk Level:** Medium  
**Speed Limit:** 30 KM/Hr  
**Coordinates:** 11.64161, 77.95177

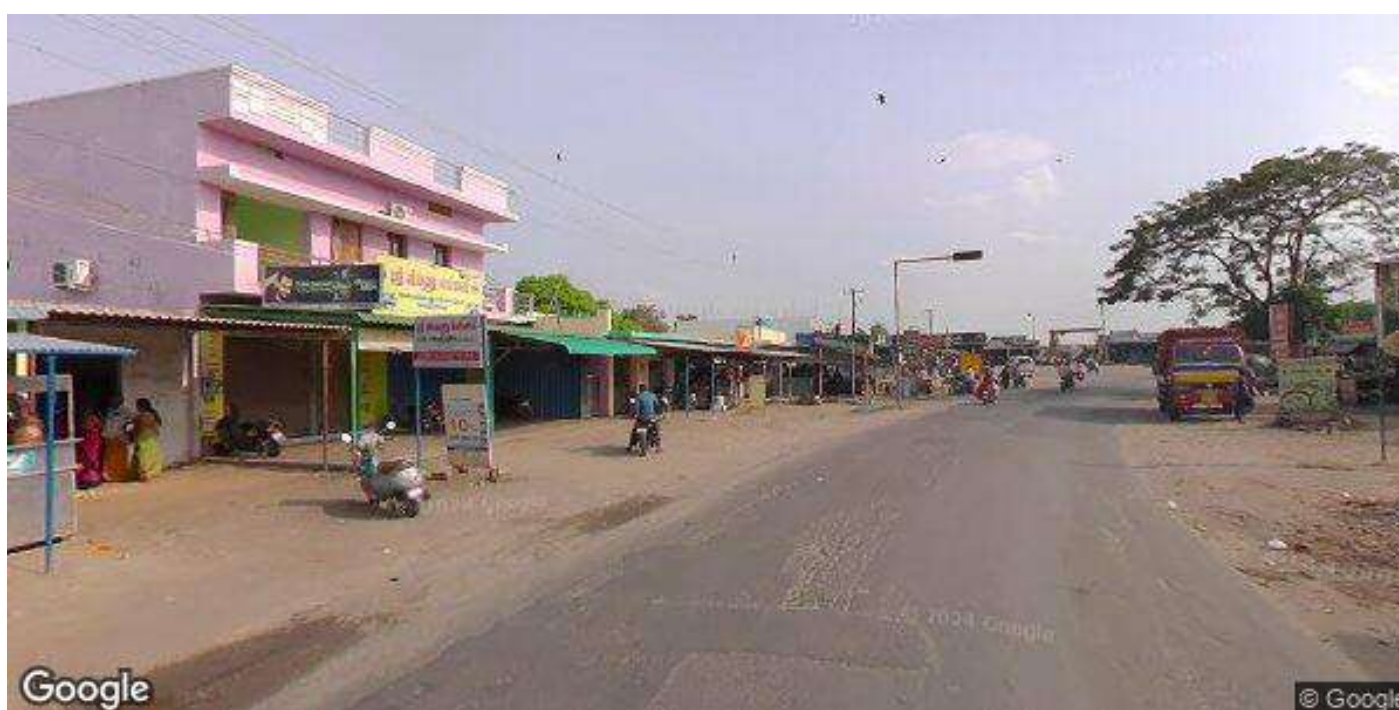
**Risk Type:** Turn  
**Risk Level:** Medium  
**Speed Limit:** 30 KM/Hr  
**Coordinates:** 11.64226, 77.95200

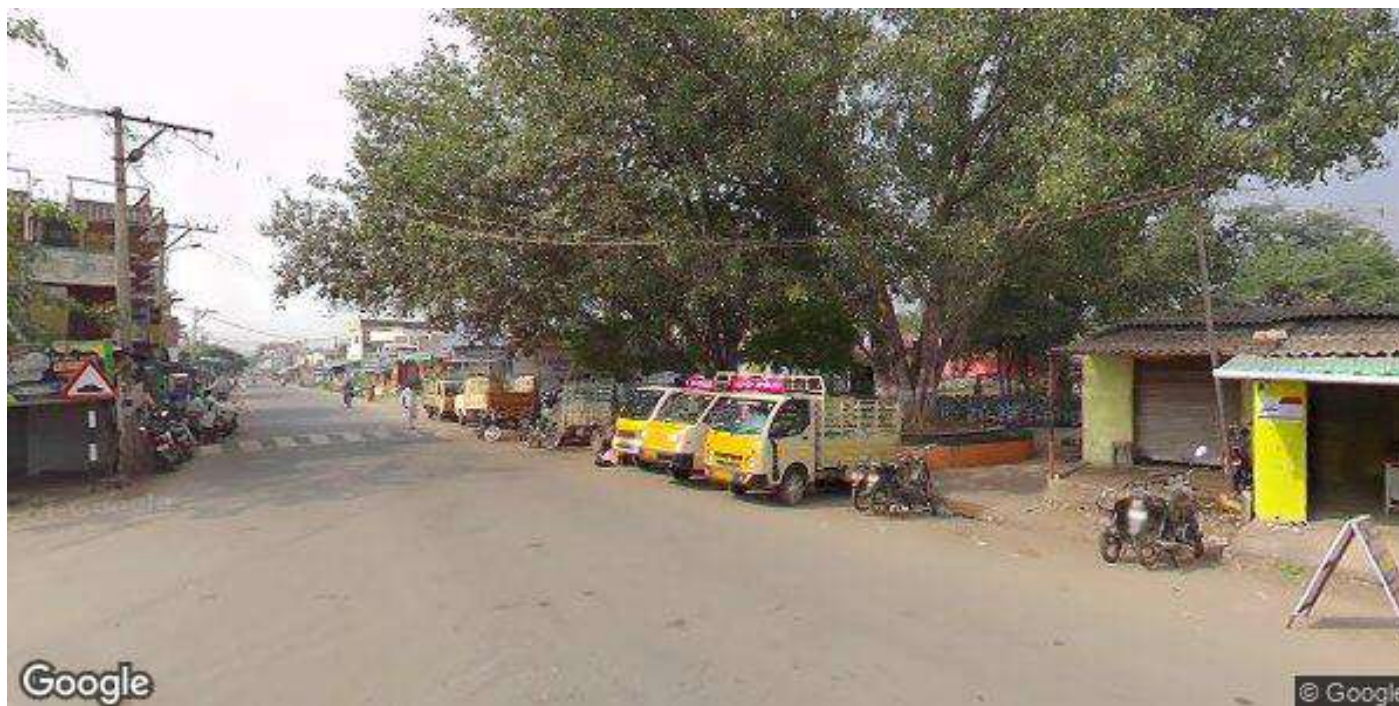
**Risk Type:** Turn  
**Risk Level:** Medium  
**Speed Limit:** 30 KM/Hr  
**Coordinates:** 11.64716, 77.95118

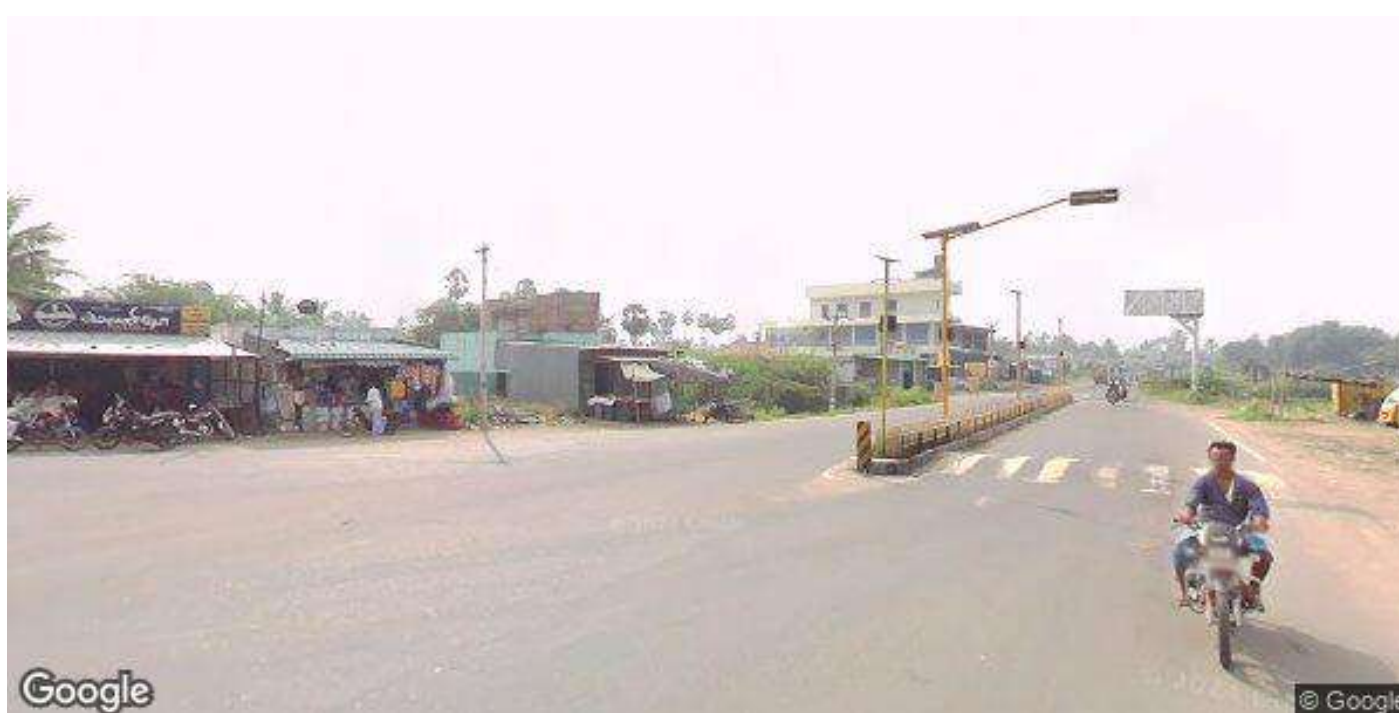
**Risk Type:** Turn  
**Risk Level:** High  
**Speed Limit:** 15 KM/Hr  
**Coordinates:** 11.67868, 77.96836

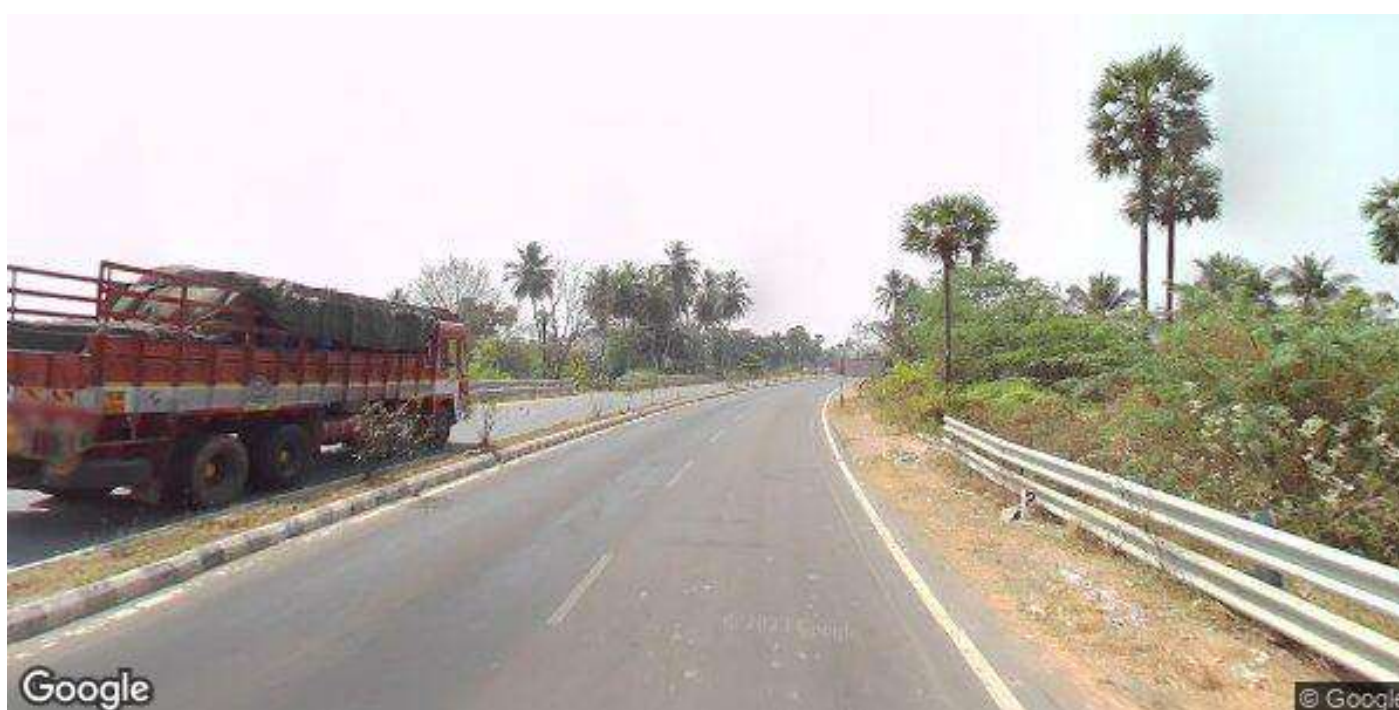
**Risk Type:** Turn  
**Risk Level:** Medium  
**Speed Limit:** 30 KM/Hr  
**Coordinates:** 11.70077, 77.97957

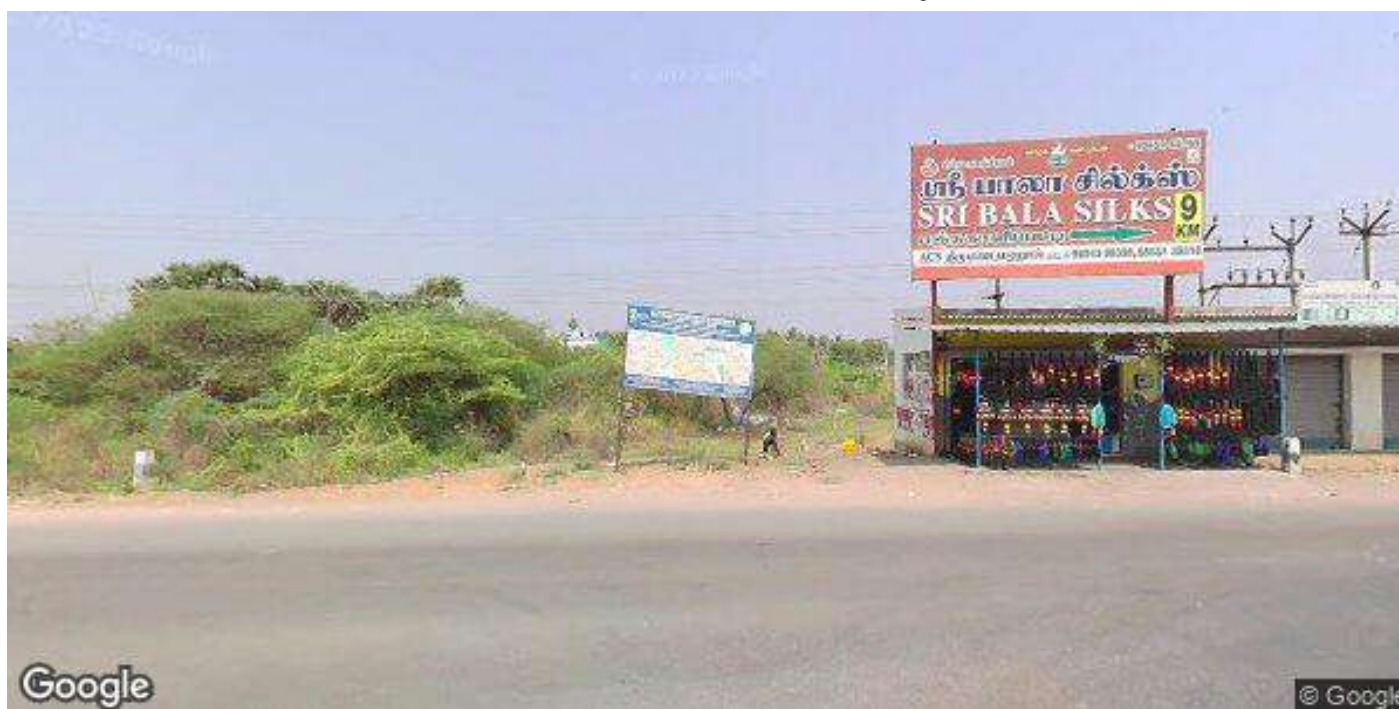
**Risk Type:** Turn  
**Risk Level:** High  
**Speed Limit:** 15 KM/Hr  
**Coordinates:** 11.70223, 77.97860

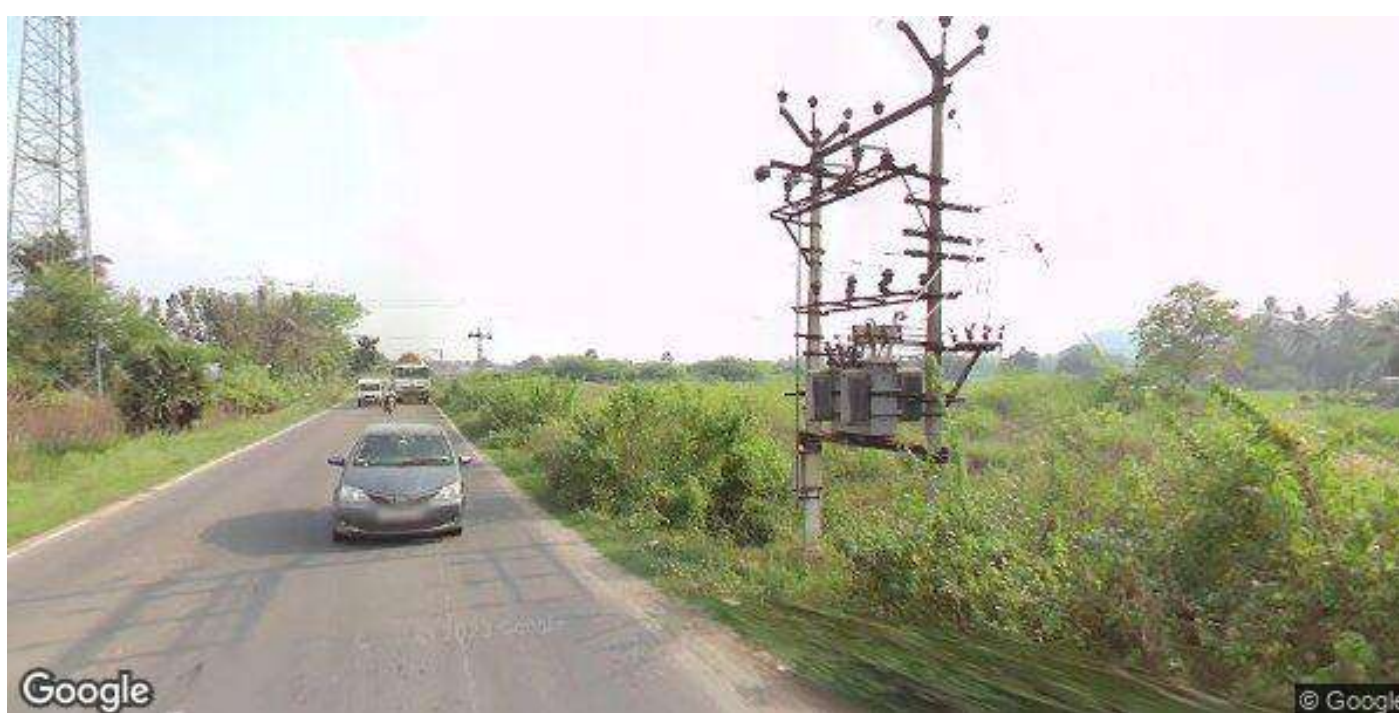
**Risk Type:** Turn  
**Risk Level:** Medium  
**Speed Limit:** 30 KM/Hr  
**Coordinates:** 11.71402, 77.99586
