# IndianOil

## JOURNEY RISK MANAGEMENT (JRM) STUDY

### Salem Terminal to SHREE RAMACHANDRAN PETROLEUM

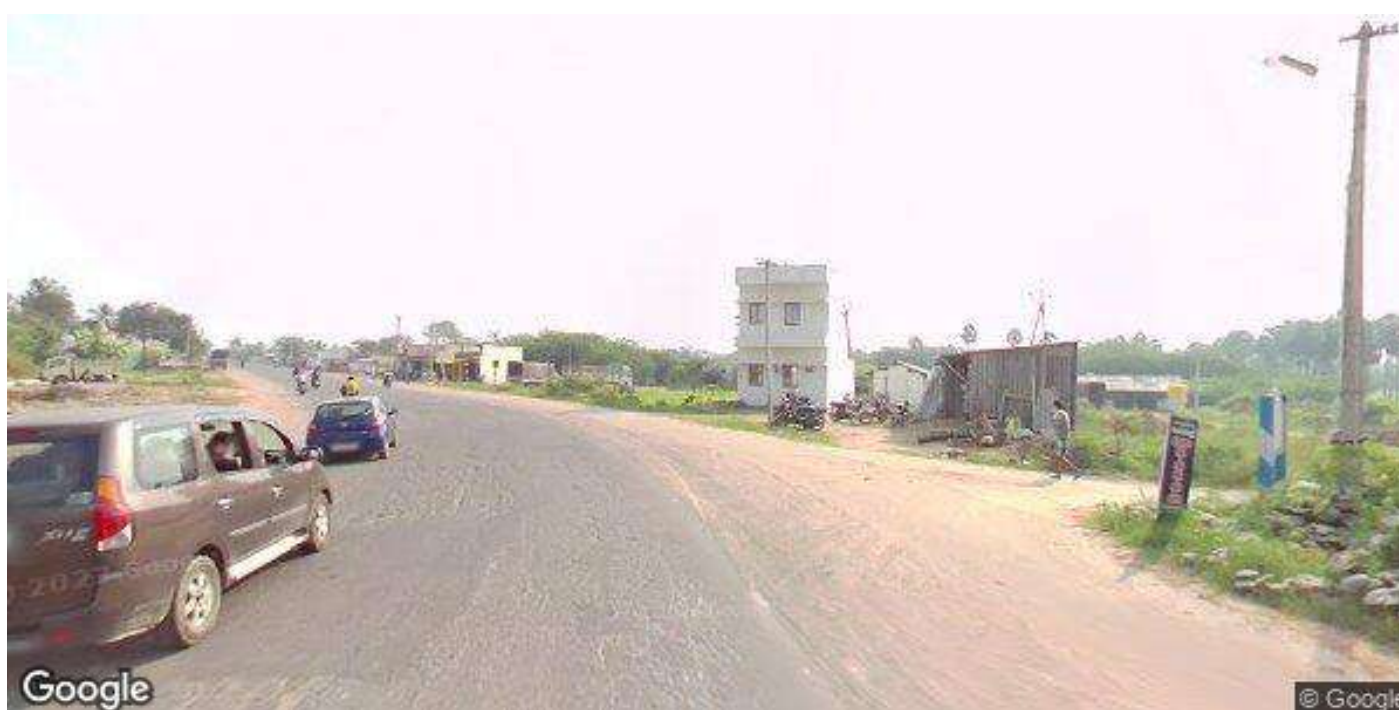
**Risk Type:** Turn  
**Risk Level:** Medium  
**Speed Limit:** 30 KM/Hr  
**Coordinates:** 11.71918, 78.01127

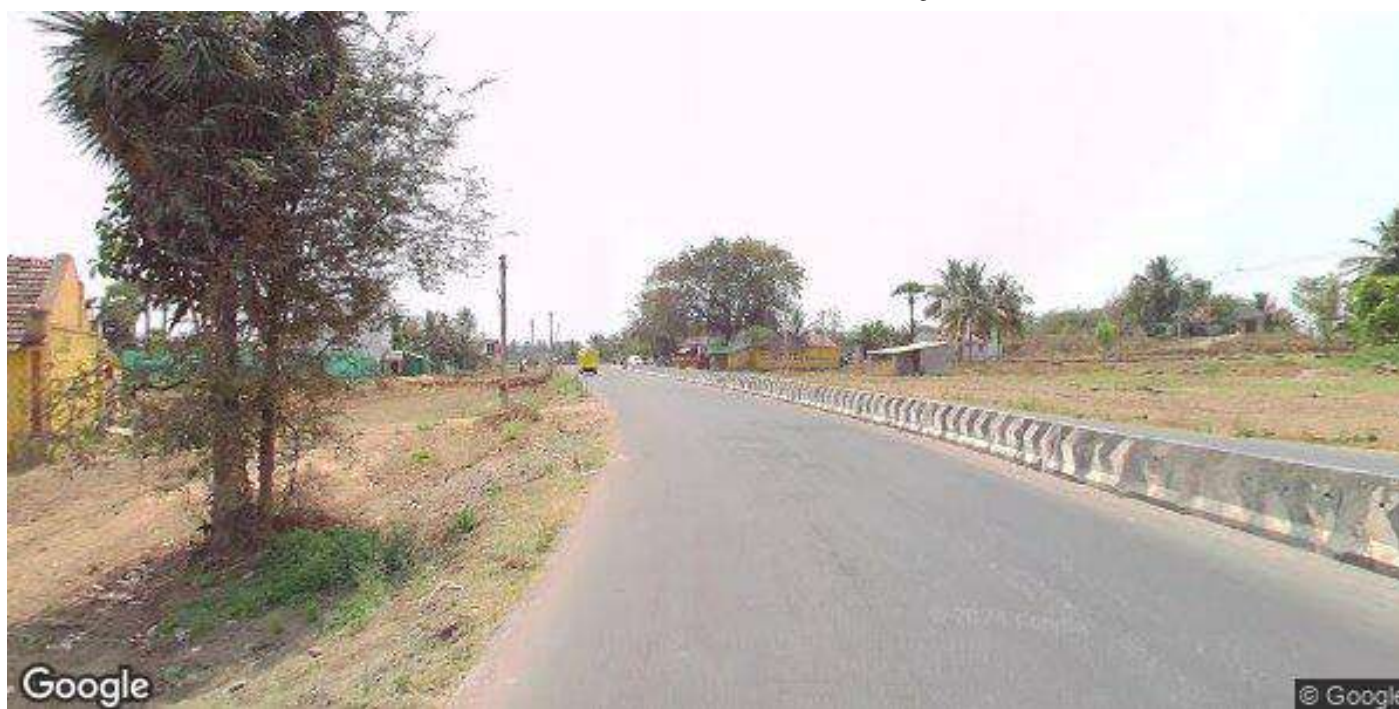
**Risk Type:** Turn  
**Risk Level:** Medium  
**Speed Limit:** 30 KM/Hr  
**Coordinates:** 11.72565, 78.01770

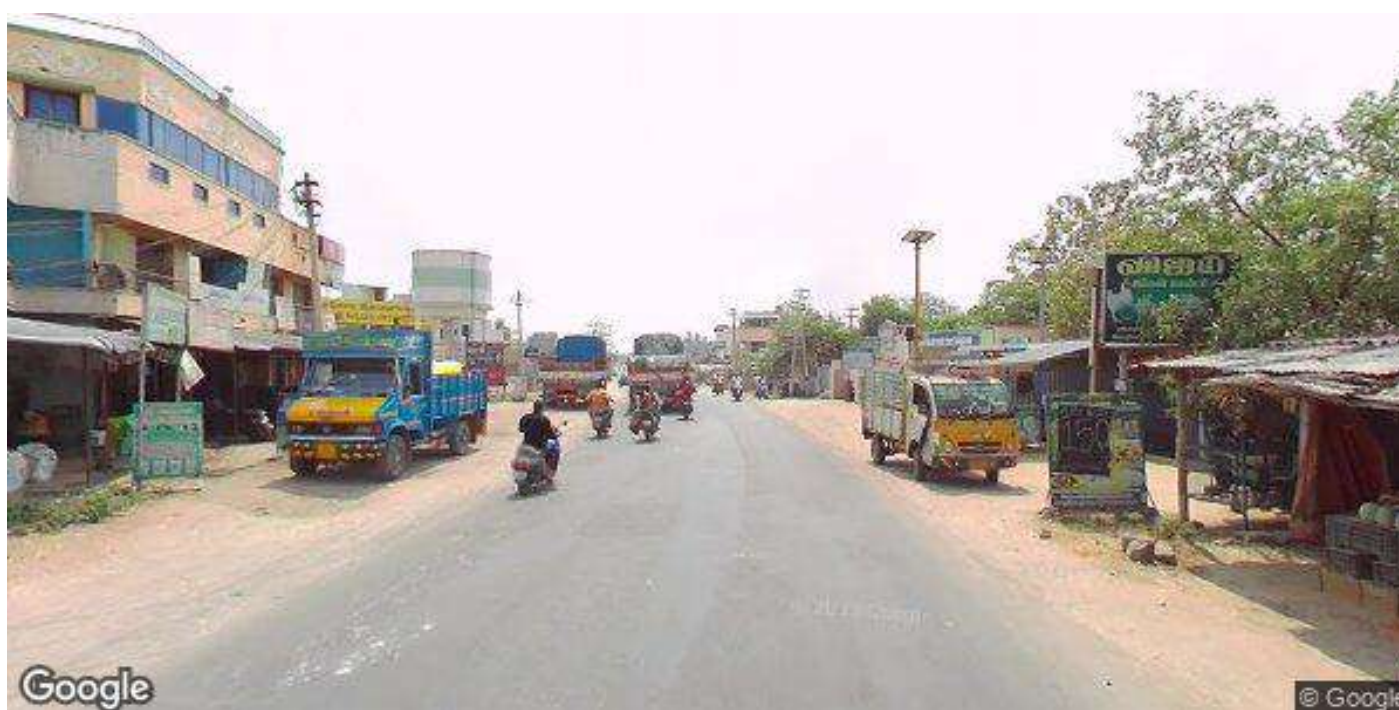
**Risk Type:** Turn  
**Risk Level:** Medium  
**Speed Limit:** 30 KM/Hr  
**Coordinates:** 11.73769, 78.03451

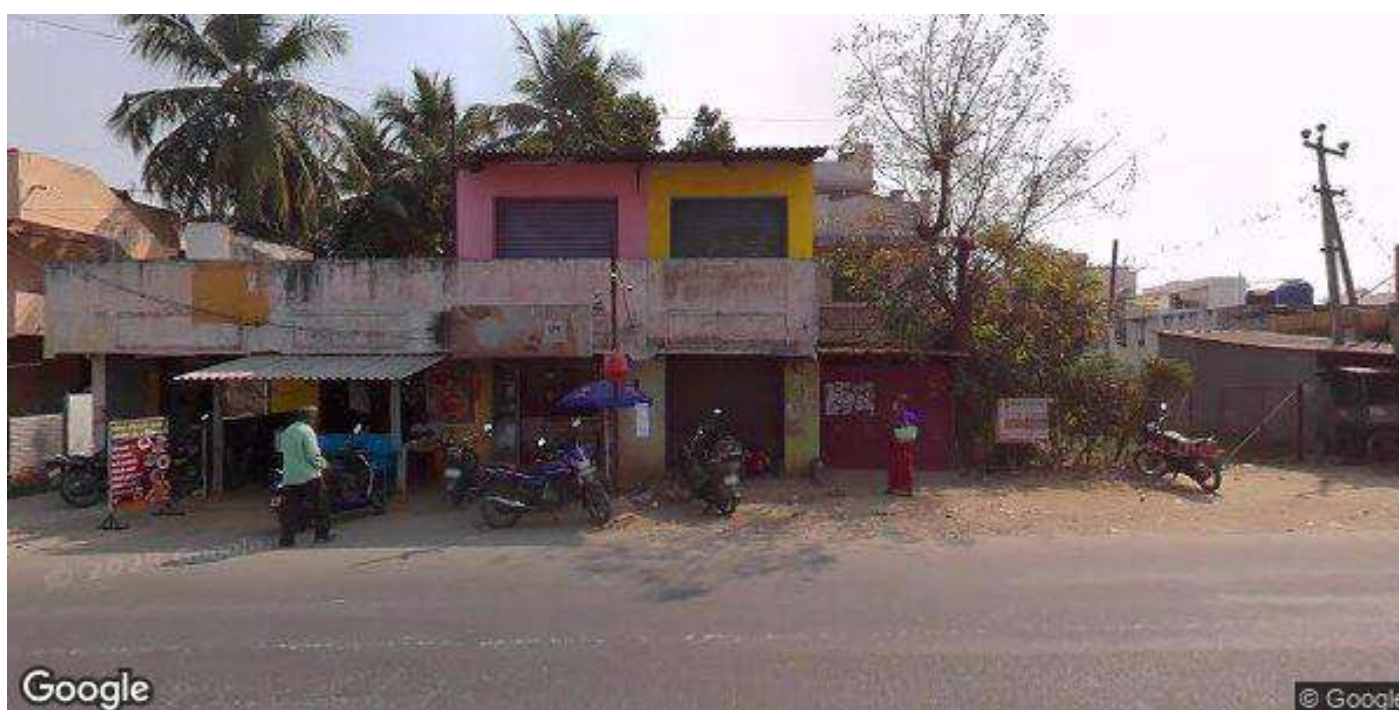
**Risk Type:** Turn  
**Risk Level:** Medium  
**Speed Limit:** 30 KM/Hr  
**Coordinates:** 11.73785, 78.03551

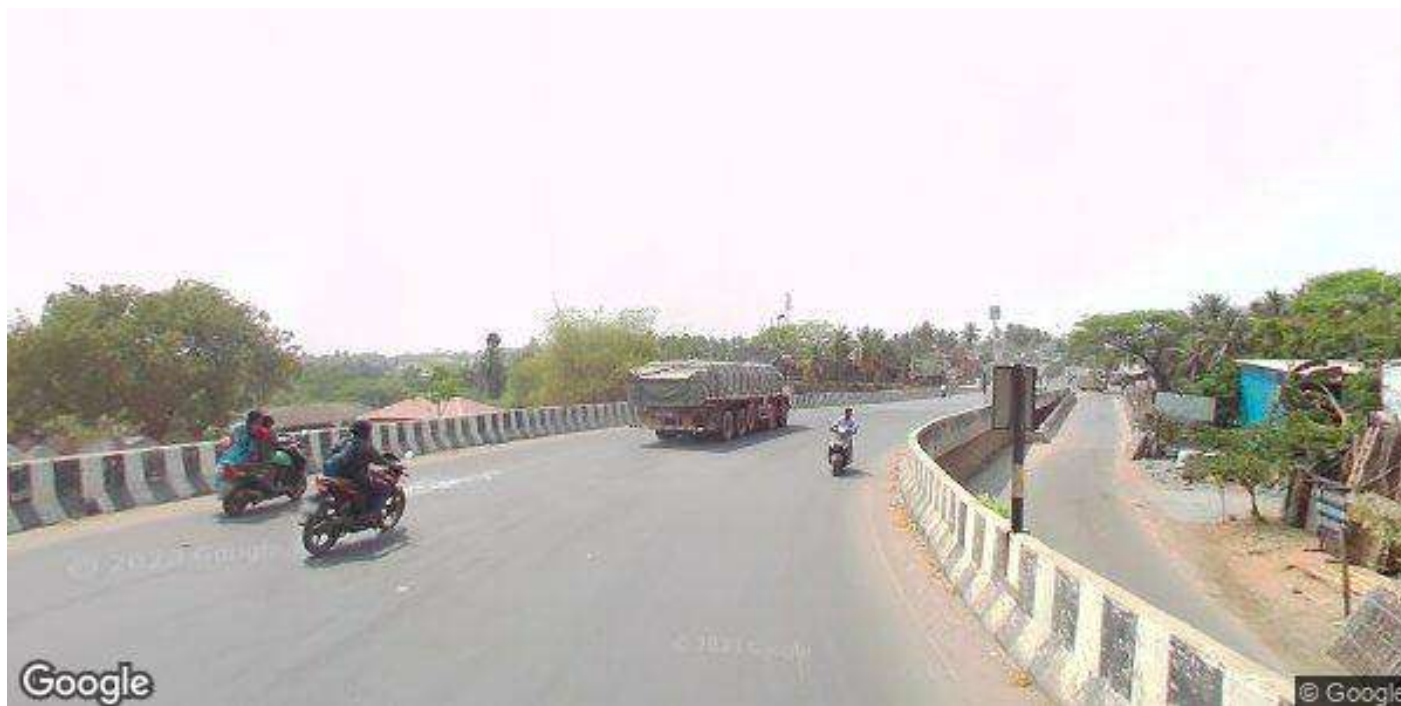
**Risk Type:** Turn  
**Risk Level:** High  
**Speed Limit:** 15 KM/Hr  
**Coordinates:** 11.73651, 78.03871

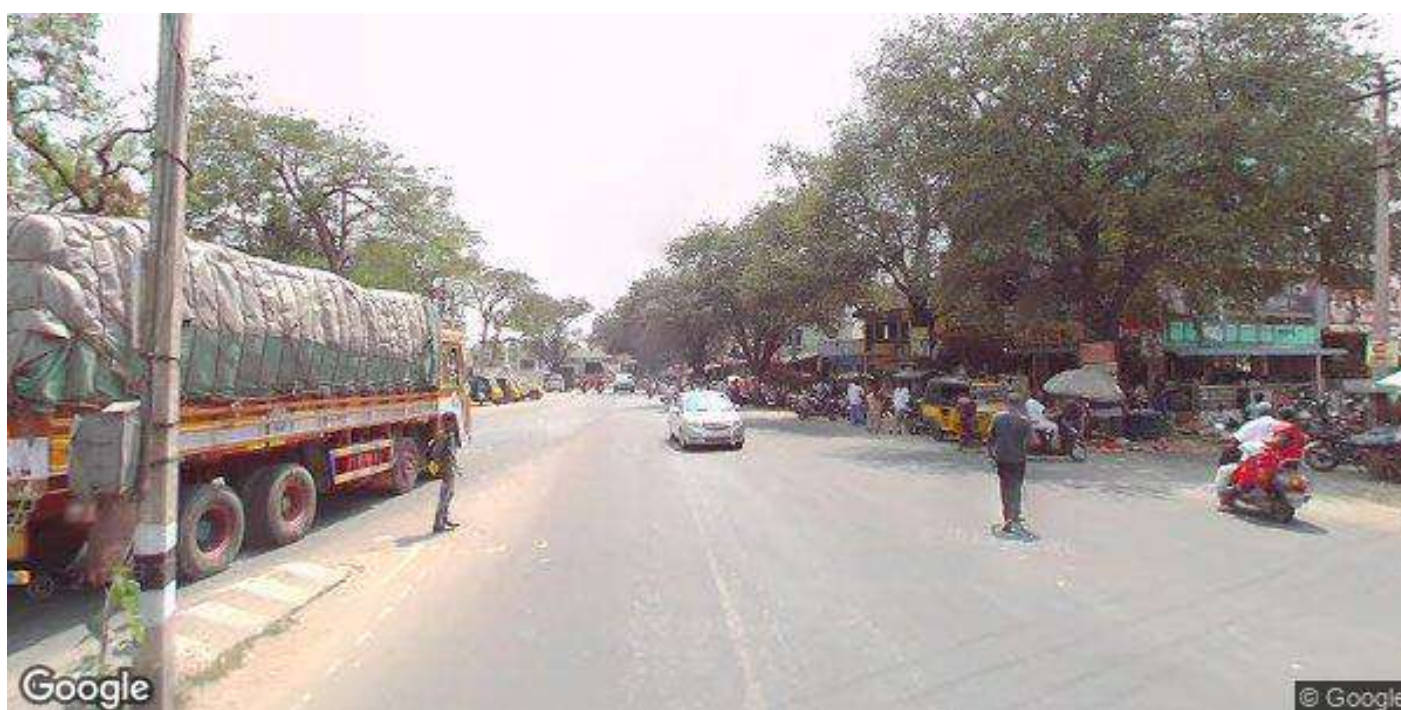
**Risk Type:** Turn  
**Risk Level:** Medium  
**Speed Limit:** 30 KM/Hr  
**Coordinates:** 11.74271, 78.04717

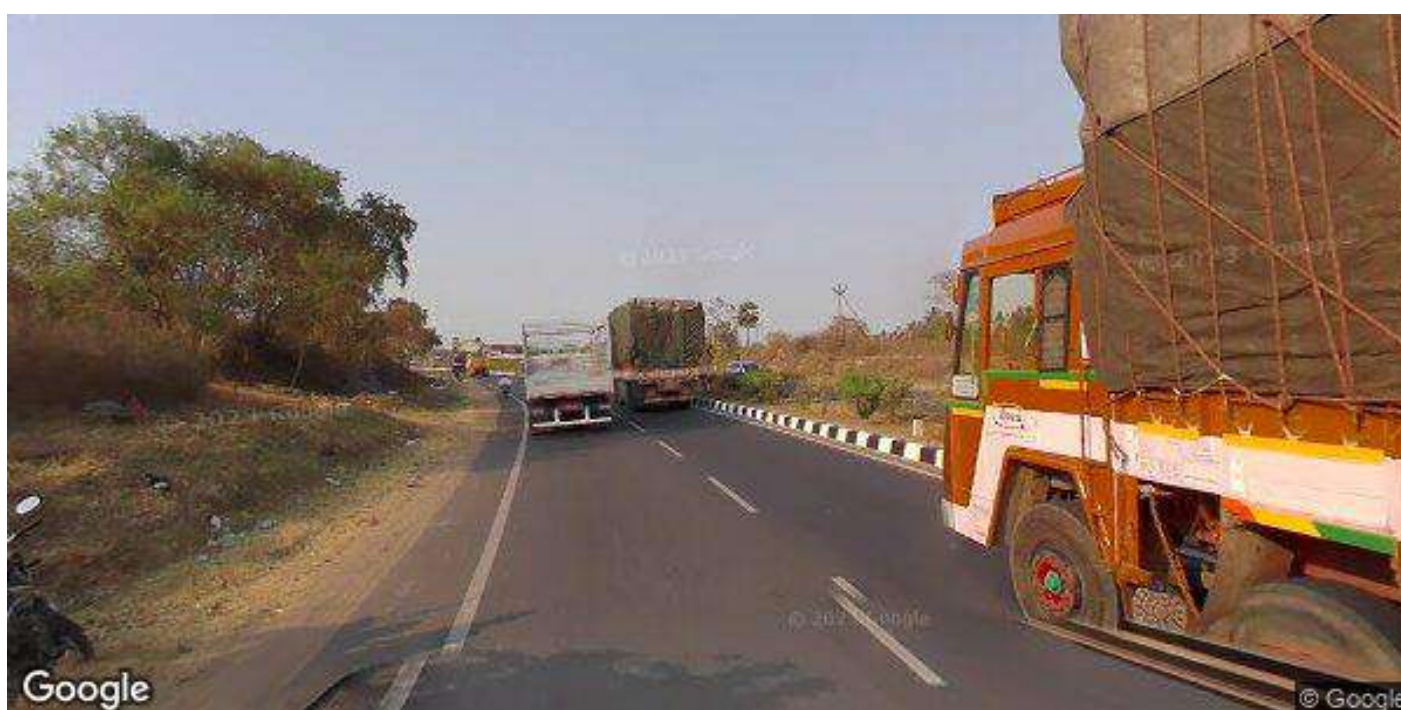
**Risk Type:** Turn  
**Risk Level:** Medium  
**Speed Limit:** 30 KM/Hr  
**Coordinates:** 11.78017, 78.05790

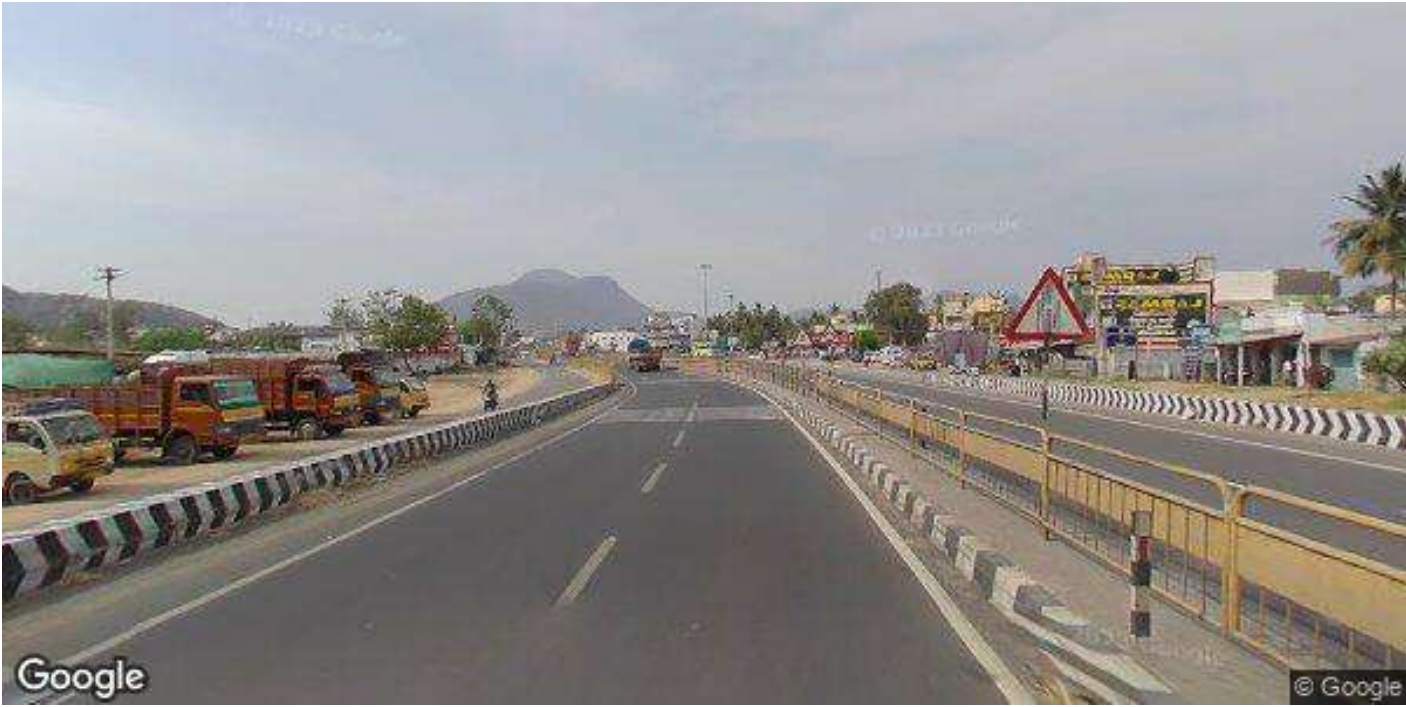
**Risk Type:** Turn  
**Risk Level:** Medium  
**Speed Limit:** 30 KM/Hr  
**Coordinates:** 11.86953, 78.08386

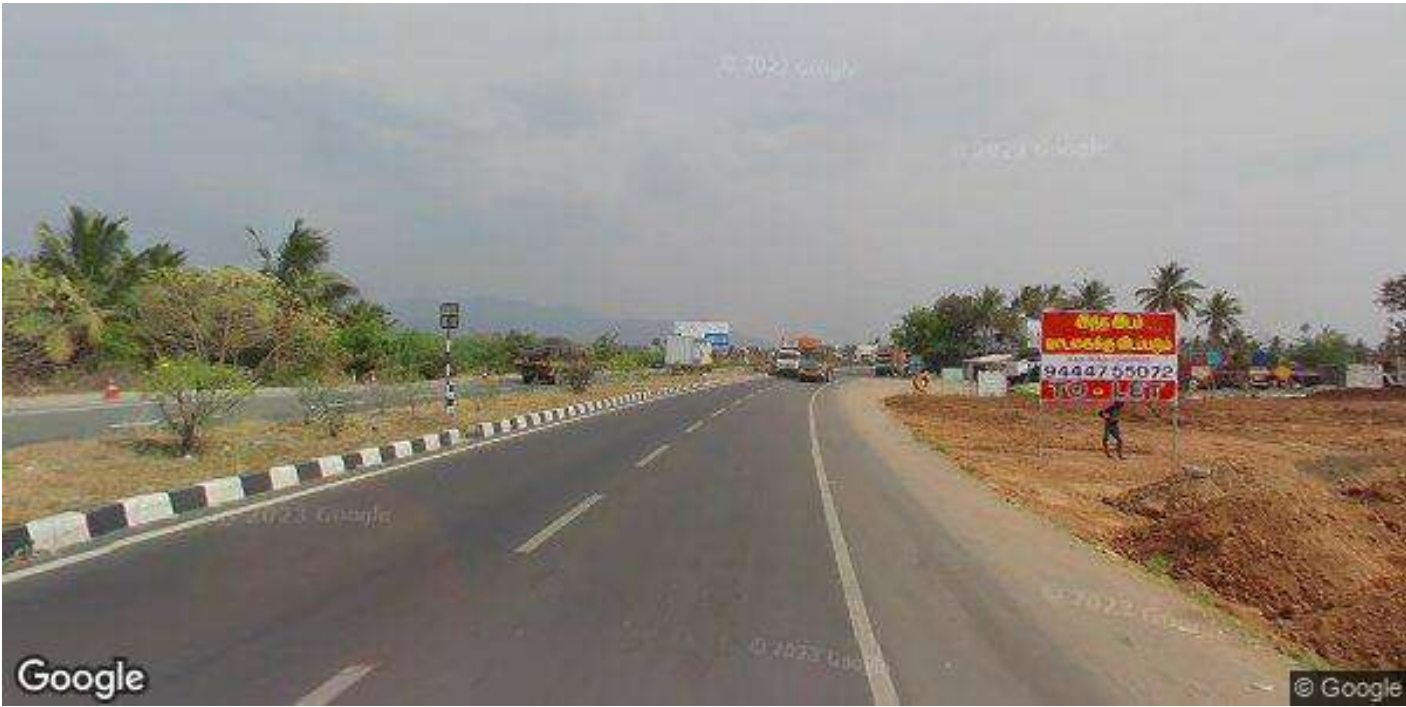
**Risk Type:** Turn  
**Risk Level:** Medium  
**Speed Limit:** 30 KM/Hr  
**Coordinates:** 11.88019, 78.08158

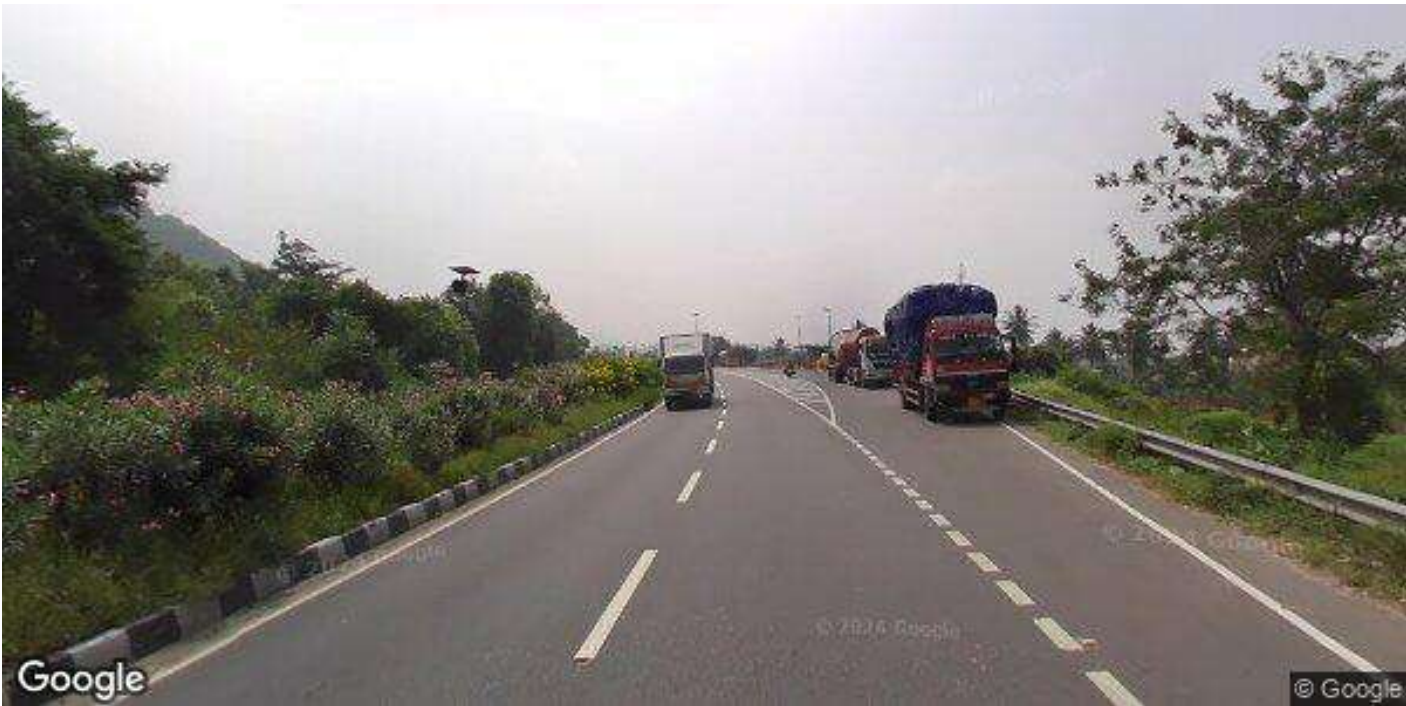
**Risk Type:** Turn  
**Risk Level:** Medium  
**Speed Limit:** 30 KM/Hr  
**Coordinates:** 11.91282, 78.05854

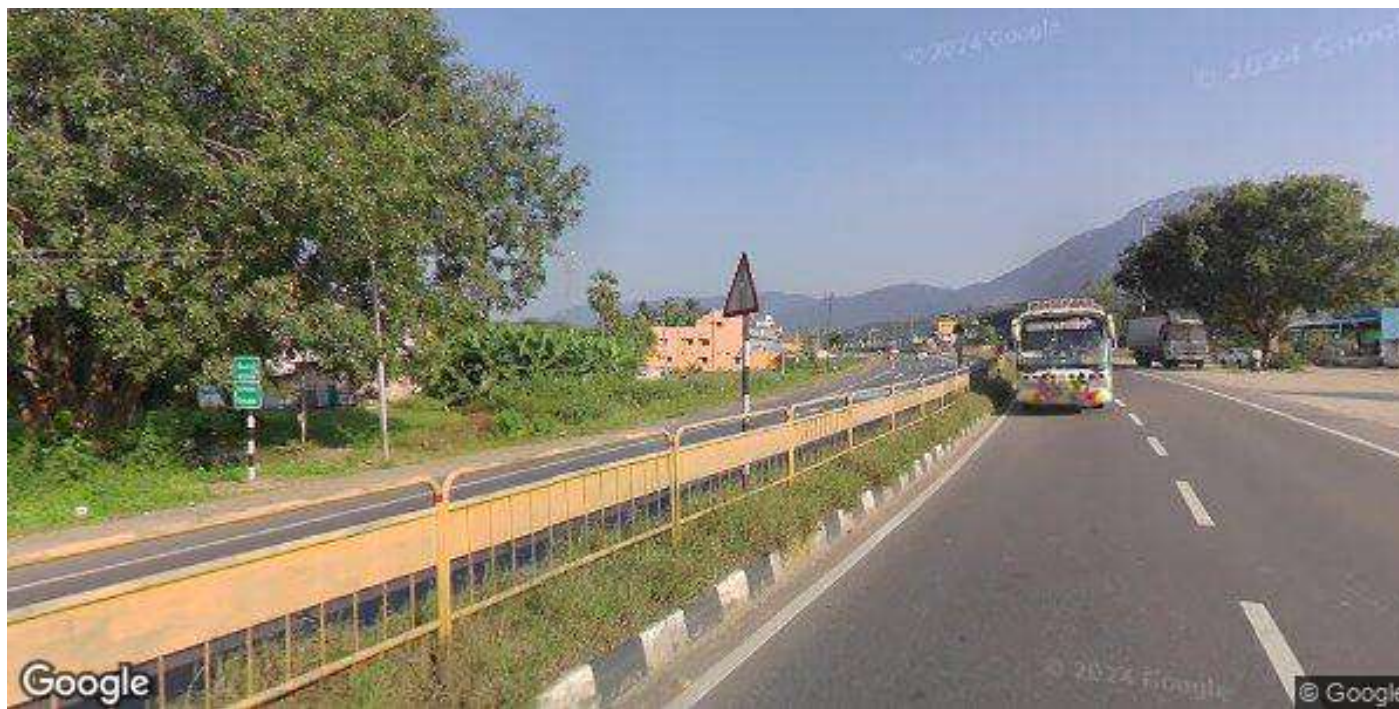
**Risk Type:** Turn  
**Risk Level:** Medium  
**Speed Limit:** 30 KM/Hr  
**Coordinates:** 11.93757, 78.05319

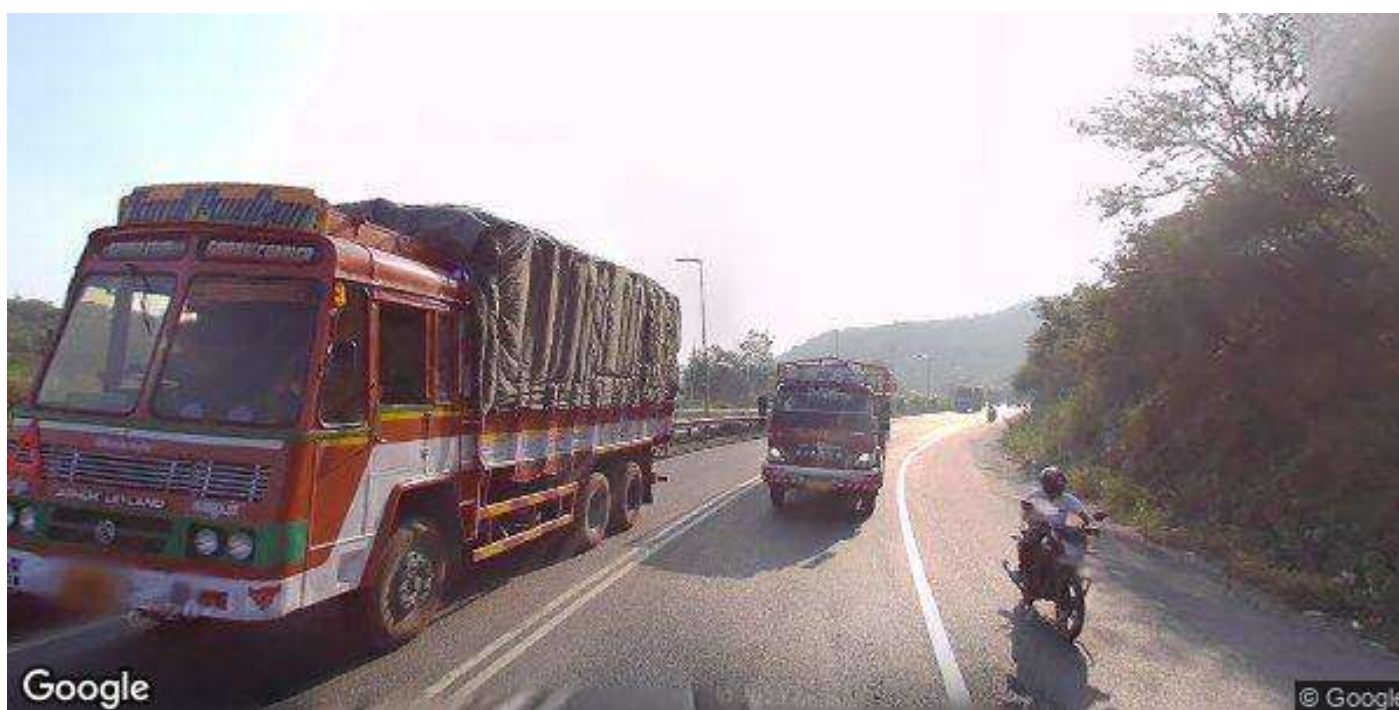
**Risk Type:** Turn  
**Risk Level:** Medium  
**Speed Limit:** 30 KM/Hr  
**Coordinates:** 11.95816, 78.04976

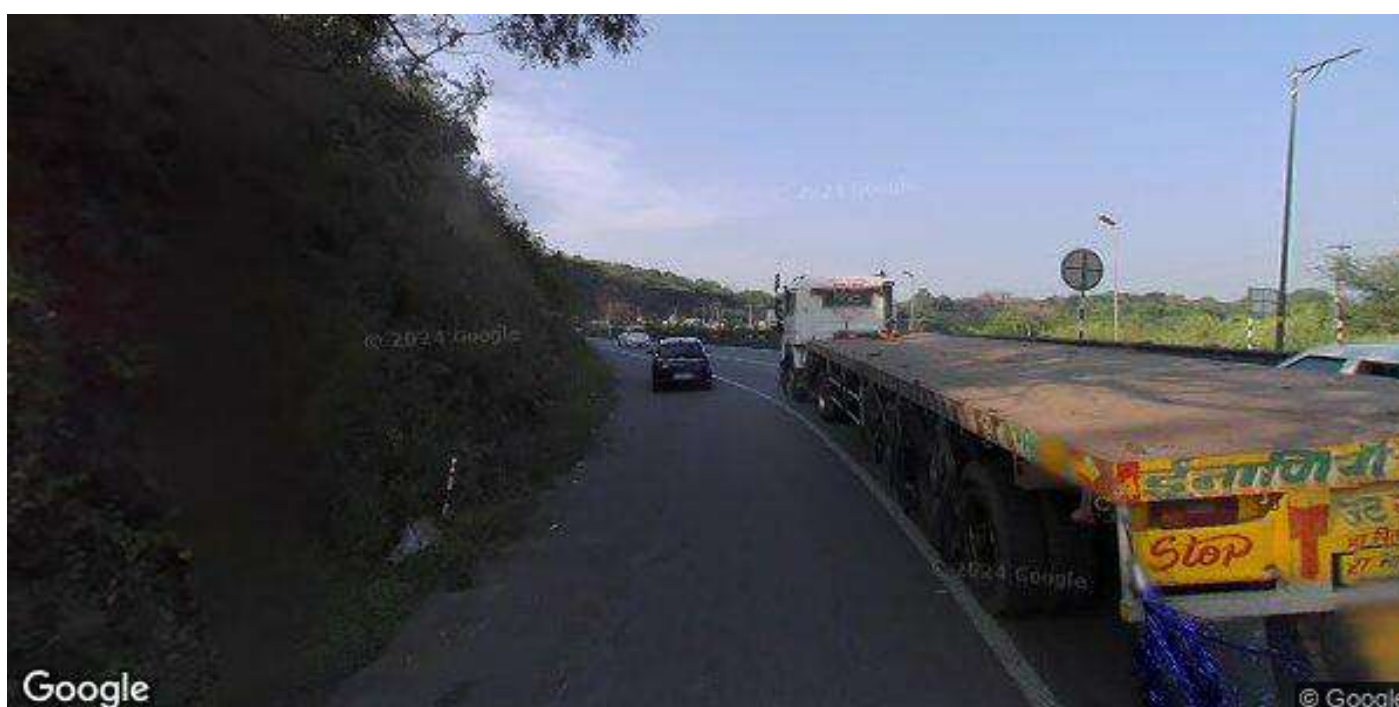
**Risk Type:** Turn  
**Risk Level:** Medium  
**Speed Limit:** 30 KM/Hr  
**Coordinates:** 11.95870, 78.04990

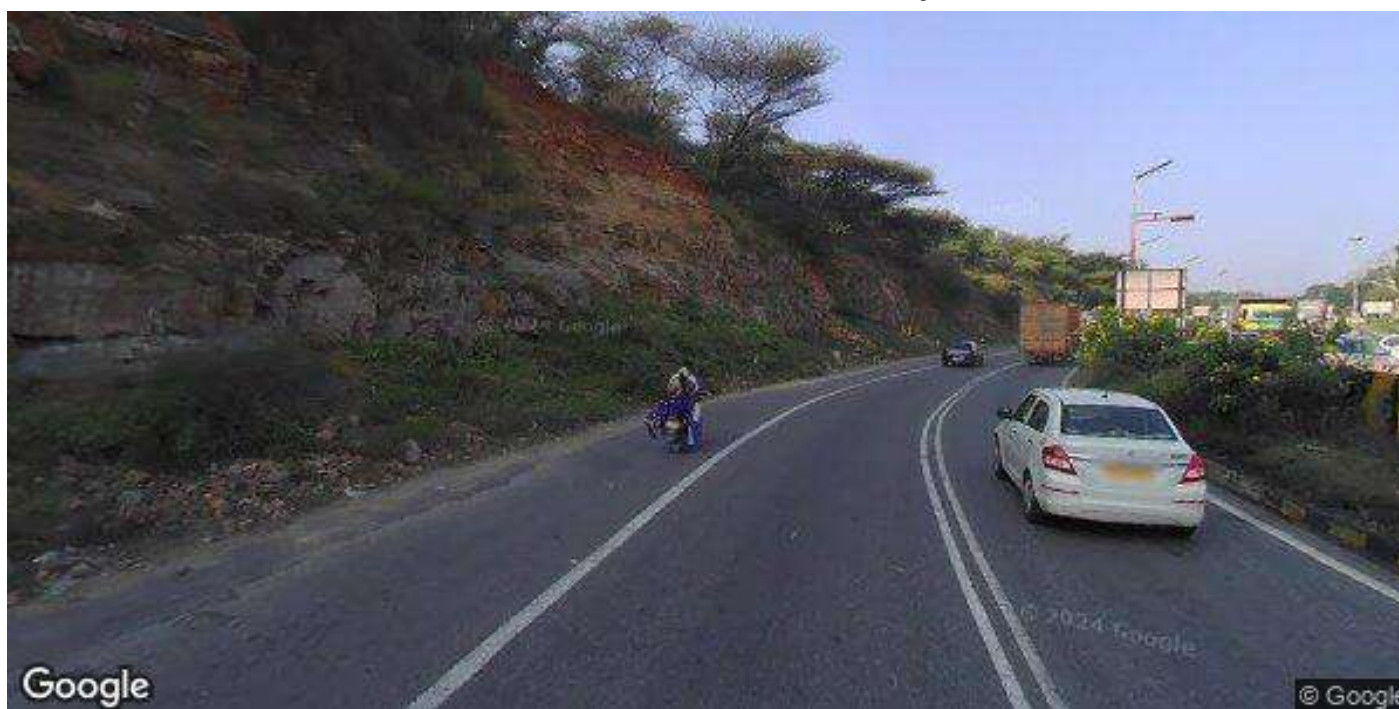
**Risk Type:** Turn  
**Risk Level:** High  
**Speed Limit:** 15 KM/Hr  
**Coordinates:** 11.96031, 78.04945

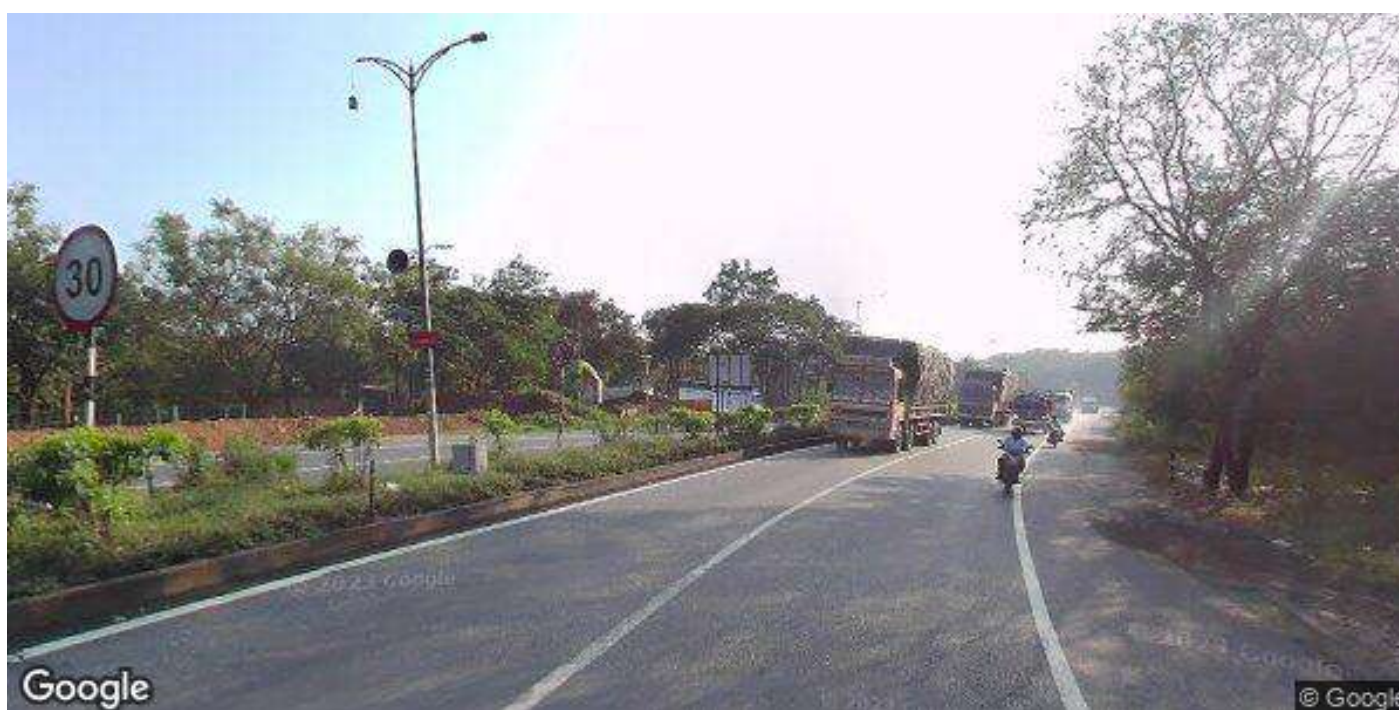
**Risk Type:** Turn  
**Risk Level:** Medium  
**Speed Limit:** 30 KM/Hr  
**Coordinates:** 11.96291, 78.05131

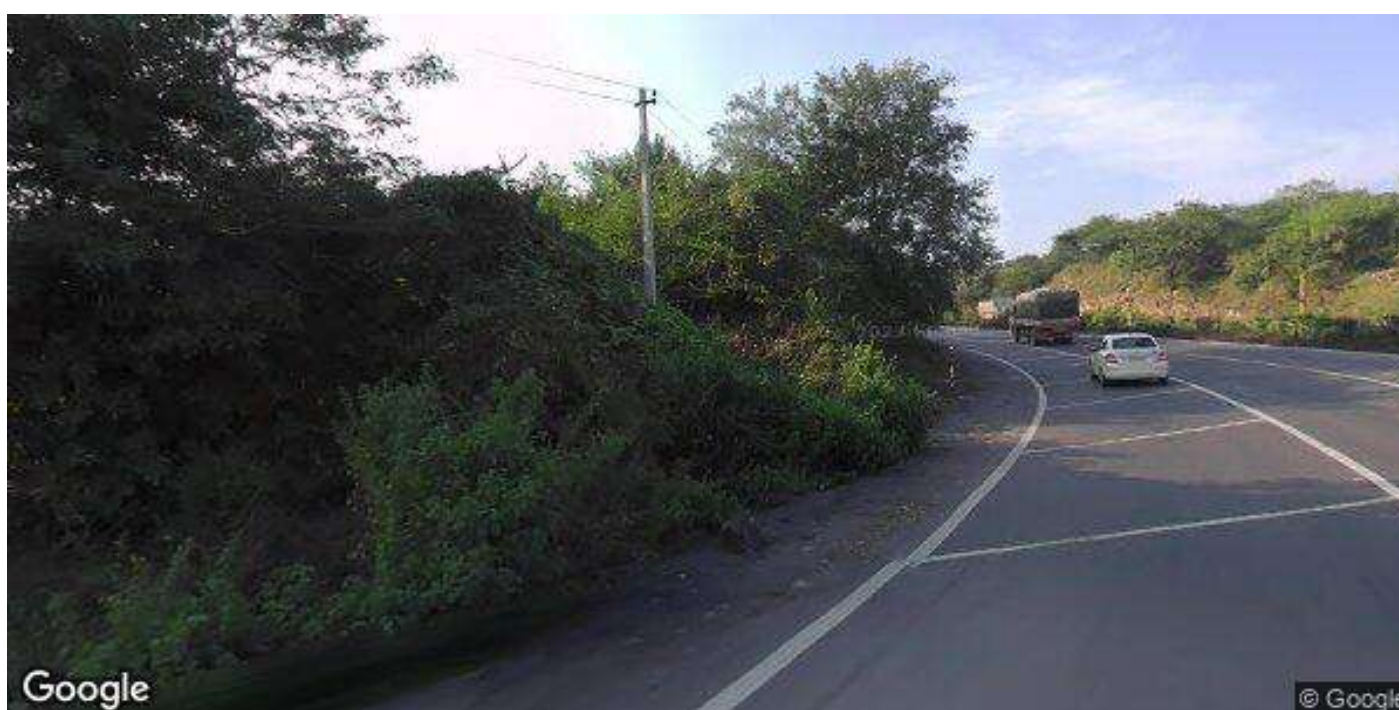
**Risk Type:** Turn  
**Risk Level:** Medium  
**Speed Limit:** 30 KM/Hr  
**Coordinates:** 11.96390, 78.05138

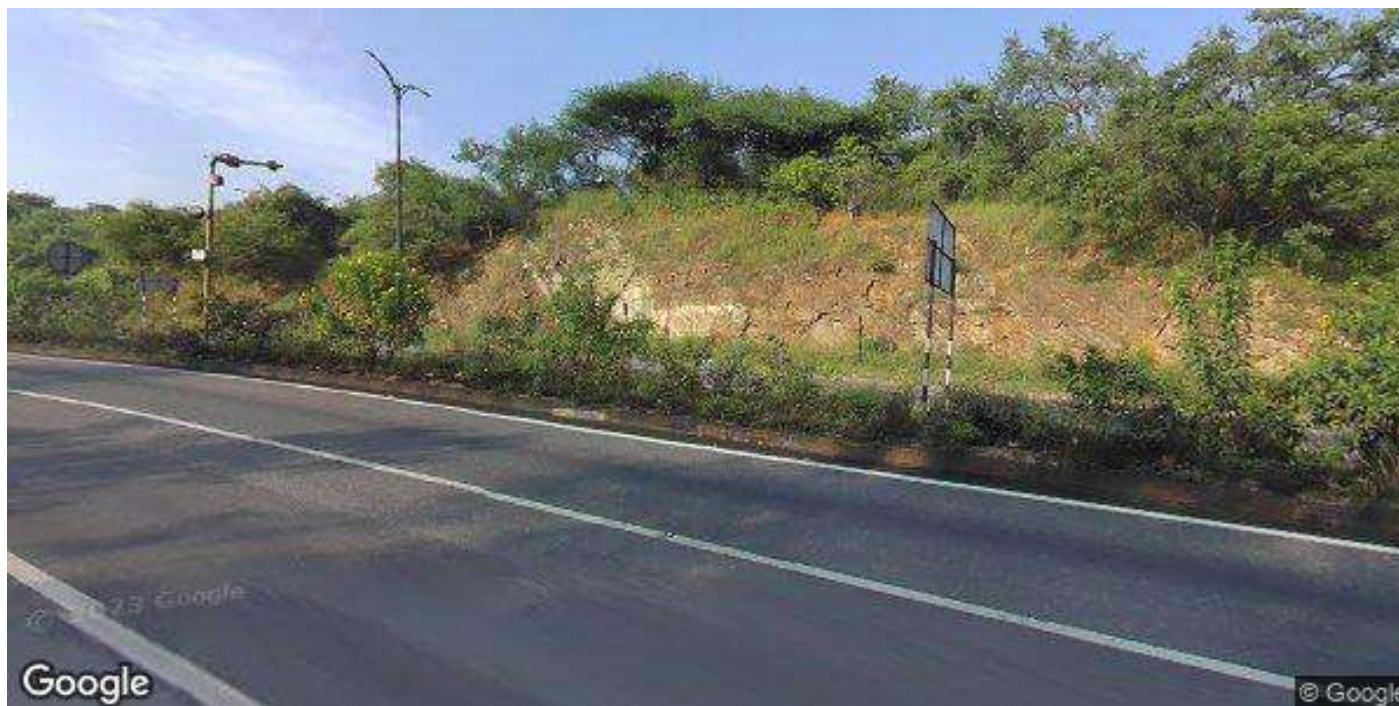
**Risk Type:** Turn  
**Risk Level:** Medium  
**Speed Limit:** 30 KM/Hr  
**Coordinates:** 11.96453, 78.05092

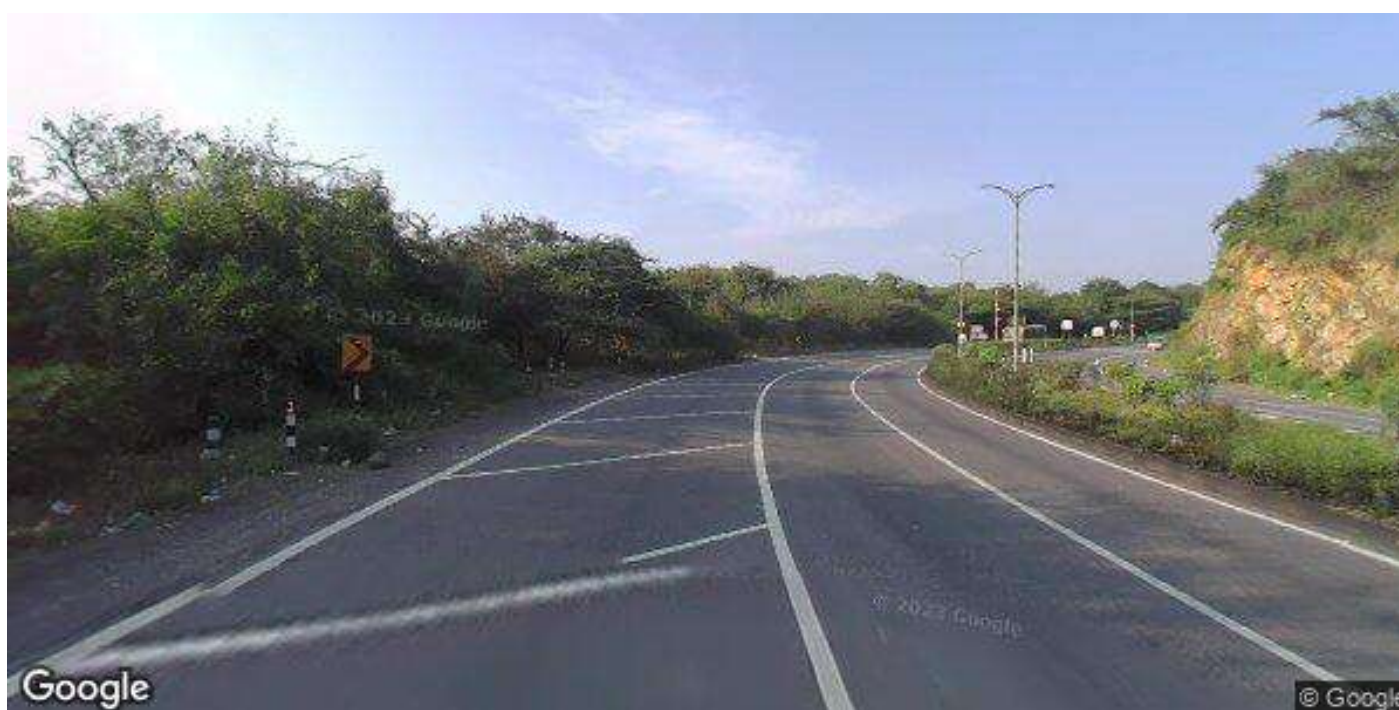
**Risk Type:** Turn  
**Risk Level:** High  
**Speed Limit:** 15 KM/Hr  
**Coordinates:** 11.96562, 78.04928

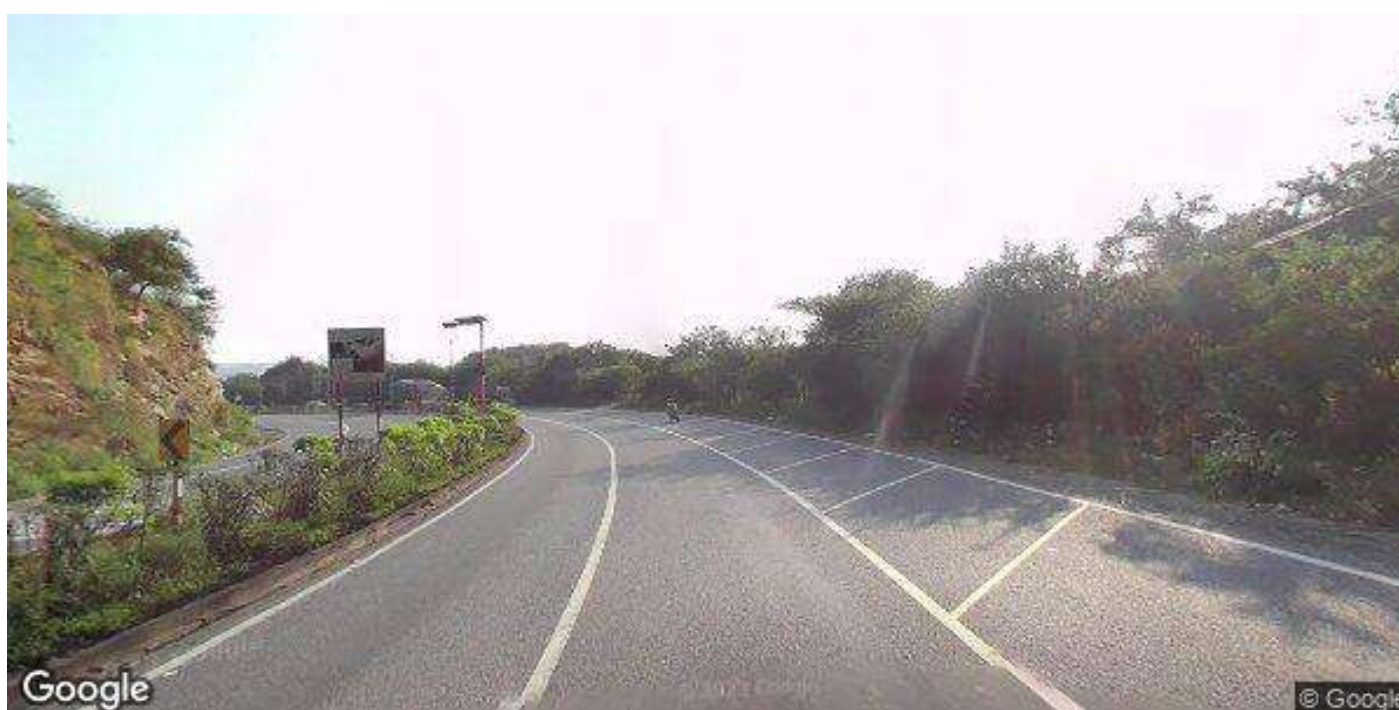
**Risk Type:** Turn  
**Risk Level:** High  
**Speed Limit:** 15 KM/Hr  
**Coordinates:** 11.96667, 78.04934

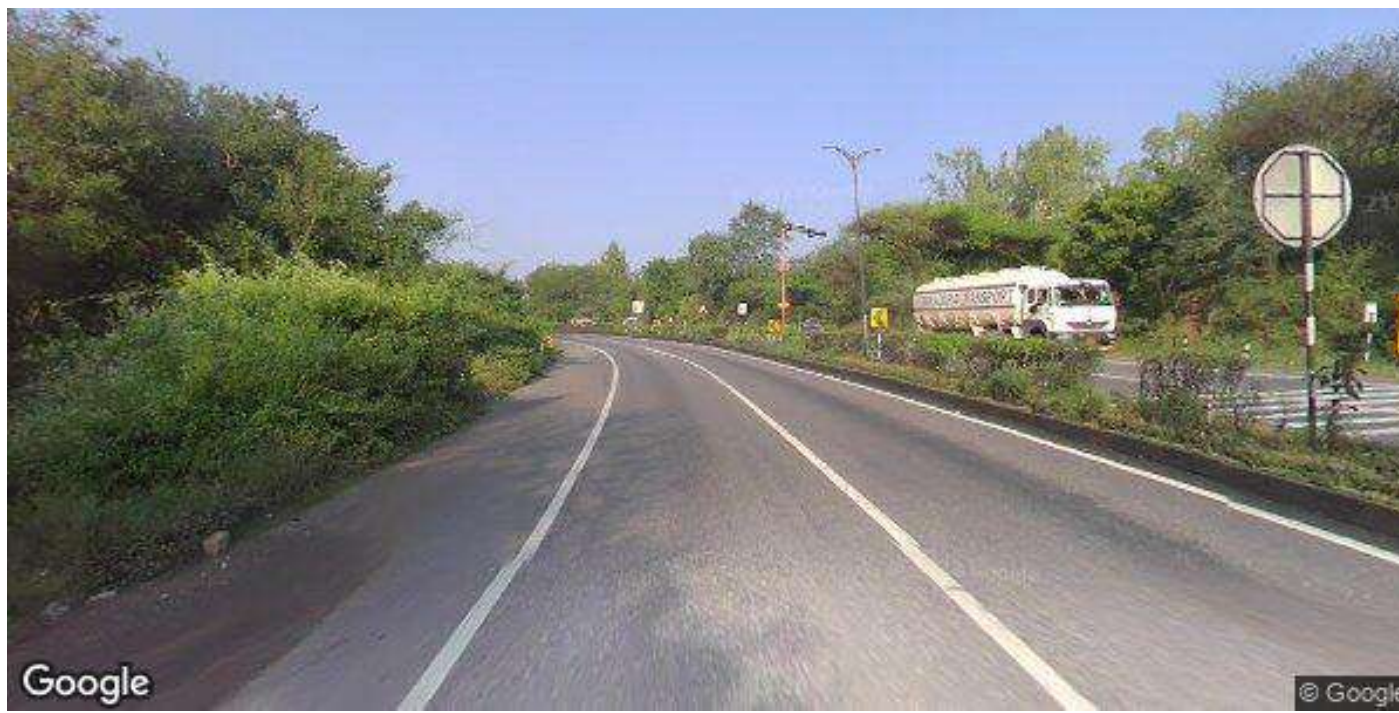
**Risk Type:** Turn  
**Risk Level:** Medium  
**Speed Limit:** 30 KM/Hr  
**Coordinates:** 11.96775, 78.05056

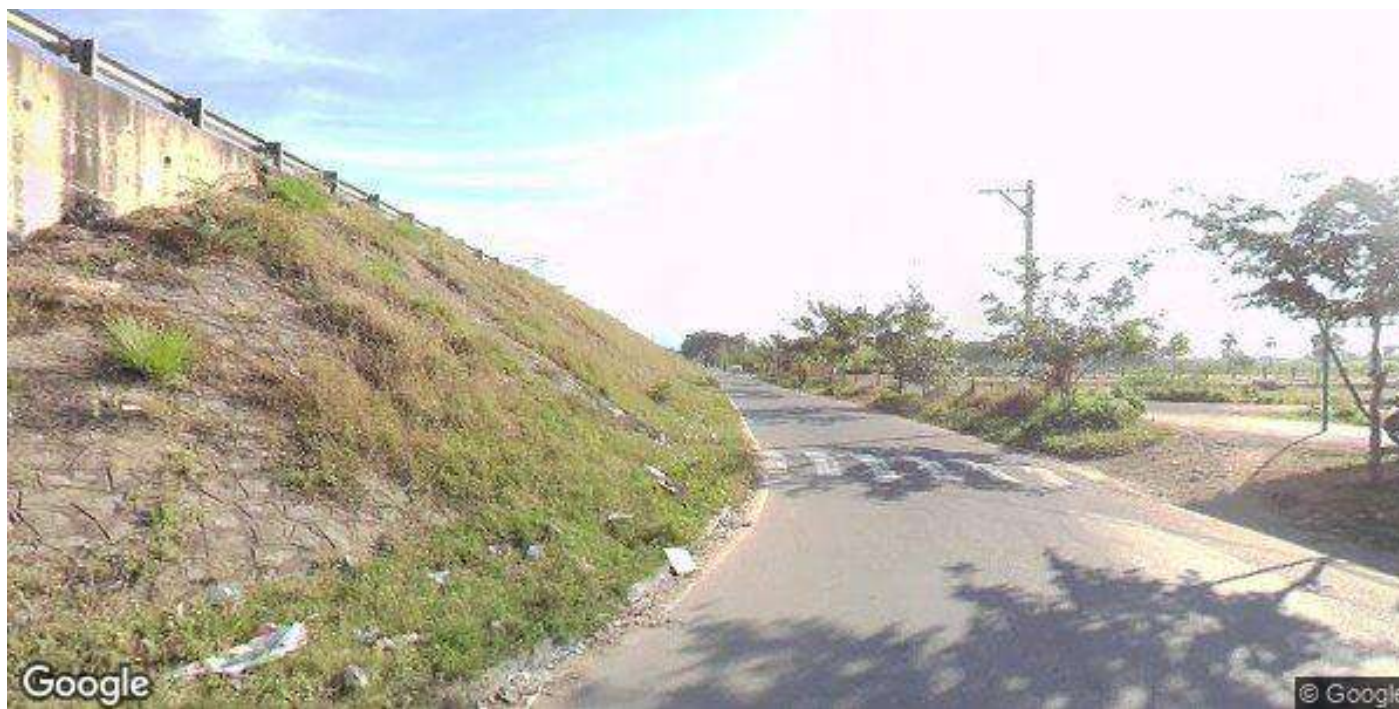
**Risk Type:** Turn  
**Risk Level:** High  
**Speed Limit:** 15 KM/Hr  
**Coordinates:** 12.05835, 78.10789

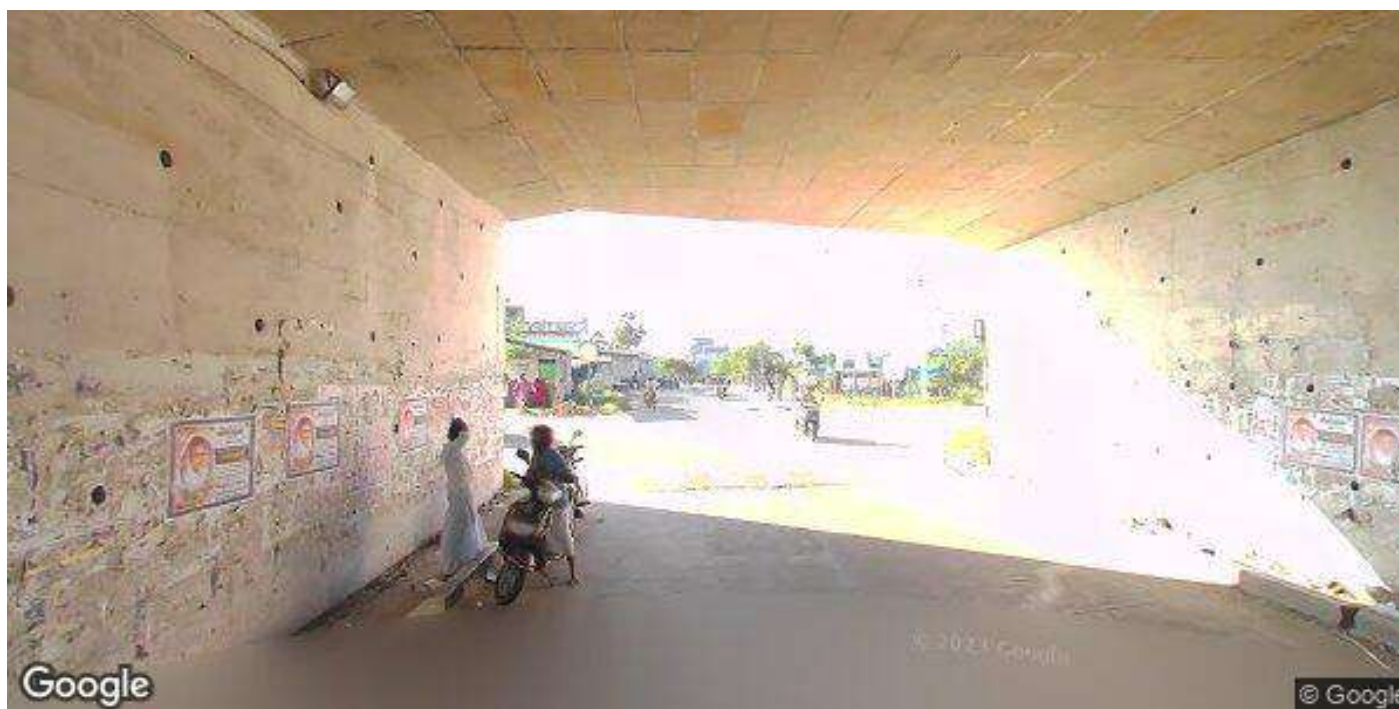
**Risk Type:** Turn  
**Risk Level:** Medium  
**Speed Limit:** 30 KM/Hr  
**Coordinates:** 12.05840, 78.10812
