# IndianOil

## JOURNEY RISK MANAGEMENT (JRM) STUDY

### Salem Terminal to SHREE RAMACHANDRAN PETROLEUM

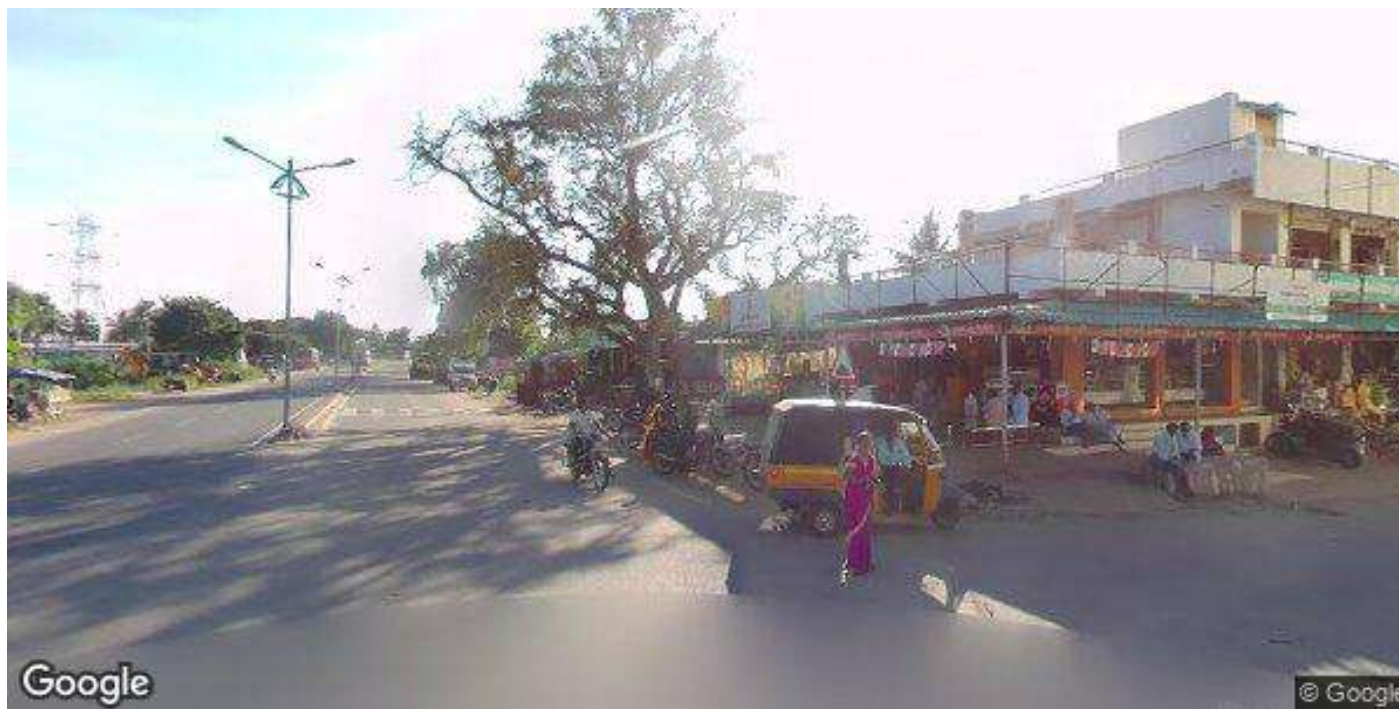
**Risk Type:** Blind Spot  
**Risk Level:** Blind Spot  
**Speed Limit:** 10 KM/Hr  
**Coordinates:** 12.05721, 78.11107

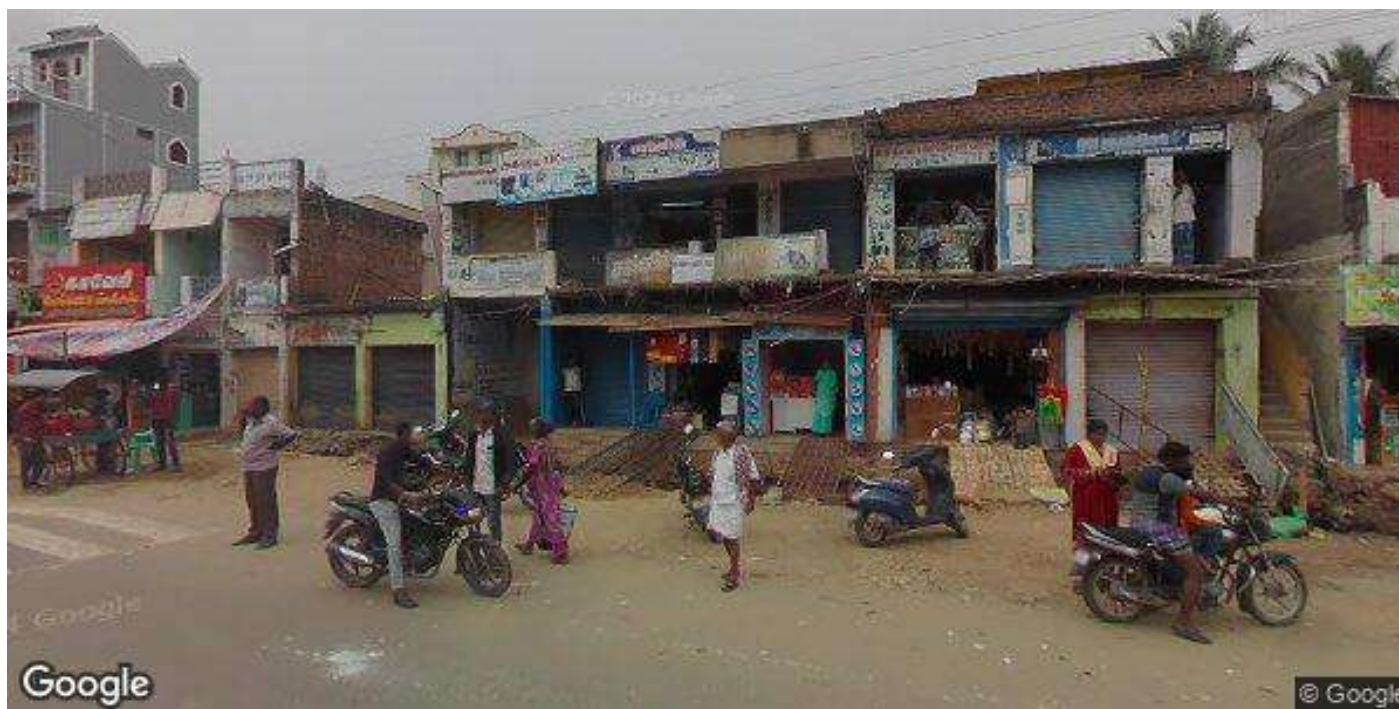
**Risk Type:** Turn  
**Risk Level:** High  
**Speed Limit:** 15 KM/Hr  
**Coordinates:** 12.06108, 78.11338

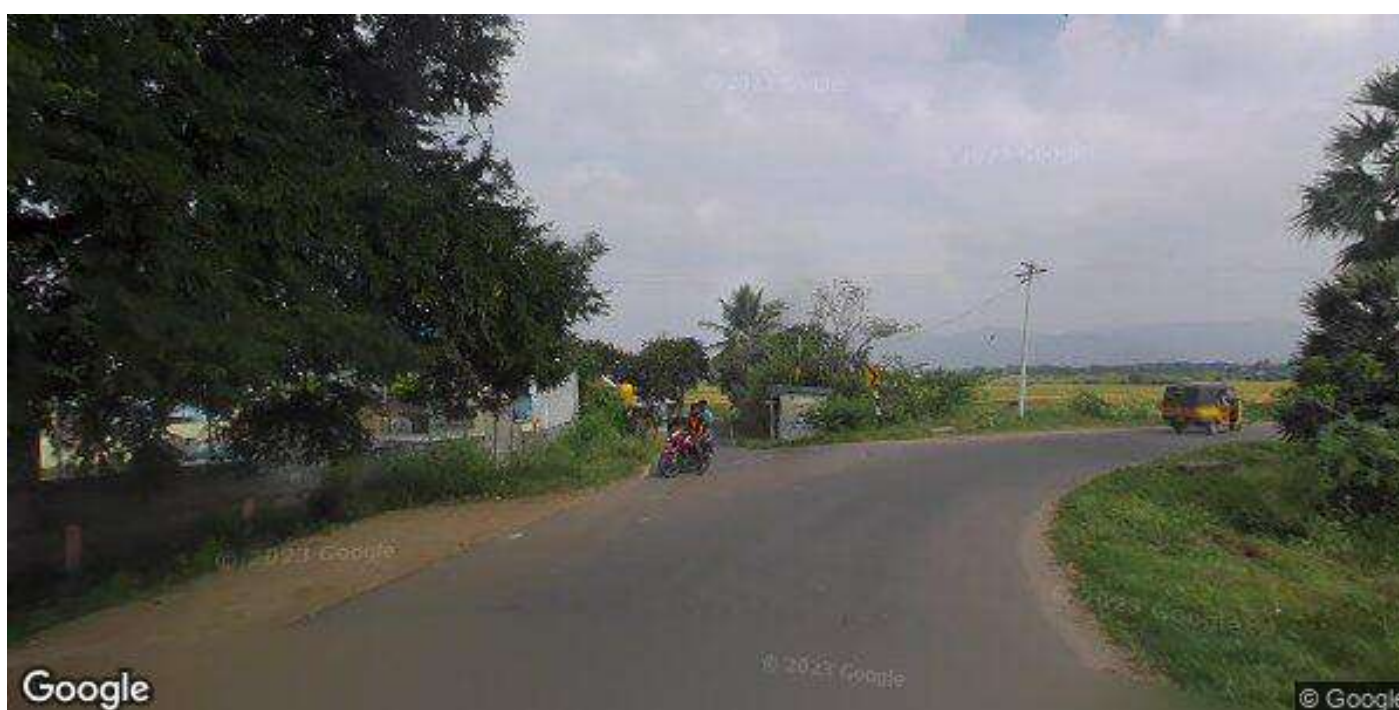
**Risk Type:** Turn  
**Risk Level:** High  
**Speed Limit:** 15 KM/Hr  
**Coordinates:** 12.05929, 78.12487
