# IndianOil

## JOURNEY RISK MANAGEMENT (JRM) STUDY

### Salem Terminal TO BHAKIYA AGENCY

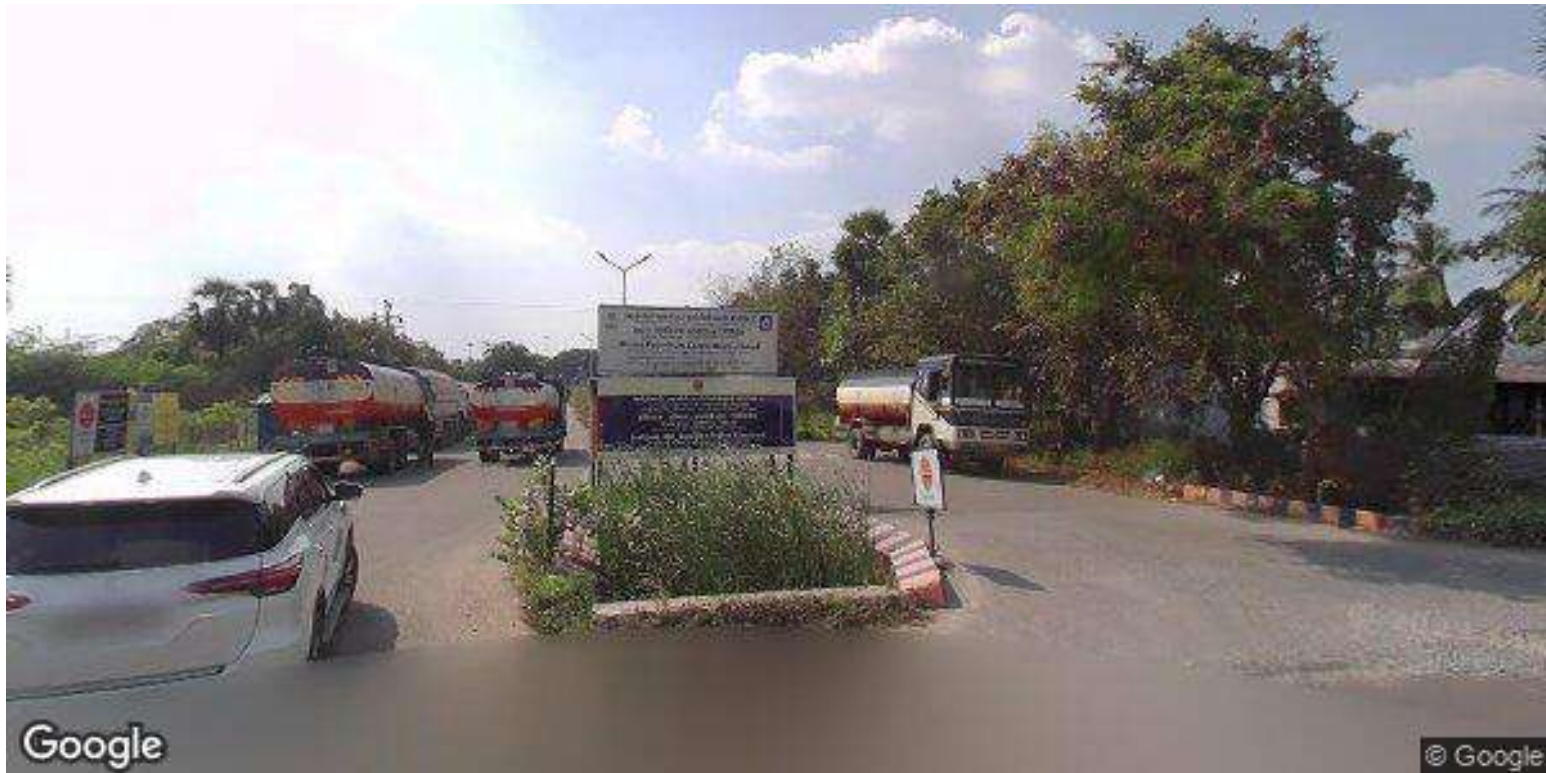
**Coordinates:** 11.44024, 77.87528

**Risk Type:** Turn

**Risk Level:** High

**Speed Limit:** 15 KM/Hr

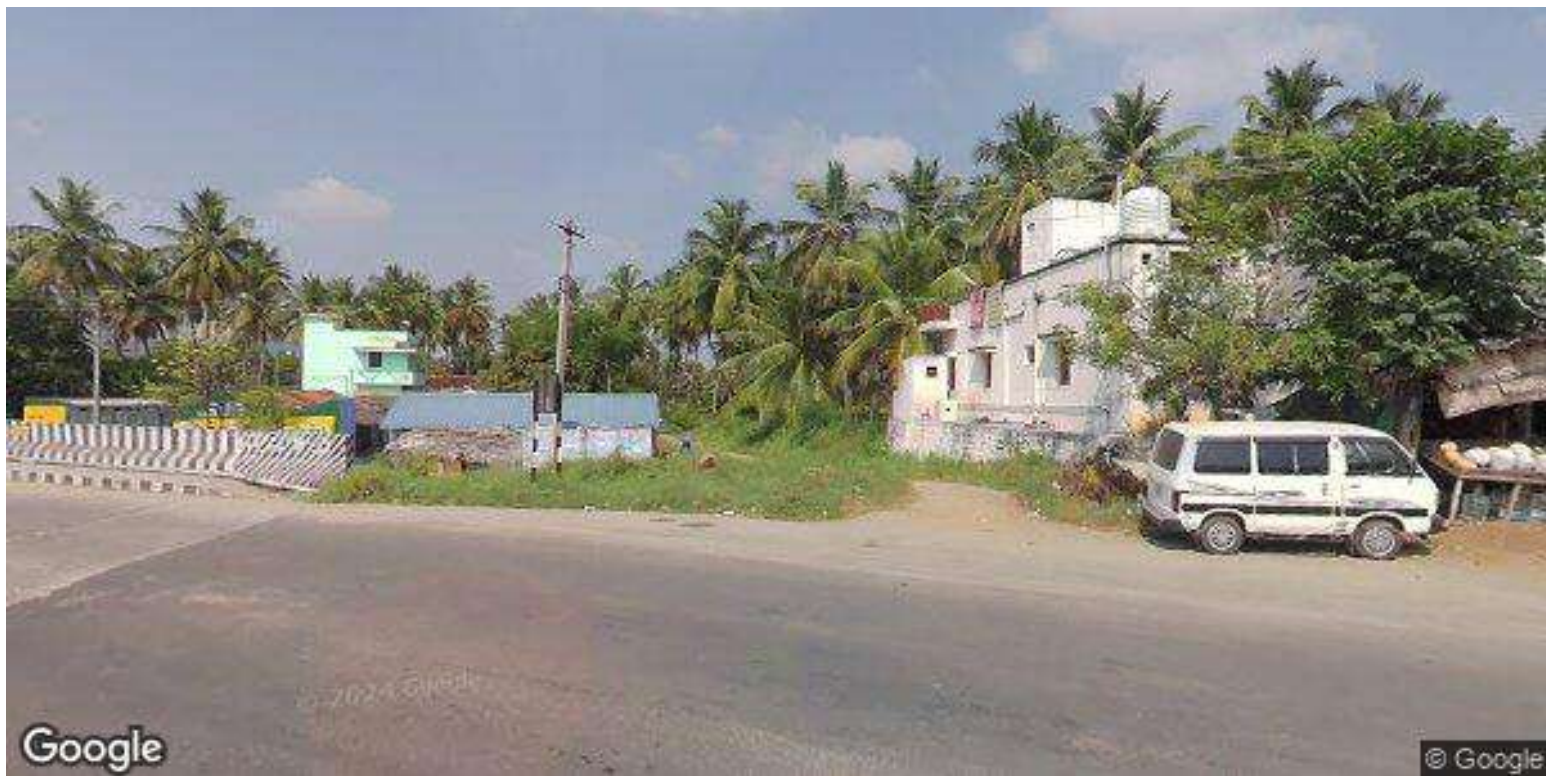
**Coordinates:** 11.44898, 77.87410

**Risk Type:** Turn

**Risk Level:** High

**Speed Limit:** 15 KM/Hr

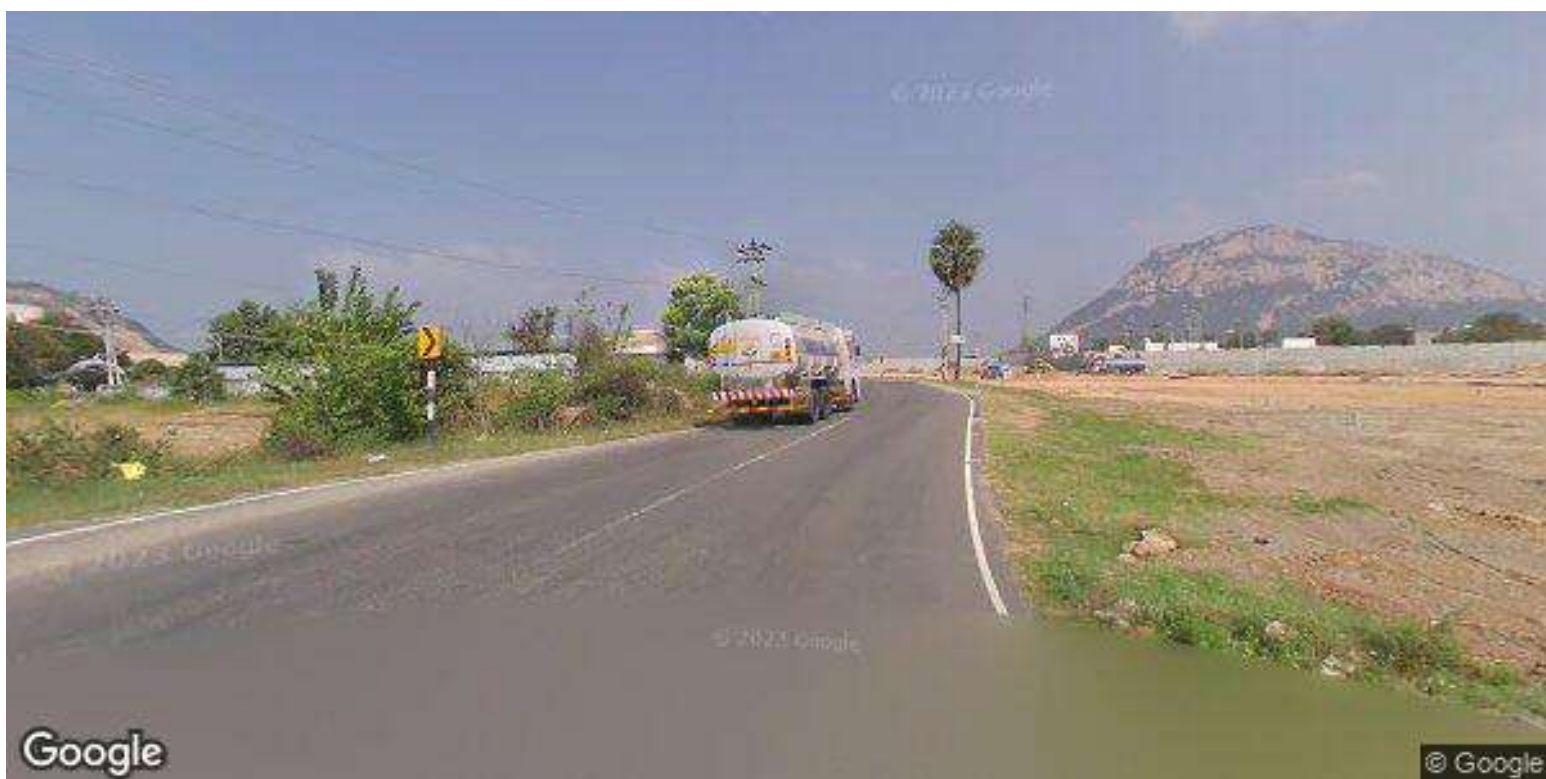
**Coordinates:** 11.45847, 77.85140

**Risk Type:** Turn

**Risk Level:** Medium

**Speed Limit:** 30 KM/Hr

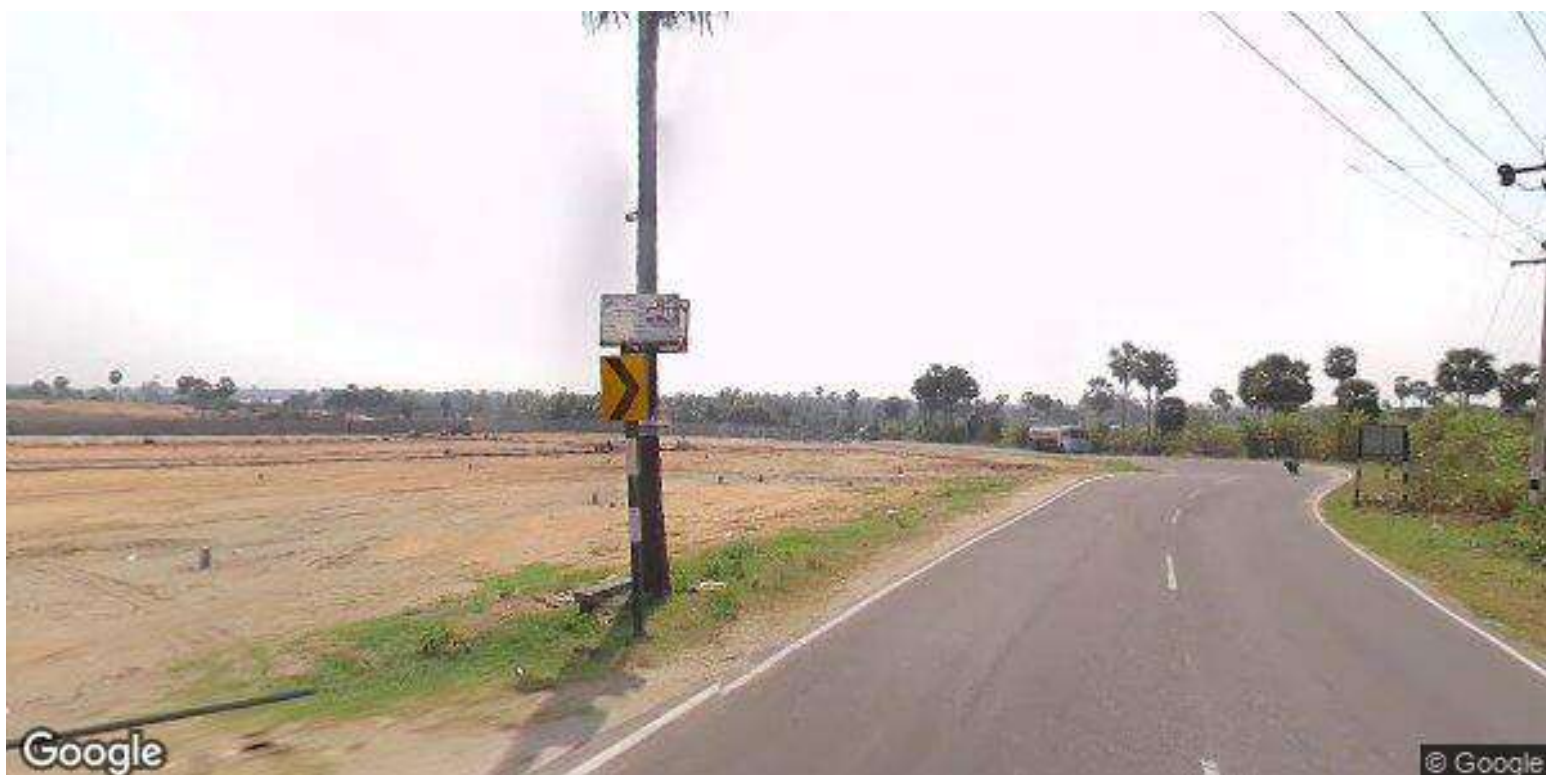
**Coordinates: 11.45898, 77.85135**

**Risk Type: Turn**

**Risk Level: Medium**

**Speed Limit: 30 KM/Hr**

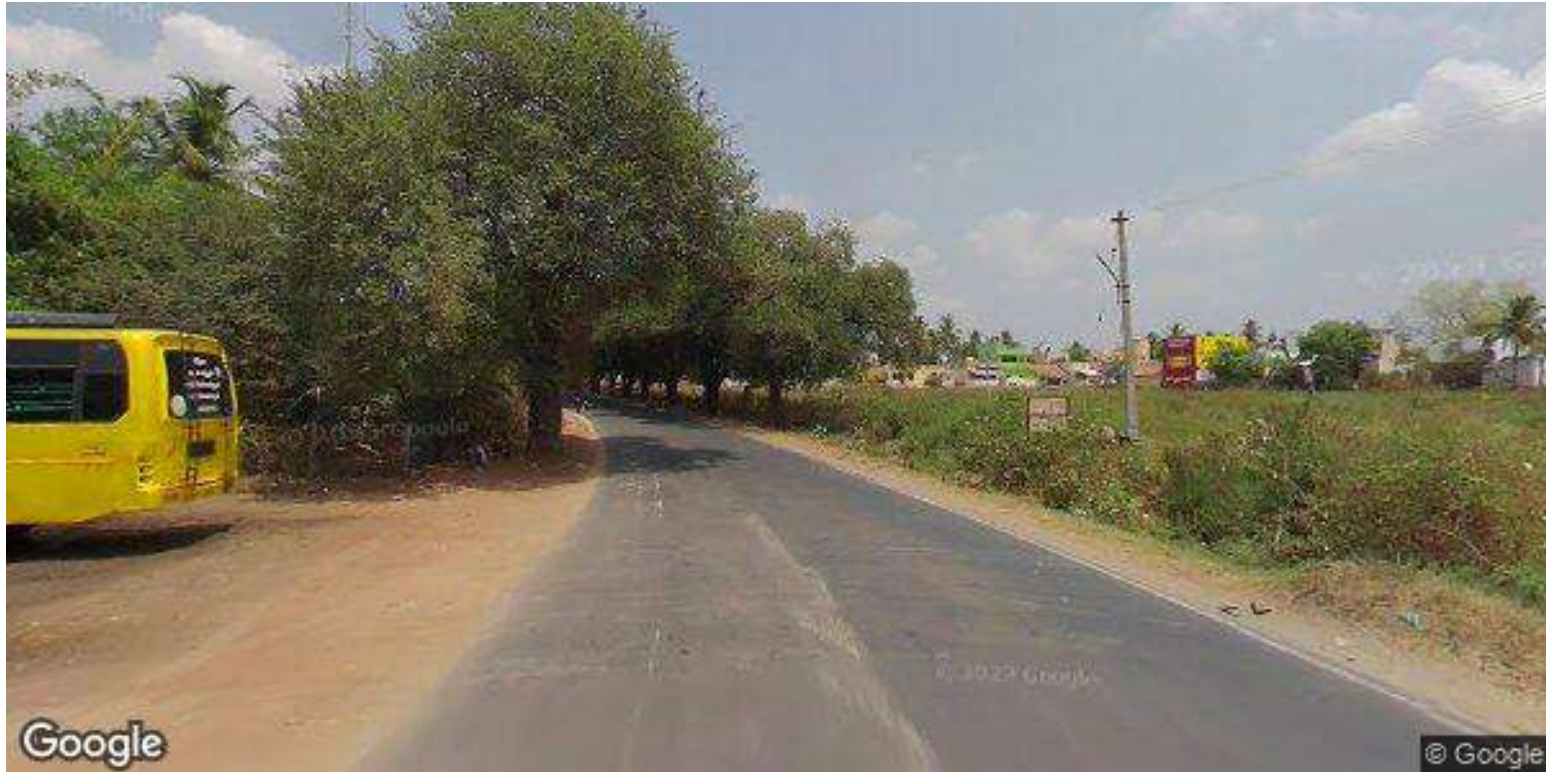
**Coordinates:** 11.56180, 77.90019

**Risk Type:** Turn

**Risk Level:** Medium

**Speed Limit:** 30 KM/Hr

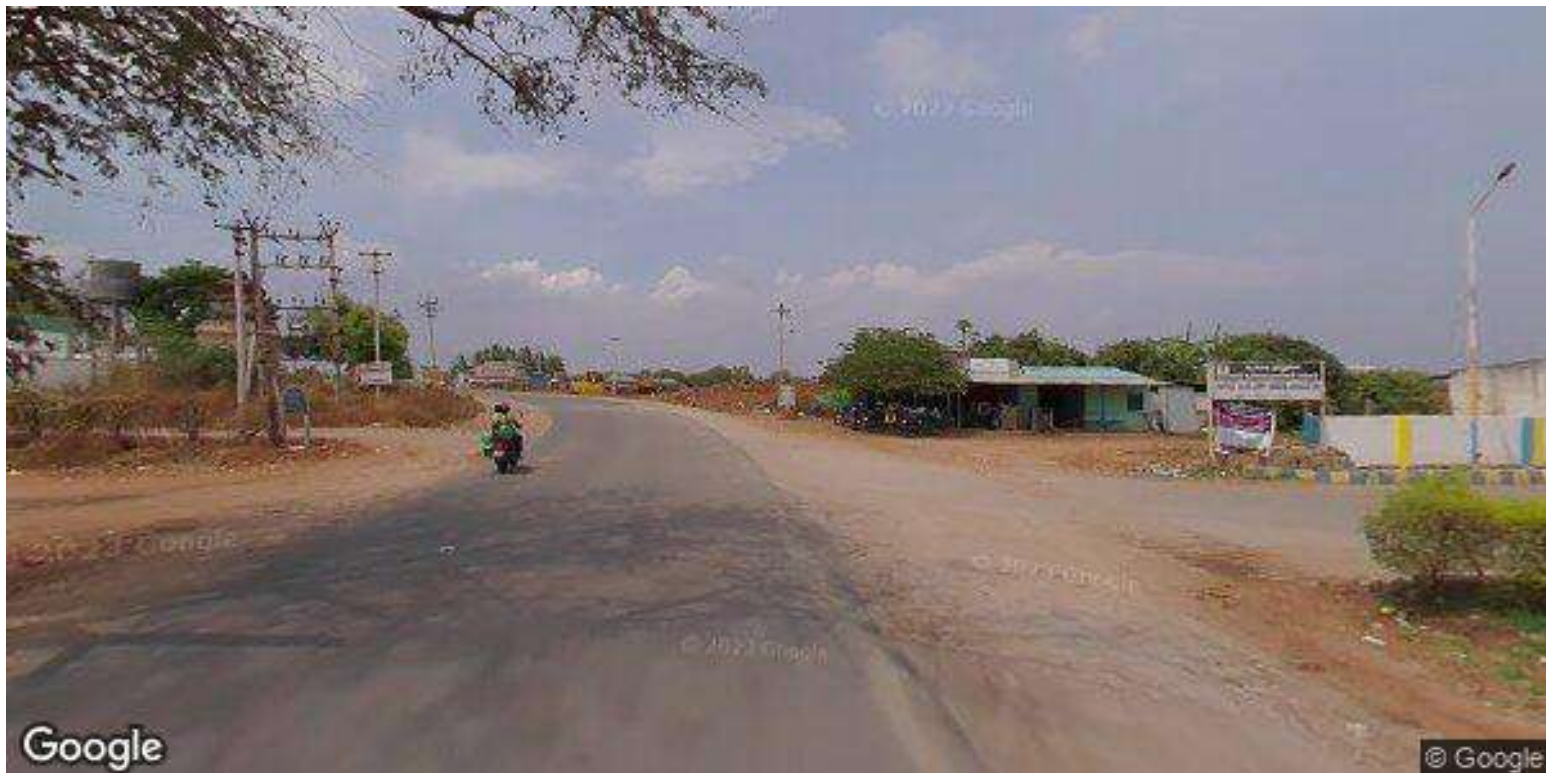
**Coordinates:** 11.58254, 77.90656

**Risk Type:** Turn

**Risk Level:** Medium

**Speed Limit:** 30 KM/Hr

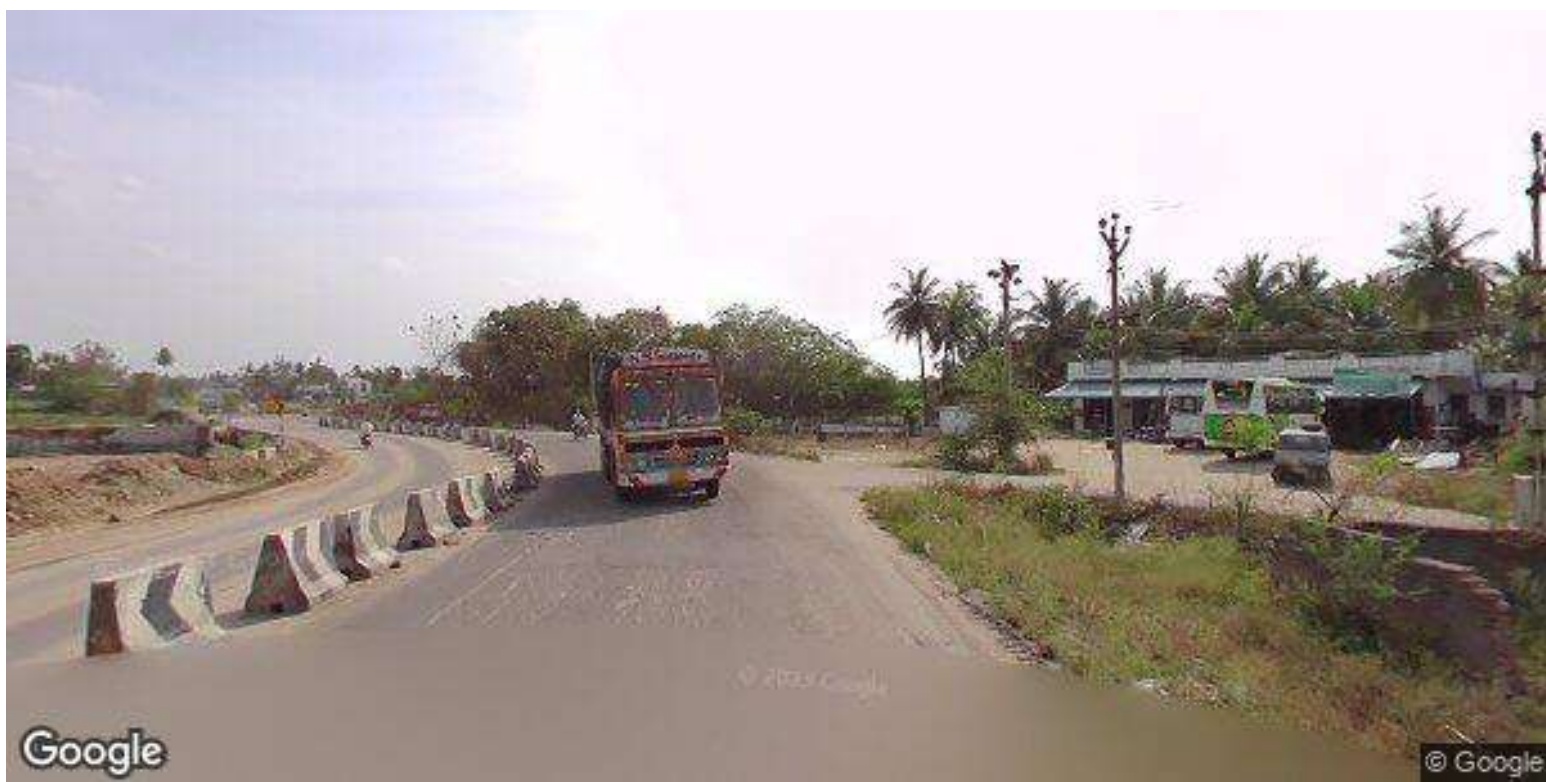
**Coordinates:** 11.63867, 77.94841

**Risk Type:** Turn

**Risk Level:** Medium

**Speed Limit:** 30 KM/Hr

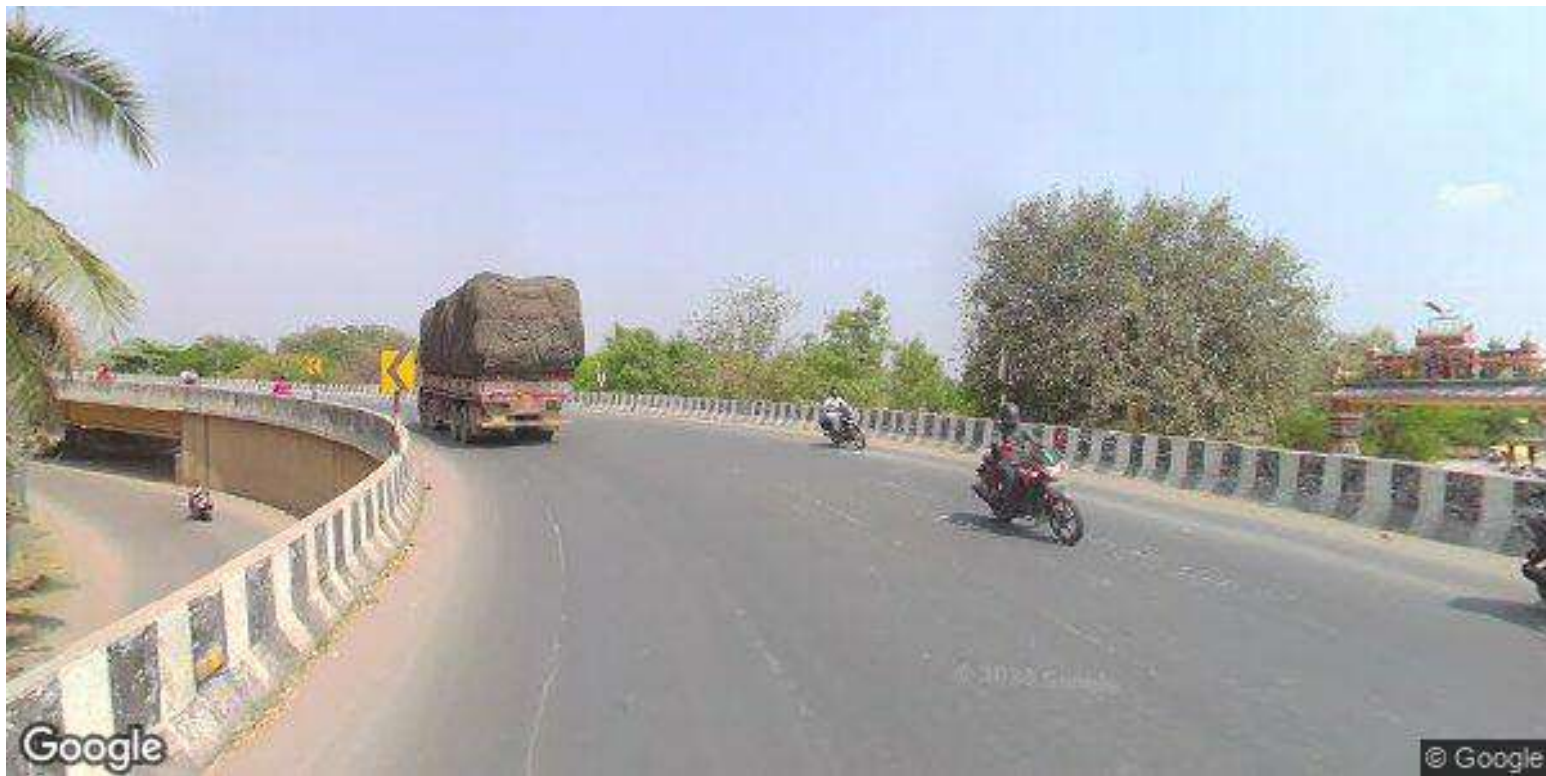
**Coordinates: 11.73651, 78.03868**

**Risk Type: Turn**

**Risk Level: High**

**Speed Limit: 15 KM/Hr**

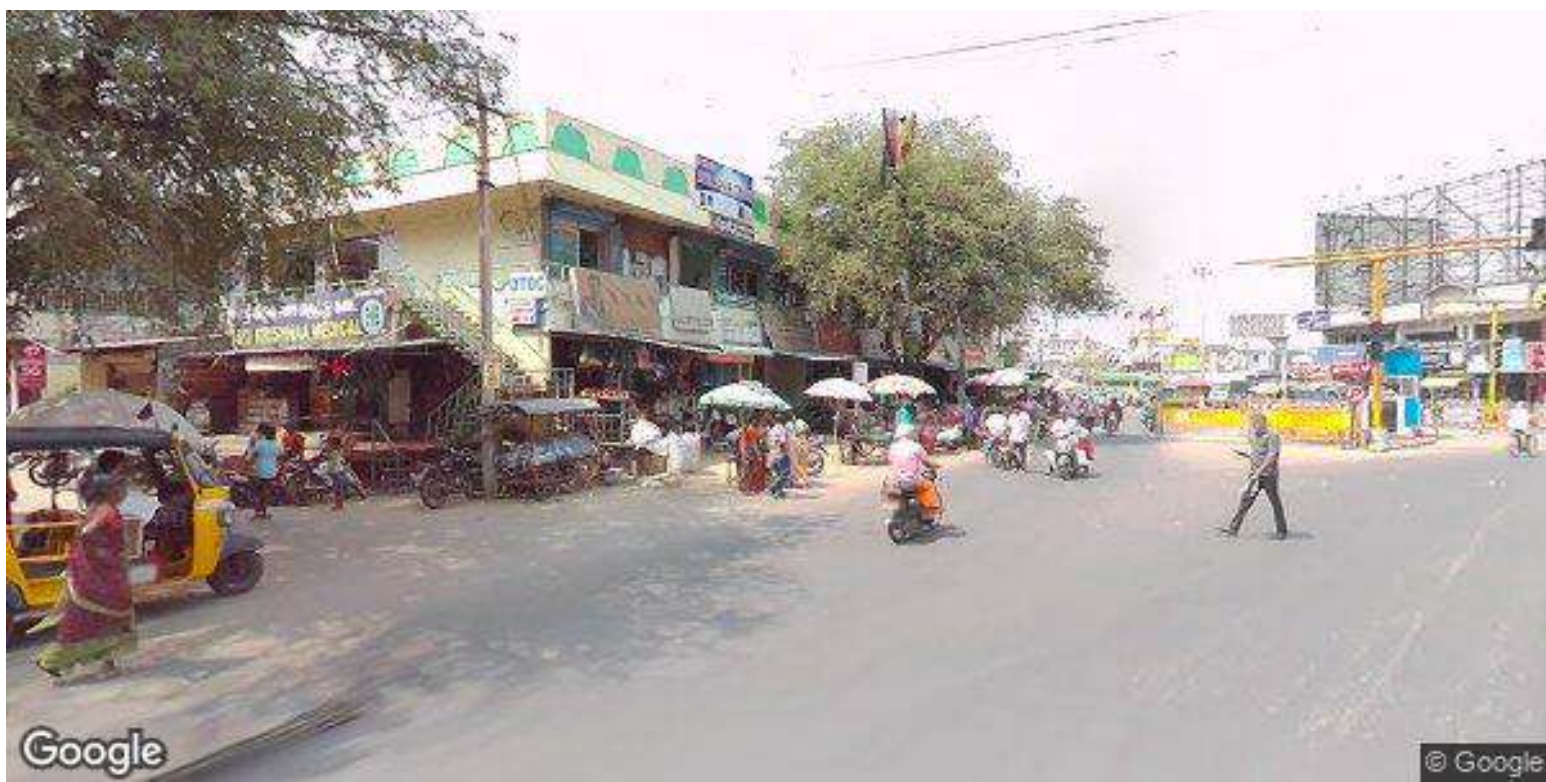
**Coordinates:** 11.74257, 78.04708

**Risk Type:** Turn

**Risk Level:** Medium

**Speed Limit:** 30 KM/Hr

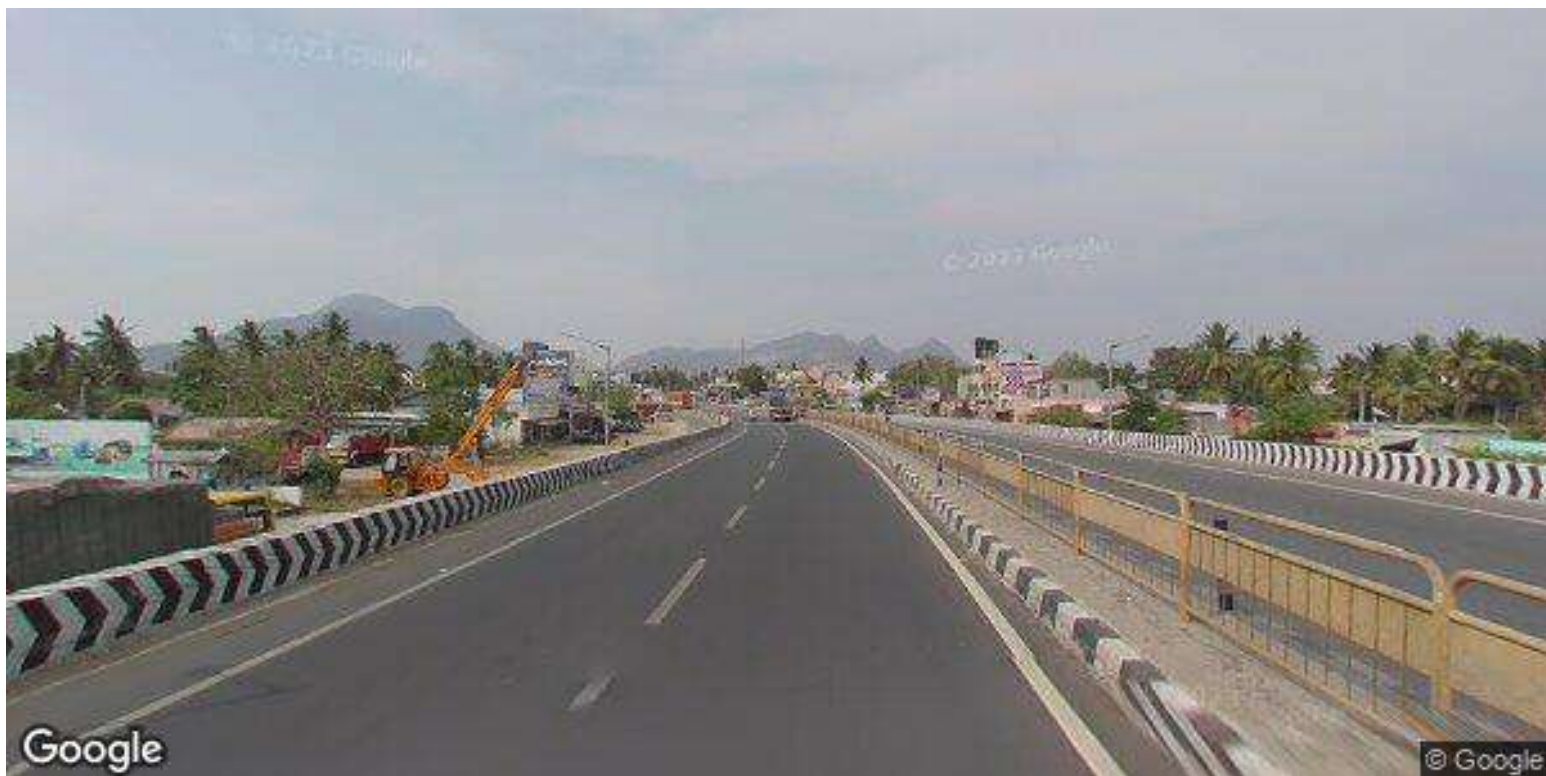
**Coordinates:** 11.86805, 78.08353

**Risk Type:** Turn

**Risk Level:** Medium

**Speed Limit:** 30 KM/Hr

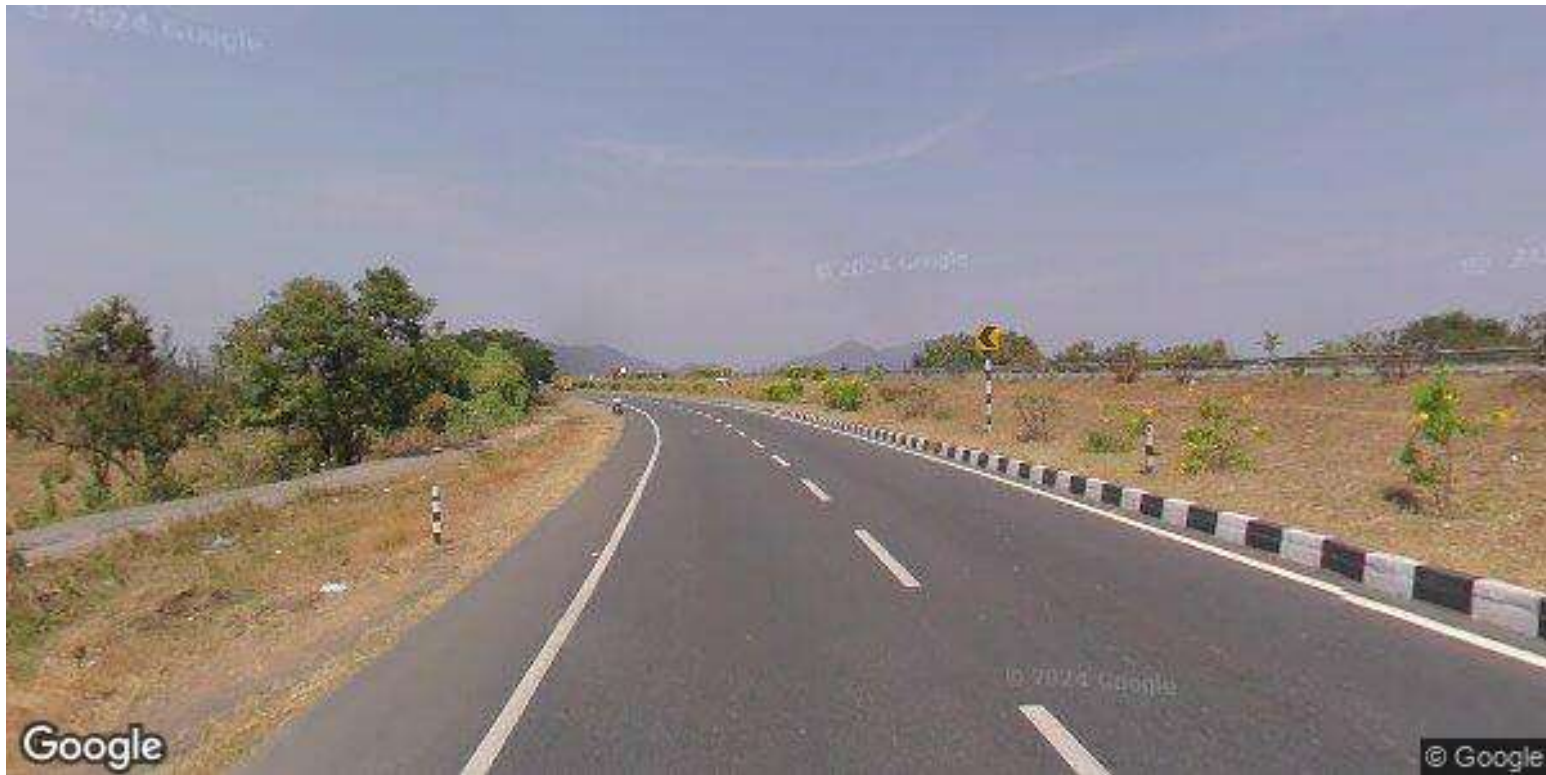
**Risk Type:** Turn  
**Risk Level:** Medium  
**Speed Limit:** 30 KM/Hr  
**Coordinates:** 11.92566, 78.06503

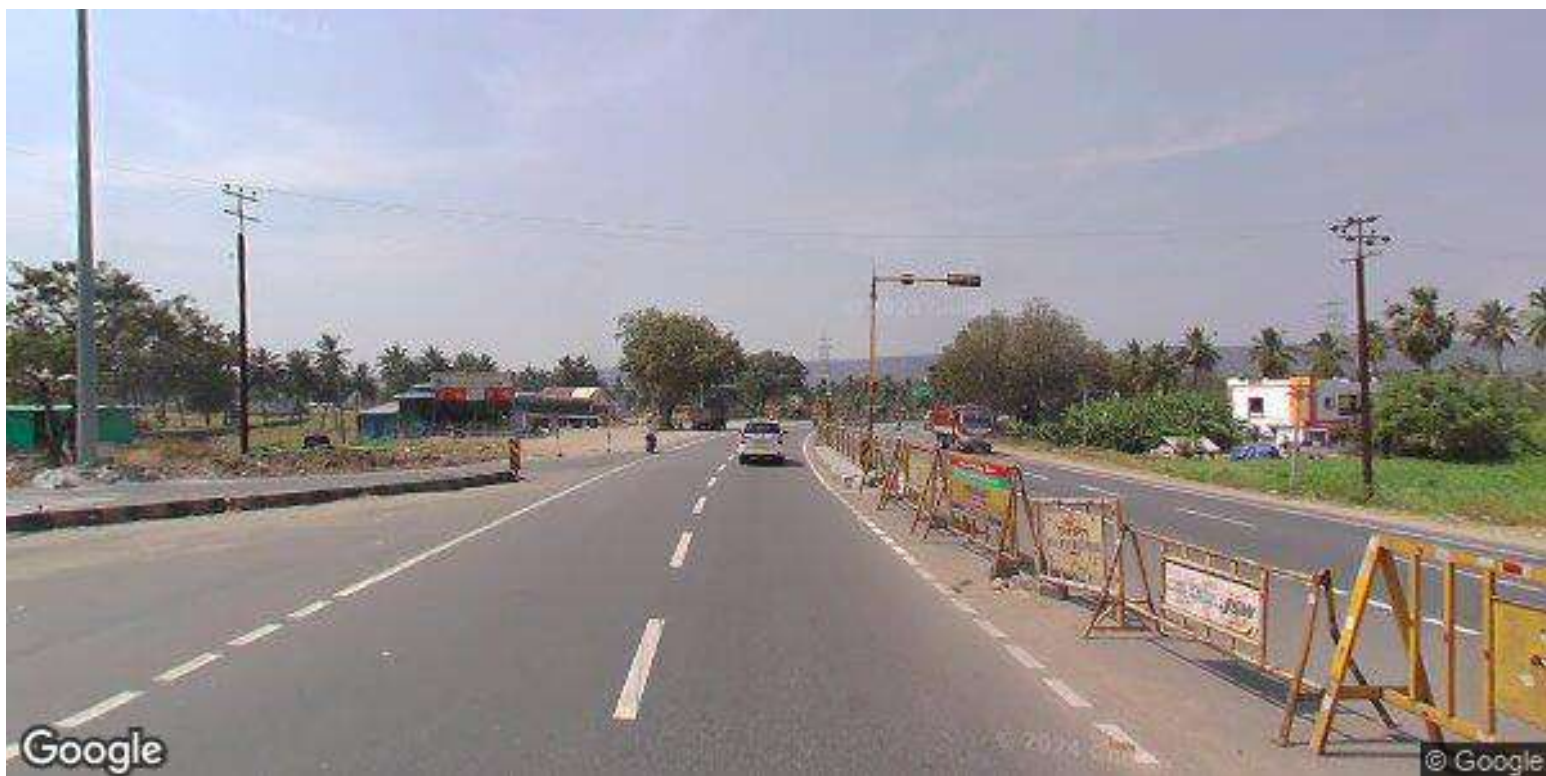
**Risk Type:** Turn  
**Risk Level:** Medium  
**Speed Limit:** 30 KM/Hr  
**Coordinates:** 11.93694, 78.05425

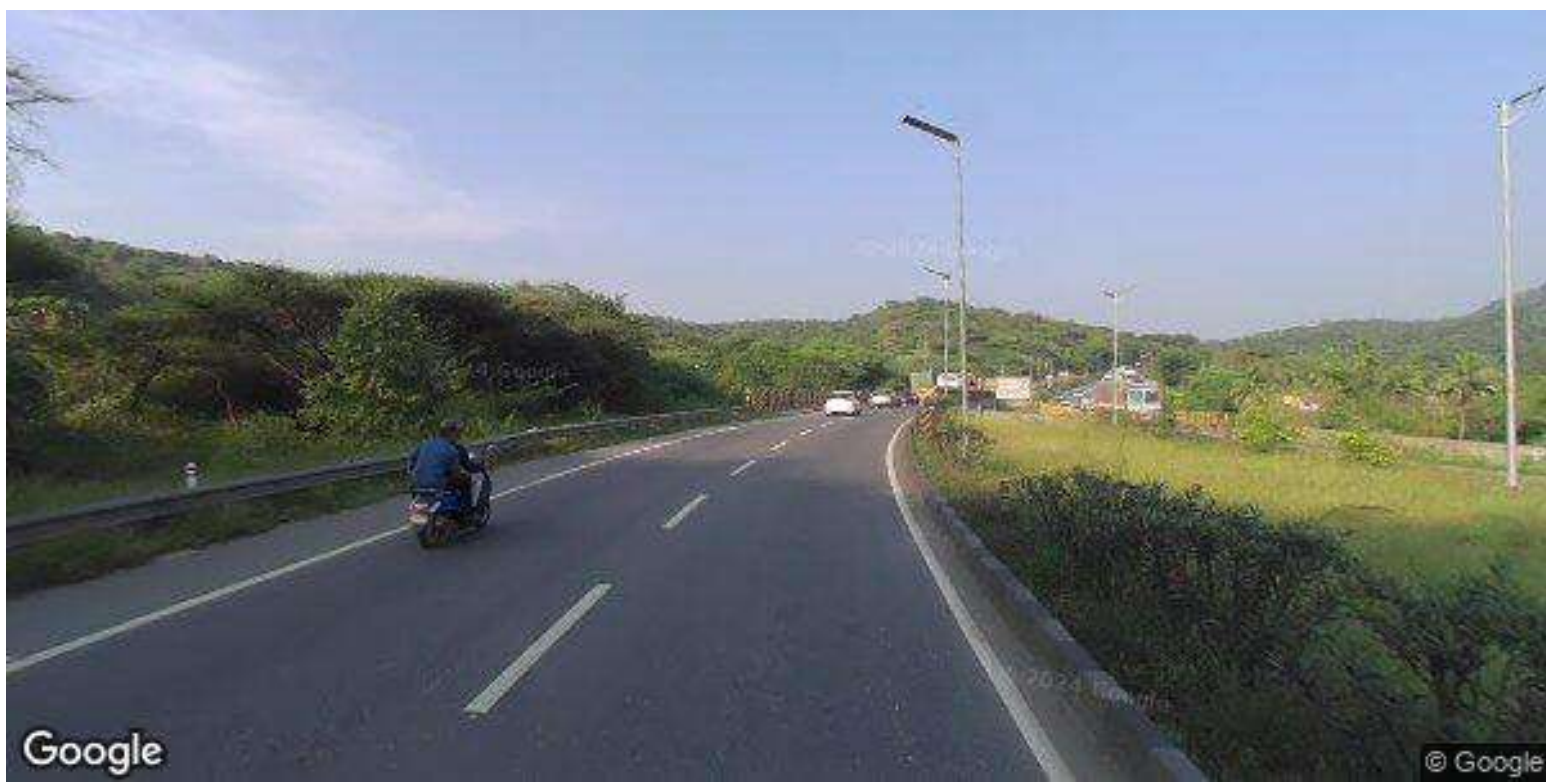
**Coordinates:** 11.95531, 78.04698

**Risk Type:** Turn

**Risk Level:** Medium

**Speed Limit:** 30 KM/Hr

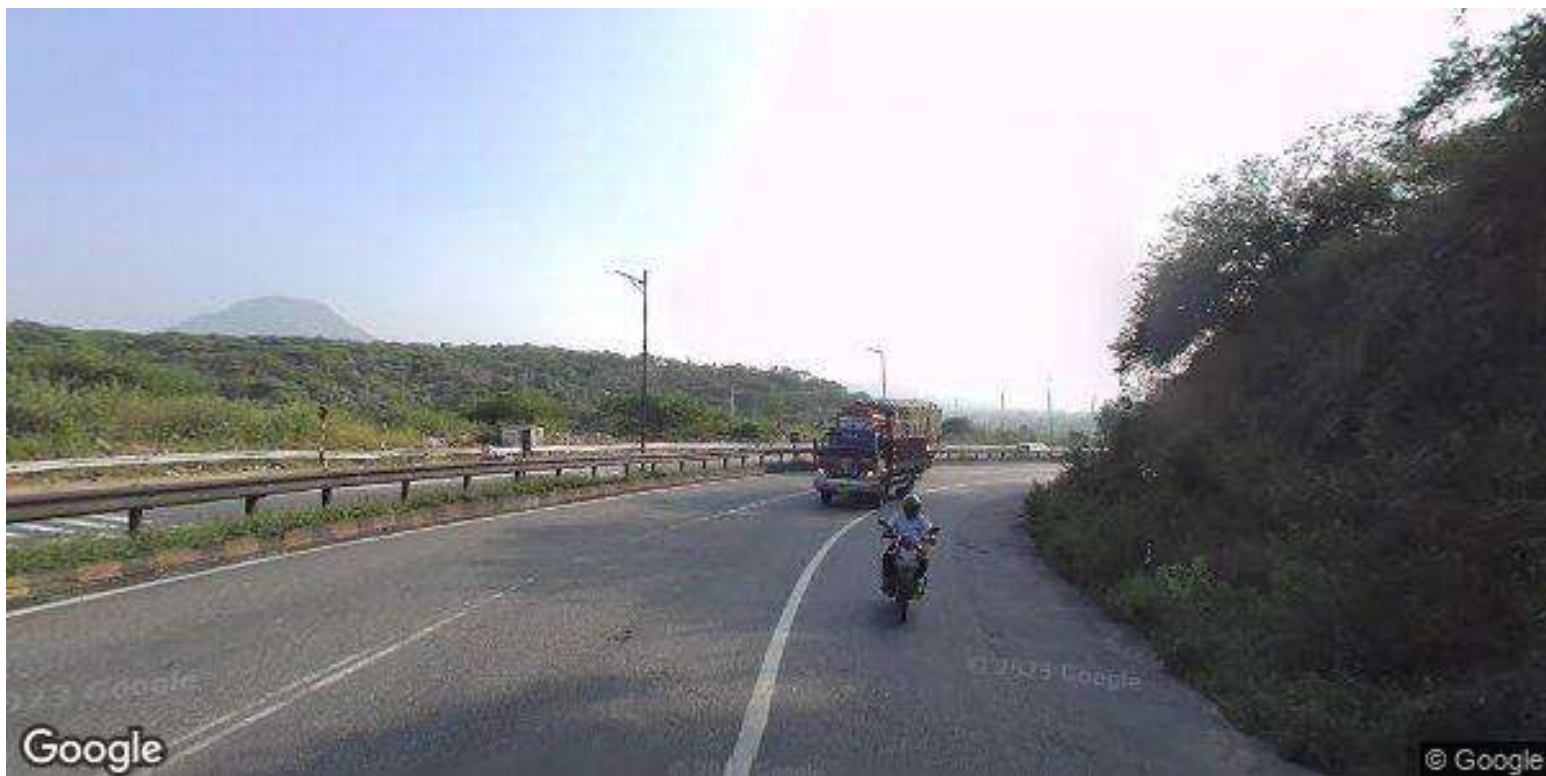
**Coordinates:** 11.95854, 78.04990

**Risk Type:** Turn

**Risk Level:** Medium

**Speed Limit:** 30 KM/Hr

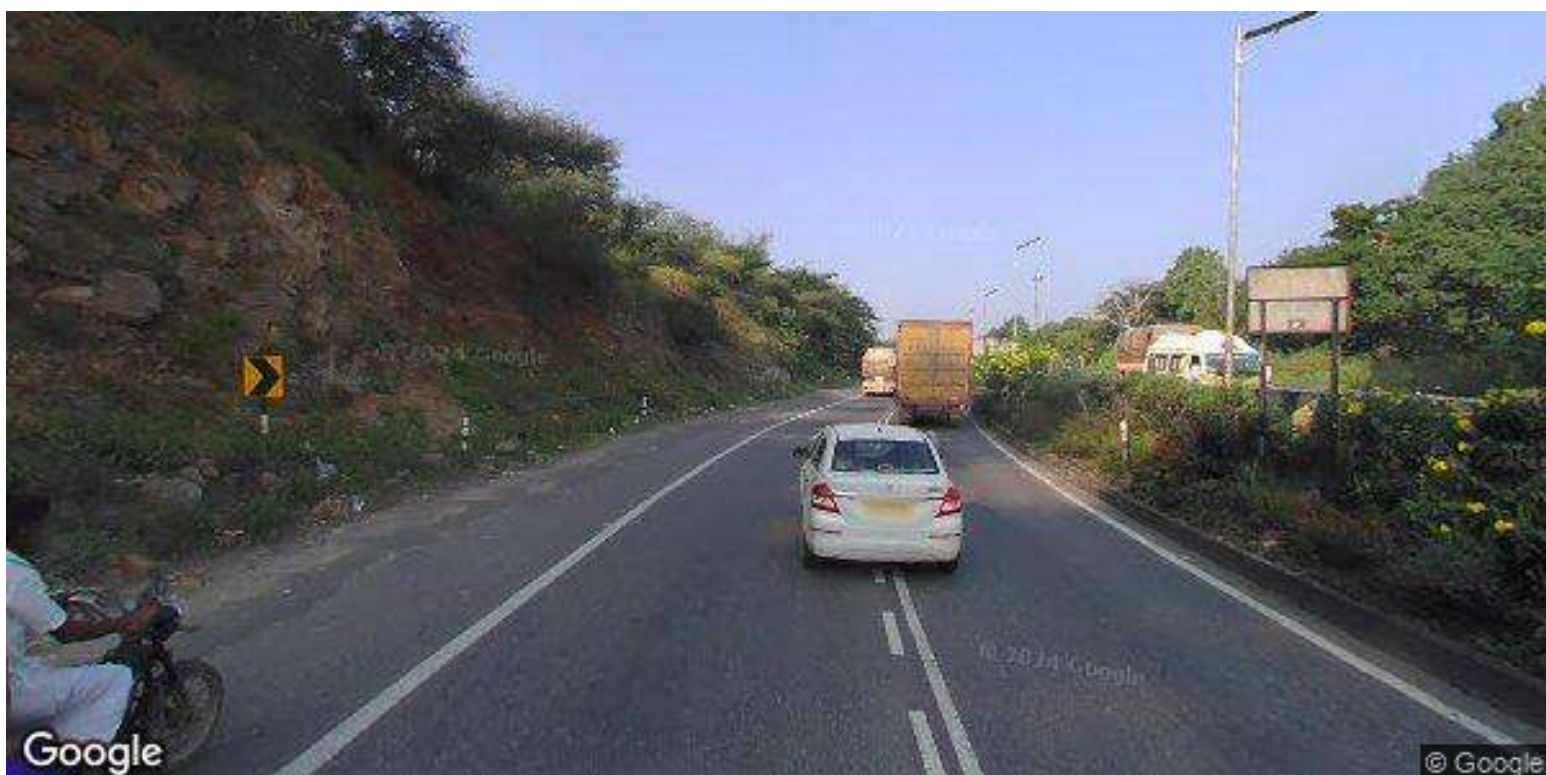
**Risk Type:** Turn  
**Risk Level:** Medium  
**Speed Limit:** 30 KM/Hr  
**Coordinates:** 11.96068, 78.04960

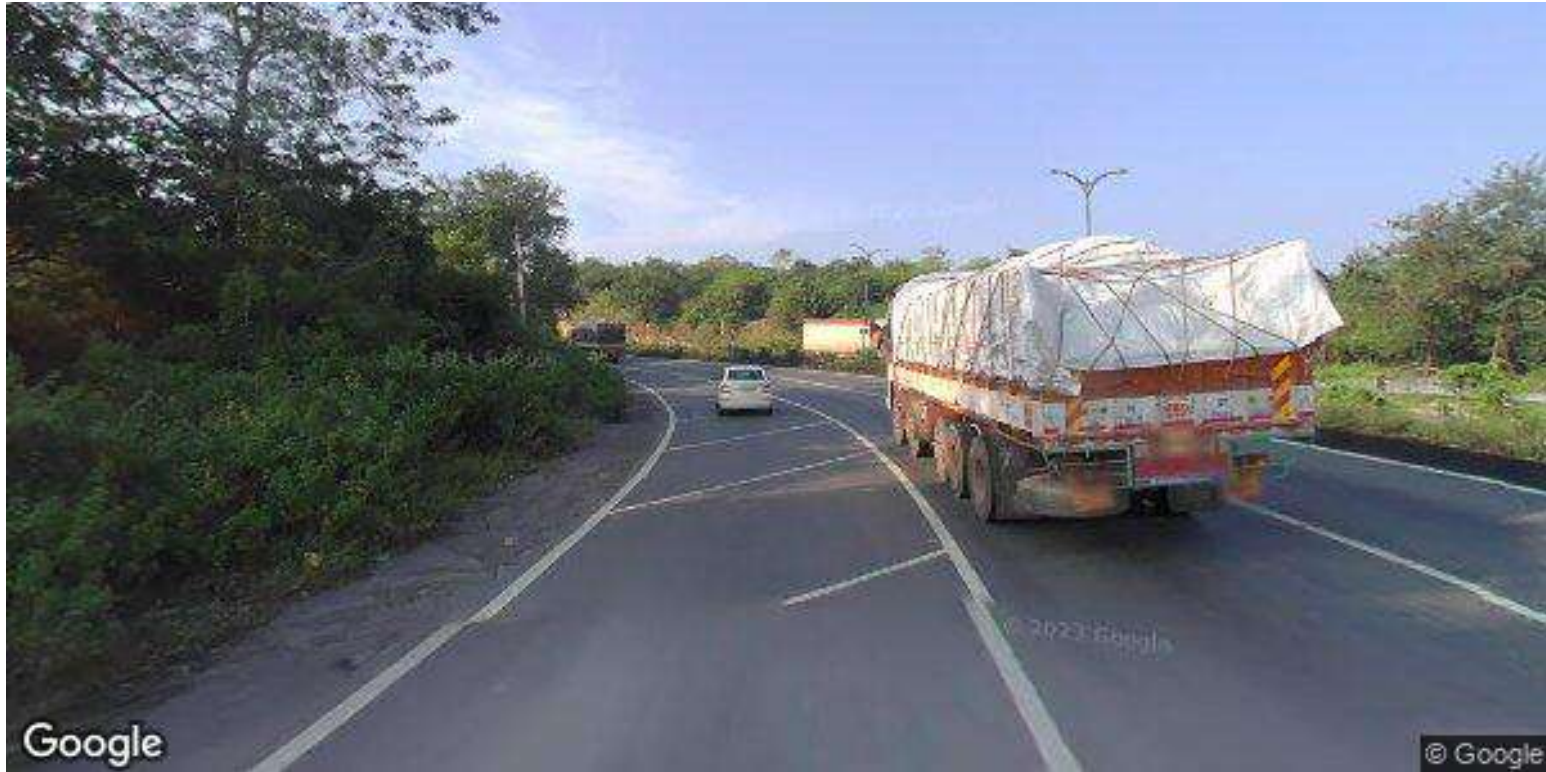
**Risk Type:** Turn  
**Risk Level:** Medium  
**Speed Limit:** 30 KM/Hr  
**Coordinates:** 11.96370, 78.05142

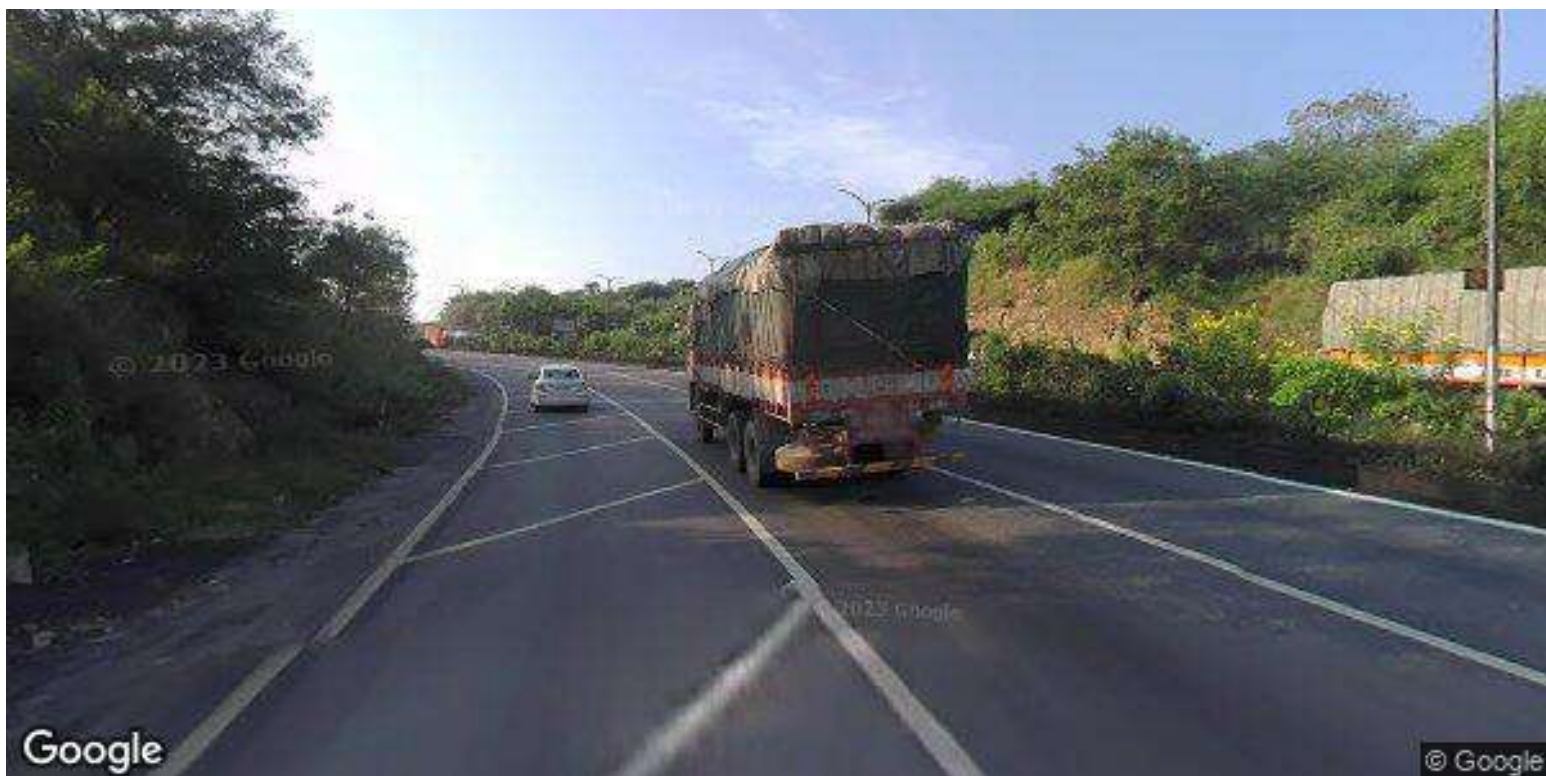
**Risk Type:** Turn  
**Risk Level:** Medium  
**Speed Limit:** 30 KM/Hr  
**Coordinates:** 11.96433, 78.05113

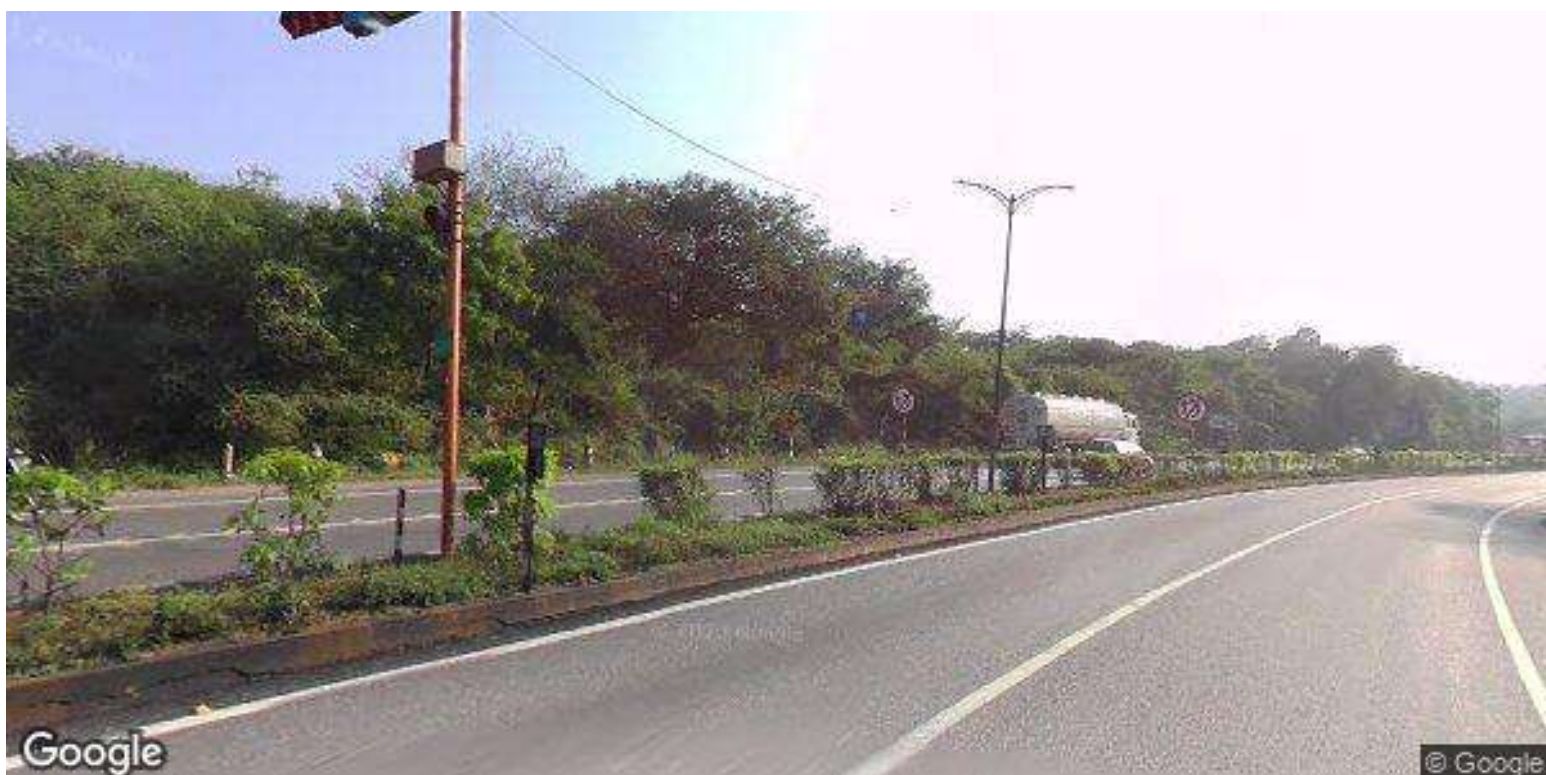
**Risk Type:** Turn  
**Risk Level:** Medium  
**Speed Limit:** 30 KM/Hr  
**Coordinates:** 11.96804, 78.05080

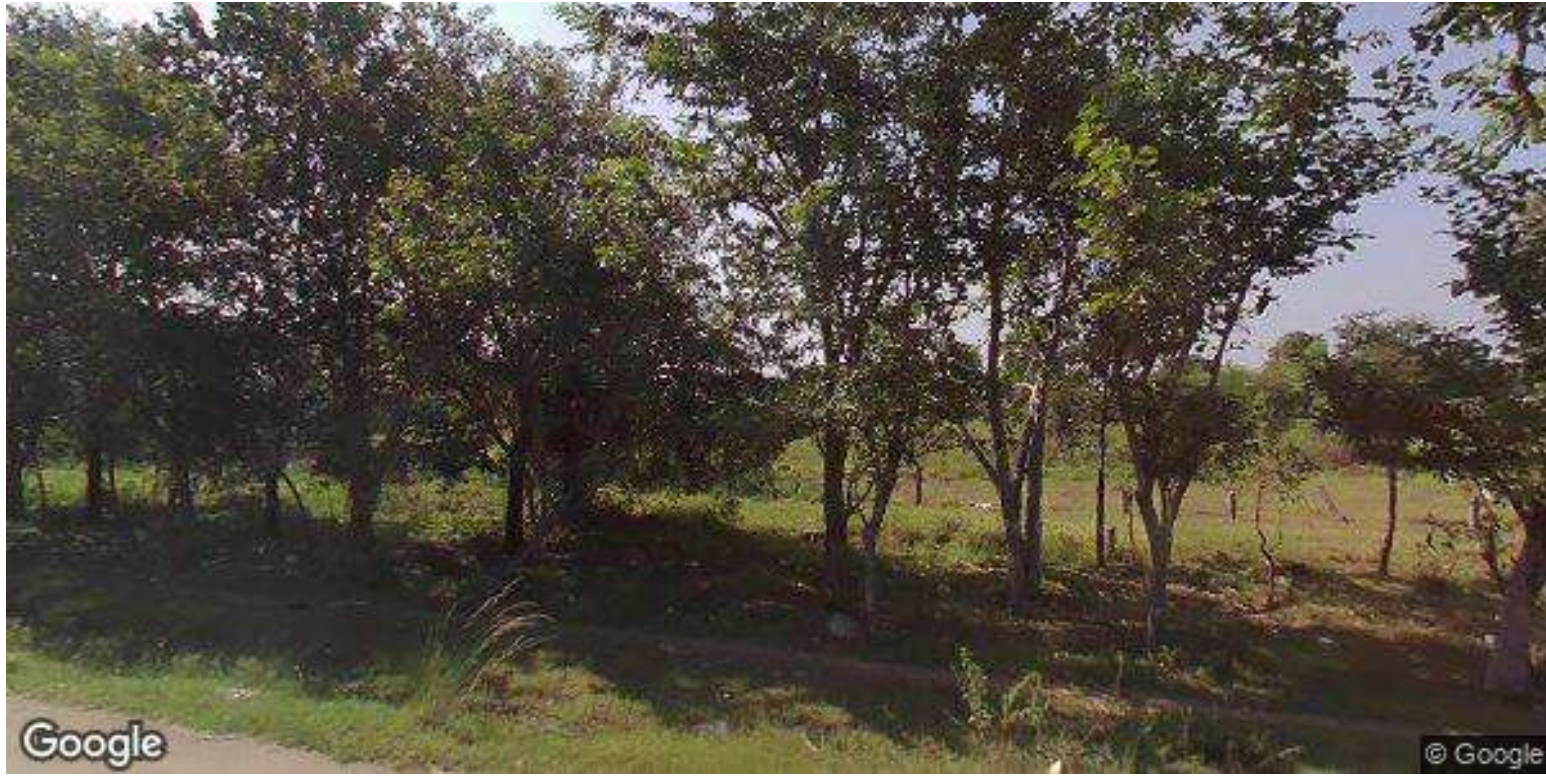
**Risk Type:** Turn  
**Risk Level:** Medium  
**Speed Limit:** 30 KM/Hr  
**Coordinates:** 12.12017, 78.13283
