# IndianOil

## JOURNEY RISK MANAGEMENT (JRM) STUDY

### Salem Terminal TO BHAKIYA AGENCY

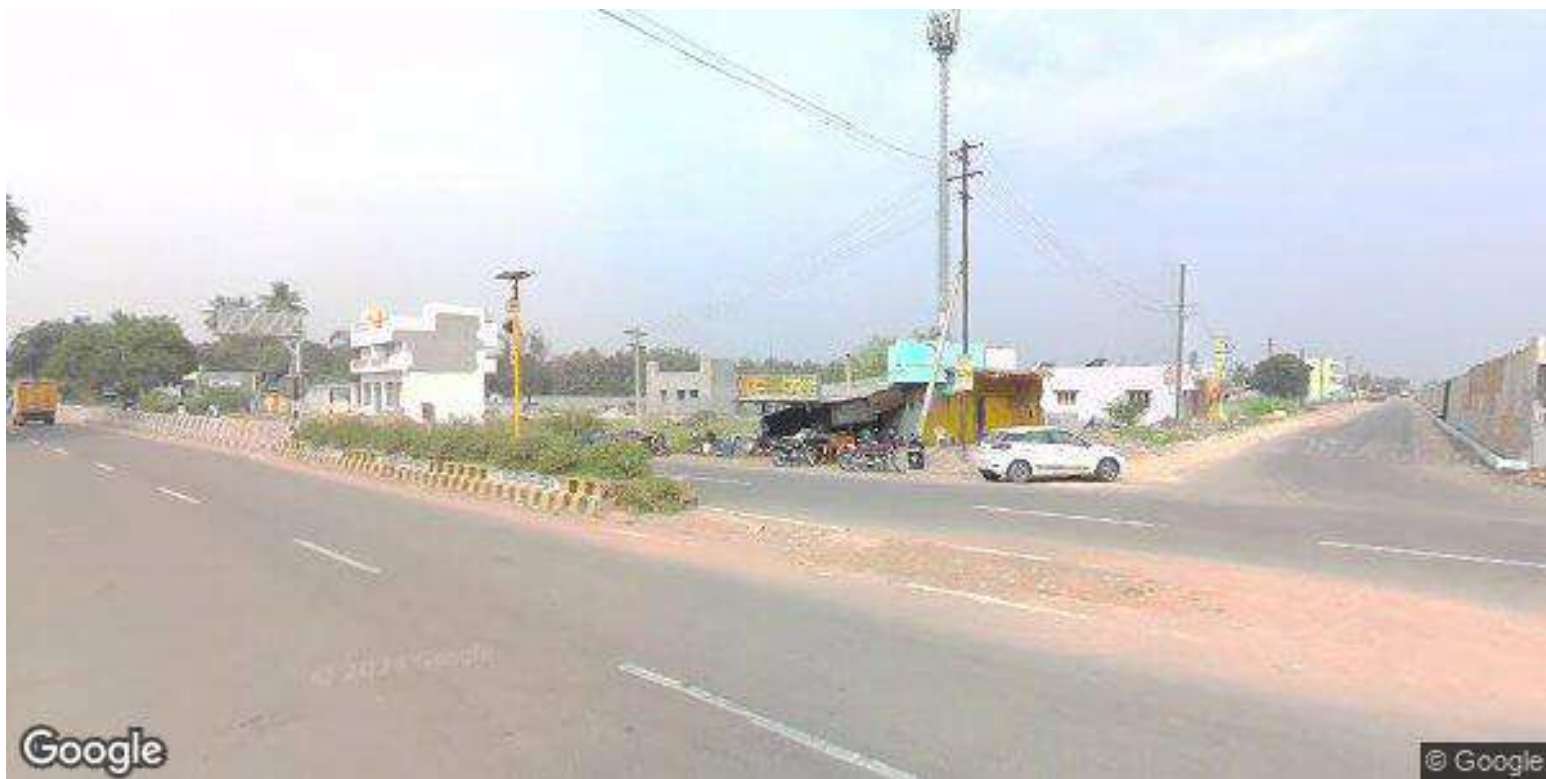
**Risk Type:** Turn  
**Risk Level:** High  
**Speed Limit:** 15 KM/Hr  
**Coordinates:** 12.14089, 78.12817

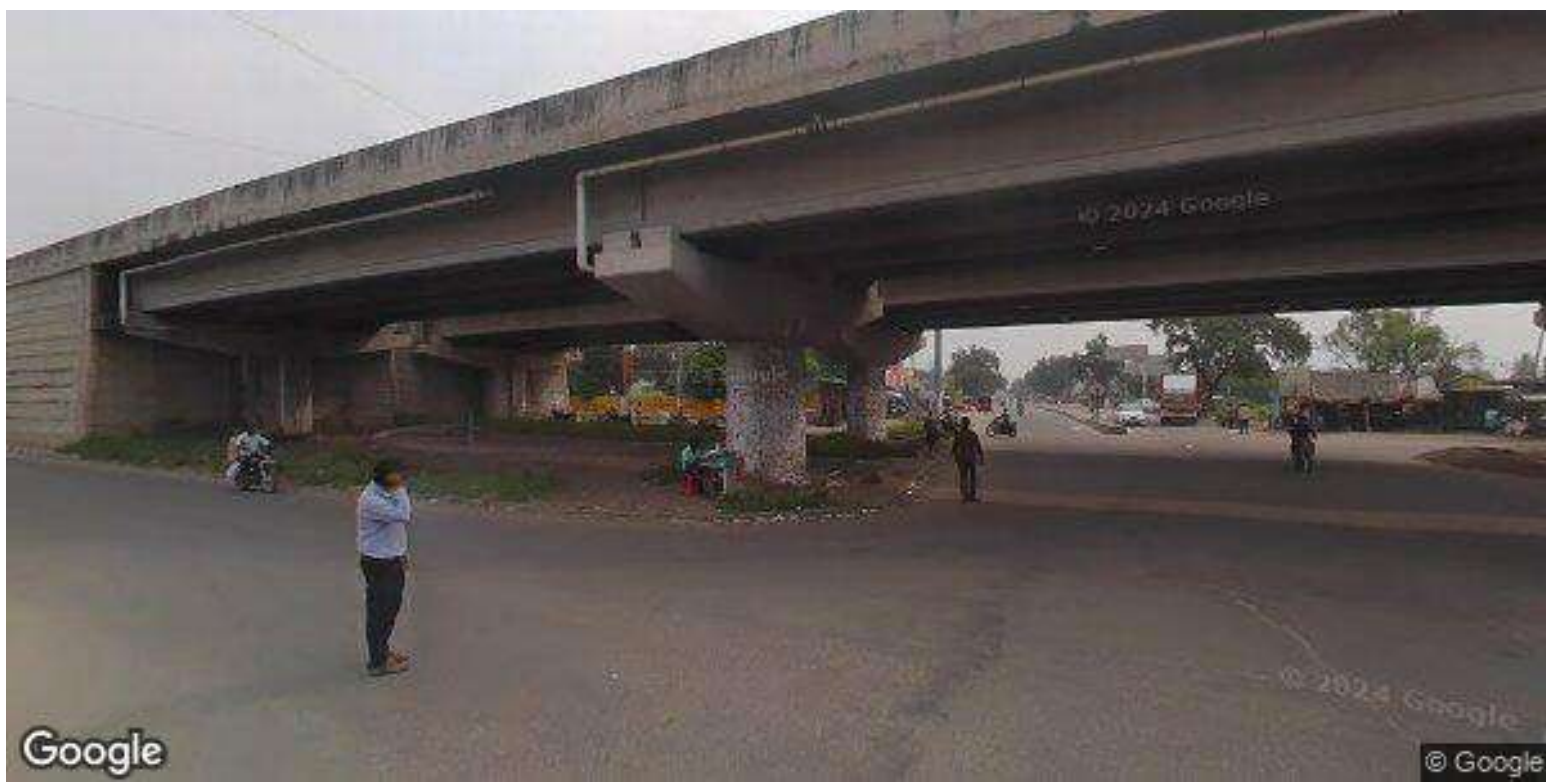
**Coordinates:** 12.14056, 78.13957

**Risk Type:** Turn

**Risk Level:** High

**Speed Limit:** 15 KM/Hr

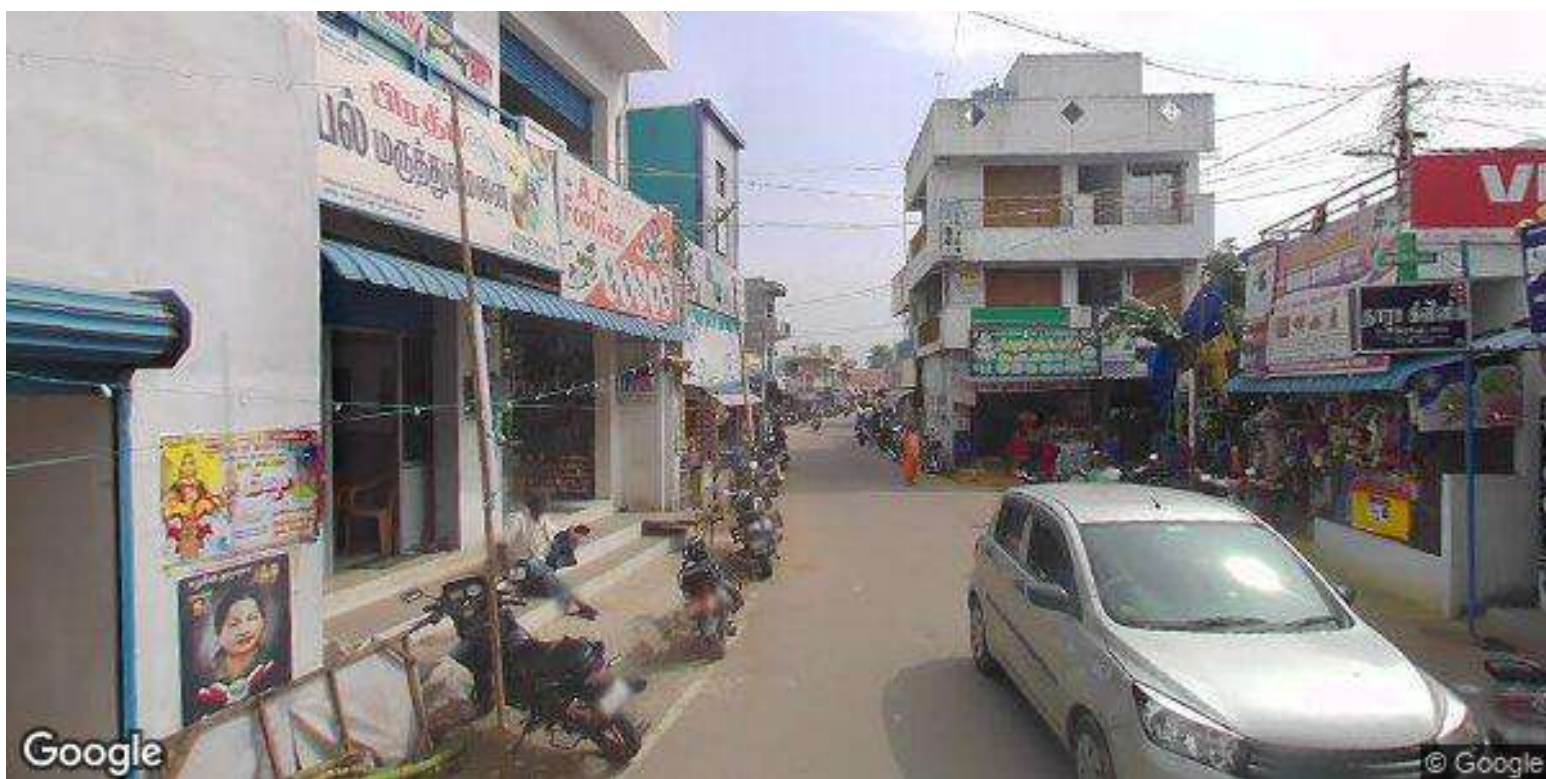
**Coordinates:** 12.25431, 78.19669

**Risk Type:** Turn

**Risk Level:** High

**Speed Limit:** 15 KM/Hr

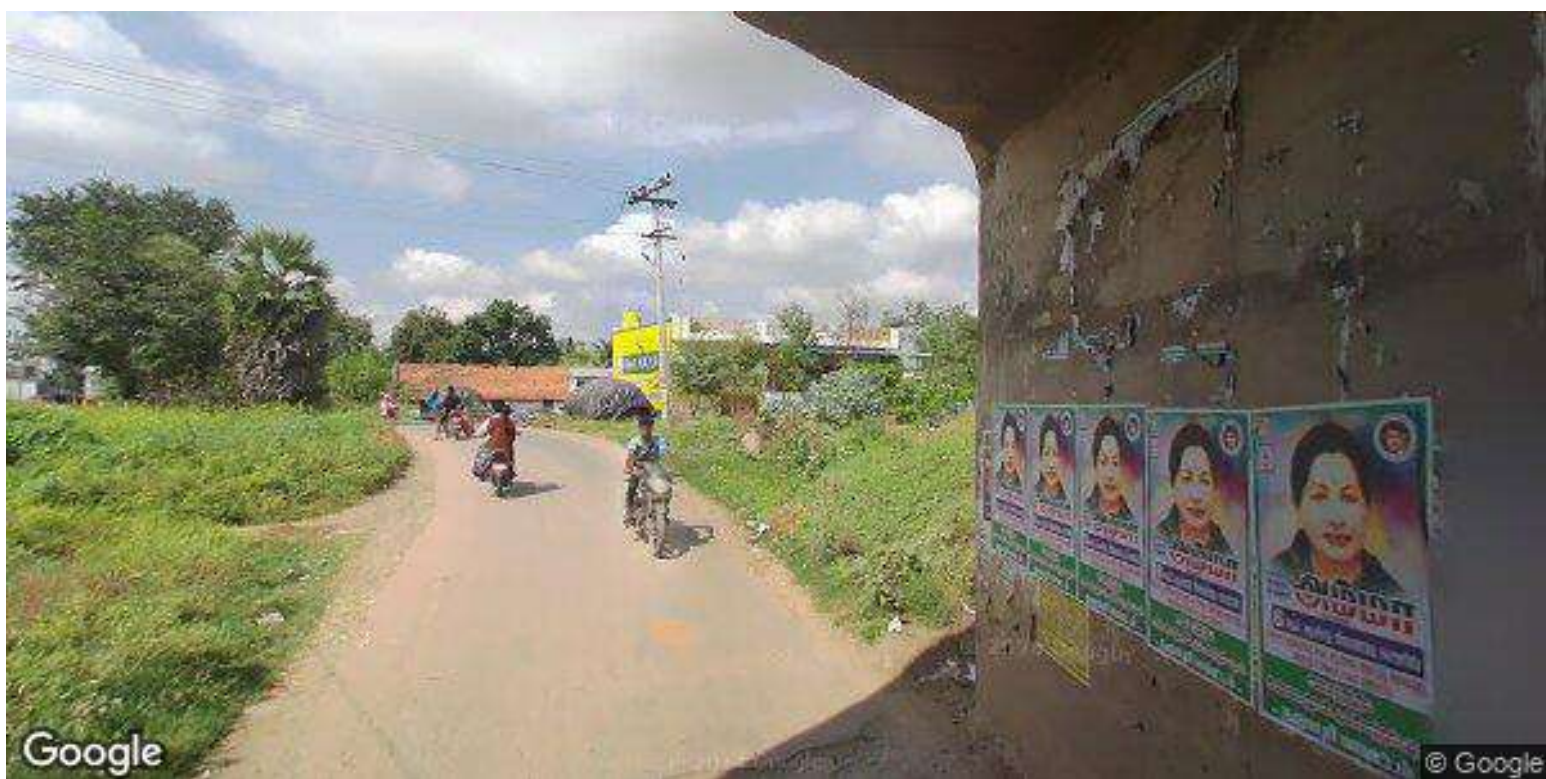
**Coordinates:** 12.25448, 78.20005

**Risk Type:** Turn

**Risk Level:** Medium

**Speed Limit:** 30 KM/Hr

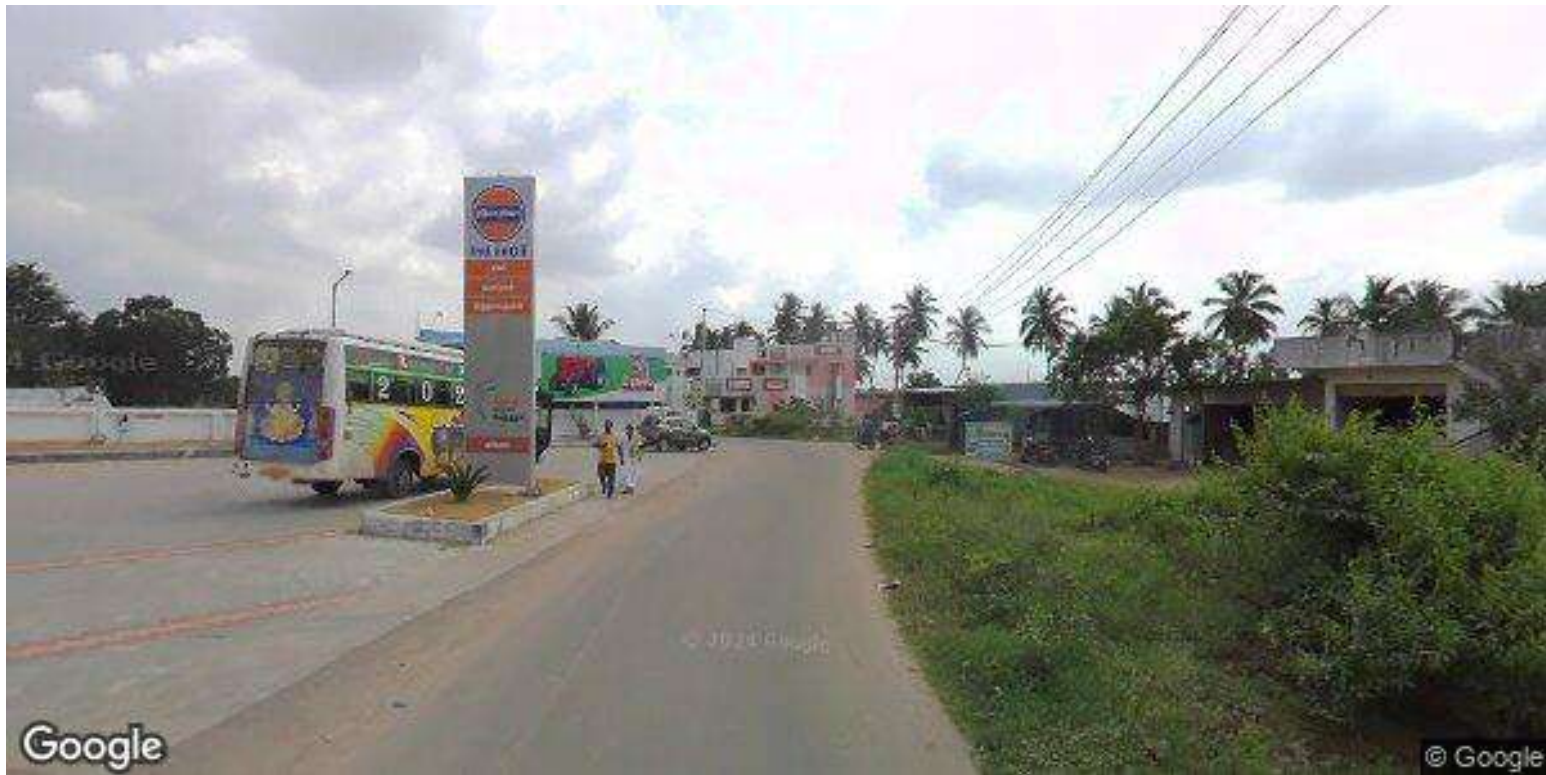
**Coordinates:** 12.25404, 78.20187

**Risk Type:** Turn

**Risk Level:** High

**Speed Limit:** 15 KM/Hr
