# IndianOil

## JOURNEY RISK MANAGEMENT (JRM) STUDY

### Salem Terminal TO CSK FUELS

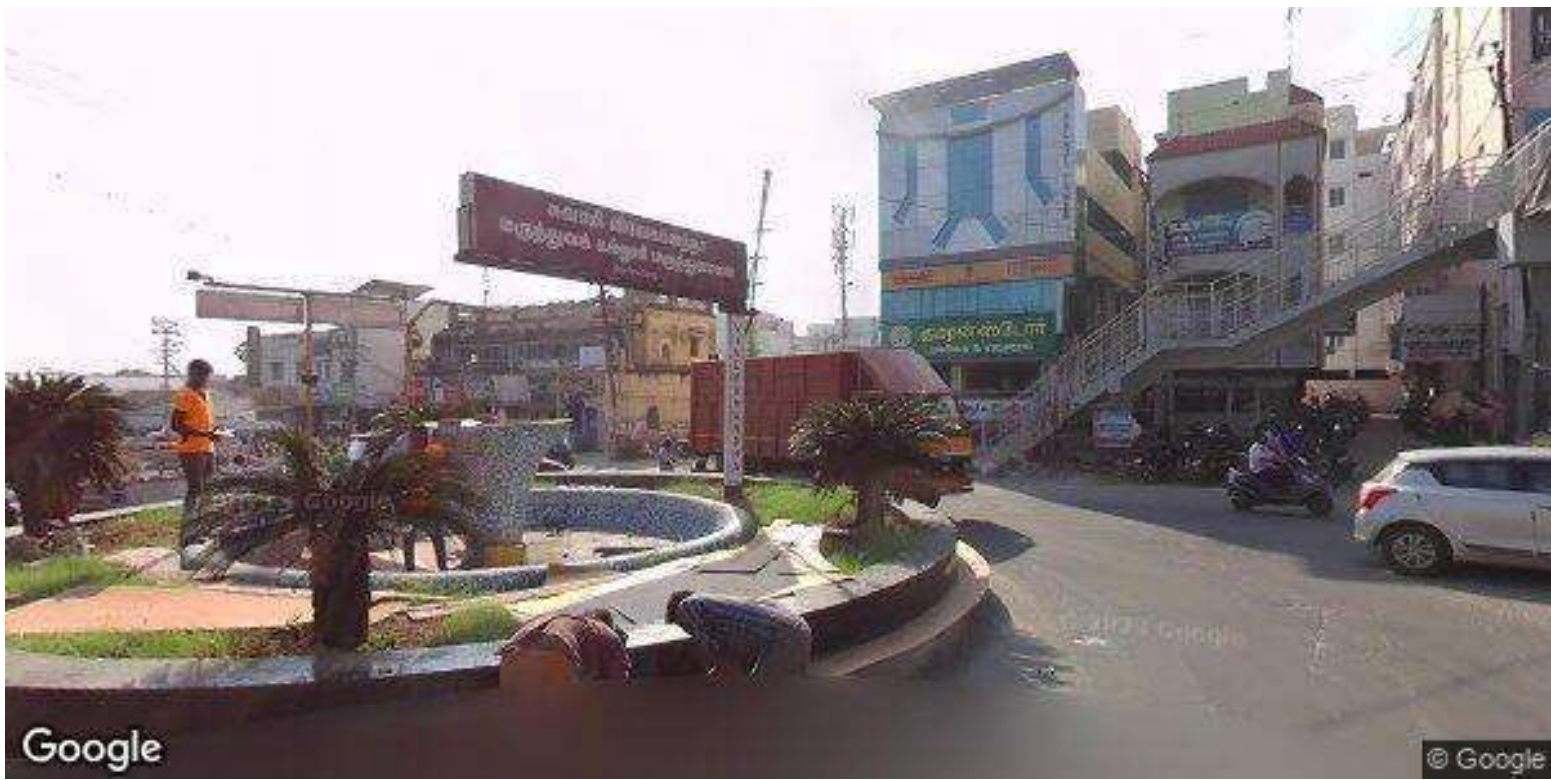
Coordinates: 11.38395, 77.89480

Risk Type: Roundabout

Risk Level: High

Speed Limit: 15 KM/Hr

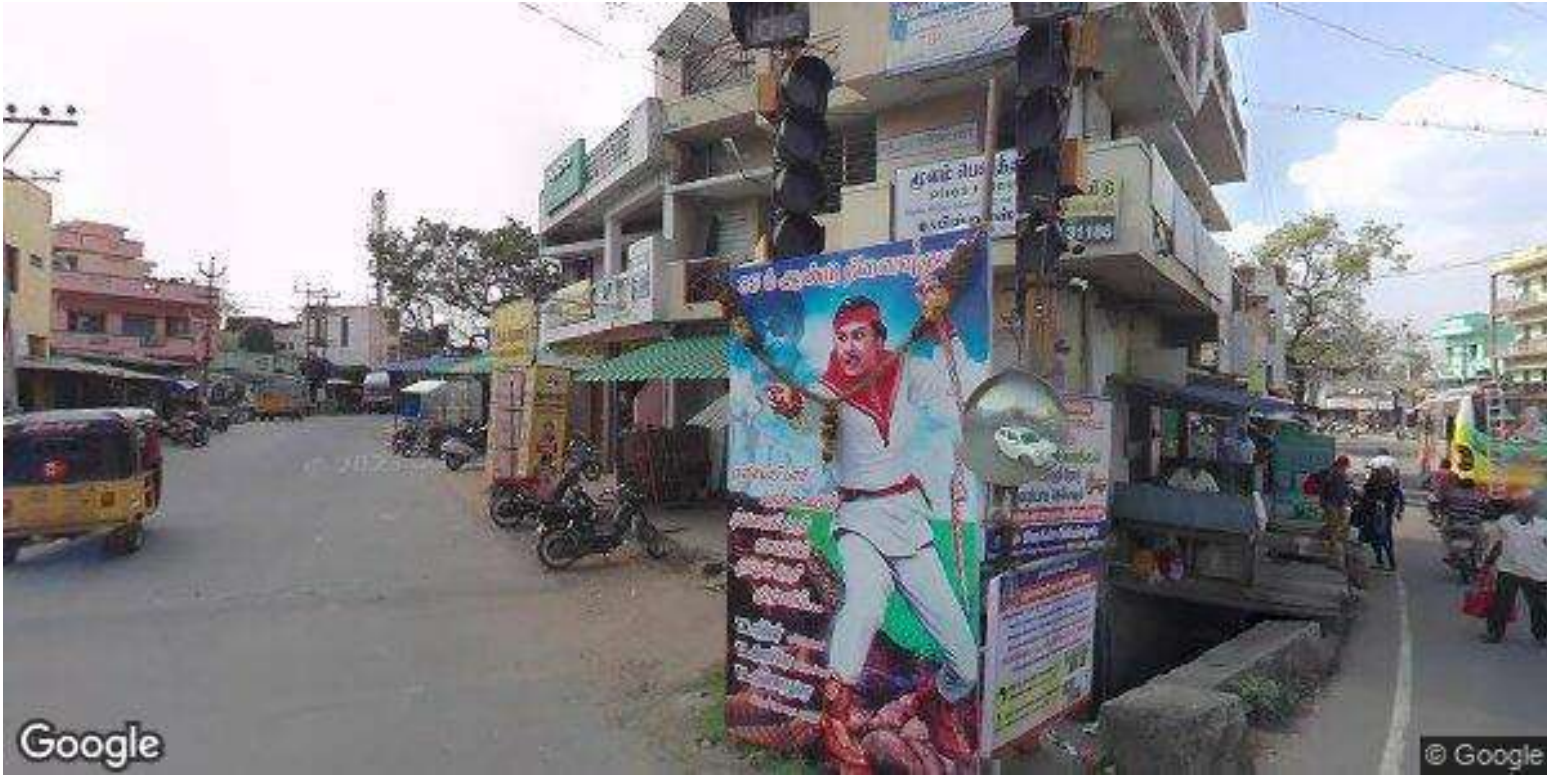
**Risk Type:** Turn  
**Risk Level:** Medium  
**Speed Limit:** 30 KM/Hr  
**Coordinates:** 11.38342, 77.89975

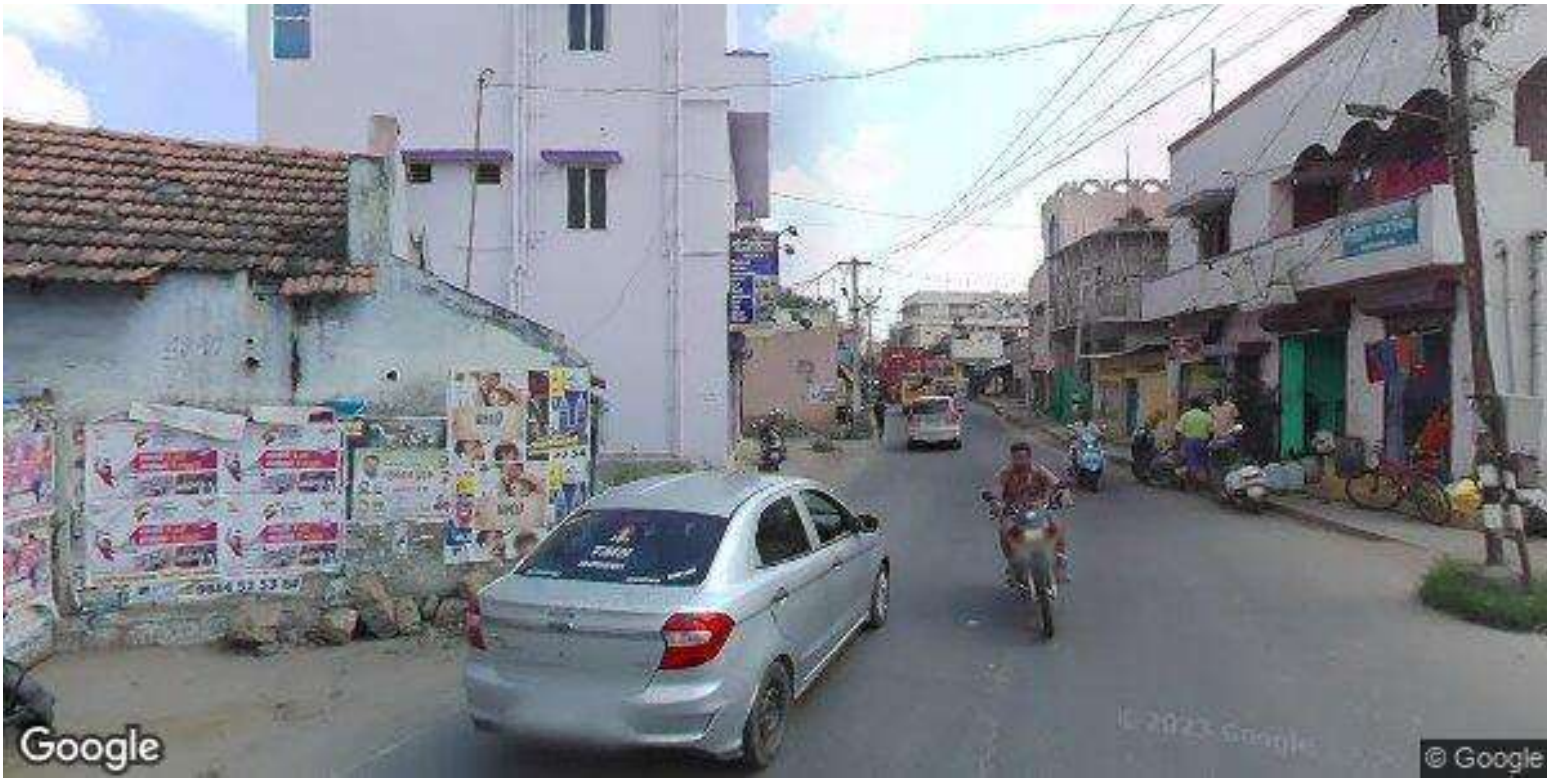
**Coordinates: 11.38295, 77.90001**

| | Risk Type | Risk Level | Coordinates | Speed Limit |
|---|---|---|---|---|
| 5 | Turn | Medium | 11.38295, 77.90001 | 30 KM/Hr |

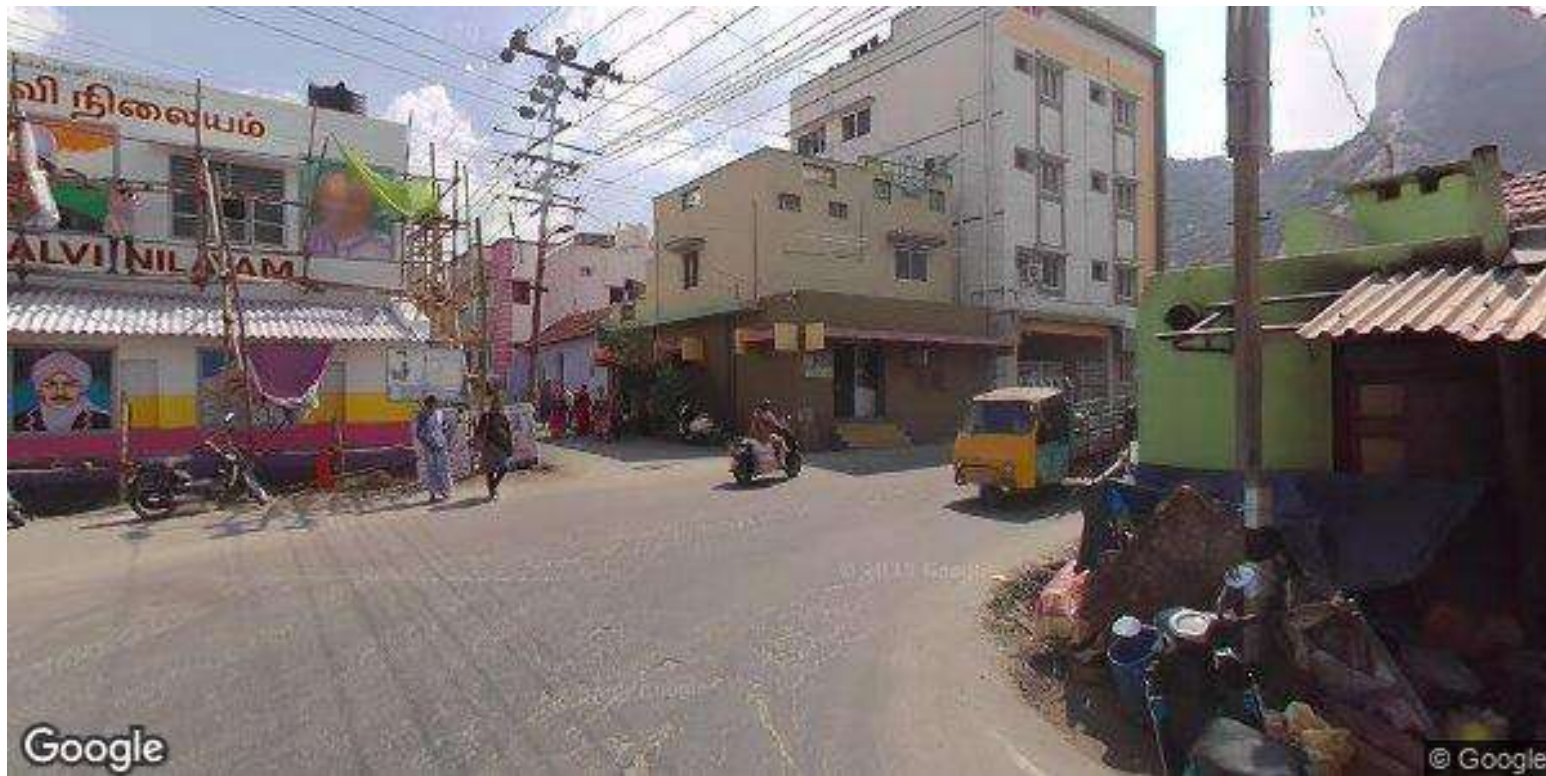
**Coordinates:** 11.38186, 77.90258

| | Risk Type | Risk Level | Coordinates | Speed Limit |
|---|---|---|---|---|
| 6 | Turn | High | 11.38186, 77.90258 | 15 KM/Hr |

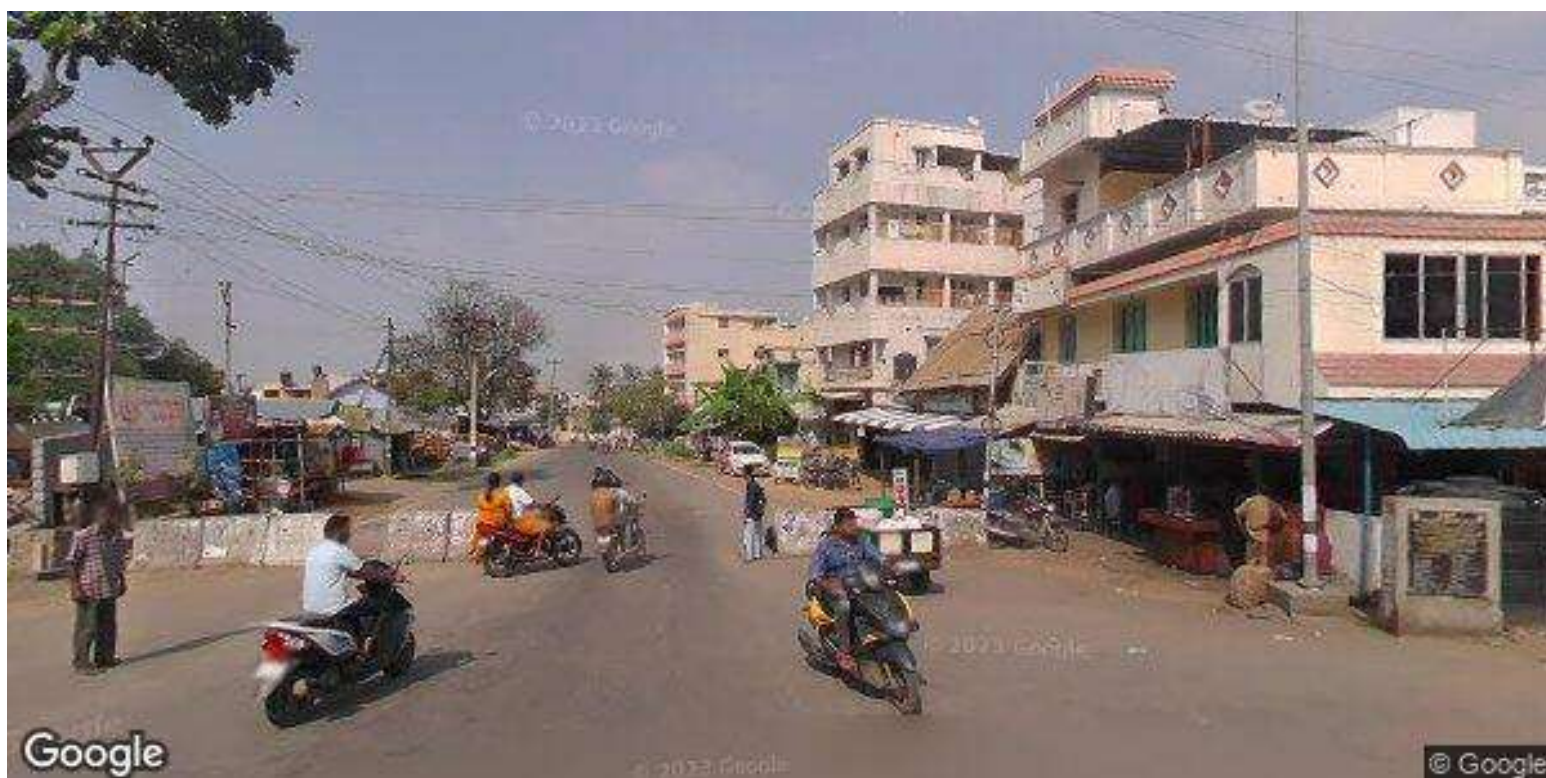
Coordinates: 11.37841, 77.90140

| | Risk Type | Risk Level | Coordinates | Speed Limit |
|---|---|---|---|---|
| 7 | Blind Spot | Blind Spot | 11.37841, 77.90140 | 10 KM/Hr |

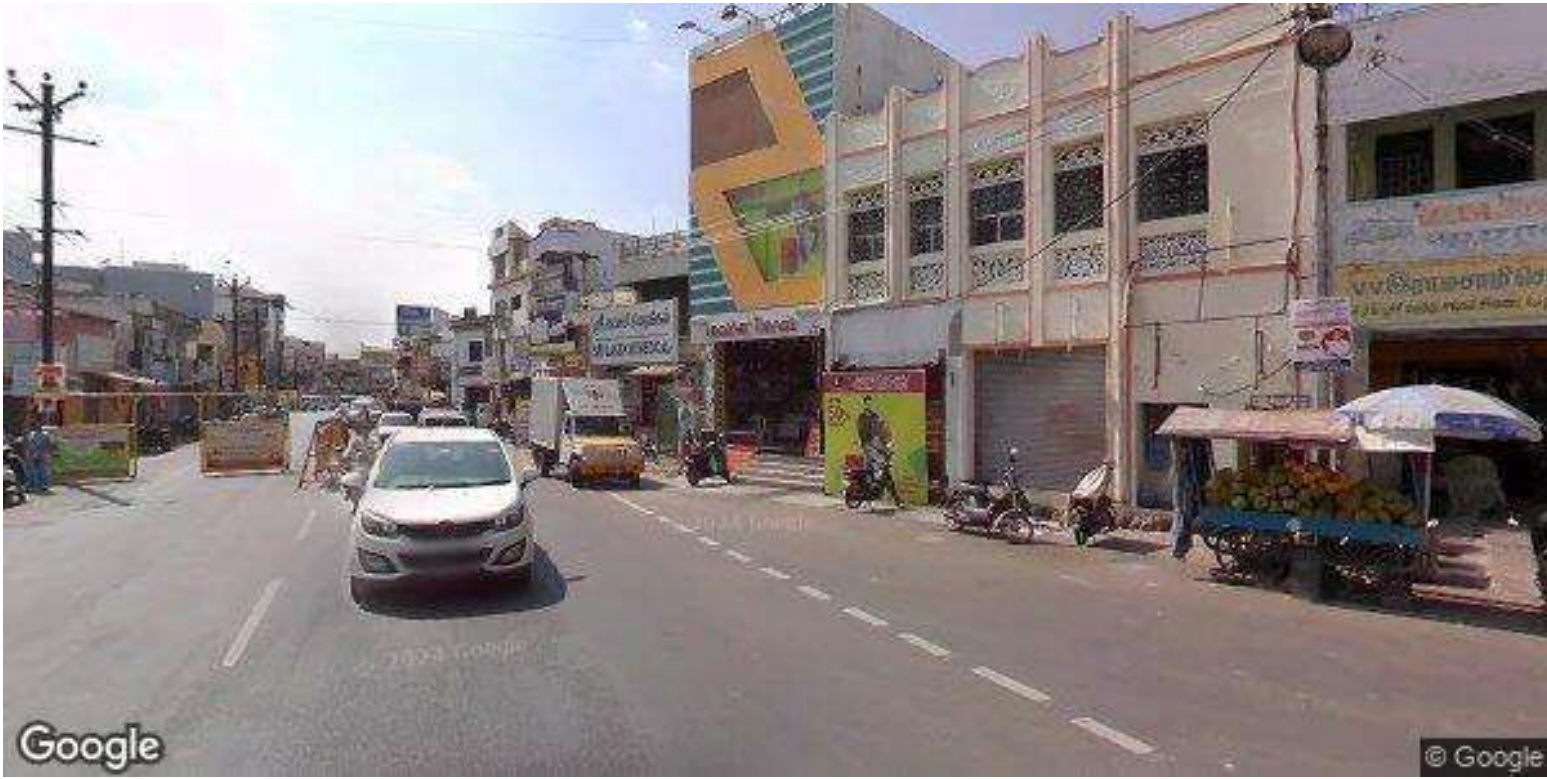
**Risk Type:** Turn  
**Risk Level:** Medium  
**Speed Limit:** 30 KM/Hr  
**Coordinates:** 11.22480, 78.16534

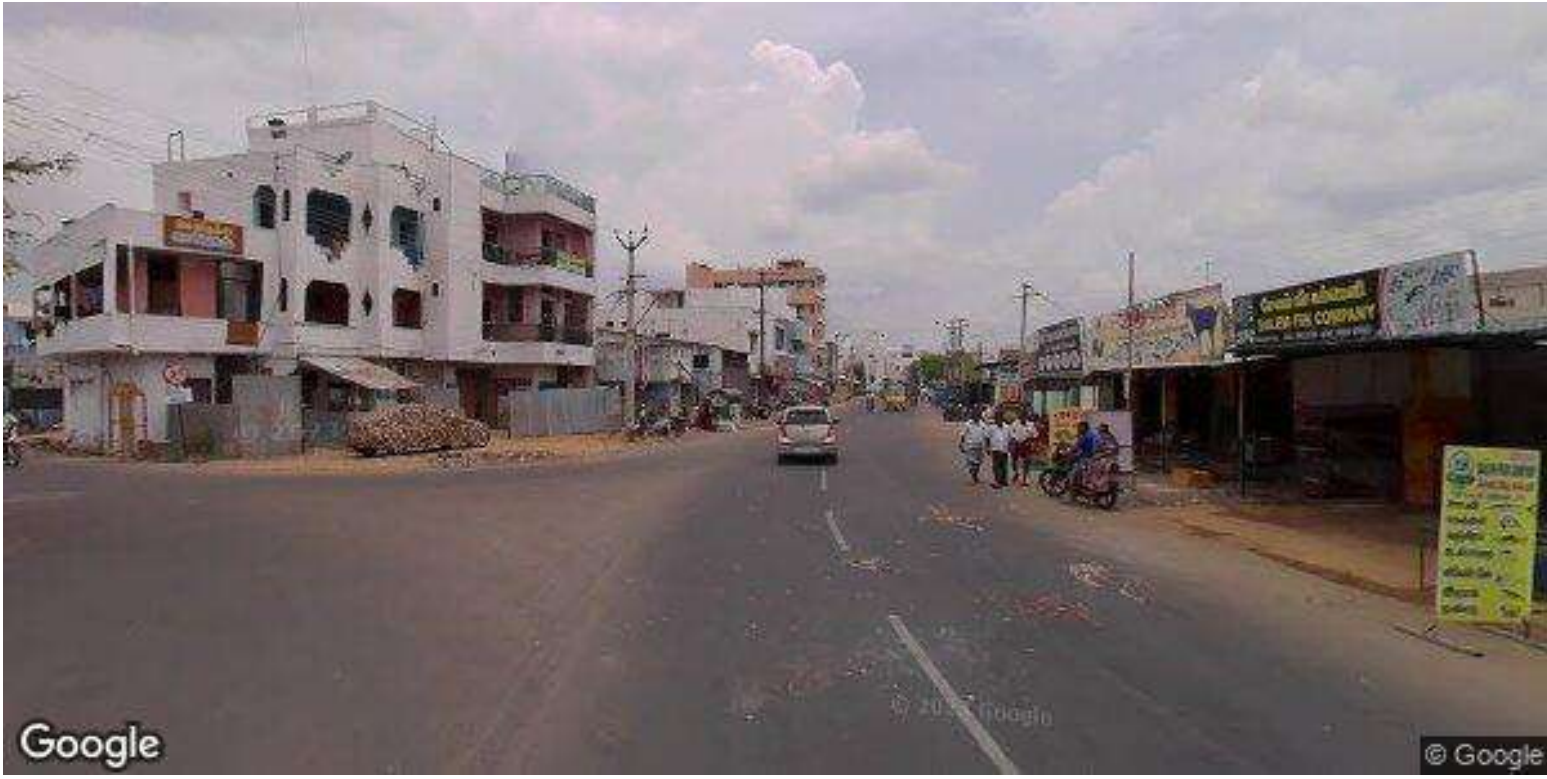
**Risk Type:** Turn  
**Risk Level:** Medium  
**Speed Limit:** 30 KM/Hr  
**Coordinates:** 11.22406, 78.17197

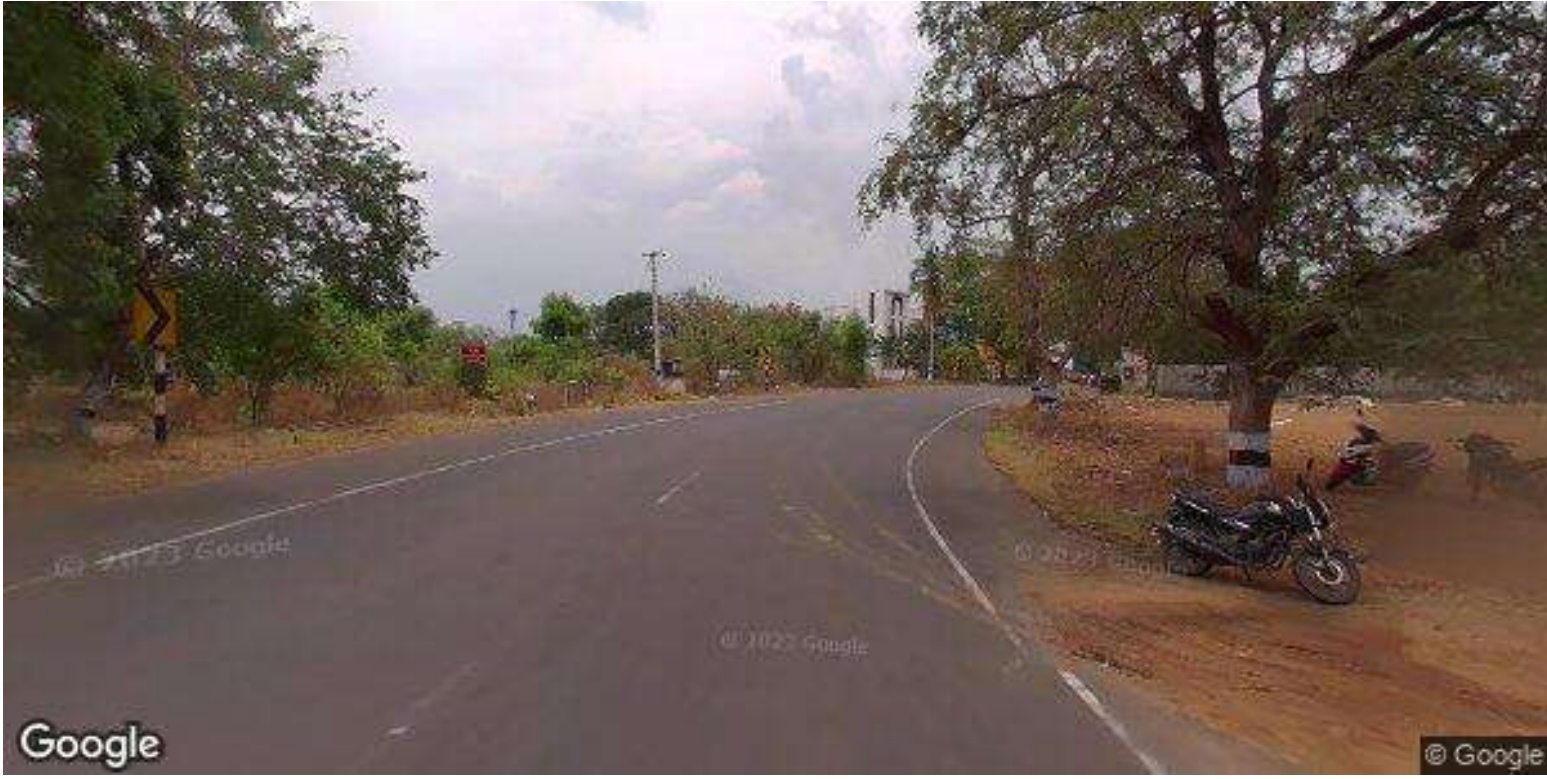
**Risk Type:** Turn  
**Risk Level:** Medium  
**Speed Limit:** 30 KM/Hr  
**Coordinates:** 11.24228, 78.21699

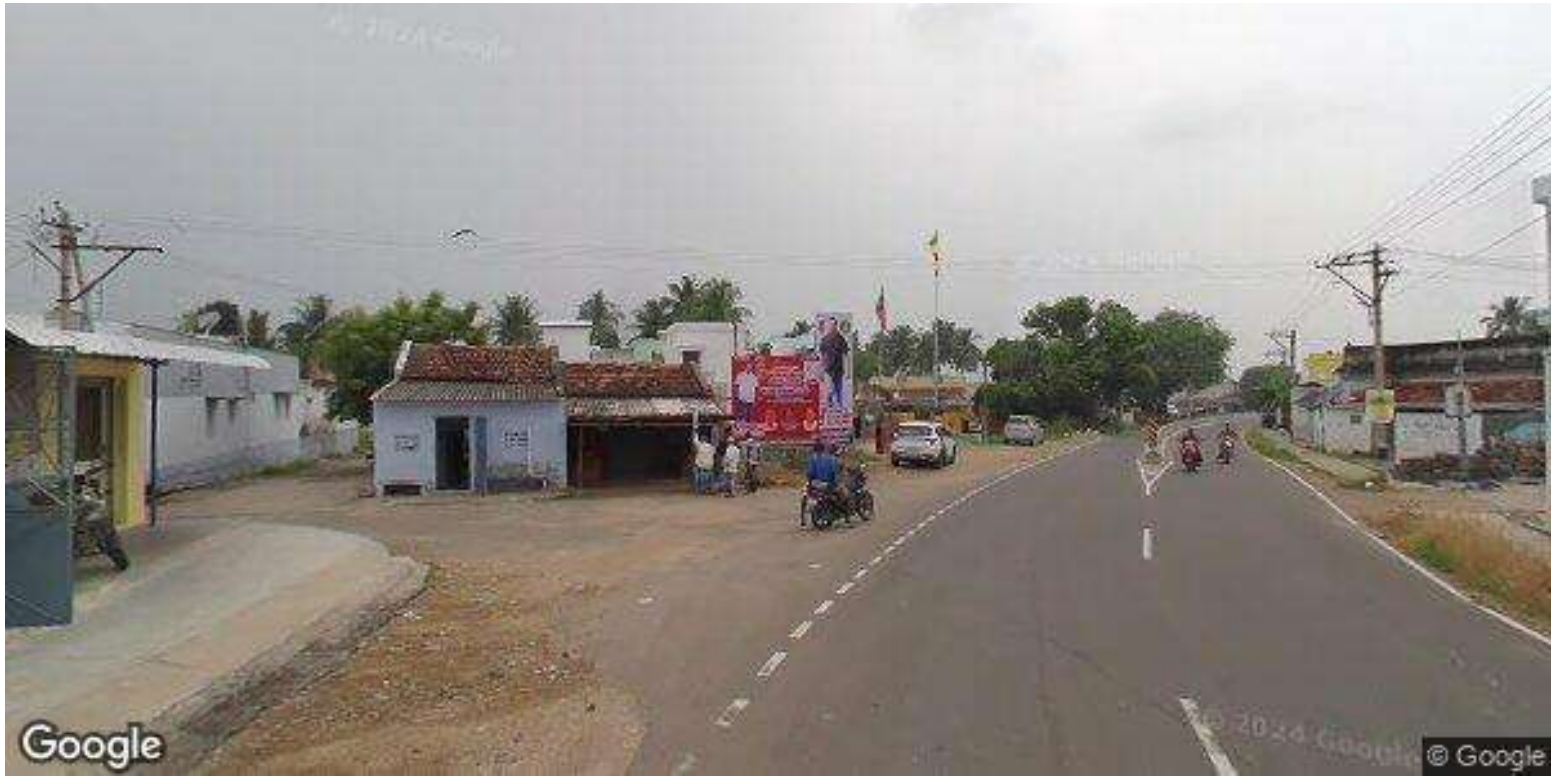
**Risk Type:** Turn  
**Risk Level:** Medium  
**Speed Limit:** 30 KM/Hr  
**Coordinates:** 11.24477, 78.22620

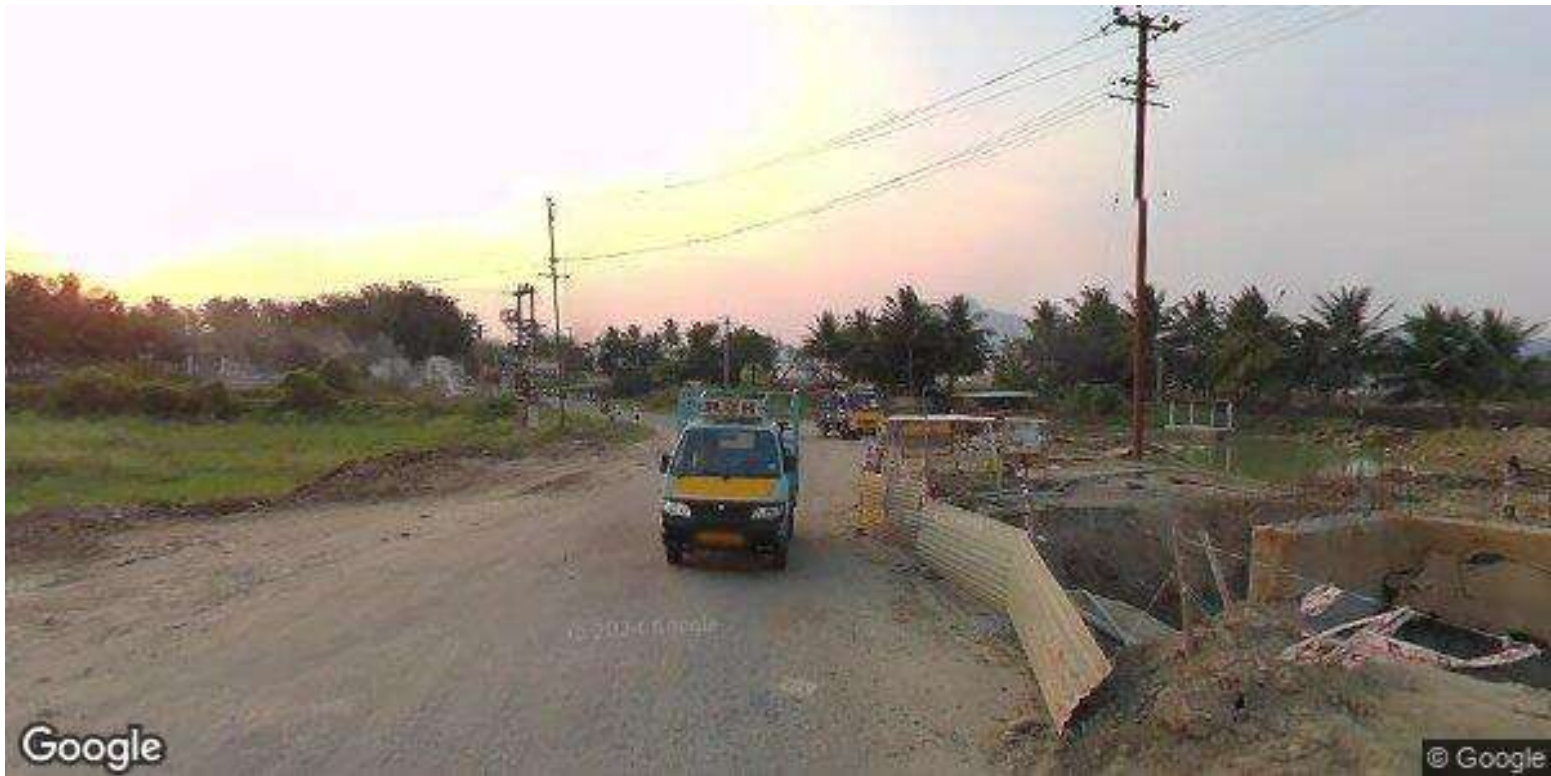
**Risk Type:** Blind Spot  
**Risk Level:** Blind Spot  
**Speed Limit:** 10 KM/Hr  
**Coordinates:** 11.29162, 78.24142

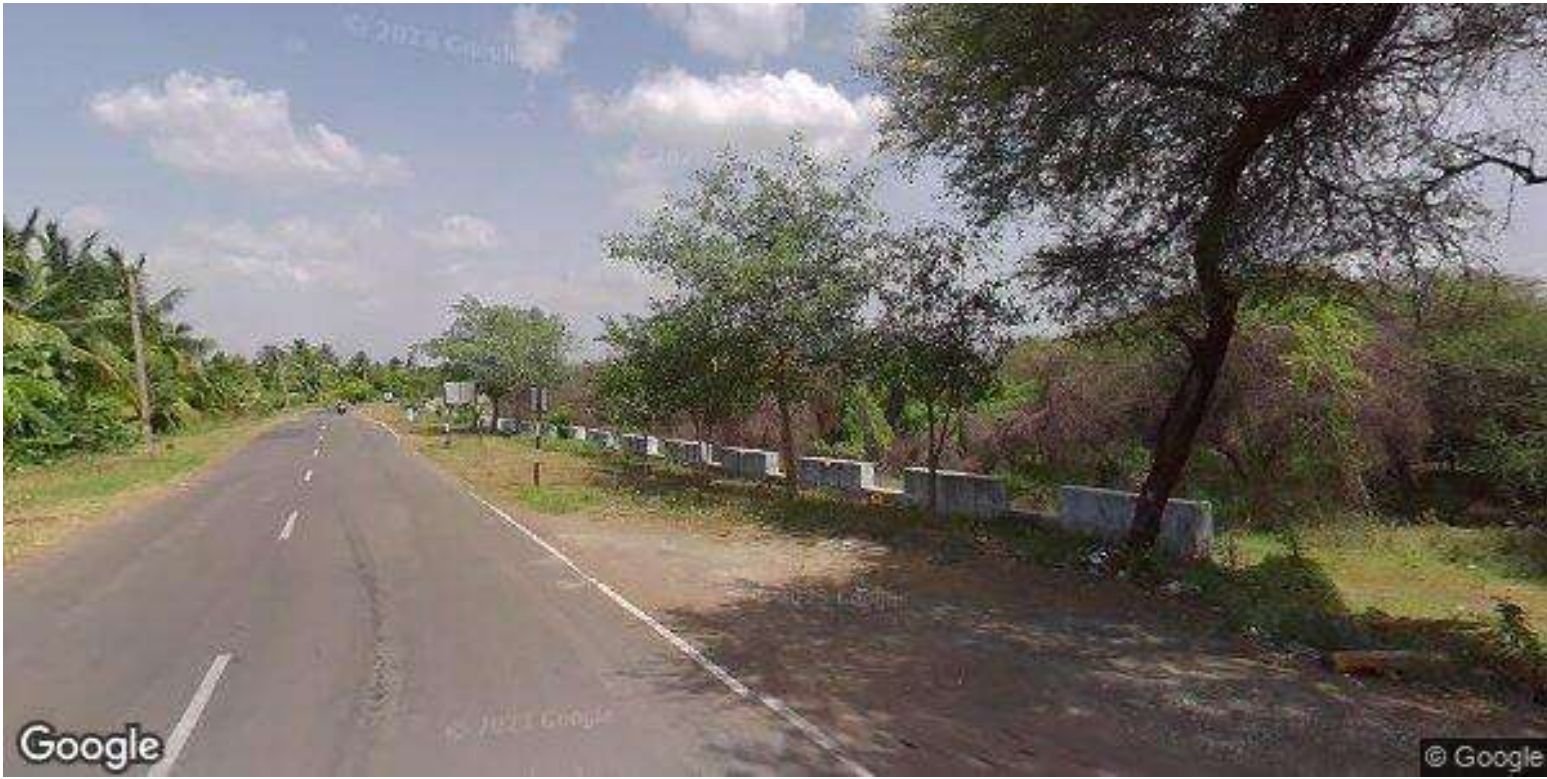
**Coordinates:** 11.29045, 78.24643

**Risk Type:** Turn

**Risk Level:** Medium

**Speed Limit:** 30 KM/Hr
