# IndianOil

## JOURNEY RISK MANAGEMENT (JRM) STUDY

**Salem Terminal to KDCMPU LTD.**

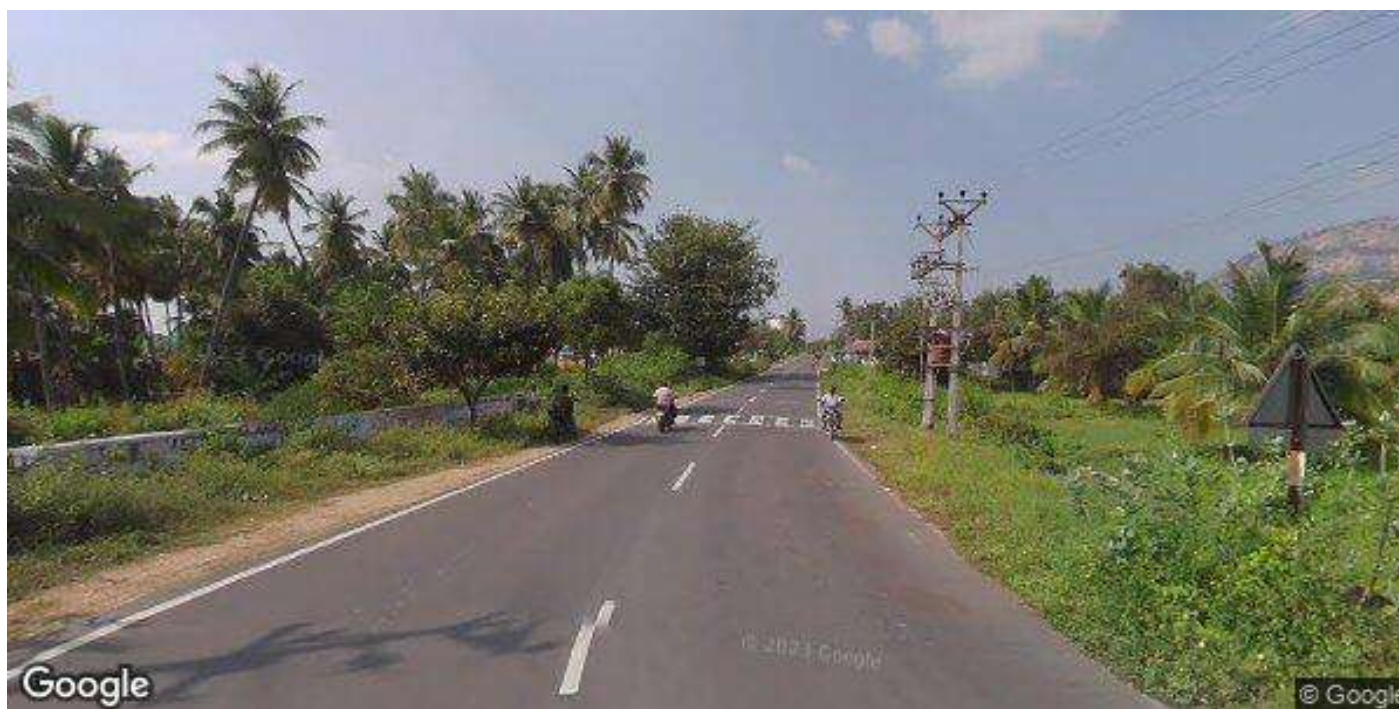
**Risk Type:** Turn  
**Risk Level:** High  
**Speed Limit:** 15 KM/Hr  
**Coordinates:** 11.45353, 77.85697

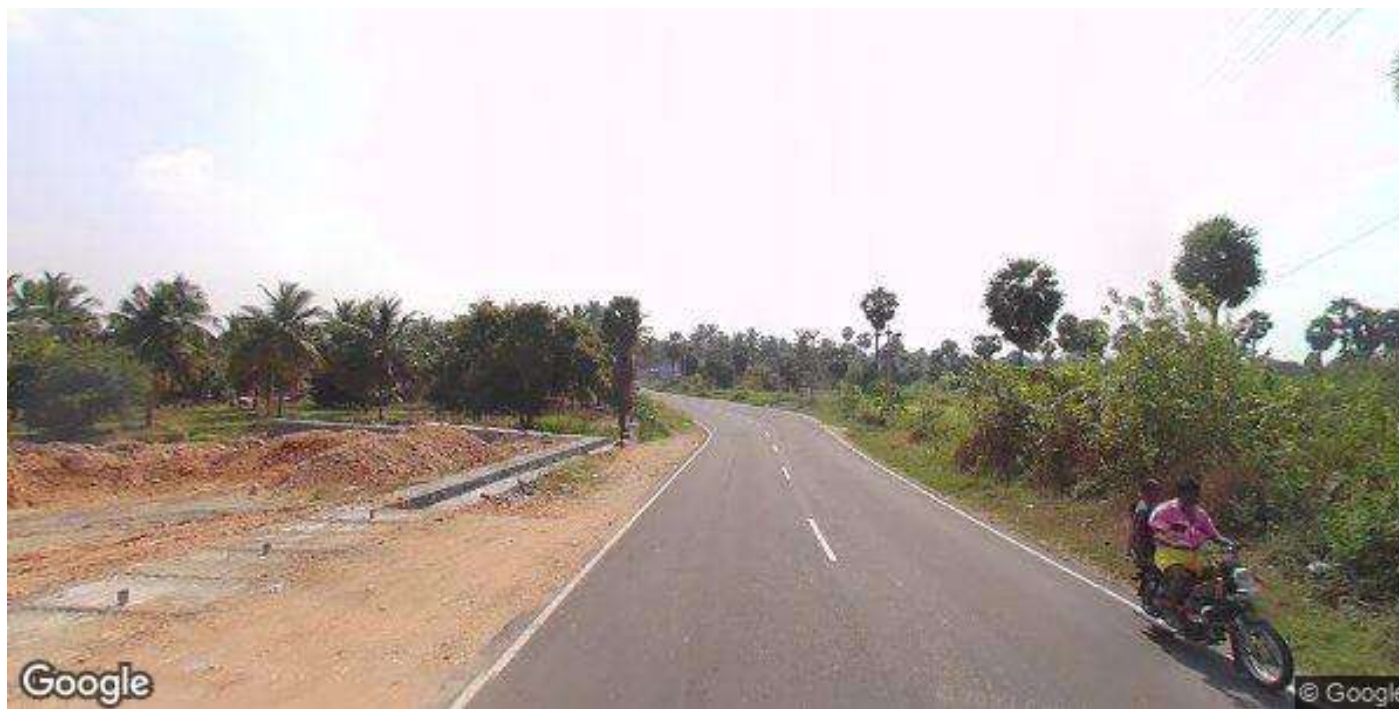
**Risk Type:** Turn  
**Risk Level:** Medium  
**Speed Limit:** 30 KM/Hr  
**Coordinates:** 11.45781, 77.85203

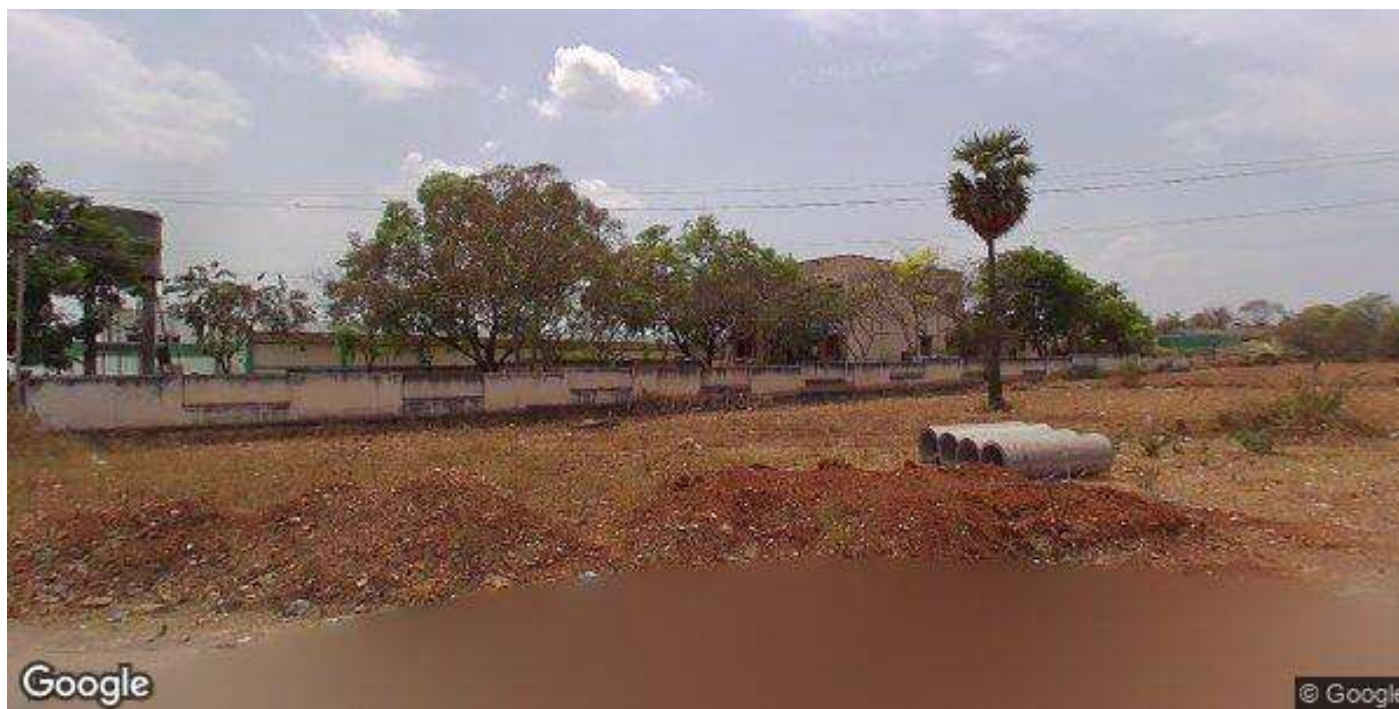
**Risk Type:** Turn  
**Risk Level:** High  
**Speed Limit:** 15 KM/Hr  
**Coordinates:** 11.58340, 77.90637

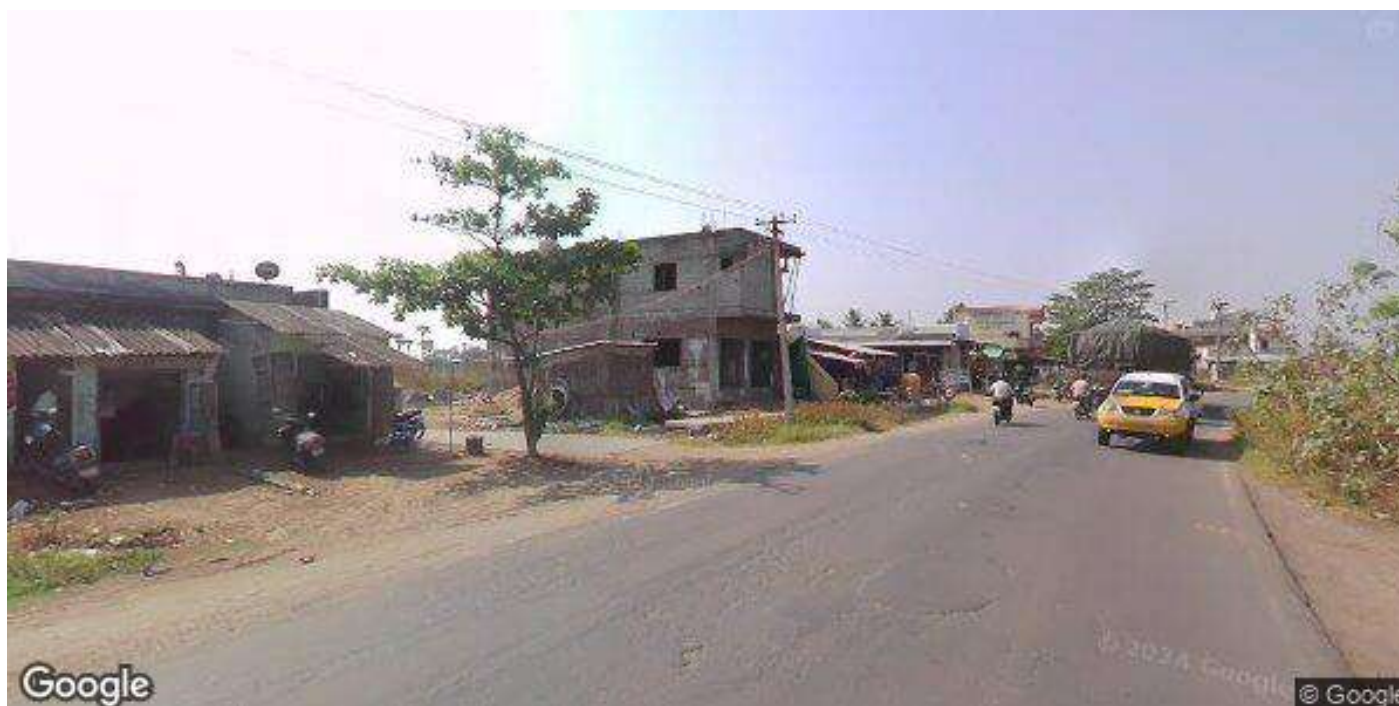
**Risk Type:** Turn  
**Risk Level:** Medium  
**Speed Limit:** 30 KM/Hr  
**Coordinates:** 11.59201, 77.90649

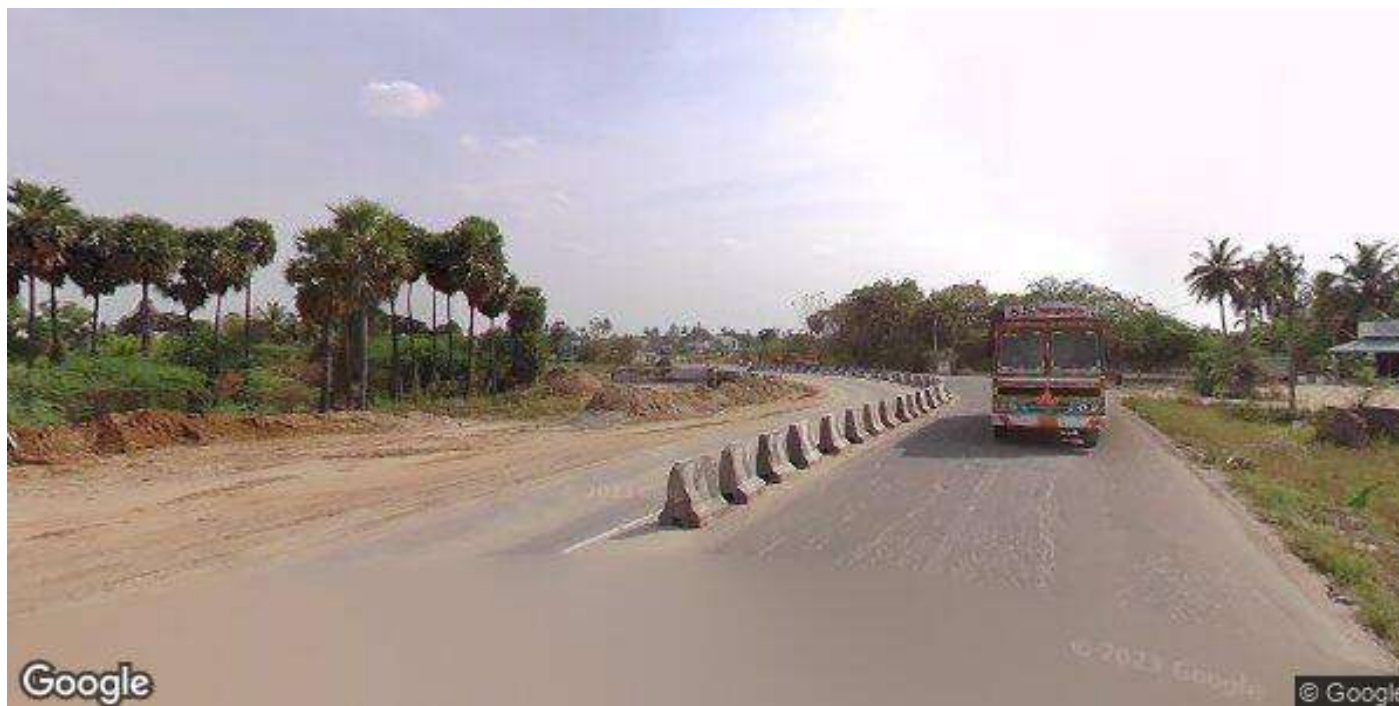
**Risk Type:** Turn  
**Risk Level:** Medium  
**Speed Limit:** 30 KM/Hr  
**Coordinates:** 11.63882, 77.94859

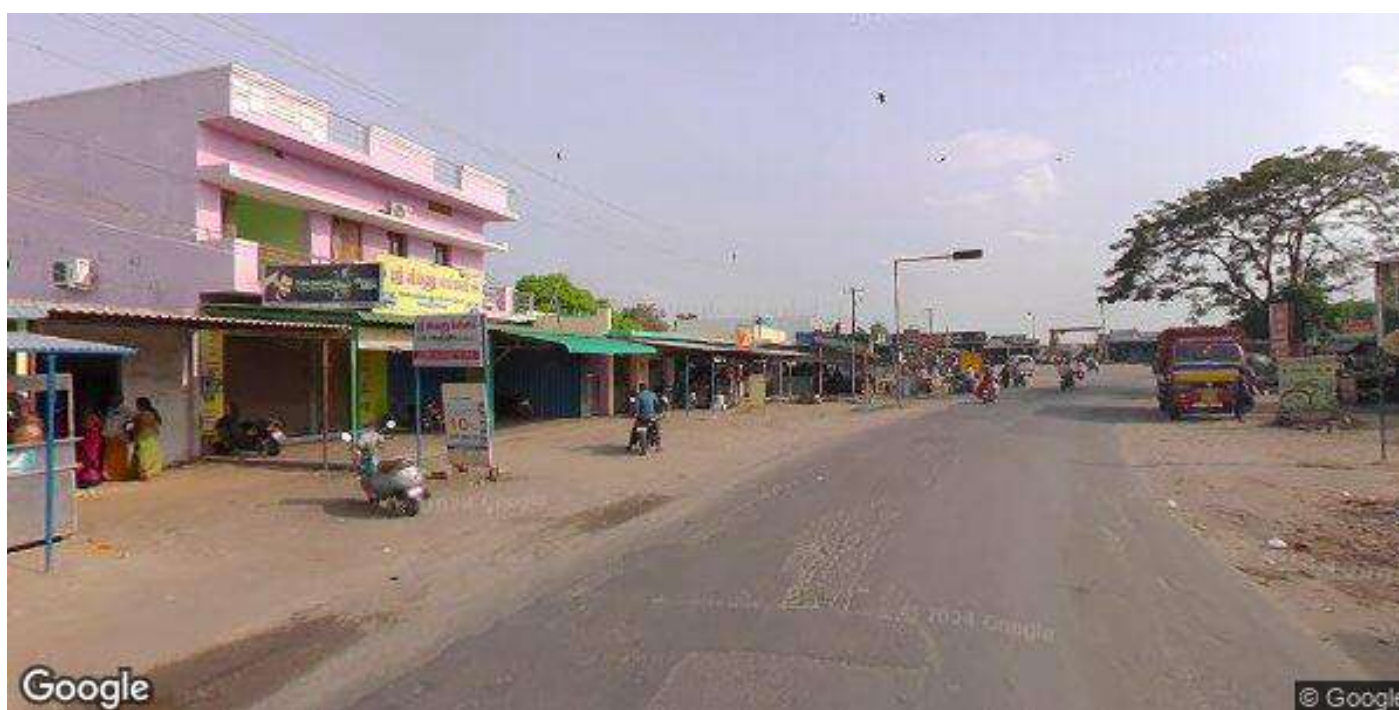
**Risk Type:** Turn  
**Risk Level:** High  
**Speed Limit:** 15 KM/Hr  
**Coordinates:** 11.64226, 77.95200

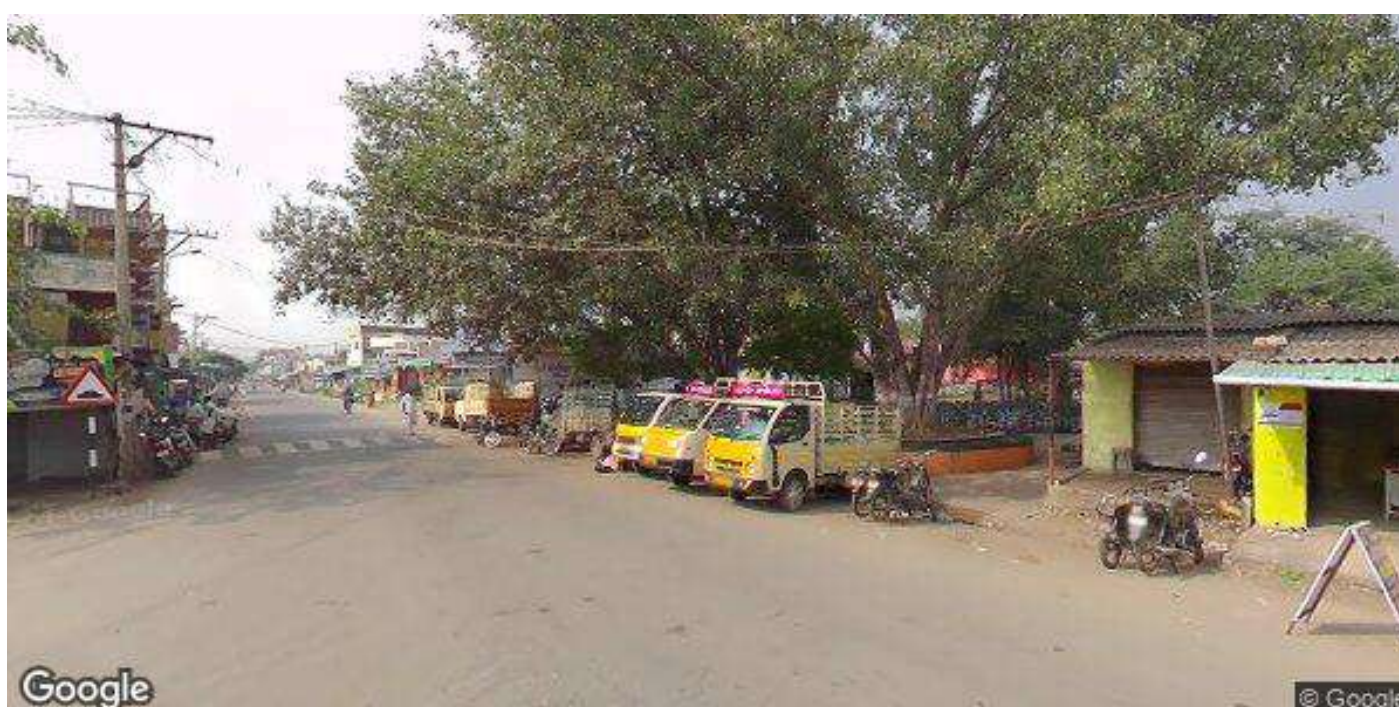
**Risk Type:** Turn  
**Risk Level:** Medium  
**Speed Limit:** 30 KM/Hr  
**Coordinates:** 11.64716, 77.95118

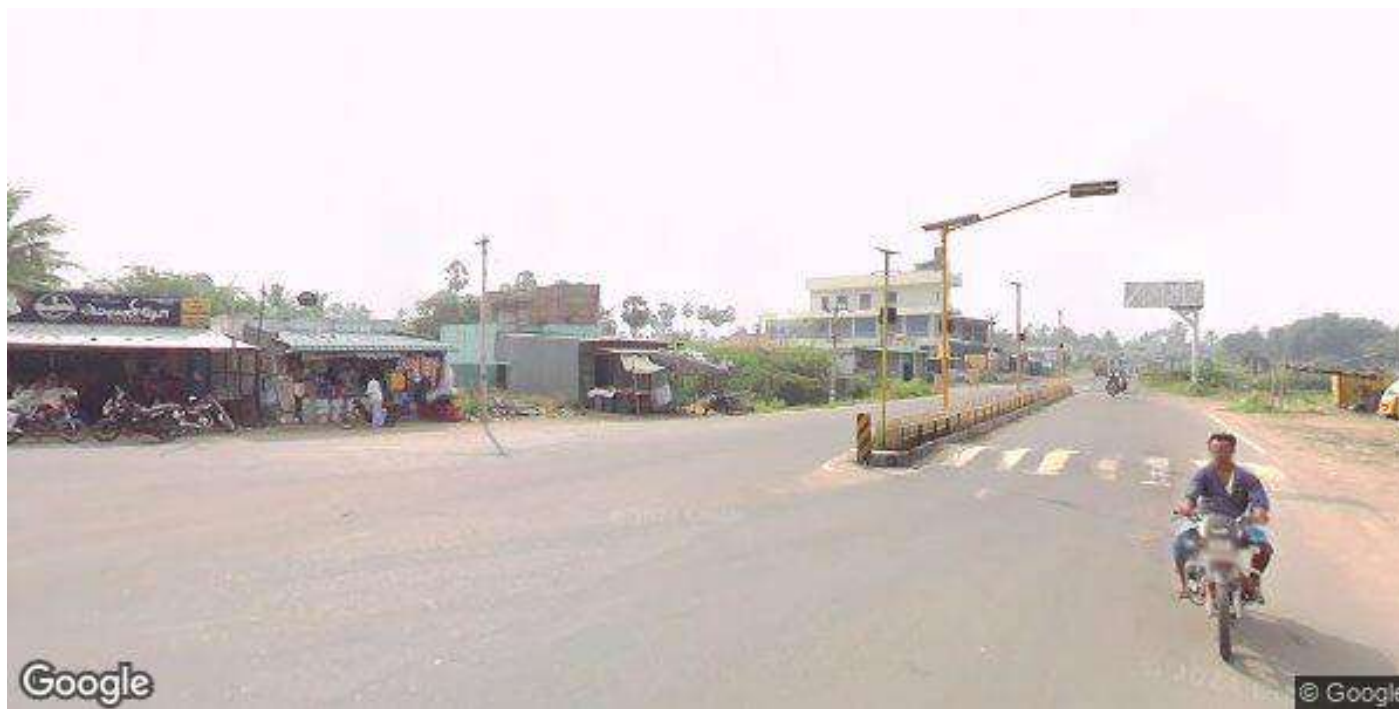
**Risk Type:** Turn  
**Risk Level:** Medium  
**Speed Limit:** 30 KM/Hr  
**Coordinates:** 11.67868, 77.96836

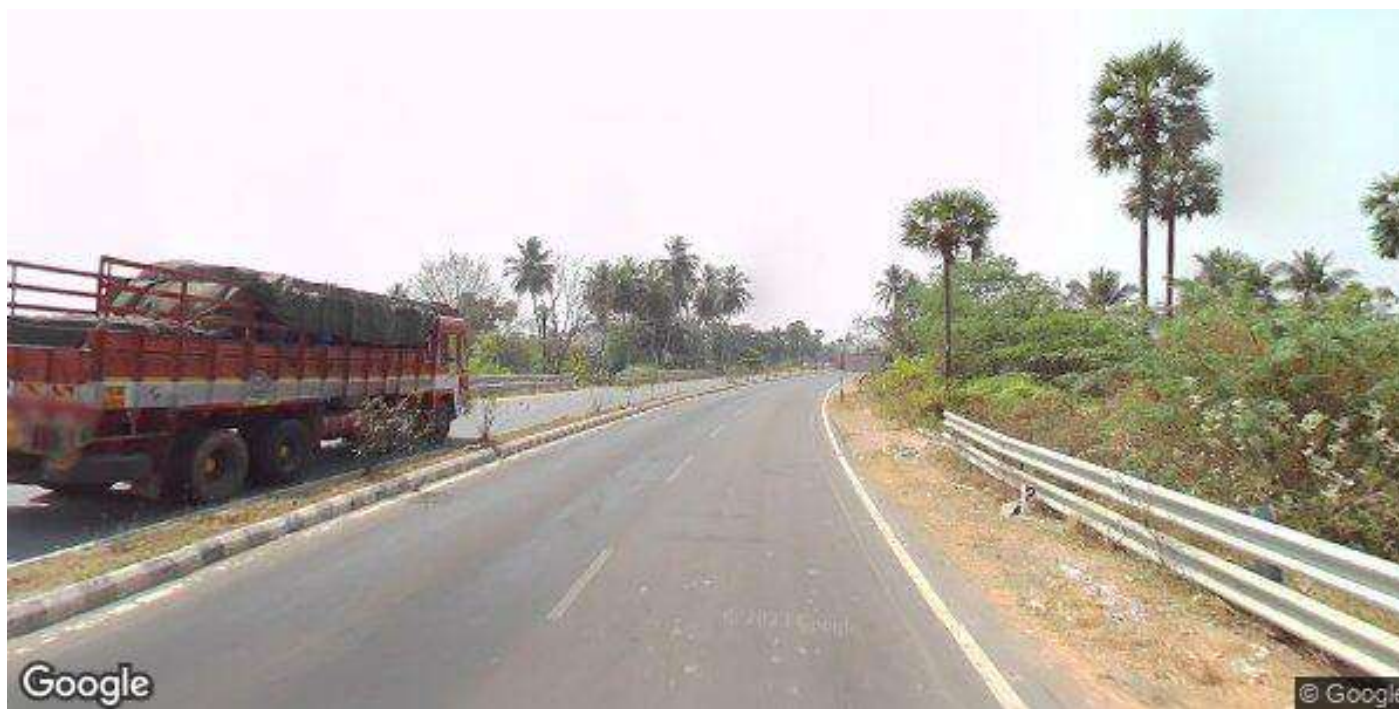
**Risk Type:** Turn  
**Risk Level:** Medium  
**Speed Limit:** 30 KM/Hr  
**Coordinates:** 11.70077, 77.97957

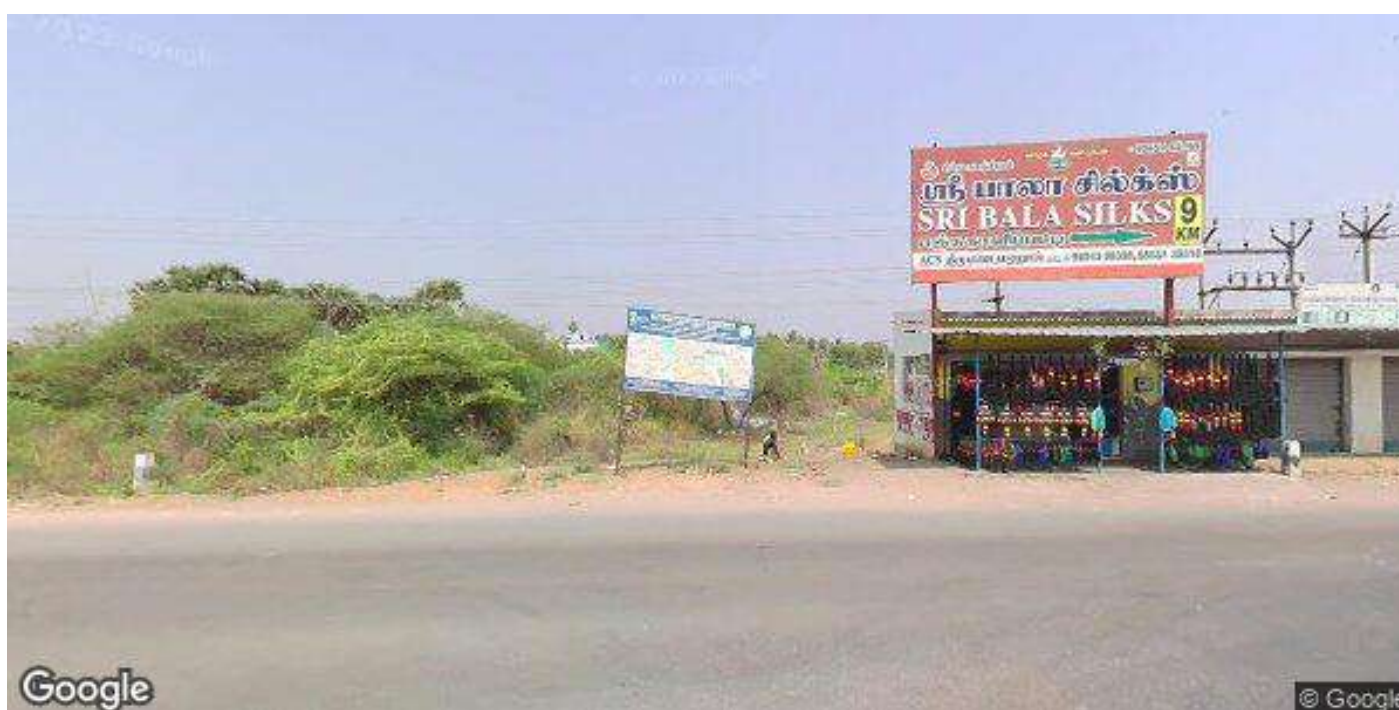
**Risk Type:** Turn  
**Risk Level:** High  
**Speed Limit:** 15 KM/Hr  
**Coordinates:** 11.70223, 77.97860

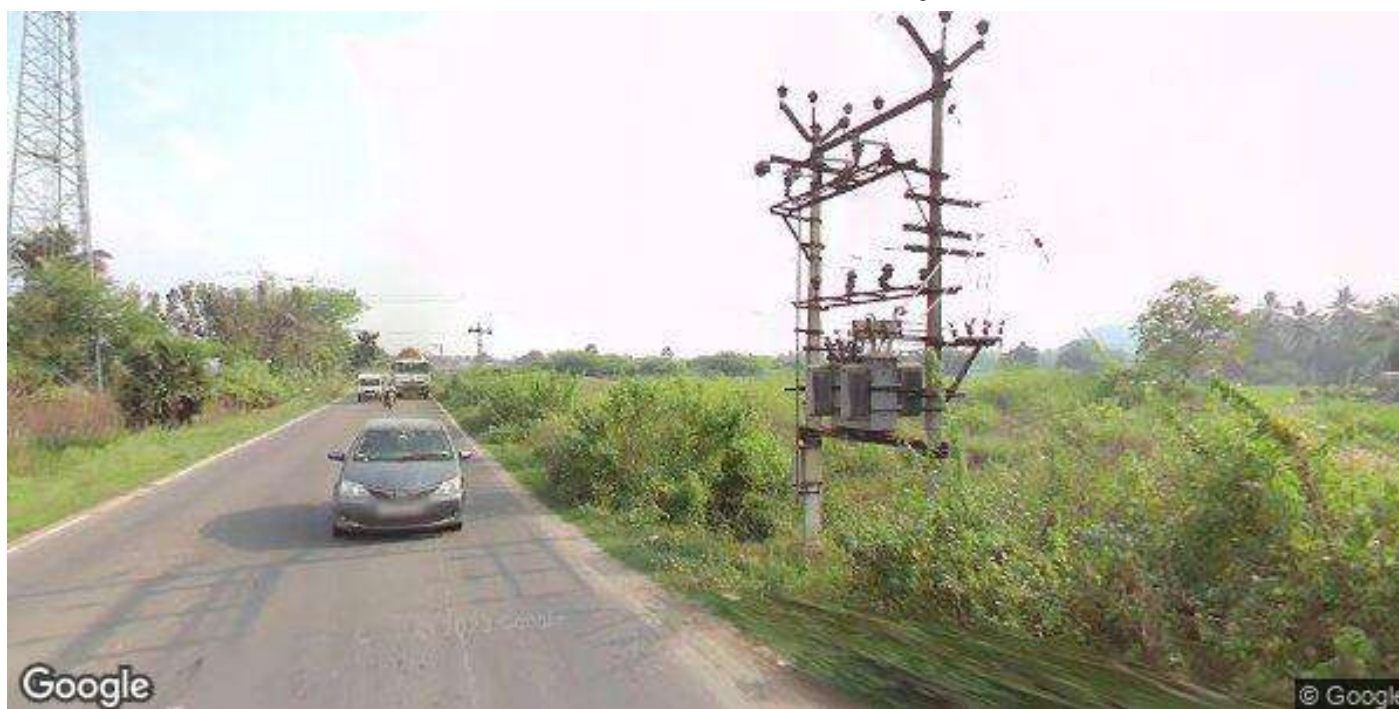
**Risk Type:** Turn  
**Risk Level:** Medium  
**Speed Limit:** 30 KM/Hr  
**Coordinates:** 11.71402, 77.99586

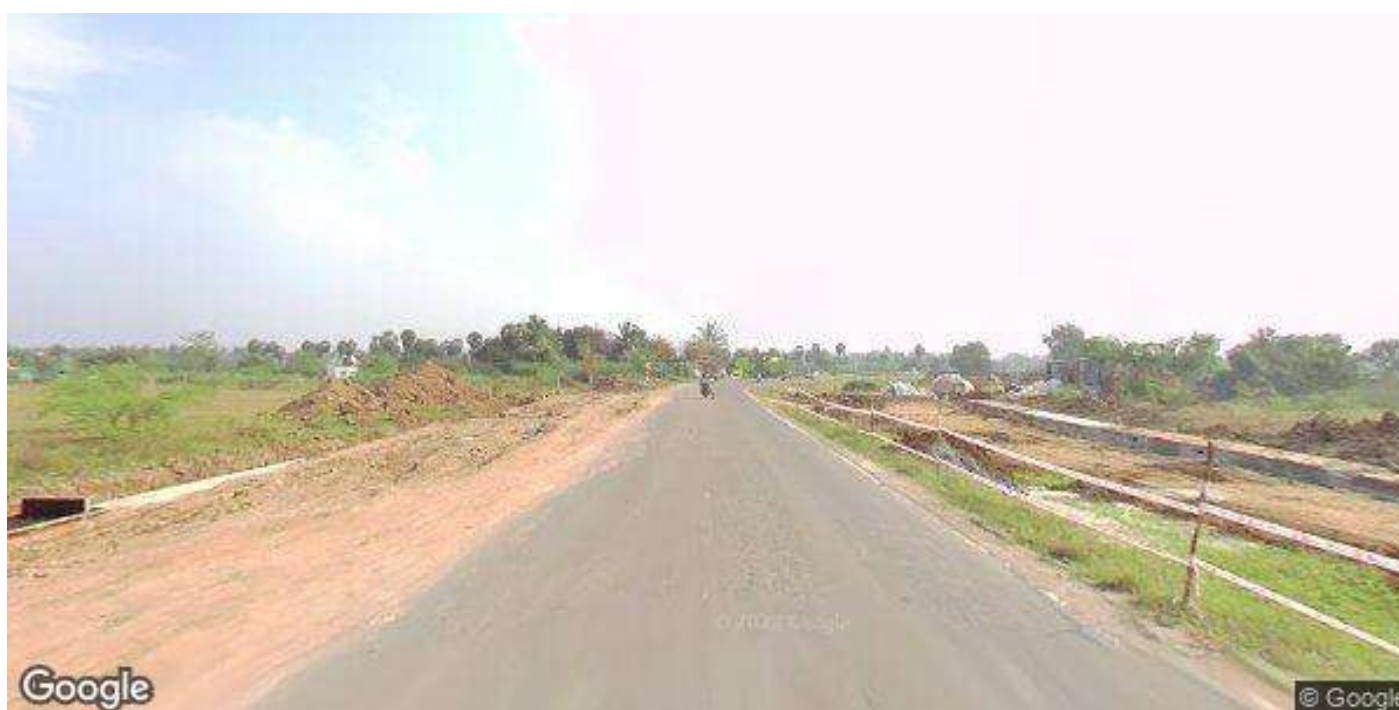
**Risk Type:** Turn  
**Risk Level:** Medium  
**Speed Limit:** 30 KM/Hr  
**Coordinates:** 11.71704, 77.99948

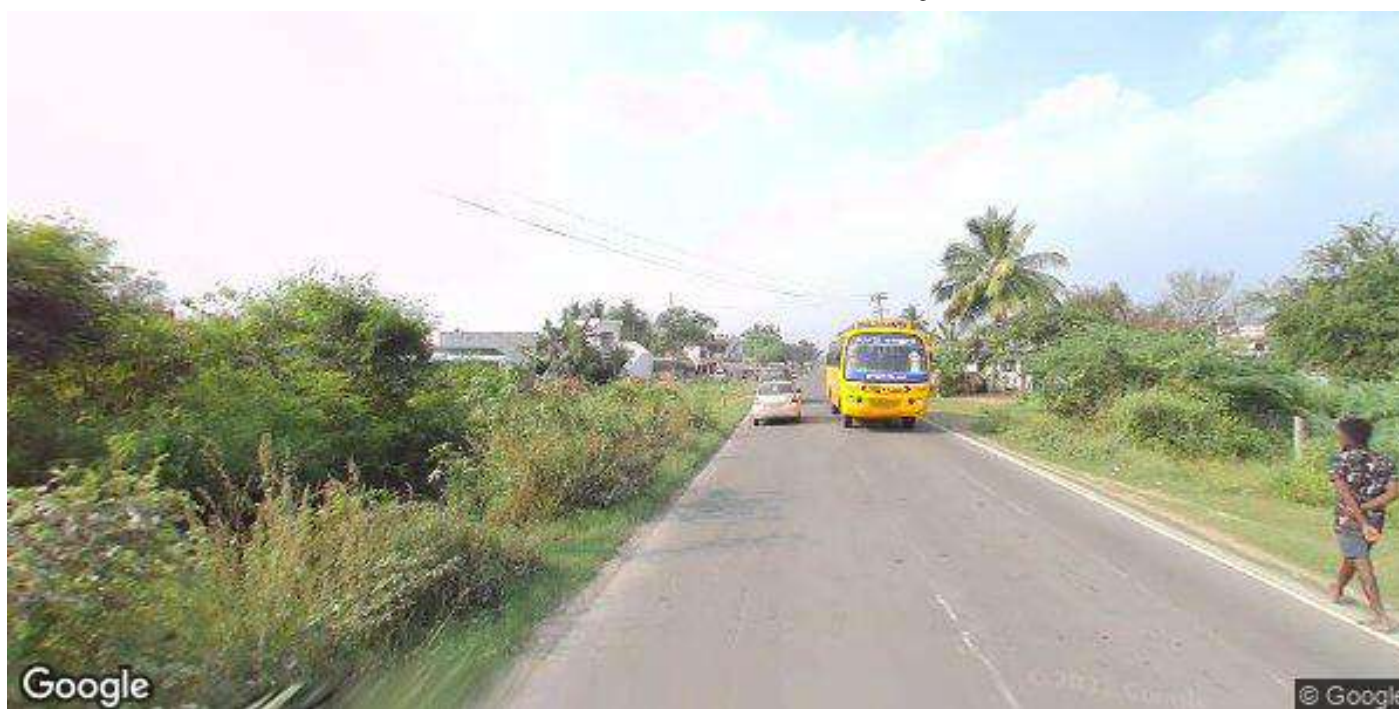
**Risk Type:** Turn  
**Risk Level:** Medium  
**Speed Limit:** 30 KM/Hr  
**Coordinates:** 11.72708, 78.02197

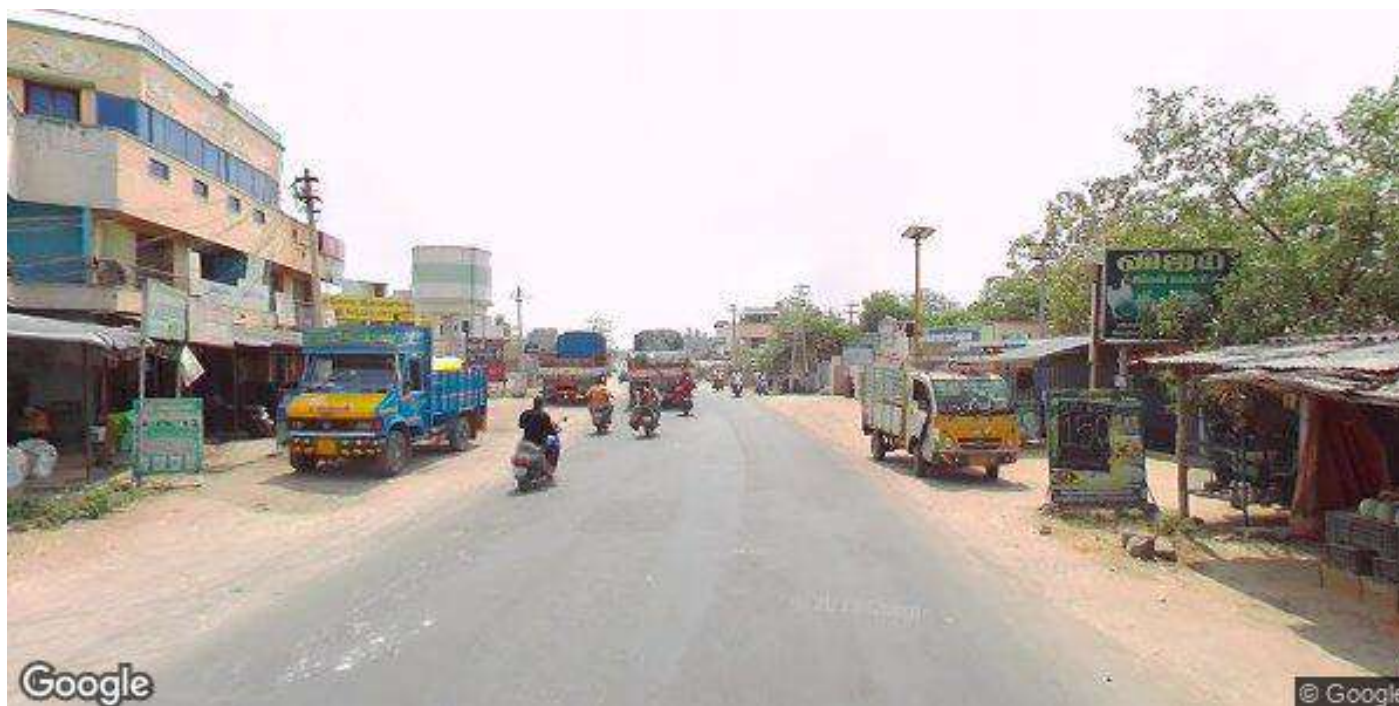
**Risk Type:** Turn  
**Risk Level:** High  
**Speed Limit:** 15 KM/Hr  
**Coordinates:** 11.73769, 78.03451

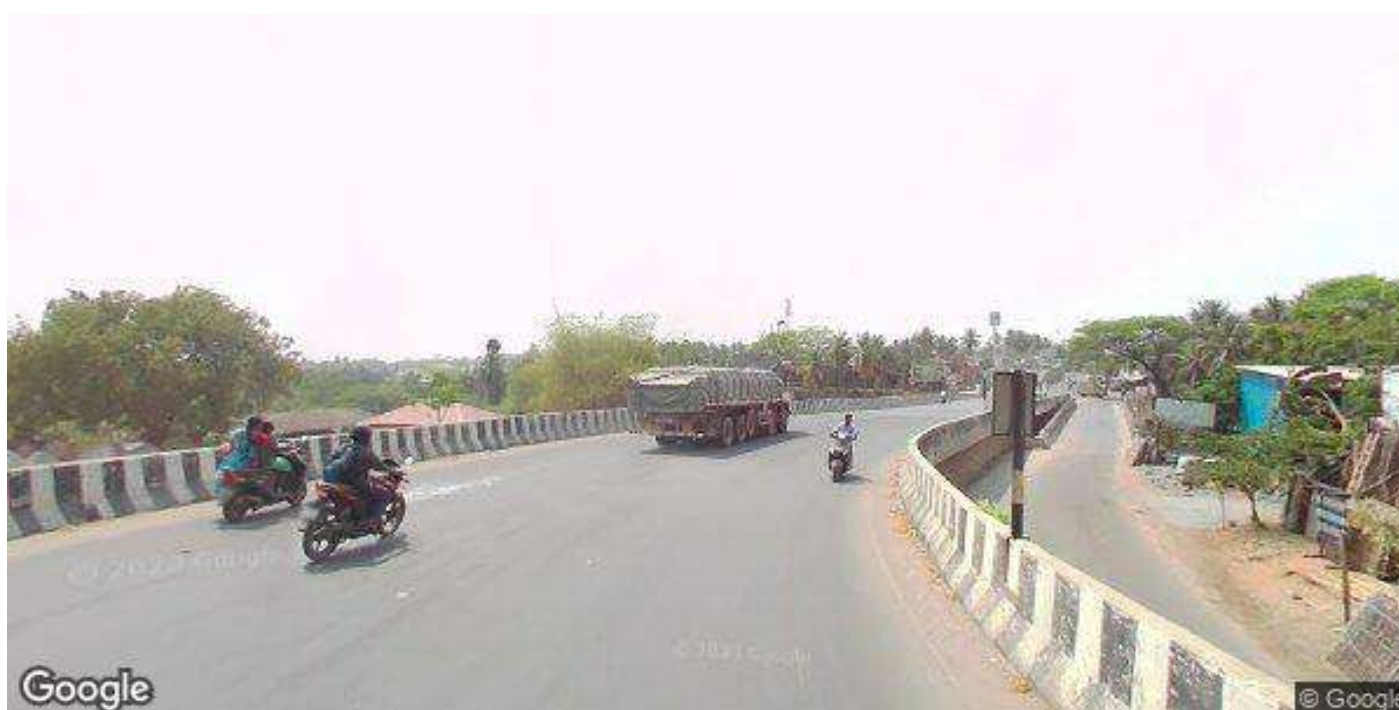
**Risk Type:** Turn  
**Risk Level:** High  
**Speed Limit:** 15 KM/Hr  
**Coordinates:** 11.73651, 78.03871

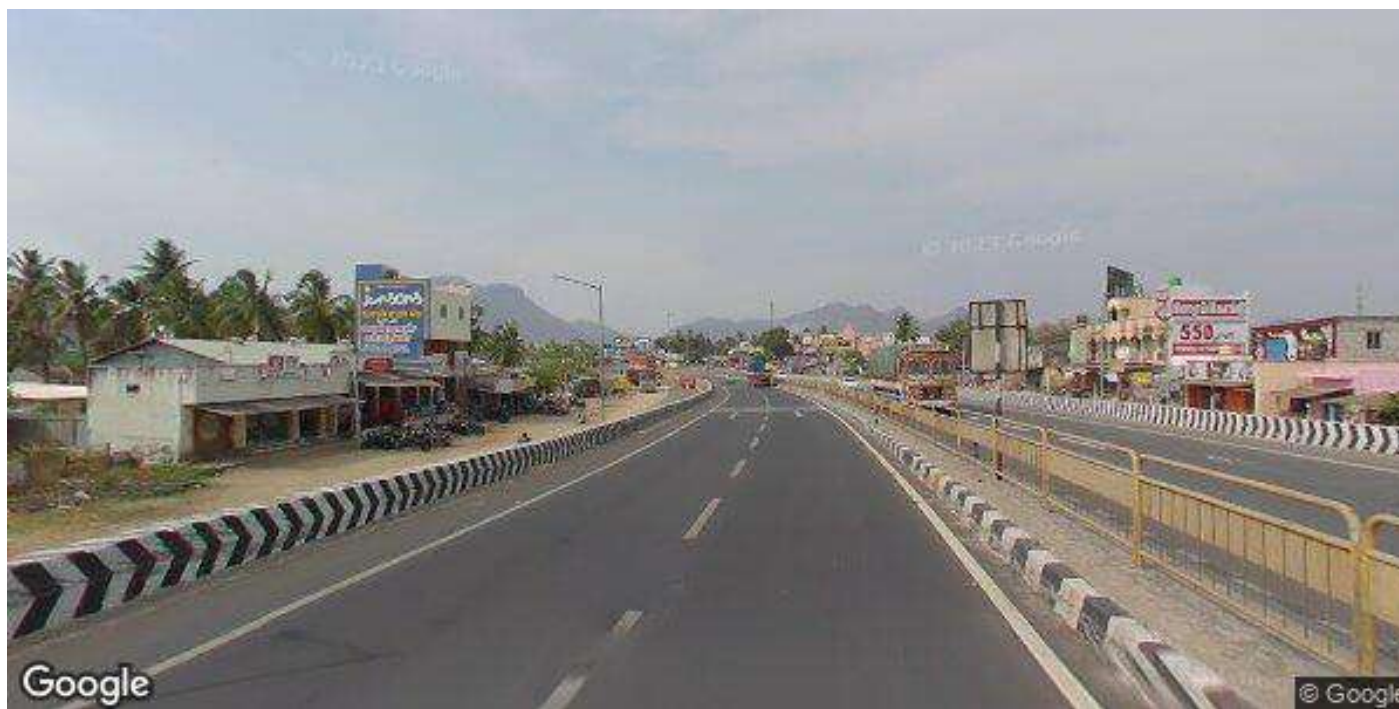
**Risk Type:** Turn  
**Risk Level:** Medium  
**Speed Limit:** 30 KM/Hr  
**Coordinates:** 11.86847, 78.08367

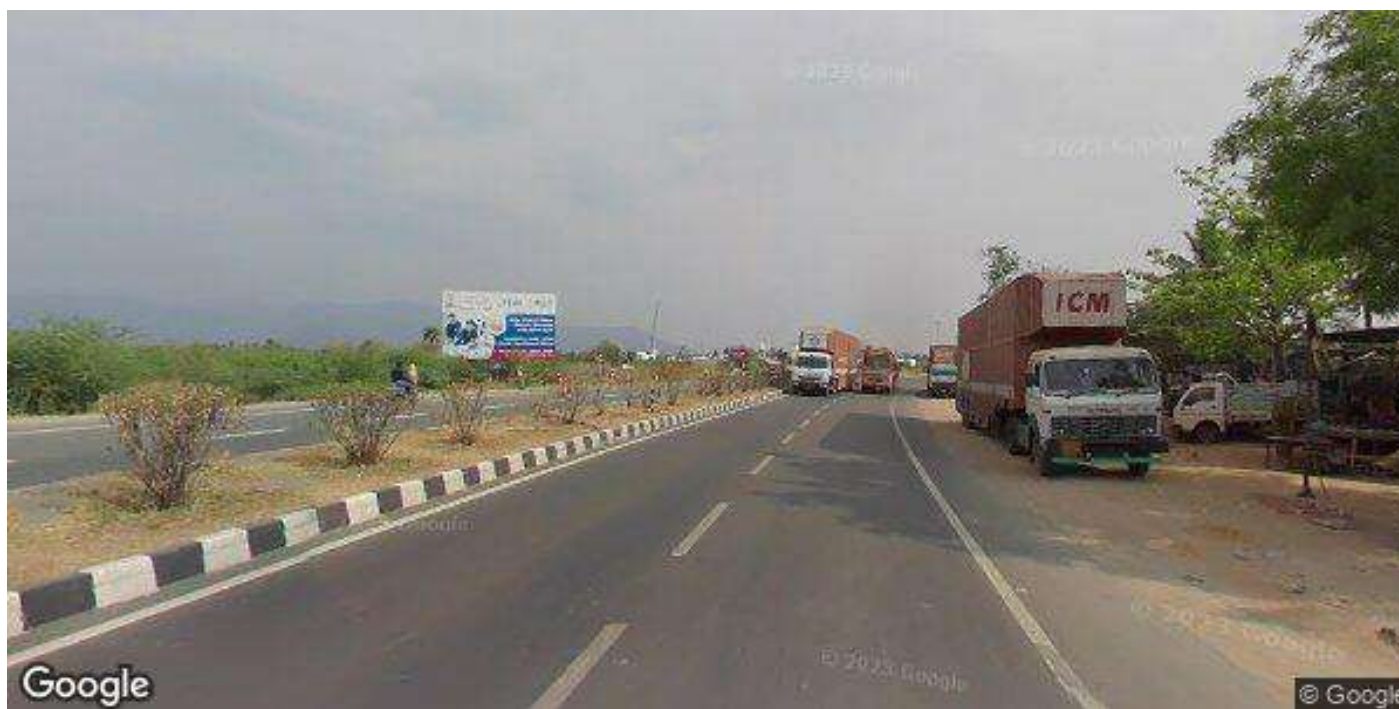
**Risk Type:** Turn  
**Risk Level:** Medium  
**Speed Limit:** 30 KM/Hr  
**Coordinates:** 11.87942, 78.08197

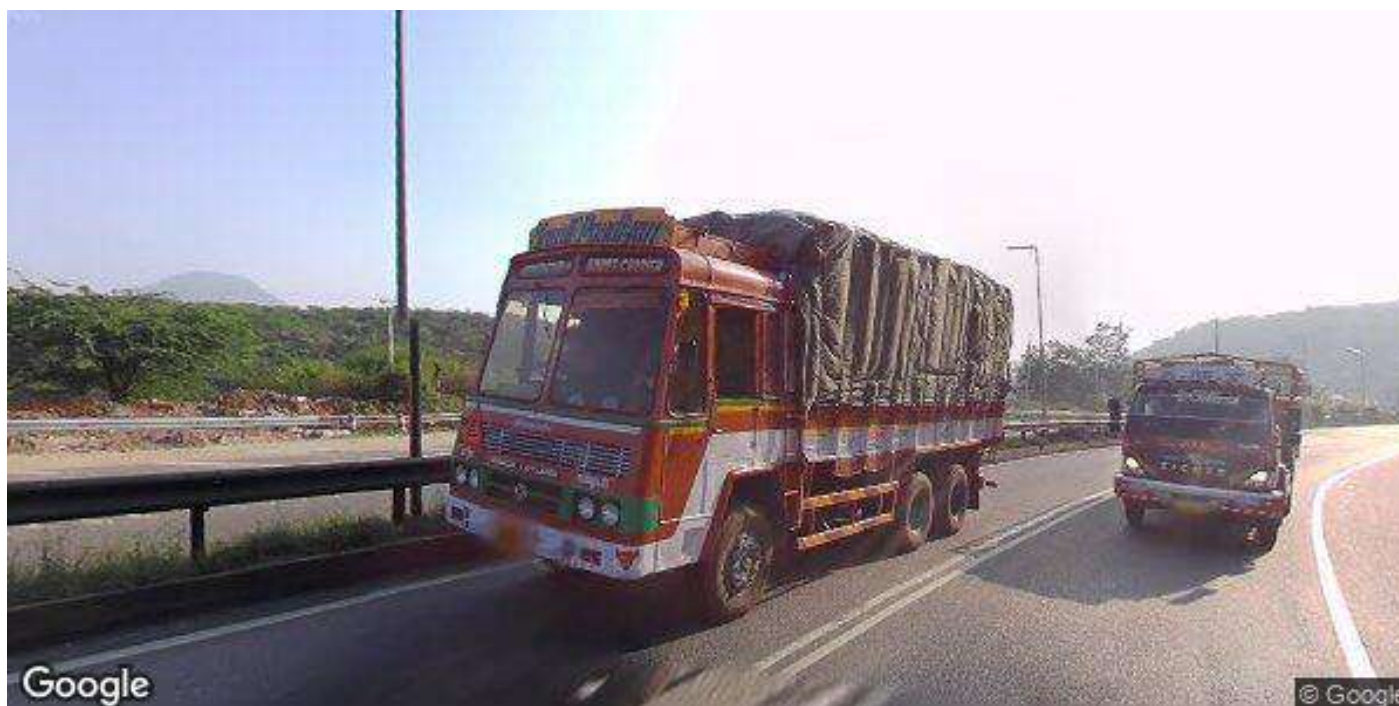
**Risk Type:** Turn  
**Risk Level:** High  
**Speed Limit:** 15 KM/Hr  
**Coordinates:** 11.95818, 78.04978

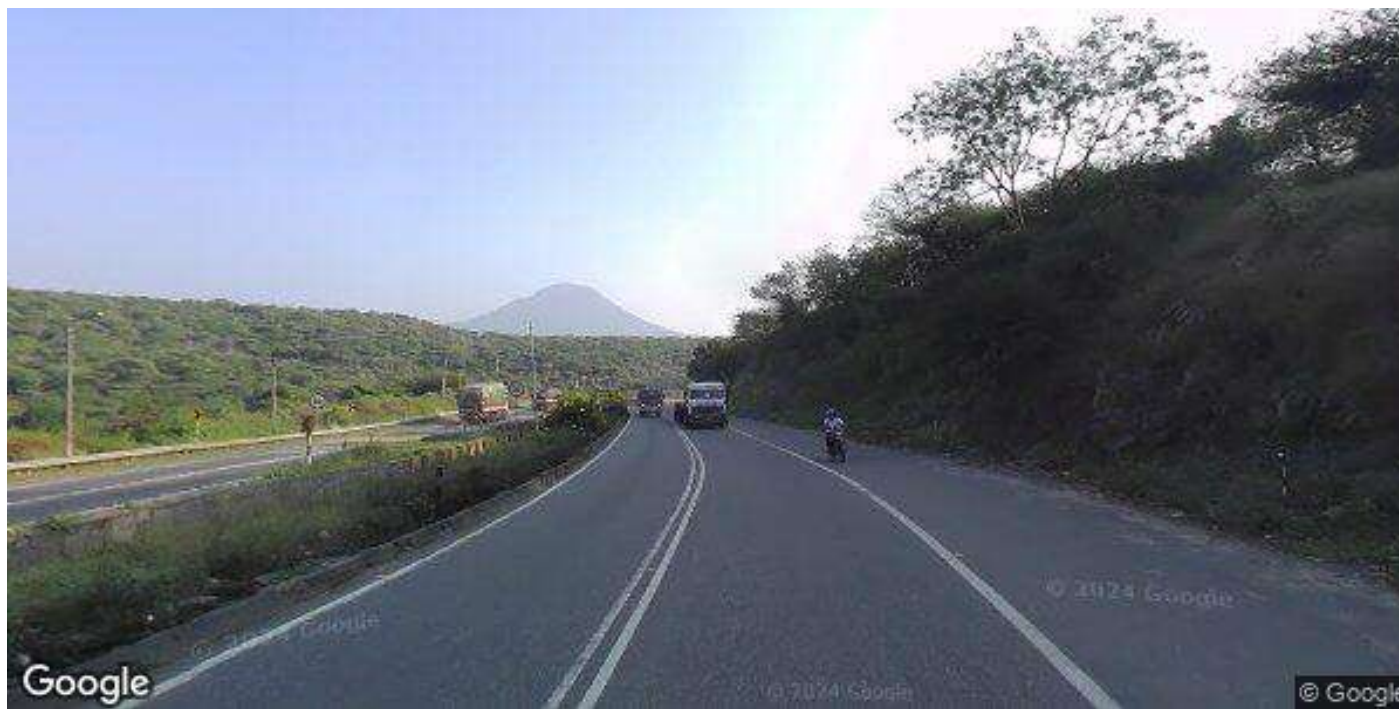
**Risk Type:** Turn  
**Risk Level:** Medium  
**Speed Limit:** 30 KM/Hr  
**Coordinates:** 11.95988, 78.04948

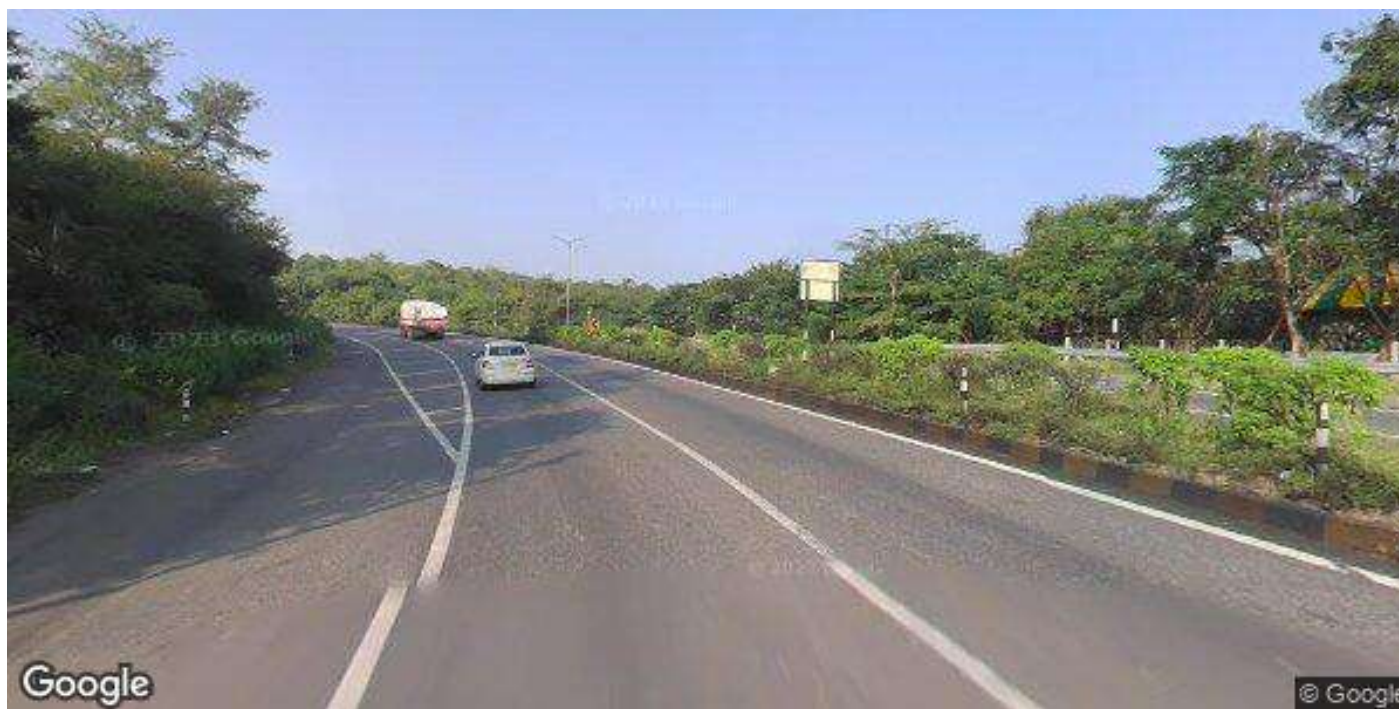
**Risk Type:** Turn  
**Risk Level:** Medium  
**Speed Limit:** 30 KM/Hr  
**Coordinates:** 11.96304, 78.05136

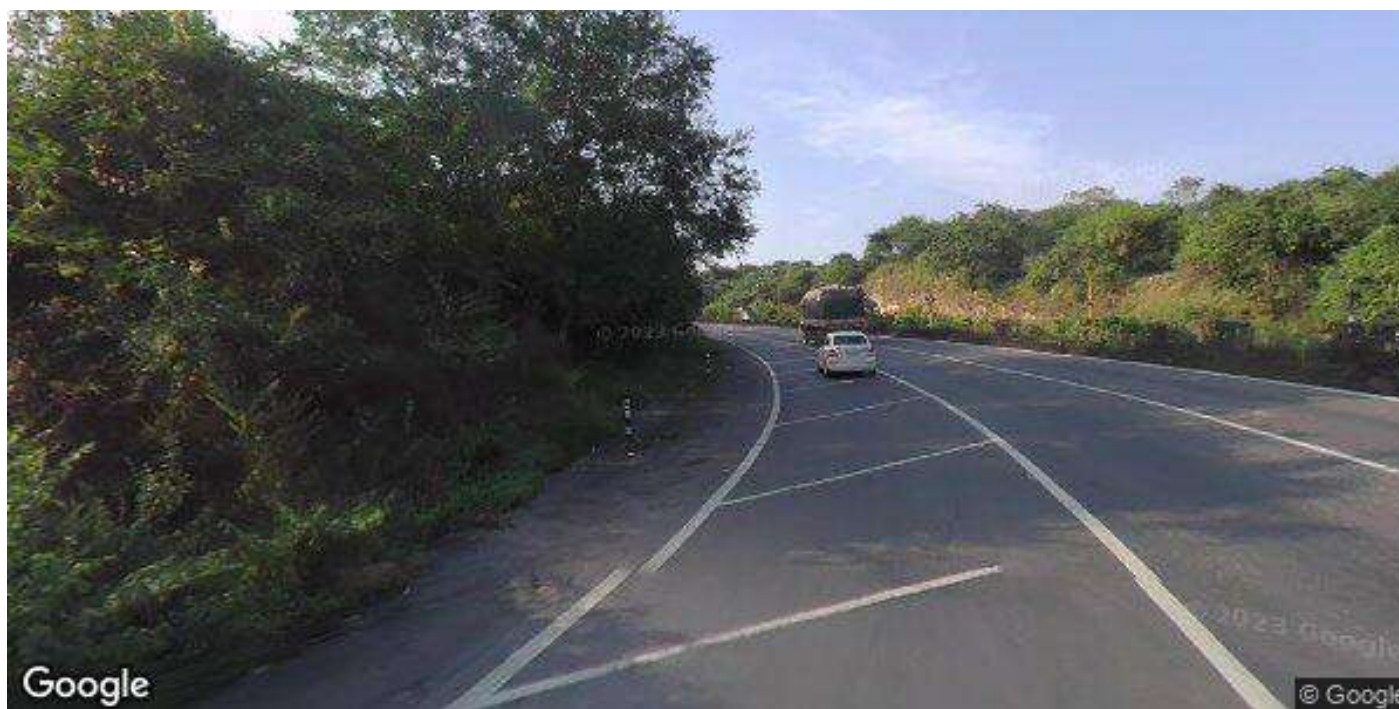
**Risk Type:** Turn  
**Risk Level:** High  
**Speed Limit:** 15 KM/Hr  
**Coordinates:** 11.96399, 78.05135

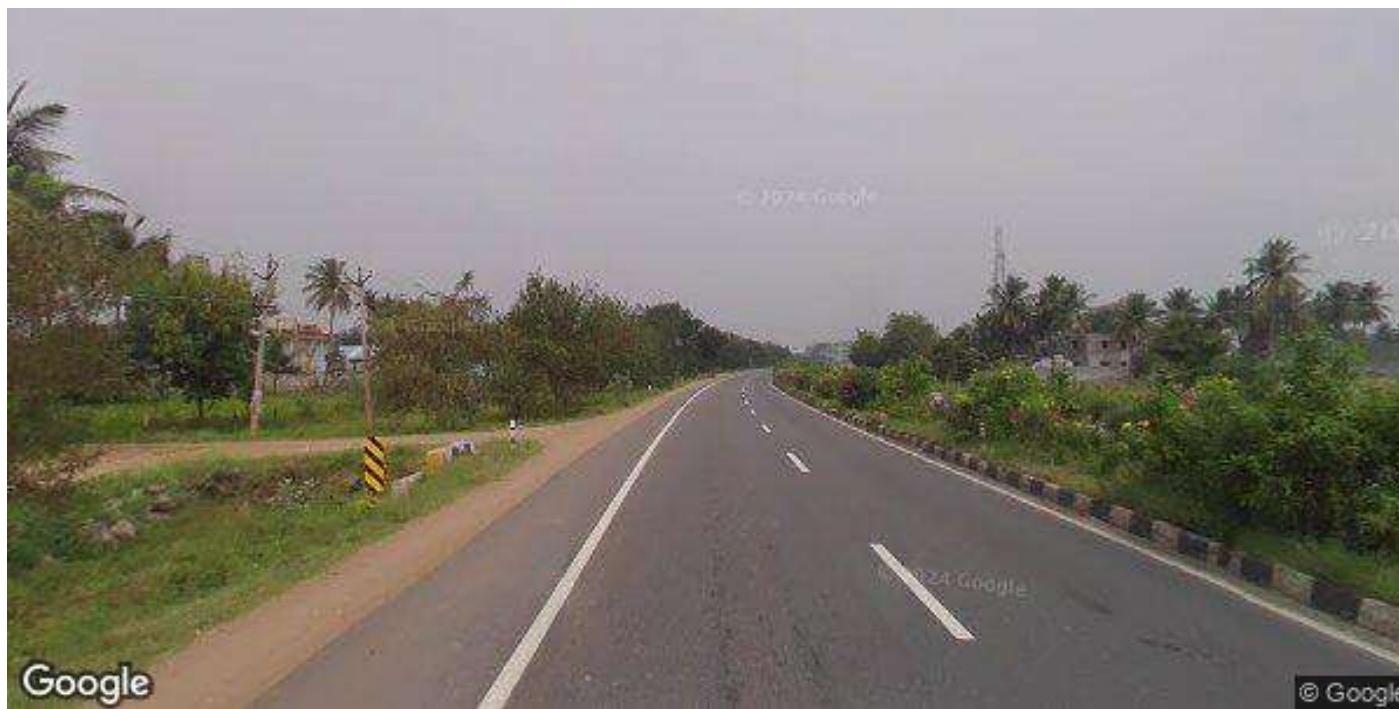
**Risk Type:** Turn  
**Risk Level:** Medium  
**Speed Limit:** 30 KM/Hr  
**Coordinates:** 12.19881, 78.18157
