# IndianOil

## JOURNEY RISK MANAGEMENT (JRM) STUDY

**Salem Terminal to KDCMPU LTD.**

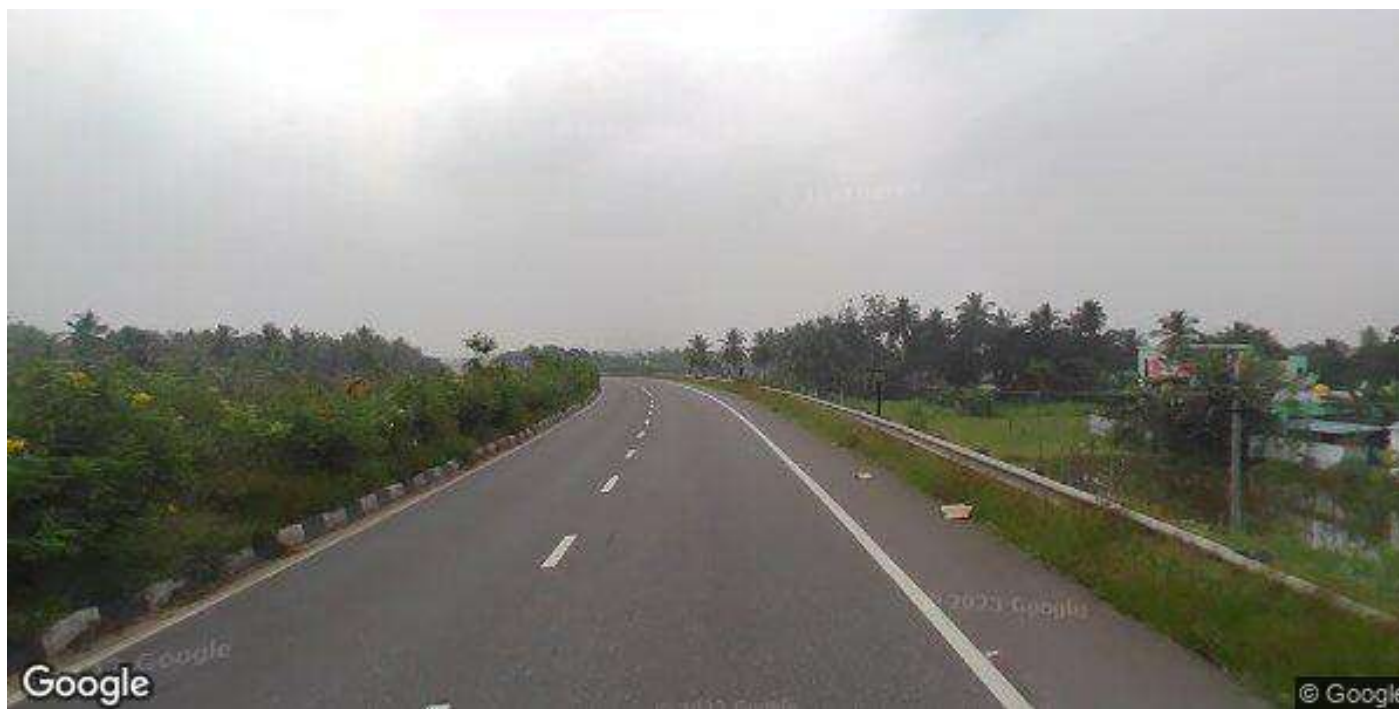
**Risk Type:** Turn  
**Risk Level:** Medium  
**Speed Limit:** 30 KM/Hr  
**Coordinates:** 12.22459, 78.19136

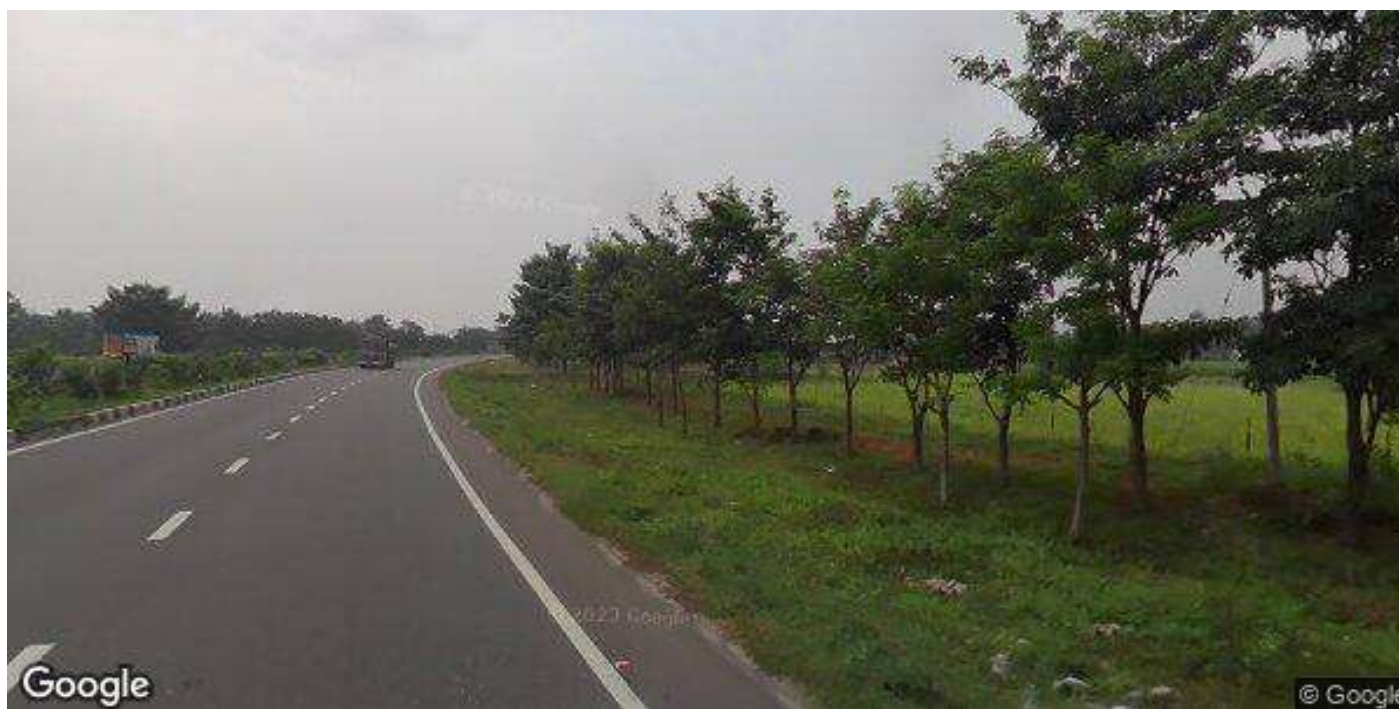
**Risk Type:** Turn  
**Risk Level:** Medium  
**Speed Limit:** 30 KM/Hr  
**Coordinates:** 12.25060, 78.19977

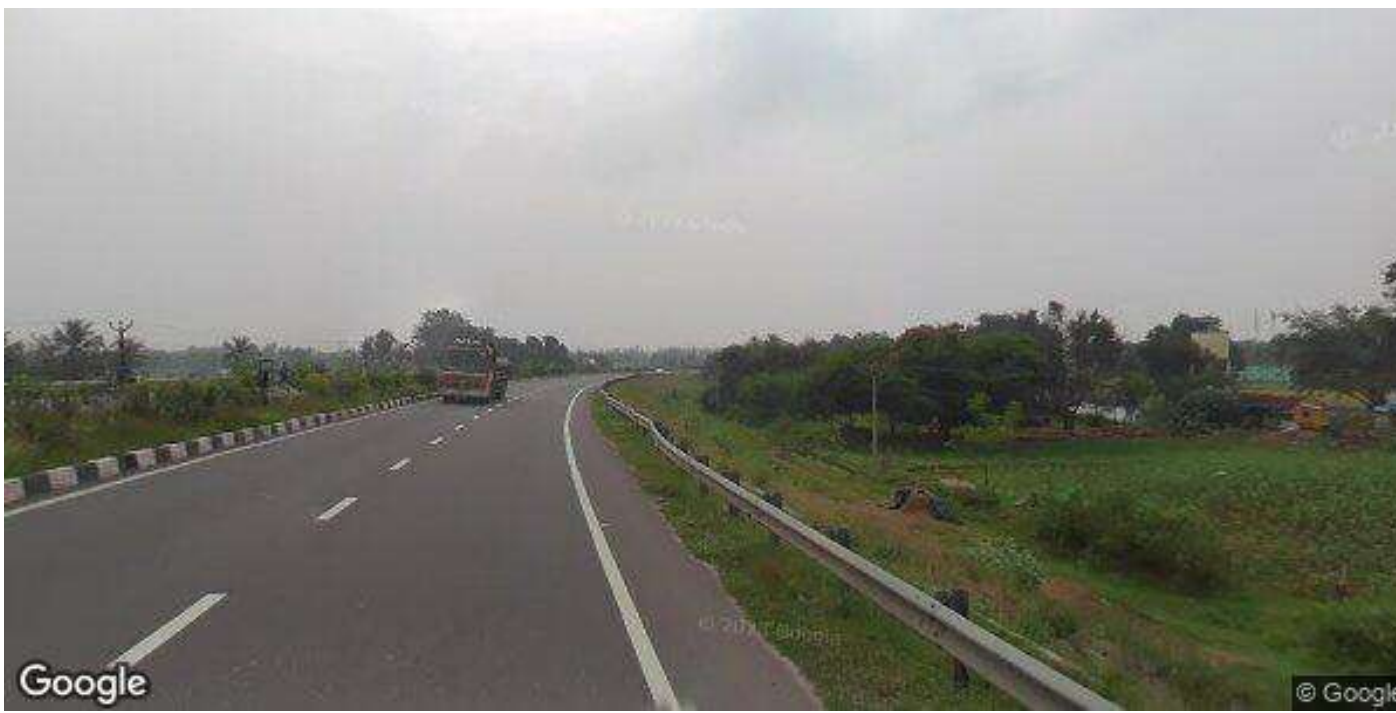
**Risk Type:** Turn  
**Risk Level:** Medium  
**Speed Limit:** 30 KM/Hr  
**Coordinates:** 12.25329, 78.20039

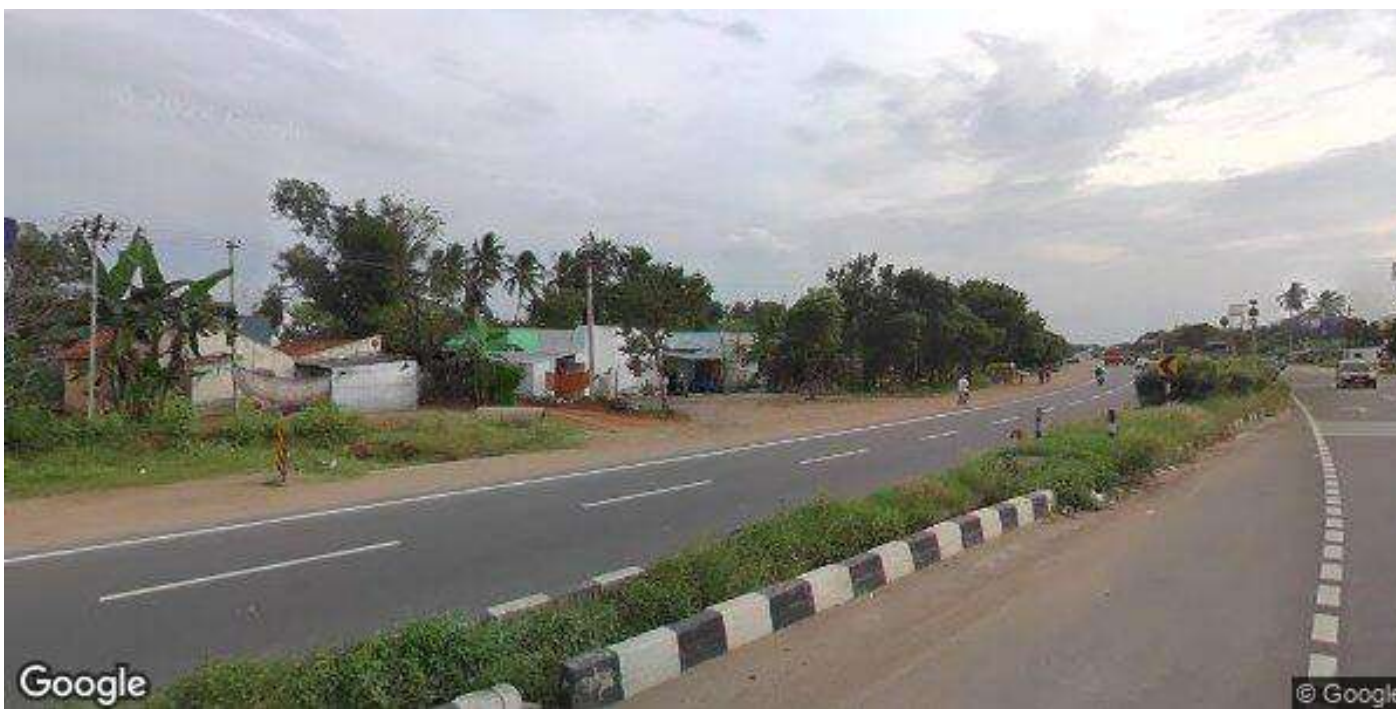
**Risk Type:** Turn  
**Risk Level:** Medium  
**Speed Limit:** 30 KM/Hr  
**Coordinates:** 12.29110, 78.19909

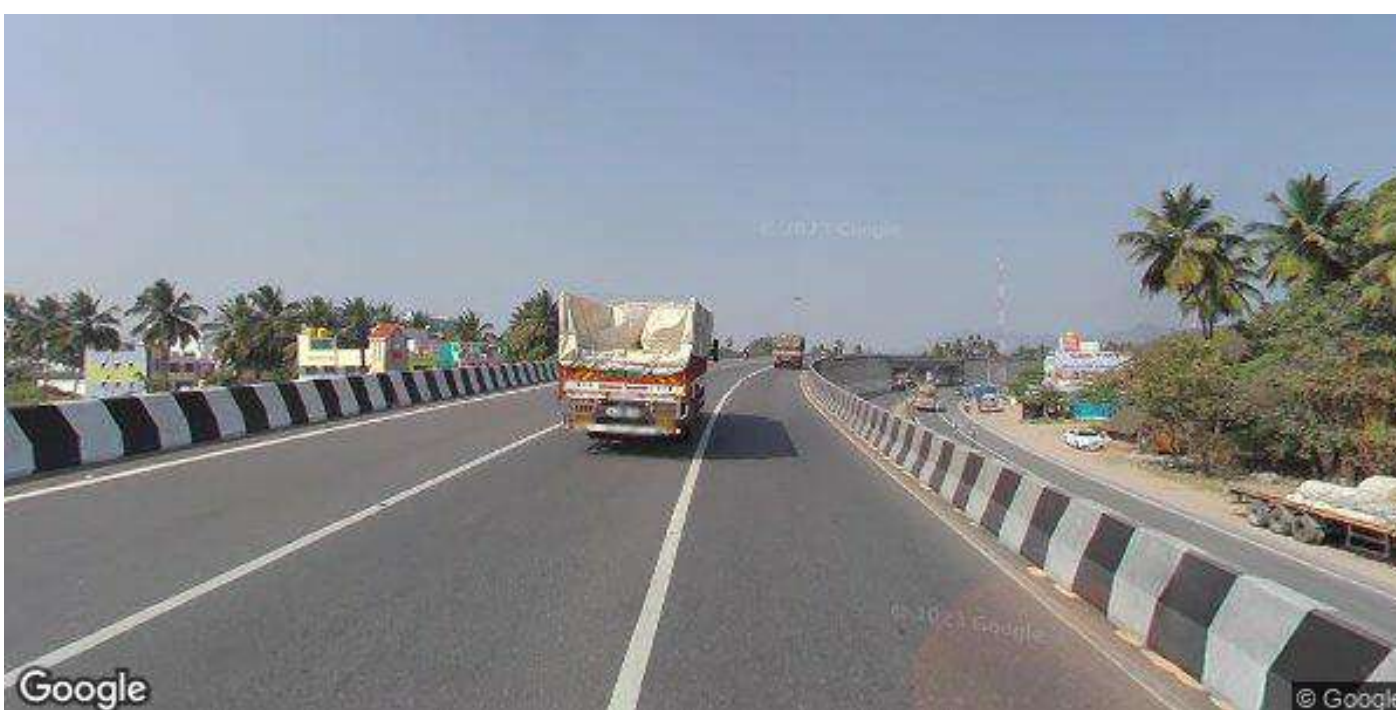
**Risk Type:** Turn  
**Risk Level:** Medium  
**Speed Limit:** 30 KM/Hr  
**Coordinates:** 12.39904, 78.21764

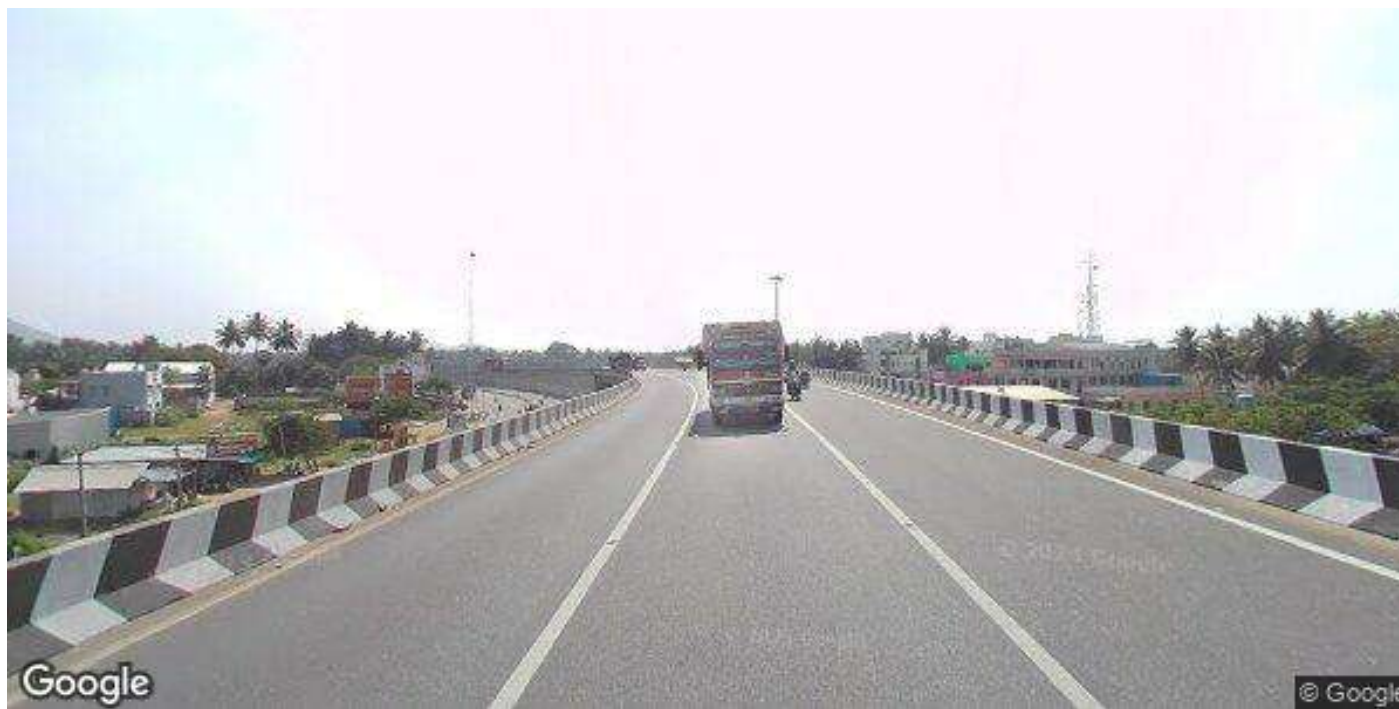
**Risk Type:** Turn  
**Risk Level:** Medium  
**Speed Limit:** 30 KM/Hr  
**Coordinates:** 12.40156, 78.21845

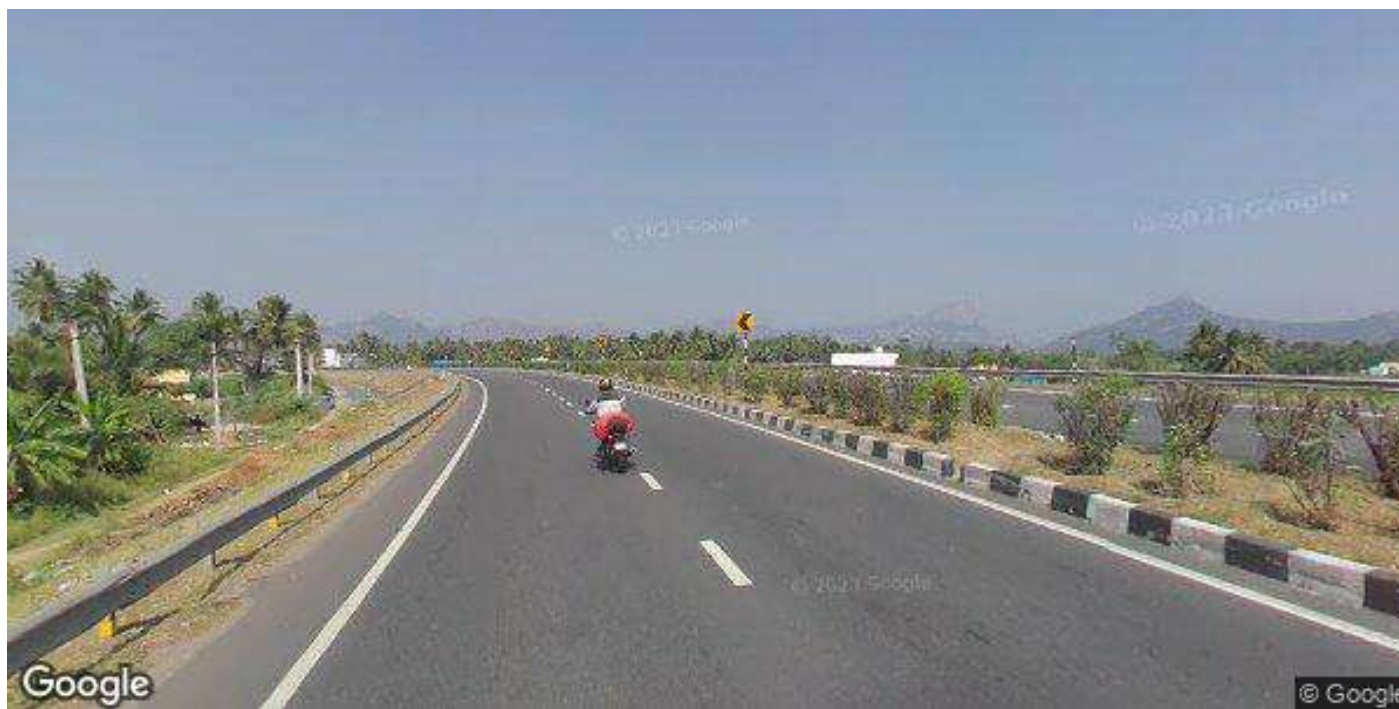
**Risk Type:** Turn  
**Risk Level:** Medium  
**Speed Limit:** 30 KM/Hr  
**Coordinates:** 12.40589, 78.22275

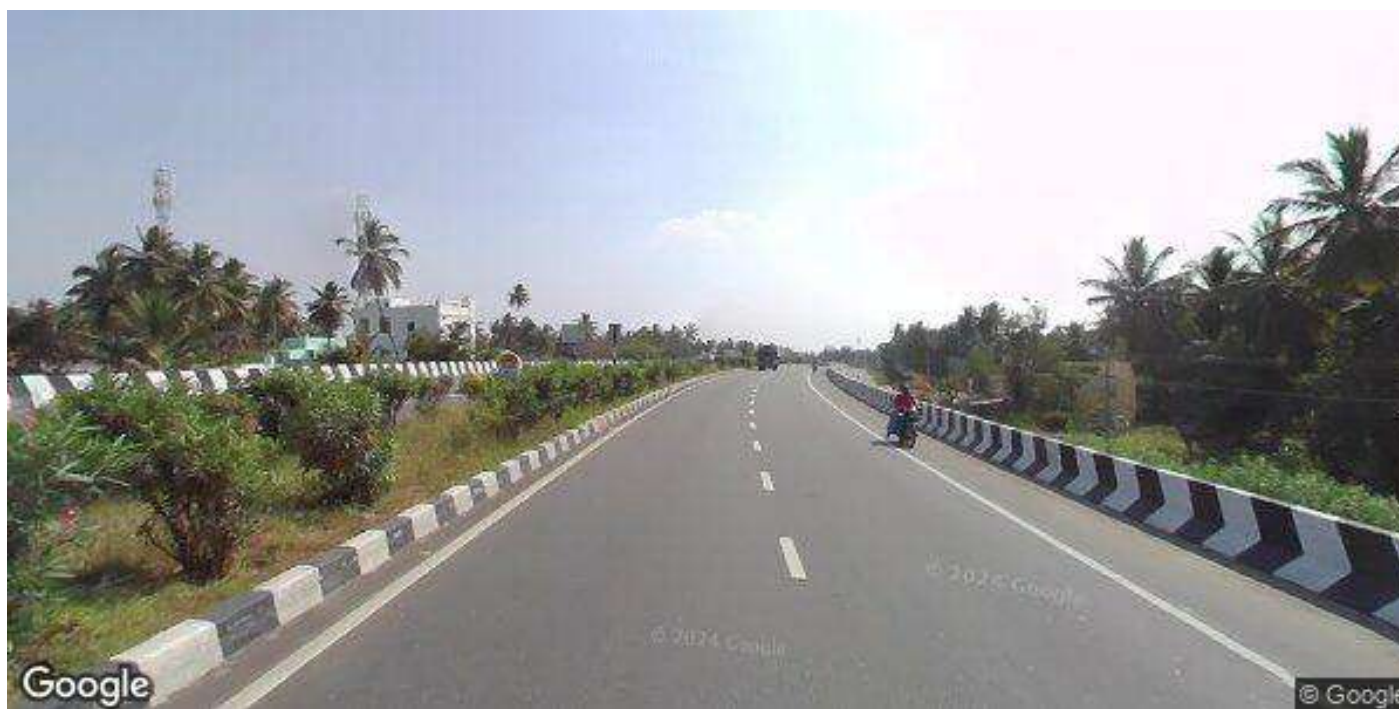
**Risk Type:** Turn  
**Risk Level:** Medium  
**Speed Limit:** 30 KM/Hr  
**Coordinates:** 12.45018, 78.21828

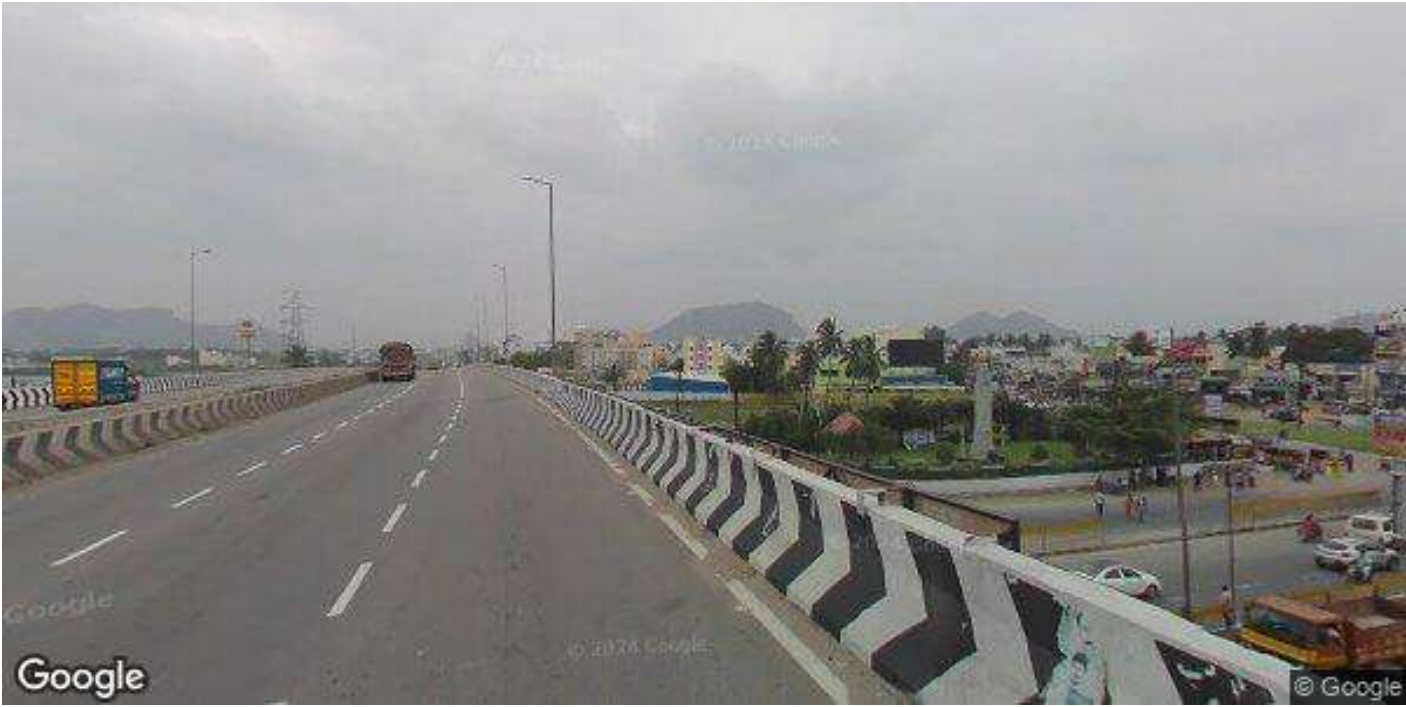
**Risk Type:** Blind Spot  
**Risk Level:** Blind Spot  
**Speed Limit:** 10 KM/Hr  
**Coordinates:** 12.50718, 78.22253
