# IndianOil

## JOURNEY RISK MANAGEMENT (JRM) STUDY

### Salem Terminal TO M/S HARAN FUELS

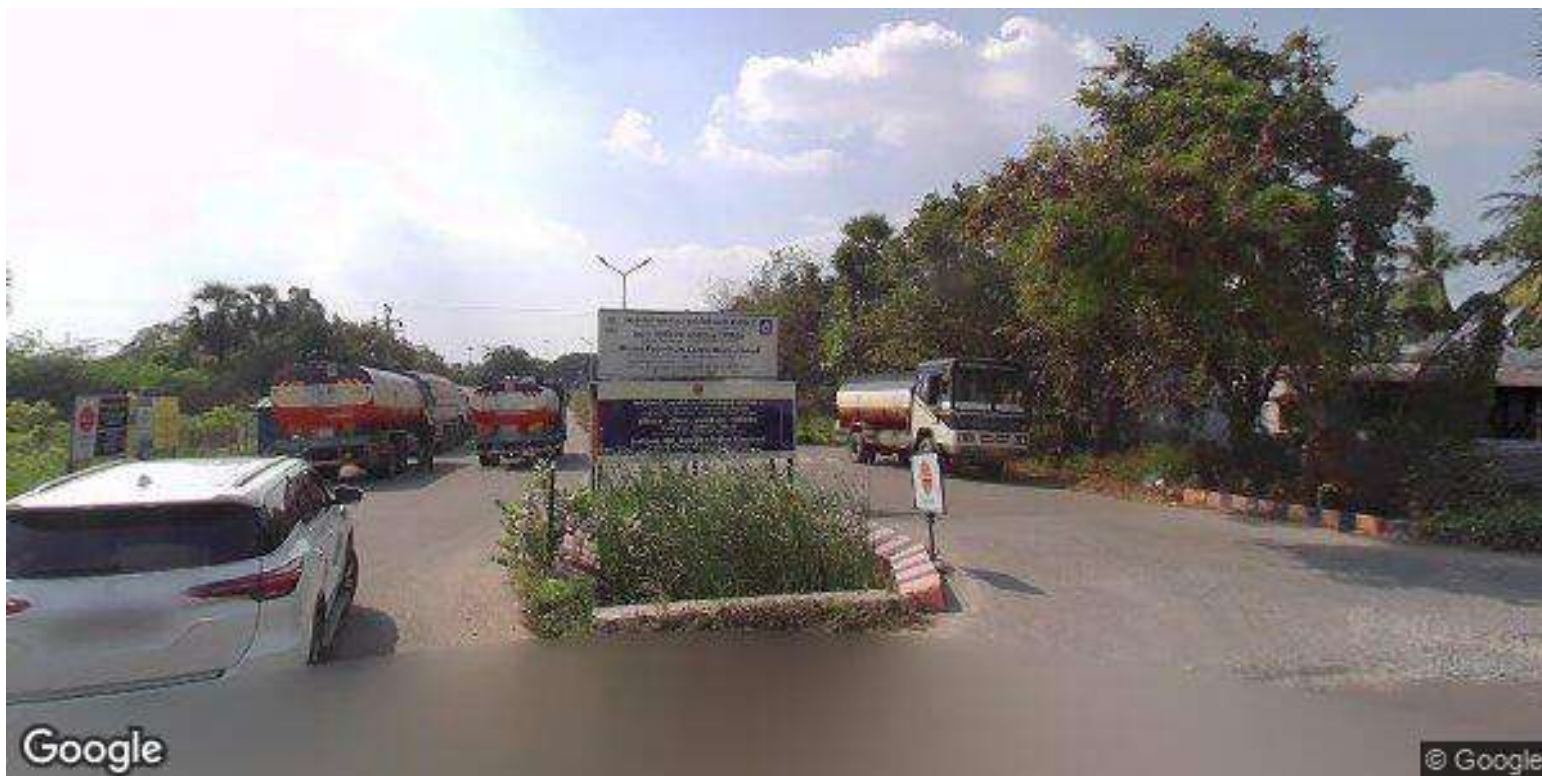
**Coordinates:** 11.44024, 77.87528

**Risk Type:** Turn

**Risk Level:** High

**Speed Limit:** 15 KM/Hr

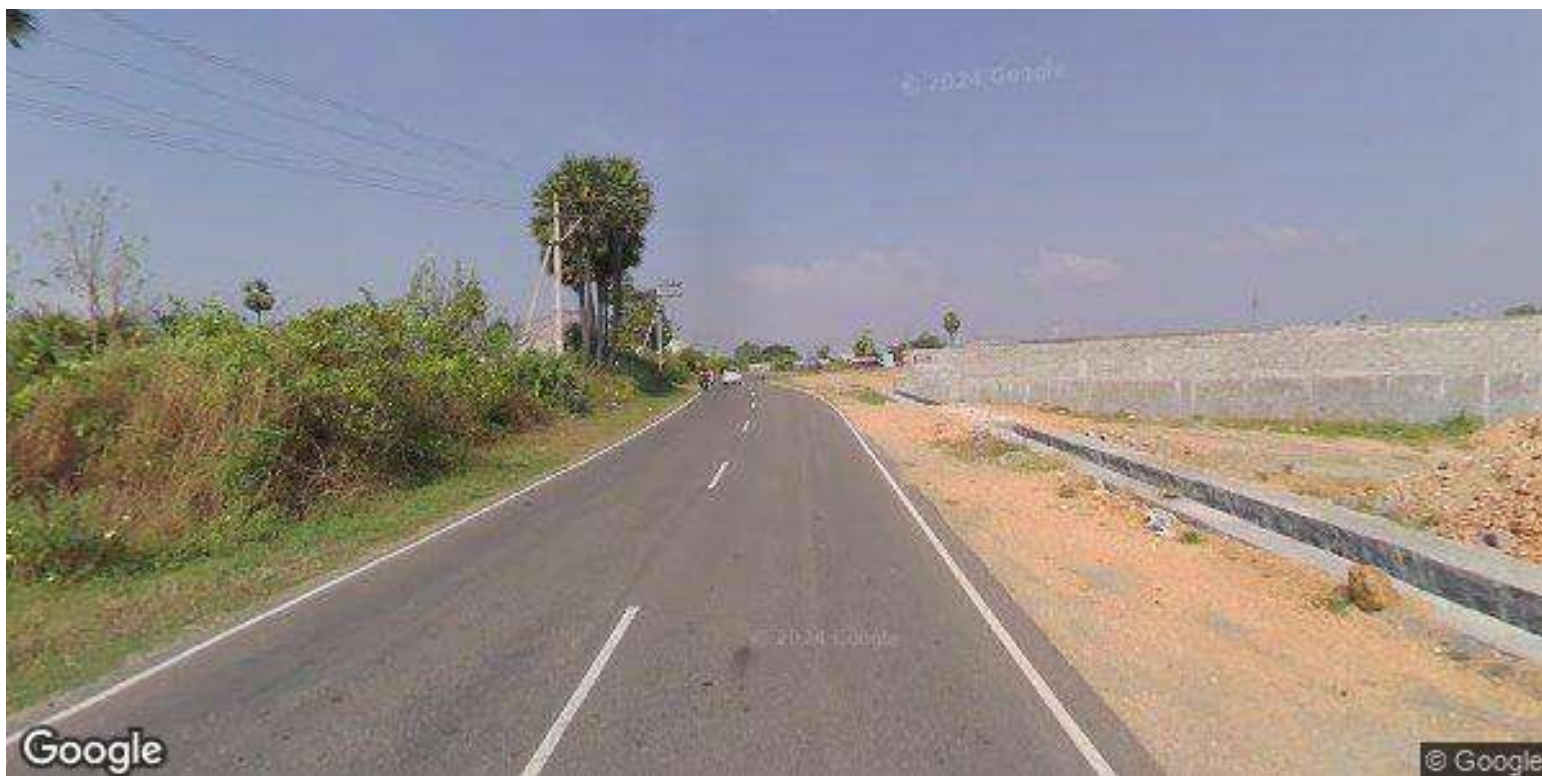
**Risk Type:** Turn  
**Risk Level:** Medium  
**Speed Limit:** 30 KM/Hr  
**Coordinates:** 11.45764, 77.85219

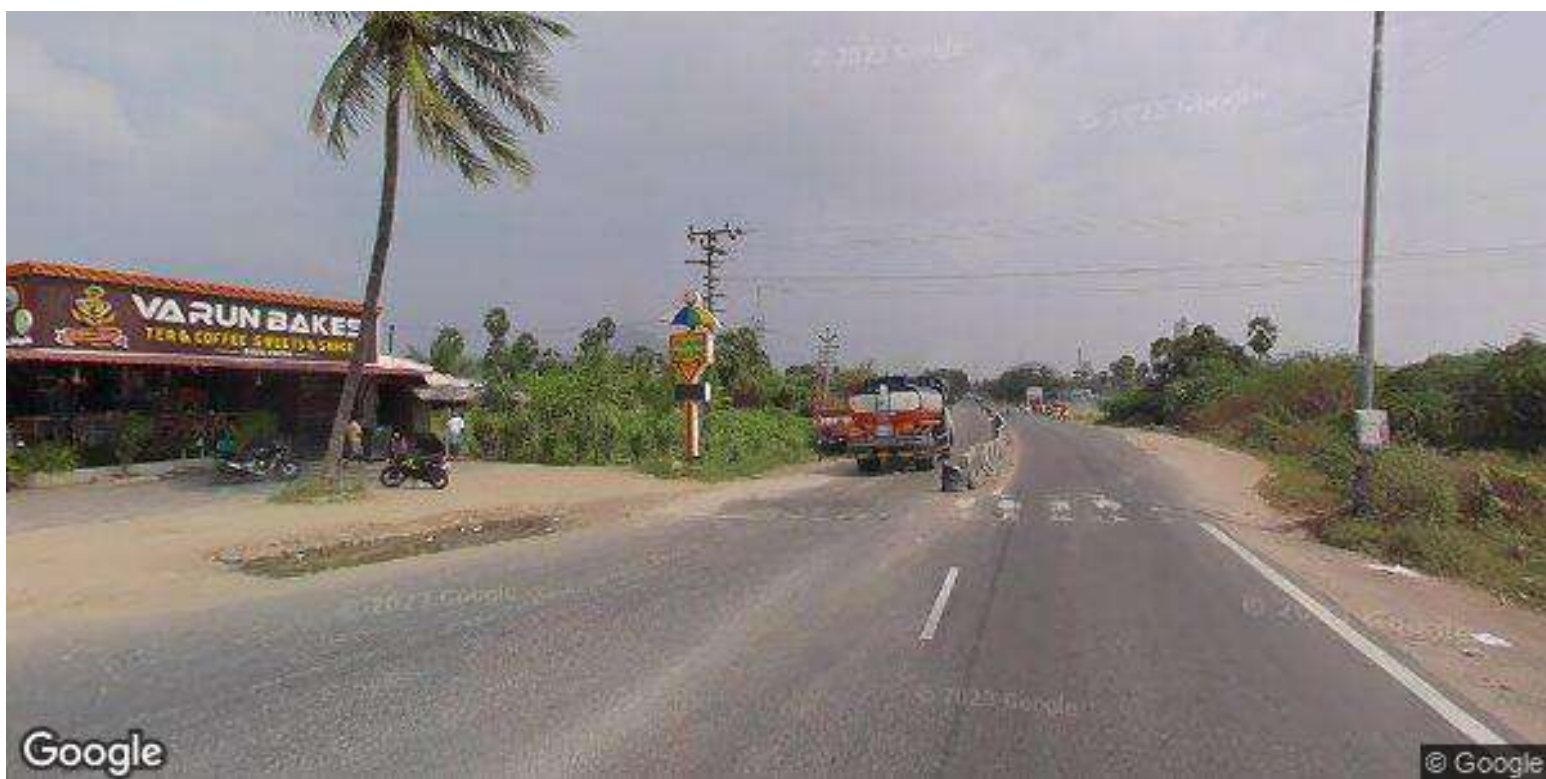
**Coordinates:** 11.45543, 77.81740

**Risk Type:** Turn

**Risk Level:** Medium

**Speed Limit:** 30 KM/Hr

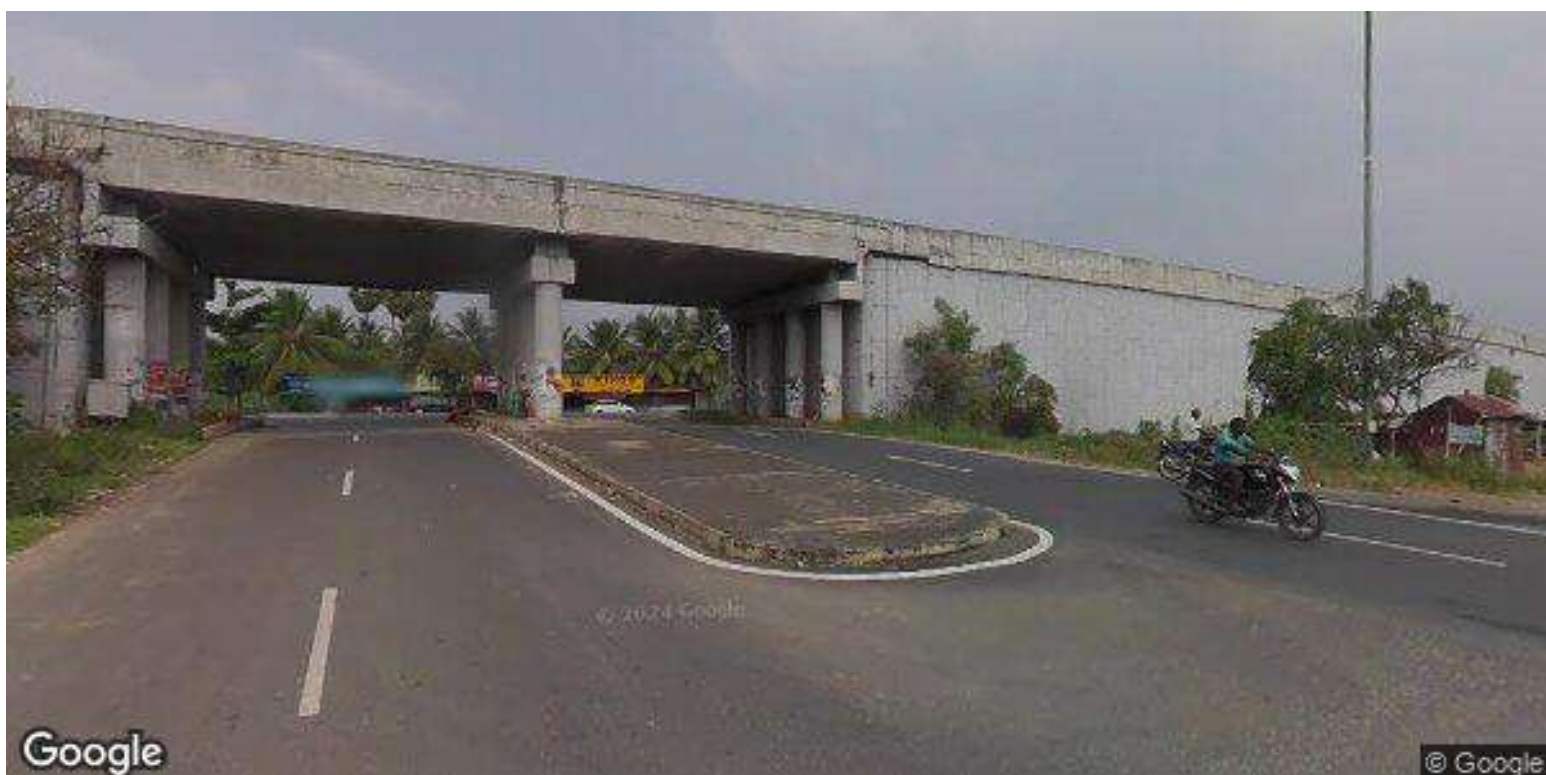
**Risk Type:** Turn  
**Risk Level:** High  
**Speed Limit:** 15 KM/Hr  
**Coordinates:** 11.45584, 77.81695

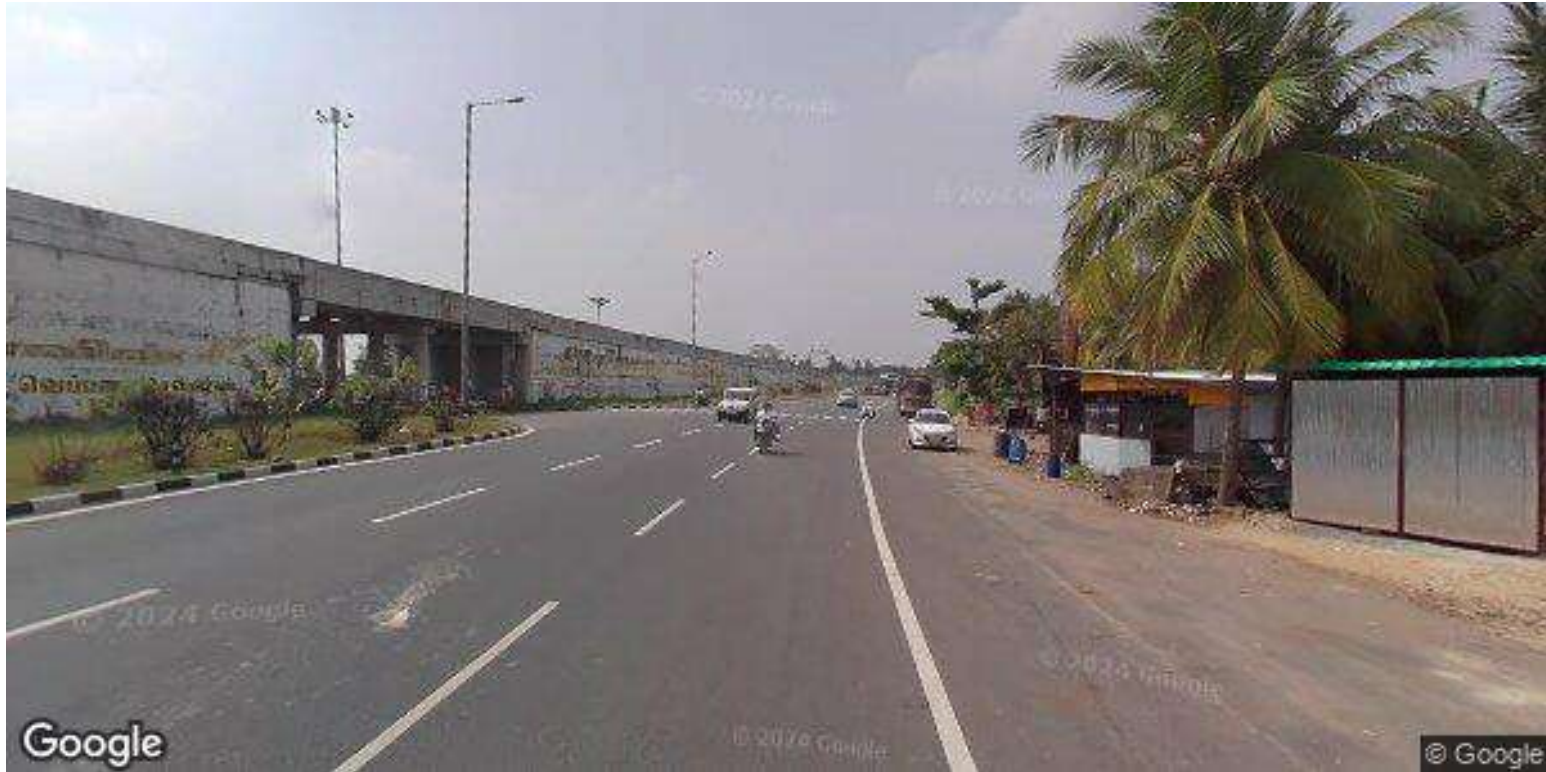
**Risk Type:** Turn  
**Risk Level:** Medium  
**Speed Limit:** 30 KM/Hr  
**Coordinates:** 11.45656, 77.81709

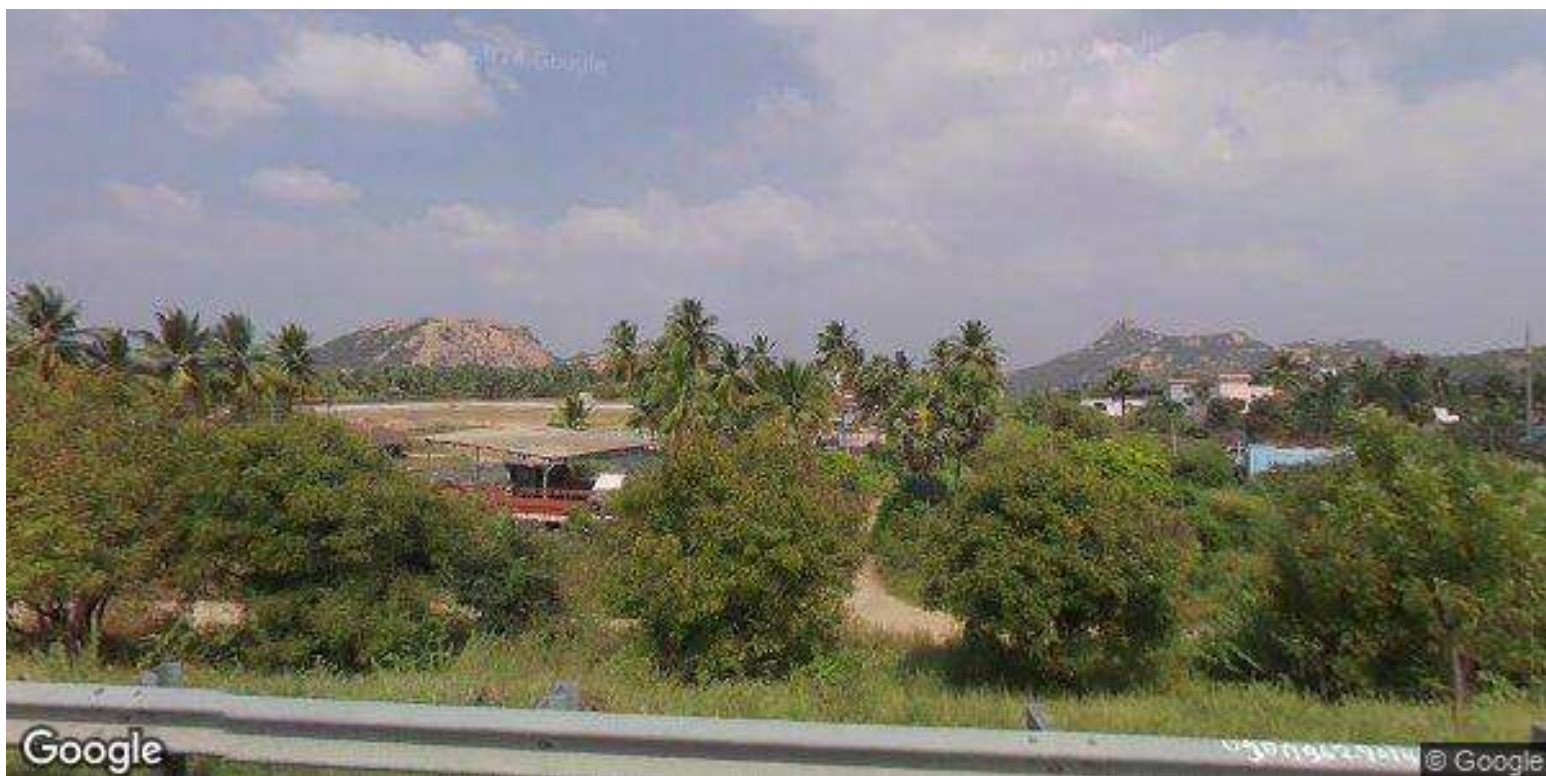
**Risk Type:** Turn  
**Risk Level:** High  
**Speed Limit:** 15 KM/Hr  
**Coordinates:** 11.49383, 77.88442

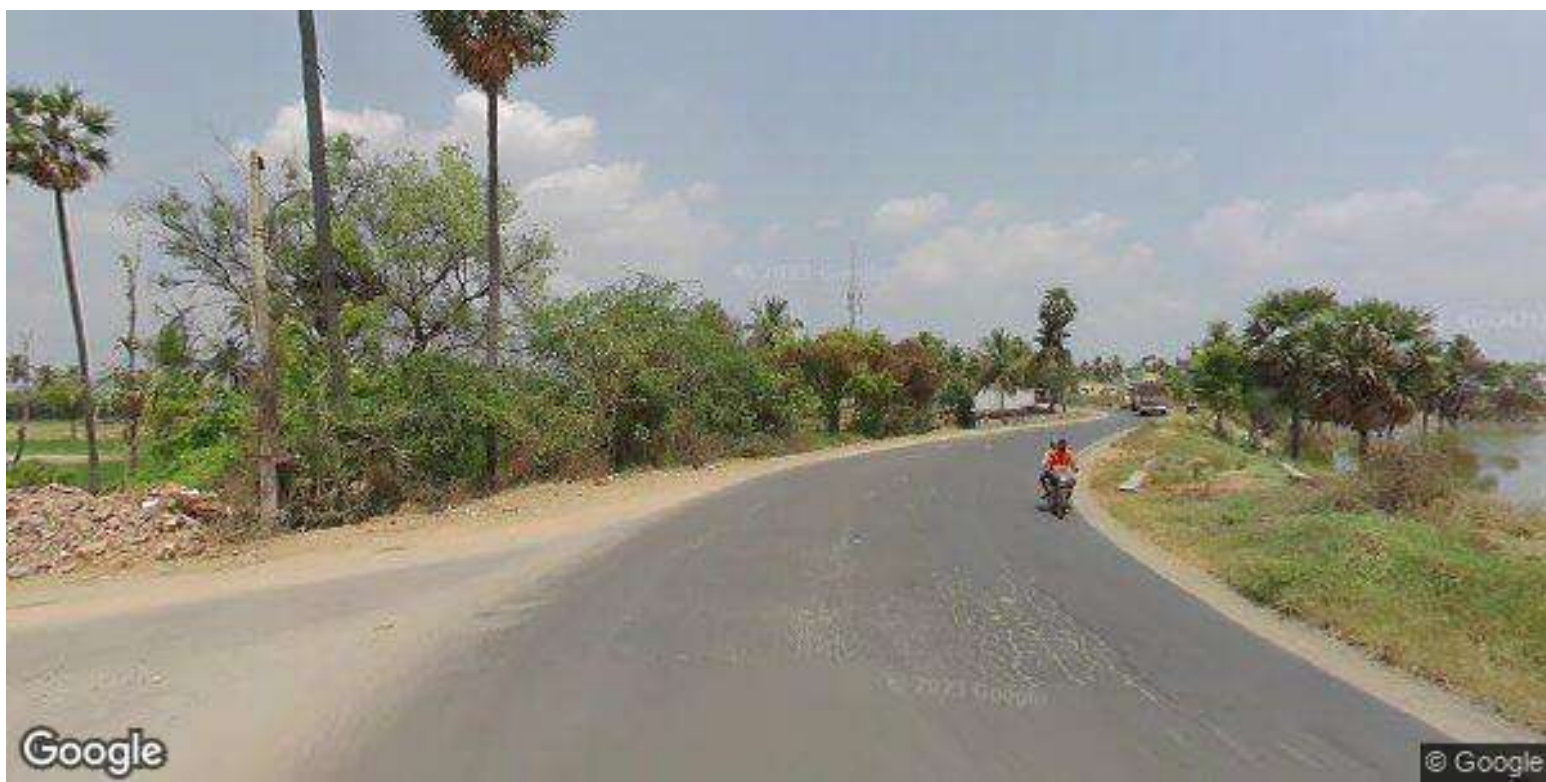
**Coordinates:** 11.56083, 77.89921

**Risk Type:** Turn

**Risk Level:** Medium

**Speed Limit:** 30 KM/Hr

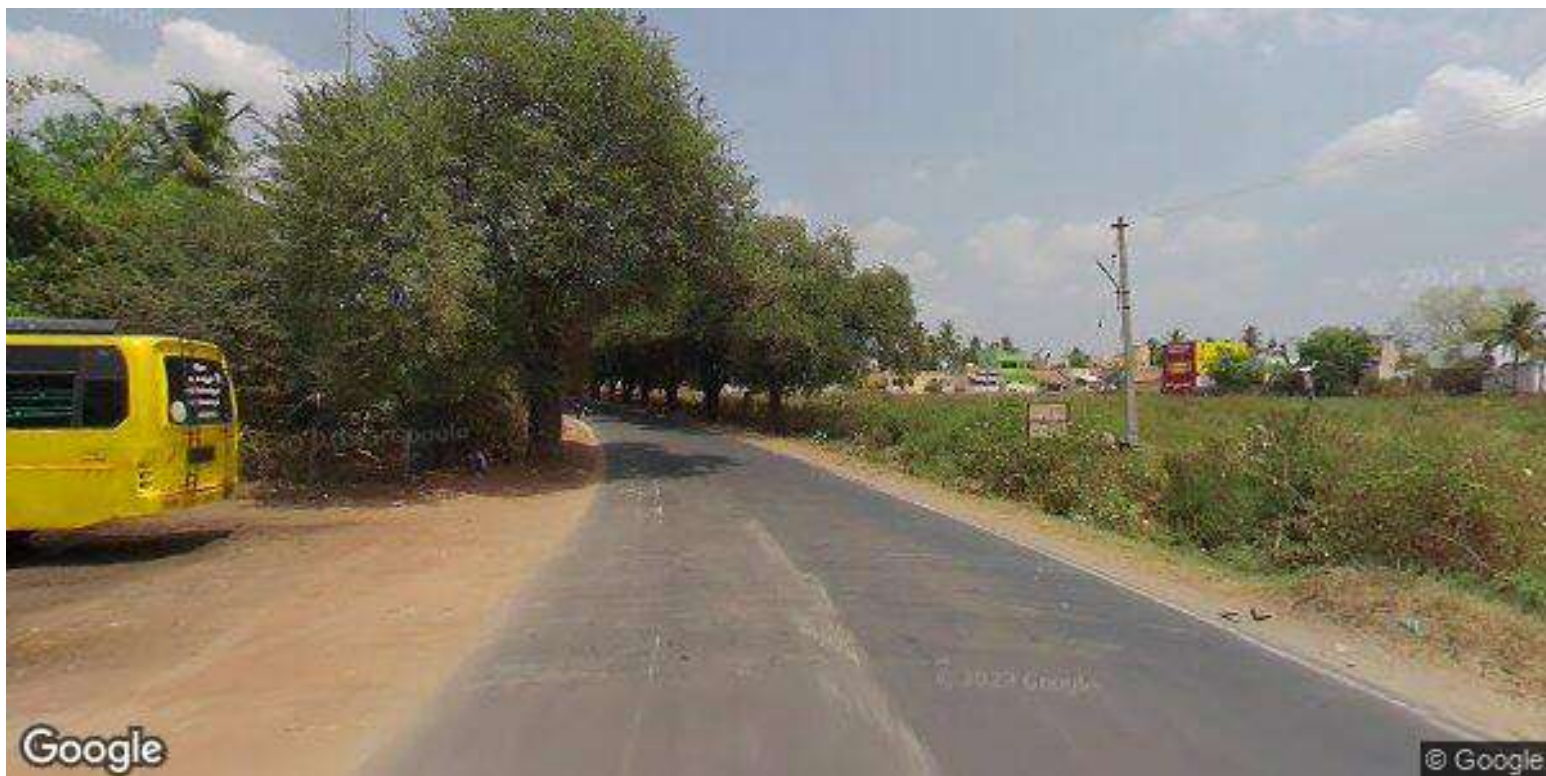
**Coordinates:** 11.56180, 77.90019

**Risk Type:** Turn

**Risk Level:** Medium

**Speed Limit:** 30 KM/Hr

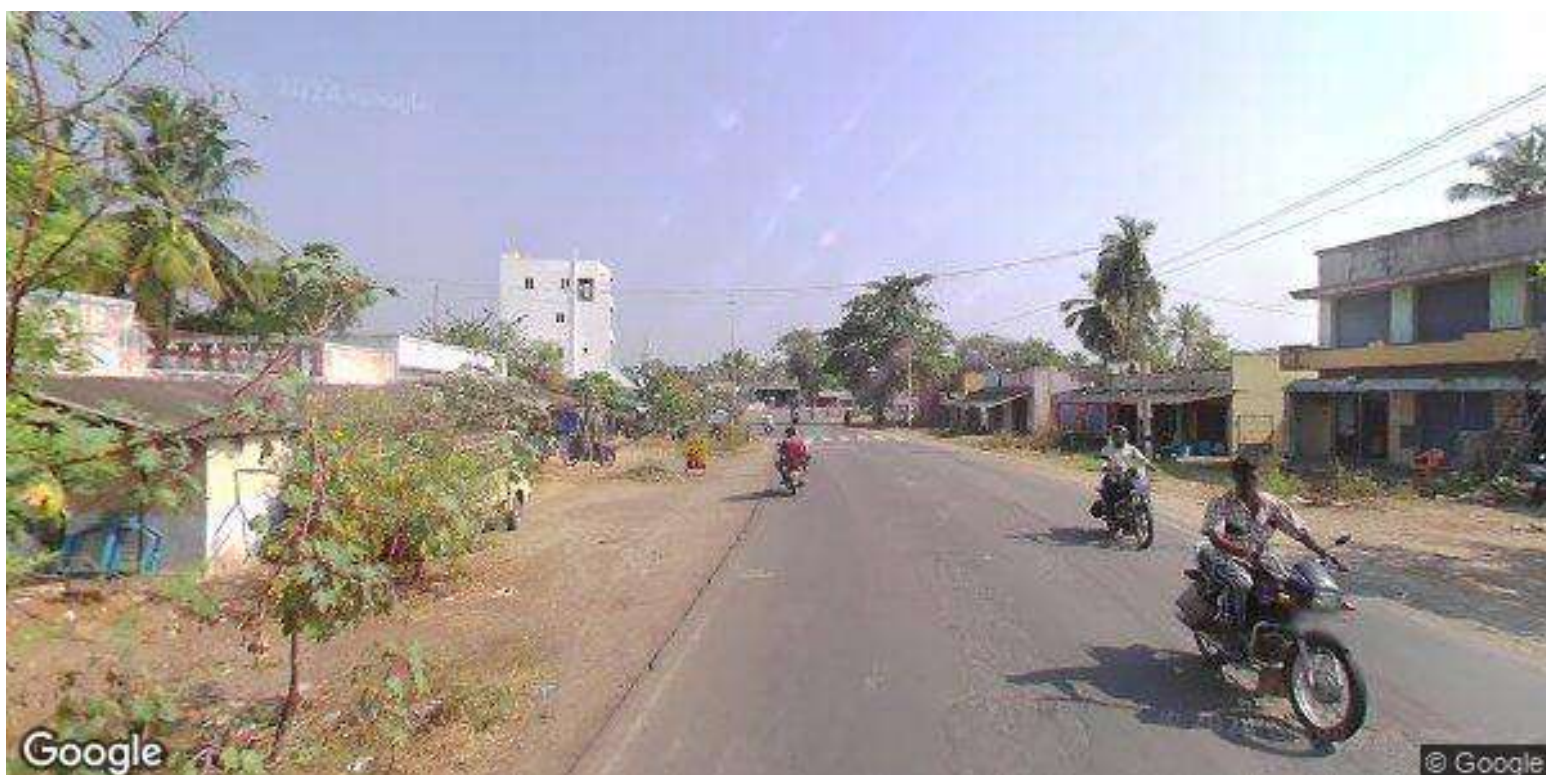
**Risk Type:** Turn  
**Risk Level:** Medium  
**Speed Limit:** 30 KM/Hr  
**Coordinates:** 11.59189, 77.90645

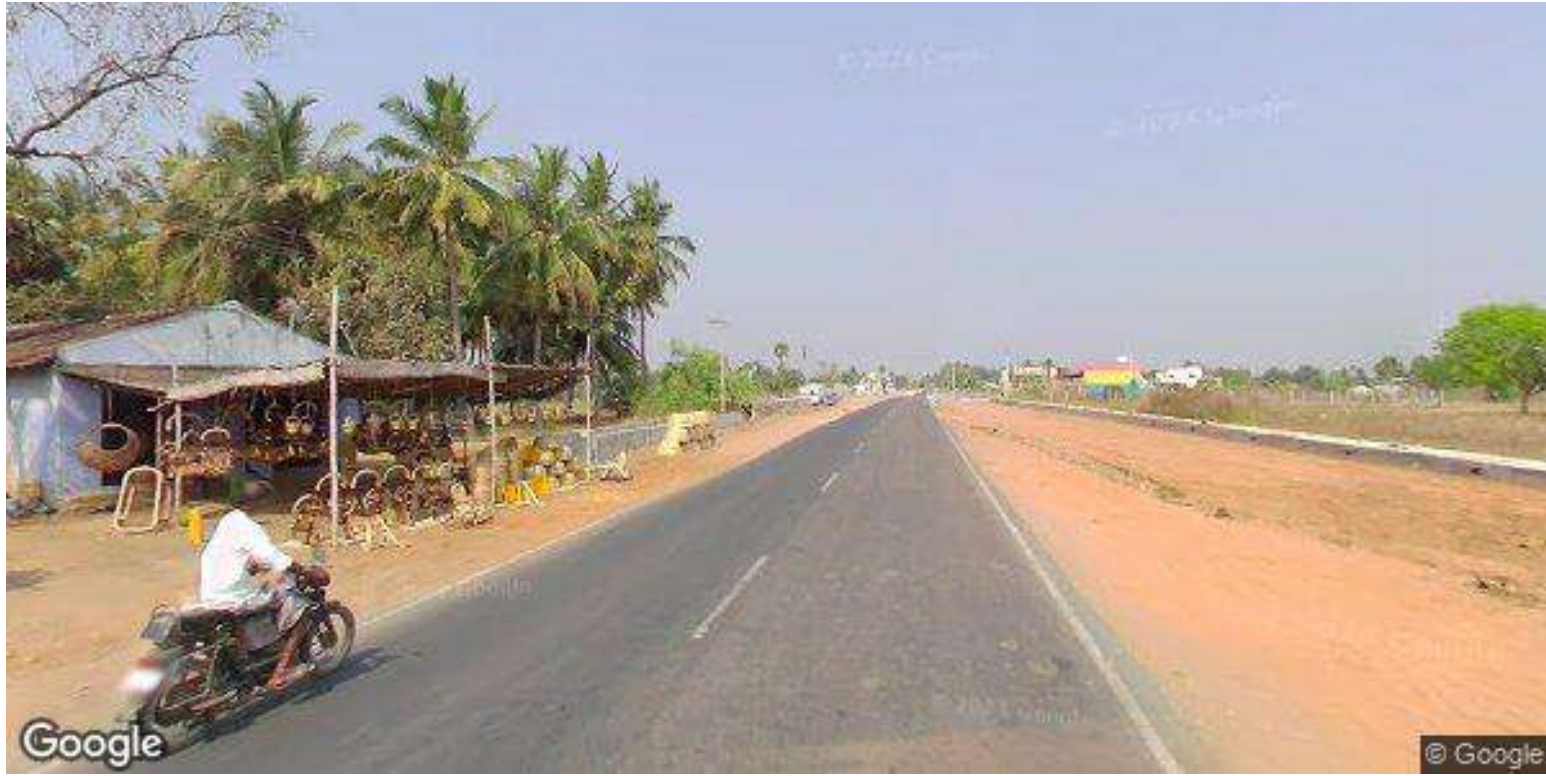
**Risk Type:** Turn  
**Risk Level:** Medium  
**Speed Limit:** 30 KM/Hr  
**Coordinates:** 11.59328, 77.90809

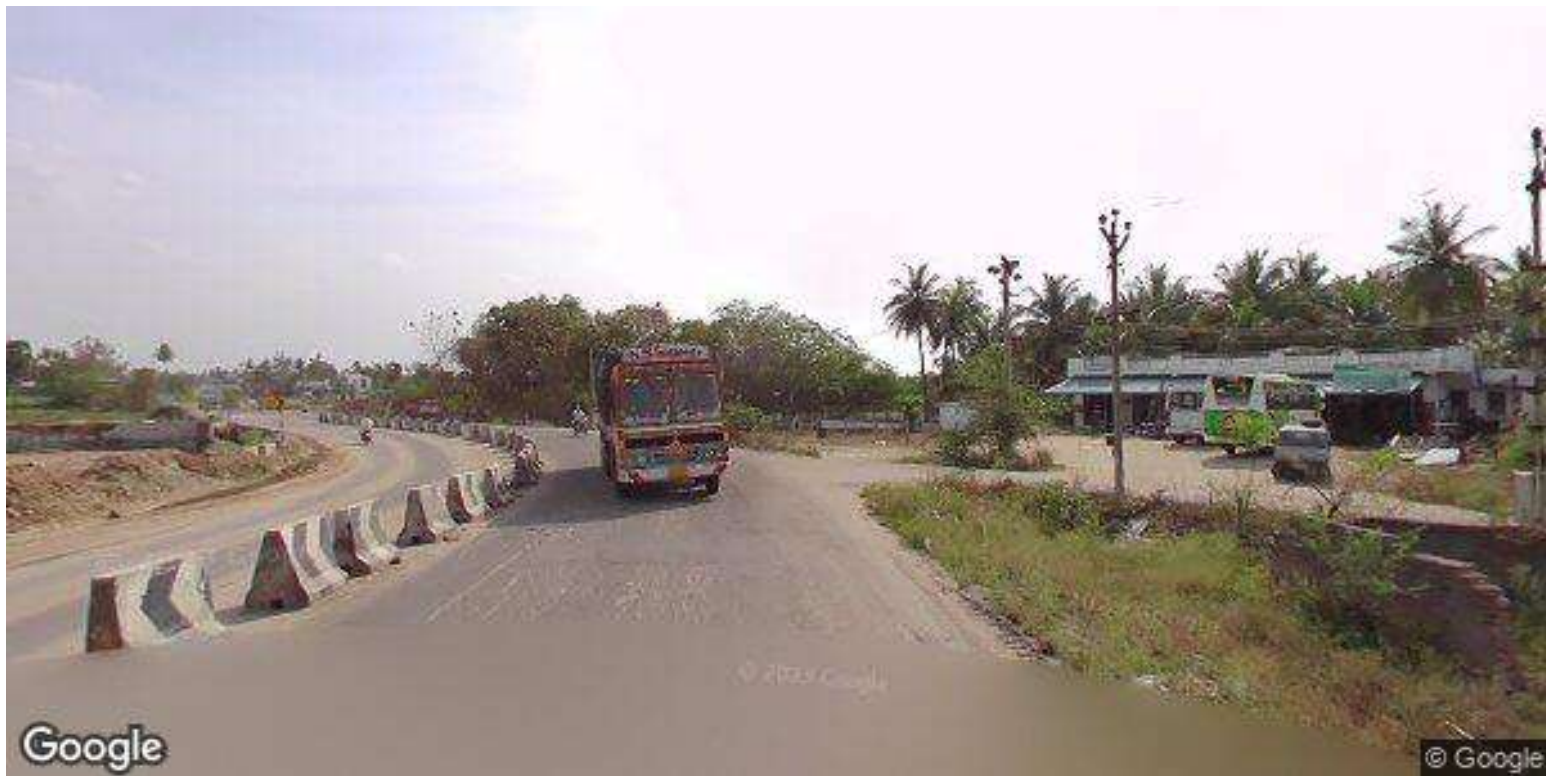
**Risk Type:** Turn  
**Risk Level:** Medium  
**Speed Limit:** 30 KM/Hr  
**Coordinates:** 11.63867, 77.94841

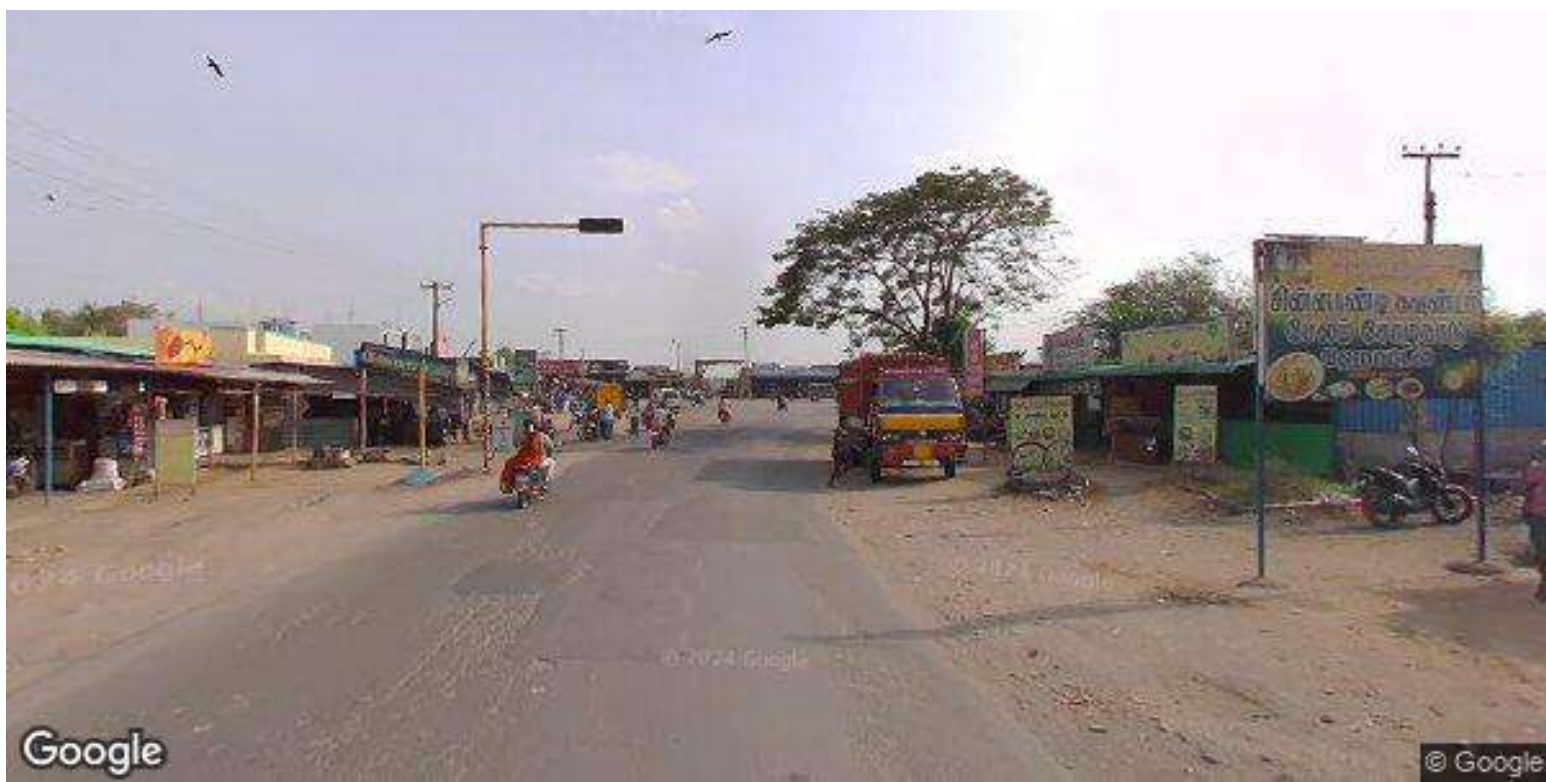
**Coordinates:** 11.64217, 77.95200

**Risk Type:** Turn

**Risk Level:** High

**Speed Limit:** 15 KM/Hr

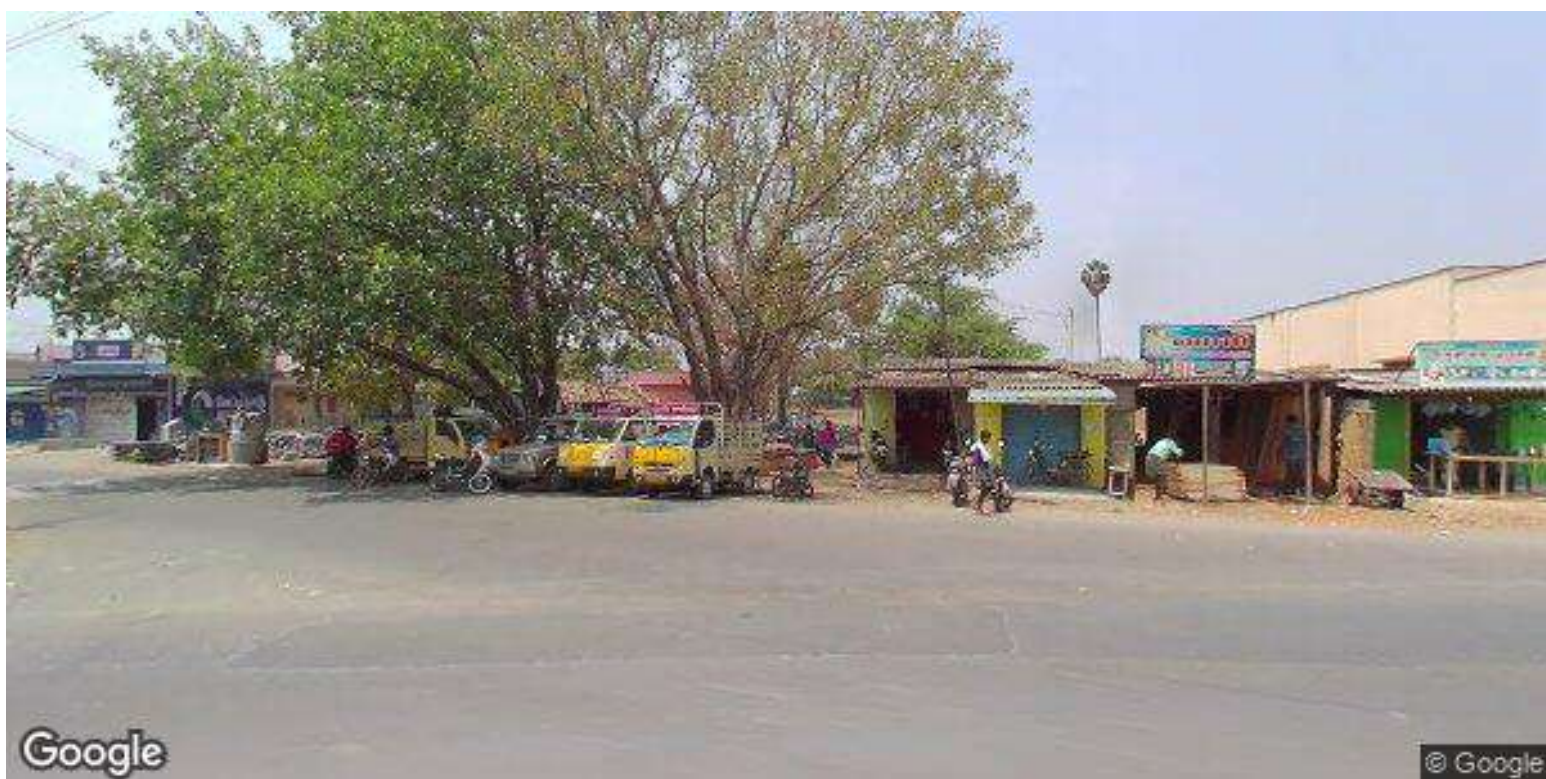
**Coordinates:** 11.64712, 77.95118

**Risk Type:** Turn

**Risk Level:** Medium

**Speed Limit:** 30 KM/Hr

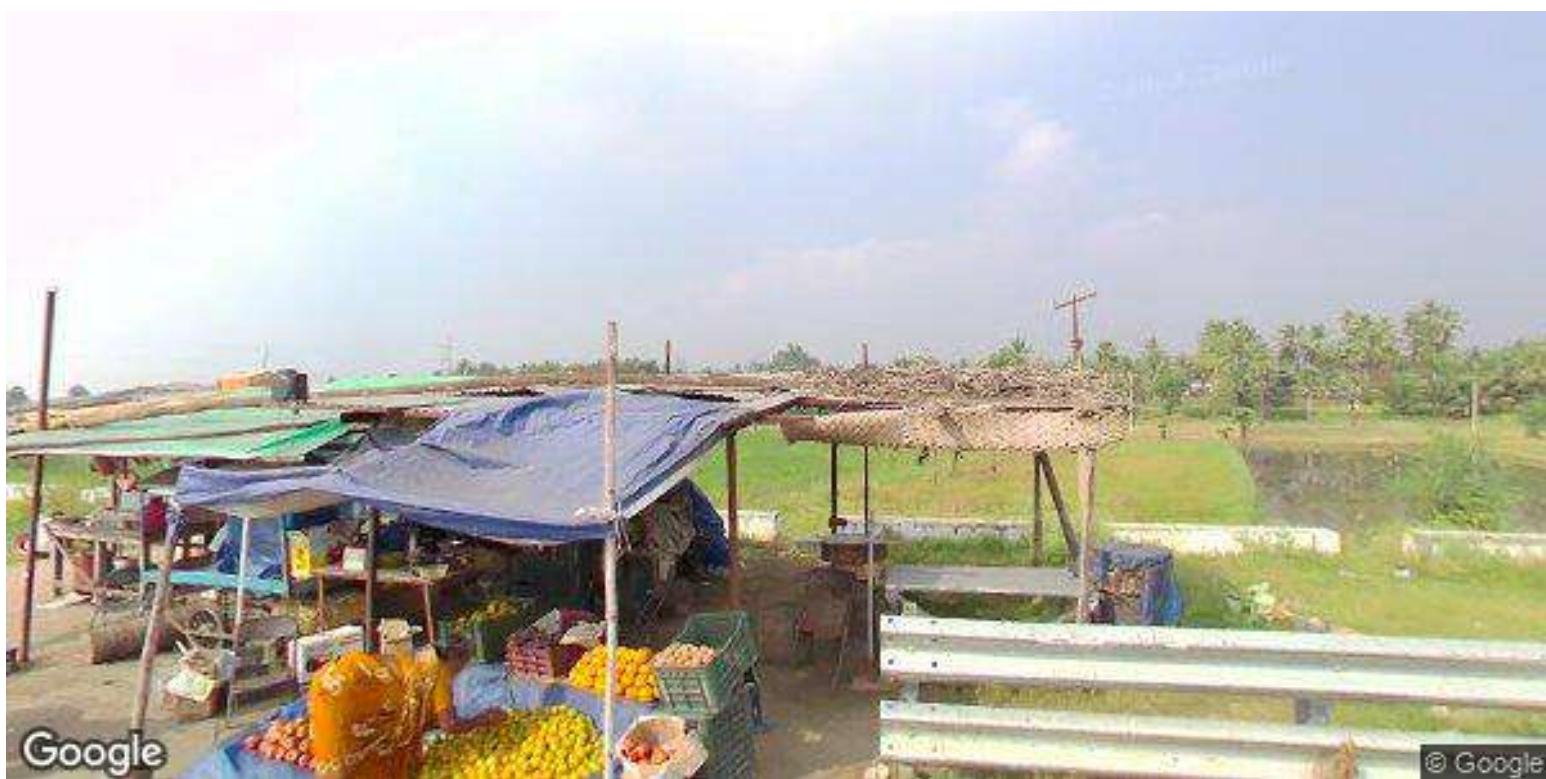
**Risk Type:** Turn  
**Risk Level:** Medium  
**Speed Limit:** 30 KM/Hr  
**Coordinates:** 11.67858, 77.96834

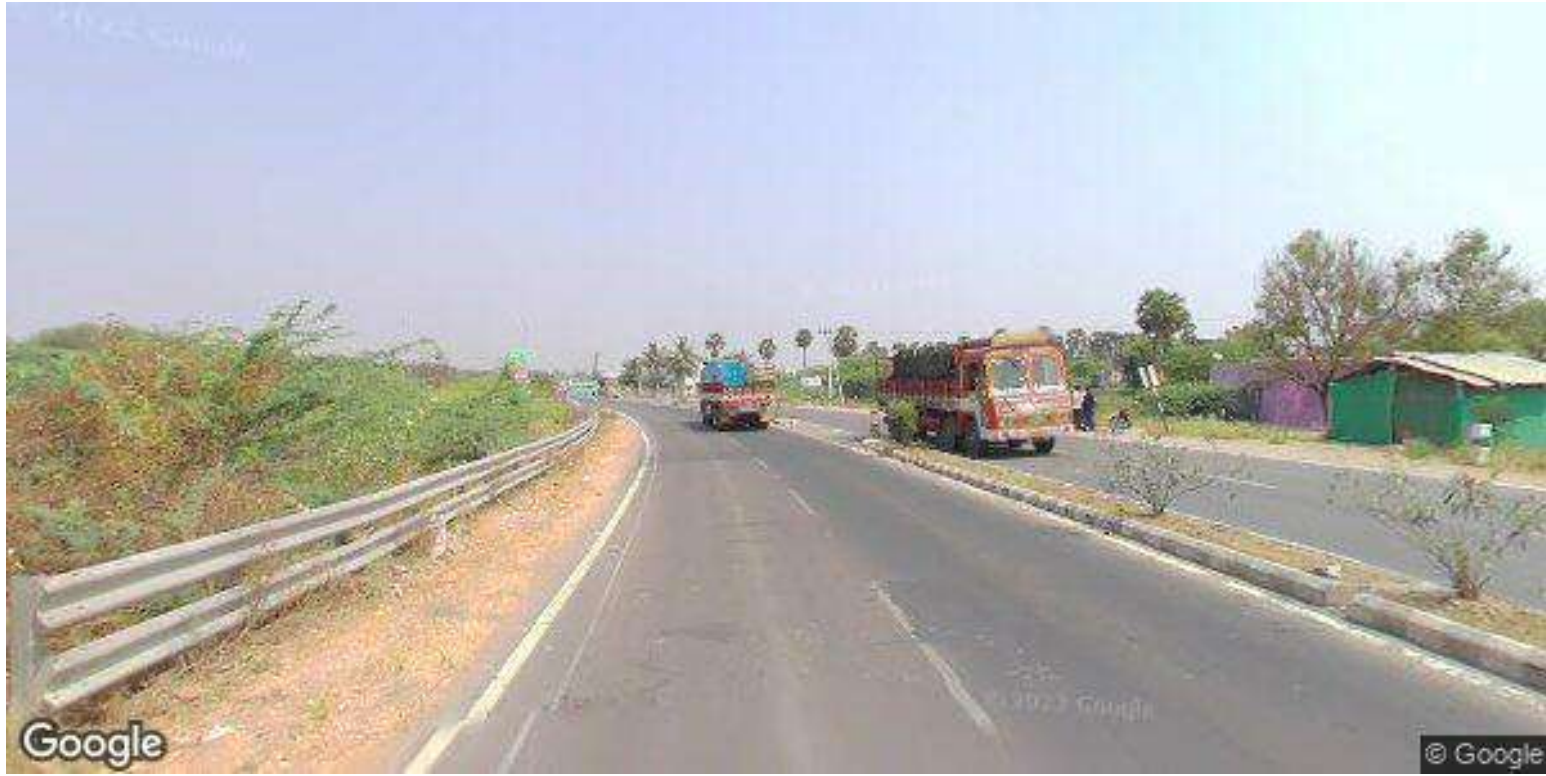
**Risk Type:** Turn  
**Risk Level:** Medium  
**Speed Limit:** 30 KM/Hr  
**Coordinates:** 11.70062, 77.97961

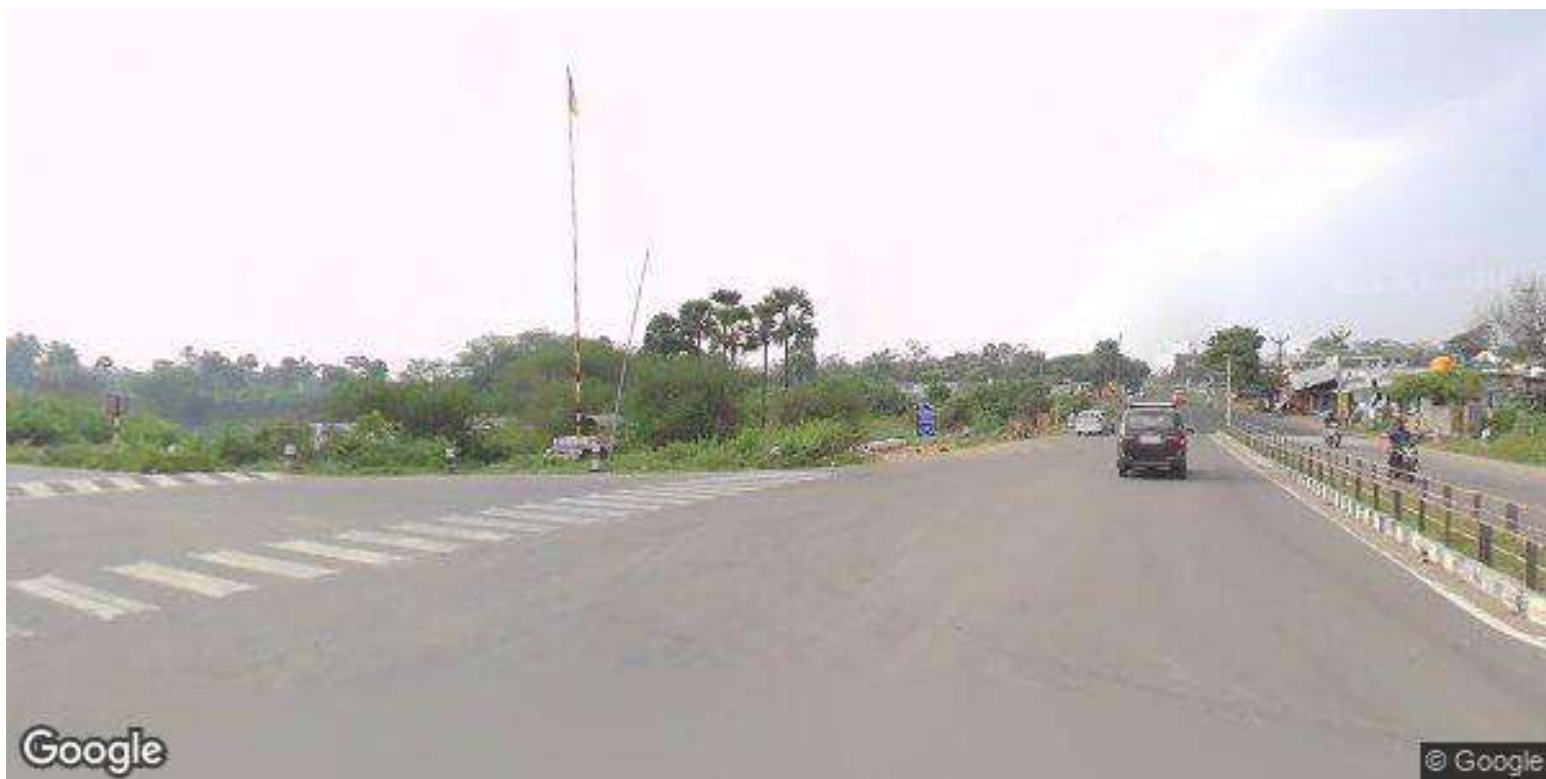
**Risk Type:** Turn  
**Risk Level:** High  
**Speed Limit:** 15 KM/Hr  
**Coordinates:** 11.70218, 77.97866

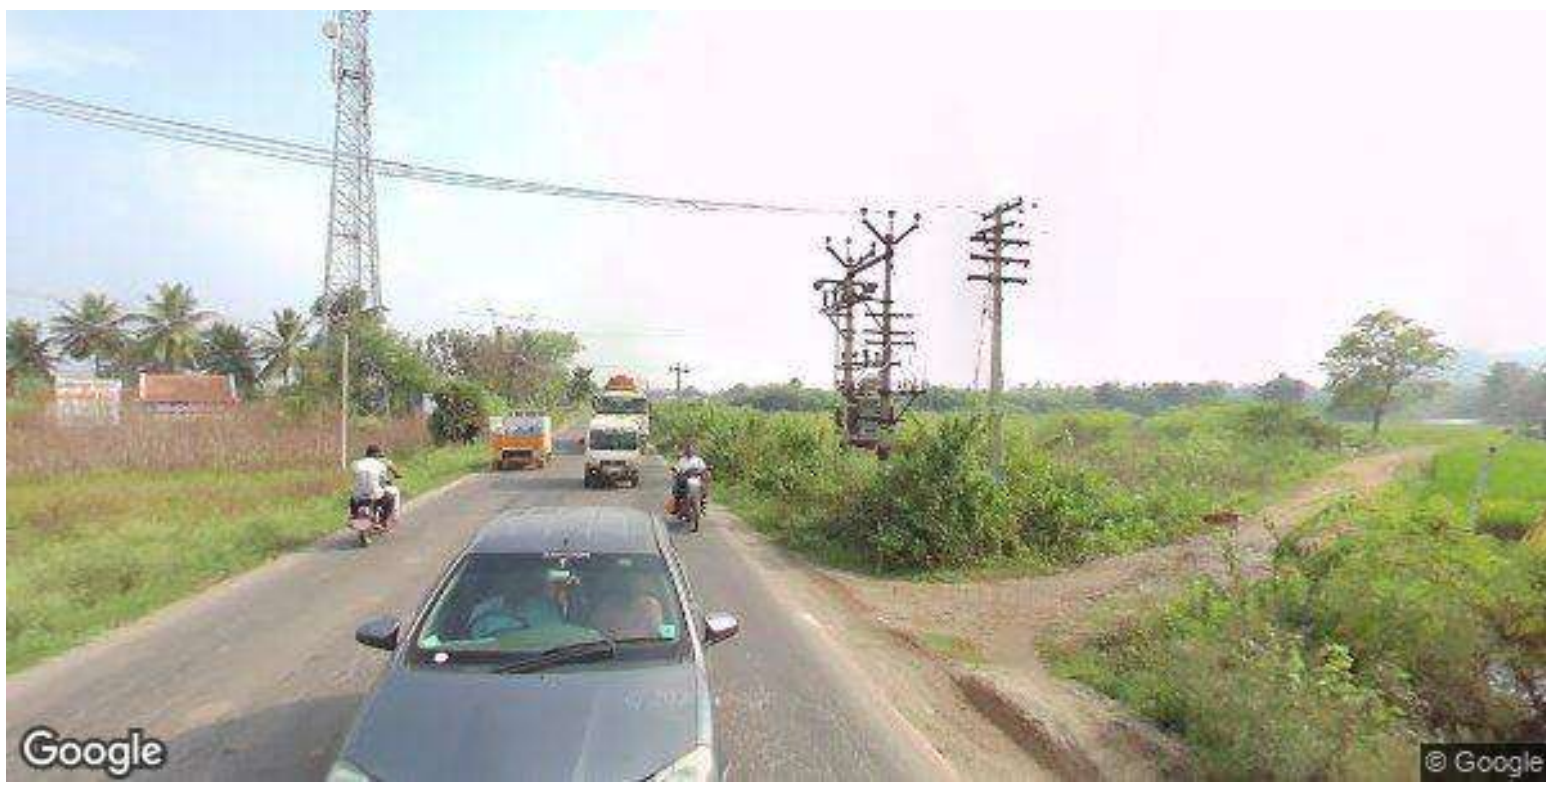
**Coordinates:** 11.71399, 77.99580

**Risk Type:** Turn

**Risk Level:** Medium

**Speed Limit:** 30 KM/Hr

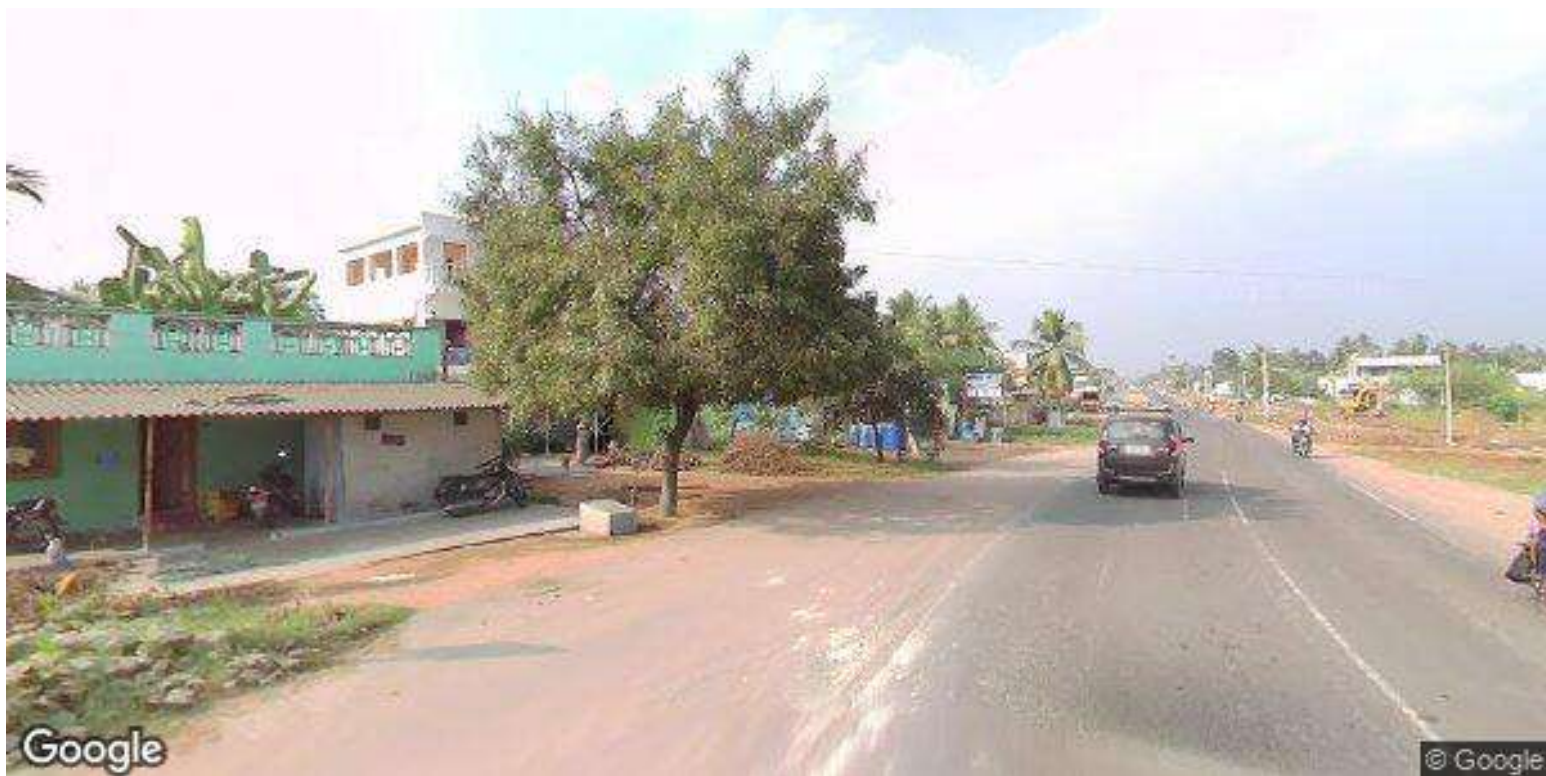
**Coordinates:** 11.71917, 78.01123

**Risk Type:** Turn

**Risk Level:** Medium

**Speed Limit:** 30 KM/Hr

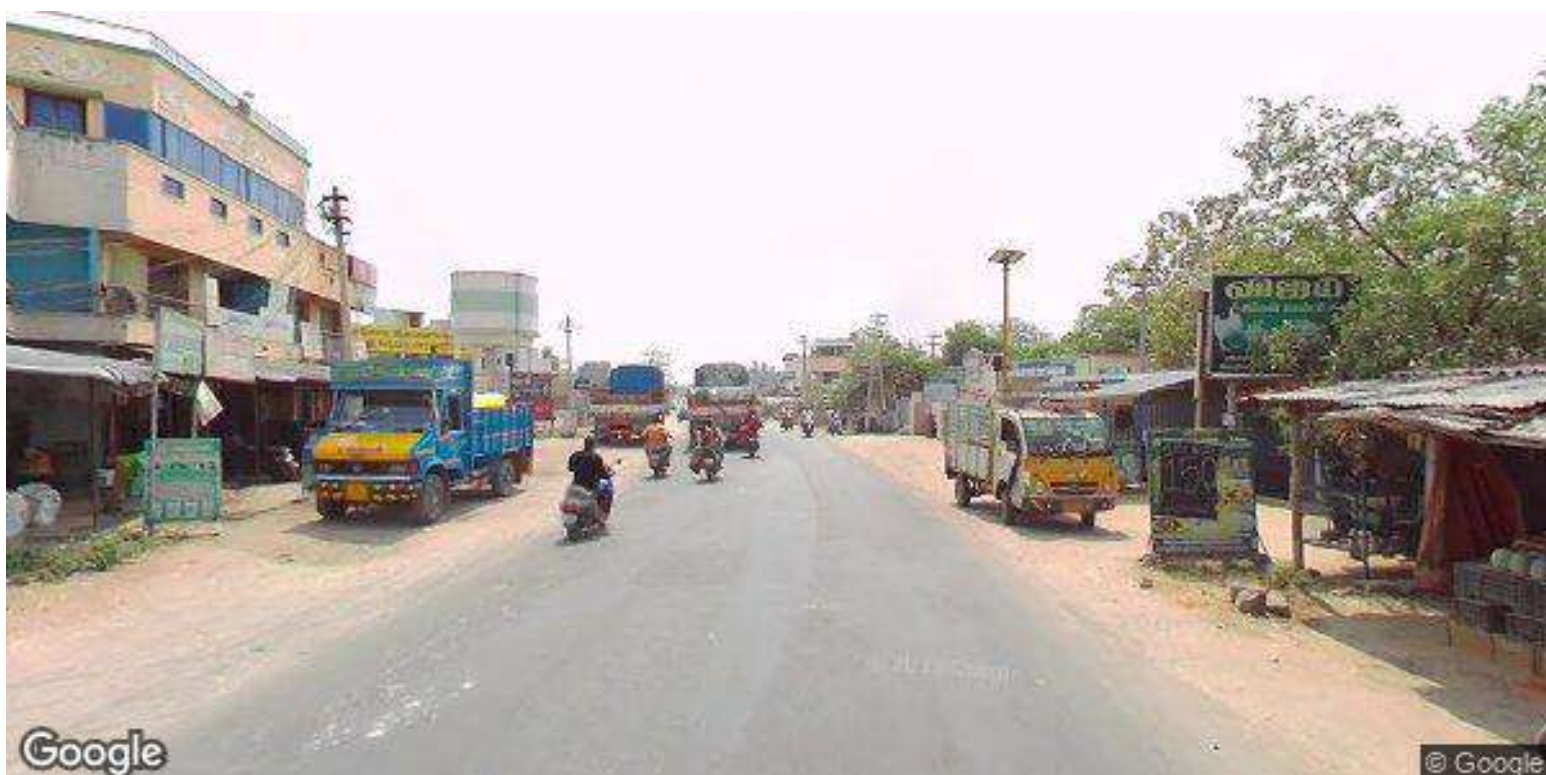
**Coordinates:** 11.73769, 78.03451

**Risk Type:** Turn

**Risk Level:** Medium

**Speed Limit:** 30 KM/Hr
