# IndianOil

## JOURNEY RISK MANAGEMENT (JRM) STUDY

### Salem Terminal TO M/S HARAN FUELS

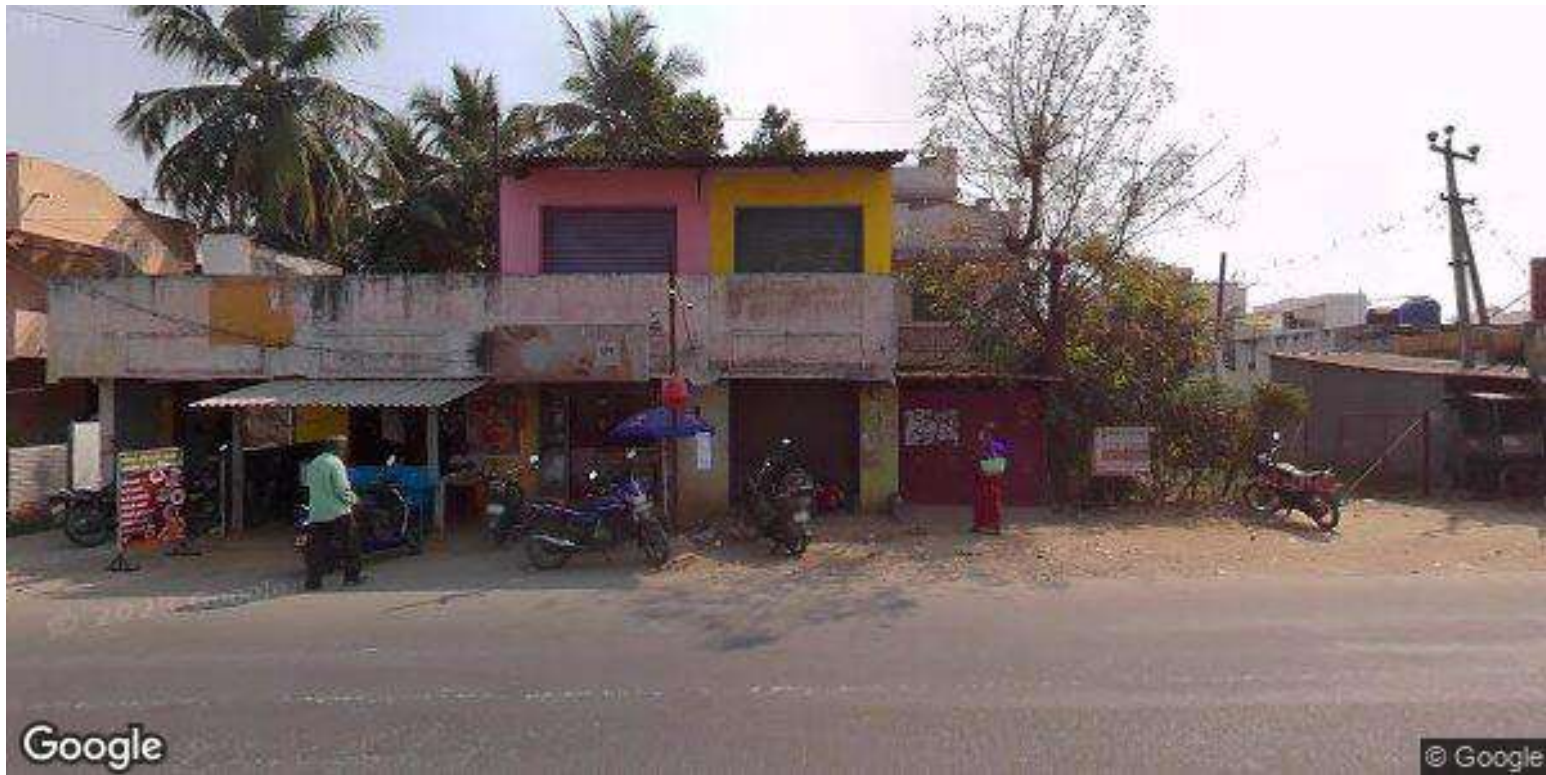
**Coordinates:** 11.73785, 78.03551

**Risk Type:** Turn

**Risk Level:** Medium

**Speed Limit:** 30 KM/Hr

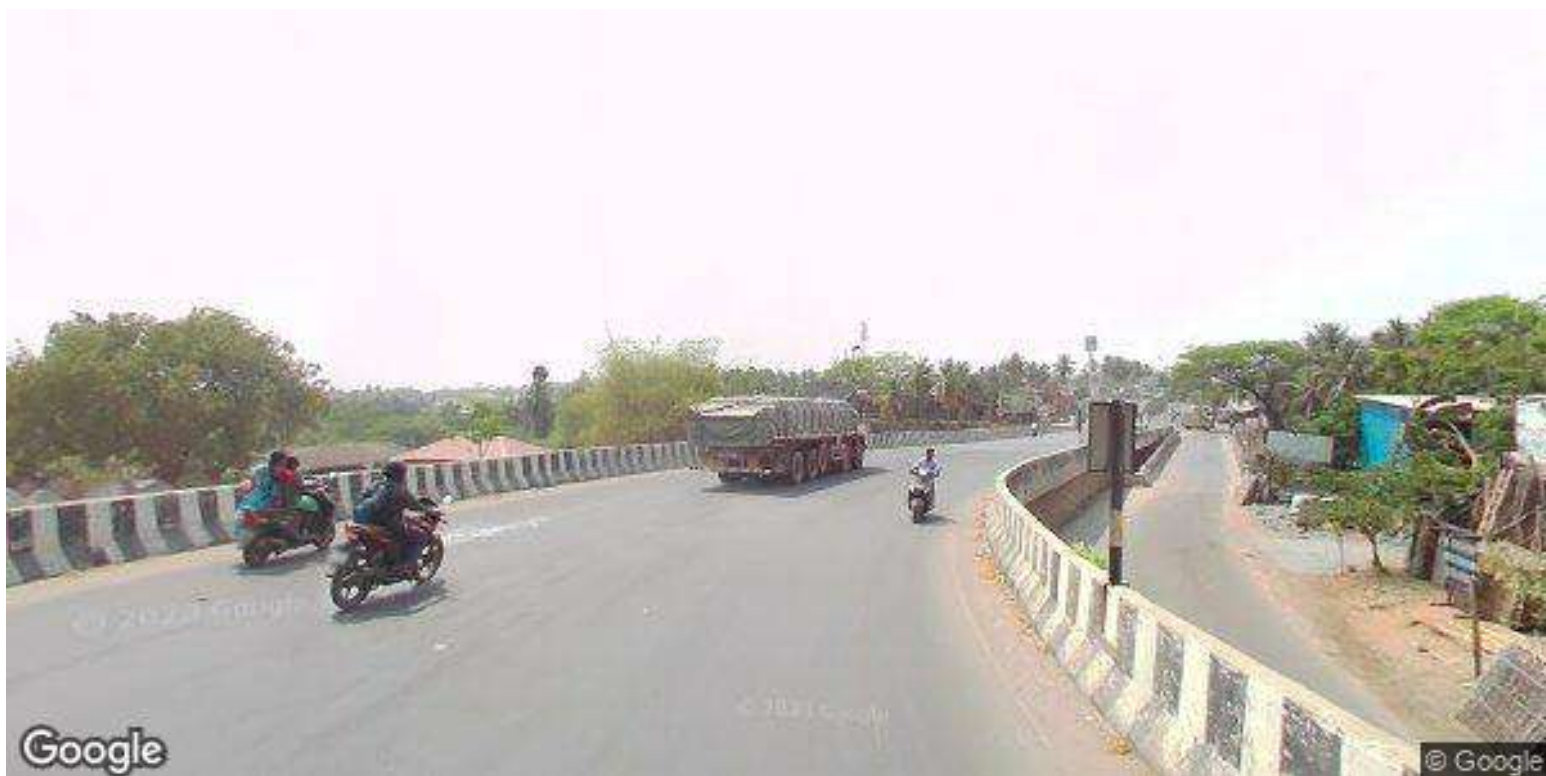
**Coordinates:** 11.73651, 78.03871

**Risk Type:** Turn

**Risk Level:** High

**Speed Limit:** 15 KM/Hr

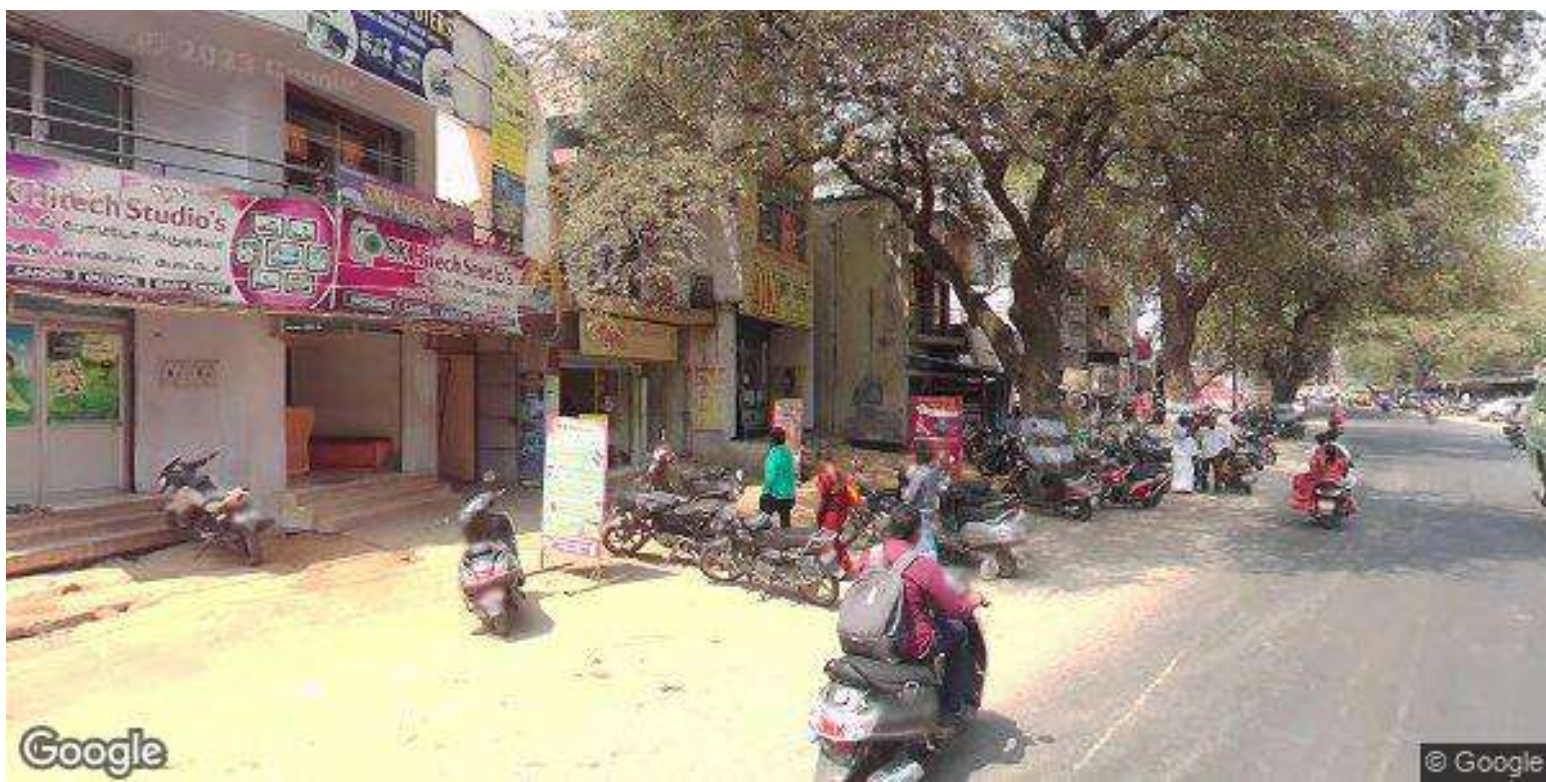
**Coordinates:** 11.74143, 78.04613

**Risk Type:** Turn

**Risk Level:** Medium

**Speed Limit:** 30 KM/Hr

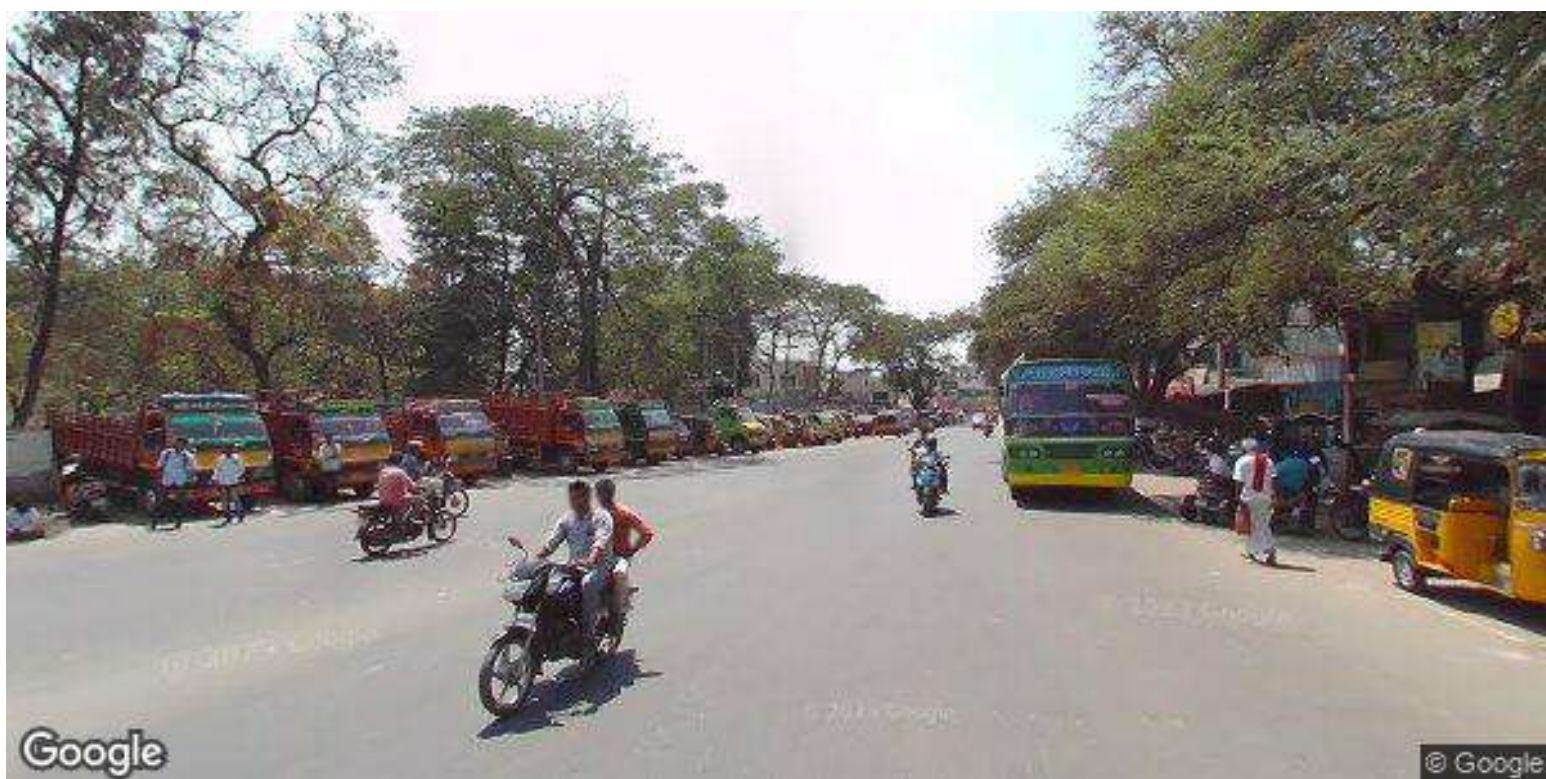
**Coordinates:** 11.74265, 78.04710

**Risk Type:** Turn

**Risk Level:** Medium

**Speed Limit:** 30 KM/Hr

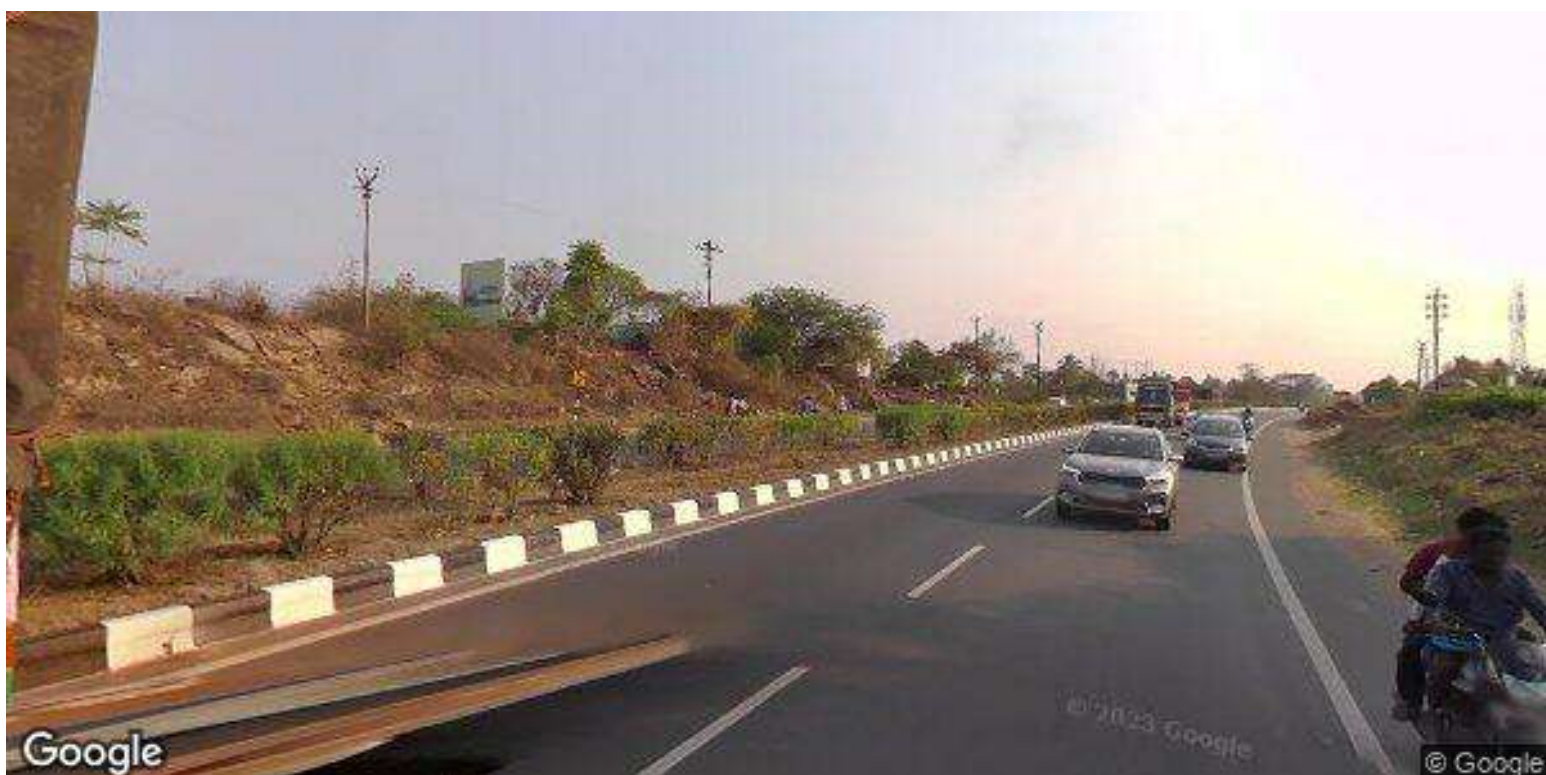
**Risk Type:** Turn  
**Risk Level:** Medium  
**Speed Limit:** 30 KM/Hr  
**Coordinates:** 11.78005, 78.05788

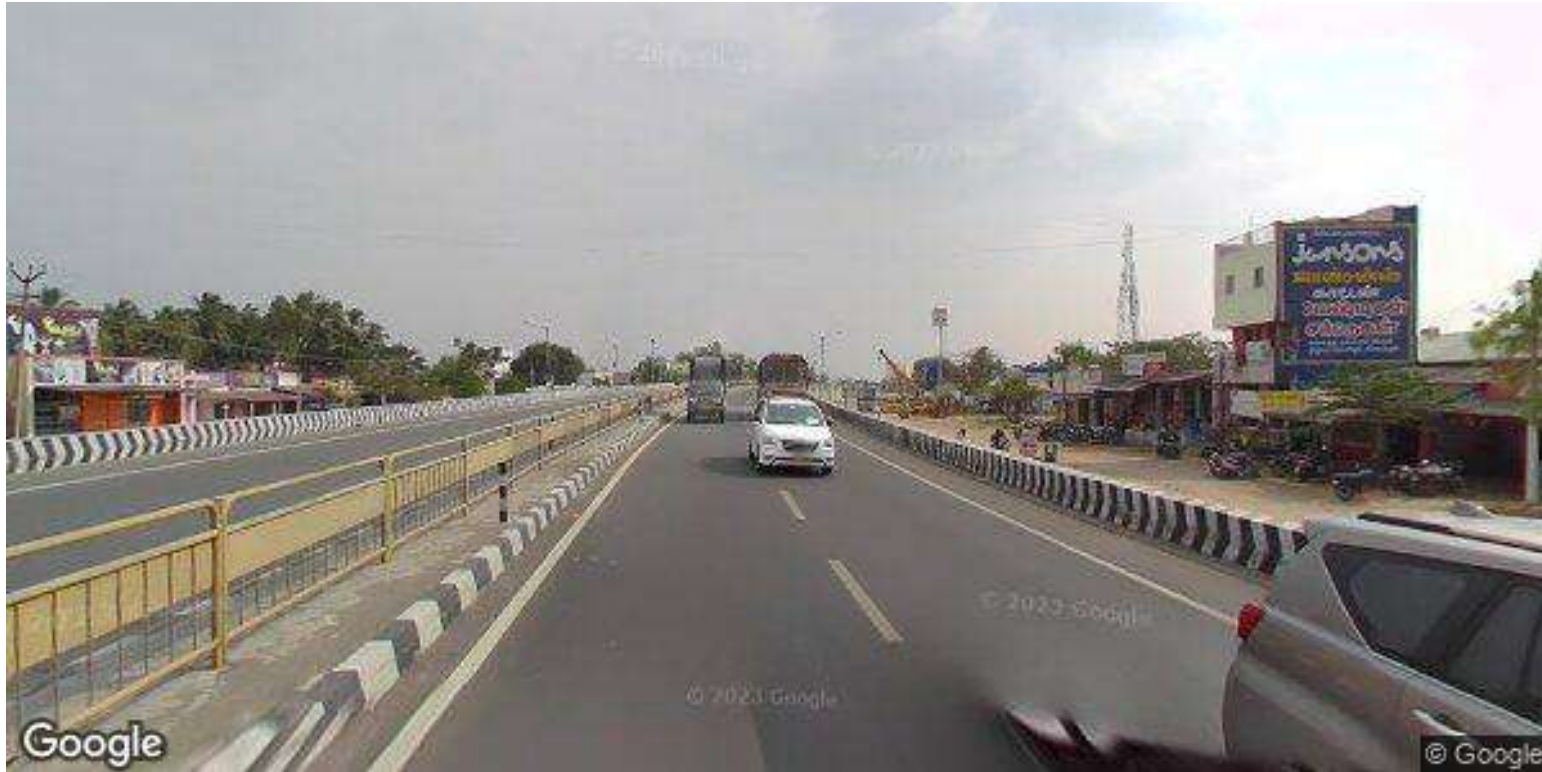
**Risk Type:** Turn  
**Risk Level:** Medium  
**Speed Limit:** 30 KM/Hr  
**Coordinates:** 11.86928, 78.08384

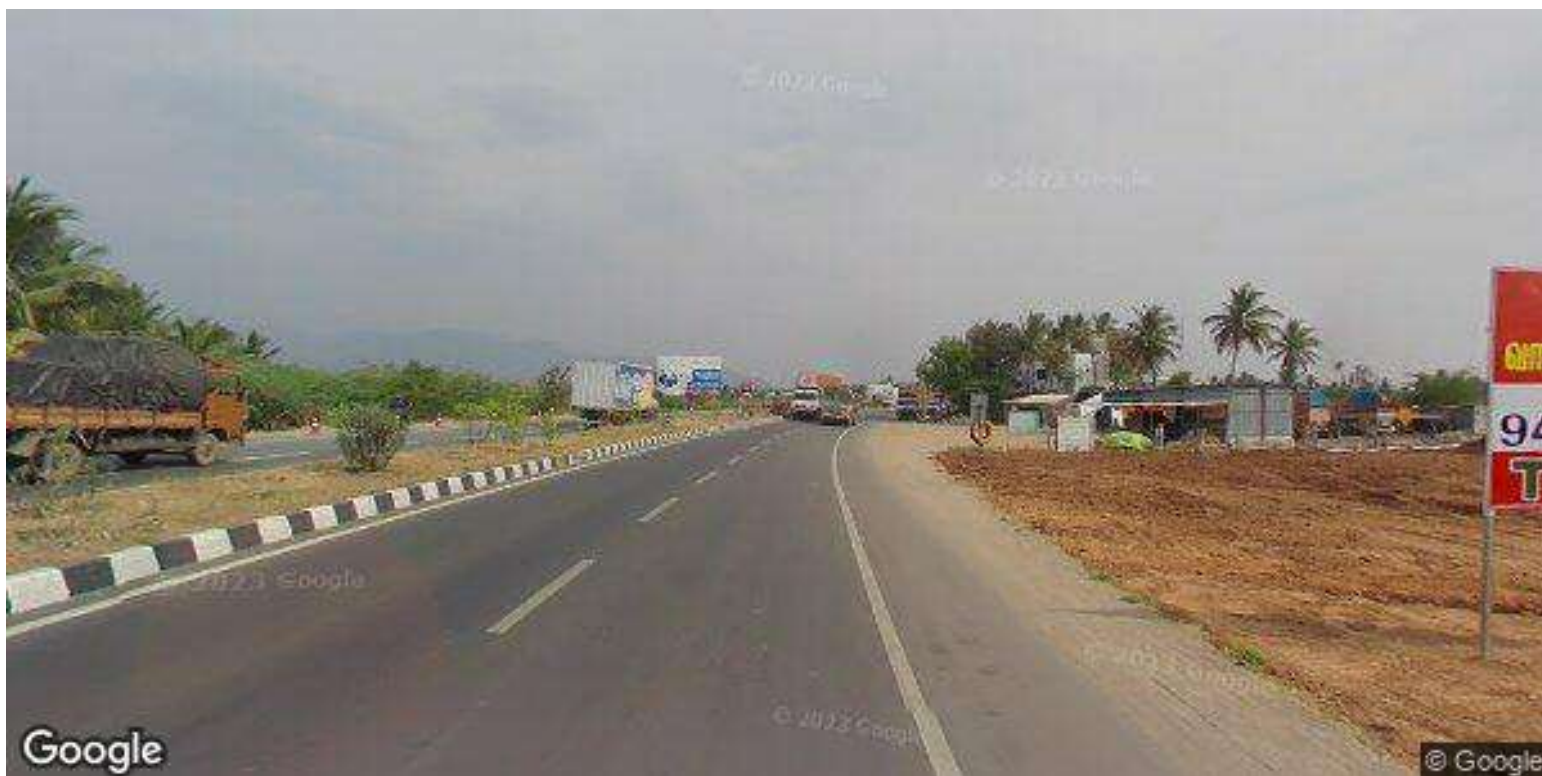
**Risk Type:** Turn  
**Risk Level:** Medium  
**Speed Limit:** 30 KM/Hr  
**Coordinates:** 11.88009, 78.08164

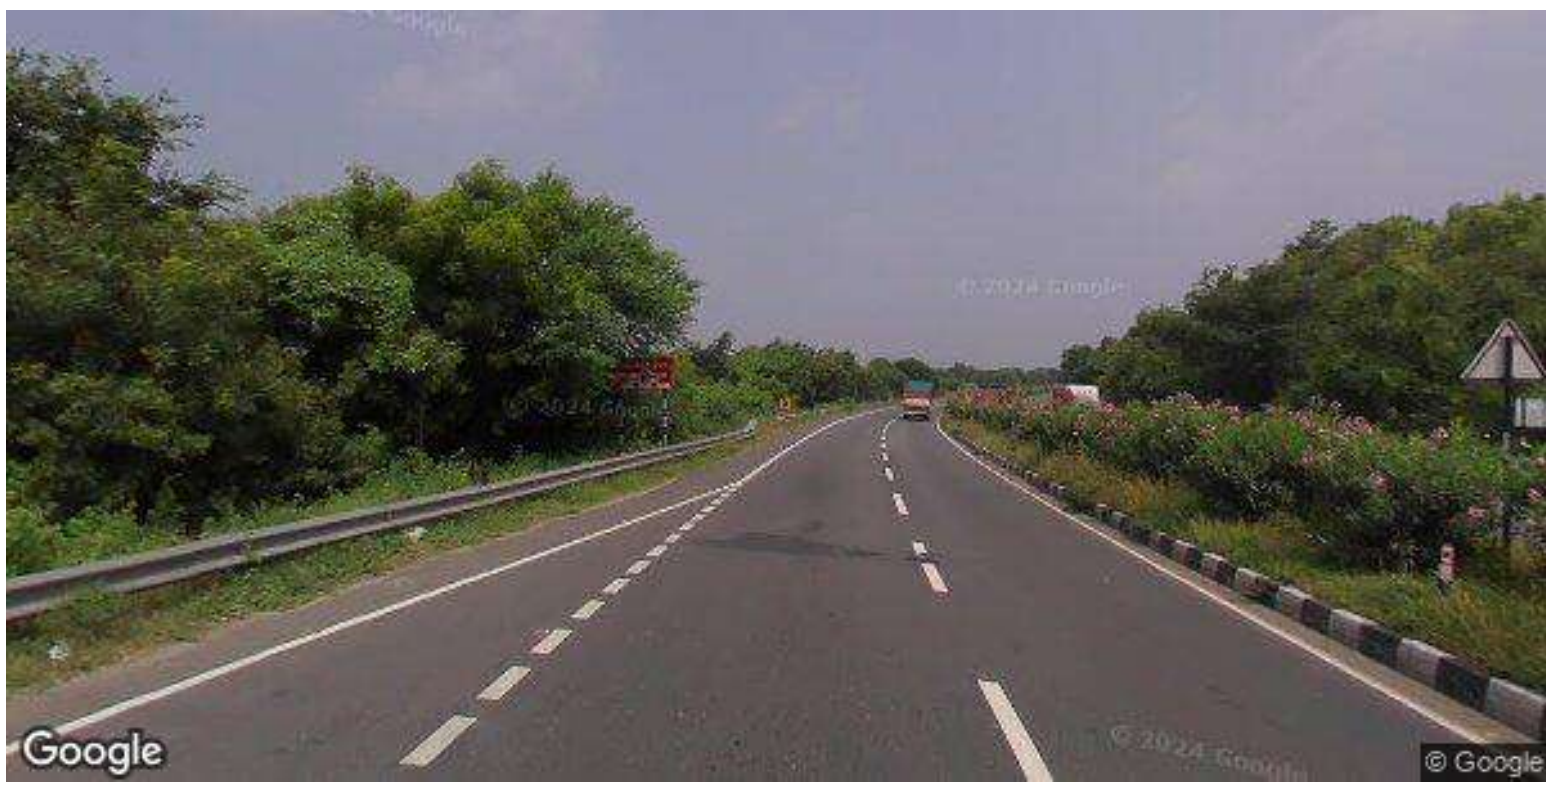
**Coordinates:** 11.91277, 78.05853

**Risk Type:** Turn

**Risk Level:** Medium

**Speed Limit:** 30 KM/Hr

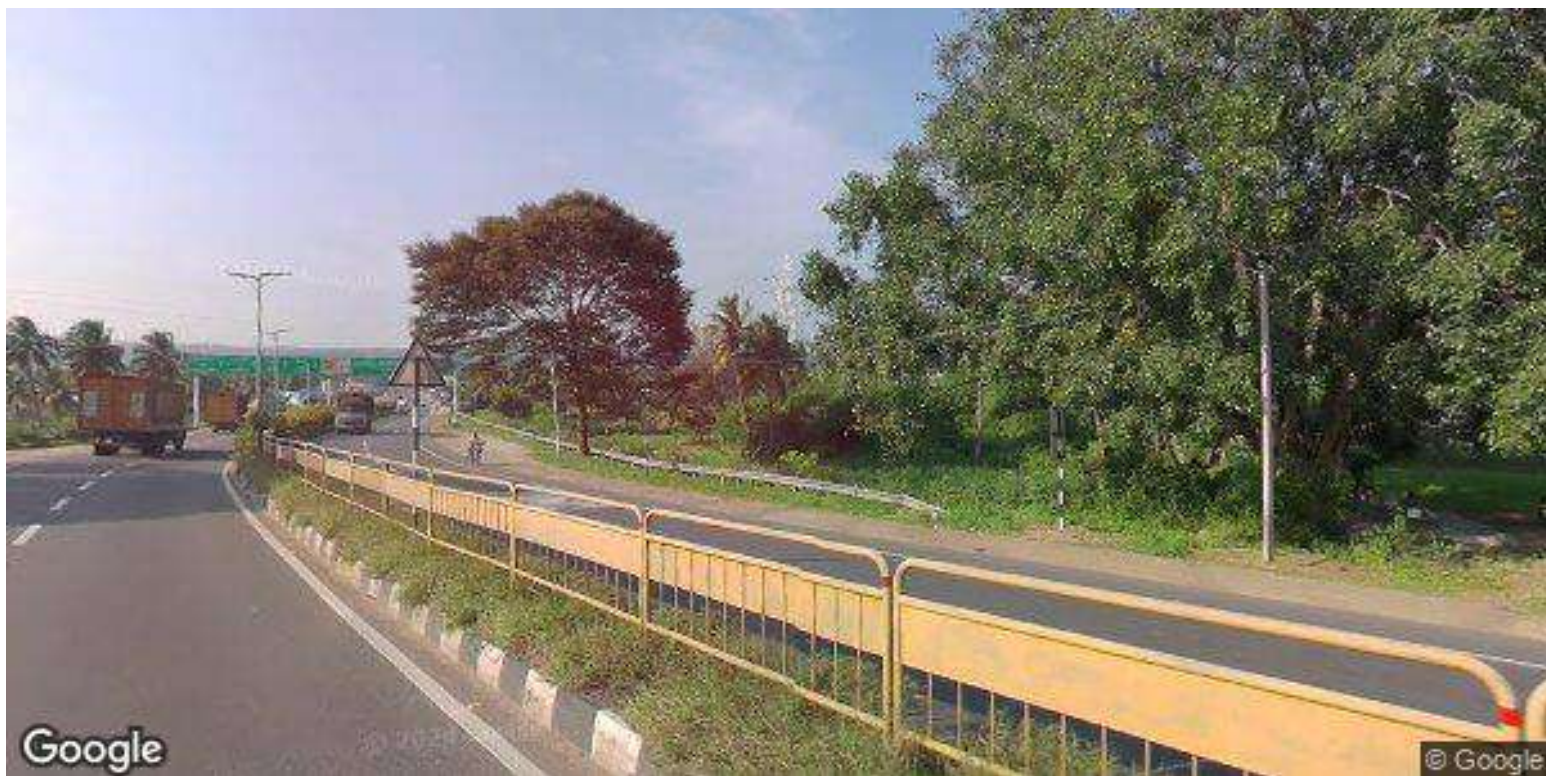
**Coordinates:** 11.93746, 78.05331

**Risk Type:** Turn

**Risk Level:** Medium

**Speed Limit:** 30 KM/Hr

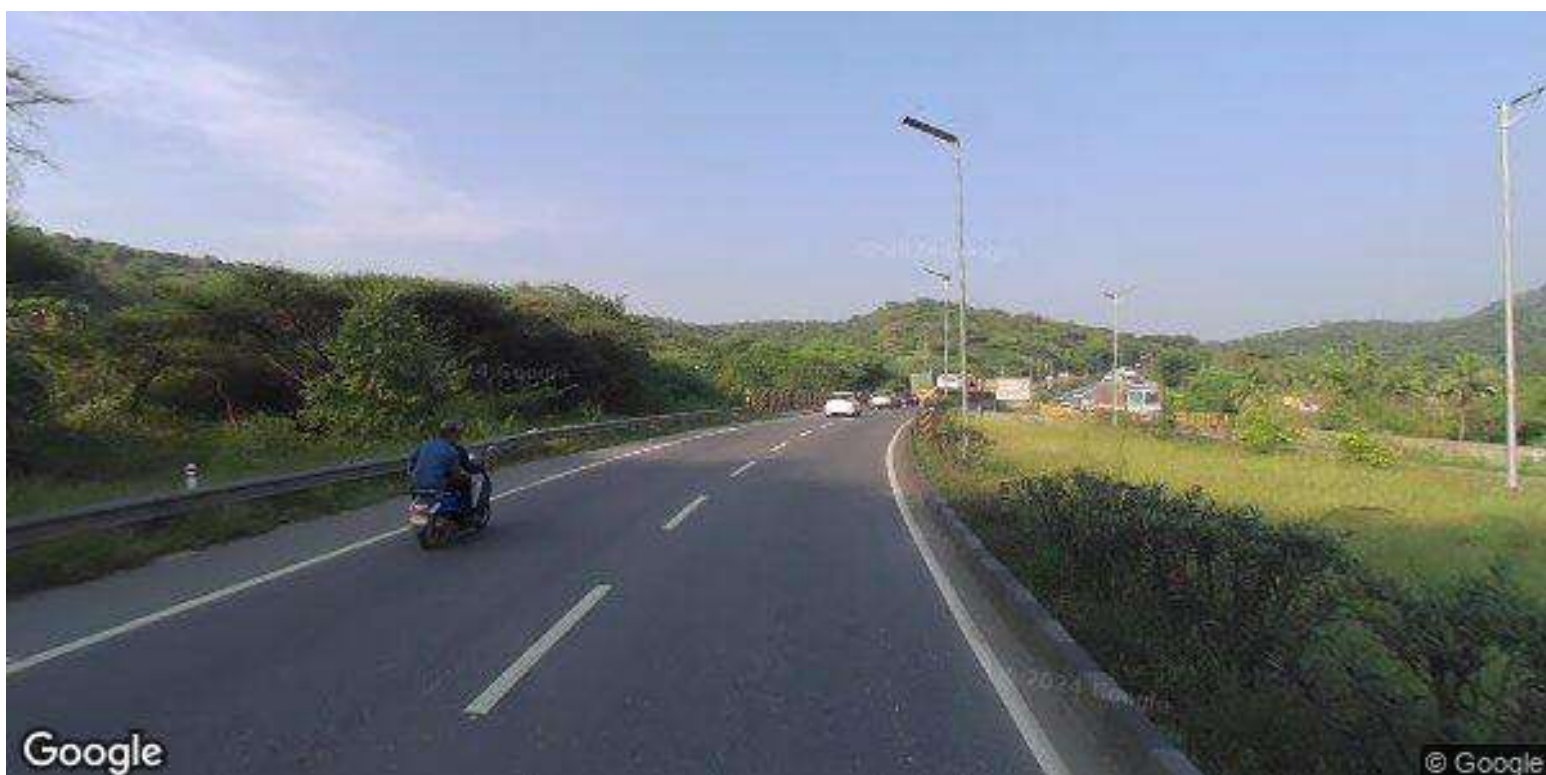
**Risk Type:** Turn  
**Risk Level:** Medium  
**Speed Limit:** 30 KM/Hr  
**Coordinates:** 11.95531, 78.04698

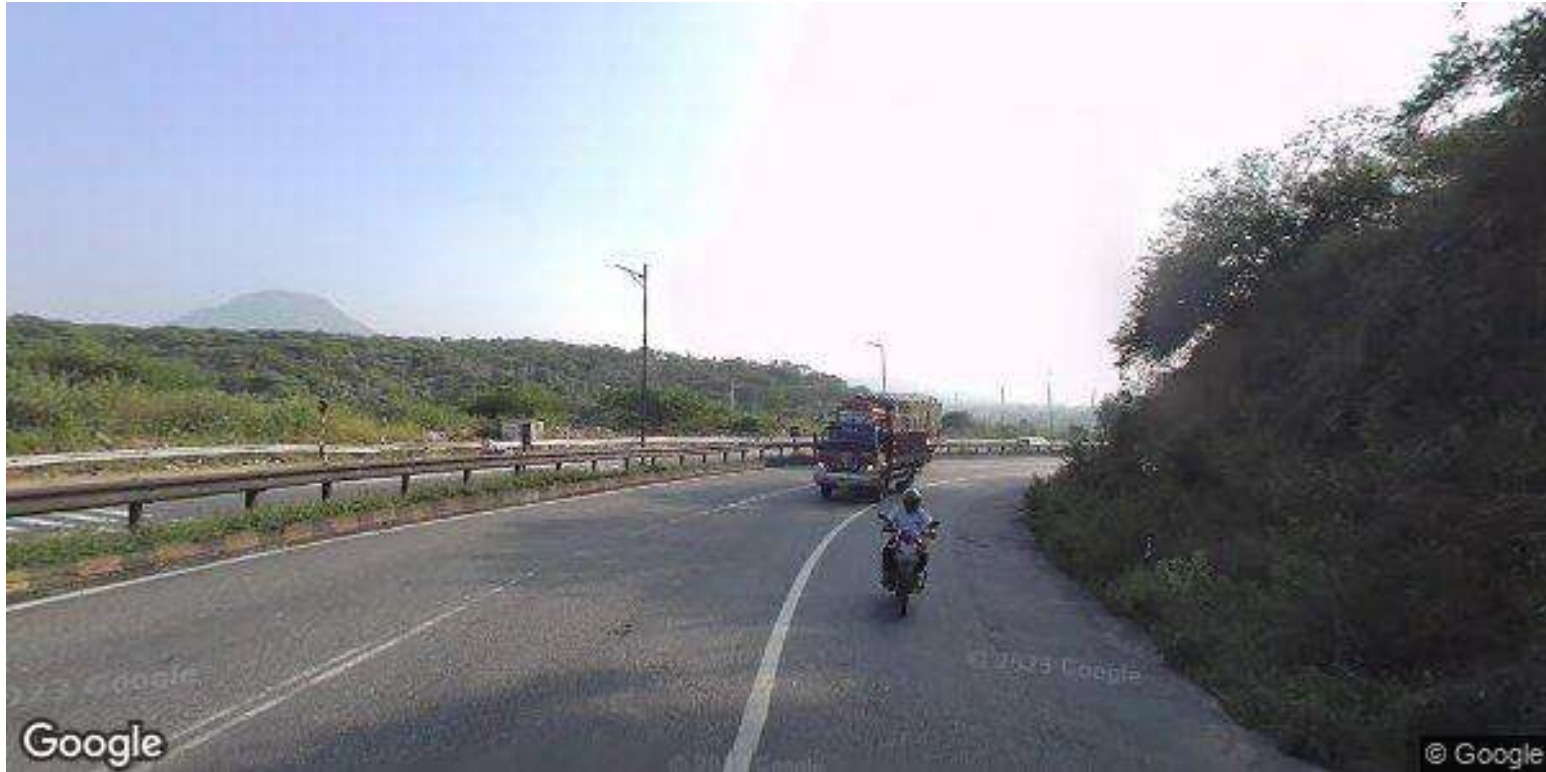
**Risk Type:** Turn  
**Risk Level:** High  
**Speed Limit:** 15 KM/Hr  
**Coordinates:** 11.95854, 78.04990

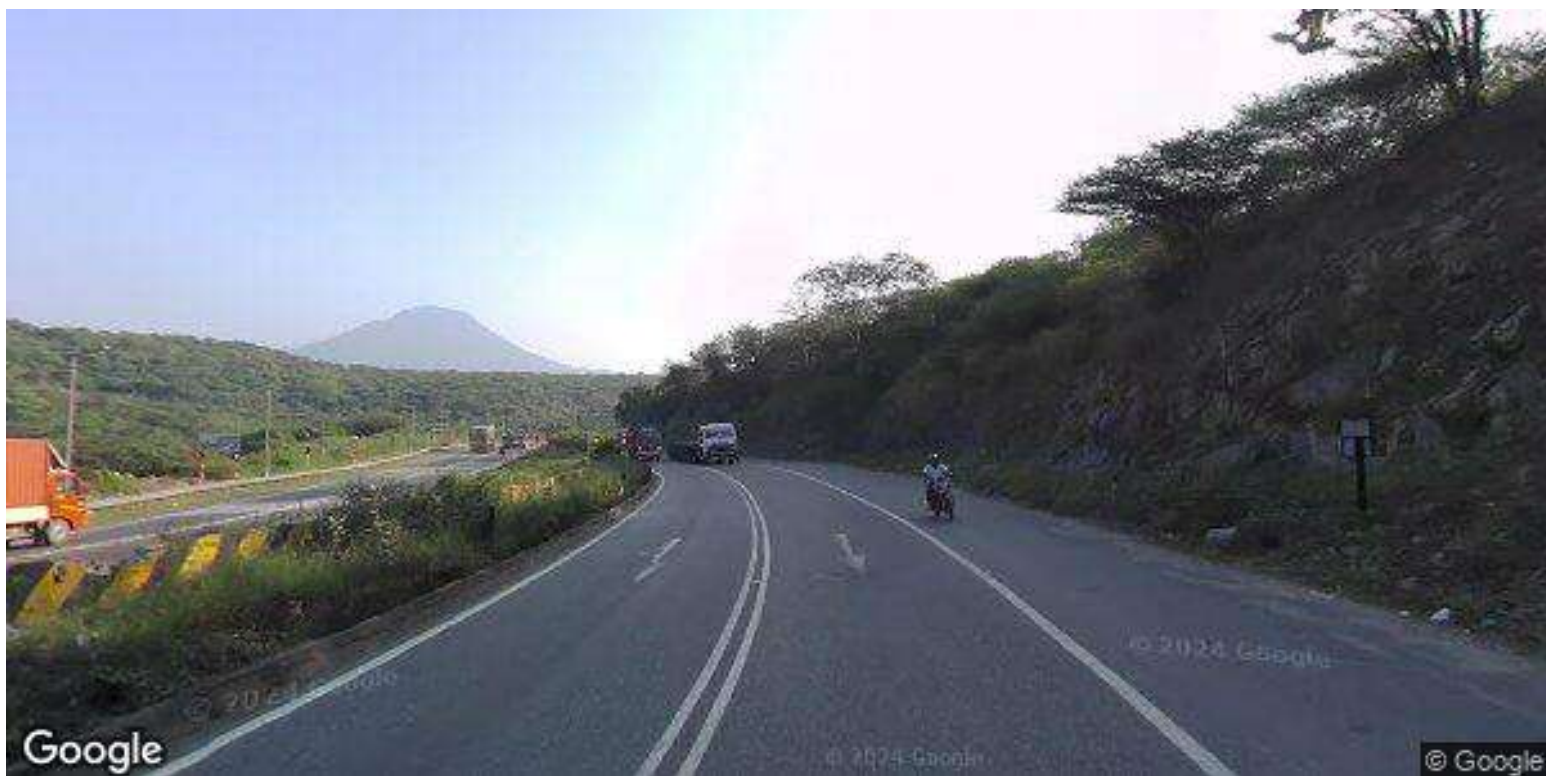
**Risk Type:** Turn  
**Risk Level:** High  
**Speed Limit:** 15 KM/Hr  
**Coordinates:** 11.96015, 78.04945

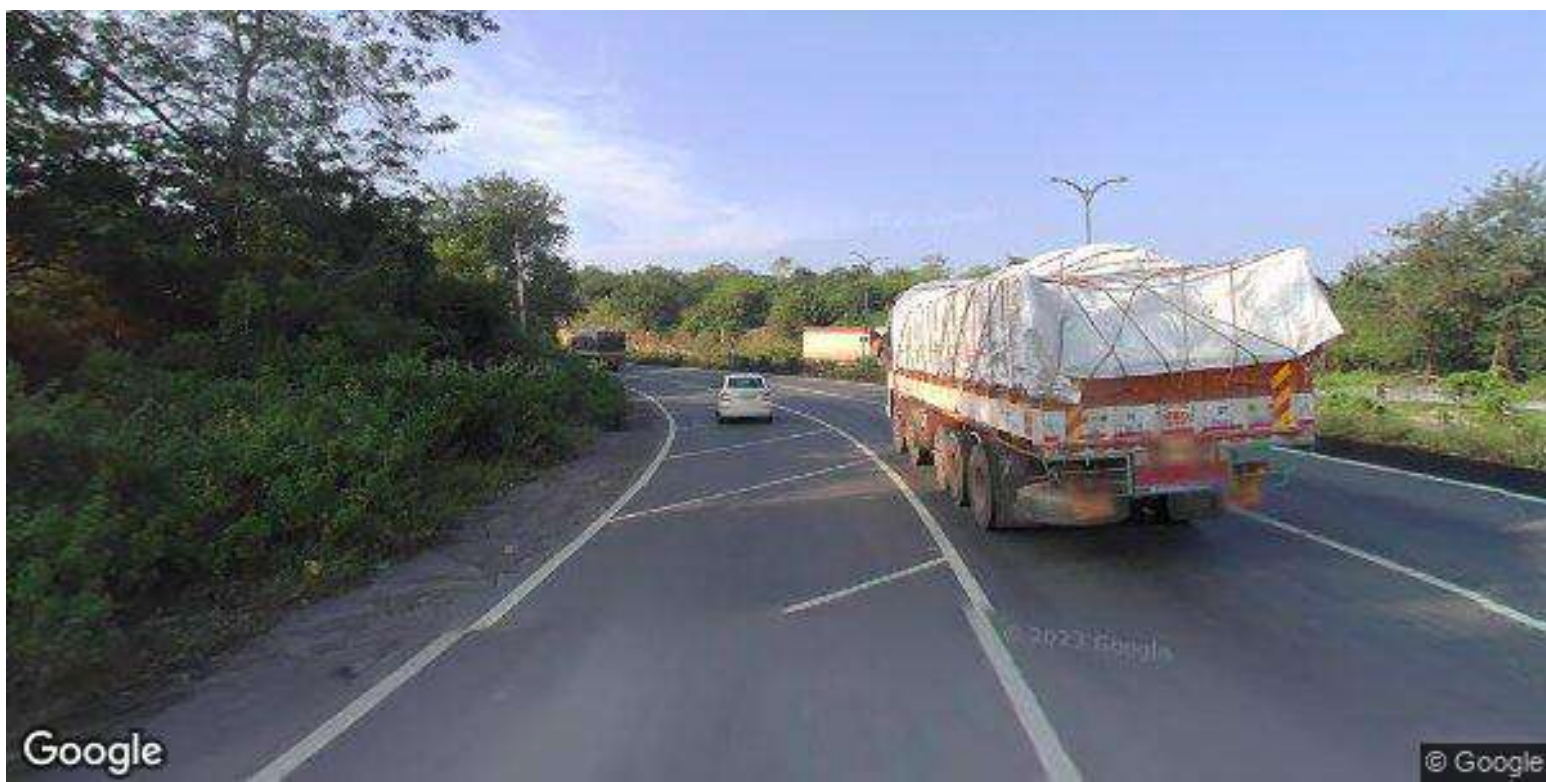
**Coordinates:** 11.96370, 78.05142

**Risk Type:** Turn

**Risk Level:** Medium

**Speed Limit:** 30 KM/Hr

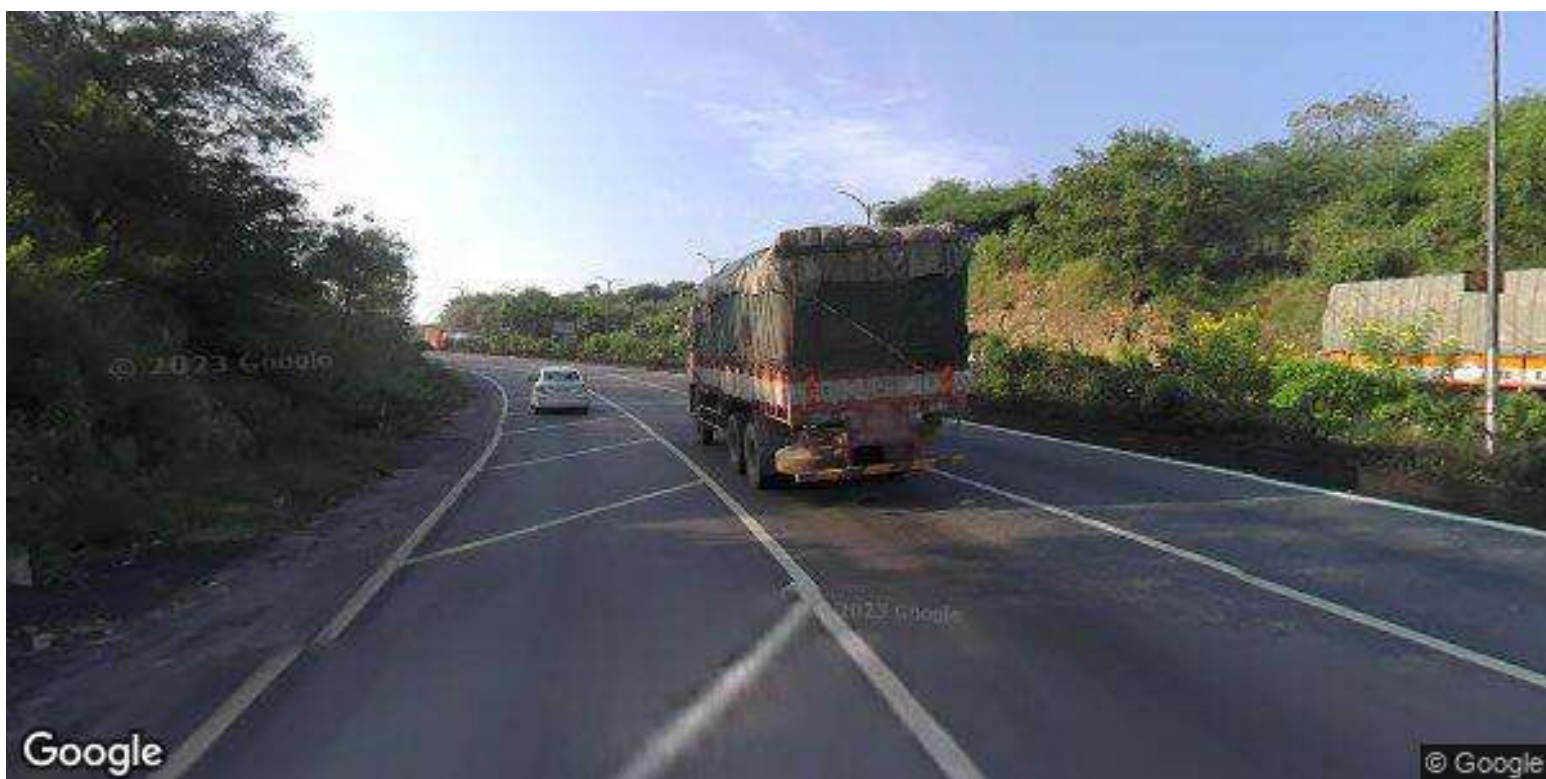
**Coordinates:** 11.96433, 78.05113

**Risk Type:** Turn

**Risk Level:** Medium

**Speed Limit:** 30 KM/Hr

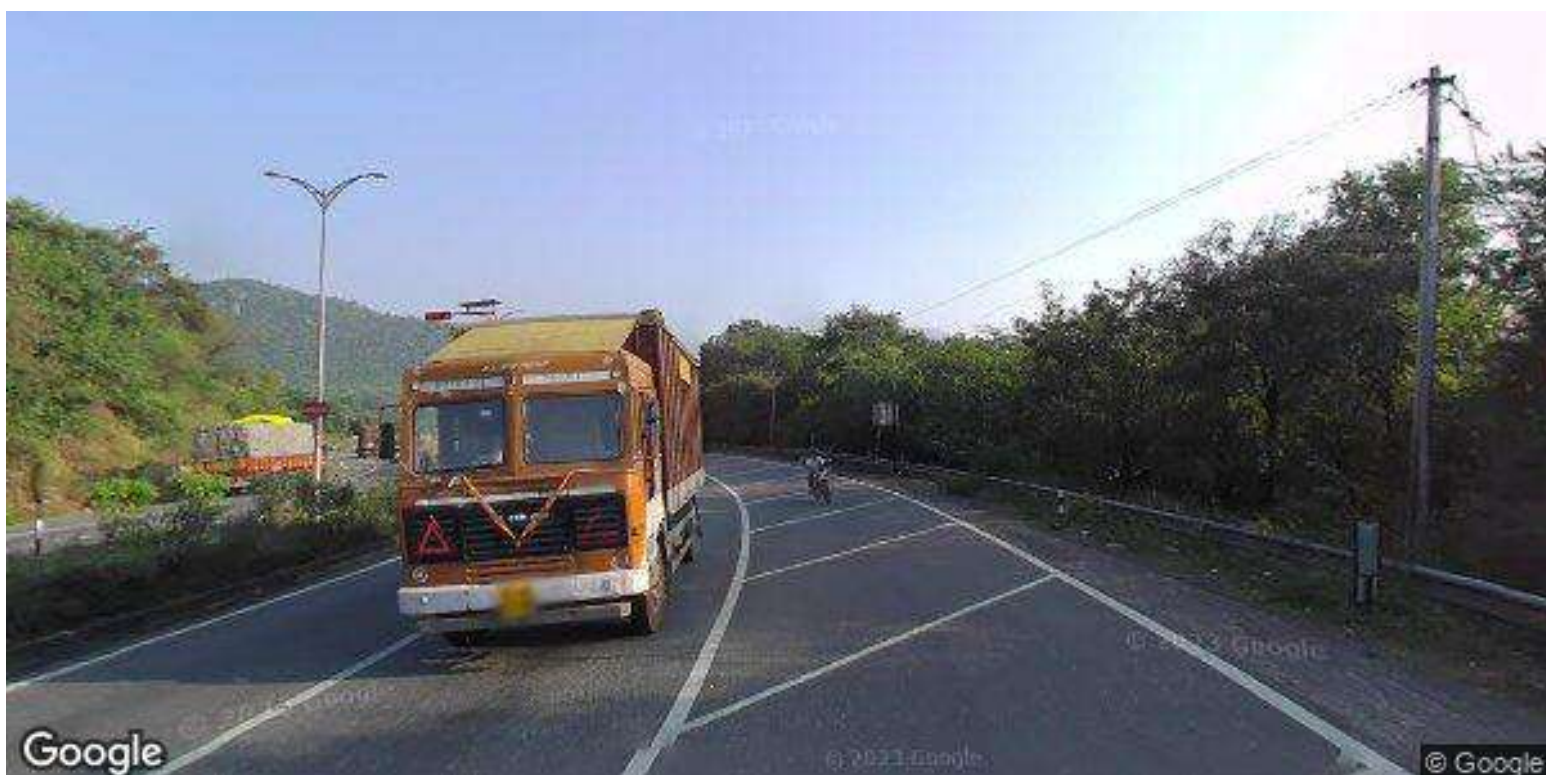
**Risk Type:** Turn  
**Risk Level:** High  
**Speed Limit:** 15 KM/Hr  
**Coordinates:** 11.96542, 78.04938

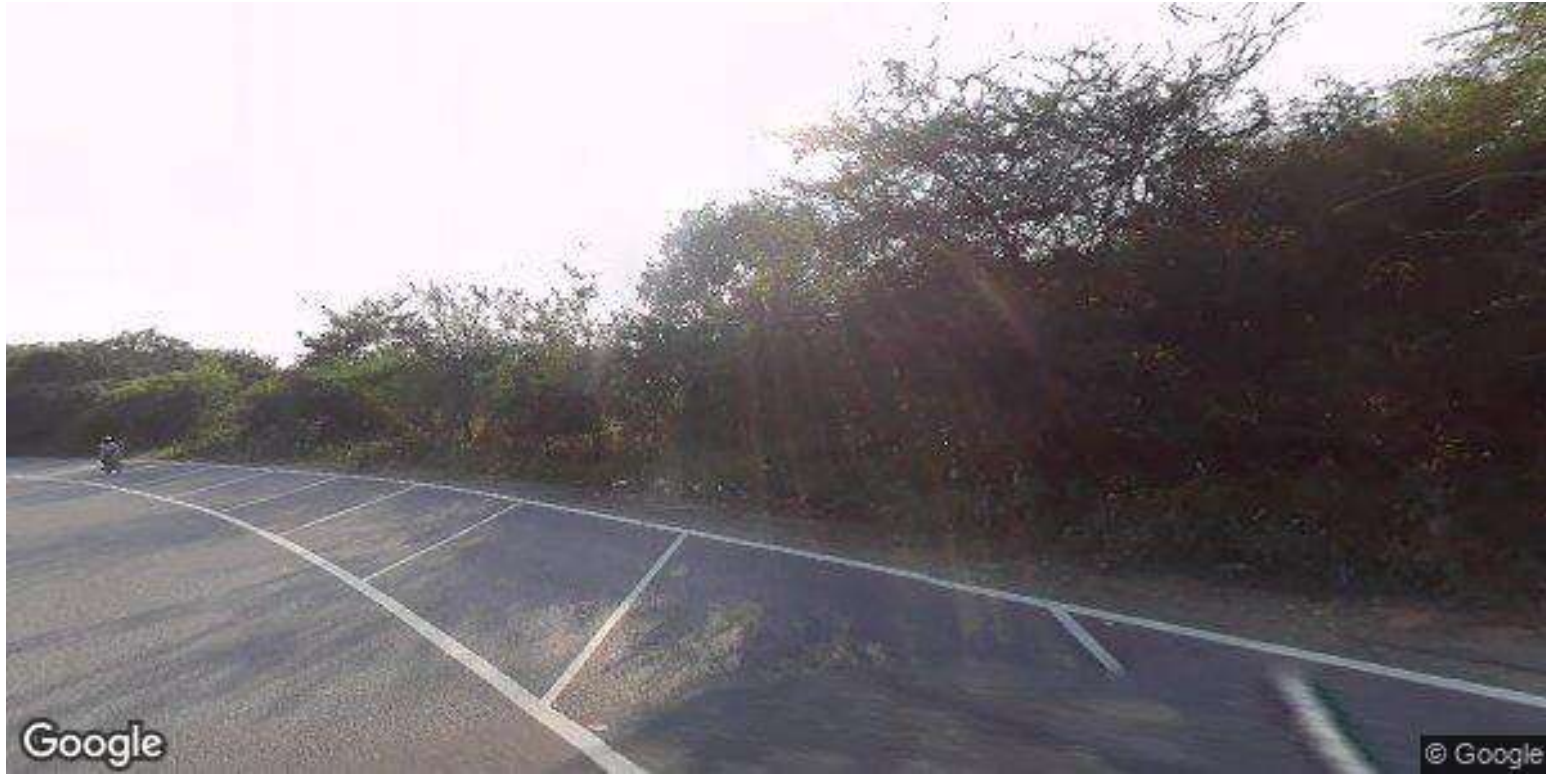
**Risk Type:** Turn  
**Risk Level:** High  
**Speed Limit:** 15 KM/Hr  
**Coordinates:** 11.96650, 78.04927

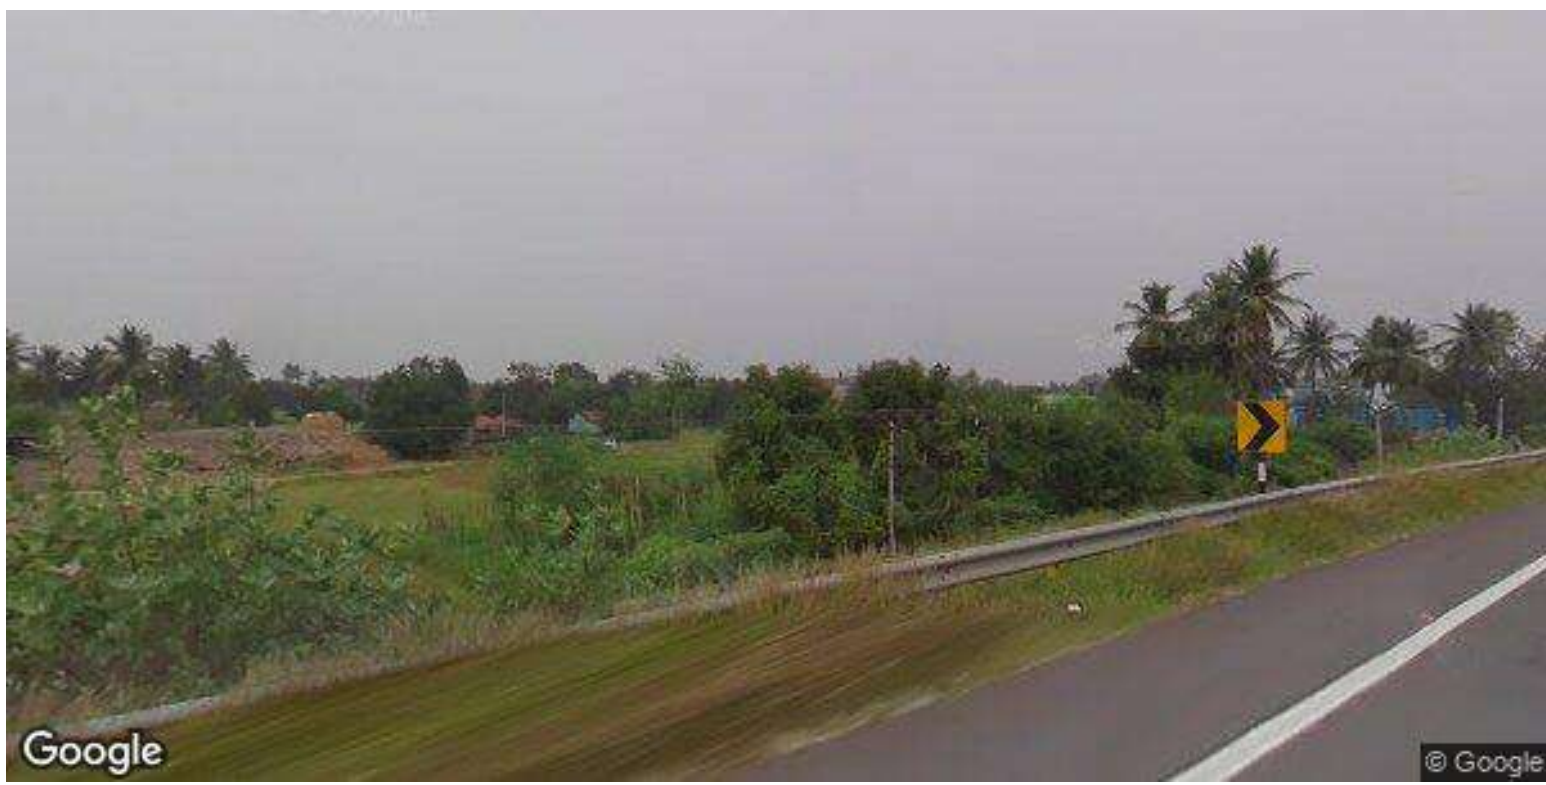
**Coordinates:** 12.22496, 78.19149

**Risk Type:** Turn

**Risk Level:** Medium

**Speed Limit:** 30 KM/Hr

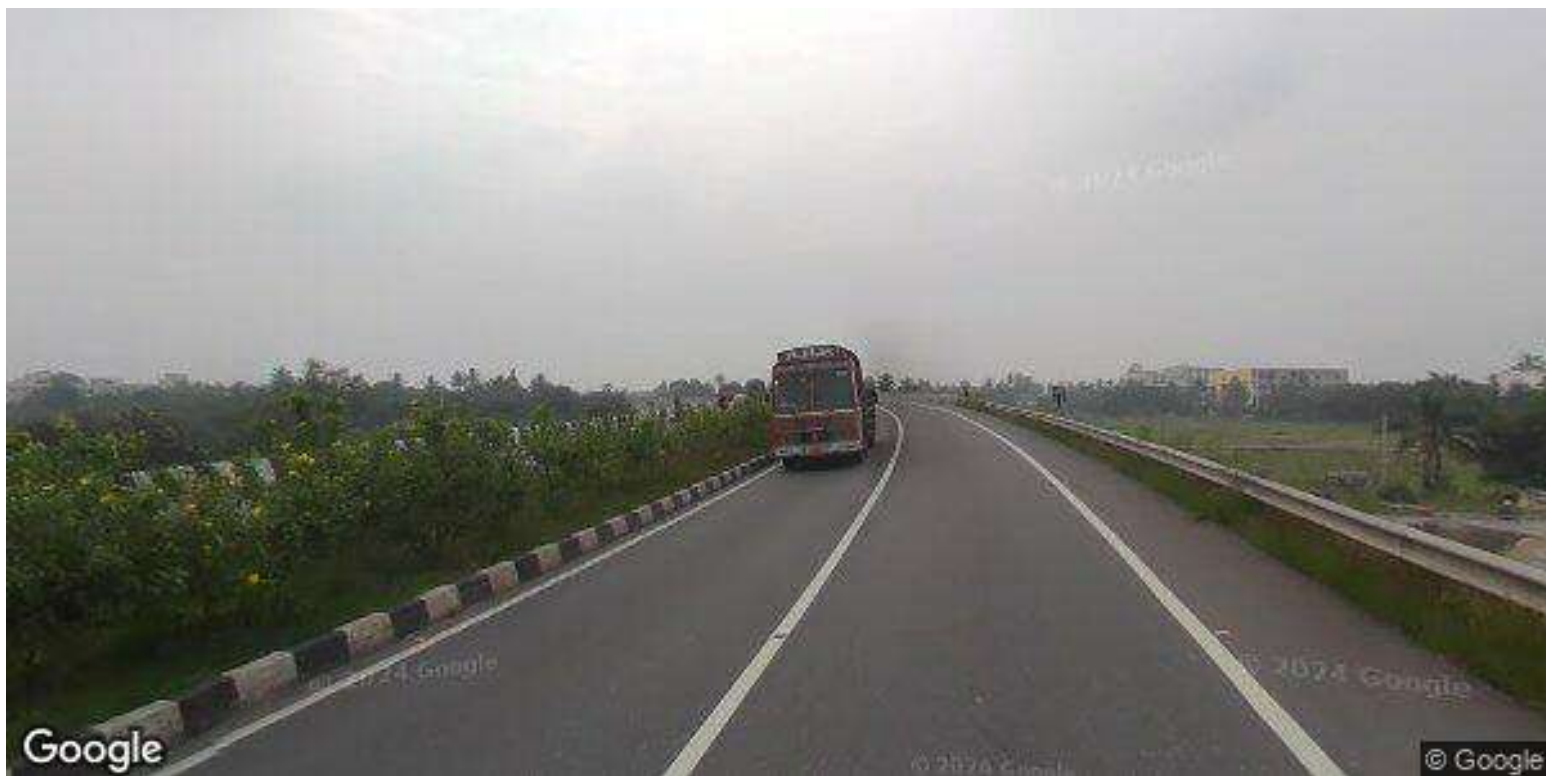
**Coordinates:** 12.24670, 78.19551

**Risk Type:** Turn

**Risk Level:** Medium

**Speed Limit:** 30 KM/Hr

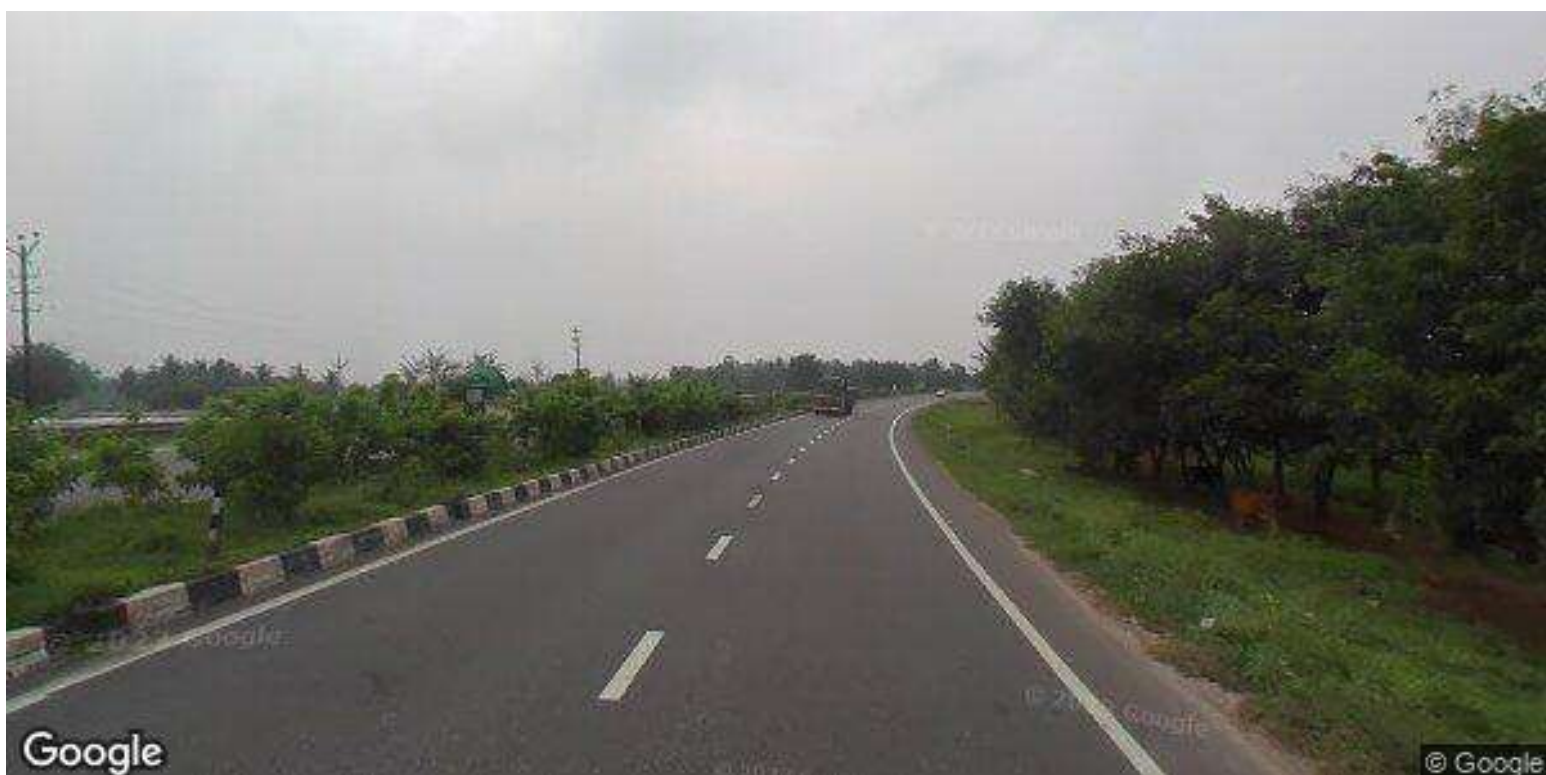
**Risk Type:** Turn  
**Risk Level:** Medium  
**Speed Limit:** 30 KM/Hr  
**Coordinates:** 12.25108, 78.20005
