# IndianOil

## JOURNEY RISK MANAGEMENT (JRM) STUDY

### Salem Terminal TO M/S HARAN FUELS

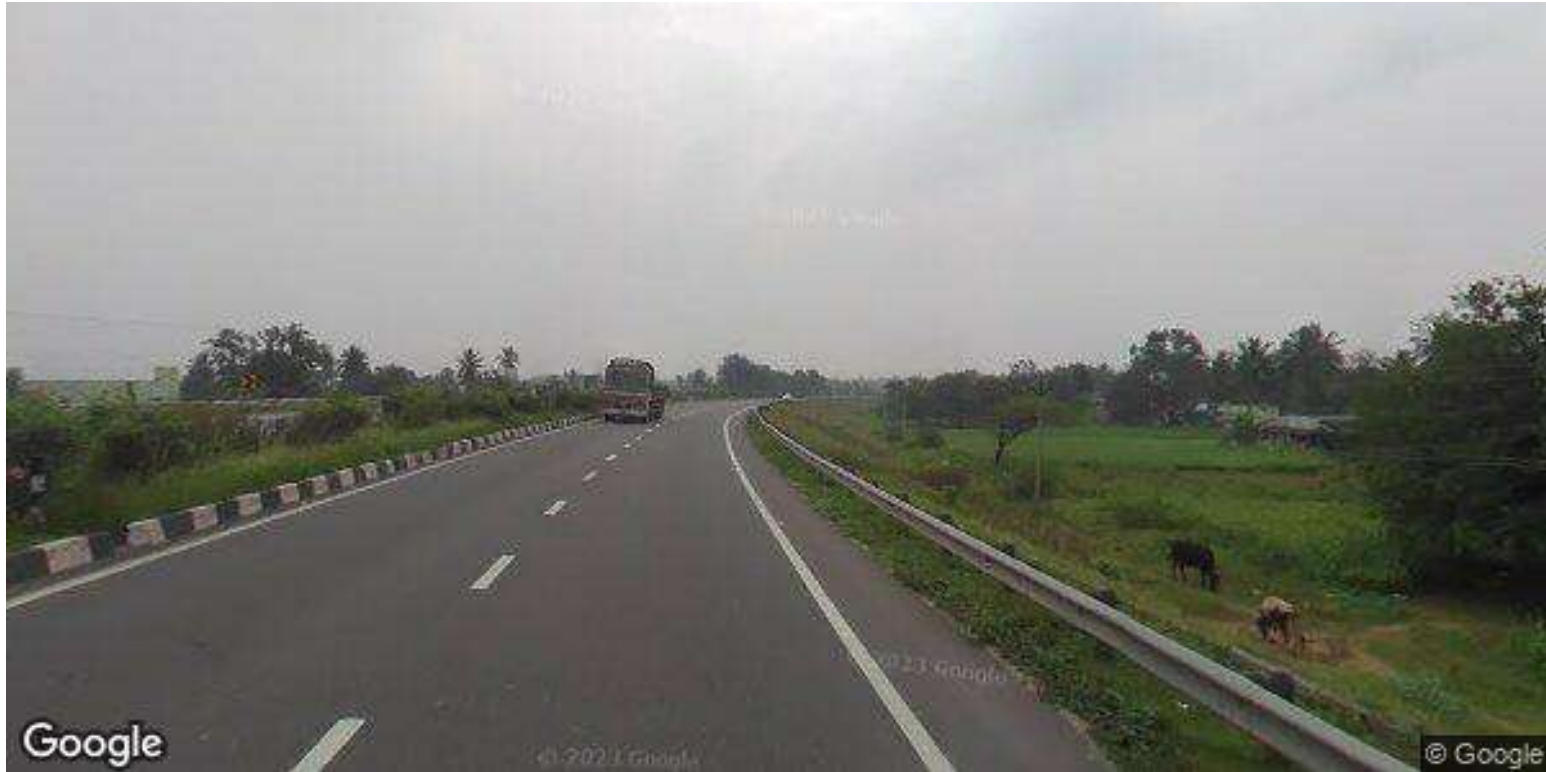
**Risk Type:** Turn  
**Risk Level:** Medium  
**Speed Limit:** 30 KM/Hr  
**Coordinates:** 12.25411, 78.20024

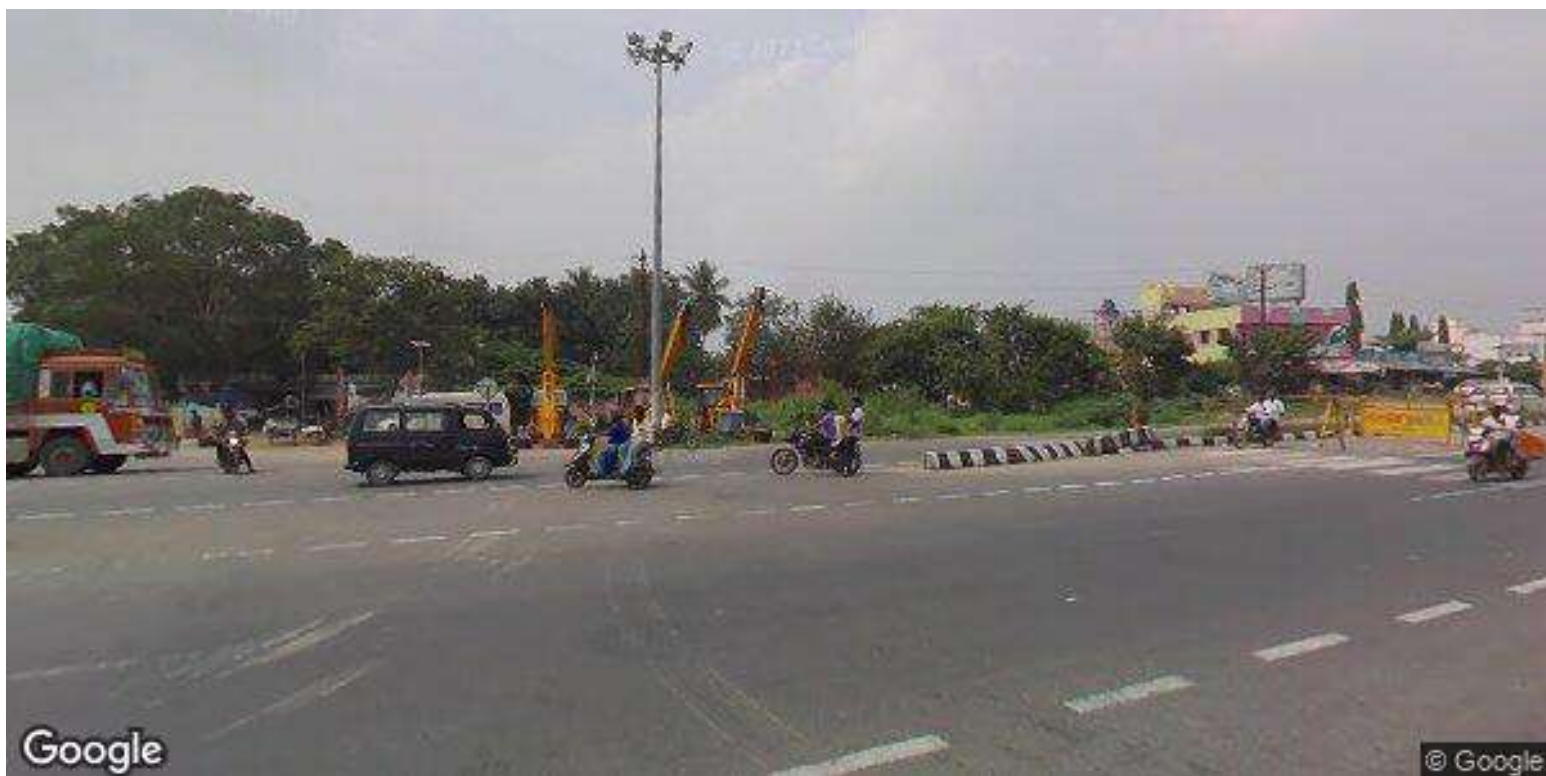
**Risk Type:** Turn  
**Risk Level:** High  
**Speed Limit:** 15 KM/Hr  
**Coordinates:** 12.31467, 78.20768

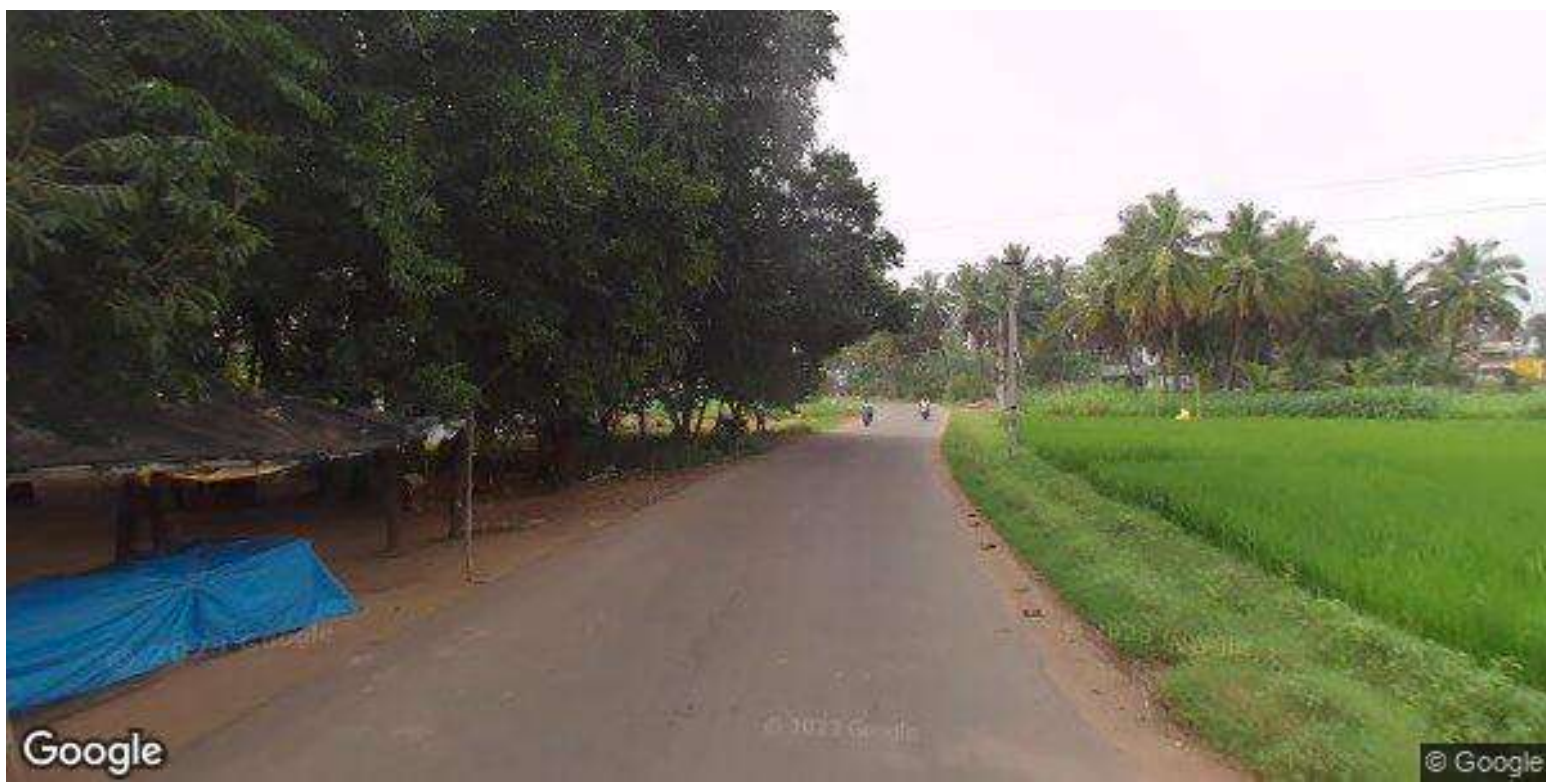
**Coordinates:** 12.31791, 78.21461

**Risk Type:** Turn

**Risk Level:** Medium

**Speed Limit:** 30 KM/Hr

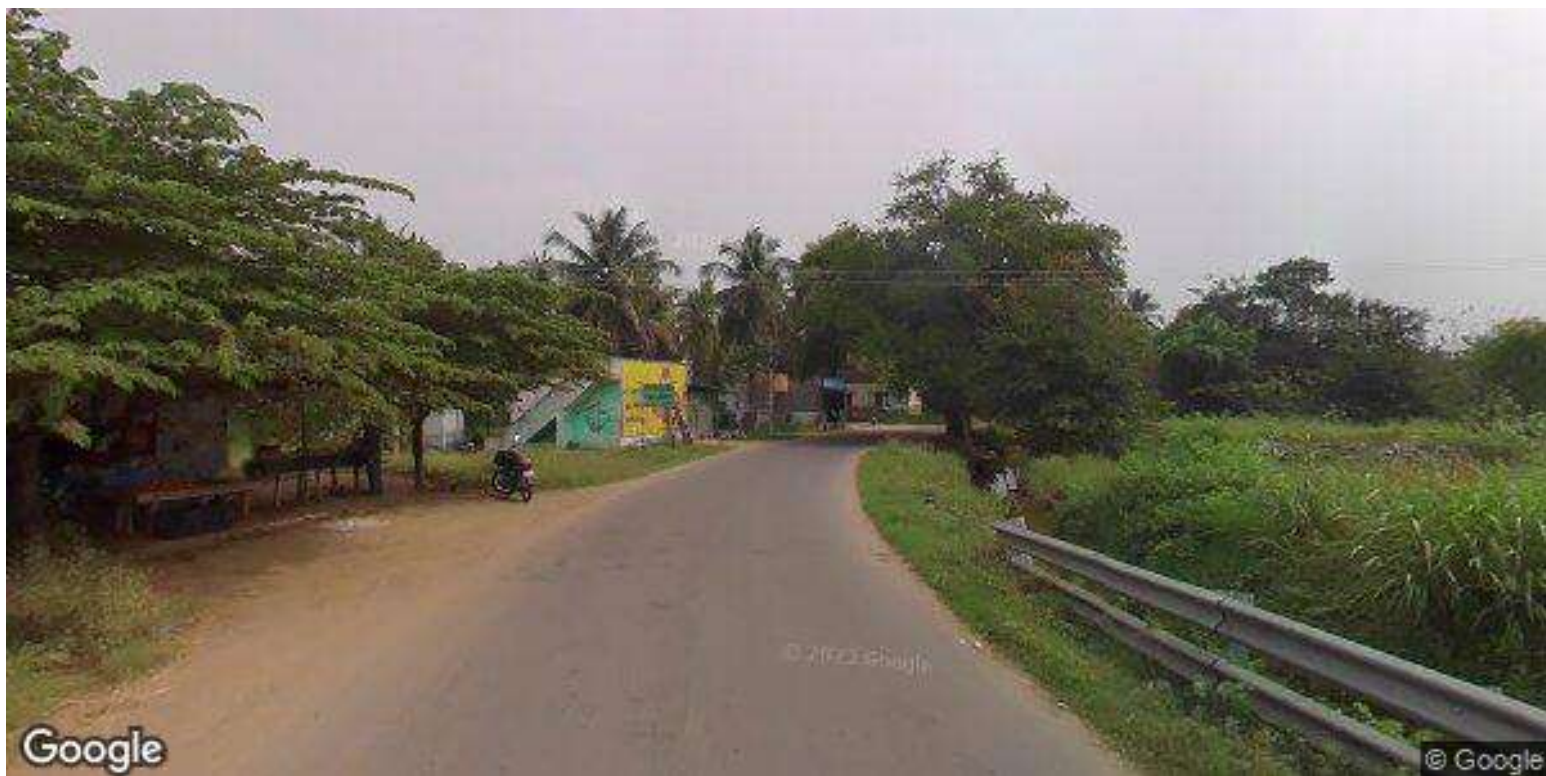
**Coordinates:** 12.31908, 78.21586

**Risk Type:** Turn

**Risk Level:** High

**Speed Limit:** 15 KM/Hr

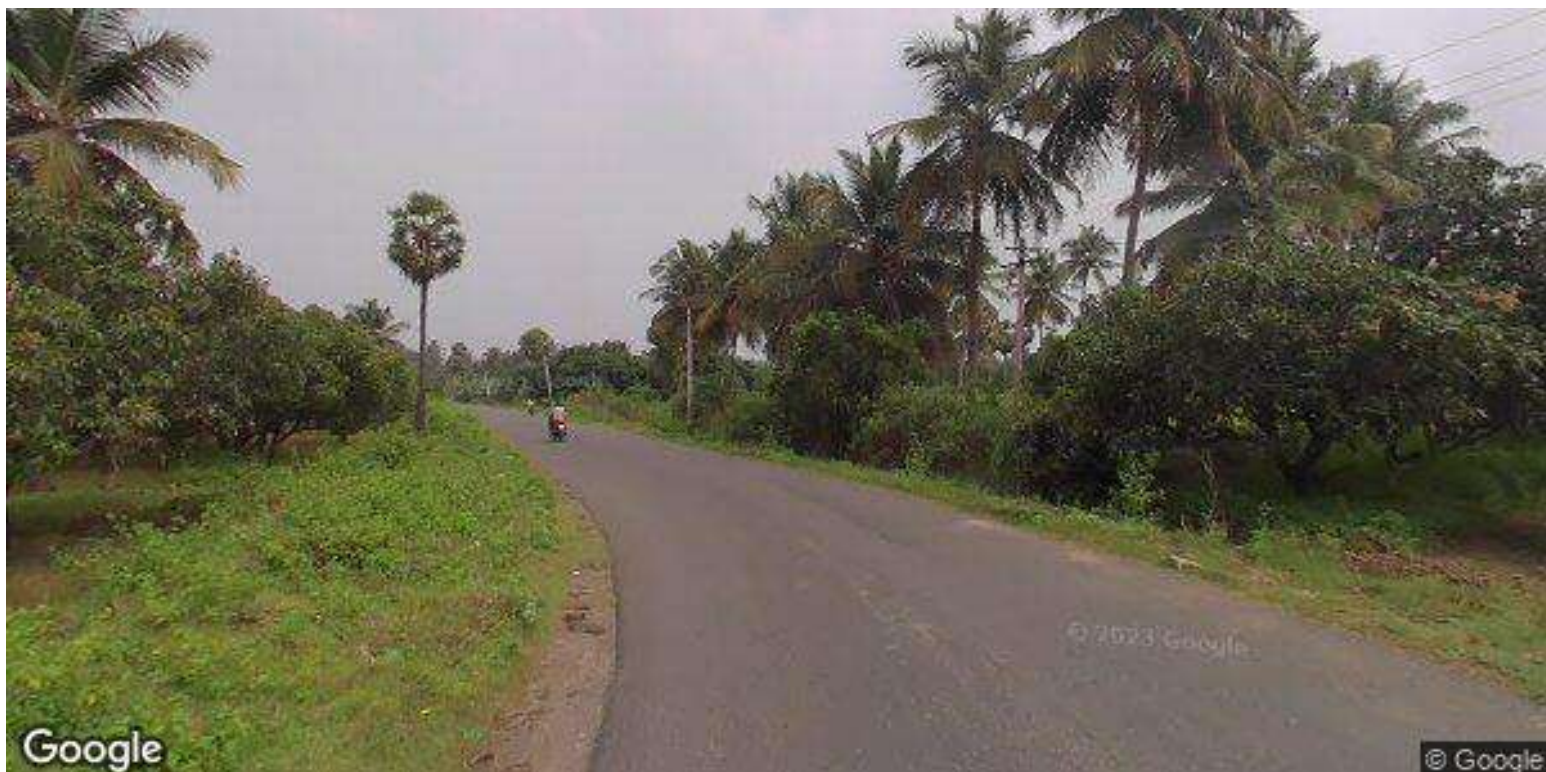
**Coordinates:** 12.32377, 78.24215

**Risk Type:** Turn

**Risk Level:** High

**Speed Limit:** 15 KM/Hr

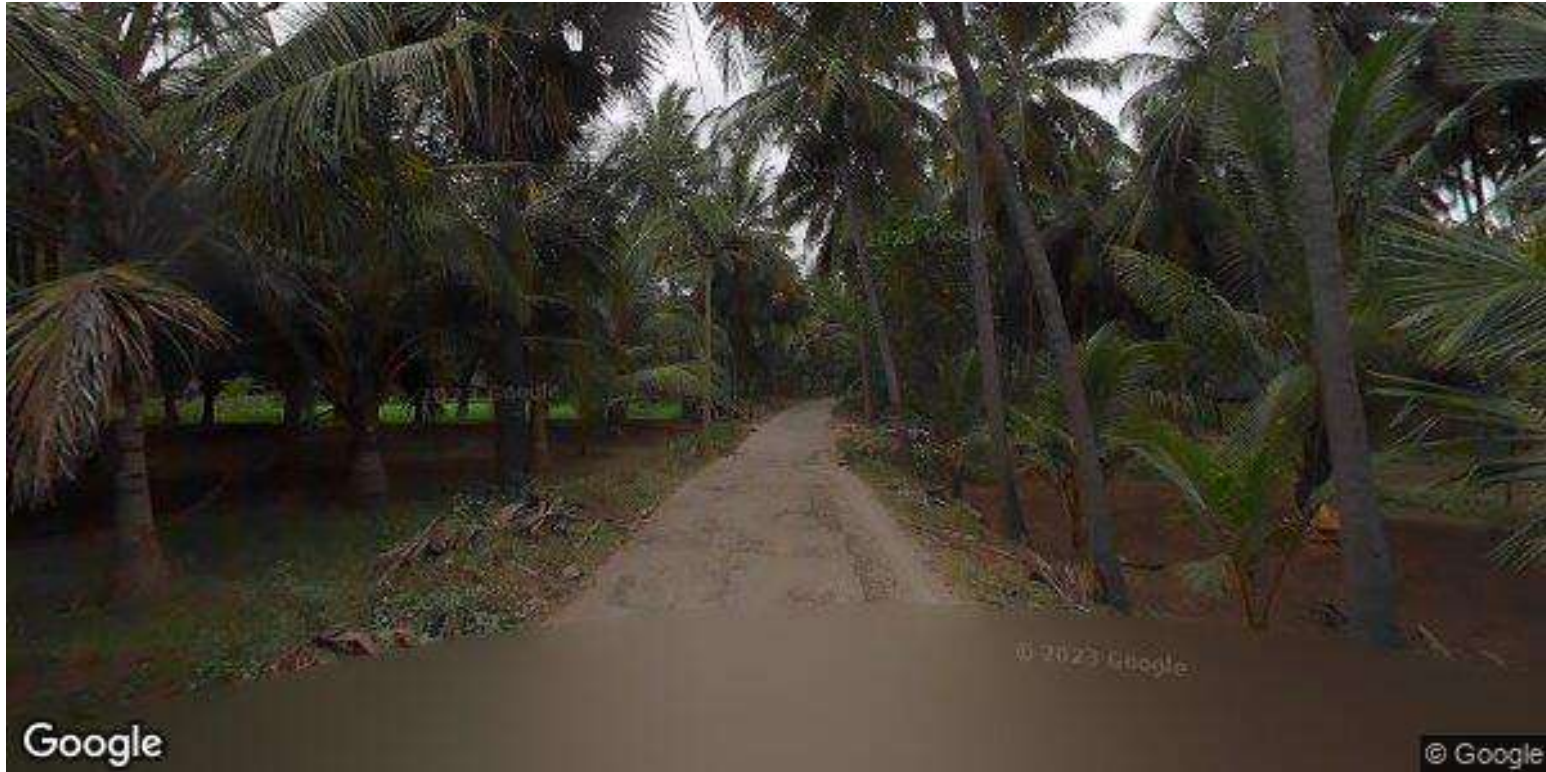
**Coordinates:** 12.35207, 78.27707

**Risk Type:** Turn

**Risk Level:** Medium

**Speed Limit:** 30 KM/Hr

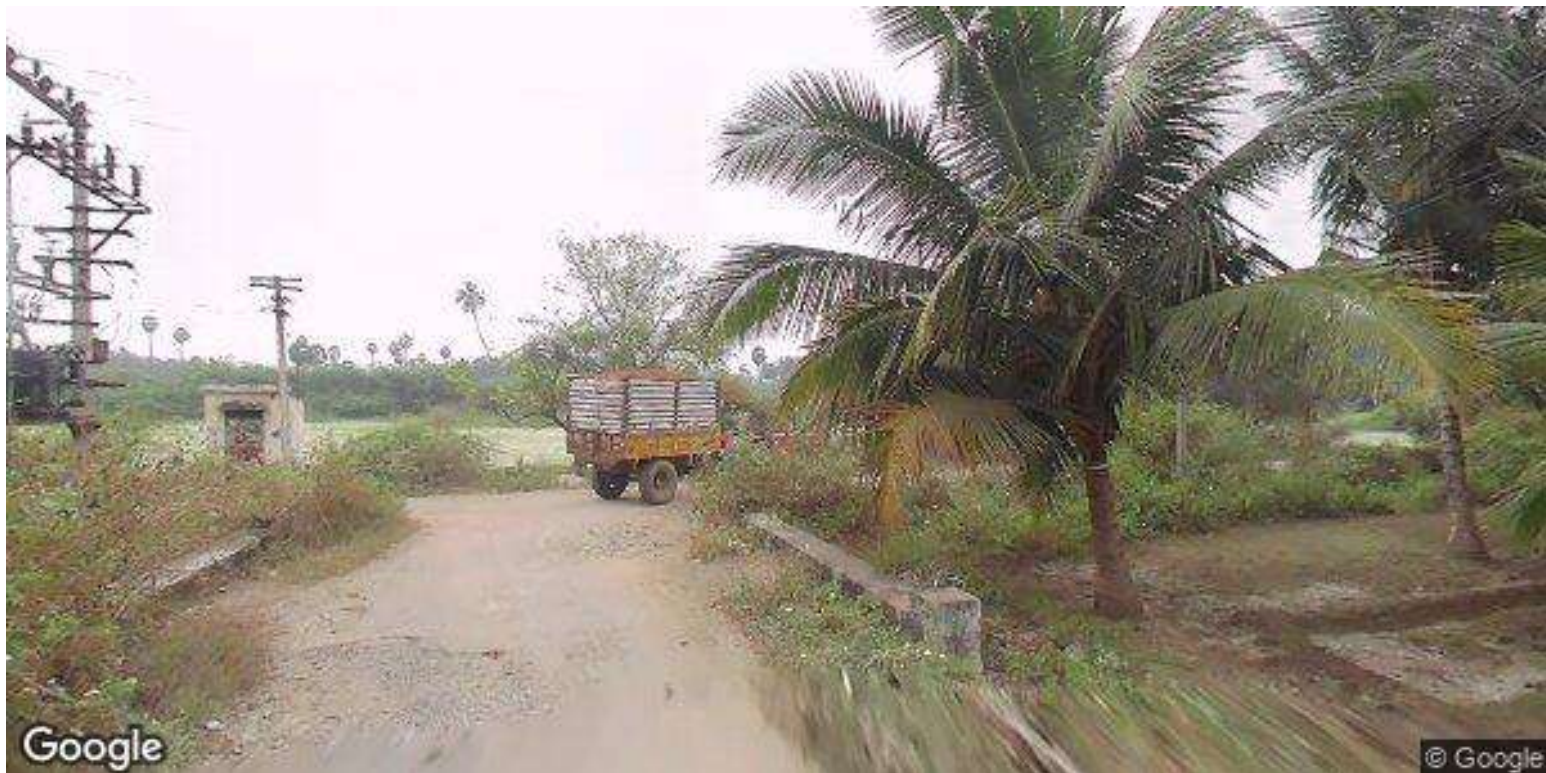
**Coordinates:** 12.35220, 78.27673

**Risk Type:** Turn

**Risk Level:** Medium

**Speed Limit:** 30 KM/Hr

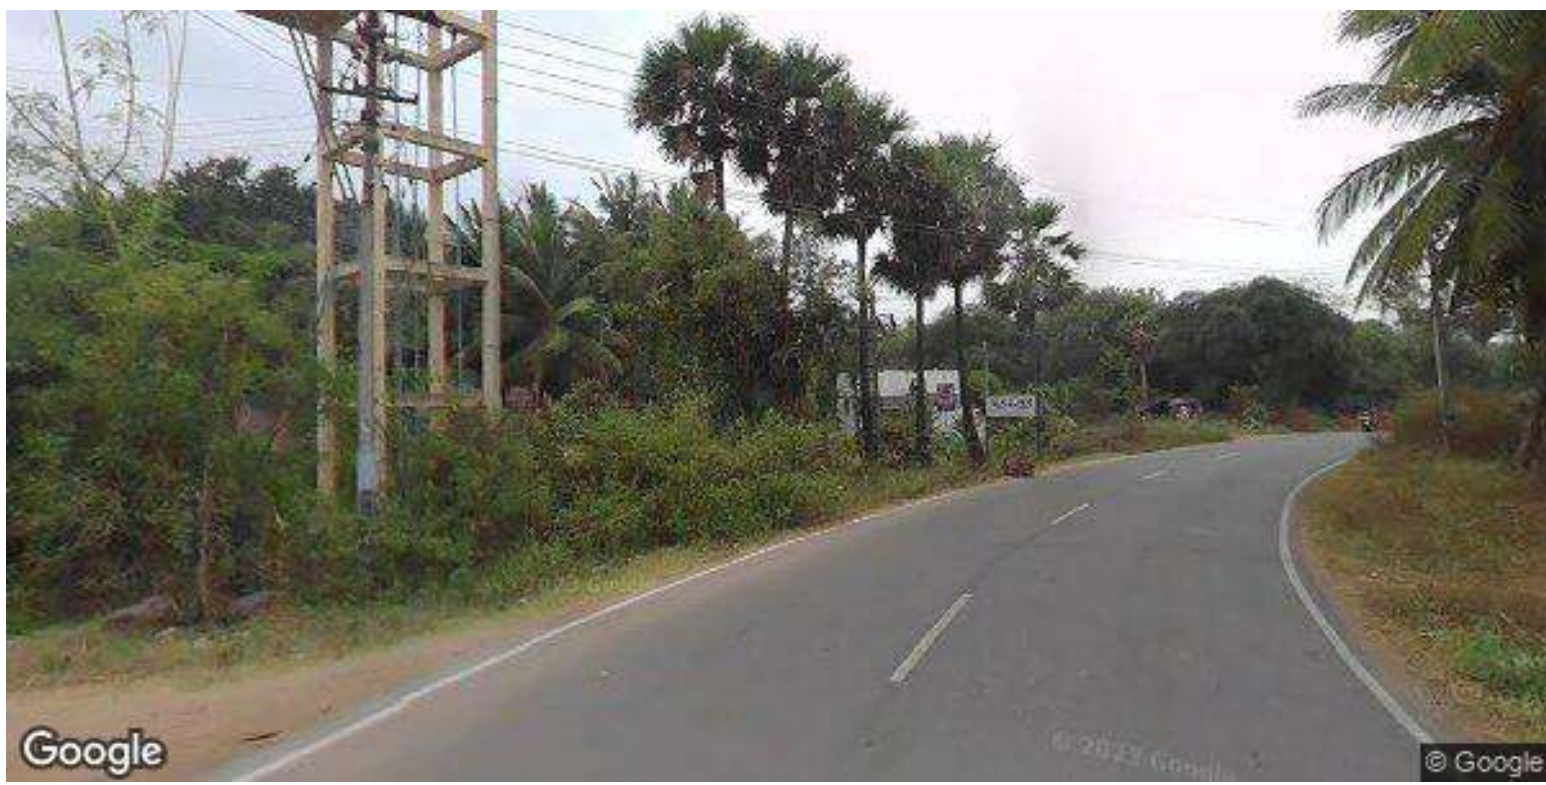
**Coordinates:** 12.35636, 78.27477

**Risk Type:** Turn

**Risk Level:** Medium

**Speed Limit:** 30 KM/Hr
