# IndianOil

## JOURNEY RISK MANAGEMENT (JRM) STUDY

### Salem Terminal TO SRI NAVAMANI FUELS

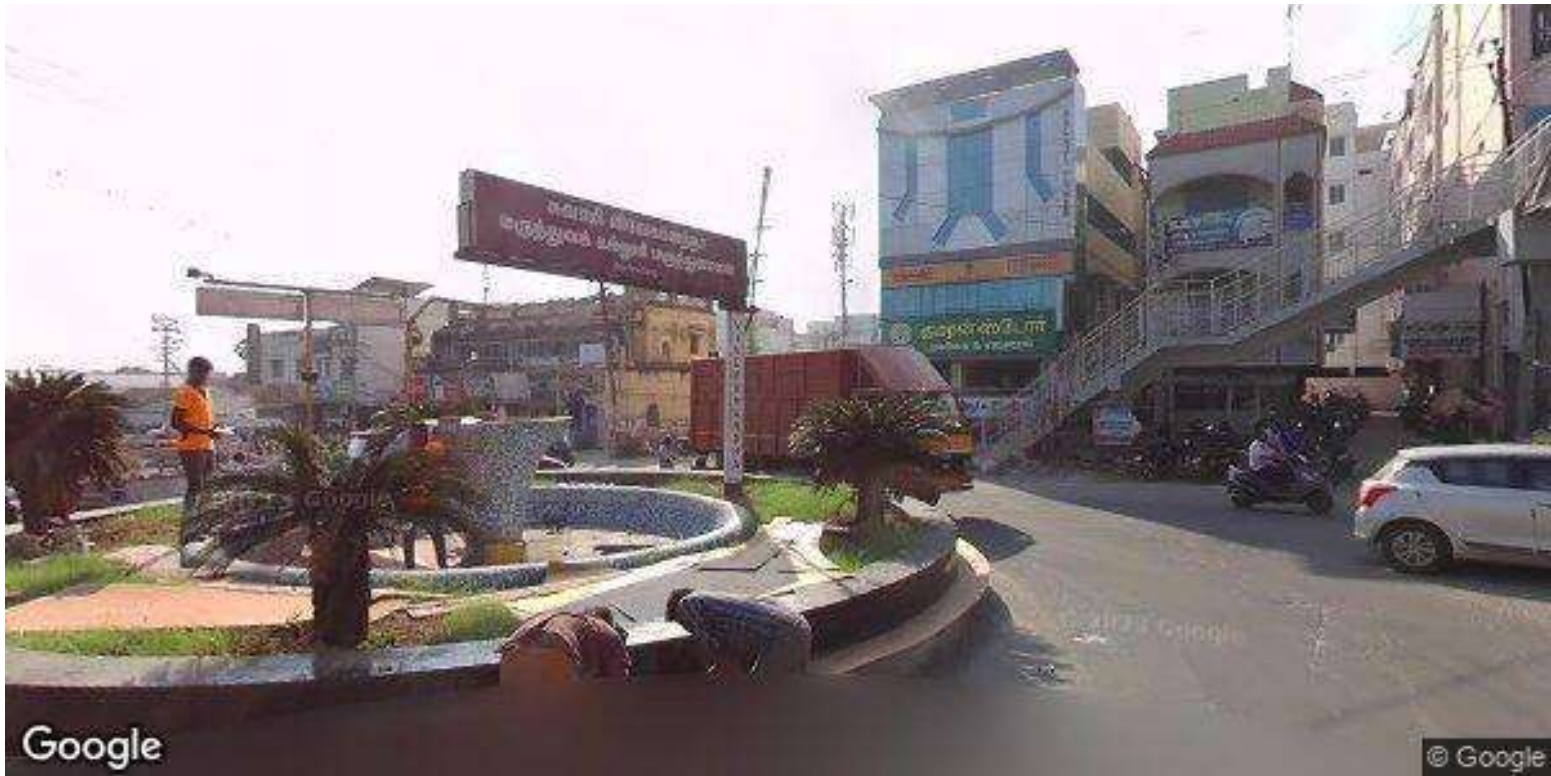
Risk Type: Roundabout  
Risk Level: High  
Speed Limit: 15 KM/Hr  
Coordinates: 11.38395, 77.89480

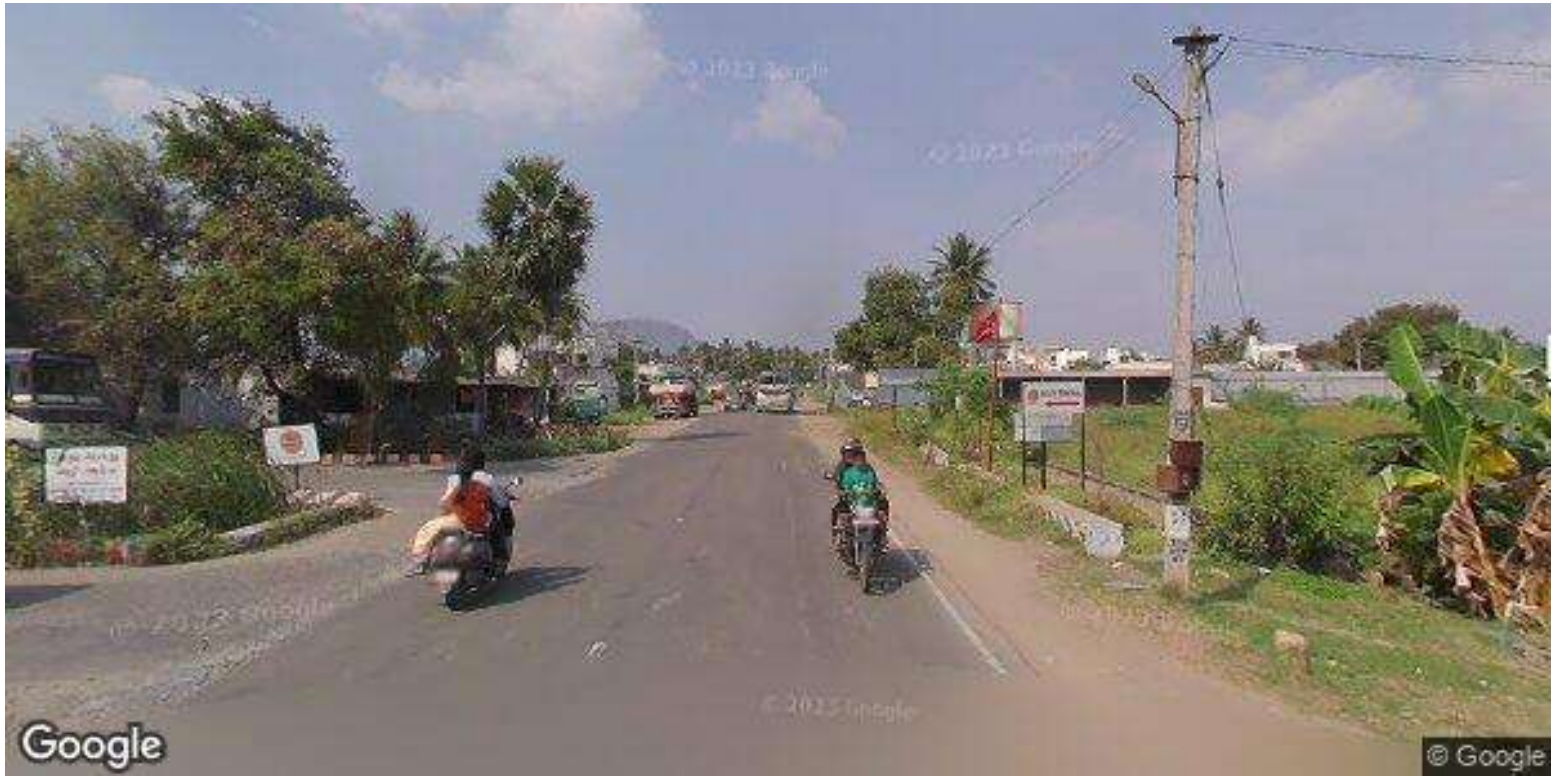
**Risk Type:** Turn  
**Risk Level:** High  
**Speed Limit:** 15 KM/Hr  
**Coordinates:** 11.44019, 77.87547

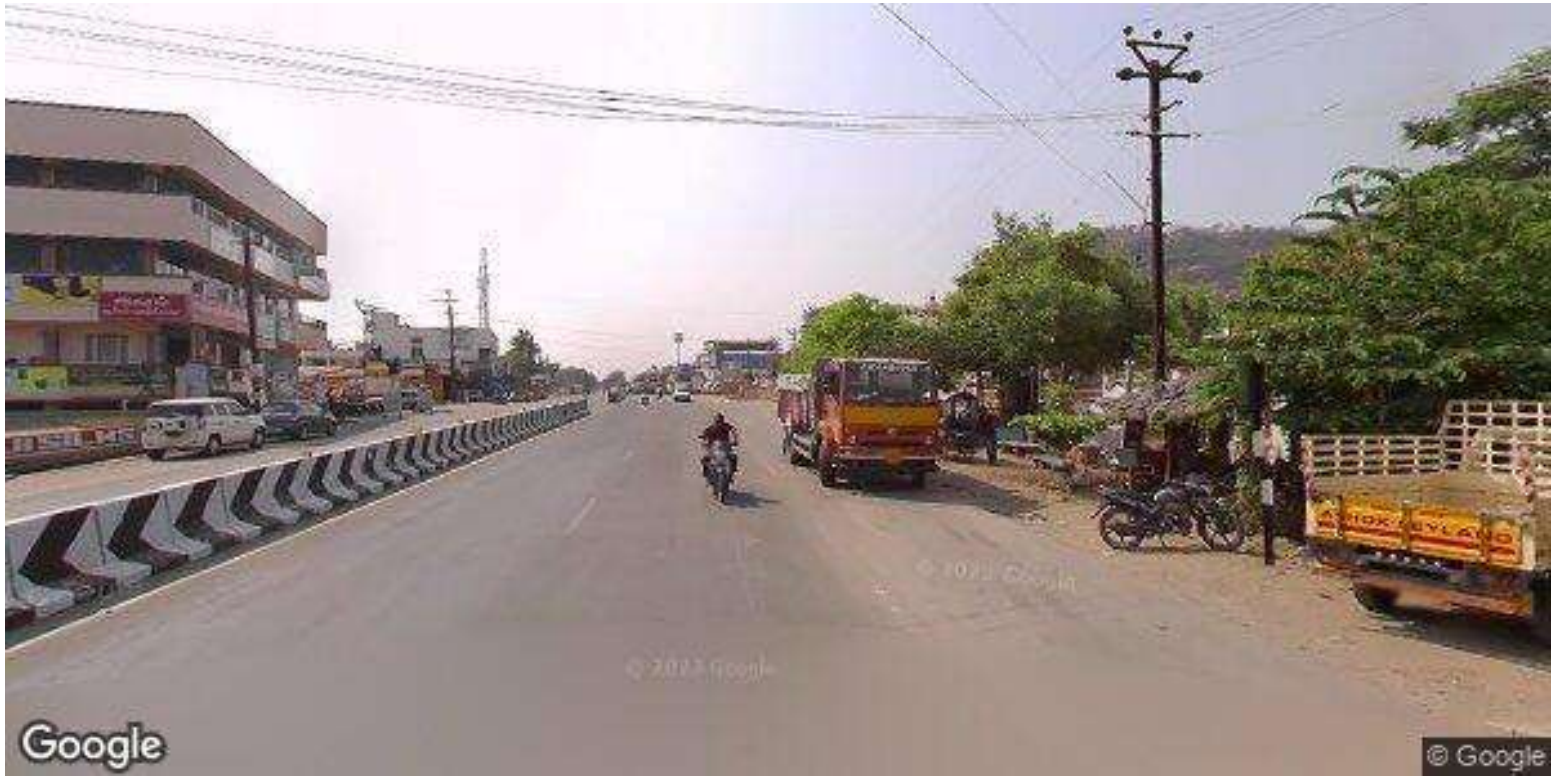
**Risk Type:** Turn  
**Risk Level:** Medium  
**Speed Limit:** 30 KM/Hr  
**Coordinates:** 11.39685, 77.88861

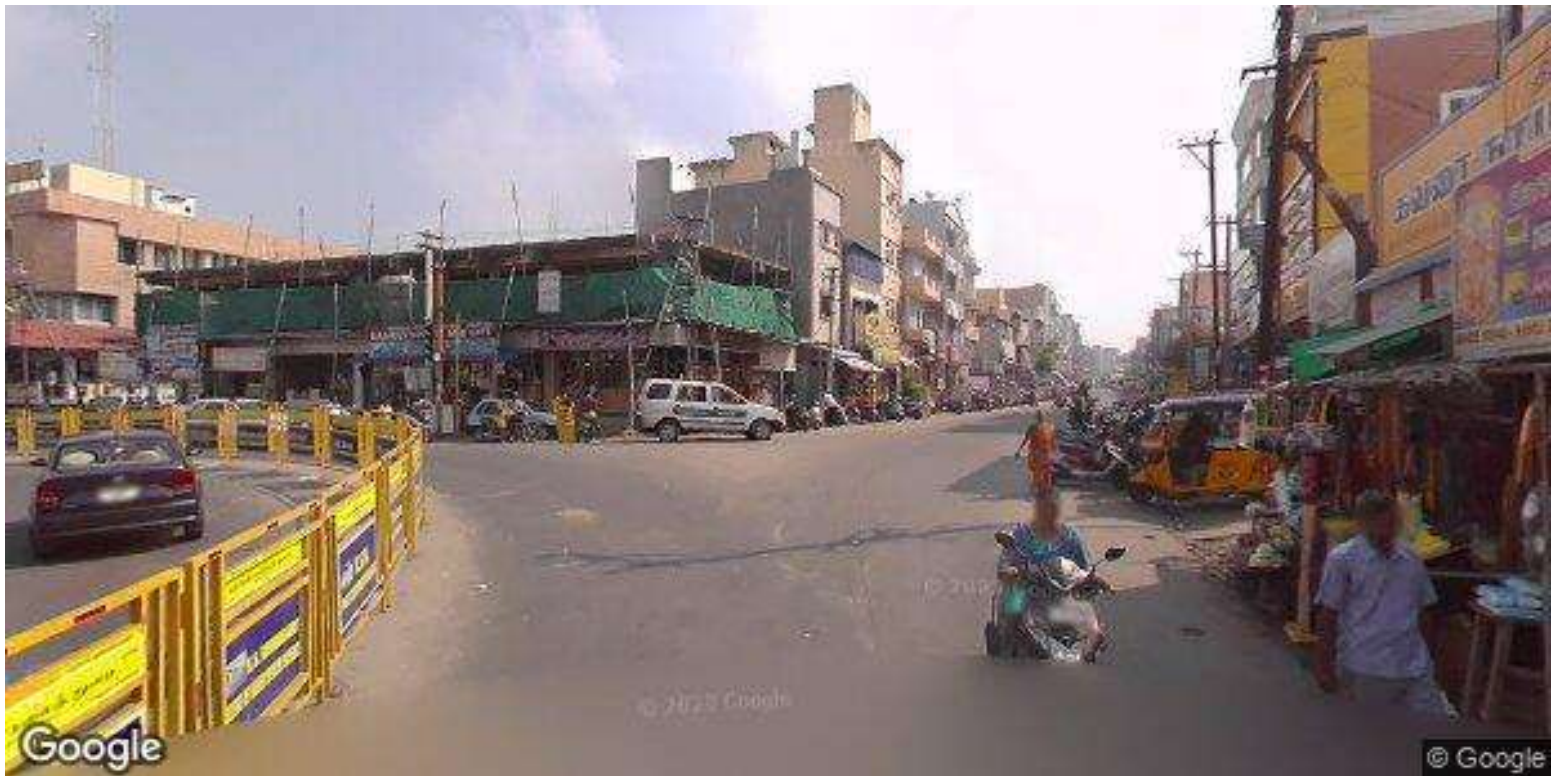
**Risk Type:** Turn  
**Risk Level:** High  
**Speed Limit:** 15 KM/Hr  
**Coordinates:** 11.37862, 77.89488

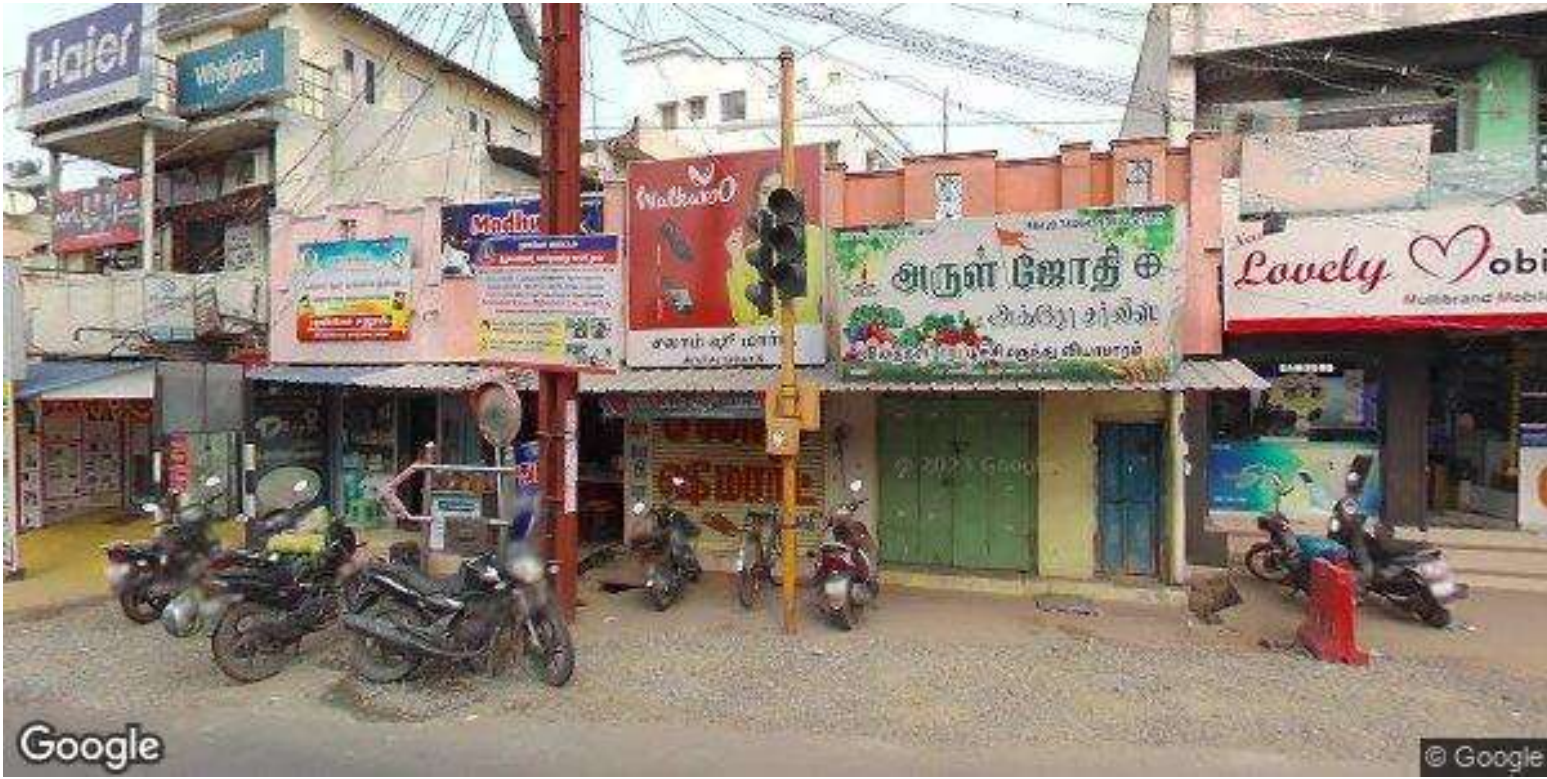
Risk Type: Turn  
Risk Level: High  
Speed Limit: 15 KM/Hr  
Coordinates: 11.37850, 77.89453

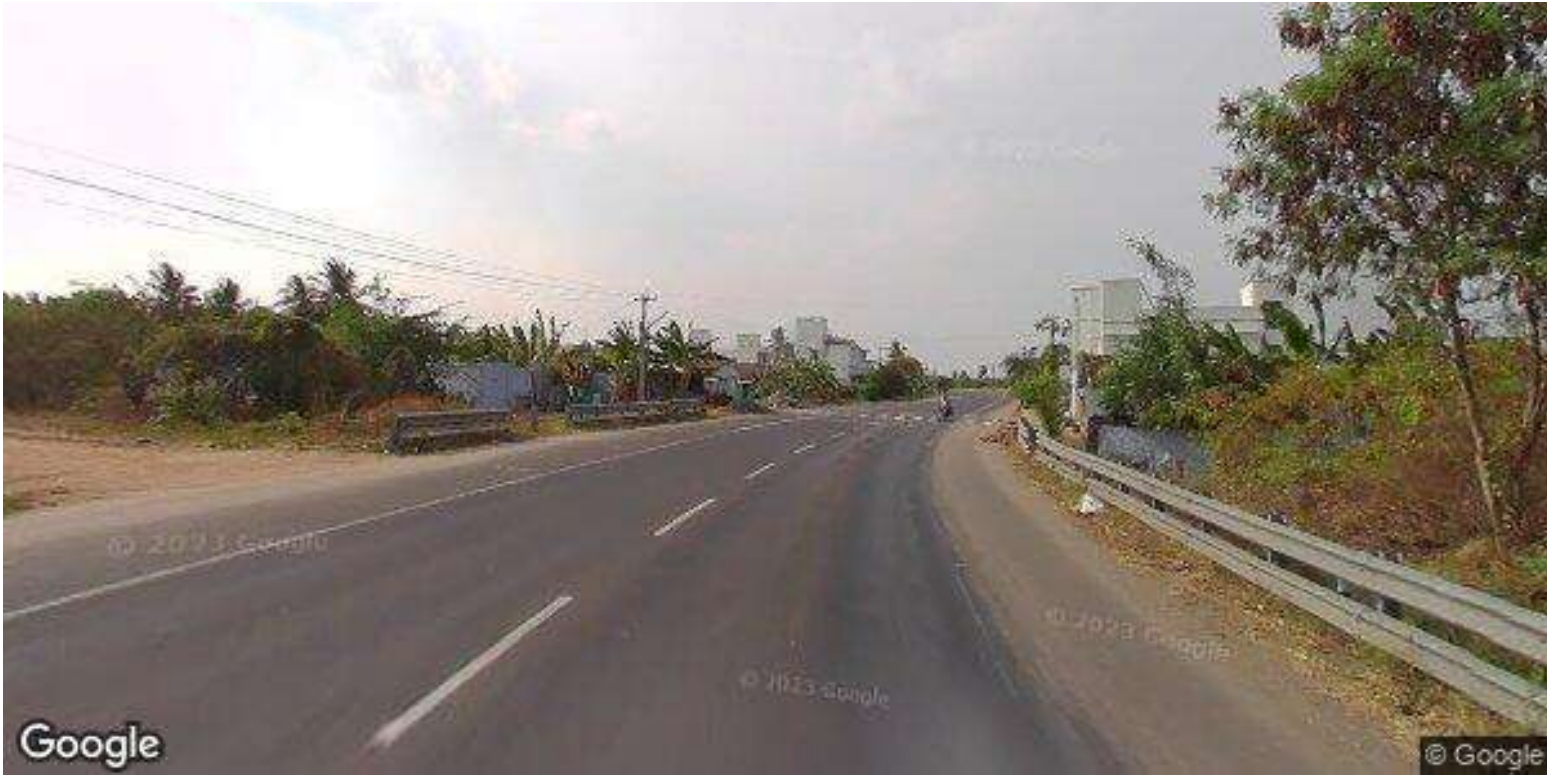
Risk Type: Turn  
Risk Level: Medium  
Speed Limit: 30 KM/Hr  
Coordinates: 11.16764, 78.01565

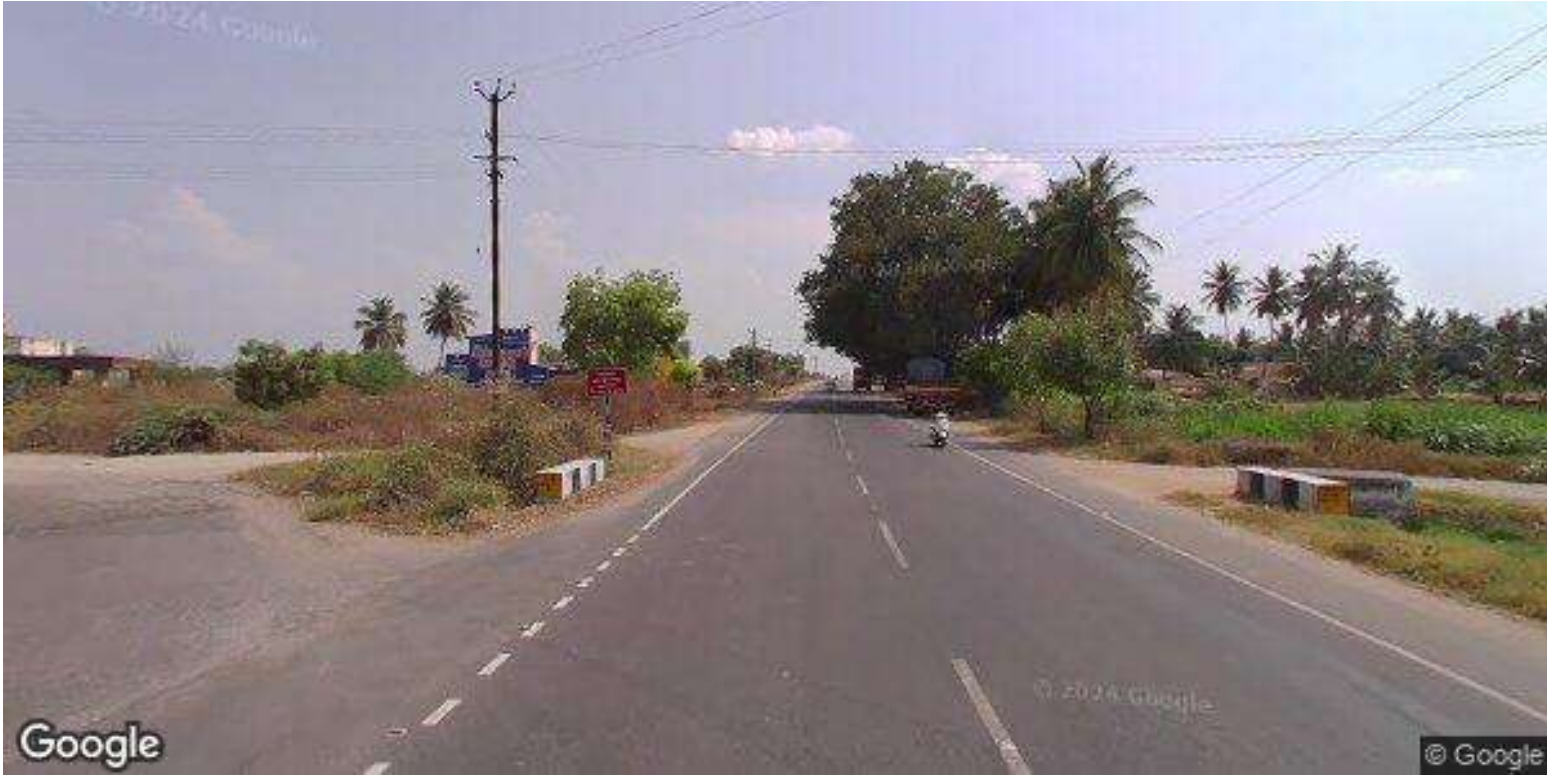
**Risk Type:** Turn  
**Risk Level:** High  
**Speed Limit:** 15 KM/Hr  
**Coordinates:** 11.14545, 78.02208

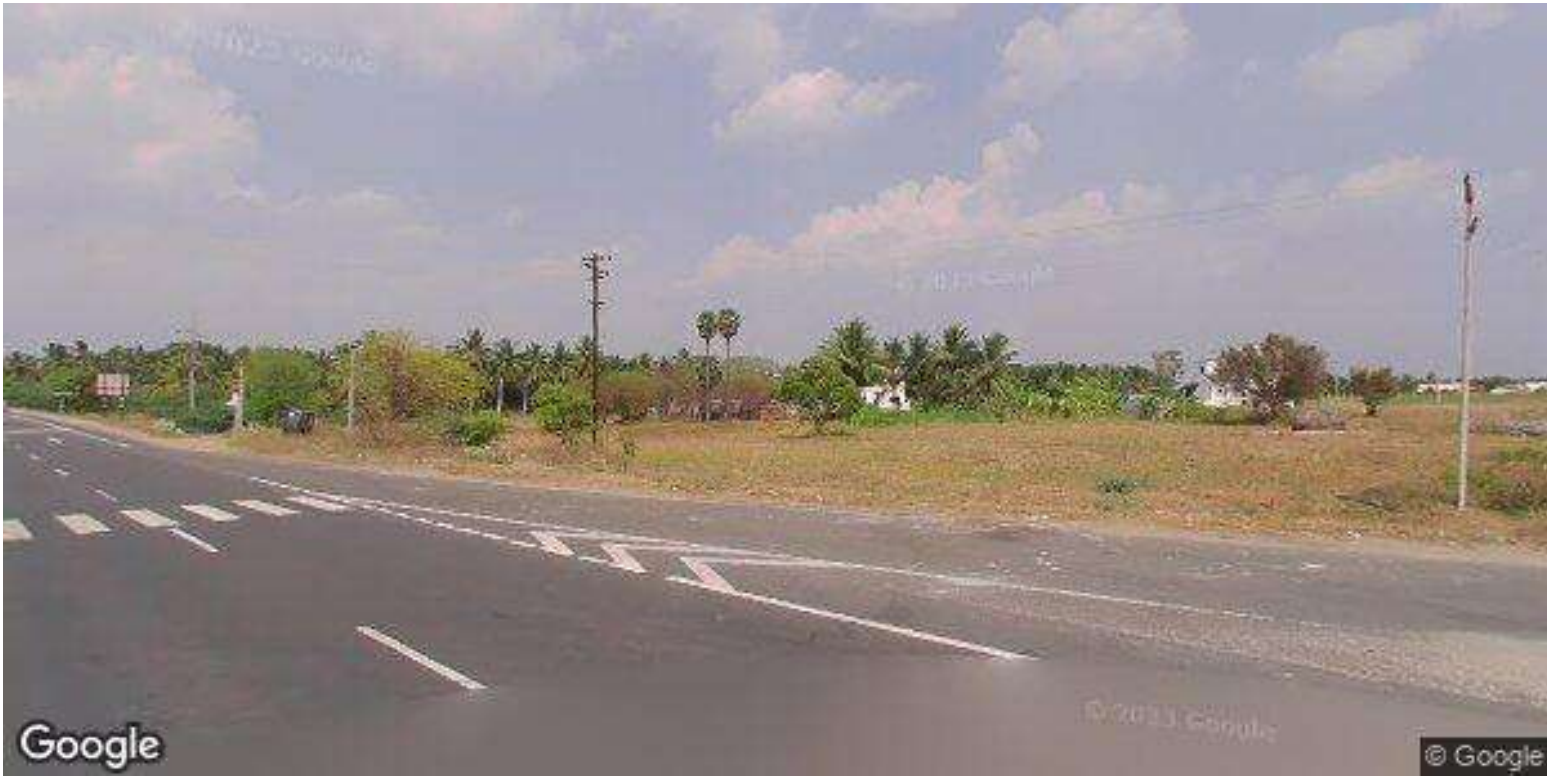
**Risk Type:** Turn  
**Risk Level:** High  
**Speed Limit:** 15 KM/Hr  
**Coordinates:** 11.14480, 78.02291

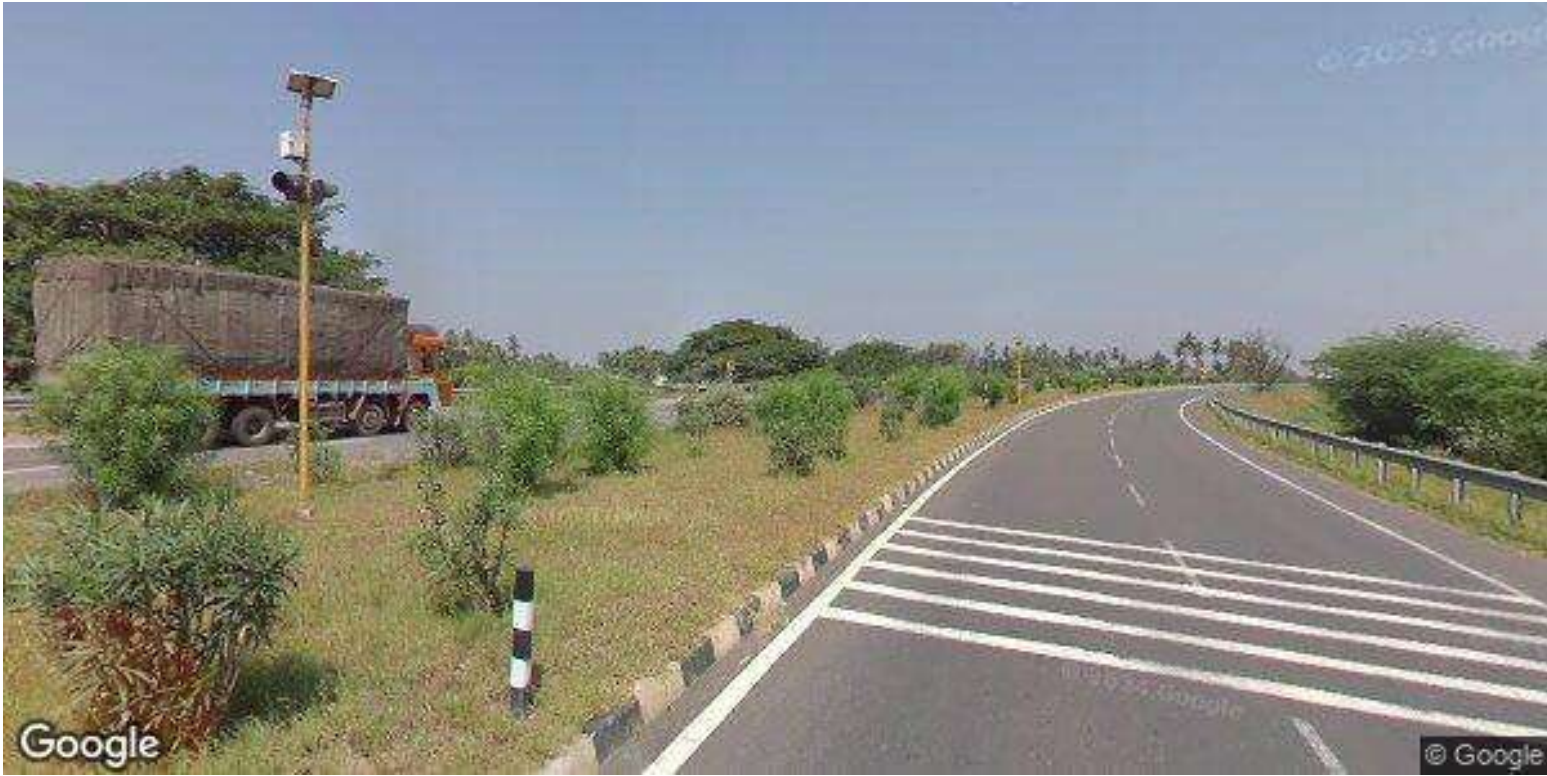
**Risk Type:** Turn  
**Risk Level:** Medium  
**Speed Limit:** 30 KM/Hr  
**Coordinates:** 11.10102, 78.00572

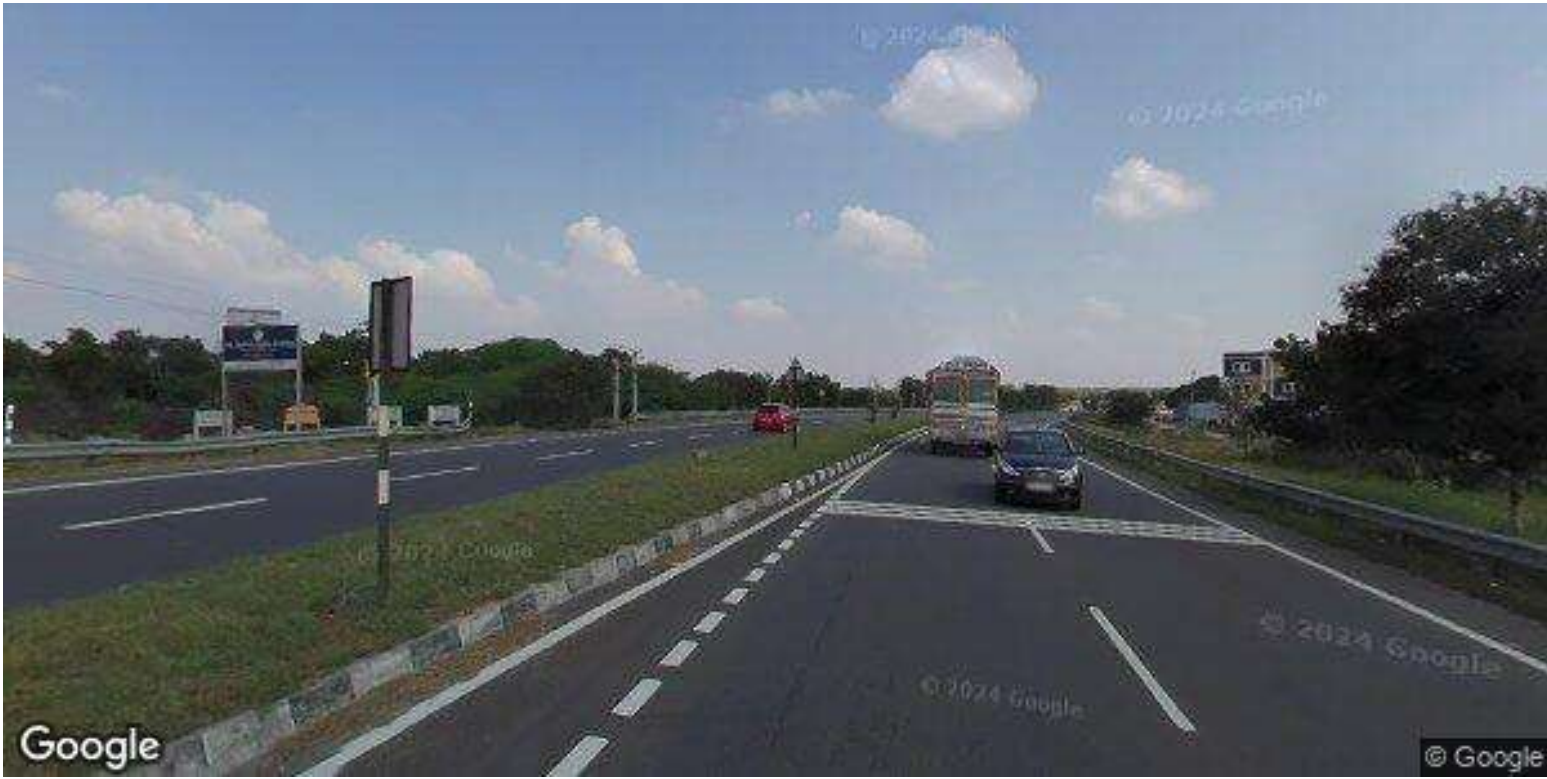
**Risk Type:** Turn  
**Risk Level:** Medium  
**Speed Limit:** 30 KM/Hr  
**Coordinates:** 10.89913, 78.03032

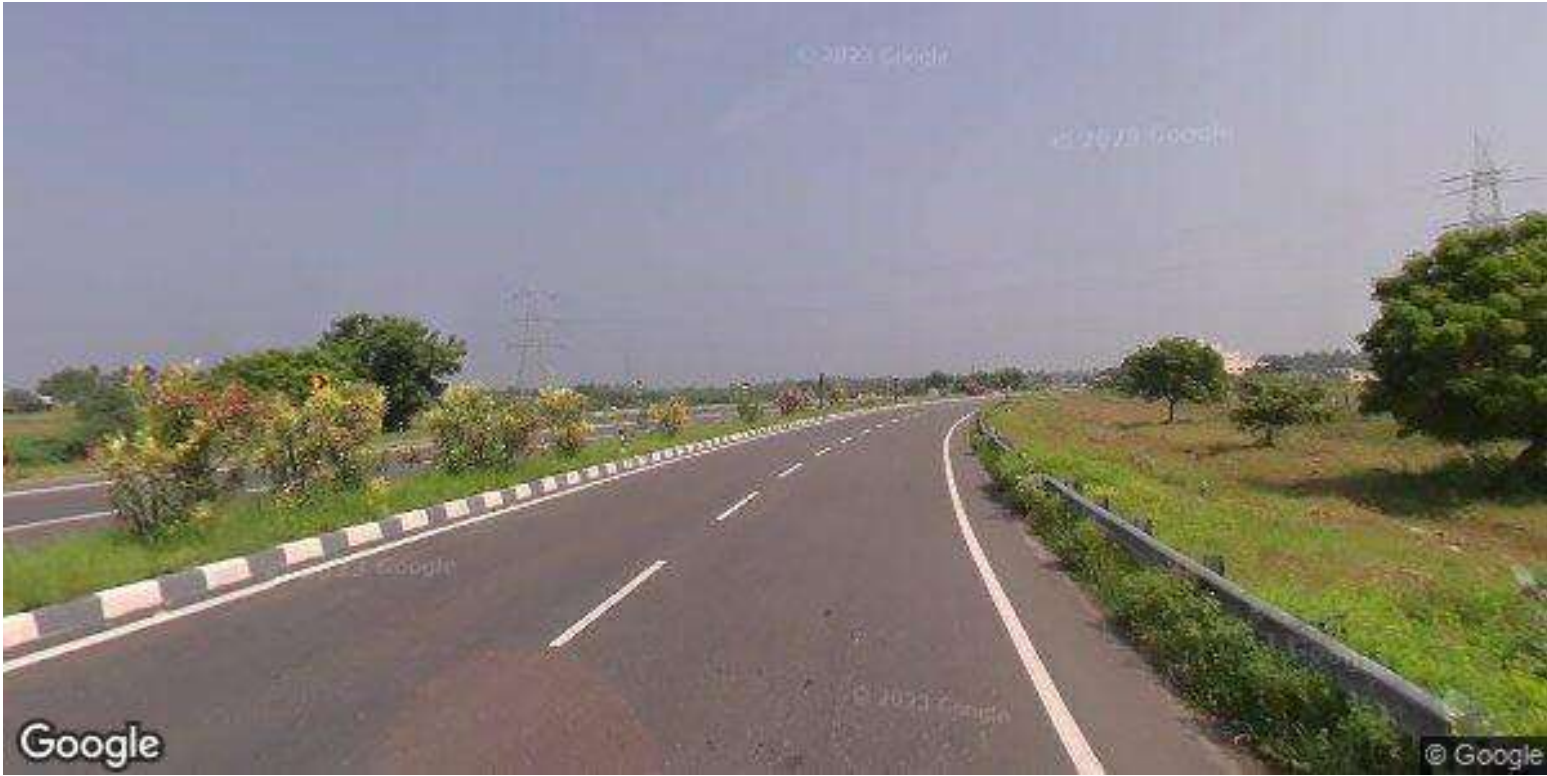
**Risk Type:** Turn  
**Risk Level:** Medium  
**Speed Limit:** 30 KM/Hr  
**Coordinates:** 10.79857, 77.92714

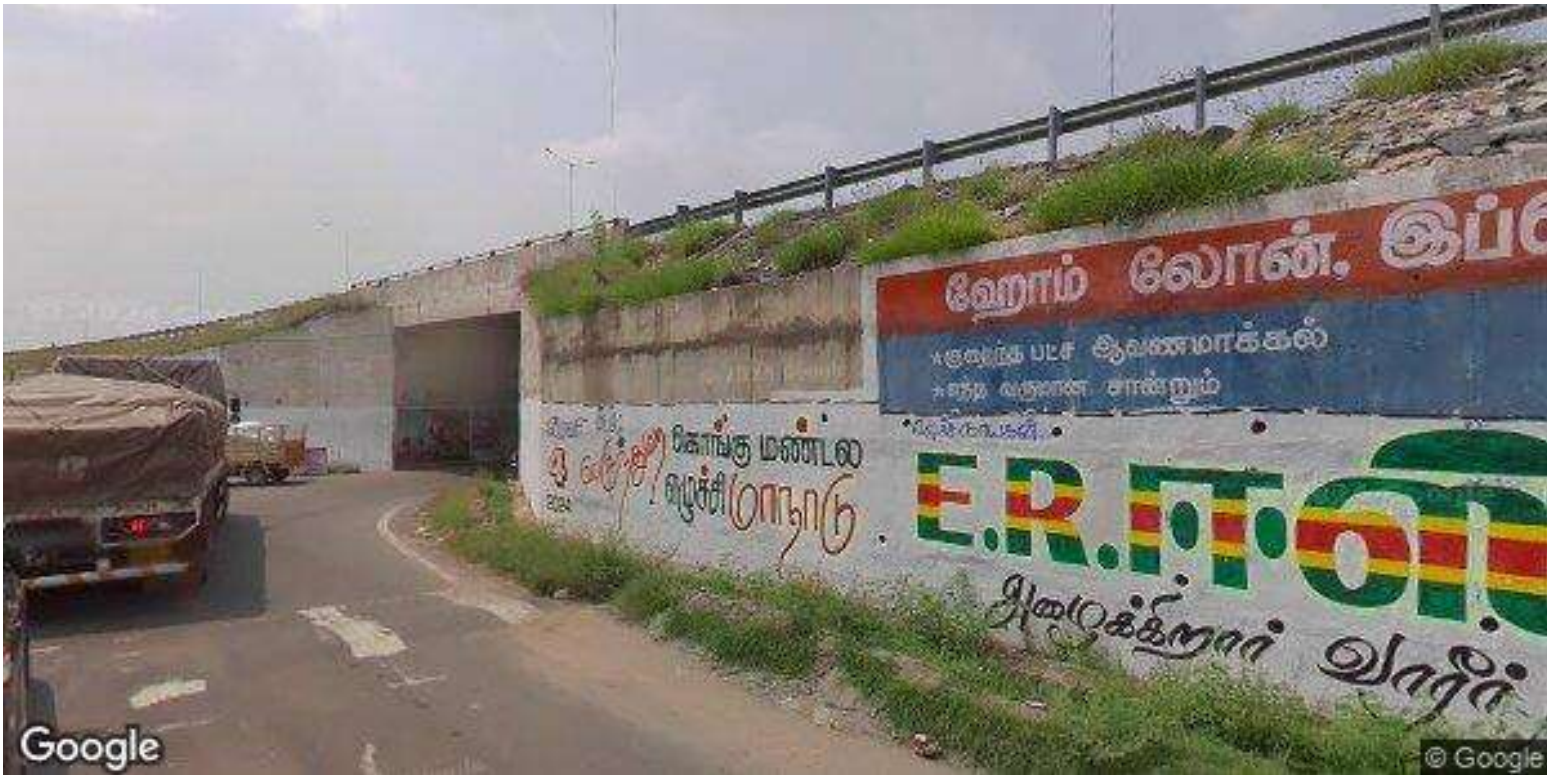
Risk Type: Turn

Risk Level: Medium

Speed Limit: 30 KM/Hr

Coordinates: 10.77148, 77.91668

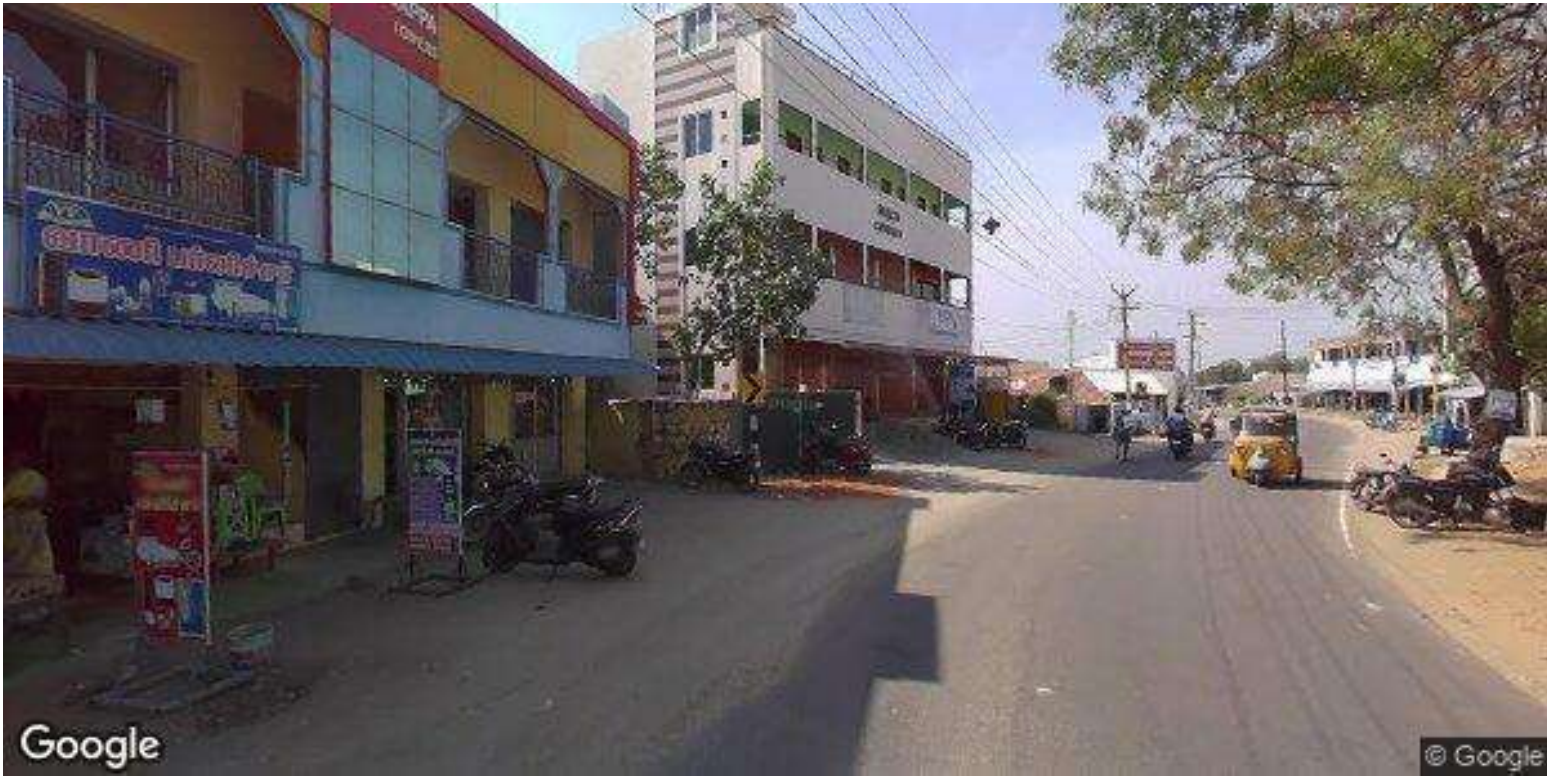
Risk Type: Turn

Risk Level: Medium

Speed Limit: 30 KM/Hr

Coordinates: 10.77216, 77.91277

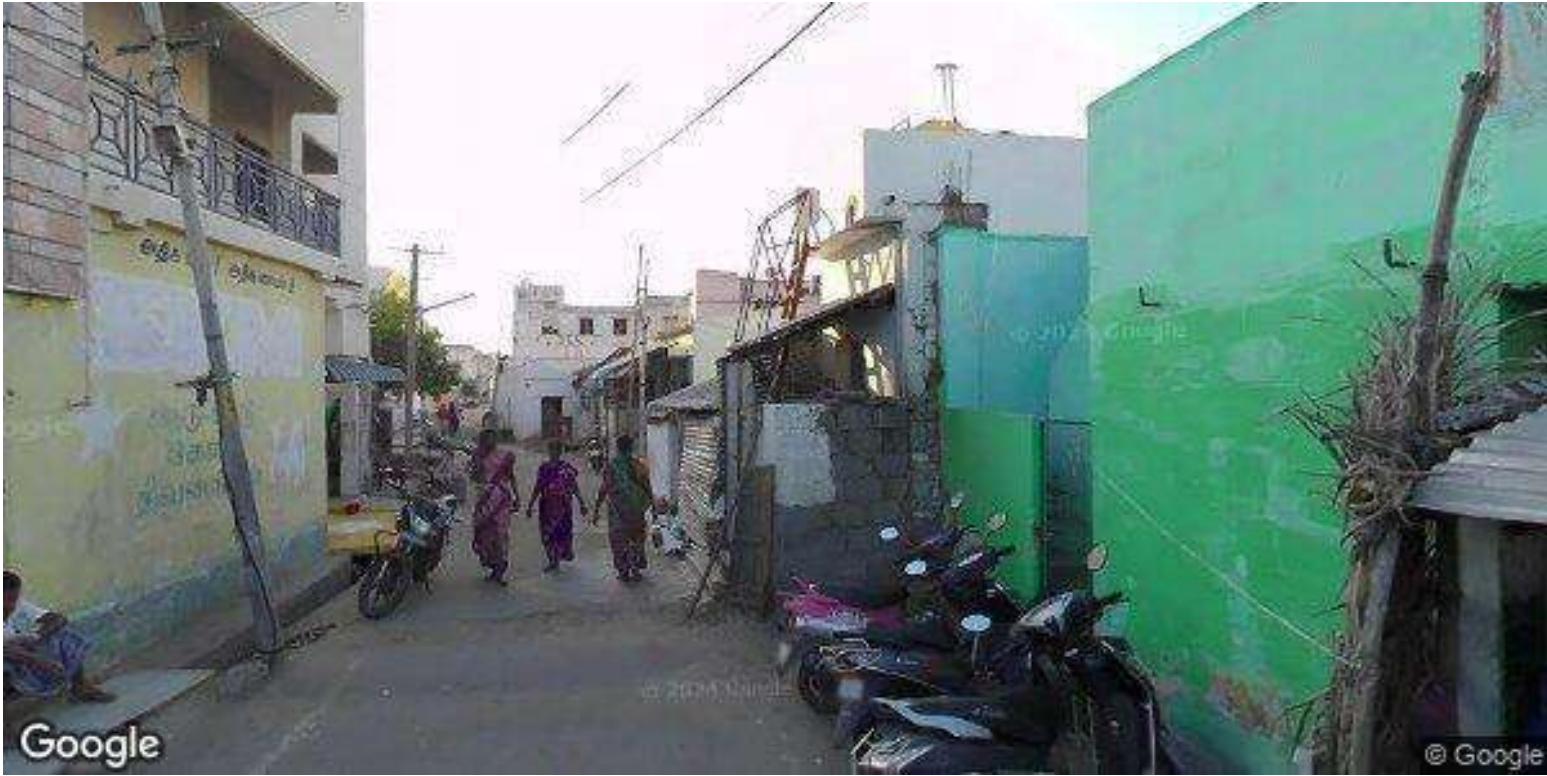
Risk Type: Turn

Risk Level: High

Speed Limit: 15 KM/Hr

Coordinates: 10.77350, 77.90980

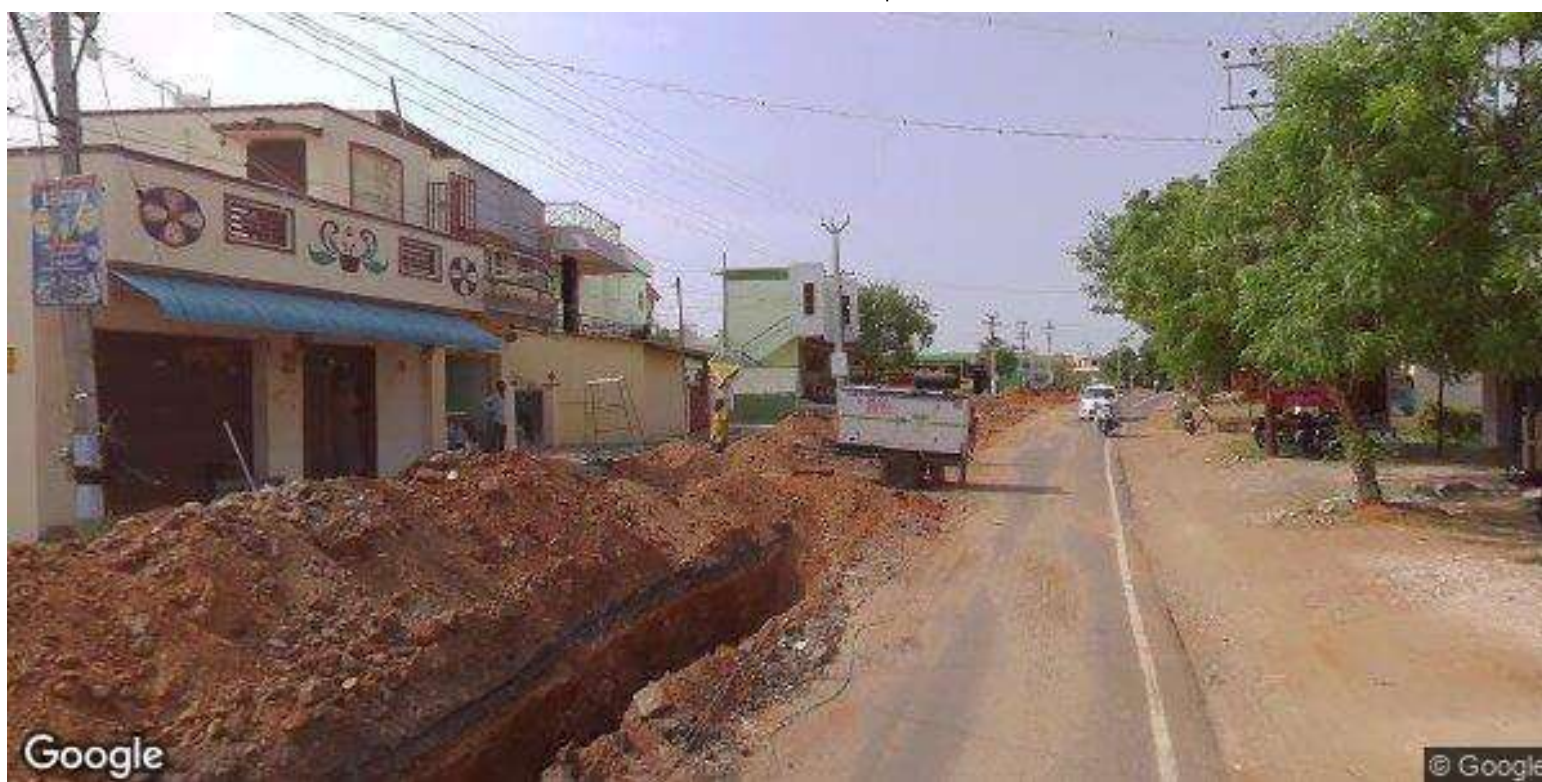
**Risk Type:** Turn

**Risk Level:** Medium

**Speed Limit:** 30 KM/Hr

**Coordinates:** 10.72943, 77.89224

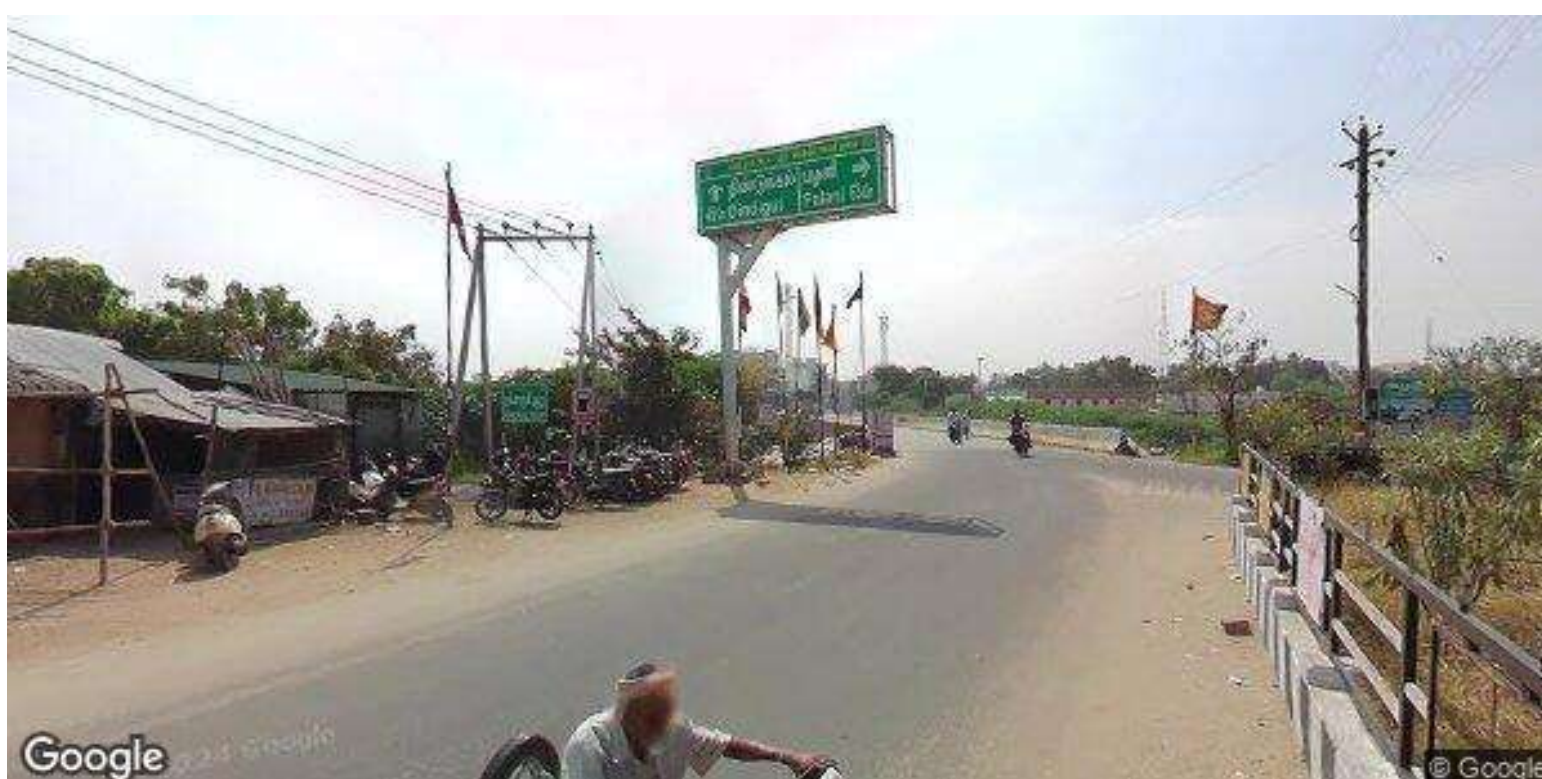
**Risk Type:** Turn

**Risk Level:** High

**Speed Limit:** 15 KM/Hr

**Coordinates:** 10.72608, 77.89166

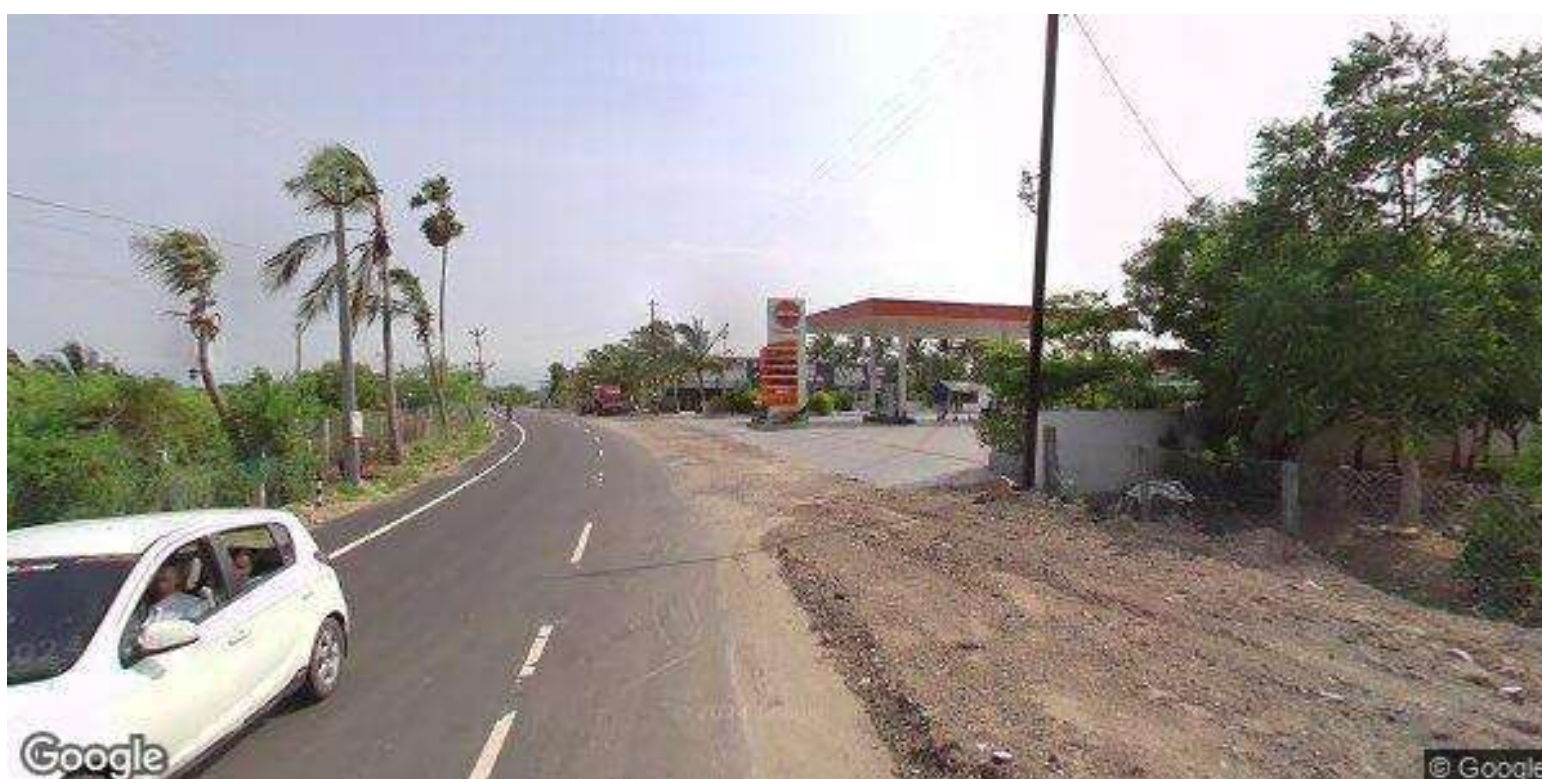
**Risk Type:** Turn

**Risk Level:** High

**Speed Limit:** 15 KM/Hr

**Coordinates:** 10.71243, 77.87776
