## JOURNEY RISK MANAGEMENT (JRM) STUDY

### Salem Terminal to VIYAN FUELS

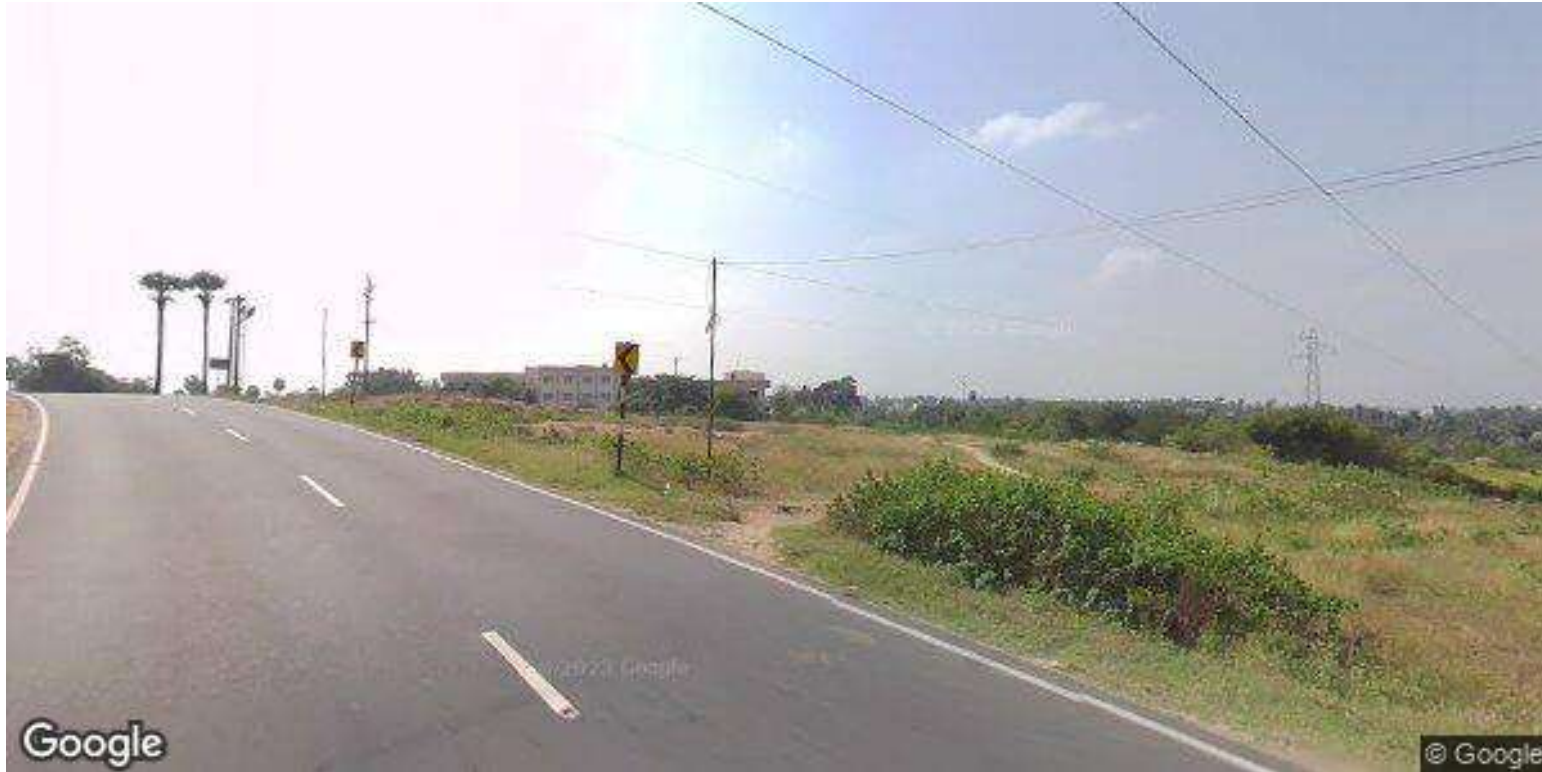
**Risk Type:** Turn  
**Risk Level:** Medium  
**Speed Limit:** 30 KM/Hr  
**Coordinates:** 11.46048, 77.85036

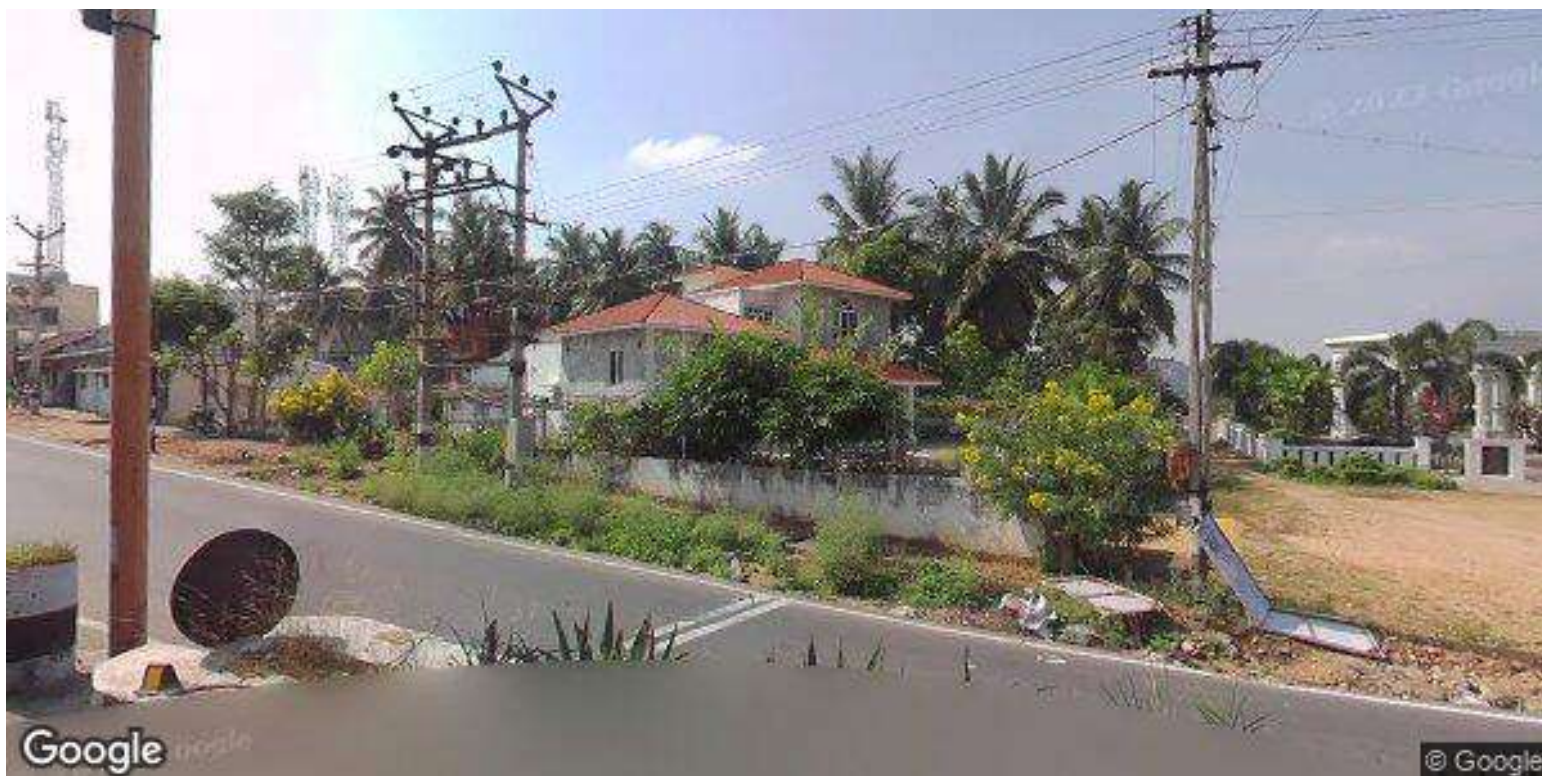
**Risk Type:** Turn  
**Risk Level:** Medium  
**Speed Limit:** 30 KM/Hr  
**Coordinates:** 11.46303, 77.84945

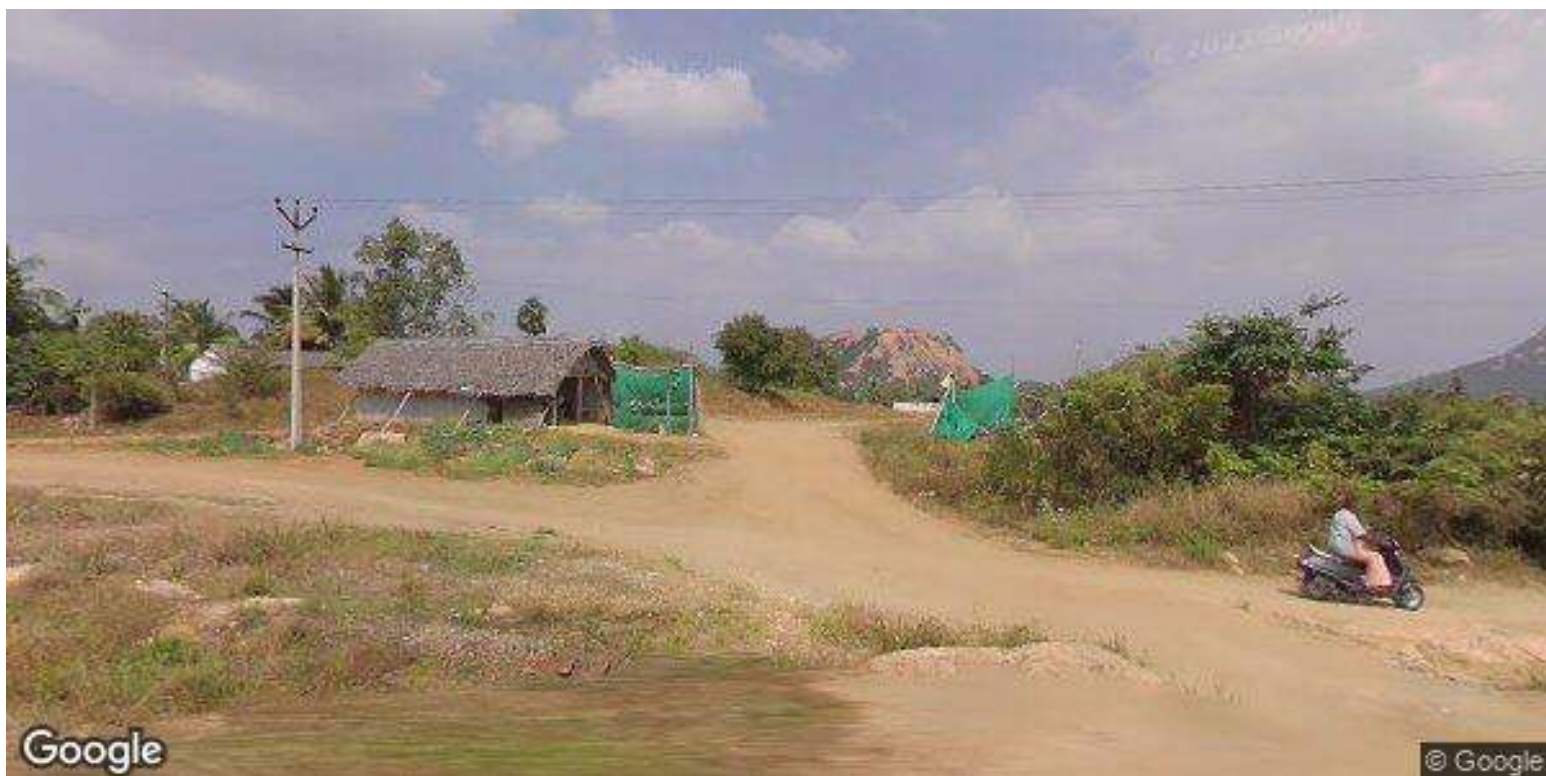
**Risk Type:** Turn  
**Risk Level:** Medium  
**Speed Limit:** 30 KM/Hr  
**Coordinates:** 11.49420, 77.88016

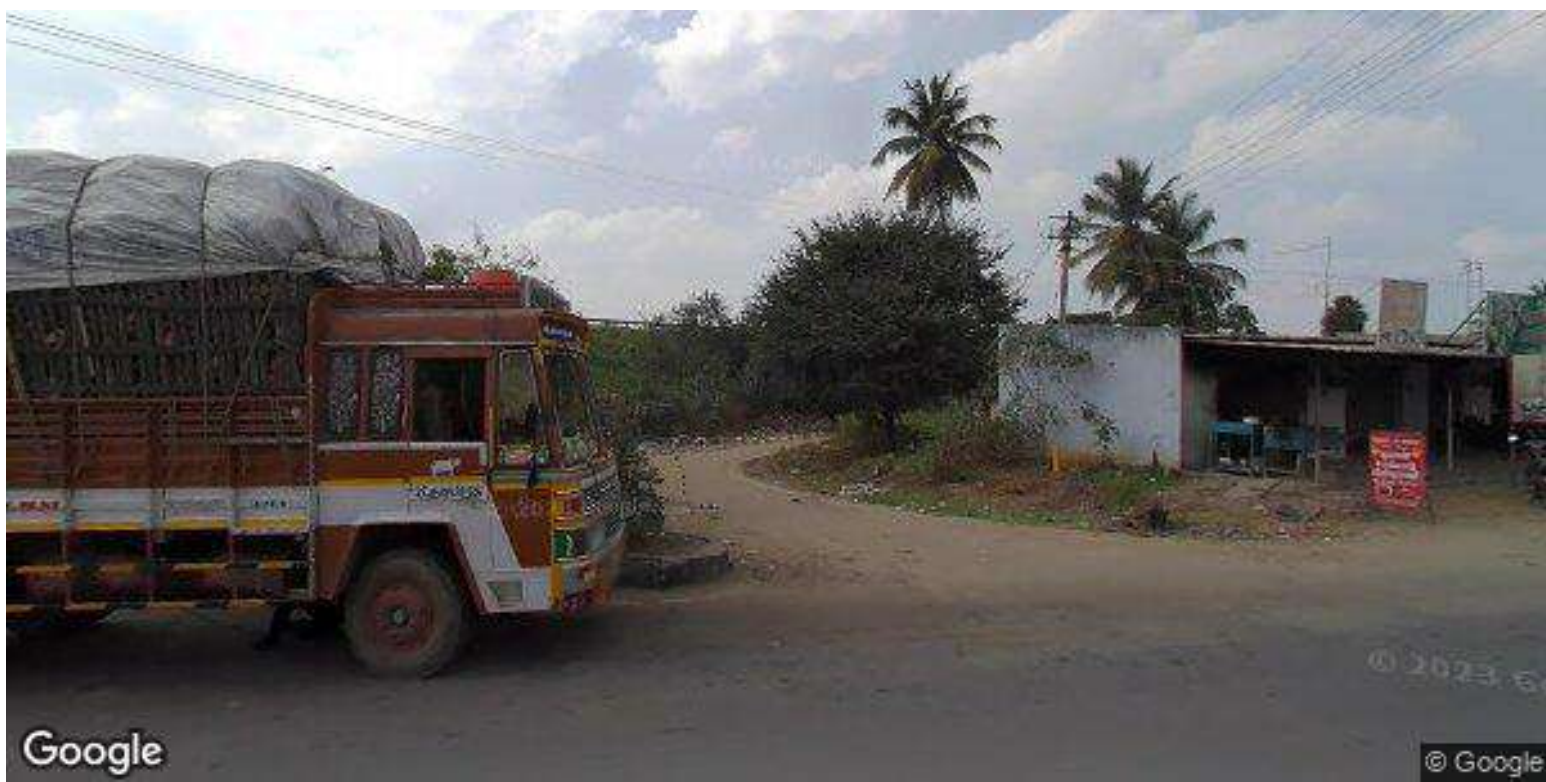
**Coordinates:** 11.49383, 77.88526

**Risk Type:** Turn

**Risk Level:** High

**Speed Limit:** 15 KM/Hr

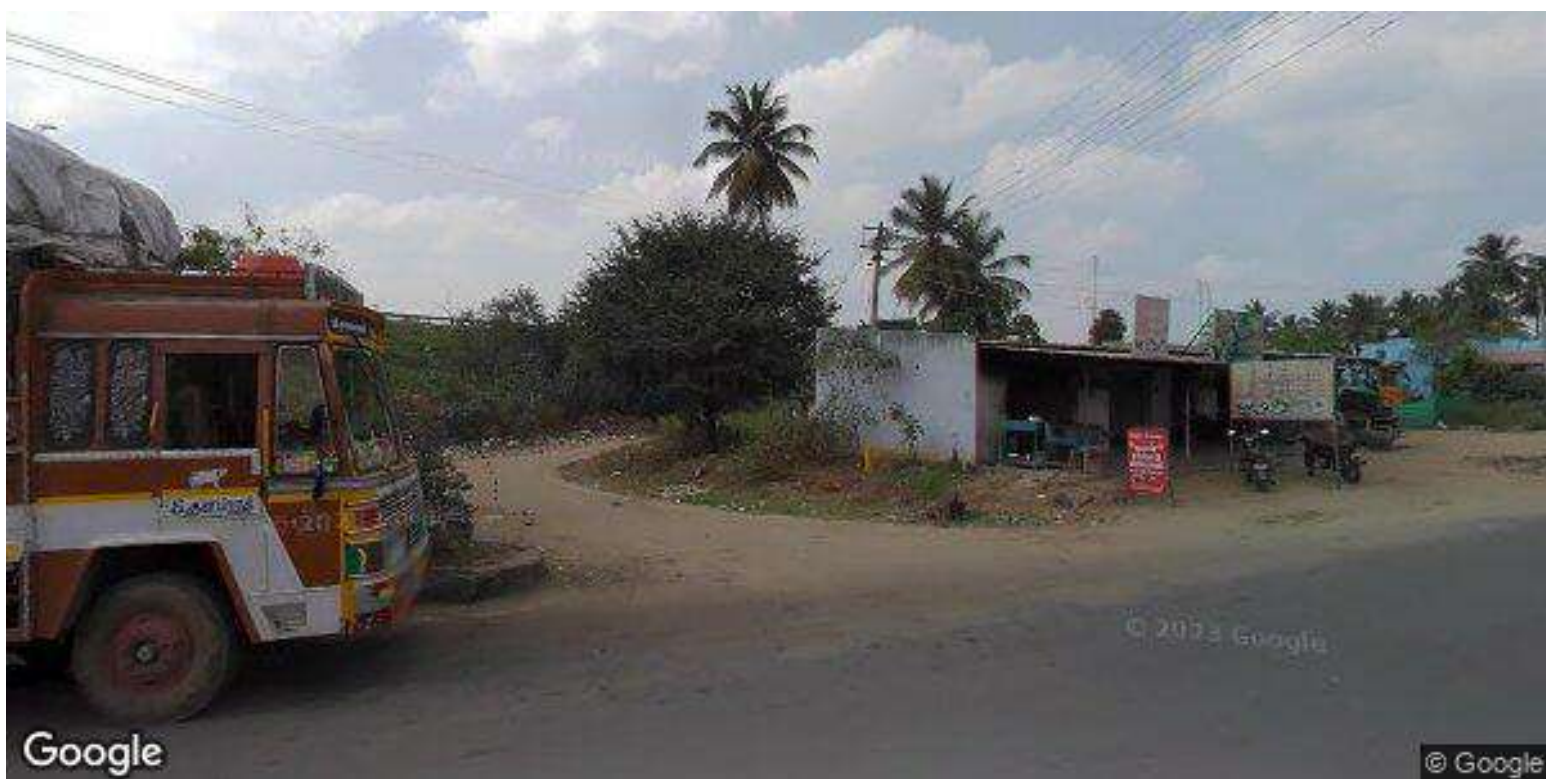
**Coordinates:** 11.49395, 77.88537

**Risk Type:** Turn

**Risk Level:** High

**Speed Limit:** 15 KM/Hr

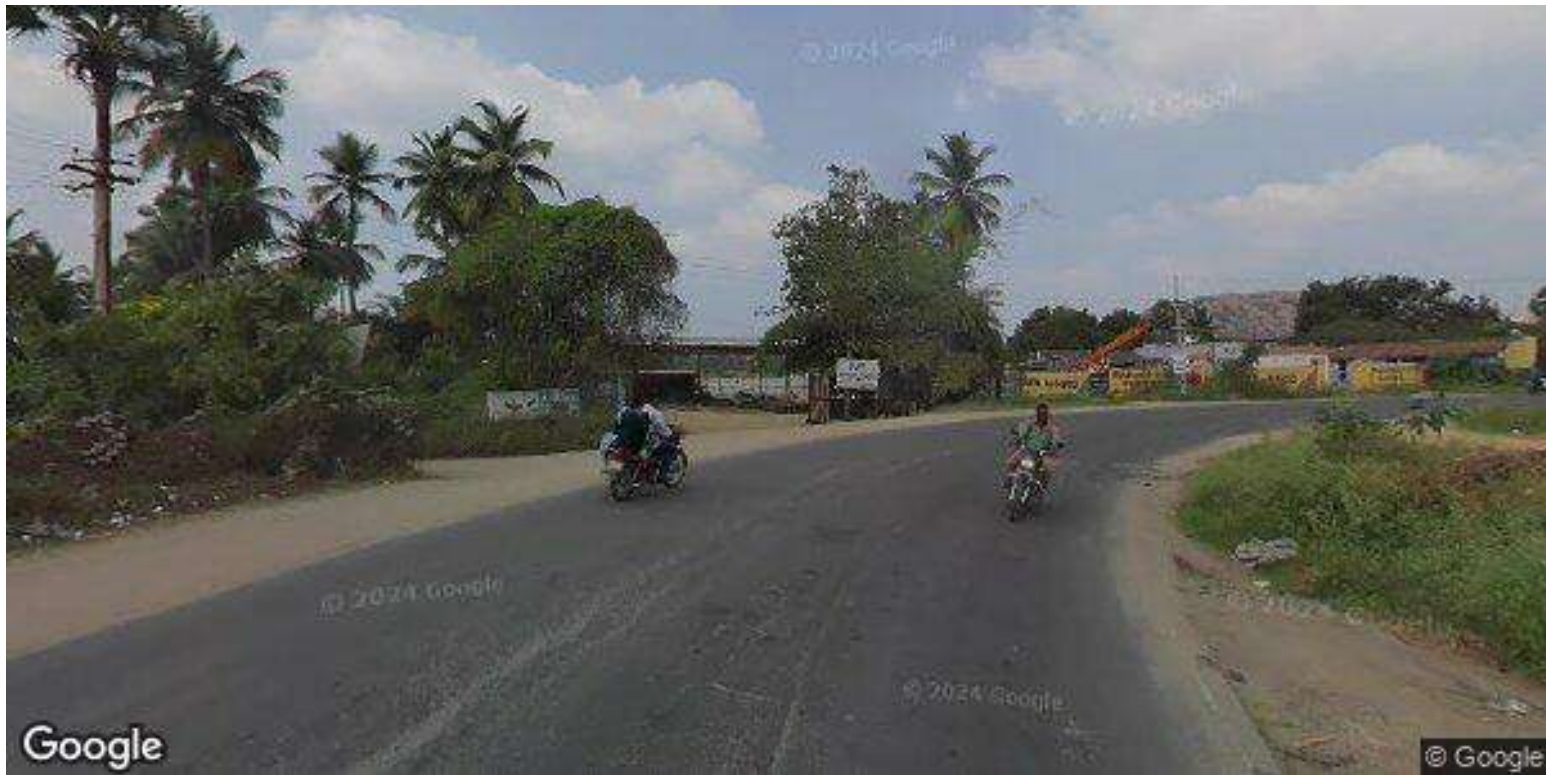
**Risk Type:** Turn  
**Risk Level:** Medium  
**Speed Limit:** 30 KM/Hr  
**Coordinates:** 11.49435, 77.88499

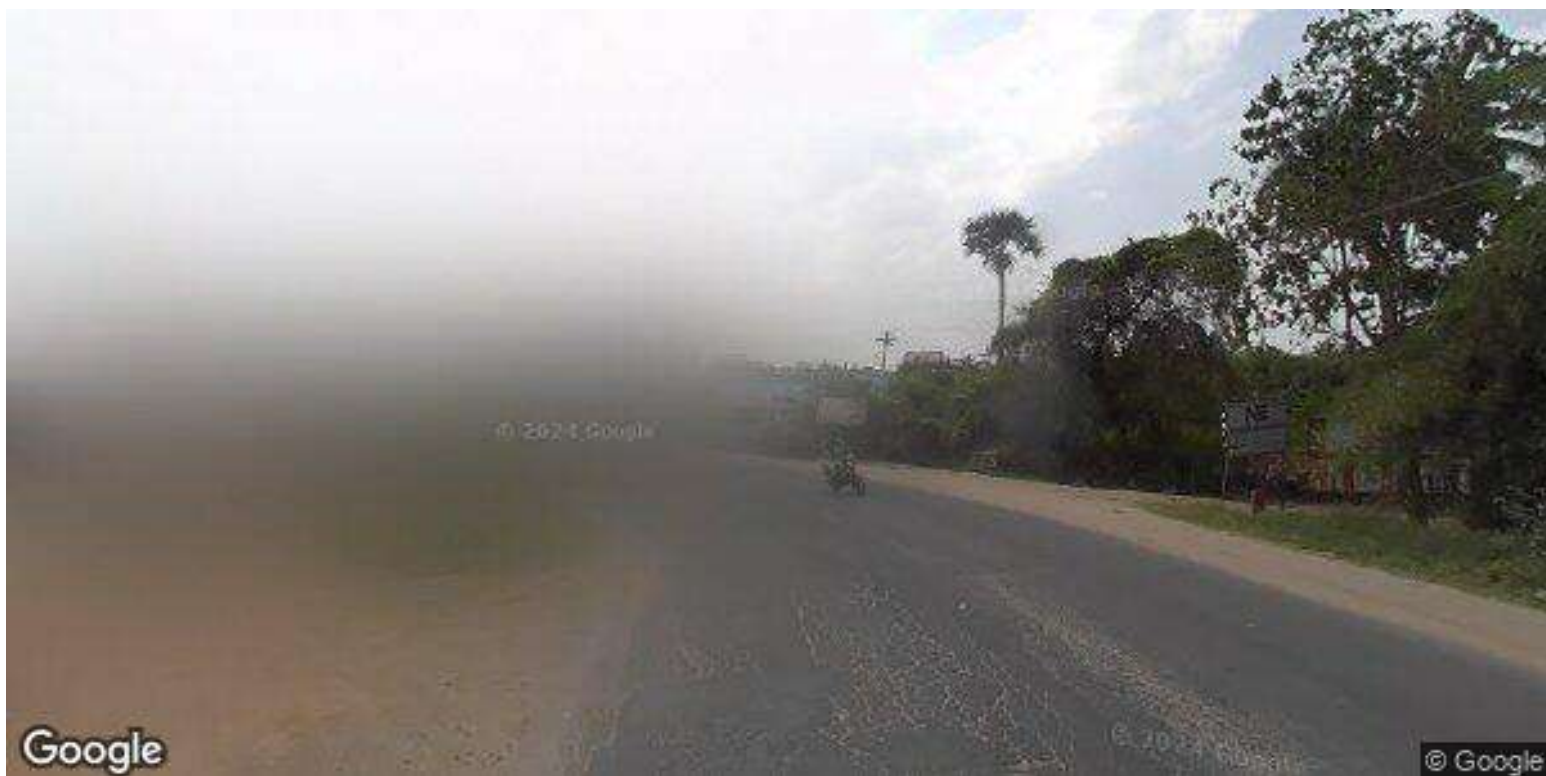
**Risk Type:** Turn  
**Risk Level:** Medium  
**Speed Limit:** 30 KM/Hr  
**Coordinates:** 11.49465, 77.88488

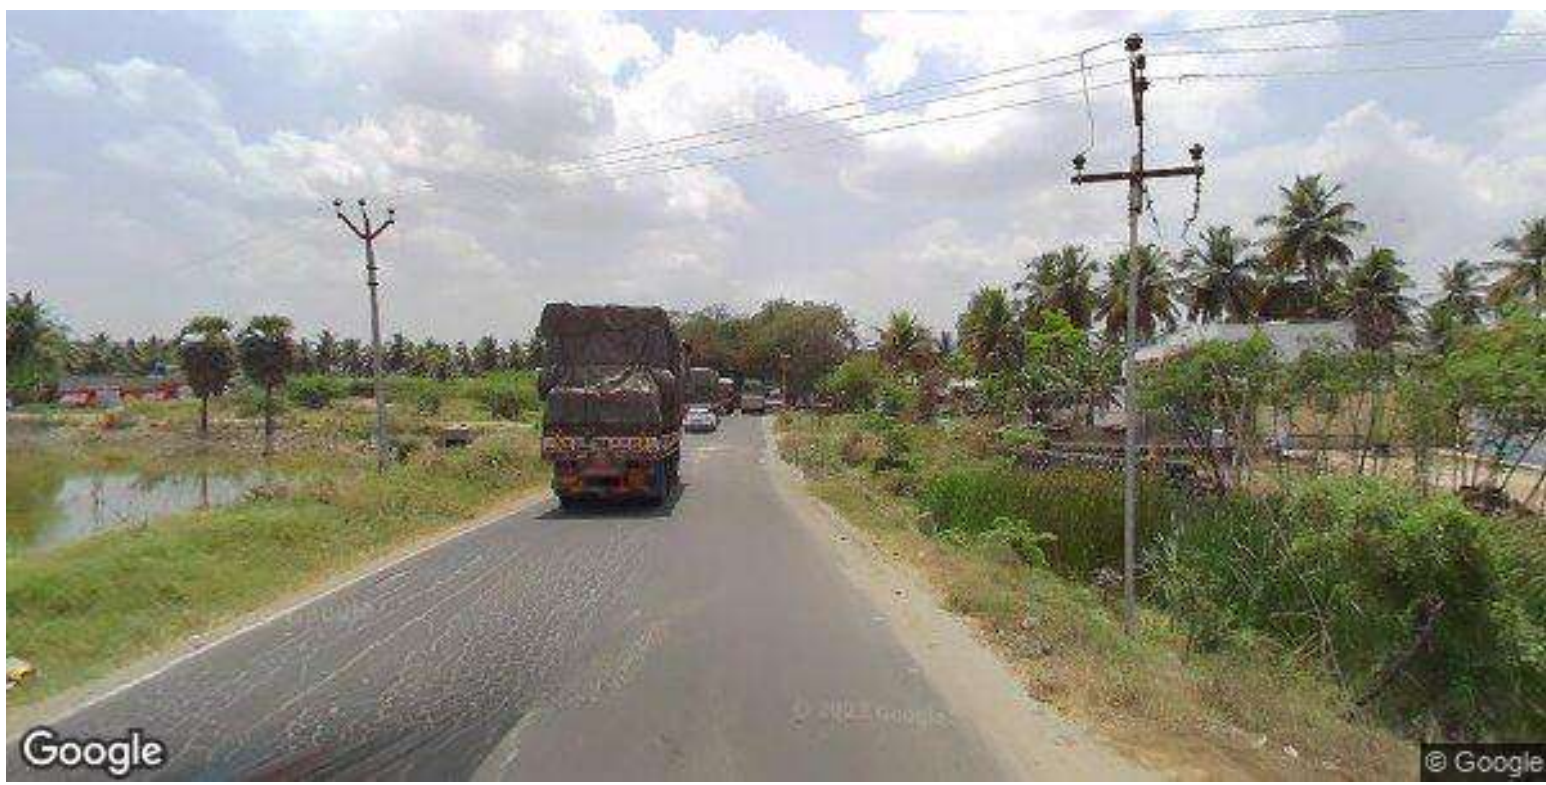
**Coordinates:** 11.56072, 77.89919

**Risk Type:** Turn

**Risk Level:** Medium

**Speed Limit:** 30 KM/Hr

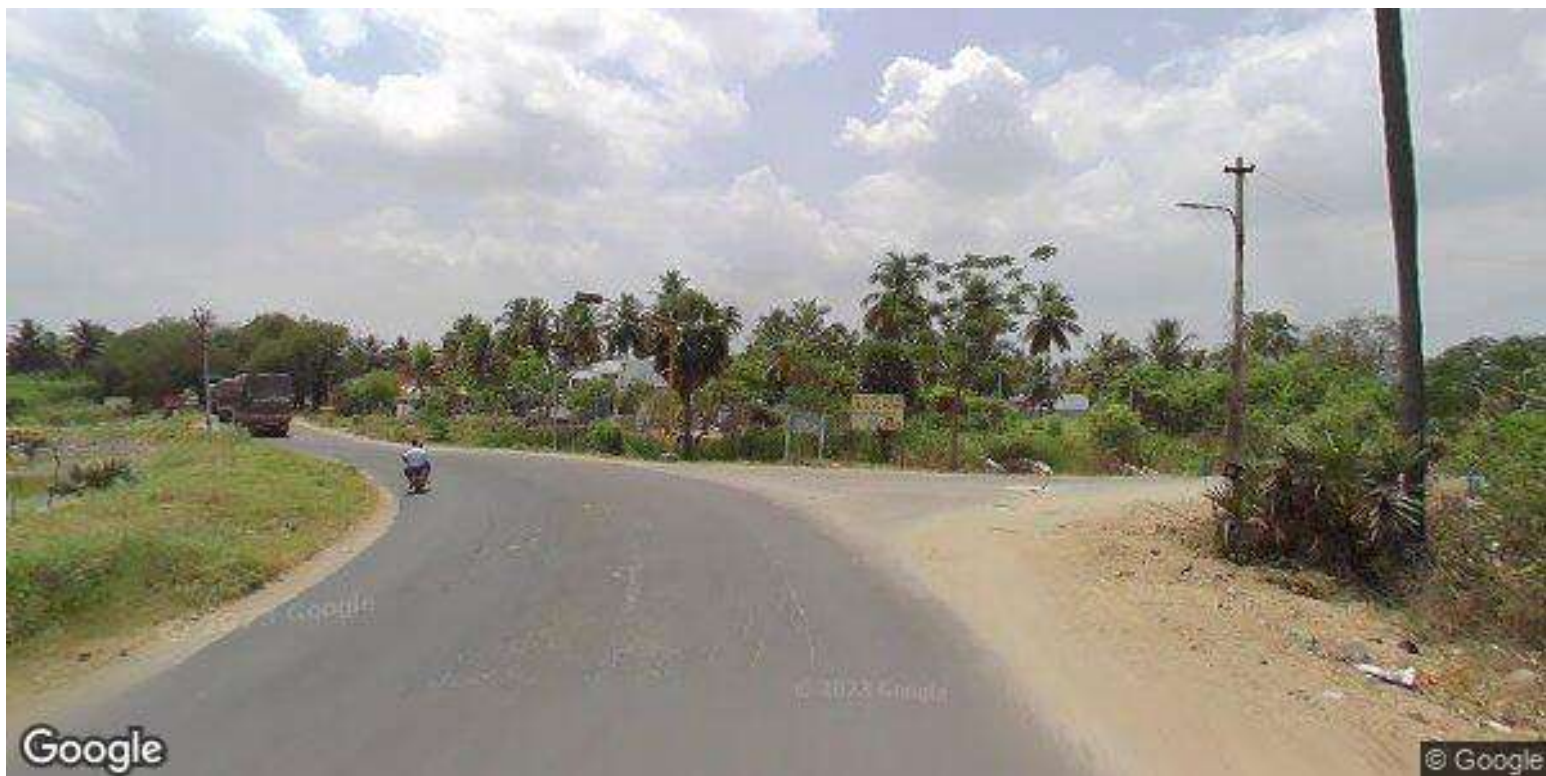
**Coordinates:** 11.56096, 77.89931

**Risk Type:** Turn

**Risk Level:** Medium

**Speed Limit:** 30 KM/Hr

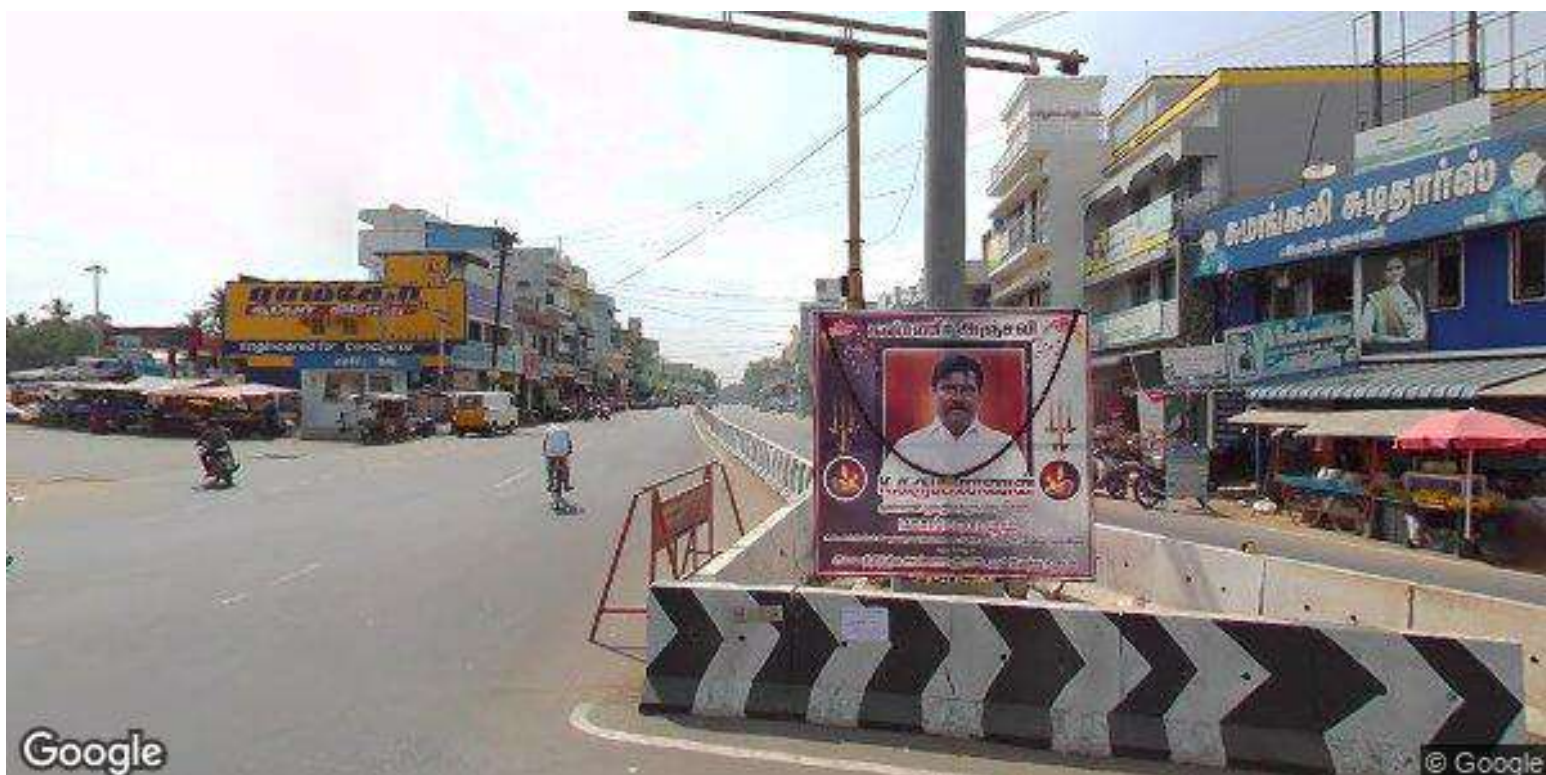
**Coordinates:** 11.57035, 77.90223

**Risk Type:** Turn

**Risk Level:** High

**Speed Limit:** 15 KM/Hr

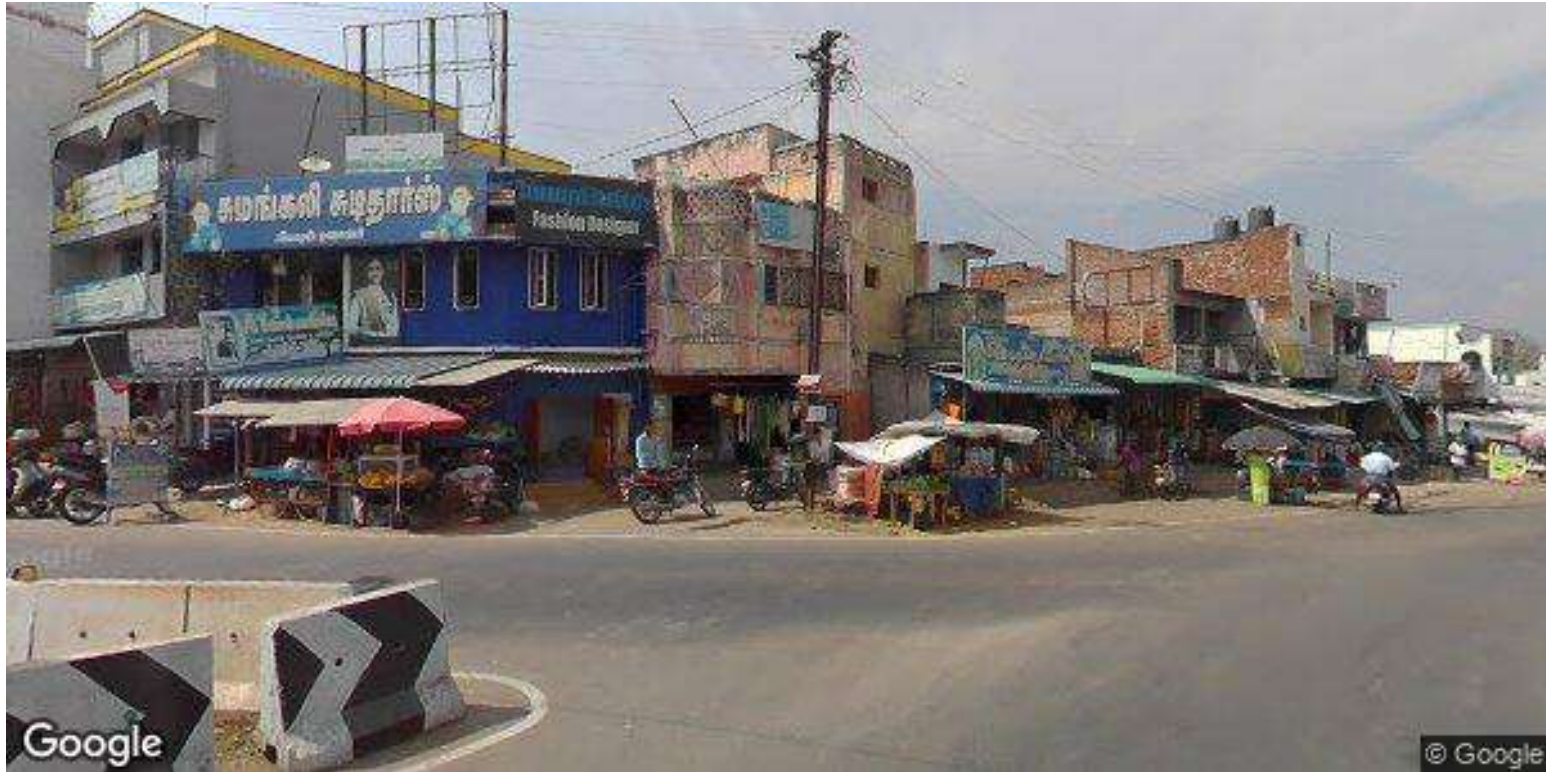
**Coordinates:** 11.57041, 77.90221

**Risk Type:** Turn

**Risk Level:** Medium

**Speed Limit:** 30 KM/Hr

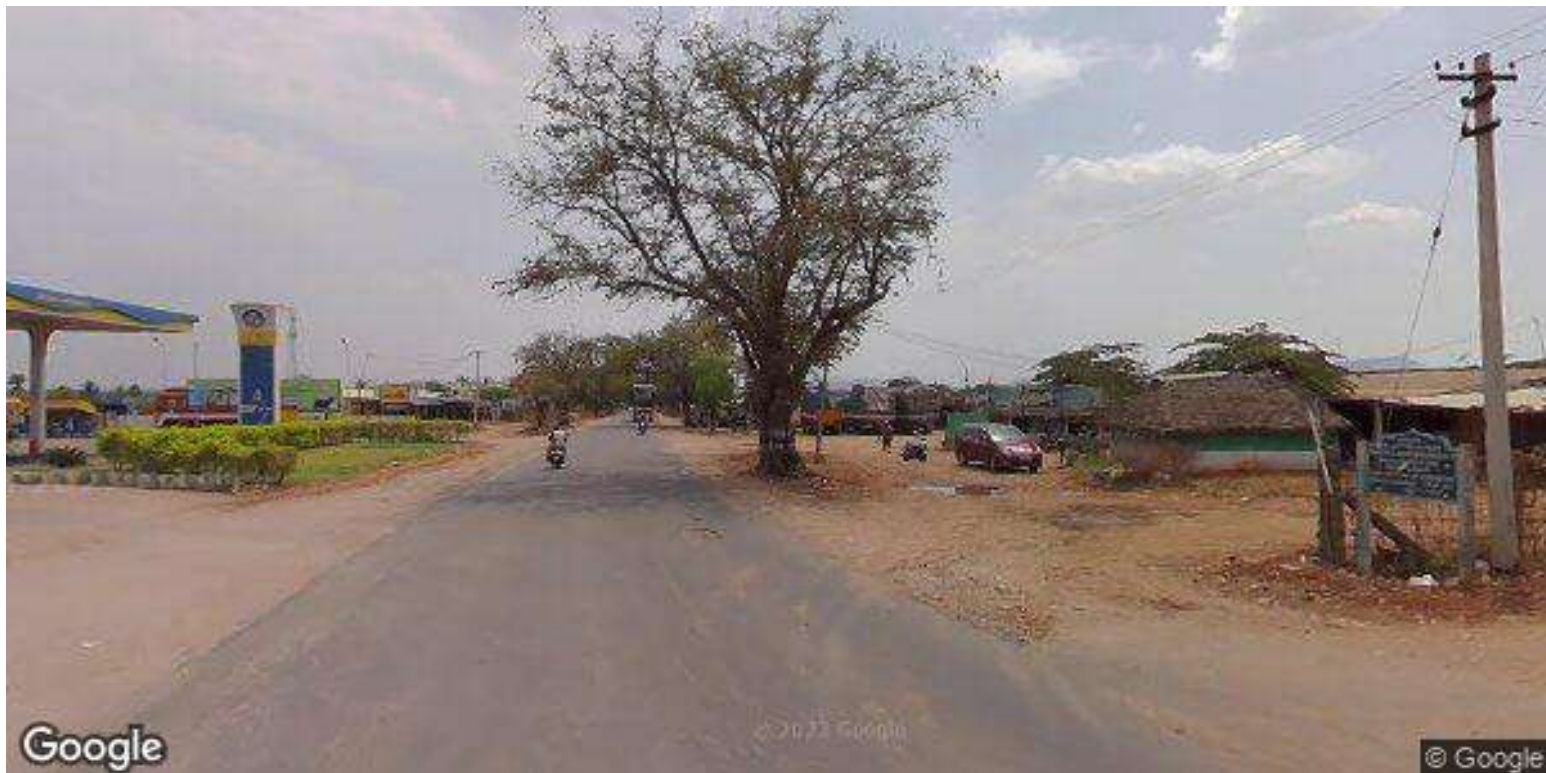
**Coordinates:** 11.58279, 77.90658

**Risk Type:** Turn

**Risk Level:** Medium

**Speed Limit:** 30 KM/Hr

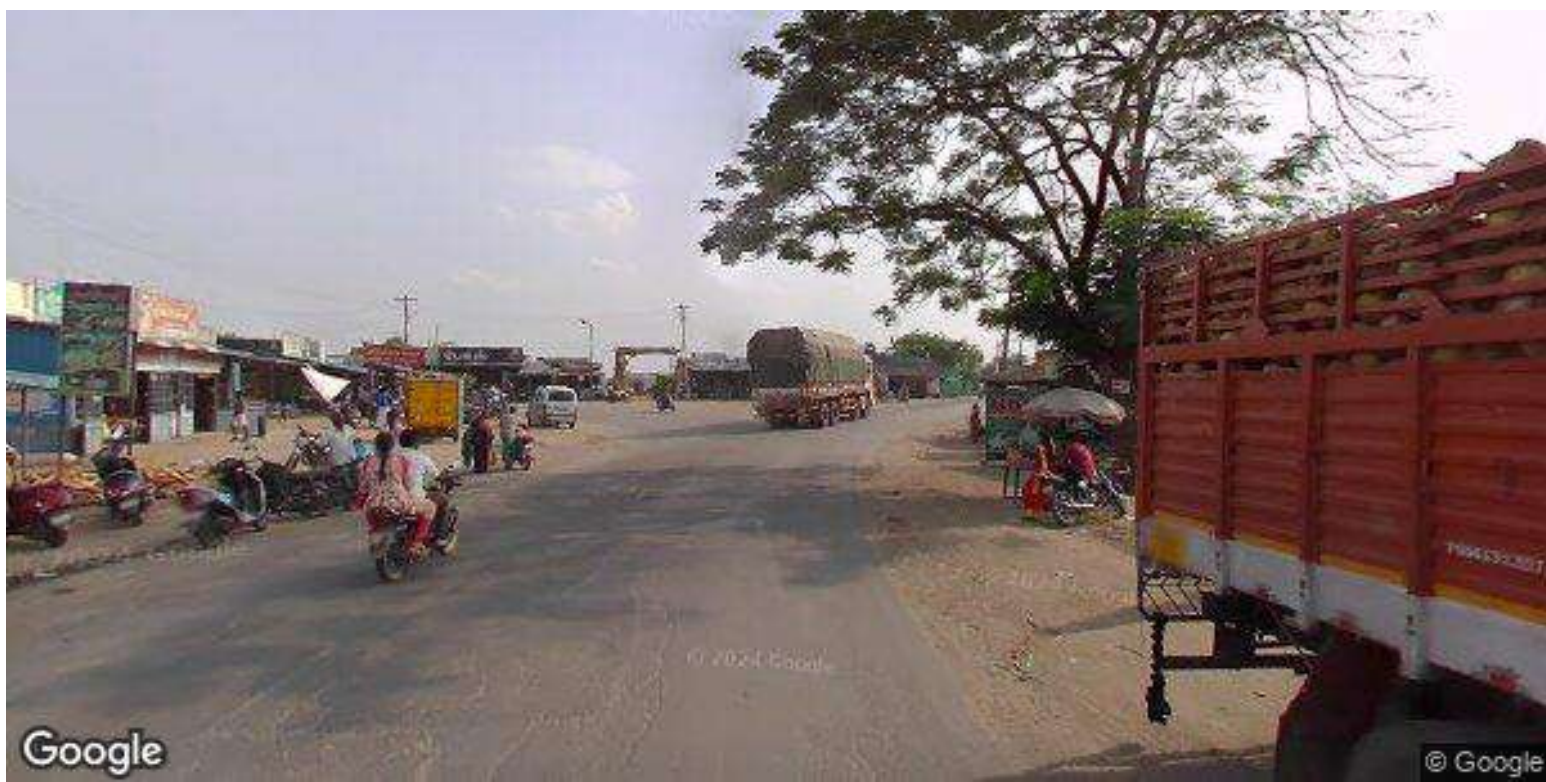
**Coordinates:** 11.64197, 77.95197

**Risk Type:** Turn

**Risk Level:** Medium

**Speed Limit:** 30 KM/Hr

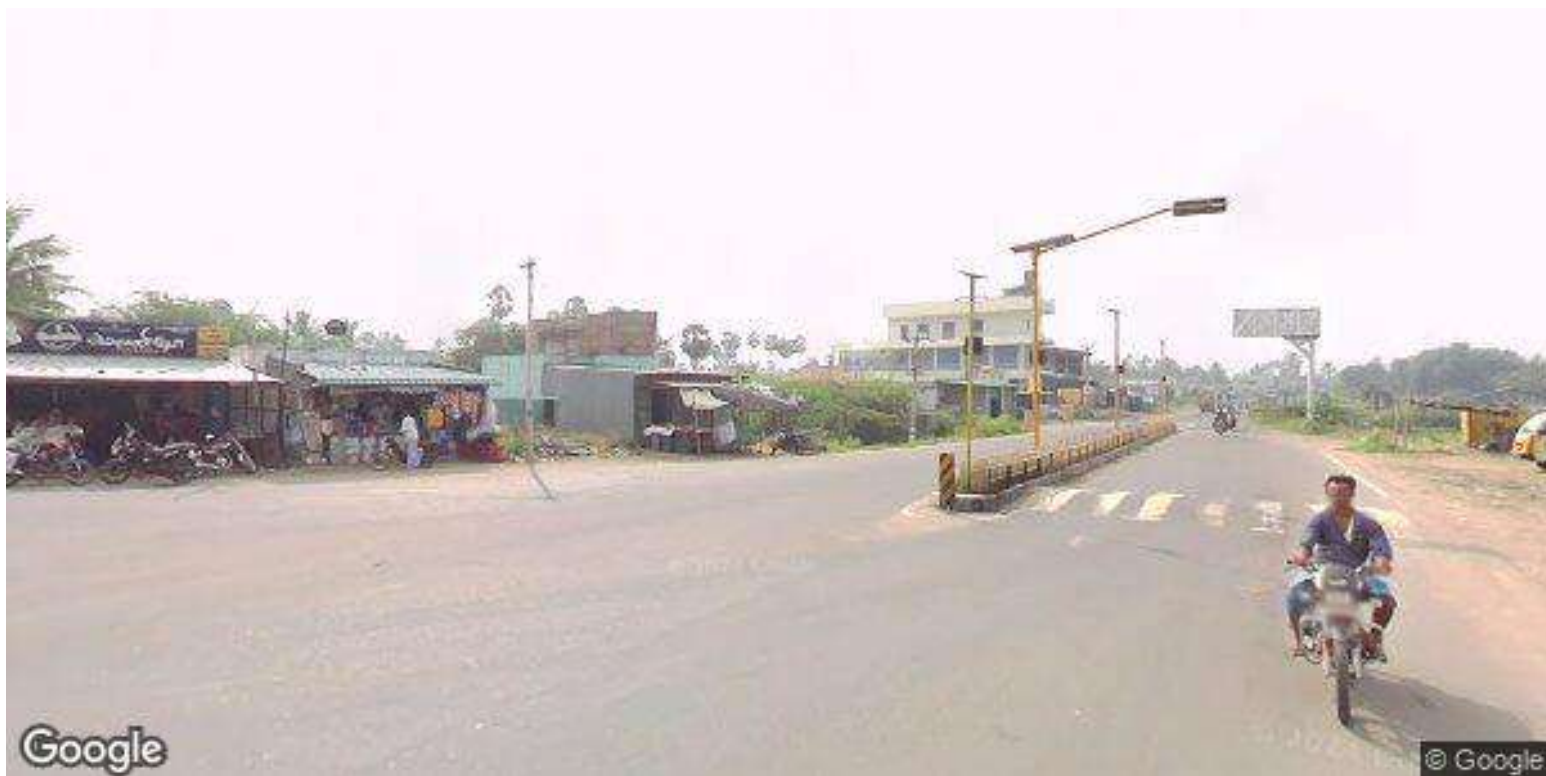
**Coordinates:** 11.67868, 77.96836

**Risk Type:** Turn

**Risk Level:** High

**Speed Limit:** 15 KM/Hr

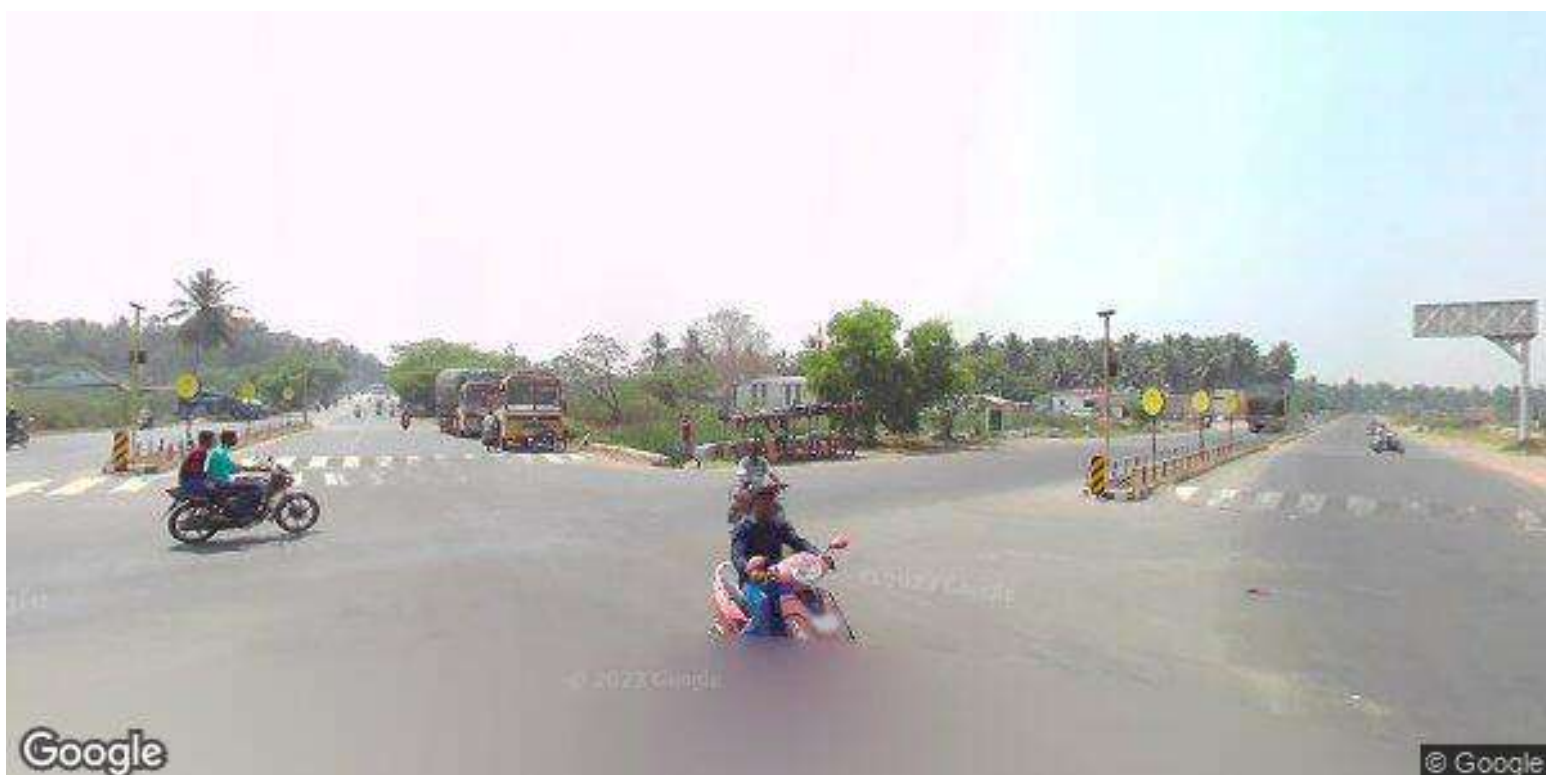
**Risk Type:** Turn  
**Risk Level:** Medium  
**Speed Limit:** 30 KM/Hr  
**Coordinates:** 11.68904, 77.97736

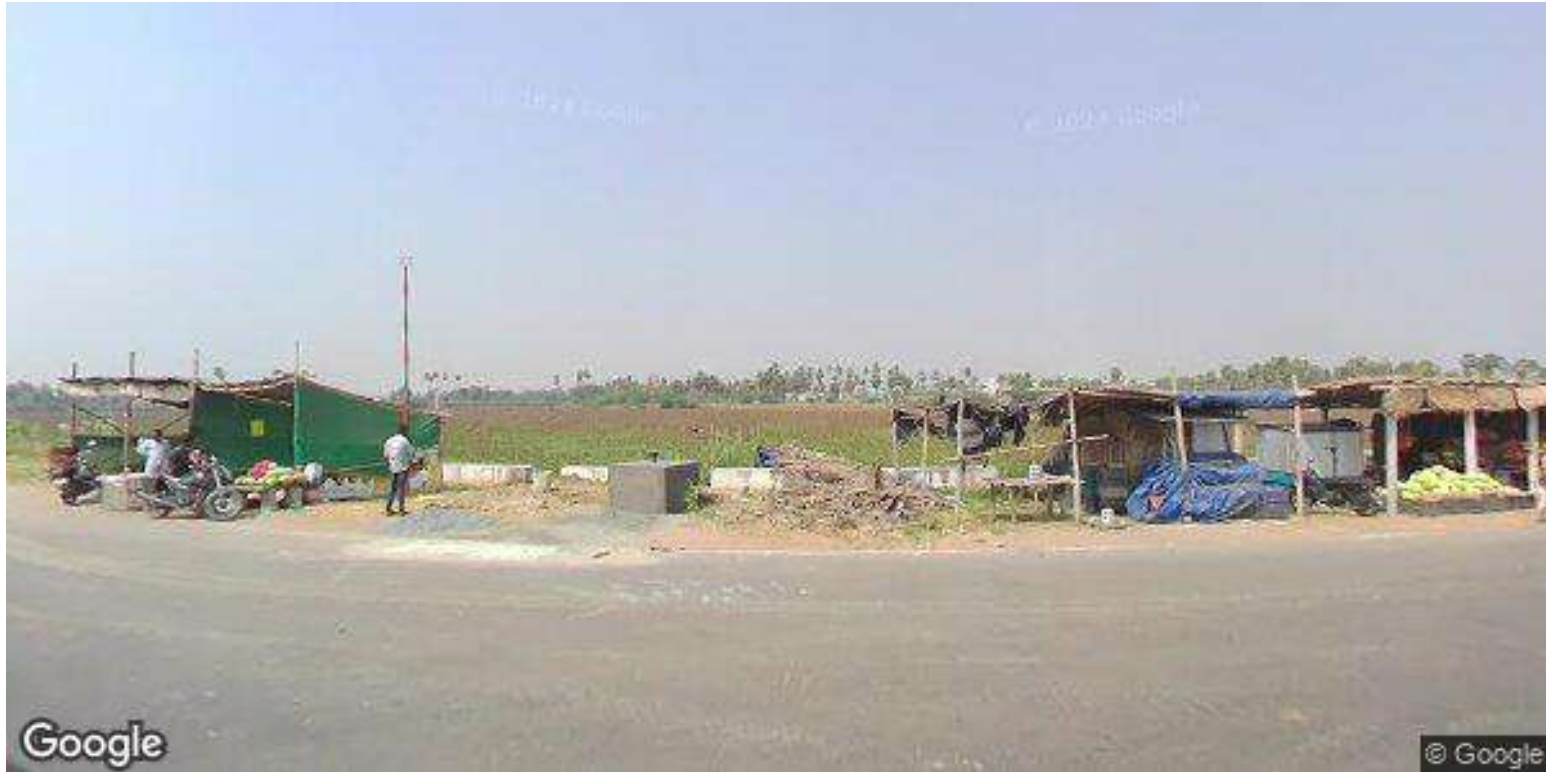
**Risk Type:** Turn  
**Risk Level:** High  
**Speed Limit:** 15 KM/Hr  
**Coordinates:** 11.68915, 77.97734

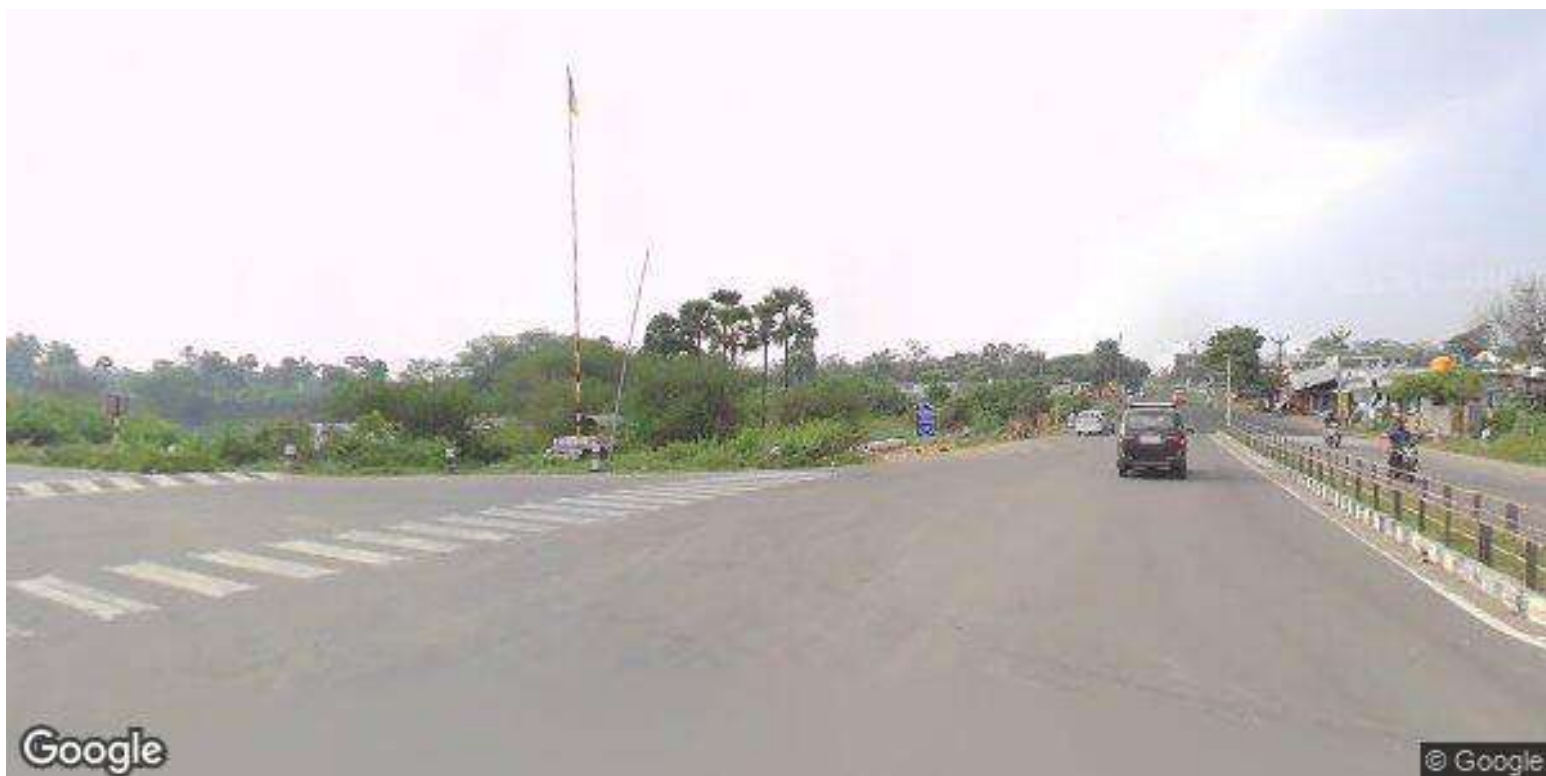
**Risk Type:** Turn  
**Risk Level:** Medium  
**Speed Limit:** 30 KM/Hr  
**Coordinates:** 11.70218, 77.97866

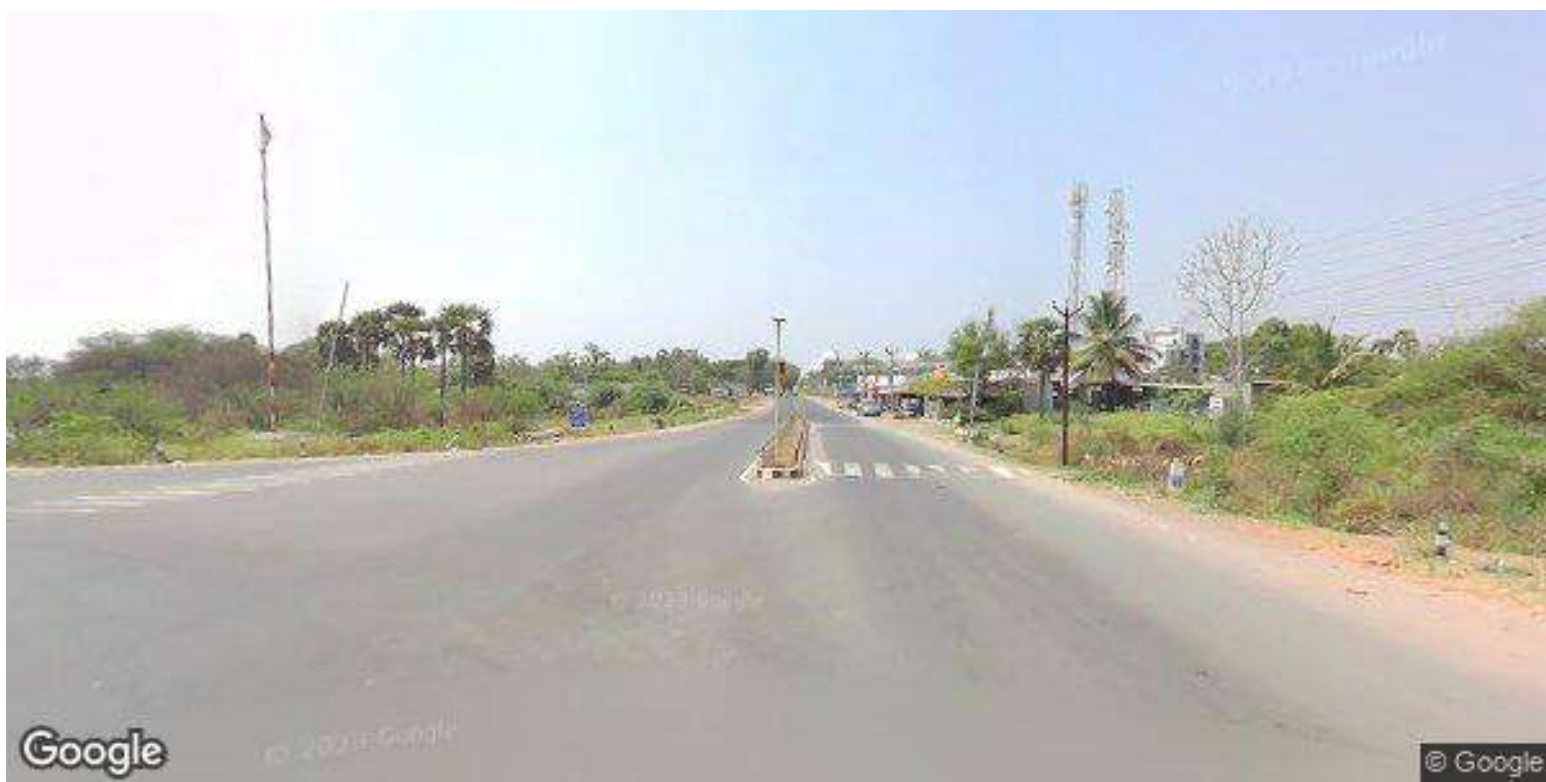
**Coordinates: 11.70227, 77.97864**

**Risk Type: Turn**

**Risk Level: High**

**Speed Limit: 15 KM/Hr**

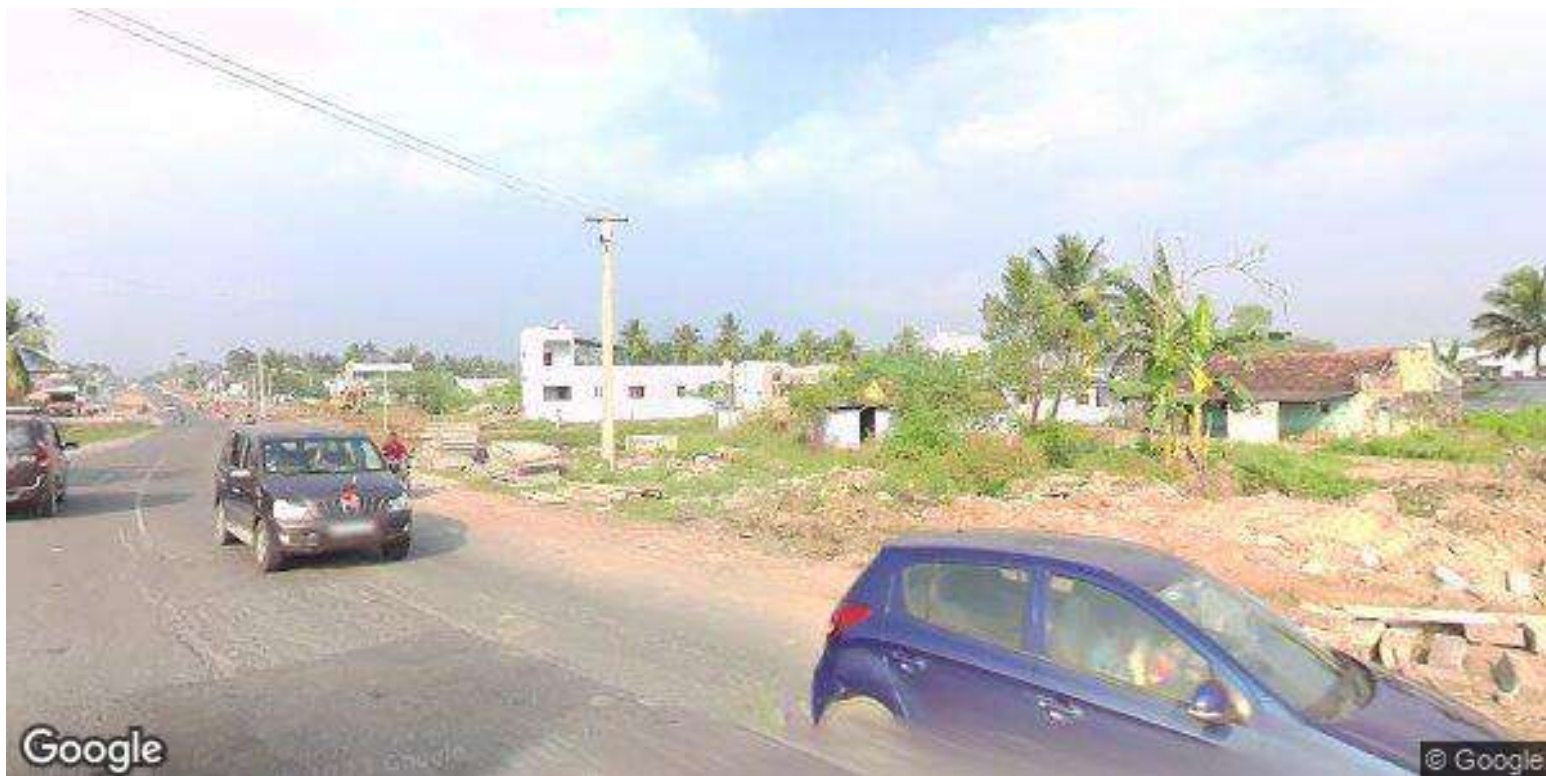
**Coordinates: 11.71921, 78.01133**

**Risk Type: Turn**

**Risk Level: Medium**

**Speed Limit: 30 KM/Hr**
