## JOURNEY RISK MANAGEMENT (JRM) STUDY

### Salem Terminal to VIYAN FUELS

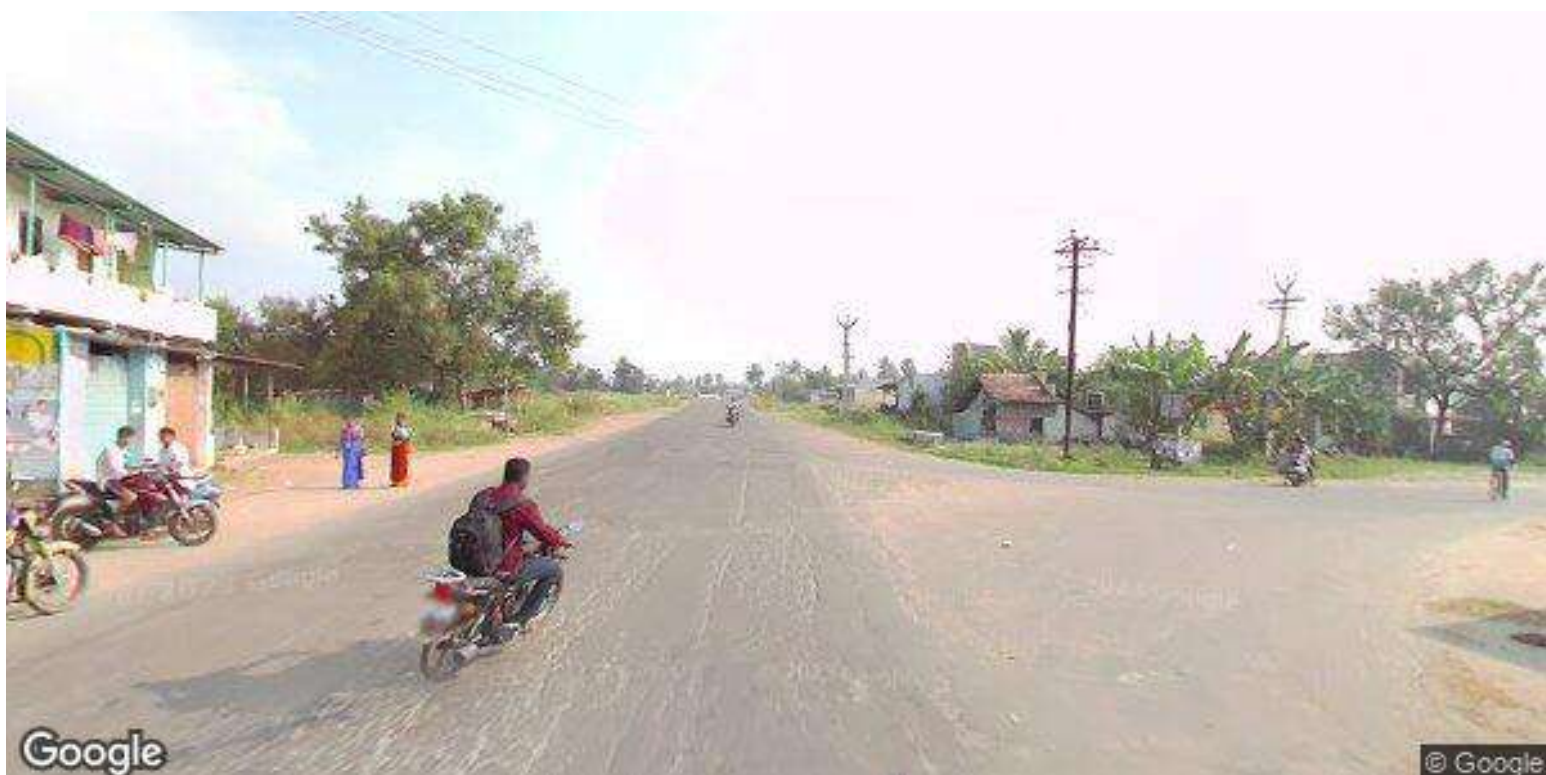
**Coordinates:** 11.72035, 78.01270

**Risk Type:** Turn

**Risk Level:** High

**Speed Limit:** 15 KM/Hr
