# IndianOil

## JOURNEY RISK MANAGEMENT (JRM) STUDY

### Salem Terminal TO NAGUL ENERGY SUPPLYIES

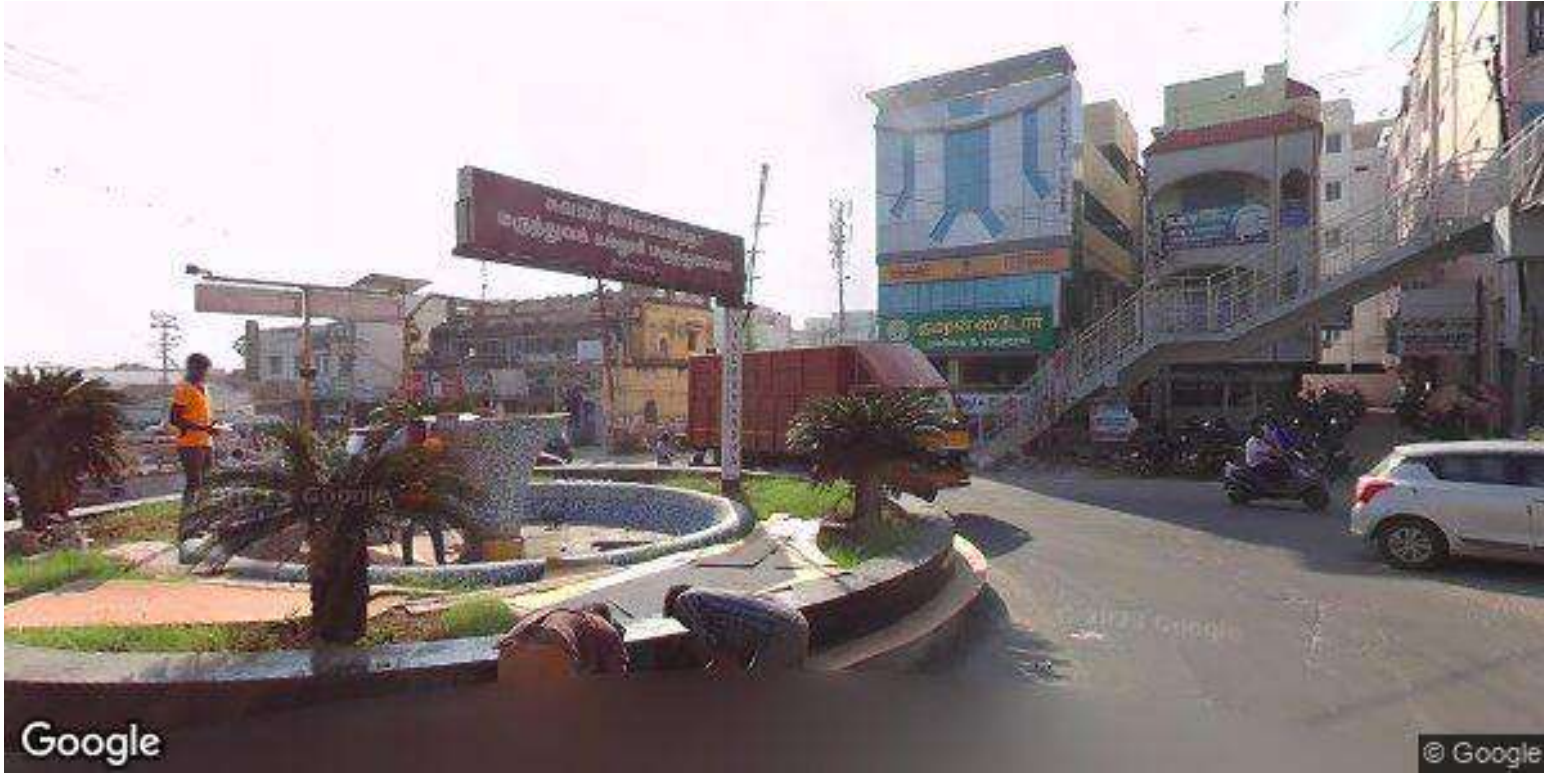
**Coordinates:** 11.38395, 77.89480

**Risk Type:** Roundabout

**Risk Level:** High

**Speed Limit:** 15 KM/Hr

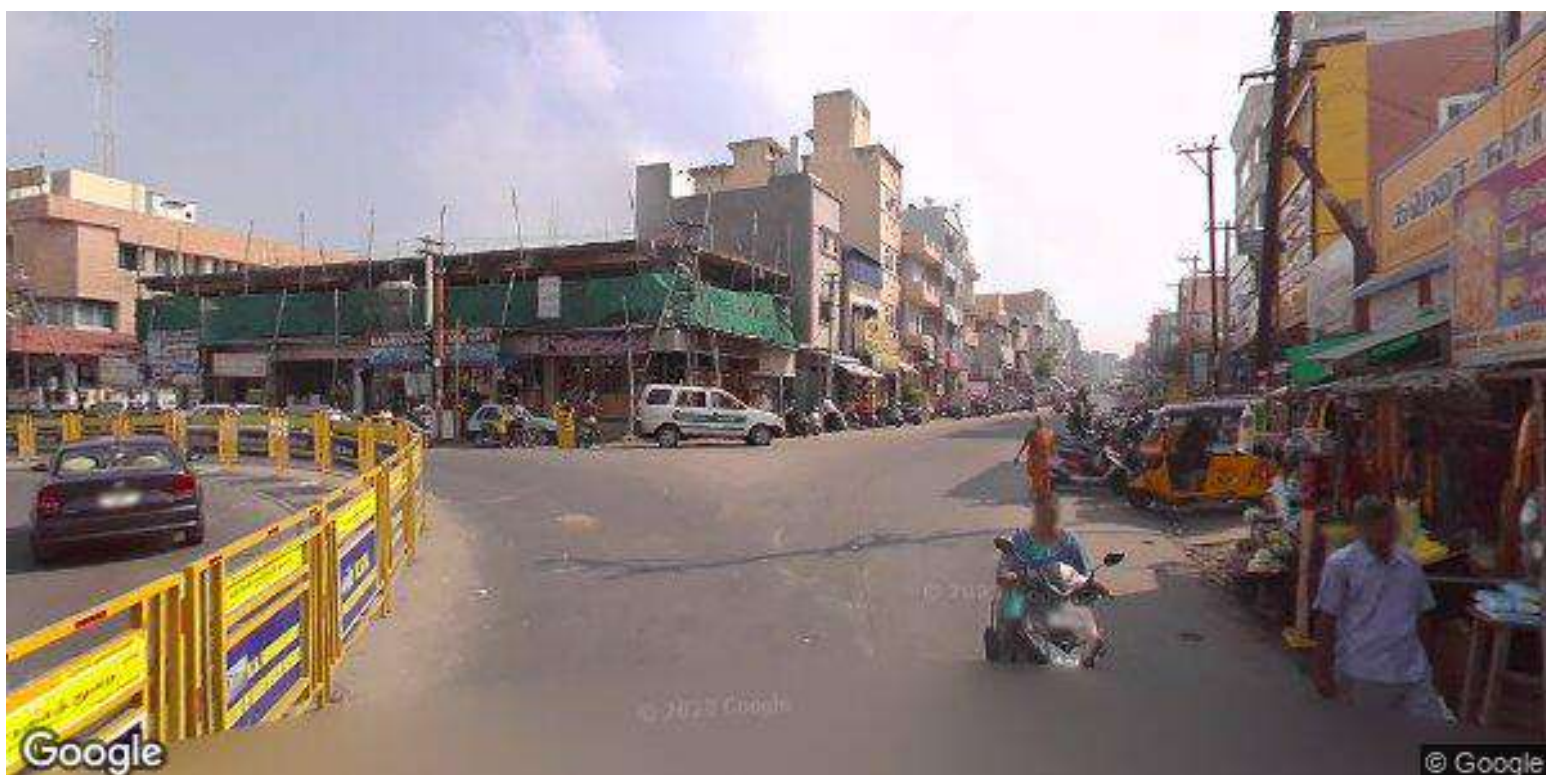
**Coordinates:** 11.37862, 77.89488

**Risk Type:** Turn

**Risk Level:** High

**Speed Limit:** 15 KM/Hr

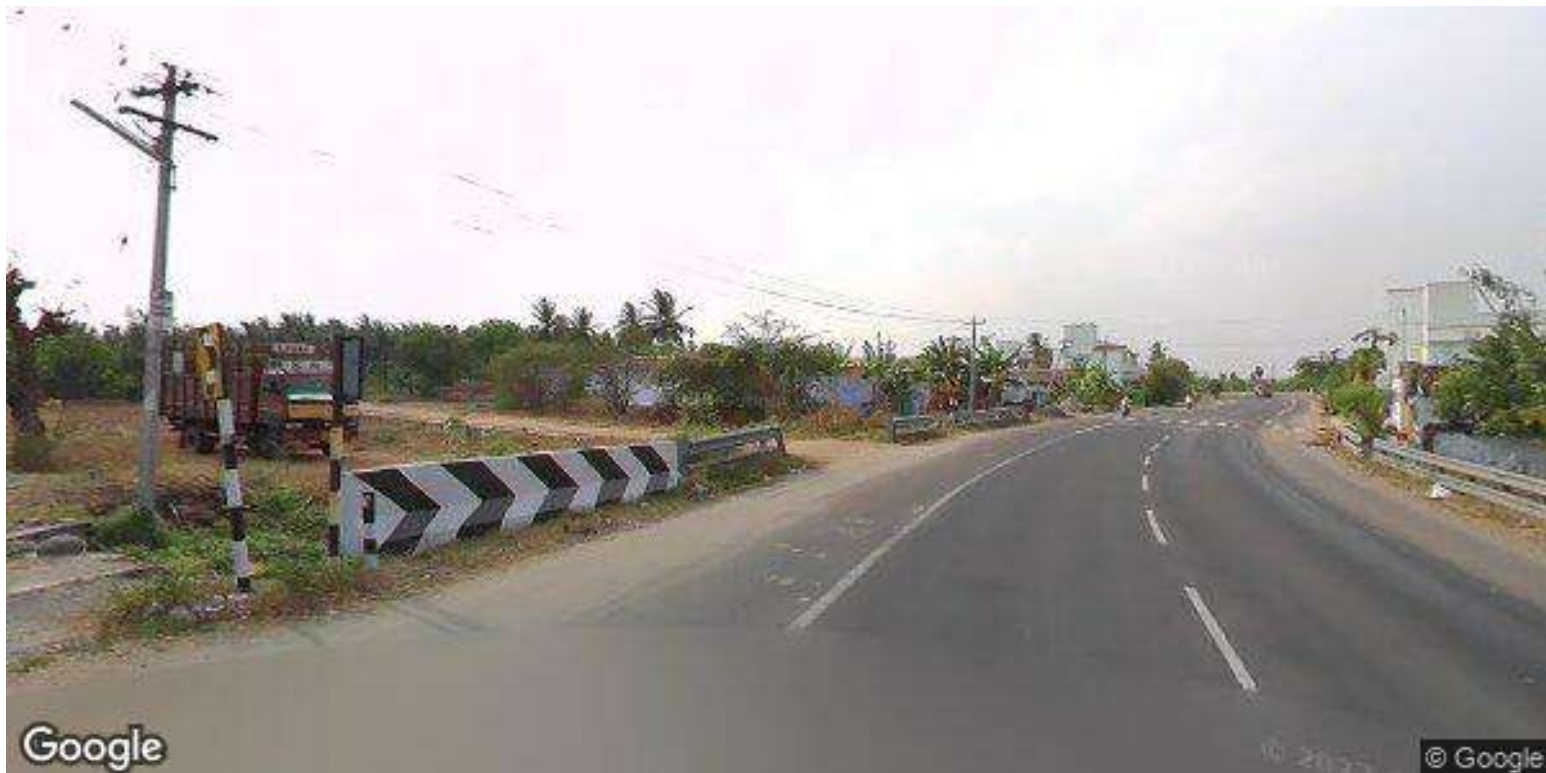
**Coordinates:** 11.16755, 78.01568

**Risk Type:** Turn

**Risk Level:** Medium

**Speed Limit:** 30 KM/Hr

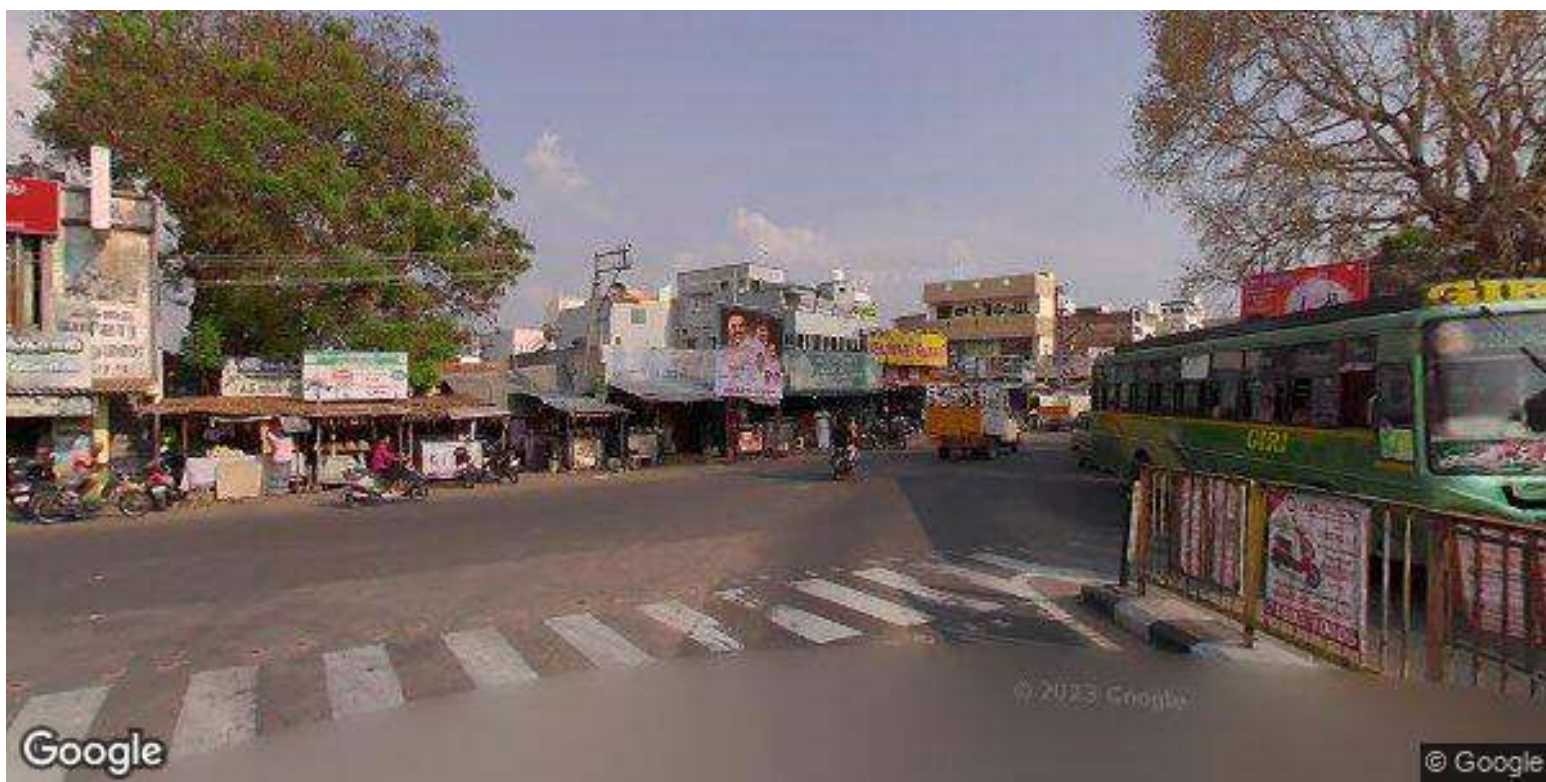
**Coordinates:** 11.15579, 78.02169

**Risk Type:** Turn

**Risk Level:** Medium

**Speed Limit:** 30 KM/Hr

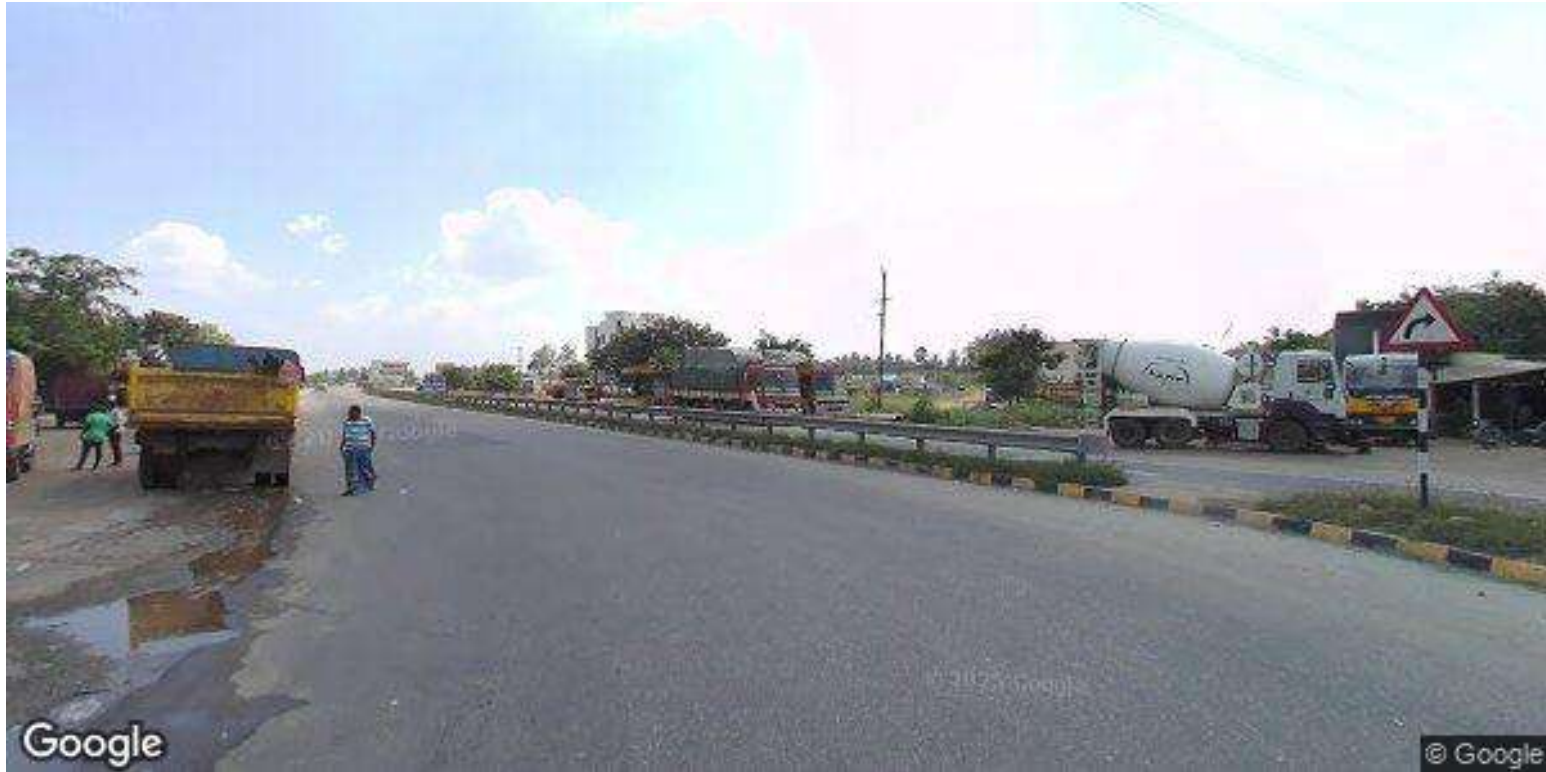
**Risk Type:** Turn  
**Risk Level:** Medium  
**Speed Limit:** 30 KM/Hr  
**Coordinates:** 10.92922, 78.05481

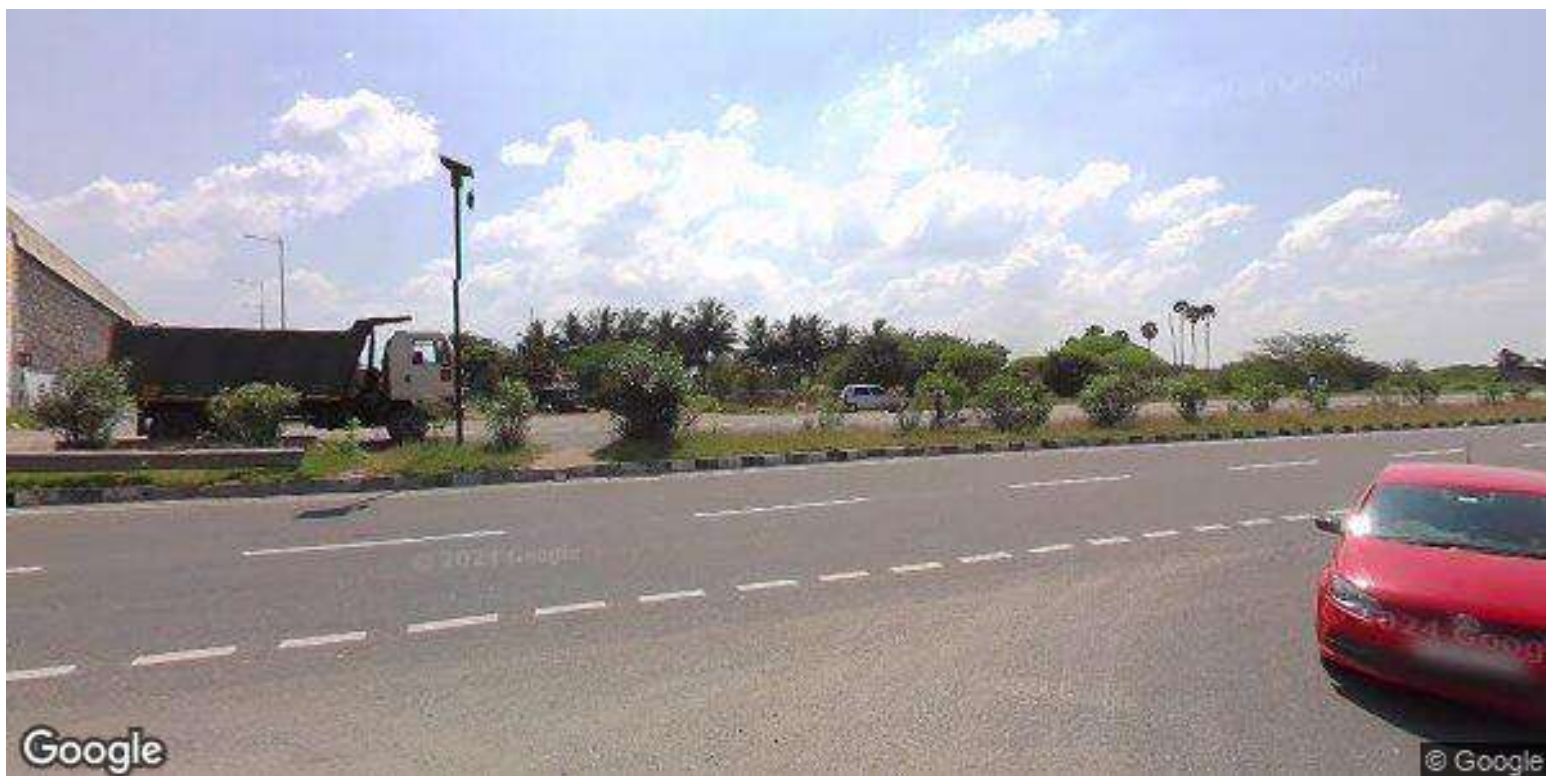
**Risk Type:** Turn  
**Risk Level:** High  
**Speed Limit:** 15 KM/Hr  
**Coordinates:** 10.90784, 78.09916
