# IndianOil

## JOURNEY RISK MANAGEMENT (JRM) STUDY

### Salem Terminal TO RL AGENCY

Route Safety Analysis Report: CVQF+23W, Sangagiri to JMWJ+6P8, Guruvareddiur

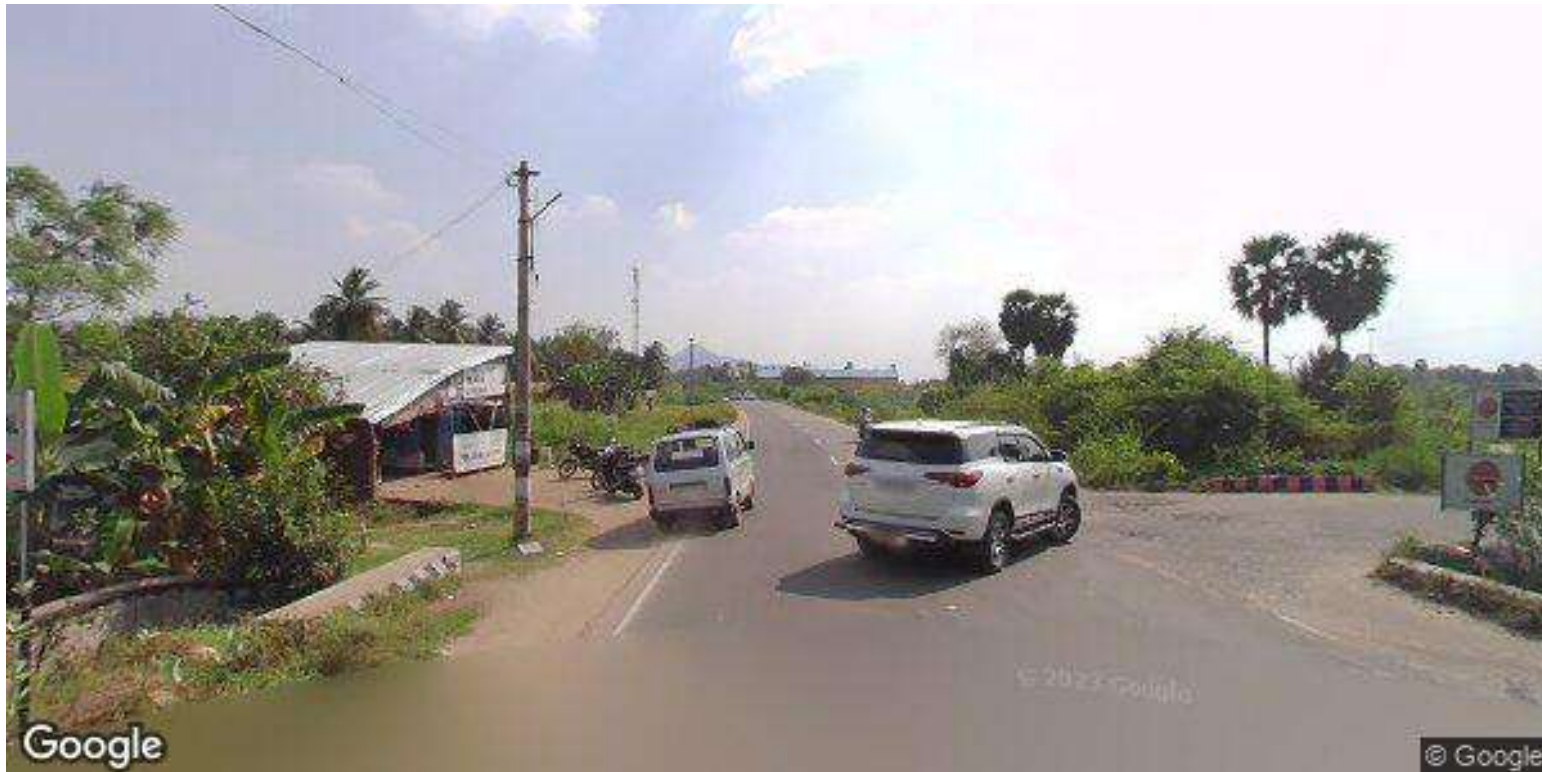
**Coordinates:** 11.44029, 77.87544

**Risk Type:** Turn

**Risk Level:** High

**Speed Limit:** 15 KM/Hr

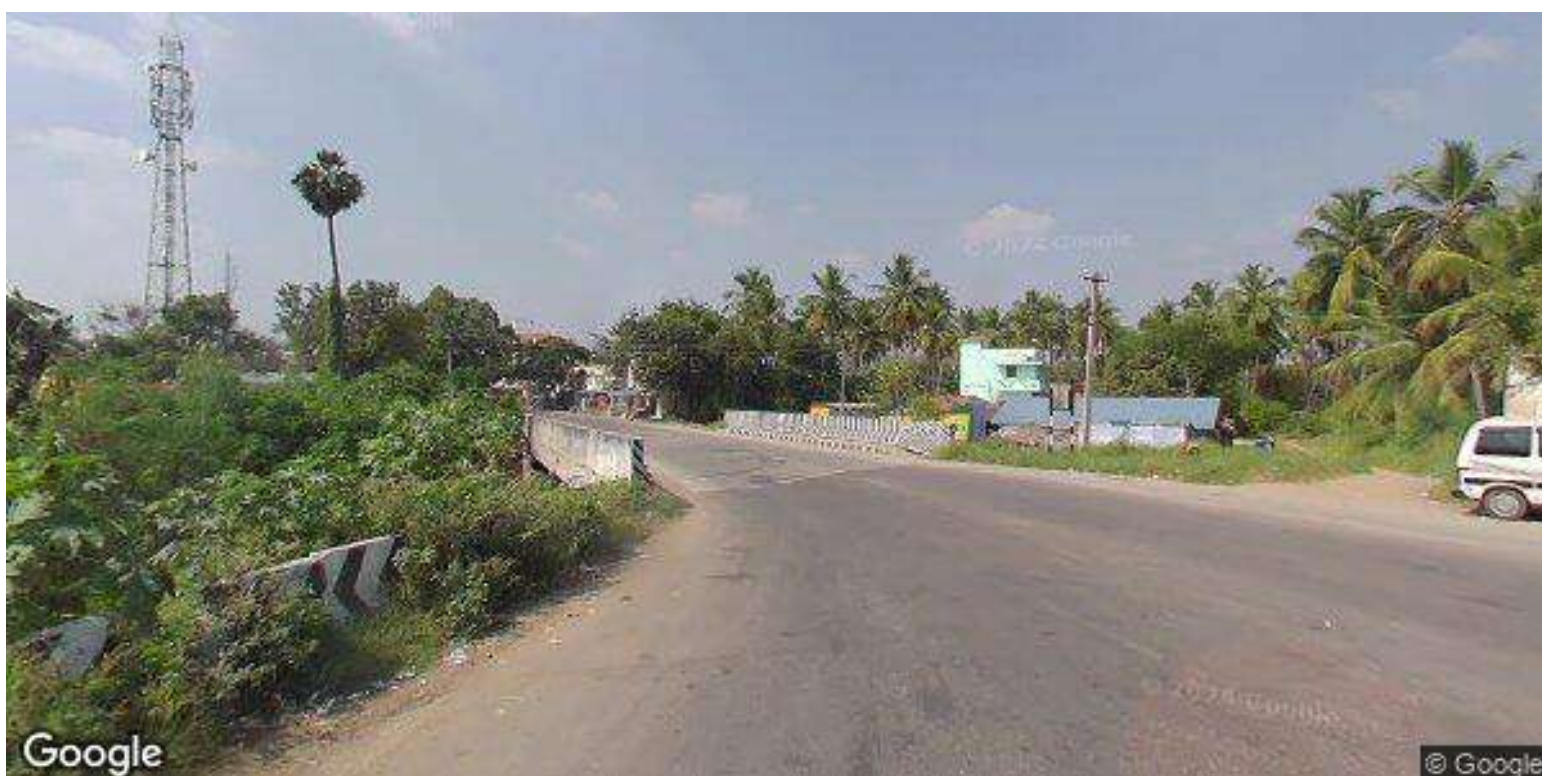
**Coordinates:** 11.44893, 77.87413

**Risk Type:** Turn

**Risk Level:** Medium

**Speed Limit:** 30 KM/Hr

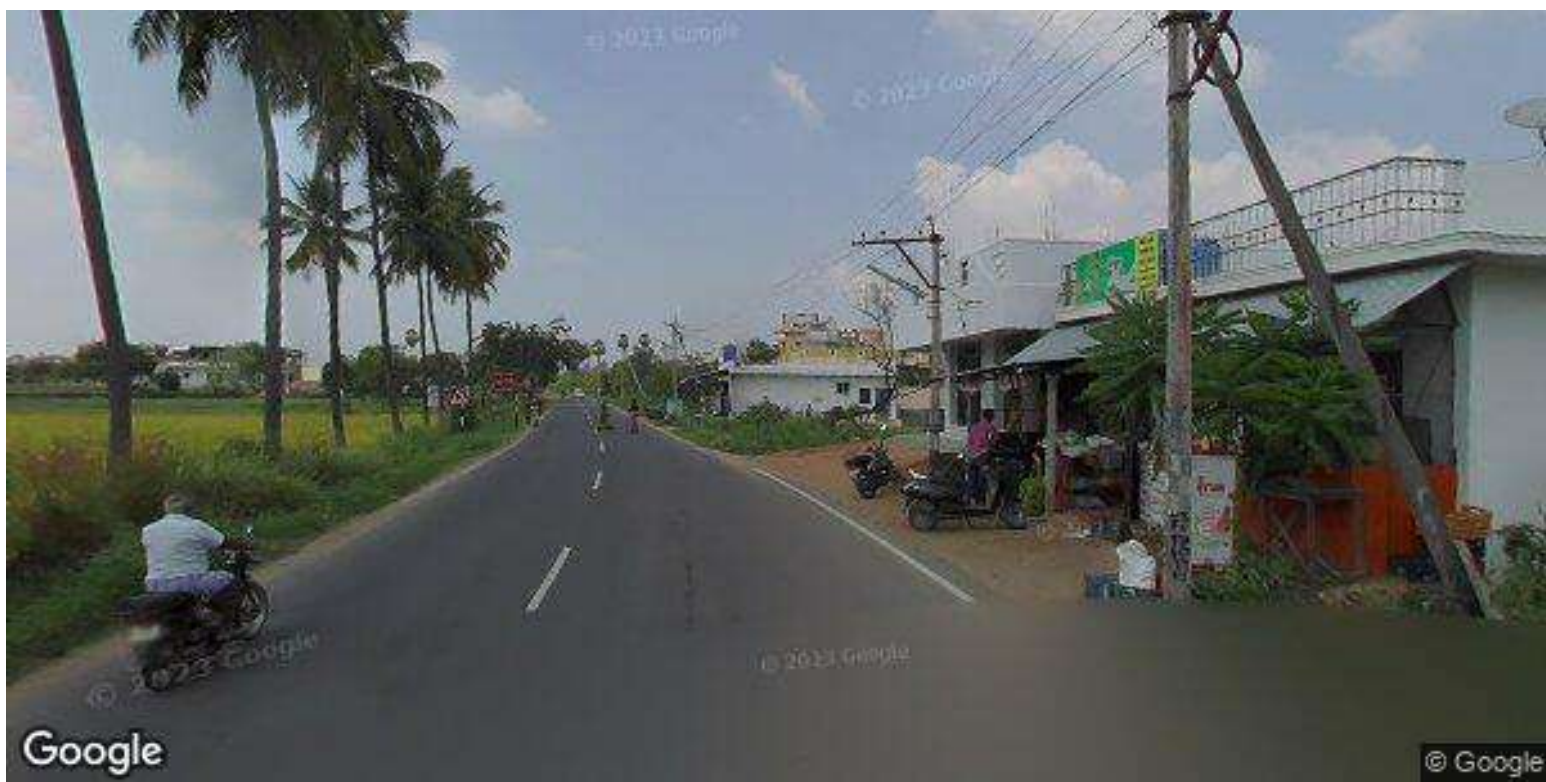
**Coordinates:** 11.45127, 77.86734

**Risk Type:** Turn

**Risk Level:** Medium

**Speed Limit:** 30 KM/Hr

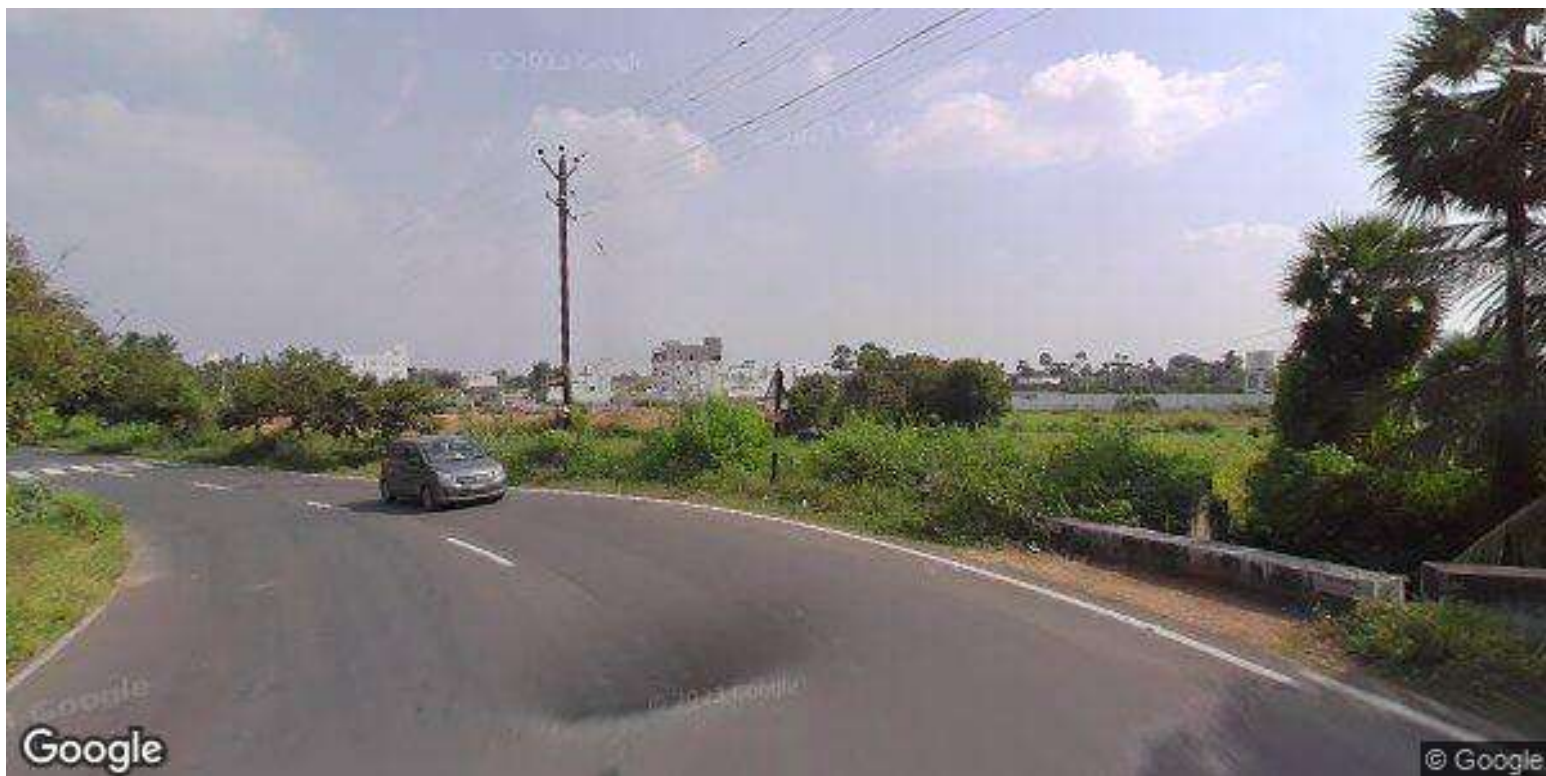
**Coordinates:** 11.45350, 77.85700

**Risk Type:** Turn

**Risk Level:** High

**Speed Limit:** 15 KM/Hr

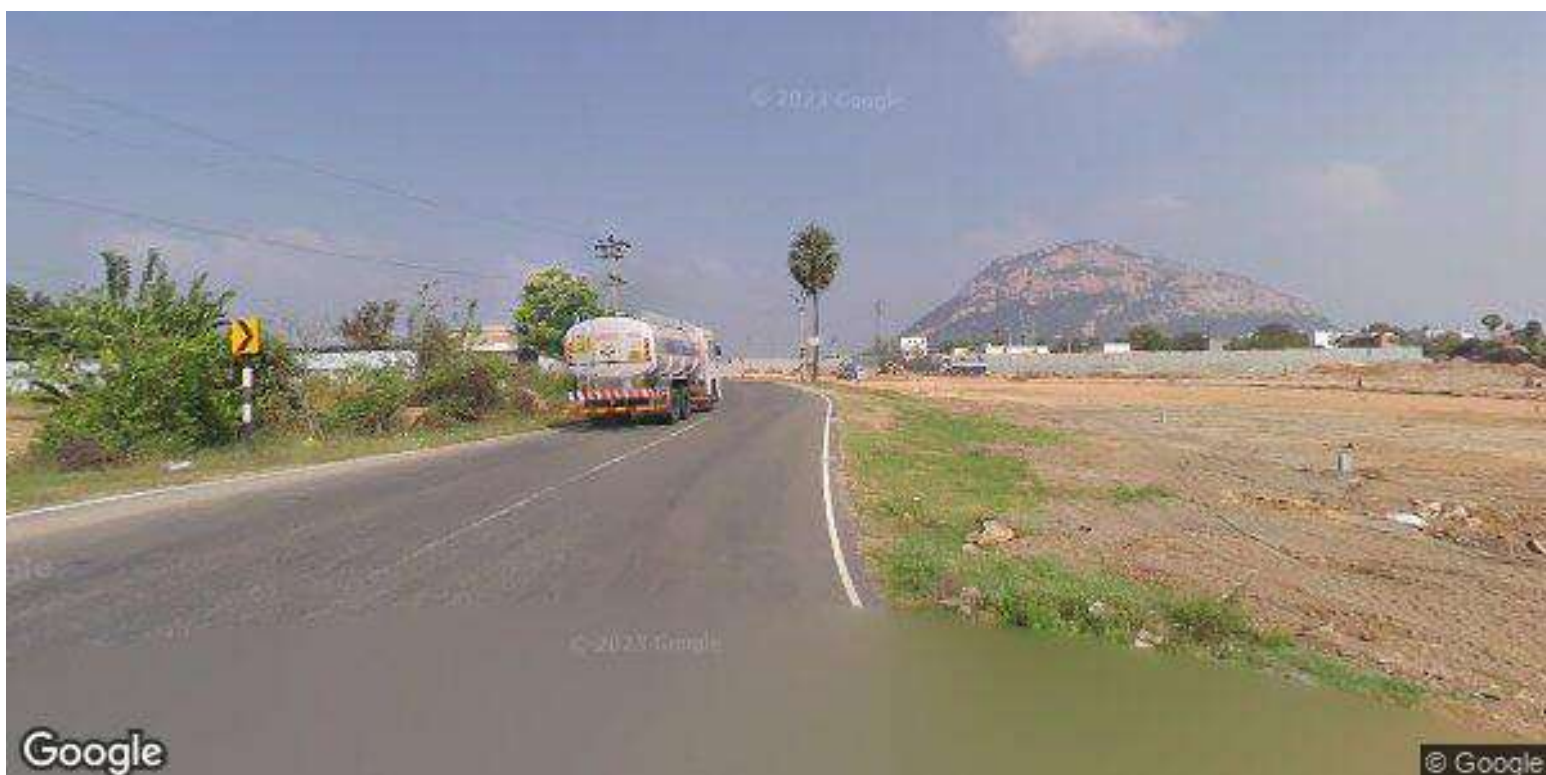
**Risk Type:** Turn  
**Risk Level:** Medium  
**Speed Limit:** 30 KM/Hr  
**Coordinates:** 11.45845, 77.85141

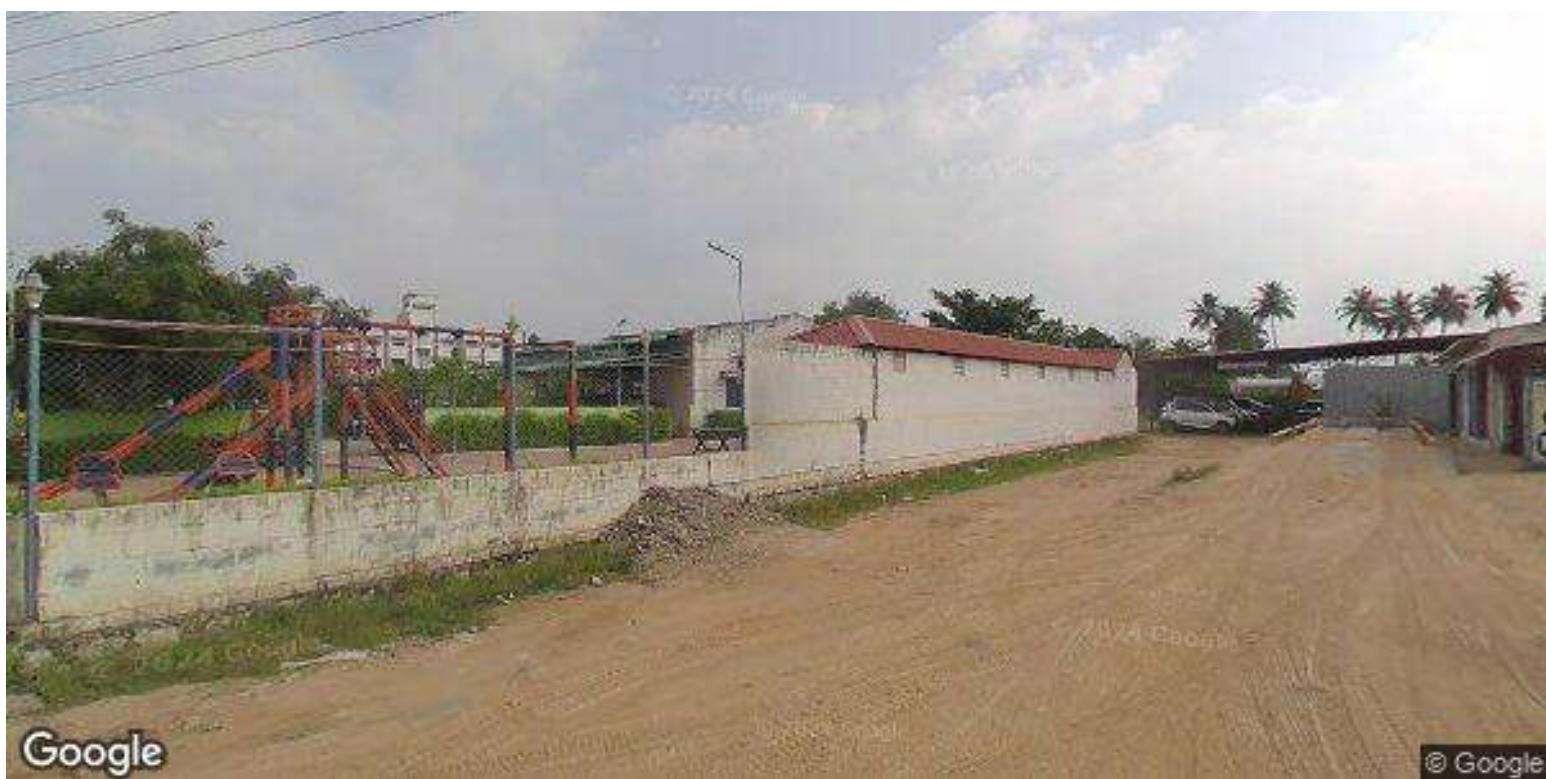
**Coordinates:** 11.44377, 77.71562

**Risk Type:** Turn

**Risk Level:** High

**Speed Limit:** 15 KM/Hr

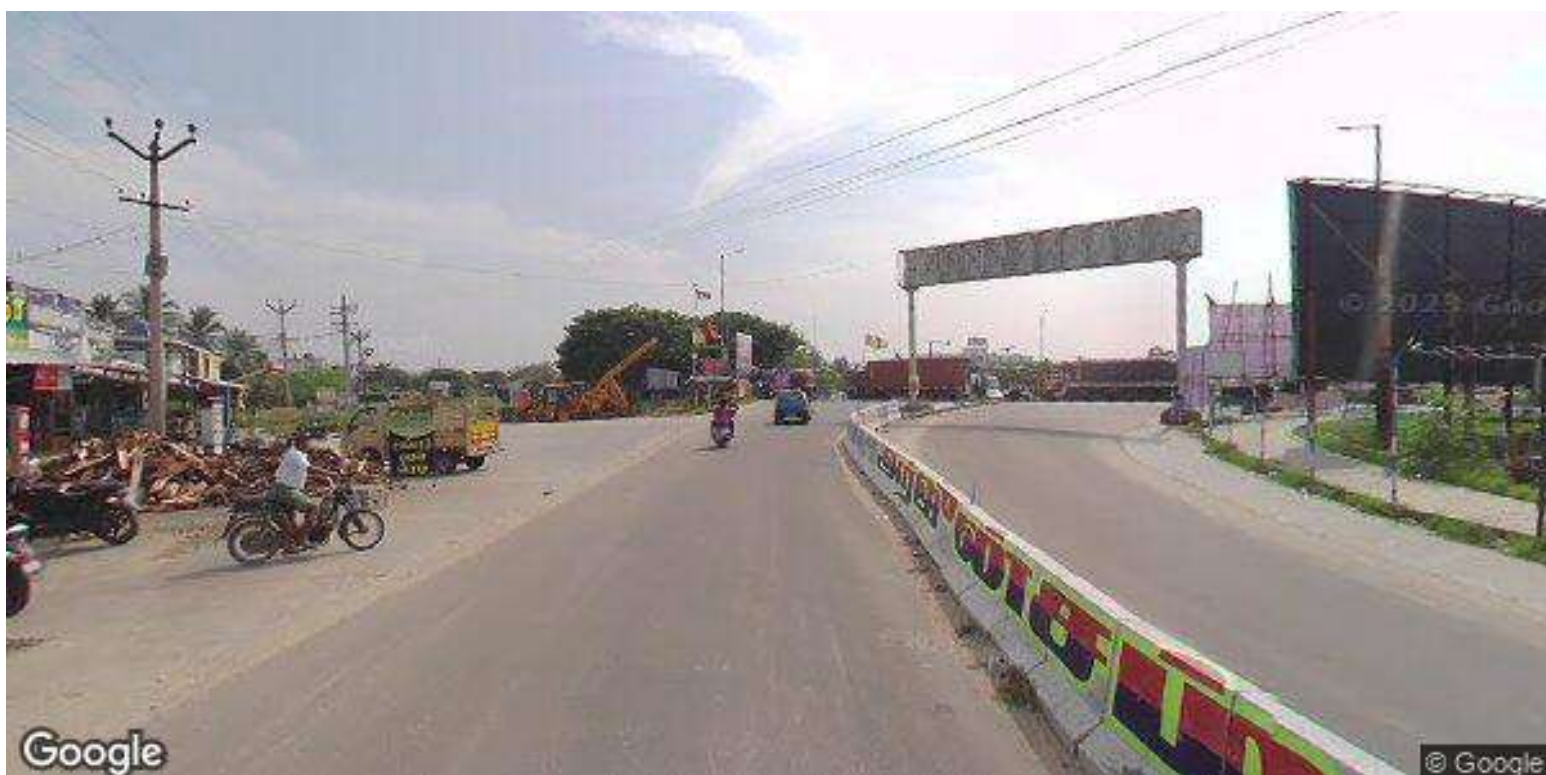
**Coordinates: 11.44438, 77.71501**

**Risk Type: Turn**

**Risk Level: Medium**

**Speed Limit: 30 KM/Hr**

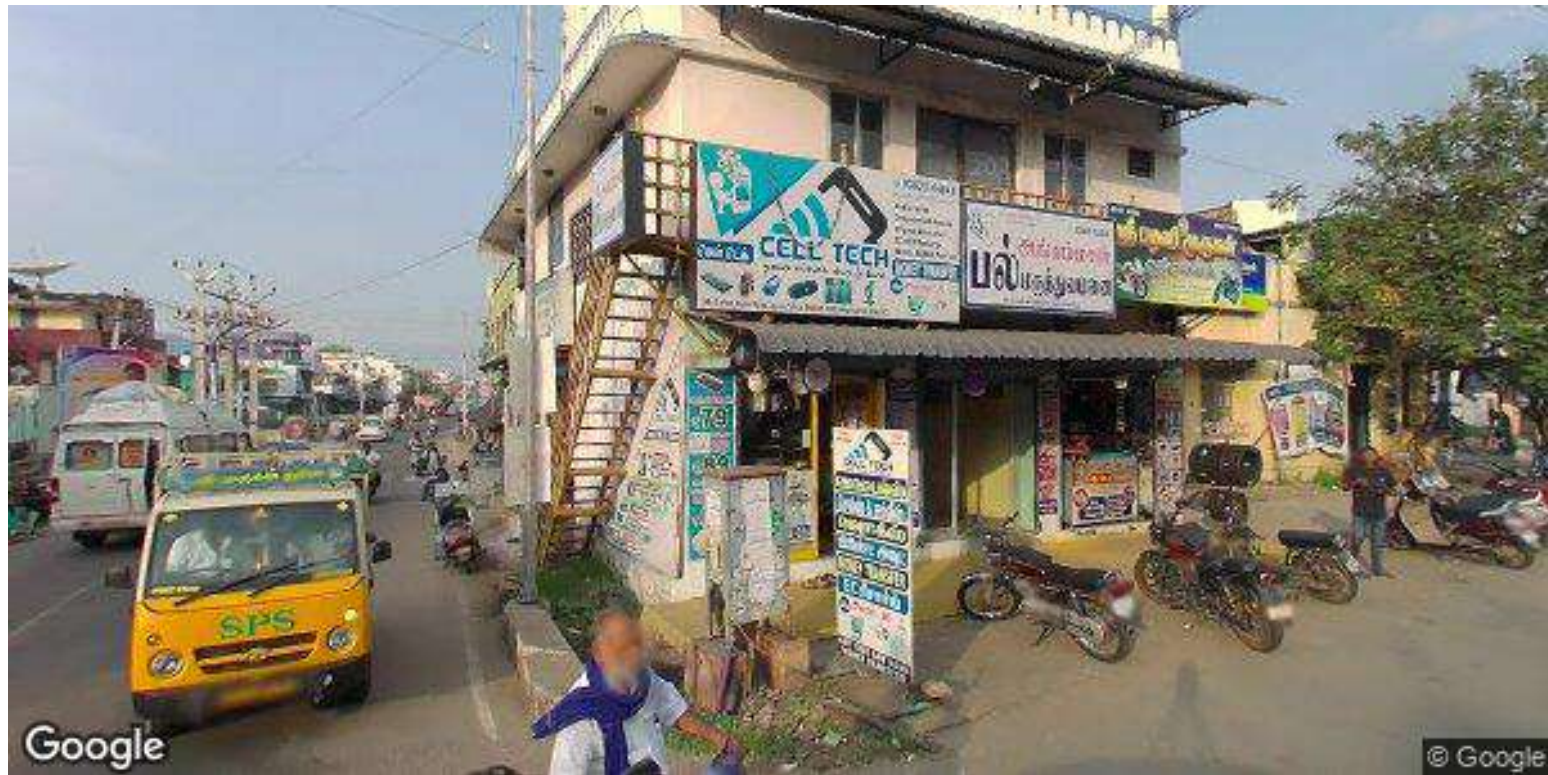
**Coordinates: 11.44111, 77.69331**

**Risk Type: Turn**

**Risk Level: High**

**Speed Limit: 15 KM/Hr**

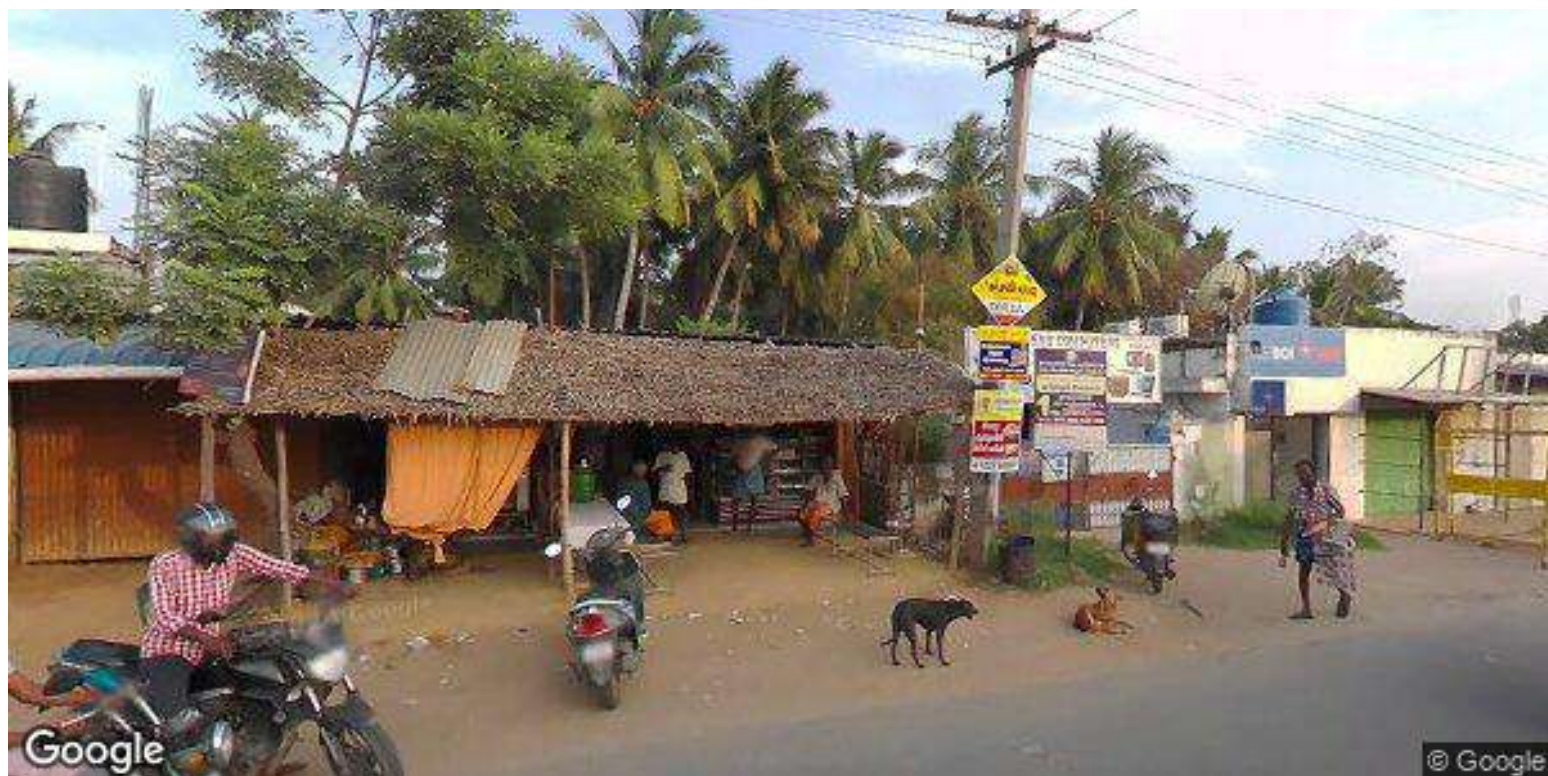
**Coordinates: 11.44985, 77.69520**

**Risk Type: Turn**

**Risk Level: High**

**Speed Limit: 15 KM/Hr**

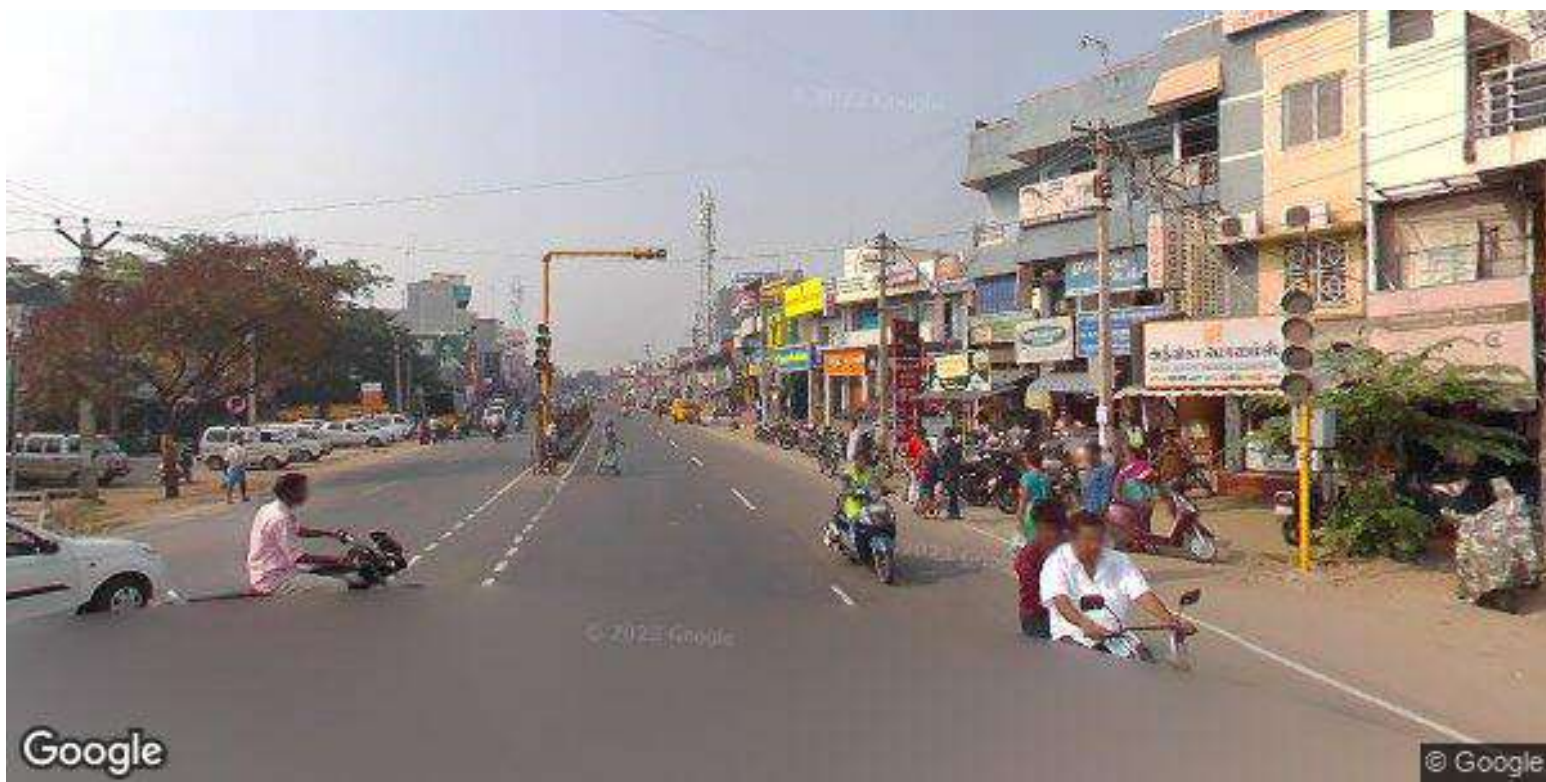
**Coordinates:** 11.45331, 77.68803

**Risk Type:** Turn

**Risk Level:** High

**Speed Limit:** 15 KM/Hr

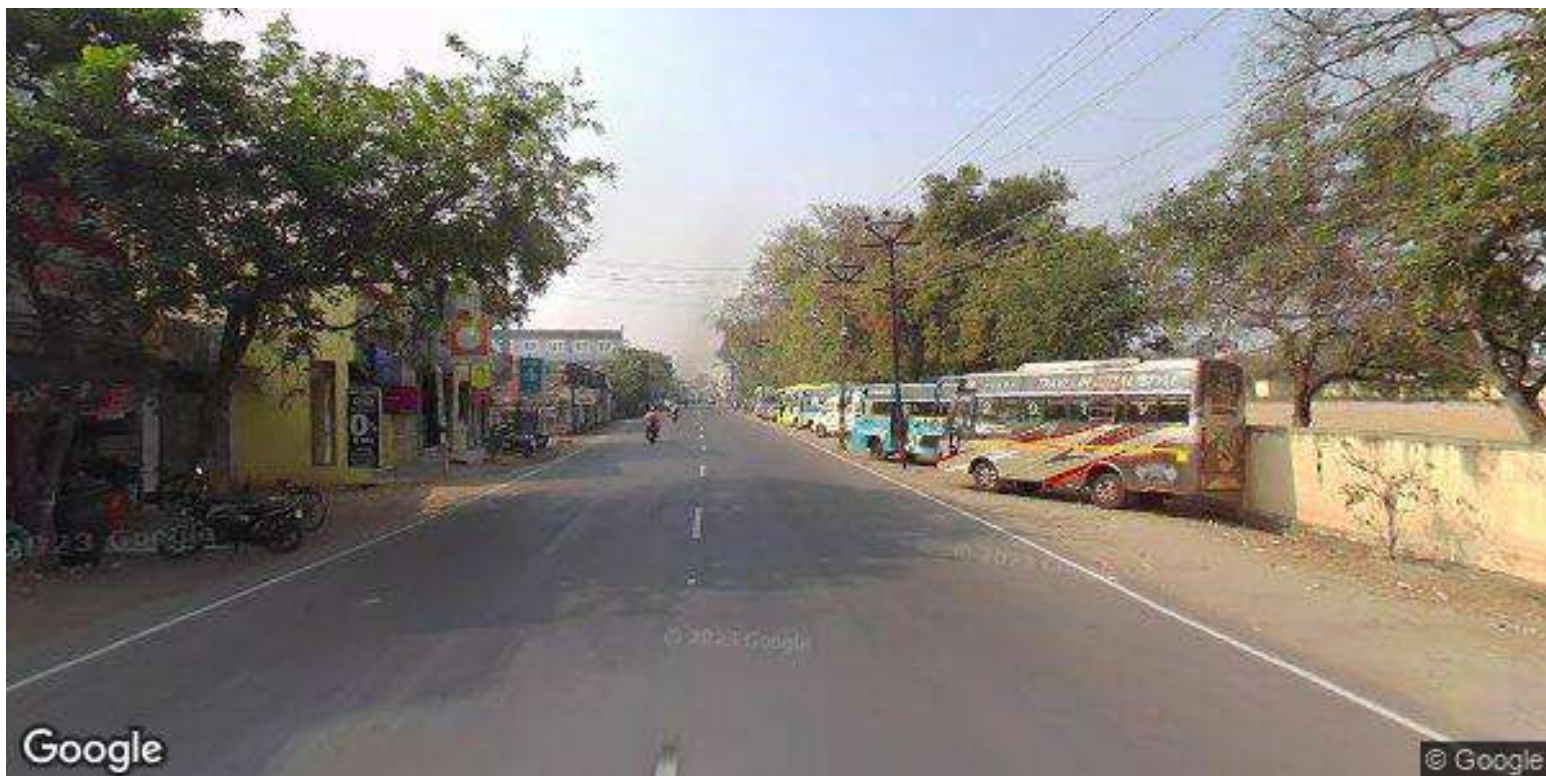
**Coordinates:** 11.44979, 77.68549

**Risk Type:** Blind Spot

**Risk Level:** Blind Spot

**Speed Limit:** 10 KM/Hr

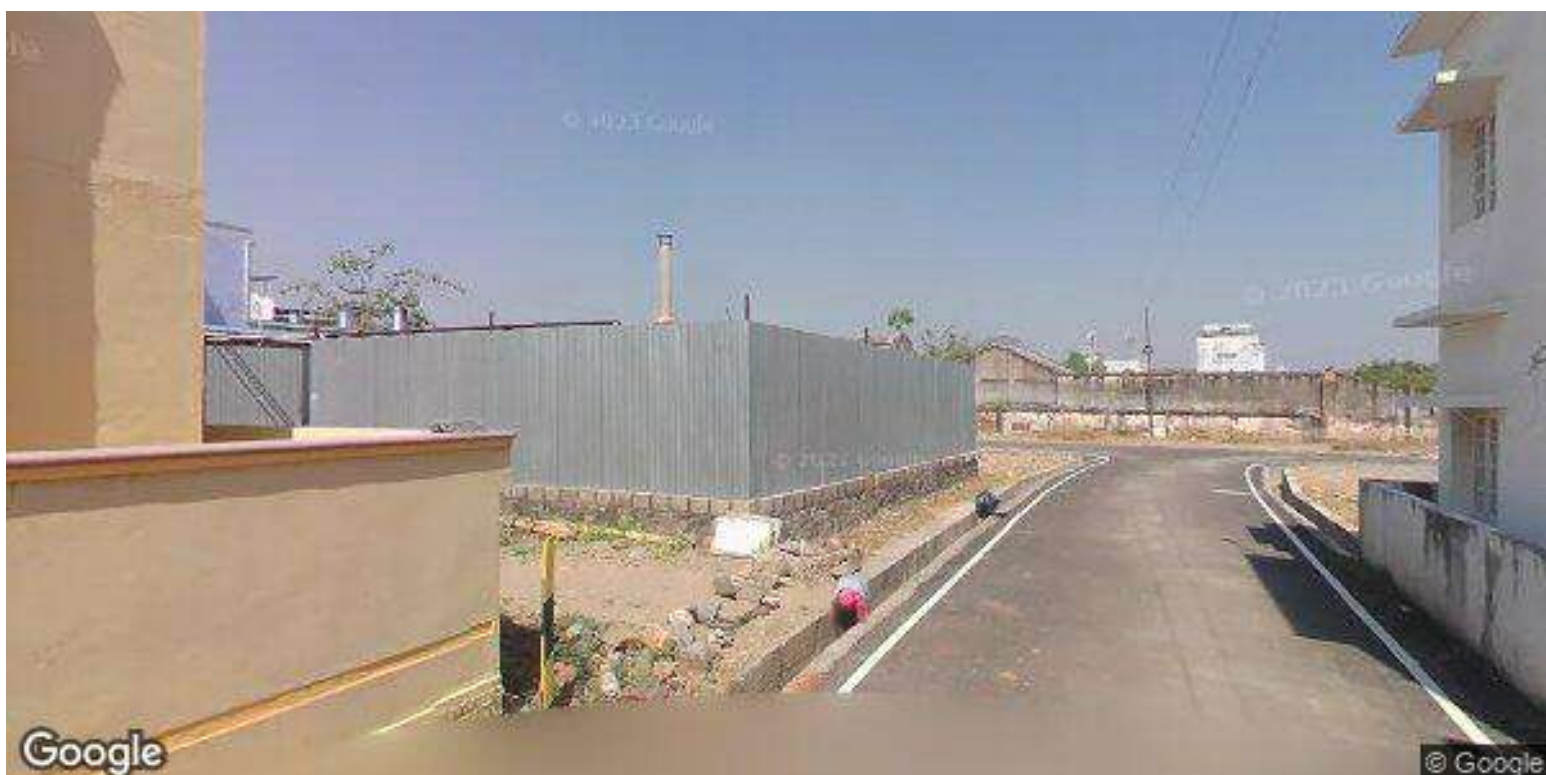
**Risk Type:** Turn  
**Risk Level:** High  
**Speed Limit:** 15 KM/Hr  
**Coordinates:** 11.44948, 77.68645

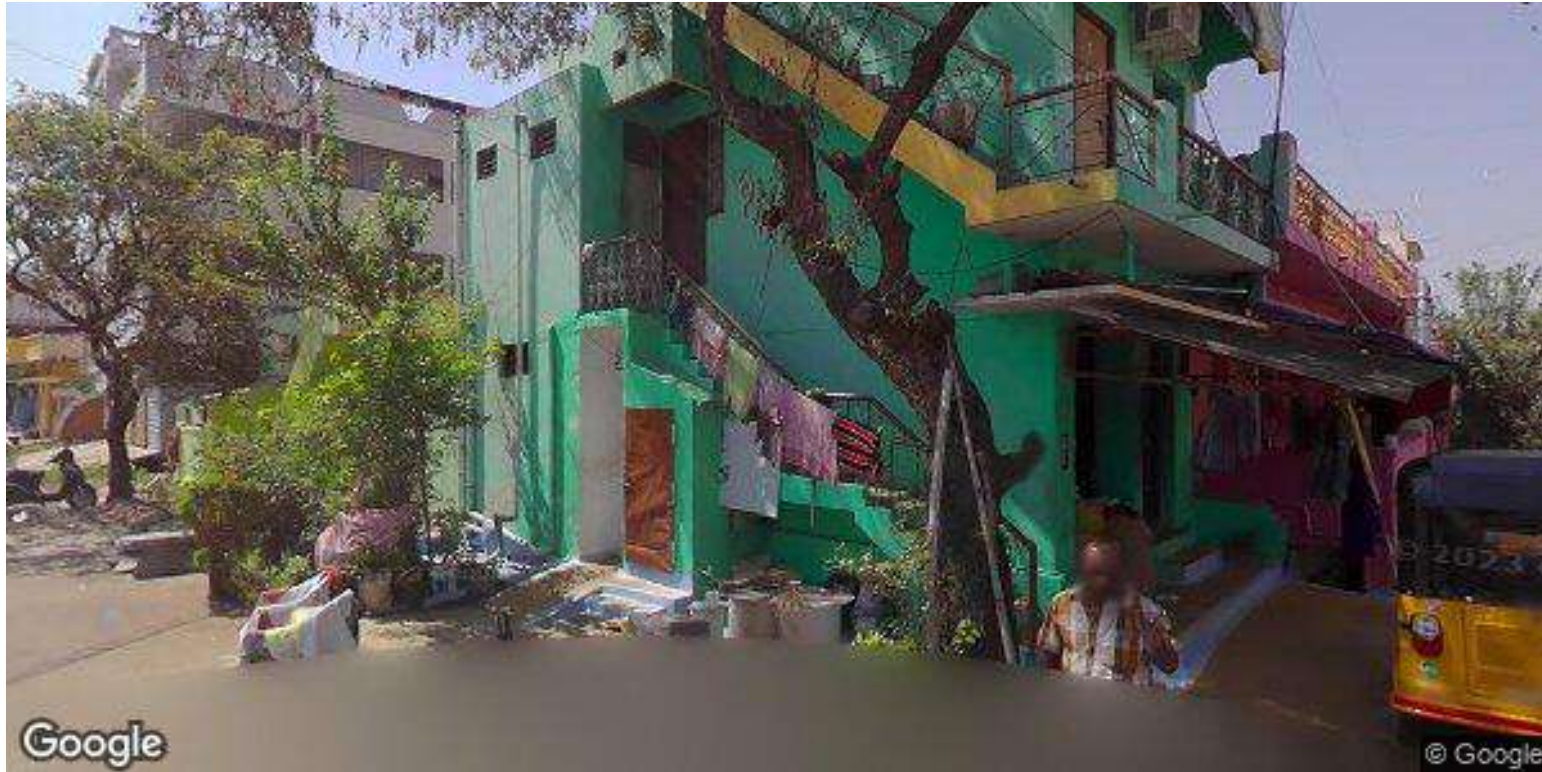
**Risk Type:** Turn  
**Risk Level:** High  
**Speed Limit:** 15 KM/Hr  
**Coordinates:** 11.44801, 77.68596

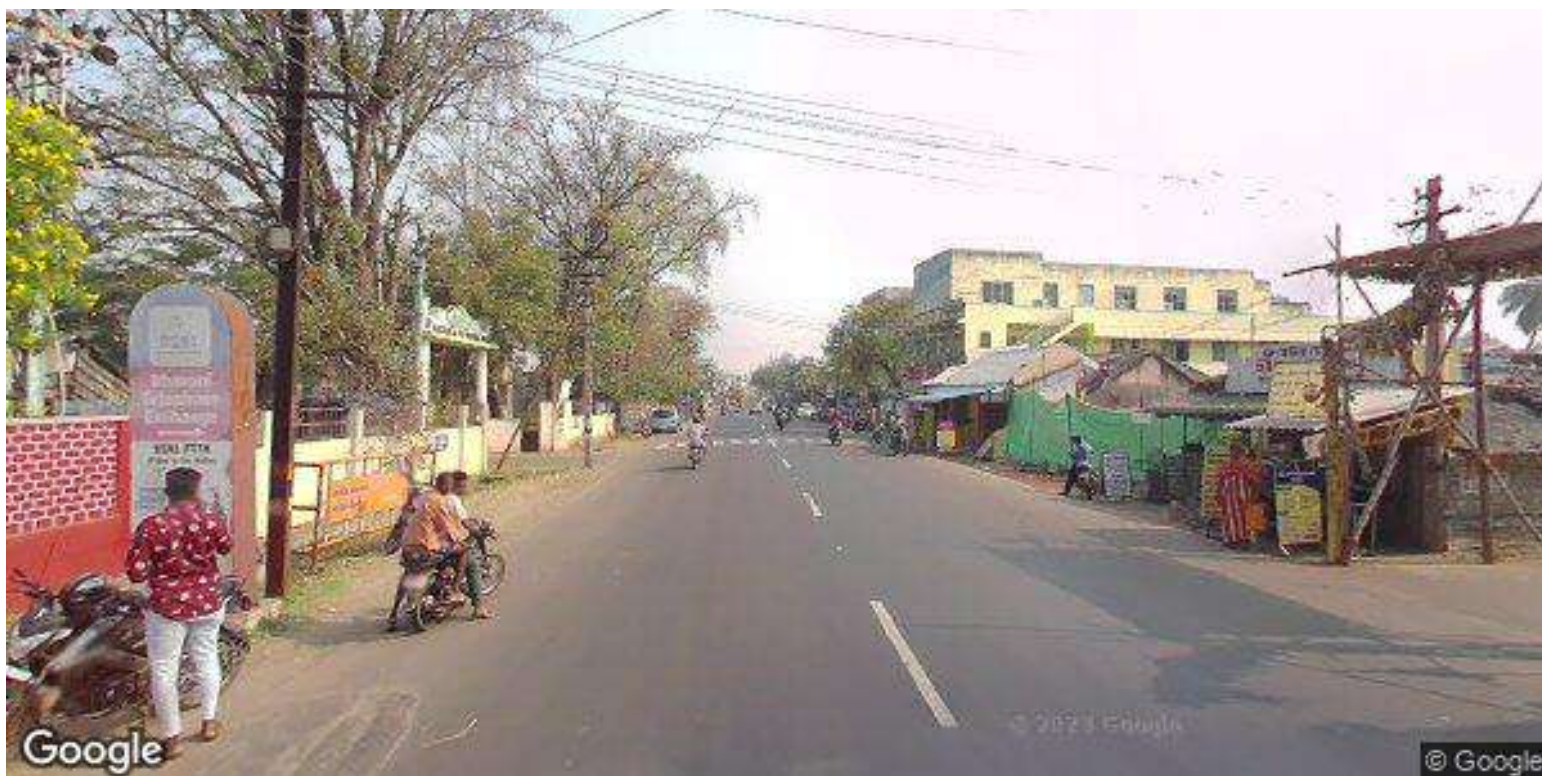
**Risk Type:** Blind Spot  
**Risk Level:** Blind Spot  
**Speed Limit:** 10 KM/Hr  
**Coordinates:** 11.44842, 77.68473

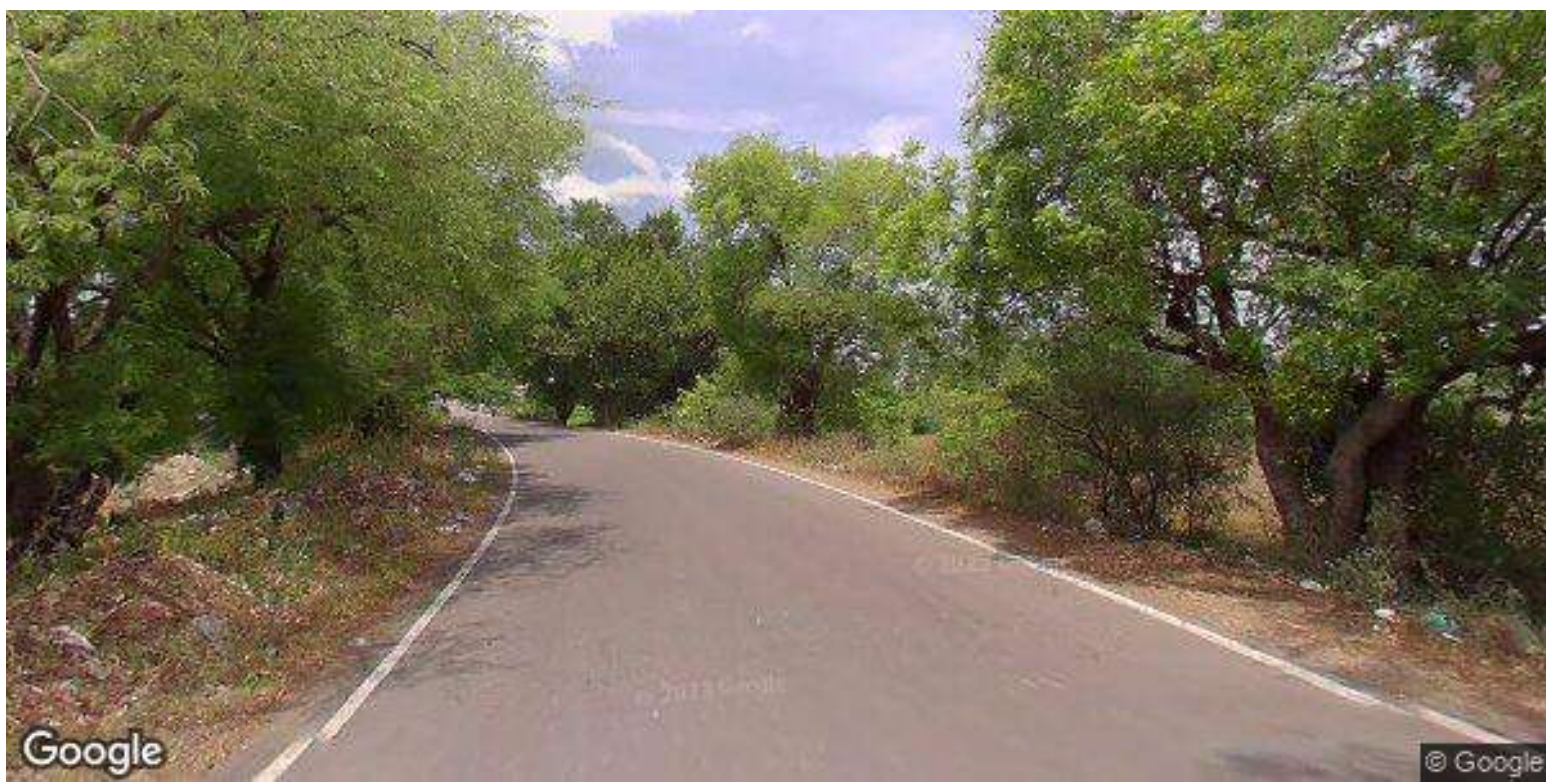
**Coordinates:** 11.55440, 77.71815

**Risk Type:** Turn

**Risk Level:** Medium

**Speed Limit:** 30 KM/Hr

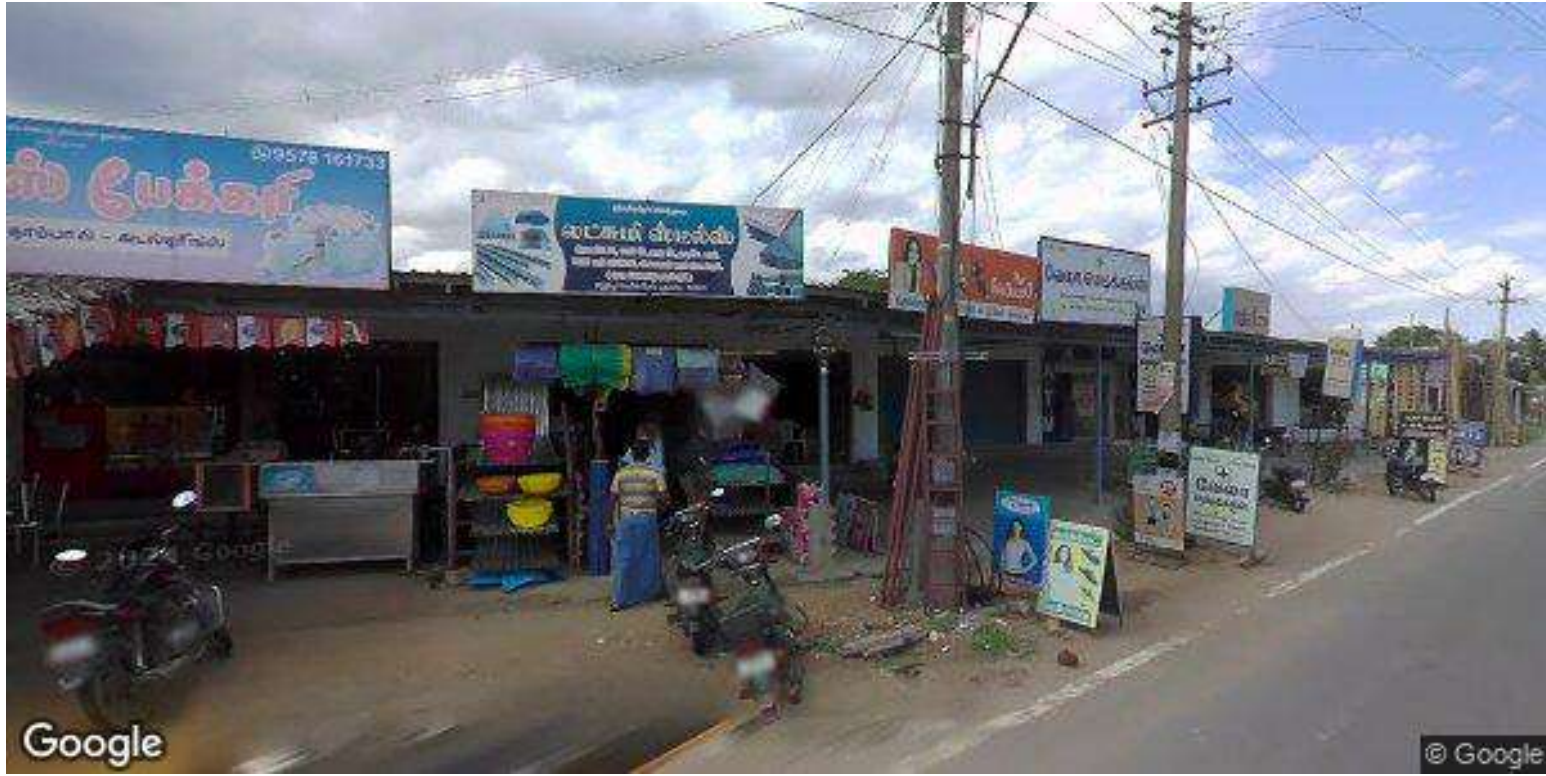
**Coordinates:** 11.61026, 77.71748

**Risk Type:** Blind Spot

**Risk Level:** Blind Spot

**Speed Limit:** 10 KM/Hr

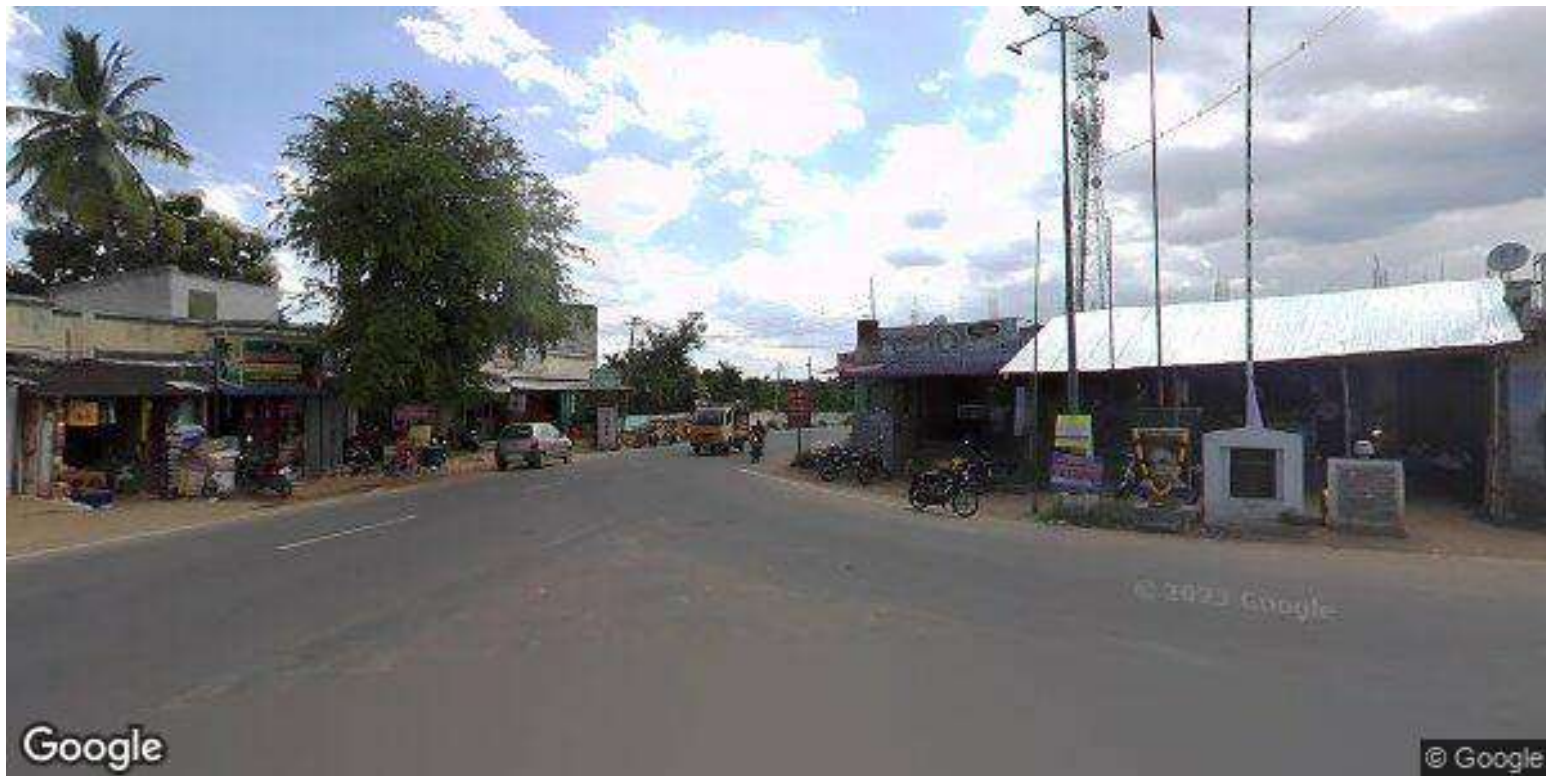
**Coordinates:** 11.60985, 77.71617

**Risk Type:** Turn

**Risk Level:** High

**Speed Limit:** 15 KM/Hr

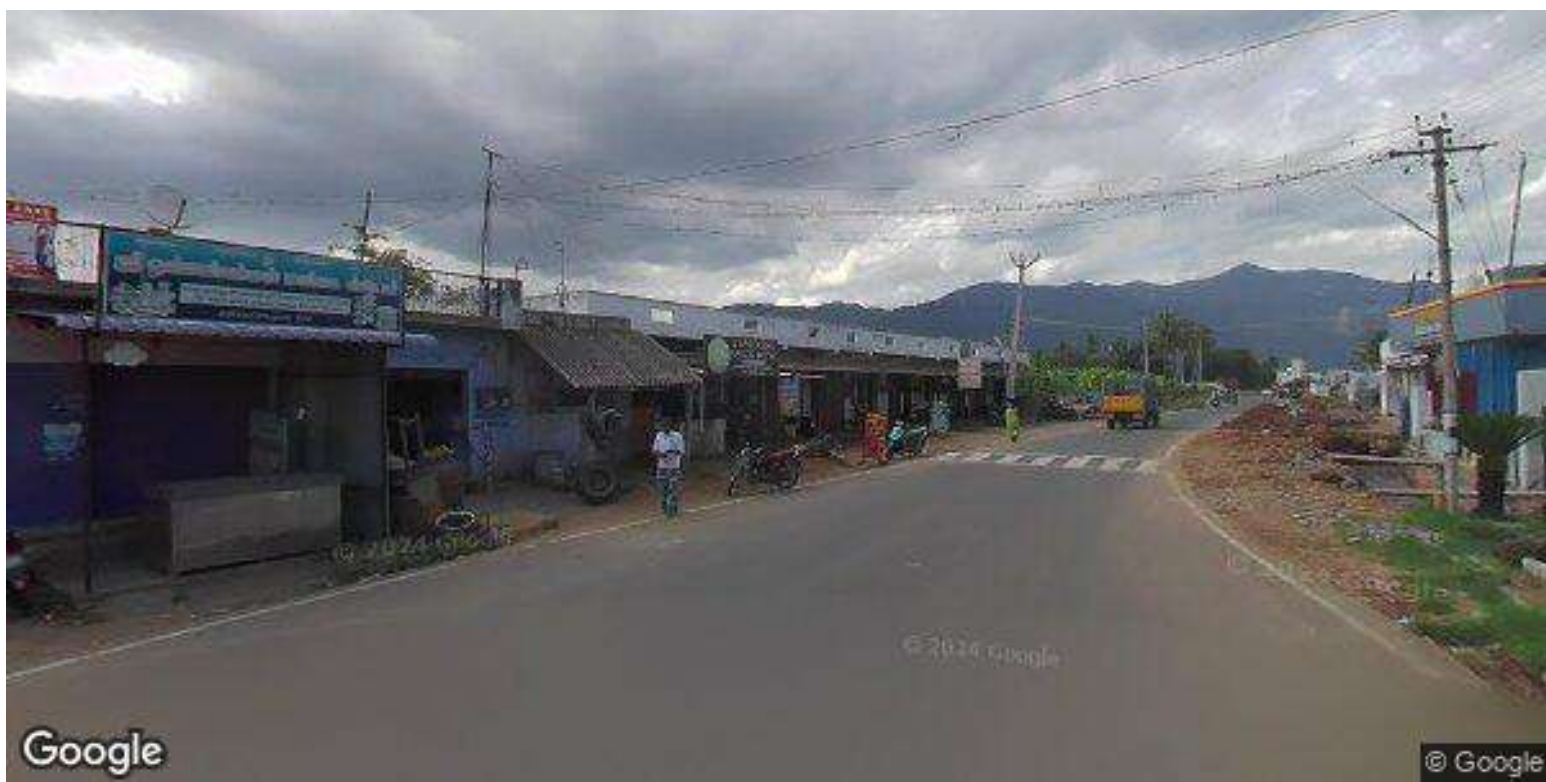
**Coordinates:** 11.60999, 77.71606

**Risk Type:** Turn

**Risk Level:** High

**Speed Limit:** 15 KM/Hr

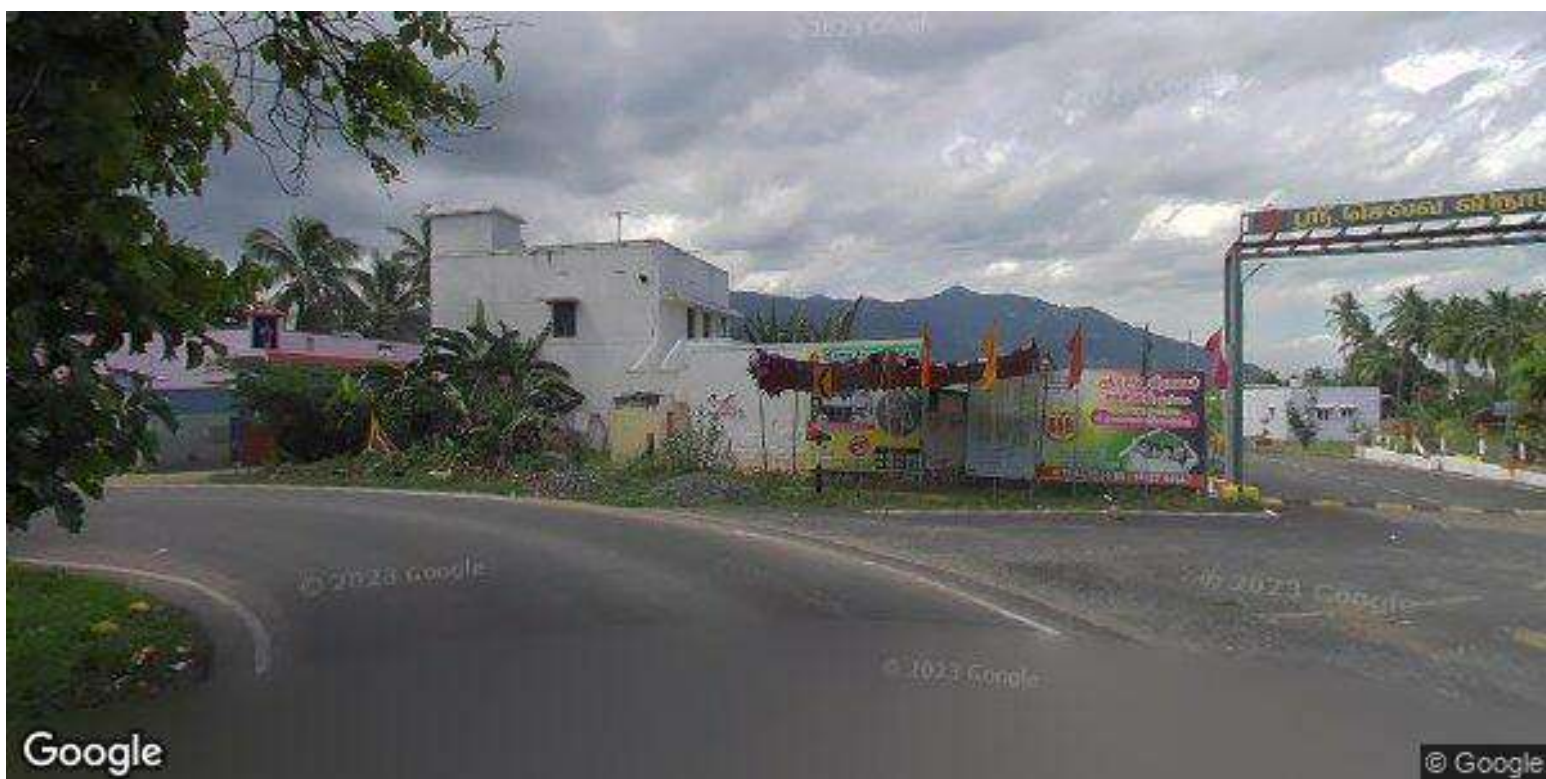
**Coordinates:** 11.61277, 77.71687

**Risk Type:** Turn

**Risk Level:** High

**Speed Limit:** 15 KM/Hr
