# IndianOil

## JOURNEY RISK MANAGEMENT (JRM) STUDY

### Salem Terminal TO RL AGENCY

Route Safety Analysis Report: CVQF+23W, Sangagiri to JMWJ+6P8, Guruvareddiur

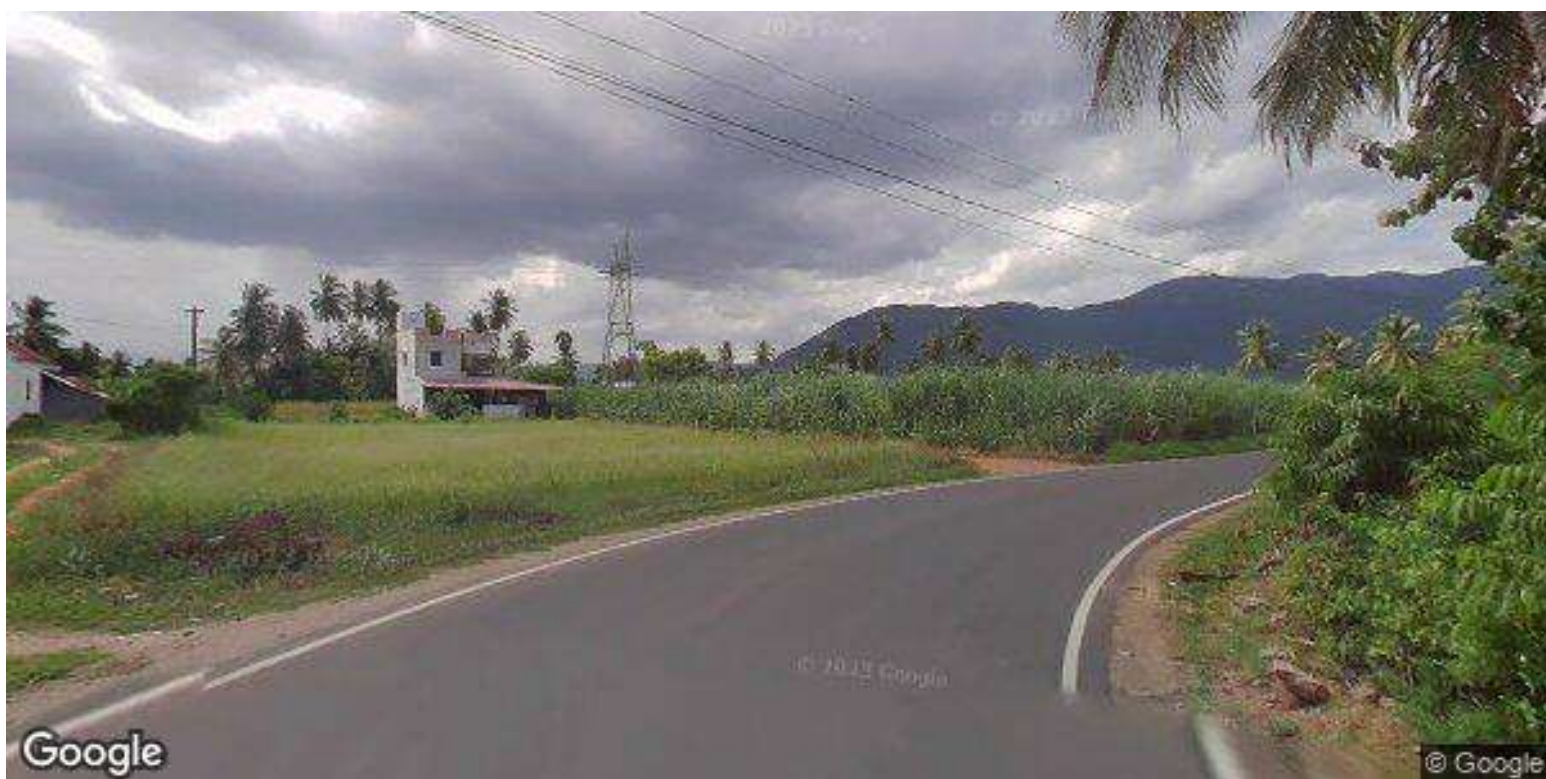
**Risk Type:** Turn  
**Risk Level:** High  
**Speed Limit:** 15 KM/Hr  
**Coordinates:** 11.61330, 77.71567

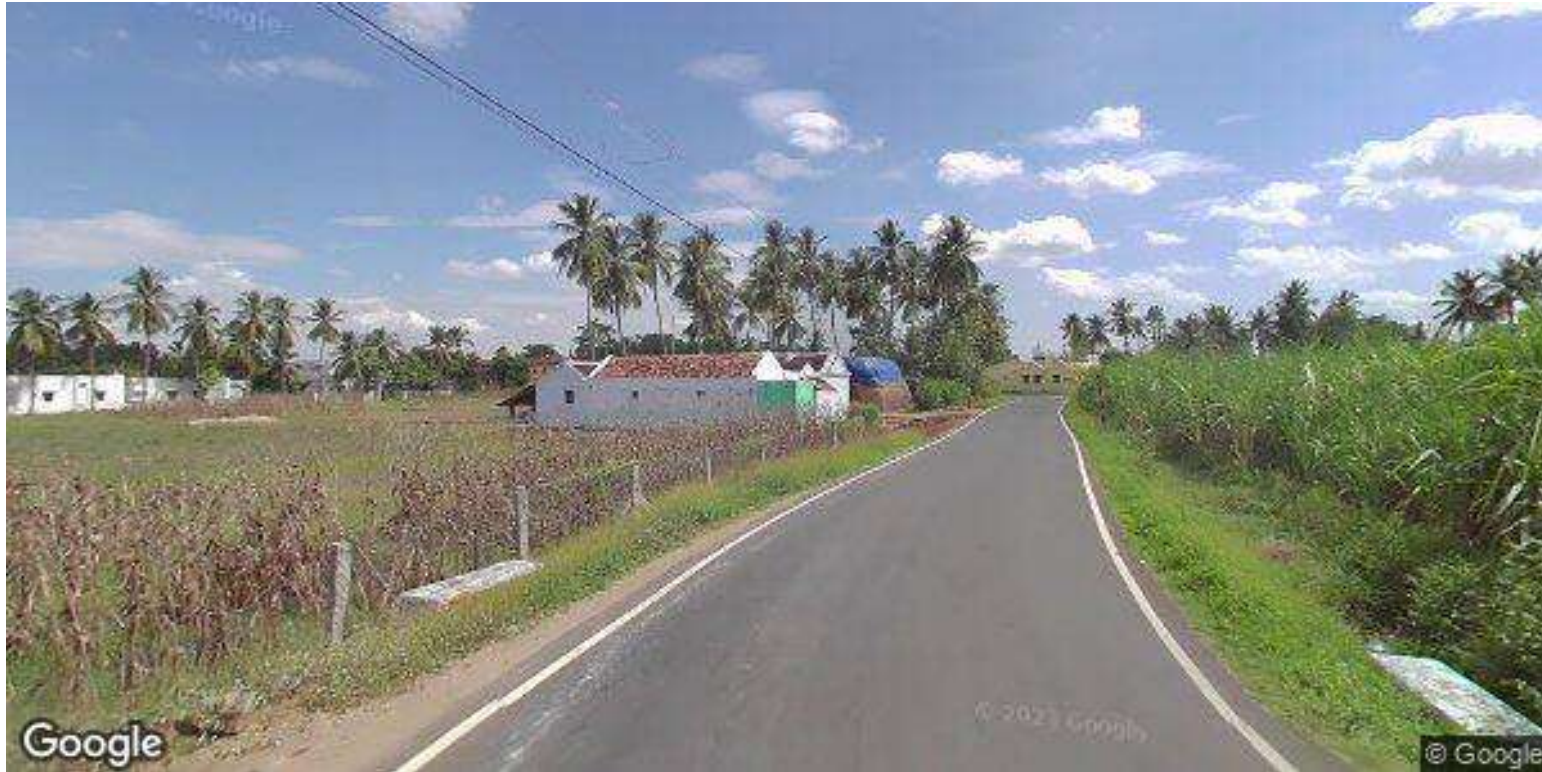
**Risk Type:** Turn  
**Risk Level:** High  
**Speed Limit:** 15 KM/Hr  
**Coordinates:** 11.61424, 77.71584

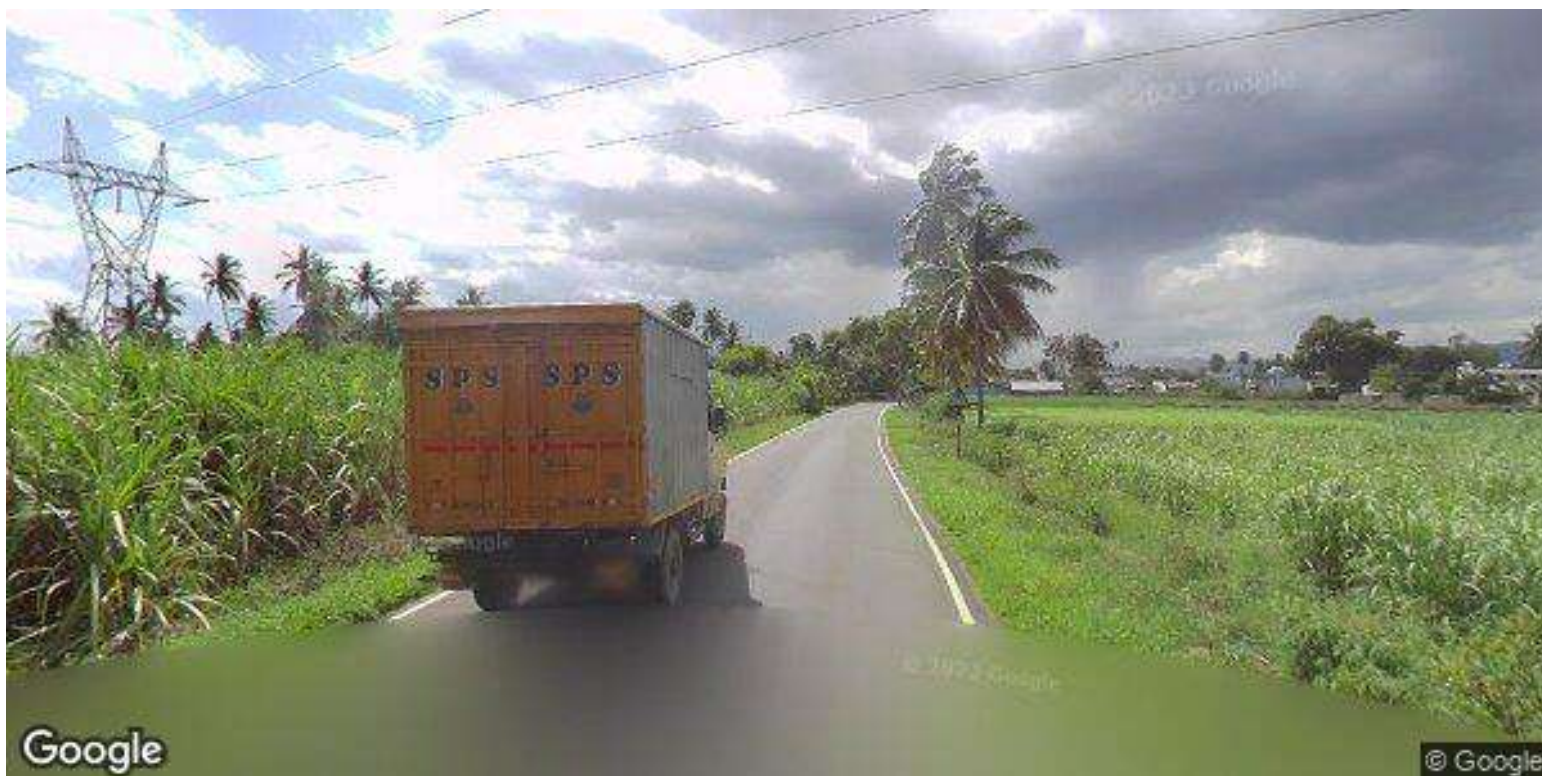
**Risk Type:** Turn  
**Risk Level:** Medium  
**Speed Limit:** 30 KM/Hr  
**Coordinates:** 11.61439, 77.71570

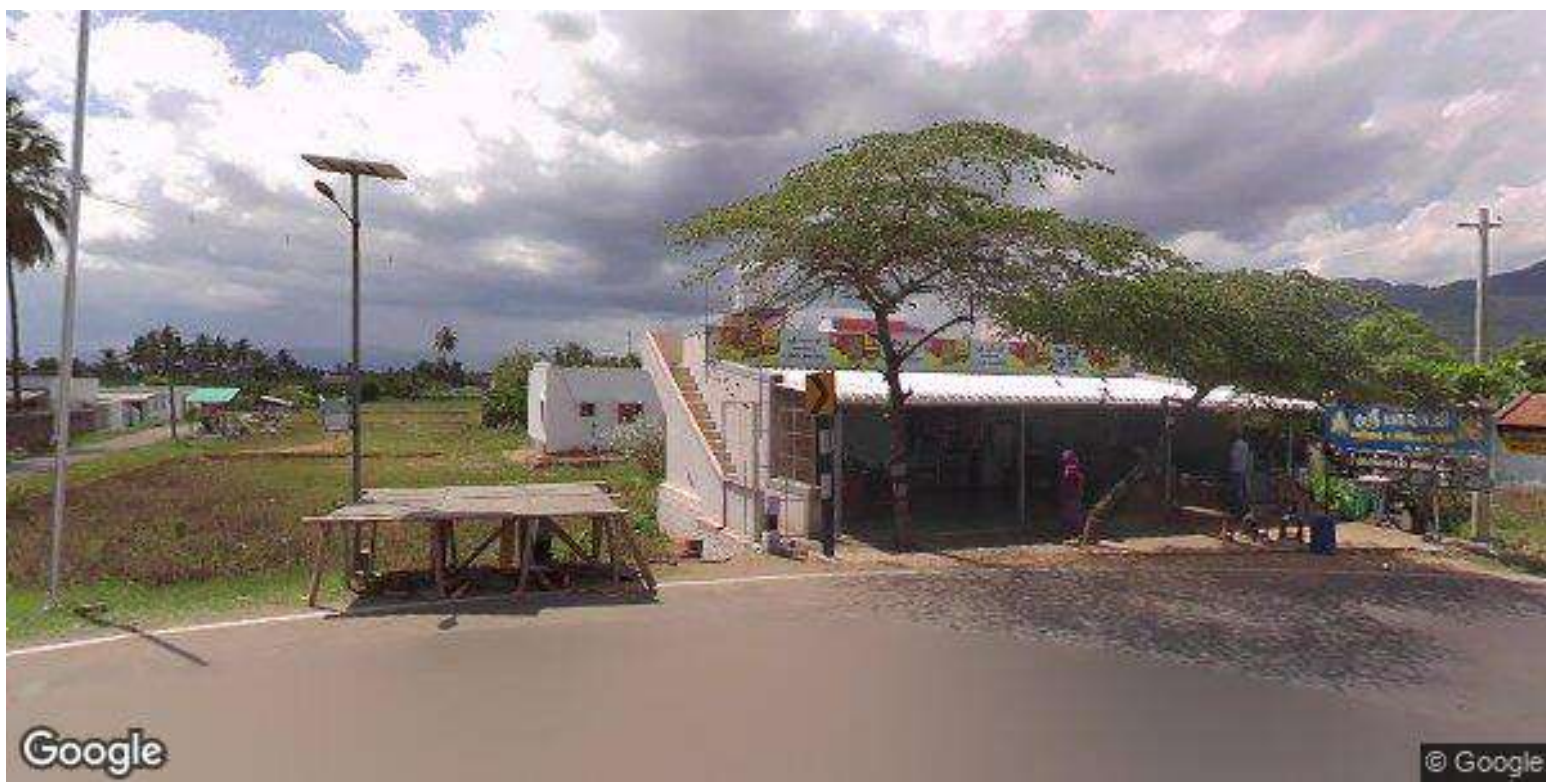
**Coordinates:** 11.61537, 77.71369

**Risk Type:** Turn

**Risk Level:** High

**Speed Limit:** 15 KM/Hr

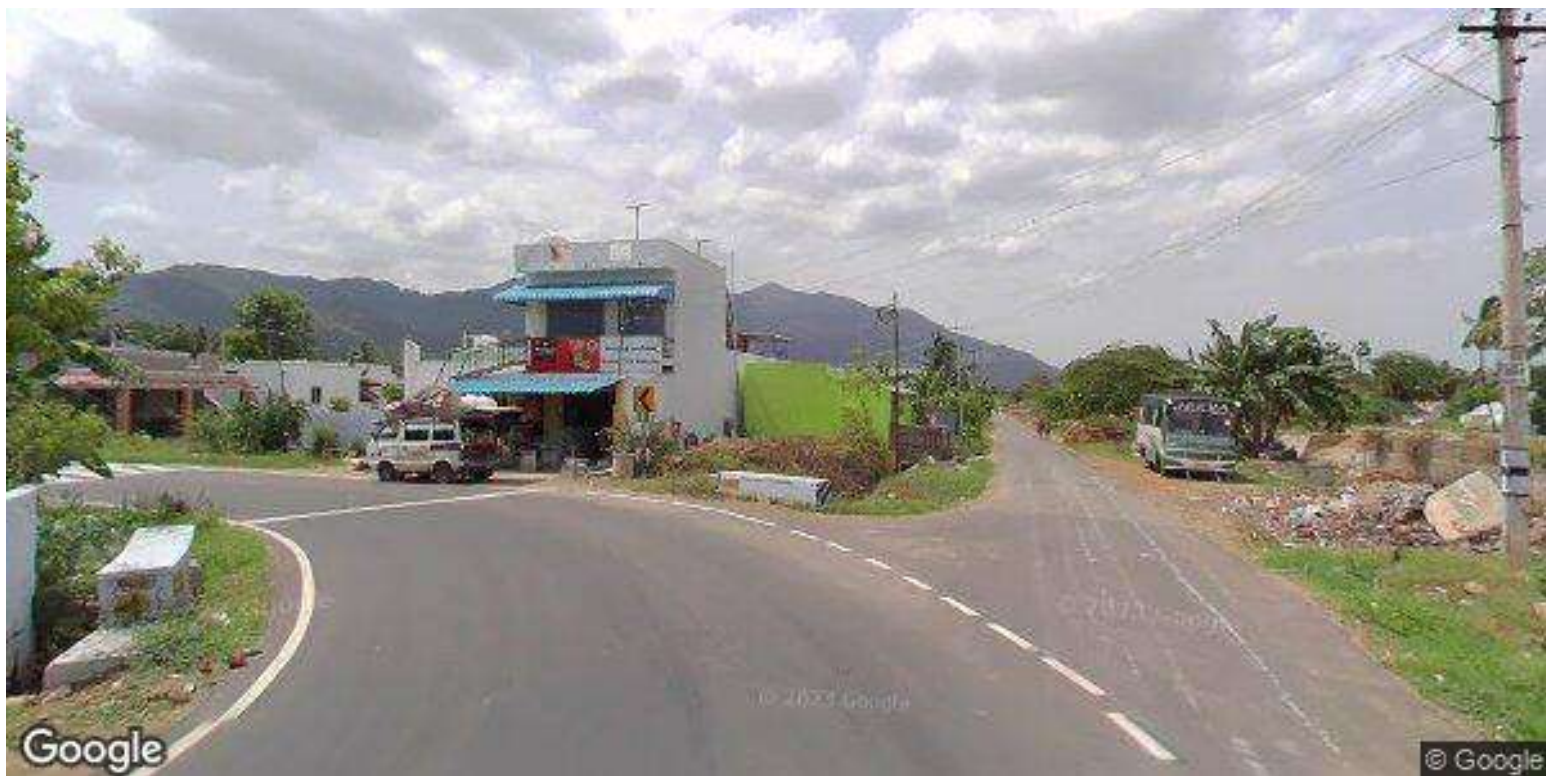
**Coordinates:** 11.61584, 77.71389

**Risk Type:** Turn

**Risk Level:** Medium

**Speed Limit:** 30 KM/Hr

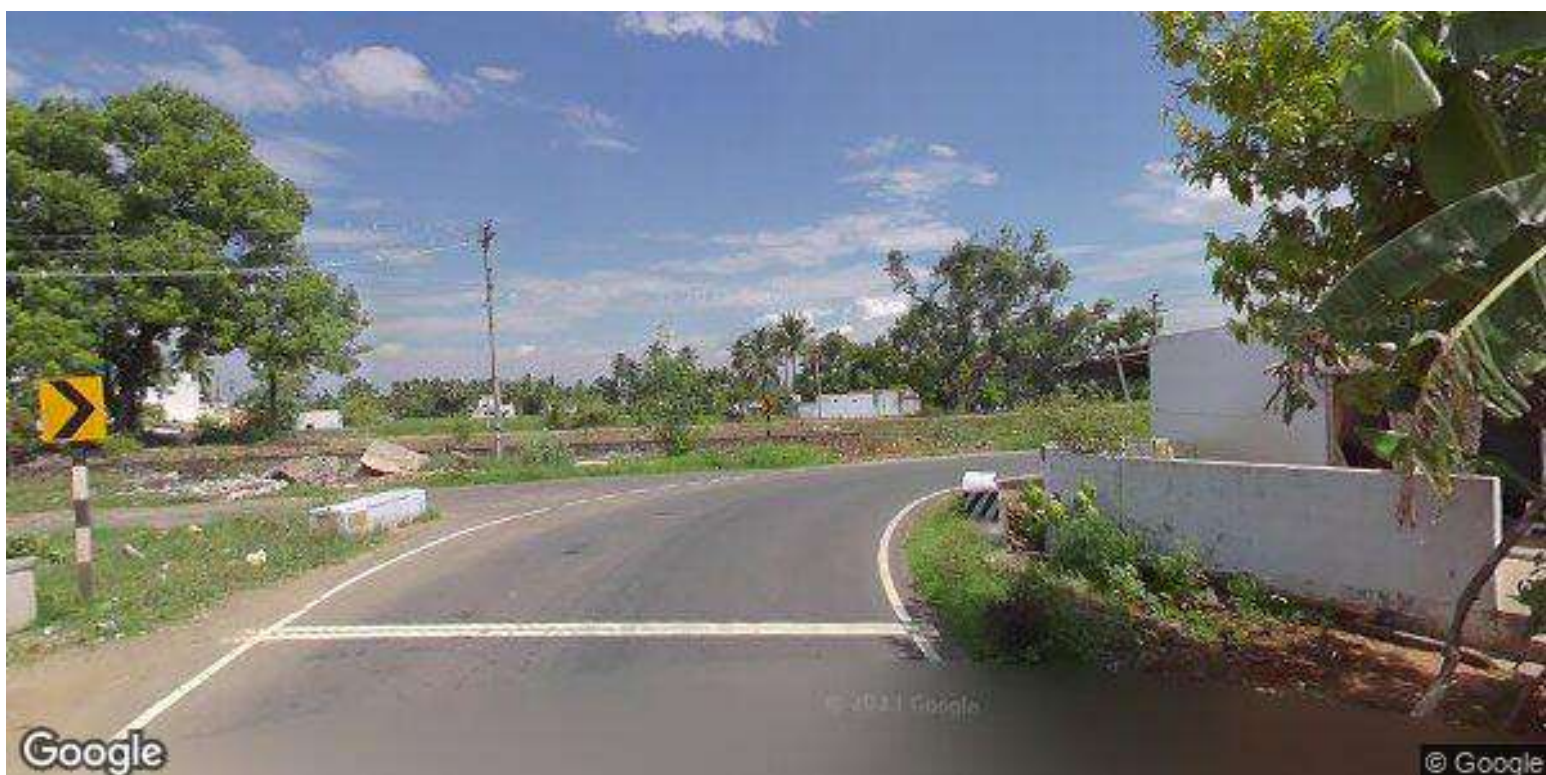
**Risk Type:** Turn  
**Risk Level:** Medium  
**Speed Limit:** 30 KM/Hr  
**Coordinates:** 11.61597, 77.71385

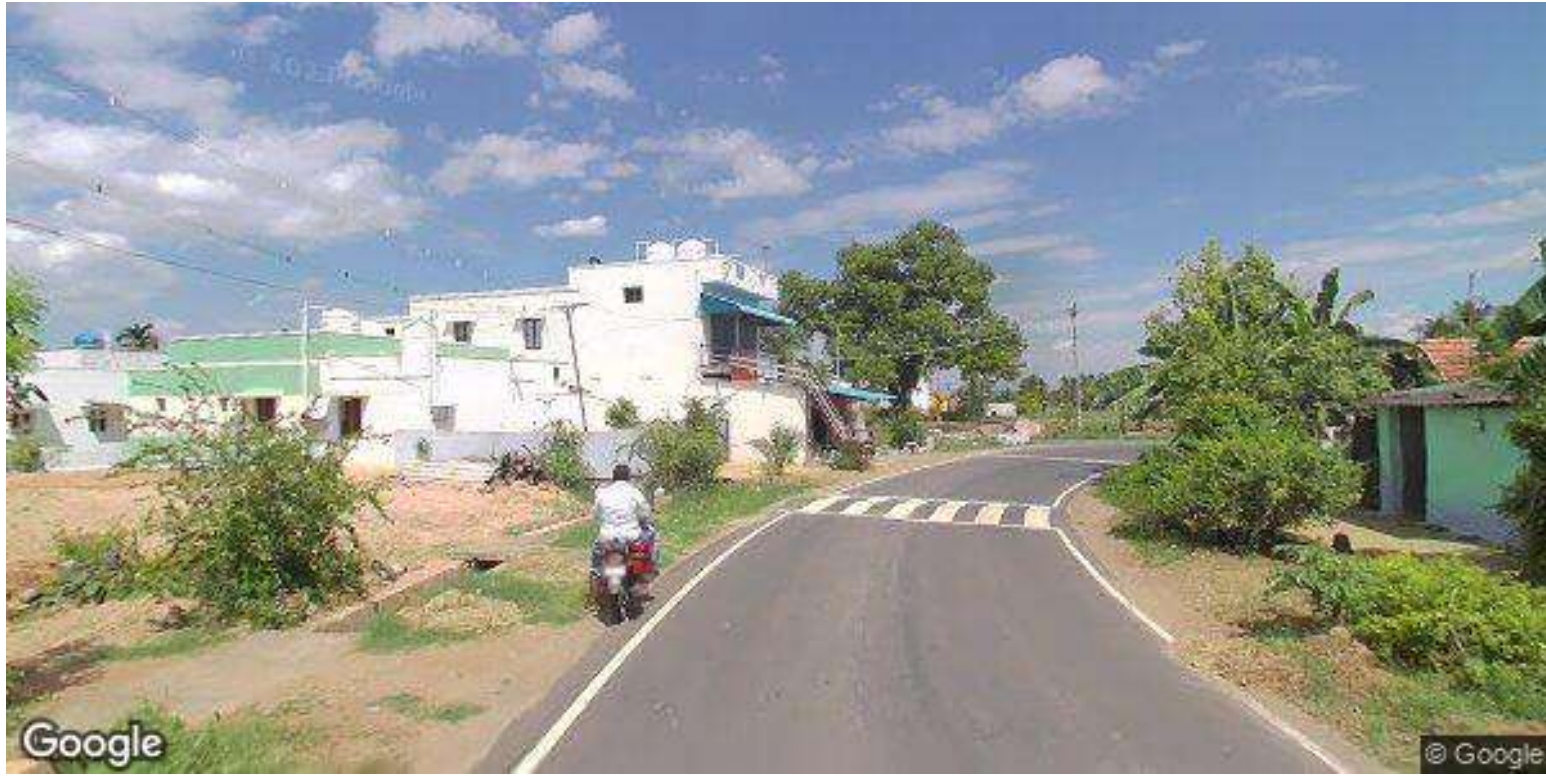
**Risk Type:** Turn  
**Risk Level:** Medium  
**Speed Limit:** 30 KM/Hr  
**Coordinates:** 11.61608, 77.71371

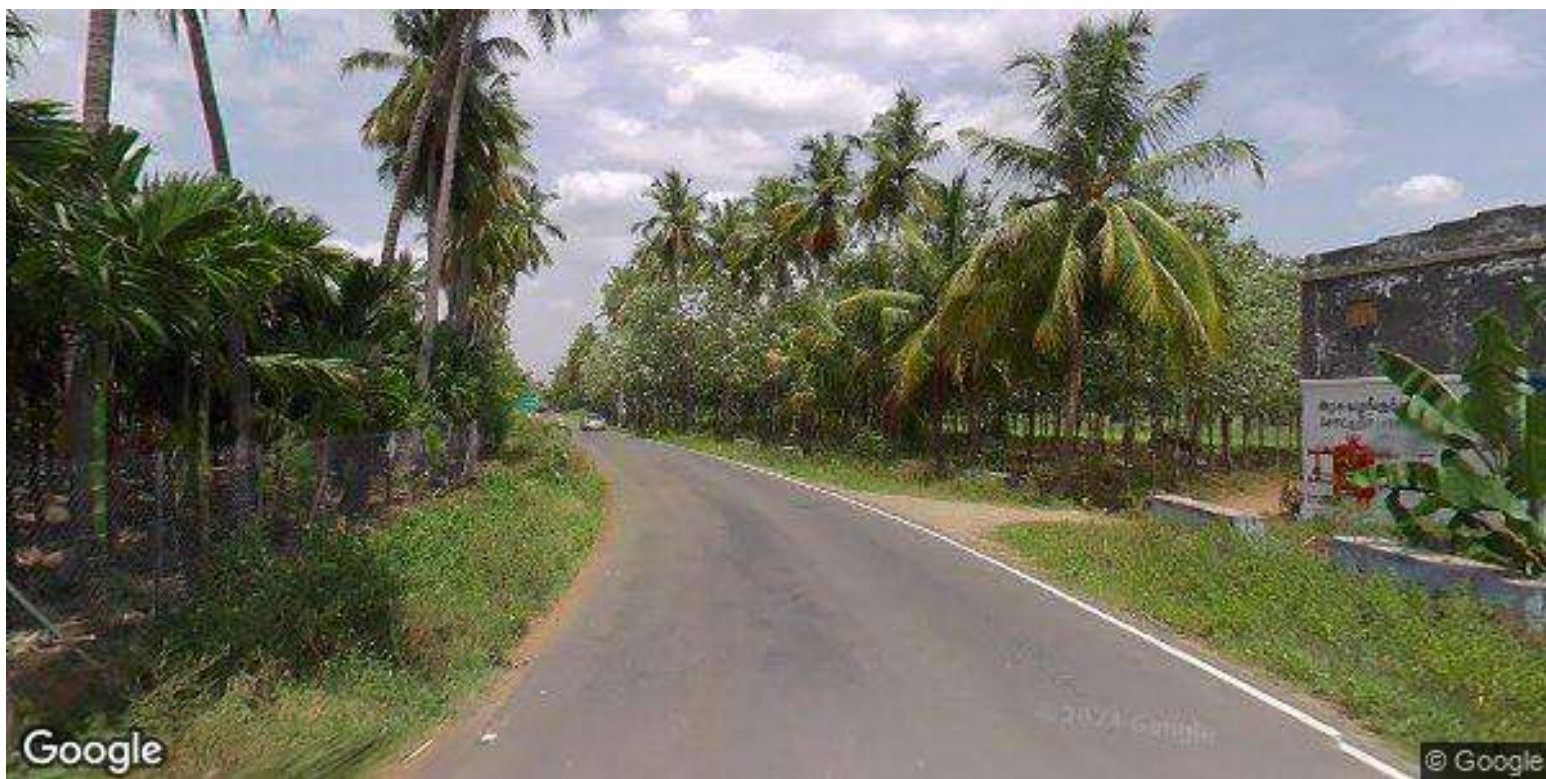
**Risk Type:** Turn  
**Risk Level:** Medium  
**Speed Limit:** 30 KM/Hr  
**Coordinates:** 11.61792, 77.71017

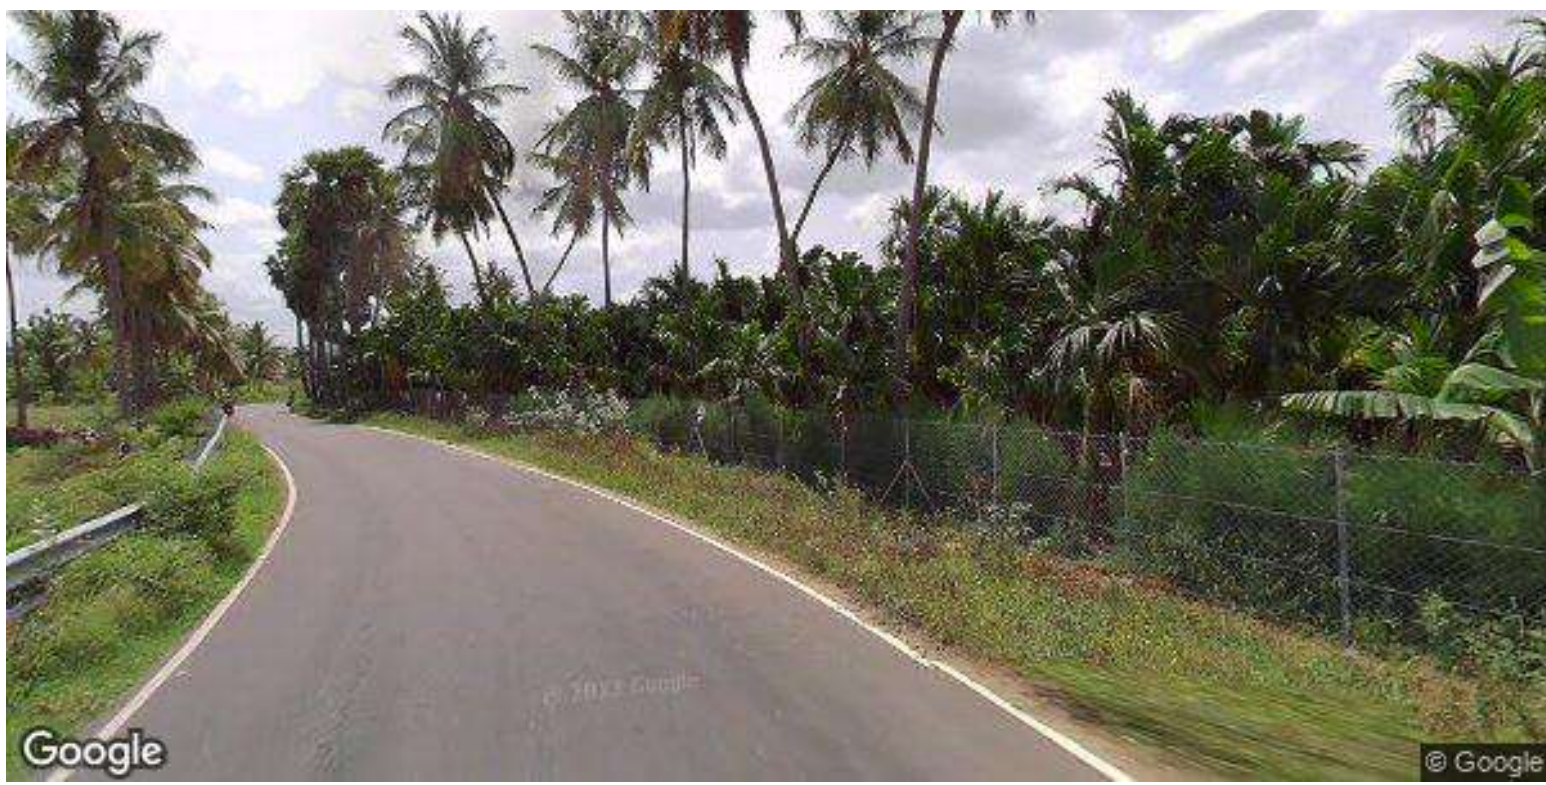
**Coordinates:** 11.61875, 77.70972

**Risk Type:** Turn

**Risk Level:** Medium

**Speed Limit:** 30 KM/Hr

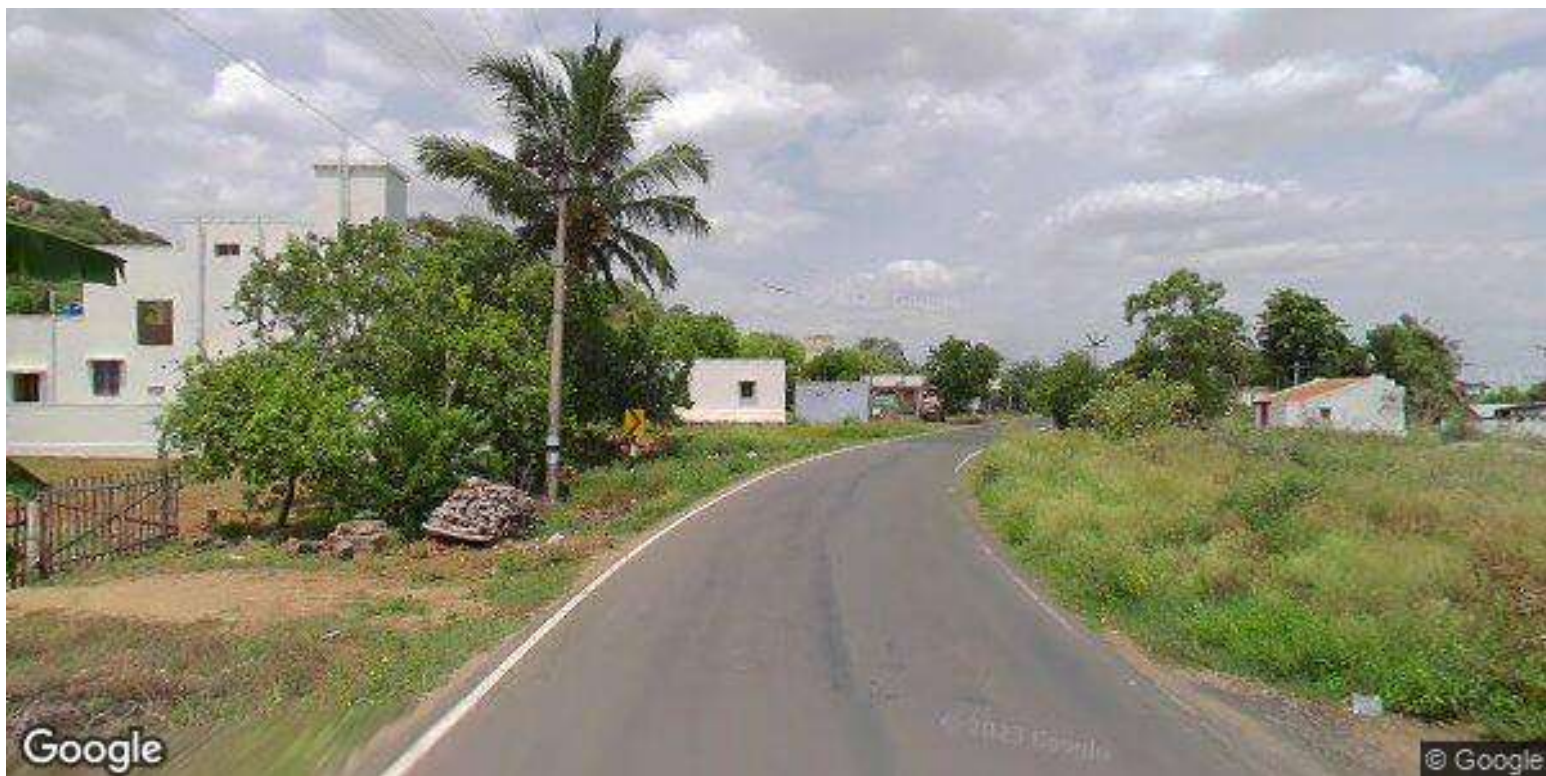
**Coordinates:** 11.63368, 77.69795

**Risk Type:** Turn

**Risk Level:** Medium

**Speed Limit:** 30 KM/Hr

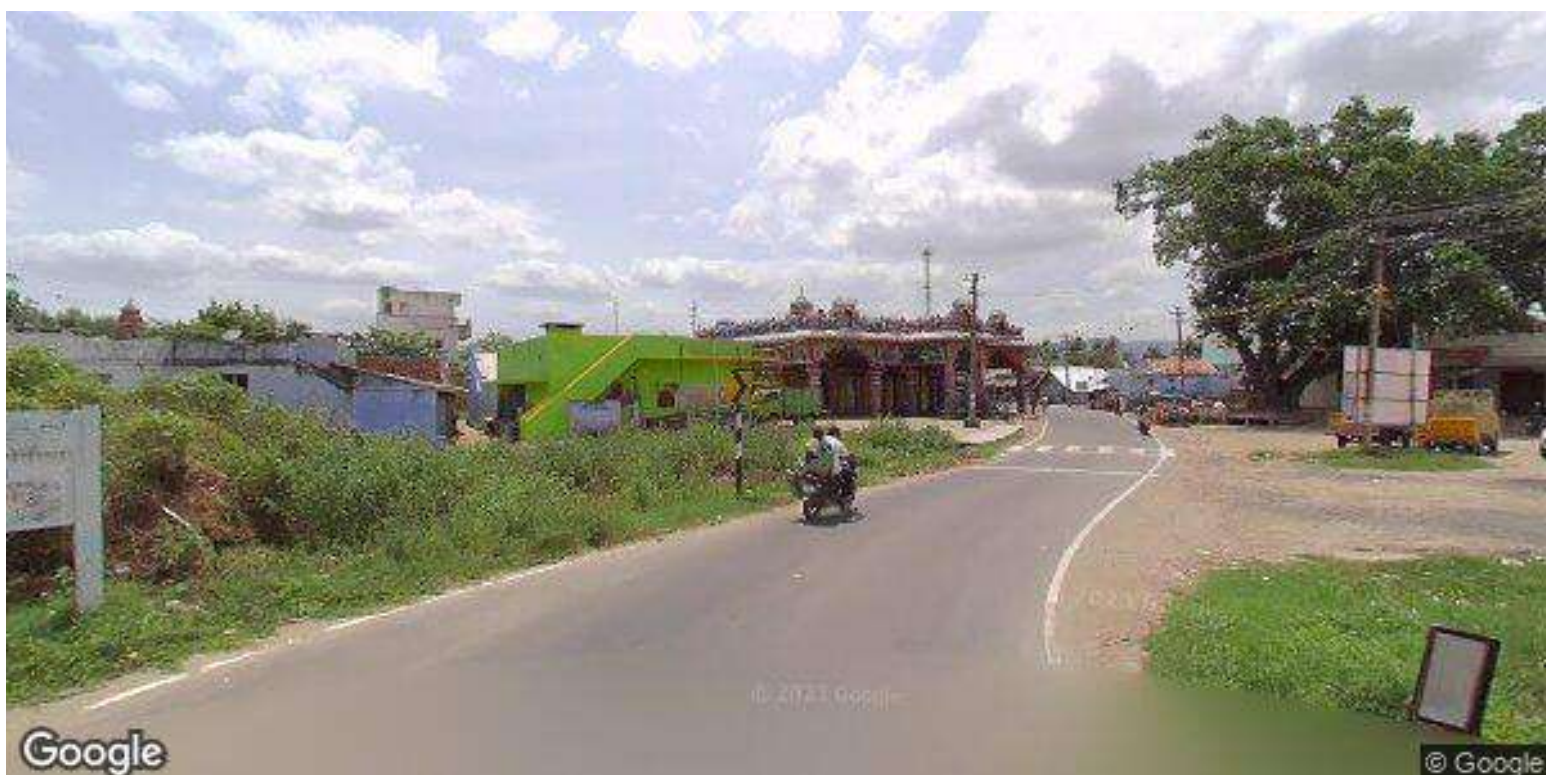
**Risk Type:** Turn  
**Risk Level:** High  
**Speed Limit:** 15 KM/Hr  
**Coordinates:** 11.63946, 77.68505

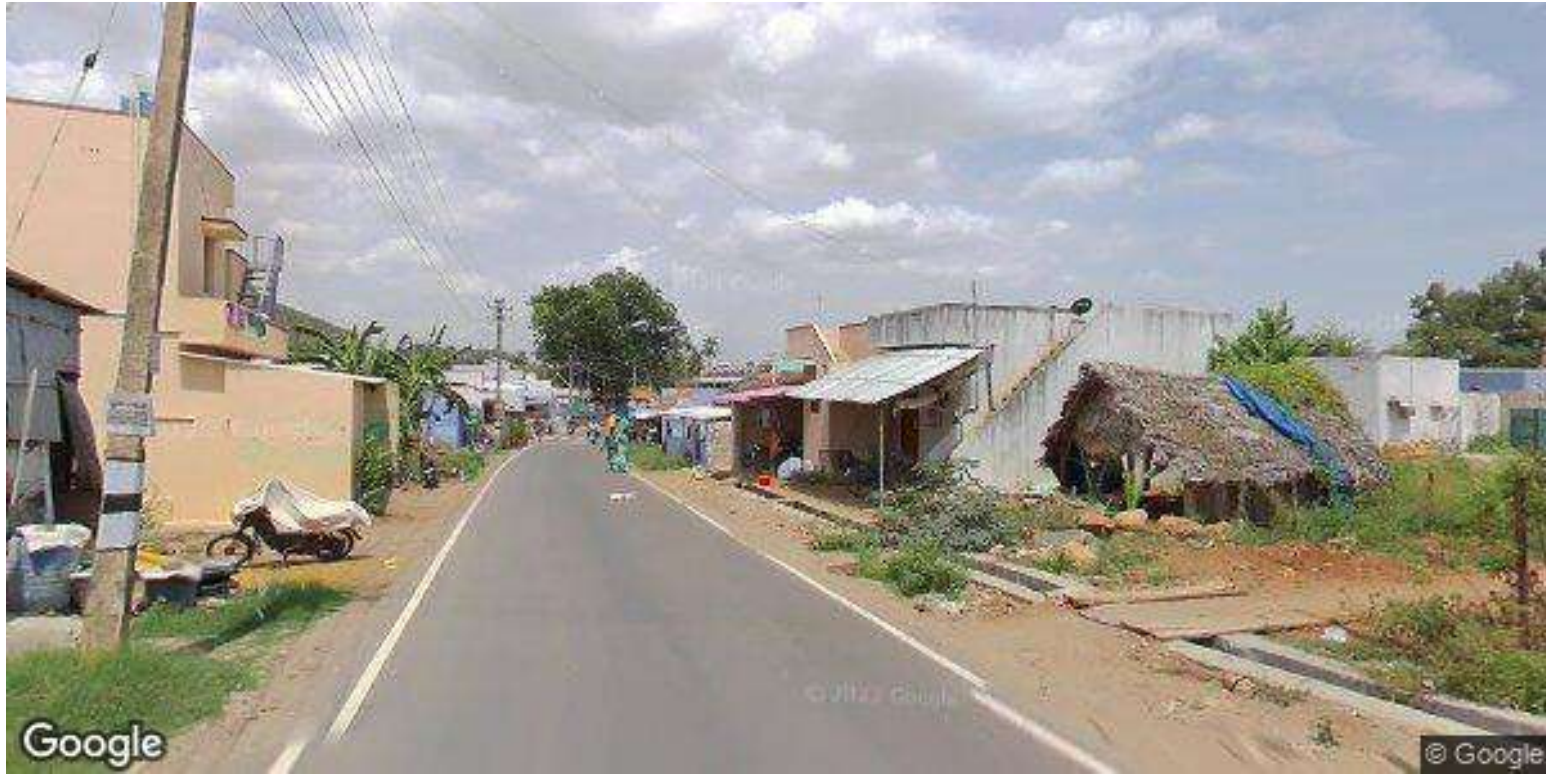
**Risk Type:** Turn  
**Risk Level:** Medium  
**Speed Limit:** 30 KM/Hr  
**Coordinates:** 11.64030, 77.68399

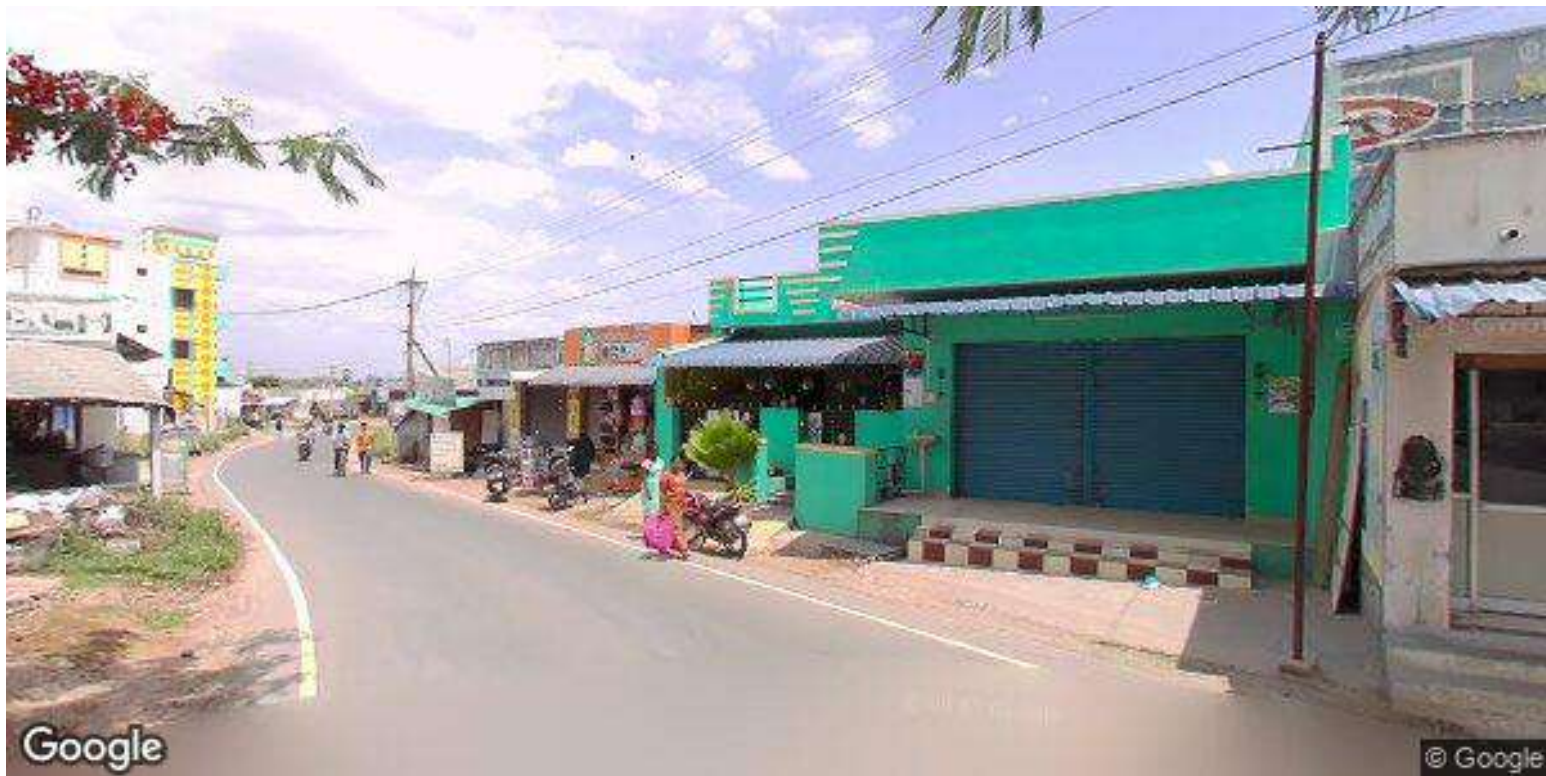
**Risk Type:** Turn  
**Risk Level:** Medium  
**Speed Limit:** 30 KM/Hr  
**Coordinates:** 11.64093, 77.68331

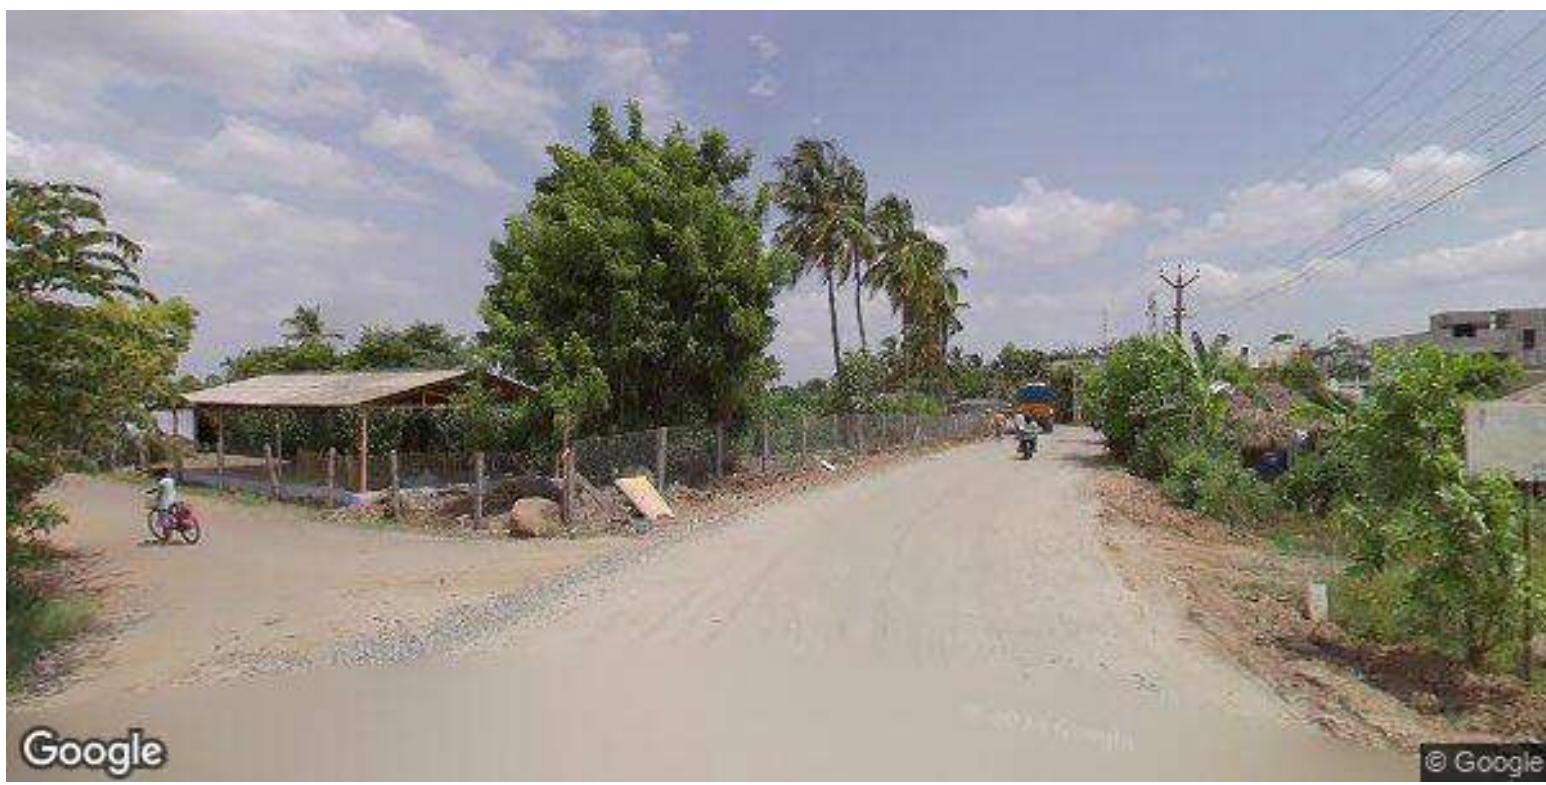
**Coordinates:** 11.64348, 77.68342

**Risk Type:** Turn

**Risk Level:** Medium

**Speed Limit:** 30 KM/Hr
