# IndianOil

## JOURNEY RISK MANAGEMENT (JRM) STUDY

### Salem Terminal TO RL AGENCY

Route Safety Analysis Report: CVQF+23W, Sangagiri to JMWJ+6P8, Guruvareddiur

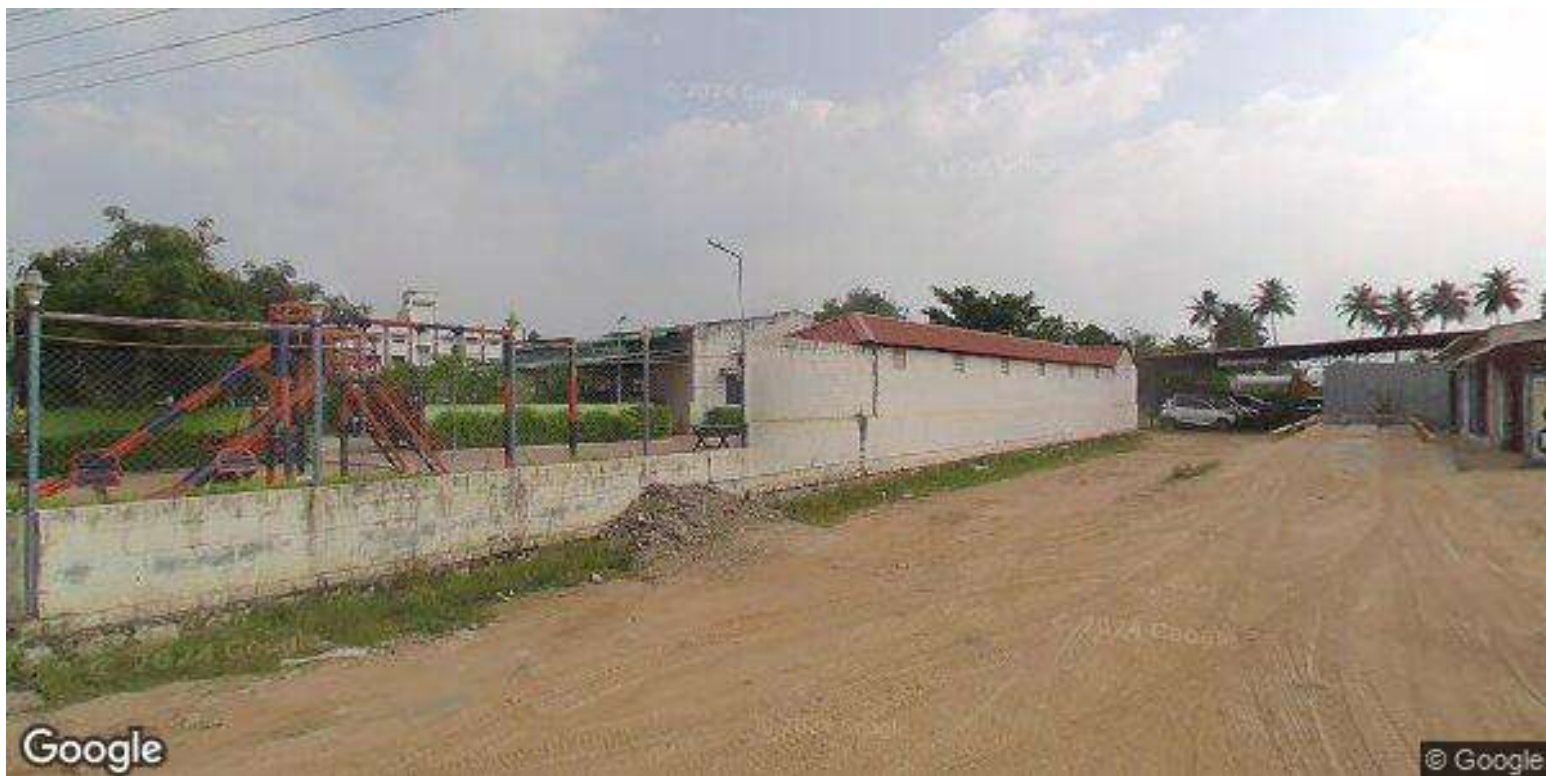
**Coordinates:** 11.44377, 77.71562

**Risk Type:** Turn

**Risk Level:** High

**Speed Limit:** 15 KM/Hr

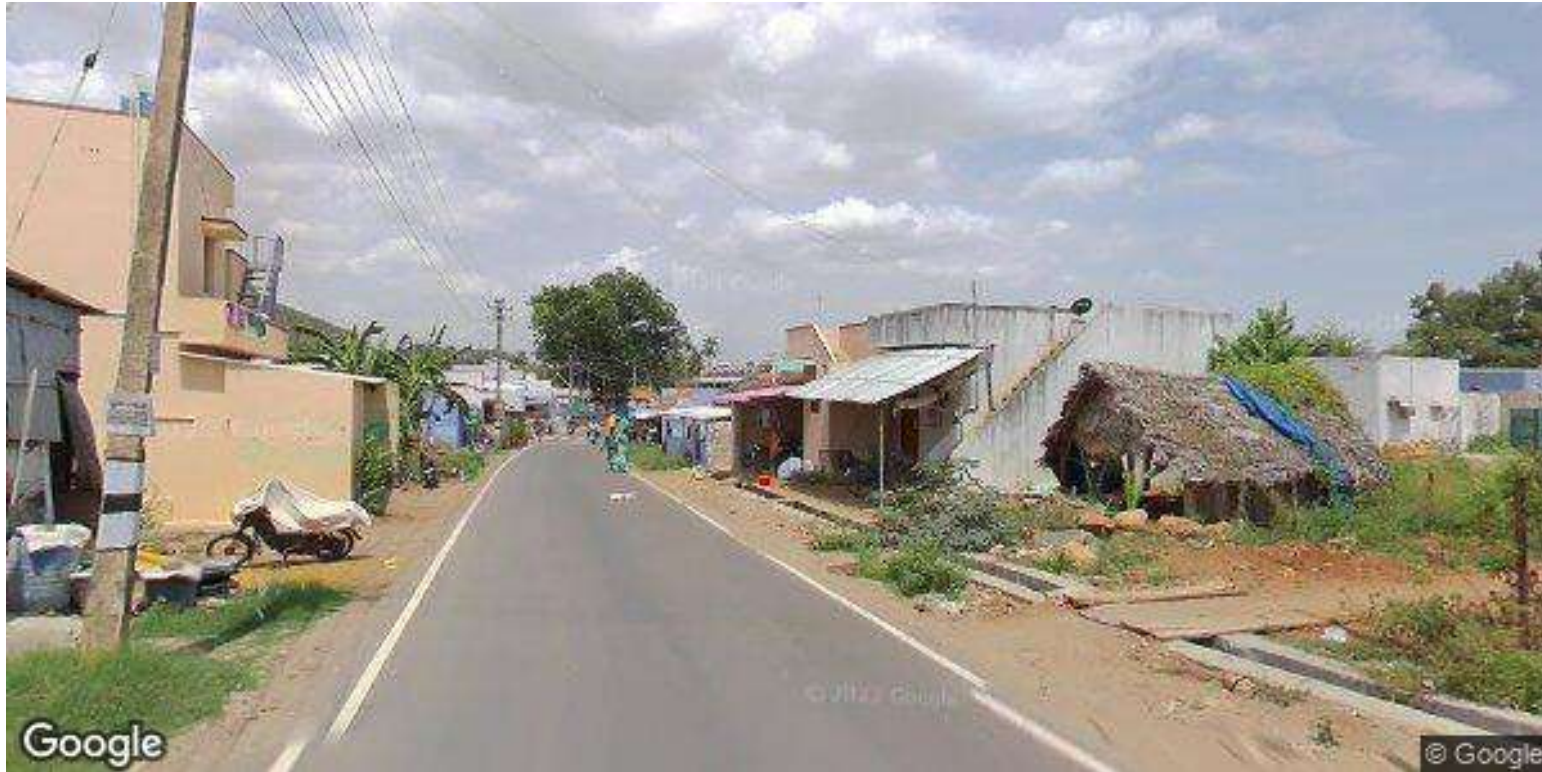
**Risk Type:** Turn  
**Risk Level:** Medium  
**Speed Limit:** 30 KM/Hr  
**Coordinates:** 11.64030, 77.68399

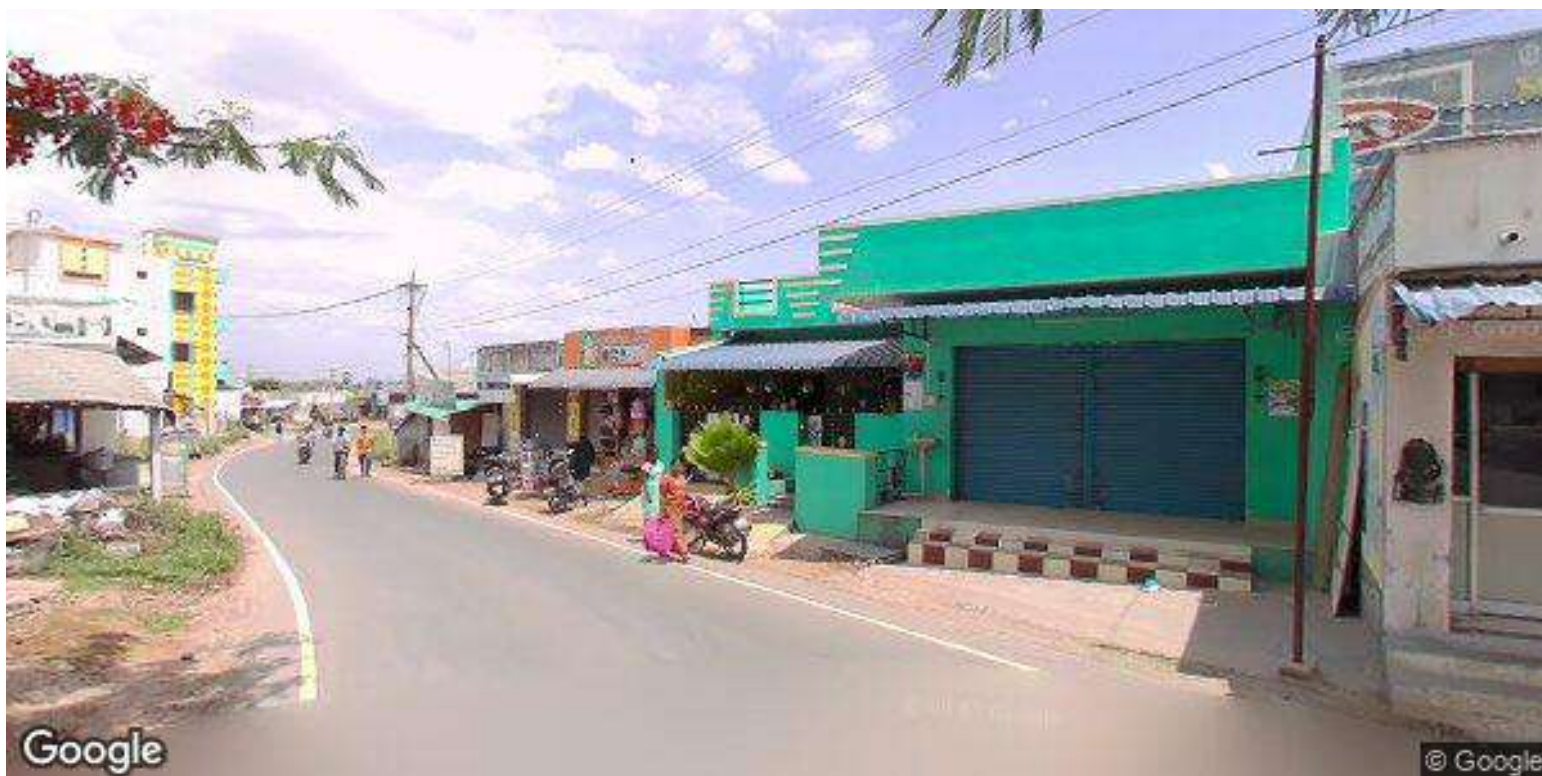
**Risk Type:** Turn  
**Risk Level:** Medium  
**Speed Limit:** 30 KM/Hr  
**Coordinates:** 11.64093, 77.68331
