## JOURNEY RISK MANAGEMENT (JRM) STUDY

### Salem Terminal TO SRI CHELLIAMMAN AGENCY

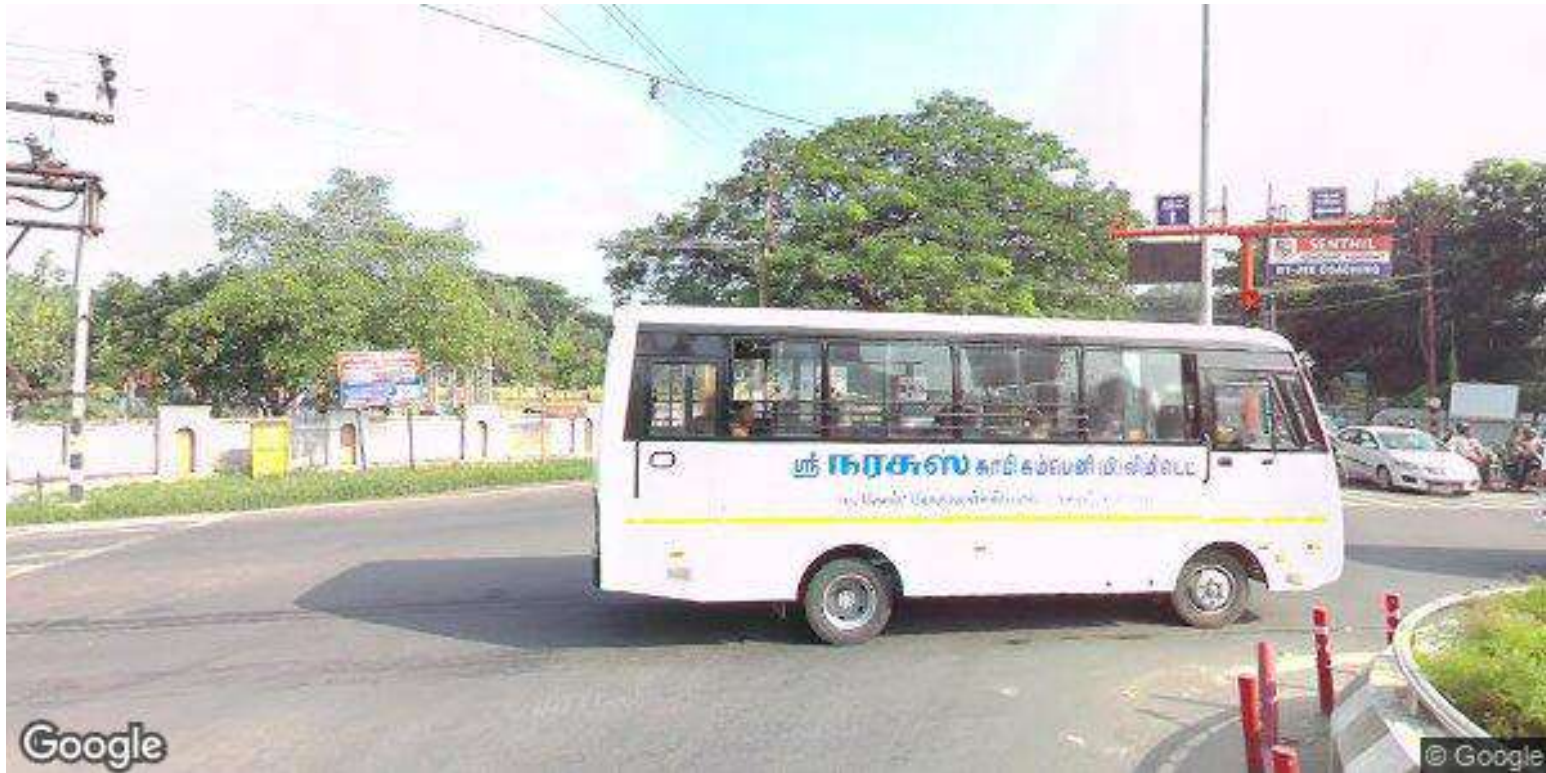
**Coordinates:** 11.67557, 78.15976

**Risk Type:** Roundabout

**Risk Level:** High

**Speed Limit:** 15 KM/Hr

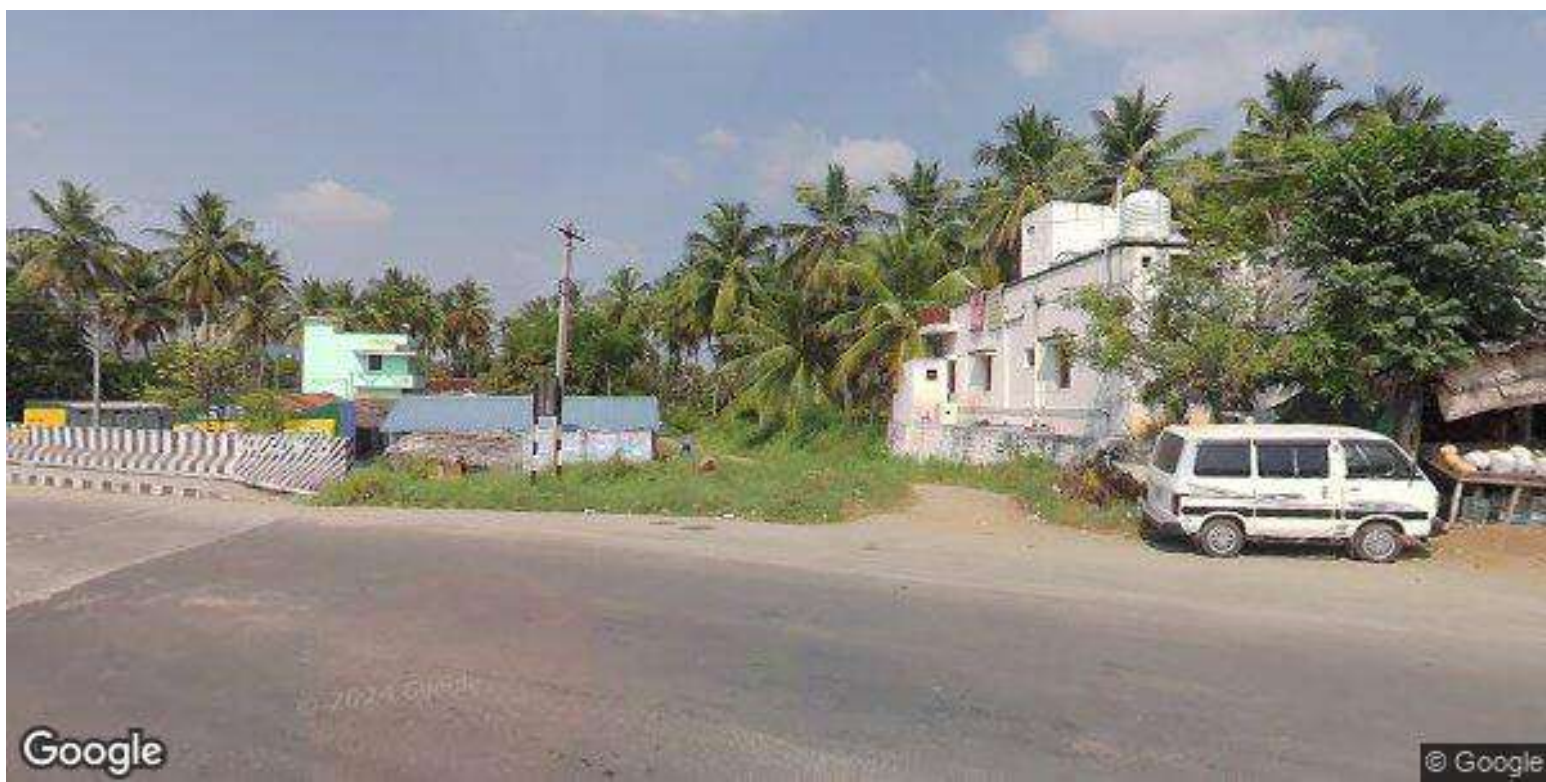
**Coordinates:** 11.44898, 77.87410

**Risk Type:** Turn

**Risk Level:** Medium

**Speed Limit:** 30 KM/Hr

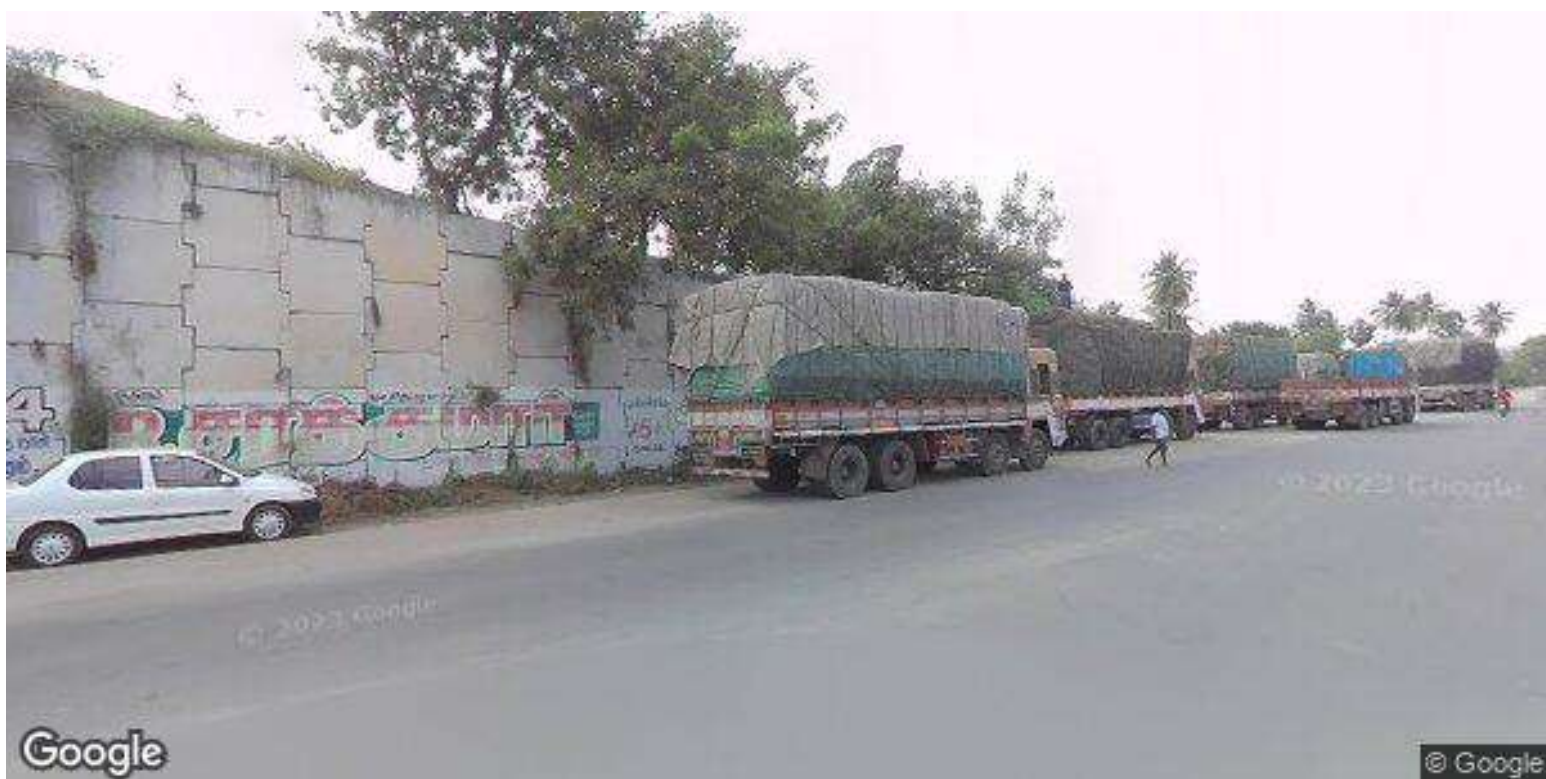
**Coordinates:** 11.49365, 77.88596

**Risk Type:** Turn

**Risk Level:** Medium

**Speed Limit:** 30 KM/Hr

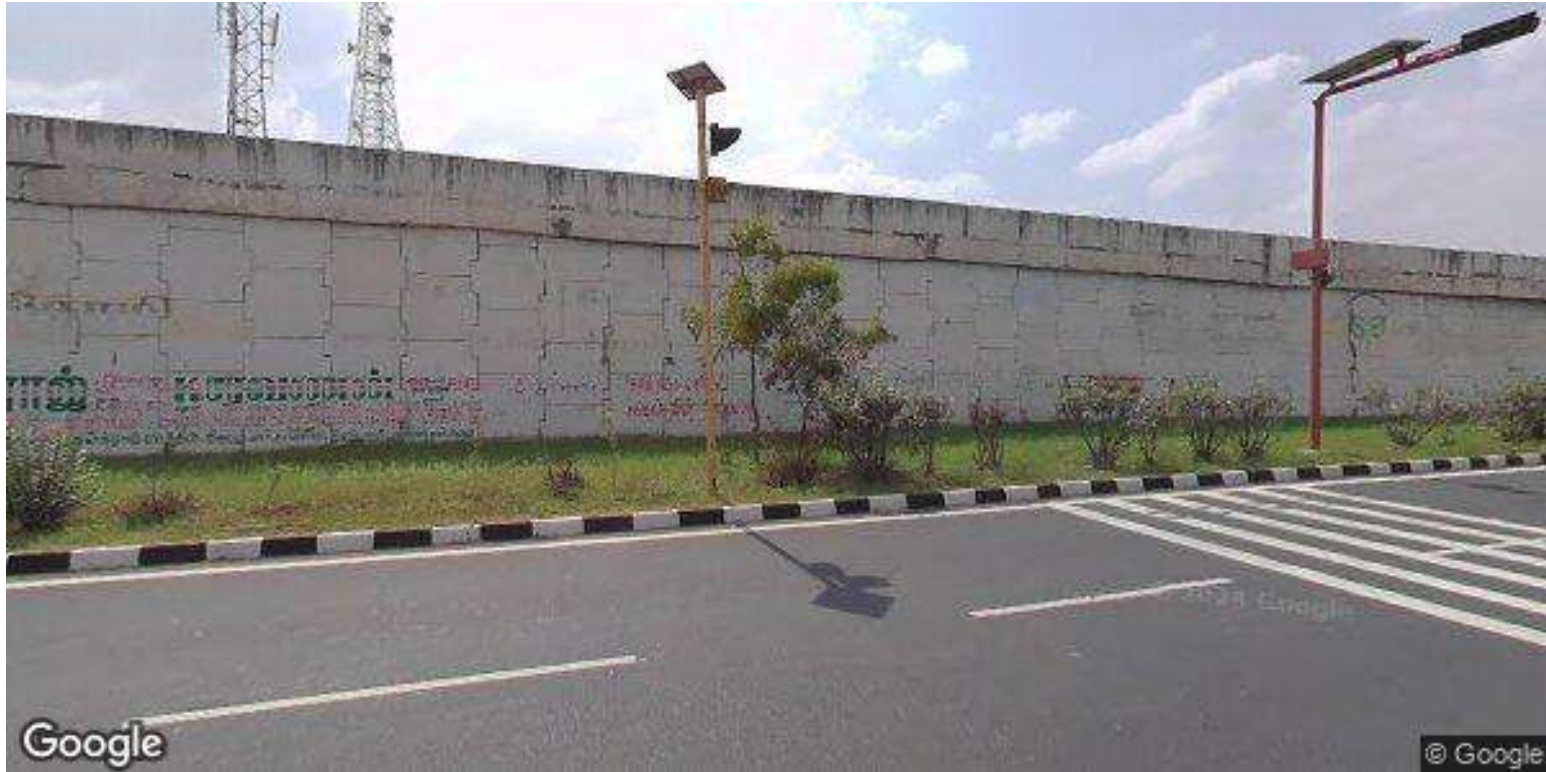
**Risk Type:** Turn  
**Risk Level:** High  
**Speed Limit:** 15 KM/Hr  
**Coordinates:** 11.49225, 77.89560

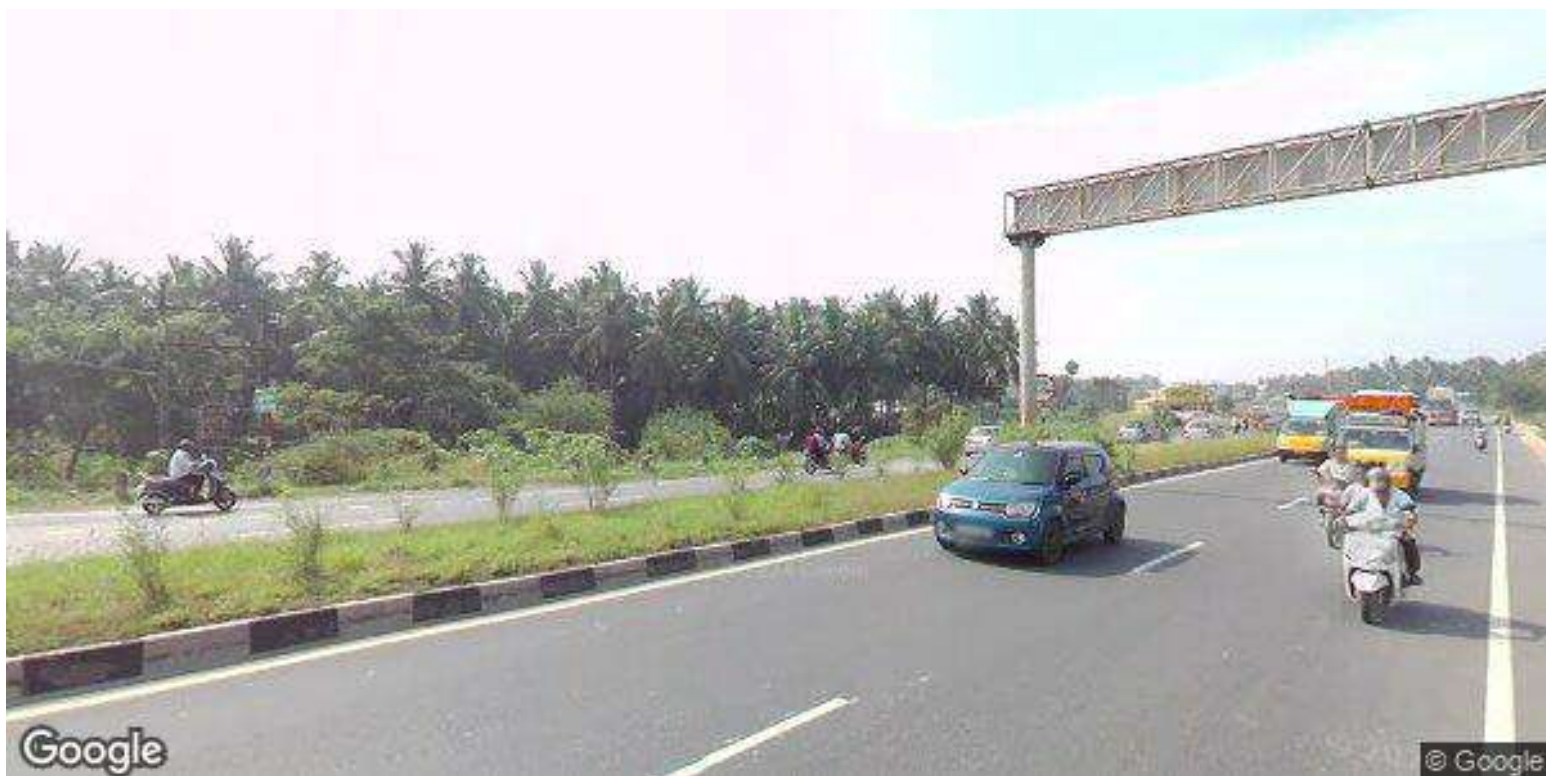
**Risk Type:** Turn  
**Risk Level:** Medium  
**Speed Limit:** 30 KM/Hr  
**Coordinates:** 11.60942, 78.10056

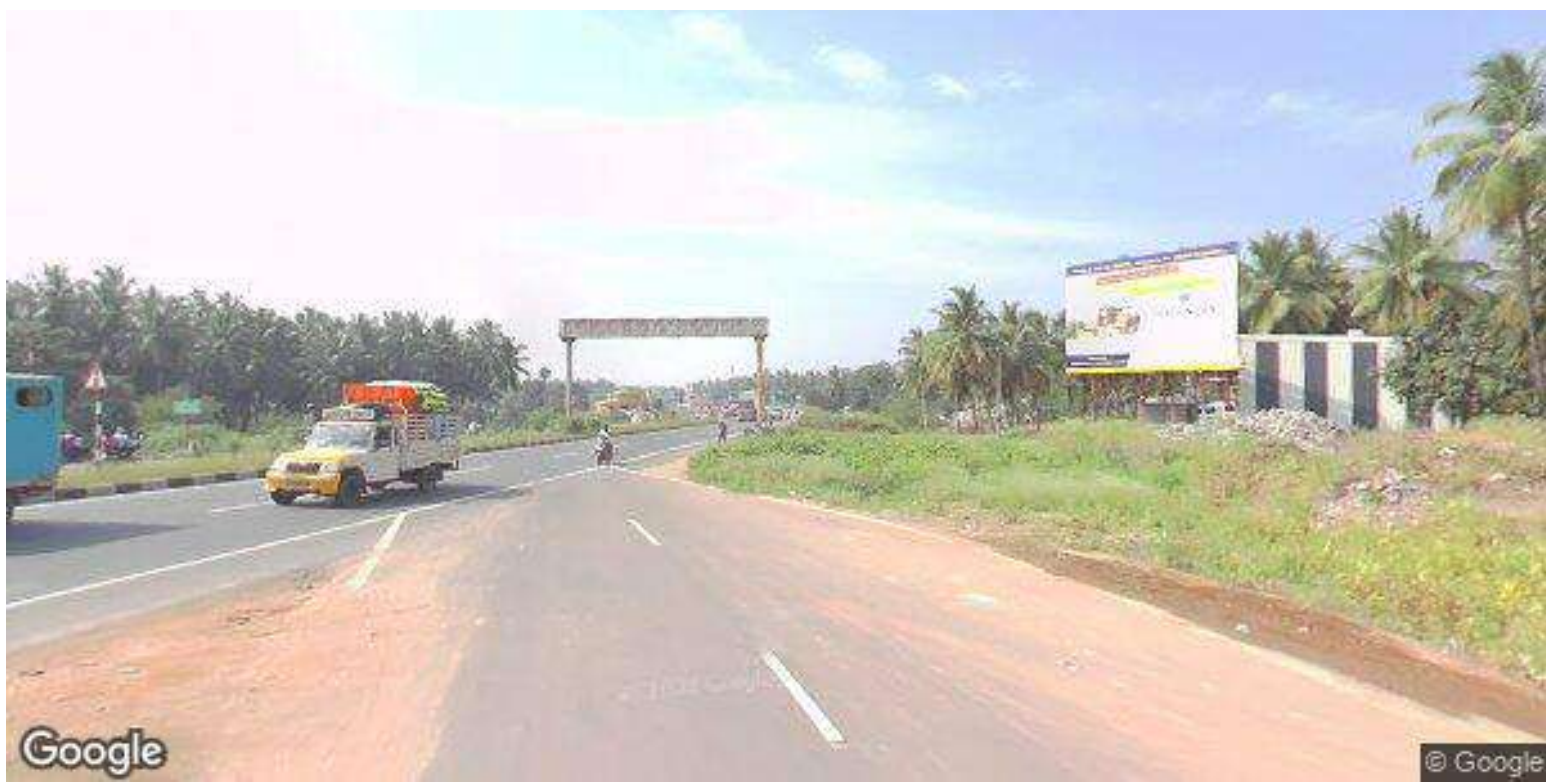
**Coordinates:** 11.60965, 78.10070

**Risk Type:** Turn

**Risk Level:** Medium

**Speed Limit:** 30 KM/Hr

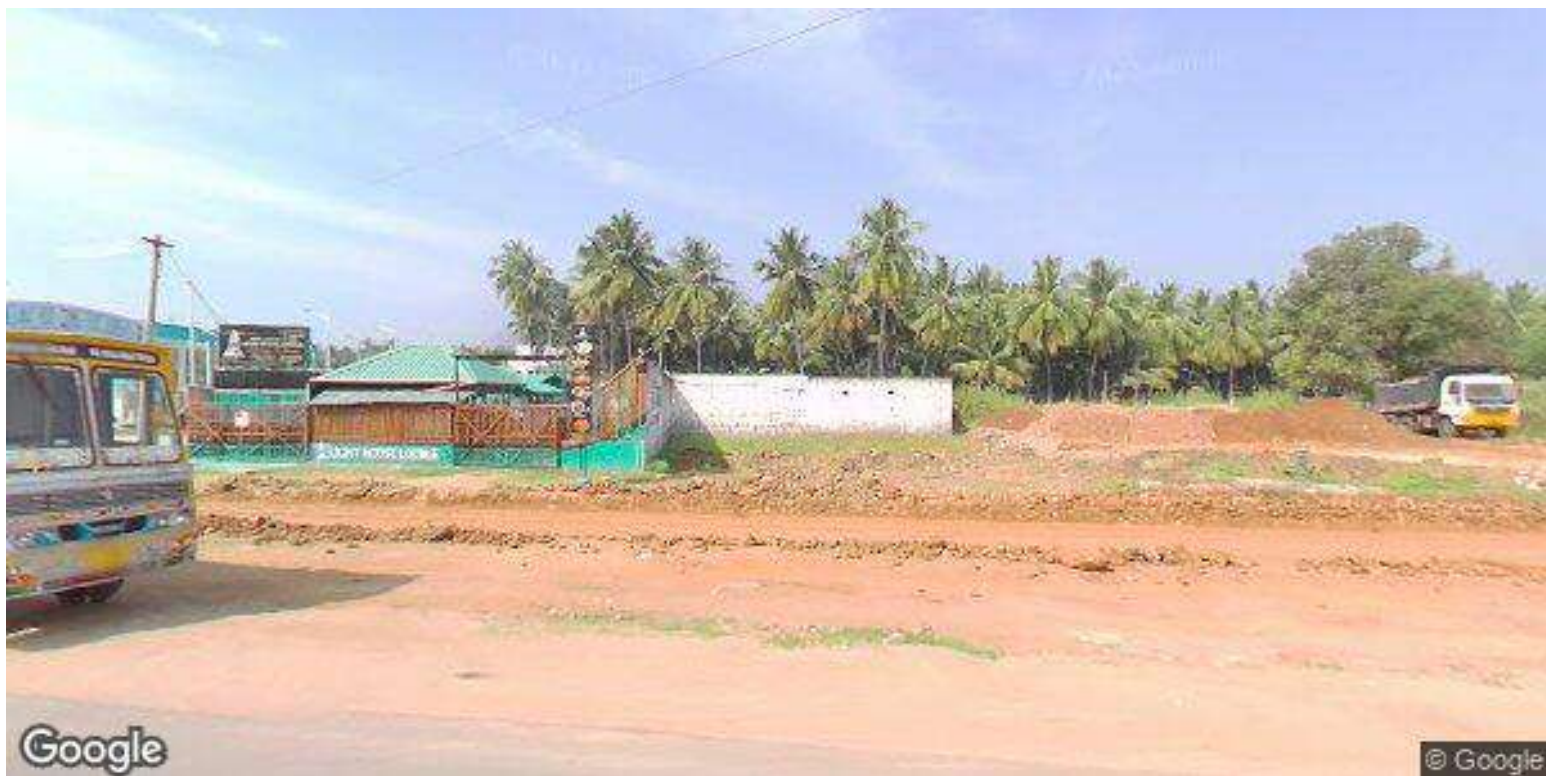
**Coordinates:** 11.61736, 78.10588

**Risk Type:** Turn

**Risk Level:** Medium

**Speed Limit:** 30 KM/Hr

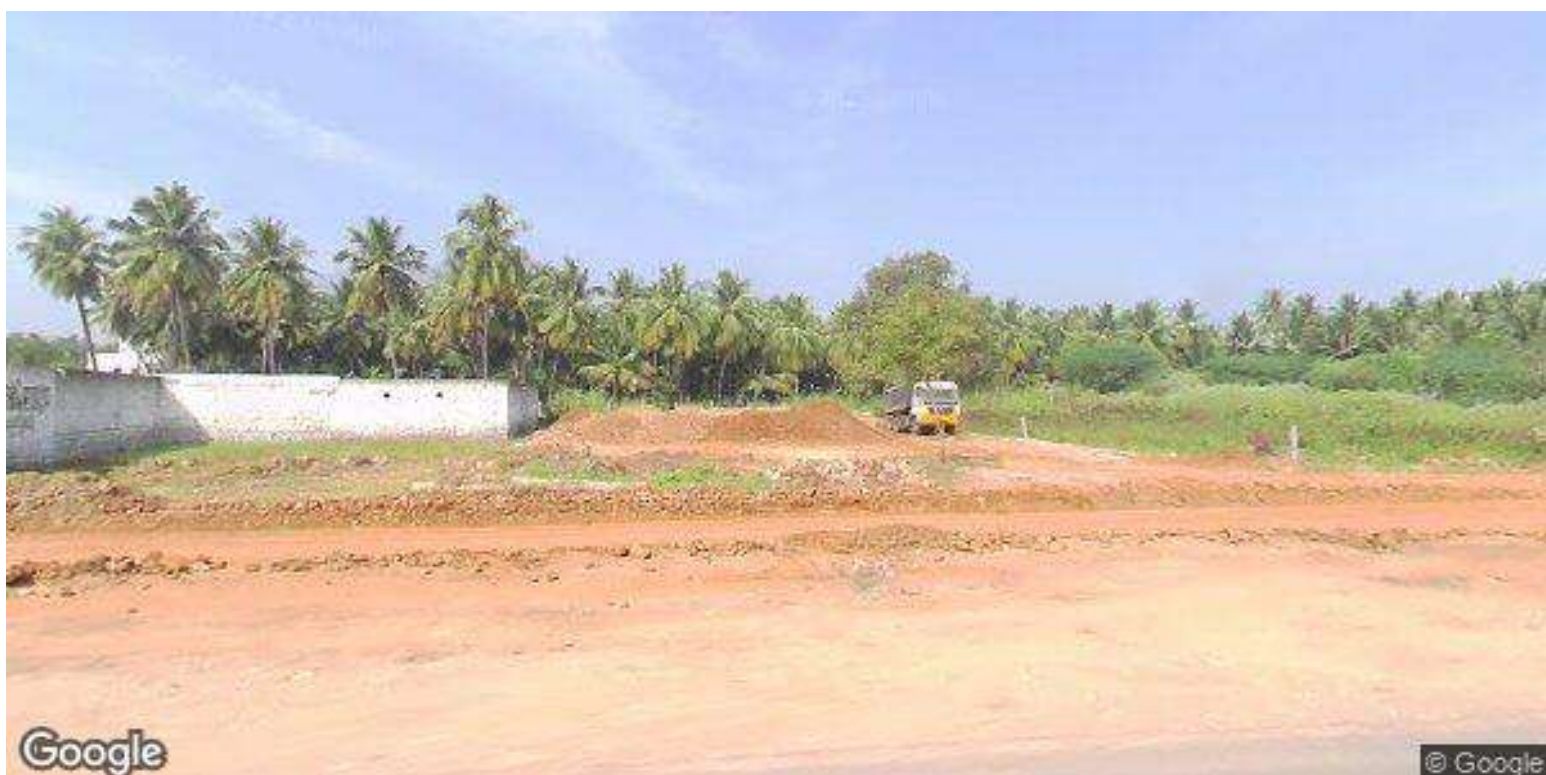
**Coordinates: 11.61745, 78.10601**

**Risk Type: Turn**

**Risk Level: Medium**

**Speed Limit: 30 KM/Hr**

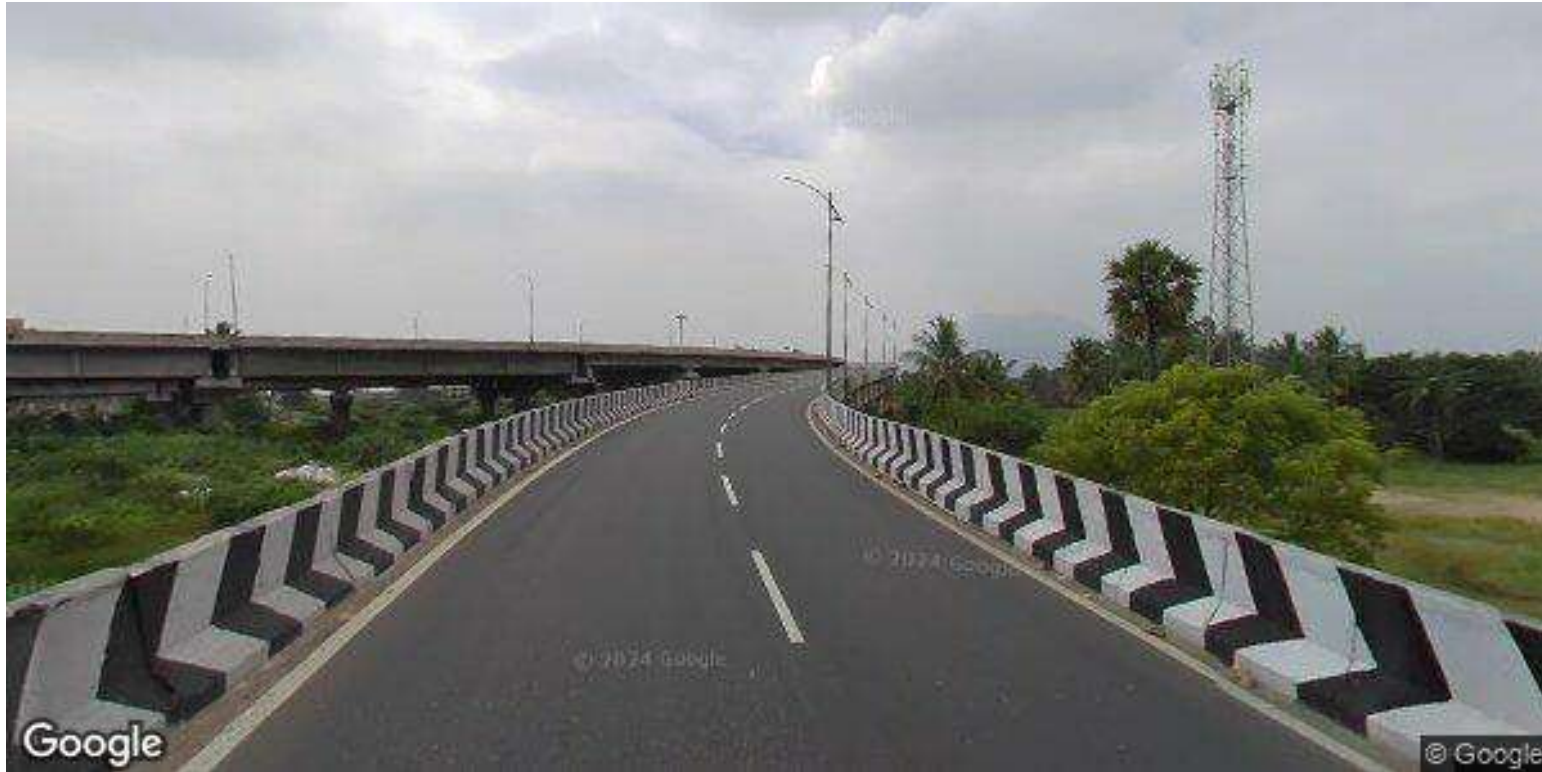
**Coordinates: 11.64310, 78.11982**

**Risk Type: Turn**

**Risk Level: Medium**

**Speed Limit: 30 KM/Hr**

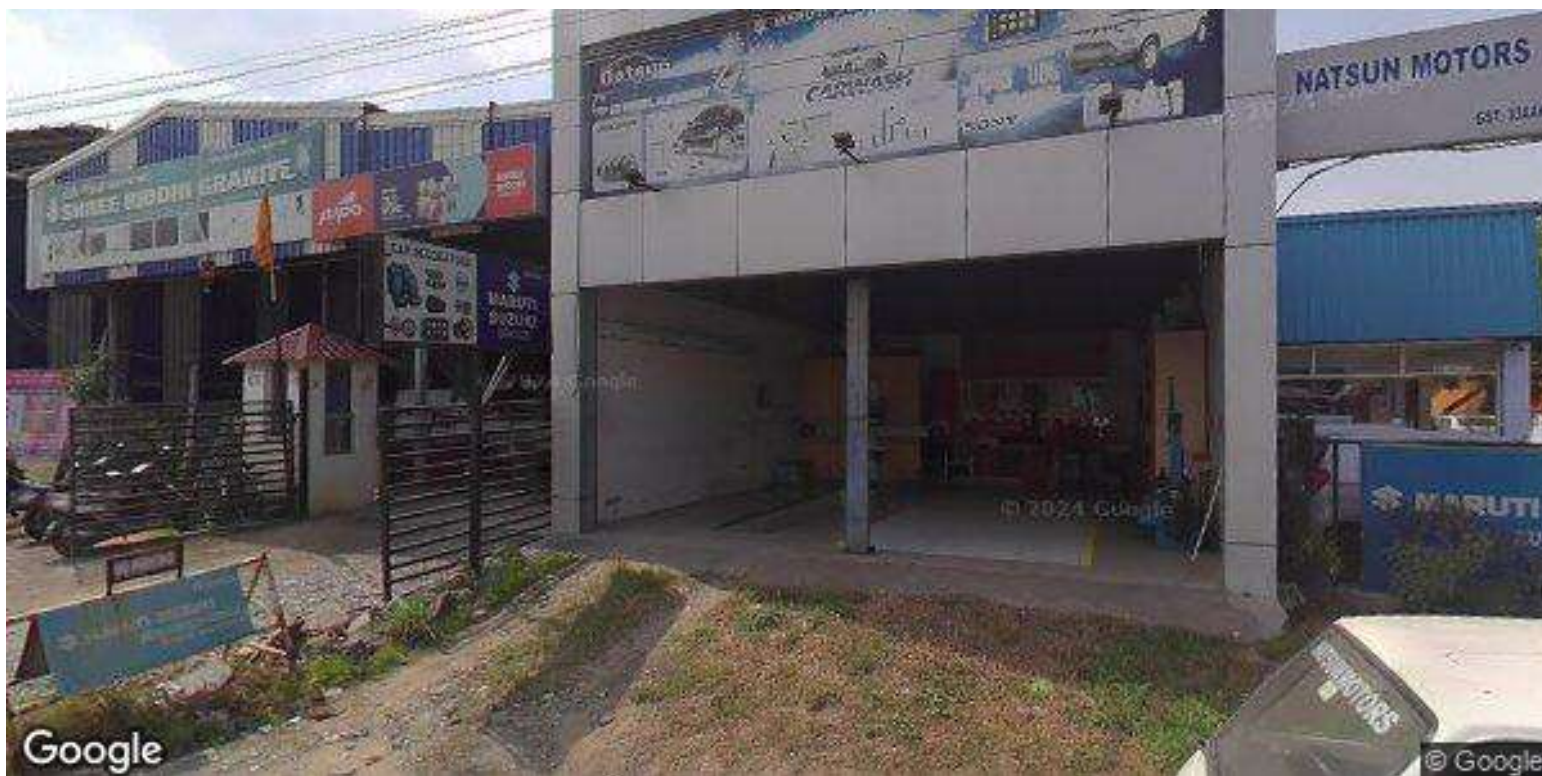
**Coordinates: 11.64490, 78.12024**

**Risk Type: Turn**

**Risk Level: Medium**

**Speed Limit: 30 KM/Hr**

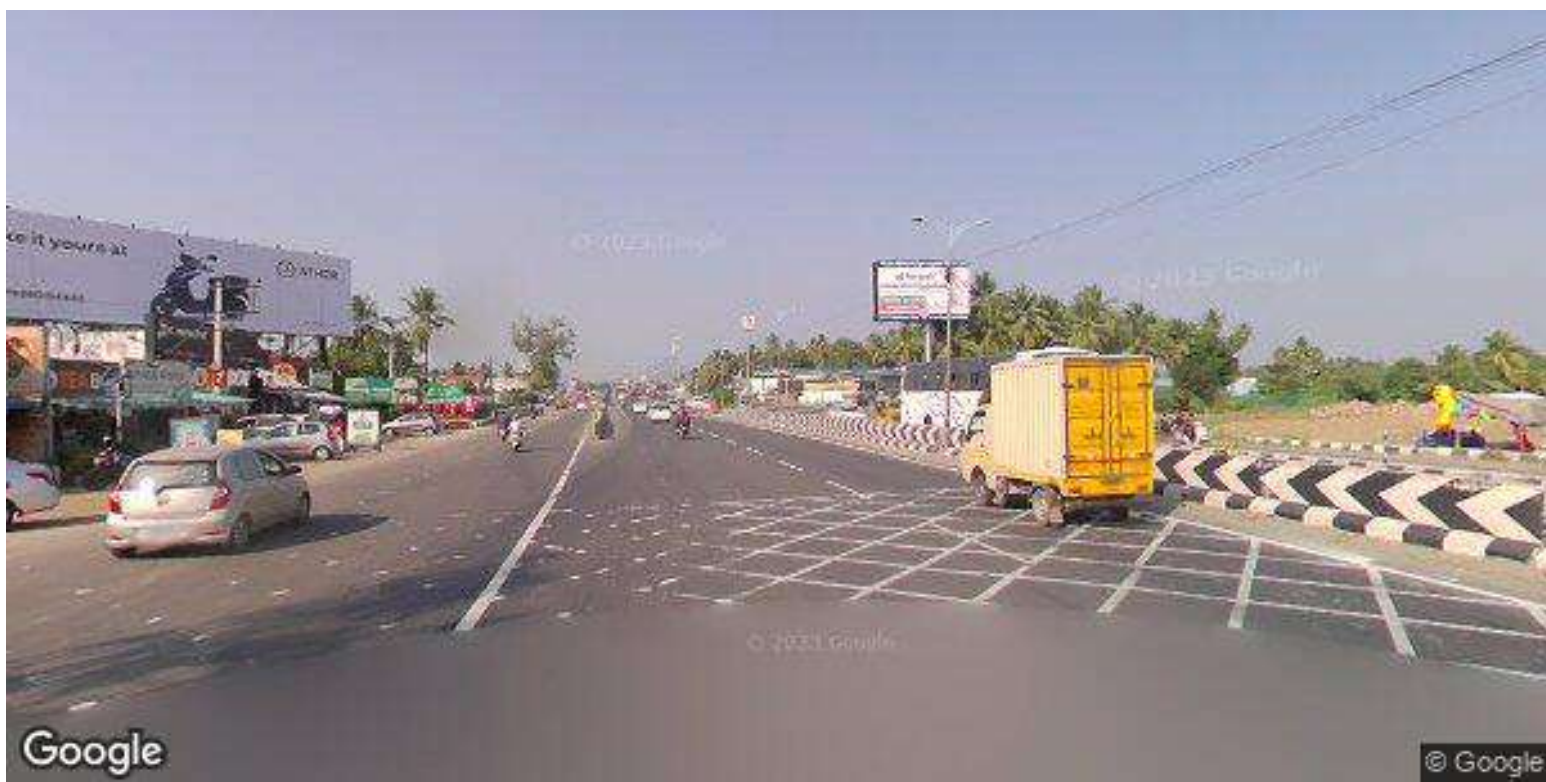
**Coordinates:** 11.64503, 78.12034

**Risk Type:** Turn

**Risk Level:** Medium

**Speed Limit:** 30 KM/Hr

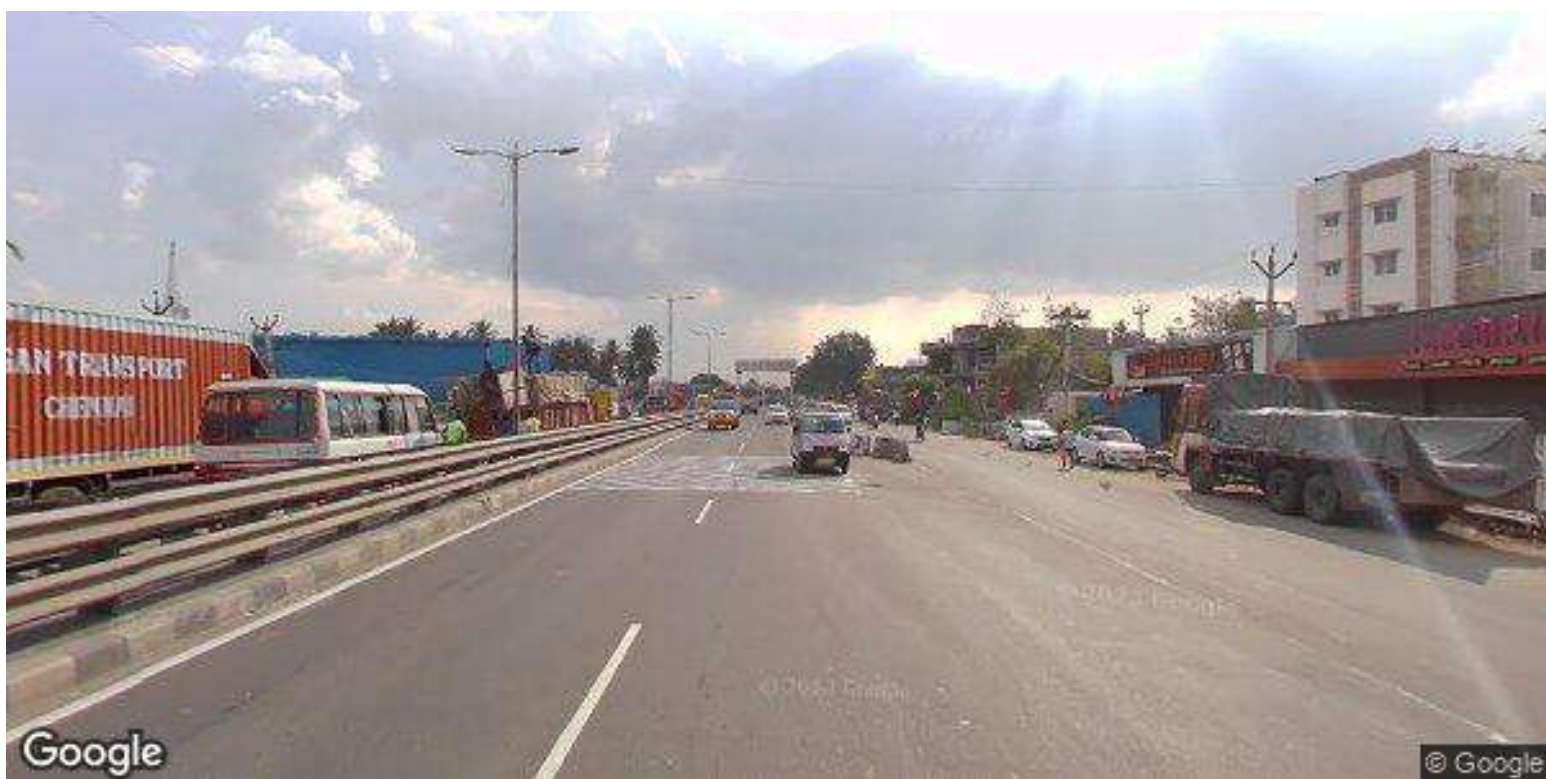
**Coordinates:** 11.67074, 78.12668

**Risk Type:** Turn

**Risk Level:** High

**Speed Limit:** 15 KM/Hr

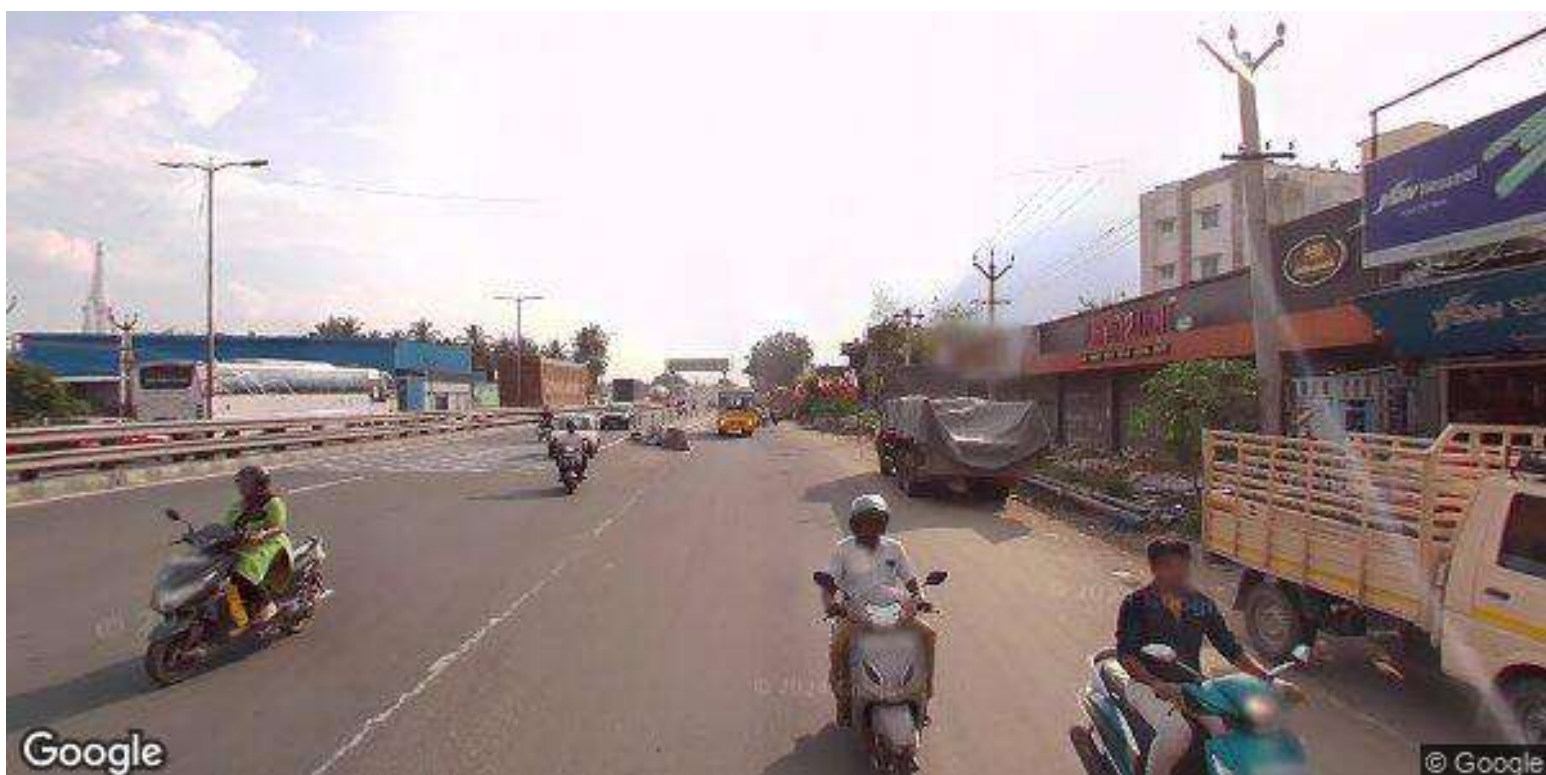
**Risk Type:** Turn  
**Risk Level:** High  
**Speed Limit:** 15 KM/Hr  
**Coordinates:** 11.67081, 78.12661

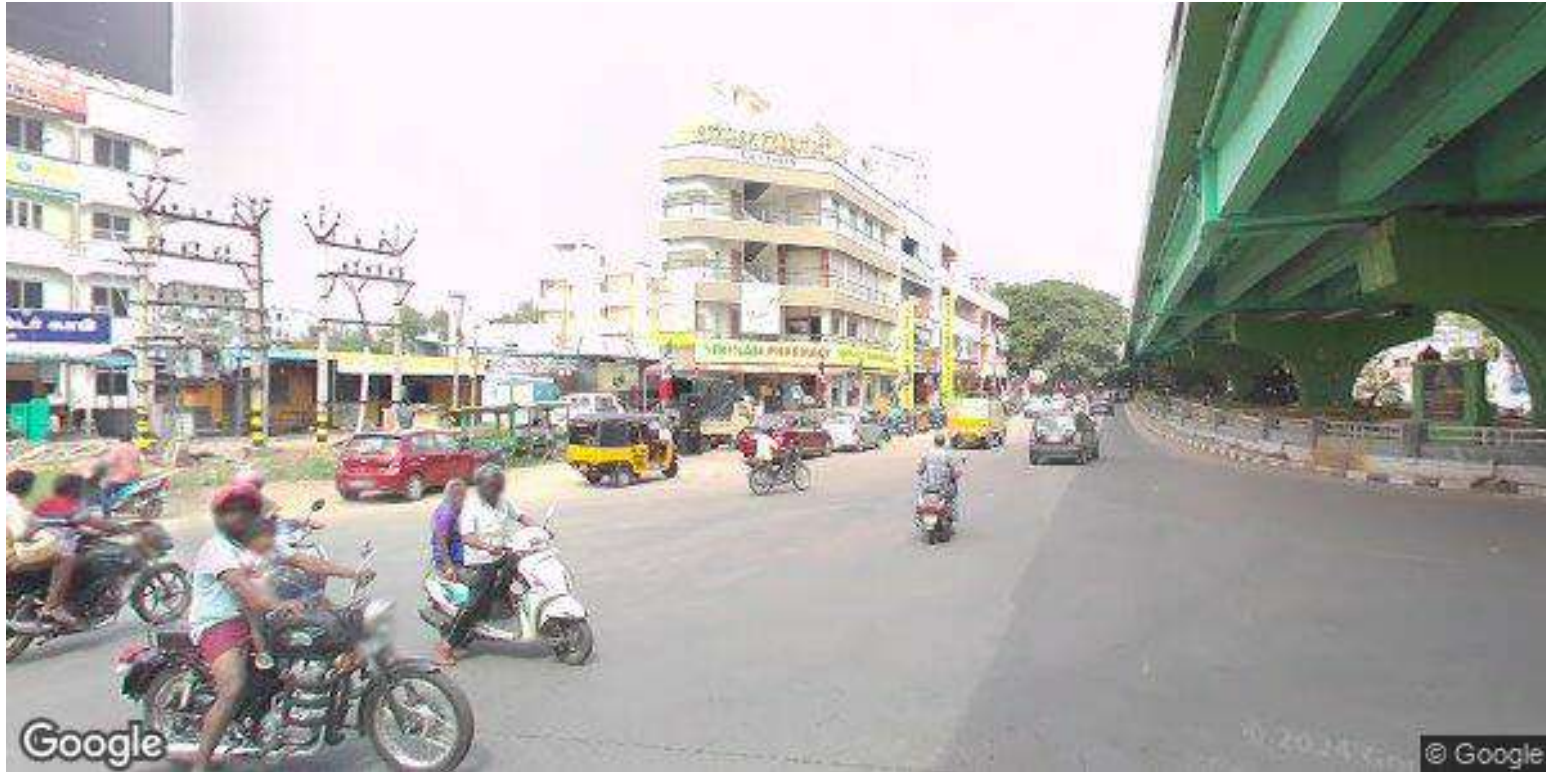
**Risk Type:** Turn  
**Risk Level:** High  
**Speed Limit:** 15 KM/Hr  
**Coordinates:** 11.67582, 78.12786

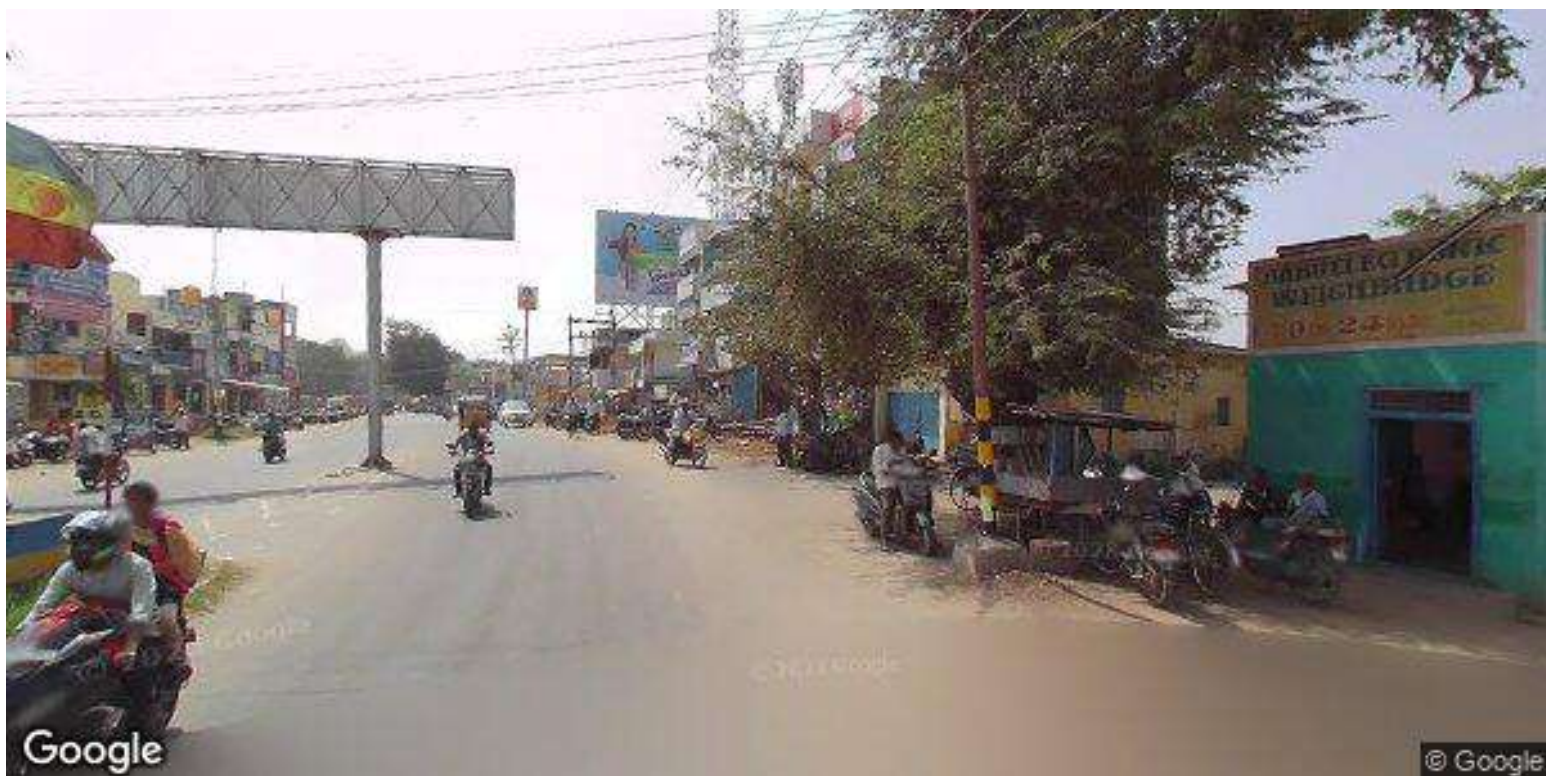
**Risk Type:** Turn  
**Risk Level:** Medium  
**Speed Limit:** 30 KM/Hr  
**Coordinates:** 11.69518, 78.16364

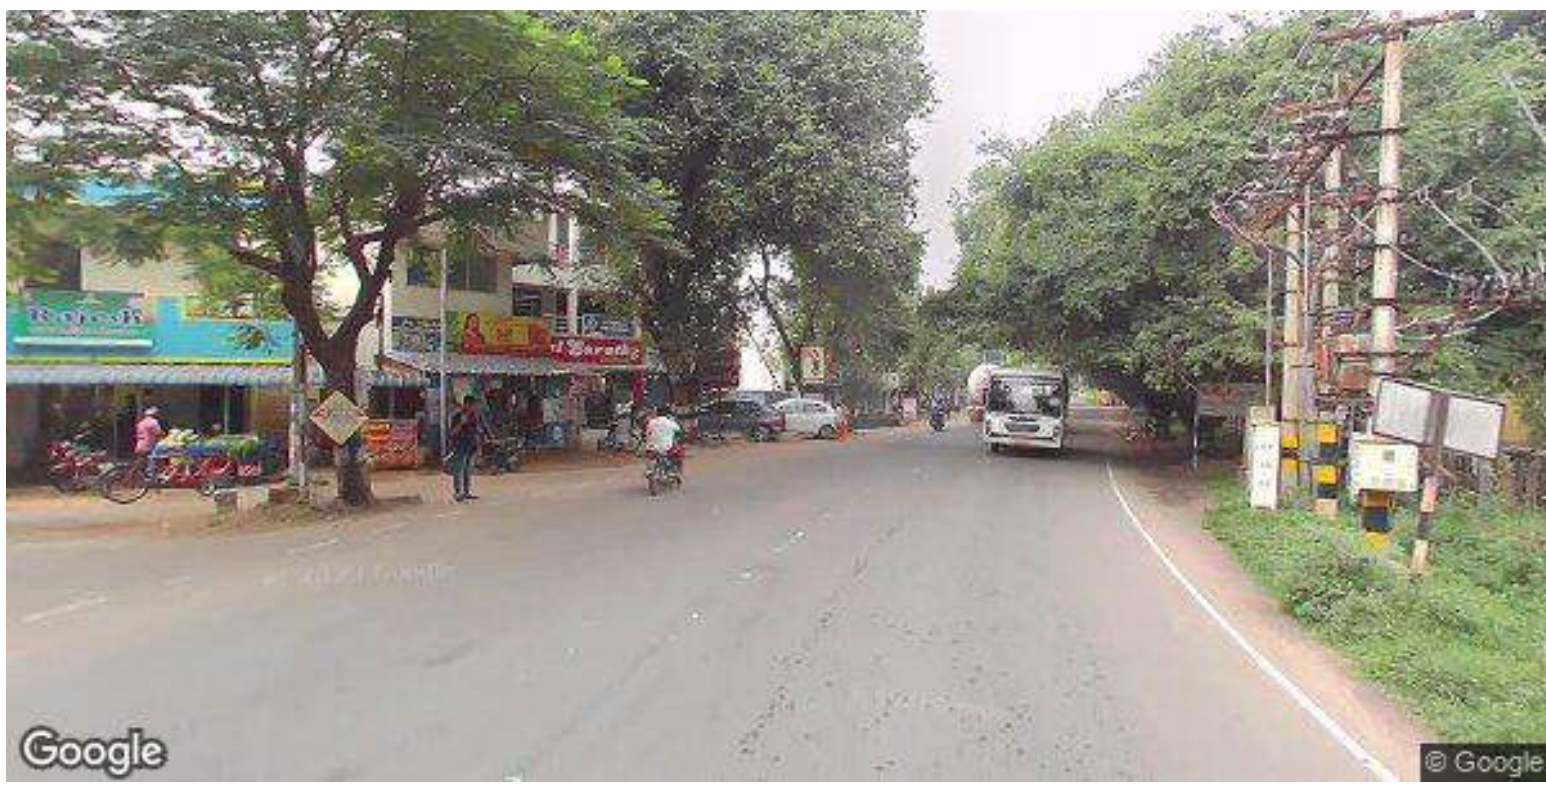
**Coordinates:** 11.70719, 78.17515

**Risk Type:** Turn

**Risk Level:** Medium

**Speed Limit:** 30 KM/Hr
