# IndianOil

## JOURNEY RISK MANAGEMENT (JRM) STUDY

### Salem Terminal to Sakthi Fuels Unit II

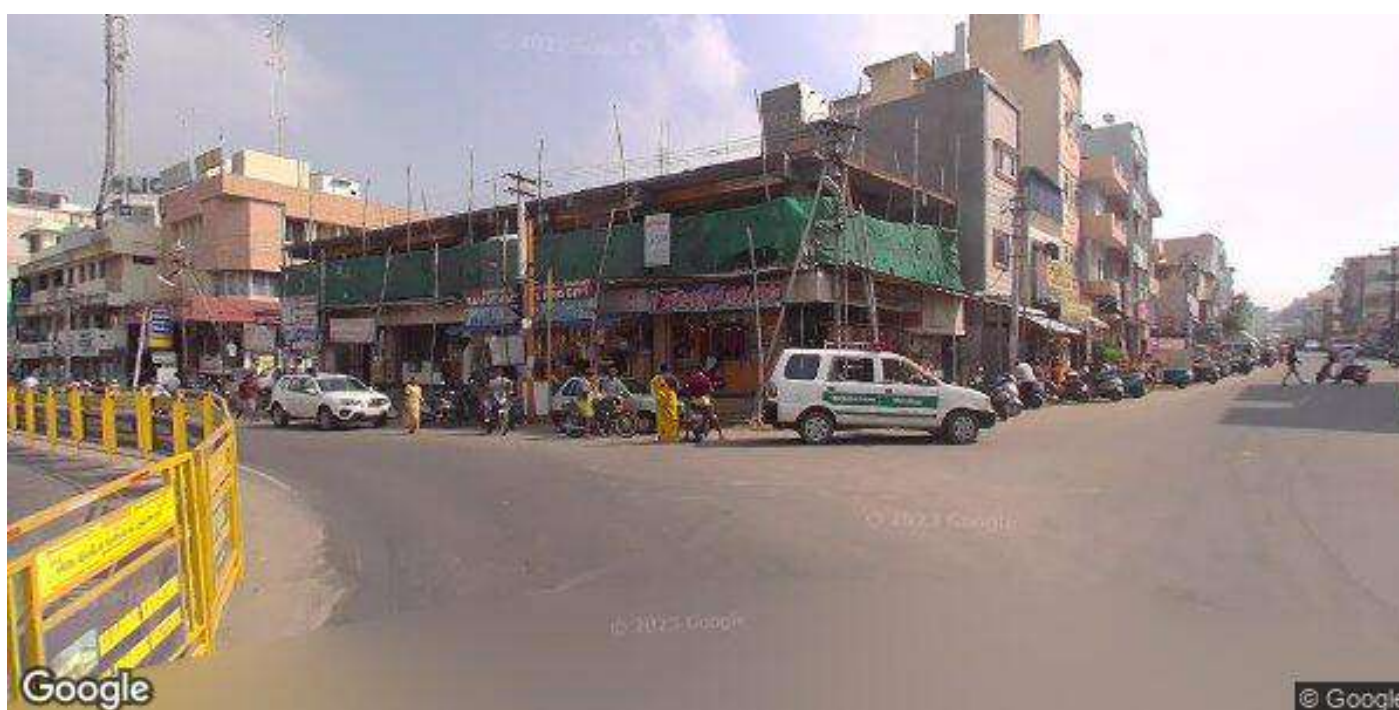
| | Risk Type | Risk Level | Coordinates | Speed Limit |
|---|---|---|---|---|
| 5 | Turn | High | 11.37868, 77.89498 | 15 KM/Hr |

**Risk Type:** Turn  
**Risk Level:** High  
**Speed Limit:** 15 KM/Hr  
**Coordinates:** 11.37868, 77.89498

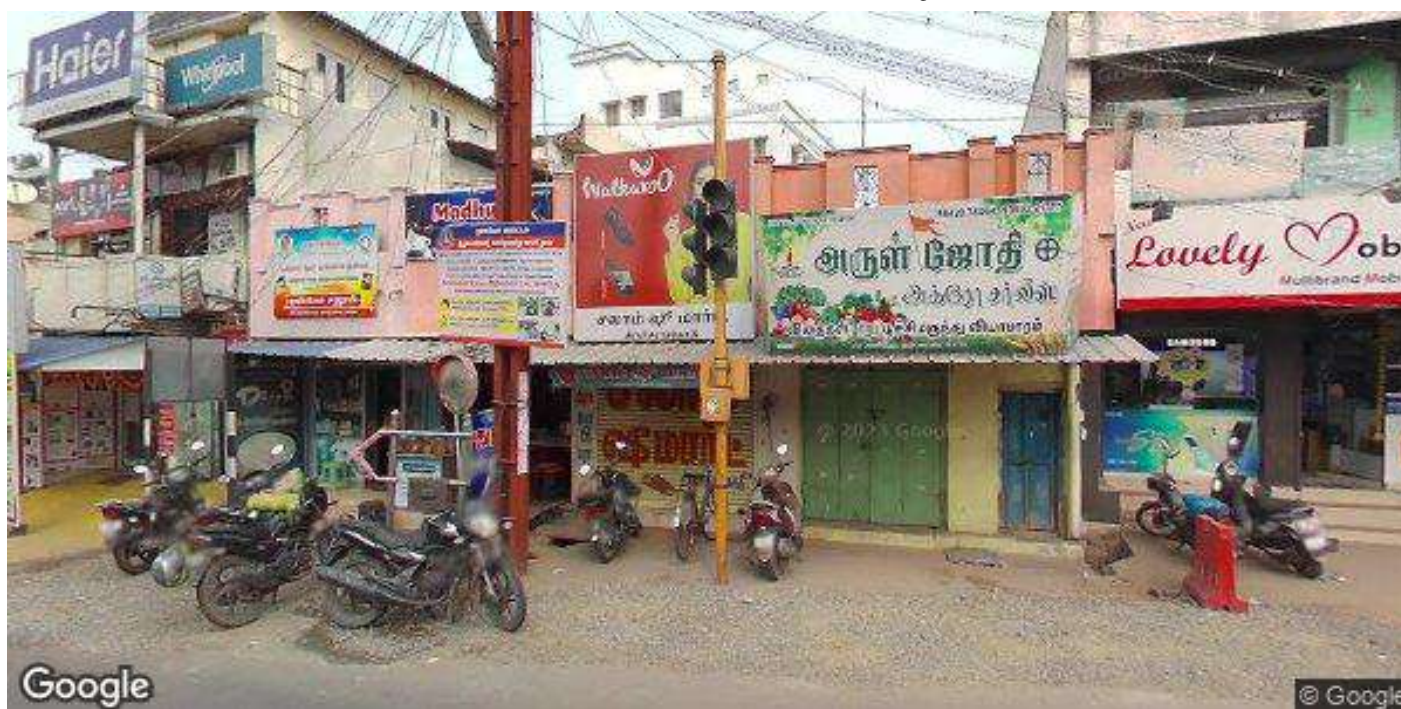
| | Risk Type | Risk Level | Coordinates | Speed Limit |
|---|---|---|---|---|
| 6 | Turn | High | 11.37850, 77.89453 | 15 KM/Hr |

**Risk Type:** Turn  
**Risk Level:** High  
**Speed Limit:** 15 KM/Hr  
**Coordinates:** 11.37850, 77.89453

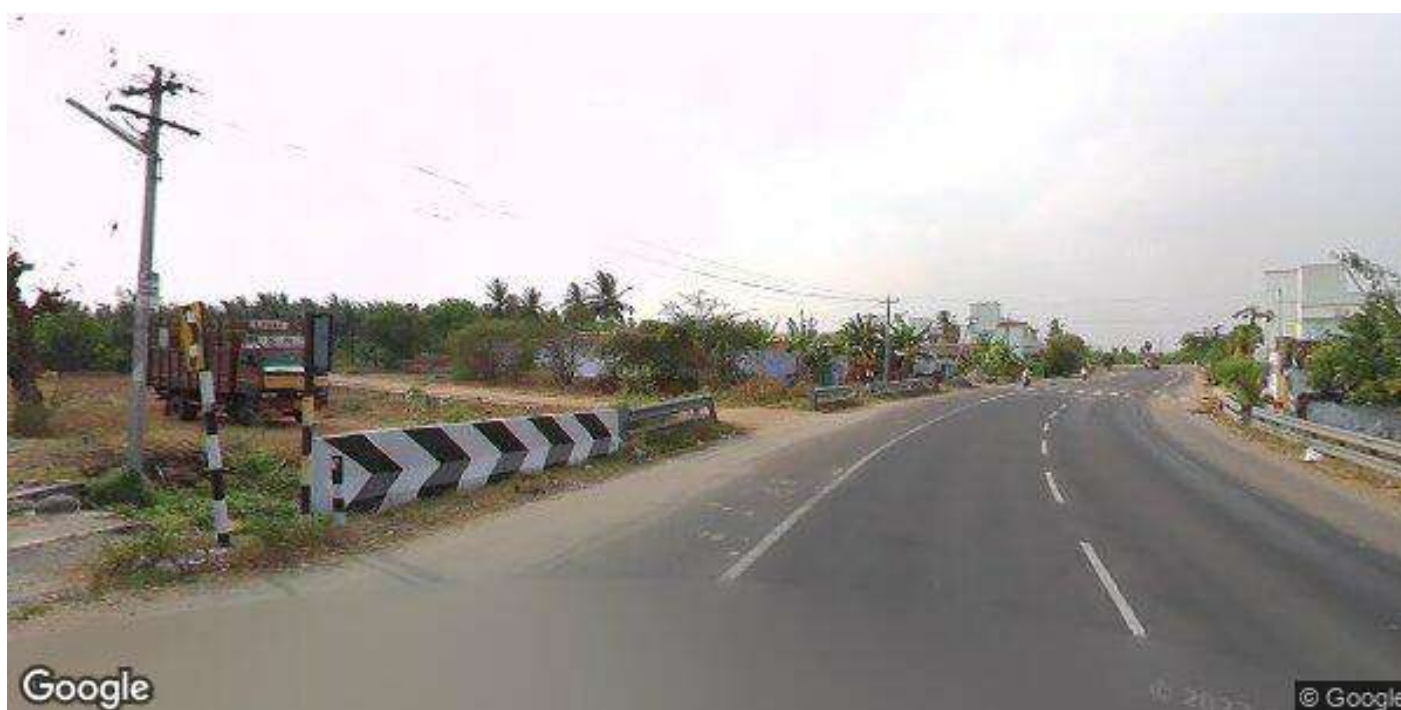
| | Risk Type | Risk Level | Coordinates | Speed Limit |
|---|---|---|---|---|
| 7 | Turn | Medium | 11.16755, 78.01568 | 30 KM/Hr |

**Risk Type:** Turn  
**Risk Level:** Medium  
**Speed Limit:** 30 KM/Hr  
**Coordinates:** 11.16755, 78.01568

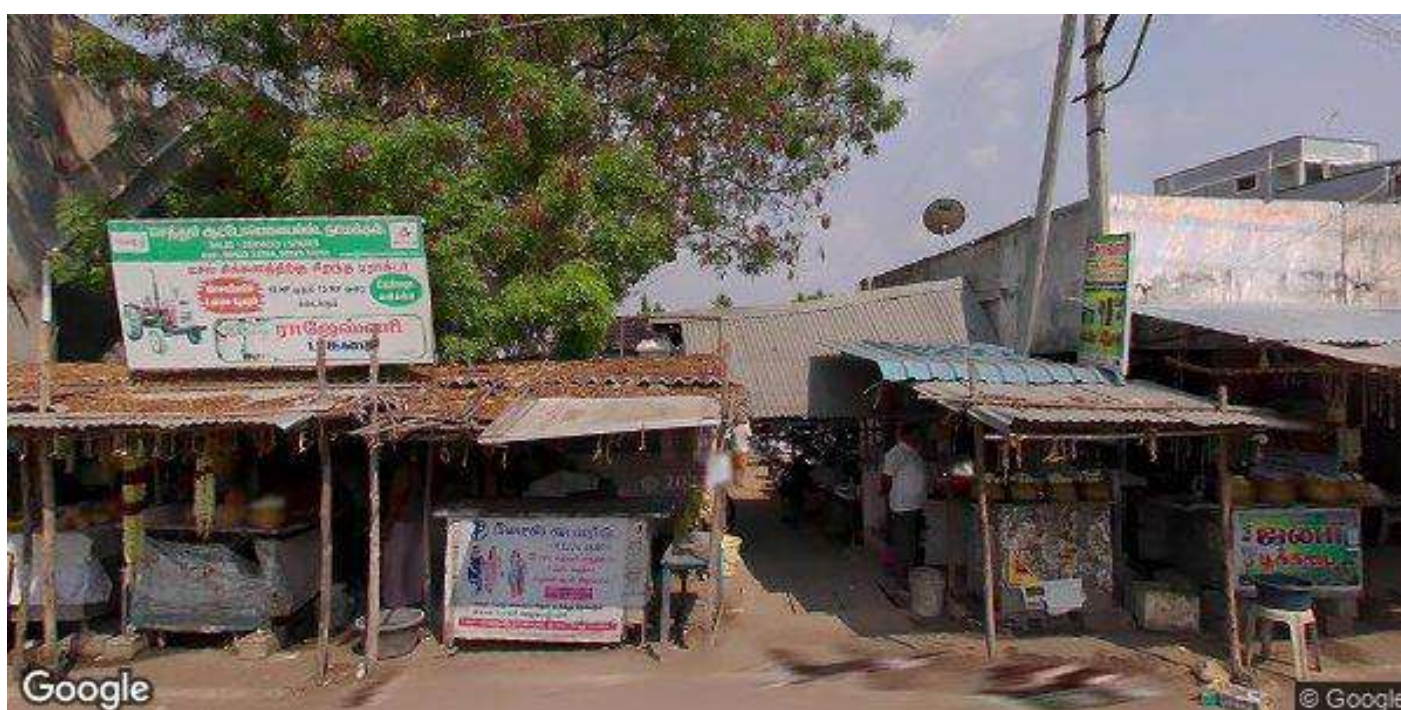
| | Risk Type | Risk Level | Coordinates | Speed Limit |
|---|---|---|---|---|
| 8 | Turn | High | 11.15573, 78.02176 | 15 KM/Hr |

**Risk Type:** Turn  
**Risk Level:** High  
**Speed Limit:** 15 KM/Hr  
**Coordinates:** 11.15573, 78.02176

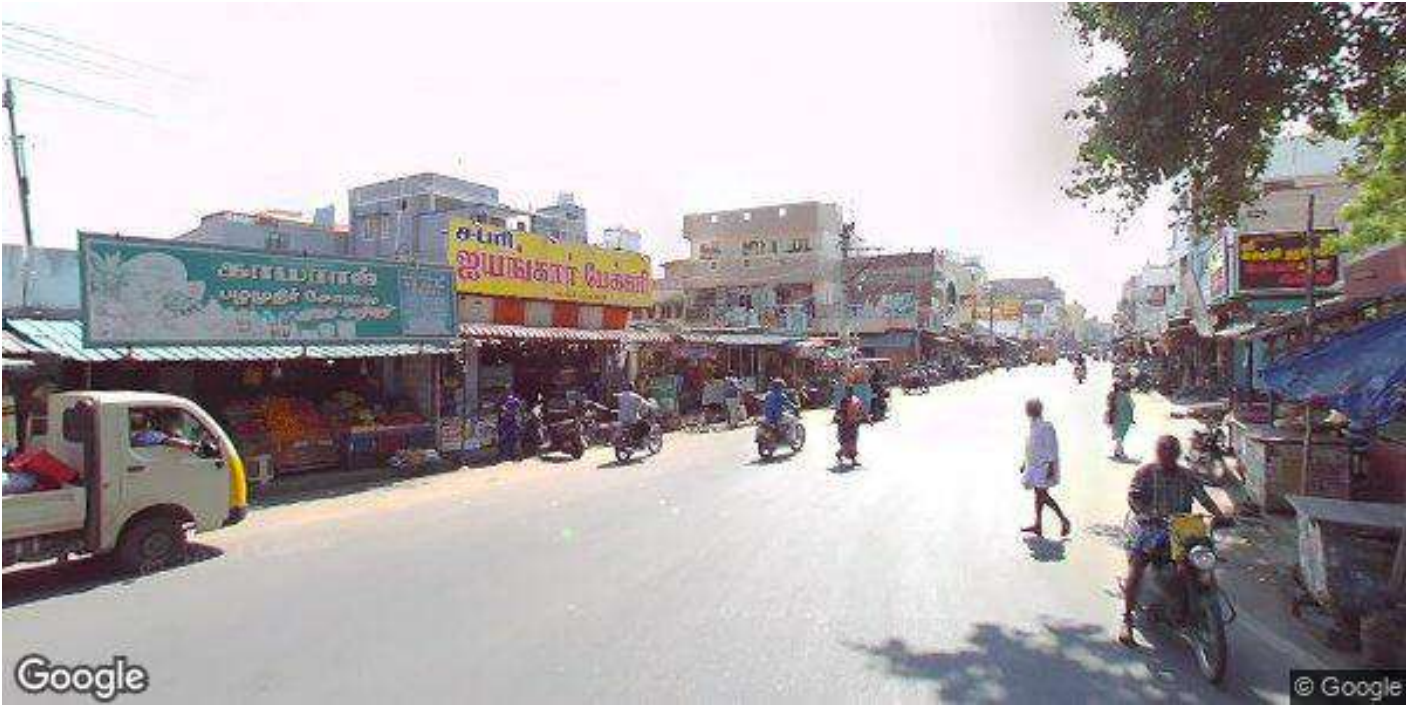
| | Risk Type | Risk Level | Coordinates | Speed Limit |
|---|---|---|---|---|
| 9 | Turn | Medium | 11.15565, 78.02171 | 30 KM/Hr |

**Risk Type:** Turn  
**Risk Level:** Medium  
**Speed Limit:** 30 KM/Hr  
**Coordinates:** 11.15565, 78.02171

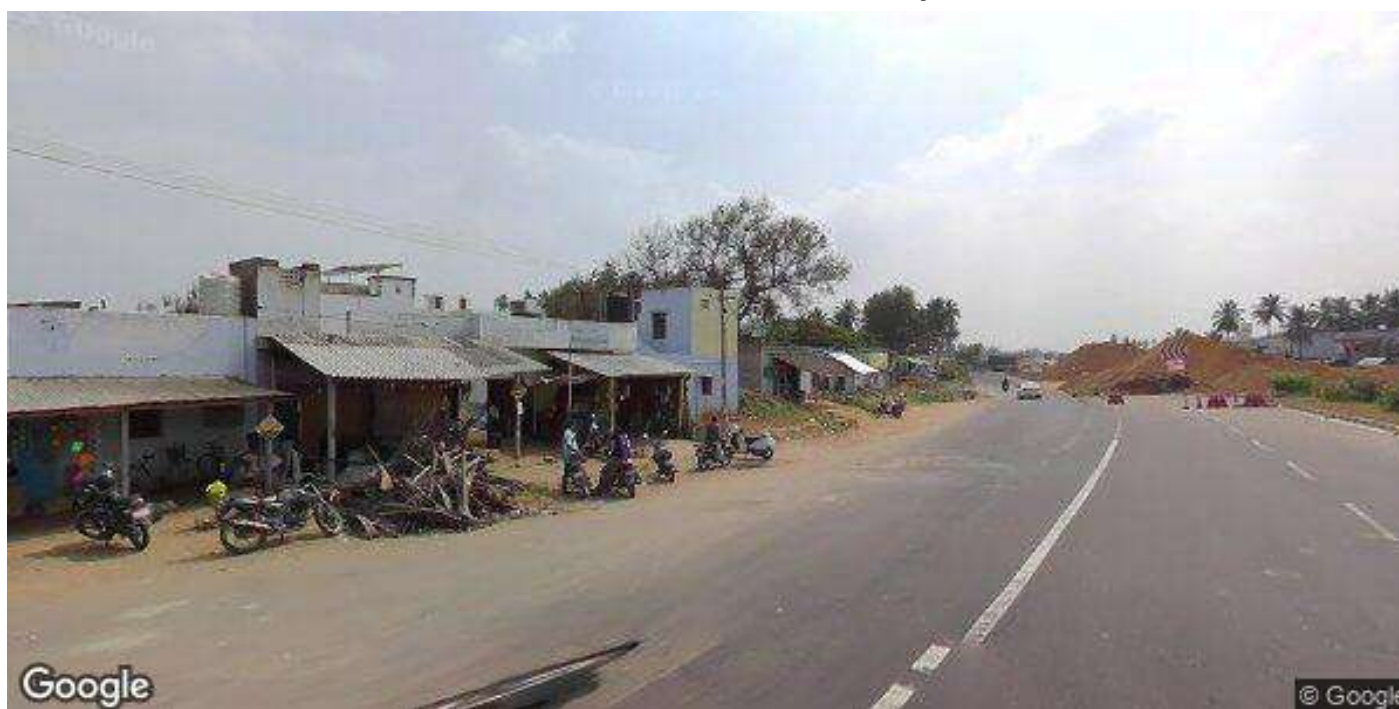
| | Risk Type | Risk Level | Coordinates | Speed Limit |
|---|---|---|---|---|
| 12 | Blind Spot | Blind Spot | 11.09003, 78.00251 | 10 KM/Hr |

**Risk Type:** Blind Spot  
**Risk Level:** Blind Spot  
**Speed Limit:** 10 KM/Hr  
**Coordinates:** 11.09003, 78.00251

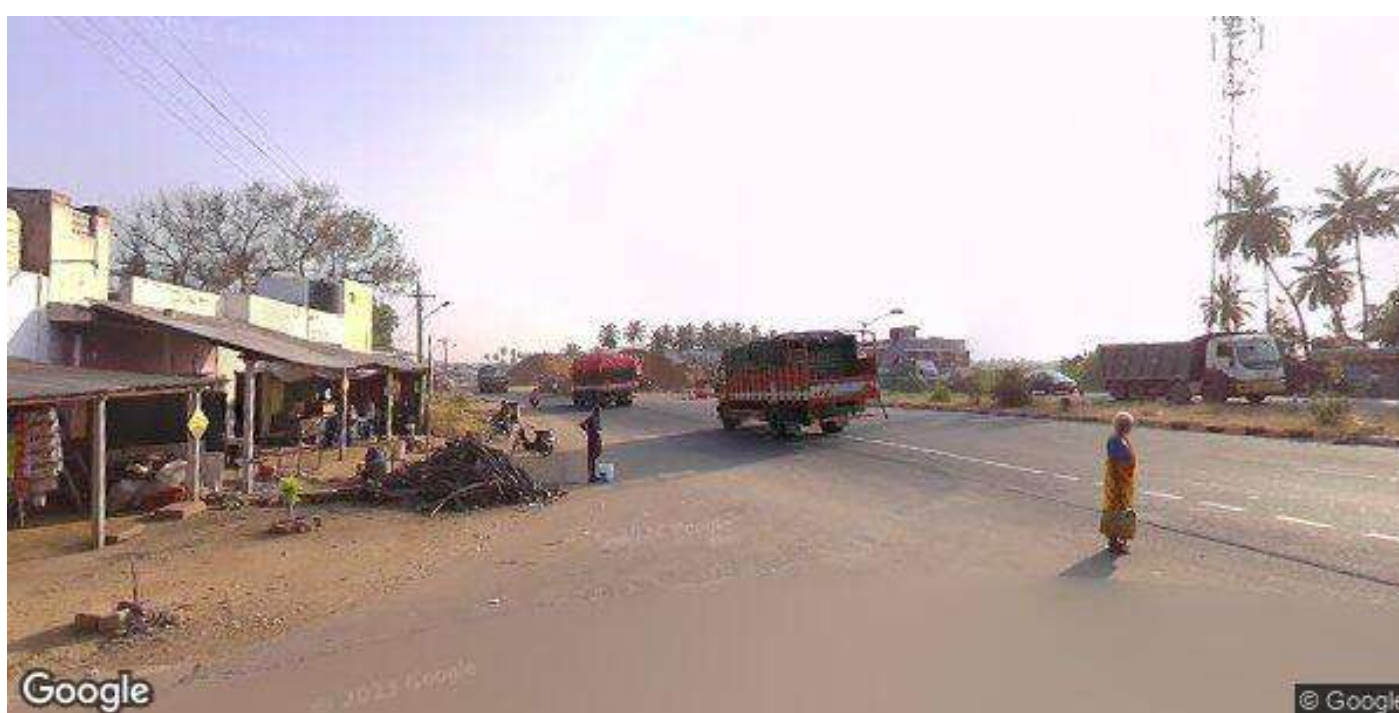
| | Risk Type | Risk Level | Coordinates | Speed Limit |
|---|---|---|---|---|
| 13 | Blind Spot | Blind Spot | 11.09005, 78.00260 | 10 KM/Hr |

**Risk Type:** Blind Spot  
**Risk Level:** Blind Spot  
**Speed Limit:** 10 KM/Hr  
**Coordinates:** 11.09005, 78.00260

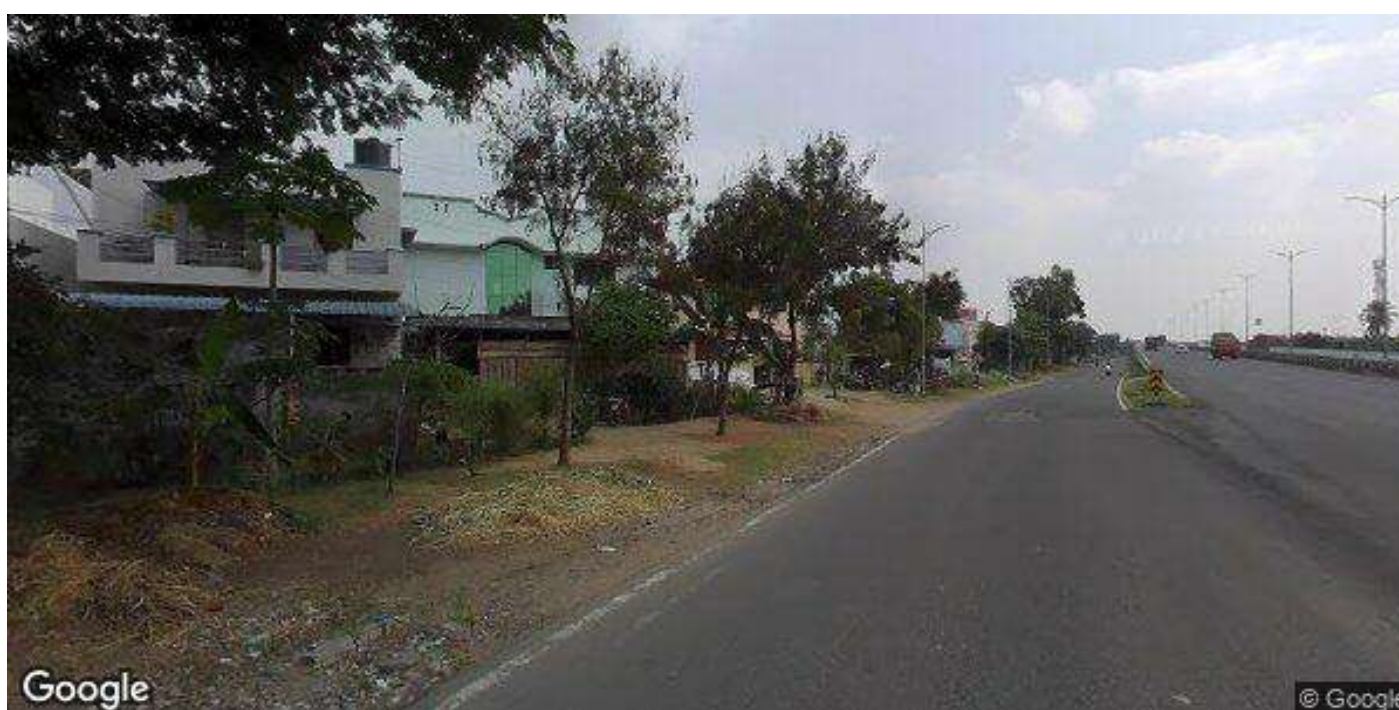
| | Risk Type | Risk Level | Coordinates | Speed Limit |
|---|---|---|---|---|
| 14 | Turn | Medium | 11.08001, 78.00539 | 30 KM/Hr |

**Risk Type:** Turn  
**Risk Level:** Medium  
**Speed Limit:** 30 KM/Hr  
**Coordinates:** 11.08001, 78.00539

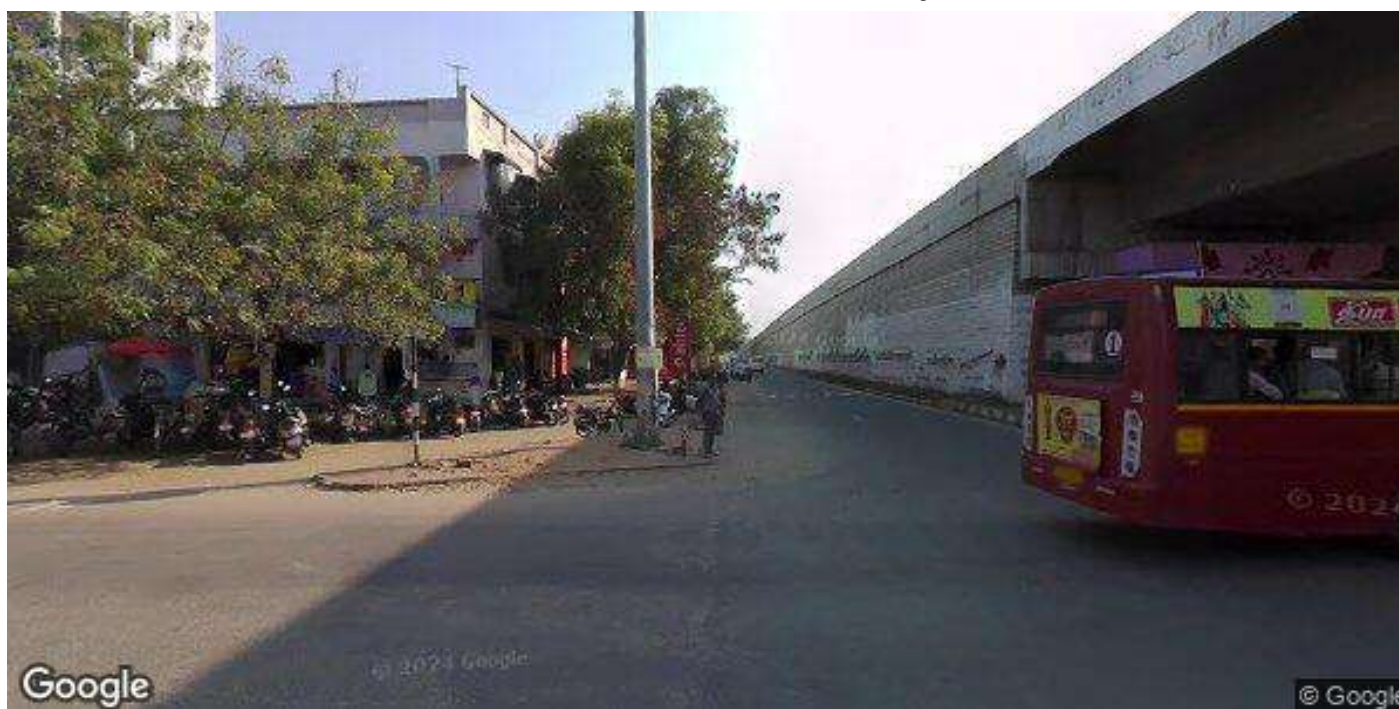
| | Risk Type | Risk Level | Coordinates | Speed Limit |
|---|---|---|---|---|
| 15 | Blind Spot | Blind Spot | 11.07467, 78.00842 | 10 KM/Hr |

**Risk Type:** Blind Spot  
**Risk Level:** Blind Spot  
**Speed Limit:** 10 KM/Hr  
**Coordinates:** 11.07467, 78.00842

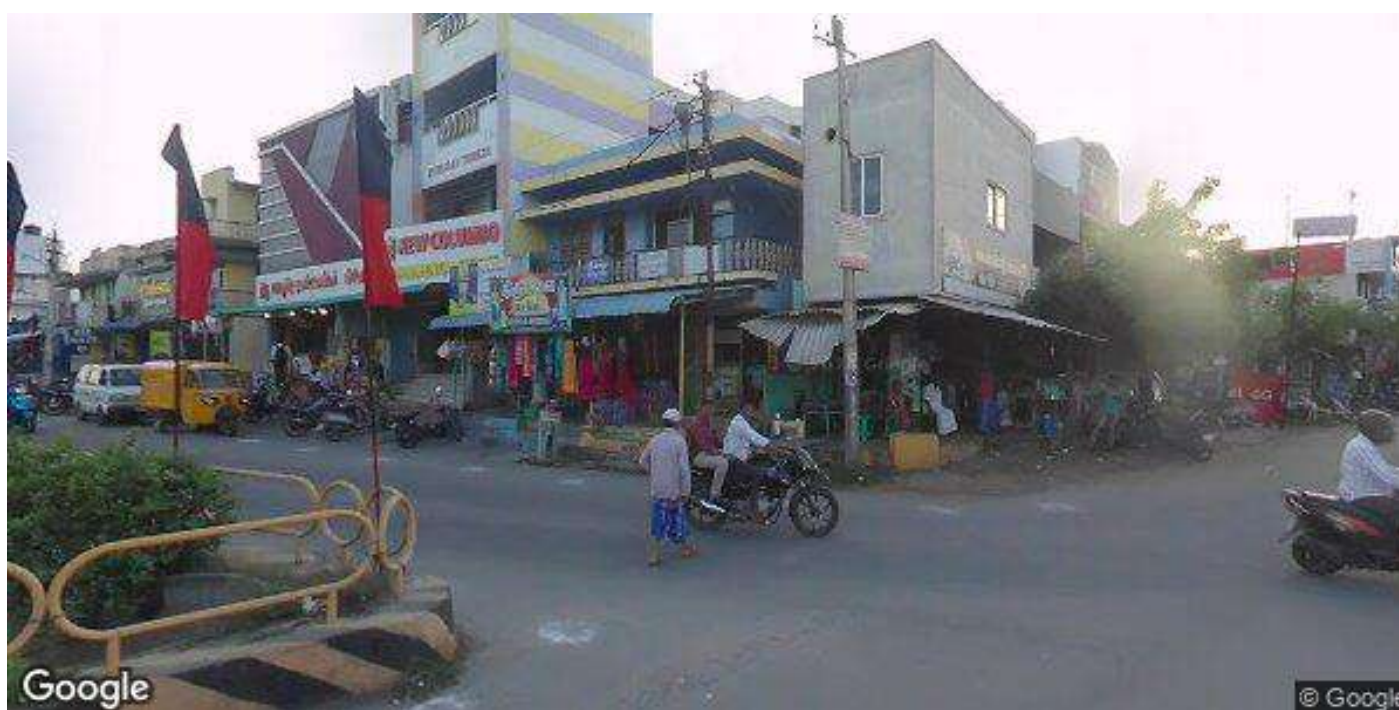
| | Risk Type | Risk Level | Coordinates | Speed Limit |
|---|---|---|---|---|
| 16 | Blind Spot | Blind Spot | 11.07476, 78.00192 | 10 KM/Hr |

**Risk Type:** Blind Spot  
**Risk Level:** Blind Spot  
**Speed Limit:** 10 KM/Hr  
**Coordinates:** 11.07476, 78.00192
