## **JOURNEY RISK MANAGEMENT (JRM) STUDY**

### **Salem Terminal To SRI KALYAN PERUMAL FUELS**

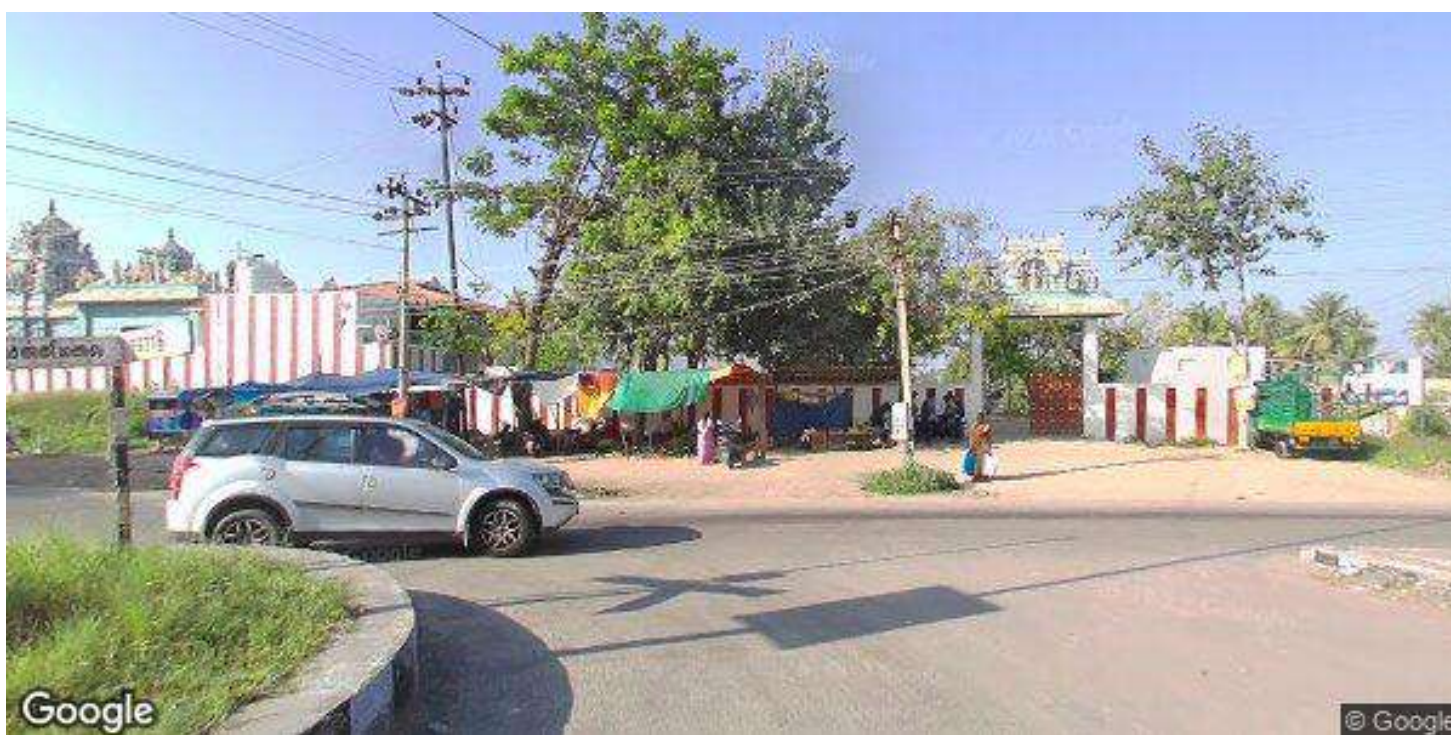
**Risk Type:** Roundabout  
**Risk Level:** High  
**Speed Limit:** 15 KM/Hr  
**Coordinates:** 11.23678, 77.65868

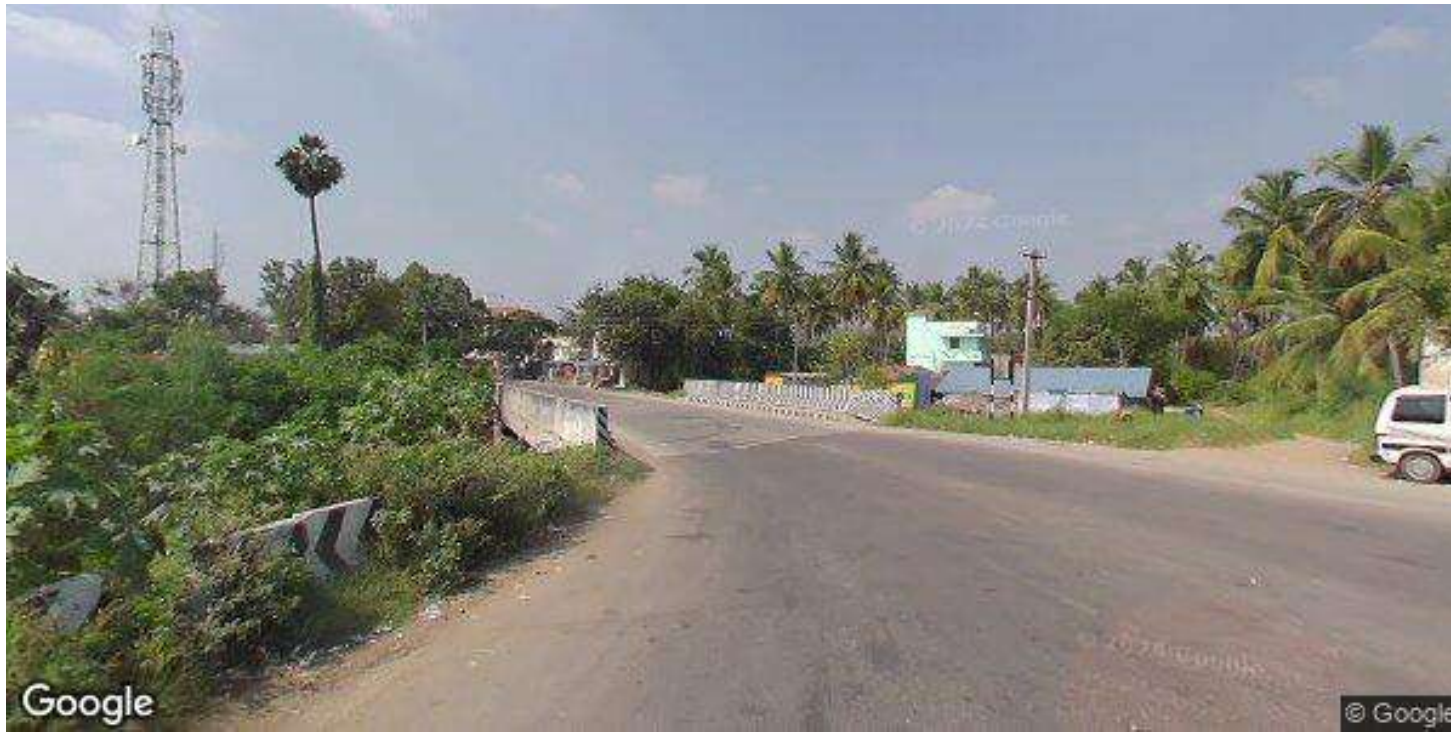
**Risk Type: Turn**

**Risk Level: Medium**

**Speed Limit: 30 KM/Hr**

**Coordinates: 11.44893, 77.87413**

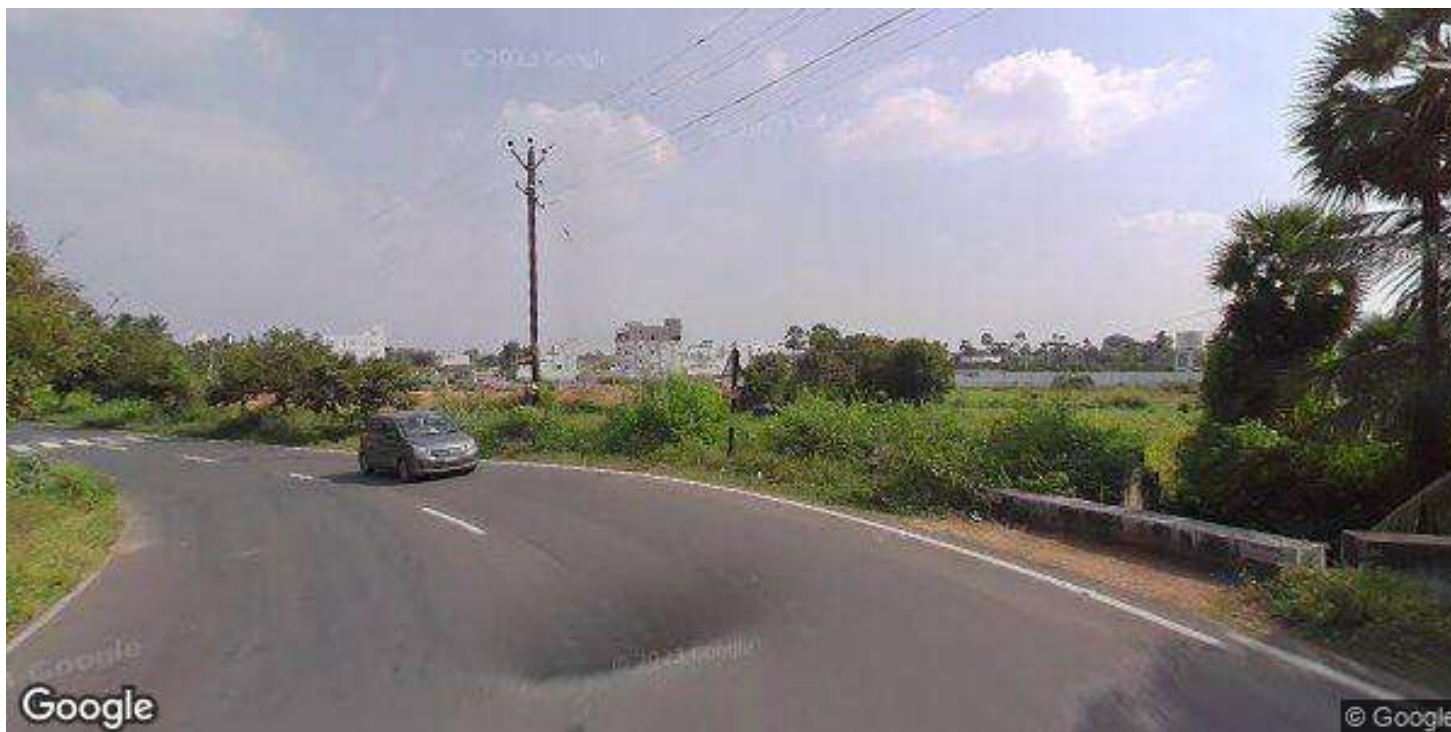
**Risk Type: Turn**

**Risk Level: High**

**Speed Limit: 15 KM/Hr**

**Coordinates: 11.45350, 77.85700**

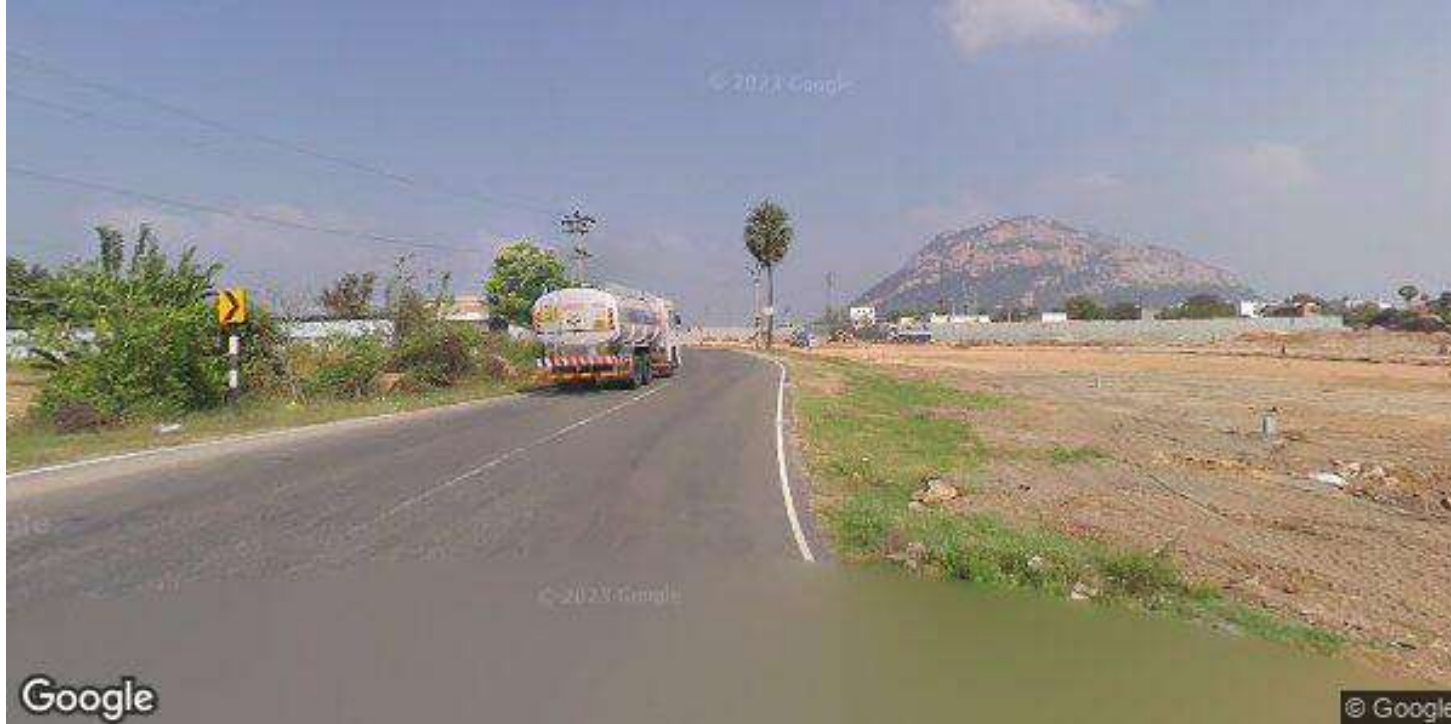
**Risk Type:** Turn  
**Risk Level:** Medium  
**Speed Limit:** 30 KM/Hr  
**Coordinates:** 11.45845, 77.85141

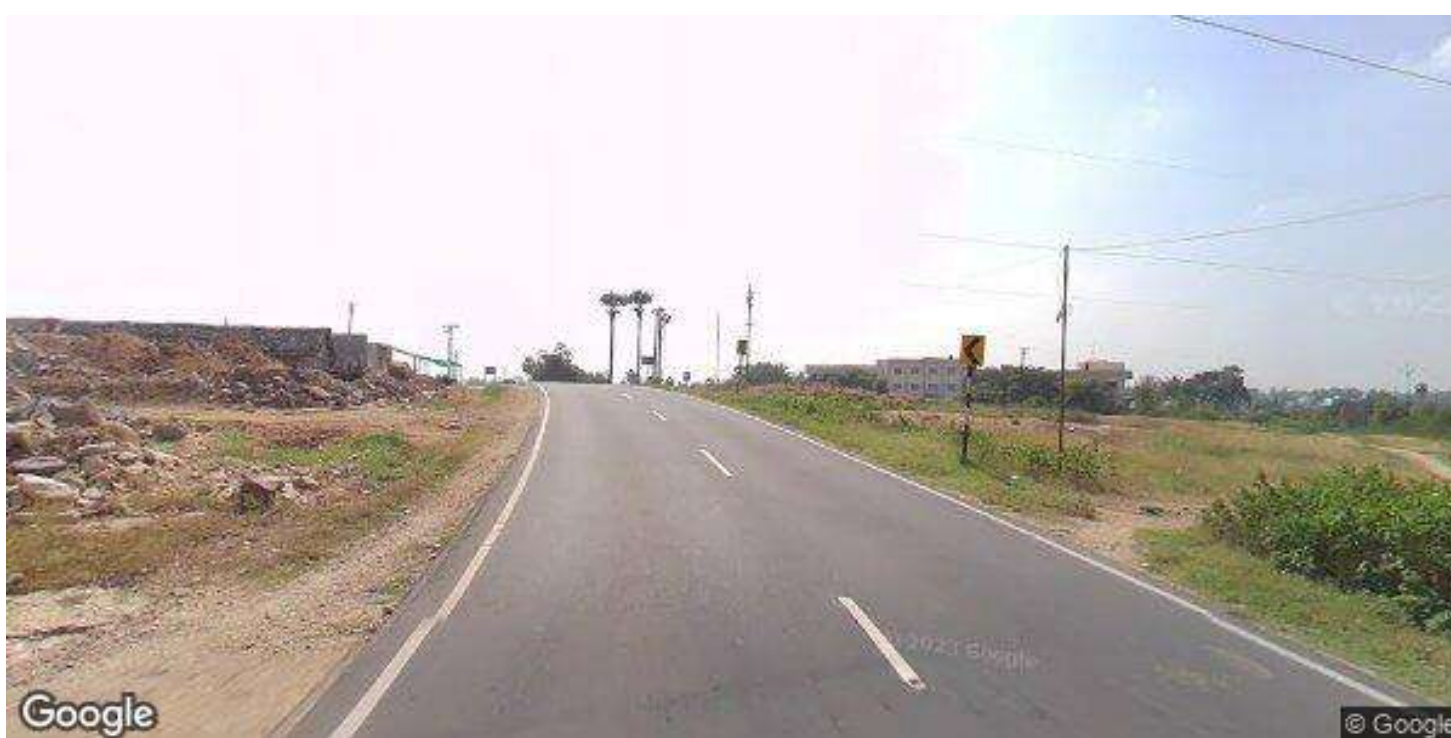
**Risk Type:** Turn  
**Risk Level:** Medium  
**Speed Limit:** 30 KM/Hr  
**Coordinates:** 11.46046, 77.85037

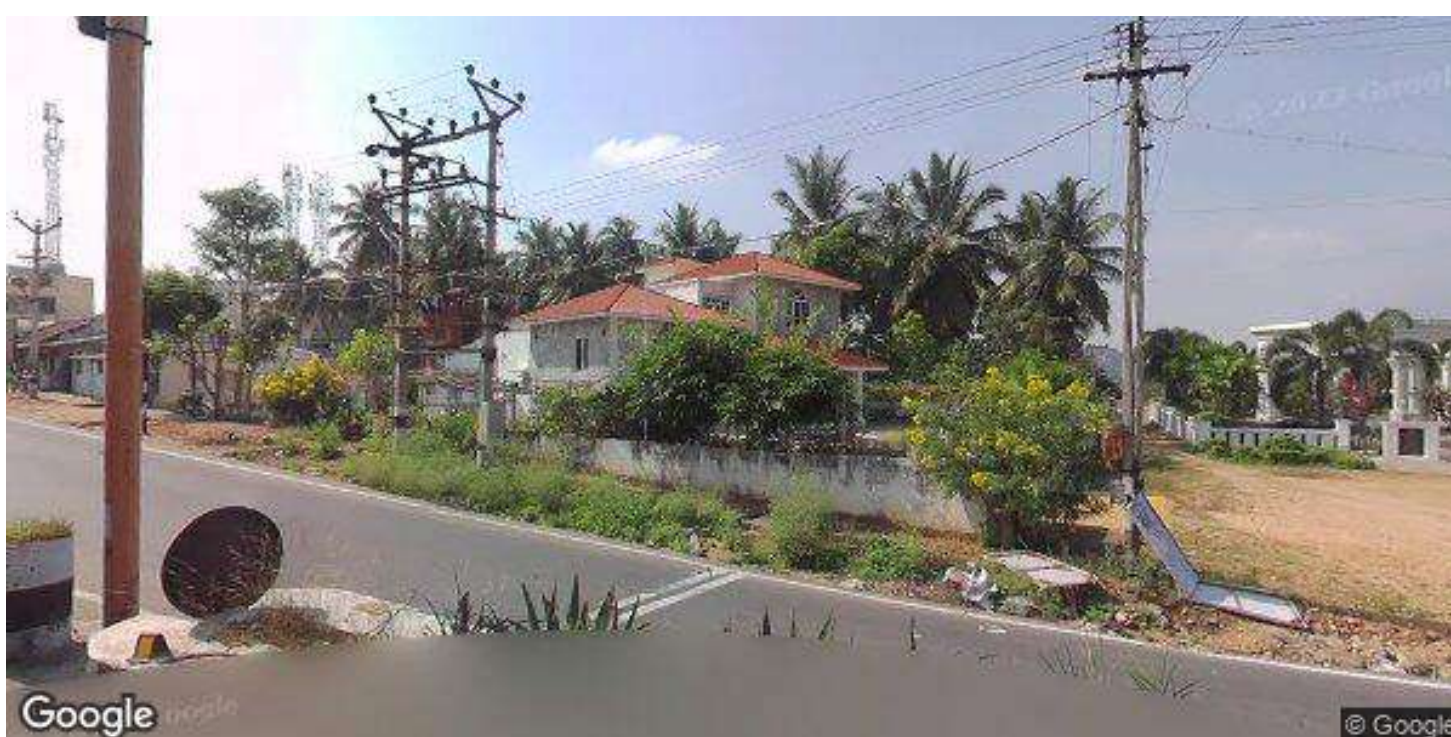
**Risk Type:** Turn  
**Risk Level:** Medium

**Speed Limit: 30 KM/Hr**

**Coordinates: 11.46303, 77.84945**

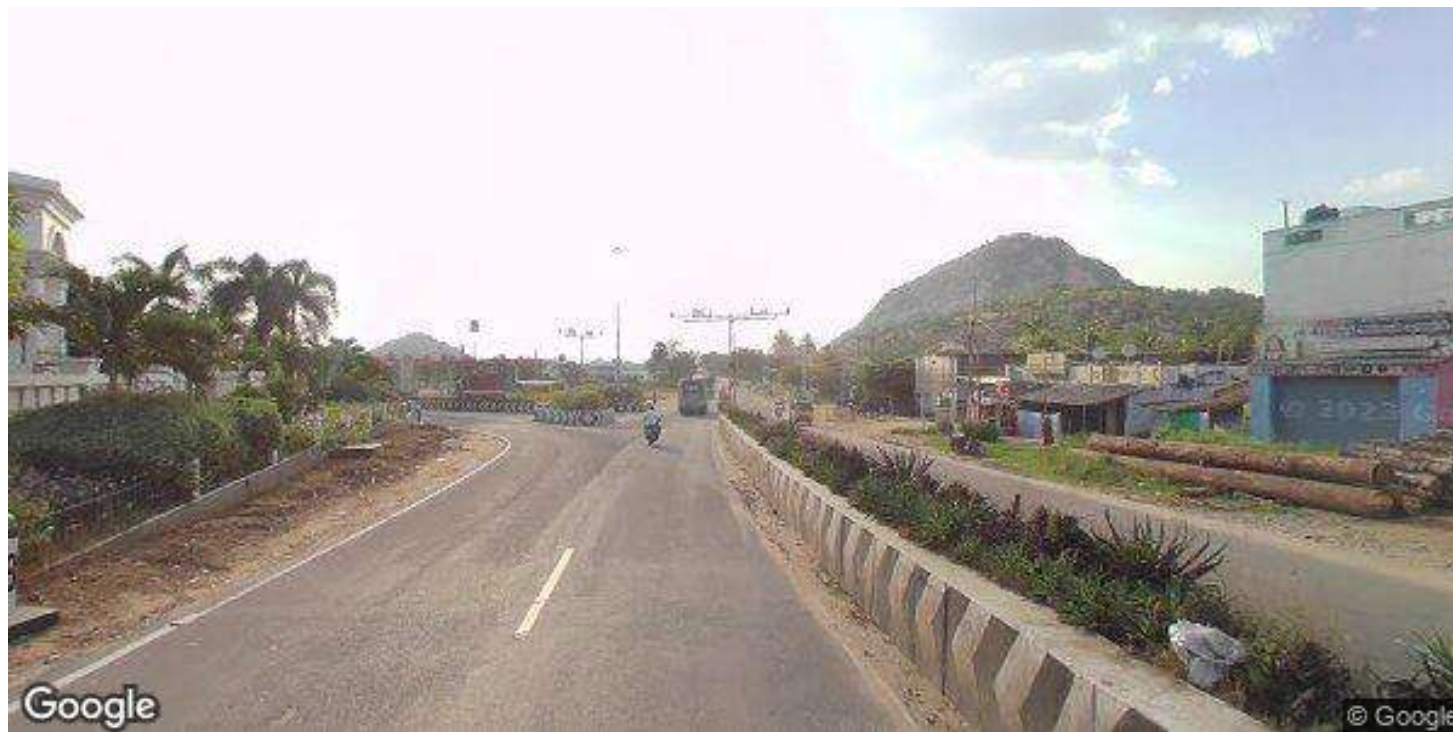
**Risk Type: Turn**

**Risk Level: Medium**

**Speed Limit: 30 KM/Hr**

**Coordinates: 11.46317, 77.84906**

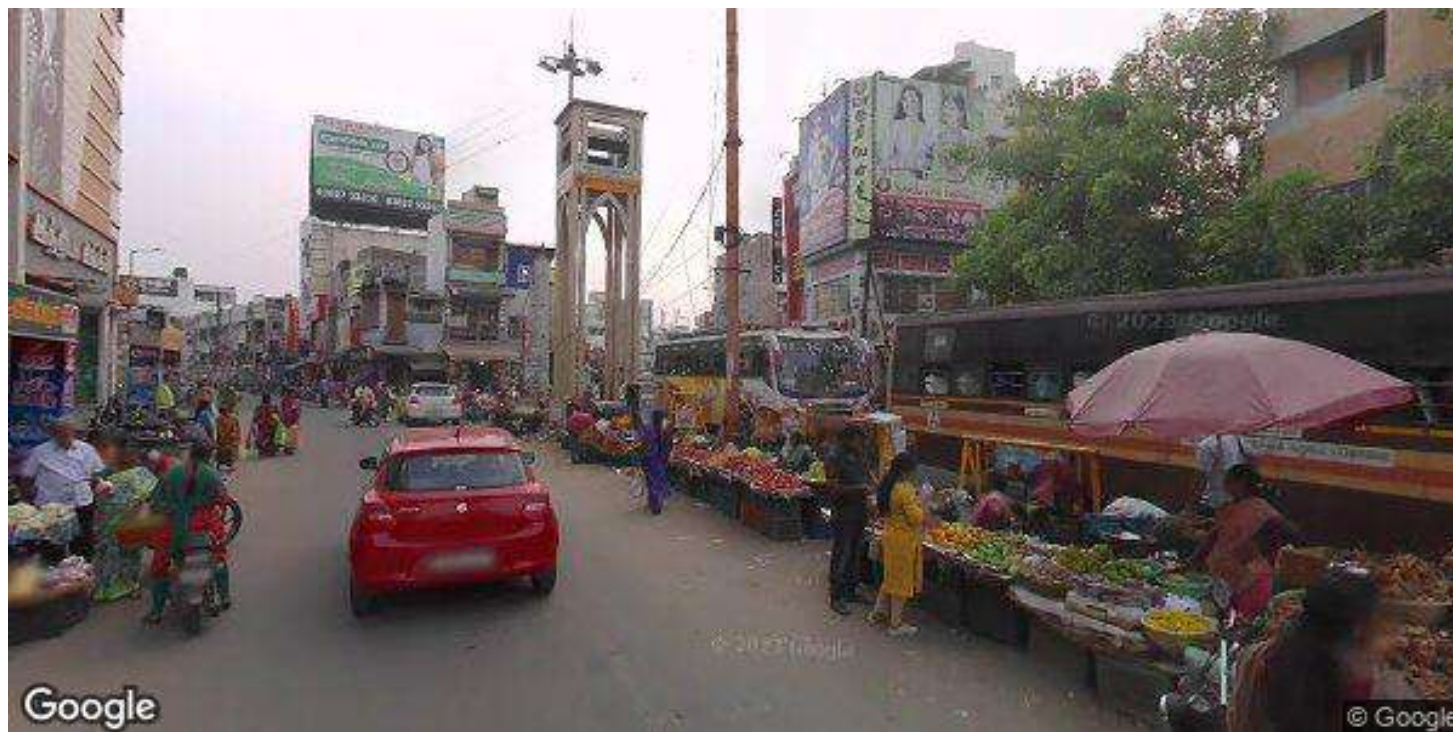
**Risk Type: Turn**

**Risk Level: Medium**

**Speed Limit: 30 KM/Hr**

**Coordinates: 11.34192, 77.72824**

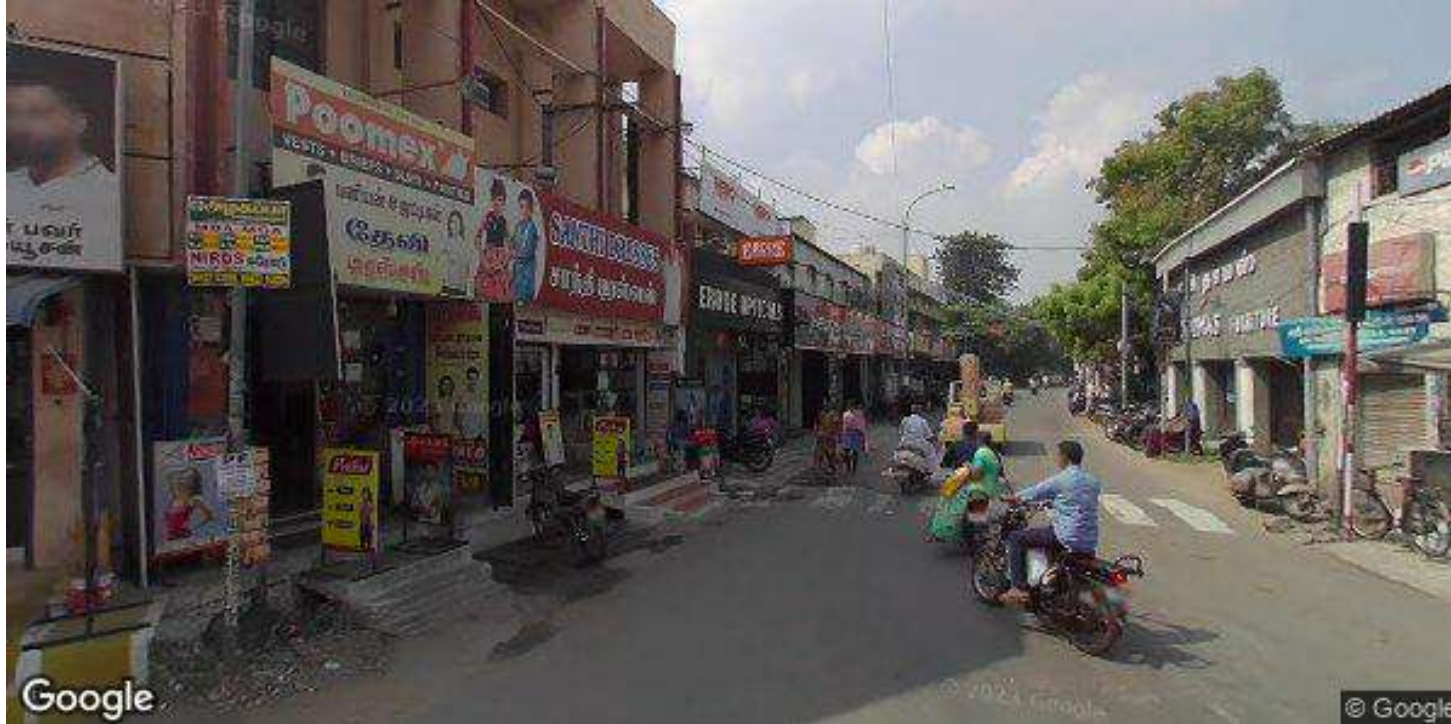
**Risk Type:** Blind Spot  
**Risk Level:** Blind Spot  
**Speed Limit:** 10 KM/Hr  
**Coordinates:** 11.33920, 77.72902

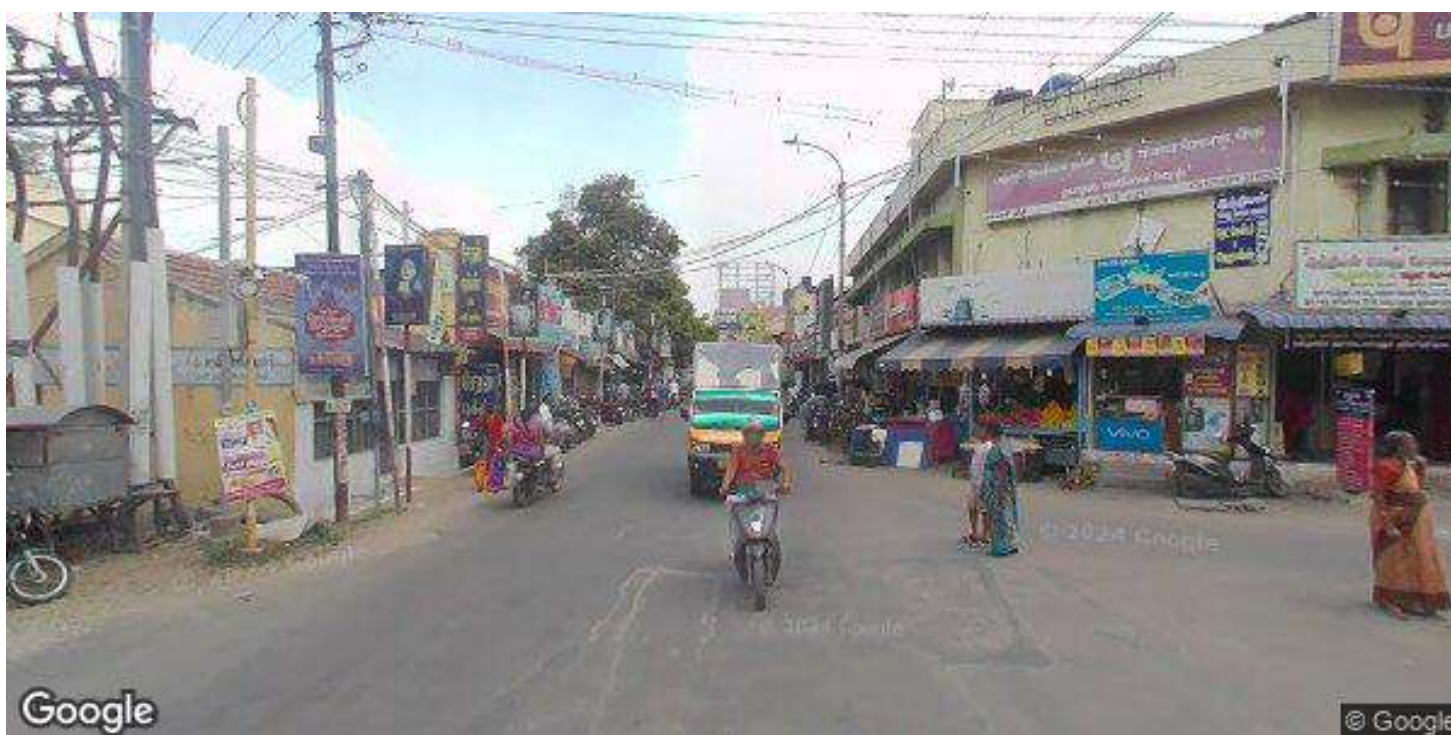
**Risk Type:** Turn  
**Risk Level:** High  
**Speed Limit:** 15 KM/Hr  
**Coordinates:** 11.33913, 77.72832

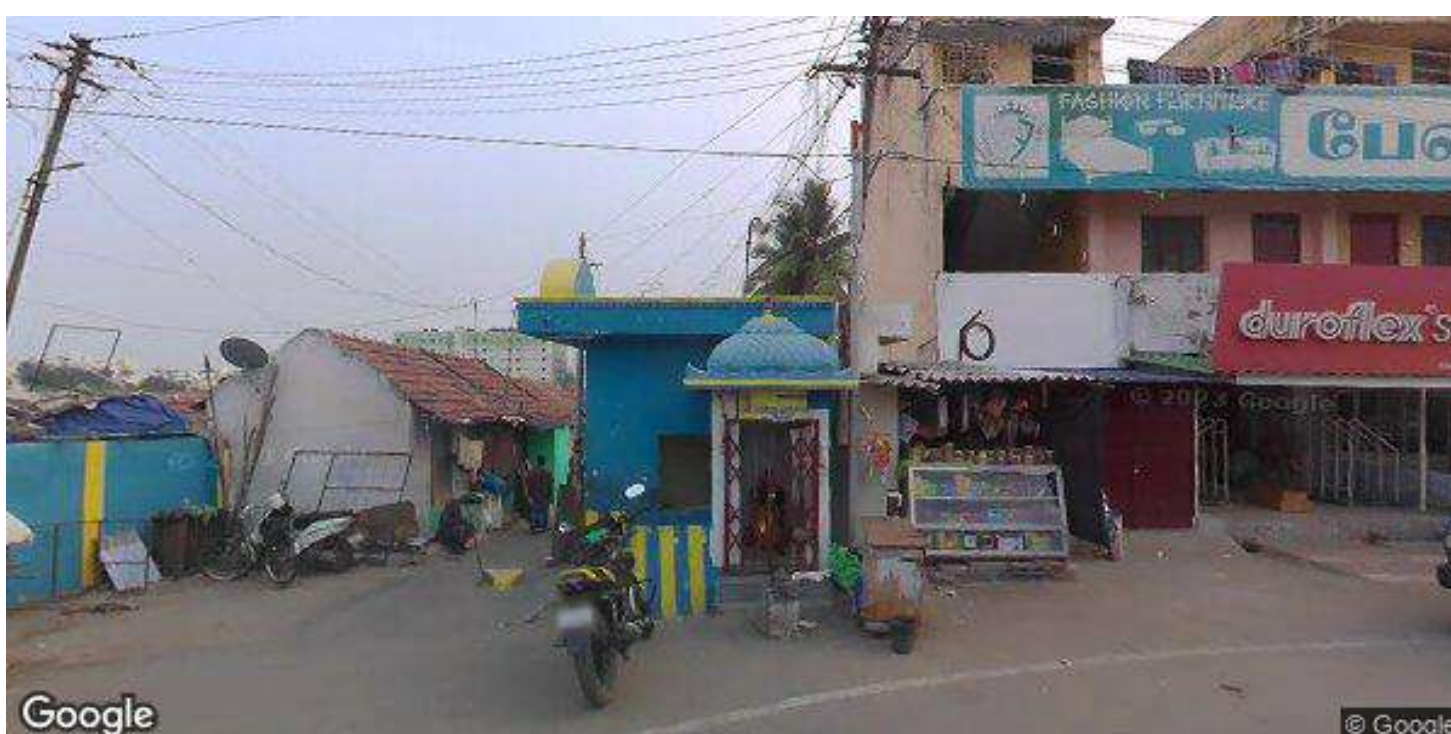
**Risk Type:** Blind Spot  
**Risk Level:** Blind Spot

Speed Limit: 10 KM/Hr

Coordinates: 11.33618, 77.72865

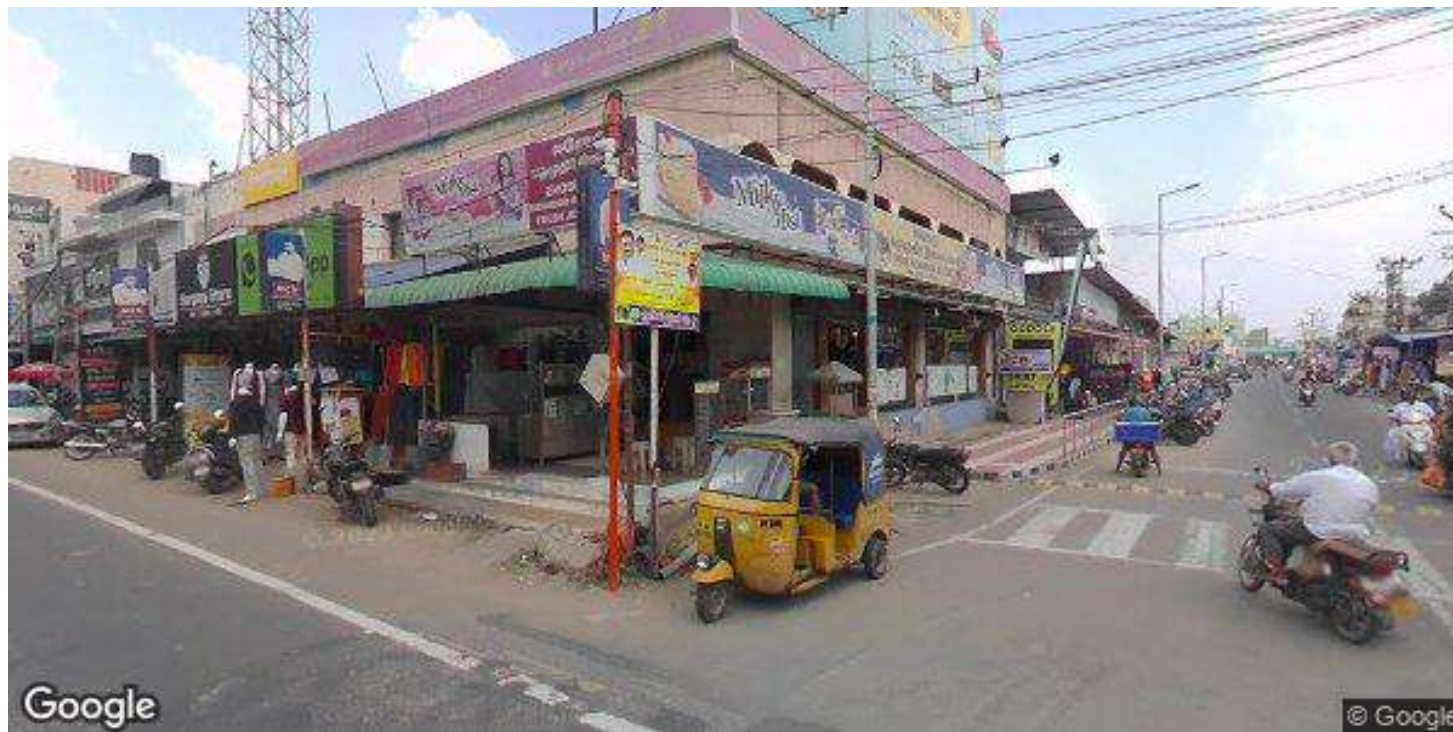
Risk Type: Blind Spot

Risk Level: Blind Spot

Speed Limit: 10 KM/Hr

Coordinates: 11.33582, 77.72712

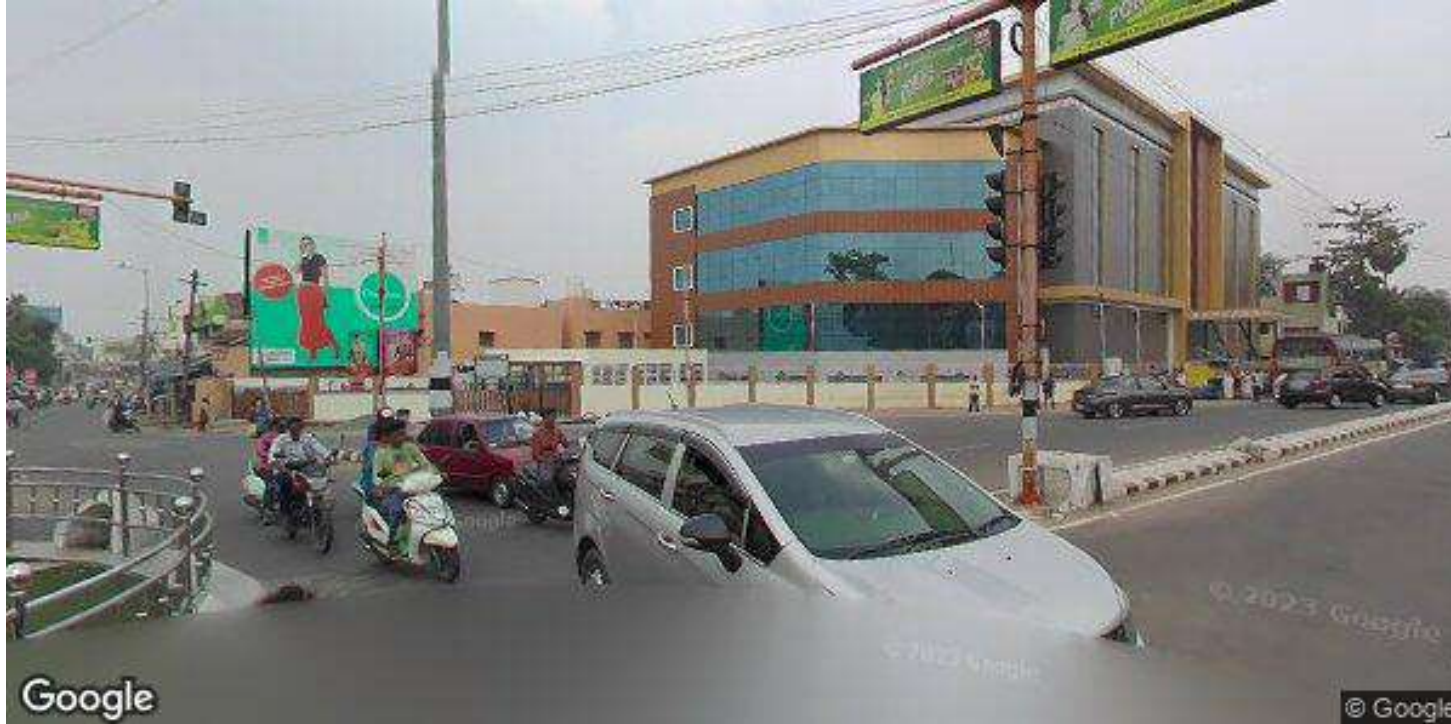
**Risk Type:** Turn

**Risk Level:** Medium

**Speed Limit:** 30 KM/Hr

**Coordinates:** 11.33088, 77.72747

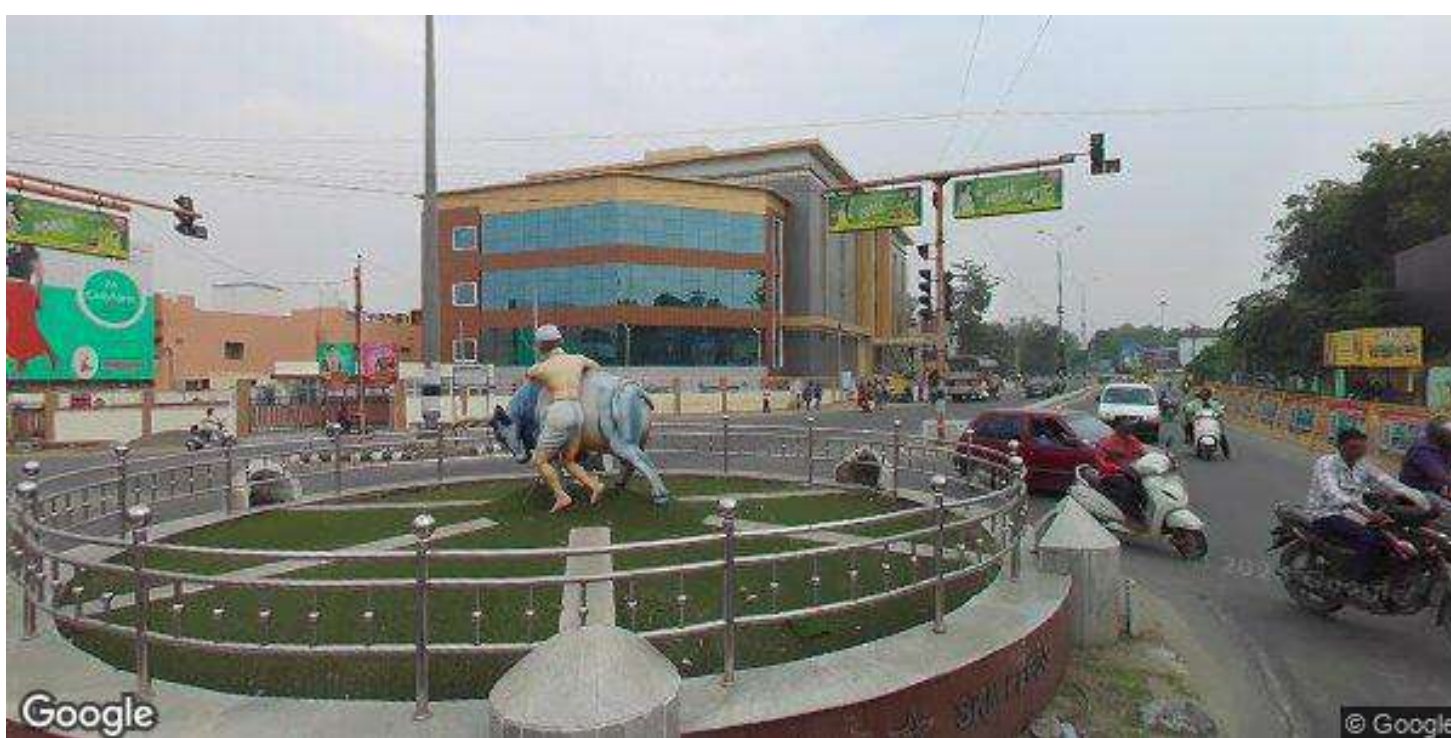
**Risk Type:** Turn

**Risk Level:** Medium

**Speed Limit:** 30 KM/Hr

**Coordinates:** 11.33083, 77.72740

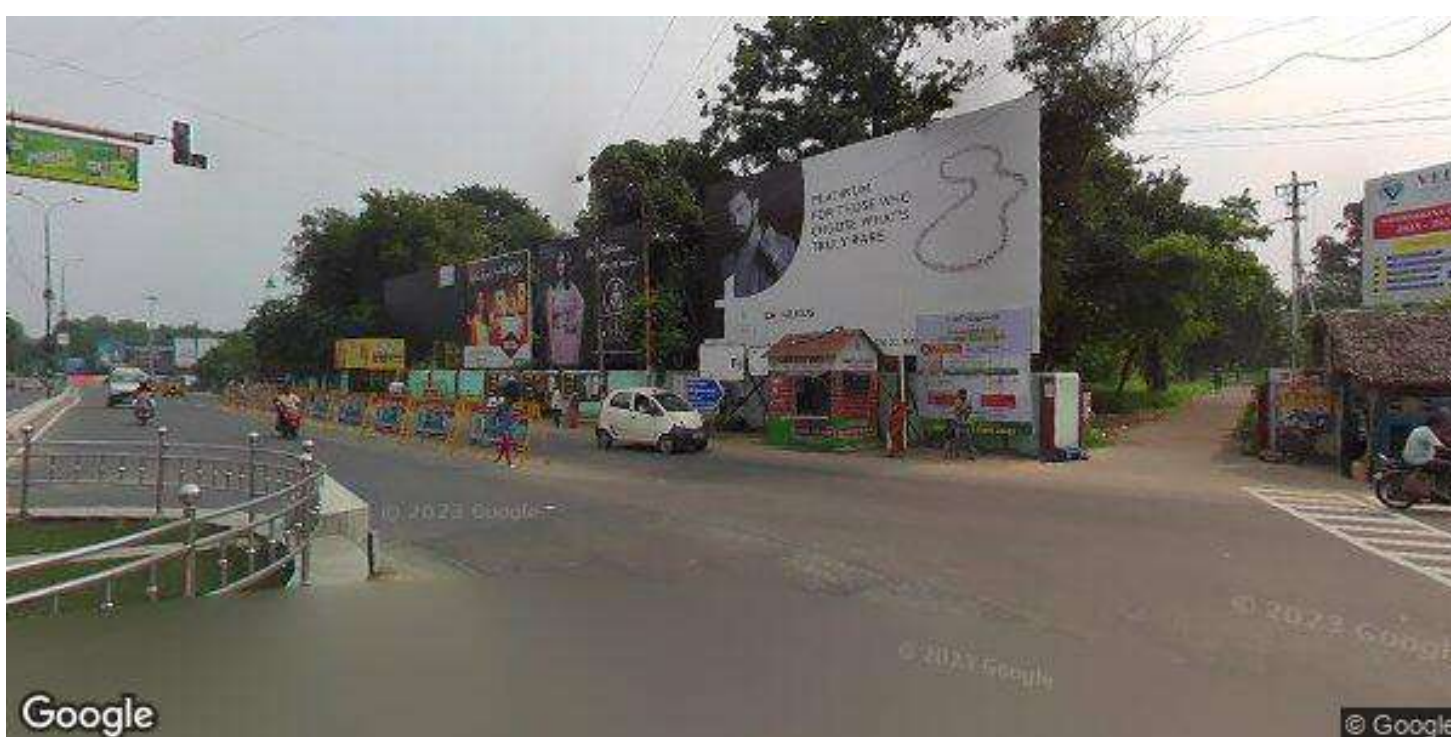
**Risk Type:** Turn

**Risk Level:** Medium

**Speed Limit: 30 KM/Hr**

**Coordinates: 11.33083, 77.72732**

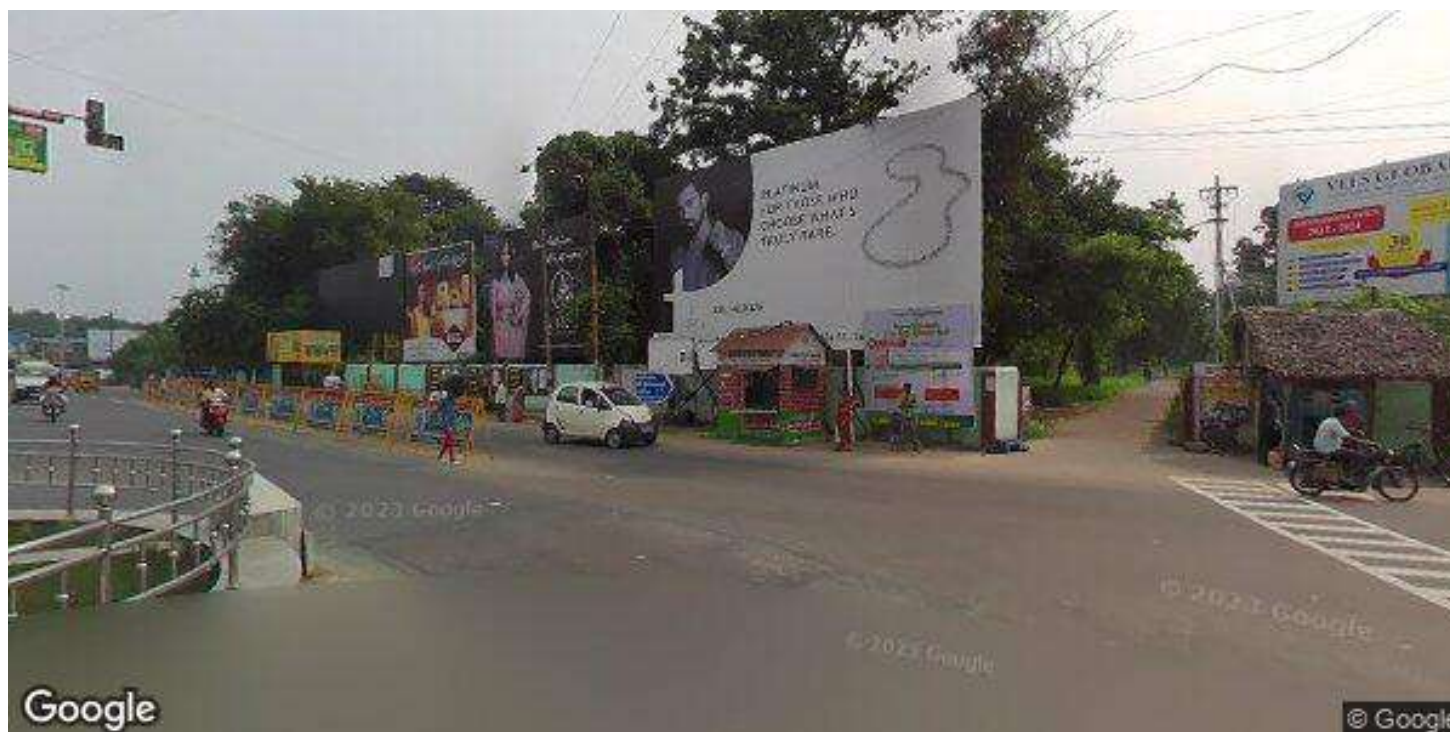
**Risk Type: Turn**

**Risk Level: High**

**Speed Limit: 15 KM/Hr**

**Coordinates: 11.33085, 77.72730**

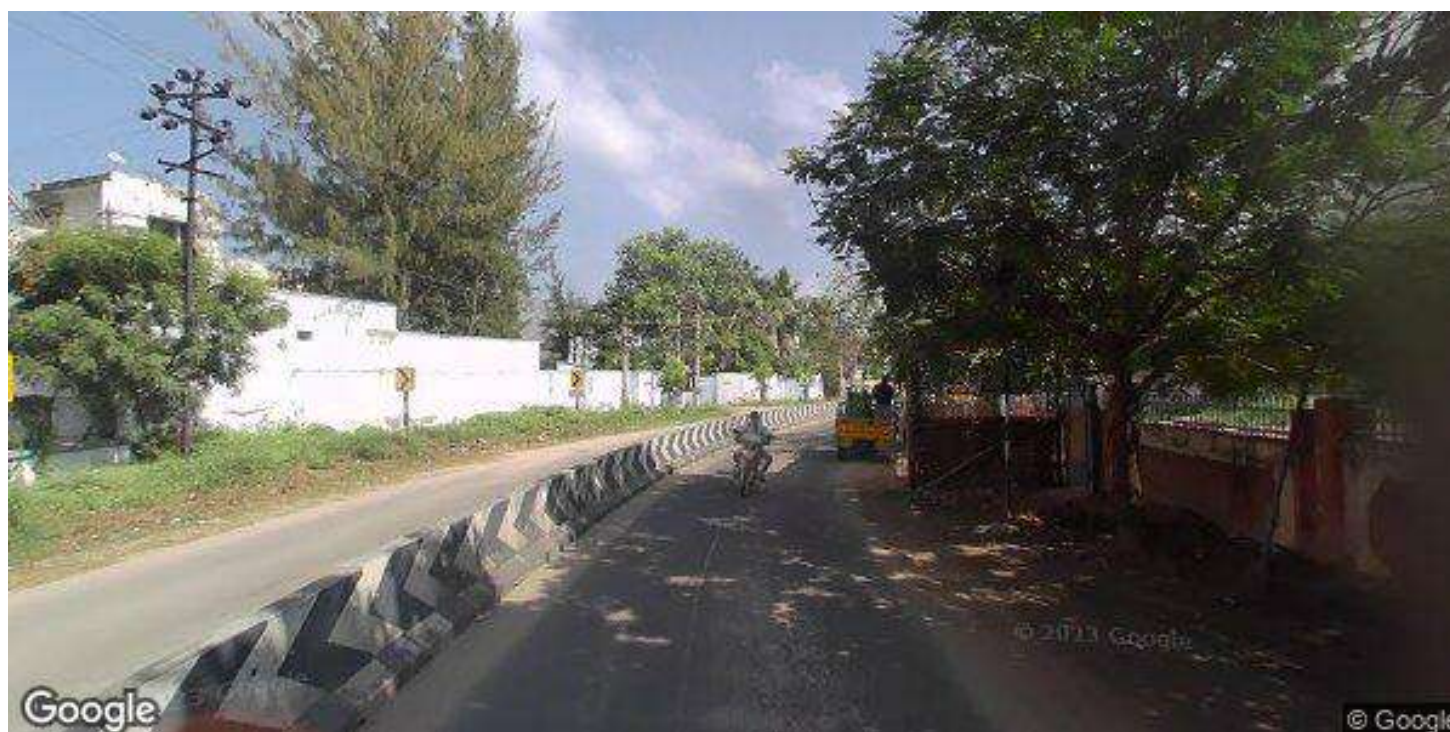
**Risk Type: Turn**

**Risk Level: Medium**

**Speed Limit: 30 KM/Hr**

**Coordinates: 11.32259, 77.71458**

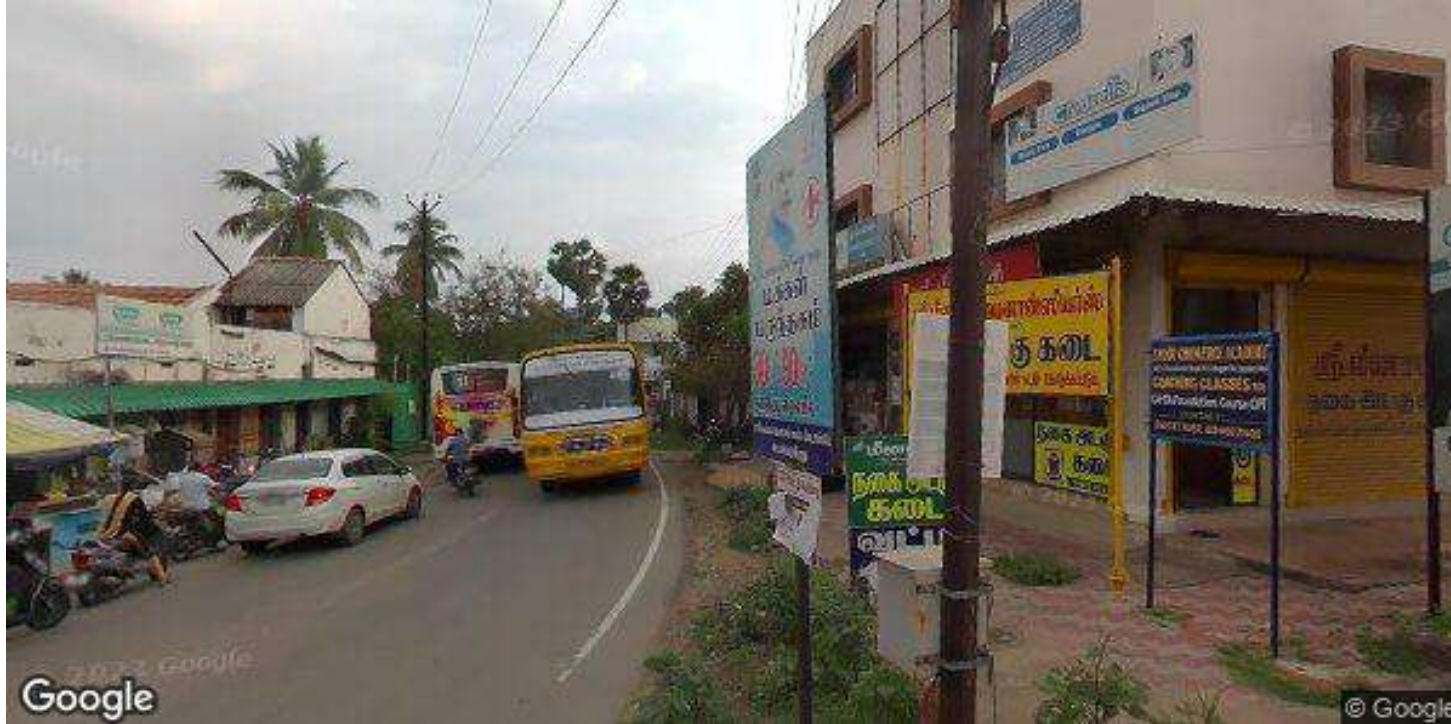
**Risk Type:** Turn

**Risk Level:** High

**Speed Limit:** 15 KM/Hr

**Coordinates:** 11.31165, 77.70717

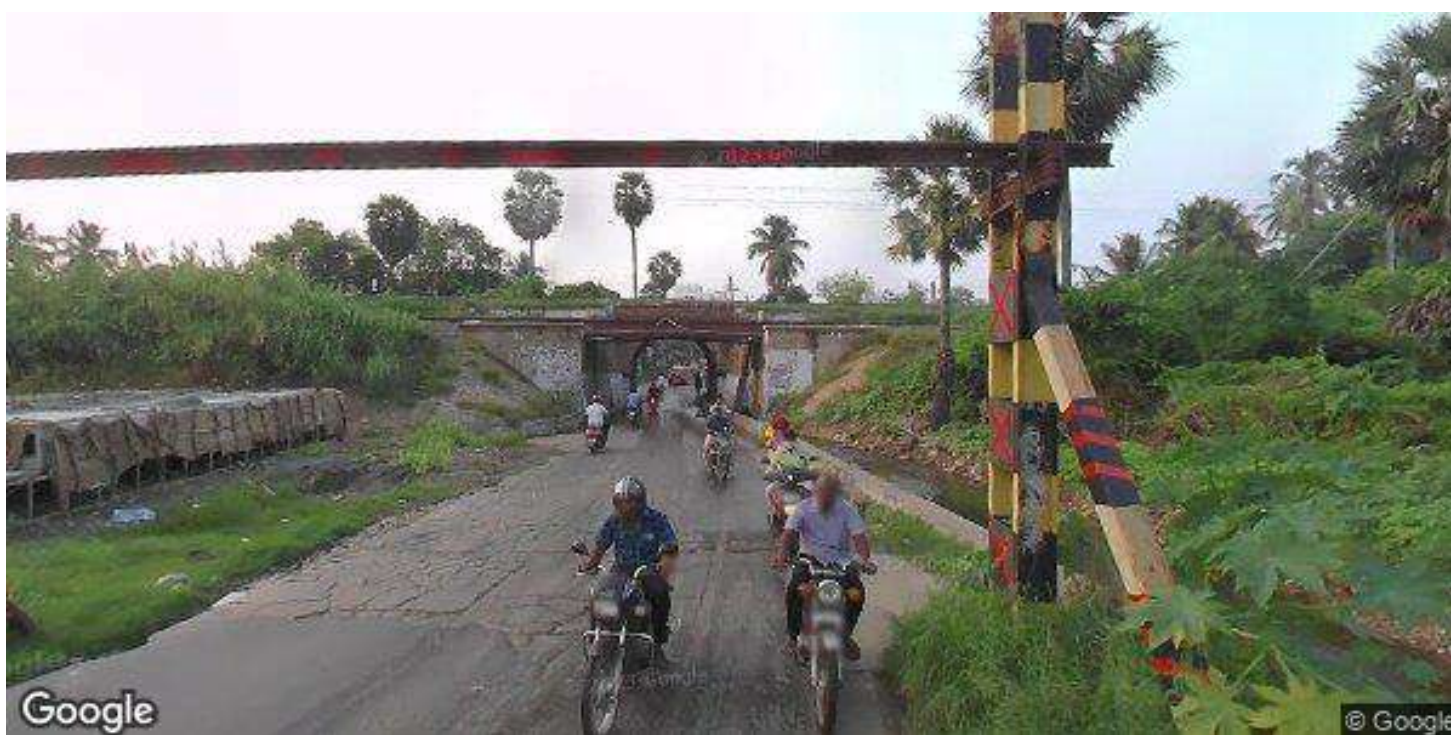
**Risk Type:** Turn

**Risk Level:** Medium

**Speed Limit:** 30 KM/Hr

**Coordinates:** 11.31050, 77.70781

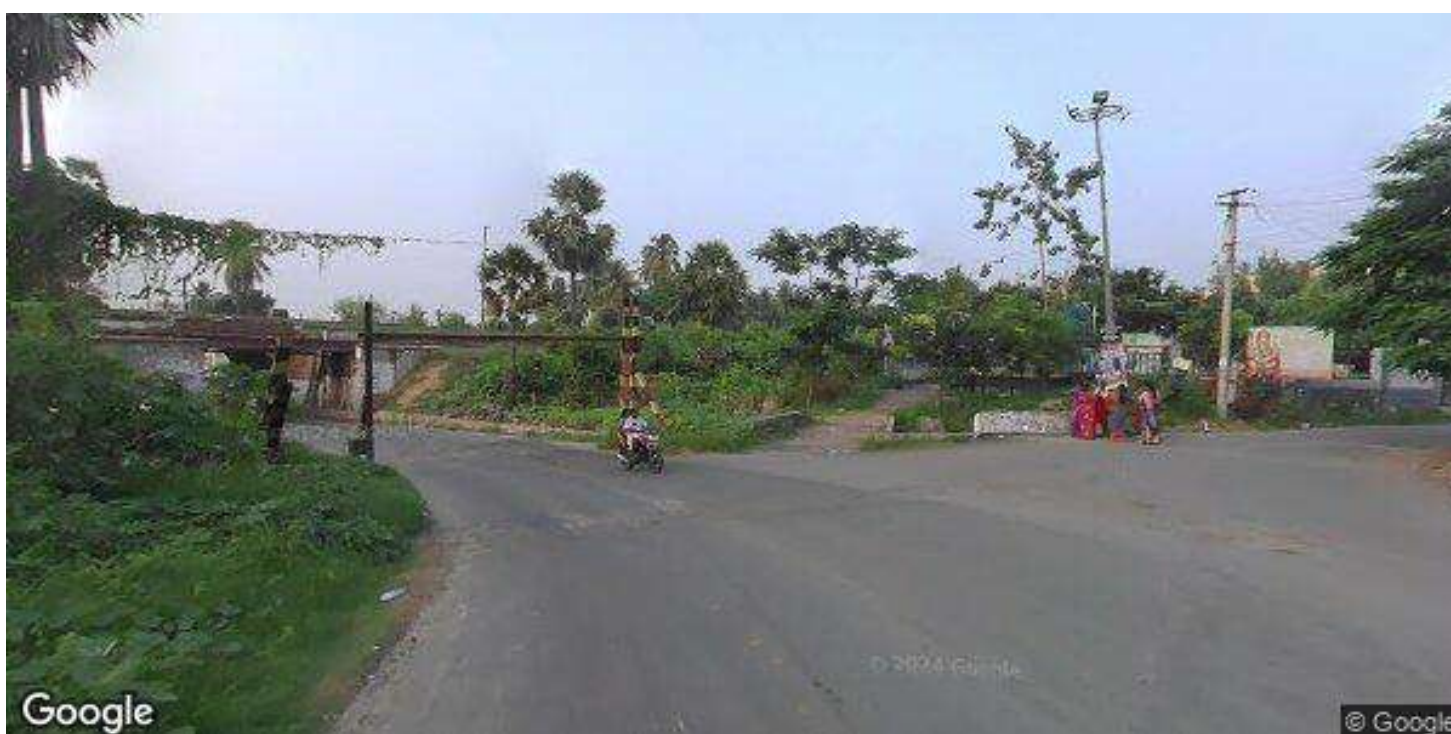
**Risk Type:** Turn

**Risk Level:** Medium

**Speed Limit: 30 KM/Hr**

**Coordinates: 11.31032, 77.70783**

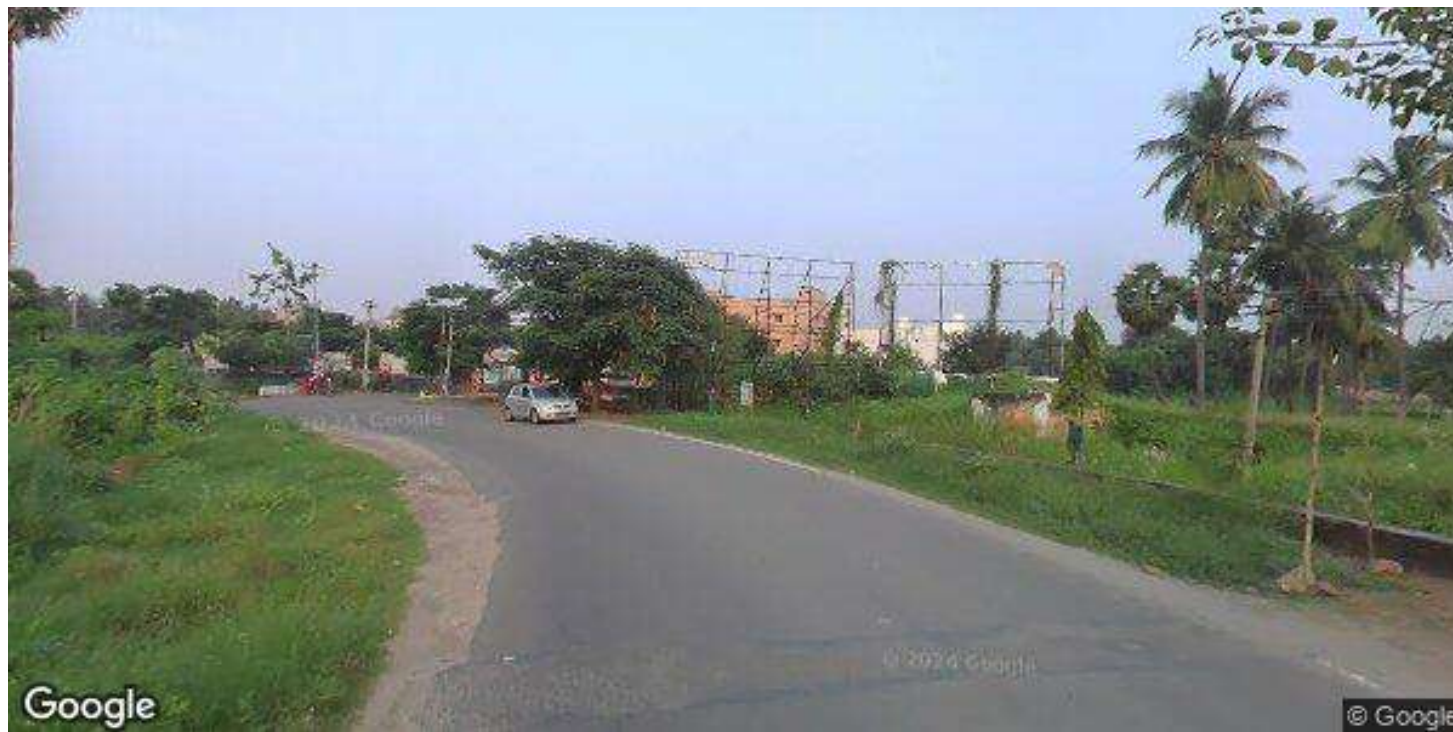
**Risk Type: Turn**

**Risk Level: Medium**

**Speed Limit: 30 KM/Hr**

**Coordinates: 11.31003, 77.70761**
