## **JOURNEY RISK MANAGEMENT (JRM) STUDY**

### **Salem Terminal To SRI KALYAN PERUMAL FUELS**

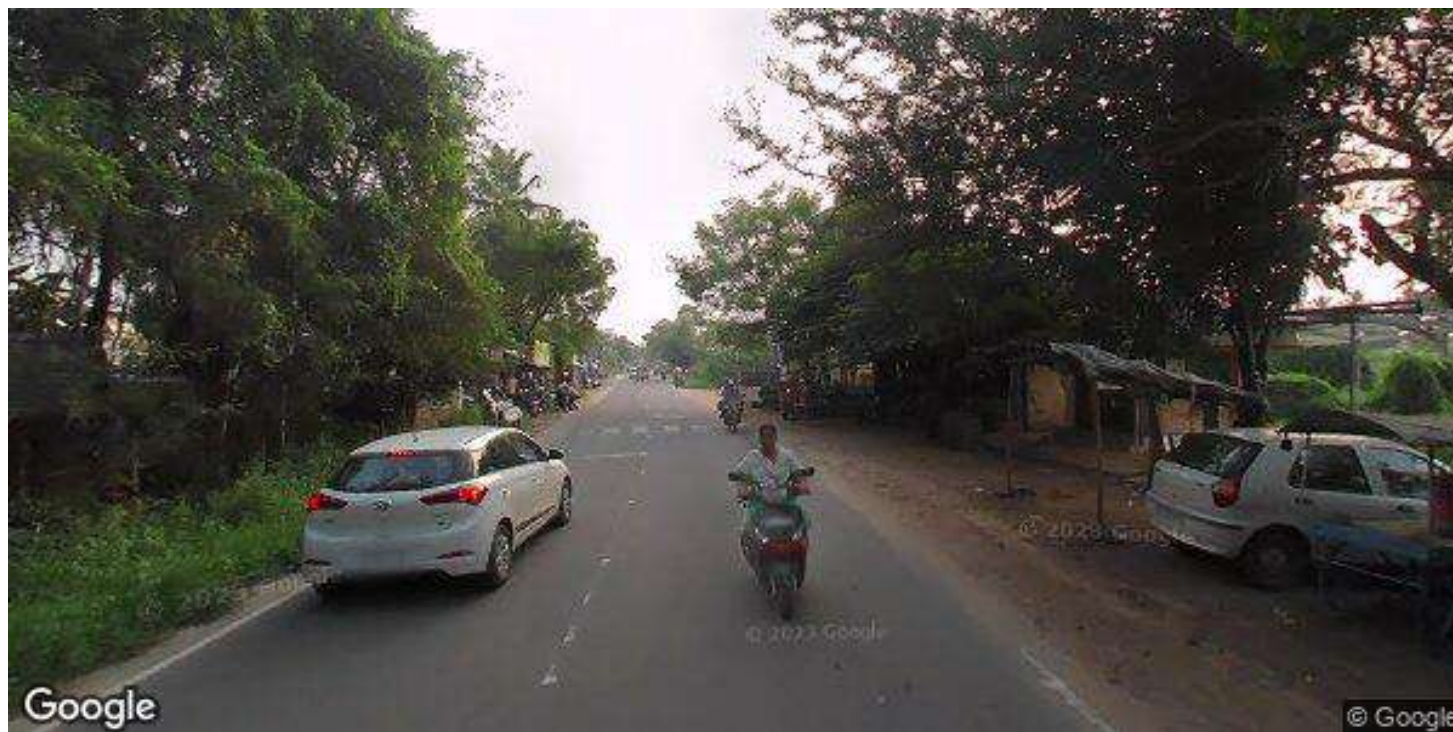
**Risk Type: Turn**

**Risk Level: Medium**

**Speed Limit: 30 KM/Hr**

**Coordinates: 11.30807, 77.70415**

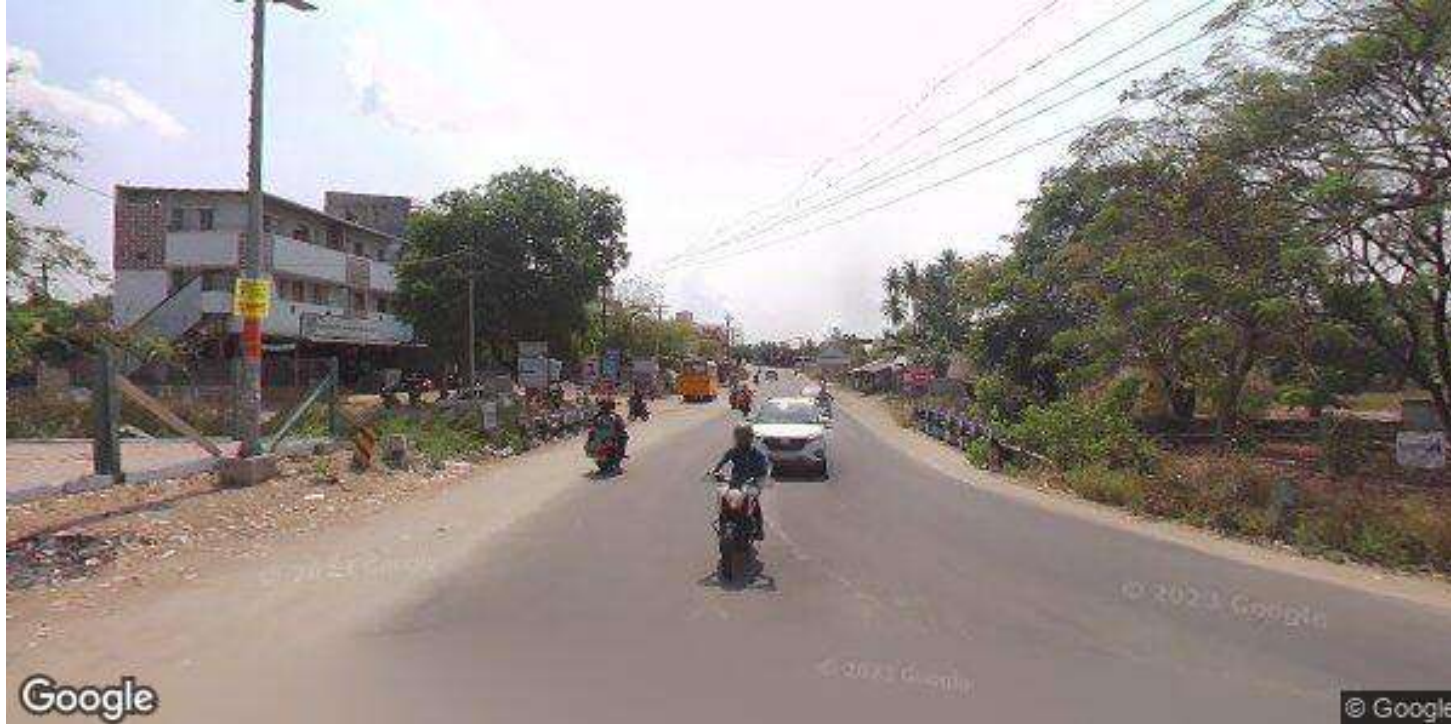
**Risk Type:** Blind Spot  
**Risk Level:** Blind Spot  
**Speed Limit:** 10 KM/Hr  
**Coordinates:** 11.23903, 77.66455

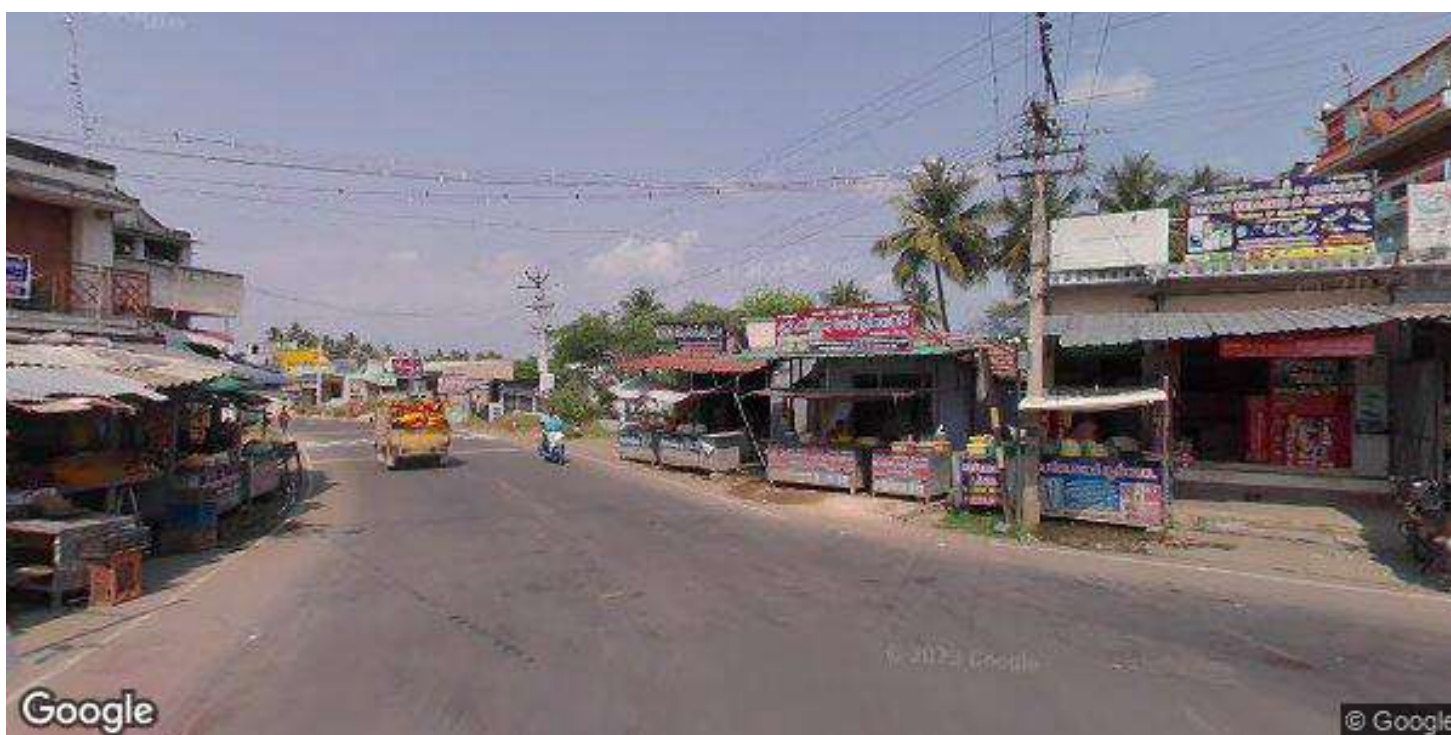
**Risk Type:** Turn  
**Risk Level:** Medium  
**Speed Limit:** 30 KM/Hr  
**Coordinates:** 11.23738, 77.66170

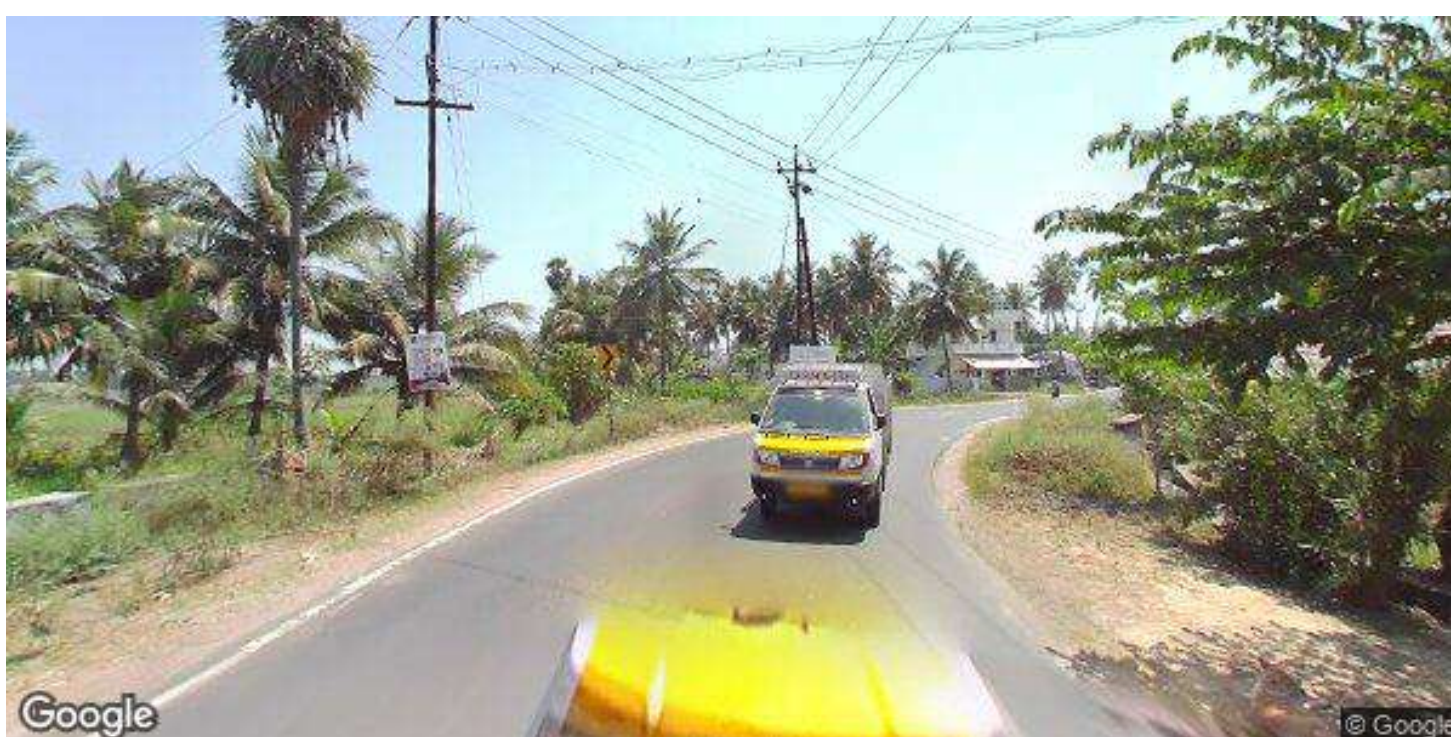
**Risk Type:** Turn  
**Risk Level:** Medium

**Speed Limit:** 30 KM/Hr  
**Coordinates:** 11.23837, 77.65729
