## **JOURNEY RISK MANAGEMENT (JRM) STUDY**

### **Salem Terminal TO SALEM DISTRICT LORRY OWNERS**

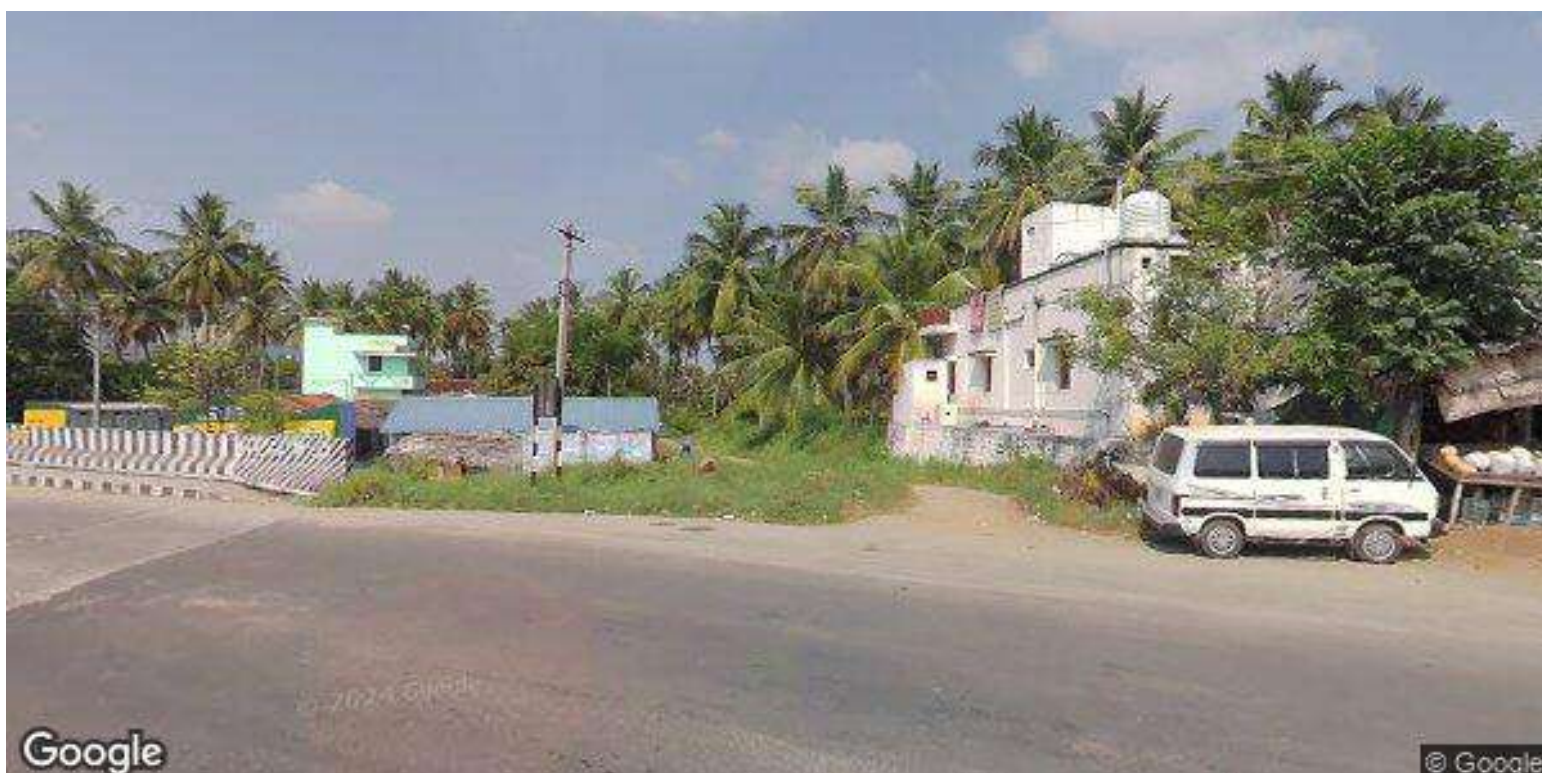
**Risk Type:** Turn  
**Risk Level:** Medium  
**Speed Limit:** 30 KM/Hr  
**Coordinates:** 11.44898, 77.87410

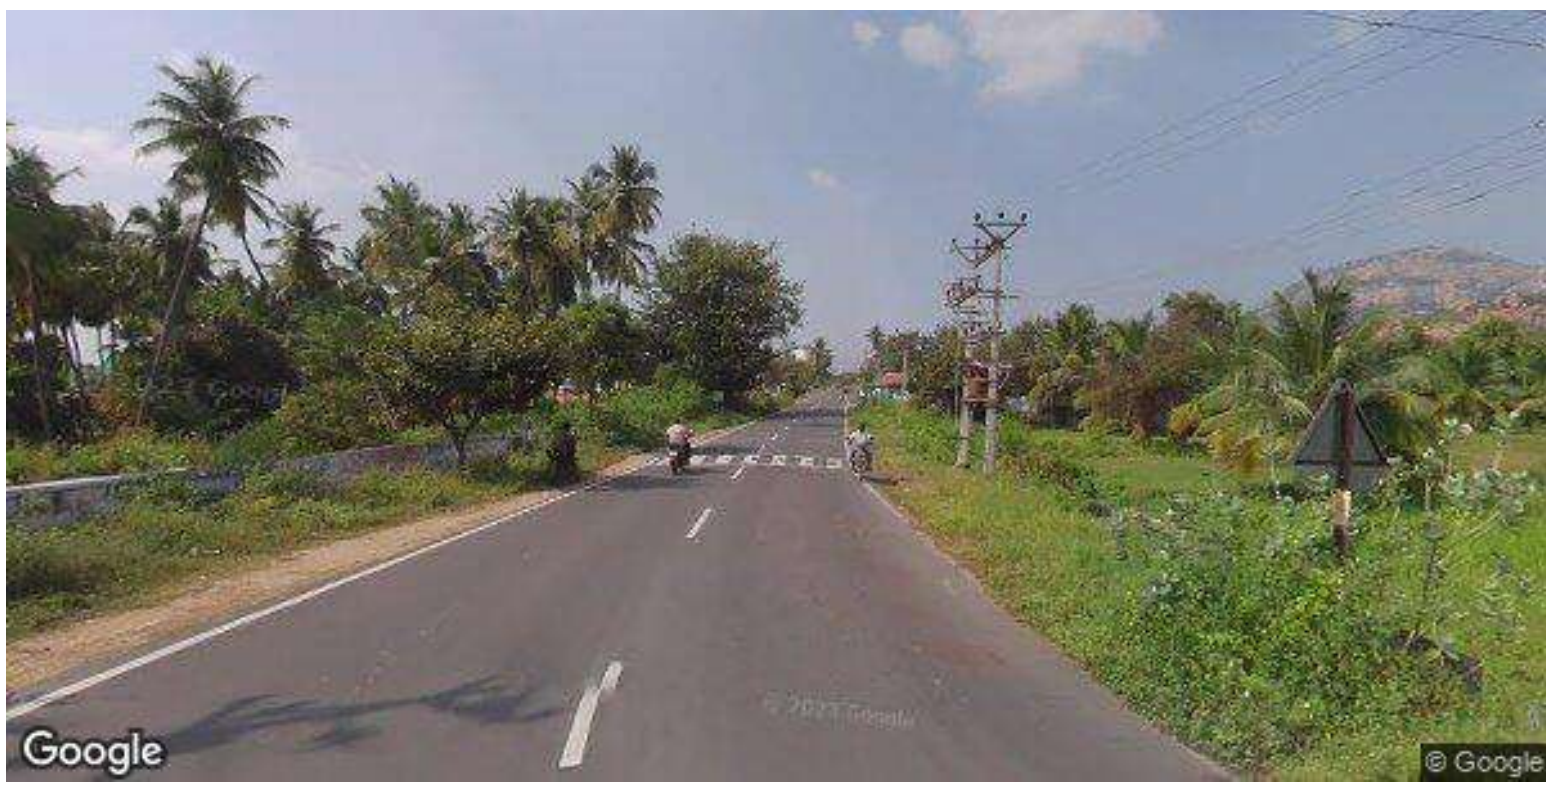
**Coordinates:** 11.45352, 77.85698

**Risk Type:** Turn

**Risk Level:** Medium

**Speed Limit:** 30 KM/Hr

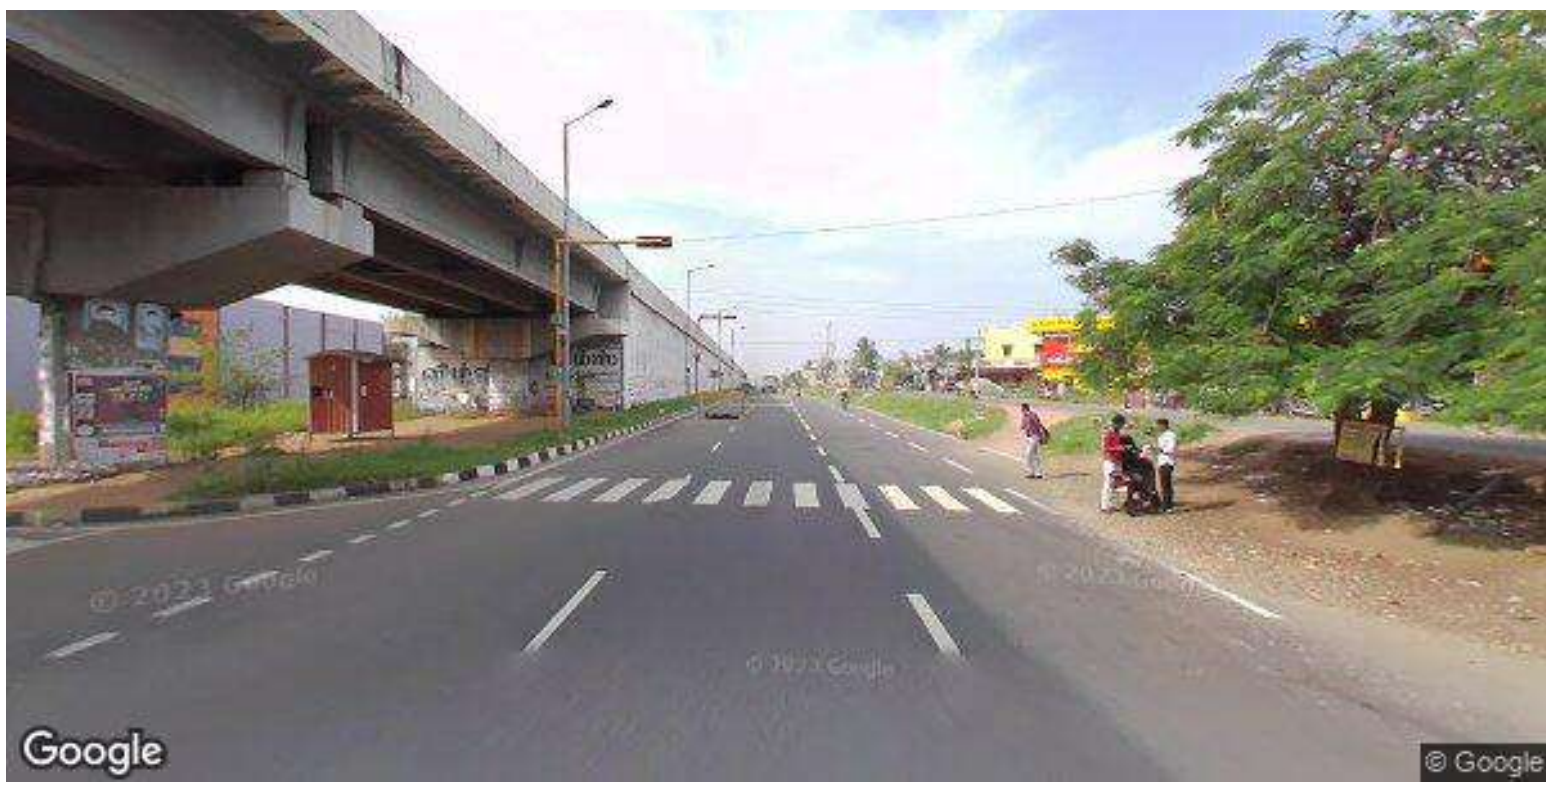
**Coordinates:** 11.58526, 78.06049

**Risk Type:** Blind Spot

**Risk Level:** Blind Spot

**Speed Limit:** 10 KM/Hr

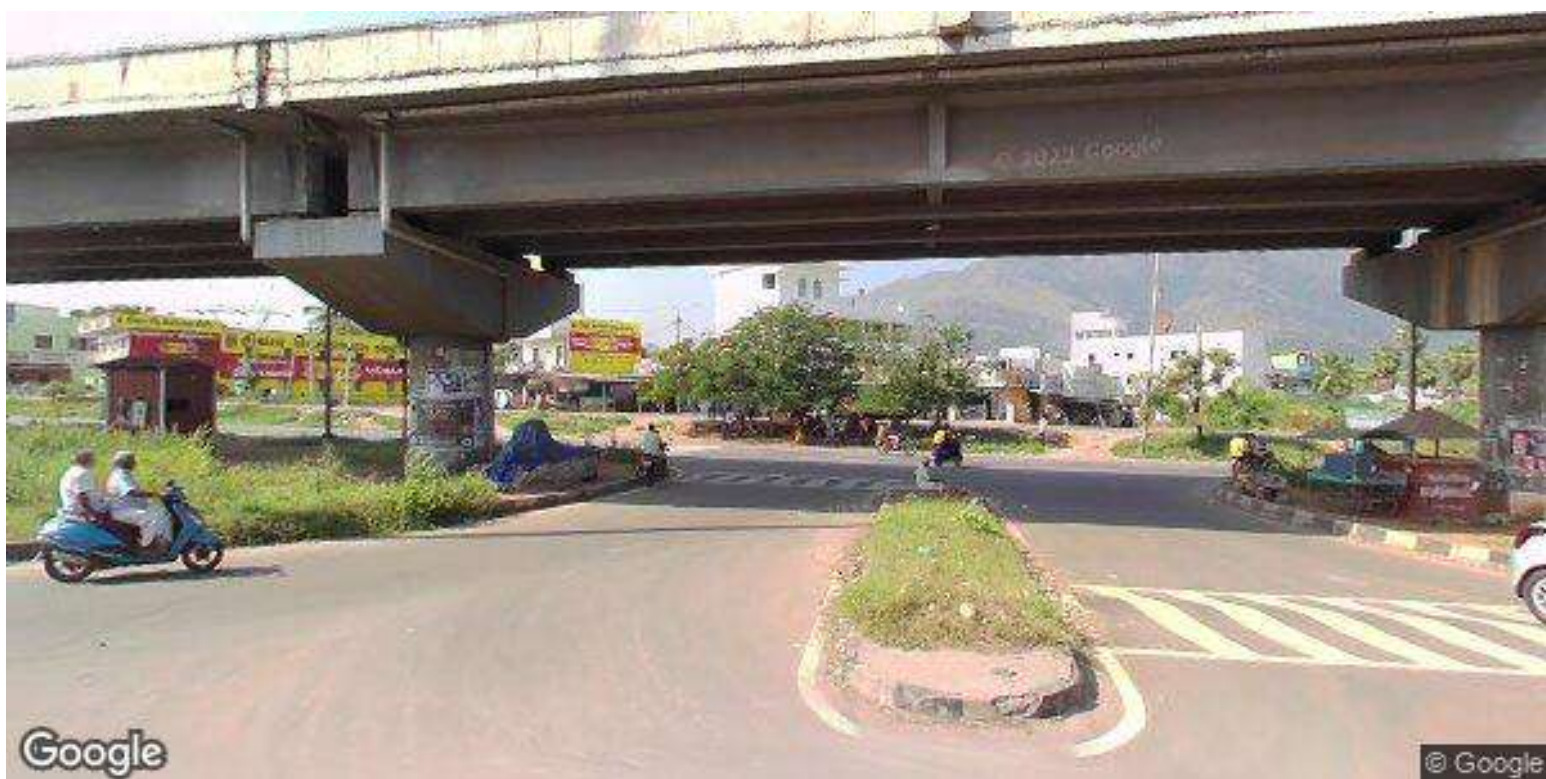
**Coordinates:** 11.58499, 78.06061

**Risk Type:** Blind Spot

**Risk Level:** Blind Spot

**Speed Limit:** 10 KM/Hr
