# IndianOil

## JOURNEY RISK MANAGEMENT (JRM) STUDY

### Salem Terminal to M/S MAGIZH FUELS

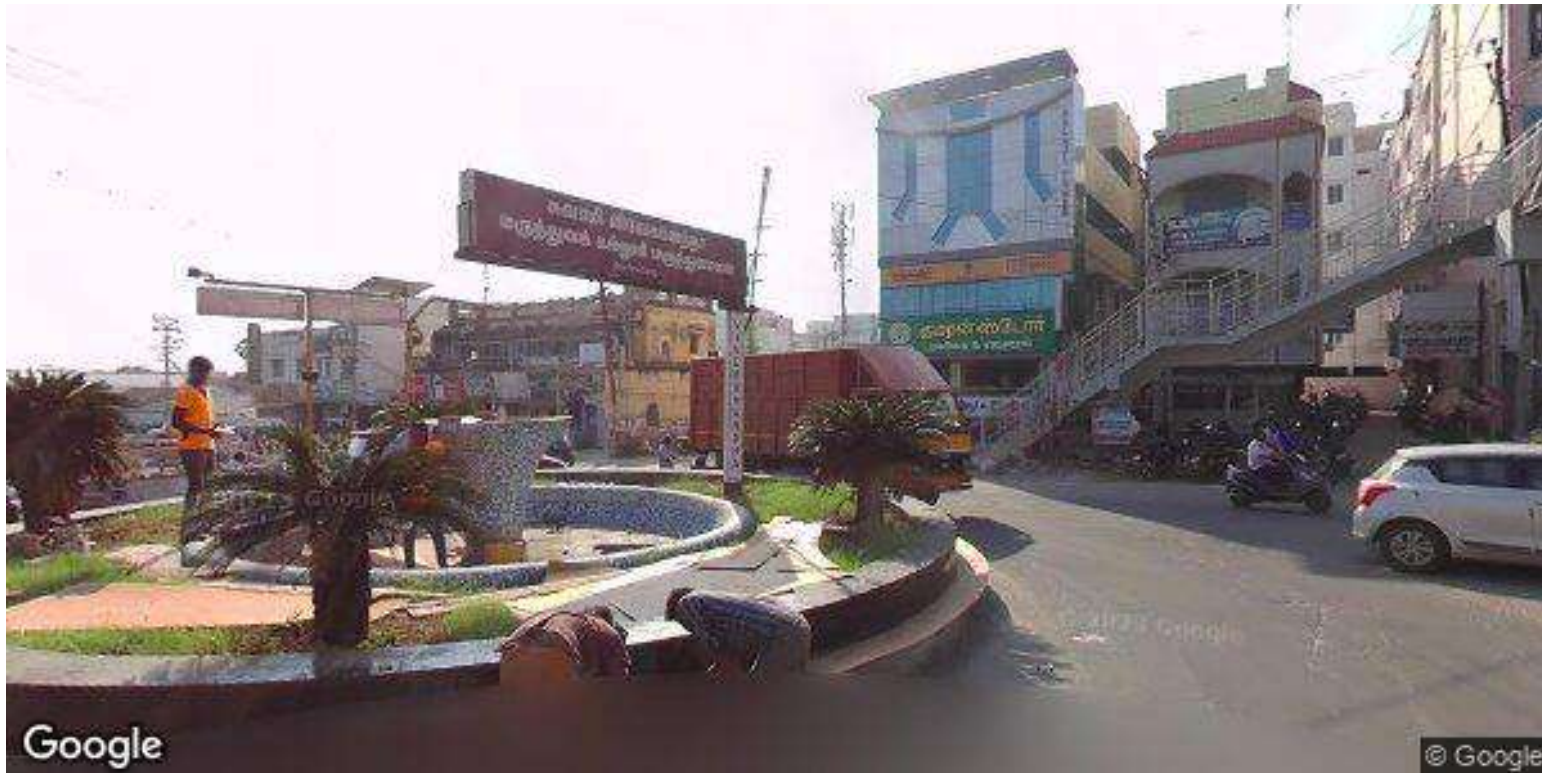
**Coordinates:** 11.38395, 77.89480

**Risk Type:** Roundabout

**Risk Level:** High

**Speed Limit:** 15 KM/Hr

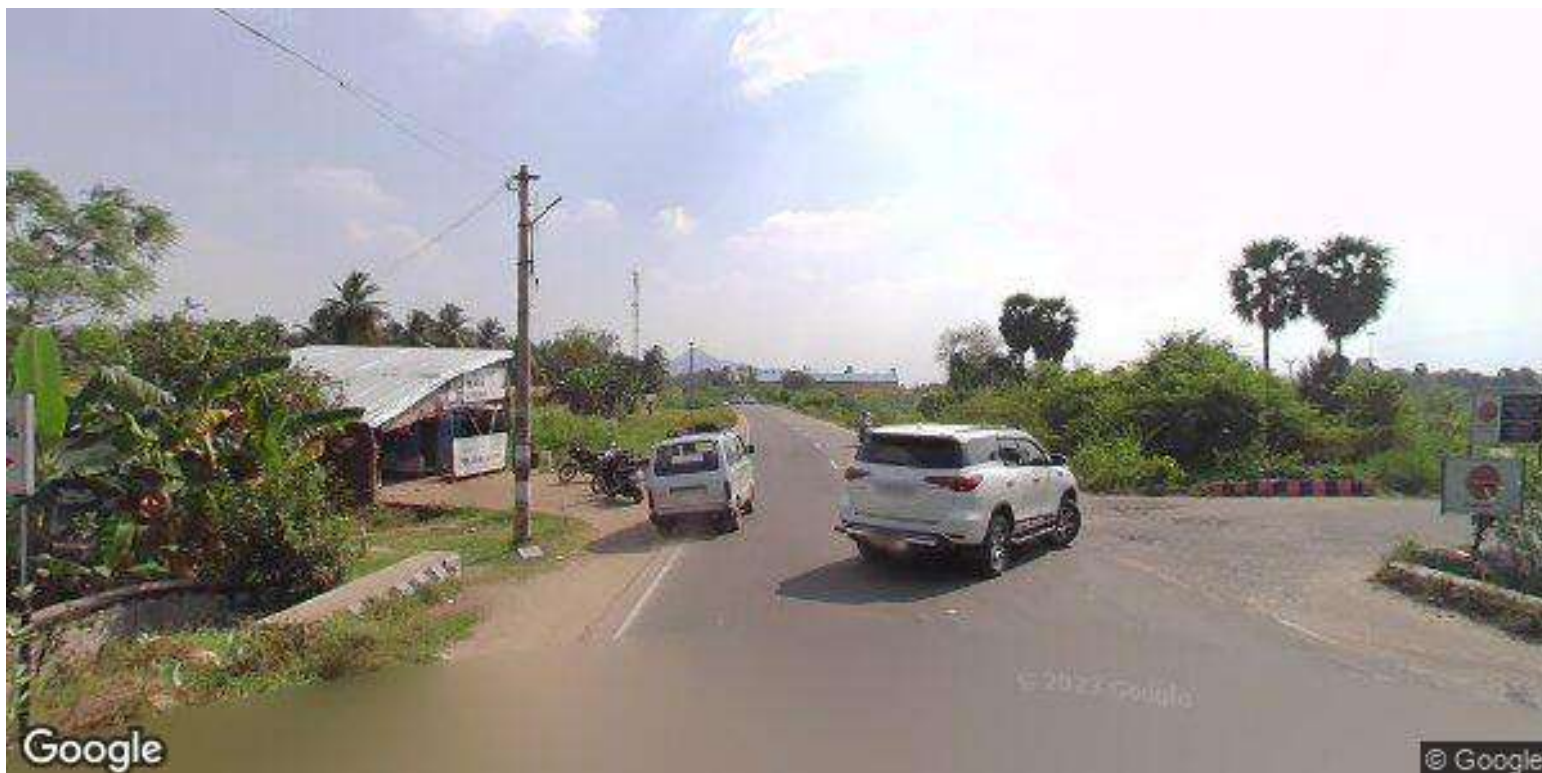
**Coordinates:** 11.44029, 77.87544

**Risk Type:** Blind Spot

**Risk Level:** Blind Spot

**Speed Limit:** 10 KM/Hr

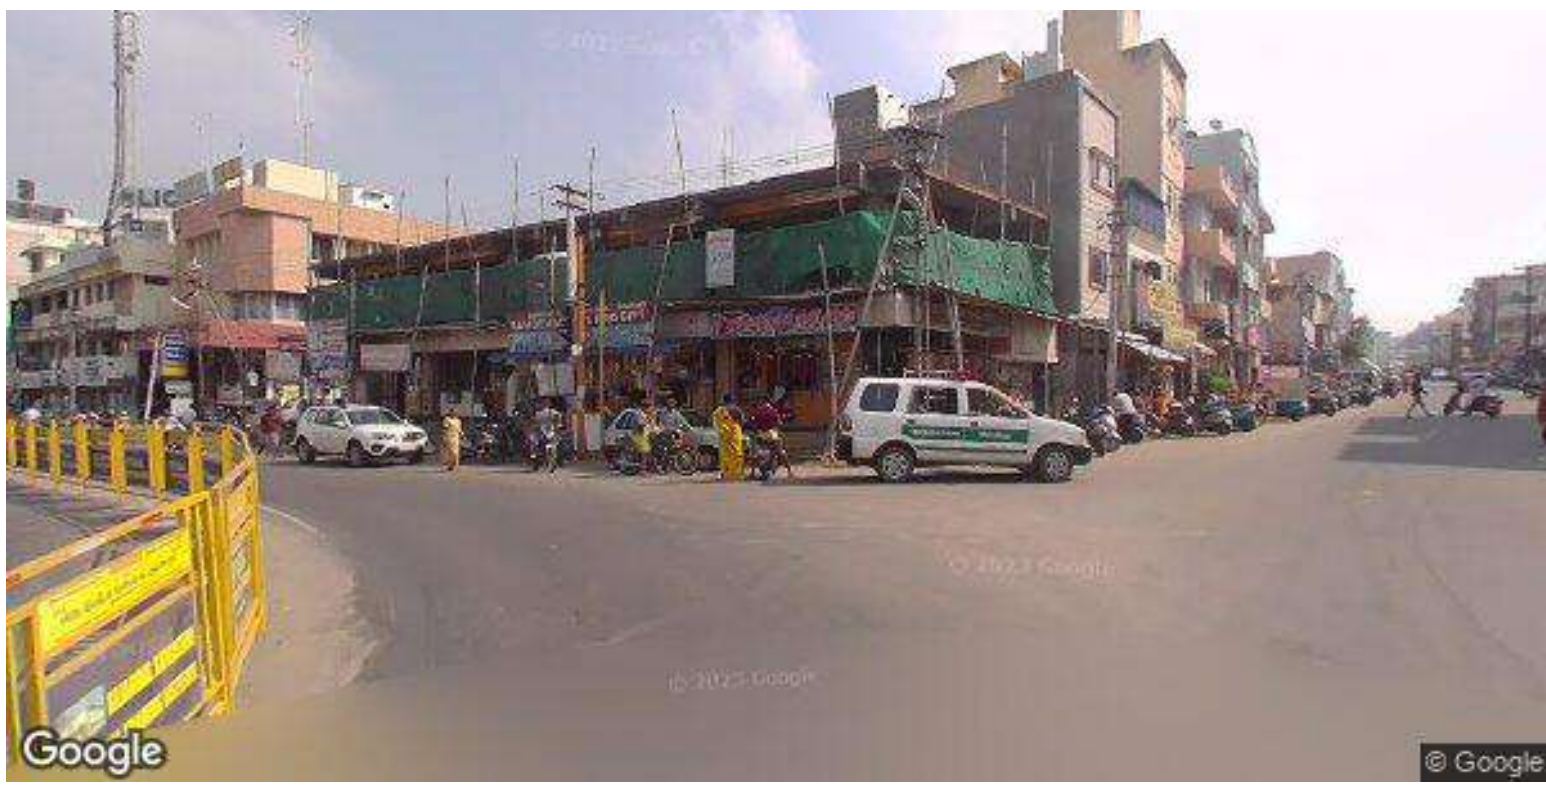
**Coordinates:** 11.37868, 77.89498

**Risk Type:** Turn

**Risk Level:** High

**Speed Limit:** 15 KM/Hr

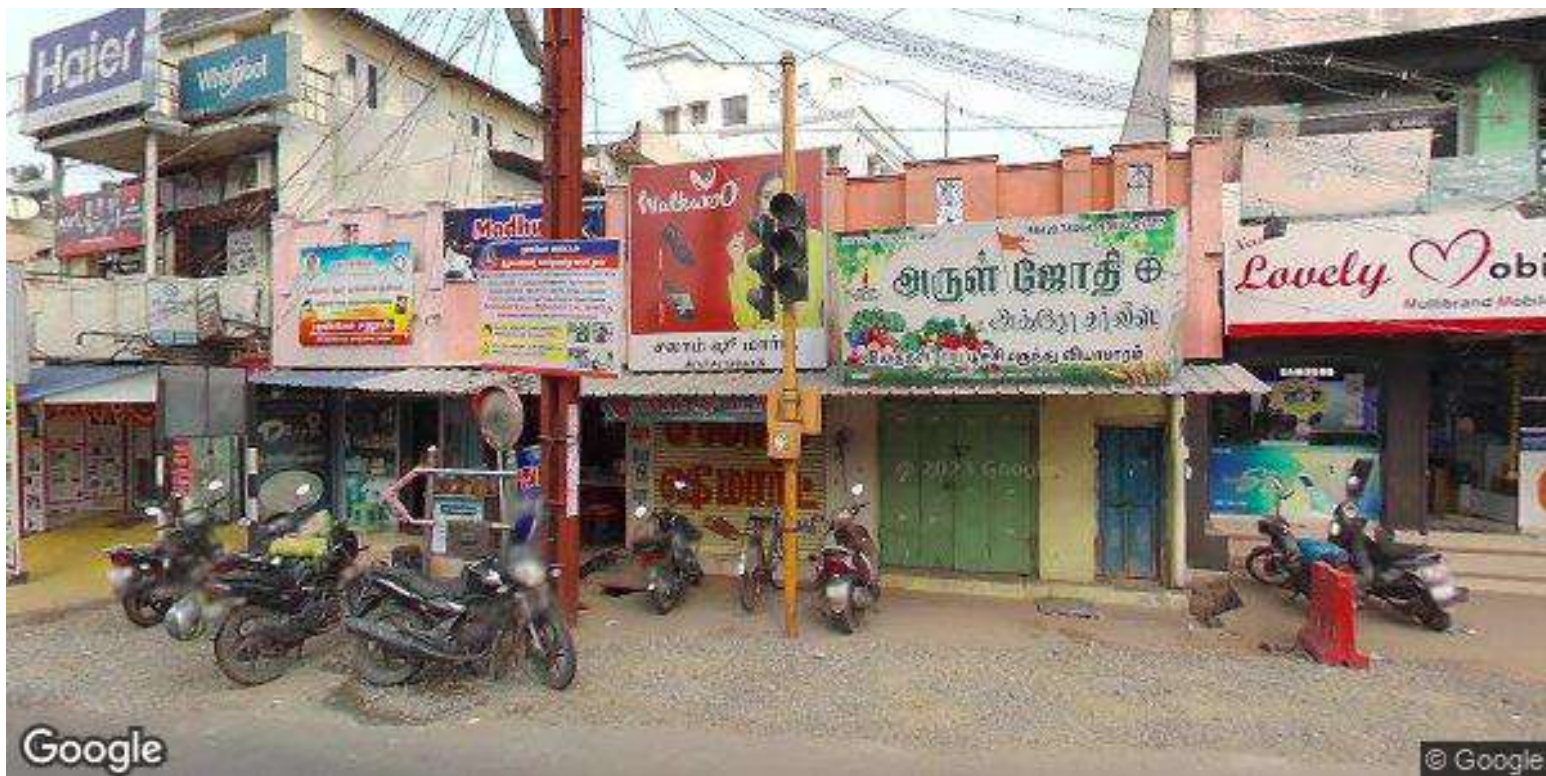
**Coordinates:** 11.37850, 77.89453

**Risk Type:** Turn

**Risk Level:** High

**Speed Limit:** 15 KM/Hr
