# IndianOil

## JOURNEY RISK MANAGEMENT (JRM) STUDY

### Salem Terminal to M/s KP SANTHAN ENTERPRISES

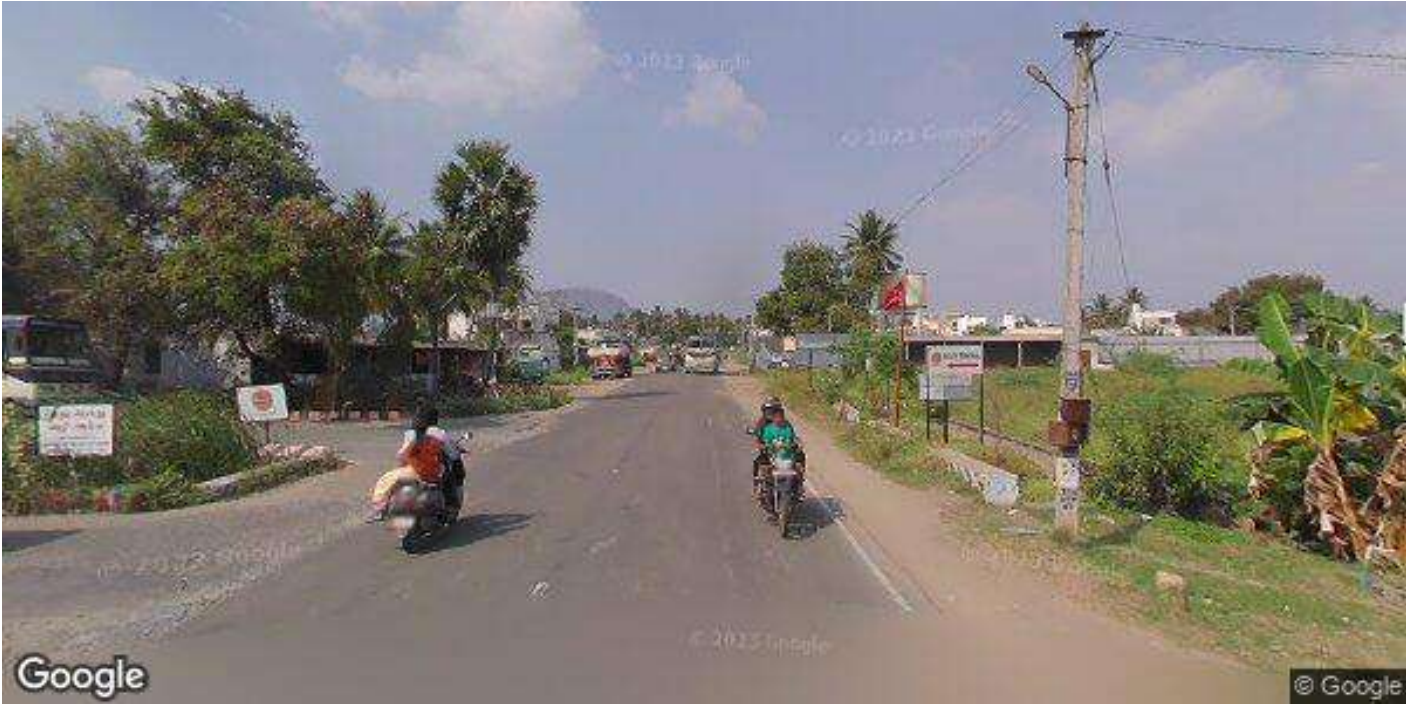
| | Risk Type | Risk Level | Coordinates | Speed Limit |
|---|---|---|---|---|
| 2 | Turn | High | 11.44019, 77.87547 | 15 KM/Hr |

**Risk Type:** Turn  
**Risk Level:** High  
**Speed Limit:** 15 KM/Hr  
**Coordinates:** 11.44019, 77.87547

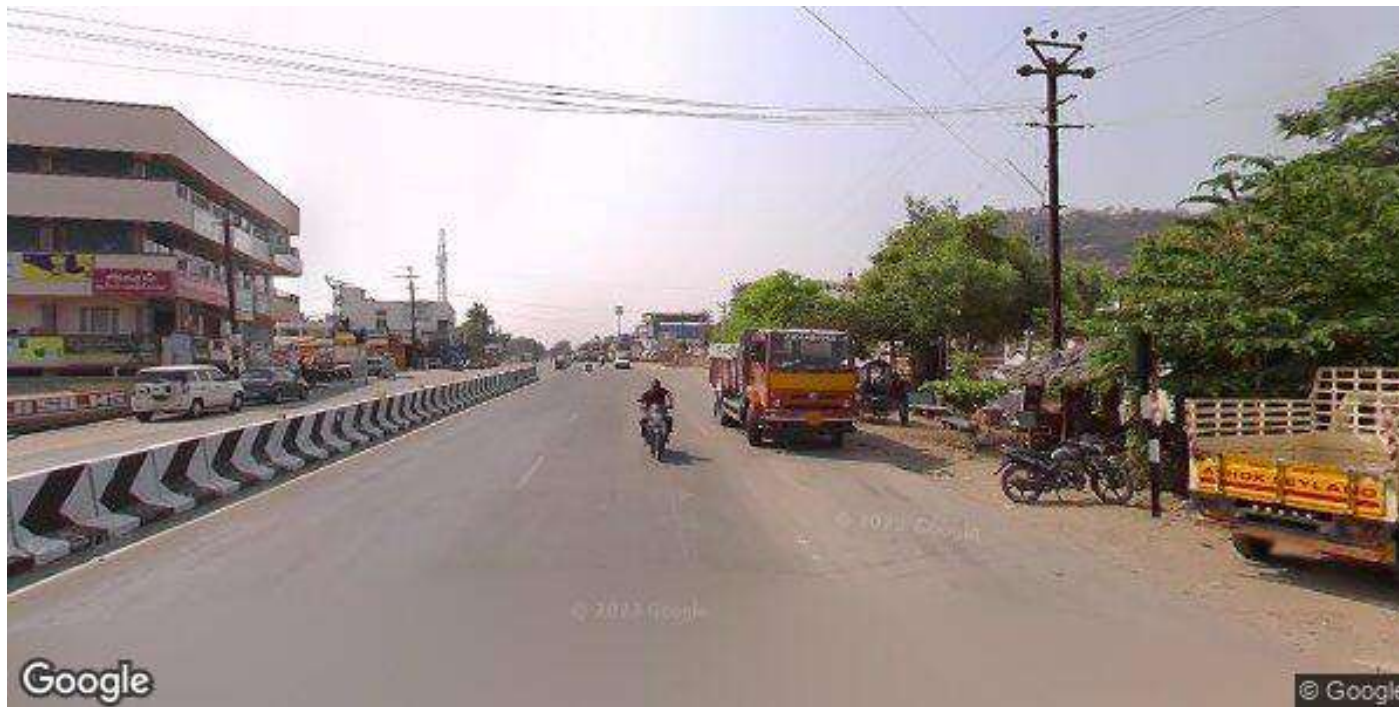
| | Risk Type | Risk Level | Coordinates | Speed Limit |
|---|---|---|---|---|
| 3 | Turn | Medium | 11.39685, 77.88861 | 30 KM/Hr |

**Risk Type:** Turn  
**Risk Level:** Medium  
**Speed Limit:** 30 KM/Hr  
**Coordinates:** 11.39685, 77.88861

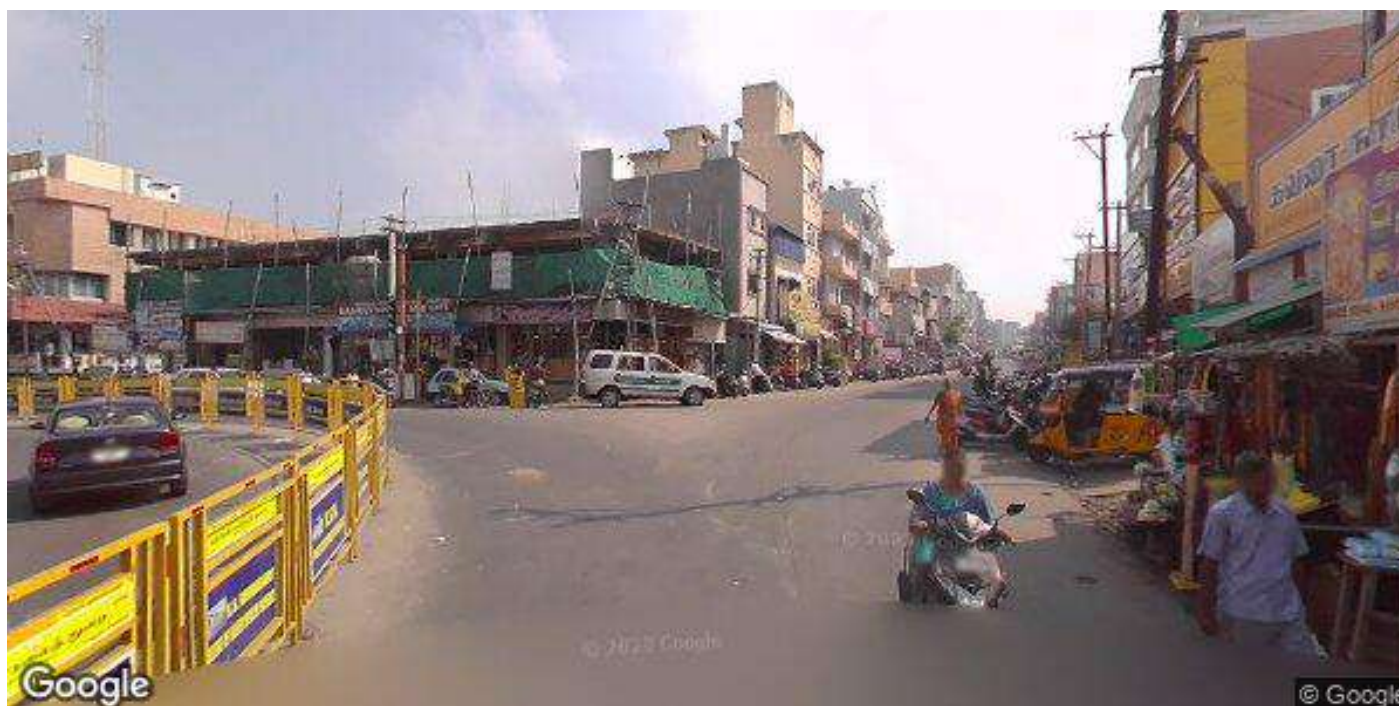
| | Risk Type | Risk Level | Coordinates | Speed Limit |
|---|---|---|---|---|
| 4 | Turn | High | 11.37862, 77.89488 | 15 KM/Hr |

**Risk Type:** Turn  
**Risk Level:** High  
**Speed Limit:** 15 KM/Hr  
**Coordinates:** 11.37862, 77.89488

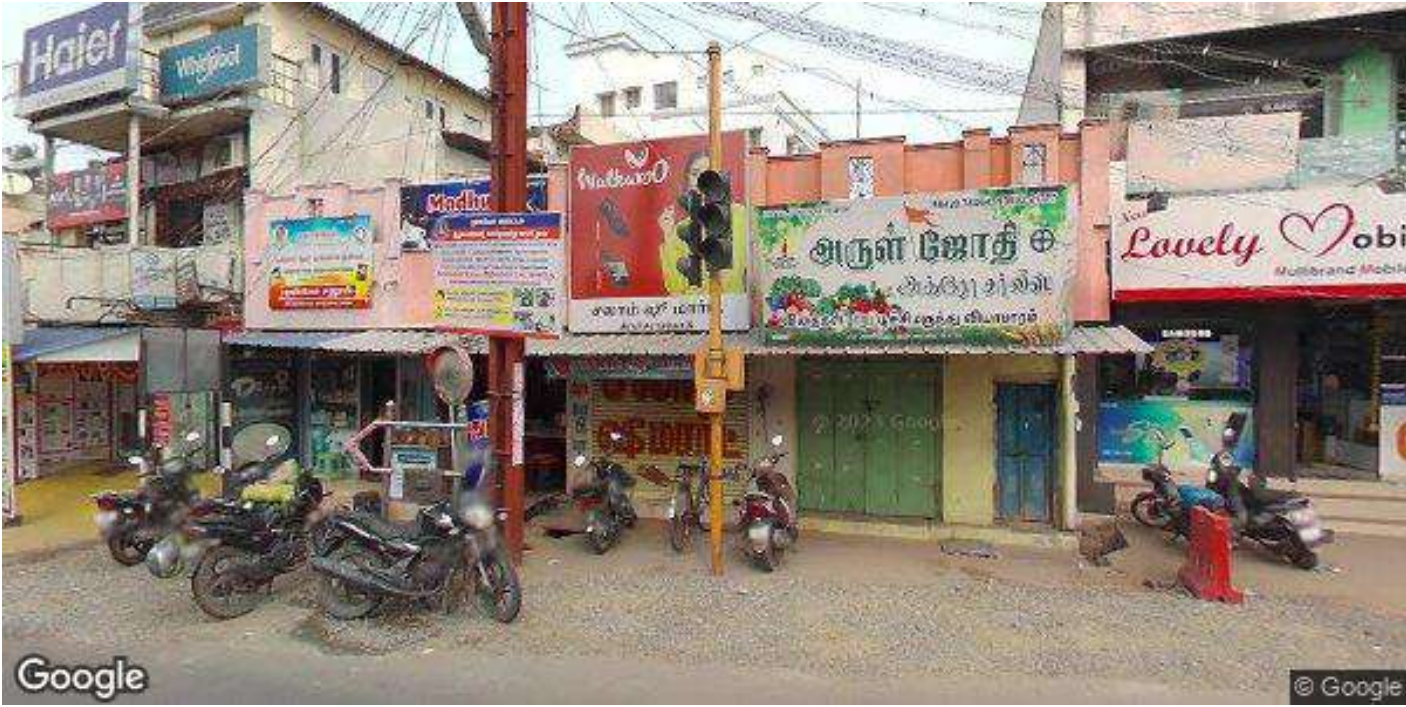
| | Risk Type | Risk Level | Coordinates | Speed Limit |
|---|---|---|---|---|
| 5 | Turn | High | 11.37850, 77.89453 | 15 KM/Hr |

Risk Type: Turn  
Risk Level: High  
Speed Limit: 15 KM/Hr  
Coordinates: 11.37850, 77.89453

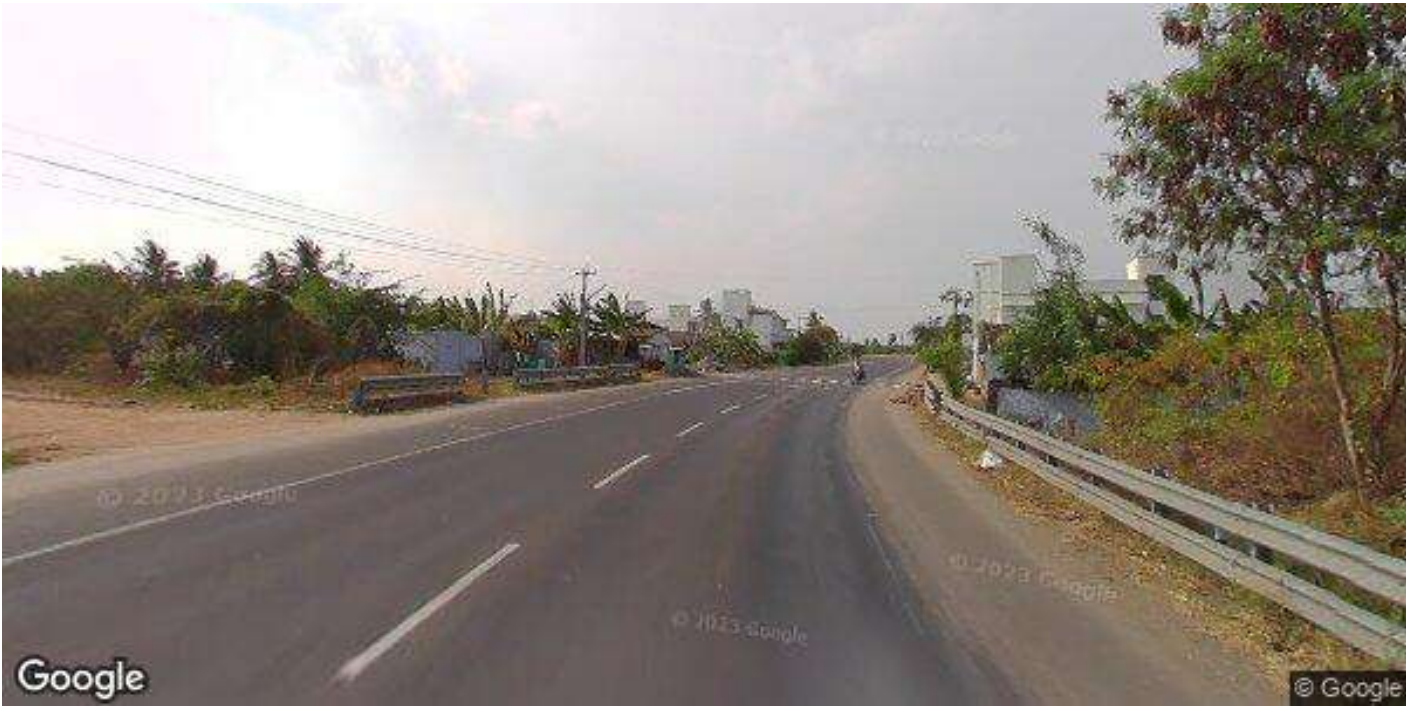
| | Risk Type | Risk Level | Coordinates | Speed Limit |
|---|---|---|---|---|
| 6 | Turn | Medium | 11.16764, 78.01565 | 30 KM/Hr |

Risk Type: Turn  
Risk Level: Medium  
Speed Limit: 30 KM/Hr  
Coordinates: 11.16764, 78.01565

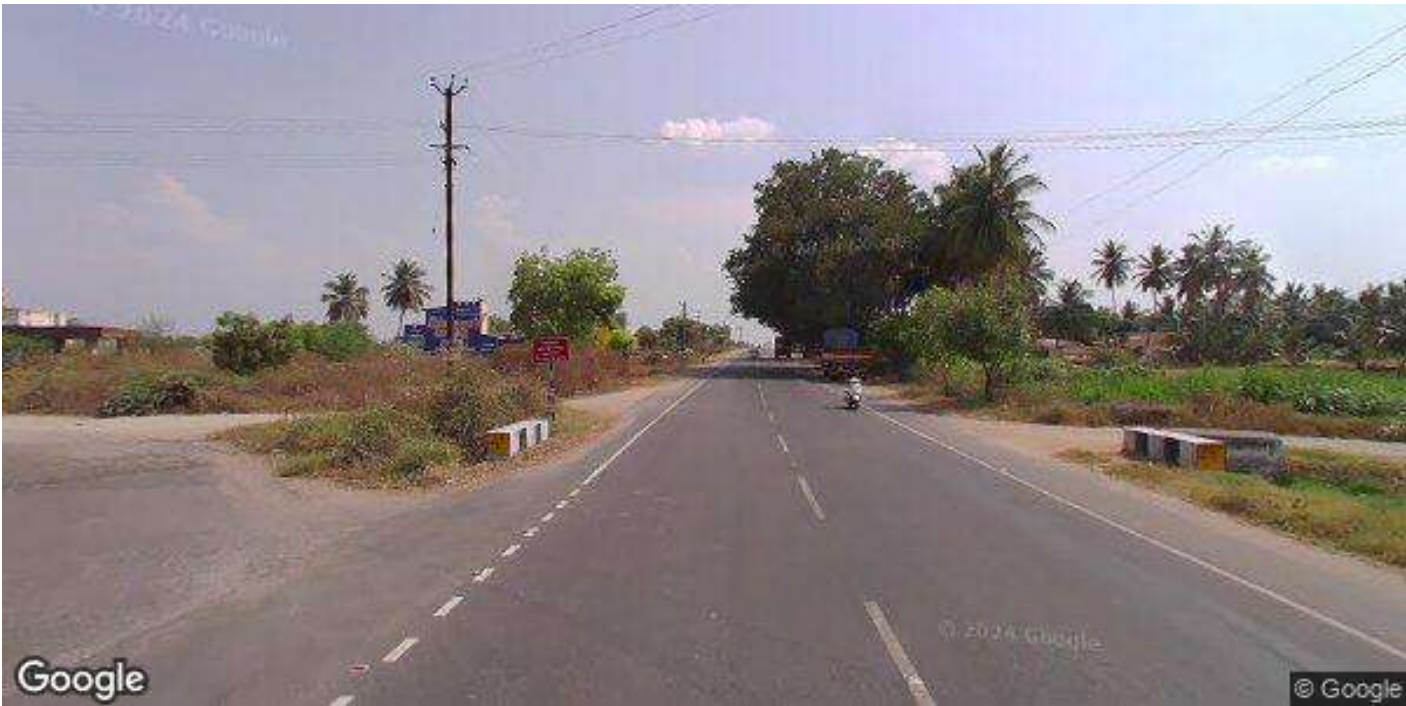
| | Risk Type | Risk Level | Coordinates | Speed Limit |
|---|---|---|---|---|
| 7 | Turn | High | 11.14545, 78.02208 | 15 KM/Hr |

Risk Type: Turn  
Risk Level: High  
Speed Limit: 15 KM/Hr  
Coordinates: 11.14545, 78.02208

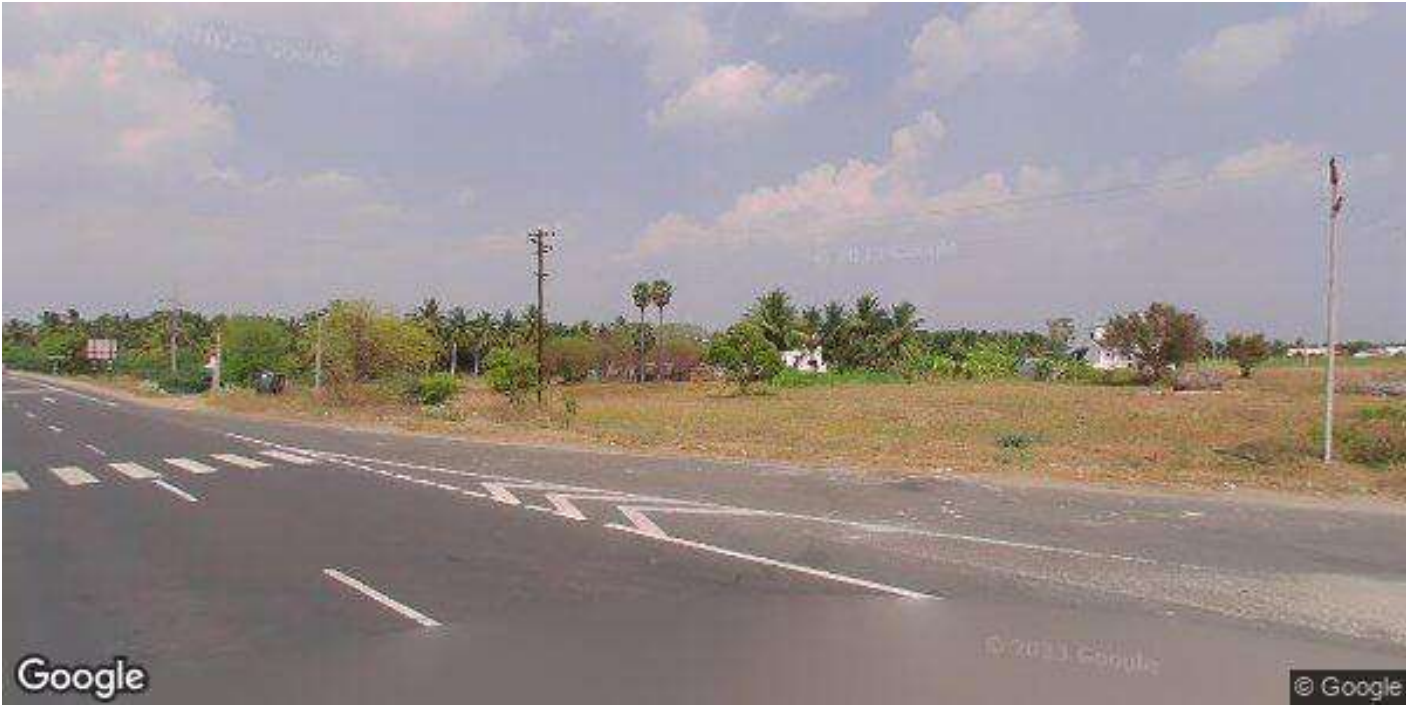
| | Risk Type | Risk Level | Coordinates | Speed Limit |
|---|---|---|---|---|
| 8 | Turn | High | 11.14480, 78.02291 | 15 KM/Hr |

**Risk Type:** Turn  
**Risk Level:** High  
**Speed Limit:** 15 KM/Hr  
**Coordinates:** 11.14480, 78.02291

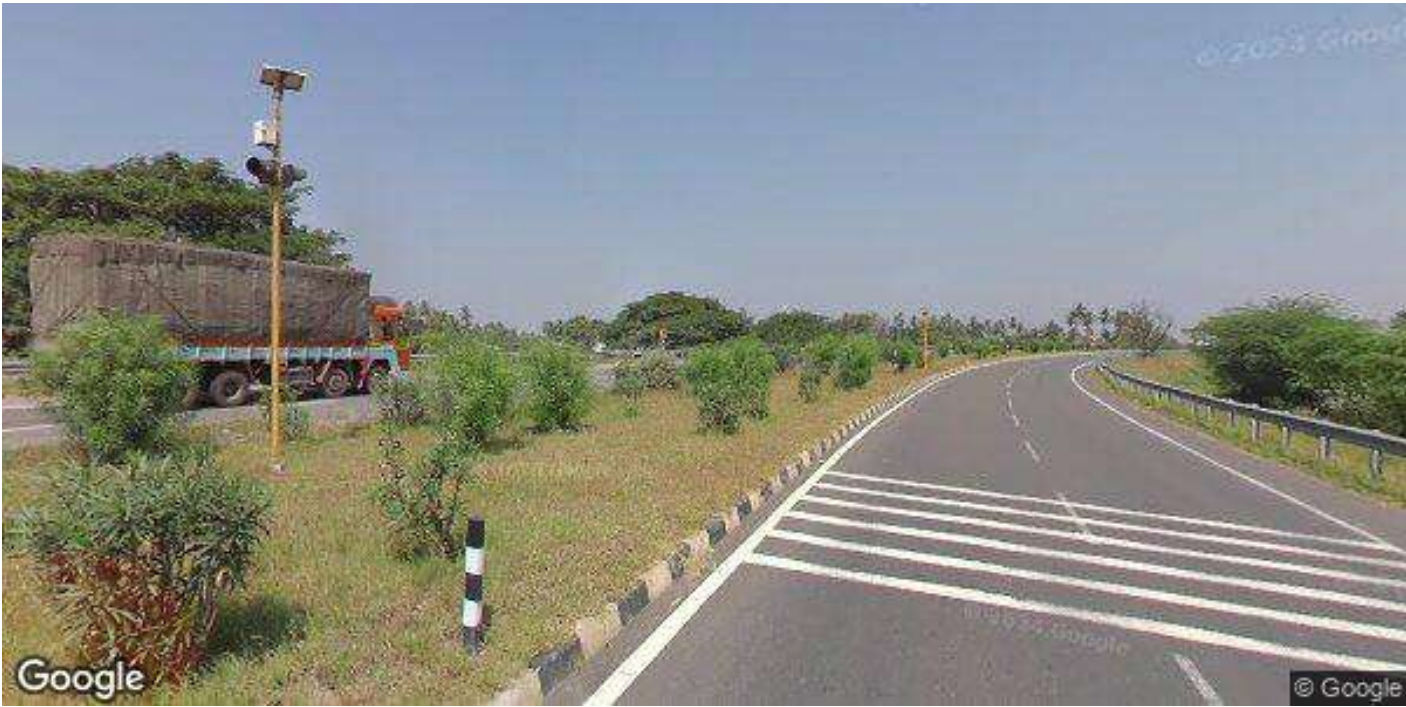
| | Risk Type | Risk Level | Coordinates | Speed Limit |
|---|---|---|---|---|
| 9 | Turn | Medium | 11.10102, 78.00572 | 30 KM/Hr |

**Risk Type:** Turn  
**Risk Level:** Medium  
**Speed Limit:** 30 KM/Hr  
**Coordinates:** 11.10102, 78.00572

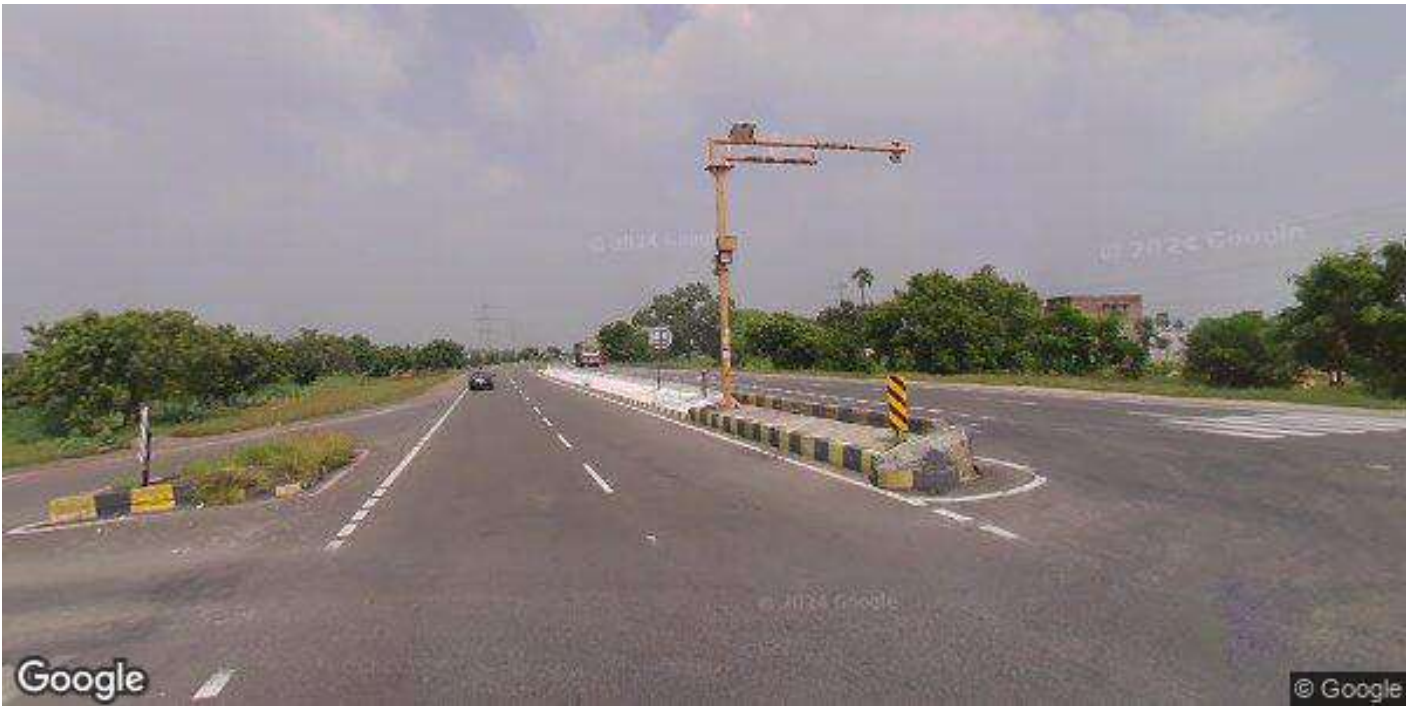
| | Risk Type | Risk Level | Coordinates | Speed Limit |
|---|---|---|---|---|
| 10 | Turn | High | 10.79637, 77.92684 | 15 KM/Hr |

**Risk Type:** Turn  
**Risk Level:** High  
**Speed Limit:** 15 KM/Hr  
**Coordinates:** 10.79637, 77.92684

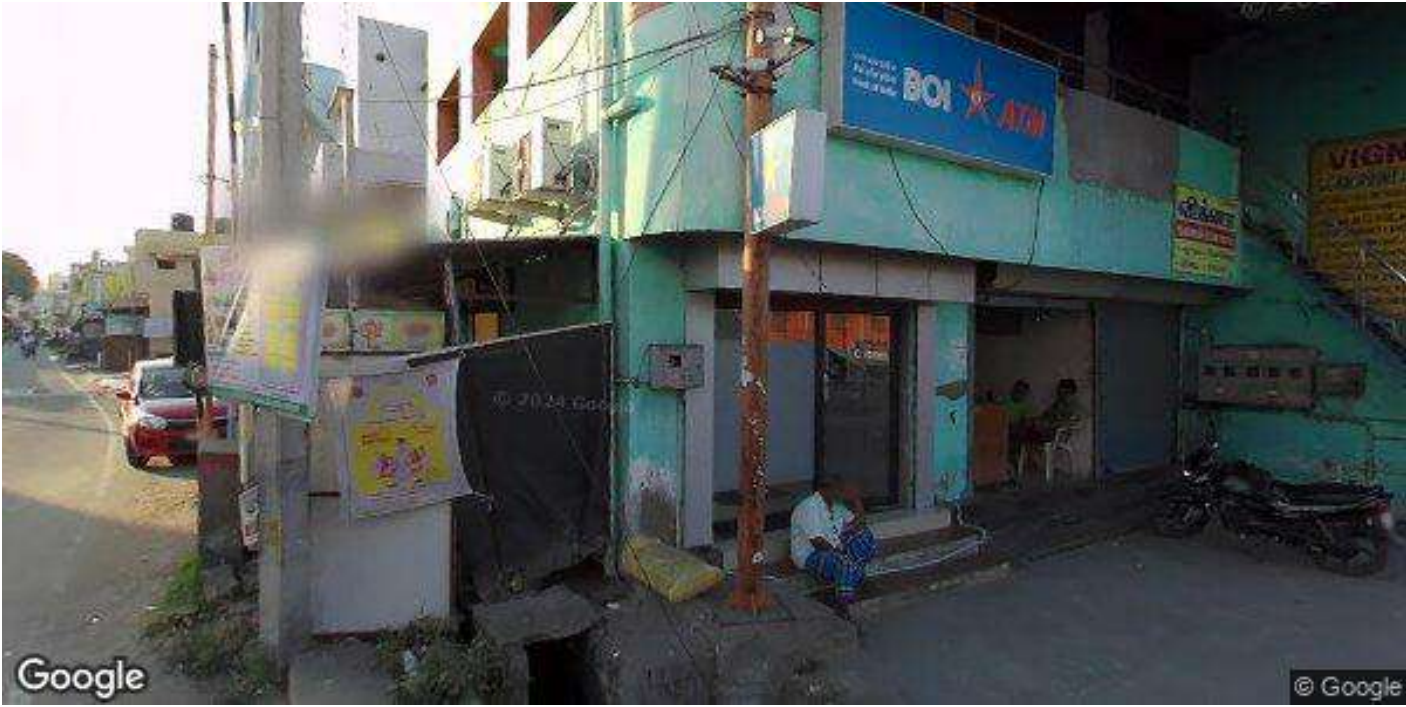
| | Risk Type | Risk Level | Coordinates | Speed Limit |
|---|---|---|---|---|
| 11 | Turn | High | 10.77656, 77.91017 | 15 KM/Hr |

**Risk Type:** Turn  
**Risk Level:** High  
**Speed Limit:** 15 KM/Hr  
**Coordinates:** 10.77656, 77.91017

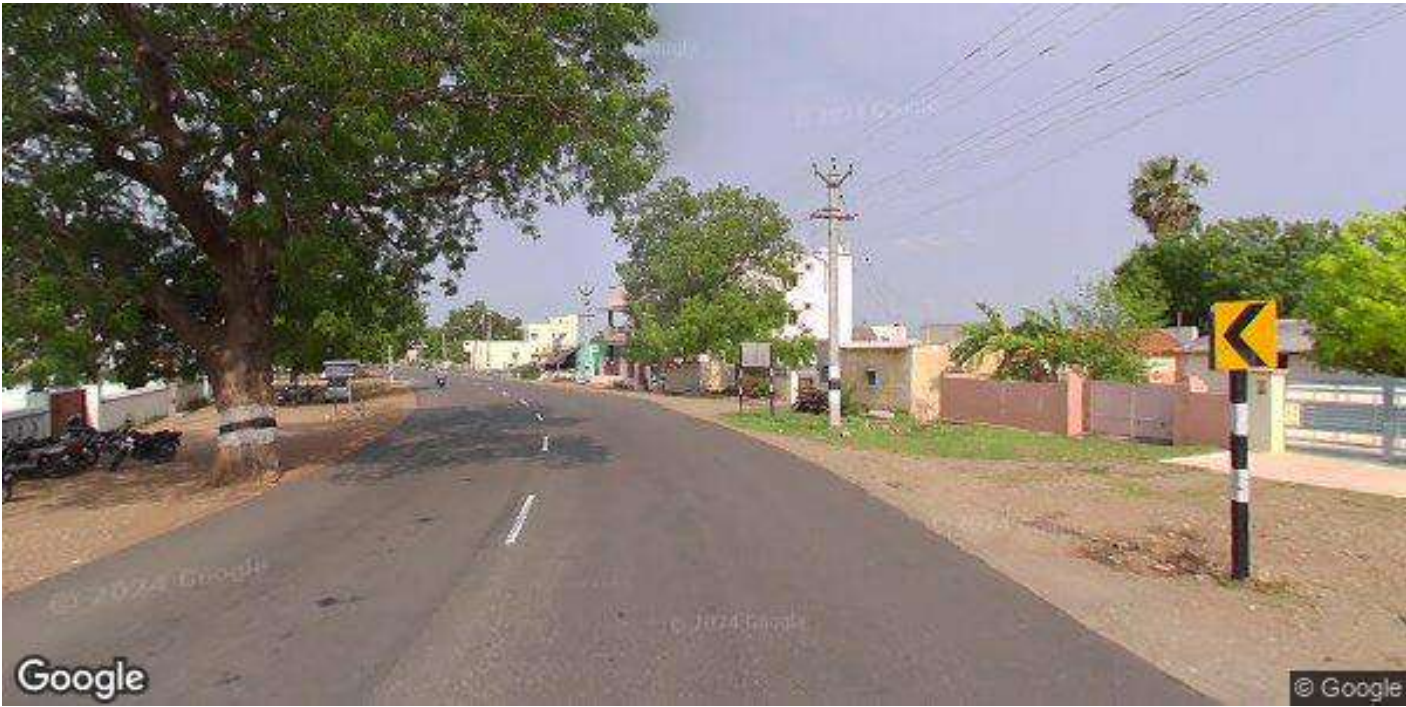
| | Risk Type | Risk Level | Coordinates | Speed Limit |
|---|---|---|---|---|
| 12 | Turn | Medium | 10.77761, 77.90150 | 30 KM/Hr |

**Risk Type:** Turn  
**Risk Level:** Medium  
**Speed Limit:** 30 KM/Hr  
**Coordinates:** 10.77761, 77.90150
