# IndianOil

## JOURNEY RISK MANAGEMENT (JRM) STUDY

### Salem Terminal TO VELAVAN FUELS

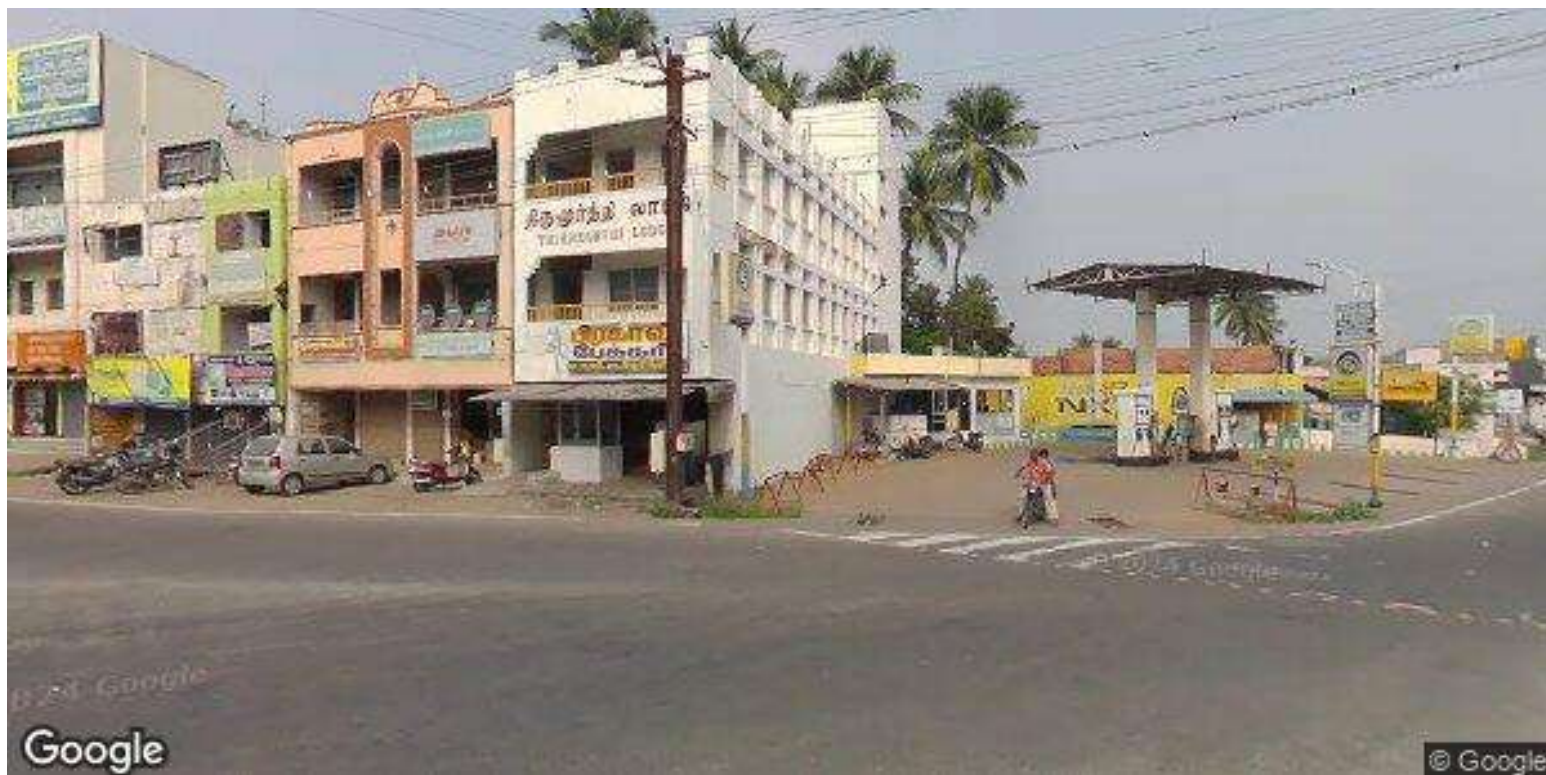
**Coordinates: 11.00172, 77.56268**

**Risk Type: Roundabout**

**Risk Level: High**

**Speed Limit: 15 KM/Hr**

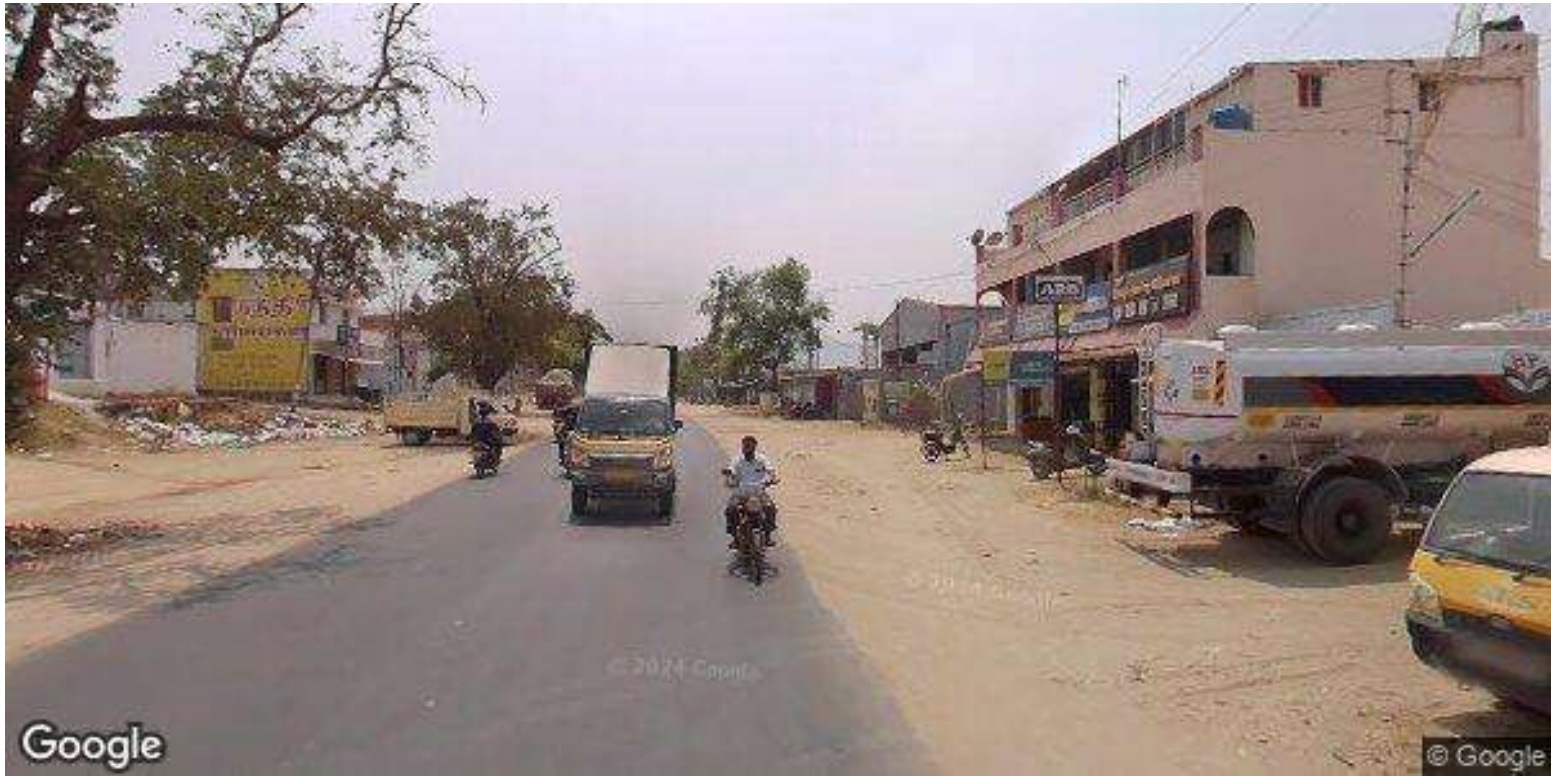
**Risk Type:** Turn  
**Risk Level:** Medium  
**Speed Limit:** 30 KM/Hr  
**Coordinates:** 11.39976, 77.88382

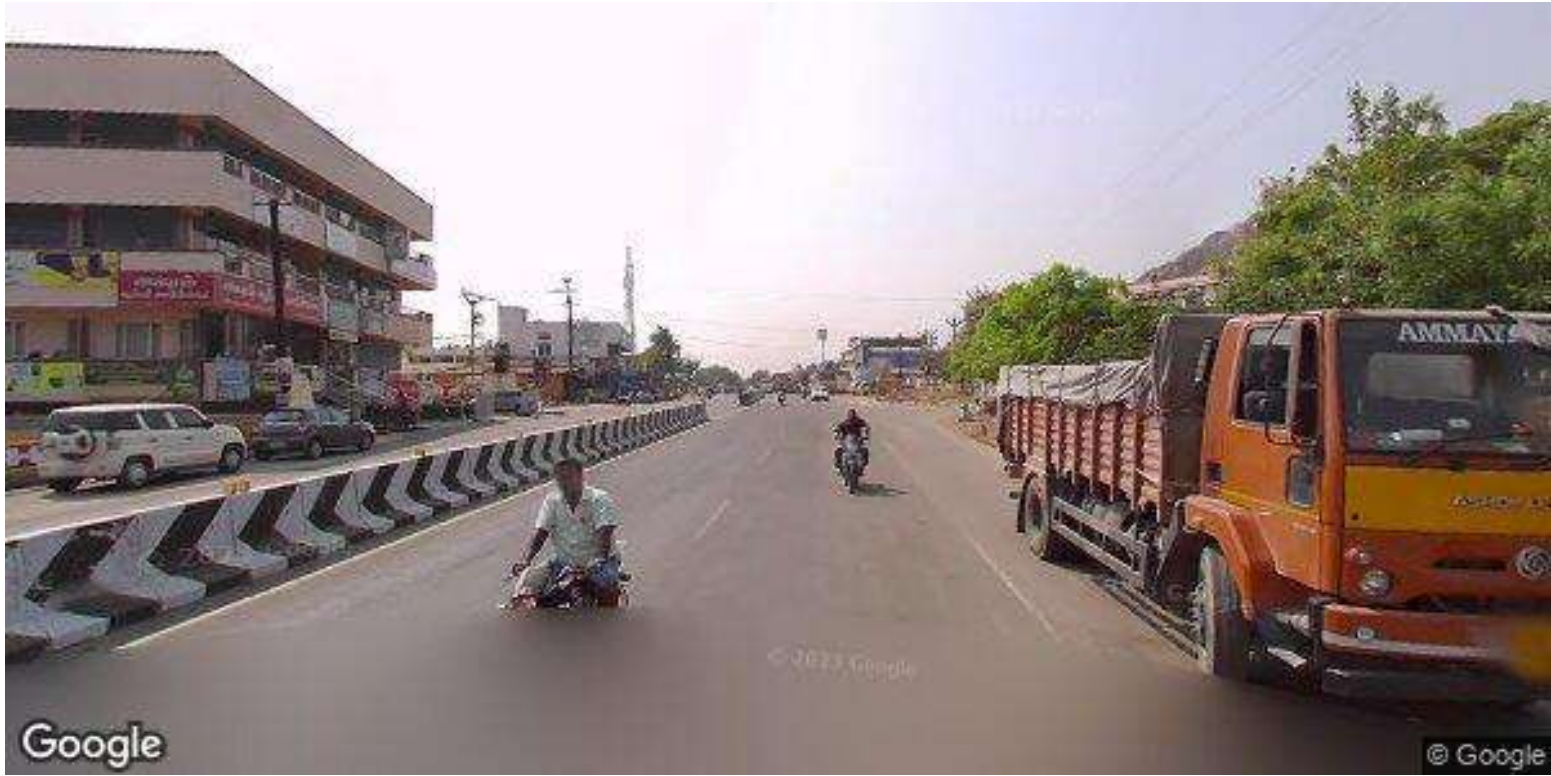
**Risk Type:** Turn  
**Risk Level:** Medium  
**Speed Limit:** 30 KM/Hr  
**Coordinates:** 11.39690, 77.88852

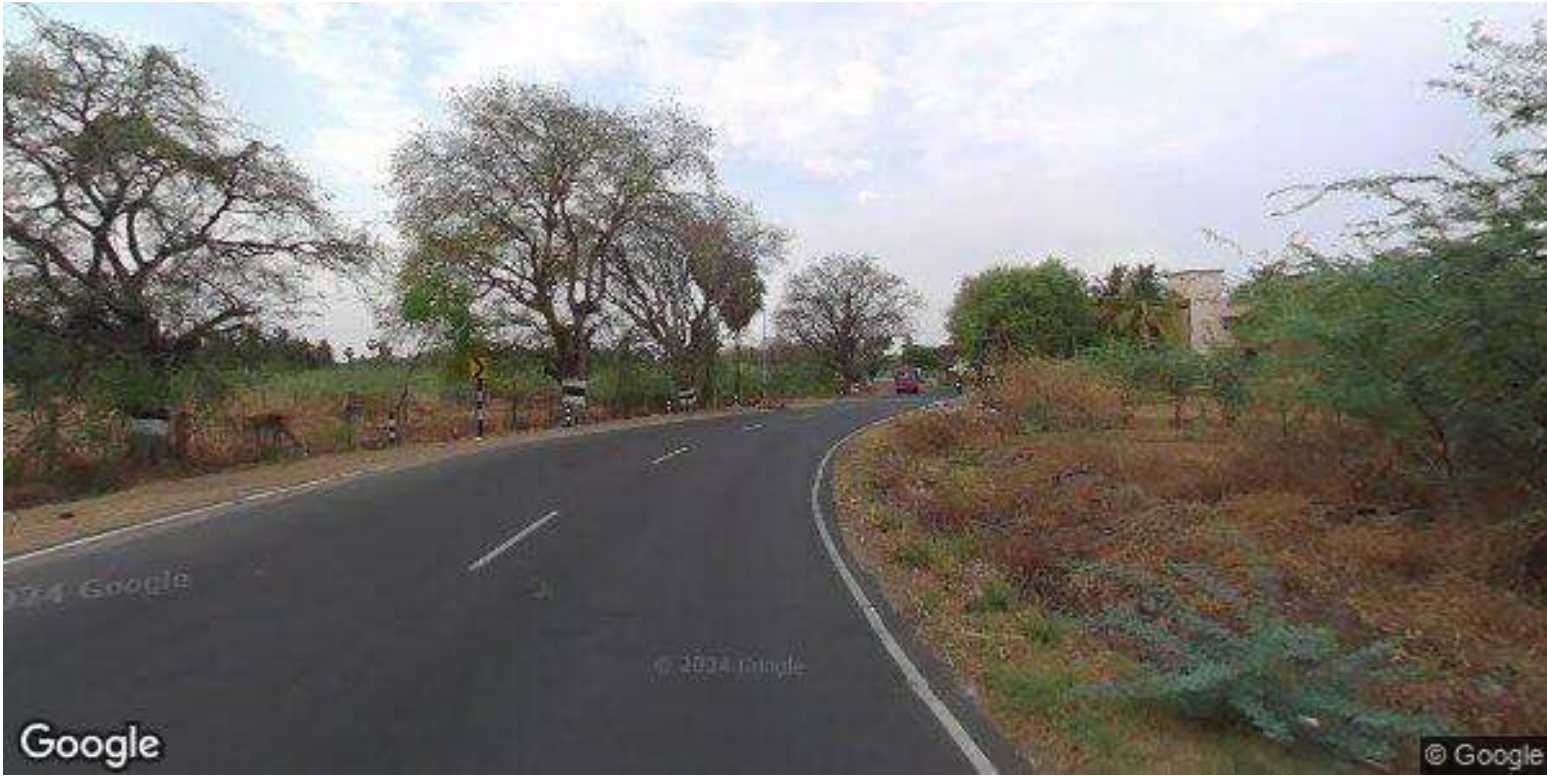
**Risk Type:** Turn  
**Risk Level:** Medium  
**Speed Limit:** 30 KM/Hr  
**Coordinates:** 11.34067, 77.86347

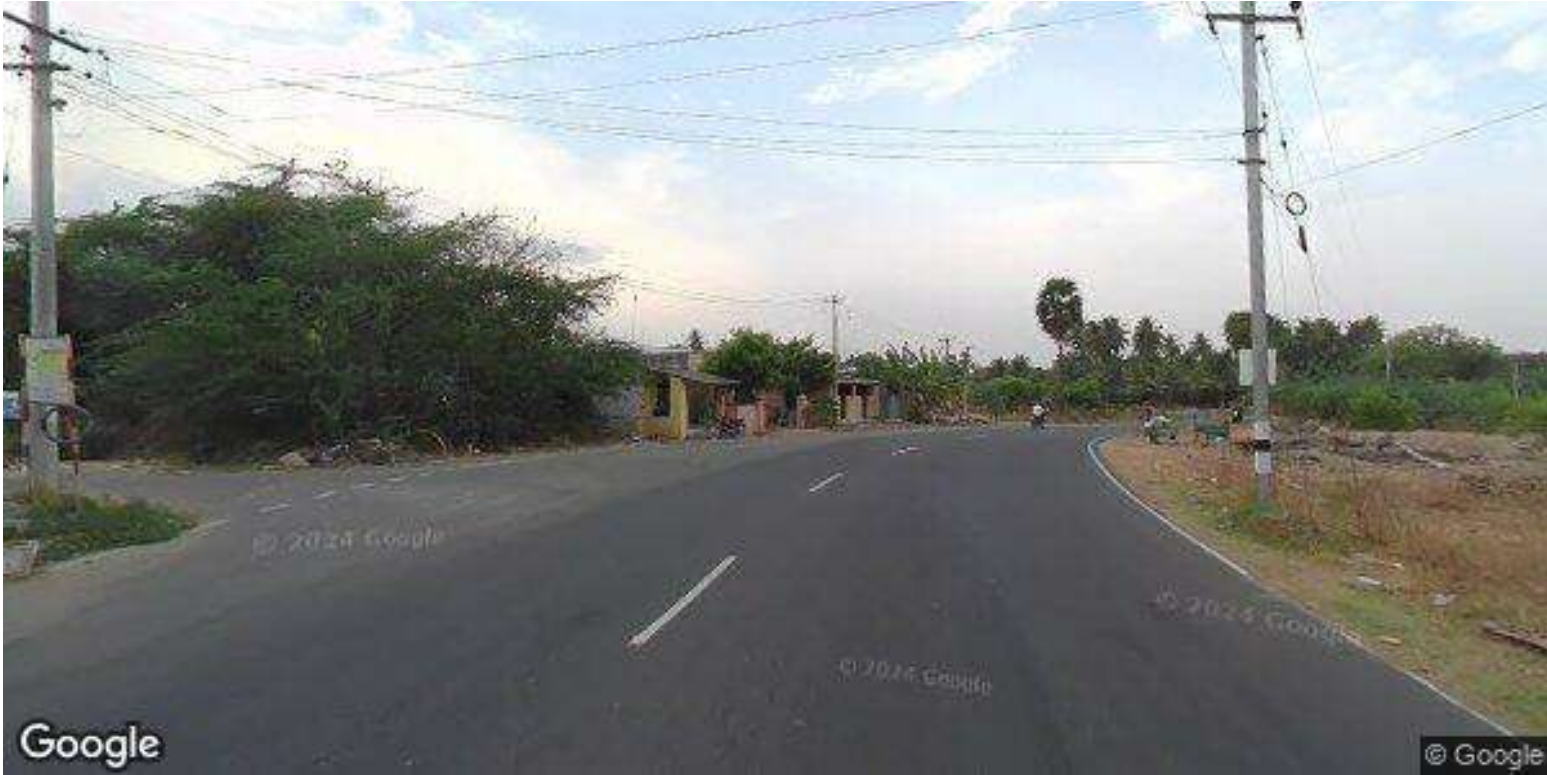
**Risk Type:** Turn  
**Risk Level:** High  
**Speed Limit:** 15 KM/Hr  
**Coordinates:** 11.33854, 77.86216

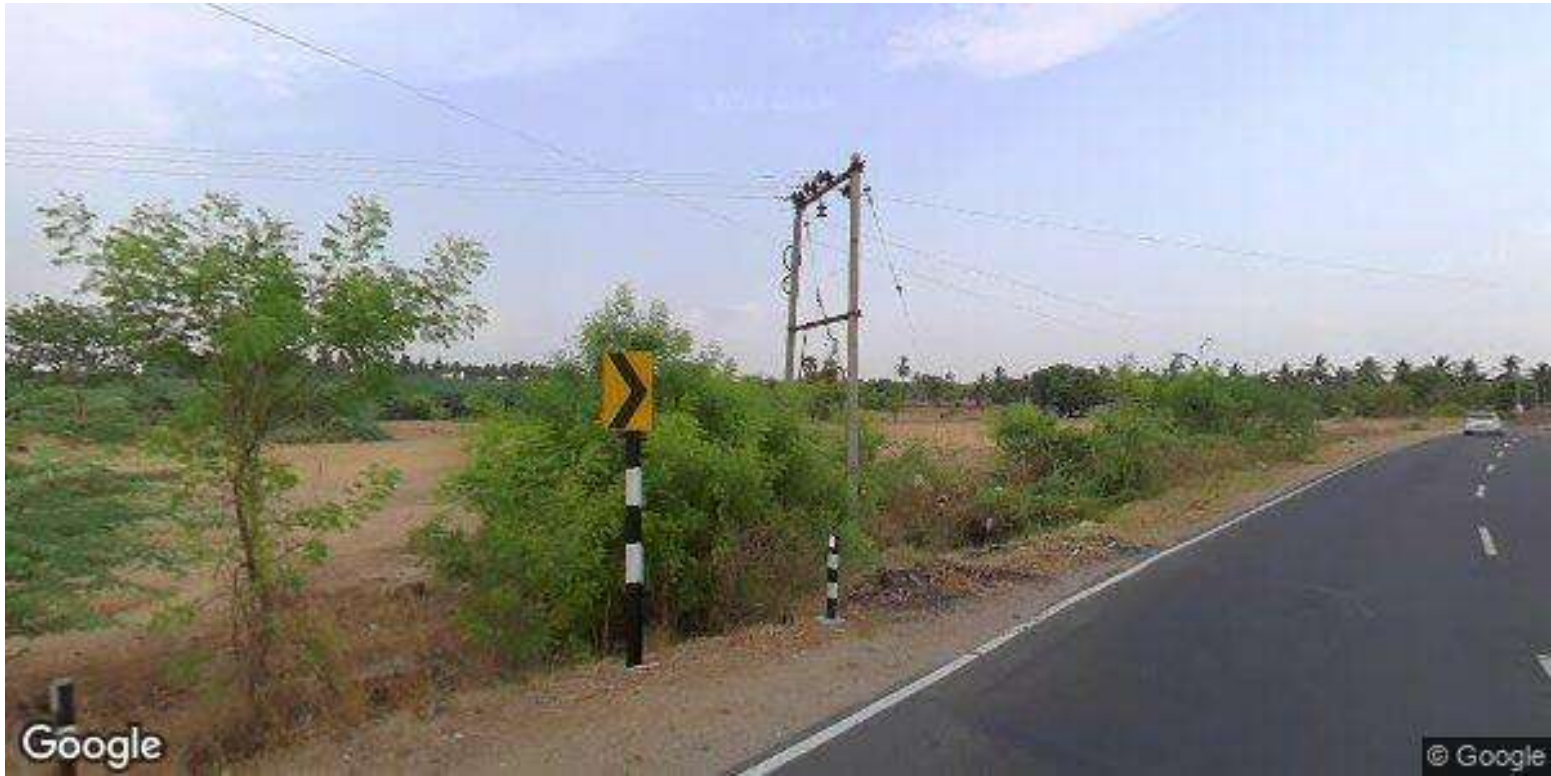
**Risk Type:** Turn  
**Risk Level:** Medium  
**Speed Limit:** 30 KM/Hr  
**Coordinates:** 11.33778, 77.86236

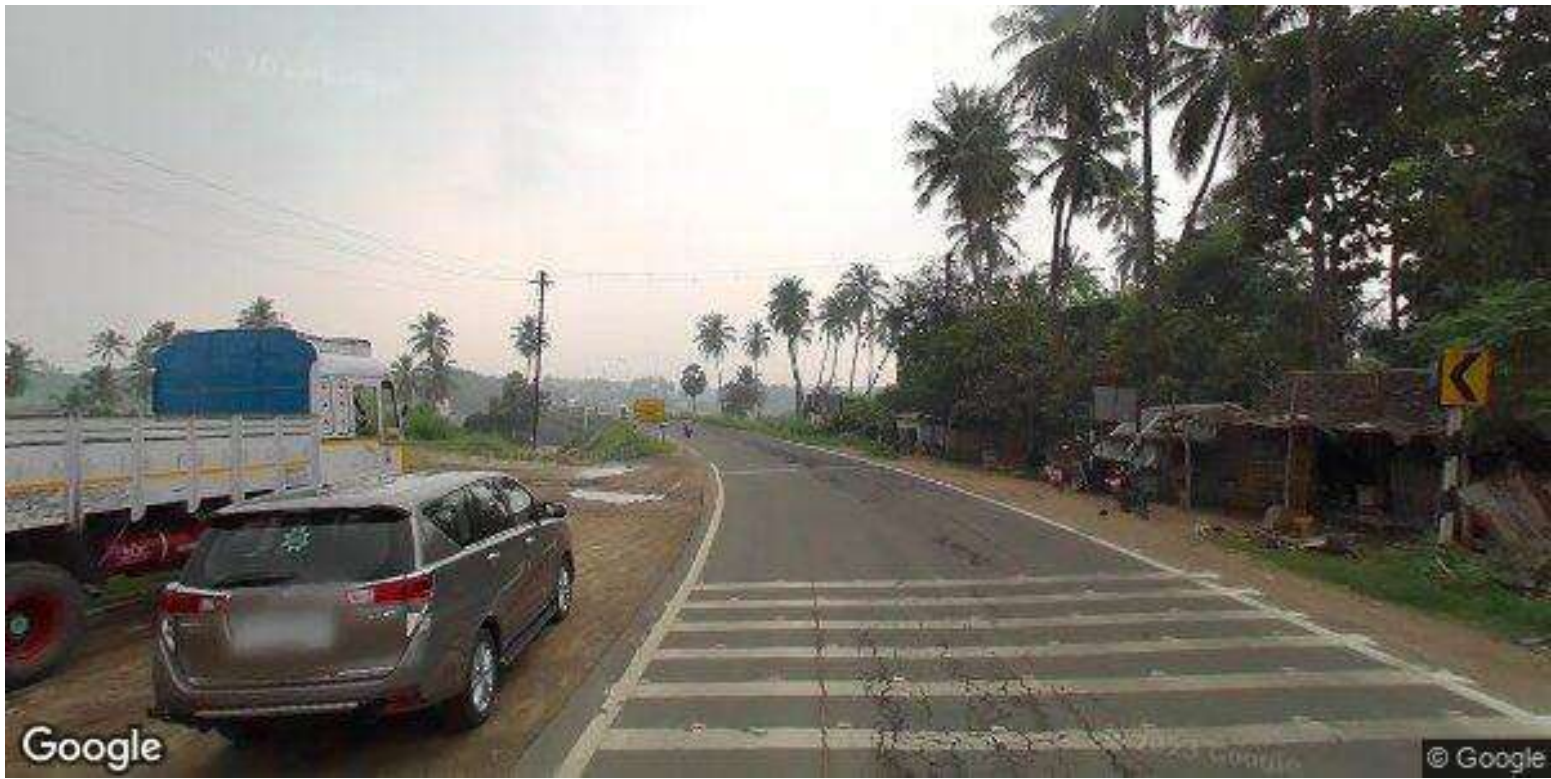
**Risk Type:** Turn  
**Risk Level:** Medium  
**Speed Limit:** 30 KM/Hr  
**Coordinates:** 11.30952, 77.77587

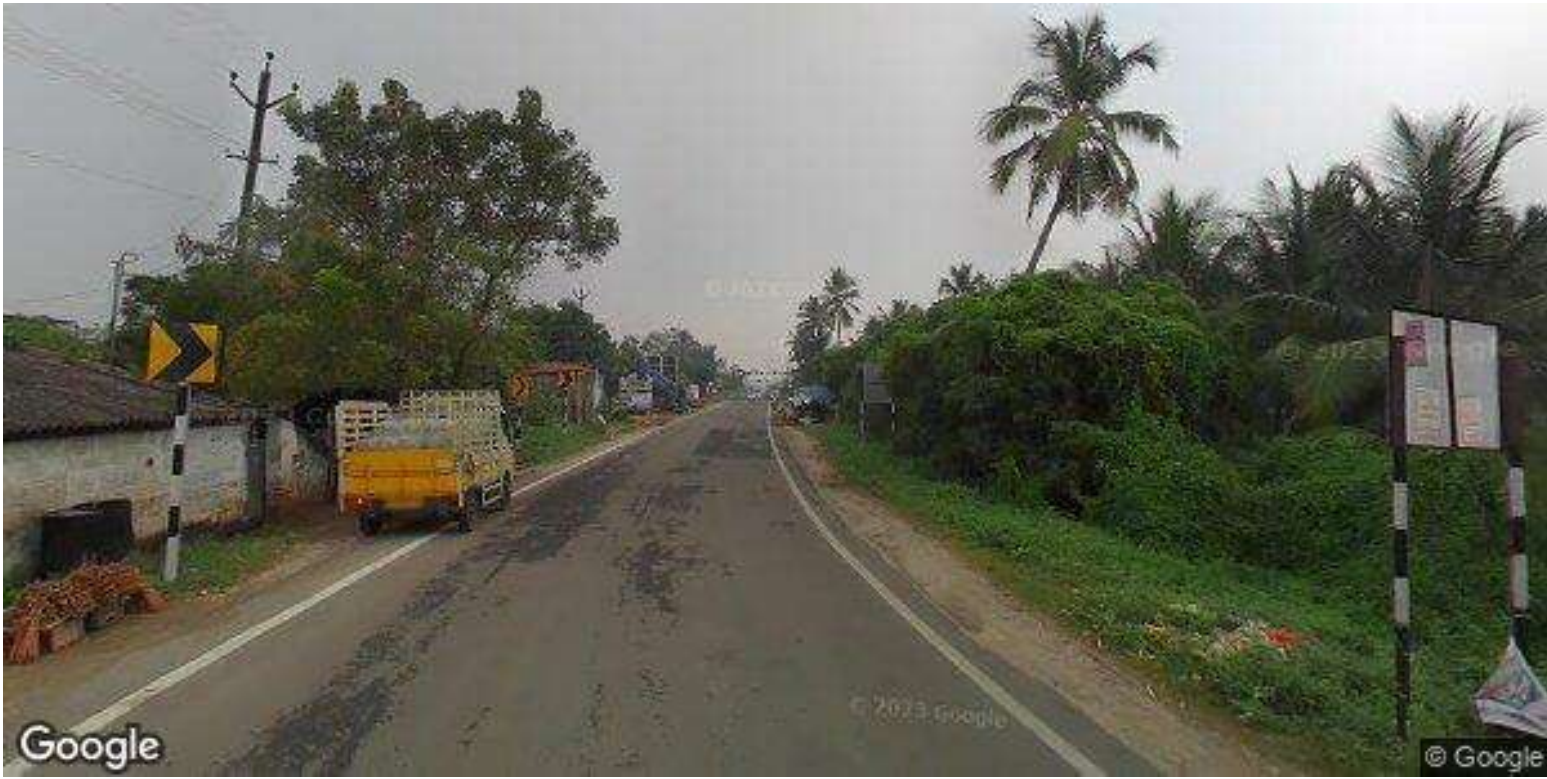
**Risk Type:** Turn  
**Risk Level:** Medium  
**Speed Limit:** 30 KM/Hr  
**Coordinates:** 11.30973, 77.76712

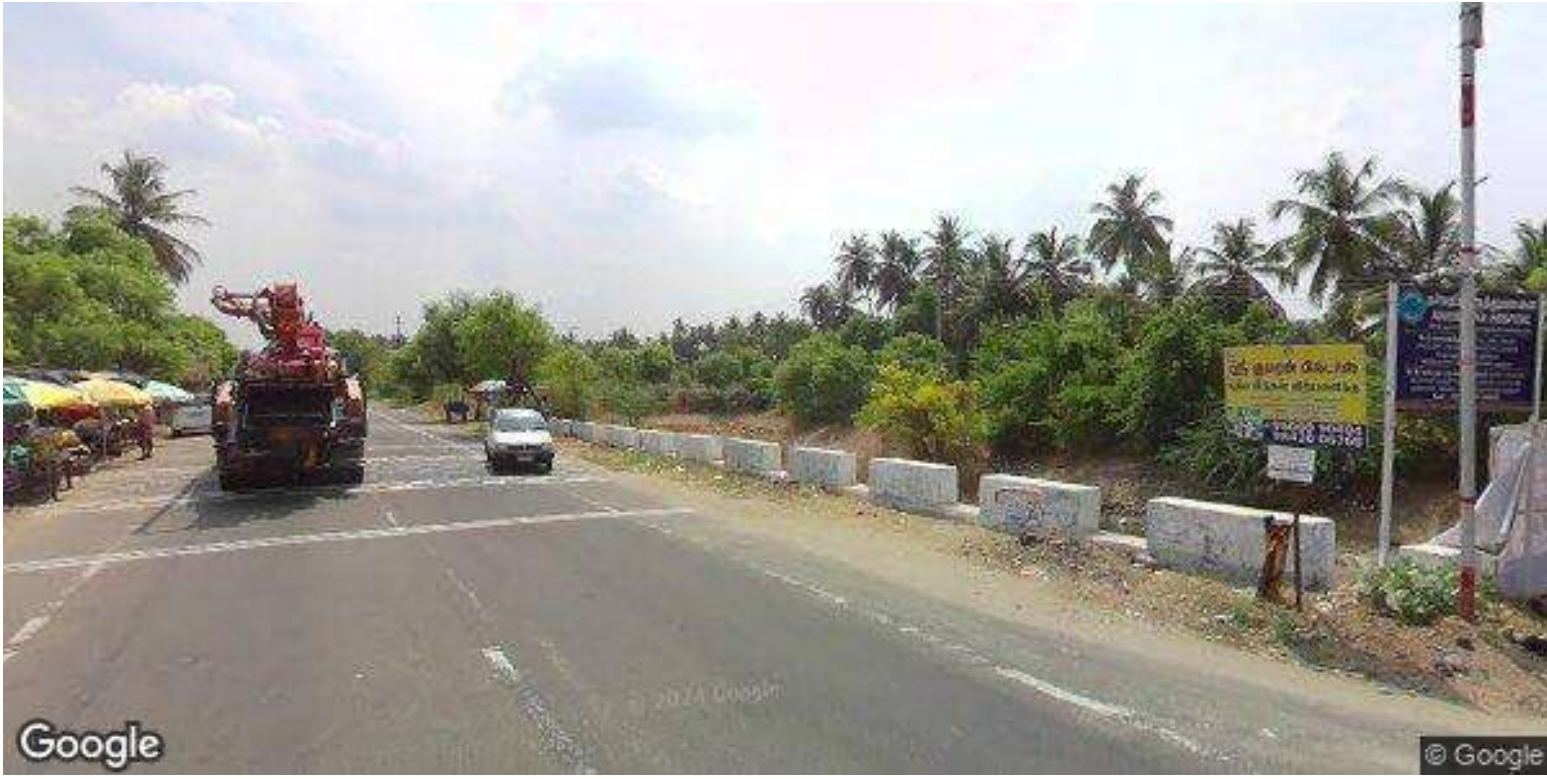
**Risk Type:** Turn  
**Risk Level:** High  
**Speed Limit:** 15 KM/Hr  
**Coordinates:** 11.29490, 77.74685

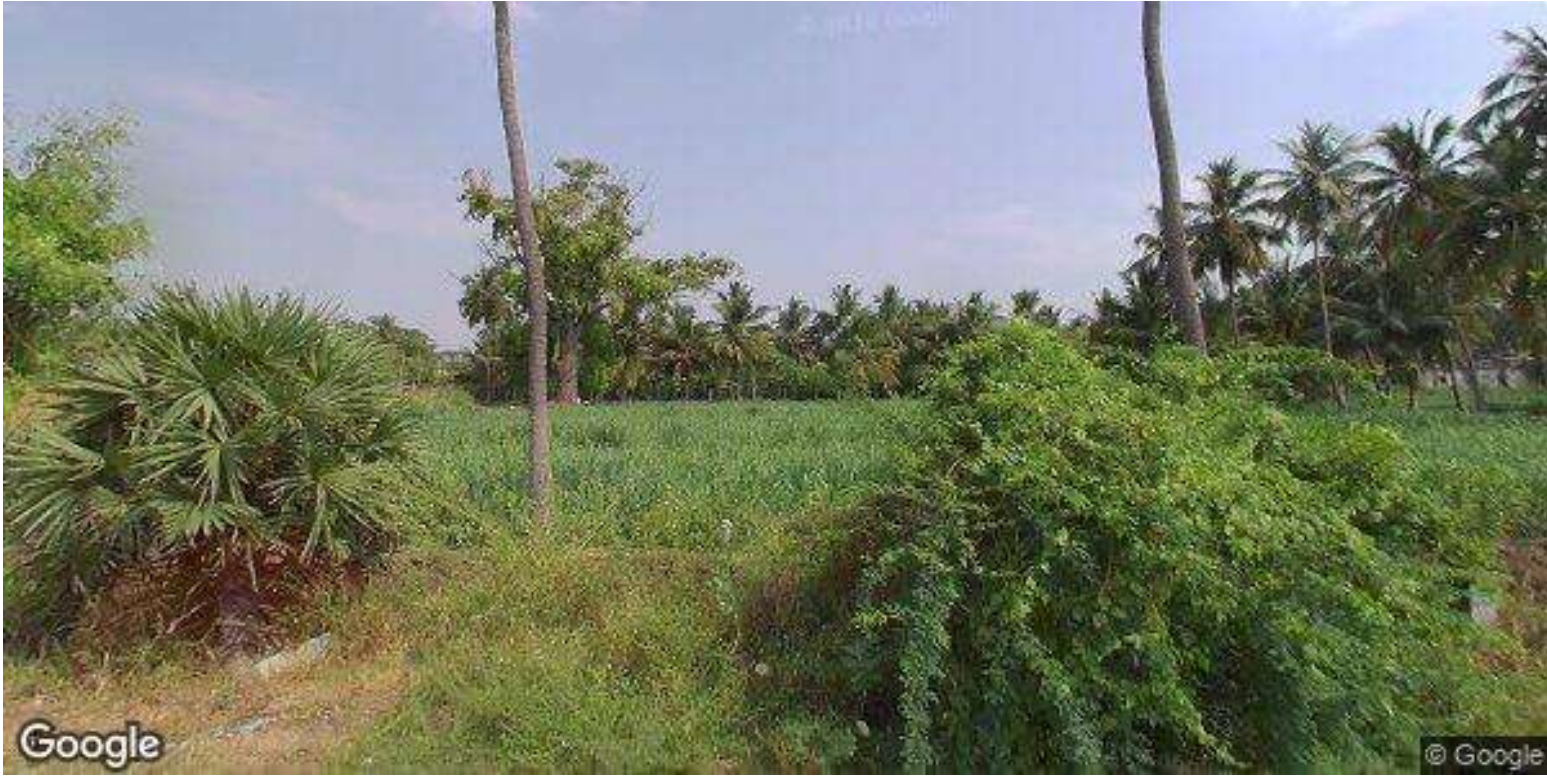
**Risk Type:** Turn  
**Risk Level:** High  
**Speed Limit:** 15 KM/Hr  
**Coordinates:** 11.29125, 77.74646

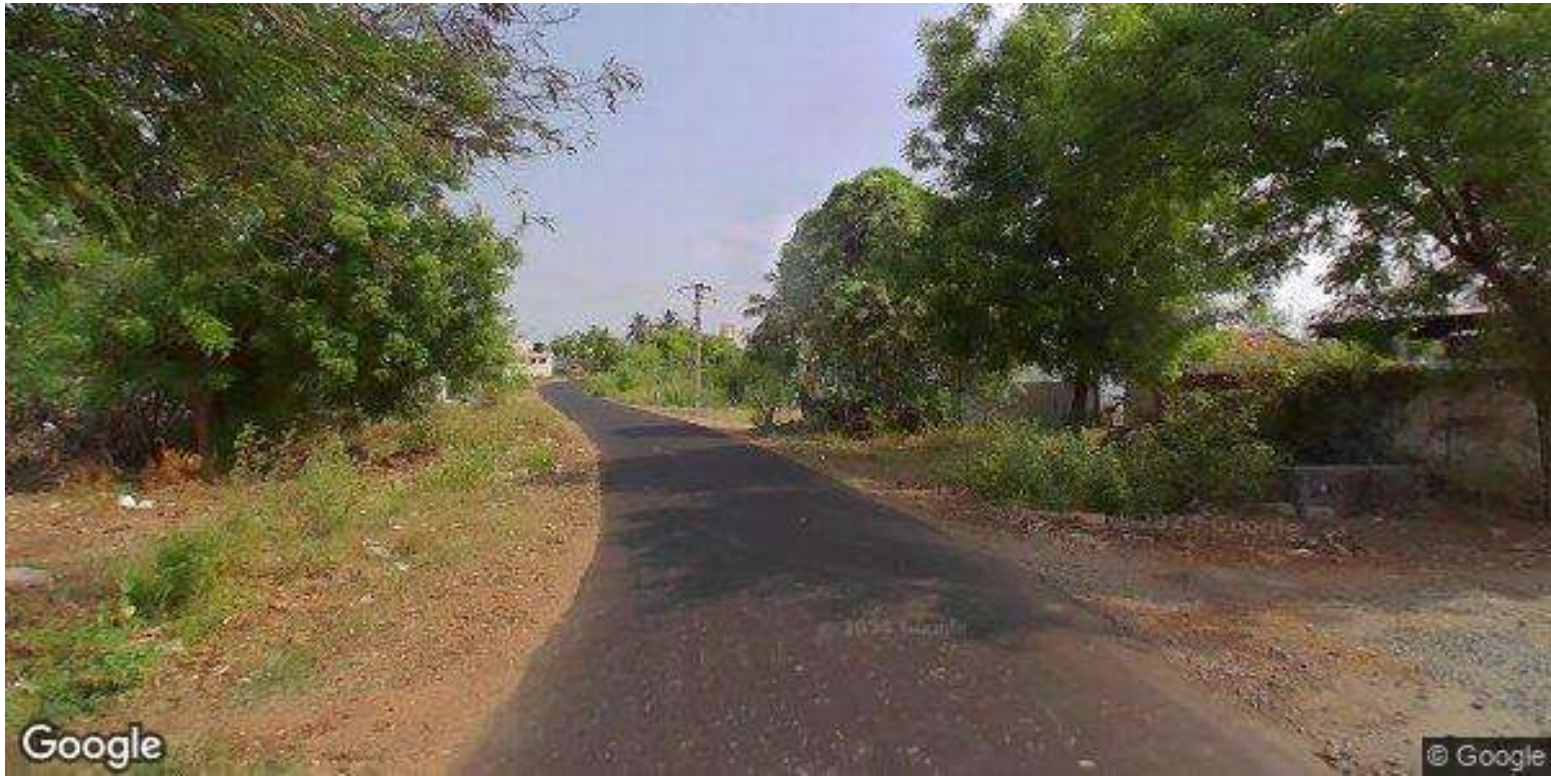
**Risk Type:** Turn  
**Risk Level:** Medium  
**Speed Limit:** 30 KM/Hr  
**Coordinates:** 11.28844, 77.74319

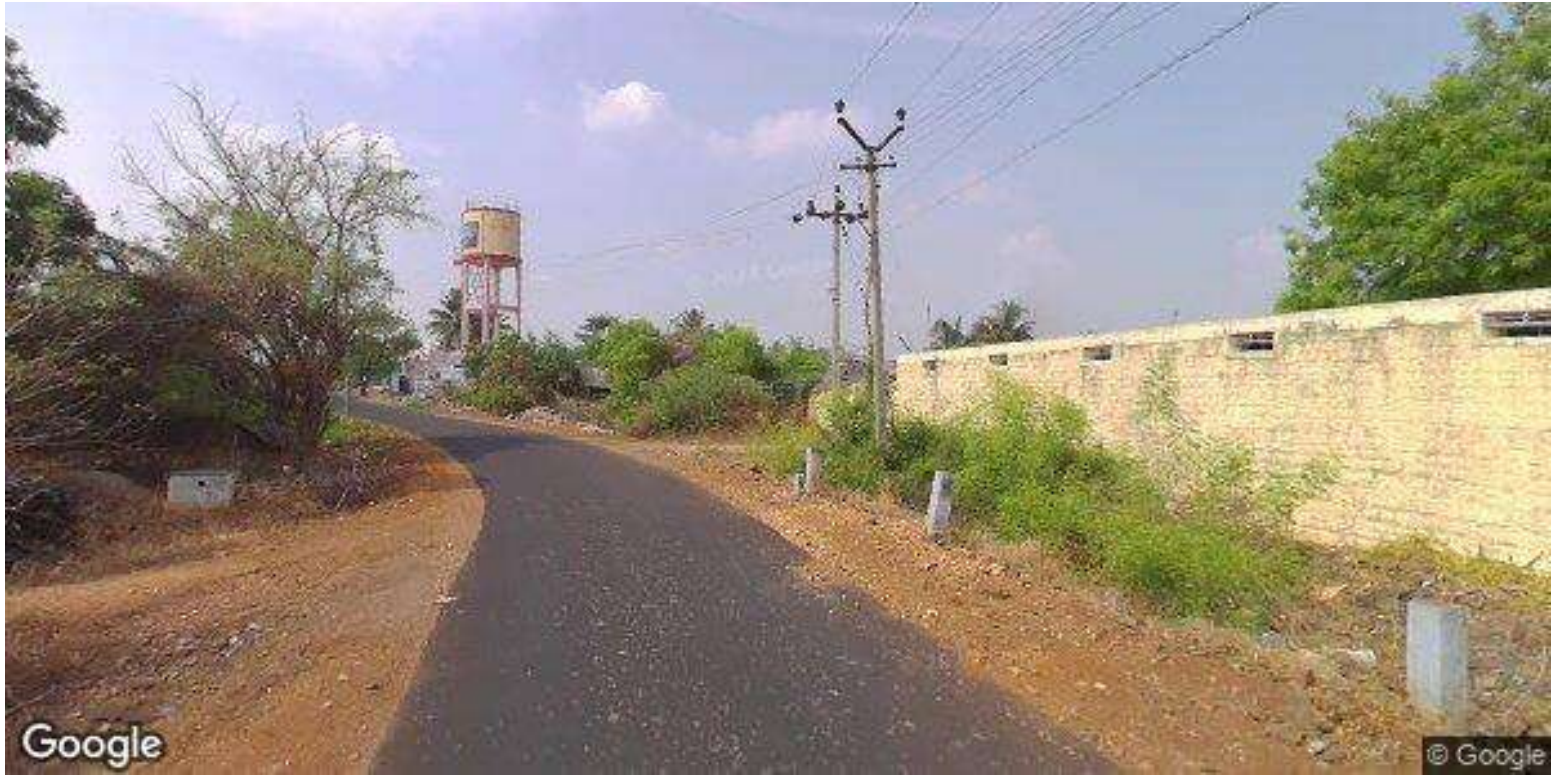
**Risk Type:** Turn  
**Risk Level:** Medium  
**Speed Limit:** 30 KM/Hr  
**Coordinates:** 11.28573, 77.74281

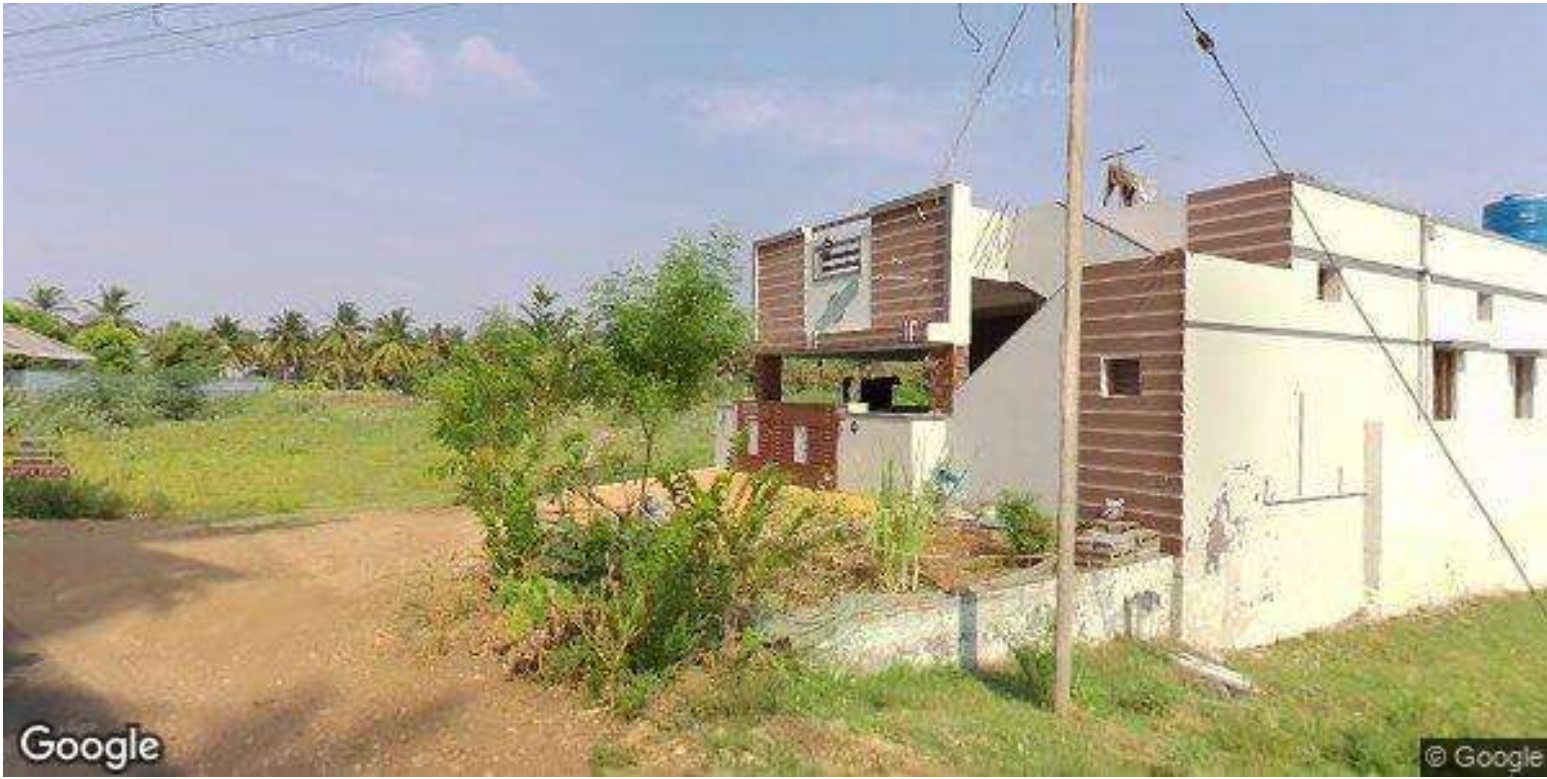
**Risk Type:** Turn  
**Risk Level:** High  
**Speed Limit:** 15 KM/Hr  
**Coordinates:** 11.27319, 77.72981

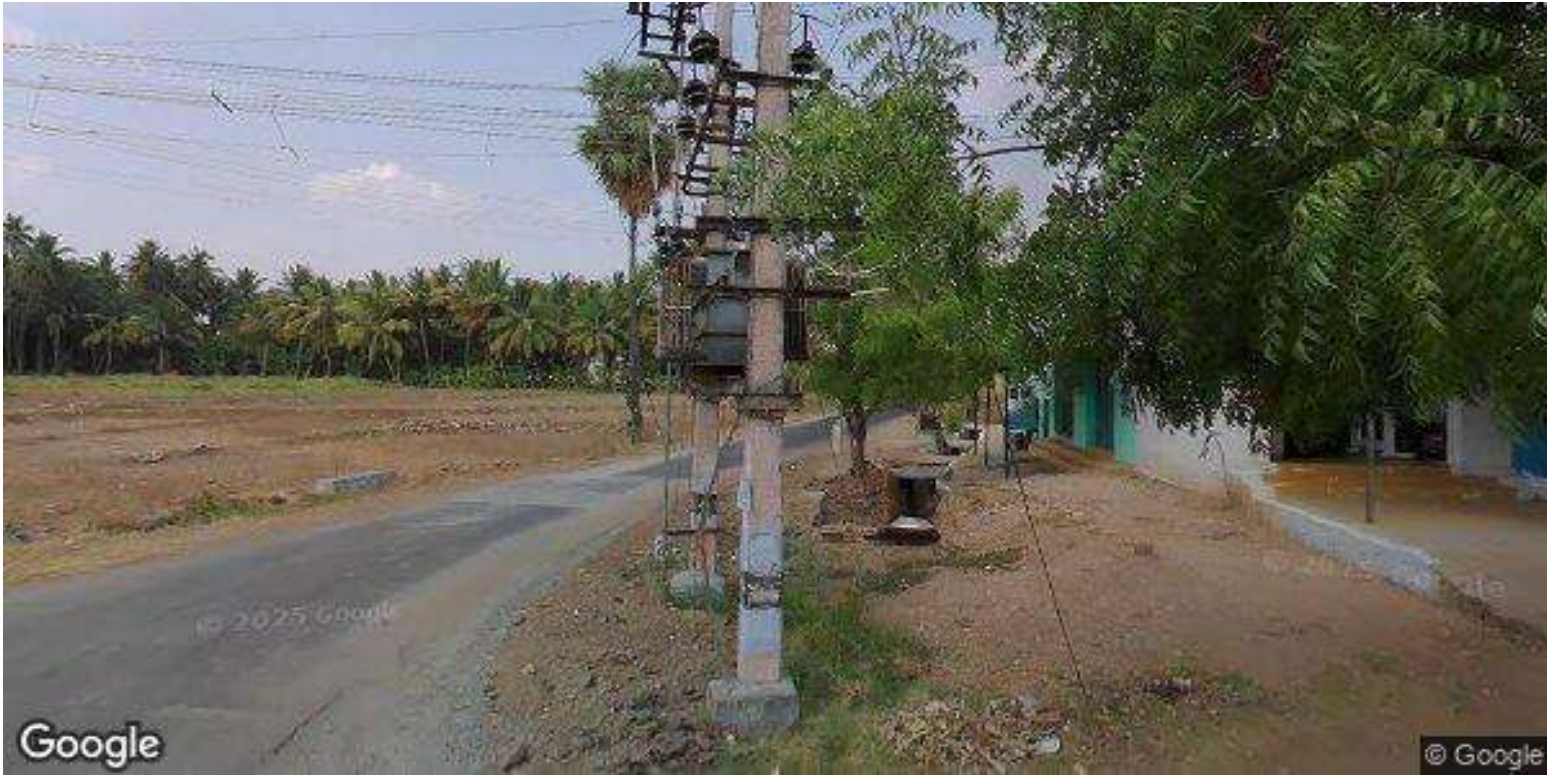
**Risk Type:** Blind Spot  
**Risk Level:** Blind Spot  
**Speed Limit:** 10 KM/Hr  
**Coordinates:** 11.27330, 77.72715

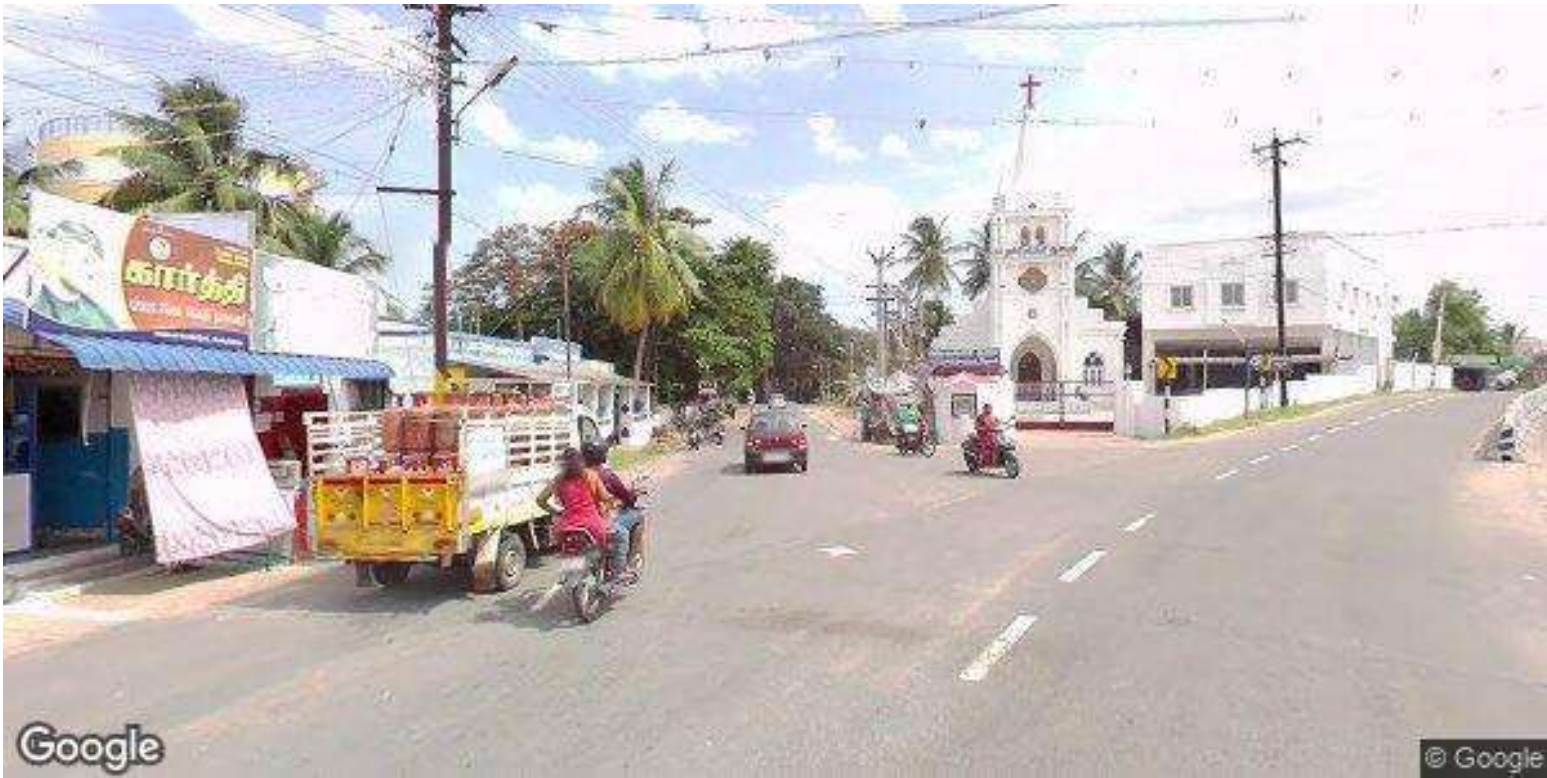
**Risk Type:** Turn  
**Risk Level:** Medium  
**Speed Limit:** 30 KM/Hr  
**Coordinates:** 11.23054, 77.71796

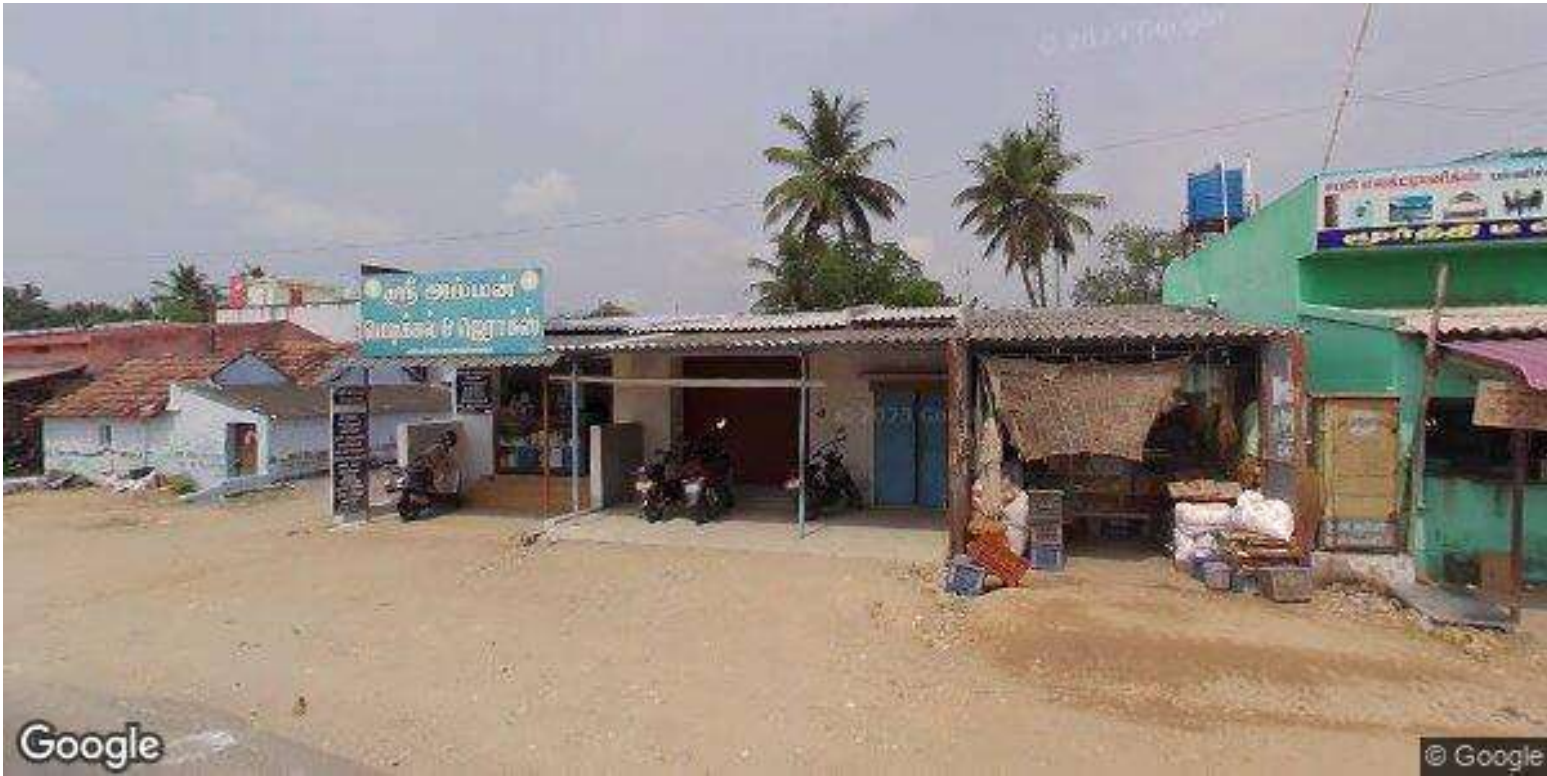
**Risk Type:** Turn  
**Risk Level:** Medium  
**Speed Limit:** 30 KM/Hr  
**Coordinates:** 11.20776, 77.70916

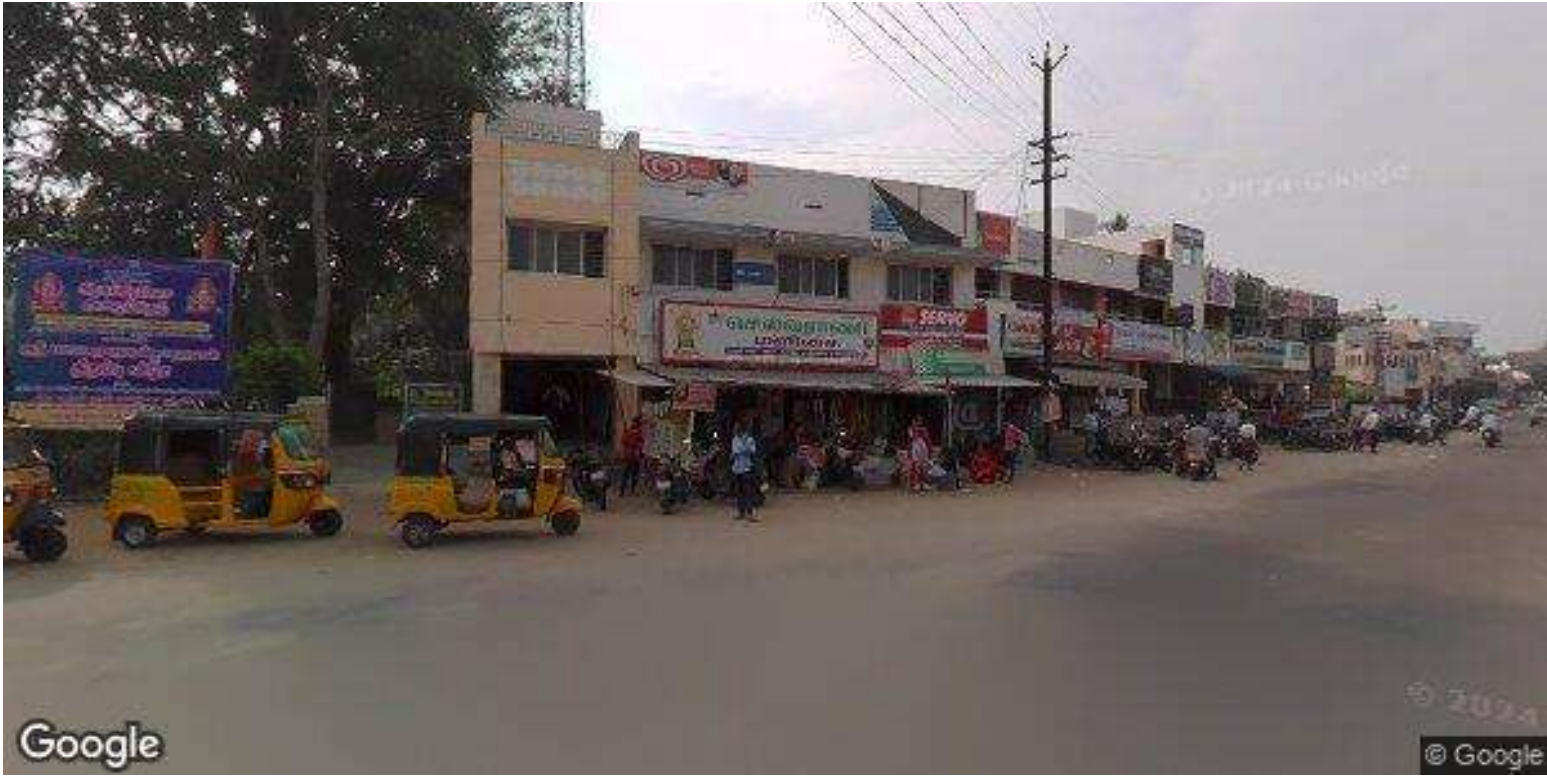
**Risk Type:** Turn  
**Risk Level:** Medium  
**Speed Limit:** 30 KM/Hr  
**Coordinates:** 11.15942, 77.70068

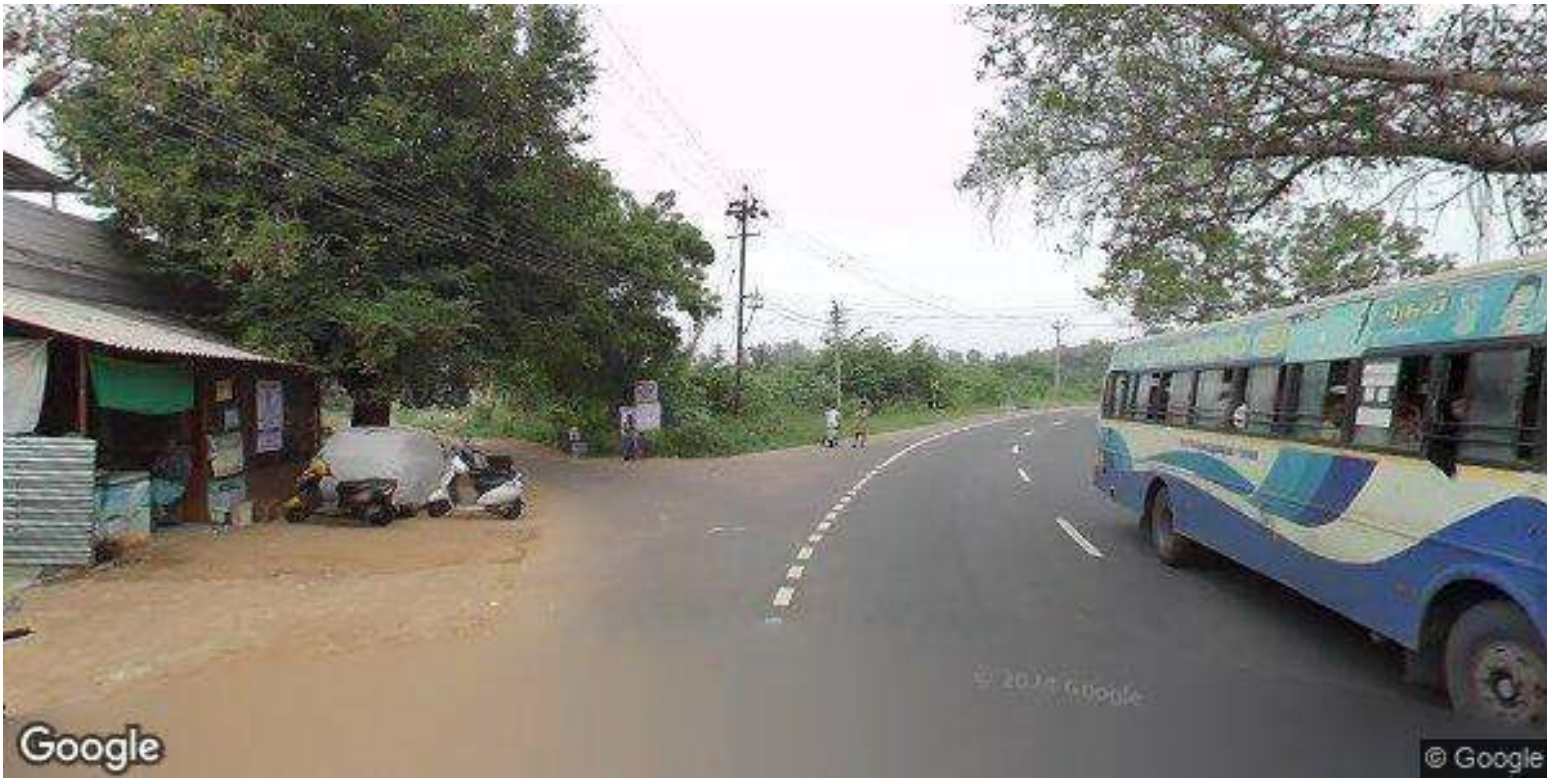
**Risk Type:** Turn  
**Risk Level:** Medium  
**Speed Limit:** 30 KM/Hr  
**Coordinates:** 11.11710, 77.67175
