# IndianOil

## JOURNEY RISK MANAGEMENT (JRM) STUDY

### Salem Terminal TO VELAVAN FUELS

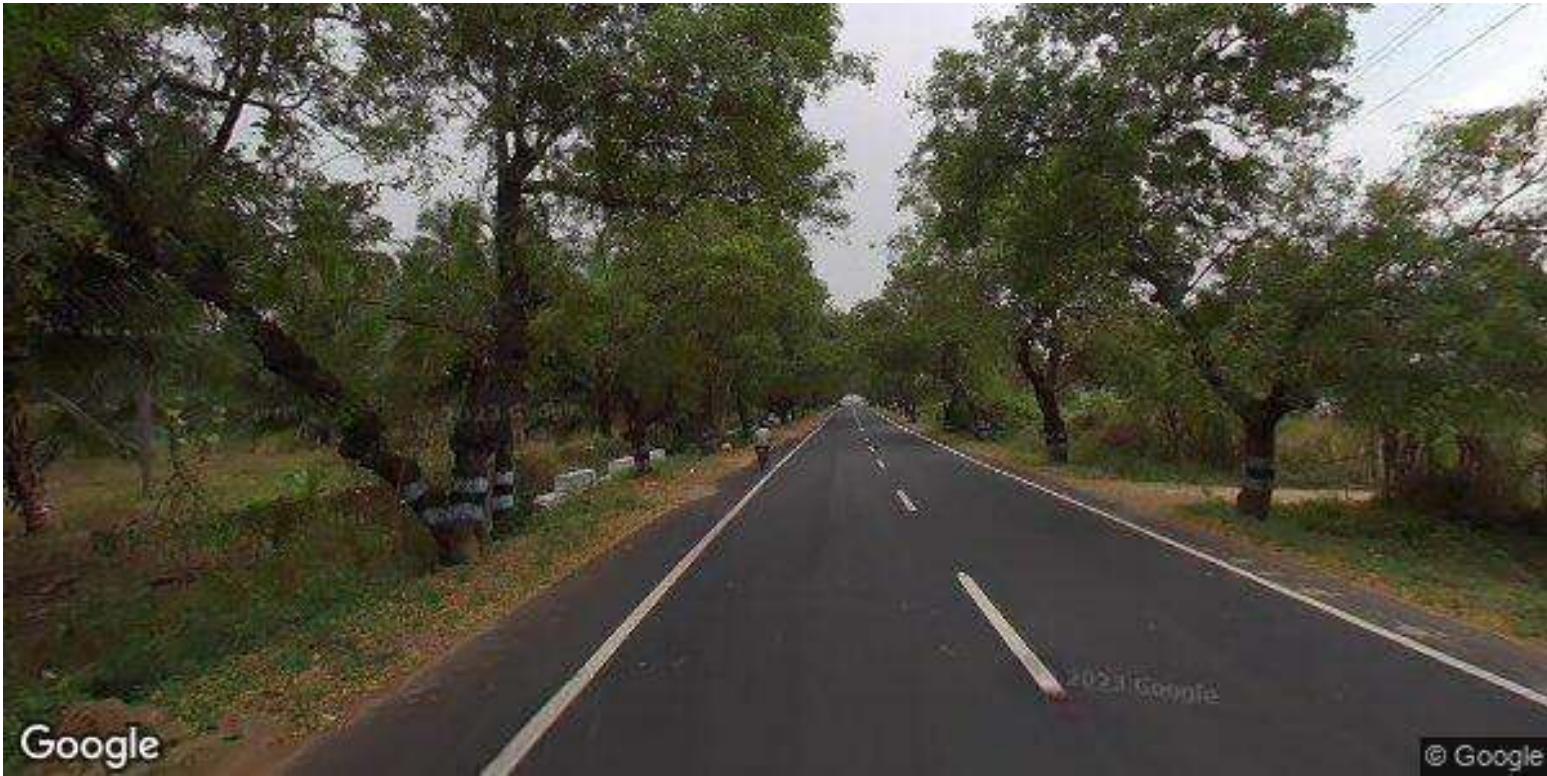
**Risk Type:** Turn  
**Risk Level:** Medium  
**Speed Limit:** 30 KM/Hr  
**Coordinates:** 11.10436, 77.67044

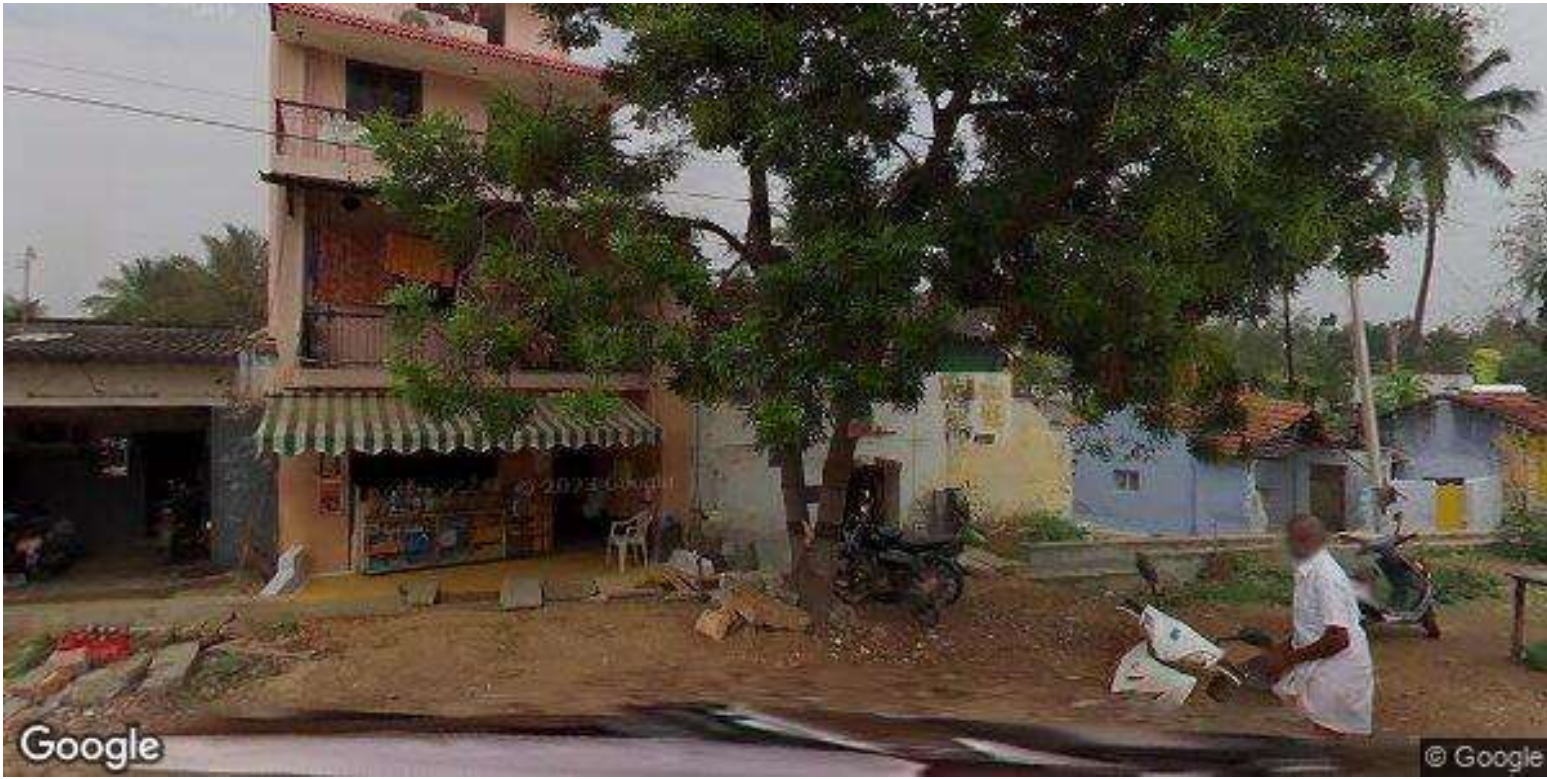
**Risk Type:** Turn  
**Risk Level:** Medium  
**Speed Limit:** 30 KM/Hr  
**Coordinates:** 11.08696, 77.66407

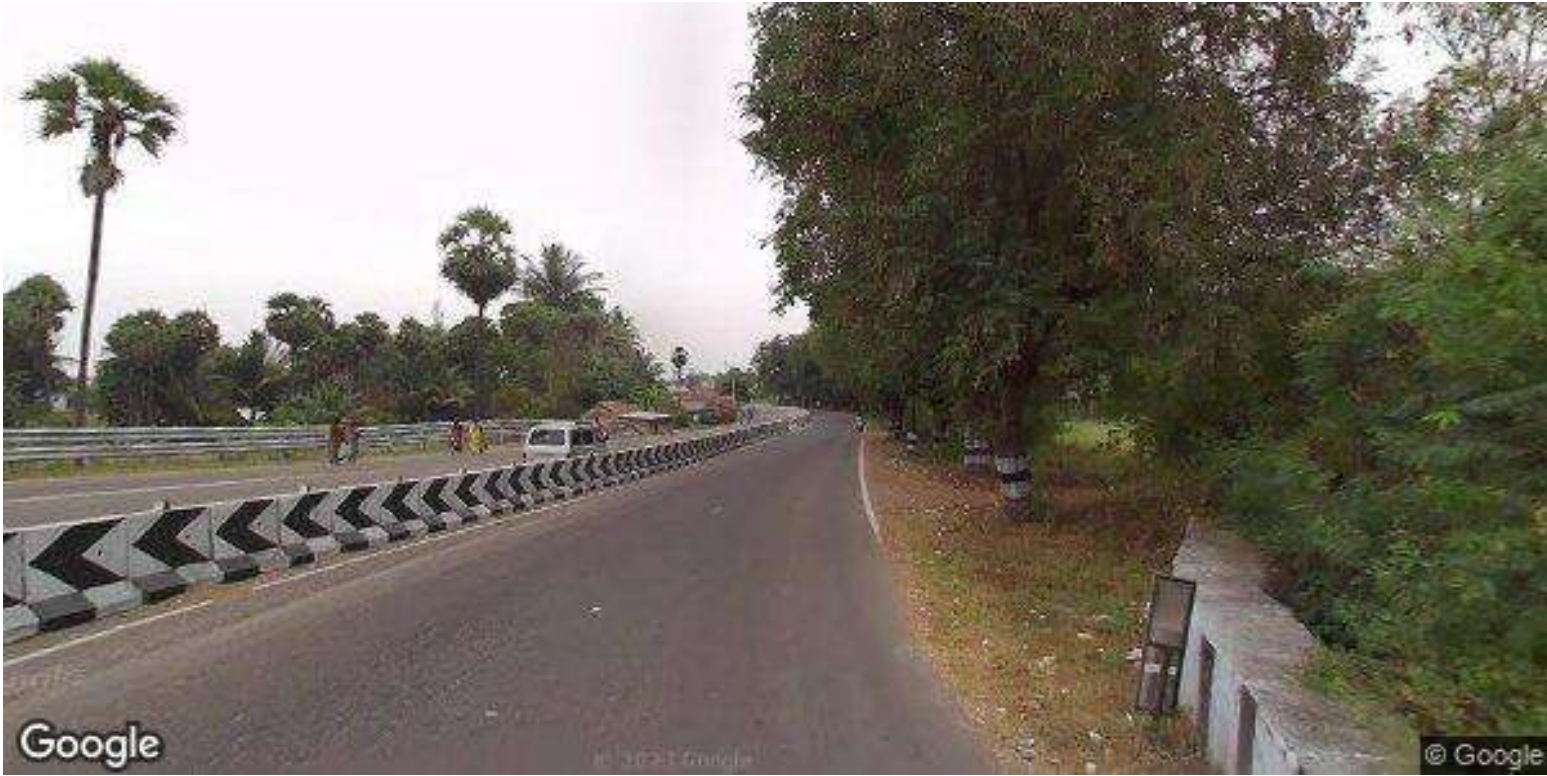
**Risk Type:** Turn  
**Risk Level:** Medium  
**Speed Limit:** 30 KM/Hr  
**Coordinates:** 11.08296, 77.65857

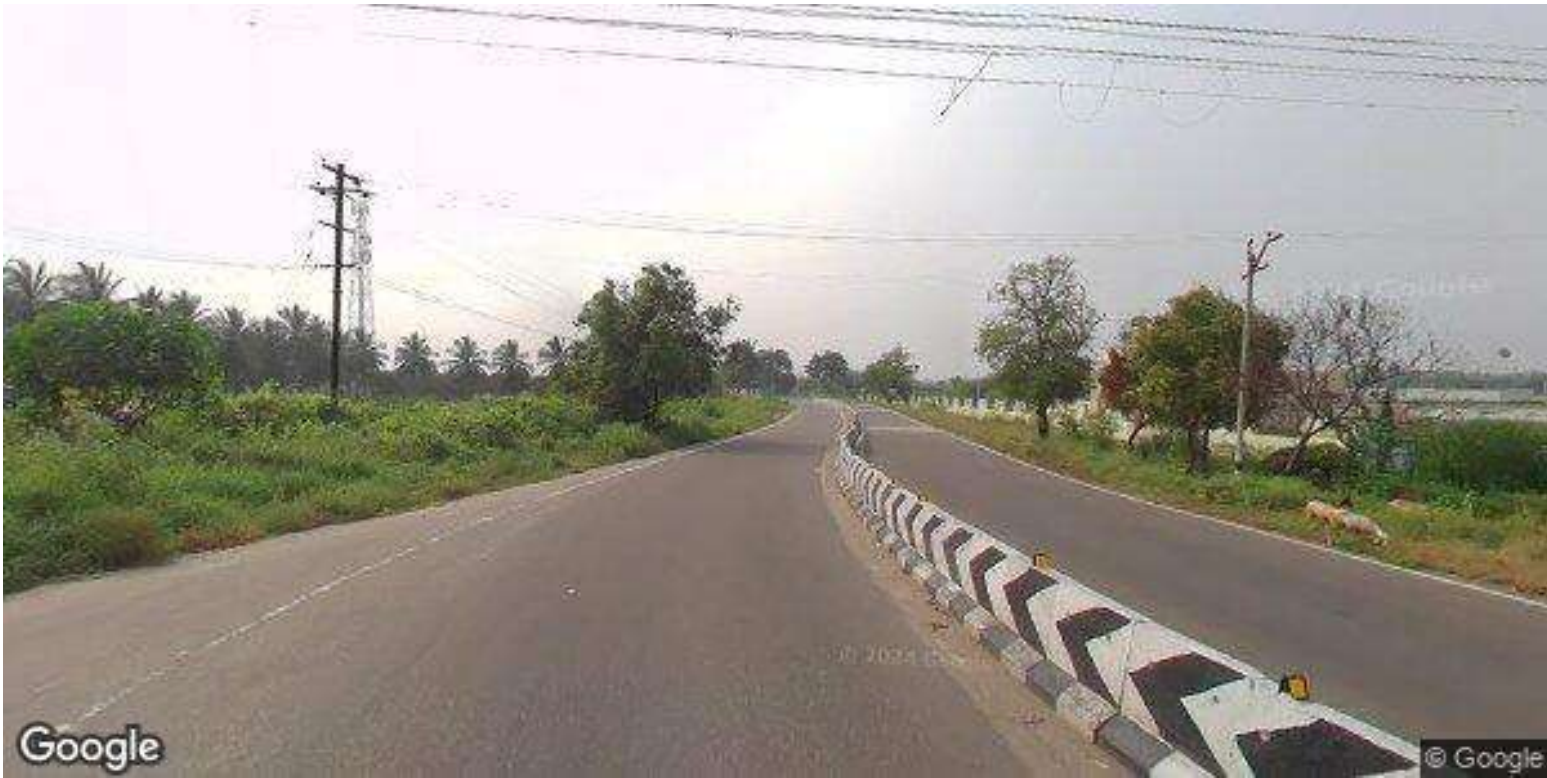
**Risk Type:** Turn  
**Risk Level:** Medium  
**Speed Limit:** 30 KM/Hr  
**Coordinates:** 11.06183, 77.63924

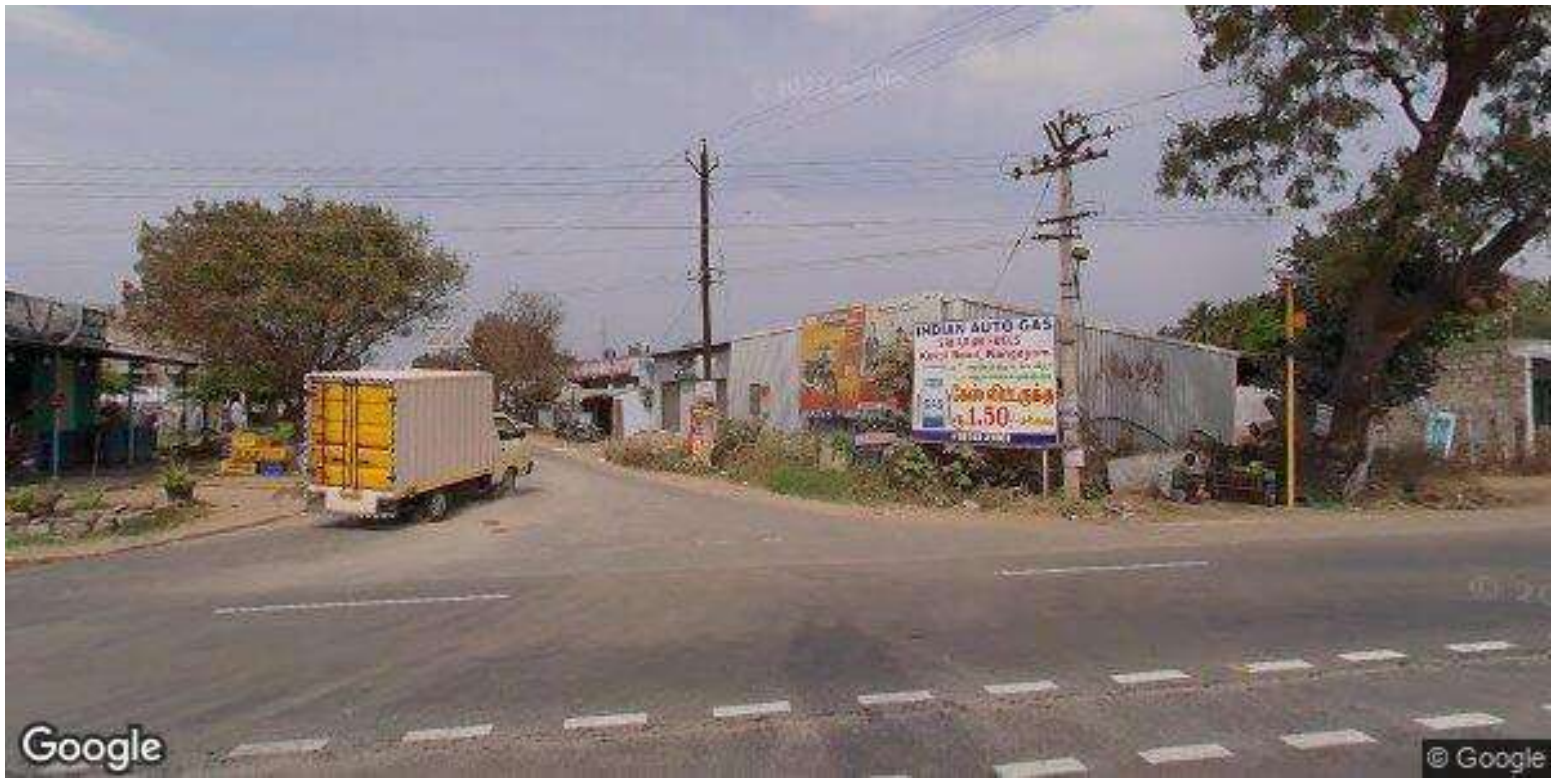
**Risk Type:** Blind Spot  
**Risk Level:** Blind Spot  
**Speed Limit:** 10 KM/Hr  
**Coordinates:** 11.00058, 77.56882

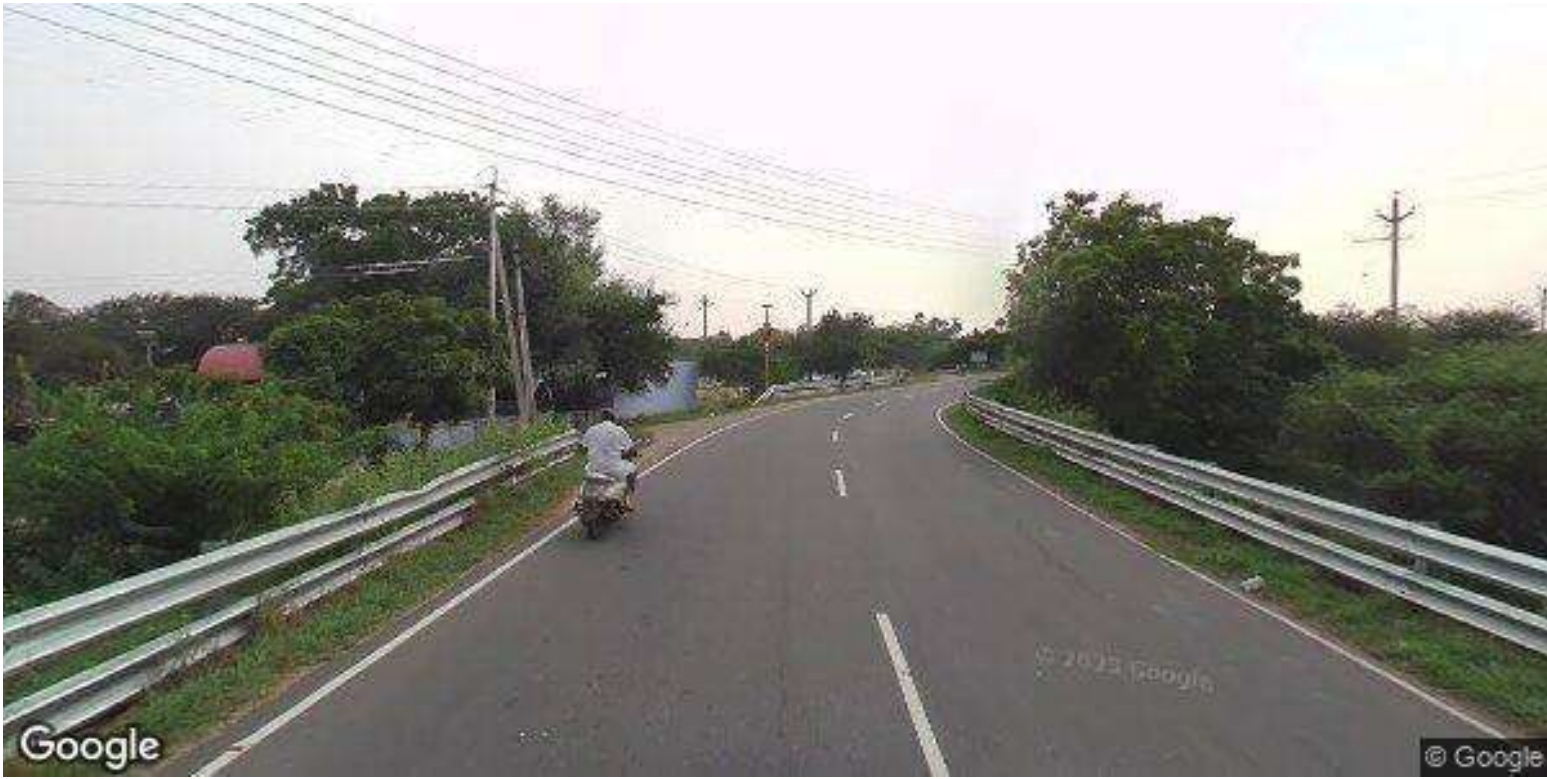
**Risk Type:** Turn  
**Risk Level:** High  
**Speed Limit:** 15 KM/Hr  
**Coordinates:** 10.94722, 77.54709

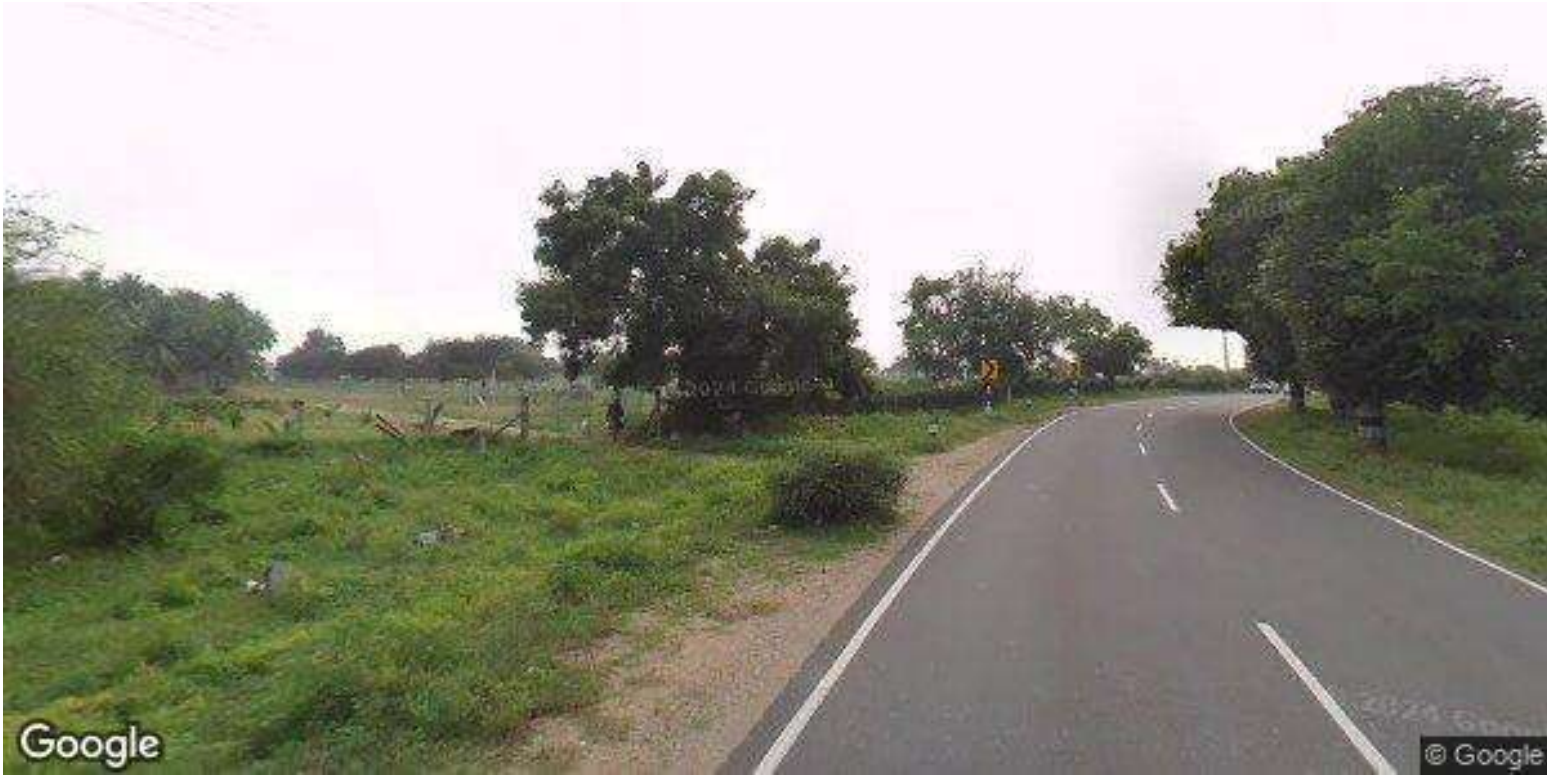
**Risk Type:** Turn  
**Risk Level:** Medium  
**Speed Limit:** 30 KM/Hr  
**Coordinates:** 10.93895, 77.53976

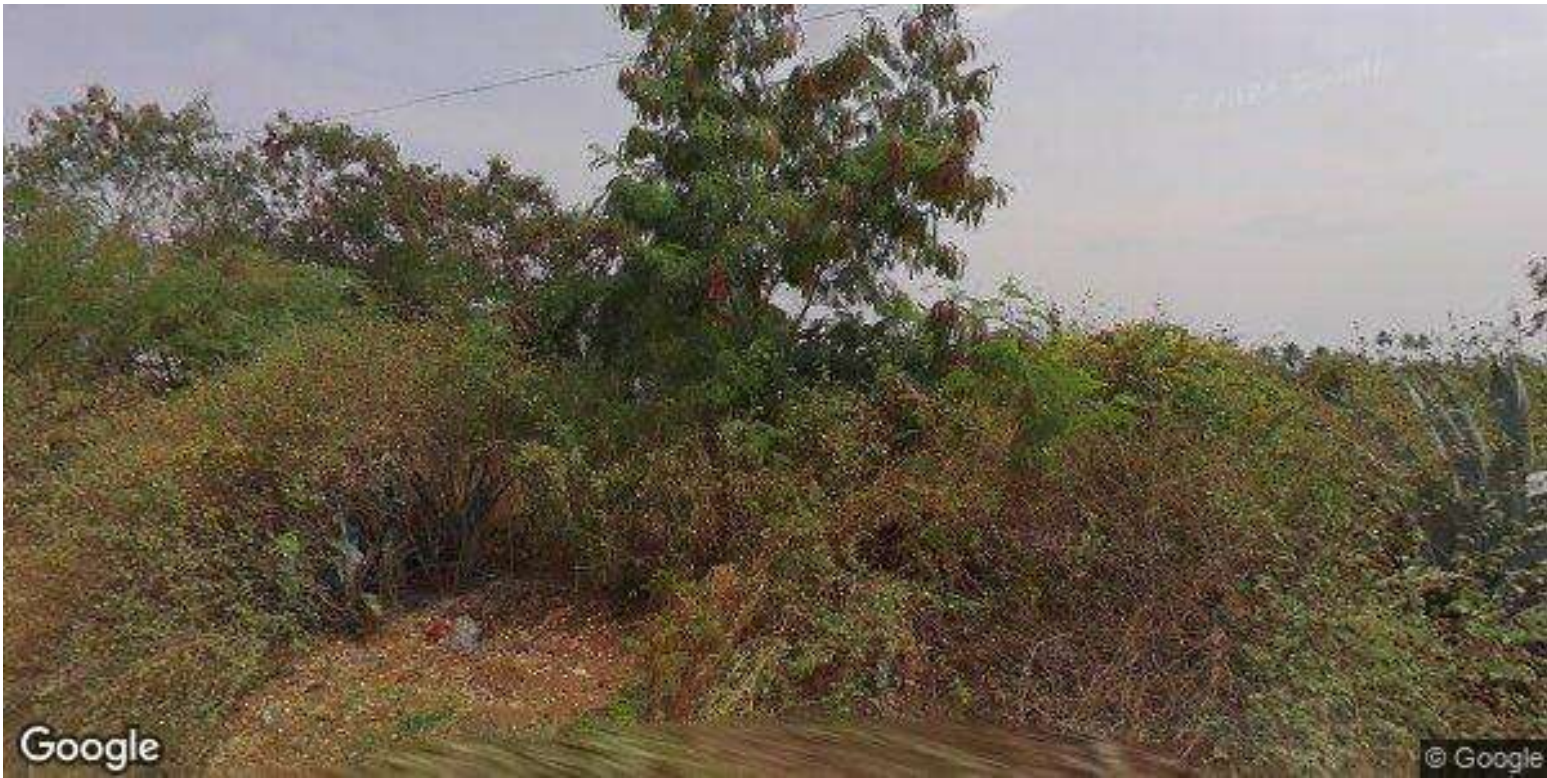
**Risk Type:** Turn  
**Risk Level:** Medium  
**Speed Limit:** 30 KM/Hr  
**Coordinates:** 10.93054, 77.53265

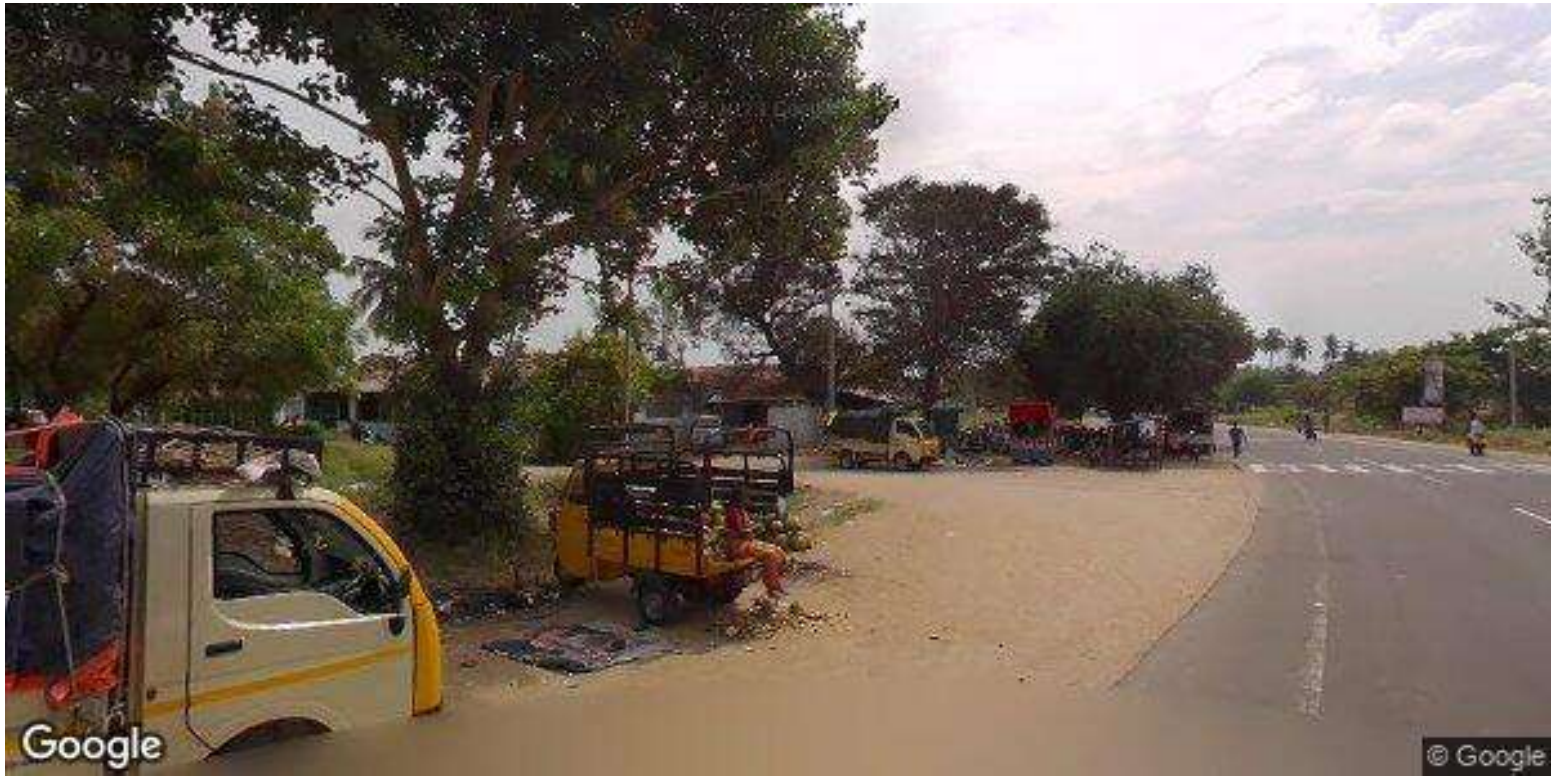
**Risk Type:** Turn  
**Risk Level:** Medium  
**Speed Limit:** 30 KM/Hr  
**Coordinates:** 10.89213, 77.52646

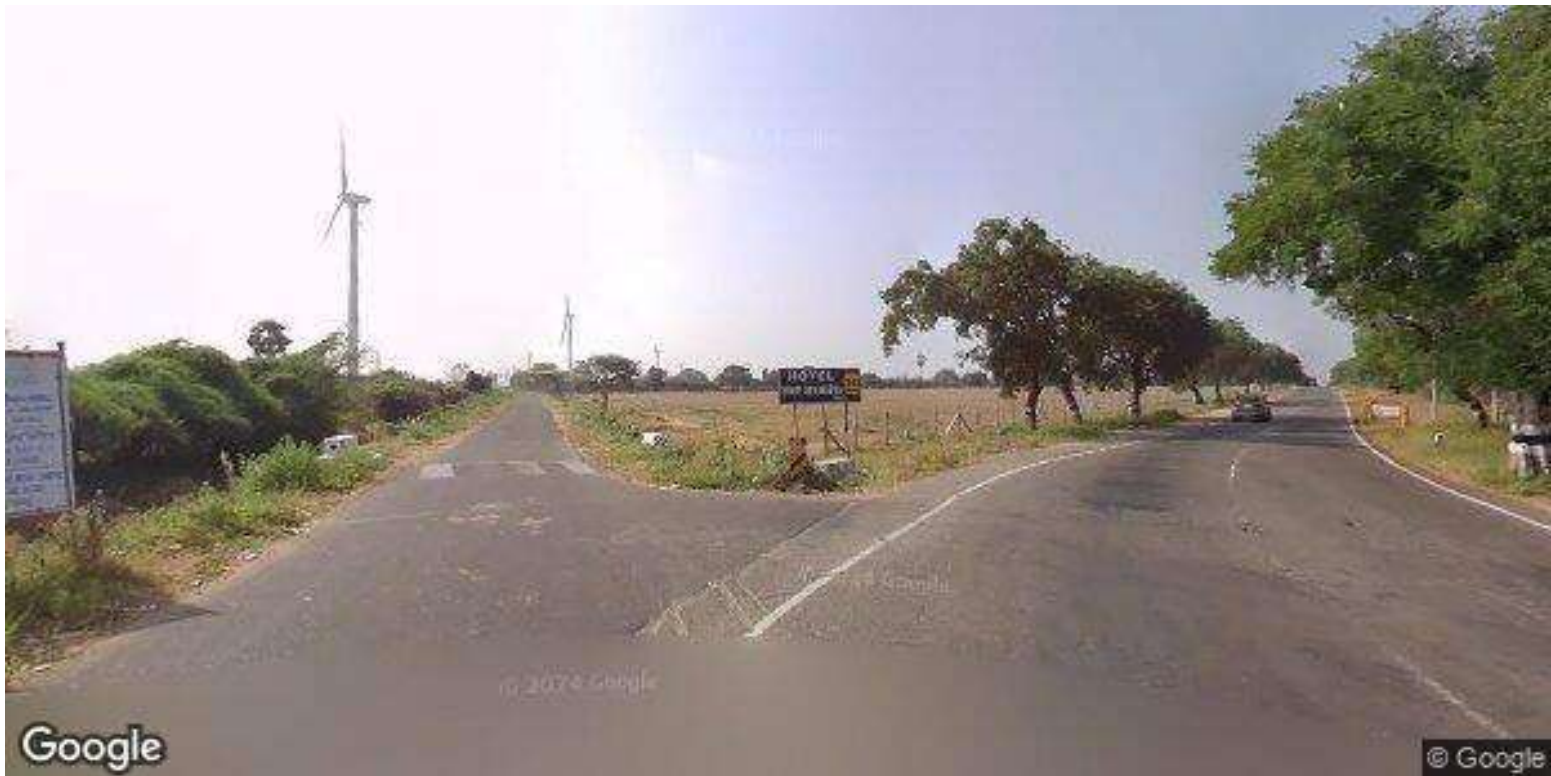
**Risk Type:** Turn  
**Risk Level:** Medium  
**Speed Limit:** 30 KM/Hr  
**Coordinates:** 10.83409, 77.52932

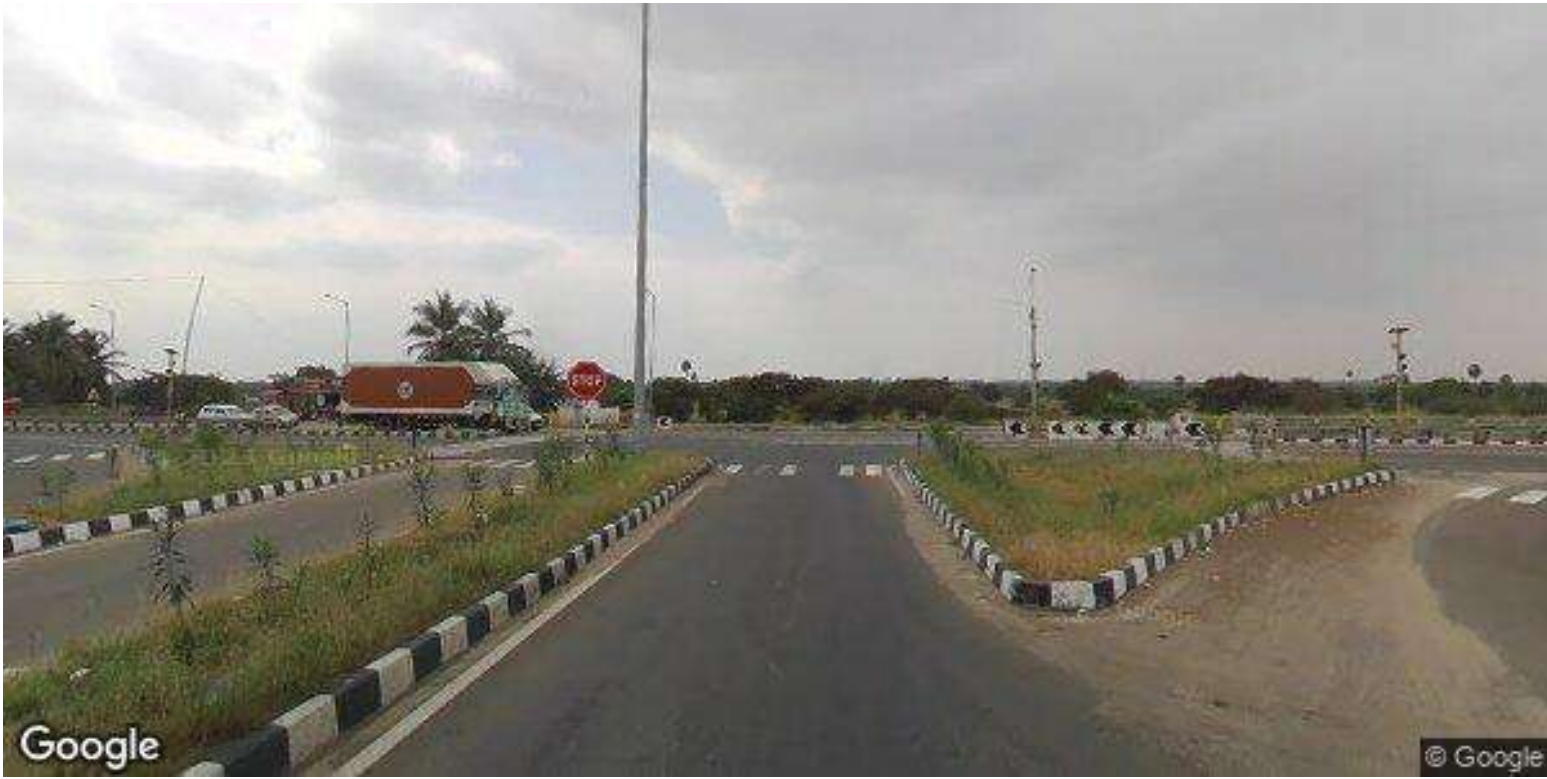
**Risk Type:** Turn  
**Risk Level:** Medium  
**Speed Limit:** 30 KM/Hr  
**Coordinates:** 10.77642, 77.50712

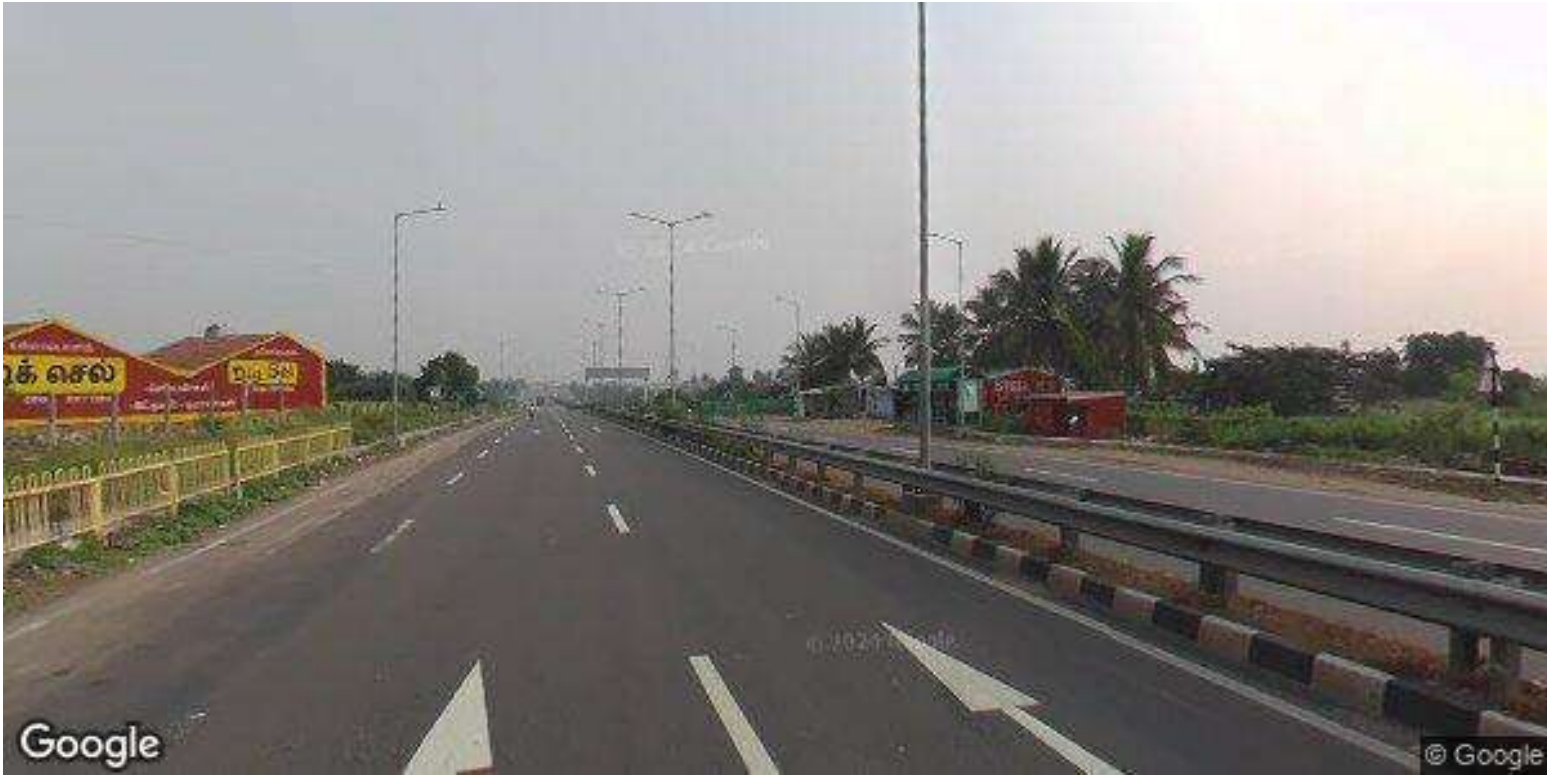
**Risk Type:** Turn  
**Risk Level:** Medium  
**Speed Limit:** 30 KM/Hr  
**Coordinates:** 10.77580, 77.50724

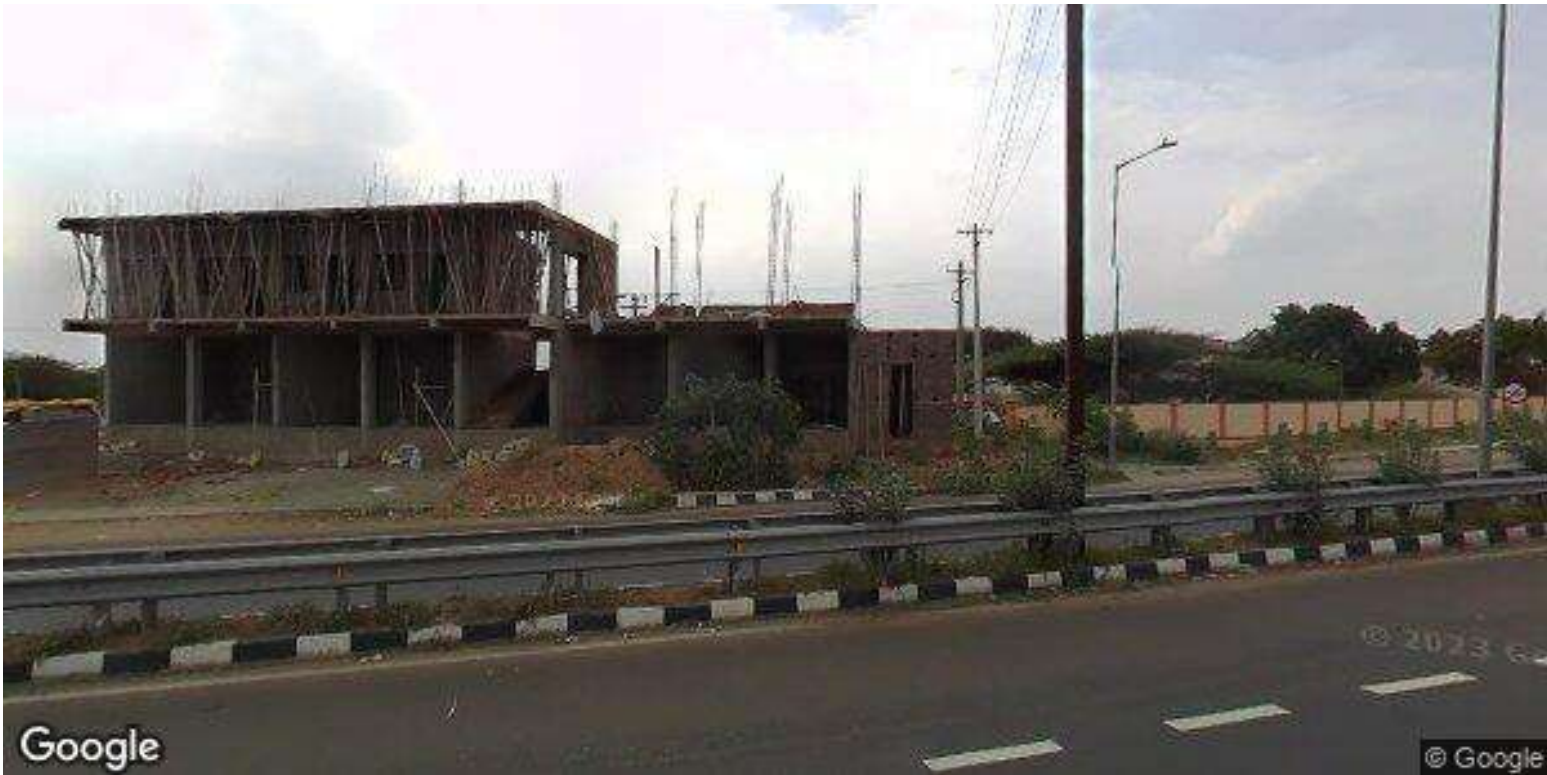
**Risk Type:** Turn  
**Risk Level:** Medium  
**Speed Limit:** 30 KM/Hr  
**Coordinates:** 10.75864, 77.51918

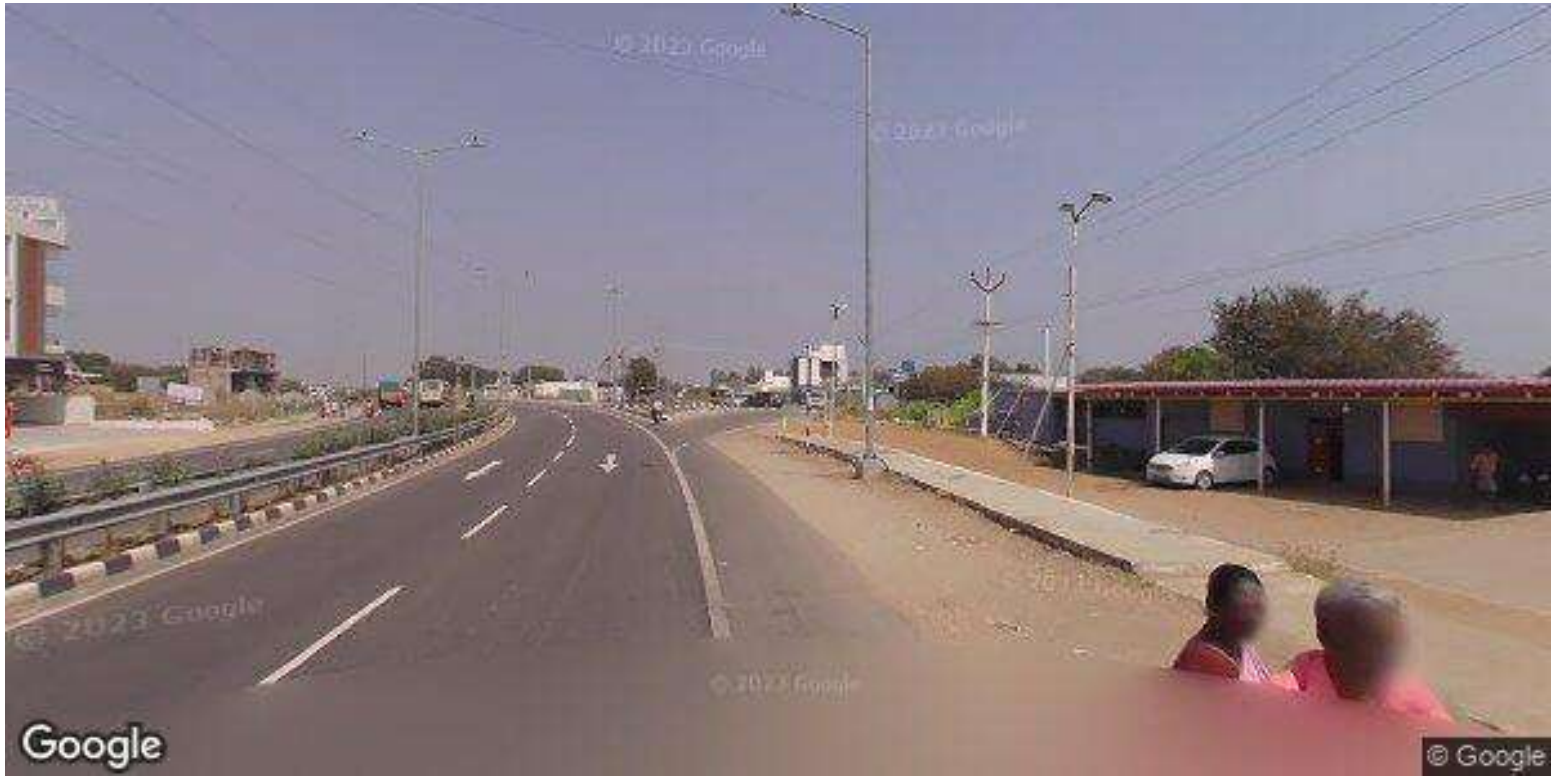
**Risk Type:** Turn  
**Risk Level:** Medium  
**Speed Limit:** 30 KM/Hr  
**Coordinates:** 10.75722, 77.51935

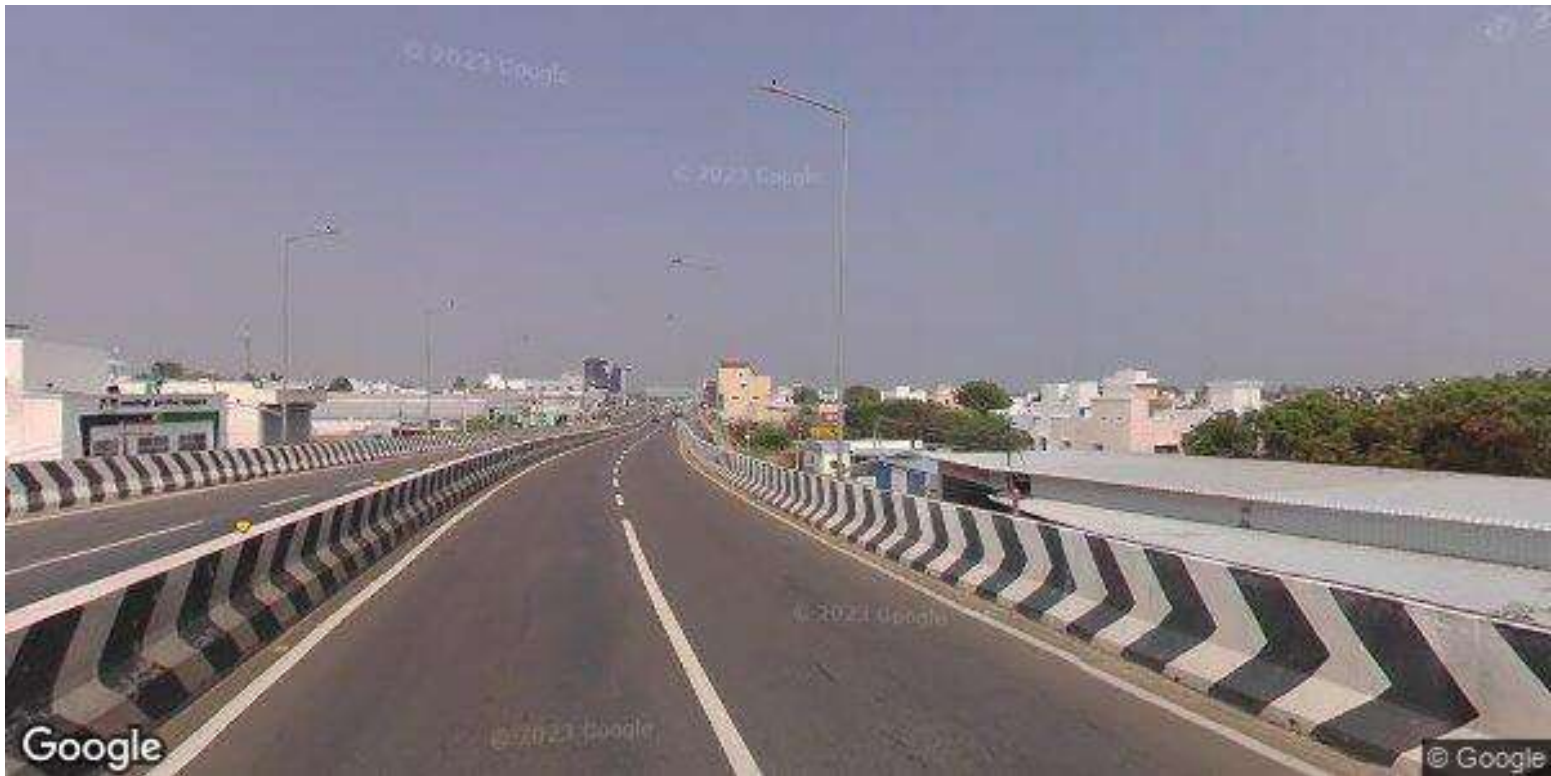
**Risk Type:** Turn  
**Risk Level:** Medium  
**Speed Limit:** 30 KM/Hr  
**Coordinates:** 10.73670, 77.51731

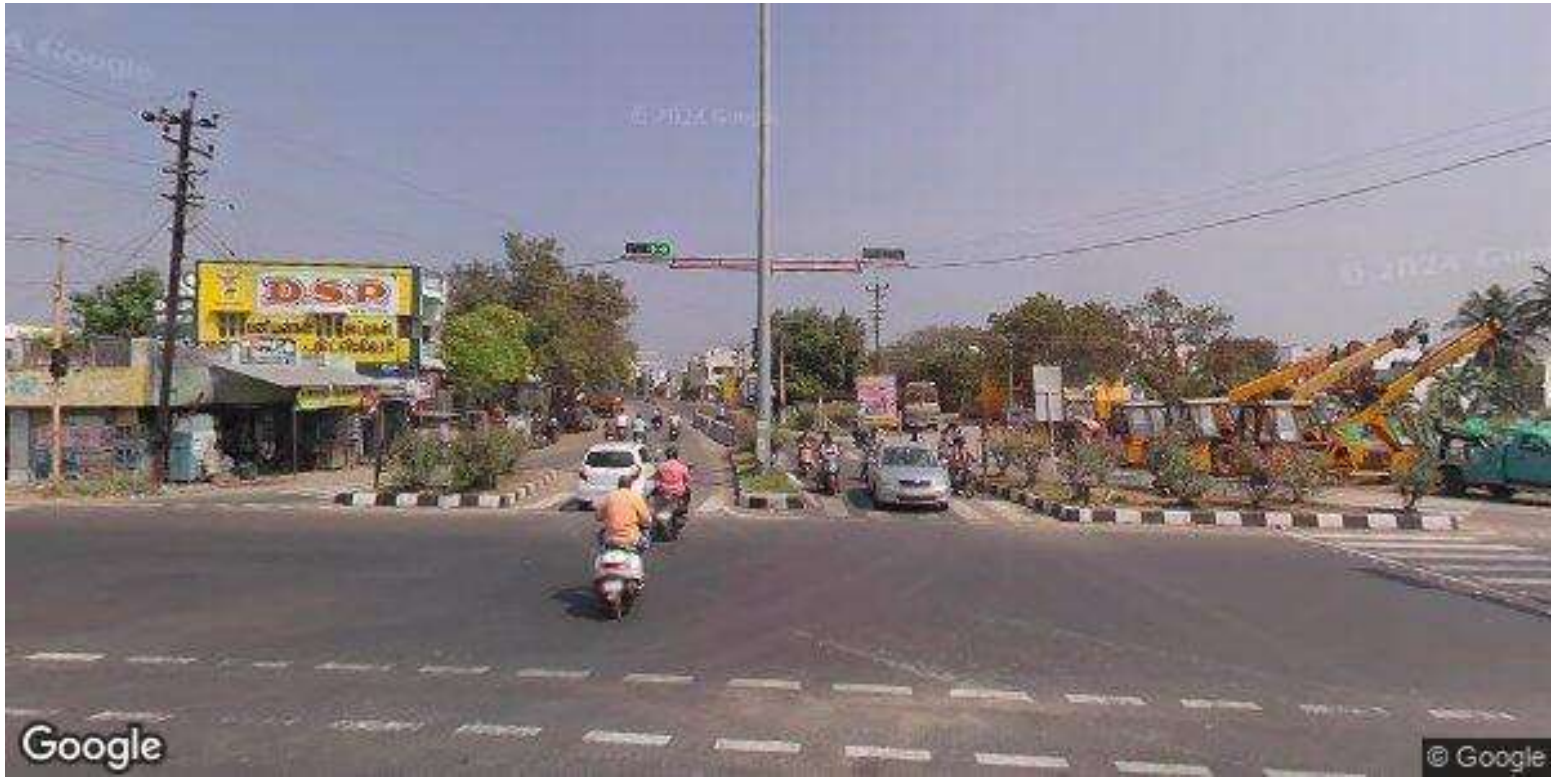
**Coordinates:** 10.72415, 77.52567

**Risk Type:** Blind Spot

**Risk Level:** Blind Spot

**Speed Limit:** 10 KM/Hr
